Evaluation of the Midwest Guardrail System Stiffness Transition with Curb

Transportation Research Board

94th Annual Meeting
January 11-15, 2015
Washington, D.C.

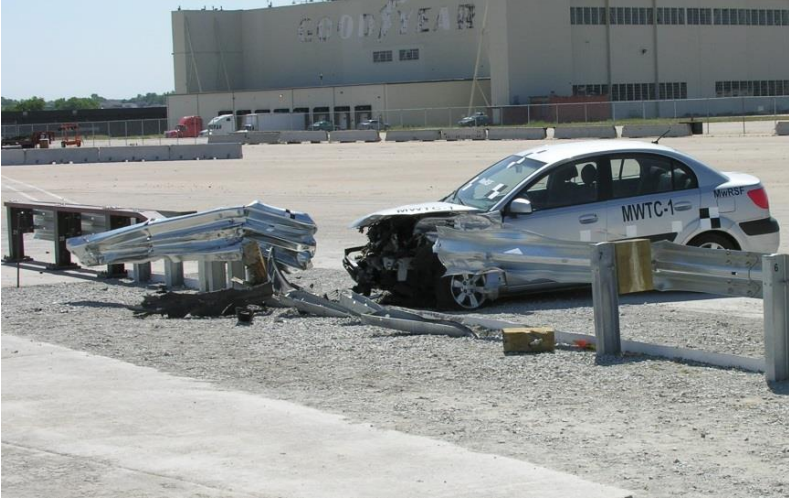
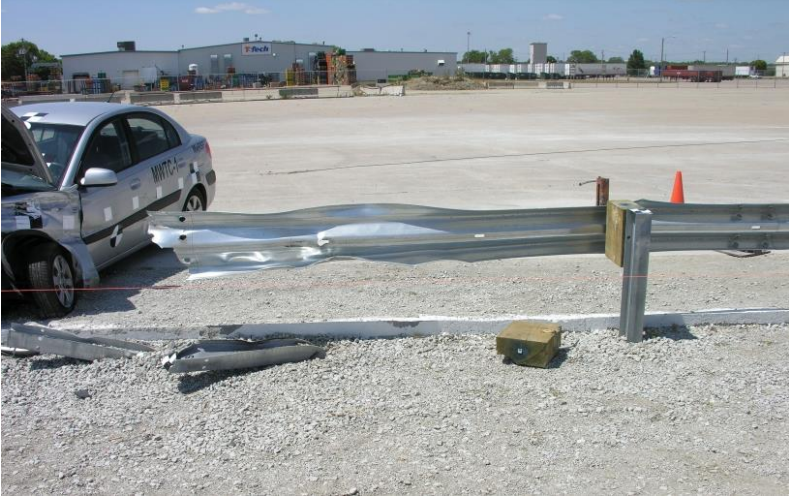
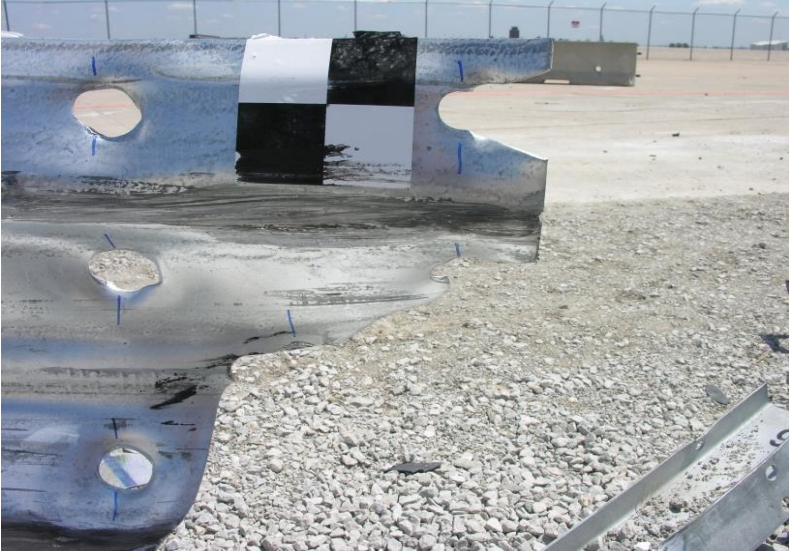
FIGURE 3 Sequential photos and system damage, test no. MWTC-1.

1 Damage to the barrier was severe, as shown in Figure 3. The rail was kinked and
2 flattened throughout the impact region, while post nos. 8 through 12 were bent and twisted. The
3 12-gauge W-beam rail ruptured at the splice at post no. 9 with all bolts remaining on the
4 downstream end of the ruptured rail, or on the 10 gauge W-to-thrie transition element. The
5 guardrail tore from the top, downstream corner of the splice diagonally to the bottom, upstream
6 corner. The downstream edge of the W-beam remained attached to the W-to-thrie transition
7 segment. The downstream end of rail folded back and behind the system at post no. 12.
8 Additionally, a 1½-in. vertical tear occurred in the thrie beam at the bottom post bolt of post no.
9 12. Finally, the top of the curb was gouged in several places from contact with the vehicle
10 bumper and undercarriage.

37 The car's front bumper began to underride the guardrail upon impact, and the left-front
38 tire overrode the curb. At 0.068 sec after impact, the car began to pitch downward, and at 0.075
39 sec, the front bumper impacted post no. 9. At 0.118 sec, the W-beam guardrail ruptured at the
40 splice between the W-beam and W-to-thrie transition segment, located at post no. 9.
41 Subsequently, the vehicle stopped redirecting and began impacting the guardrail posts head-on.
42 The vehicle stopped moving downstream by 0.188 sec after impact, but pitched downward over
43 35 degrees bringing the rear tires above the top of the guardrail. The vehicle eventually came to
44 rest in front of post no. 11 (15.8 ft downstream of impact) and was facing the barrier. The vehicle
45 trajectory and final position are shown in Figure 2.

21 Due to the w-beam rail rupturing, the loss of vehicle containment, and the excessive ORA
22 values recorded by the accelerometers, test no. MWTC-1 on the MGS to thrie beam stiffness
23 transition with curb was determined to be unacceptable according to the MASH safety
24 performance criteria for test designation no. 3-20. More comprehensive test results are detailed
25 in the test report by Winkelbauer et al. (11).

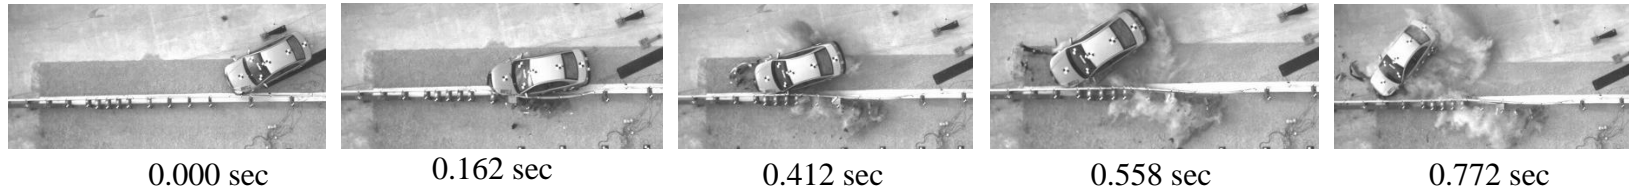
FIGURE 5 Summary of test results, test no. MWTC-2.

25 The calculated OIVs and ORAs in both the longitudinal and lateral directions were within
26 the suggested limits provided in MASH, as shown in Figure 5. Also, deformations to the
27 occupant compartment were minor. Therefore, test no. MWTC-2, conducted on the MGS to thrie
28 beam stiffness transition with curb, was determined to be acceptable according to the MASH
29 safety performance criteria for test designation no. 3-20. More comprehensive test results are
30 detailed in the test report by Winkelbauer et al. (11).

7 Upon impact, the left-front corner of the vehicle underrode the rail, and the vehicle
8 pitched down. The left-front tire proceeded to override the curb, and contact post nos. 8 and 9.
9 This time, the rail and splices held together and contained the vehicle as it continued to contact
10 posts within the system. The vehicle was eventually redirected and exited the system 0.312 sec
11 after impact at an angle of 11 degrees. The vehicle came to rest 43.0 ft downstream of impact
12 and 3.8 ft laterally in front of the system. The vehicle trajectory and final position are shown in
13 Figure 5.

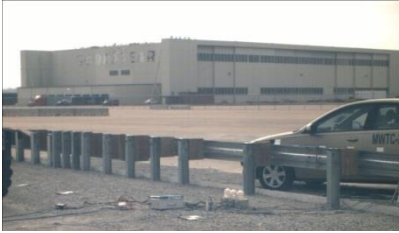
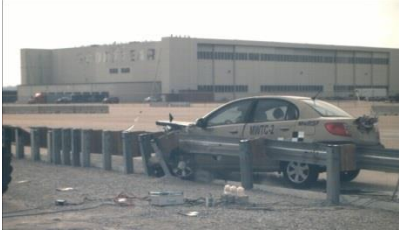
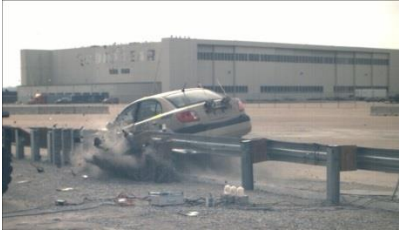
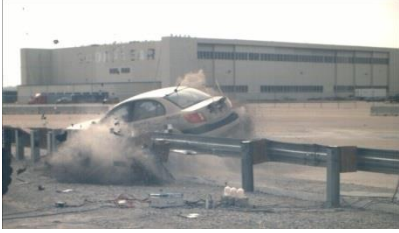
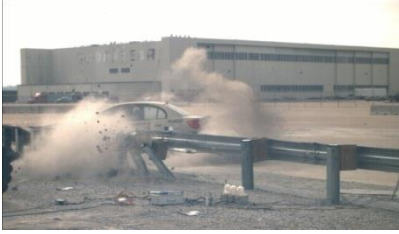
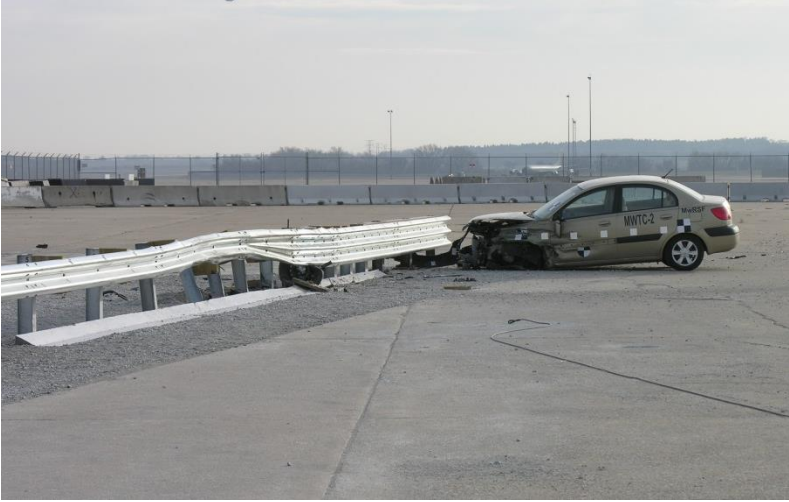
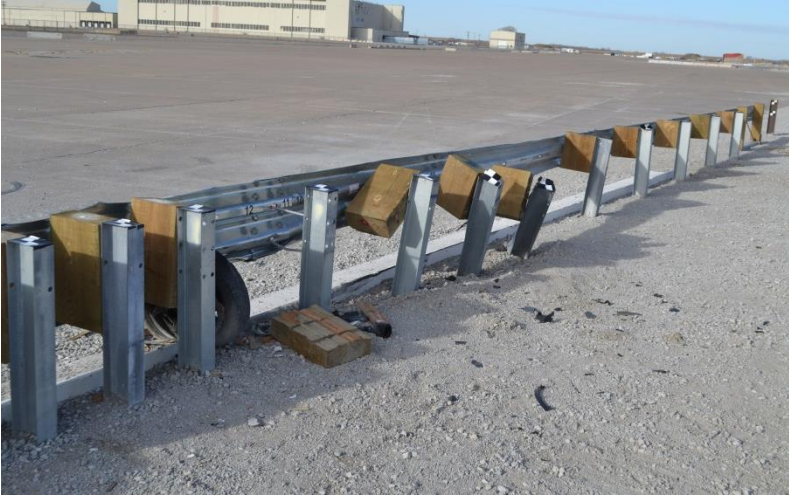
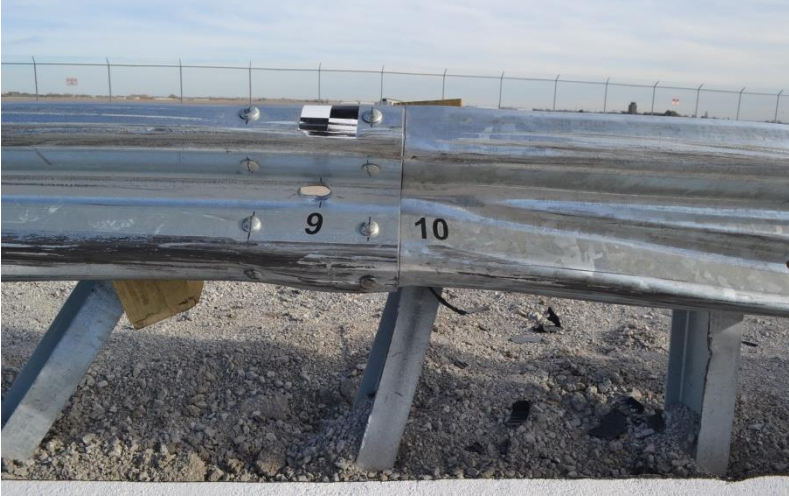
FIGURE 6 Sequential photos and system damage, test no. MWTC-2.

14 Damage to the barrier was moderate, as shown in Figure 6. The guardrail was kinked and
15 flattened throughout the impact region, and the rail disengaged from post nos. 8 through 10. Post
16 nos. 8 through 11 were bent back and downstream. The top of the curb had spalling between post
17 nos. 7 and 9. The maximum lateral dynamic post and barrier deflections were 14.4 in. at post no.
18 9 and 16.4 in. at post no. 8, respectively. The working width of the system was found to be 32.5
19 in.

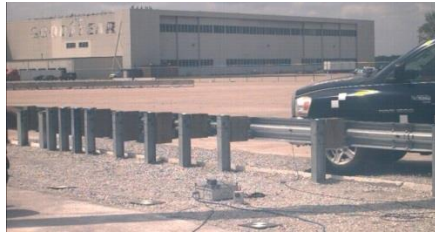
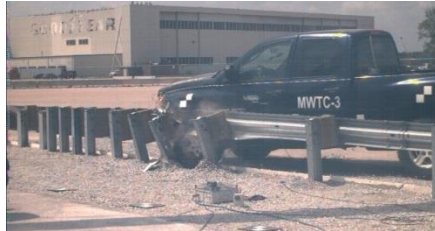
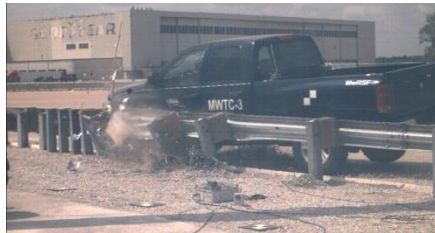
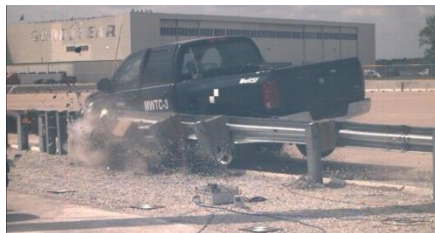
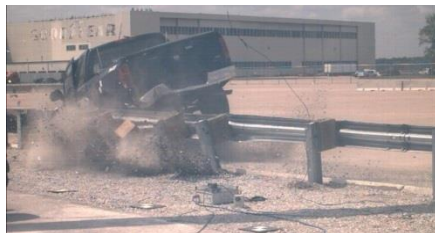
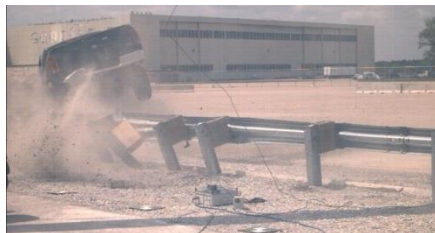
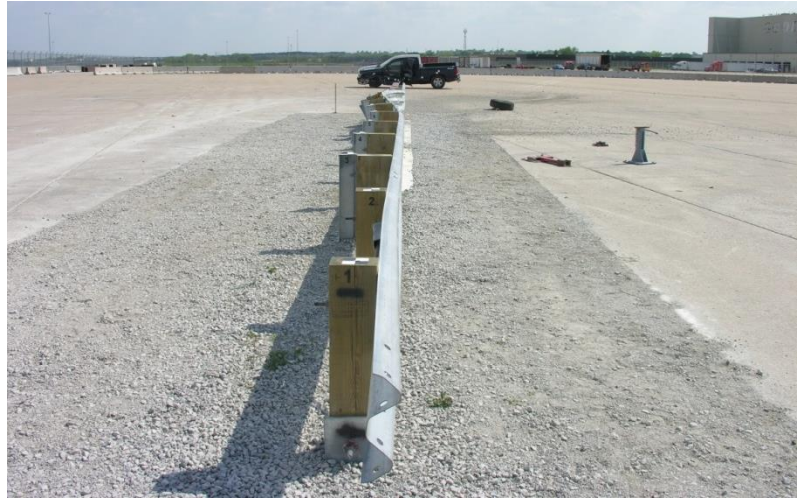
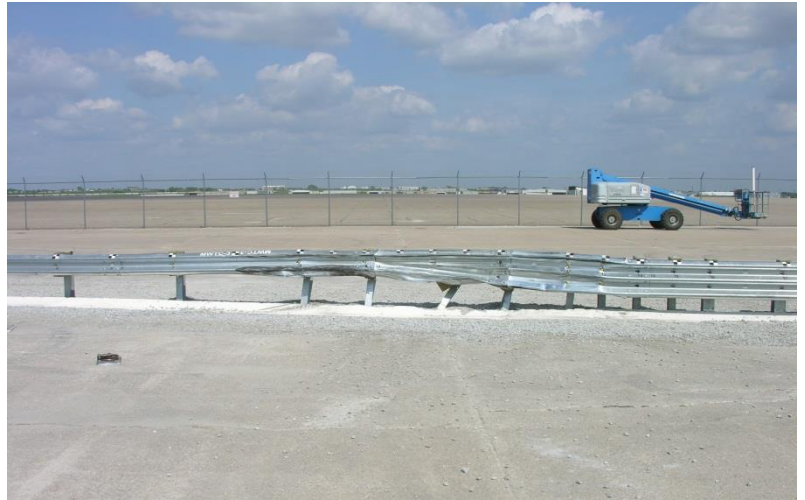
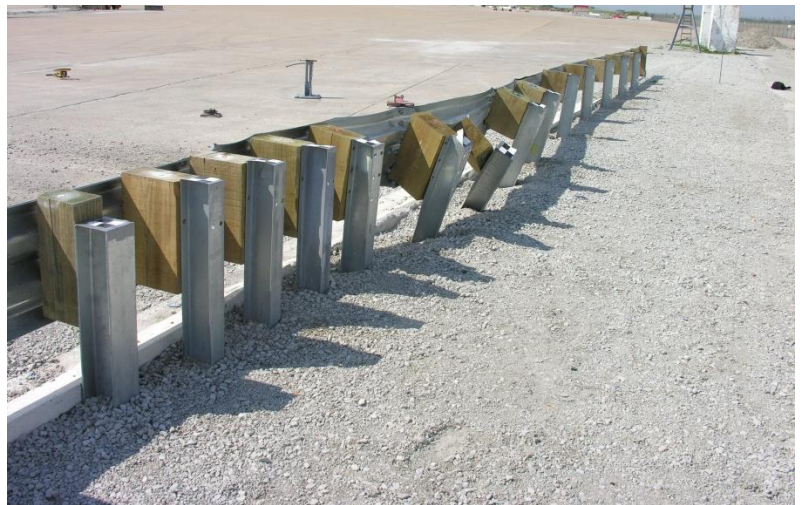
FIGURE 8 Sequential photos and system damage, test no. MWTC-3.

15 Damage to the barrier was moderate, as shown in Figure 8. The guardrail was kinked and
16 flattened throughout the impact region and disengaged from post nos. 6, 8, and 10 through 12.
17 Post nos. 7 through 12 were bent back and downstream. The maximum lateral dynamic post and
18 rail deflections were 23.9 in. and 22.0 in., respectively, at post no. 10. The working width of the
19 system was found to be 40.8 in.

8 Upon impact, post nos. 7 through 10 began deflecting backward. The left-front tire
9 overrode the curb 0.044 sec after impact and underrode the guardrail 0.070 sec after impact. The
10 tire then contacted post no. 9 and detached from the vehicle. The posts and the rail continued to
11 deflect backward as the vehicle was captured and redirected. The vehicle became parallel to the
12 system at 0.218 sec and exited the system 0.326 sec after impact at an angle of 12 degrees. The
13 vehicle came to rest 101 ft directly downstream of impact. The vehicle trajectory and final
14 position are shown in Figure 7.
