**Paper No. 18-05386**

# **Development of a Standardized Buttress for Approach Guardrail Transitions**

**Transportation Research Board**

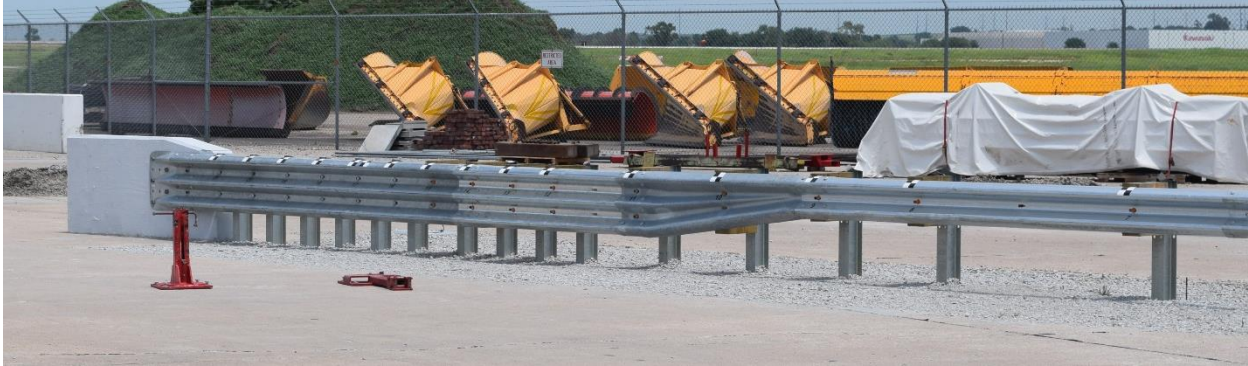
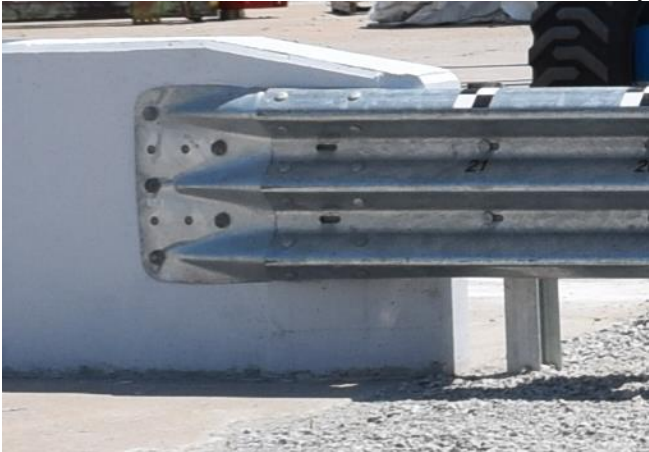
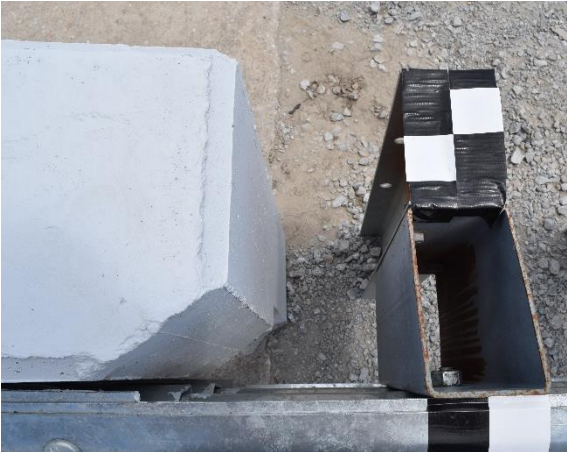
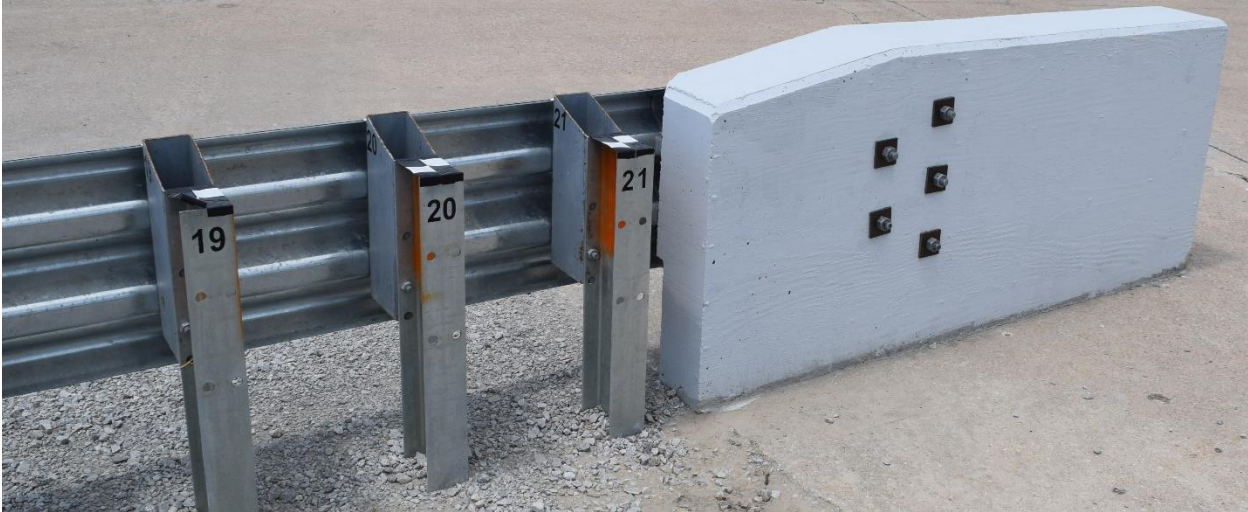
**FIGURE 6** Test installation photographs: (a) layout, (b) buttress connection, (c) buttress overhead, and (d) adjacent posts.

A second MASH 3-21 full-scale crash test was conducted on the redesigned standardized end buttress in combination with the critical AGT. The transition design and post-to-buttress offset distance remained the same from test AGTB-1, and only the geometry changes to the buttress were different. Photographs of the test installation for test AGTB-2 are shown in Figure 6.

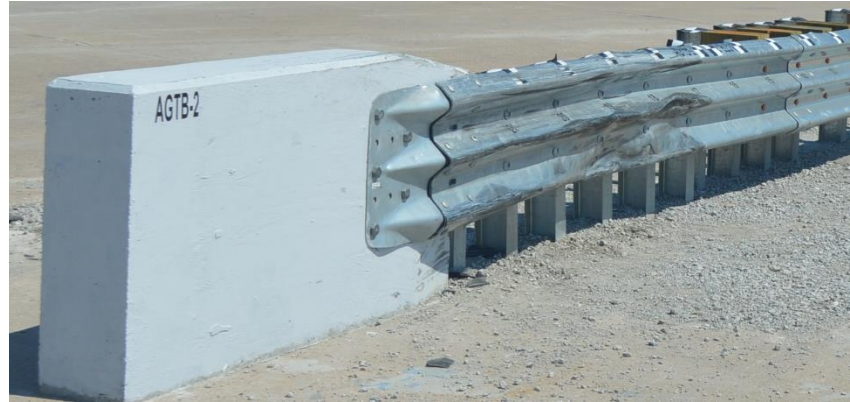
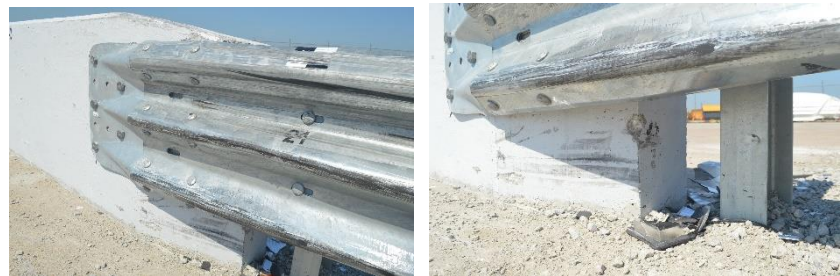
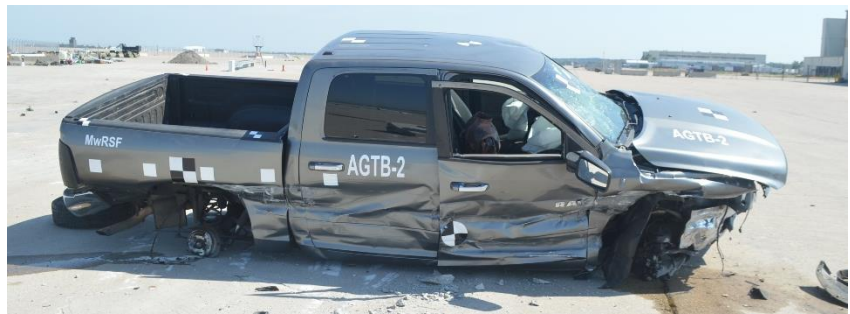
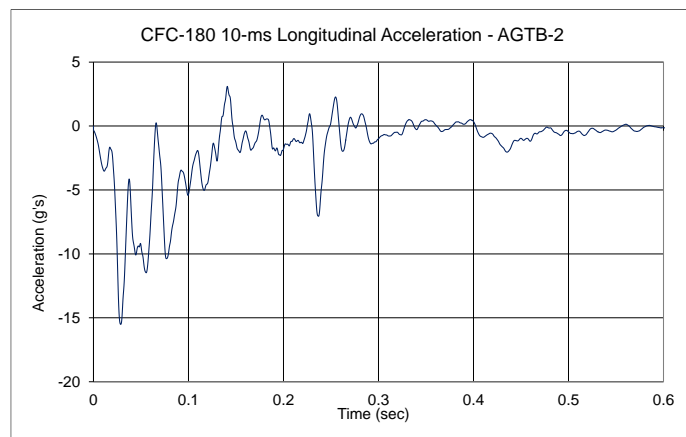
**FIGURE 7 Test results from test AGTB-2, (a) sequential photos, (b) system damage, (c) AGT and buttress damage, (d) vehicle damage, and (e) longitudinal acceleration.**

The 2270P pickup truck impacted the AGT at 62.4 mph and a 25.4-degree impact angle approximately 86 in. upstream of the buttress to maximize the potential for vehicle snag on the buttress. The pickup was contained, redirected, and remained relatively stable throughout the impact event. The maximum deflection of the three-beam guardrail and the support posts adjacent to the buttress was 5.3 inches. The right-front tire extended under the rail and snagged on the lower taper of the buttress, which caused it to push backward into the wheel well and toe pan. However, occupant compartment deformations were all within the MASH limits. A summary of the test results, including sequential photographs, is shown in Figure 7.

During the test, the windshield had shattered and deformed a maximum of 4 $\frac{1}{8}$  inches. However, high-speed video showed the windshield was damaged due to airbag deployment, not from interaction with the barrier. Airbags have been shown to shatter, and even tear, windshields in previous oblique angle impacts (25). Similar to the previous tests, the windshield was not considered in the evaluation of test no. AGTB-2 because the windshield damage was not due to interaction with the barrier system.

Lateral and longitudinal OIVs and ORA were calculated from the on-board accelerometers, and all values satisfied the MASH limits. The longitudinal ORA was -7.1 g's, showing a significantly reduced value than compared to test AGTB-1. Therefore, the standardized concrete buttress satisfied the evaluation criteria of MASH test 3-21. Complete details of the crash test can be found in Rosenbaugh, et al. (12).
