1 **APPLICATION OF A PRECAST CONCRETE BARRIER ADJACENT TO A STEEP**  
2 **ROADSIDE SLOPE**

42           When concrete barriers are installed adjacent to drop-offs or steep roadside slopes such as  
43 1.5H:1V, a cast-in-place concrete moment slab is usually attached to the base of the barrier to  
44 resist lateral and overturning forces during vehicle impact. Cast-in-place construction can require  
45 more time on site to build forms, pour the concrete, and allow for curing. This results in an  
46 increase in disruption to traffic and more exposure for construction workers. Furthermore, the  
47 installation of a moment slab is very costly and requires an additional construction phase to build  
48 the slab. Since the slab is normally under the shoulder and possibly the lanes, the disruption of  
49 traffic flow is increased. This paper presents a new application of a precast 42-inch tall single  
50 slope concrete barrier for use in front of steep slopes, without requiring a moment slab. The

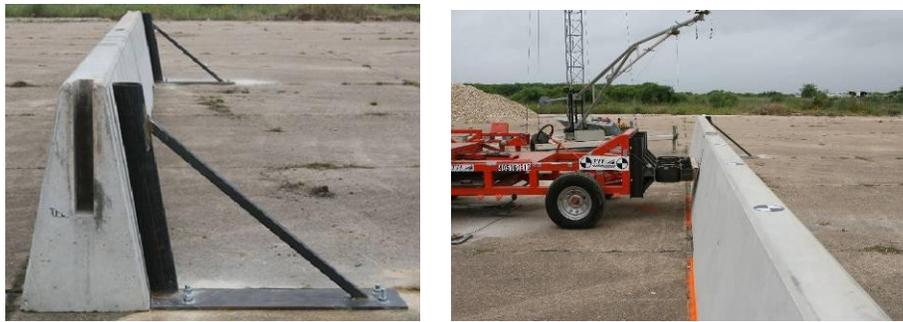
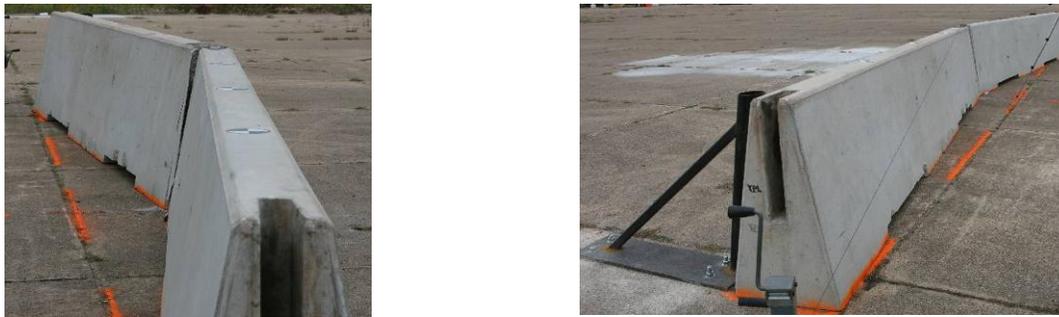
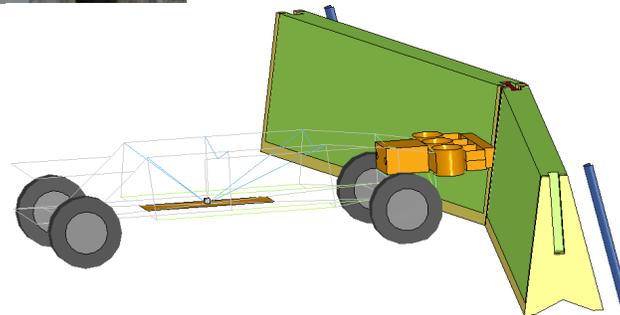
(a) Bogie test setup

(b) Test and simulation results

183 **Figure 2: Evaluation of free standing rebar-grid connection using bogie testing and simulation analysis.**

145  
146 To evaluate the performance of the free-standing single slope barrier with grouted rebar-  
147 grid connection, the researchers first determined the response of a single barrier connection using  
148 surrogate bogie vehicle testing. Two 42-inch tall and 20-ft long single-slope barrier segments  
149 were connected using the grouted rebar-grid connection. The outside ends of the barrier  
150 segments were constrained from moving laterally by a 5 inch diameter pipe that was anchored to  
151 the concrete pavement as shown in Figure 2-a. A 5000-lb bogie vehicle impacted the barrier at  
152 the connection with an impact speed of 14 mi/h and an angle of 90 degrees. The impact in the  
153 test resulted in a maximum permanent lateral deflection of 22 inches. Due to the impact, the  
154 grouted rebar-grid connection cracked near the centerline of the connection.

160  
161 A finite element model of the barrier installation used in the bogie test was developed. A  
162 surrogate grouted rebar-grid connection was modeled with a block of bi-linear elastic-plastic  
163 material and a rebar-grid comprising of beam elements. Simulations were performed with a  
164 5000-lb bogie vehicle impacting the barrier connection at test speed and location. The properties  
165 of the surrogate connection in the simulation were calibrated to match the lateral deflection of  
166 the barrier observed in the test. Figure 2-b shows the calibrated simulation results compared to  
167 the crash test results.

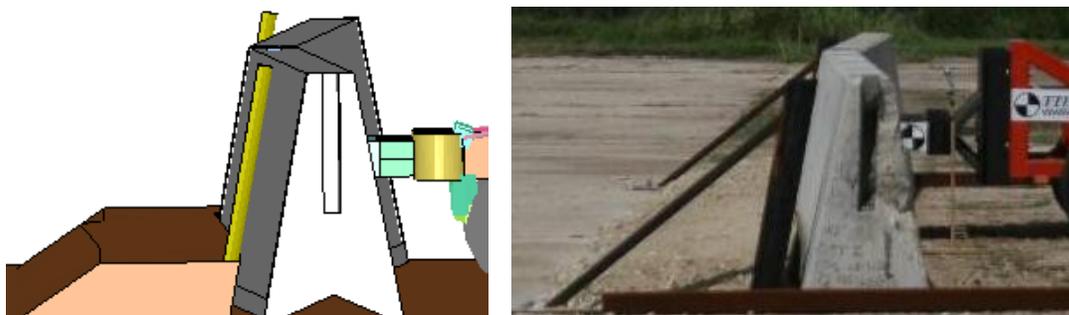
(a) Bogie test setup

(b) Test and simulation results

216 **Figure 3: Evaluation of the embedded barrier with grouted rebar-grid connection using bogie testing and**  
217 **simulation analysis.**

204 To evaluate the barrier in embedded configuration, the researchers conducted another  
205 bogie impact test with two single-slope barrier segments connected via grouted rebar-grid  
206 connection and embedded 10 inches in soil behind the barrier. The width of the soil was 24  
207 inches behind the barrier and a 1.5H:1V slope was used for the soil cut, as shown in the test  
208 setup in Figure 3-a. The type of soil and the compaction method used were as specified in the  
209 MASH criteria. Use of this bogie test helped evaluate the response of a single grouted rebar-grid  
210 connection when embedded in a 10-inch soil layer. As a result of the impact from a 5004-lb  
211 bogie vehicle at a speed of 14.4 mi/h, the maximum permanent barrier deflection was 4.45 inches  
212 at the joint. The researchers then incorporated the 10-inch soil layer into the finite element model  
213 of the bogie test and calibrated soil properties to match the barrier deflection observed in the test

214 (see Figure 3-b).  
215

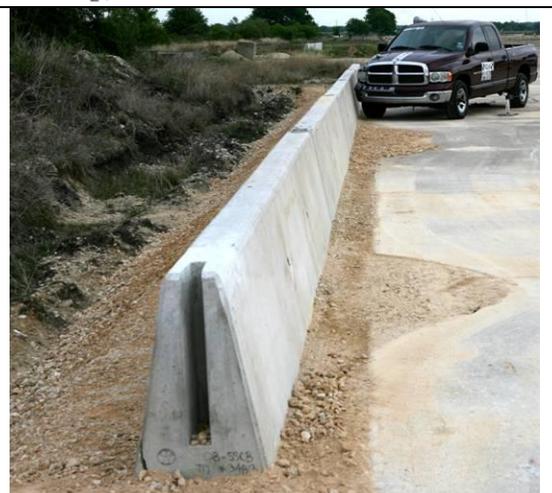
Figure 5: Test article details and barrier installation.

The single-slope barrier segments were 42 inches tall, 24 inches wide at the base and 8 inches wide at the top. At each end of the barrier segments, a 3-inch wide, 24-inch deep, and 10.5-inch long slot was cast into the barrier to incorporate the grouted rebar-grid connection. The concrete reinforcement of the barrier segments comprised of #4 vertical bars that were bent to approximately match the profile of the barrier faces and were spaced 12 inches apart along the length of the barrier. The spacing of the vertical bars was reduced around the slot cast at each end for the grouted rebar-grid connection. In addition to the vertical bars, ten #5 longitudinal bars were located along the height of the barrier. The barrier segments had a 4-inch wide and a 2-inch high slot cast at the bottom.

The barrier was embedded in crushed limestone road base material that conformed to MASH standard soil. To embed the barrier a 2-ft depth of the native soil adjacent to the testing facility's concrete pavement was excavated. The excavated area was then backfilled with standard MASH soil and compacted in approximately 6-inch lifts. Once the backfill soil reached a level of 10 inches below the concrete pavement surface, the barrier was set in place and further soil was added and compacted in front and back of the barrier. The barrier was placed adjacent to the concrete pavement at a 1-ft lateral offset. The soil widening behind the barrier was 2 ft. As the soil was backfilled, a 1.5H:1V slope was built into the embankment.

A rebar-grid was then dropped into the slot at each barrier connection location. It comprised of two vertical #6 bars that were spaced 10 inches apart, and three longitudinal #8 bars that were spaced eight inches apart. With the rebar-grid in place, the connection was grouted using a non-shrink grout. Details of the test article and its installation are shown in Figure 5.

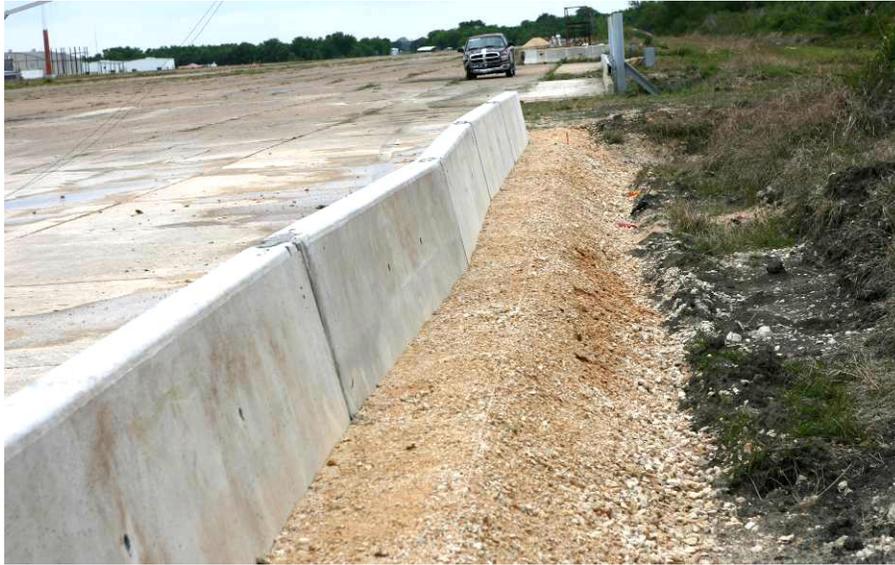
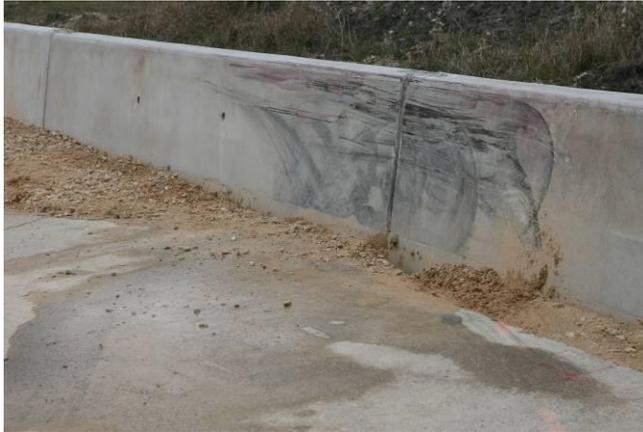
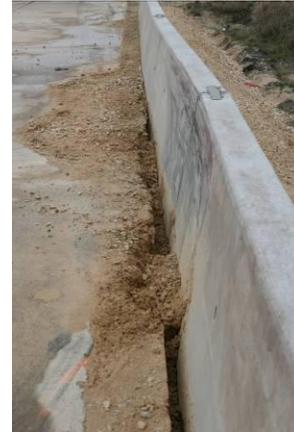
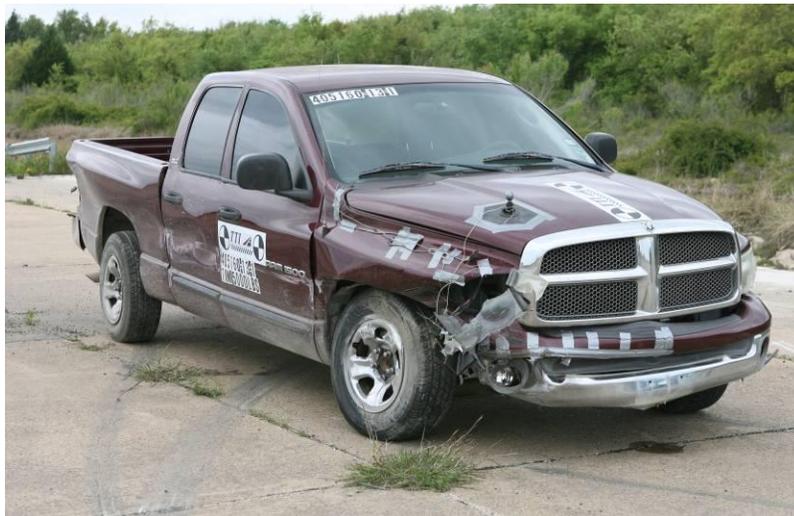
(a) Test article damage

(b) Vehicle damage

Figure 6: Test article and vehicle damage.

Damage to the impacted barrier segments was minimal as shown in Figure 6-a. Tire marks were on the traffic face of the barrier and there was no evidence of cracking in the barrier. Length of contact of the vehicle with the barrier was 14.0 ft. Maximum permanent deflection of the barrier was 5.5 inches. The working width was 19.6 inches. Maximum dynamic deflection during the test was 5.6 inches.

The 2270P vehicle sustained damage to the right front corner and along the right side, as shown in Figure 6-b. The right upper A-arm, right tie rod end, and sway bar were deformed. Also damaged were the front bumper, grill, right front fender, right front and rear doors, right exterior side of bed, rear bumper, and tailgate. The right front and rear wheel rims were deformed and the right front tire was deflated. Maximum exterior crush to the vehicle was 14.0

332 inches in the side plane at the right front corner at bumper height. Maximum occupant  
333 compartment deformation was 0.5 inches in the right front door at hip height.
