## **IMPROVEMENTS TO THE WEAK-POST W-BEAM GUARDRAIL**

80<sup>th</sup> Annual Meeting of the  
Transportation Research Board  
Washington, D.C.

January 2001

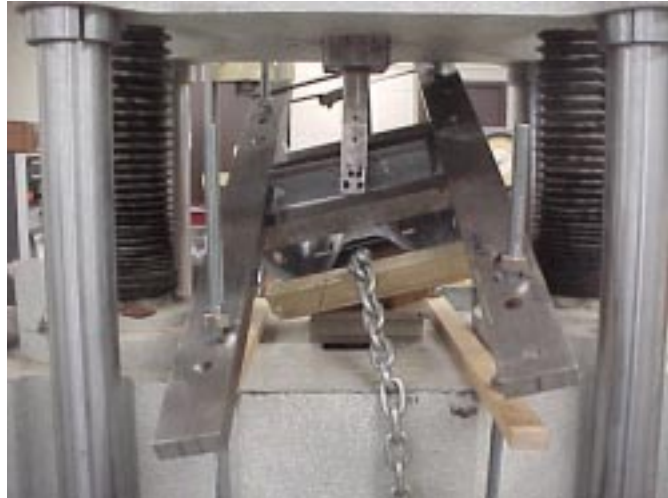
(A) Quasi-static test setup for rail-post connection.

The standard connection for the weak-post w-beam guardrail consists of one 7.94 mm A307A bolt which connects two thickness of guardrail to the flange of an S75x8.5 post. One 44-mm square 12 gauge washer is positioned under the head of the bolt since the guardrail slot is 16 mm wide. A nut is attached to the bolt on the flange-side of the post completing the connection. This standard connection was assembled and subjected to a series of quasi-static pull-tests in the 400,000 lbs load tester shown in the top portion of figure 1.

The loading experienced by a bolt in a guardrail connection is likely to be much more complicated than the conditions replicated by a simple axial tension test. In order to explore the performance of the bolted connection in more realistic conditions, a load testing fixture was built as shown in the top portion of Figure 1. The fixture allowed the load to be applied to the connection through the guardrail and flange in the same manner as occurs in an actual collision event. The guardrail was attached to one side of the loading frame and the web of the post was attached to the other. The connection was positioned at several angles to replicate the bending and twisting that occurs in a typical collision. The fixture simulated two loading conditions: bending about a 30 degree angle about the longitudinal direction of the guardrail and bending about a 30 degree angle about the guardrail axis in combination with a 15 degree twist in the axial direction of the post. In addition to these orientations, the bolts were sometimes positioned in the center of the slot and sometimes at the edge of the slot. This combination of loading

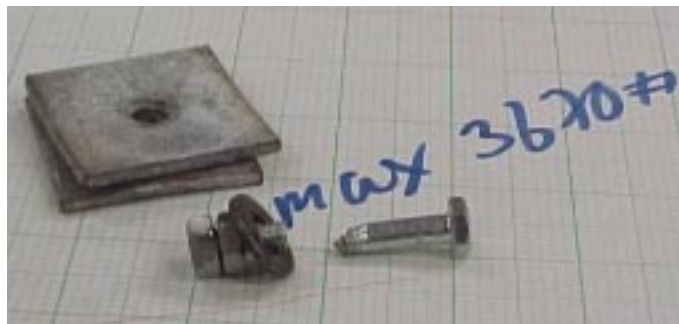
(C) Typical failure of improved connection detail

Figure 1. Laboratory tests of connection components.

An improved connection featuring two 44-mm square washers and two nuts and a smaller bolt was then tested and the results are shown in Table 1. The double square washers prevent the washers from pulling through the slot and the double nuts prevent the nuts from stripping the bolt threads. This isolates the failure in the bolt. As shown in Table 1, the failure mode is very repeatable for this connection and all six tests resulted in the same type of failure.

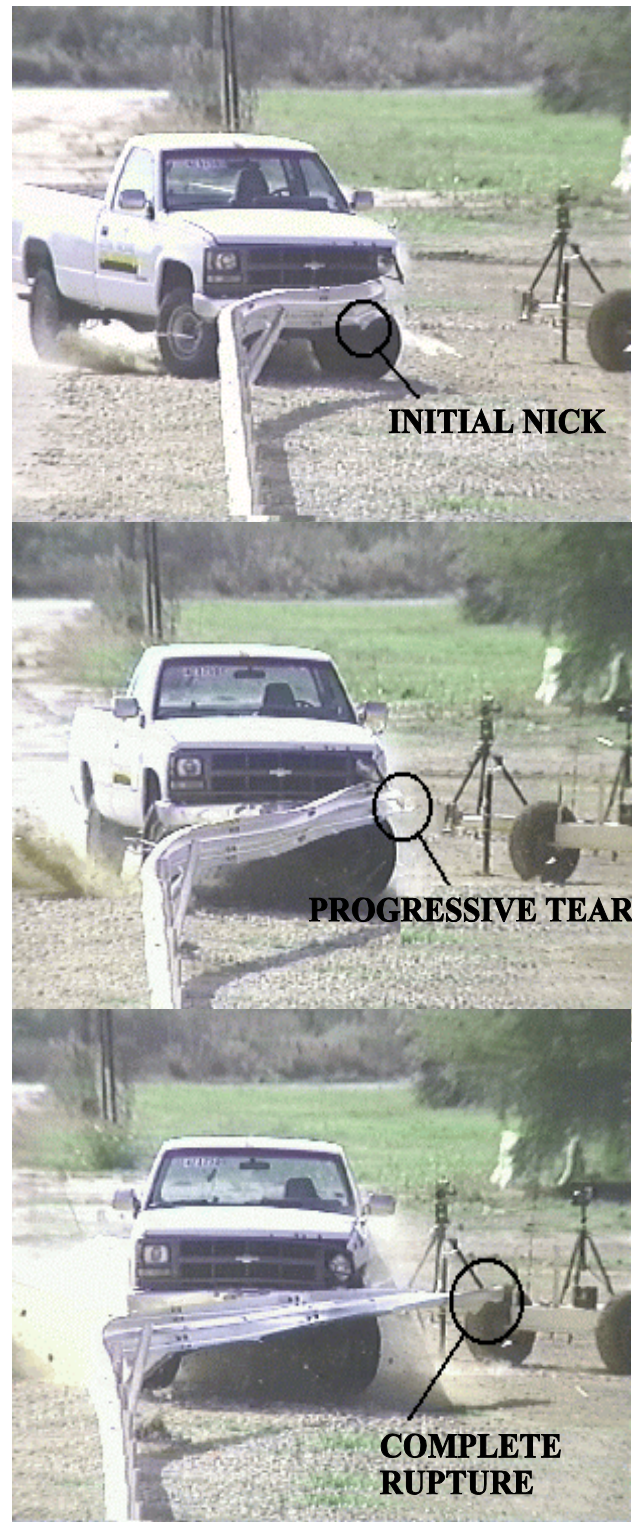
Figure 3. Test of a weak-post w-beam guardrail with splice at the mid-span and an improved connection showing the rupture of the guardrail.(3)

As shown in Figure 3, the test resulted in an unexpected guardrail rupture. A nick formed on the rail at the second post downstream of the impact point. The nick can be seen in the upper photograph in Figure 3. The nick passed across the front of the vehicle (see the middle photograph of Figure 3) and, when it passed the bumper and reached the tension side of the guardrail, the guardrail material ruptured completely as shown in the bottom portion of Figure 3.

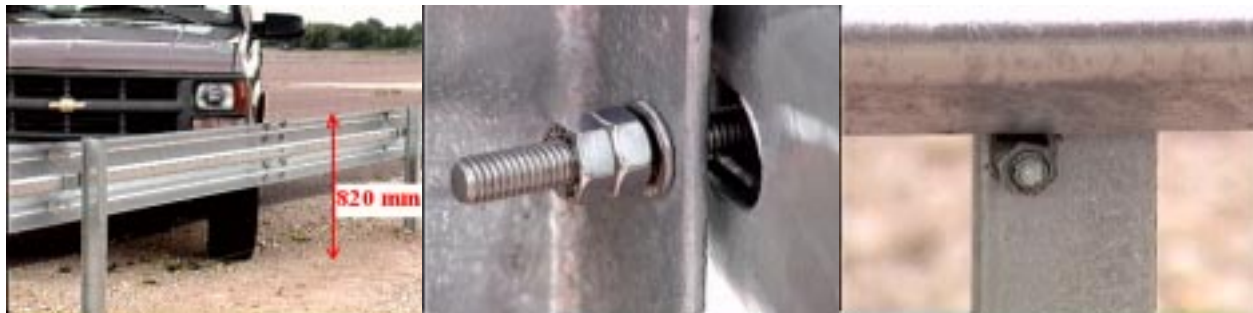
(A) Midspan splices, rail height and backup plates. (B) Improved connection. (C) Rail support bolt.

Figure 8. Final design details of the improved weak-post w-beam guardrail.

The two full-scale crash tests described above indicate that the final modifications to the weak-post w-beam guardrail resulted in a system that satisfies the requirements of NCHRP Report 350 for test level three. The final modified system, shown in figure 8, consists of the following components:

- 12 gauge w-beam guardrail mounted 820-mm above the ground with splices at mid-span,
- S75x8.5 weak steel posts with soil plates spaced at 1308 mm and attached to the rail at non-splice locations
- W-beam backup plates at each post,
- A post-rail connection consisting of one 7.94 A307A bolt with two 40-mm square washers and two nuts and
- A rail support bolt.
