INVESTIGATING THE USE OF SMALL- DIAMETER SOFTWOOD AS GUARDRAIL POSTS (DYNAMIC TEST RESULTS)

MwRSF Research Report No. TRP-03-179-07

March 28, 2007

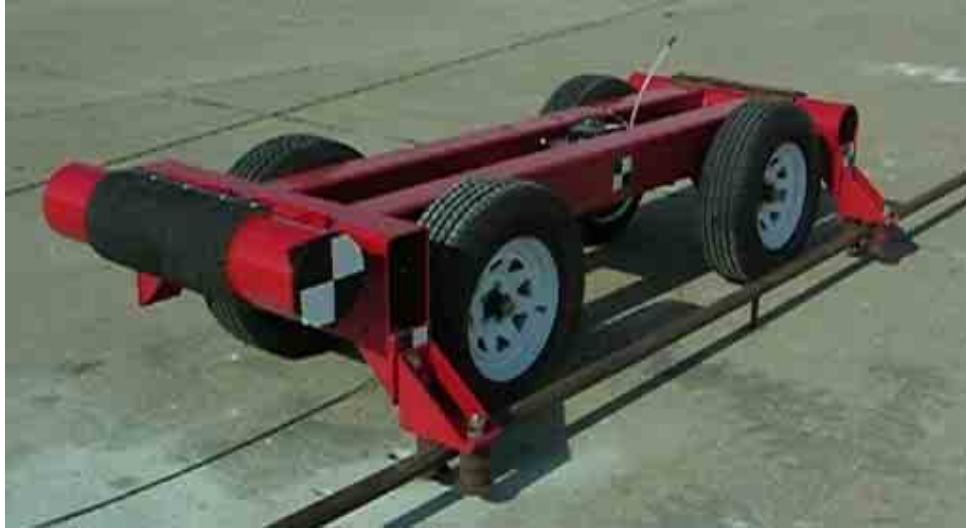
Figure 6. Rigid Frame Bogie on Guidance Track

A rigid-frame bogie was used to impact the posts. A variable height, detachable impact head was constructed and used in the testing. The bogie head was constructed of 203-mm (8-in.) diameter, 12.5-mm (0.5-in.) thick standard steel pipe, with 19-mm (0.75-in.) neoprene belting wrapped around the pipe to prevent local damage to the post from the impact. The impact head was bolted to the bogie vehicle, creating a rigid frame. The bogie with the impact head is shown on the guidance track in Figure 6. Use of this impact head allowed a 632-mm (24.875-in.) impact height, corresponding to the MGS mounting height. The weight of the bogie with the addition of the mountable impact head was 728 kg (1,605 lbs). The speed chosen for the first set of impact tests, 32 km/h (20 mph), approximated the lateral velocity of the posts in a full scale system impact.

A pickup truck with a reverse cable tow system was used to propel the bogie. When the bogie reached the end of the guidance system, it was released from the tow cable, allowing it to be free rolling when it impacted the post. A remote braking system was installed on the bogie allowing it to be safely brought to rest after the test.

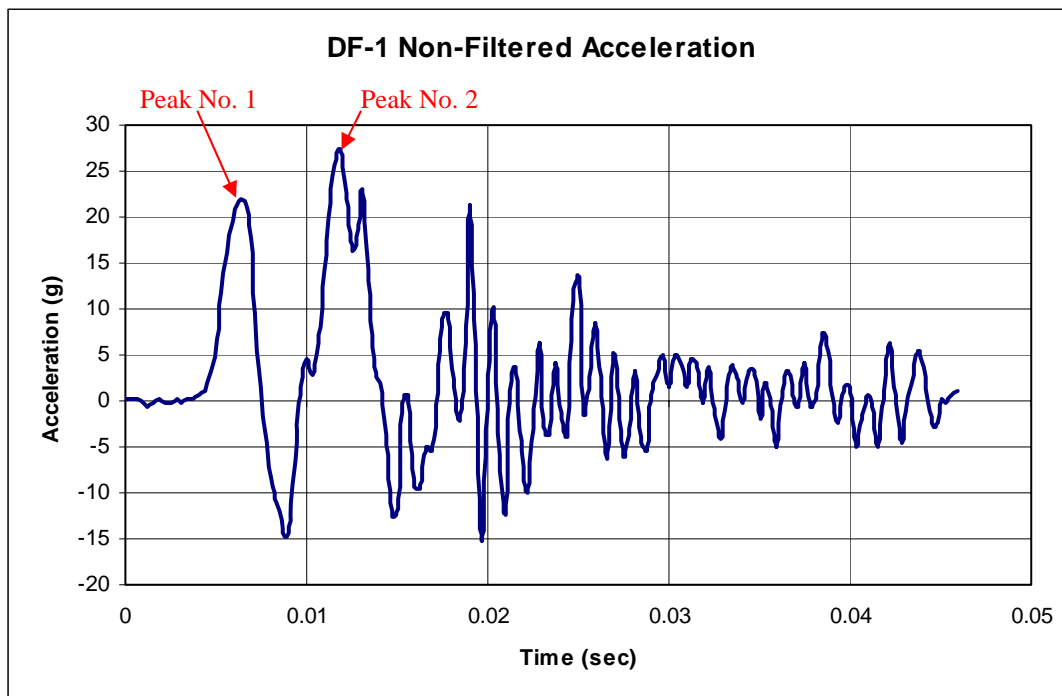
Figure 10. Bogie Test DF-1 Non-Filtered Acceleration

A sample raw acceleration plot is presented in Figure 10. The bogie acceleration trace exhibits two large distinct and separate acceleration peaks. The question was, is wood capable of behaving like this plot suggests?

The data shown in Figure 10 suggested that the wood post reached a peak force, relaxed, and then reached a second peak force, sometimes higher and sometimes lower than the first. The cases in which the second peak was lower than the first suggests that the fibers reached some maximum stress value, relaxed, and then failed at some stress value lower than the maximum reached previously.
