# PERFORMANCE EVALUATION OF KDOT W-BEAM SYSTEMS

## Volume I: Full-Scale Crash Testing

May 1996

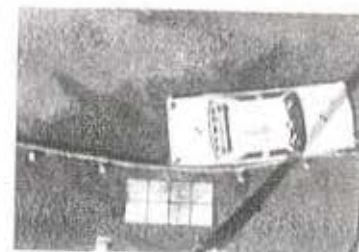
Figure 15. Sequential Photographs, KSWB-1

Test KSWB-1 was conducted with a 1985 Ford LTD weighing 4,399-lbs at an impact speed of 61.9 mph and impact angle of 25.1 degrees. The impact location was approximately 12 ft. upstream of post No. 15. The test installation was G4(1S) system consisting of single 12-gauge W-beam and 6 ft - 3 in. post spacing. A summary of the test results and sequential photographs are presented in Figure 14. Additional sequential photographs are shown in Figure 15. Documentary photographs of the crash test are shown in Figures 16 and 17.

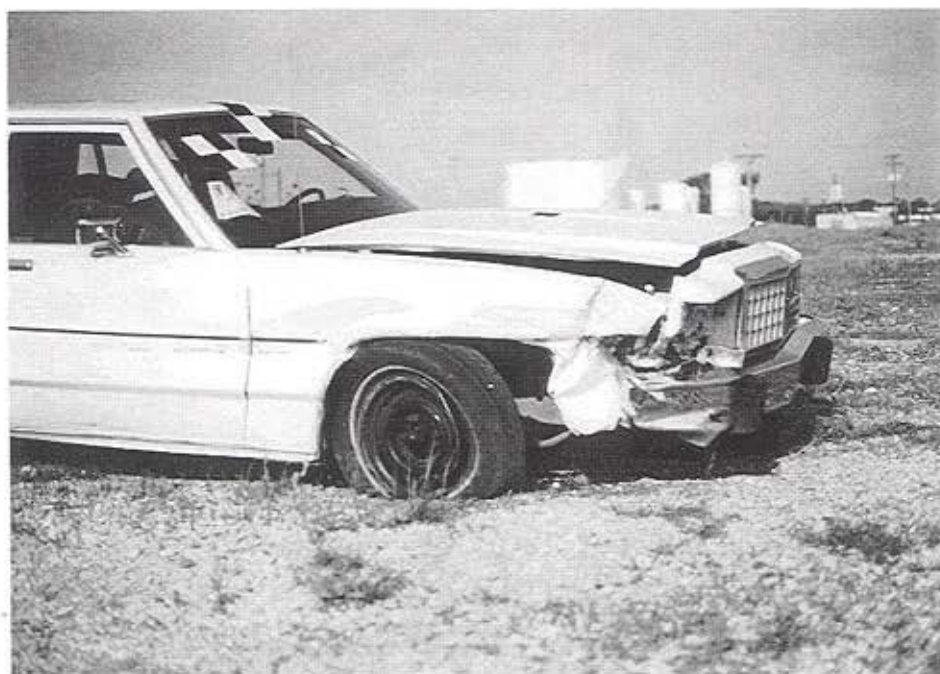
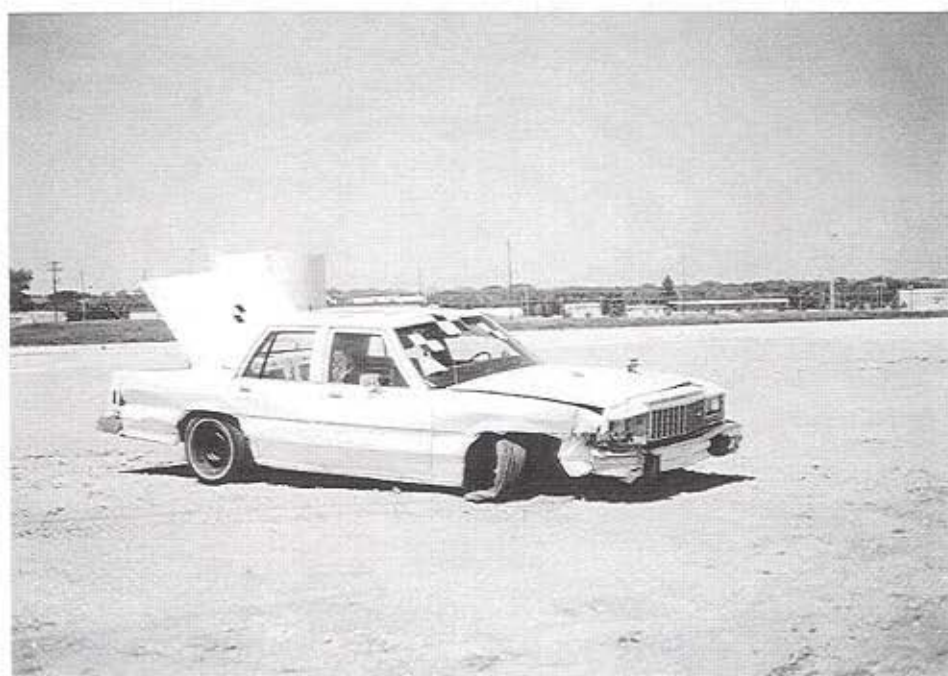
Figure 18. Test Vehicle Damage, KSWB-1

Vehicle damage is shown in Figure 18, and consisted primarily of right front corner crush, including tire blowout and rim damage, and passenger side W-beam interlock damage. There was no interior occupant compartment damage detected. The guardrail damage is shown in Figure 19. Guardrail damage was moderate and consisted of deformation of the impacted 25-ft beam section.

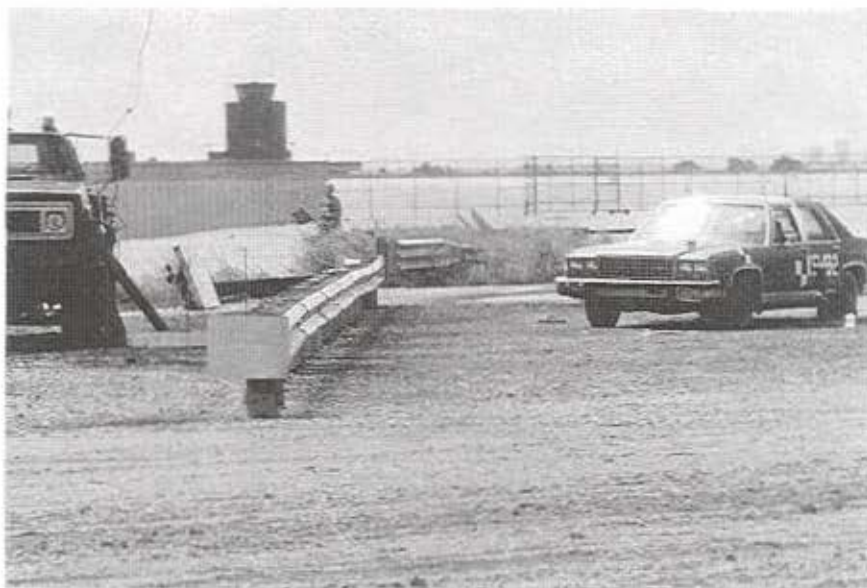
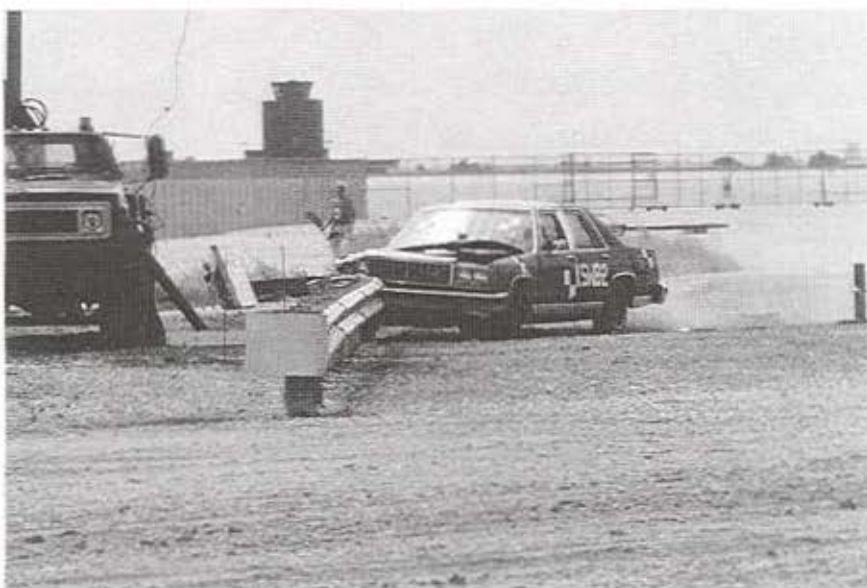
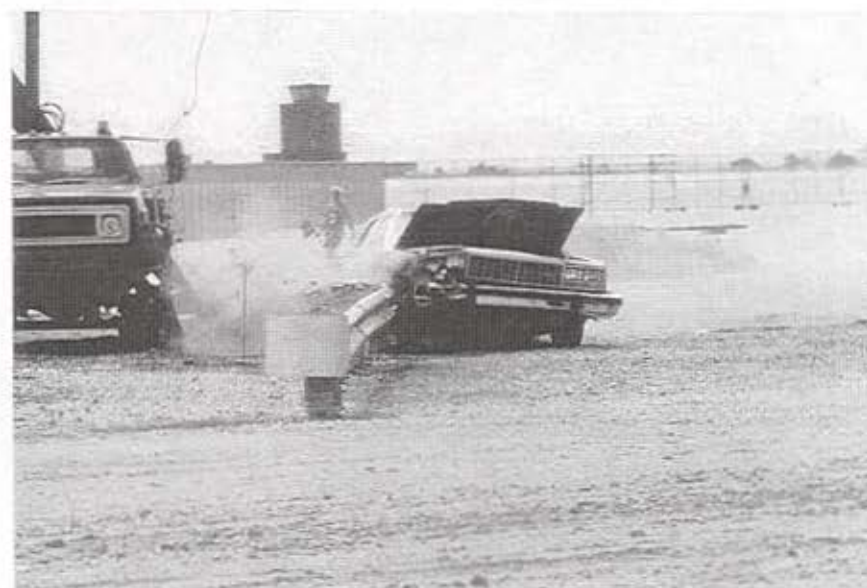
Figure 23. Full-Scale Crash Test, KSWB-2

Test KSWB-2 was conducted with a 1984 Ford LTD weighing 4,486-lbs at an impact speed of 60.5 mph and impact angle of 25.4 degrees. The impact location was approximately 12 ft. upstream of post No. 15. The test installation was a G4(1S) system consisting of nested 12-gauge W-beam and 6 ft - 3 in. post spacing. A summary of the test results and sequential photographs are presented in Figure 21. Additional sequential photographs are shown in Figure 22. Documentary photographs of the crash test are shown in Figures 23 and 24.

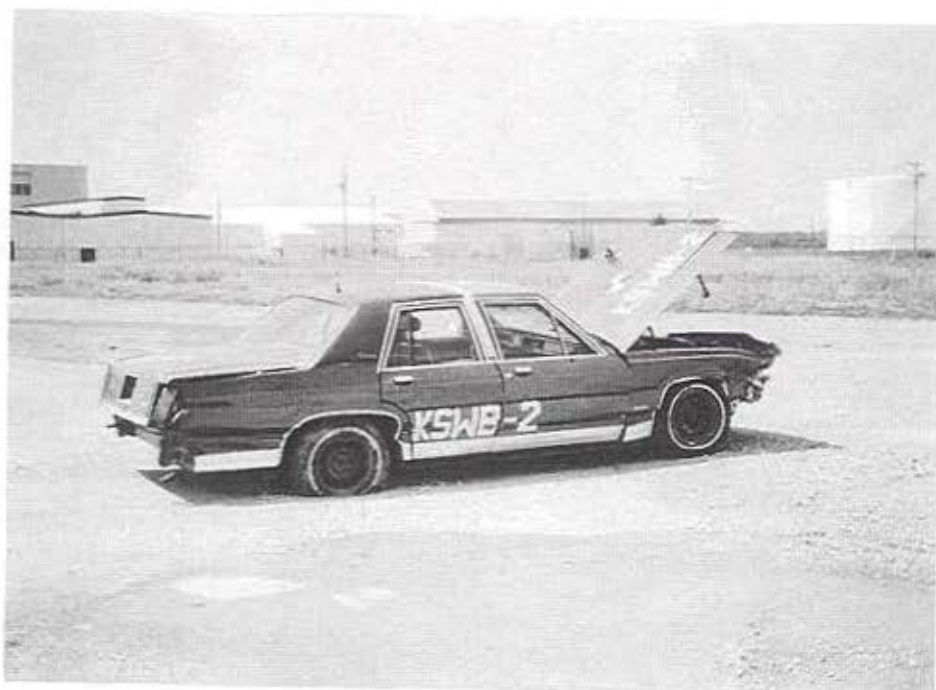
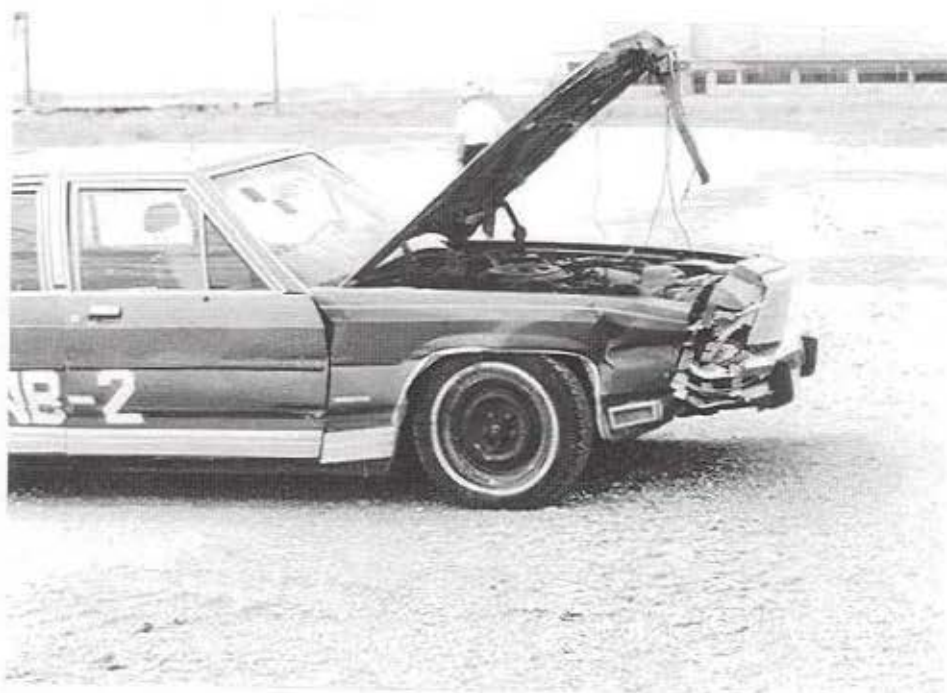
Figure 25. Test Vehicle Damage, KSWB-2

Vehicle damage is shown in Figure 25, and consisted primarily of right front corner crush and passenger side W-beam interlock damage. There was no interior occupant compartment damage detected. The rear bumper was disengaged and the right rear tire was blown during tail slap impact with the rail. Guardrail damage is shown in Figure 26, and consisted of only moderate deformation and flattening of the lower portion of the impacted 25-ft nested beam section. The measured contact length between the vehicle and the rail was approximately 22 ft. The maximum permanent set deflection of 24.8 in. occurred at Post No. 14, and the maximum dynamic deflection of 35.5 in.

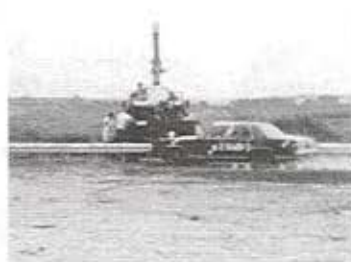
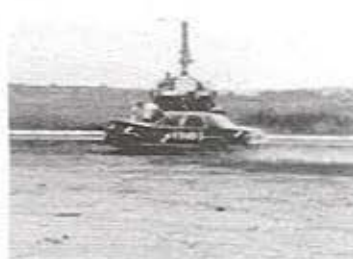
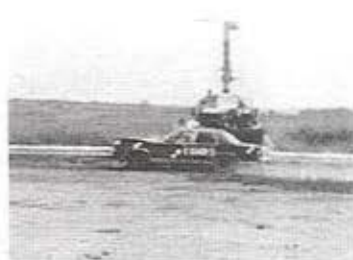
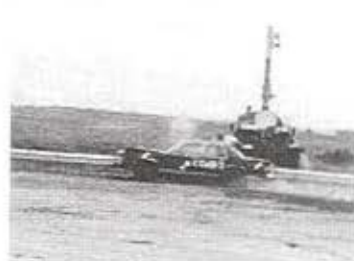
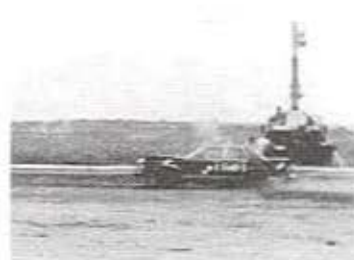
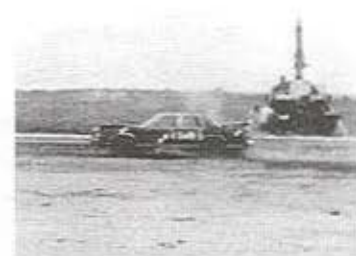
Figure 29. Sequential Photographs, KSWB-3

Test KSWB-3 was conducted with a 1985 Mercury Grand Marquis weighing 4,486-lbs at an impact speed of 59.7 mph and an angle of 24.8 degrees. The impact location was approximately 12 ft. upstream of post No. 25. The test installation was a G4(1S) system consisting of single 12-gauge W-beam and 3 ft - 1½ in. post spacing. A summary of the test results and sequential photographs are presented in Figure 28. Additional sequential photographs are shown in Figure 29. Documentary photographs of the crash test are shown in Figures 30 and 31.

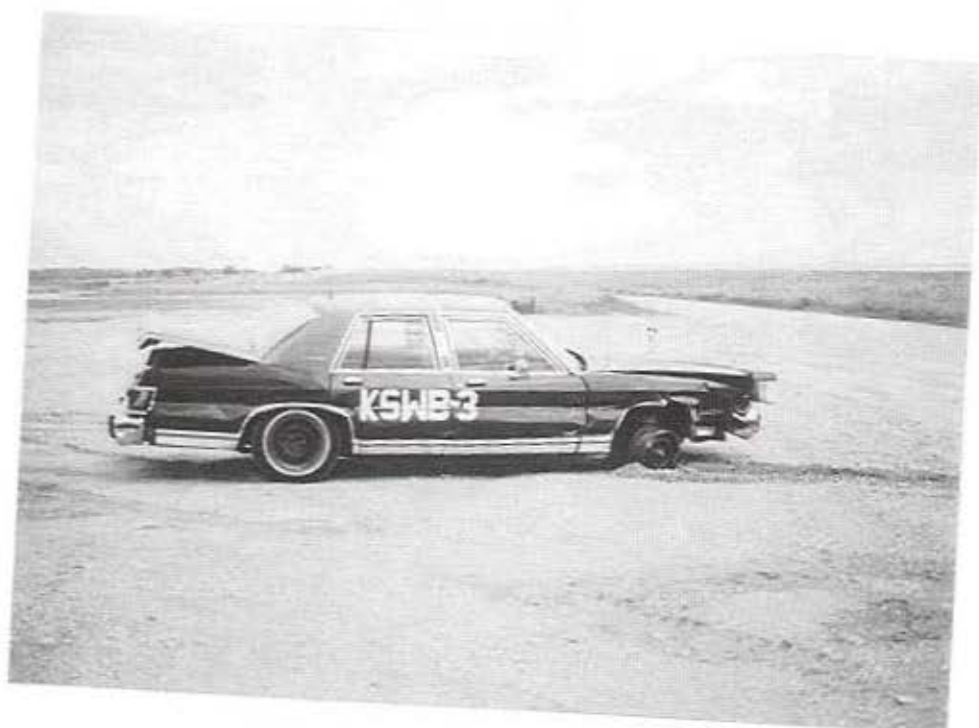
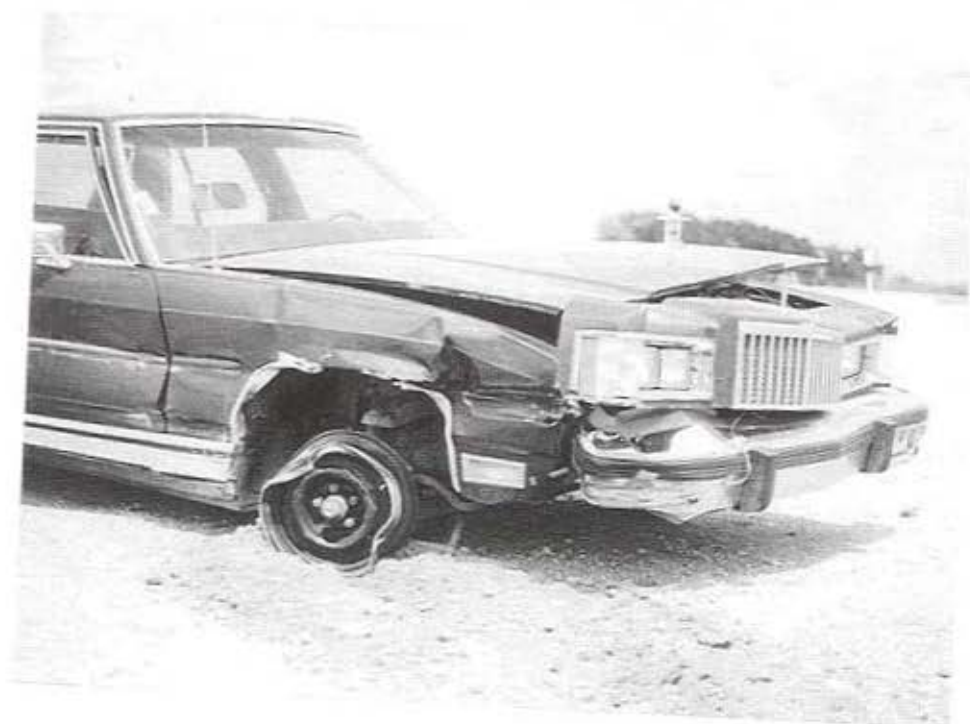
Figure 32. Test Vehicle Damage, KSWB-3

Vehicle damage is shown in Figure 32, and consisted primarily of right-front corner crush and passenger side W-beam interlock damage. There was no interior occupant compartment damage detected. The right front tire was blown and disengaged from the rim, and the rim contained excessive deformation. Guardrail damage is shown in Figure 33, and consisted of only moderate deformation and flattening of the lower portion of the impacted 25-ft beam section. The measured contact length between the vehicle and the rail was approximately 18 ft. The maximum permanent set deflection of 20.3 in. and the maximum dynamic deflection of 23.5 in. occurred

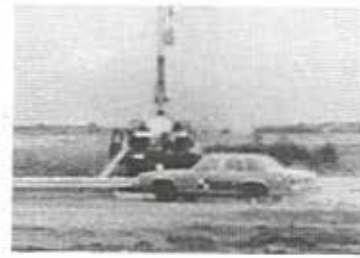
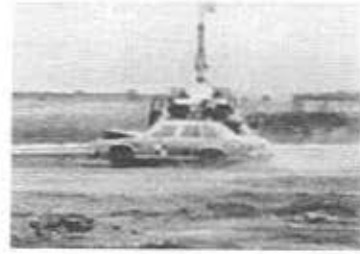
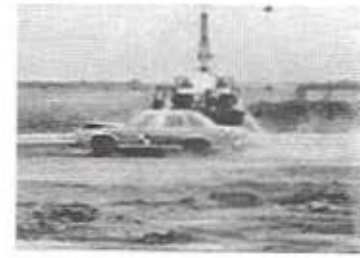
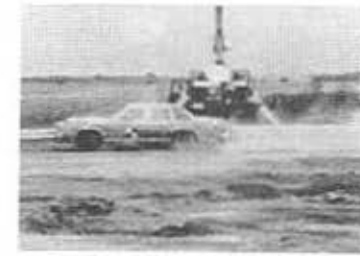
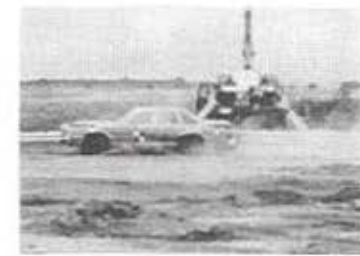
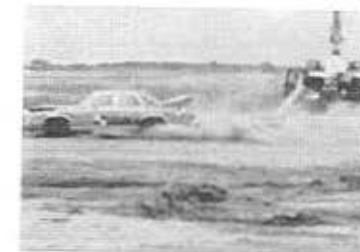
Figure 36. Sequential Photographs, KSWB-4

Test KSWB-4 was conducted with a 1985 Mercury Grand Marquis weighing 4,501-lbs at an impact speed of 60.4 mph and impact angle of 28.4 degrees. The impact location was approximately 12 ft. upstream of post No. 25. The test installation was a G4(1S) system consisting of nested 12-gauge W-beam and 3 ft - 1½ in. post spacing. A summary of the test results and sequential photographs are presented in Figure 35. Additional sequential photographs are shown in Figure 36. Documentary photographs of the crash test are shown in Figures 37 and 38.

Following the initial impact with the W-beam guardrail, the vehicle began to redirect coinciding with Post No. 24 at approximately 112 msec after impact. At 143 msec after impact the right-front wheel contacted Post No. 25. At 194 msec proceeding impact the vehicle was approximately parallel to the guardrail. The maximum dynamic lateral deflection of 19.6 in. occurred approximately 225 msec after impact between Post Nos. 23 and 24. The vehicle exited the guardrail at approximately 429 msec with a speed and angle of 46.8 mph and 14.1 deg respectively. As shown in Figure 36, the vehicle came to rest approximately 163.5 ft downstream from impact and had a maximum rebound distance of approximately 14 ft.

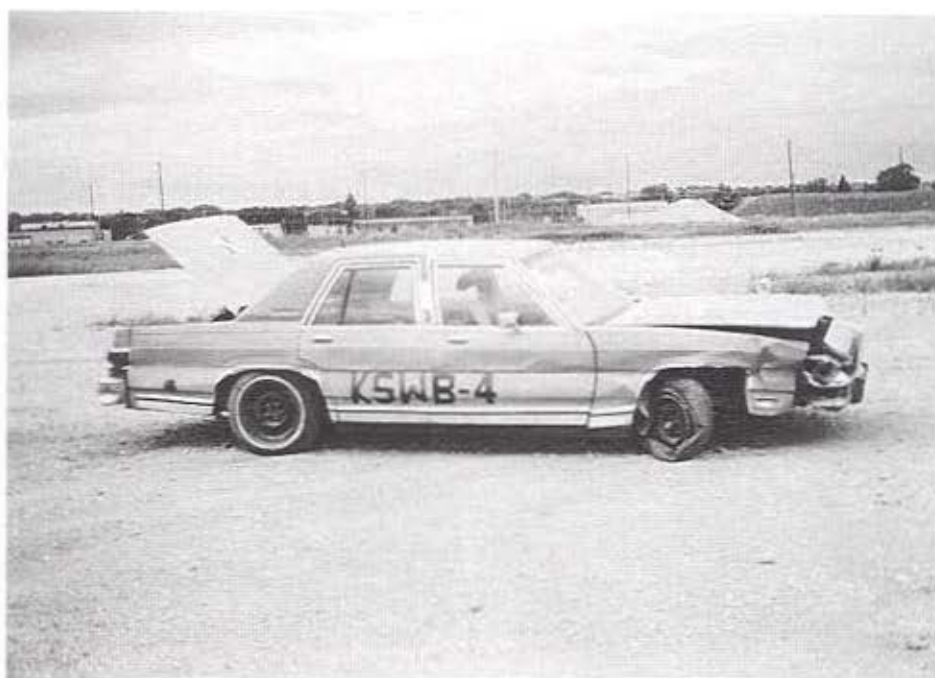
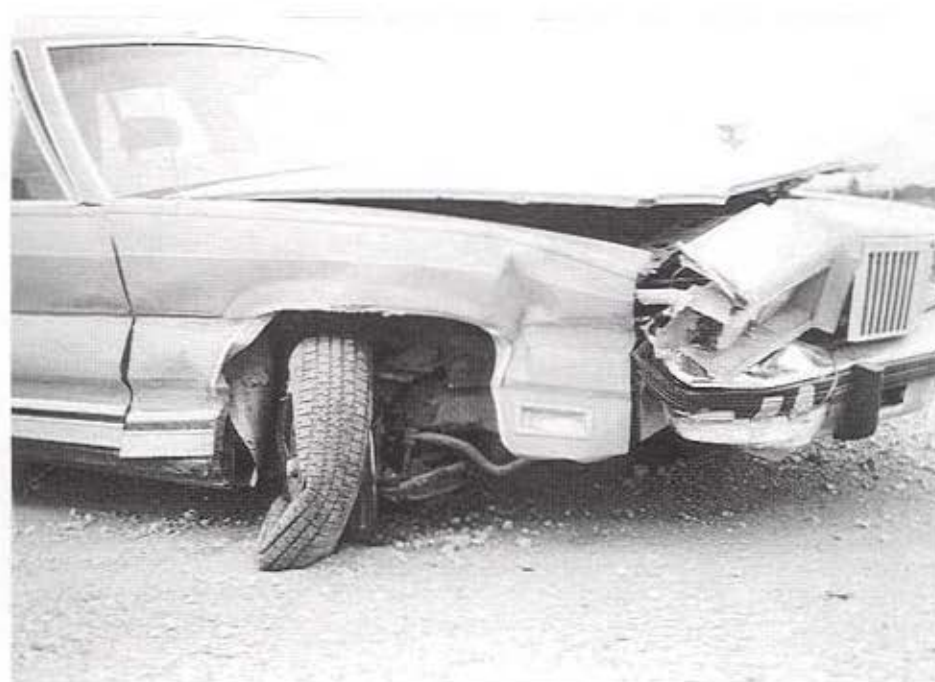
Figure 39. Test Vehicle Damage, KSWB-4

Vehicle damage is shown in Figure 39, and consisted primarily of right front corner crush and passenger side W-beam interlock damage. There was minor interior occupant damage to the right front floor board. The right front tire was blown and the rim contained considerable deformation. Guardrail damage is shown in Figure 40, and consisted of only moderate deformation and flattening of the lower portion of the impacted 25 ft beam section. The measured contact length between the vehicle and the rail was approximately 15 ft. The maximum permanent

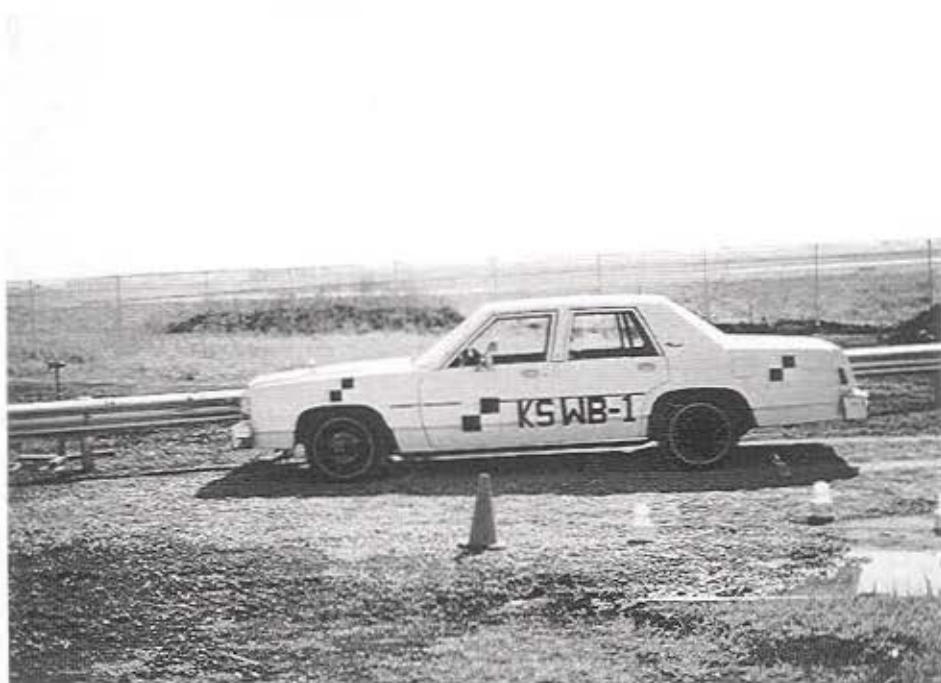
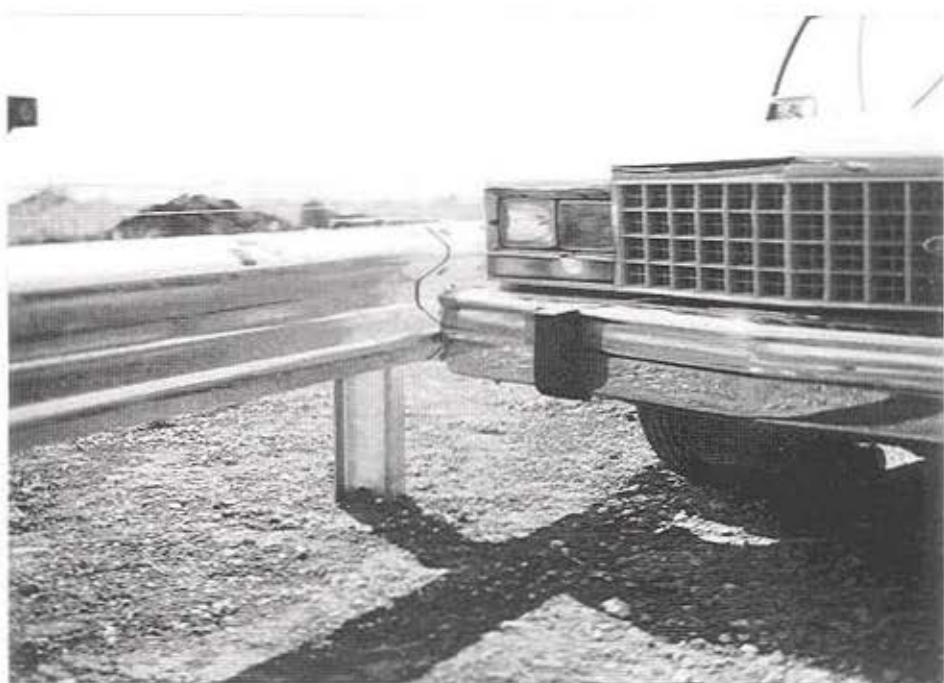
Figure A-1. 4500 lb Test Vehicle, KSWB-1

Make: Ford Test No.: KSWB-1  
 Model: LTD Crown Victoria Tire Size: P215-75R15  
 Year: 1985 VIN: 2FABP43G5FX172657

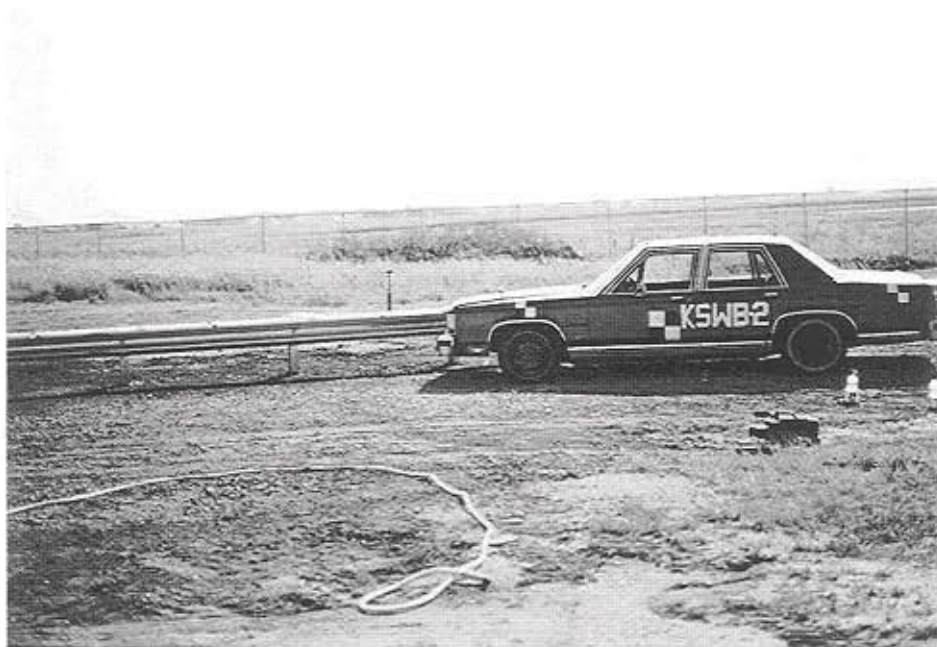
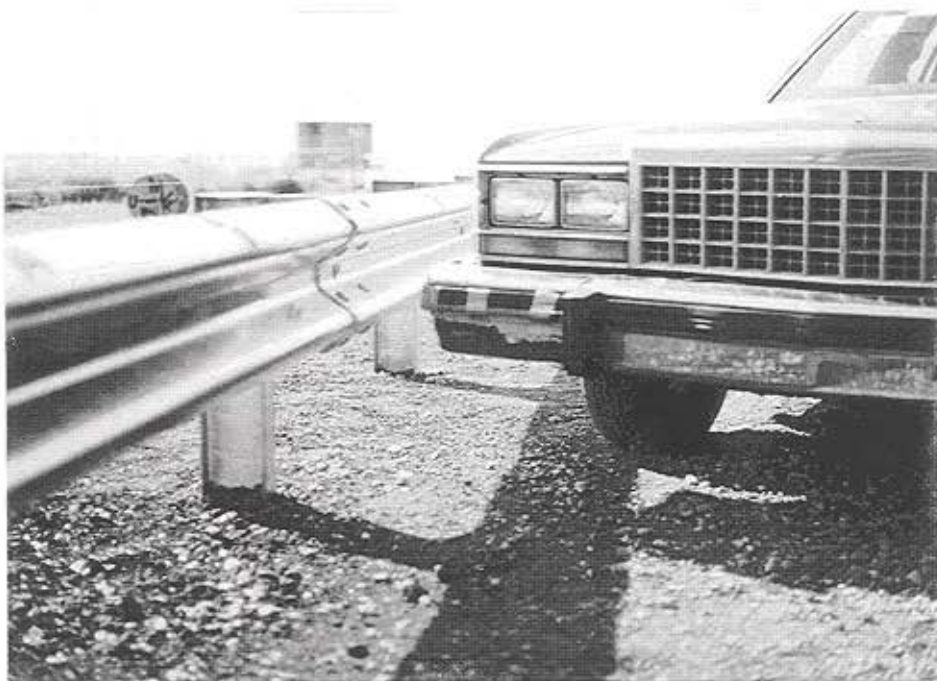
Figure A-3. 4500 lb Test Vehicle, KSWB-2

Make: Ford Test No.: KSWB-2  
 Model: LTD Crown Victoria Tire Size: P215-70R15  
 Year: 1984 VIN: 2FABP43FXEX121970

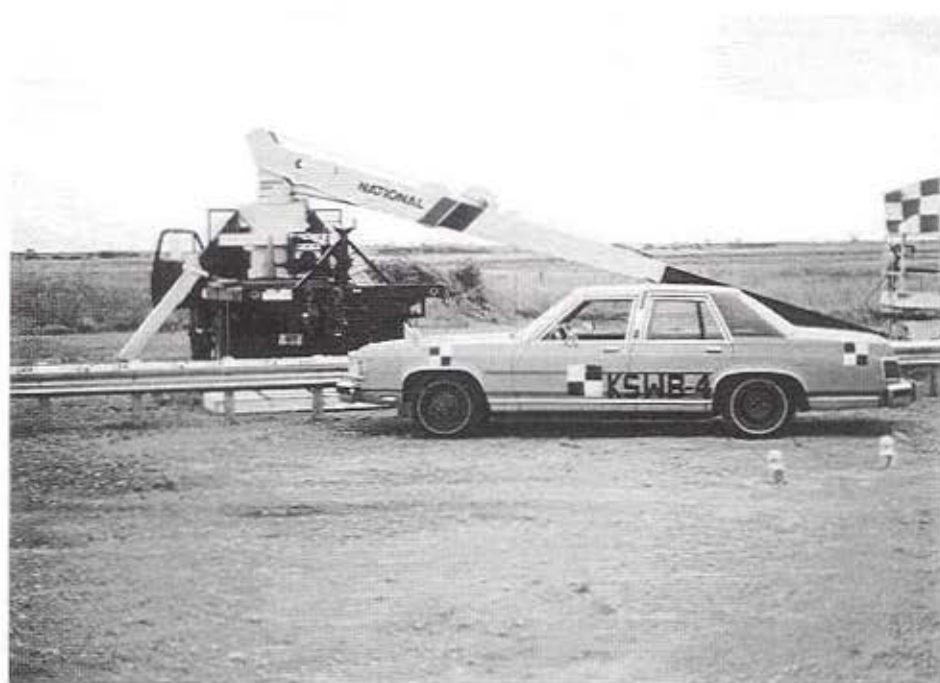
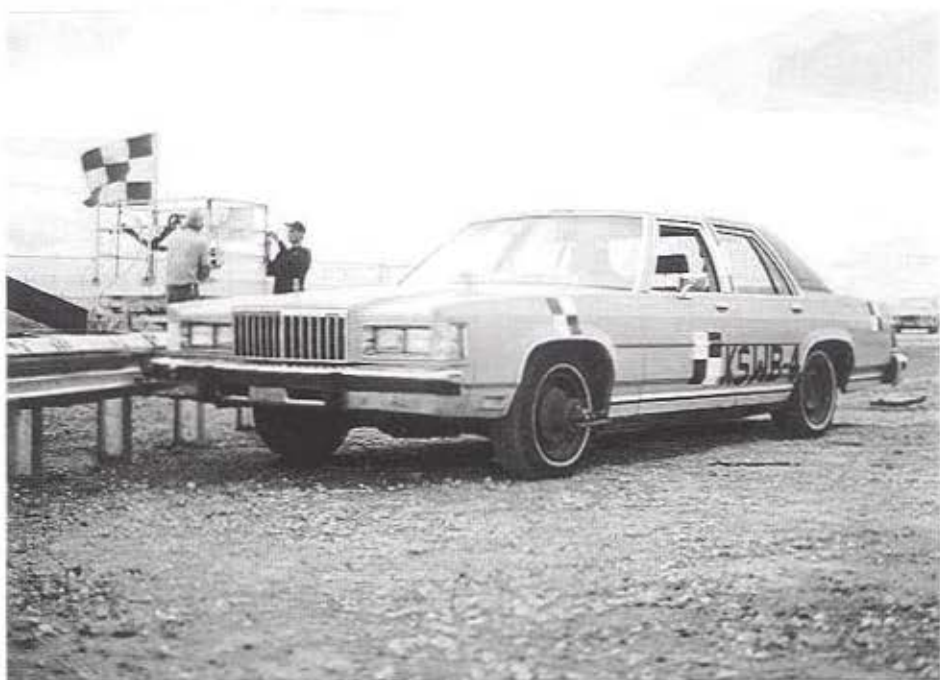
Figure A-7. 4500 lb Test Vehicle, KSWB-4

Make: Mercury Test No.: KSWB-4  
 Model: Grand Marquis Tire Size: P215-75R15  
 Year: 1985 VIN: 2MEBP95F1FX635162
