# **DEVELOPMENT OF A TL-3 F-SHAPE TEMPORARY CONCRETE MEDIAN BARRIER**

## **MIDWEST ROADSIDE SAFETY FACILITY**

*MwRSF Research Report No. TRP-03-64-96*  
December 1996

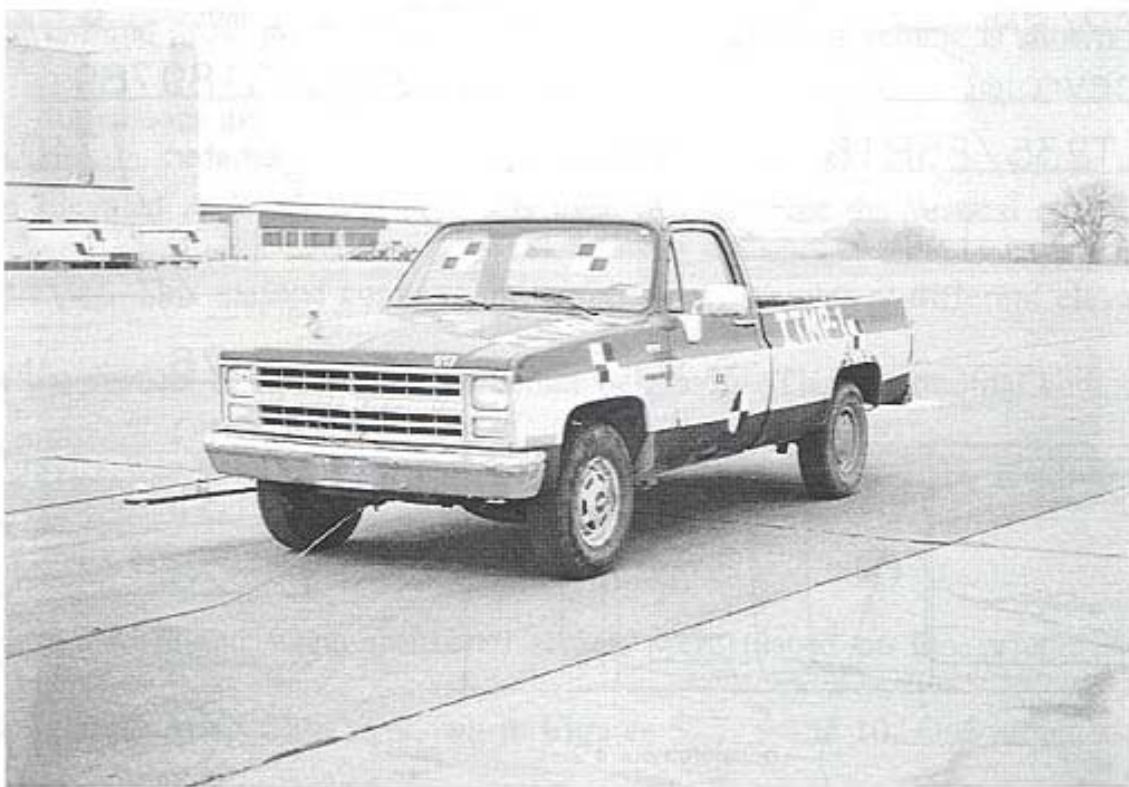
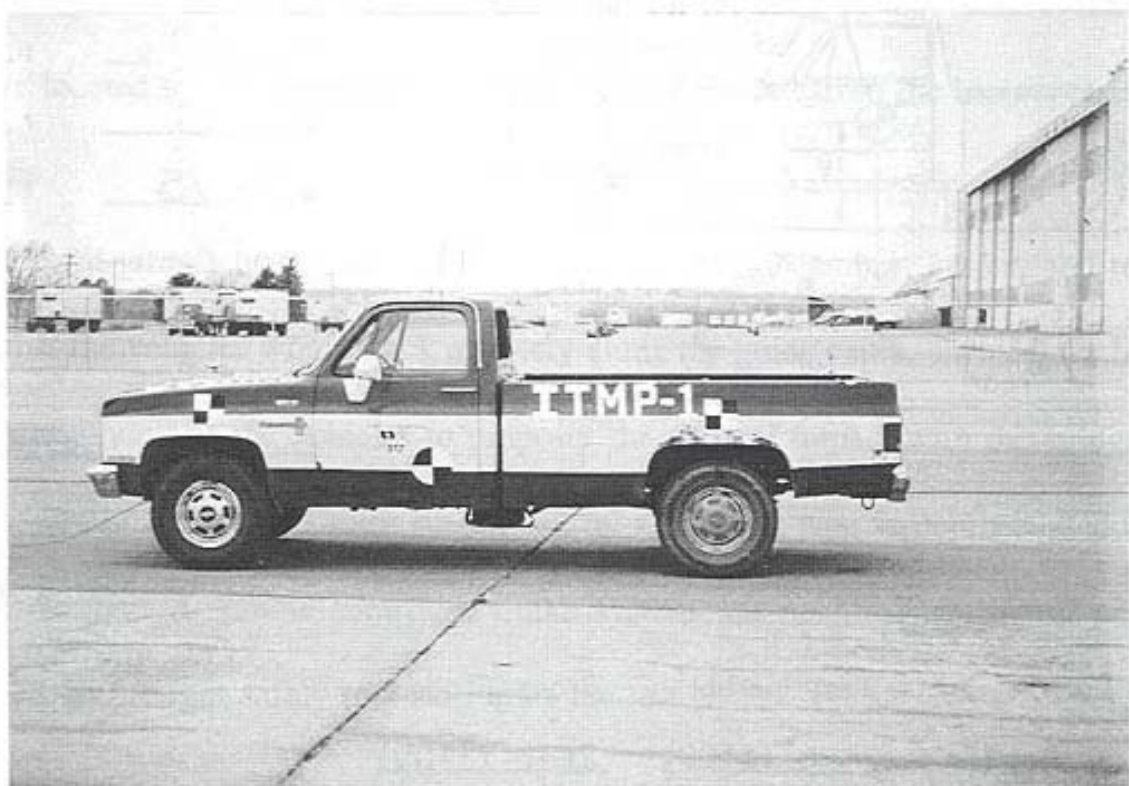
Figure 5. Test Vehicle, Test ITMP-1

For test ITMP-1, a 1985 Chevrolet C-20 ¾-ton pickup truck was used as the test vehicle. The test inertial and gross static weights were 2,000 kg. The test vehicle is shown in Figure 5, and vehicle dimensions are shown in Figure 6.

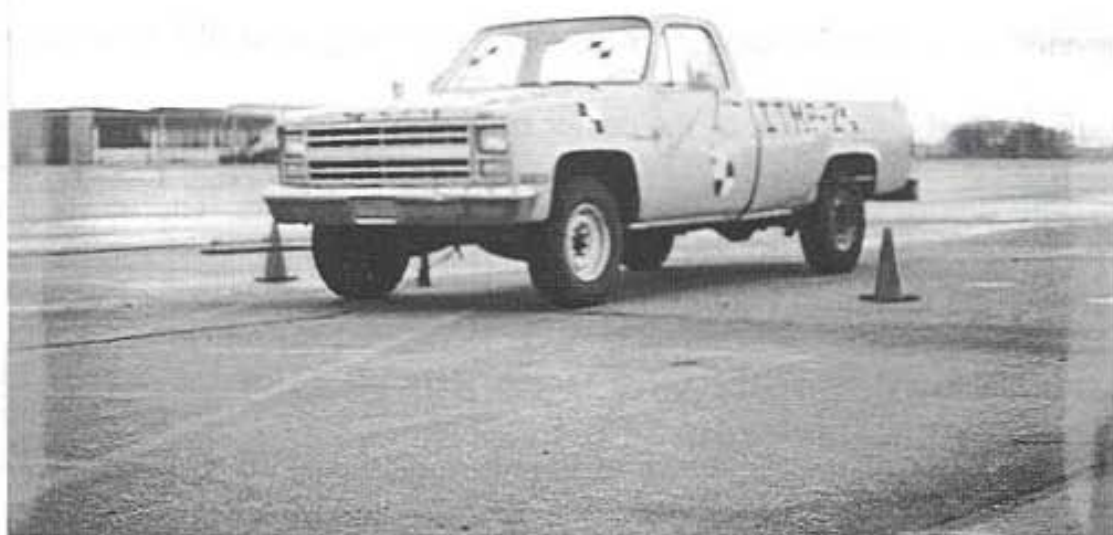
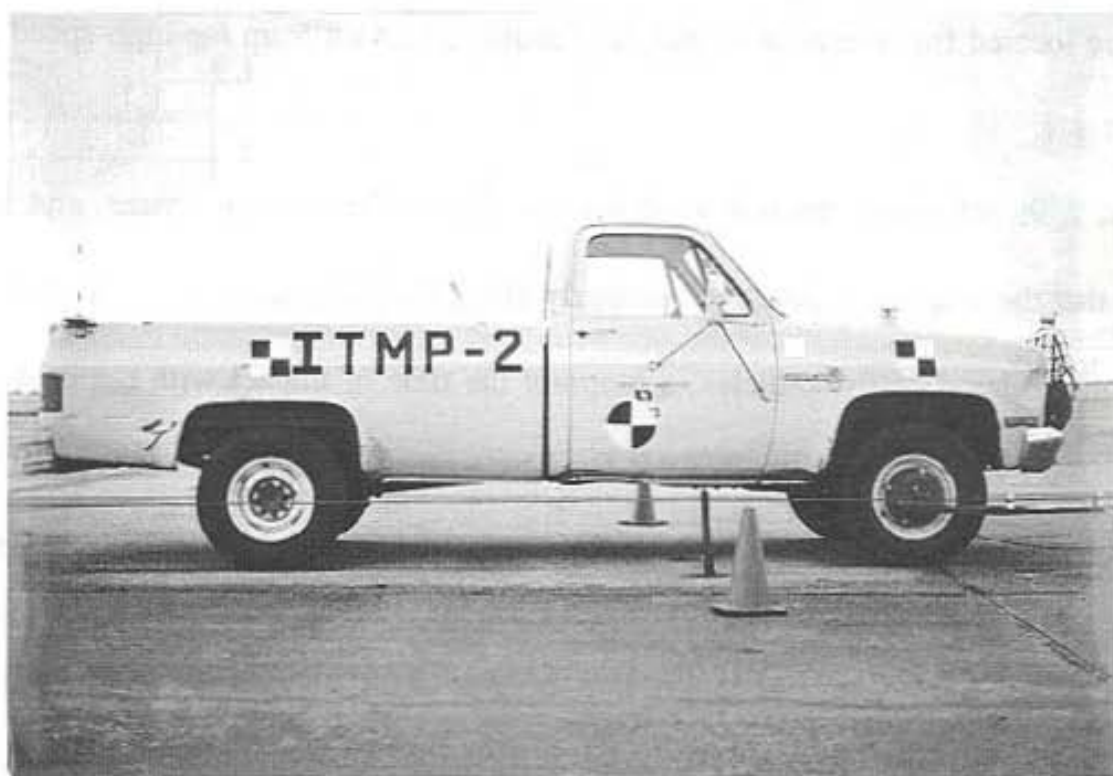
Figure 7. Test Vehicle, Test ITMP-2

Date: 5/9/96 Test Number: ITMP-2 Model: Custom Deluxe  
 Make: CHEVY Vehicle I.D.#: 1GCEC24H56F423544  
 Tire Size: LT235/85R16 Year: 1986 Odometer: 93561

For test ITMP-2, a 1986 Chevrolet C-20 ¾-ton pickup truck was used as the test vehicle. The test inertial and gross static weights were 2,005 kg. The test vehicle is shown in Figure 7, and vehicle dimensions are shown in Figure 8.

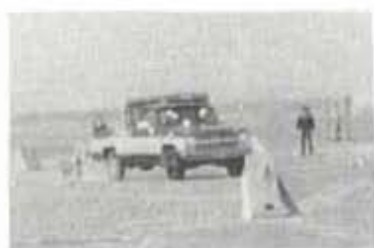
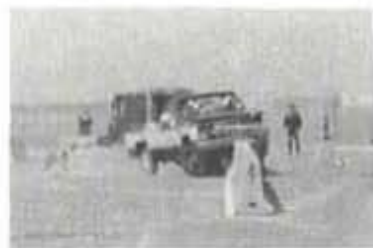
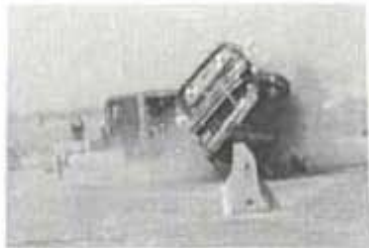
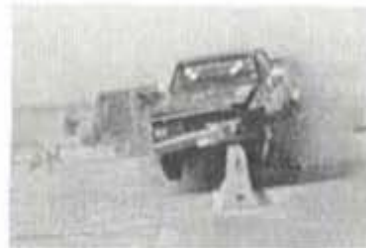
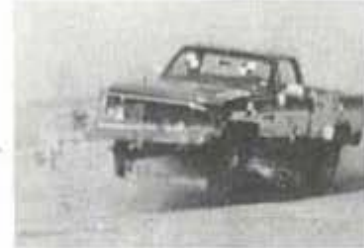
0.000 sec

0.117 sec

0.587 sec

1.076 sec

1.761 sec

- Vehicle Angle
  - Impact ..... 27.6 deg
  - Exit ..... NA
- Vehicle Snagging ..... Minor contact at gap between barrier nos. 8 and 9
- Vehicle Stability ..... Unsatisfactory
- Occupant Ridedown Deceleration
  - Longitudinal ..... NA < 20 G's
  - Lateral (not required) ..... NA
- Occupant Impact Velocity (Normalized)
  - Longitudinal ..... NA < 12 m/s
  - Lateral (not required) ..... NA
- Vehicle Damage ..... Moderate
  - TAD<sup>15</sup> ..... I-LFQ-5
  - SAE<sup>16</sup> ..... 01LFEW3
- Vehicle Stopping Distance ..... 33.90 m downstream  
8.30 m behind
- Barrier Damage ..... Extensive
- Maximum Deflections
  - Permanent Set ..... 0.99 m
  - Dynamic ..... NA

The 2,000-kg pickup truck impacted the concrete barrier (Design No. 1) at a speed of 103.1 km/hr and an angle of 27.6 degrees. A summary of the test results and the sequential photographs are shown in Figure 13. Additional sequential photographs are shown in Figure 14. Documentary photographs of the crash test are shown in Figures 15 and 16.

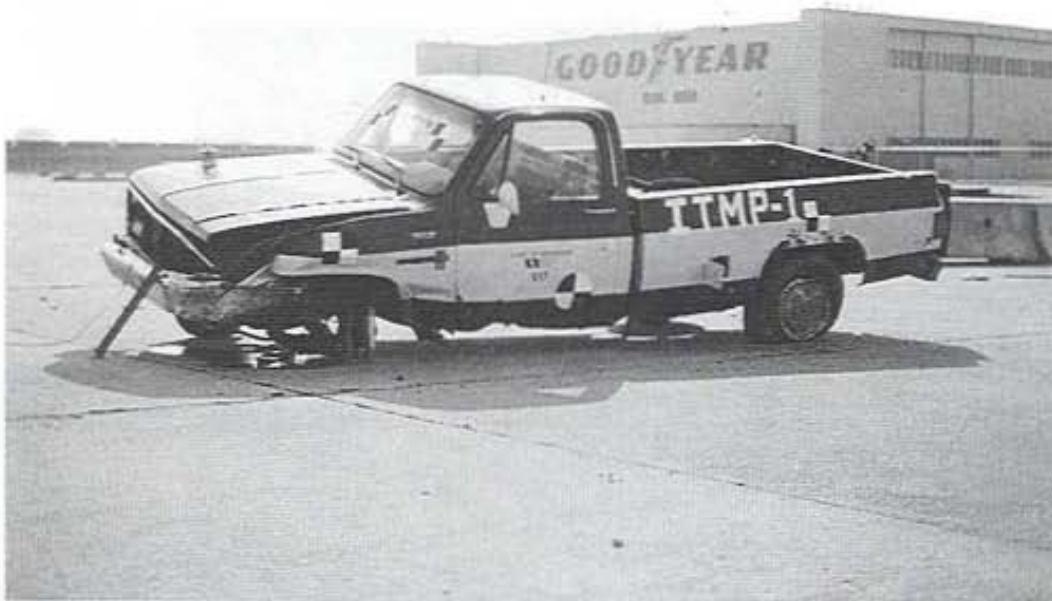
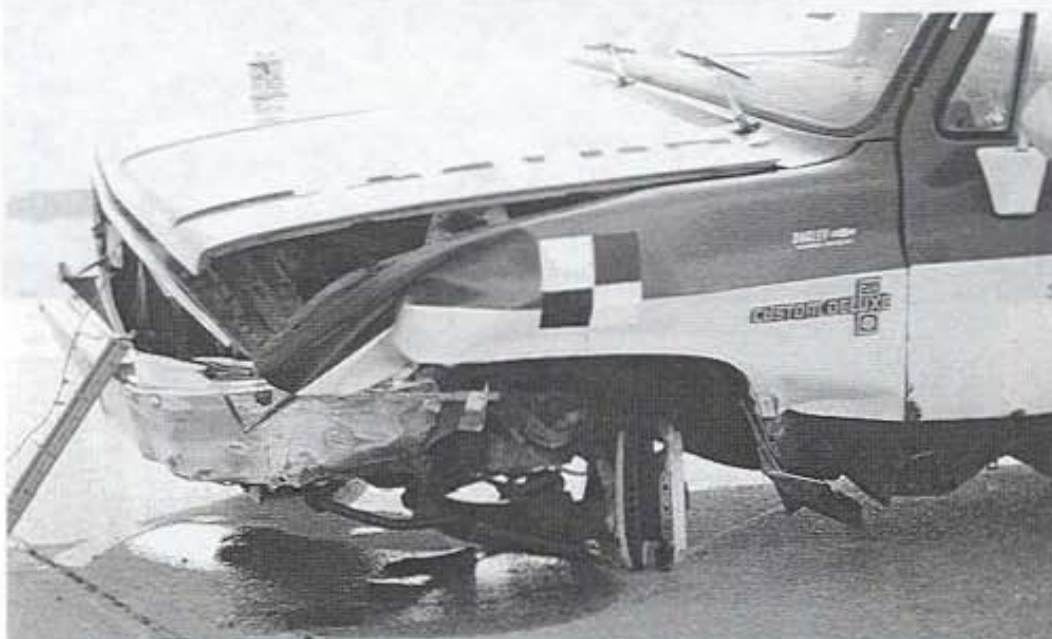
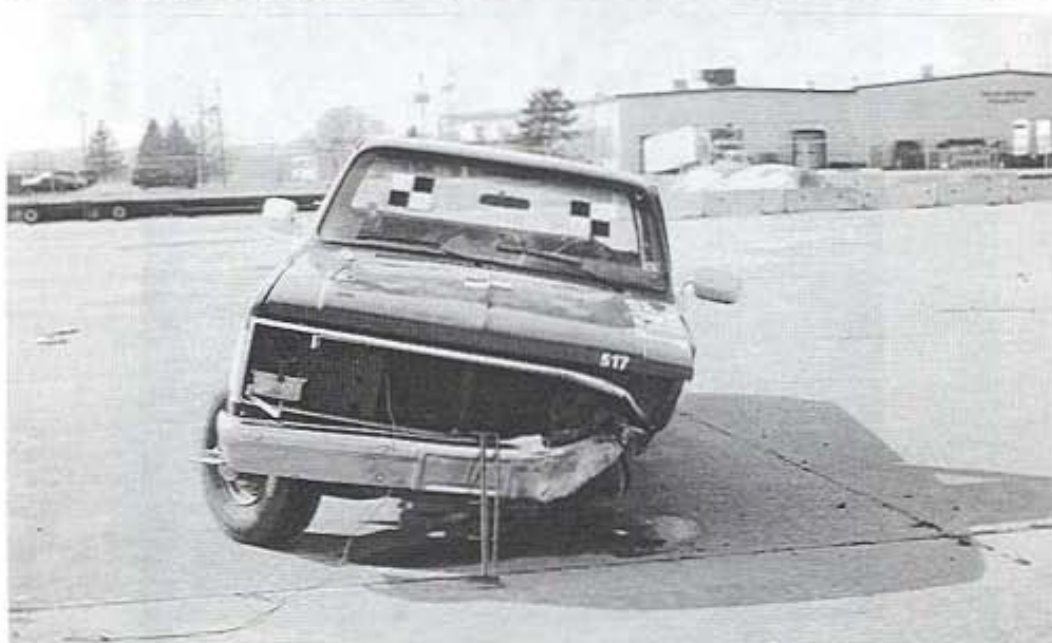
Figure 18. Vehicle Damage, Test ITMP-1

Vehicle damage was moderate, as shown in Figure 18. The front bumper and left-front quarter panel were crushed inward. The left-front wheel assembly was dislodged during the impact as the outer steel rim fractured from the inner region attached to the wheel hub. The steel frame was slightly bent inward near the front with a slight twist along its length from front to rear. Maximum occupant compartment deformations to the floorboard were 127 mm of longitudinal displacement near the center firewall region and a vertical displacement of 32 mm and 51 mm near left-side floorpan and center hump, respectively. The deformations to the floorboard were judged insufficient to cause serious injury to the vehicle occupants.

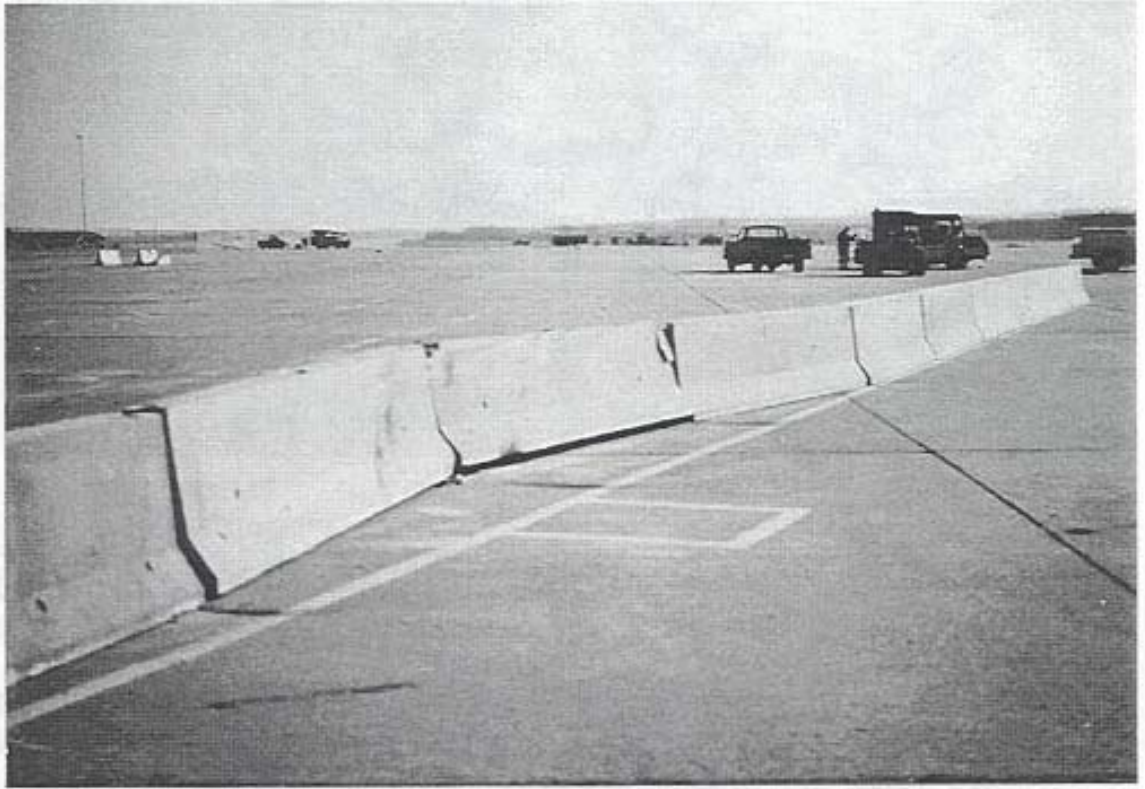
Figure 19. Barrier Damage, Test ITMP-1

Barrier damage was extensive, as shown in Figures 19 through 22. Concrete damage consisted of tire marks, scrapes, gouges, spalling, and fractured concrete pieces. The ends of barriers nos. 7 through 10 were cracked and fractured at various locations, and two cracks were also observed to extend through barrier no. 9. Ten of the steel connector pins were also deformed, ranging from slight to extensive. The maximum permanent set deflection of the barrier was 0.99 m.

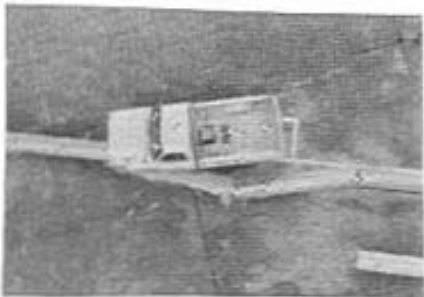
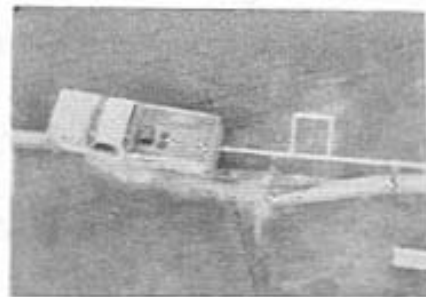
Figure 27. Additional Sequential Photographs, Test ITMP-2

0.197 sec

0.393 sec

The 2,005-kg pickup truck impacted the concrete barrier (Design No. 2) at a speed of 100.3 km/hr and an angle of 27.1 degrees. A summary of the test results and the sequential photographs are shown in Figure 26. Additional sequential photographs are shown in Figure 27. Documentary photographs of the crash test are shown in Figures 28 and 29. It is noted that five additional barrier sections were placed on the upstream end of the installation to provide extra weight for resisting longitudinal barrier movement.

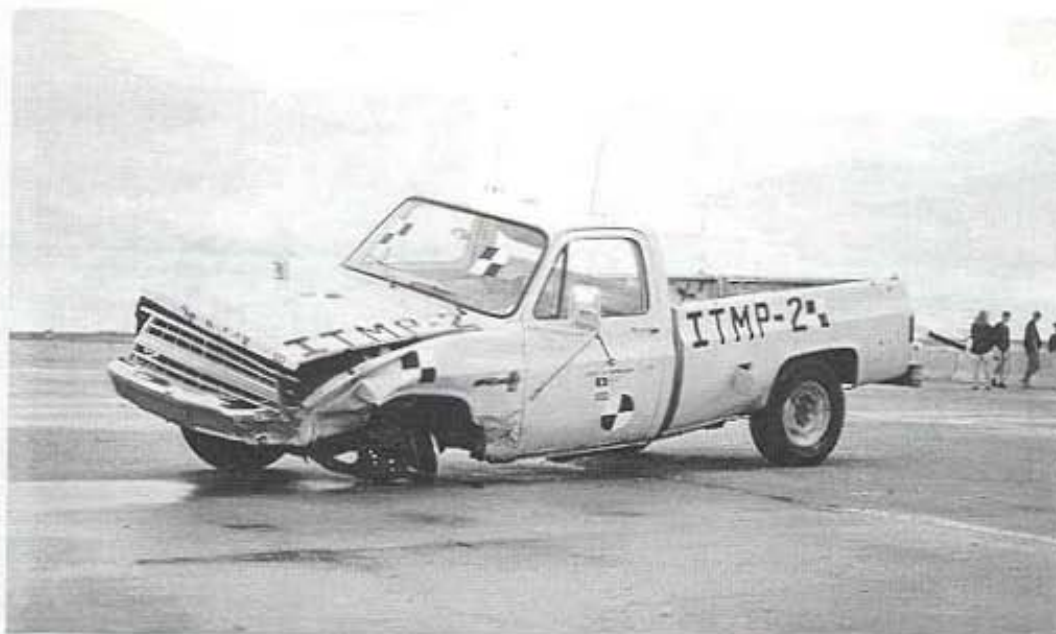
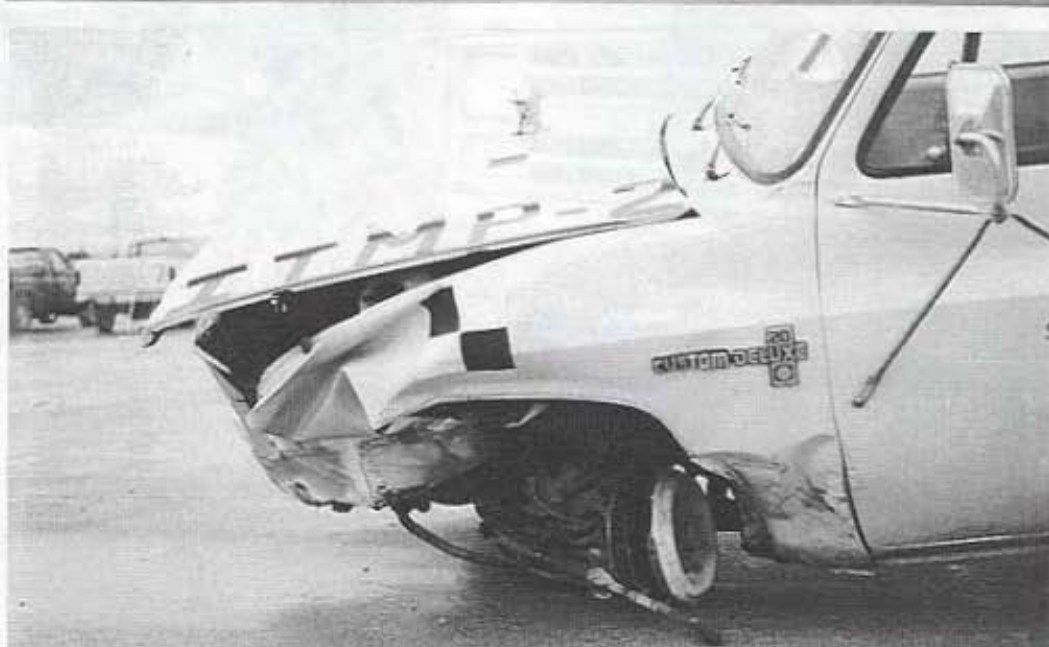
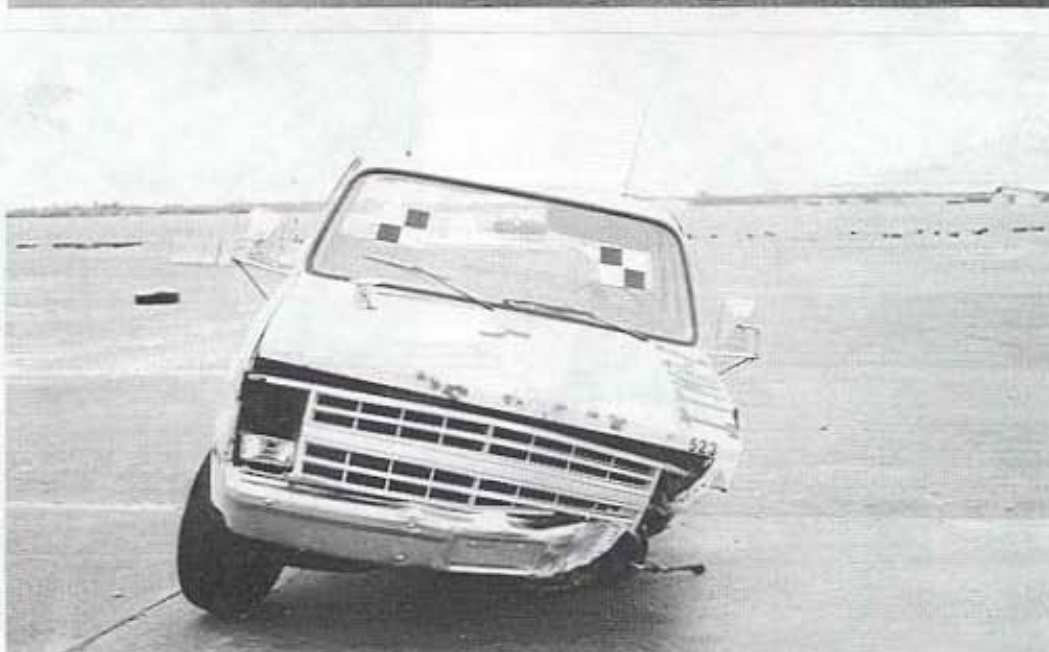
Figure 31. Vehicle Damage, Test ITMP-2

Vehicle damage was moderate, as shown in Figure 31. The front bumper and left-front quarter panel were crushed inward. The left-front wheel assembly was dislodged during the impact as the outer steel rim fractured from the inner region attached to the wheel hub. The steel frame was bent inward near the front with a significant twist along its length from front to rear. Maximum occupant compartment deformations to the floorboard were 55 mm of lateral displacement near the firewall and both a vertical and longitudinal displacement of 38 mm near the center hump behind the gear shift. The deformations to the floorboard were judged to be insufficient to cause serious injury to the vehicle occupants.

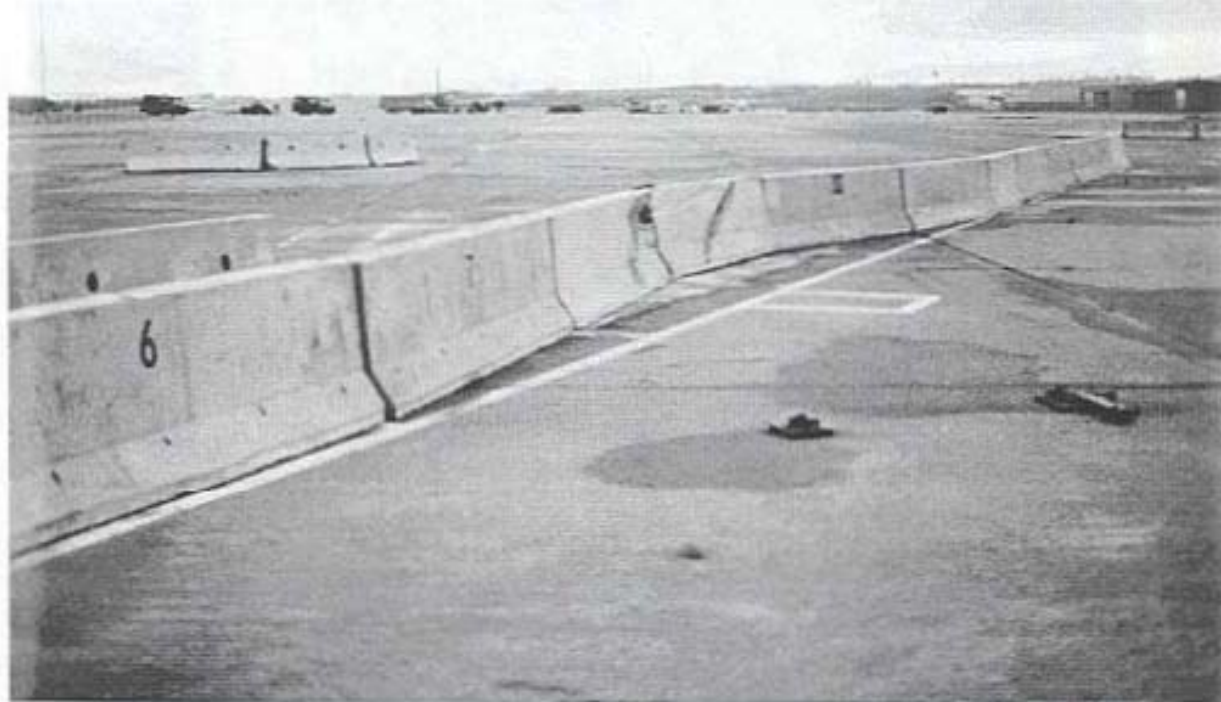
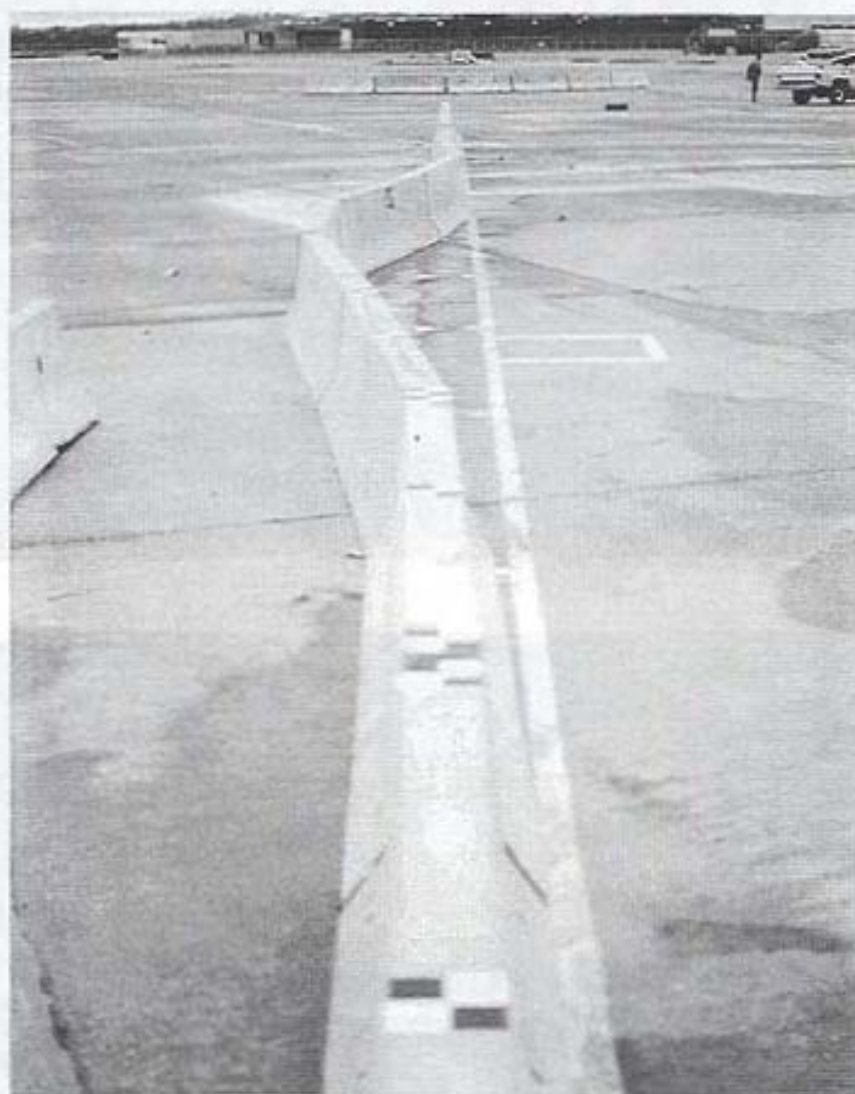
Figure 32. Barrier Damage, Test ITMP-2

Barrier damage was minor, as shown in Figures 32 through 34. Concrete damage was mostly cosmetic, consisting of tire marks, scrapes, gouges, and minor spalling. Nine steel pins were also deformed, ranging from slight to extensive. The maximum permanent set deflection of the barrier was 1.14 m.
