**FULL-SCALE 5,400 LB. VEHICLE CRASH TEST
ON THE
IOWA W-BEAM APPROACH GUARDRAIL
TO THE
CONCRETE SAFETY SHAPE BRIDGE RAIL**

TRANSPORTATION RESEARCH REPORT TRP-03-21-90

One full-scale vehicle crash test was conducted on the Iowa W-Beam Approach Guardrail Transition Section to the Concrete Safety Shape Bridge Rail. Test I6-1 was conducted with a 5,420 lb. vehicle at 20.0 degrees and 61.45 mph.

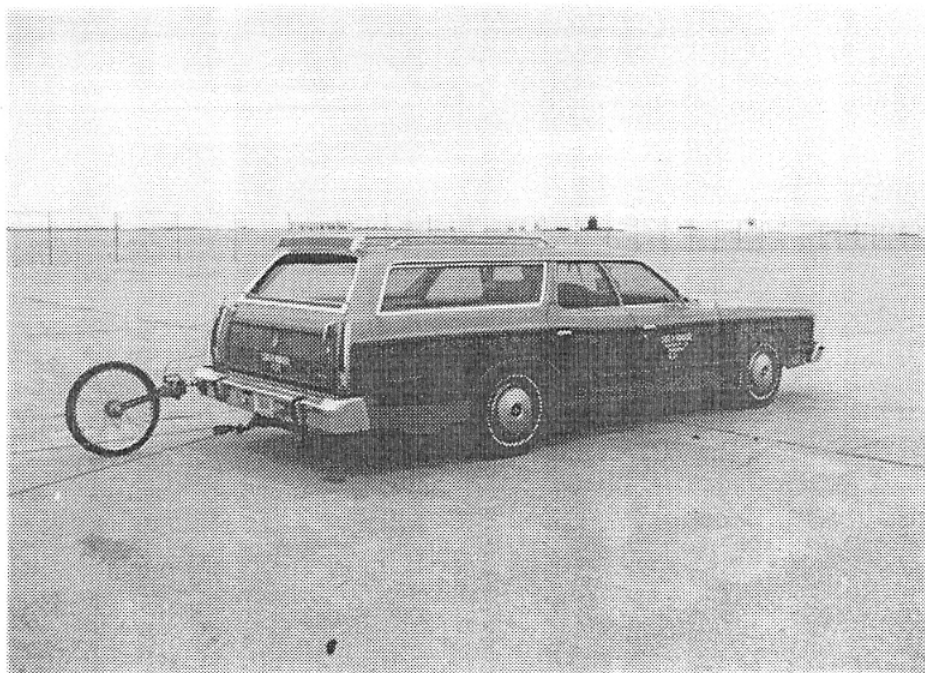
FIGURE 3. PHOTOGRAPH OF TOW VEHICLE AND FIFTH WHEEL

A reverse cable tow, with a 1:2 mechanical advantage, was used to propel the test vehicle. The distance traveled and the speed of the tow vehicle are one-half that of the test vehicle. A sketch of the cable tow system is shown in Figure 2. The test vehicle was released from the tow cable approximately 18 feet before impact with the W-Beam Approach Guardrail Transition Section. Photographs of the tow vehicle and the attached fifth-wheel are shown in Figure 3. The fifth-wheel, built by the Nucleus Corporation, was used for accurately towing the test vehicle at the required target speed with the aid of a digital speedometer in the tow vehicle.

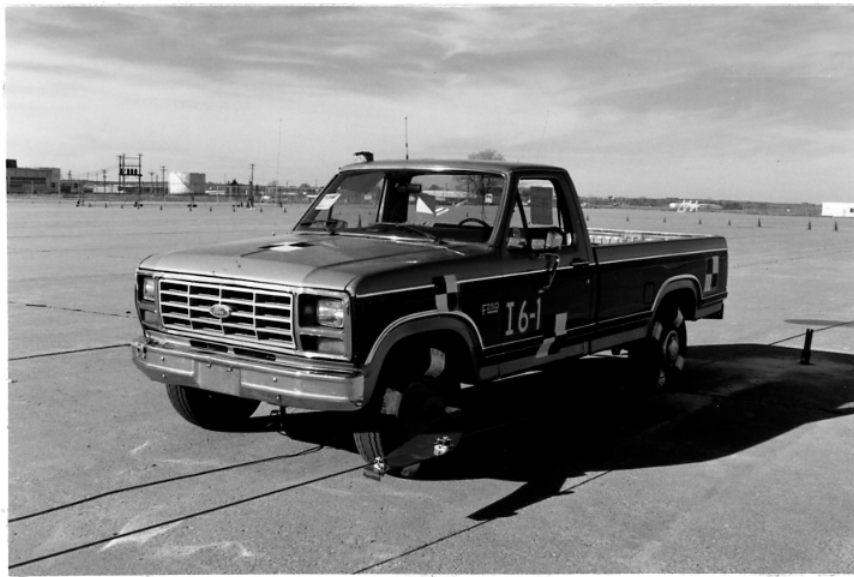
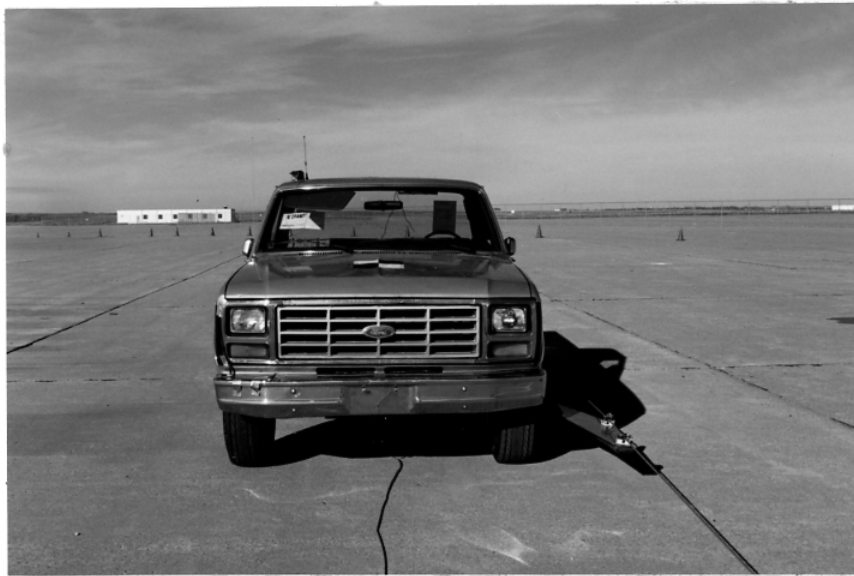
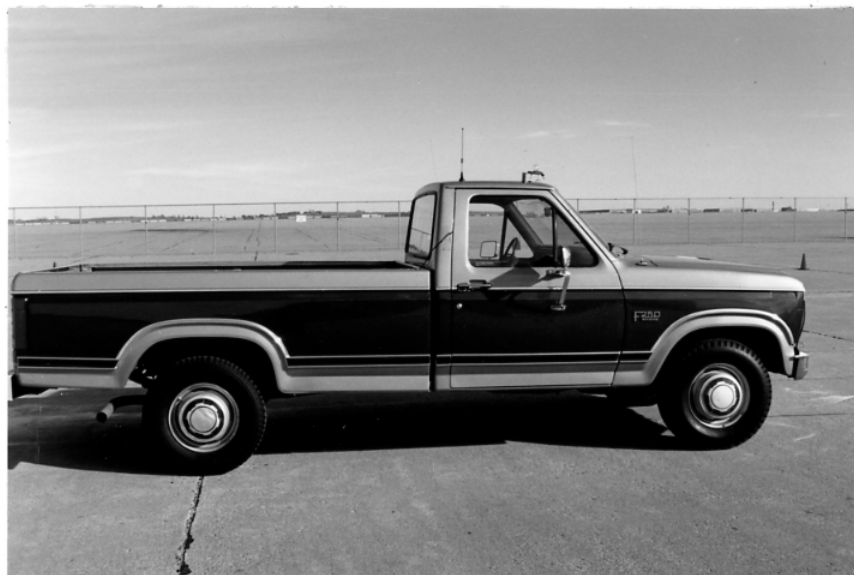
FIGURE 15. PHOTOGRAPHS OF TEST VEHICLE.

Three 8-in. square, black and white checkered targets were placed on the centerline of the top of the test vehicle. The middle target was placed over the center of mass.

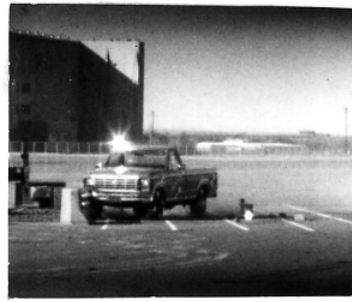
FIGURE 21(a). TIME-SEQUENTIAL PHOTOGRAPHS.

Test I6-1 was conducted with a 5,420 lb. Ford F-250 pickup under the impact conditions of 61.45 mph and 20.0 degrees. The location of impact was 15 ft. upstream from the end of the concrete end-section. A summary of the test results is shown in Figure 20. The sequential photographs are shown in Figures 21 (a), (b), and (c).

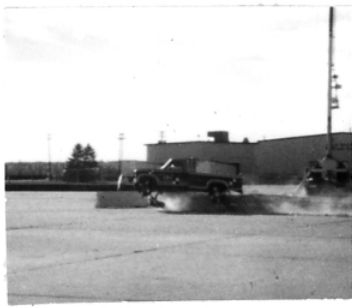
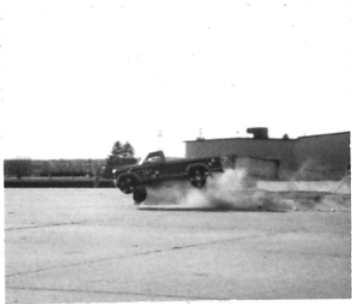
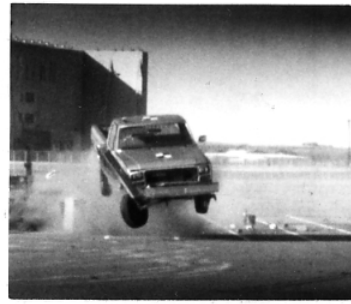
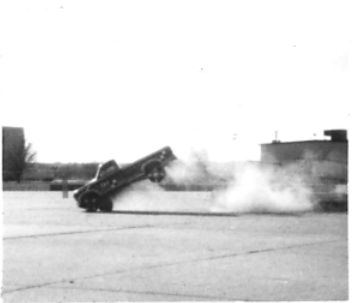
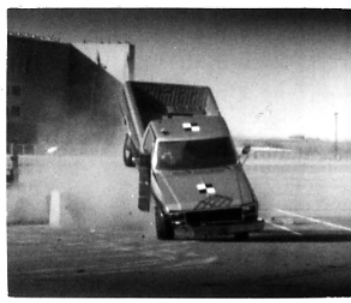
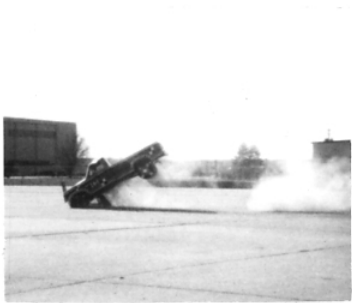
FIGURE 21(c). TIME-SEQUENTIAL PHOTOGRAPHS.

The vehicle was airborne after being redirected at approximately 0.350 sec. At about 0.521 sec., the vehicle began to fall back toward the ground. At approximately 0.807 sec., the vehicle impacted the concrete apron surface.

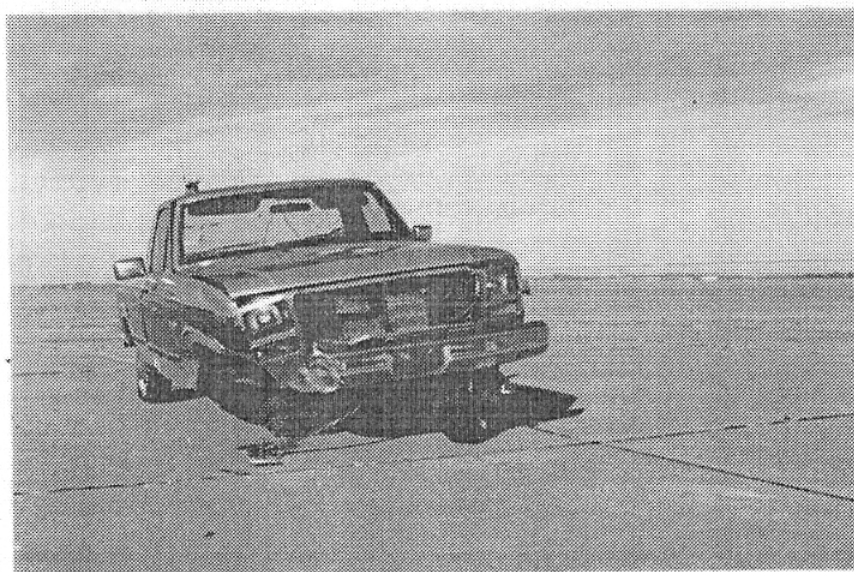
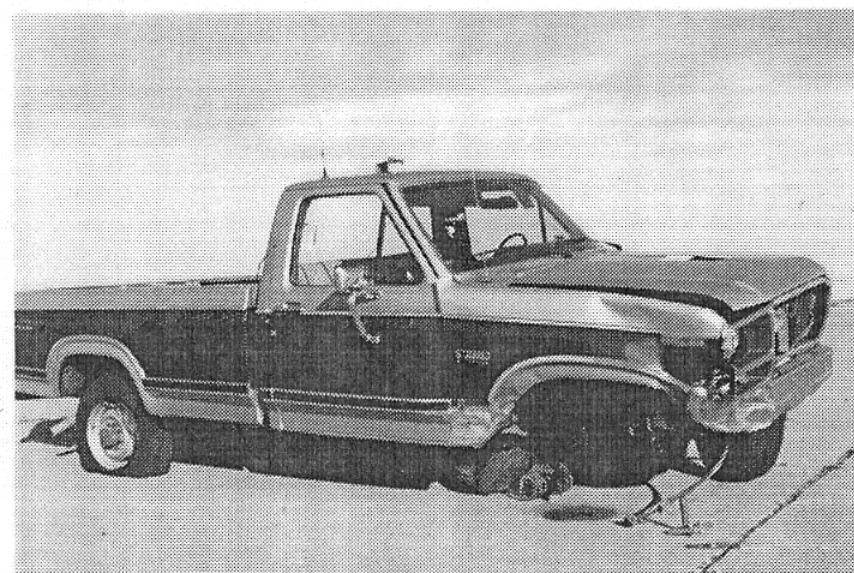
FIGURE 22. PHOTOGRAPHS OF VEHICLE DAMAGE.

Photographs of the vehicle damage are shown in Figure 22. As evident, the vehicle damage was marginal. The TAD and VDI damage classifications are shown in Figure 20.
