Concept Design and Analysis of Nebraska Turned-Down Approach Terminal Sections

Midwest Roadside Safety Facility (MwRSF) Center for Infrastructure Research

Transportation Research Report TRP 03-45-95

January 1995

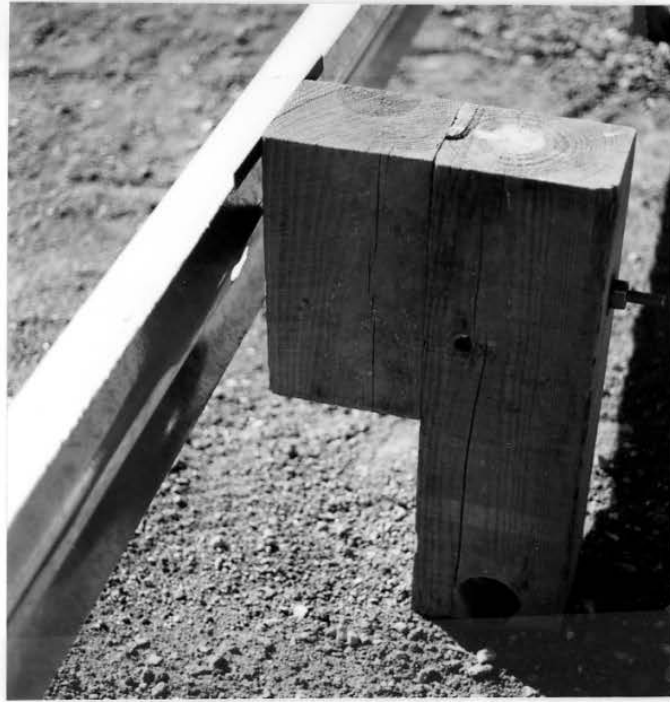
FIGURE 22. Post, Blockout, and Backup Plate Configuration.

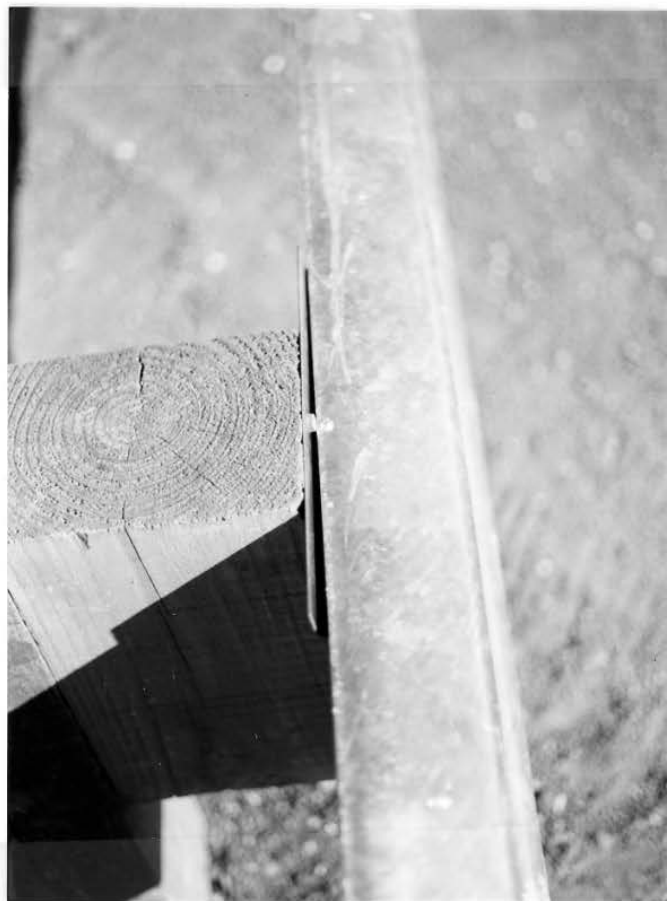
FIGURE 23. Guardrail-to-Backup Plate Connection.

through 9. The guardrail was bolted to the Reid Backup Plates with a No. 10 bolt at Post Nos. 1, 3, and 6 (Figure 23).

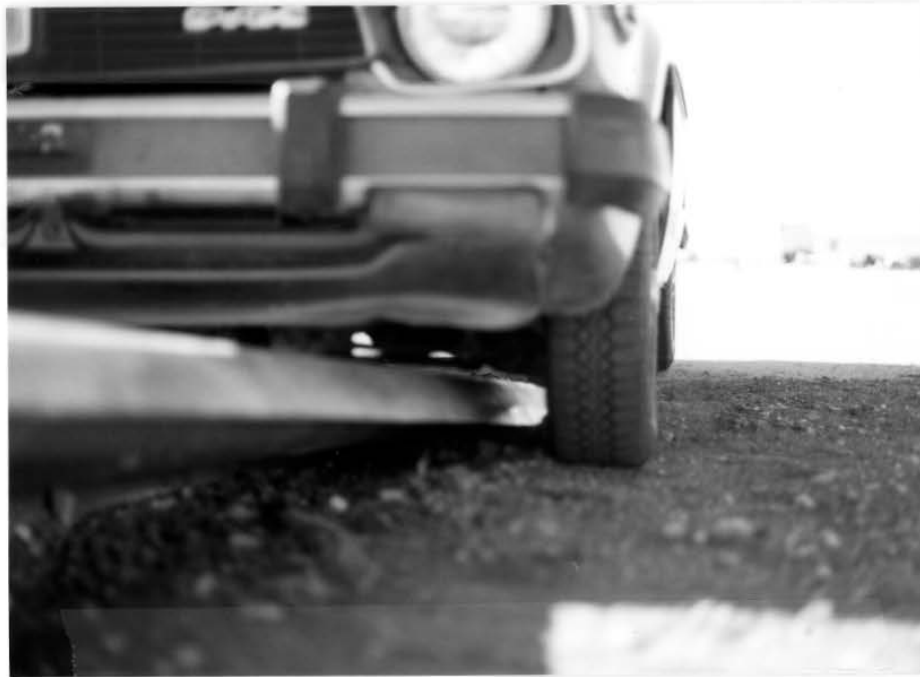
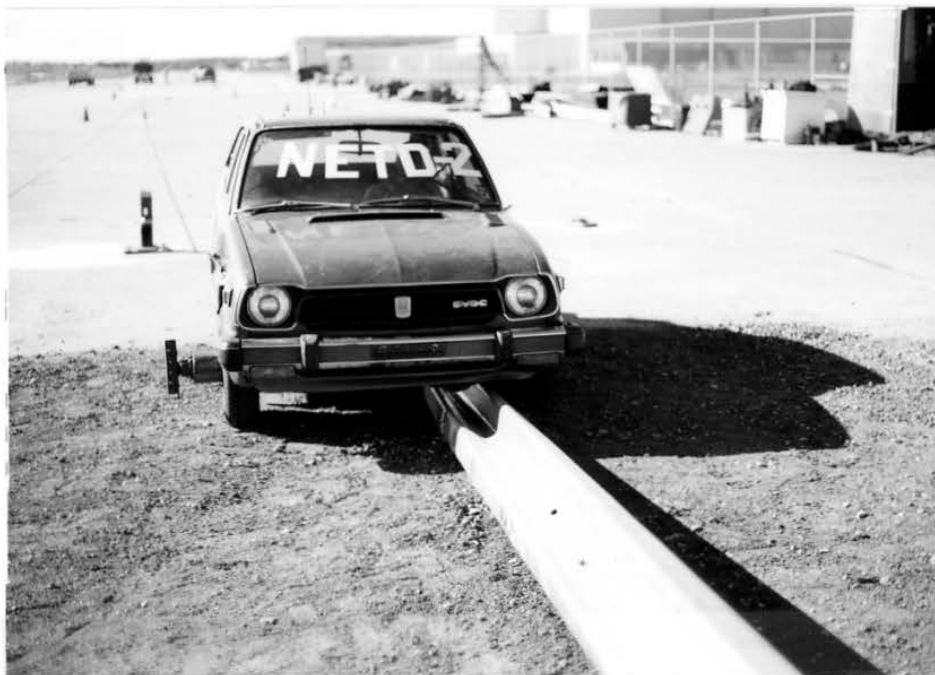
FIGURE 25. Impact Location

Test NETD-LS1 was conducted with a 1979 Honda Civic under the impact conditions of 16 kph (10 mph) and 0 deg (head-on) with respect to a line parallel to the roadway and offset 36 cm (14 in.) toward the roadway. The impact location is shown in Figure 25.

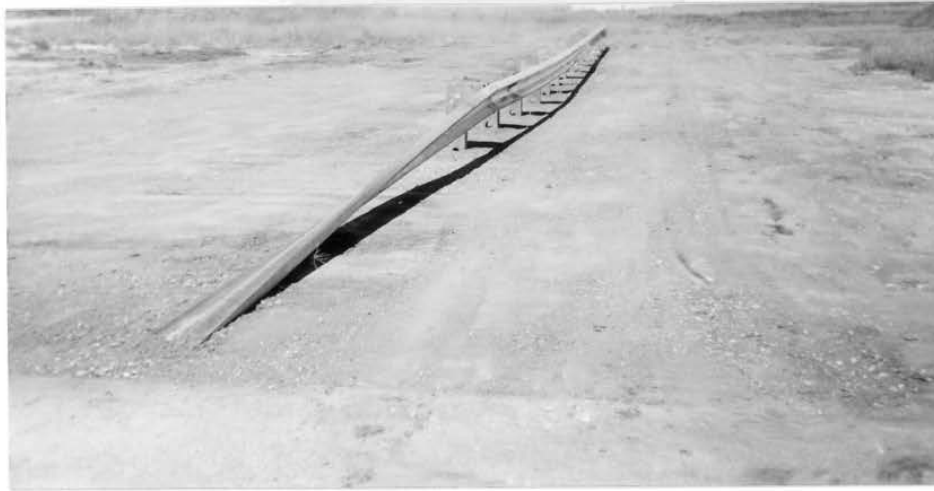
FIGURE 26. Turned-Down Terminal Section with 90 deg CW Twist.

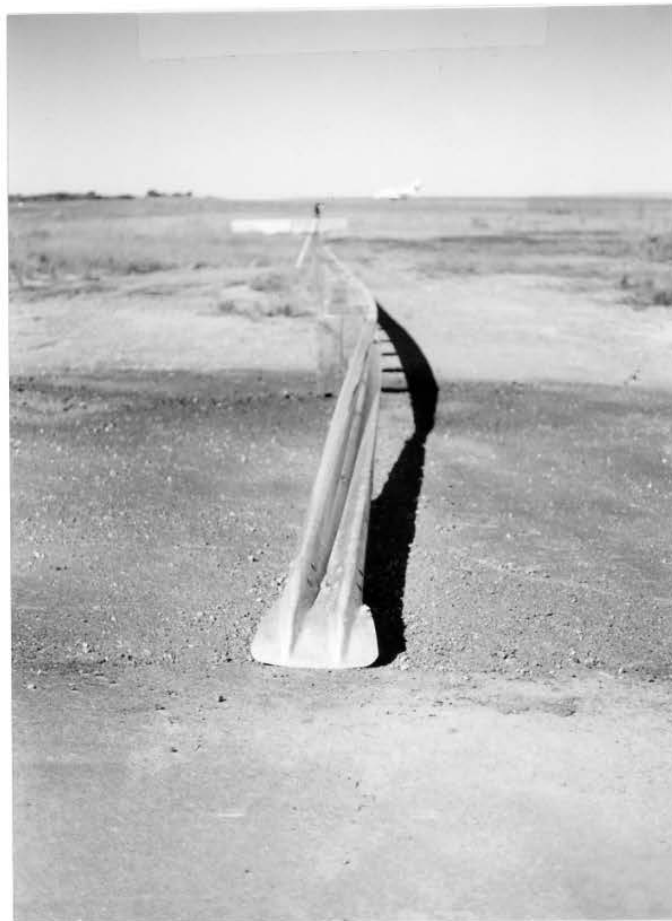
FIGURE 27. Turned-Down Terminal Anchored Above Grade with Michigan End Shoe

The turned-down section for this test was rotated 90 deg counter-clockwise (CCW) and anchored 23 cm (9 in.) above grade. A Michigan end shoe was added to the end of the beam. A No. 8 shear bolt fastened the W-beam rail to the Reid Backup Plate at Post Nos. 1 and 6.

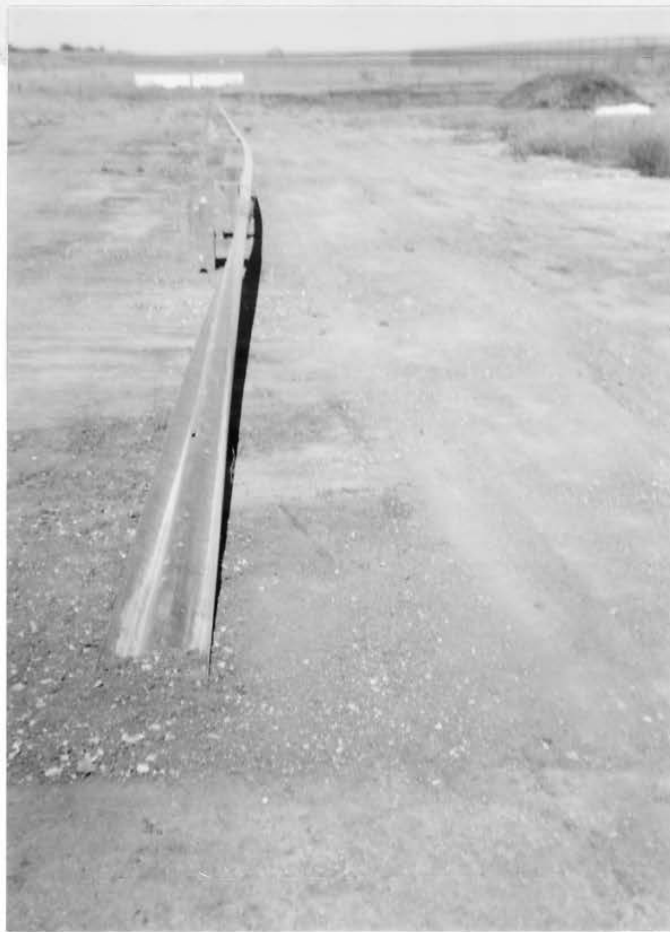
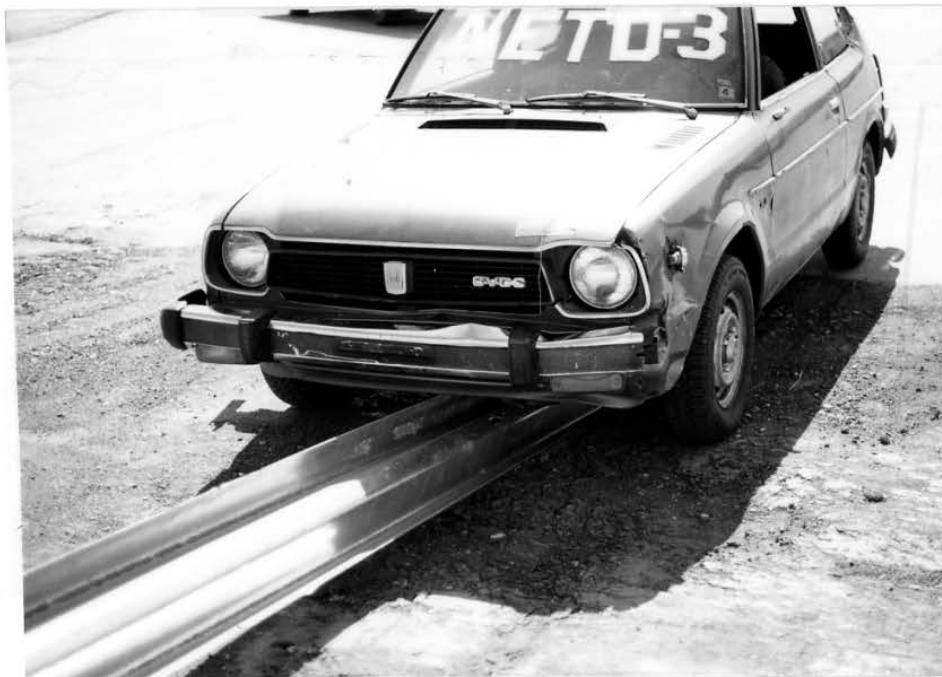
FIGURE 28. System Configuration and Impact Location for NETD-3.

Test NETD-3 was conducted with a 1979 Honda Civic under the impact conditions of 96 kph (59.5 mph) and 0 deg (head-on) with respect to a line parallel to the roadway and offset 36 cm (14 in.) toward the roadway, as shown in (Figure 28).

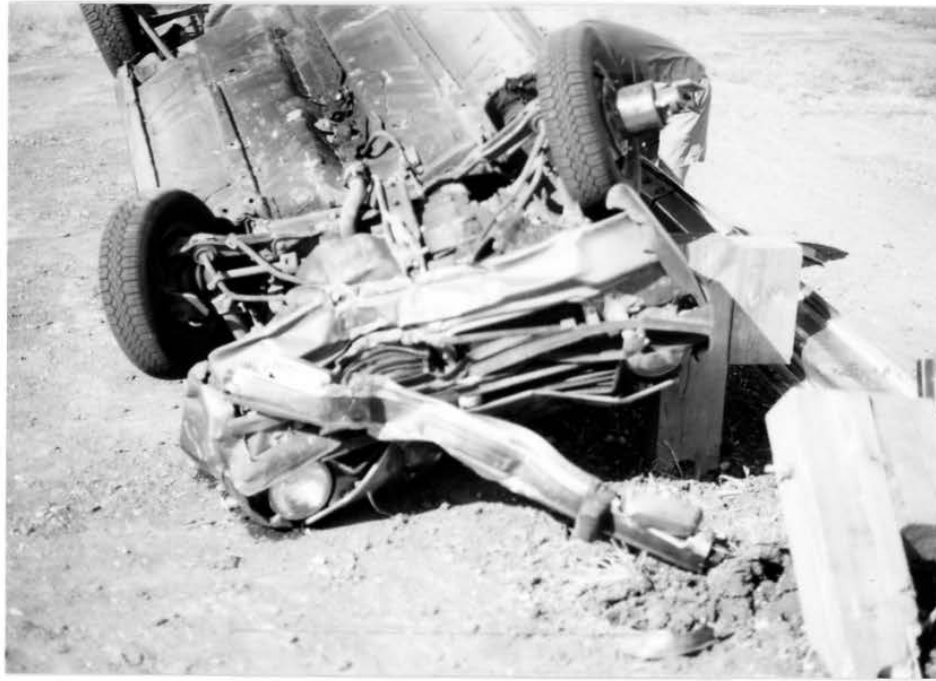
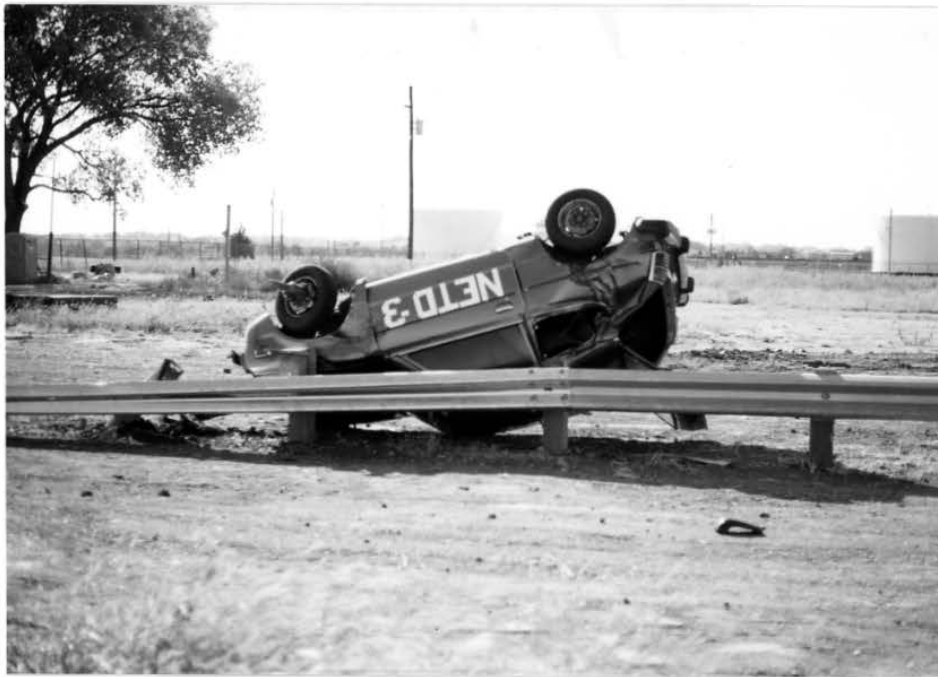
FIGURE 30. Test Vehicle Damage.

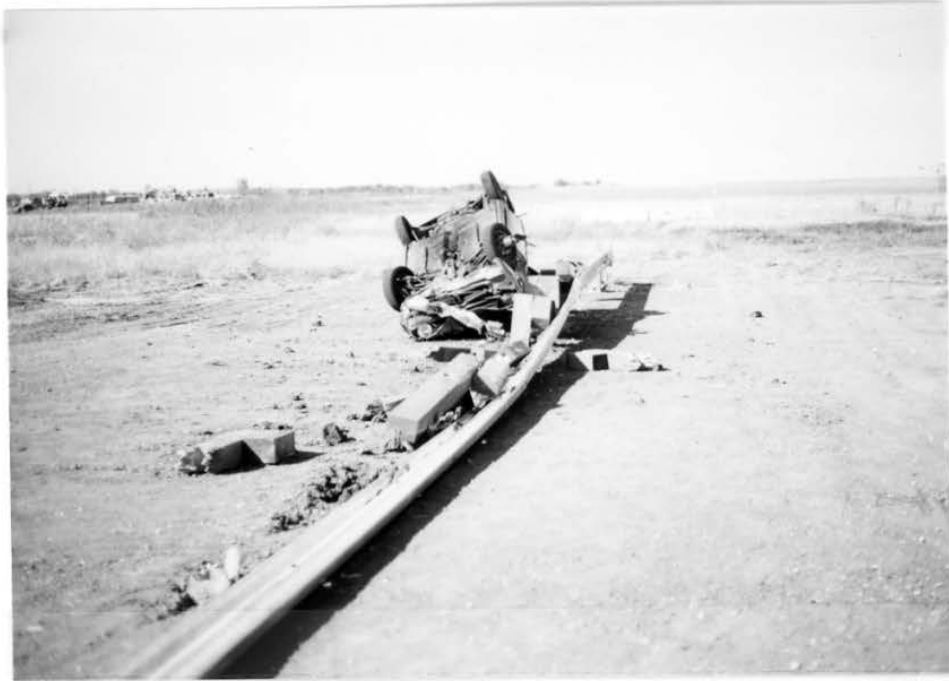
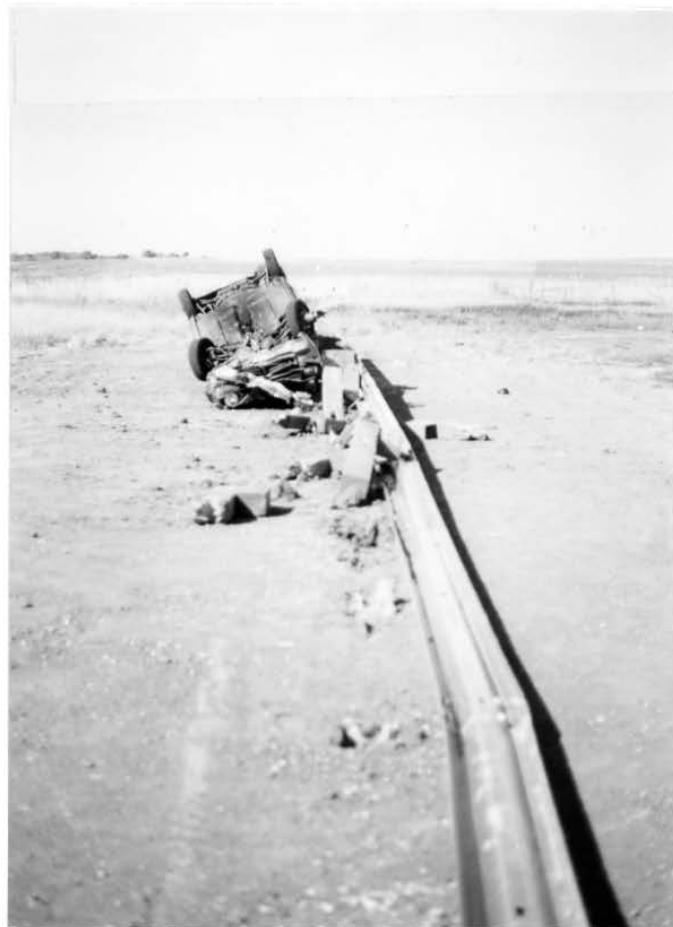
FIGURE 31. Guardrail Damage

Damage to the guardrail is shown in Figure 31. The guardrail is laying on the ground and the posts are sheared off as described above. Figures 32 and 33 show the post damage for Post No. 3. Figure 32 shows the top portion of Post No. 1. The post has been gouged and scuffed by the test vehicle. Post No. 1 came to rest just past the hole for Post No. 3. In the upper right corner of the photograph in Figure 32, the hole for Post No. 3 can be seen. The hole for Post No. 3 is elongated where the post was pulled out of the ground. Figure 33 shows Post No. 3 laying at the location of Post No. 4. The top half of Post No. 4 is shown laying under Post No. 3. Figure 34 shows a different view of the post damage.

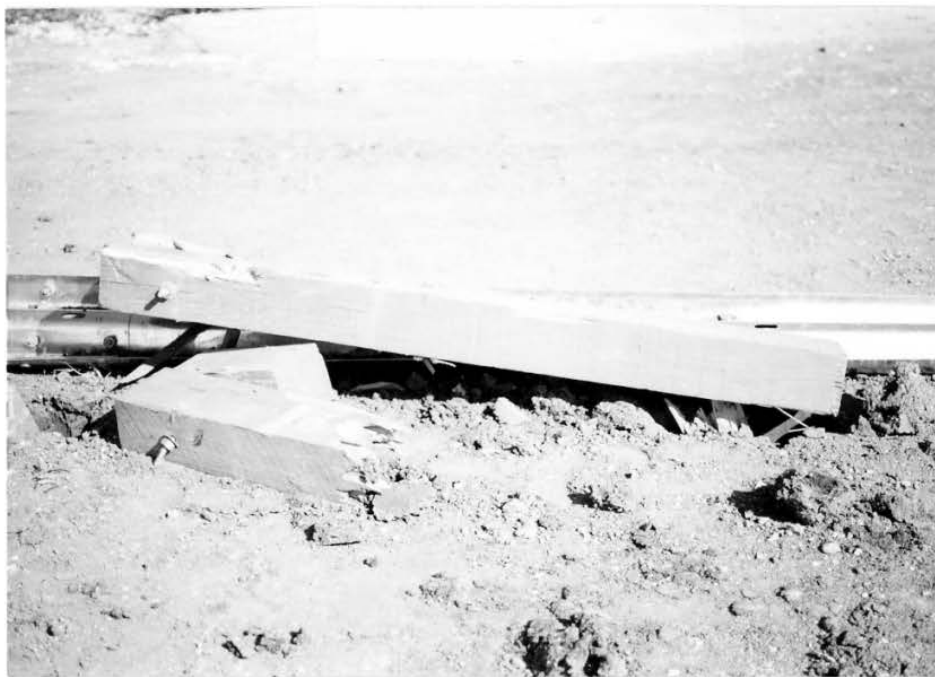
FIGURE 33. Post No. 3 After Impact.

When the test vehicle impacted Post No. 3, the post was pulled out of the ground instead of fracturing. After Post No. 3 pulled out of the ground, it slid along the surface of the ground. The test vehicle began to pitch forward prior to impacting Post No. 4. The vehicle continued to pitch over its front end as it sheared off Post Nos. 4, 5, and 6.

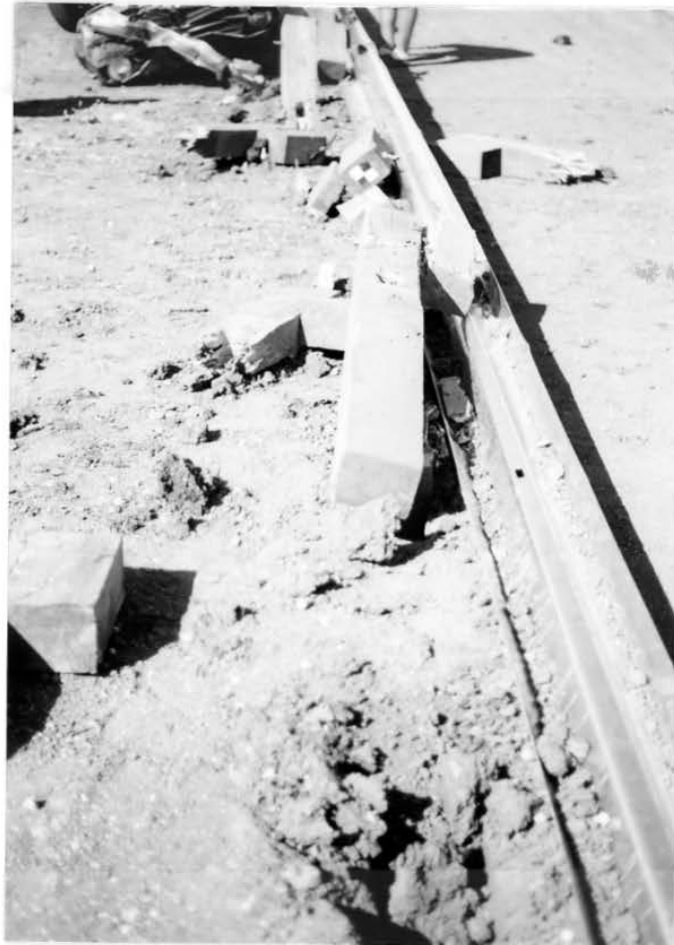
FIGURE 34. Post Damage.
