# **TL-1 Curb-Type Bridge Railing for Longitudinal Glulam Timber Decks Located on Low-Volume Roads**

## **MIDWEST ROADSIDE SAFETY FACILITY**

*MwRSF Research Report No. TRP-03-54-96*

April 1996

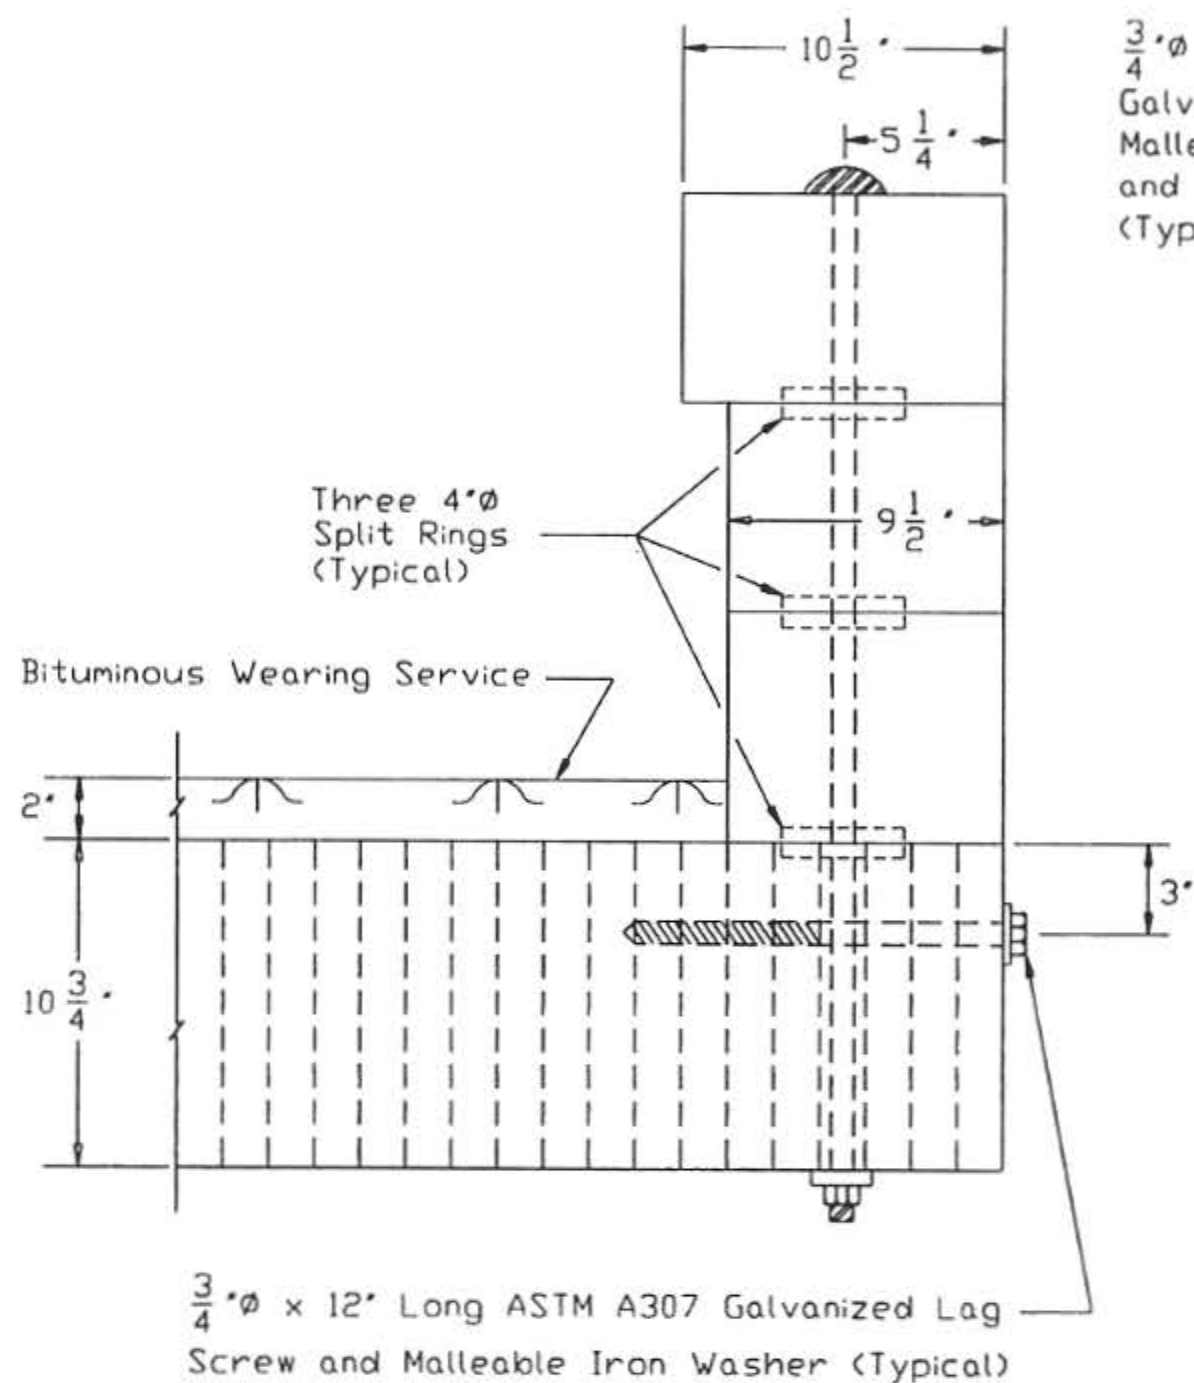
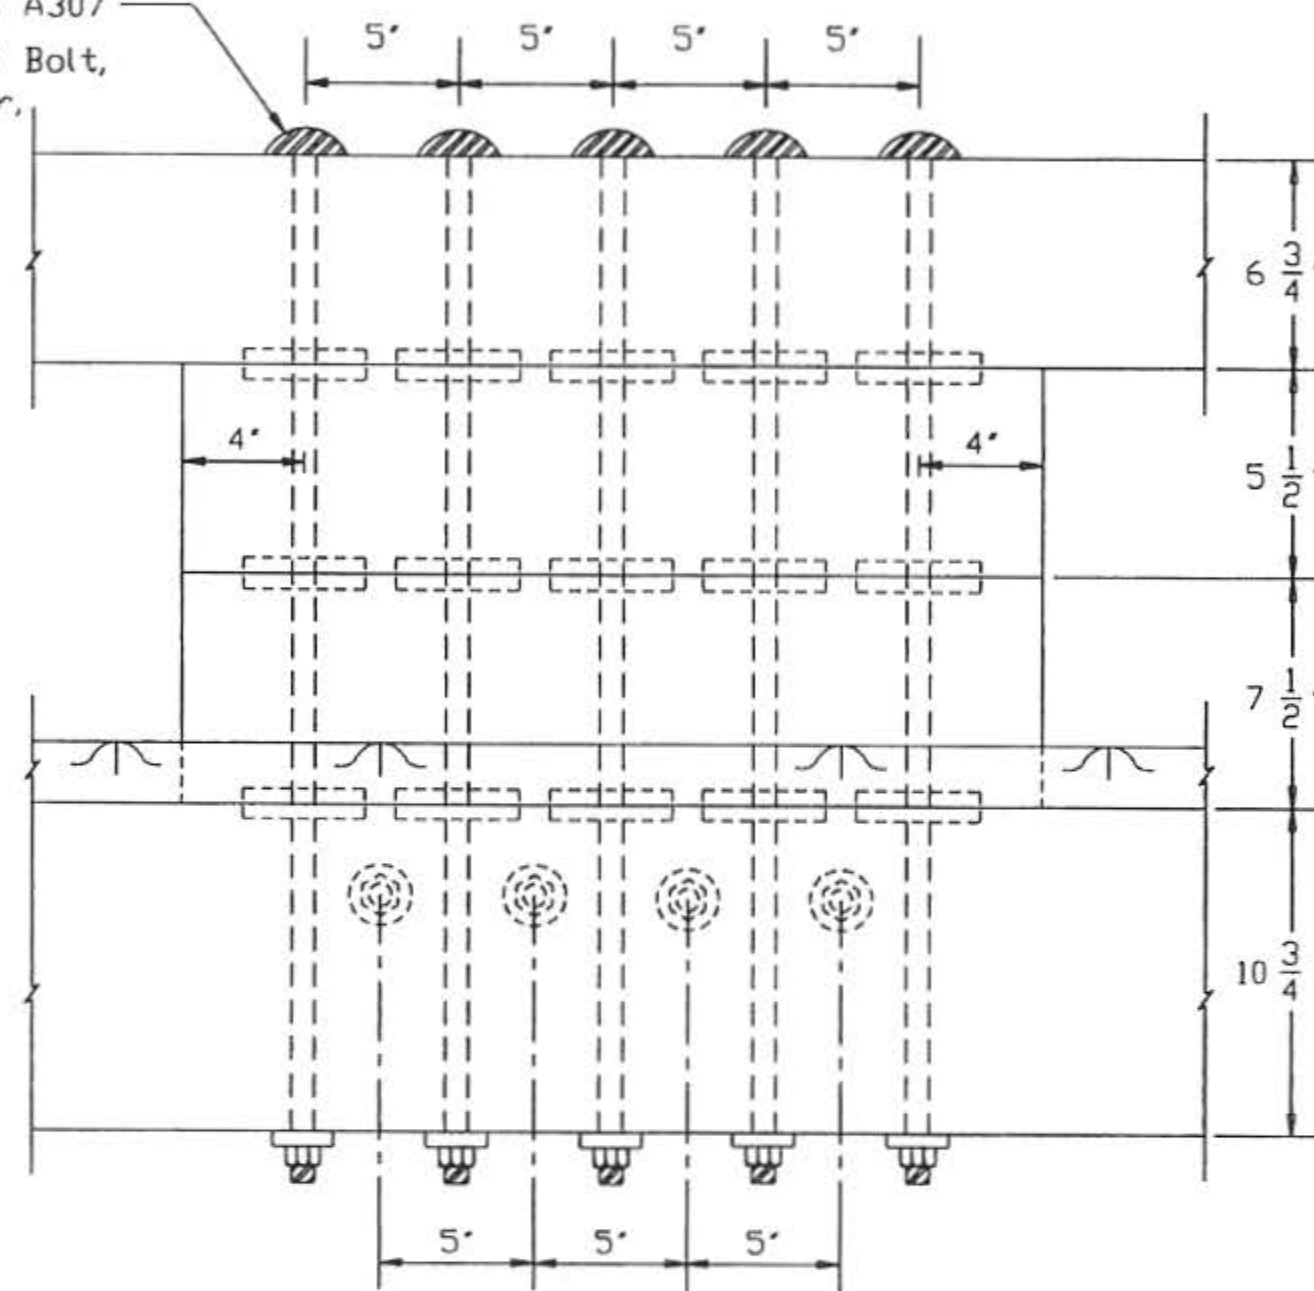
Figure 2. Design No. 1 Details

END VIEW

ELEVATION VIEW (Traffic-Side)

Analysis of vehicular impacts with timber curbs revealed that the curb's shape and top mounting height could effect the redirective capacity of bridge railing system by allowing the vehicle's tire to climb, mount, or traverse the railing. A rectangular curb, with the long dimension oriented perpendicular to the vertical axis, was selected for the rail element since it provided greater economy and increased moment capacity over a square curb. Based on crash tests of previously developed timber curb barriers, the researchers also estimated that 15 $\frac{3}{4}$  to 19 $\frac{3}{4}$ -in. (400 to 502-mm) high curbs should be capable of meeting the desired safety standards (8,14,15). Therefore, it was determined that a top mounting height of 17 $\frac{3}{4}$  in. (451 mm), as measured from the top of rail to the top of wearing surface, would be used for the TL-1 curb-type bridge railing, as shown in Figure 2. The 17 $\frac{3}{4}$ -in. (451-mm) top mounting height of the rail was obtained by using a standard 6 $\frac{3}{4}$ -in. (171-mm) wide glulam rail element supported by timber scupper blocks measuring 11 in. (279 mm) above the wearing surface.

The peak lateral design force imparted to the curb railing was estimated to be 15,230 lbs (67,746 N) using the procedures described previously. Therefore, it was concluded that the timber curb railing system, when attached to a longitudinal glulam timber deck, should be capable of withstanding the design impact conditions without causing significant damage to the barrier or the timber deck. Delamination and cracking of the glulam deck could be minimized by attaching the rail and scupper blocks to the deck surface with an adequate number of vertical bolts and shear plates (or split rings). Horizontal lag screws, placed into the deck's vertical edge, could also be used to help distribute the lateral impact loads, resulting in tensile stresses in the

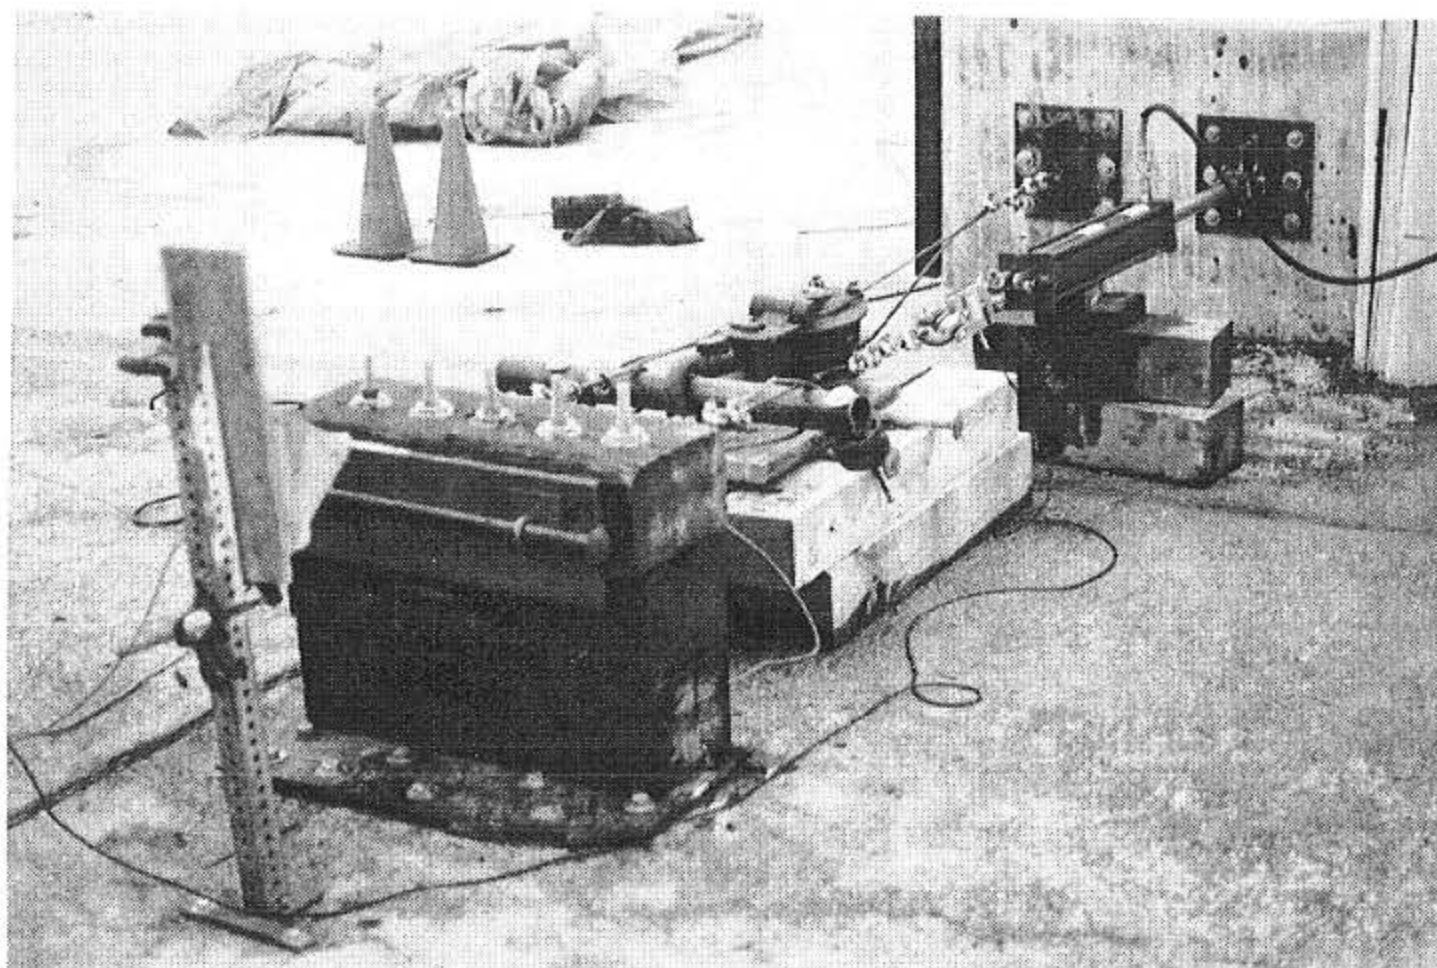
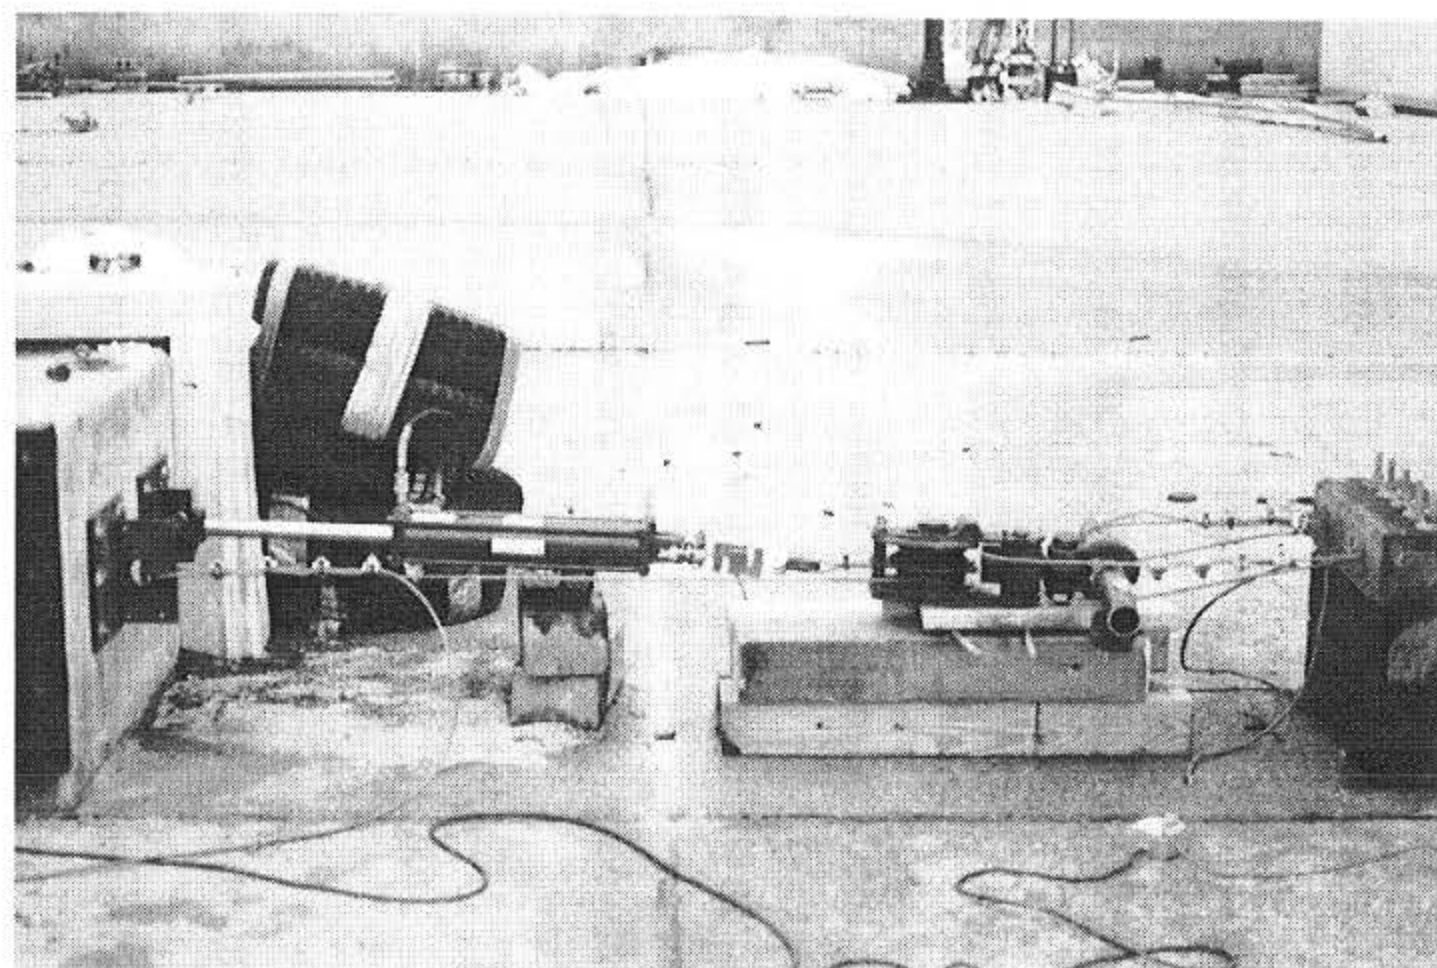
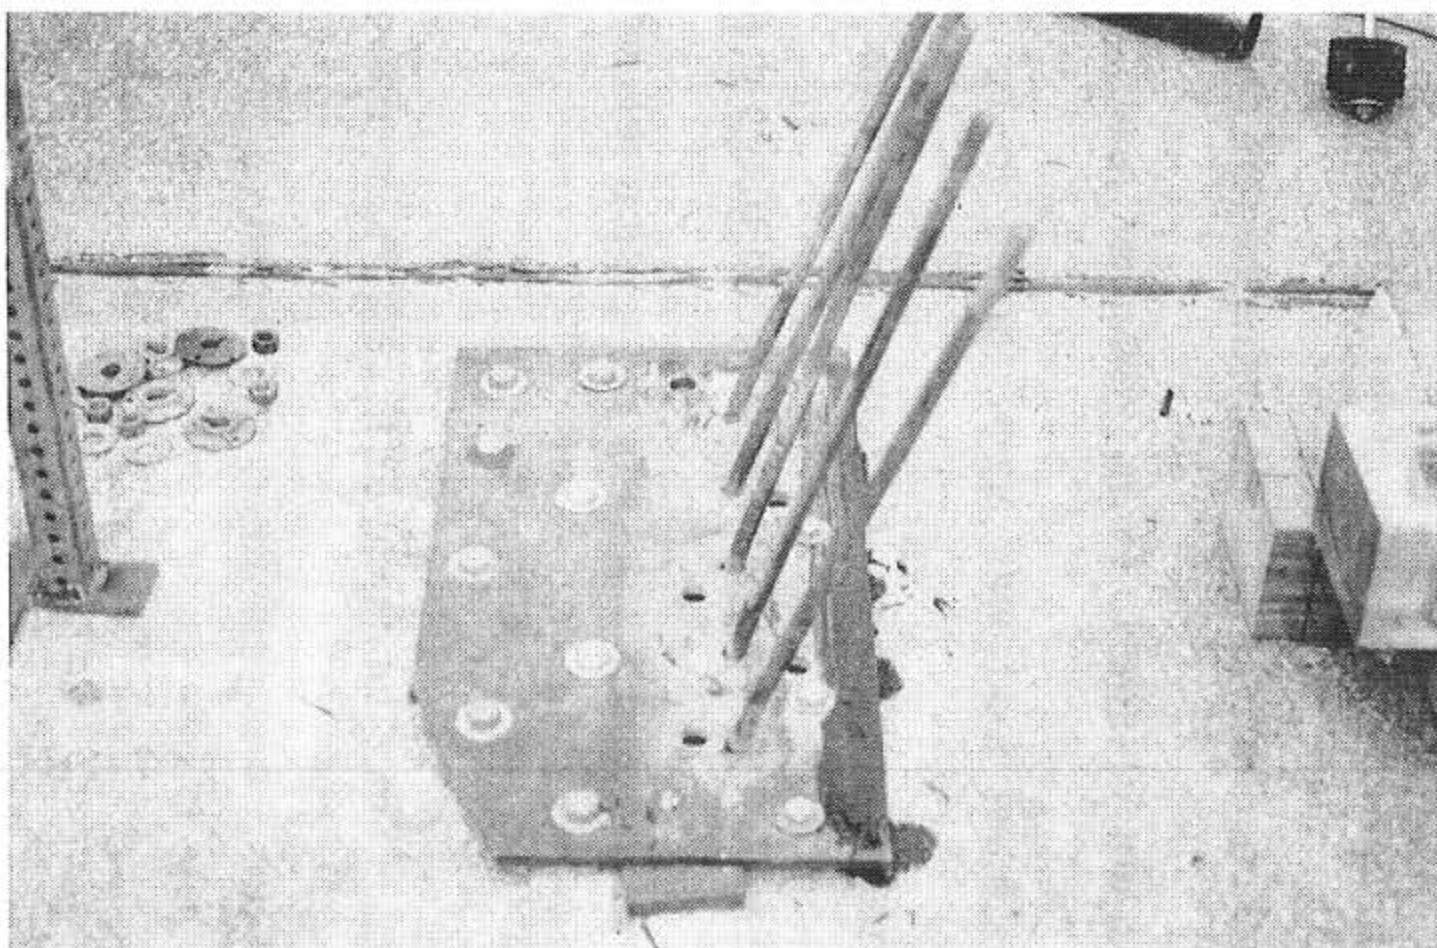
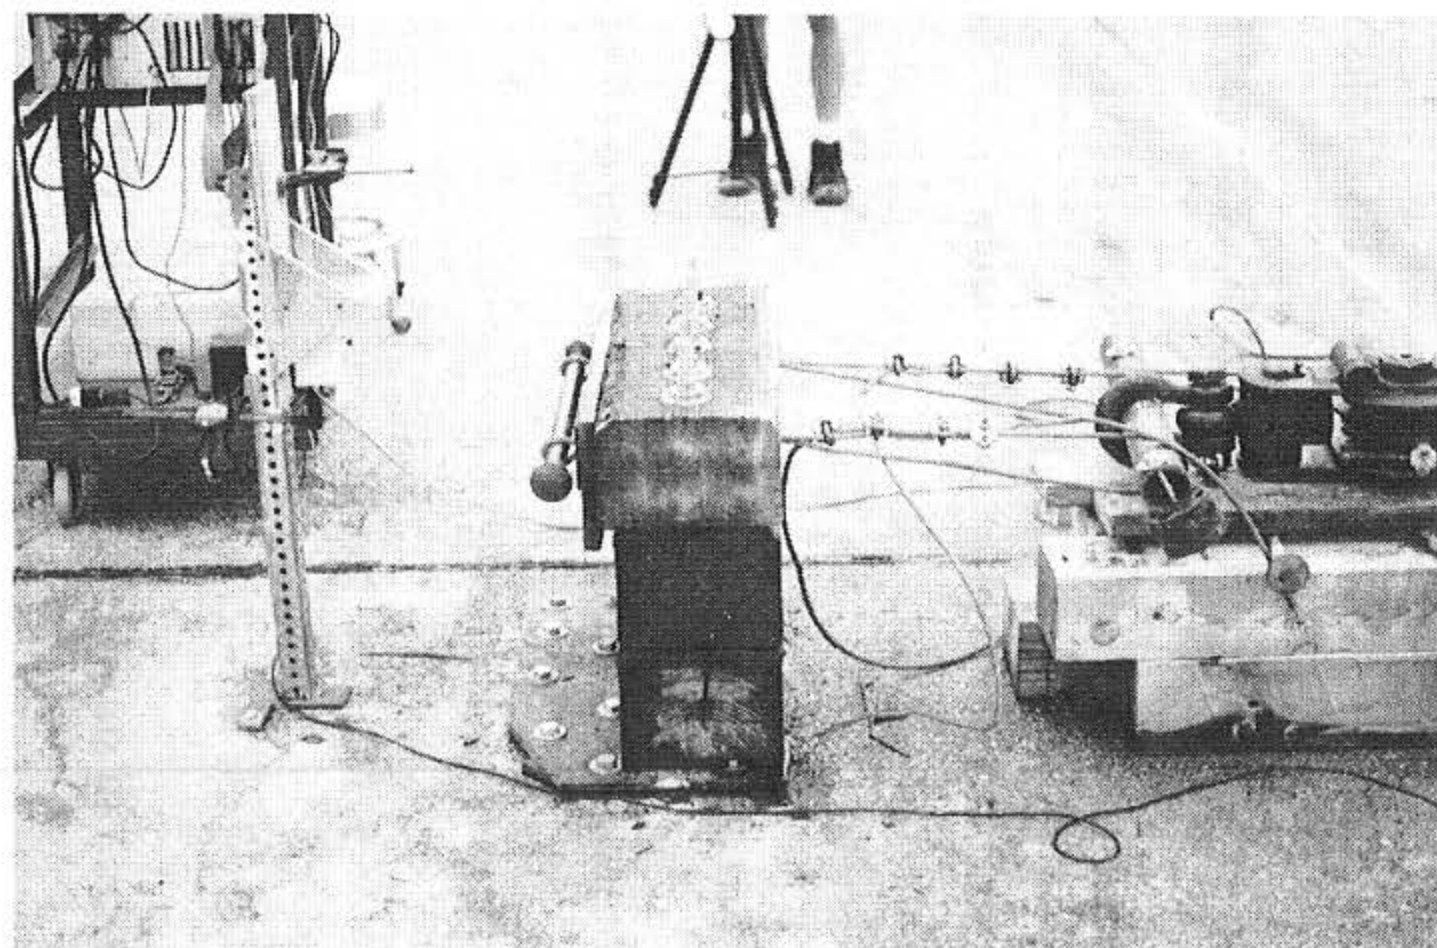
Figure 3. Static Testing Apparatus

The static testing apparatus, as shown in Figure 3, was configured to simulate the bolted connection between the glulam rail, scupper blocks, and bridge deck. A ½-in. (13-mm) thick steel plate was bolted to a concrete foundation and was positioned above the concrete foundation to provide adequate clearance for the heads of the vertical bolts. The scupper blocks and glulam rail were then placed on the vertical bolts using shear plates on each timber surface, except on the top of the glulam rail where malleable iron washers and nuts were used instead.

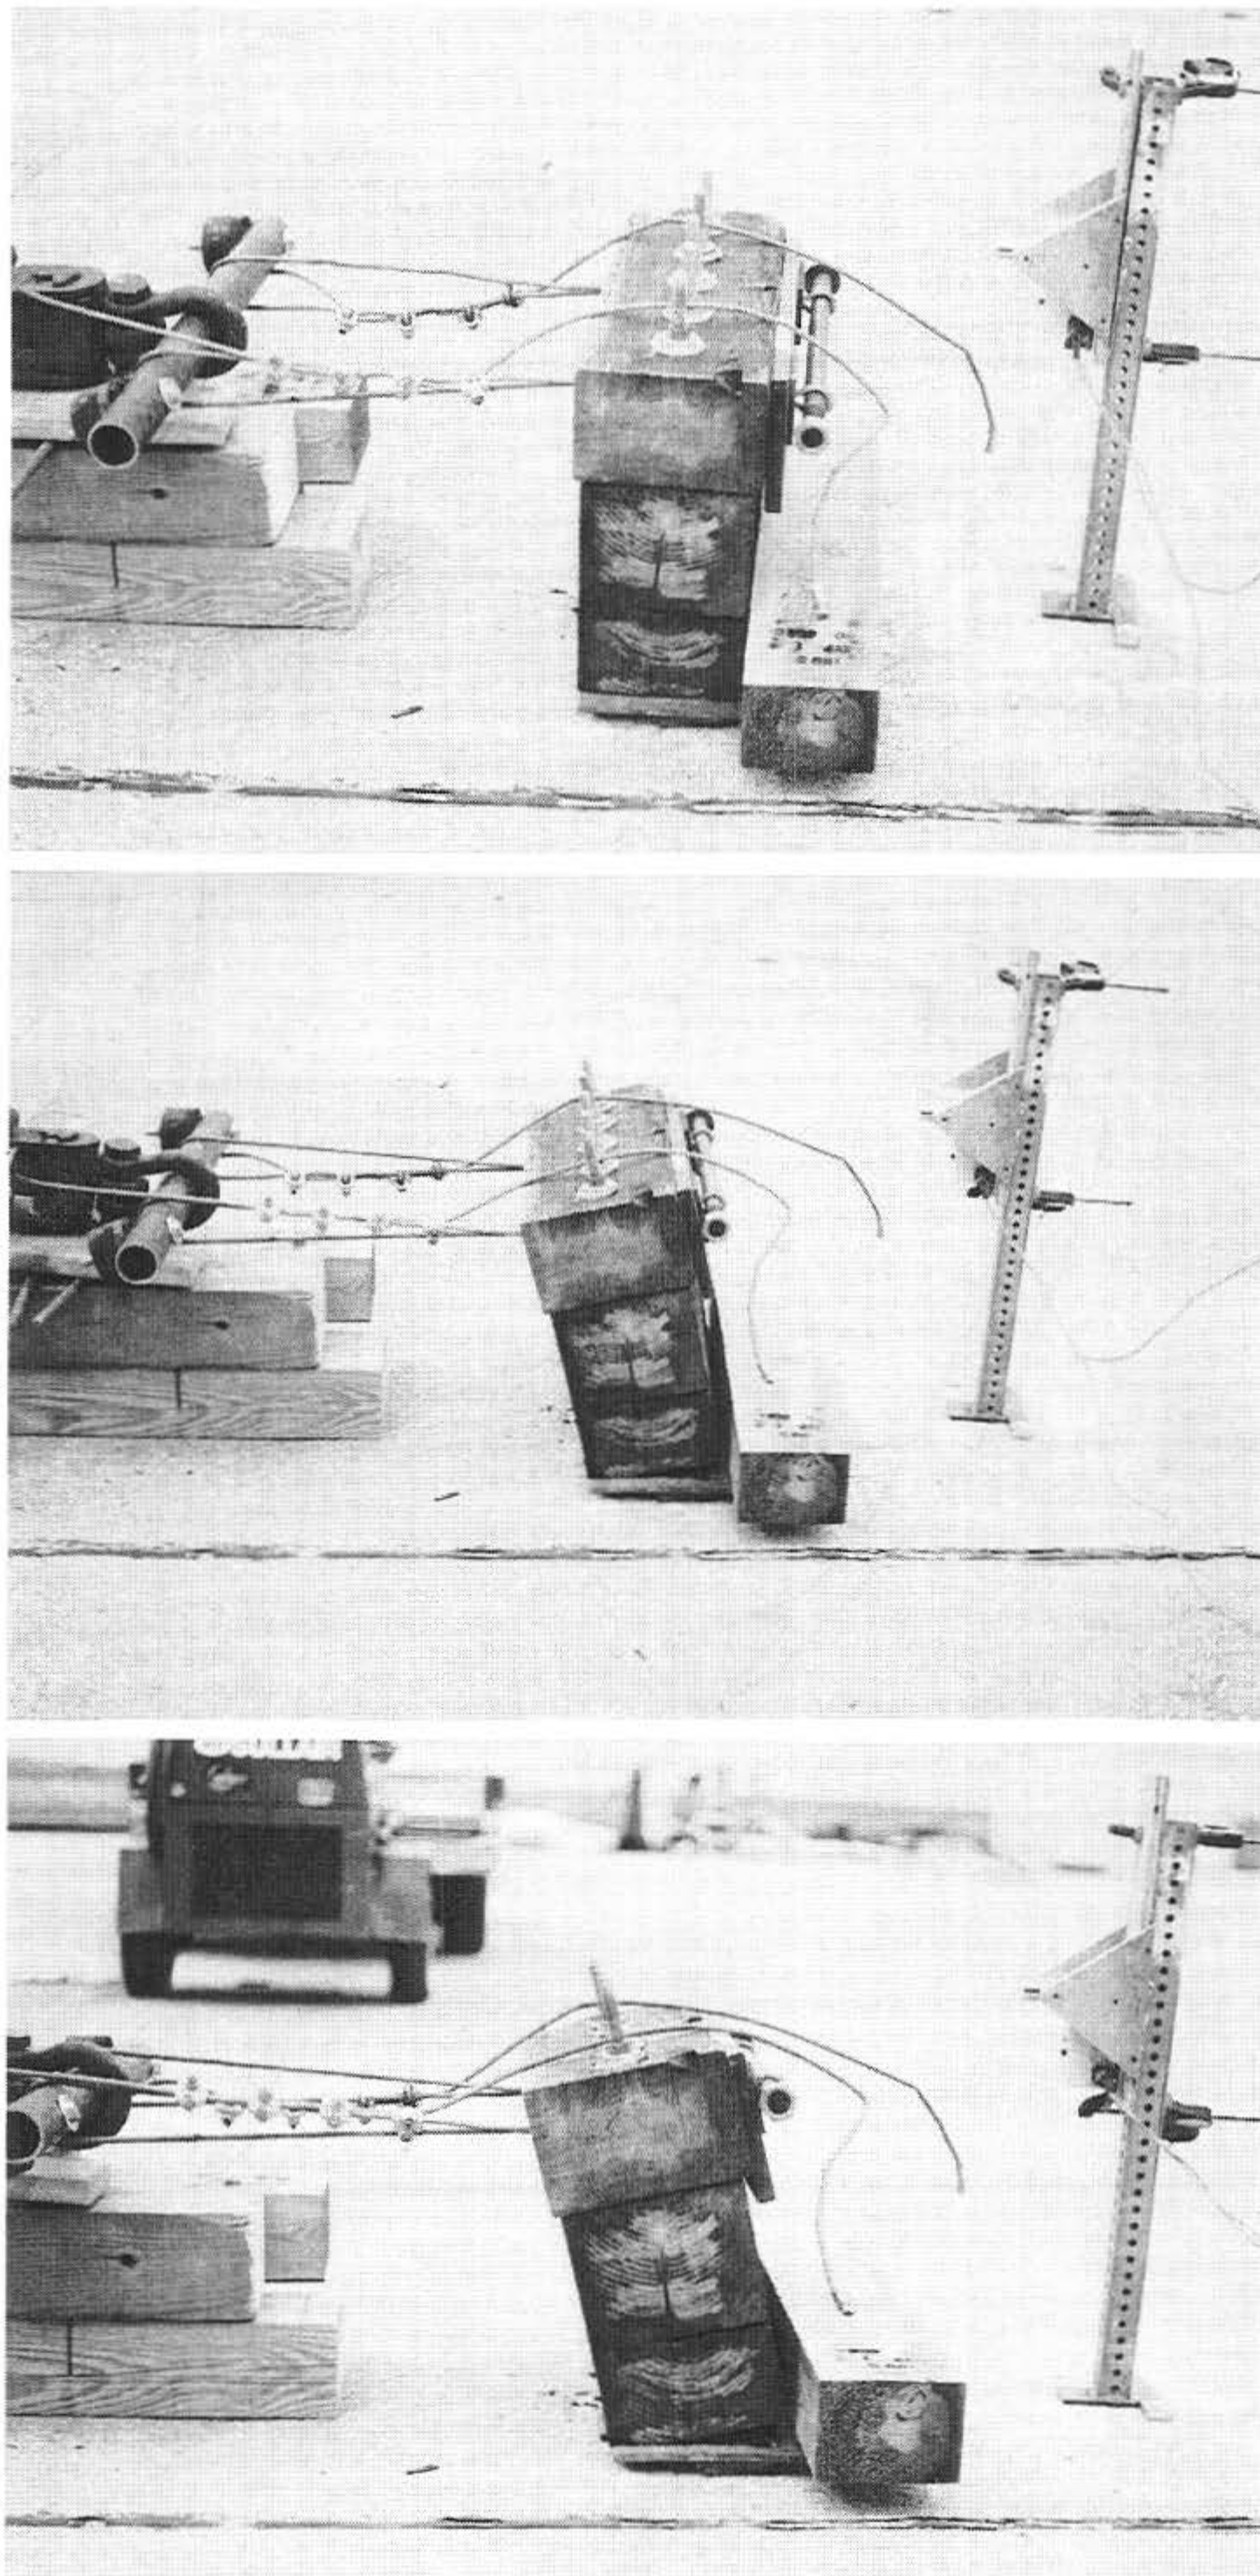
Figure 4. Test No. 1 Configuration and Deflected Position

Test no. 1 was conducted on a configuration consisting of a 6¾-in. (171-mm) high glulam rail supported by two scupper blocks - one 7½-in. (190-mm) high and one 5½-in. (140-

mm) high., as shown in Figure 4. Five bolts were placed along the 28-in. (711-mm) long blocks using shear plates at all available locations. Photographs of the deflected configuration are also shown in Figure 4. The force-deflection curve for test no. 1 is provided in Figure 5. The maximum load applied to the system was 15,400 lbs (68,500 N) which corresponded with a rail deflection of 4.9 in. (124 mm), as measured at the top of the glulam rail. Significant rail deformations occurred due to rotations caused by both the compaction of wood fibers in the compression regions and the formation of gaps between timber blocks in the tension regions, as shown in Figure 4.

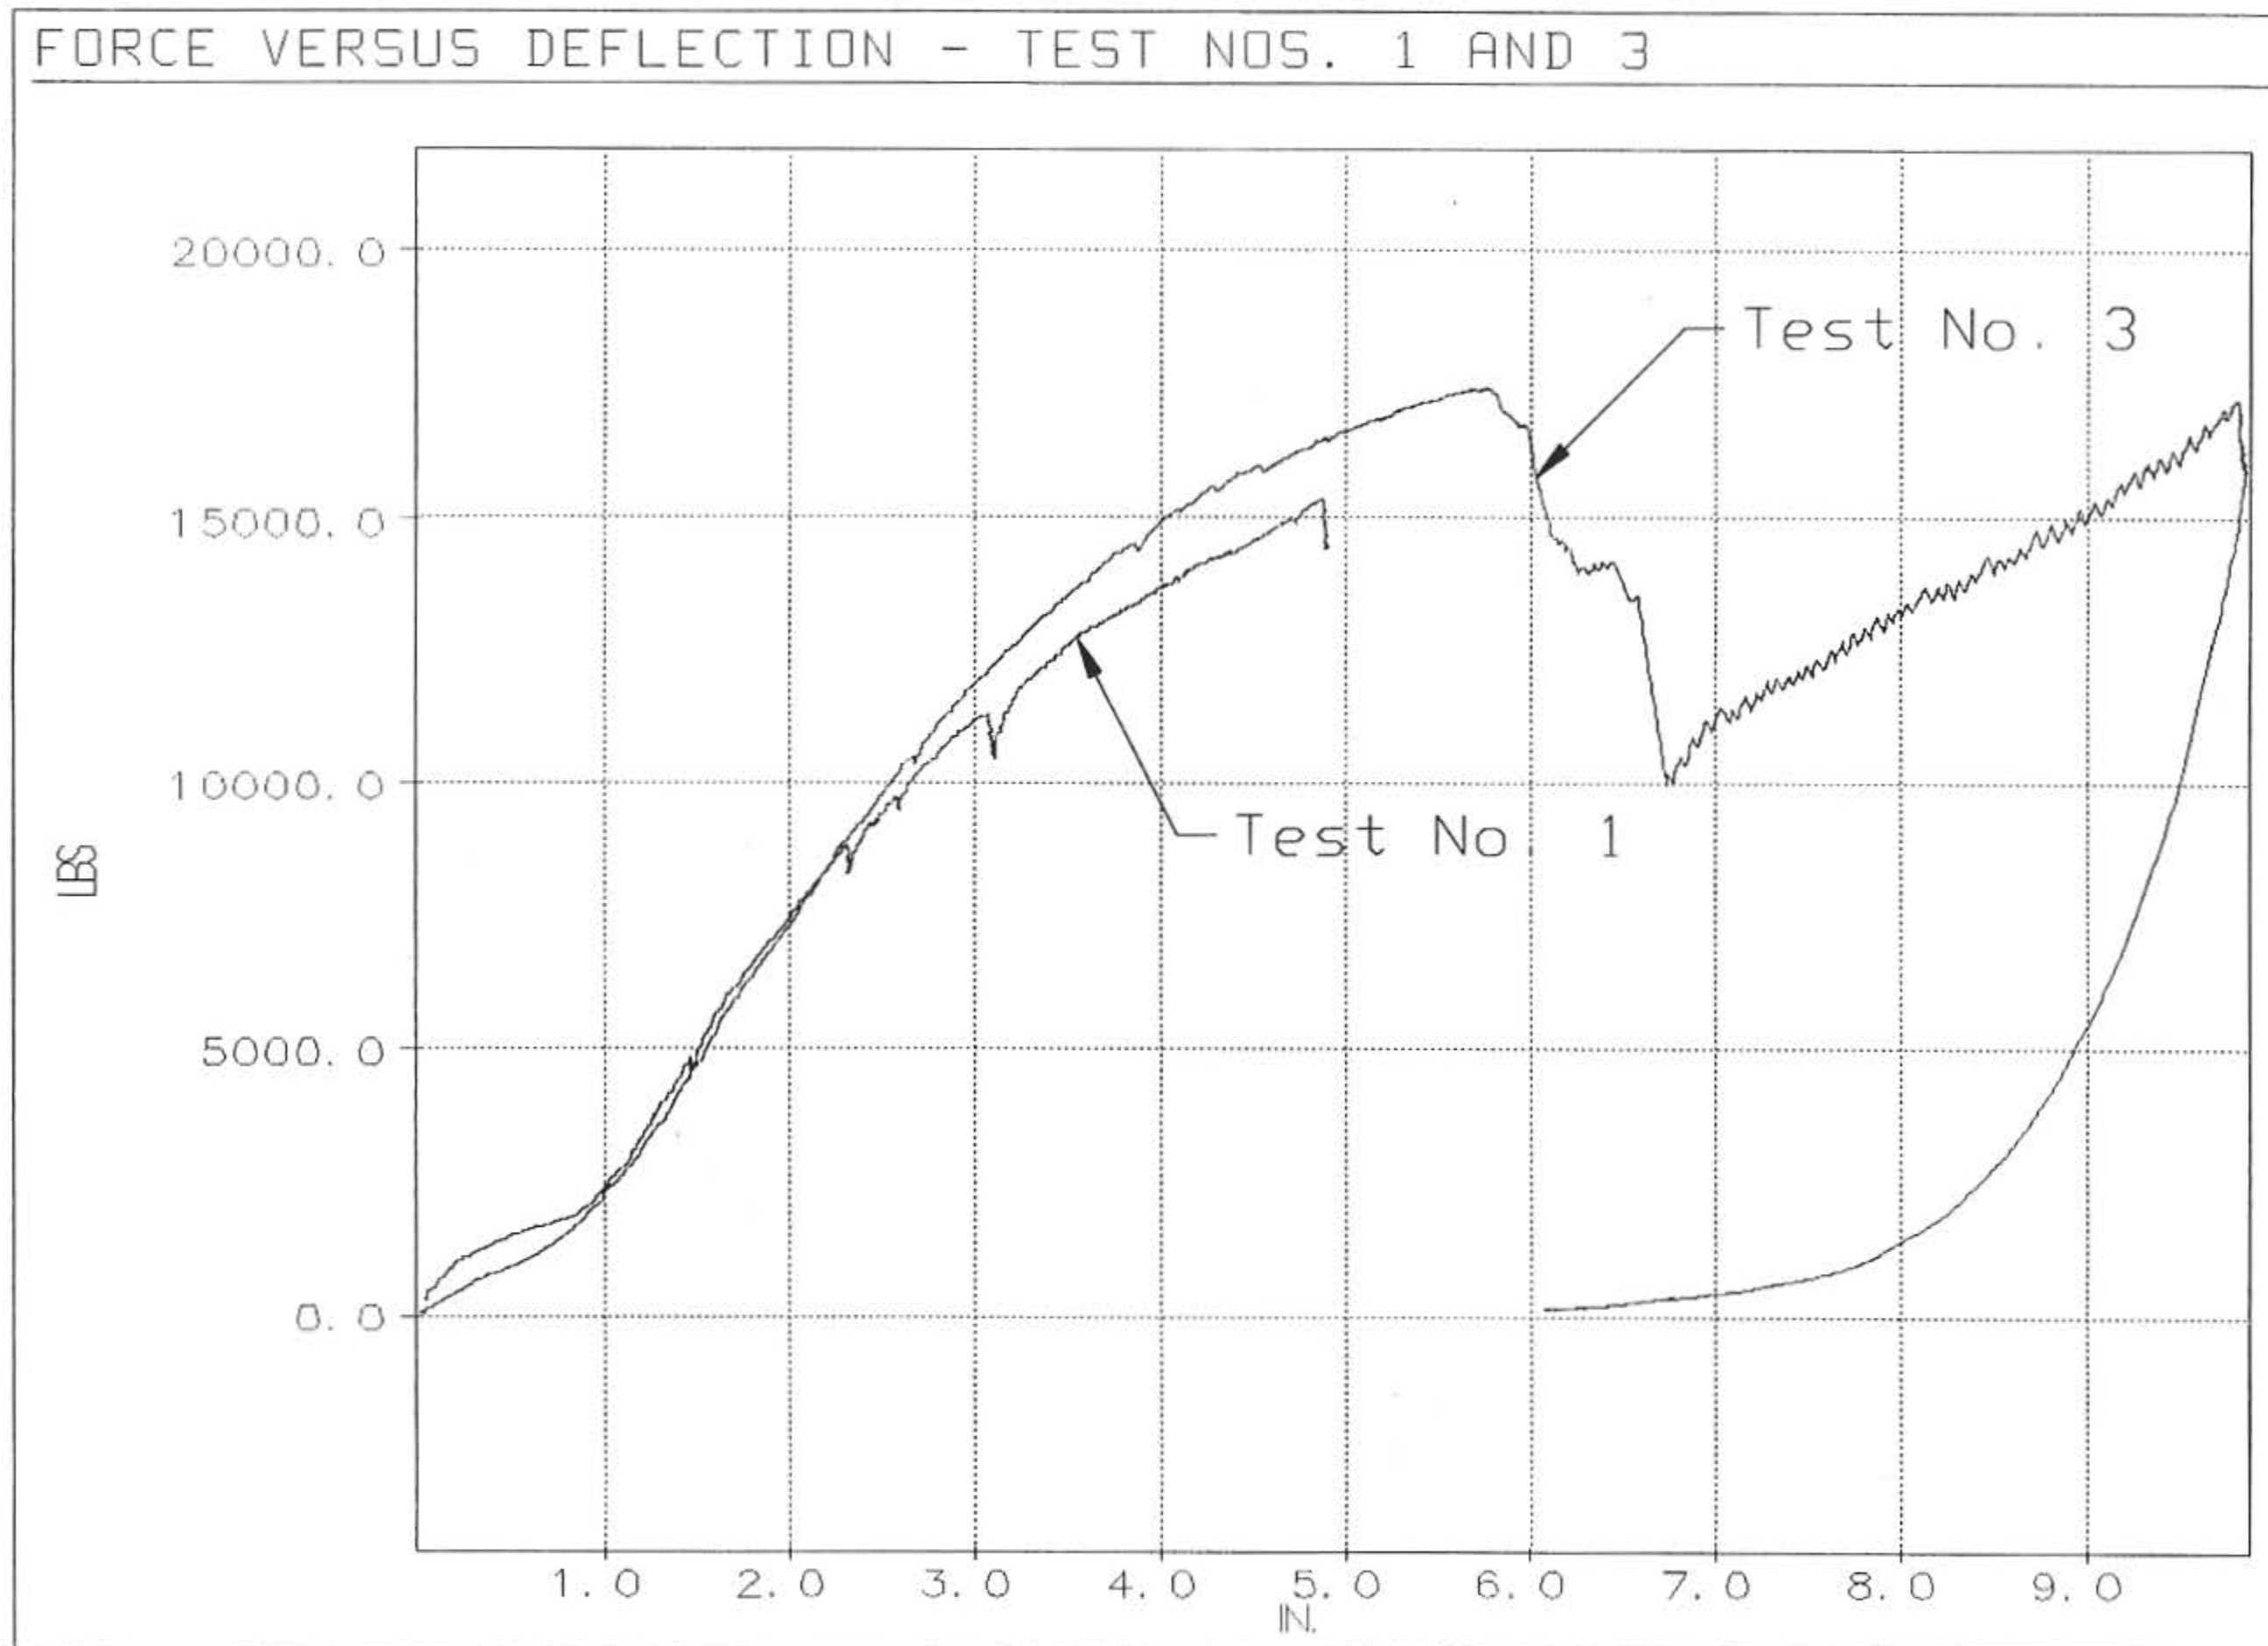
Figure 5. Force-Deflection Curves for Test Nos. 1 and 3

Figure 7. Photographs of the deflected position are also shown in Figure 7. The force-deflection curve for test no. 3 is provided in Figure 5. The maximum load applied to the system was 17,400 lbs (77,400 N) which corresponded with a rail deflection of 5.7 in. (145 mm). Test no. 3 was continued until the rail had deflected approximately 10 in. (254 mm) or half of the stroke of the 20-in. (508-mm) hydraulic ram. During that time, the load dropped off to approximately 10,100 lbs (44,900 N) at a rail deflection of approximately 6.8 in. (173 mm). Subsequently, the load increased linearly to 17,200 lbs (76,500 N) at a rail deflection of 9.8 in. (249 mm), indicating that the increase in capacity is due to the bolts being placed in tension. The load was then released, resulting in a permanent set of approximately 6.1 in. (155 mm). The rail deformations occurred due to rotations caused by the compaction of wood fibers in the compression regions, the formation of gaps between timber blocks in the tension regions, and a combination of tension and shear failures of the lower scupper block propagating from the bolt line, as shown in Figure 7.

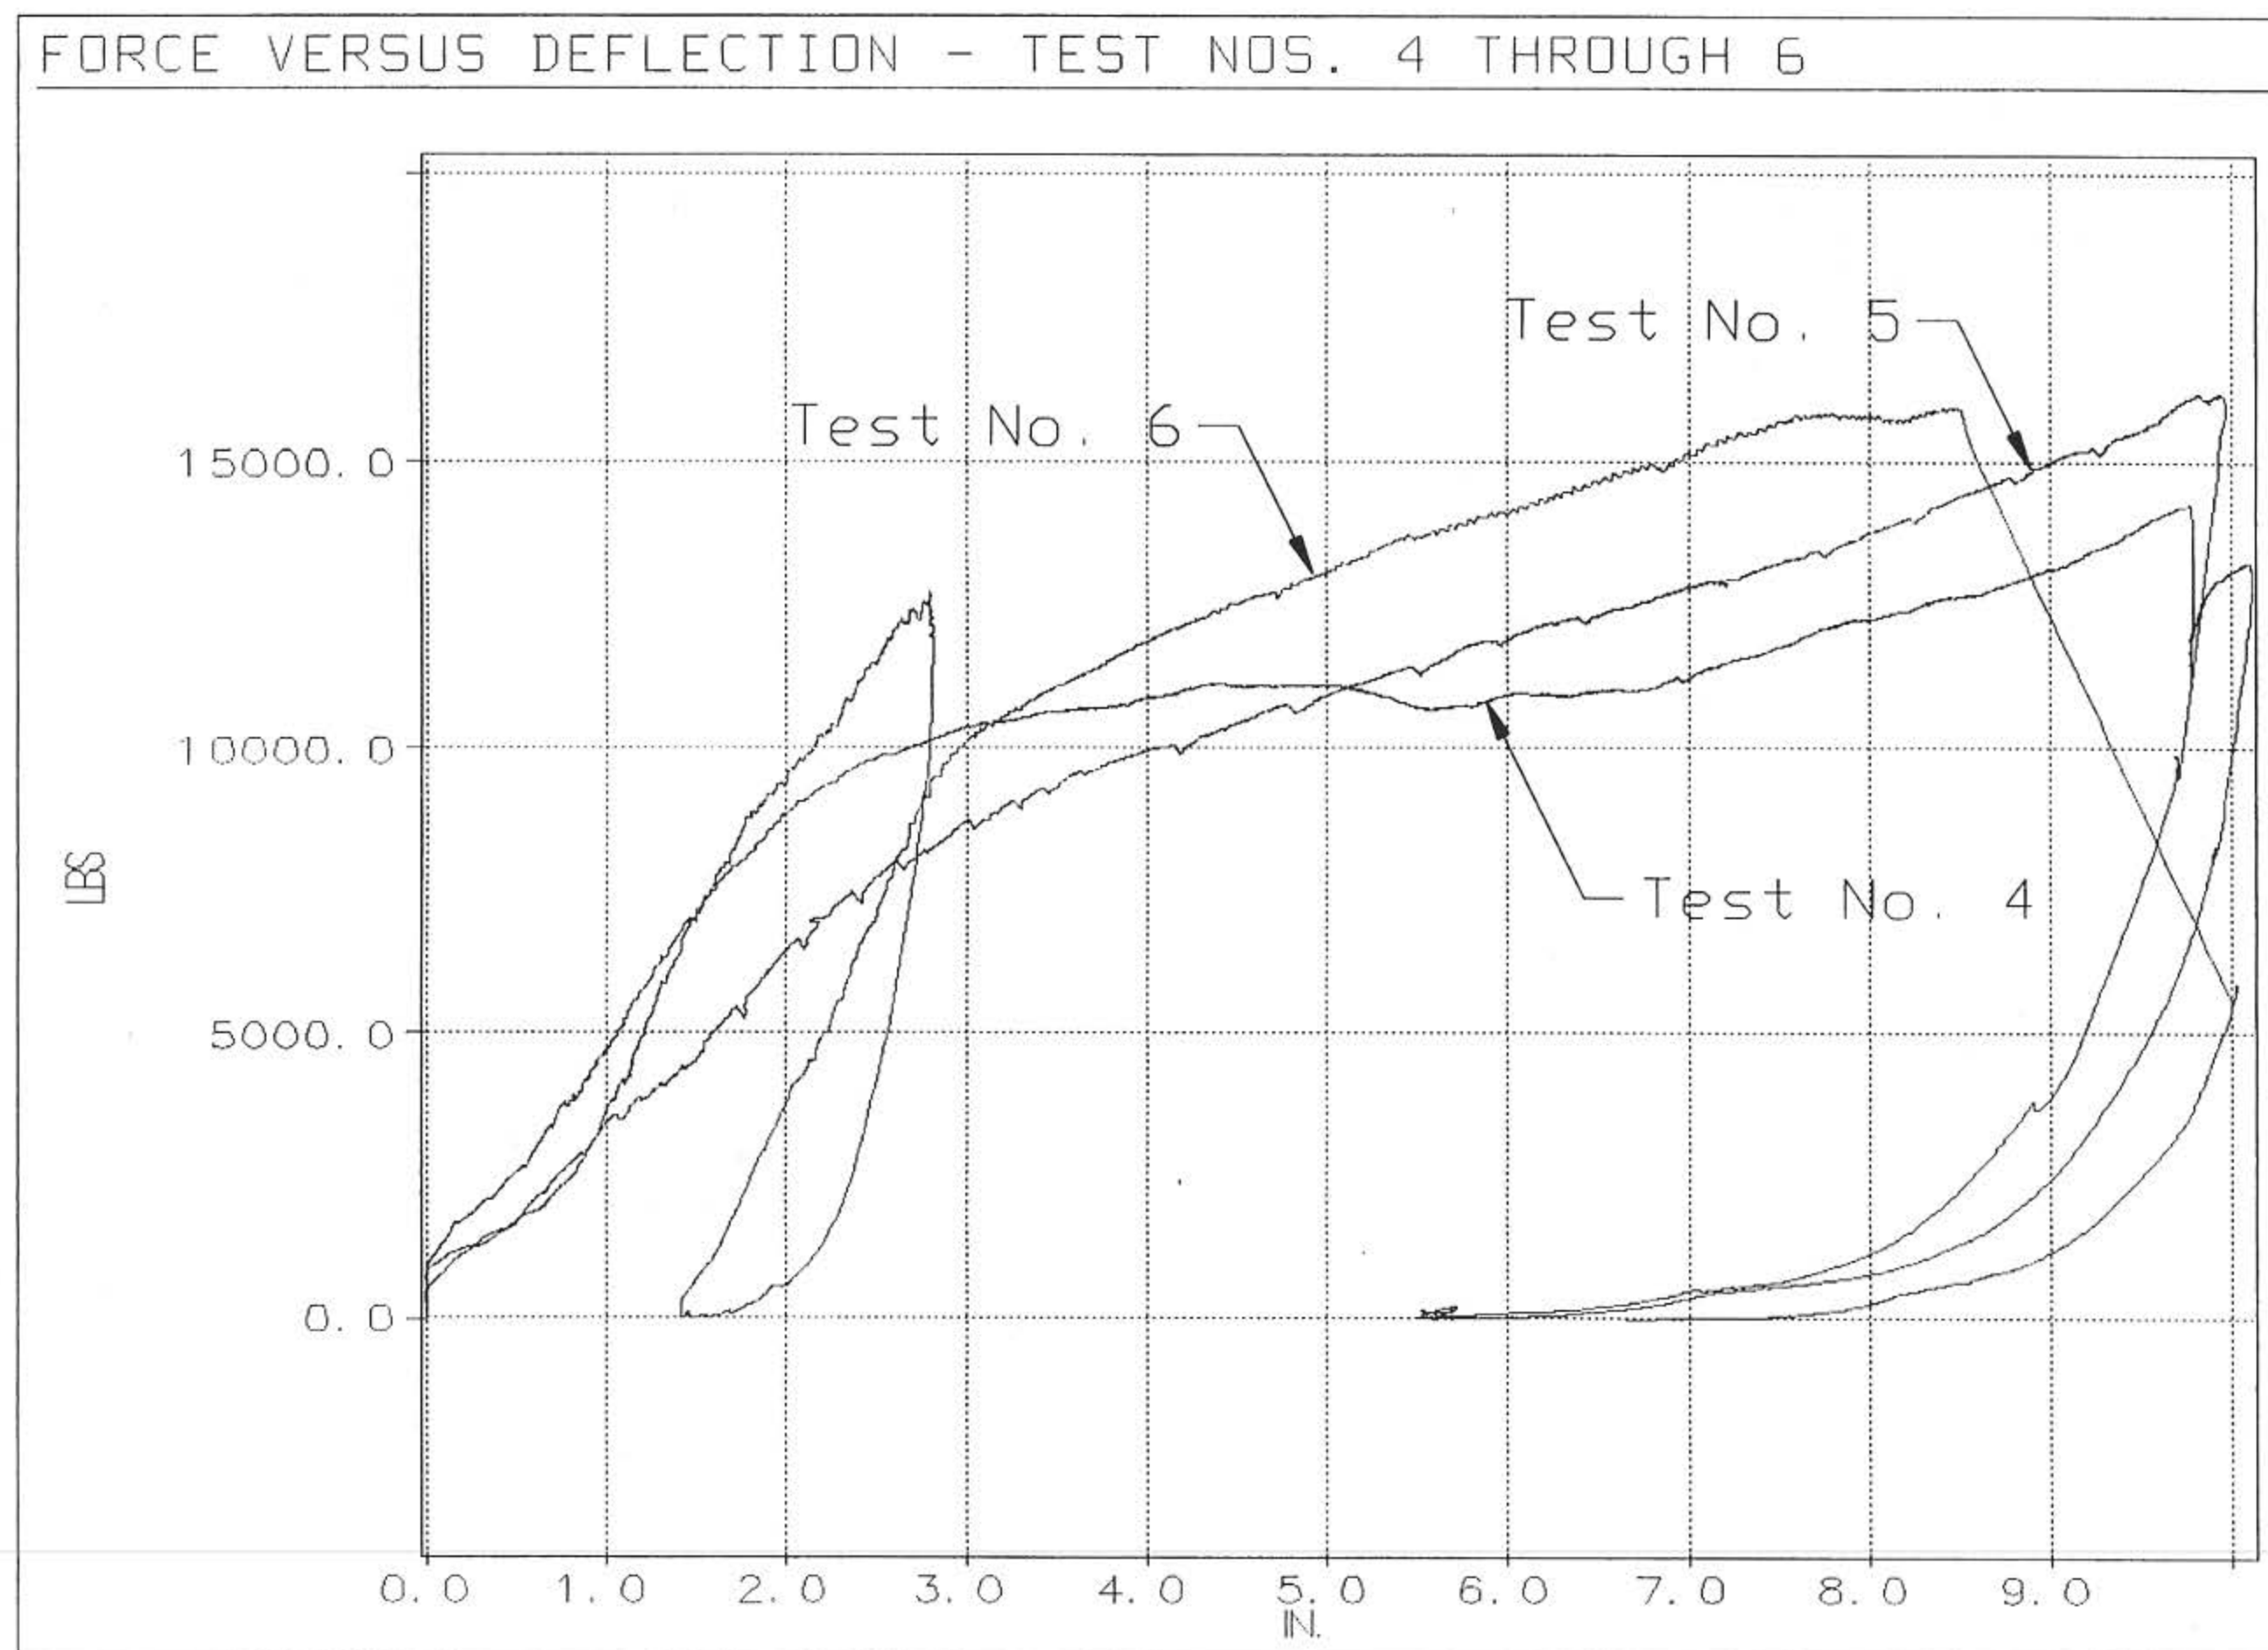
Figure 9. Force-Deflection Curves for Test Nos. 4, 5, and 6

test no. 4, except that no shear plates were used at any timber surface. Photographs of the deflected configuration are also shown in Figure 10. The force-deflection curve for test no. 5 is provided in Figure 9. The maximum load applied to the system was 16,200 lbs (72,100 N) which corresponded with a rail deflection of 9.8 in. (249 mm), as measured at the top of the glulam rail. The load was then released, resulting in a permanent set of approximately 5.5 in. (140 mm). The rail deformations occurred due to rotations caused by the compaction of wood fibers in the compression regions, the formation of gaps between timber blocks in the tension regions, and a tension failure of the lower scupper block propagating from the bolt line, as shown in Figure 10.
