# **TL-1 Curb-Type Bridge Railing for Longitudinal Glulam Timber Decks Located on Low-Volume Roads**

## **MIDWEST ROADSIDE SAFETY FACILITY**

*MwRSF Research Report No. TRP-03-54-96*

April 1996

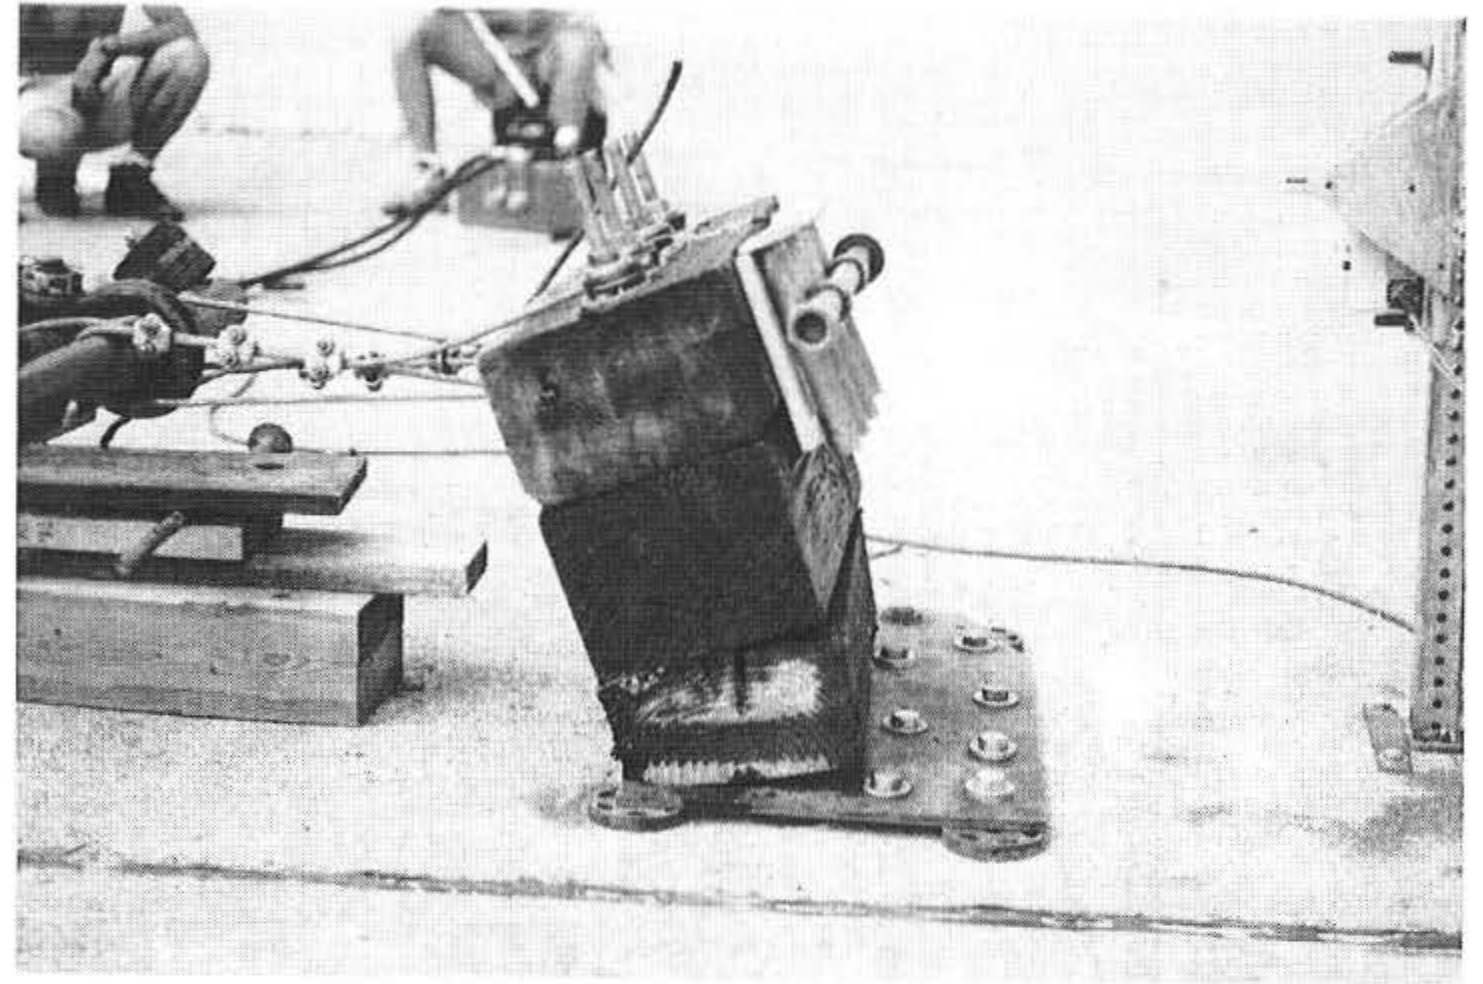
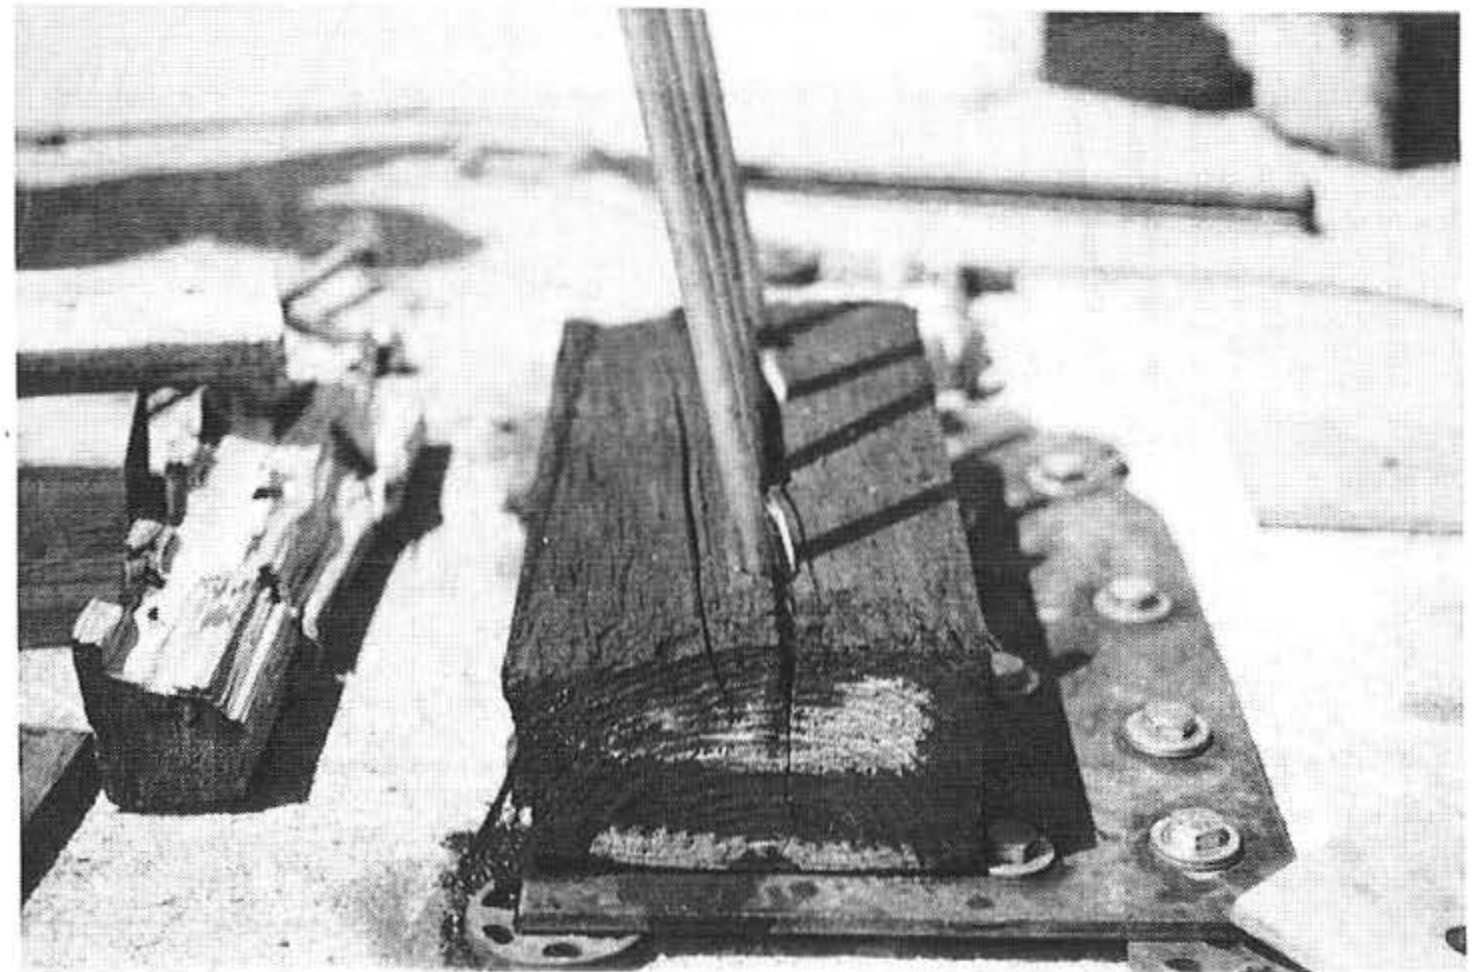
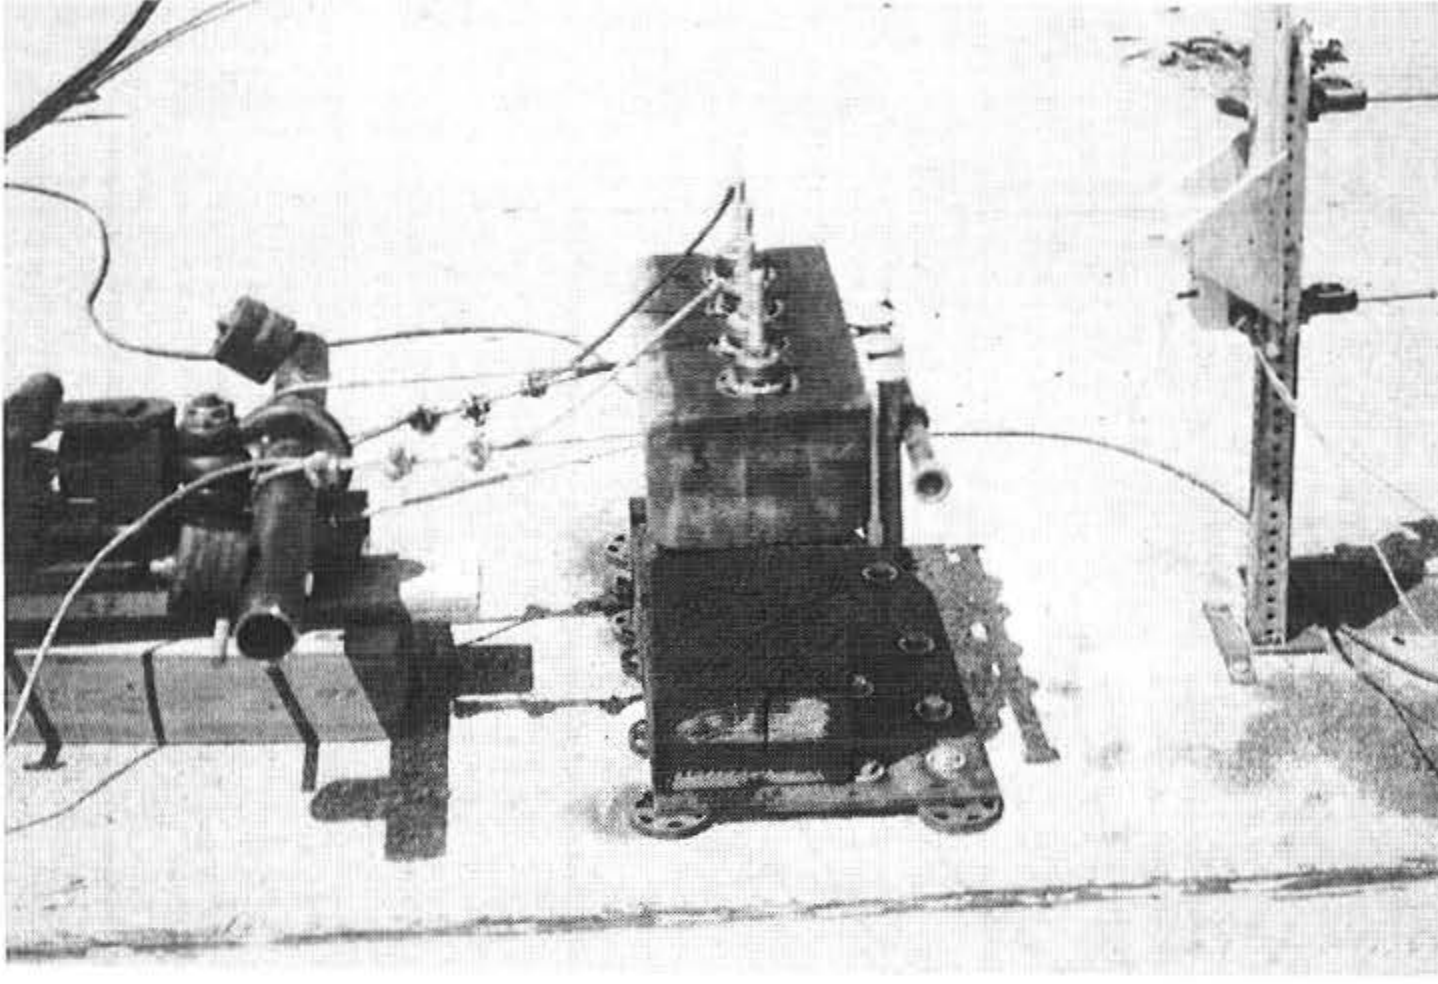
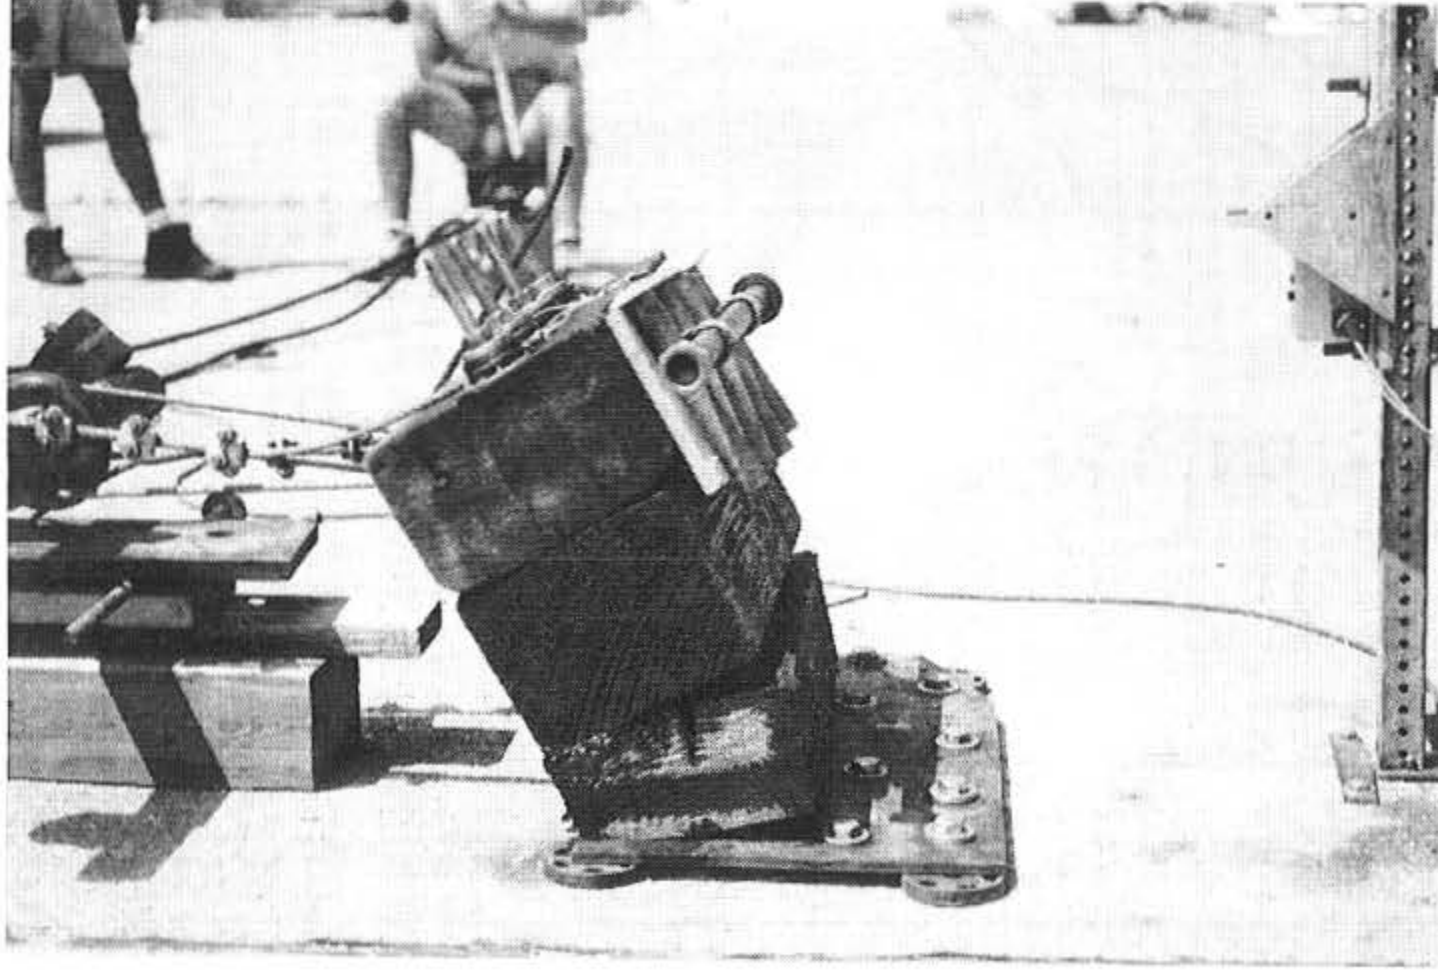
Figure 10. Test No. 5 Configuration and Deflected Position

Test no. 5, as shown in Figure 10, was conducted on the same configuration as used for

test no. 4, except that no shear plates were used at any timber surface. Photographs of the deflected configuration are also shown in Figure 10. The force-deflection curve for test no. 5 is provided in Figure 9. The maximum load applied to the system was 16,200 lbs (72,100 N) which corresponded with a rail deflection of 9.8 in. (249 mm), as measured at the top of the glulam rail. The load was then released, resulting in a permanent set of approximately 5.5 in. (140 mm). The rail deformations occurred due to rotations caused by the compaction of wood fibers in the compression regions, the formation of gaps between timber blocks in the tension regions, and a tension failure of the lower scupper block propagating from the bolt line, as shown in Figure 10.

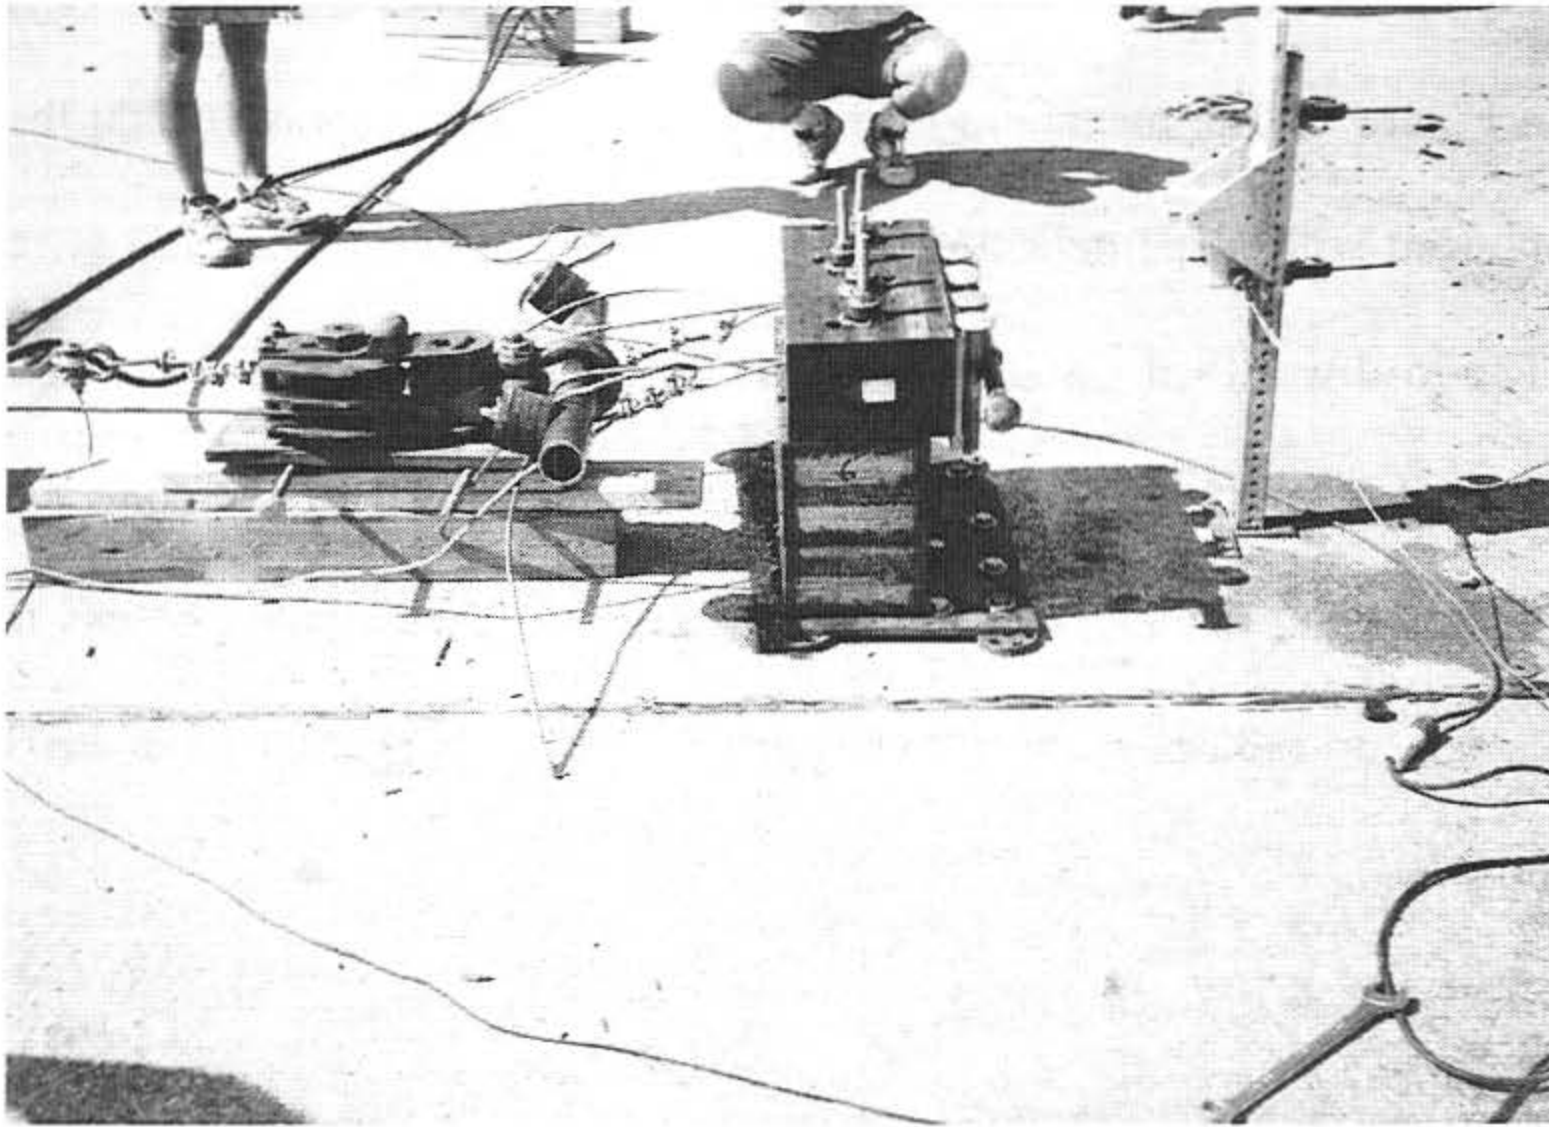
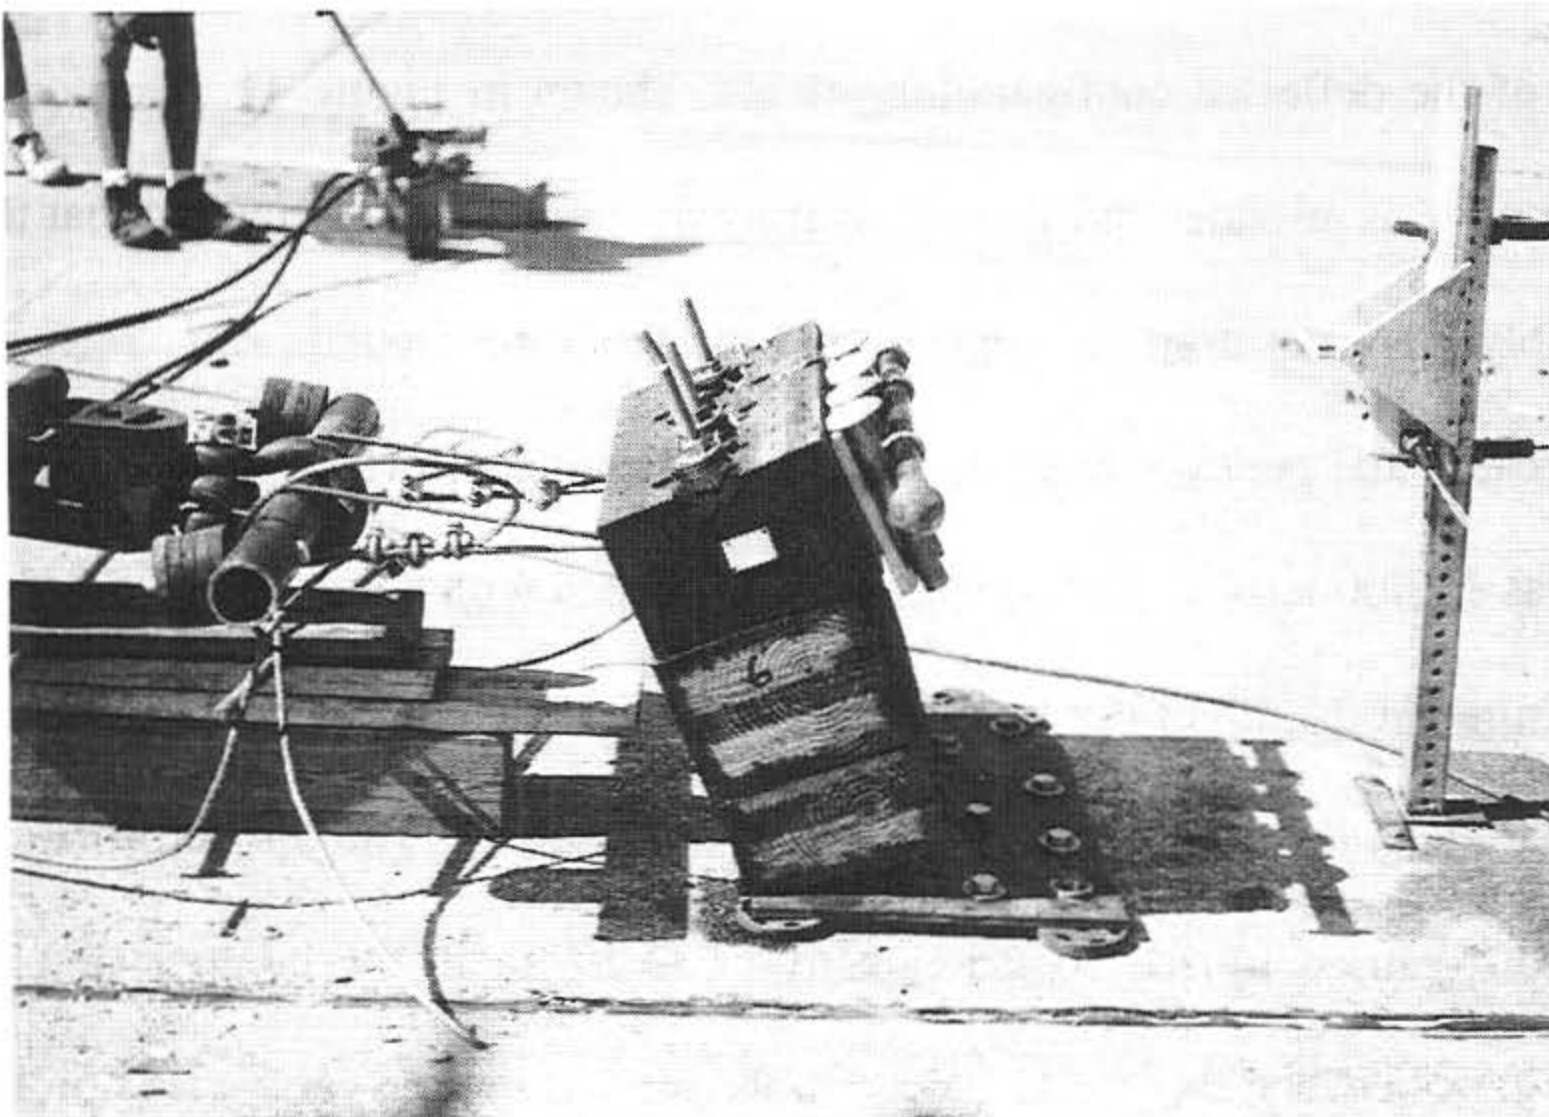
Figure 11. Test No. 6 Configuration and Deflected Position

Test no. 6, as shown in Figure 11, was conducted on the same configuration as used for test no. 5, except that shear plates were used on the bottom surface of the lower scupper block. Photographs of the deflected configuration are also shown in Figure 11. The force-deflection curve for test no. 6 is provided in Figure 9. During the test, it was discovered that the cable and pulley assembly were not properly aligned, and the test was stopped. After releasing the load to repair the cable and pulley assembly, the test was continued. The maximum load applied to the system was 15,900 lbs (70,700 N) which corresponded with a rail deflection of 8.5 in. (216 mm), as measured at the top of the glulam rail. It is noted that the maximum load was measured at the time that the glulam rail fractured, as shown in Figure 11. The rail deformations occurred due to rotations caused by the compaction of wood fibers in the compression regions, the formation of gaps between the timber blocks in the tension regions, and a tension failure of the lower scupper block propagating from the bolt line, as shown in Figure 11.

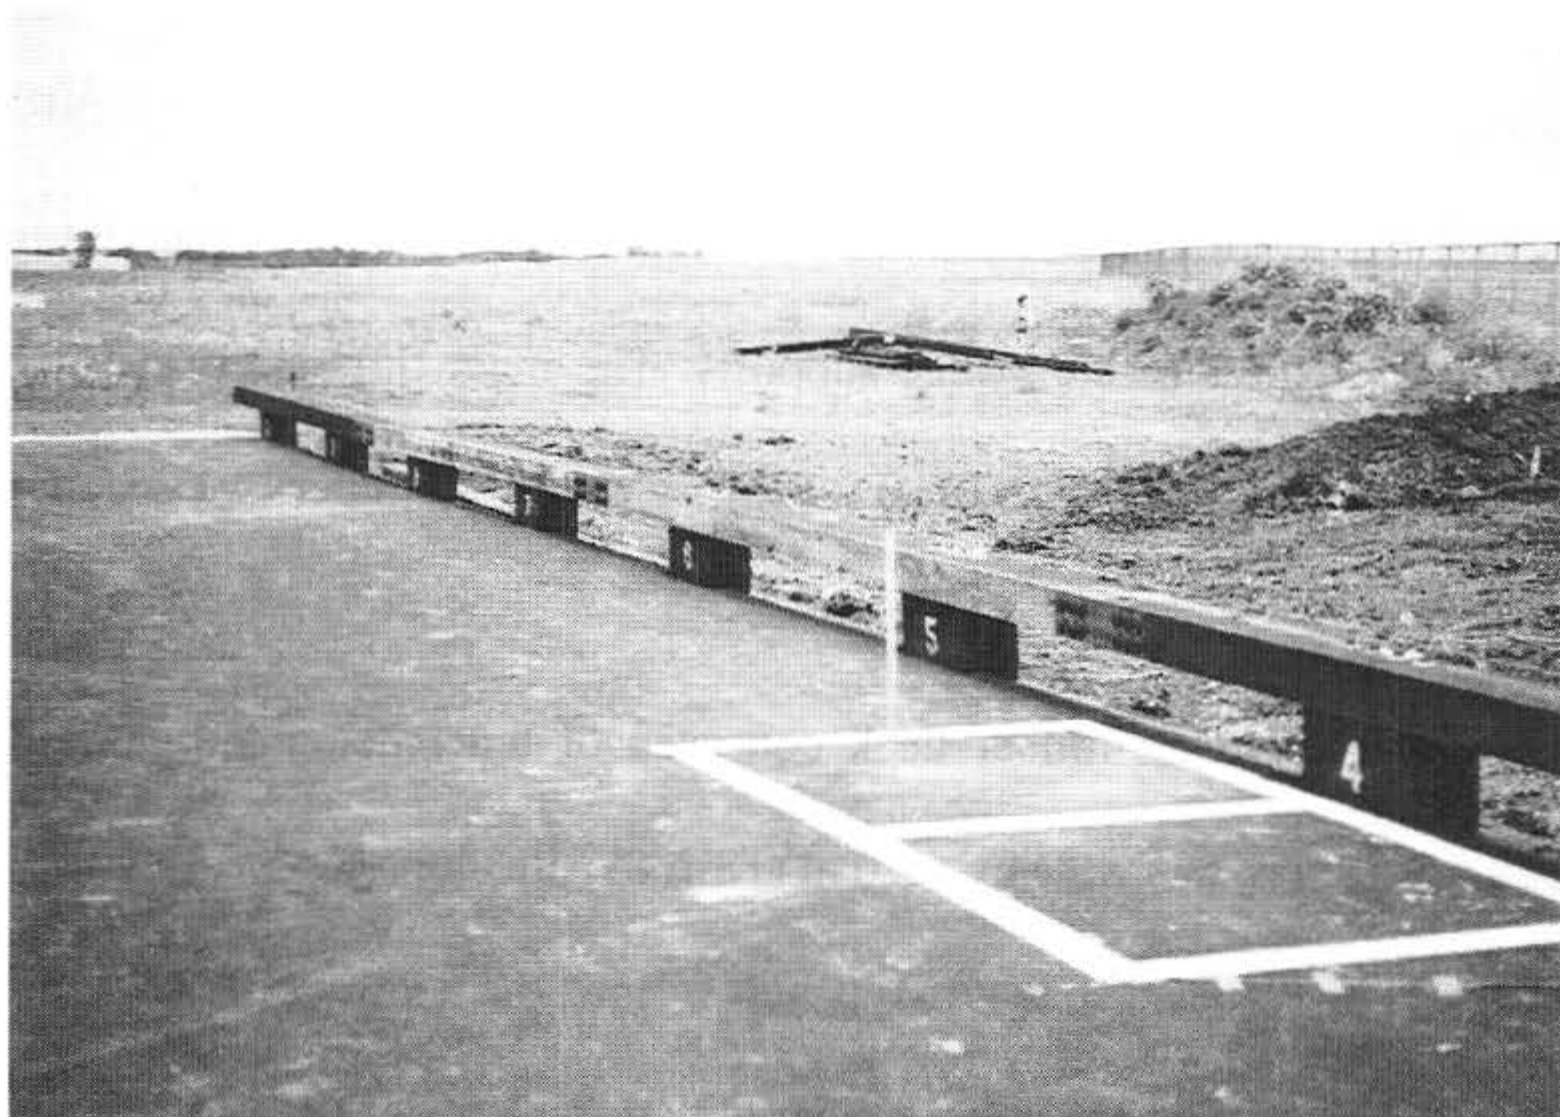
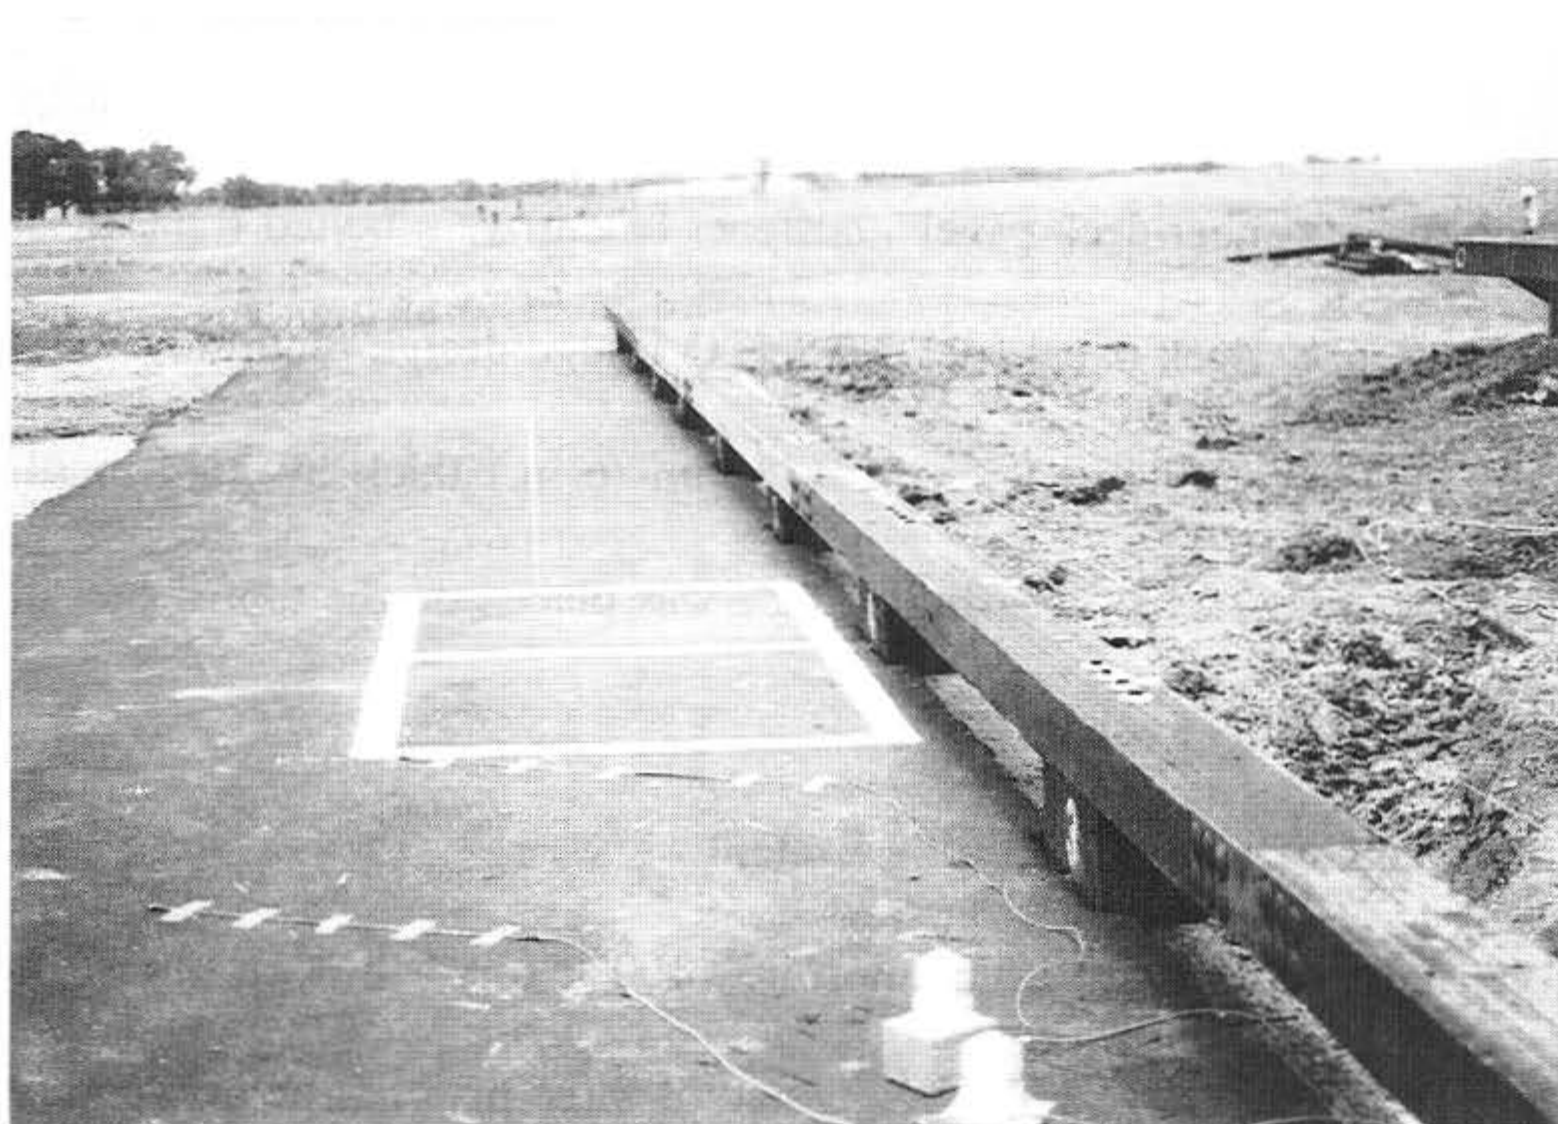
Figure 12. Curb-Type Bridge Railing System

The total length of the test installation was 100 ft (30.48 m), as shown in Figures 12 through 14. The curb-type bridge railing consisted of three major structural components: (1) a longitudinal glulam timber rail; (2) sawn lumber scupper blocks; and (3) steel splice plates.

The bridge railing system incorporated five 19-ft 11½-in. (6083 mm) long timber glulam rail sections supported by ten timber scupper blocks spaced on 10-ft (3048-mm) centers. The glulam rail was fabricated from Combination No. 2 West Coast Douglas Fir and treated in the same manner as the timber deck. The glulam rail was 6¾-in. (171-mm) deep by 10½-in. (267-mm) wide. The top mounting height of the glulam rail was 17¾ in. (451-mm) above the asphalt wearing surface.

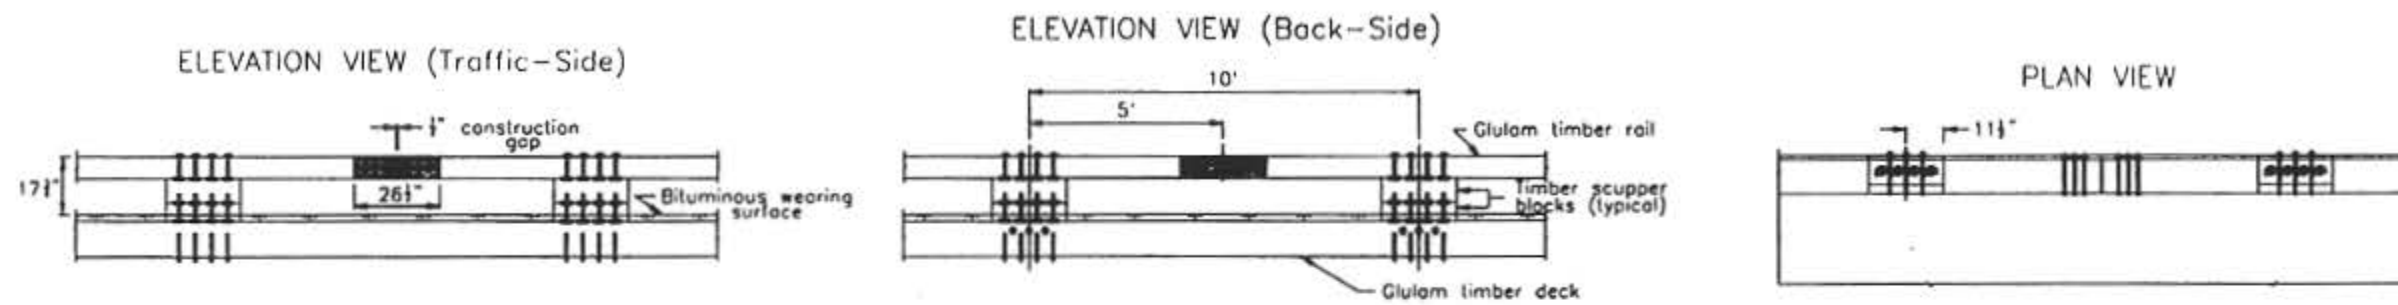
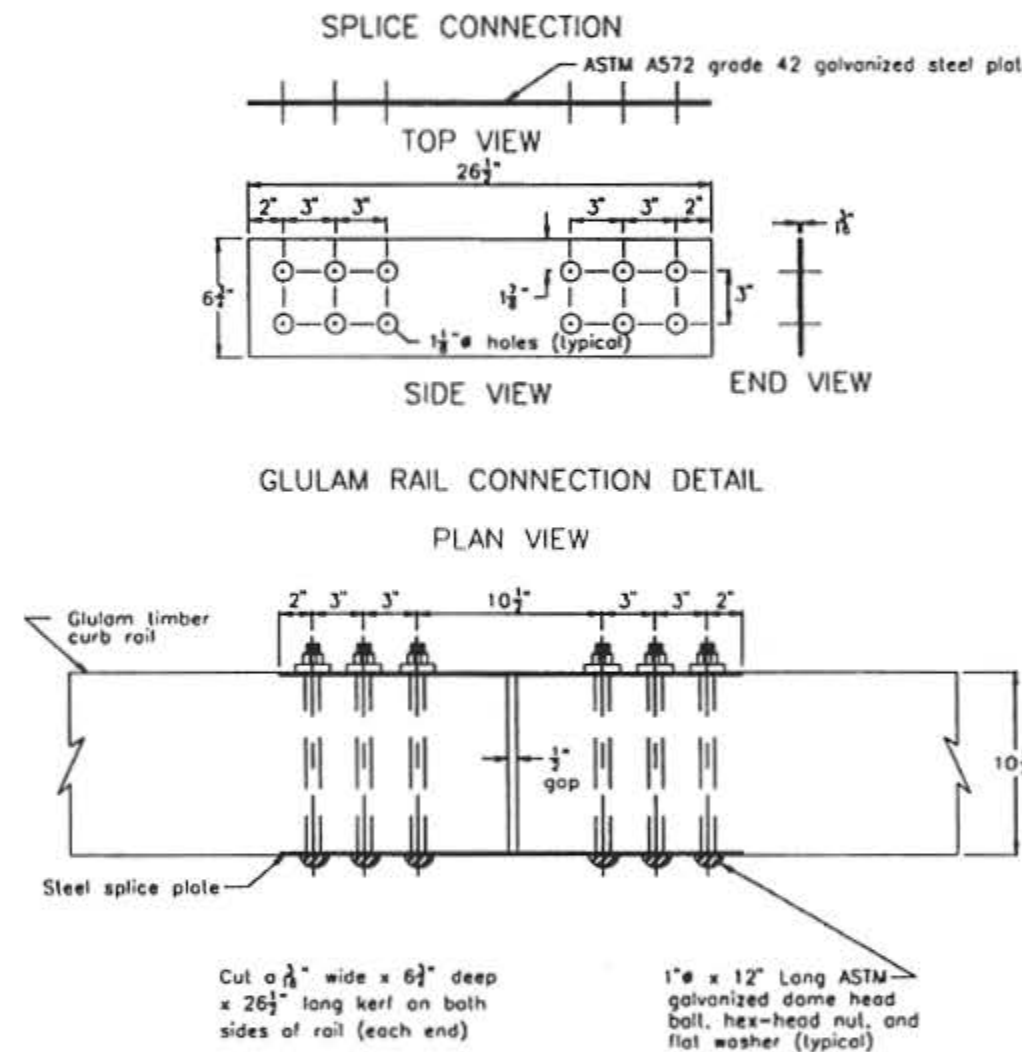
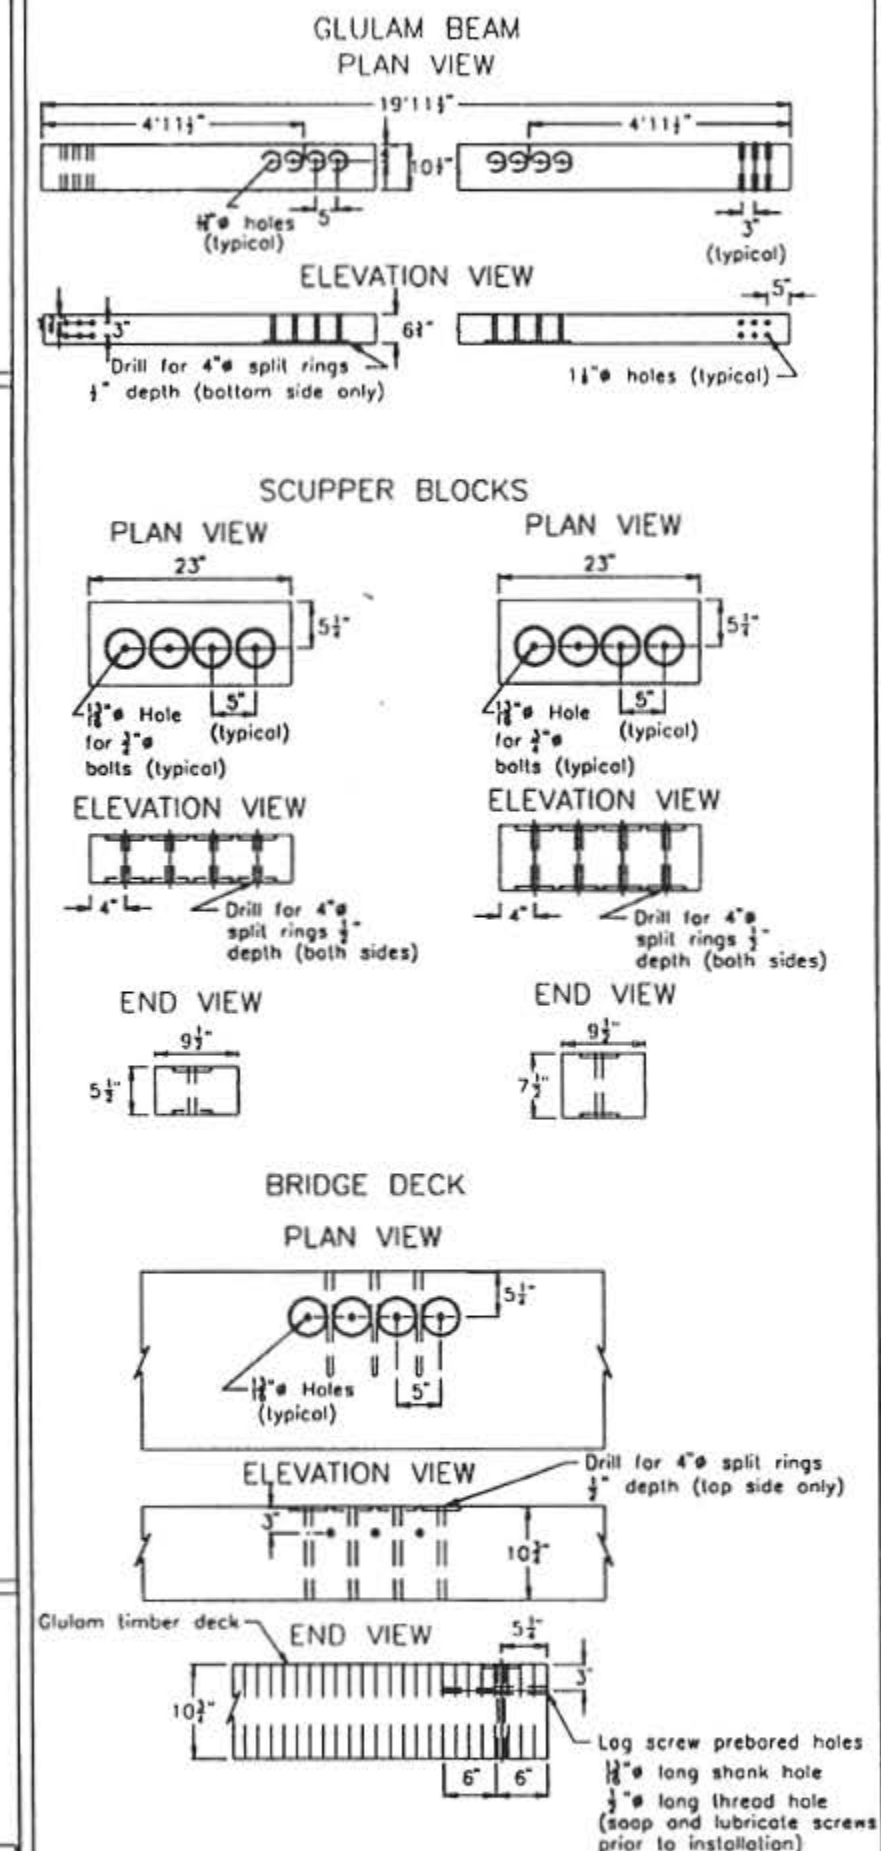
Figure 15. Bridge Rail Design Details (Design No. 2)

Detailed drawings of the bridge rail components are provided in Figure 15.

NCHRP 350 Test Level 1 (TL-1)  
Timber Curb - Type  
Bridge Railing System for  
Low - Volume Roads

The glulam rail sections were spliced together with 3/16-in. (4.8-mm) thick ASTM A572 grade 42 steel plates on the traffic- and back-side faces of the glulam rail using twelve 1-in. (25-mm) diameter by 12-in. (305-mm) long ASTM A307 galvanized dome head bolts.

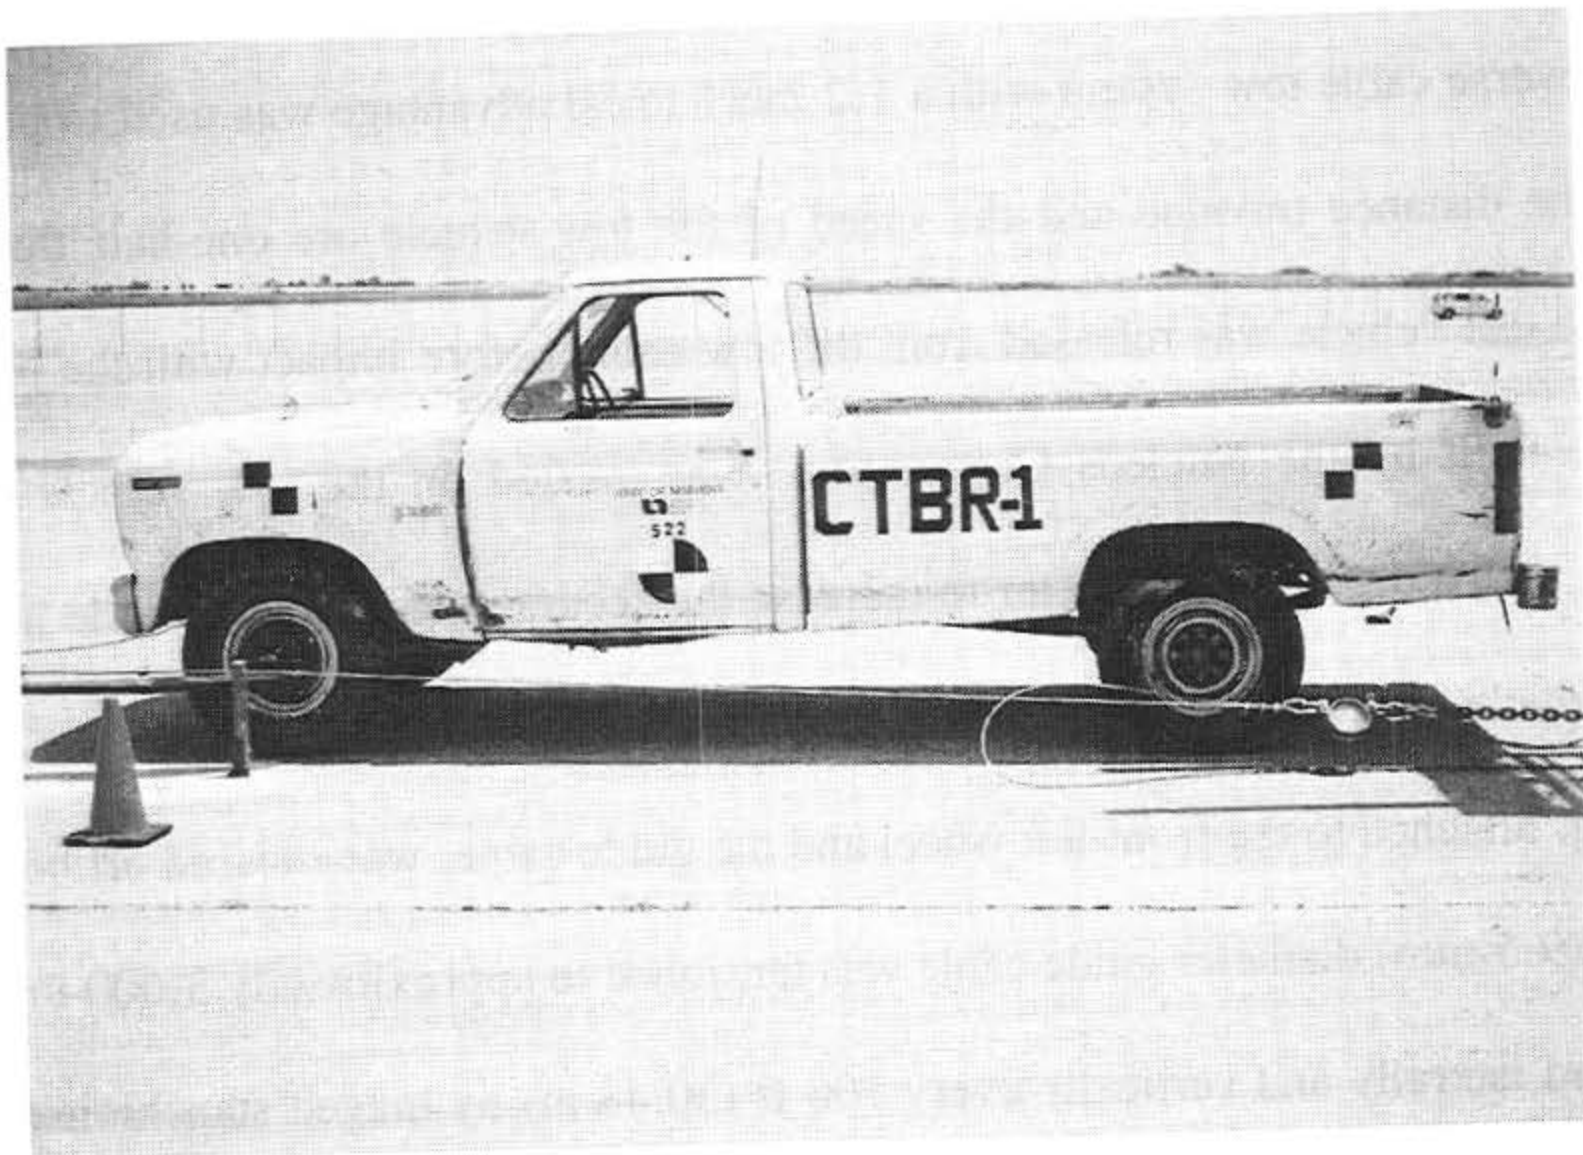
Figure 16. Test Vehicle, Test CTBR-1

A 1985 Ford F-250 ¾-ton pickup truck was used as the test vehicle. The test inertial and gross static weights were 4,435 lbs (2,012-kg). The test vehicle is shown in Figure 16 and vehicle dimensions are shown in Figure 17.

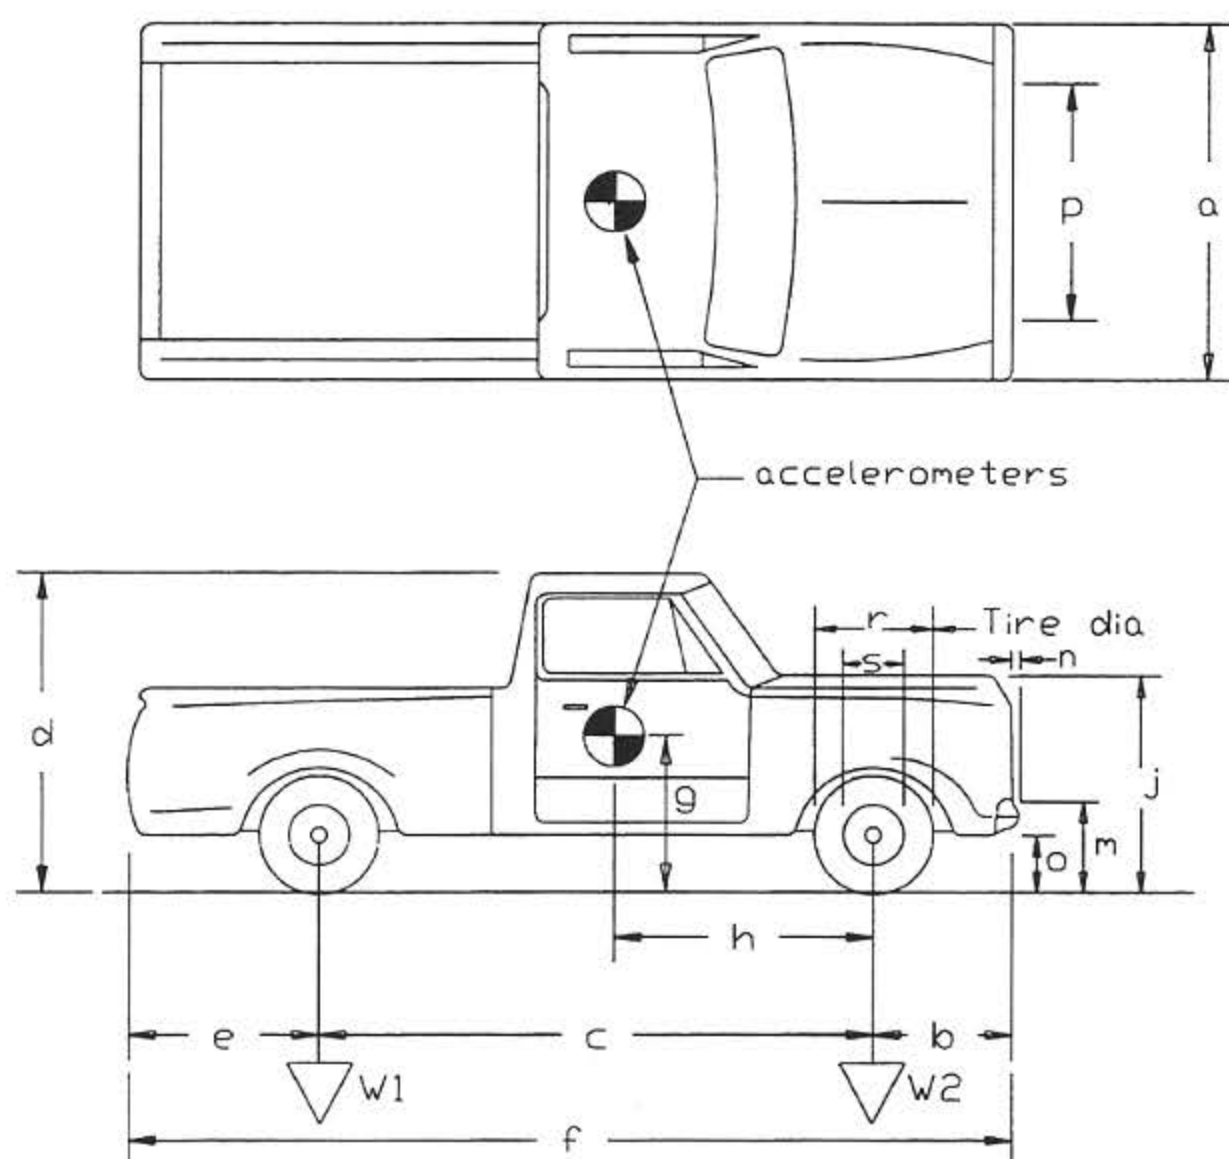
Date: 6/23/95 Test Number: CTBR-1 Model: F250  
 Make: Ford Vehicle I.D.#: 1FTEF25Y9EPA99219  
 Tire Size: LT215/85 R16 Year: 1984 Odometer: 51960

a 74" b 28"  
 c 133.5" d 71.5"  
 e 51.5" f 213"  
 g 28.75" h 60"  
 i --- j 49.5"  
 k --- l ---  
 m 26.0" n 1"  
 o 16.75" p 65"  
 r 29.25" s 17.5"
