# **TL-1 Curb-Type Bridge Railing for Longitudinal Glulam Timber Decks Located on Low-Volume Roads**

## **MIDWEST ROADSIDE SAFETY FACILITY**

*MwRSF Research Report No. TRP-03-54-96*

April 1996

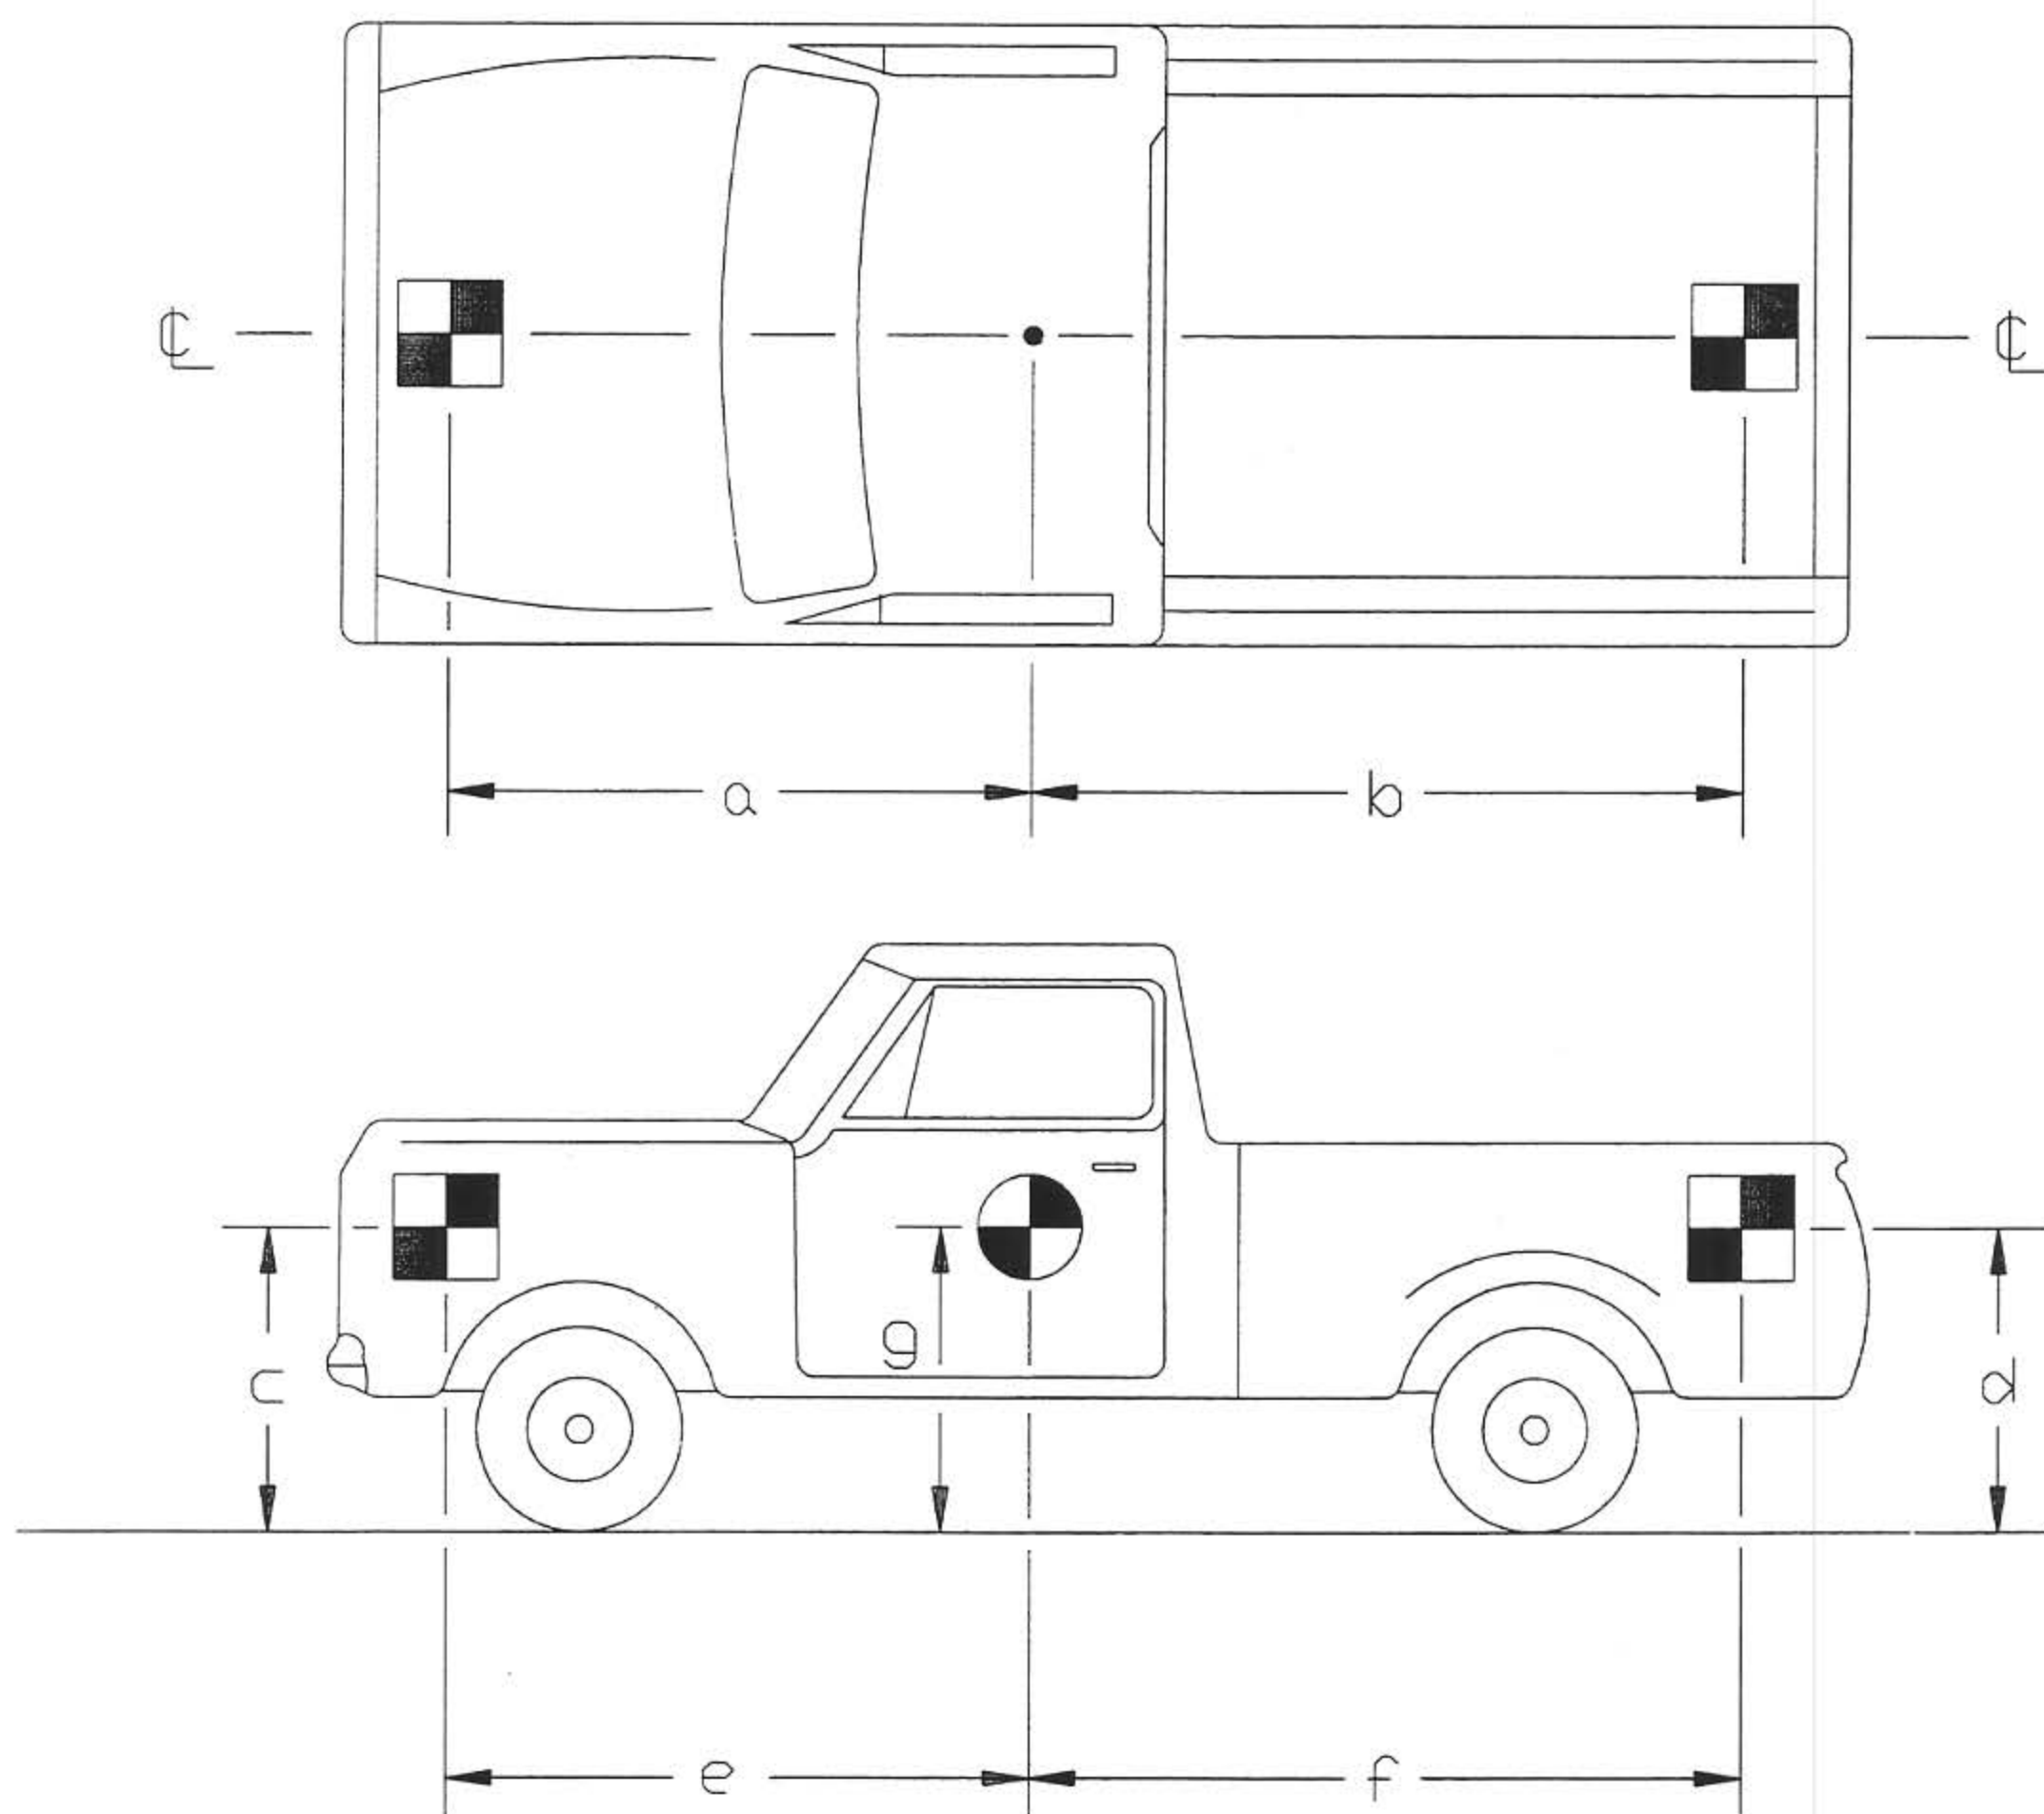
TEST #: CTBR-1

TARGET GEOMETRY  
INCHES

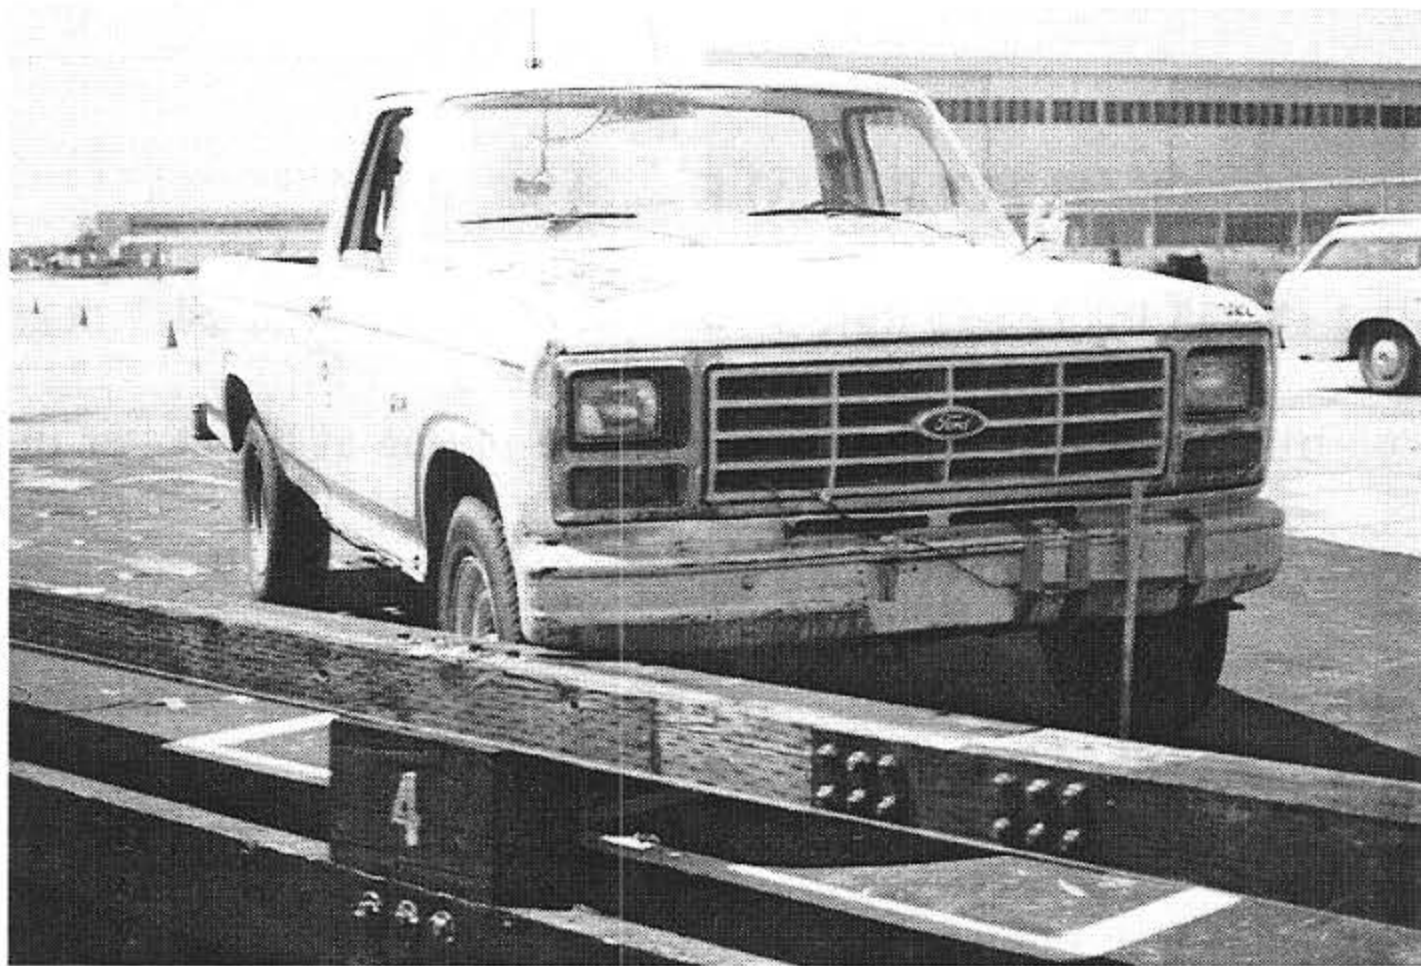
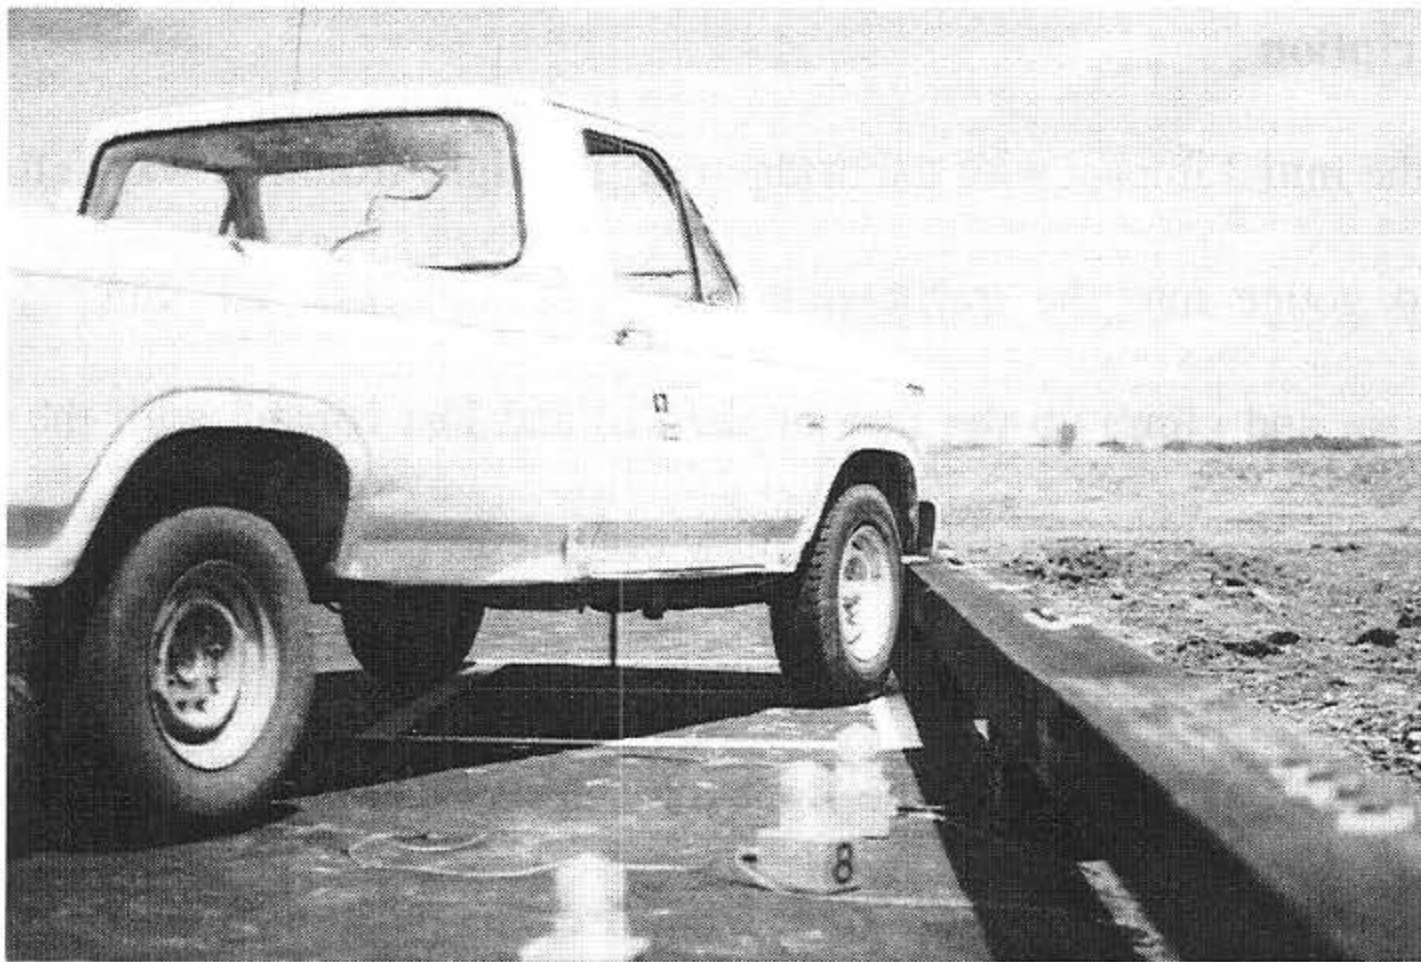
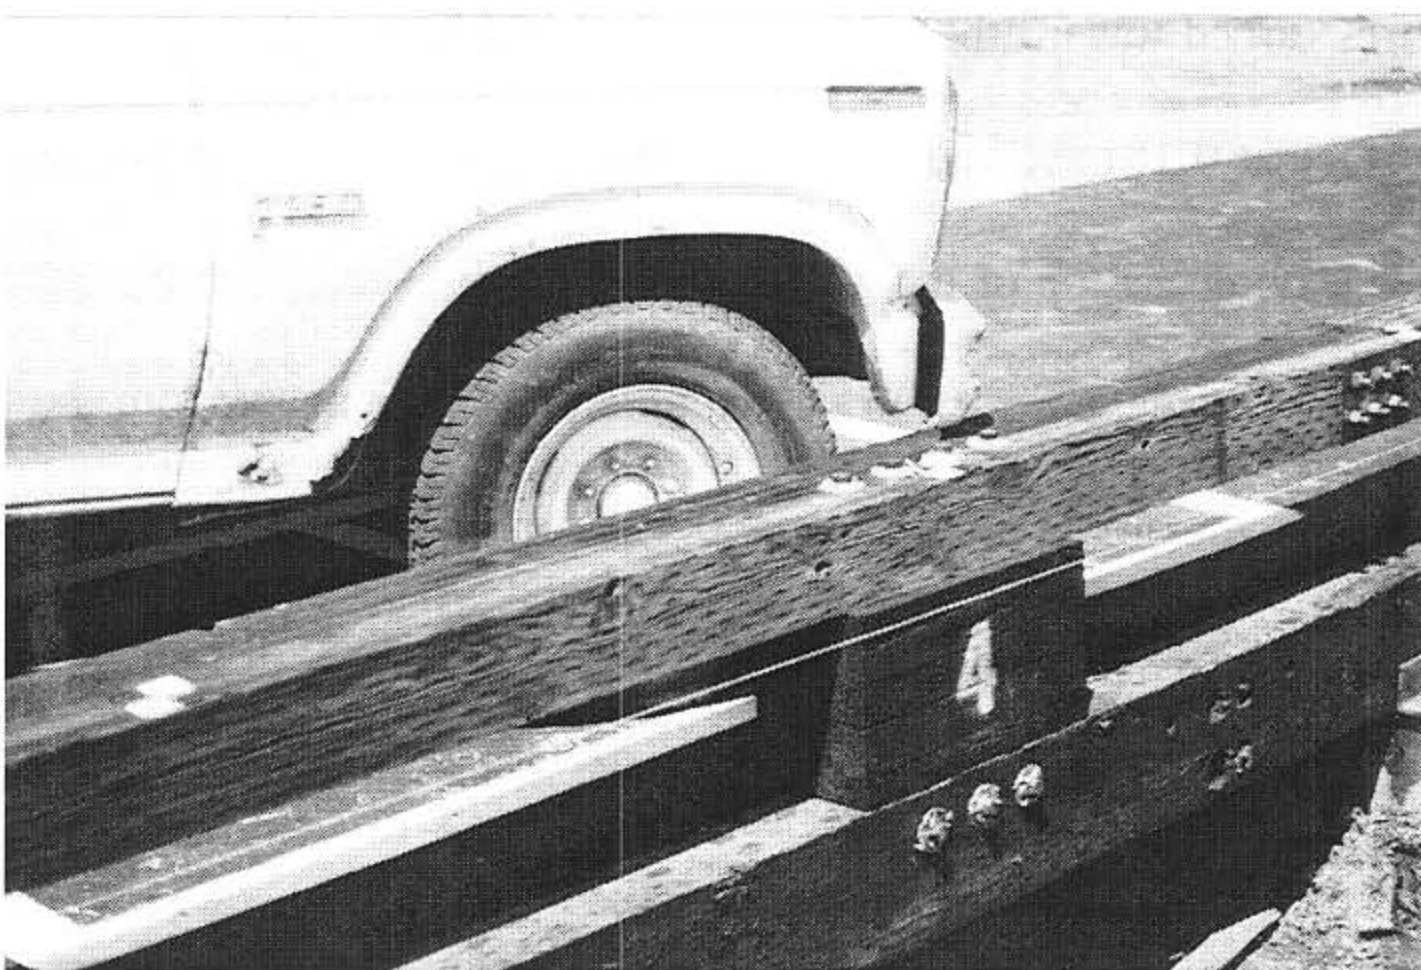
Figure 20. Impact Location, Test CTBR-1

During the initial impact with the bridge rail, the right-front tire was deformed, allowing the steel rim to gouge into the traffic-side face of the glulam rail. Subsequently, the tire continued to rotate and climb up the face of the rail and lost contact with the deck surface at 0.026 sec. At 0.119 sec, the right-front tire blew out due to contact with the glulam rail. From the overhead high-speed film, the maximum dynamic lateral deflection of 2.7 in. (69 mm) was observed at post no. 4 at 0.124 sec. The right-front tire was at the midspan between post nos. 4 and 5 at 0.144 sec. At 0.171 sec, the right-front tire was positioned on the top of the glulam rail with front tires turned toward the bridge rail. The left-front and right-rear tires lost contact with the deck surface at 0.181 sec and 0.231 sec, respectively. At 0.241 sec, the right-front tire became airborne, leaving the top of the glulam rail. The right-rear tire impacted the bridge rail at 0.353 sec, causing the pickup truck to yaw counterclockwise away from the bridge rail. The pickup truck reached a maximum pitch angle at 0.422 sec. Subsequently, the pickup truck nearly became parallel to the bridge rail at 0.433 sec. At 0.539 sec, the left-rear tire lost contact with deck surface, and the right-front tire contacted the top of the glulam rail at 0.542 sec. At 0.723

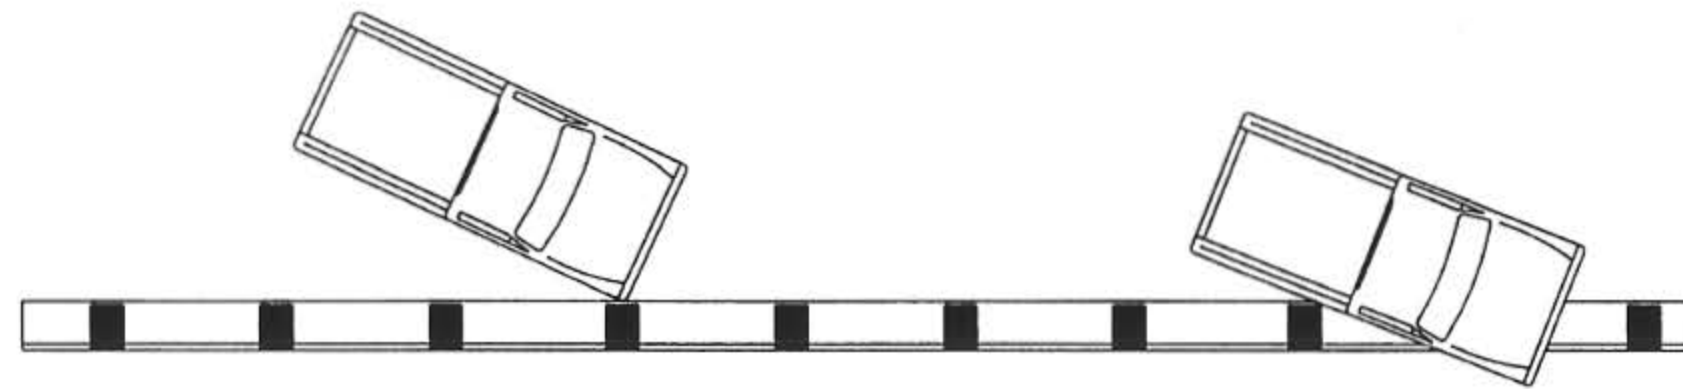
• Test Number	CTBR-1
• Date	6/23/95
• Bridge Rail Installation	TL-1 Curb-Type Railing System
• Total Length	100 ft
• Glulam Curb Rail	
Size	6¾ in. x 10½ in.
Top Mounting Height	17¾ in.
Material	West Coast Douglas Fir
Grade	Combination No. 2
• Scupper Blocks	
Size	7½ in. x 9½ in. 23 in. & 5½ in. x 9½ in. 23 in.
Material	Douglas Fir
Grade	No. 1
Spacing	10 ft
• Anchorage Bolts	
Type	ASTM A307, Galvanized
Size	Four ¾-in. $\phi$ Bolts Per Location
Length	33 in.
• Bridge Deck Installation	Longitudinal Glulam Timber Bridge Deck Panels
Panel Size	10¾ in. x 4 ft x 18 ft - 9 in.
Material	West Coast Douglas Fir
Grade	Combination No. 2
• Vehicle Model	1985 Ford F-250
Curb Weight	4,110 lbs
Test Inertial Weight	4,435 lbs
Gross Static Weight	4,435 lbs

• Vehicle Speed	
Impact	31.6 mph
Exit	NA
• Vehicle Angle	
Impact	24.3 degrees
Exit	NA
• Vehicle Snagging	Minor steel rim and undercarriage gouging on the rail
• Vehicle Stability	Satisfactory but with moderate vaulting on traffic-side face of bridge railing
• Occupant Ridedown Deceleration (0.010-sec average)	
Longitudinal	7.1 G's $\leq$ 20 G's
Lateral	4.1 G's $\leq$ 20 G's
• Occupant Impact Velocity (normalized)	
Longitudinal	3.9 m/s $\leq$ 12 m/s
Lateral	3.2 m/s $\leq$ 12 m/s
• Vehicle Damage	Minor
TAD <sup>22</sup>	1-RFQ-1
SAE <sup>23</sup>	01RDWN2
• Vehicle Stopping Distance	50 ft
• Barrier Damage	Minor scrapes and gouges on the rail as well as deformed steel splice plates
• Maximum Rail Deflections	
Permanent Set	0.1 in.
Dynamic	2.7 in.

sec and 0.867 sec, the left-front and left-rear tires contacted the deck surface, respectively. At 2.610 sec, the pickup truck came to rest approximately 15.24 m (50 ft) downstream from impact with the front axle on top of the glulam rail and the right-front tire positioned behind the glulam rail, as shown in Figure 27. The vehicle's post-test trajectory is shown in Figure 21.

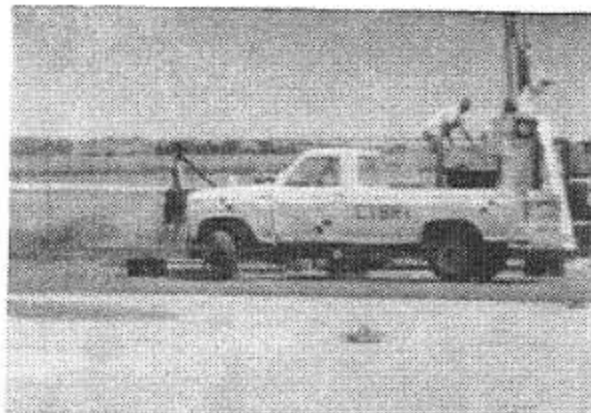
0.119 sec

Figure 22. Additional Sequential Photographs, Test CTBR-1

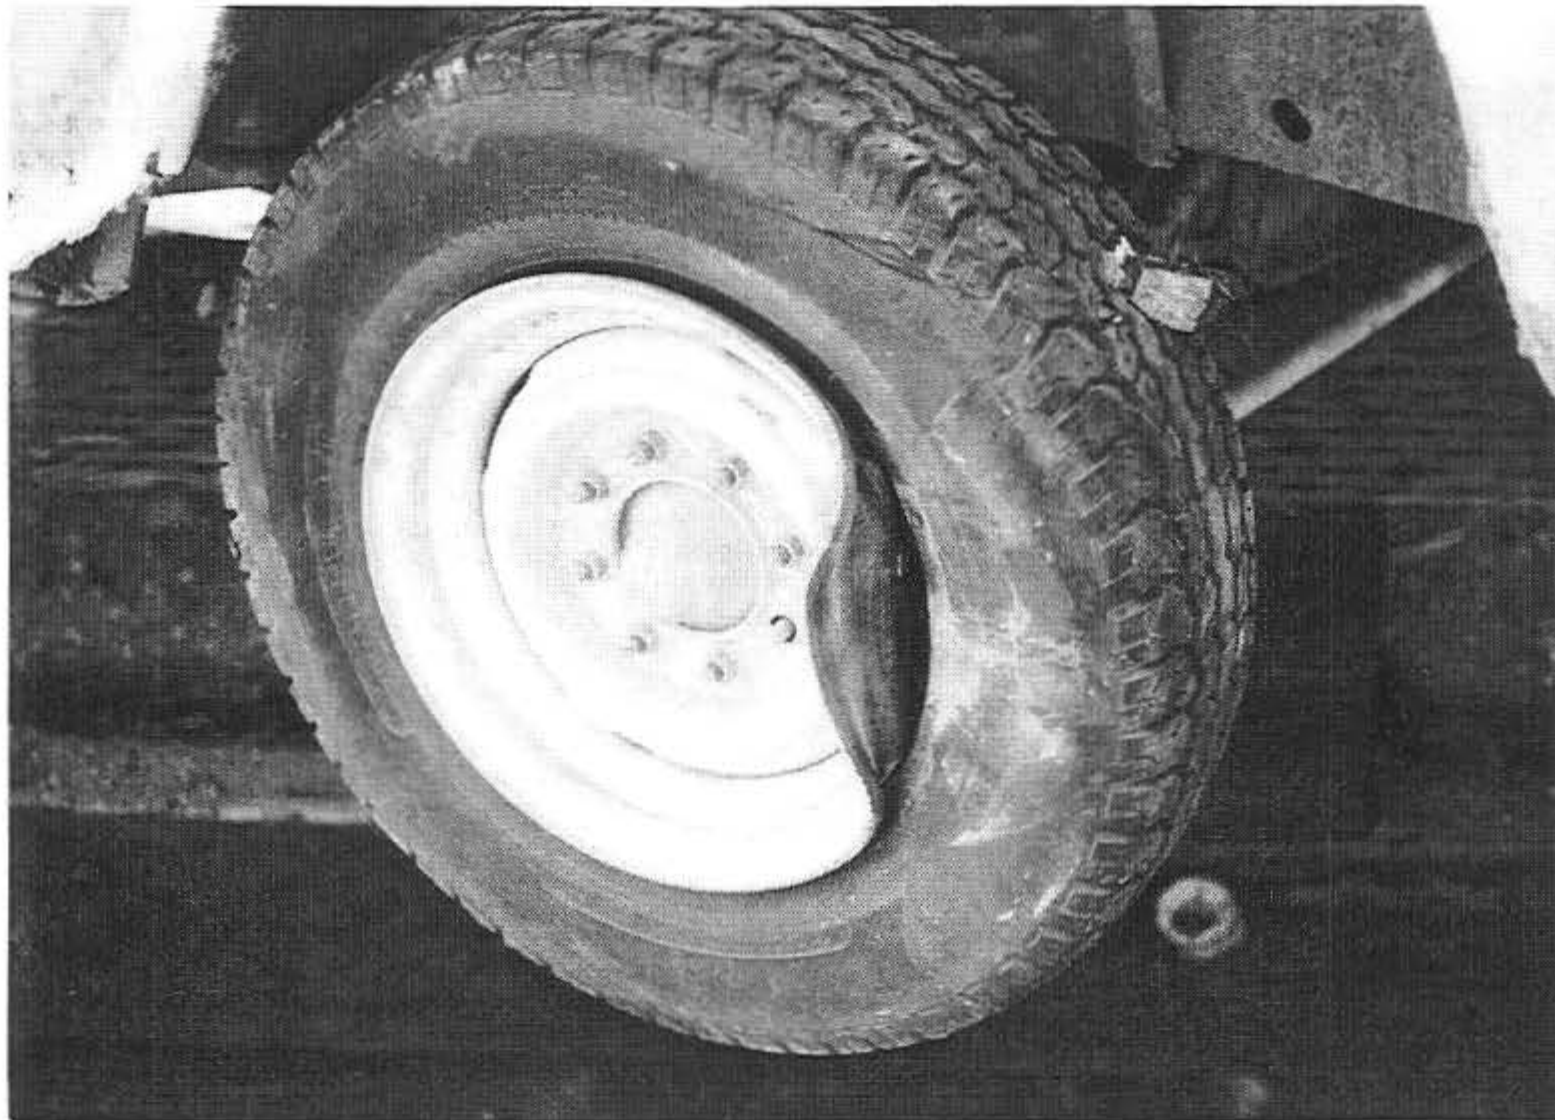
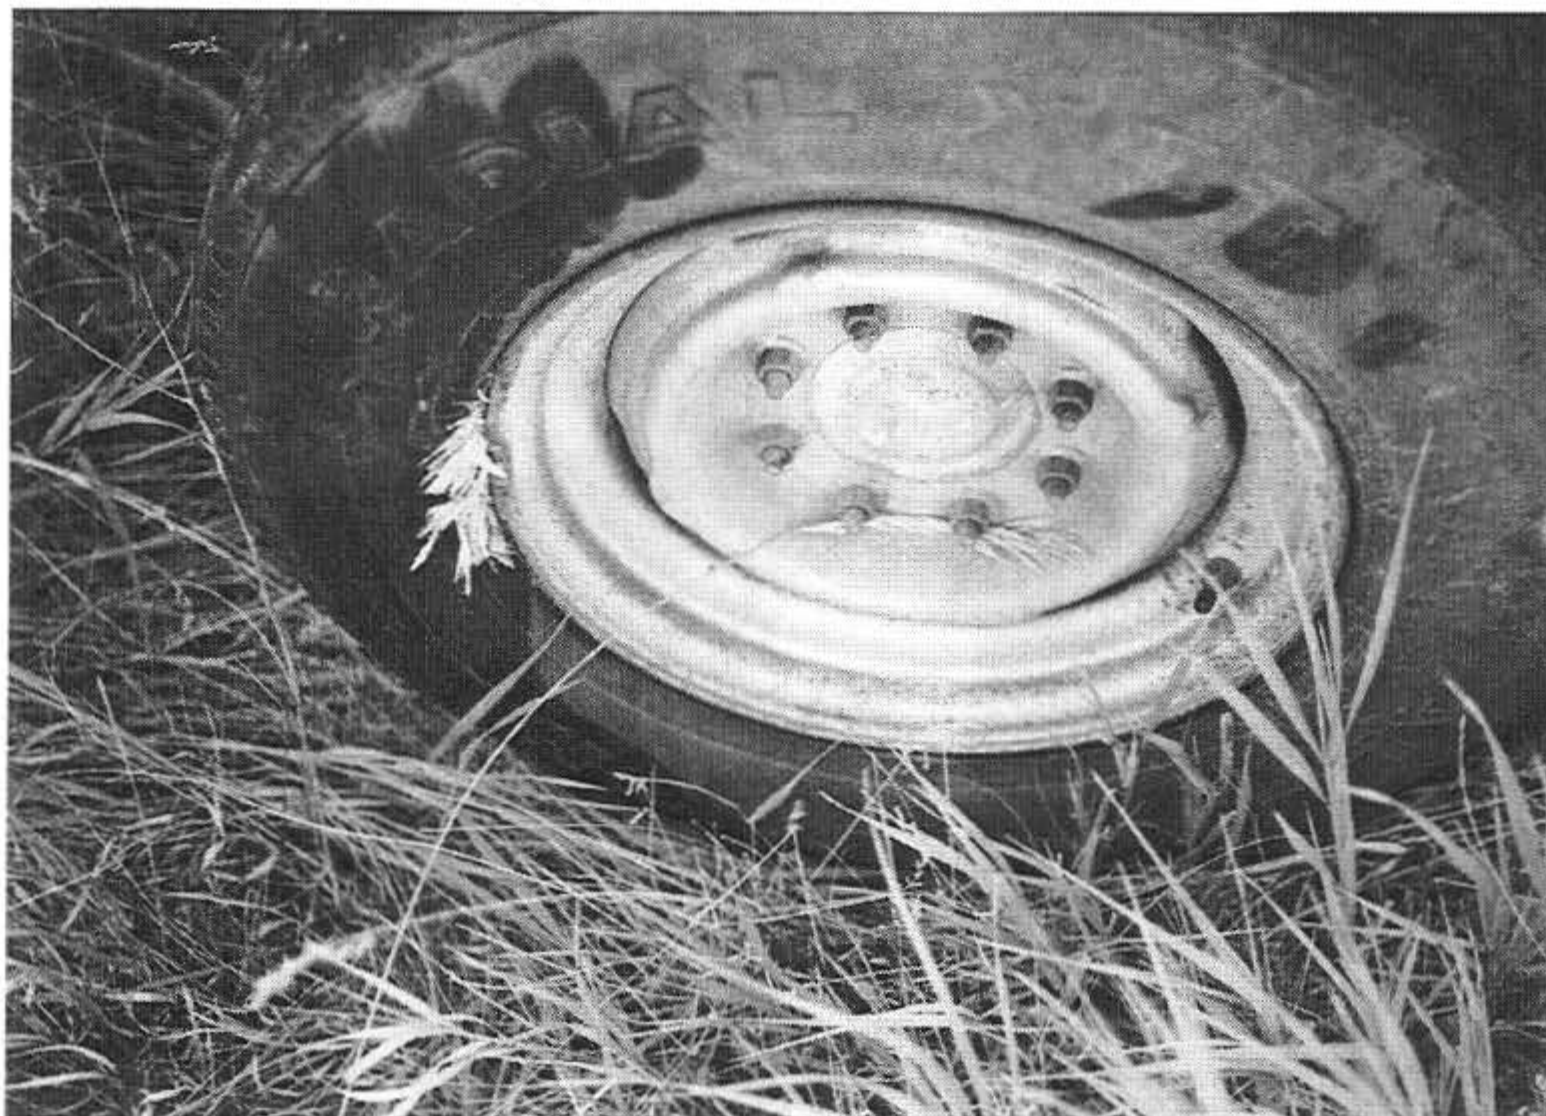
Figure 28. Steel Rim Deformations, Test CTBR-1

Exterior vehicle damage was minor and was limited to deformations of the steel frame and the steel rims of the right-side wheels. The steel frame was shifted slightly due to the oblique impact with the bridge rail. As shown in Figure 28, the right-front and right-rear steel rims were deformed due to the contact with the glulam rail, as evidenced by the wood fibers lodged between the tire and rim and gouges on the face of the glulam rail. Minor undercarriage damage was also observed. No damage occurred to the interior occupant compartment. The vehicle damage was also assessed by the traffic accident scale (TAD) (22) and the vehicle damage index (VDI) (23), as shown in Figure 21.

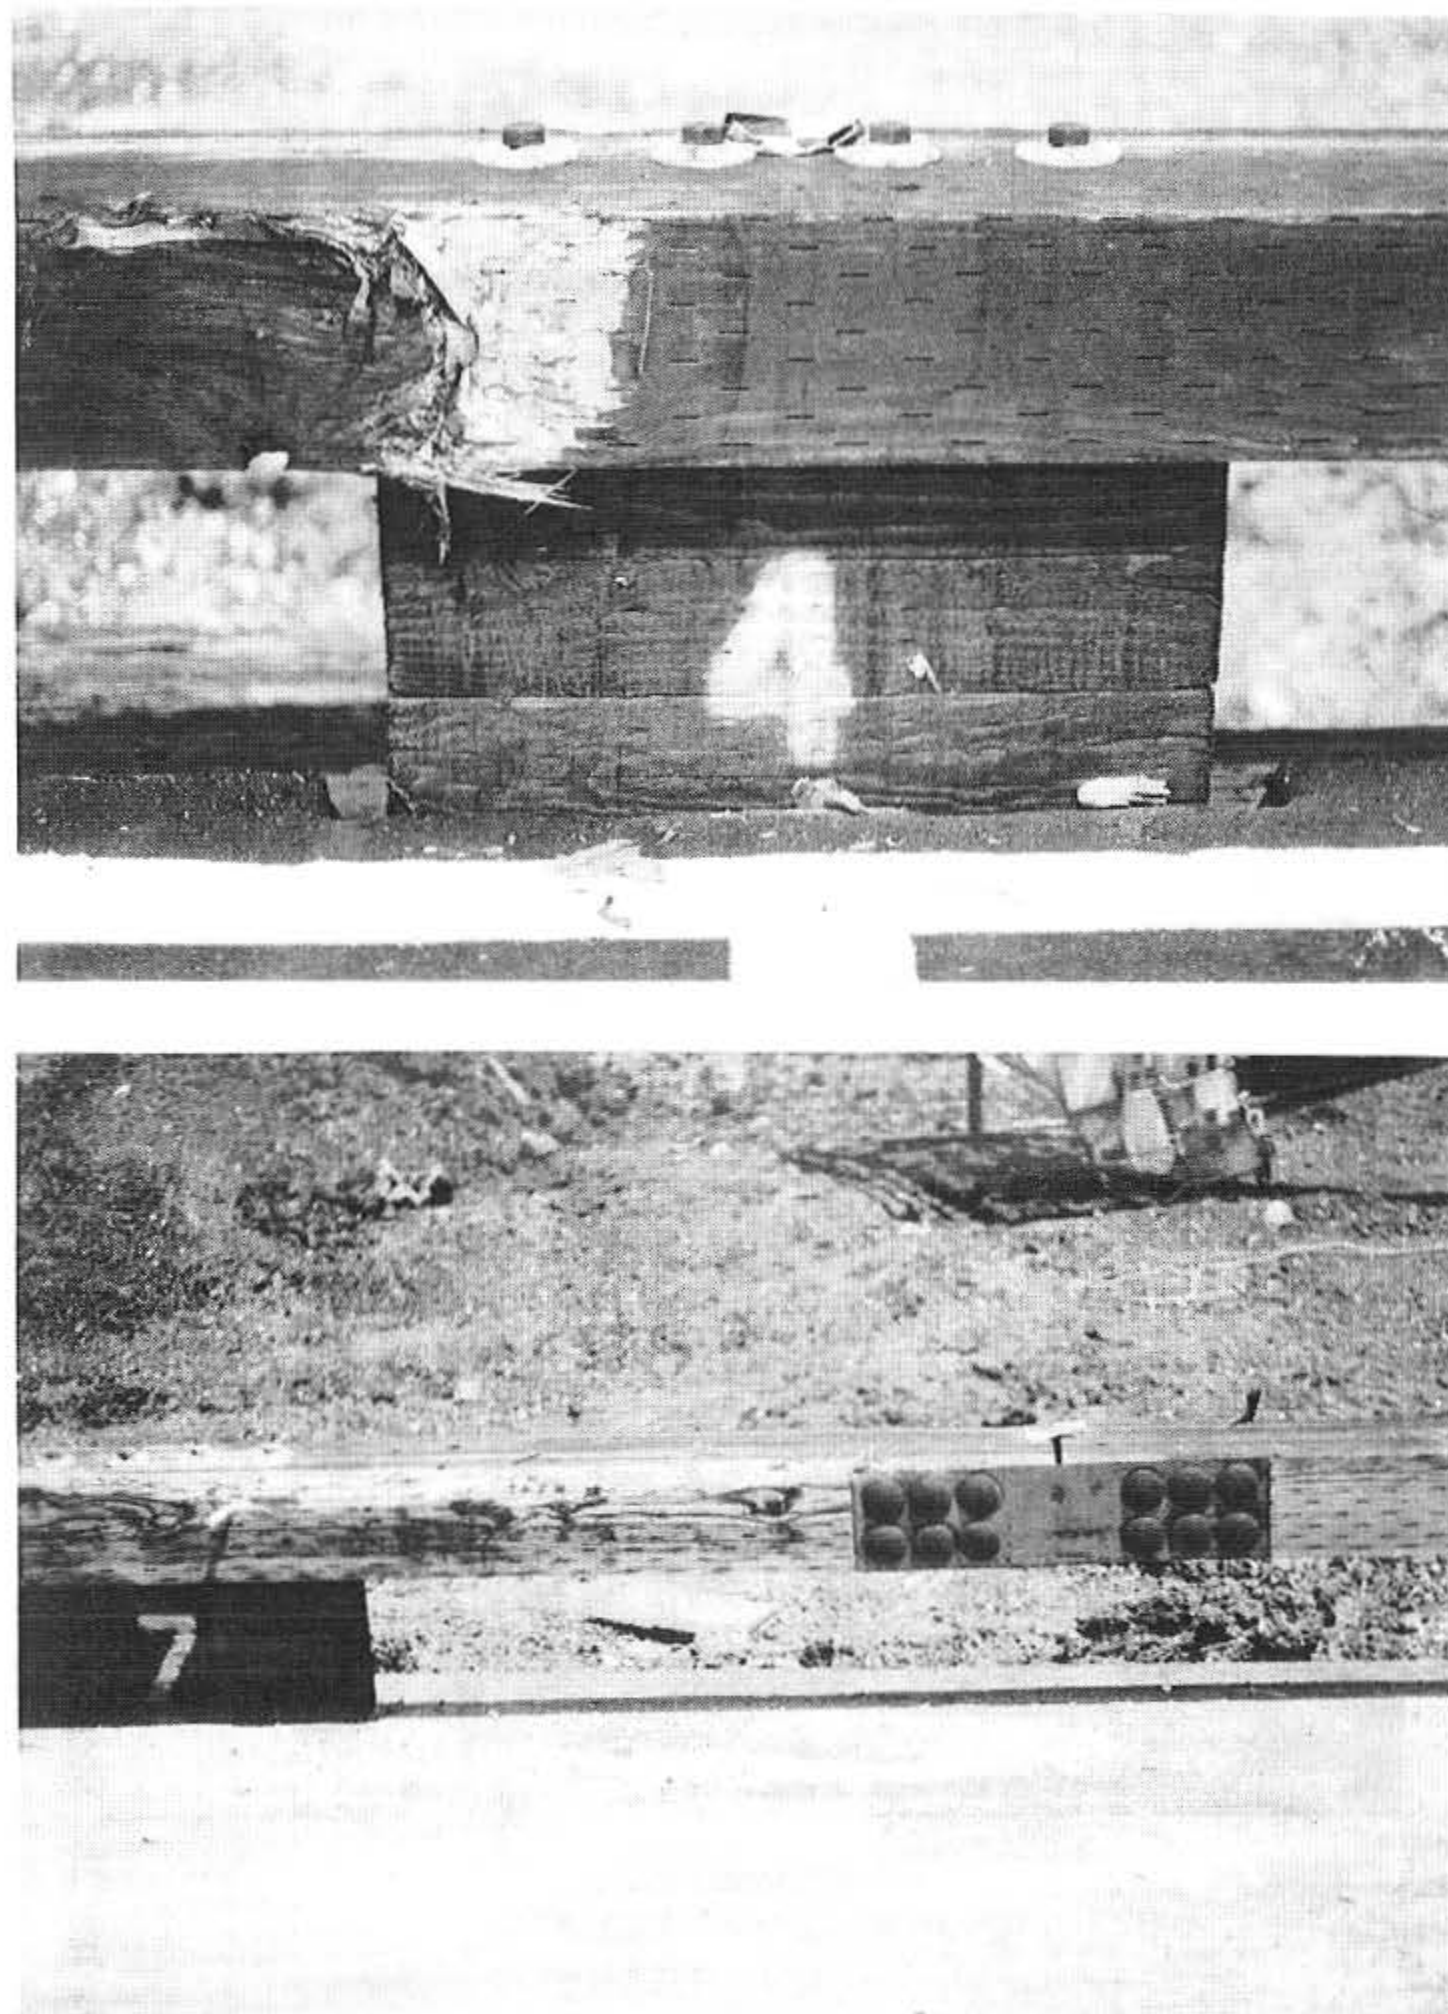
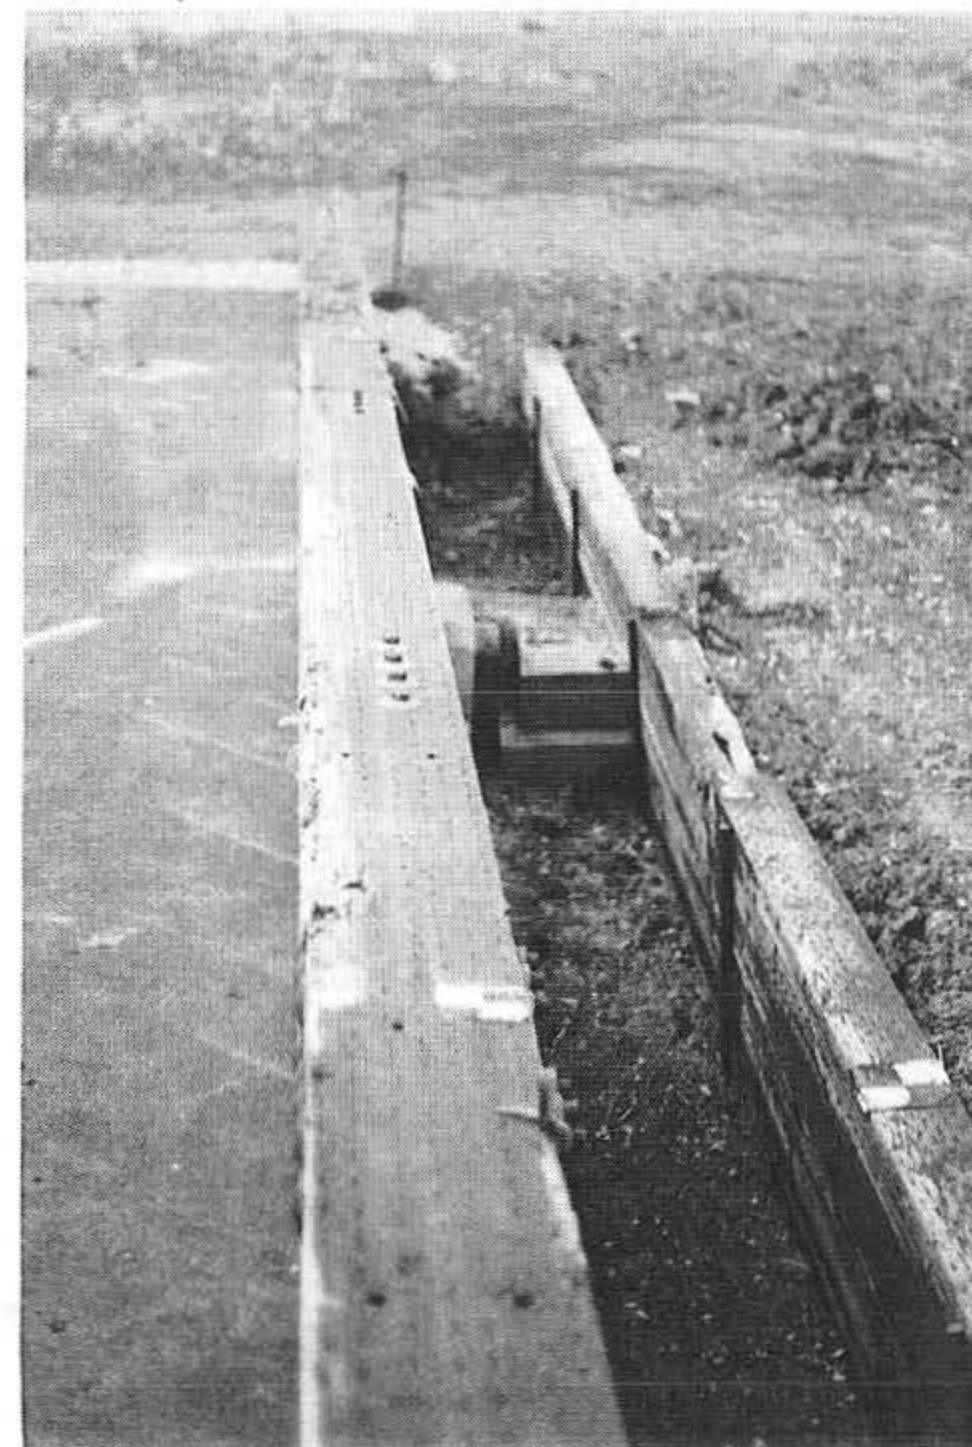
Figure 29. Glulam Rail Damage, Test CTBR-1

The minor bridge railing damage is shown in Figures 29 and 30. Scrapes and gouging occurred to the glulam rail along the entire impact distance and on the front, top, and back-side faces of the glulam rail, as shown in Figure 29. As shown in Figure 29, a large scrape and a 19 mm ( $\frac{3}{4}$ -in.) deep gouge, resulting from the rim-rail contact, was observed on the front face of the glulam rail approximately 203 mm (8 in.) downstream from impact. Damage to the glulam rail was mostly superficial, resulting in little or no compromise of the structural integrity of the bridge rail. The maximum permanent set and dynamic deflections were 3 mm (0.1 in.) and 69 mm (2.7 in.), respectively. The steel splice plate connection located at the midspan

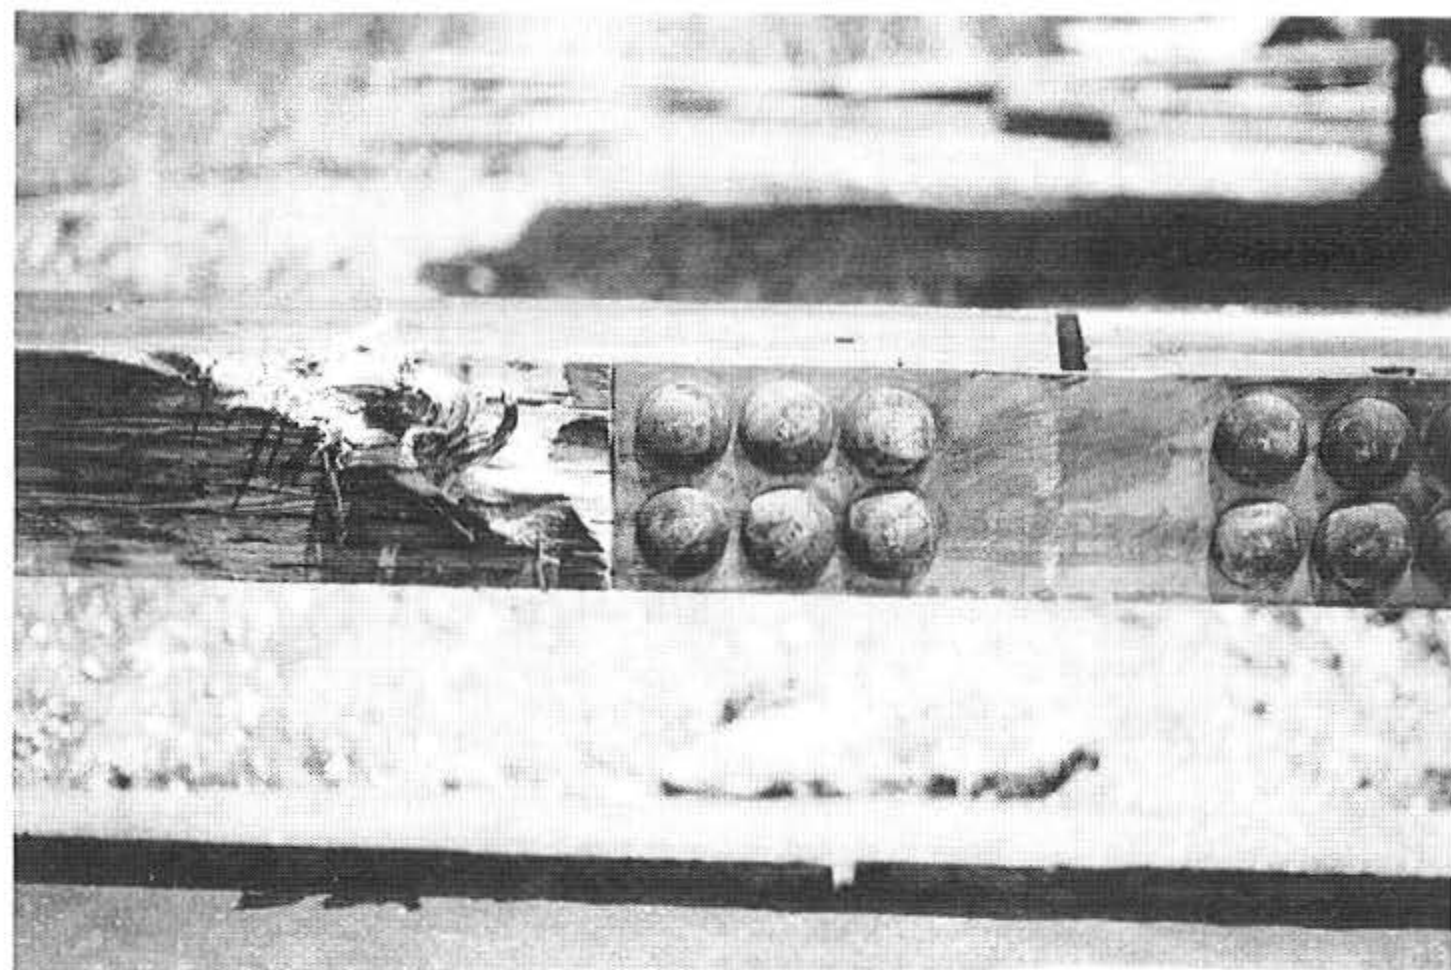
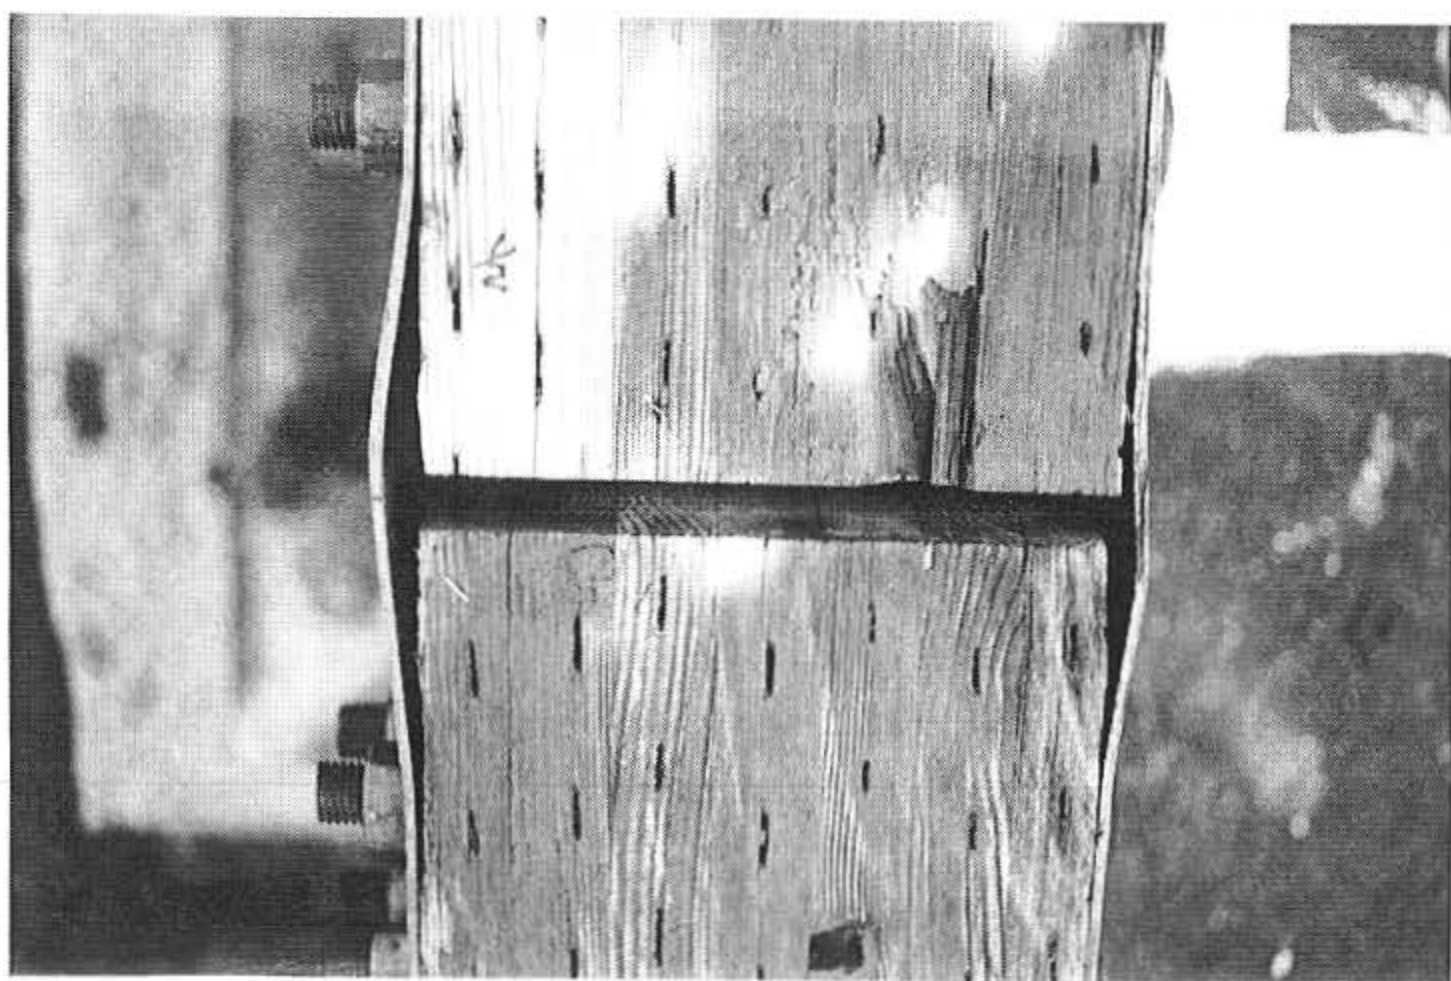
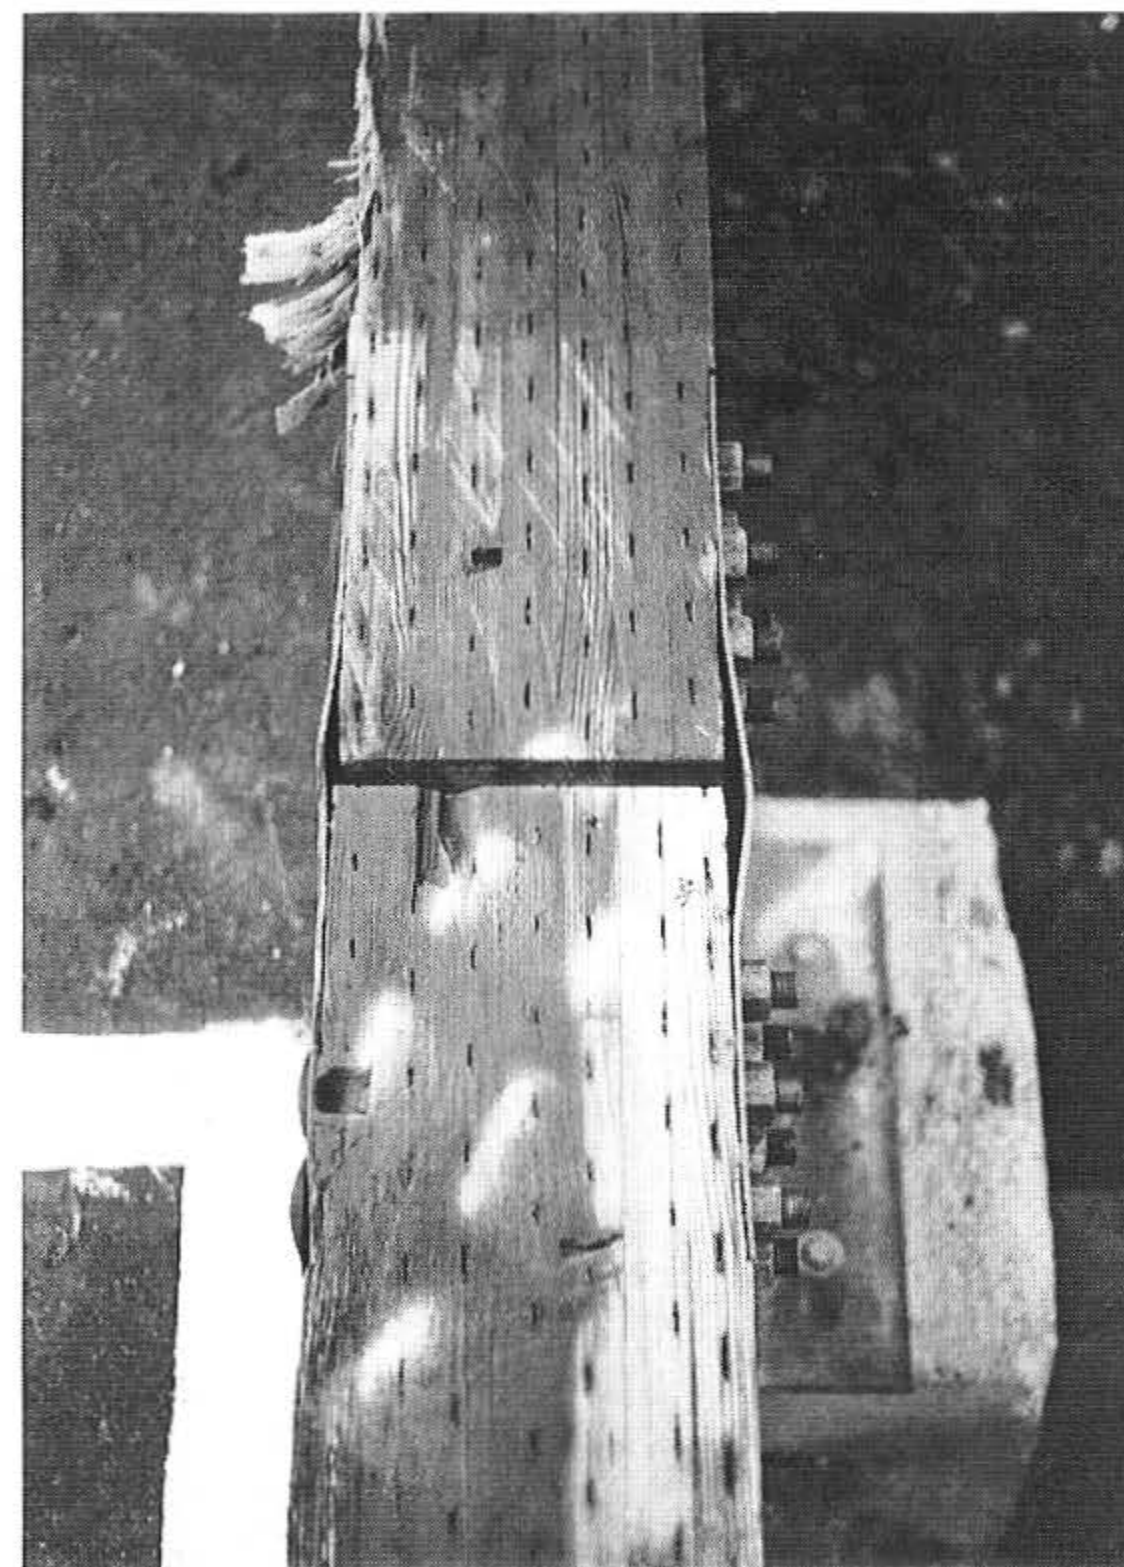
Figure 30. Damage to Glulam Rail and Splice Plate Connection, Test CTBR-1

between post nos. 4 and 5 was deformed, as shown in Figure 30. Figure 30 also shows a gouge which occurred on the face of the glulam rail and downstream of the steel splice plate from the impact of the right-rear steel rim. No damage occurred to the deck, lag screws, or scupper blocks.
