# **TL-1 Curb-Type Bridge Railing for Longitudinal Glulam Timber Decks Located on Low-Volume Roads**

## **MIDWEST ROADSIDE SAFETY FACILITY**

*MwRSF Research Report No. TRP-03-54-96*

April 1996

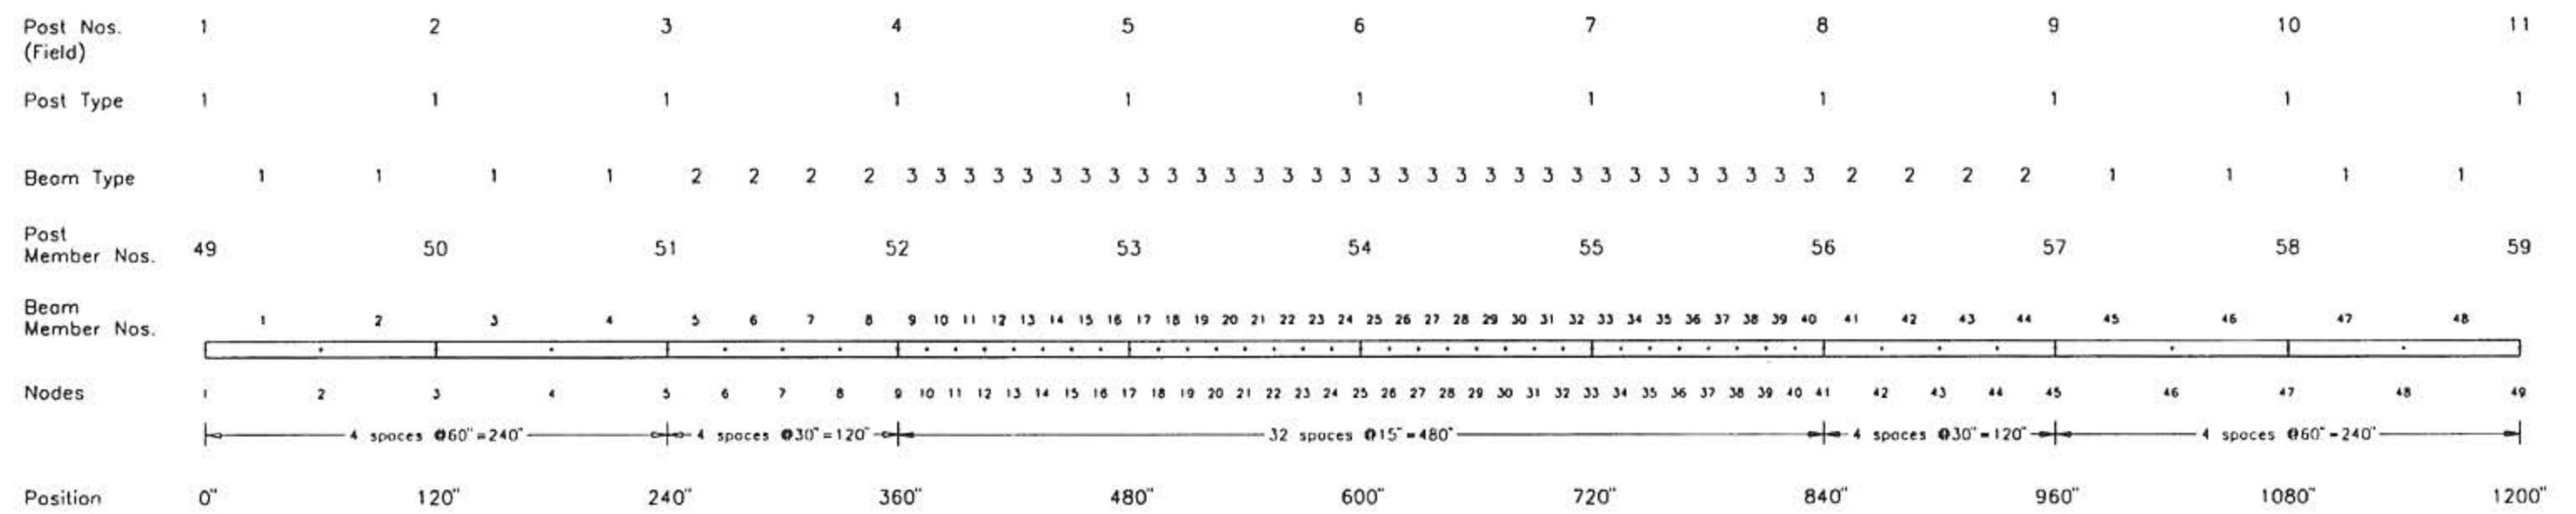
Figure A-1. Finite Element Model of the Curb-Type Bridge Railing

Figure A-2. Idealized finite element, 2 dimensional vehicle model for the 2,000-kg pickup truck
