# **DEVELOPMENT OF AN APPROACH GUARDRAIL TRANSITION ATTACHED TO A THREE BEAM AND CHANNEL BRIDGE RAILING**

MwRSF Research Report No. TRP-03-91-99

March 21, 2000

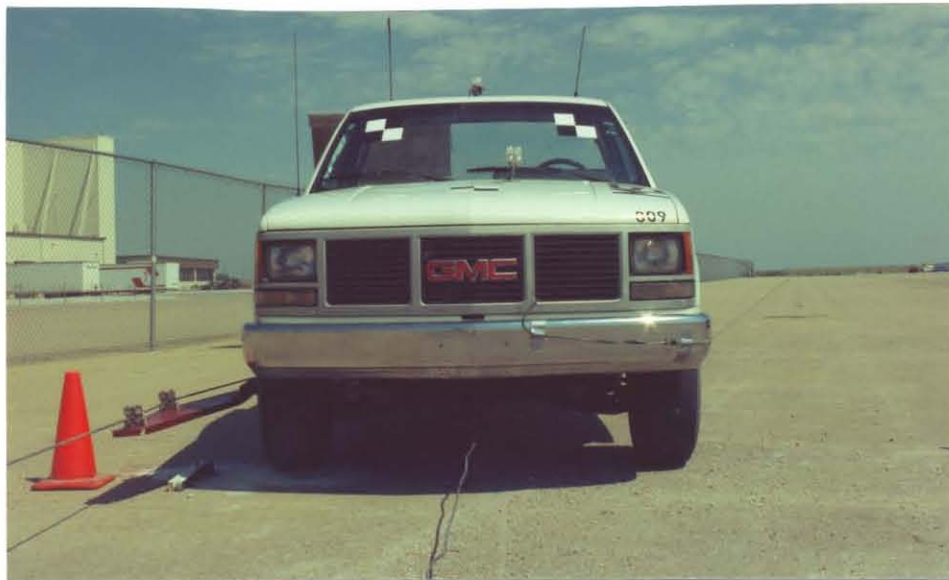
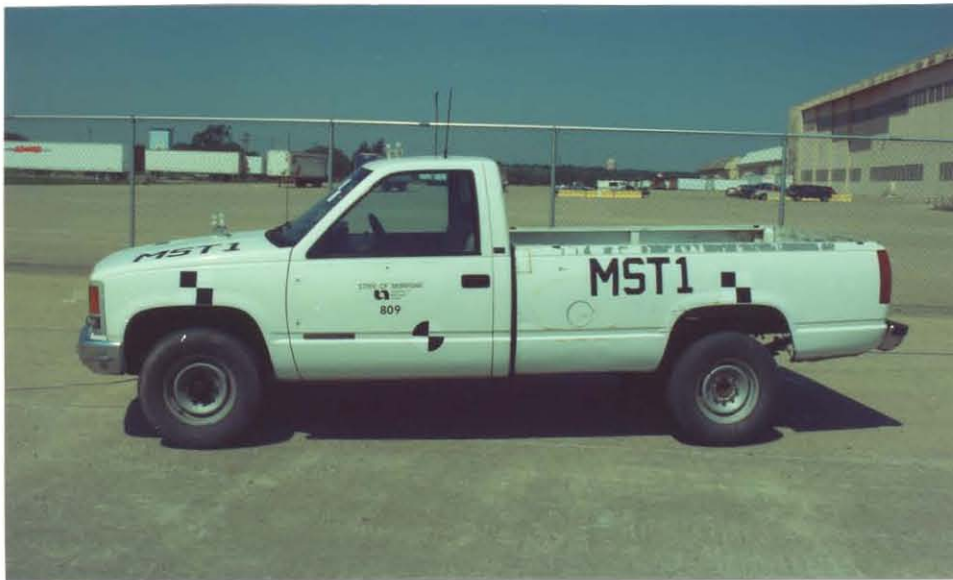
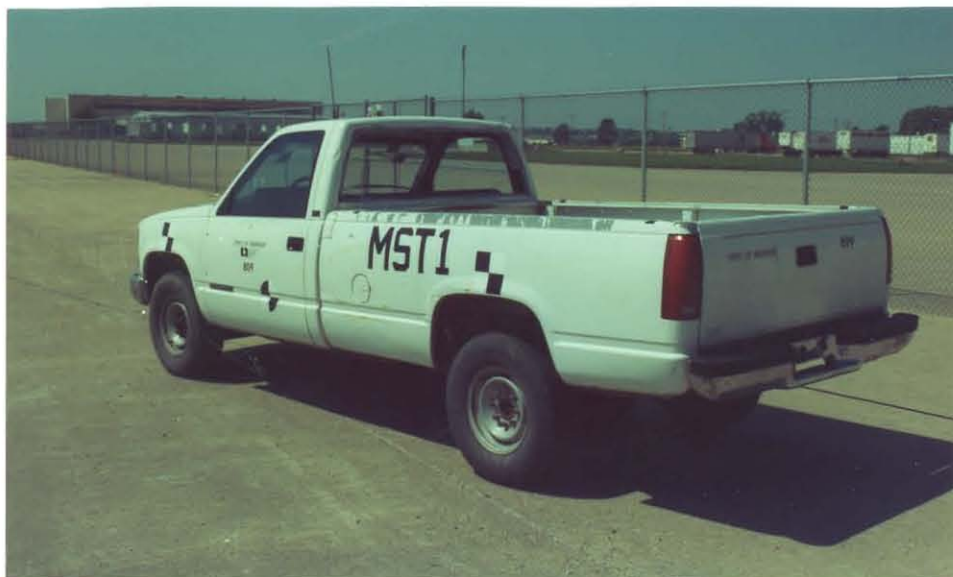
Figure 9. Test Vehicle, Test MST-1

For test MST-1, a 1992 GMC 2500 ¾-ton pickup truck was used as the test vehicle. The test inertial and gross static weights were 1,991 kg. The test vehicle is shown in Figure 9, and vehicle dimensions are shown in Figure 10.

Square, black and white-checked targets were placed on the vehicle to aid in the analysis of the high-speed film, as shown in Figures 9 through 14. One target was placed on the center of gravity on the driver's side door, the passenger's side door, and on the roof of the vehicle. The remaining targets were located for reference so that they could be viewed from the high-speed cameras for film analysis.

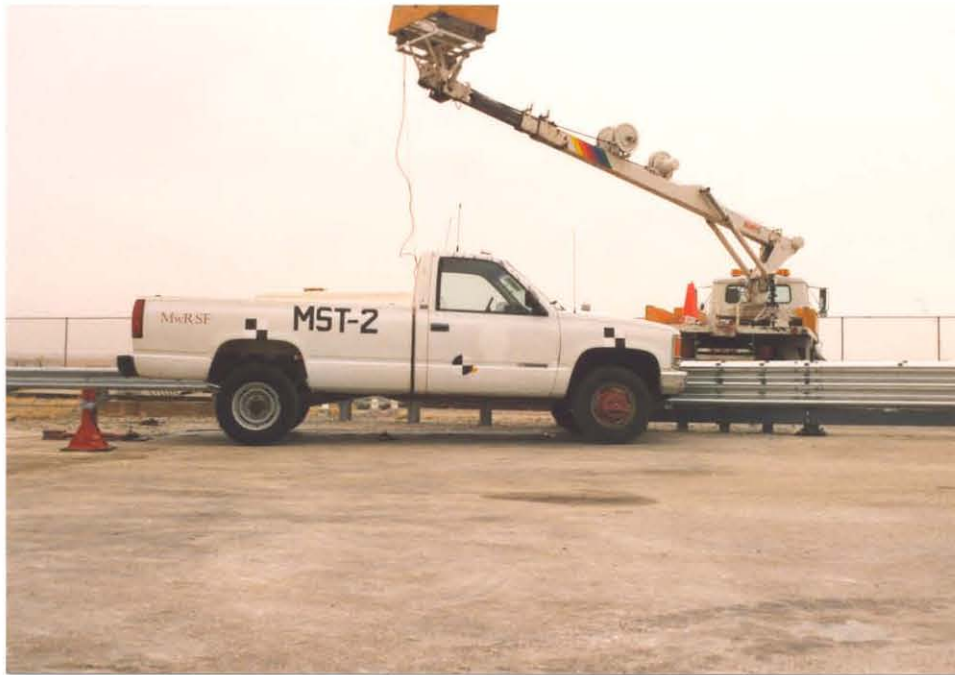
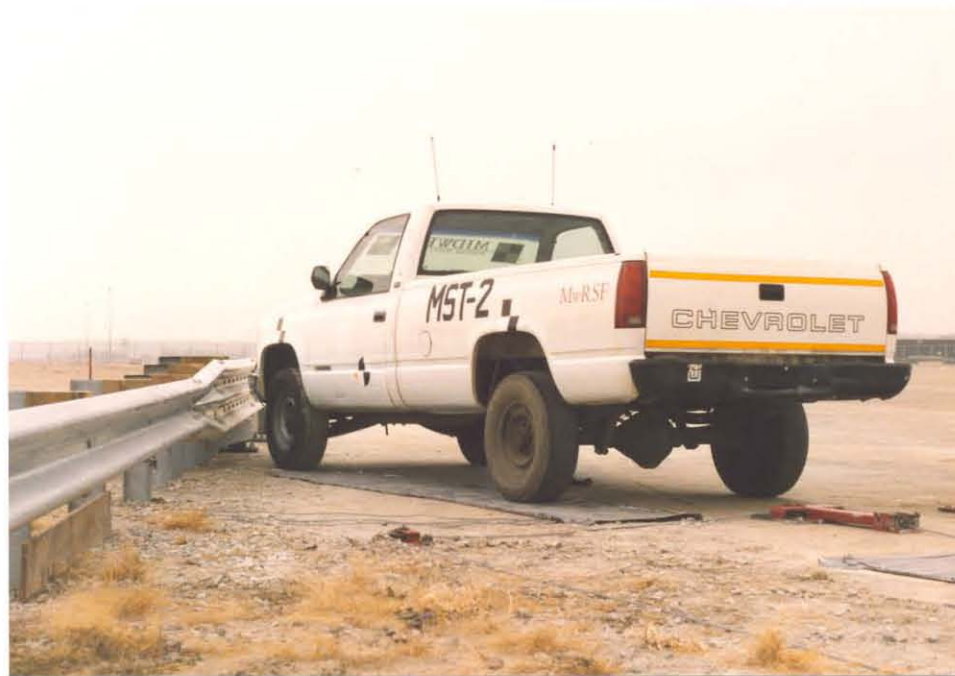
Figure 11. Test Vehicle, Test MST-2

For test MST-2, a 1993 Chevrolet C-2500 ¾-ton pickup truck was used as the test vehicle. The test inertial and gross static weights were 2,042 kg. The test vehicle is shown in Figure 11, and vehicle dimensions are shown in Figure 12.

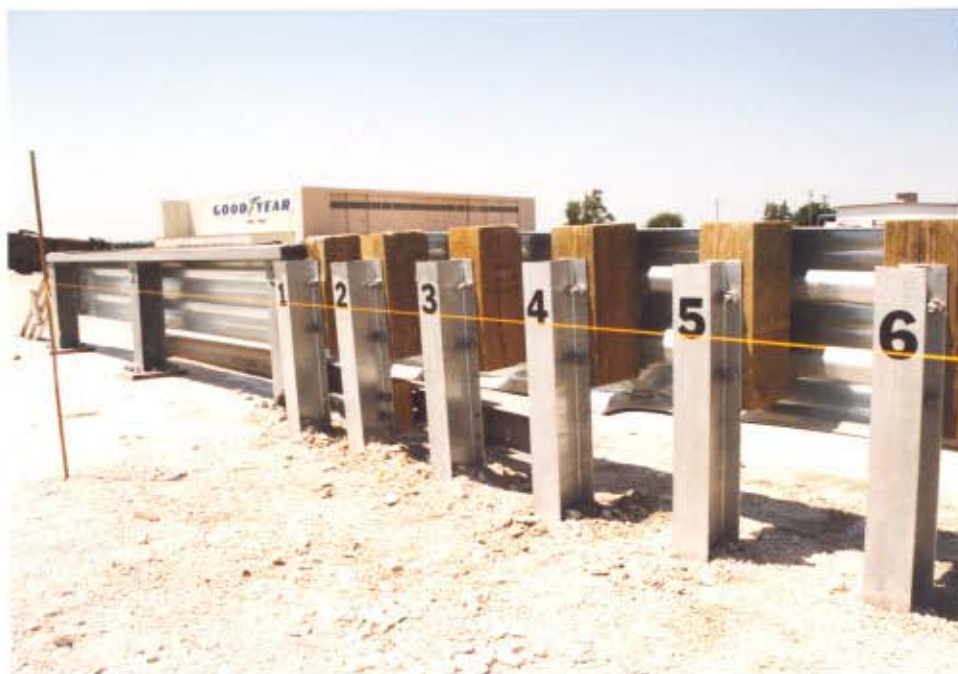
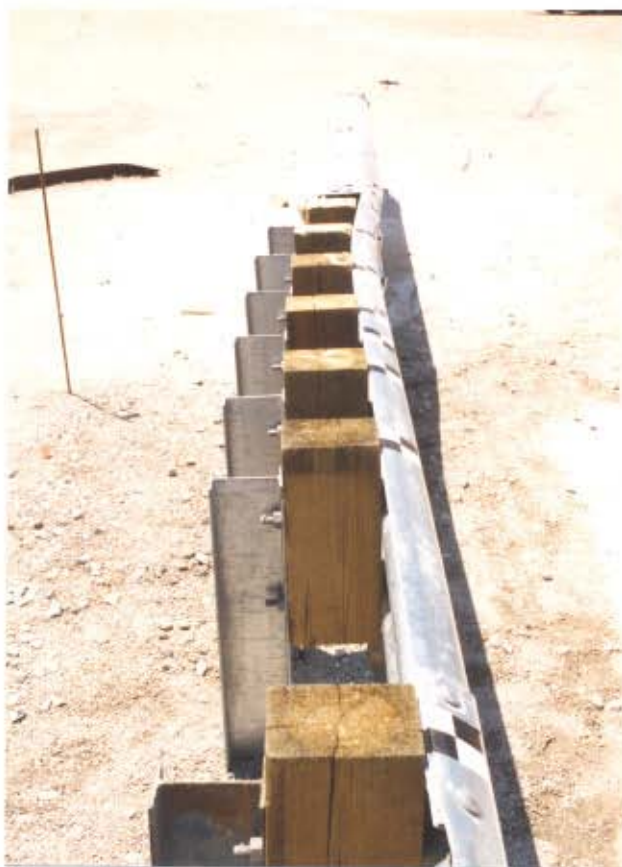
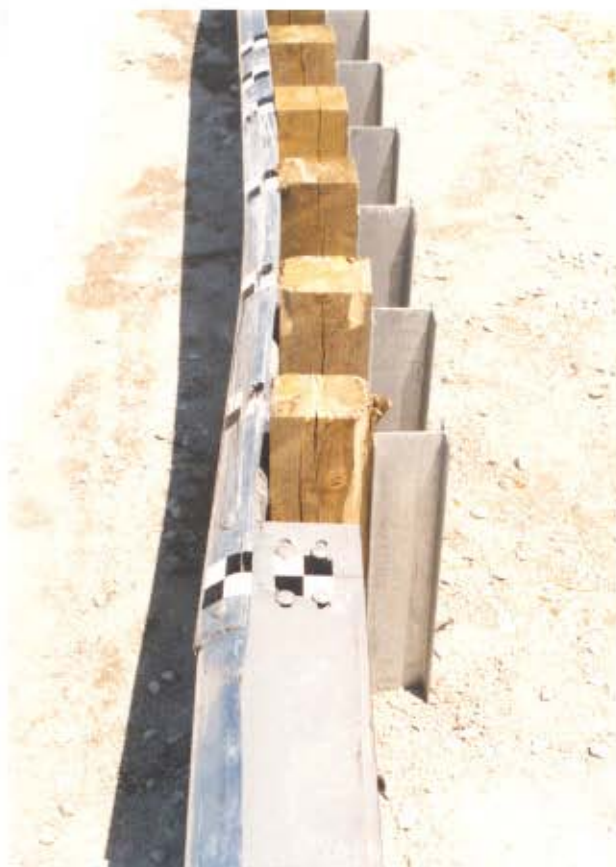
Figure 24. Approach Guardrail Transition Damage, Test MST-1

Damage to the barrier was moderate, as shown in Figures 24 through 25. Barrier damage consisted mostly of deformed thrie beam, contact marks on the thrie beam, top channel, rubrail, and bridge post base plate, and damaged spacer blocks. The thrie beam damage consisted of moderate deformation and flattening of the impacted section between post nos. 5 and B3. Contact marks were found on the thrie beam between post nos. 5 and B2. Contact marks were also found on the rubrail

from the centerline of post no. 3 to 330 mm downstream of bridge post no. B3. Superficial contact marks were found on the top face of the upper channel and the base plate of bridge post no. B3. The wooden spacer blocks of post nos. 1 through 3 were contacted by the thrie beam rail and were damaged. No significant damaged occurred to the posts, the W-beam, nor the W-beam to thrie beam transition rails.

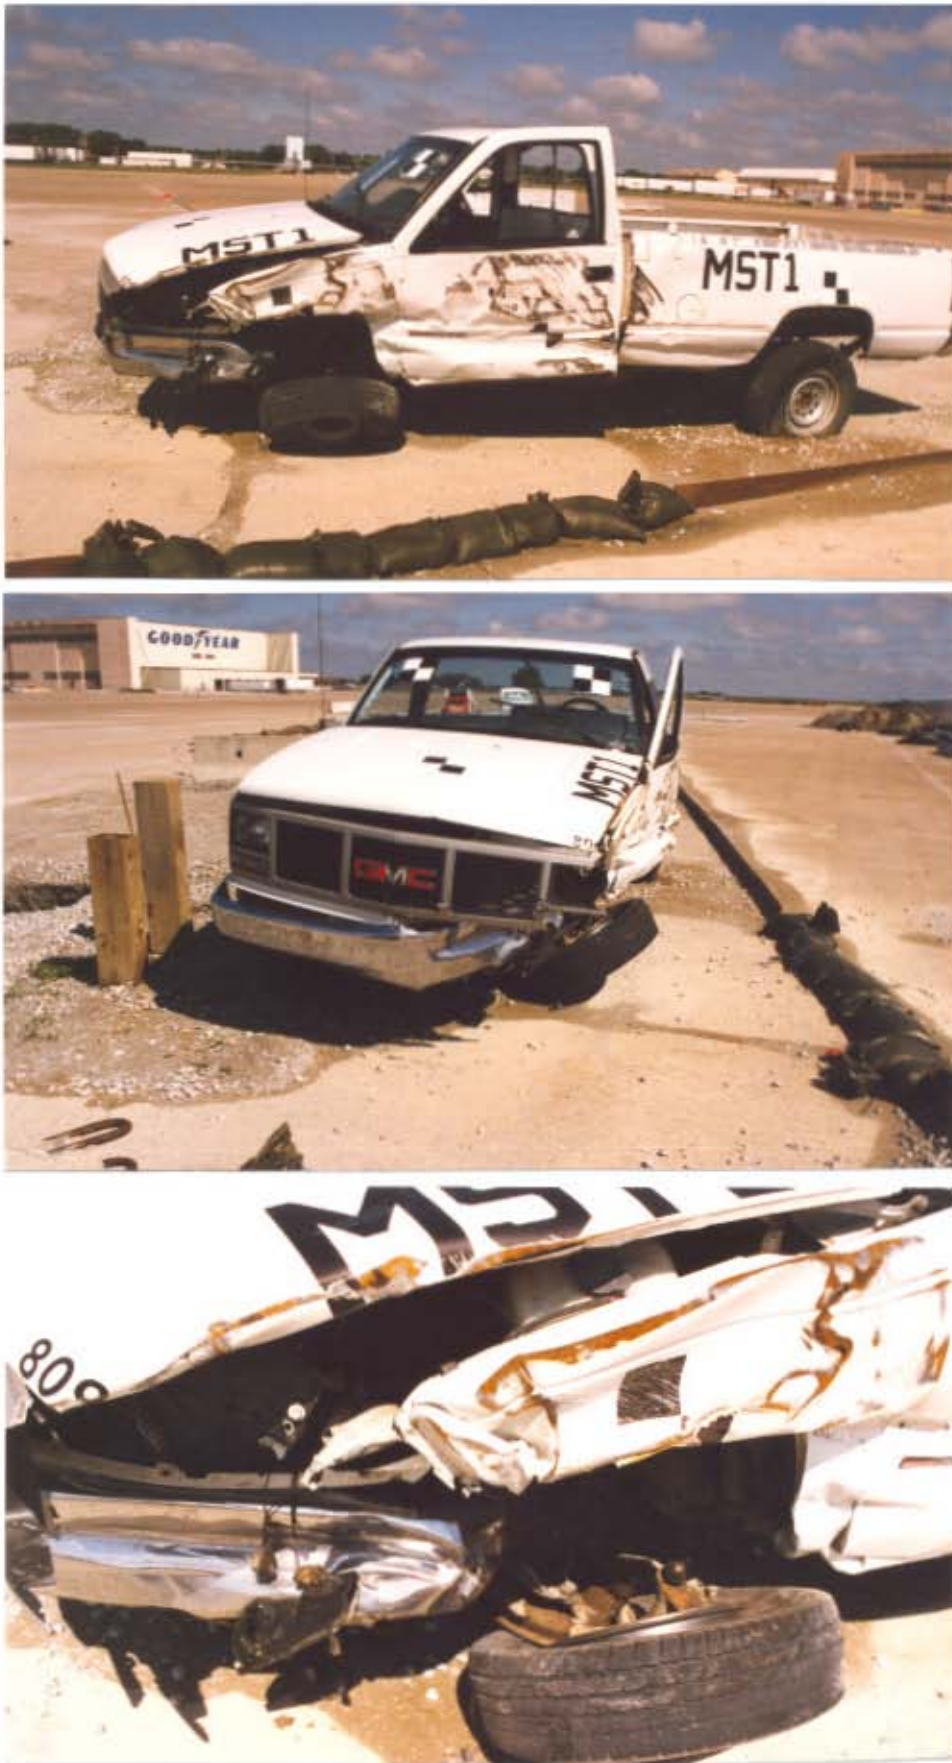
Figure 26. Vehicle Damage, Test MST-1

Exterior and interior vehicle damage was extensive and occurred at several body locations, as shown in Figures 26 through 28. The left-front quarter, including the fender, bumper, wheel assembly, and suspension components were crushed inward toward the engine compartment. The left-front upper control arm was disengaged, and the tire rod was ripped off. The perimeter of the left-rear steel rim had minor damage, and the tire was flat. The left-rear leaf spring shackle was disengaged. Scrape marks were found along the left side. Major damage occurred to the left door, including a rip in the lower rear of the door, outward buckling of the top of the door, and a shattered window. The hood popped open, and the right door was ajar. Minor cracking occurred to the windshield and the dash was also buckled. The floorboard of the occupant compartment also sustained significant plastic deformations due to the severe impact with the barrier as well as from

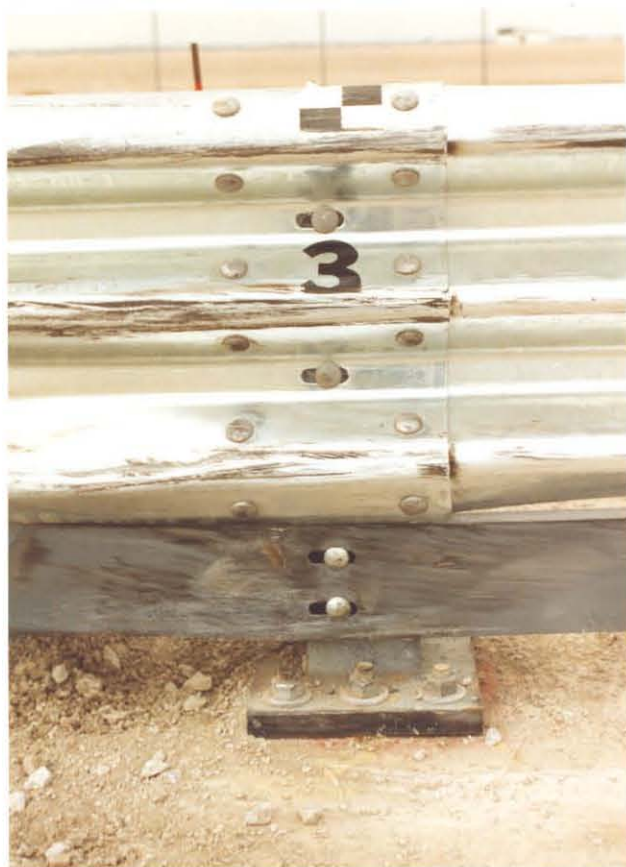
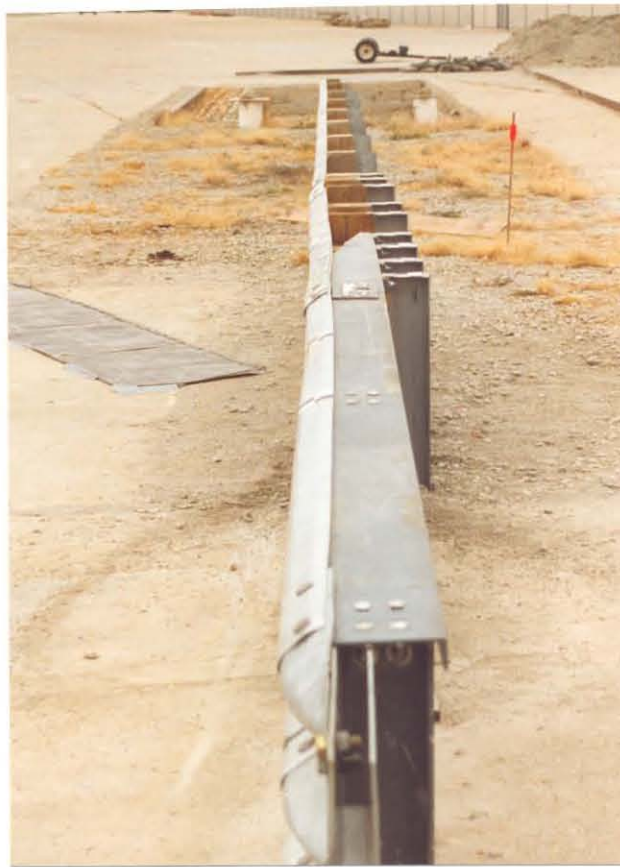
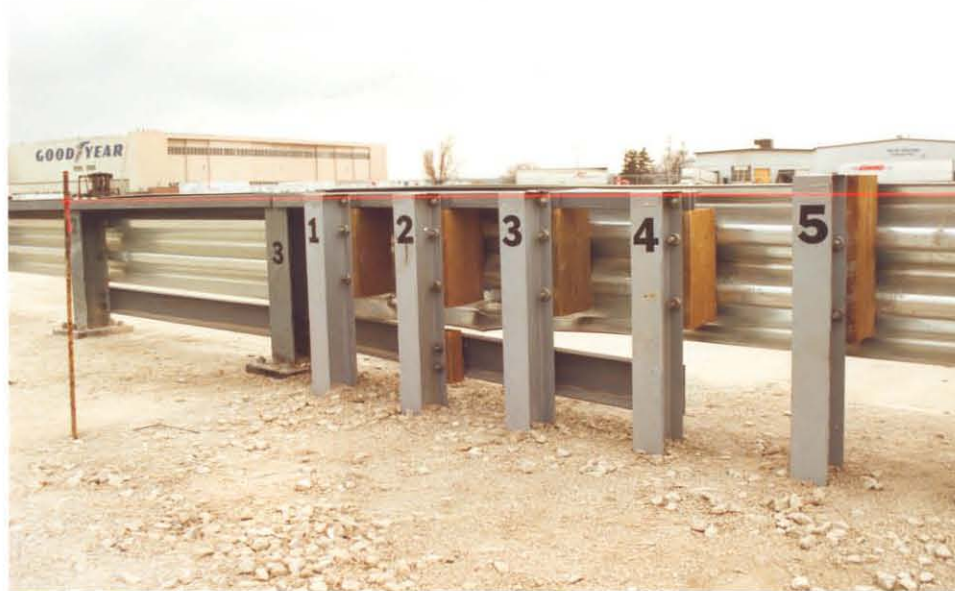
Figure 44. Approach Guardrail Transition Damage, Test MST-2

Damage to the barrier was moderate, as shown in Figures 44 through 46. Barrier damage consisted mostly of deformed thrie beam and contact marks on the thrie beam and rubrail. The thrie beam damage consisted of moderate deformation and flattening of the impacted section of rail between post nos. 3 through B3. Contact marks were found on the thrie beam between post nos. 3 and B2. Contact marks were also found on the rubrail from the center line of post no. 1 to the midpoint of the span between bridge post nos. B2 and B3. No significant damage occurred to the posts, wood blockouts, the W-beam, nor the W-beam to thrie beam transition section.

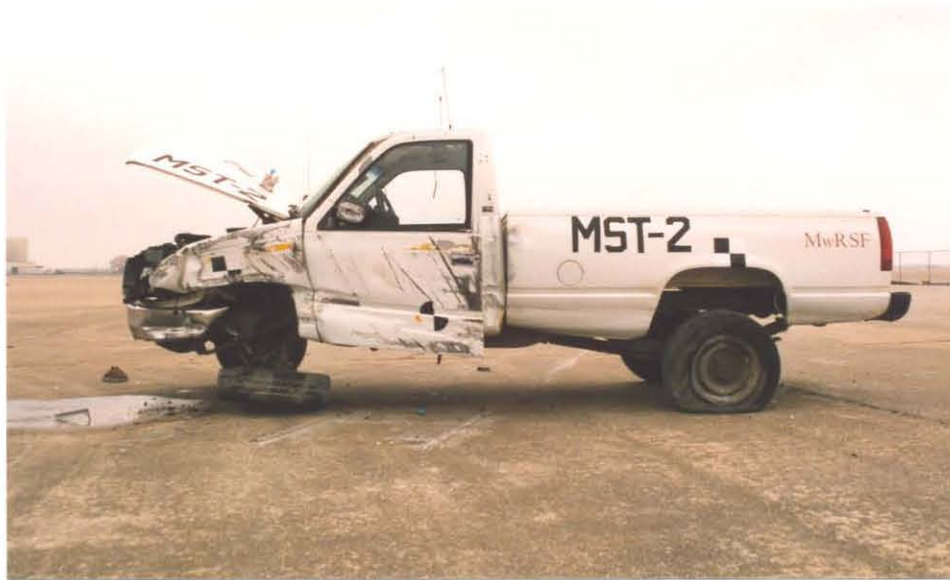
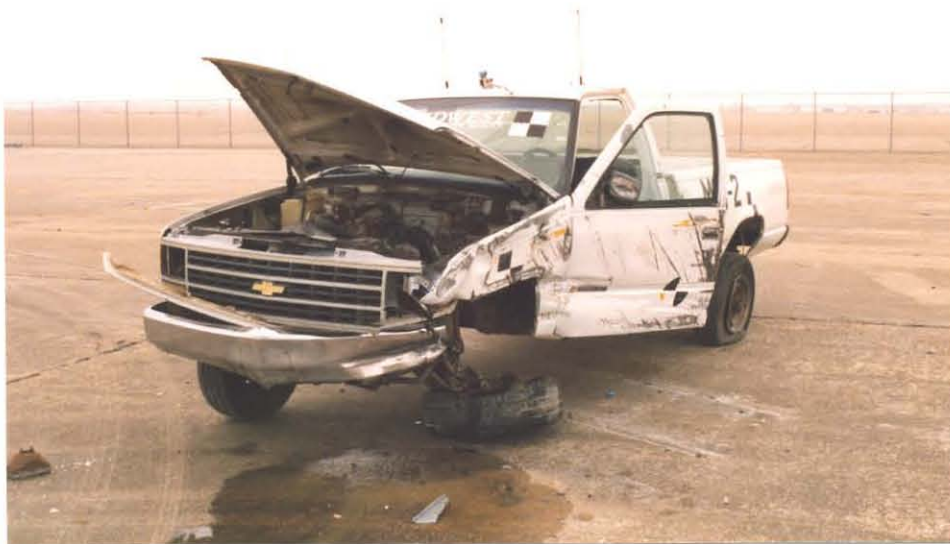
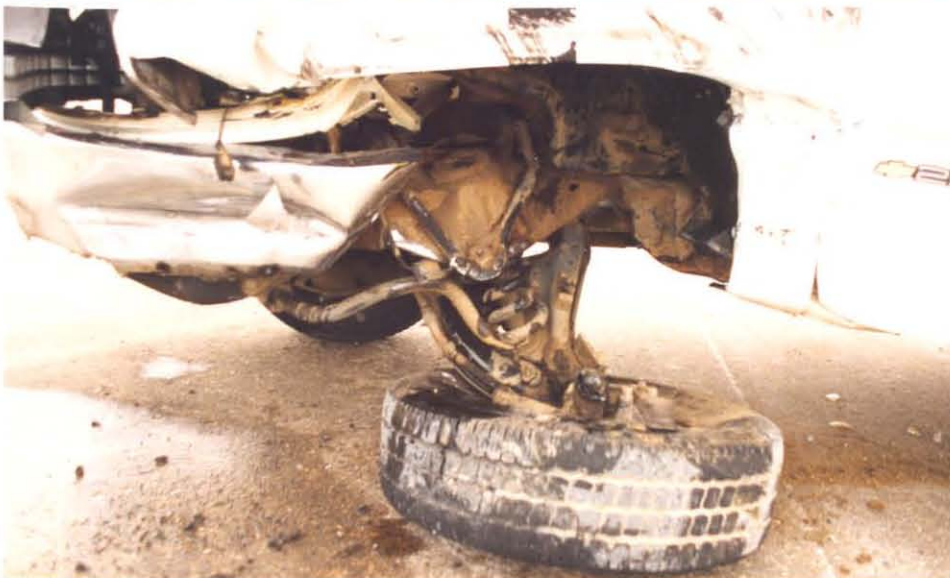
Figure 47. Vehicle Damage, Test MST-2

Exterior and interior vehicle damage was extensive and occurred at several body locations, as shown in Figures 47 through 49. Most of the vehicle damage occurred near the left-front corner

of the vehicle, consisting primarily of damage to the fender, hood, bumper, and door. This damage also included disengagement of the front wheel from the upper A-frame connection, disengagement of the tie rod end, and deformation of the lower A-frame. The rear of the cab was crushed on the left side. The engine hood of the vehicle buckled, and the windshield was cracked. The left-rear tire was deflated. The floorboard of the occupant compartment also sustained significant plastic deformations due to the severe impact with the barrier as well as from vehicle rollover. The right door, left door, and rear windows remained undamaged.
