# DEVELOPMENT OF A TEMPORARY BARRIER SYSTEM FOR OFF-ROAD APPLICATIONS

## **MIDWEST ROADSIDE SAFETY FACILITY**

*MwRSF Research Report No. TRP-03-66-98*

March 1998

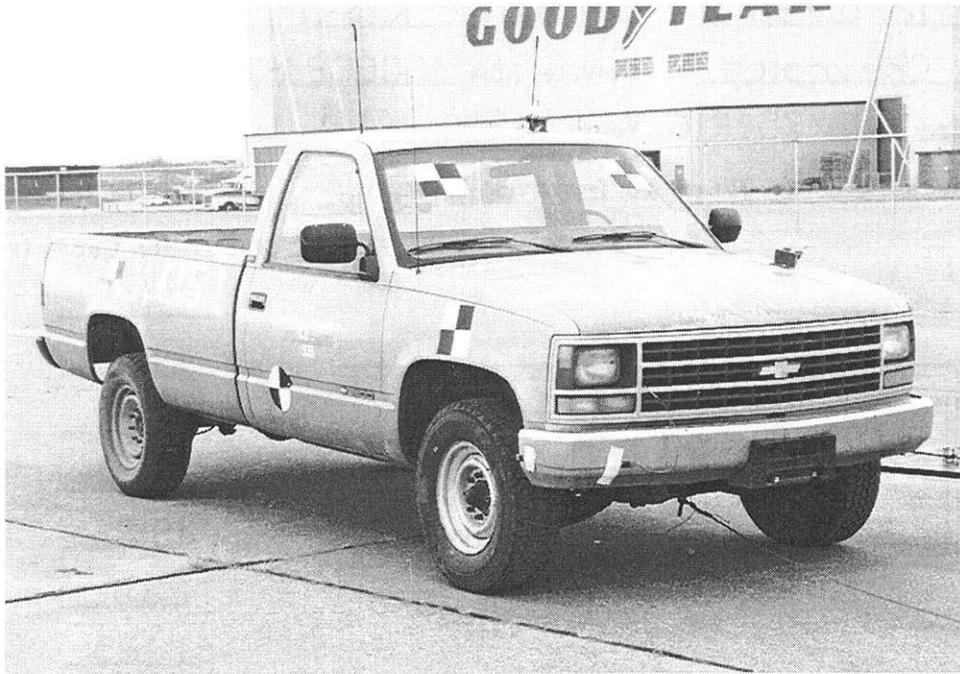
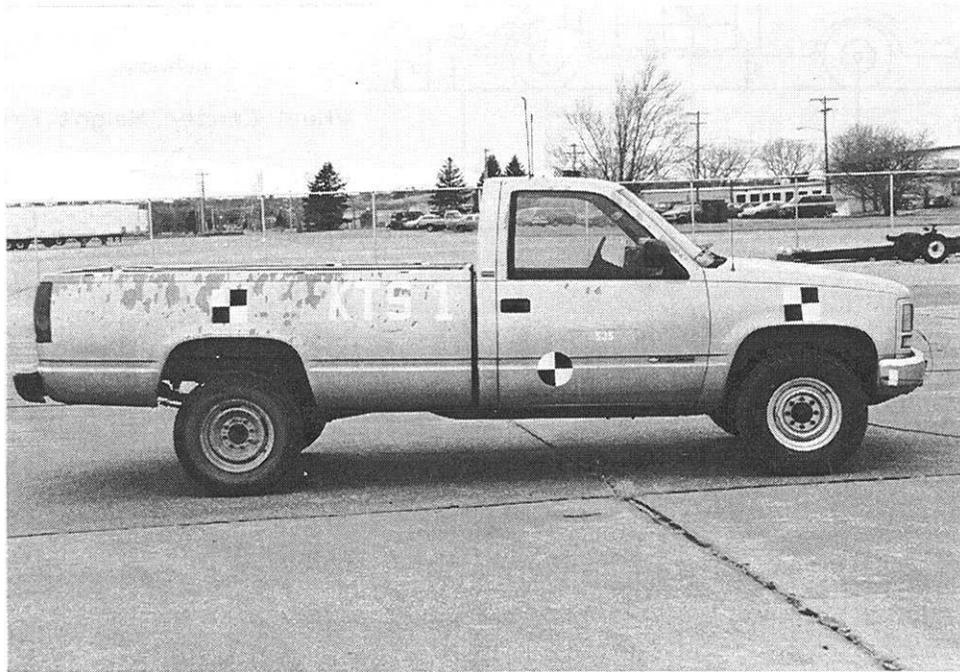
Figure 4. Test Vehicle, Test KTS-1

The test vehicle used for test KTS-1 was a 1990 Chevy 2500 Series 3/4-ton pickup truck. The test inertial and gross static weights were 1998-kg (4404-lbs). The test vehicle is shown in Figure 4, and its dimensions are shown in Figure 5.

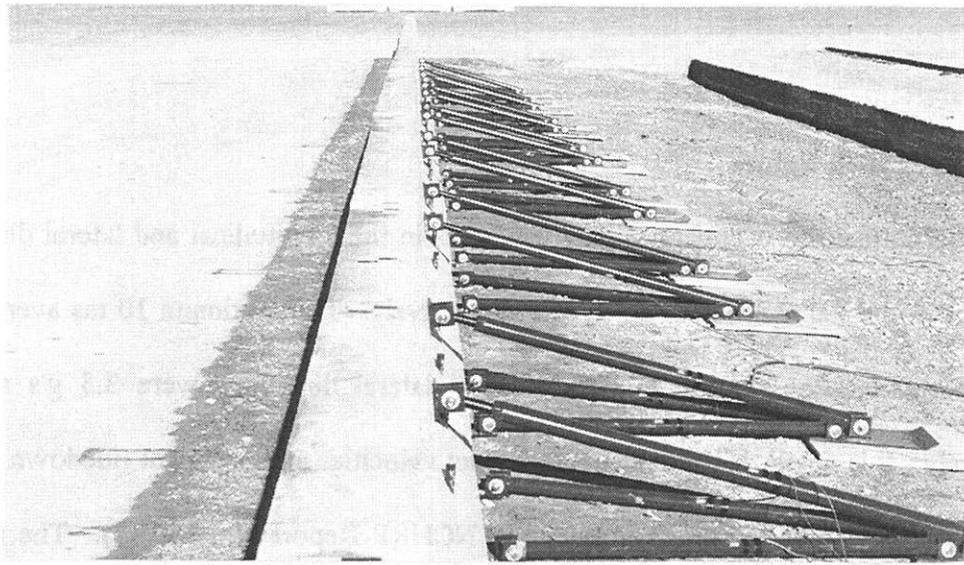
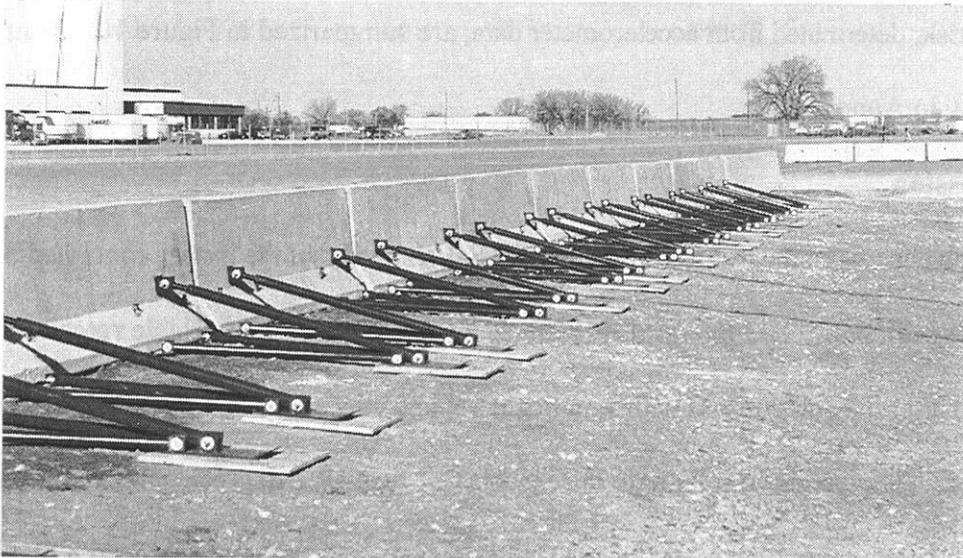
Figure 8. Portable Concrete Barrier System with Ski Design, Test KTS-1

A 62.0-m long barrier system was constructed on soil at the MwRSF outdoor test site, as shown in Figure 8. The barrier system consisted of 17 PCBs, each measuring 3,800 mm. The ski configuration discussed earlier was connected to the impact barrier, as well as three additional barriers upstream from impact, and six barriers downstream from impact. Design details for the joint connections and steel reinforcement are shown in Appendix B. It is noted that five additional barrier sections were connected to the upstream end of the installation to better represent an actual field installation.

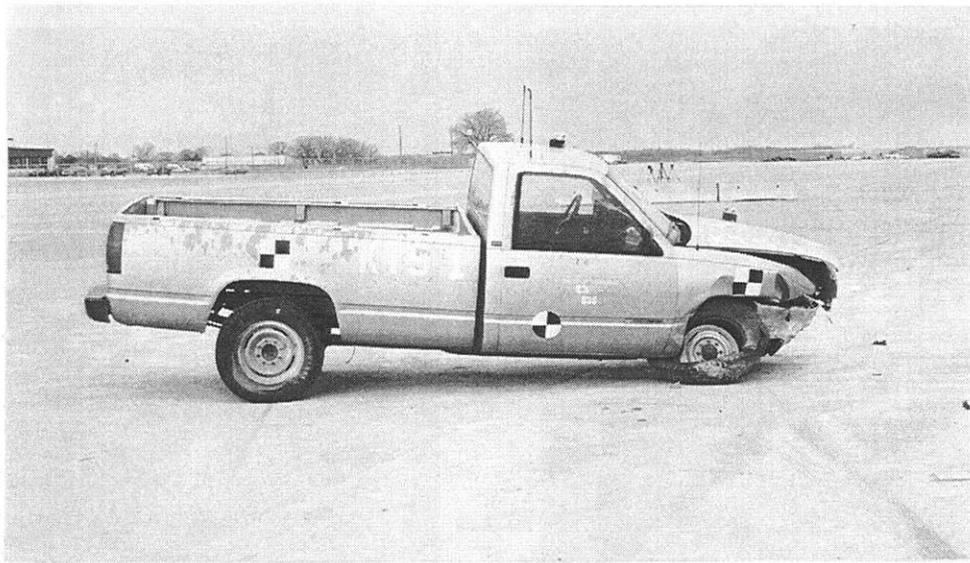
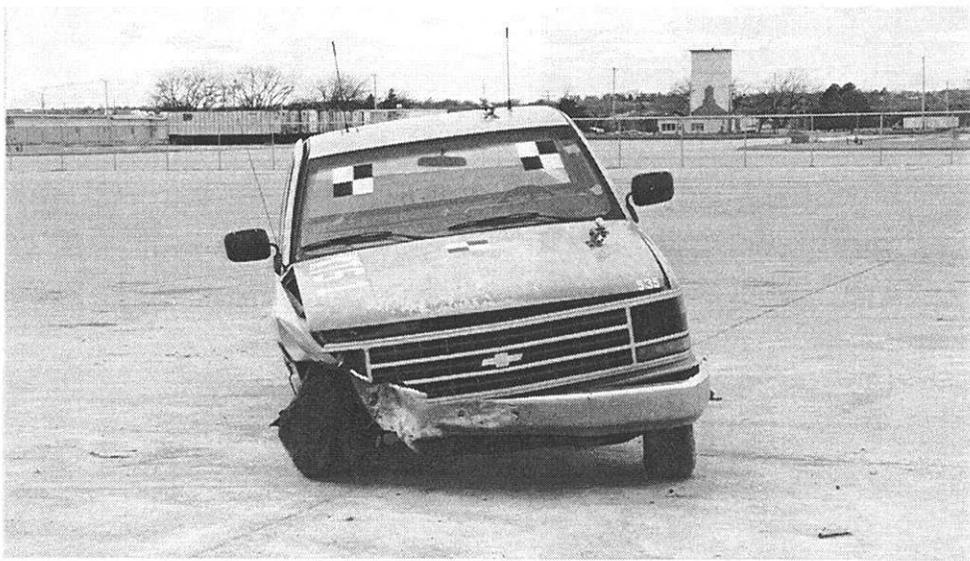
Figure 14. Vehicle Damage, Test KTS-1

Vehicle damage was acceptable, as shown in Figure 14. The right-front quarter panel was crushed in and the right door was deformed outward at the top. The right-front rim was bent in two different places and the tire was torn. There was no major undercarriage damage or disengagements and there was also no box contact. There was only a slight amount of occupant compartment damage with a small crease in the back portion of the passenger side. The deformations were judged to be insufficient to cause serious injury to the vehicle occupants.

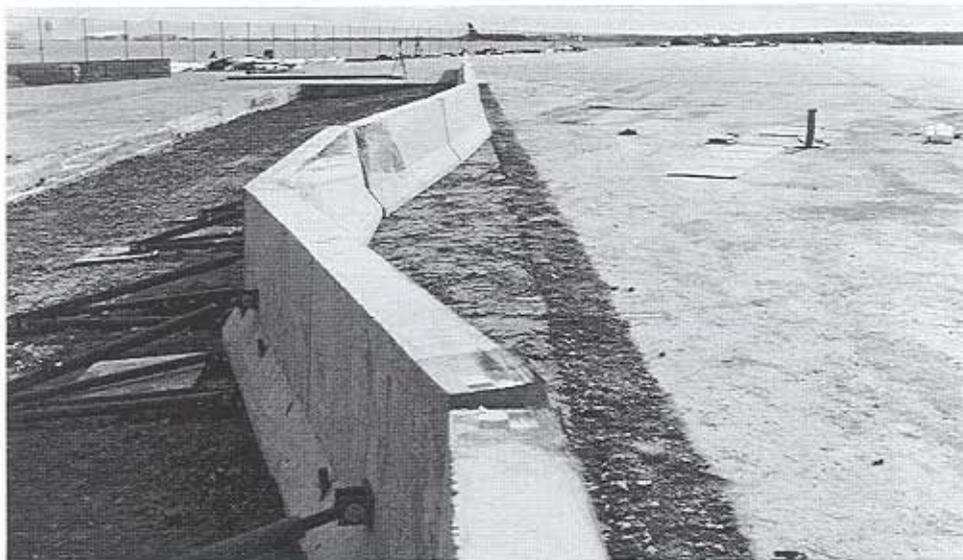
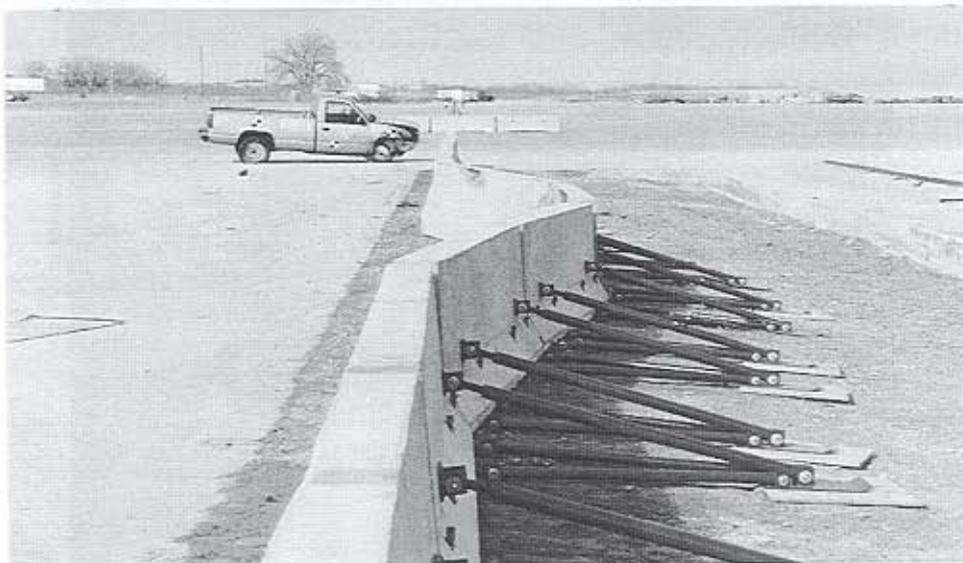
Figure 15. Barrier Damage, Test KTS-1

Barrier damage was minor, as shown in Figures 15 through 17. Concrete damage was mostly cosmetic, consisting of tire marks, scrapes, gouges, and minor spalling. Eleven steel pins were also deformed, with the damage ranging from slight to extensive. The maximum permanent set deflection of the barrier was 1.16 m. No damage was done to the skis with the exception of slight ski plate damage, as shown in Figure 18.
