FULL-SCALE VEHICLE CRASH TEST ON THE IOWA TEMPORARY CONCRETE BARRIER RAIL HALF-SECTION

TRANSPORTATION RESEARCH REPORT TRP-03-014-88

Civil Engineering Department
W348 Nebraska Hall
University of Nebraska-Lincoln
Lincoln, Nebraska
68588-0531

December, 1988

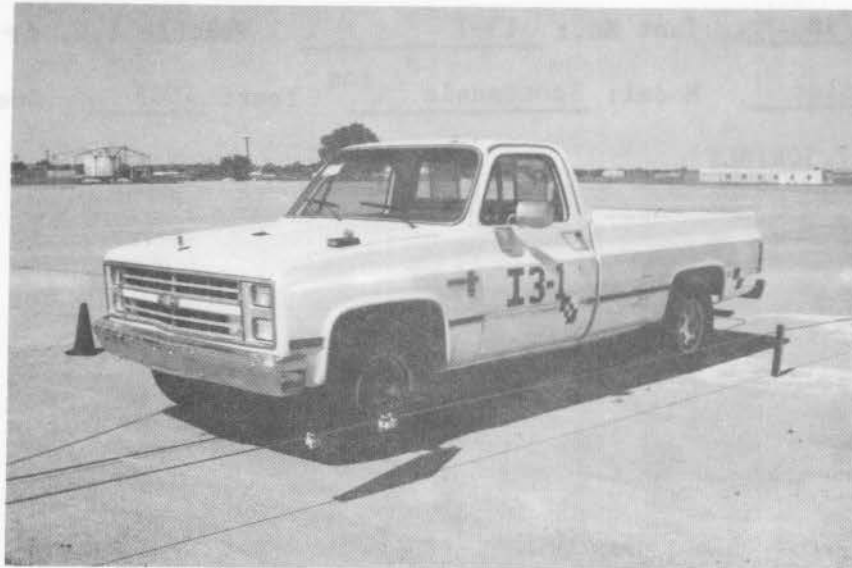
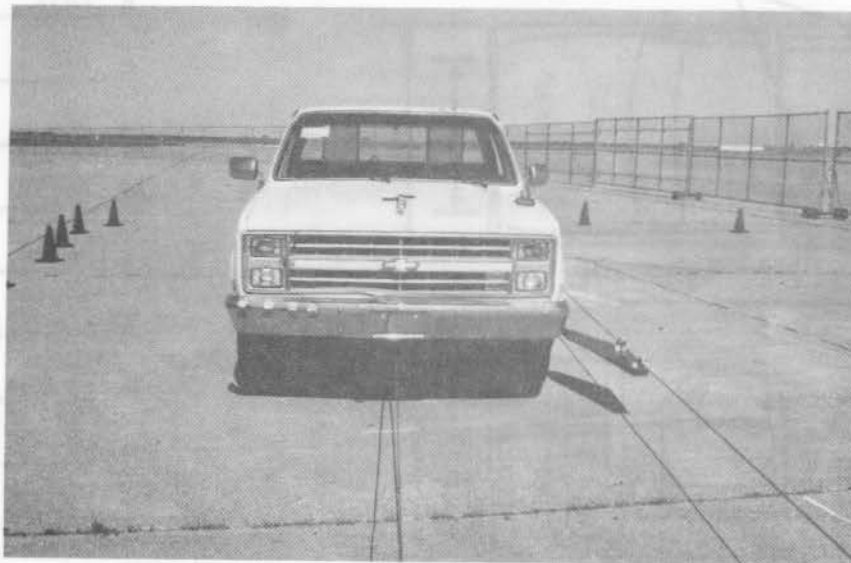
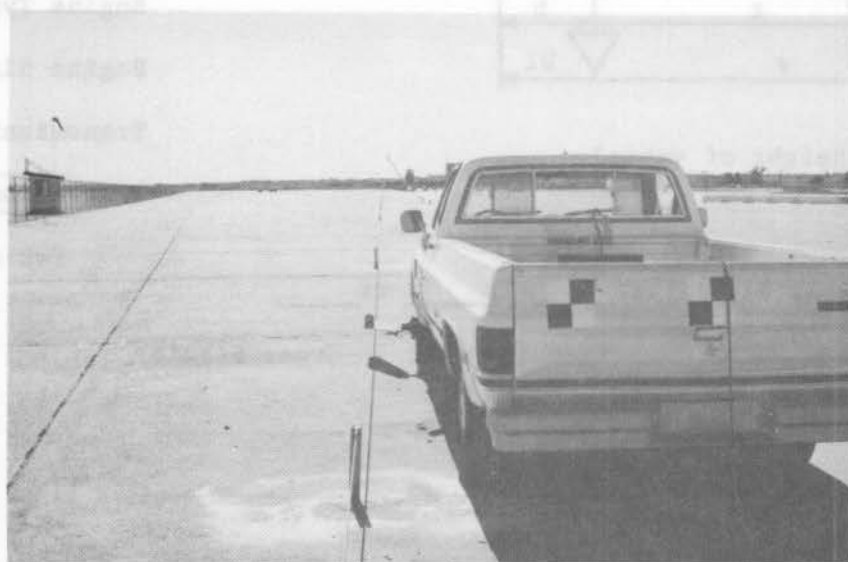
FIGURE 7. PHOTOGRAPHS OF TEST VEHICLE

Three 8-in. square, black and white checkered targets were placed on the centerline of the top of the test vehicle. The middle target was placed over the center of mass. The front and rear targets were placed 5 ft. ahead and 6 ft. behind, the center of mass, respectively. The targets were used in the analysis of the high speed film. In addition to the roof targets, side and rear targets were also placed at known distances to aid in the evaluation process.

Two 5B flash-bulbs were mounted on the front hood of the test vehicle to record the time of impact with the temporary concrete barrier rail on the high-speed film. The flash bulbs were fired by a pressure tape switch mounted on the front face of the bumper.

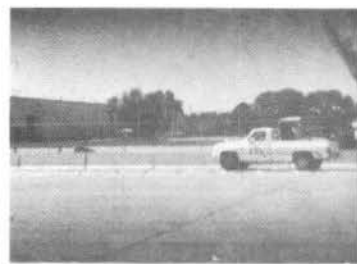
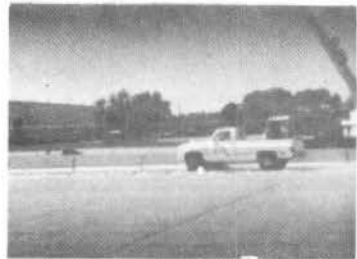
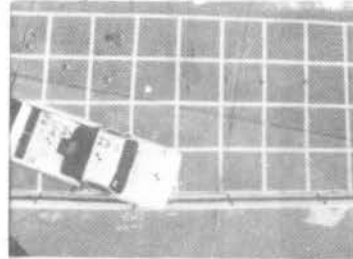
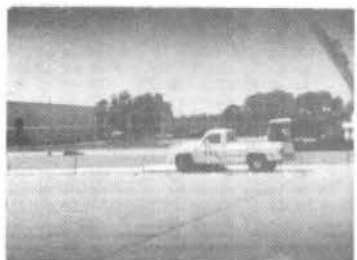
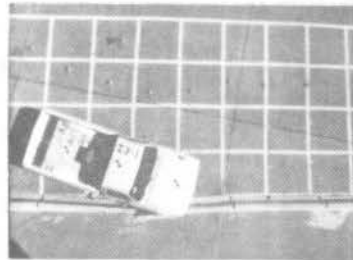
FIGURE 14(a). TIME-SEQUENTIAL PHOTOGRAPHS

Upon impact with the temporary concrete barrier rail, the right front corner of the vehicle began to crush inward at approximately 0.042 sec. At this time, it was also evident that the crack in barrier No. 6 began to form. At about 0.063 sec, the right front wheel started to climb over the barrier rail.

Test I3-1 was conducted with a 5,386 lb. pickup under the impact conditions of 62.3 mph and 20 degrees. A summary of the test results is shown in Figure 13. The sequential photographs are shown in Figures 14(a) and (b).

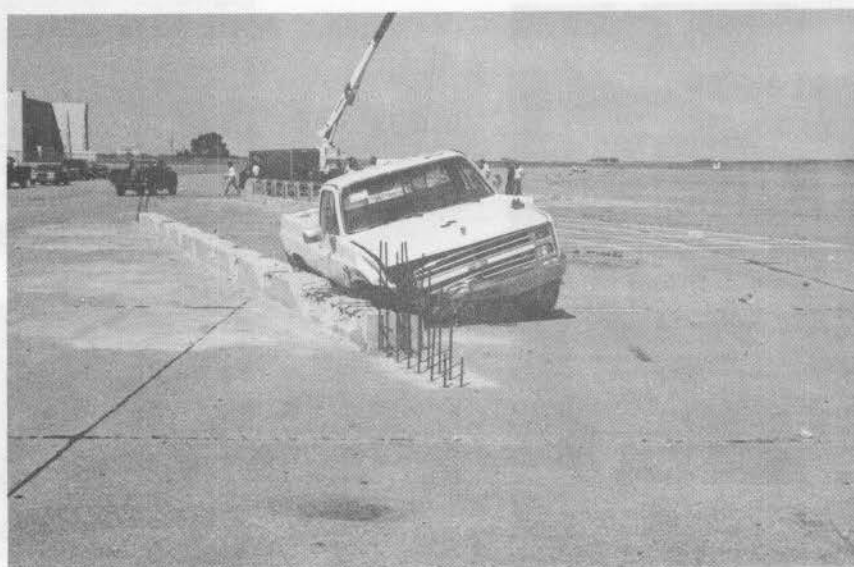
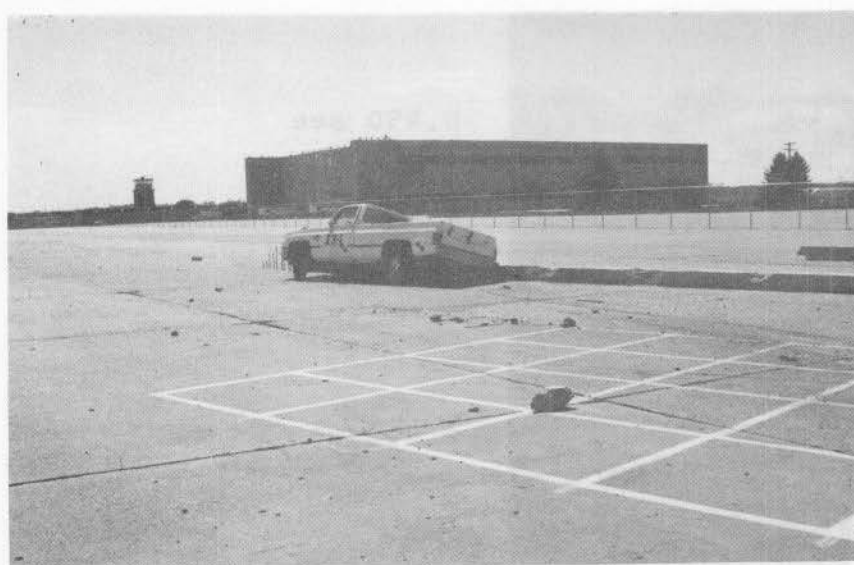
FIGURE 15. VEHICLE DAMAGE, TEST I3-1

Photographs of the vehicle damage are shown in Figure 15. As evident, the vehicle damage was marginal. The TAD and VDI damage classifications are shown in Figure 13. Photographs of the extensive damage to the barrier rail are shown in Figures 16 and 17. During the crash test, medium-size pieces of concrete were thrown away from the barrier.

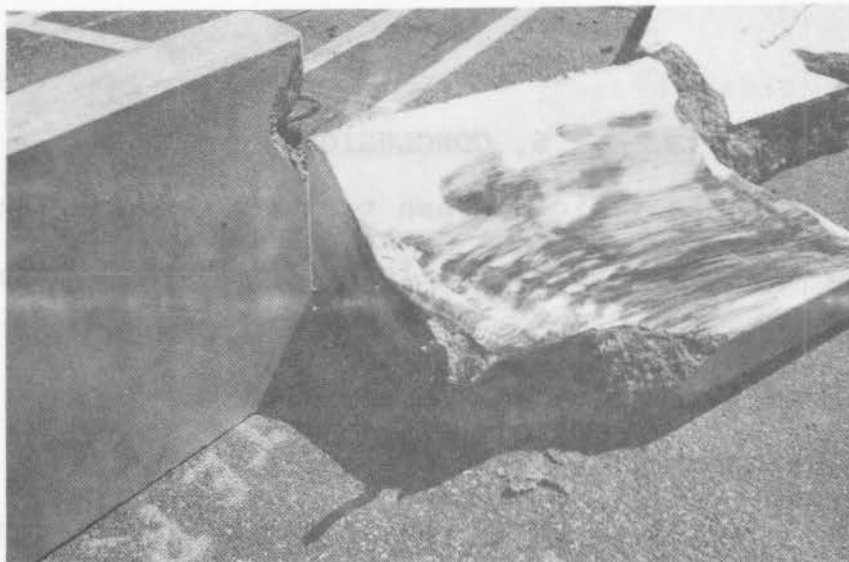
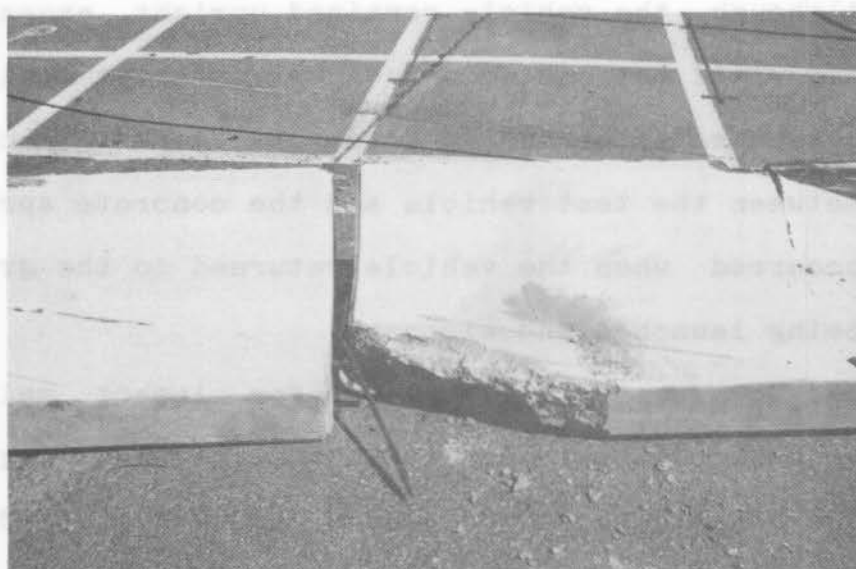
FIGURE 17. TEMPORARY CONCRETE BARRIER RAIL
CONNECTOR DAMAGE

After impact, the excessive barrier rotation caused the steel rod between barriers No. 5 and No. 6 to bend. This allowed the steel rod to pull out of the cable loops. This was evident in the photographs in Figure 17. The top embedded cable in barrier No. 7, at the joint between barriers No. 6 and No. 7, pulled out of the concrete barrier. This may have occurred when the front undercarriage of the vehicle snagged at the top of barrier No. 7 as it climbed over the end of the section.

The cable or wire rope connector faired reasonably well. The only major problem occurred at the point of impact. The steel rod bent and pulled through the wire loops. It is not known if this would still occur if the barrier (section No. 6) would not have fractured at midspan due to inadequate reinforcement. Thus, if proper reinforcement was located, it is in our opinion that the connector assembly at impact may have performed in a more predictable manner.
