**FULL-SCALE VEHICLE CRASH TESTS**  
**on**  
**GUARDRAIL-BRIDGERAIL TRANSITION DESIGNS**  
**with**  
**SPECIAL POST SPACING**

TRANSPORTATION RESEARCH REPORT TRP-03-008-87

May 1987

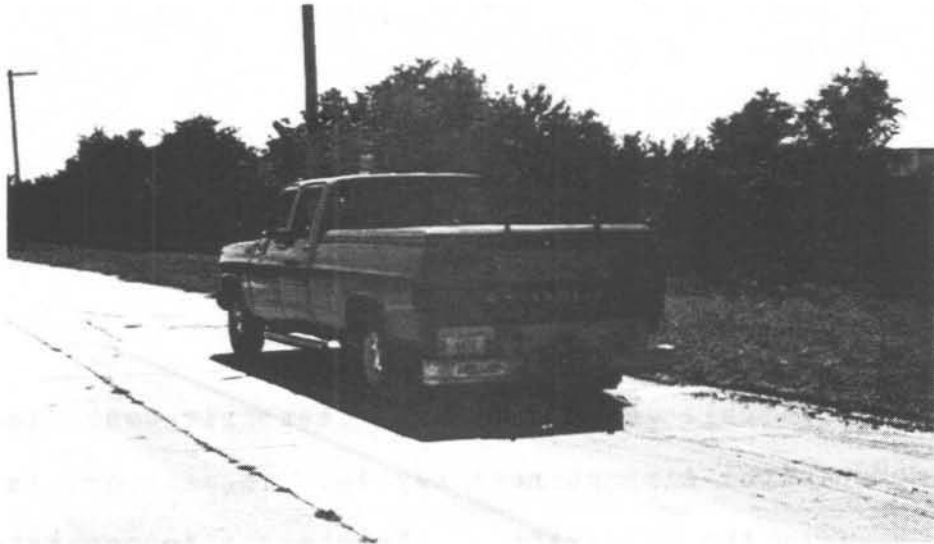
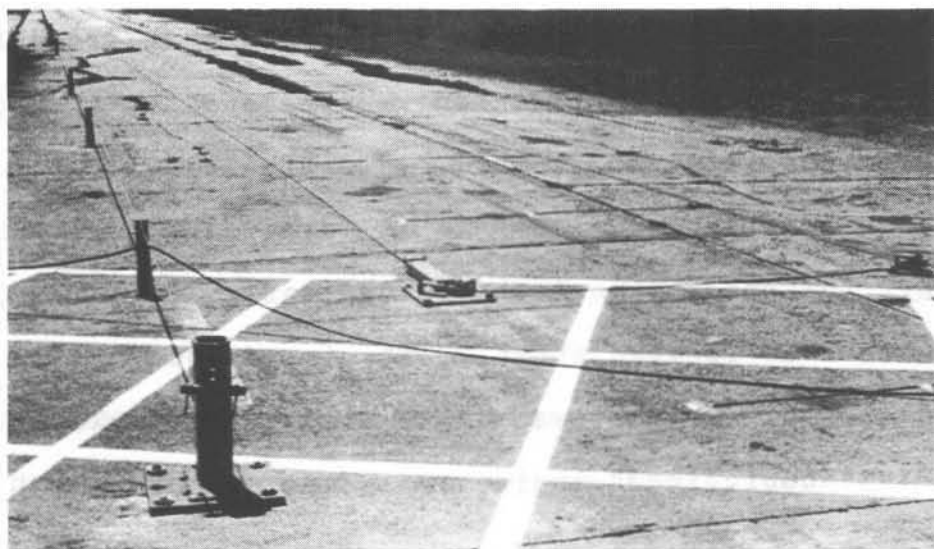
Figure 3  
PHOTOGRAPHS OF CABLE TOW SYSTEM

A cable tow system having a 2:1 mechanical advantage was used to tow the crash test vehicle. Photographs of the system are shown in Figure 3, and a detailed sketch of the system is shown in Figure 4. In this type of system, the test vehicle is travelling at a speed and distance that are exactly two times that of the tow vehicle.

One end of the tow cable was attached to a smooth vertical rod bolted to the front cross-frame member under the engine of the test vehicle, whereas, the other end was clamped to a dead-end anchor. The cable loop attached to the rod on the test vehicle was held-up in place with a piece of soft 18 Ga. wire. The tow cable was pulled down off the rod as the test vehicle passed over the pulley with a chute which was located about 25 ft. in advance of the barrier.

The towing vehicle was a 1981 Chevrolet Pickup truck with a large "454 cubic-inch" engine and a no-spin differential rear-end.

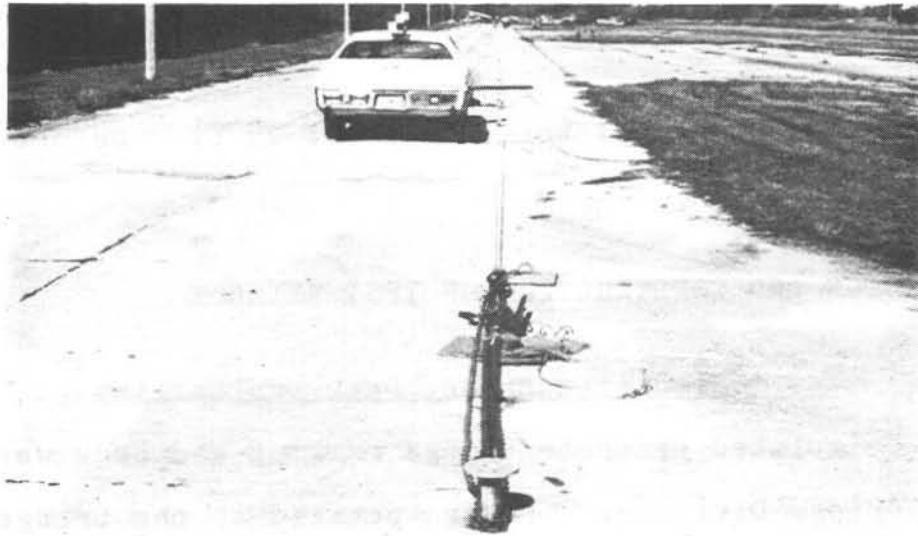
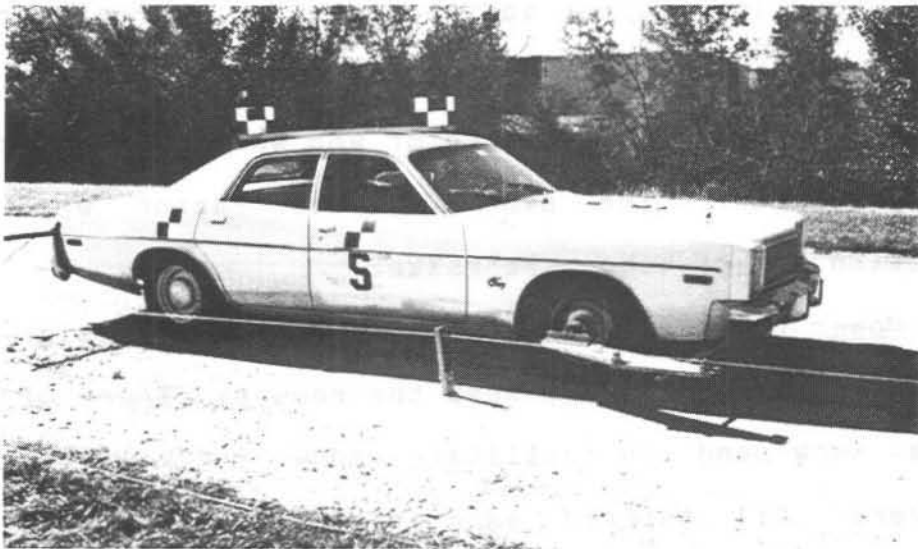
Figure 5  
PHOTOGRAPHS OF CABLE GUIDANCE SYSTEM

The 3/8 in. dia. Guide Cable (wire rope) was 1,000 ft. long and it was tensioned to 3,000 lb. by use of a Come-Along. The Dynamometer used to measure the tension in the cable was located between the Come-Along and upstream end anchor post. The stanchions, placed 50 ft. on centers, were used to minimize sag and lateral sway. The Stanchions were placed in cored holes in the concrete road slab and had a "hinge" that permitted them to fall to the roadway when struck by the Guide Flag. The Guide Flag was bolted to the rim of the right front wheel and was connected to the guide cable by two sets of roller bearings. The vehicle was released from the guide cable when two small 1/8 in. machine screws were sheared-off as the guide flag impacted the downstream end anchor post. The end anchor post was located so that the vehicle was

"free-wheeling" for a distance of about 25 ft. before impacting the barrier.

Referring to Figure 5 (p11), the two reference targets used in the analysis of the high-speed film and mounted on the centerline of the roof of the vehicle were spaced 5 ft. on centers. The forward target was mounted directly above the center-of-gravity of the vehicle.

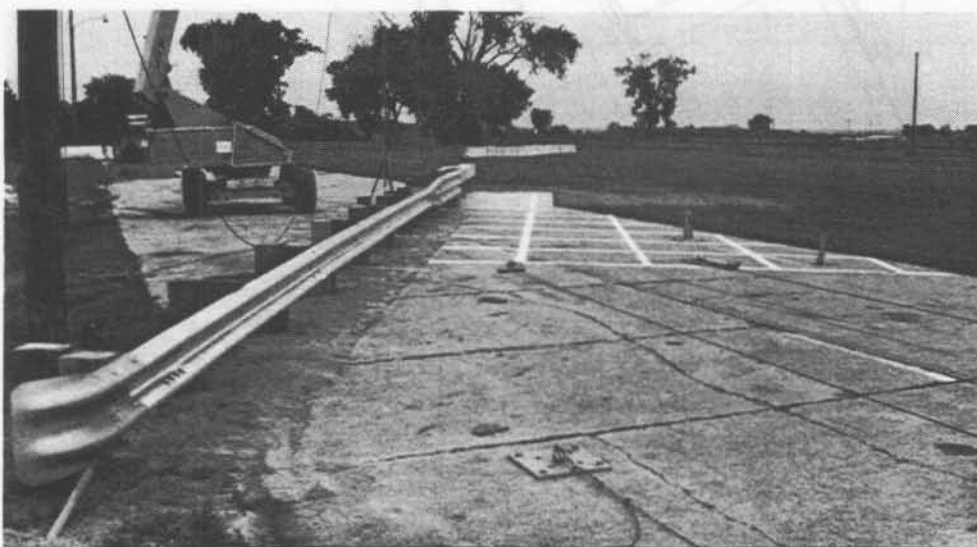
Figure 9  
PHOTOGRAPHS OF APPROACH GUARDRAIL INSTALLATION

Design details of the combination W-Beam and Thrie Beam approach guardrail system are shown in Figure 8, and photographs of the installation are shown in Figure 9. The overall length of the guardrail installation was 56 ft.-3 in. A 6 ft. wide strip of the concrete roadway slab was sawcut and removed for the installation of

the guardrail in native soil. The guardrail was installed at an angle of 25 deg. relative to the centerline of the roadway.

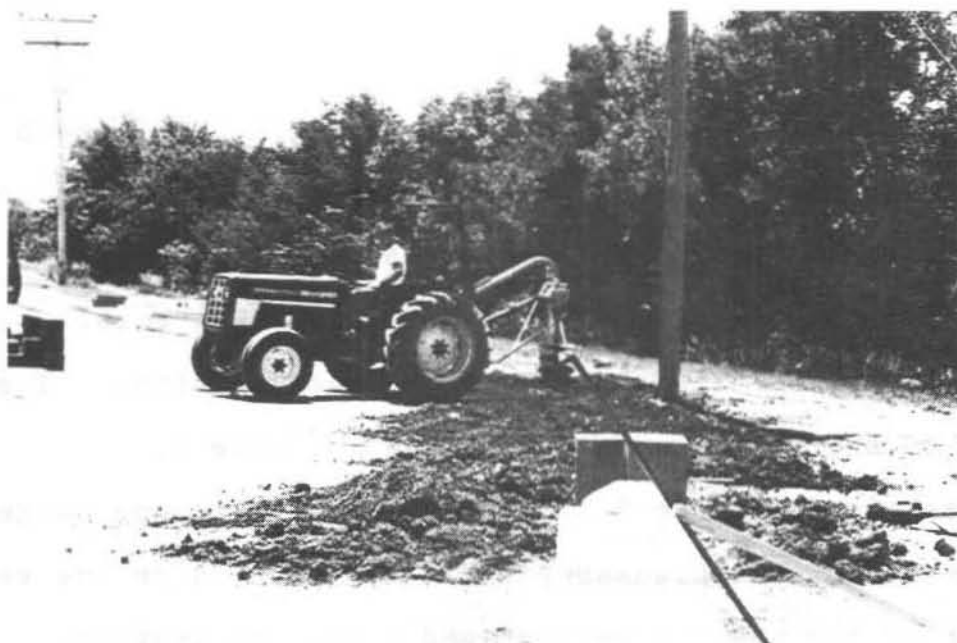
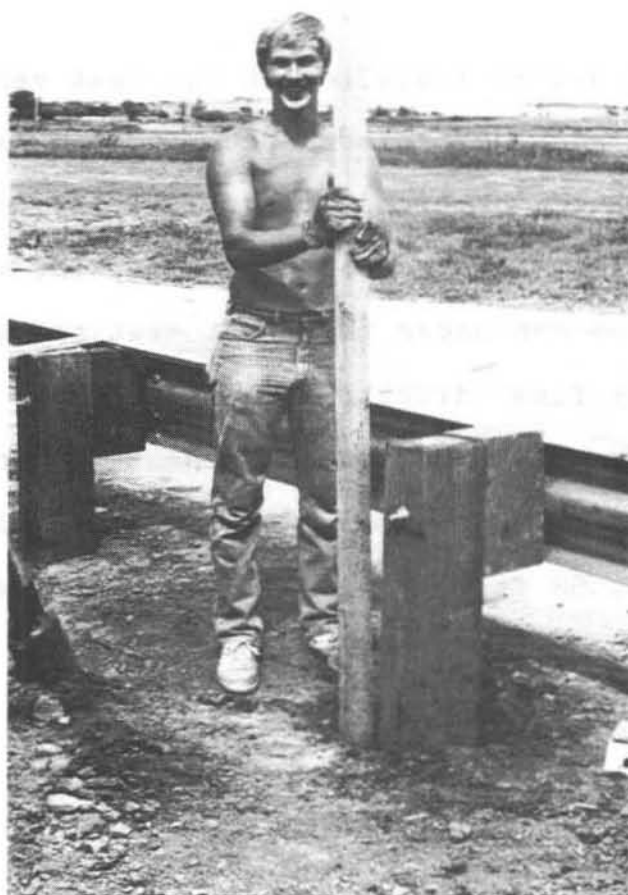
Figure 10  
PHOTOGRAPHS OF WOOD POST INSTALLATION

The wood posts were placed in 18 to 20 in. dia. holes. The backfill soil around the posts was compacted by hand (as shown in Figure 10) in 6-in. layers to a density of approximately 92%. The soil tests conducted by the NDR and a private soil testing agency (Geotechnical Services, Inc.) are presented in Appendix A. The field density of the soil was measured by a Troxler Nuclear Density Meter.

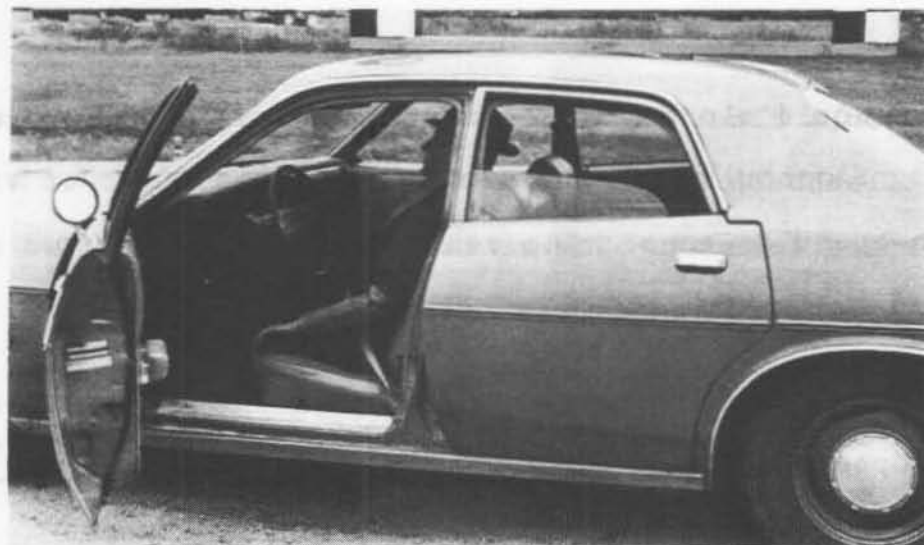
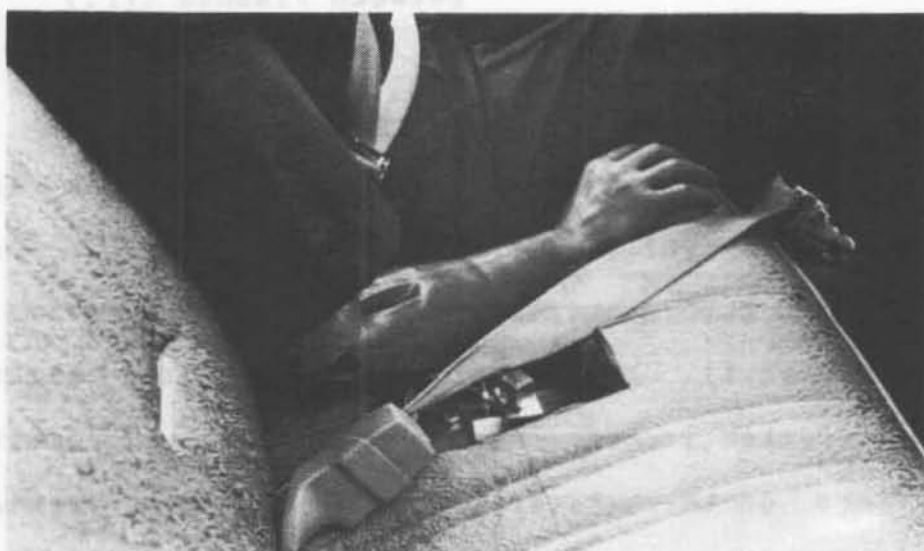
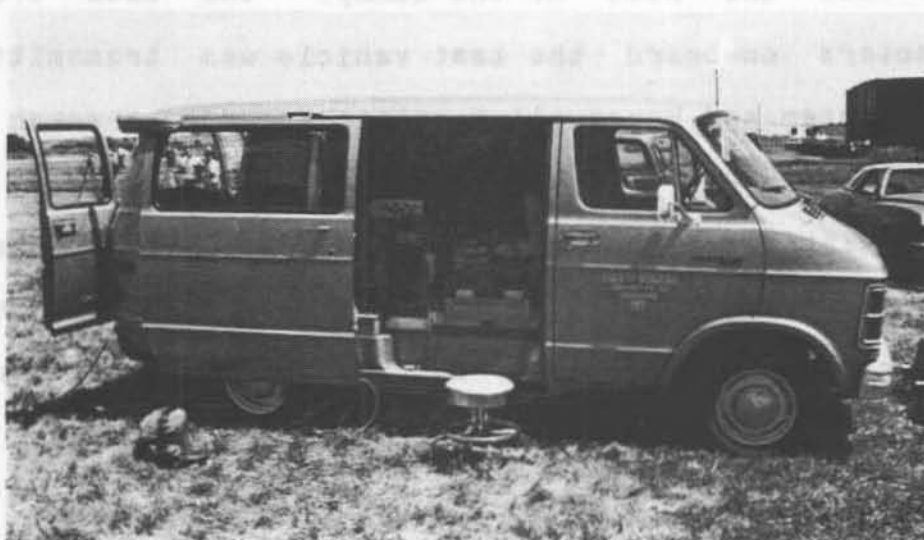
Figure 11  
PHOTOGRAPHS OF DUMMY AND ELECTRONIC EQUIPMENT

Photographs of the 160 lb. Anthropometric Dummy in the test vehicle, the tri-axial accelerometer unit on the C.G. of the test vehicle, and the data acquisition system placed in a van vehicle are shown in Figure 11. A schematic diagram of the electronic data acquisition system is presented in Figure 12. In addition to the accelerometers on the vehicle, a tri-axial accelerometer unit was placed inside the head of the dummy. The data from the six accelerometers on-board the test vehicle was transmitted to the Metraplex System and Honeywell Magnetic Recorder through a 1,200 ft. length of a an 18 pair, 36 conductor cable.

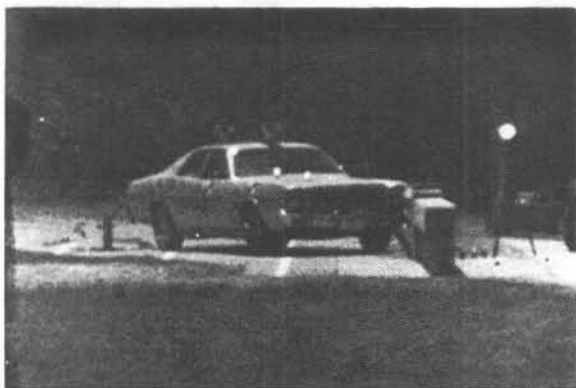
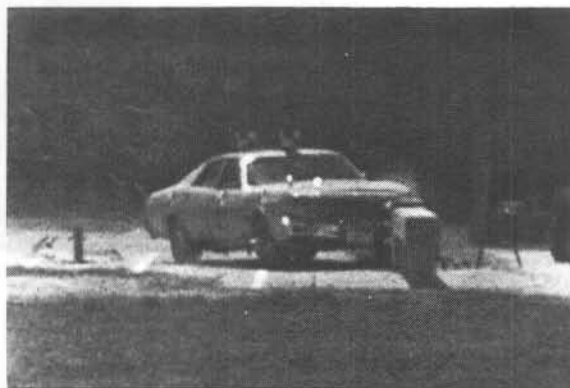
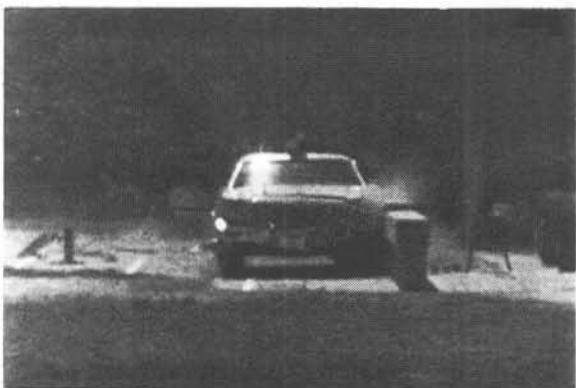
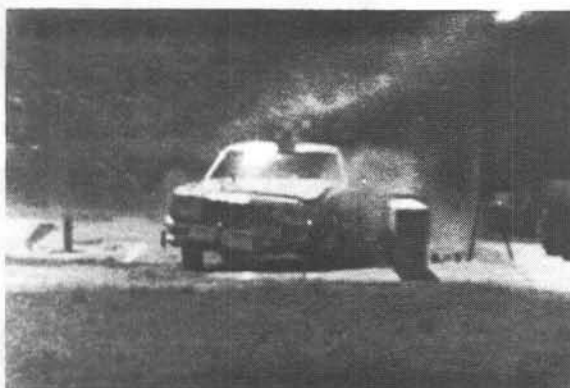
Figure 13  
SEQUENTIAL PHOTOGRAPHS OF TEST NO. 1

Sequential photographs of Test No. 1 are shown in Figure 13, and a description of the sequential events is presented in Table 5. At a time of 76 msec after impact, the vehicle reached its greatest depth of crushing into the guardrail. At a time of 194 msec, the "lateral" velocity component of the vehicle was zero as the vehicle became parallel to an extended centerline of the traffic barrier. Somewhere in between 76 and 194 msec, an occupant would have moved laterally 12 in. and struck the side of the vehicle.

Time (msec)	E V E N T
0	Vehicle Impact
76	Max. Vehicle Crushing of 22 in.
194	Vehicle Becomes Parallel to Center Line of Traffic Barrier
294	Vehicle Exit

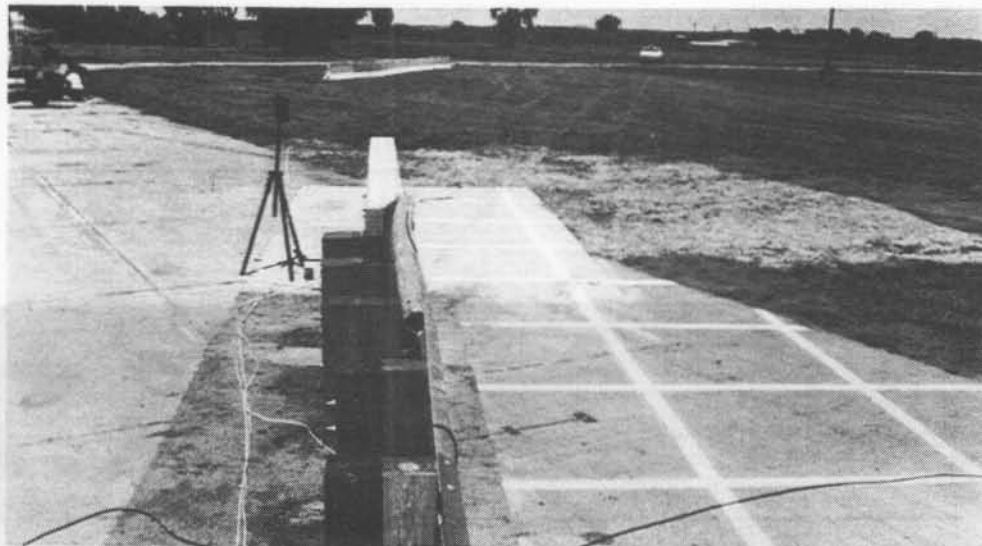
Figure 14  
PHOTOGRAPHS OF TEST NO. 1 GUARDRAIL DAMAGE

Photographs of the guardrail damage are shown in Figure 14, and measurements of the guardrail permanent set deflections are shown in Figure 15. The tubular thrie beam was fabricated by a local steel manufacturer by shop welding two thrie beams back-to-back (see Figure 2c). The end shoe was welded on the outside of the tubular thrie beam. As evident, the damage to the guardrail was very minor with a maximum guardrail permanent set of only 2 1/2 in. Due to a technical problem with the overhead camera, no measurement was made of the maximum guardrail dynamic deflection. Assuming a typical impact factor of 1.5, an estimate of the maximum dynamic deflection would be 4 in.

As can be seen in Figure 14, the vehicle tire scuff marks were relatively straight after exit from the barrier. The vehicle exit angle was 15 deg, and the vehicle travelled 270 ft. before it came to a stop with no braking. The tire scuff marks were caused by the deformed inward alignment of the two front wheels. The vehicle rebound distance was 72 ft.

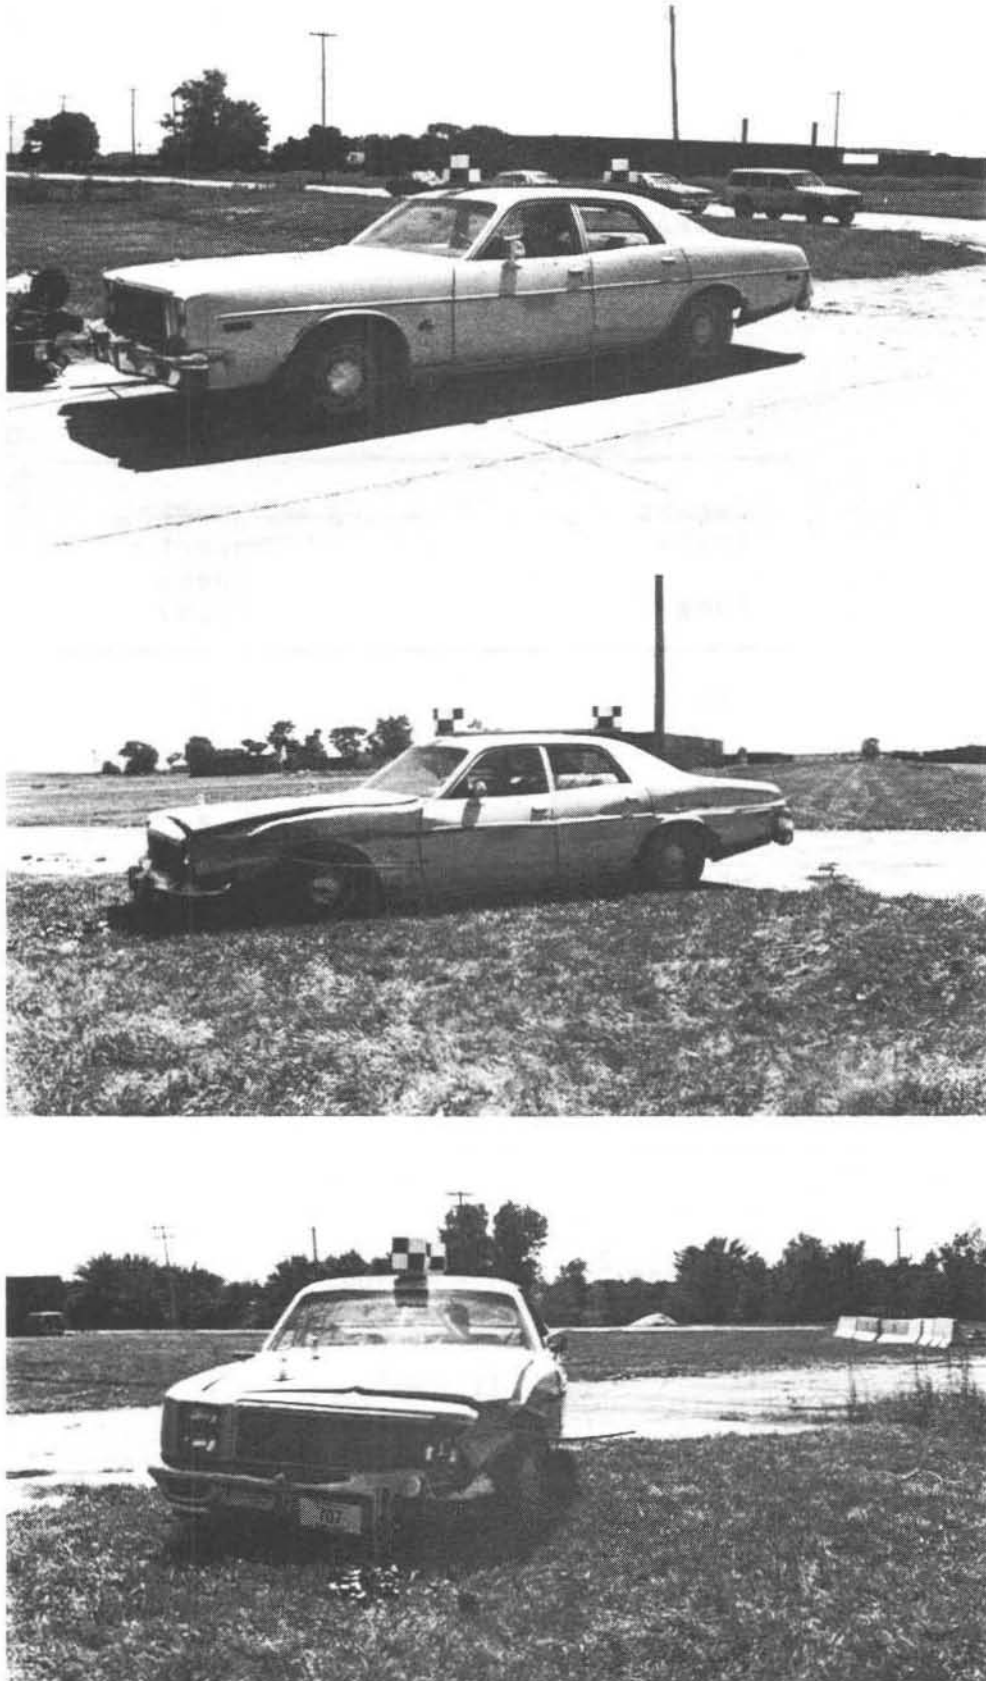
Figure 16  
PHOTOGRAPHS OF TEST VEHICLE BEFORE AND AFTER TEST NO. 1

Photographs of the test vehicle before and after impact are shown in Figure 16. As evident, damage to the vehicle was moderate and repairable. The left front door was not sprung open under the lateral side impact loading of the dummy. The left front corner was crushed 15 in. and the right front corner was deformed outward 3 in. The left rear corner was crushed 4 in. The vehicle damage was assigned a NSC (7) TAD rating of LFQ-3. Based on the findings in NCHRP 86 (8), the damage rating indicates that injuries will occur in 18% of the vehicles damaged to this extent that. The method to determine injury accident probability in NCHRP 86 is presented in Appendix E.

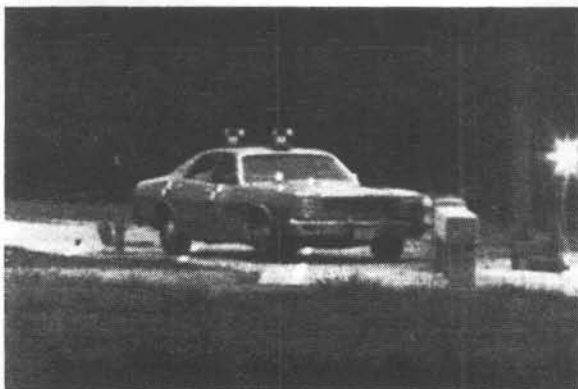
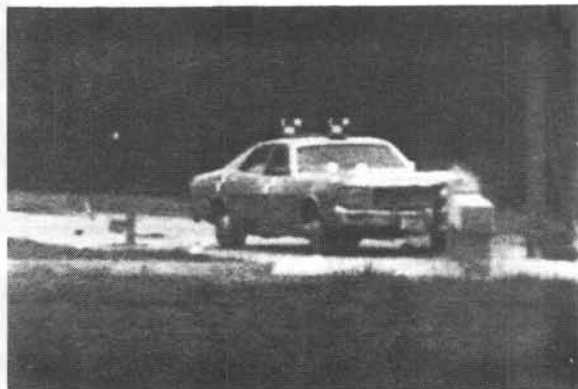
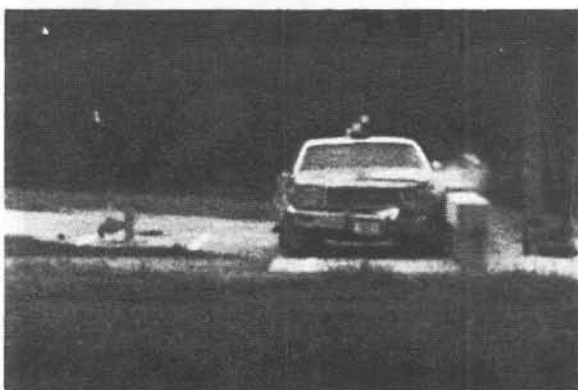
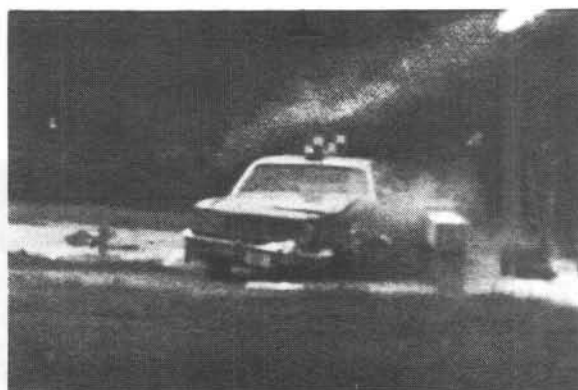
Figure 17  
SEQUENTIAL PHOTOGRAPHS OF TEST NO. 2

Sequential photographs of Test No. 2 are shown in Figure 17, and a description of the sequential events is presented in Table 8. The maximum vehicle crushing of 16 in. occurred at a time of 70 msec after impact. At a time of 193 msec, the "lateral" velocity component of the vehicle was zero as the vehicle became parallel to the centerline of the traffic barrier. The vehicle exit from the barrier occurred at a time of about 331 msec.

Time (msec)	E V E N T
0	Vehicle Impact
70	Max. Vehicle Crushing of 16 in.
193	Vehicle Becomes Parallel to Center Line of Traffic Barrier
331	Vehicle Exit

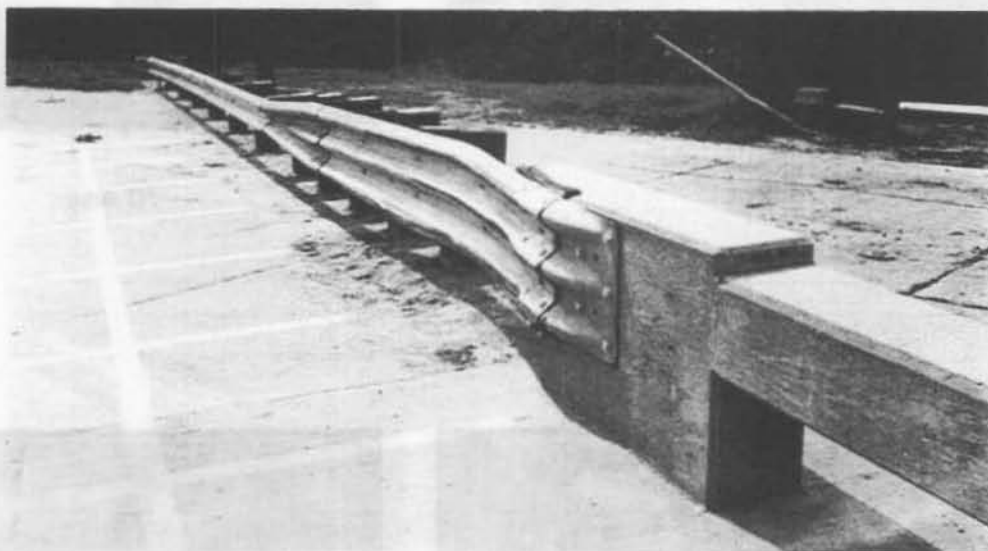
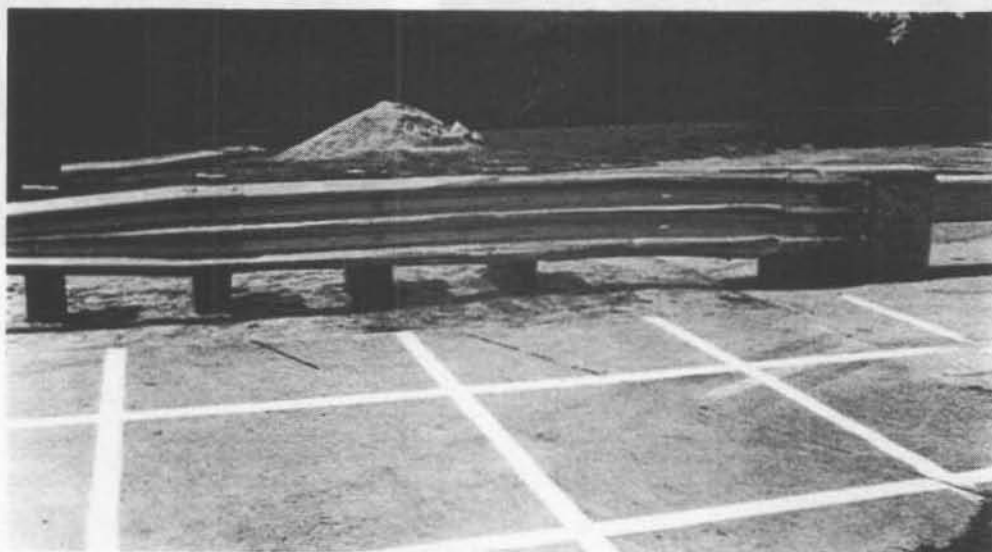
Figure 18  
PHOTOGRAPHS OF TEST NO. 2 GUARDRAIL DAMAGE

Photographs of the guardrail damage are shown in Figure 18, and measurements of the guardrail permanent set deflections are shown in Figure 19. As evident, the damage was relatively minor and there was evidence of vehicle snagging. The maximum permanent set was approximately 6 in. Due to technical problems with the overhead camera, no measurements were made of the guardrail dynamic deflections. Assuming an impact factor of 1.5, it was estimated that the maximum dynamic deflection was 9 in.

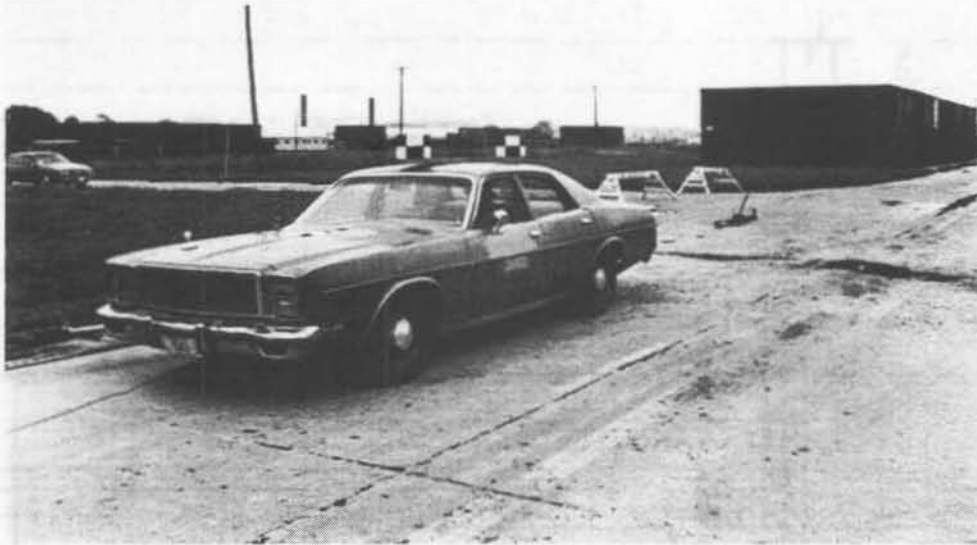
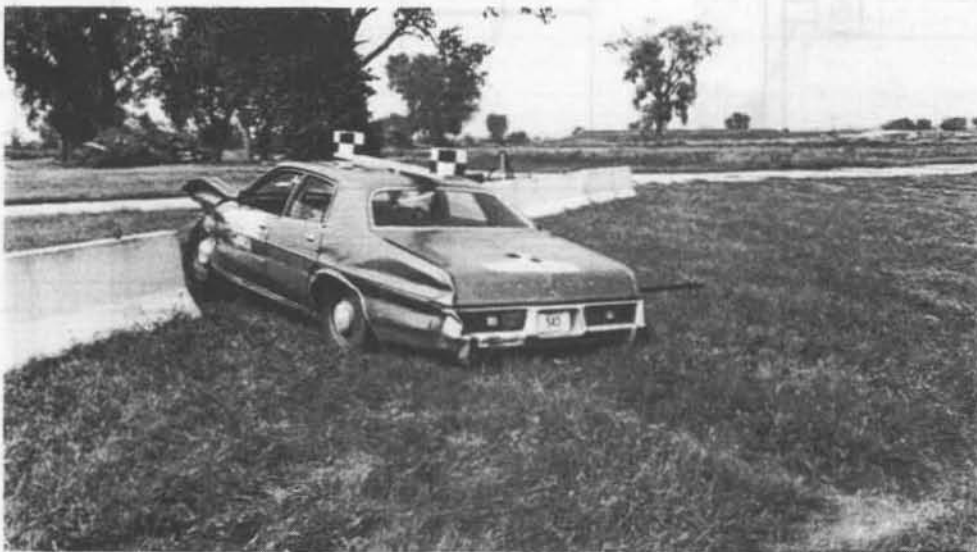
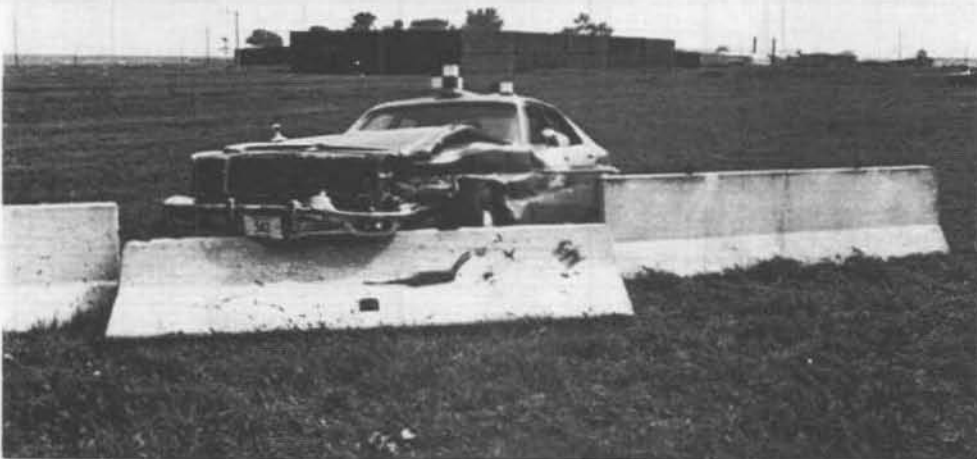
Figure 20  
PHOTOGRAPHS OF TEST VEHICLE BEFORE AND AFTER TEST NO. 2

the vehicle was travelling at a speed of 10 mph or less when it was stopped by the CMB. Because the 20 ft. CMB sections were not connected and were free to slide and rotate as an individual section, it was assumed that most of the damage to the vehicle had occurred during impact with the traffic barrier. As evident, the damage to the vehicle was moderate and repairable. The damage was assigned a NSC (7) TAD rating of LFQ-3. Based on the findings in NCHRP 86 (8), it was predicted that in vehicles damaged to this extent that injuries would occur in 18% of the accidents.

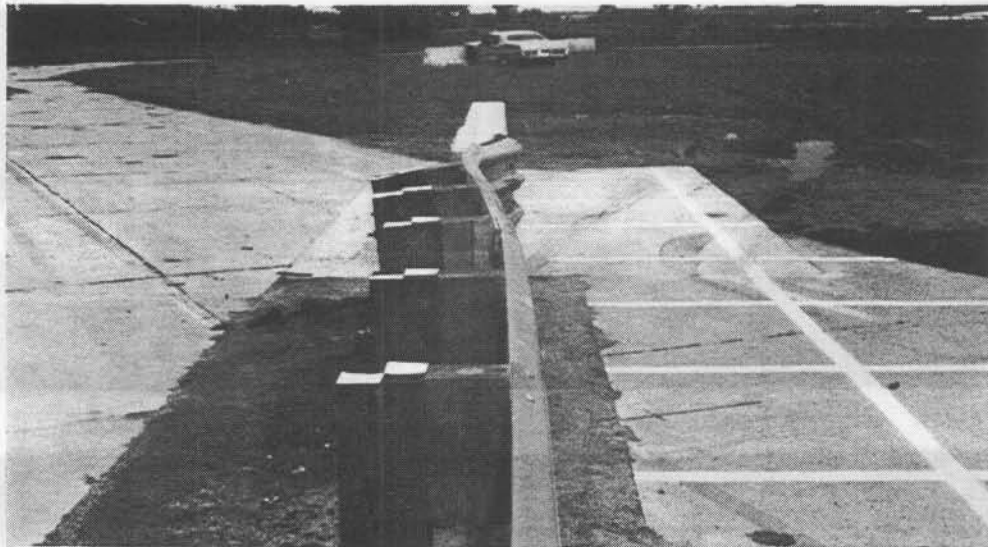
Figure 22  
PHOTOGRAPHS OF TEST NO. 3 GUARDRAIL DAMAGE

Photographs of the guardrail damage are shown in Figure 22 (2 pages), and measurements of the guardrail permanent set deflections are shown in Figure 23. The area where the upstream end anchor was bolted to the W-Beam guardrail buckled inward under the tensile loading of about 48 kips. as computed by the BARRIER VII model (see Appendix C). As clearly visible in the photographs, a "moderate" amount of vehicle snagging occurred in the lower half of the thrie beam in the area of the tapered end of the concrete bridgerail. The

The vehicle exit angle, as visible in one of the photographs in Figure 22, was 11 deg. Due to the high drag forces from the badly damaged left front wheel, the vehicle turned back-in toward an extended centerline of the traffic barrier after it had travelled a distance of 78 ft. The maximum rebound distance of the vehicle C.G. path was 20 ft.

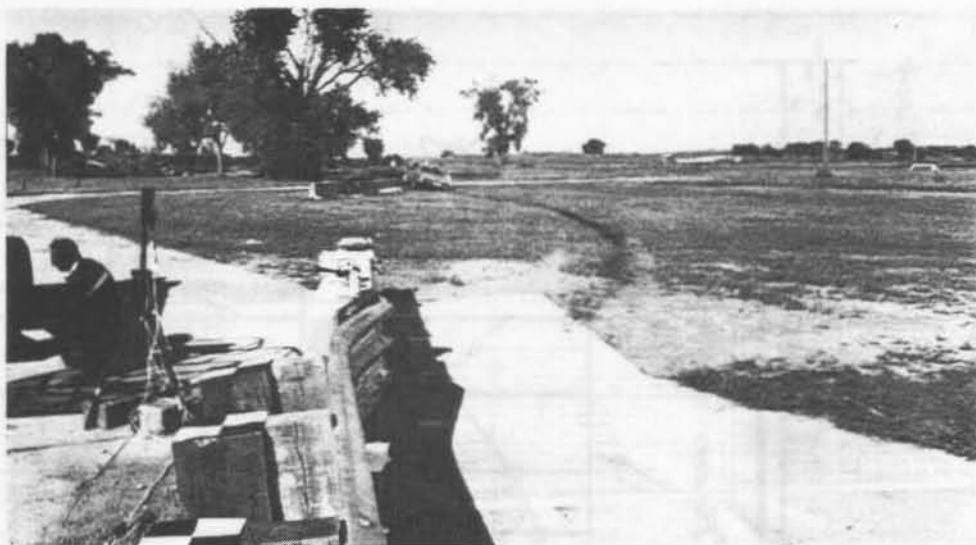
Figure 26  
PHOTOGRAPHS OF TEST NO. 4 GUARDRAIL DAMAGE

Photographs of the guardrail damage are shown in Figure 26, and measurements of the guardrail permanent set deflections are shown in Figure 27. The damaged guardrail shows no indication of vehicle snagging. The vehicle change-in-speed of 14 mph was also supportive of the fact that no snagging occurred as the change-in-speed was below the 15 mph limit specified in NCHRP 230. Overall, the guardrail "smoothly" redirected the vehicle. The maximum permanent set in the guardrail was 7 1/2 in.

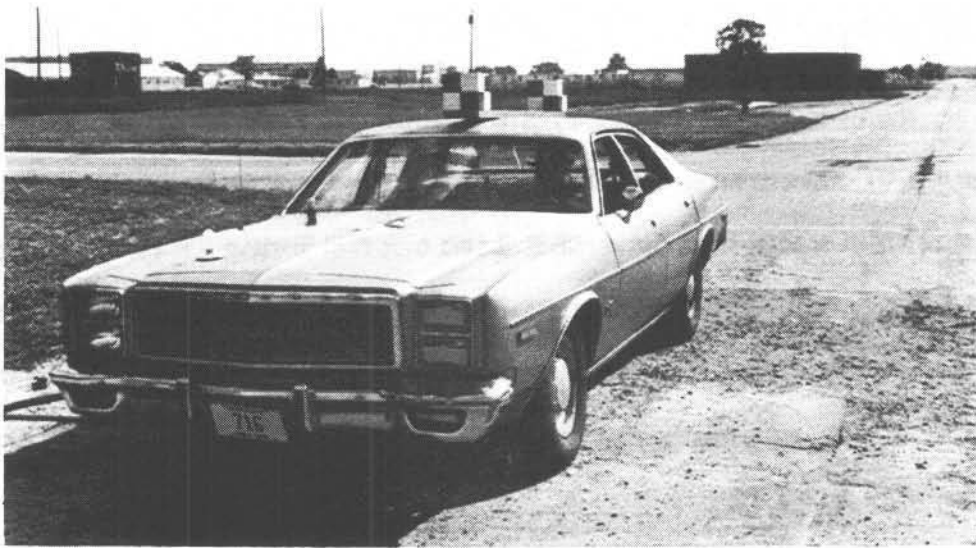
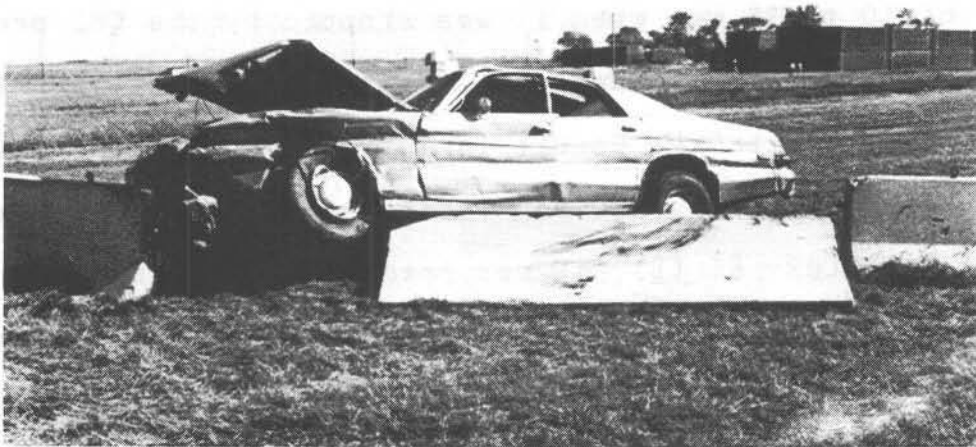
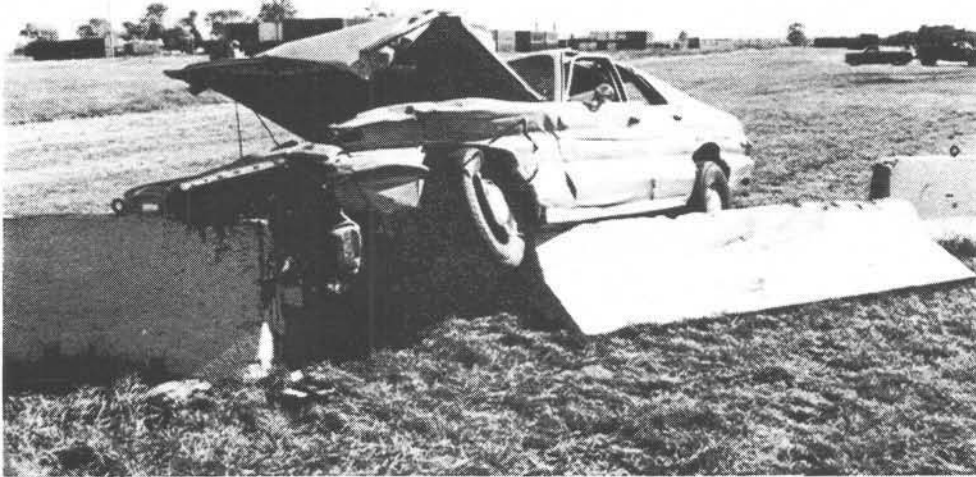
Figure 28  
PHOTOGRAPHS OF TEST VEHICLE BEFORE AND AFTER TEST NO. 4

Photographs of the vehicle before and after the test are shown in Figure 28. It was estimated that the vehicle was travelling at a speed of 10 to 15 mph when it was stopped by the CMB protecting the downstream high-speed camera. Most of the damage was incurred during impact with the Double Thrie Beam Transition. The vehicle damage was assigned a NSC TAD rating of LFQ-4 1/2. Based on the findings in NCHRP 86 (8), it was predicted that injuries would occur in vehicles damaged to this extent in 41% of the accidents.

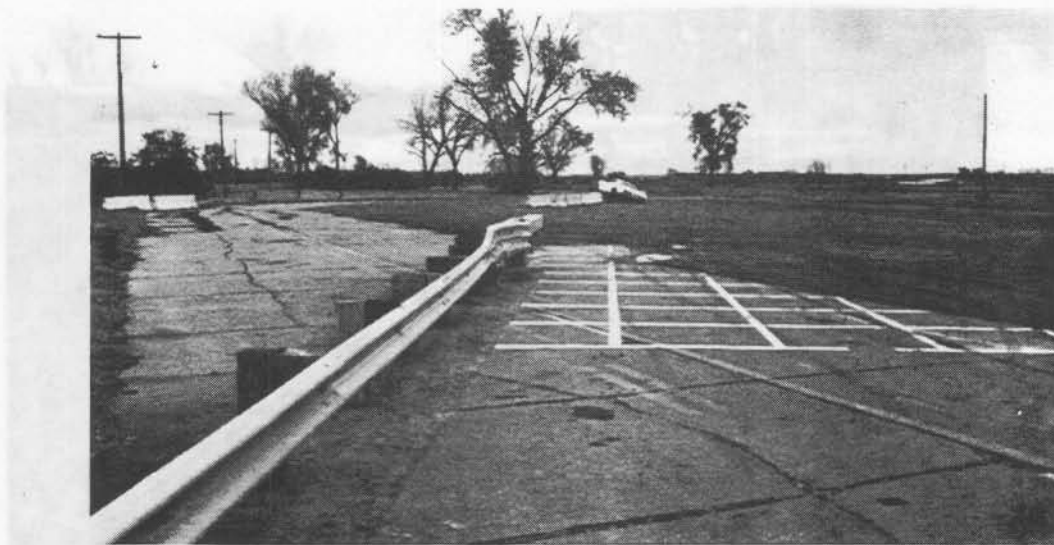
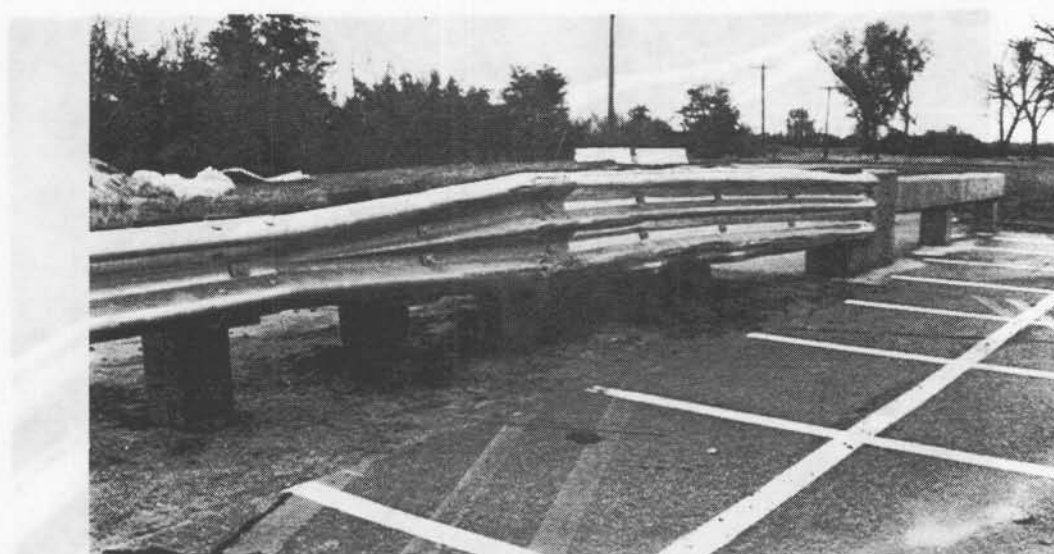
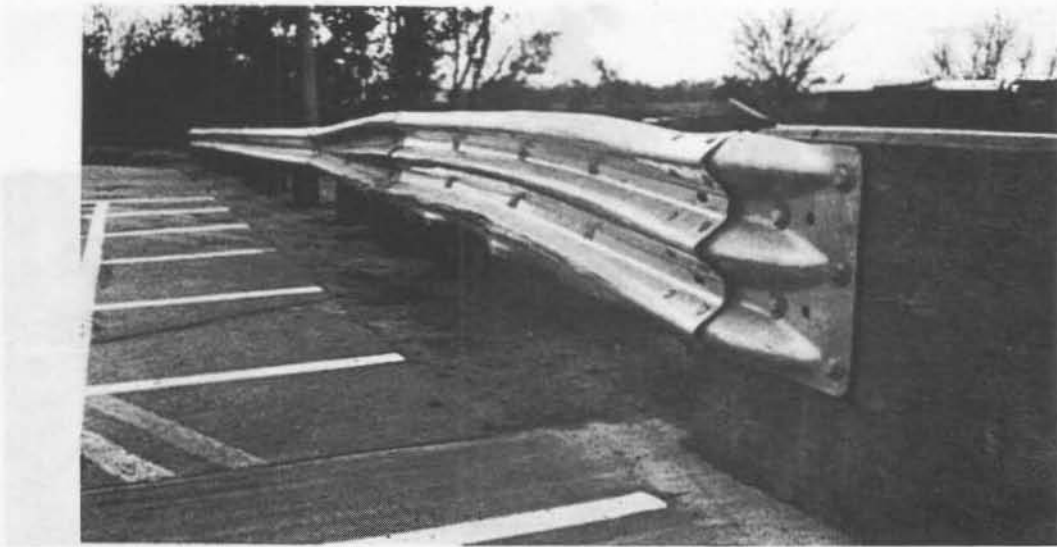
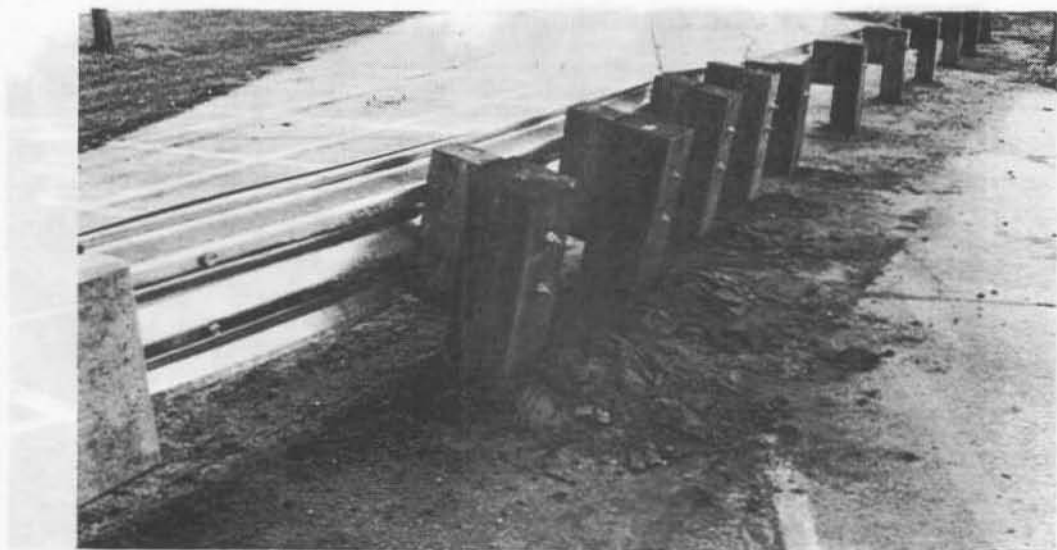
Figure 30  
PHOTOGRAPHS OF TEST NO. 5 GUARDRAIL DAMAGE

Photographs of the guardrail damage are shown in Figure 30 (2 pages), and measurements of the guardrail permanent set deflections are shown in Figure 31. The soil was saturated from a heavy 2 day storm preceding the day of the test. The decision to test under a

saturated soil condition was made by the NDR as this condition would be representative of the lowest possible soil shearing strength. The damaged guardrail shows no indication of vehicle snagging. The vehicle change-in-speed of 13 mph was also supportive of the fact that no snagging occurred as the change-in-speed was below the 15 mph limit specified in NCHRP 230. Overall, the guardrail "smoothly" redirected the vehicle. The maximum permanent set in the guardrail was 11 in.

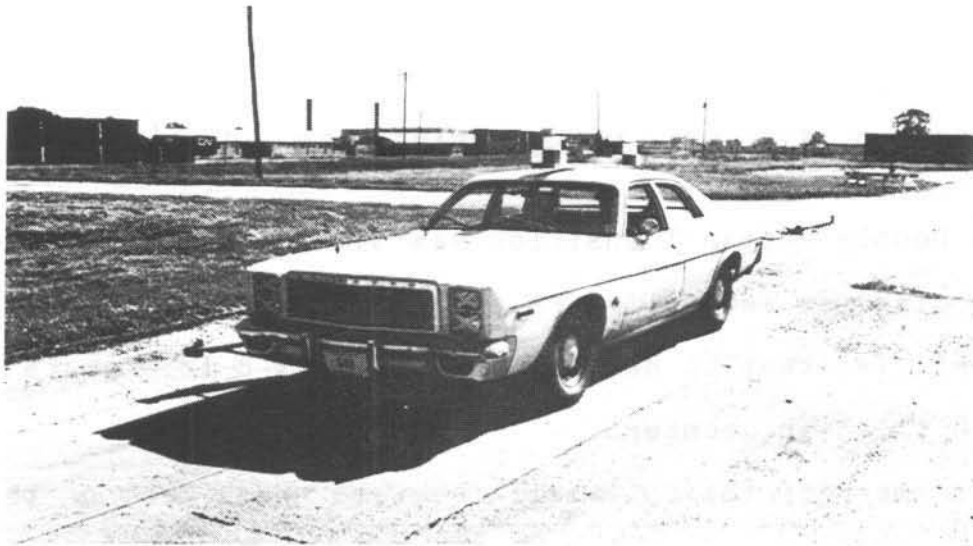
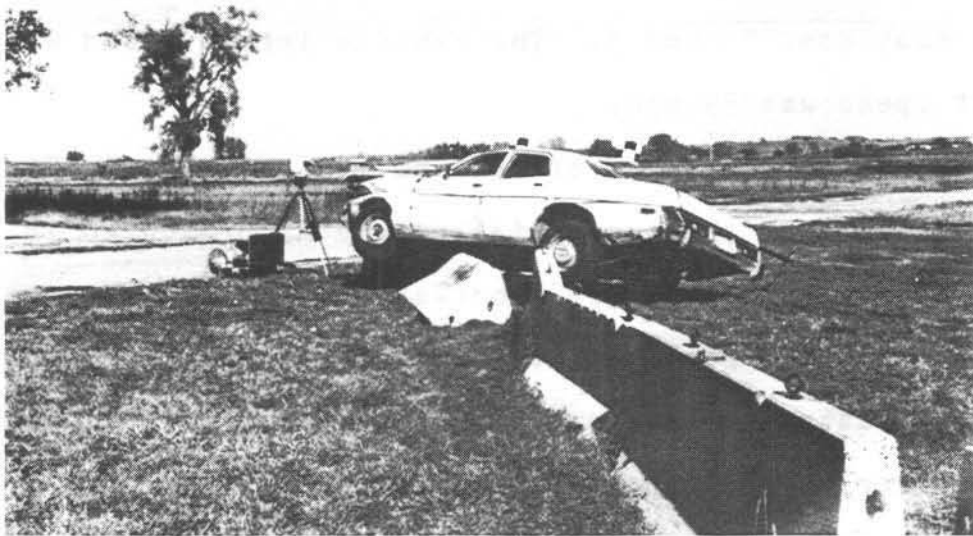
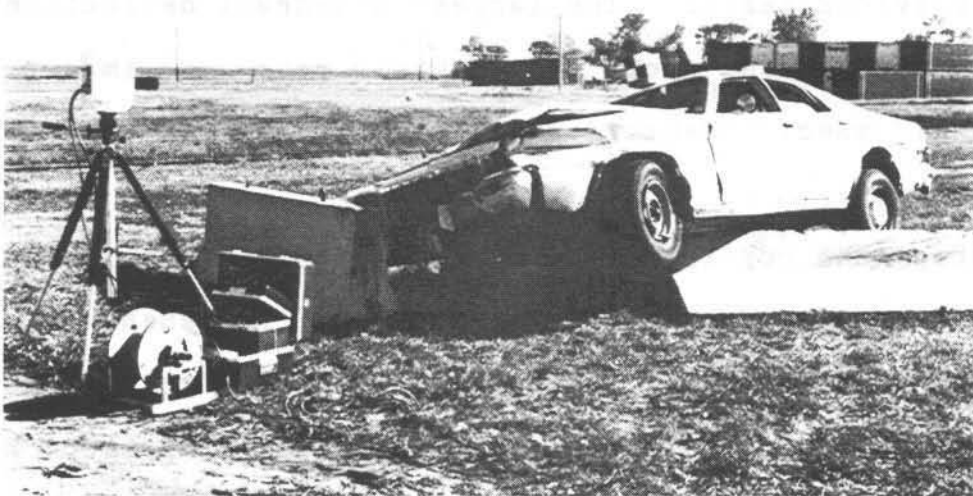
Figure 32  
PHOTOGRAPHS OF TEST VEHICLE BEFORE AND AFTER TEST NO. 5

Photographs of the vehicle before and after the test are shown in Figure 32. It was assumed that the vehicle was travelling at a speed of 10 to 15 mph when it was stopped by the CMB protecting the downstream high-speed camera. Most of the damage was incurred during impact with the Double Thrie Beam Transition. The vehicle damage was assigned a NSC TAD rating of LFQ-4. Based on the findings in NCHRP 86 (8), it was predicted that injuries would occur in vehicles damaged to this extent in 33% of the accidents.
