**FULL-SCALE VEHICLE CRASH TESTS**  
**on**  
**GUARDRAIL-BRIDGERAIL TRANSITION DESIGNS**  
**with**  
**SPECIAL POST SPACING**

TRANSPORTATION RESEARCH REPORT TRP-03-008-87

May 1987

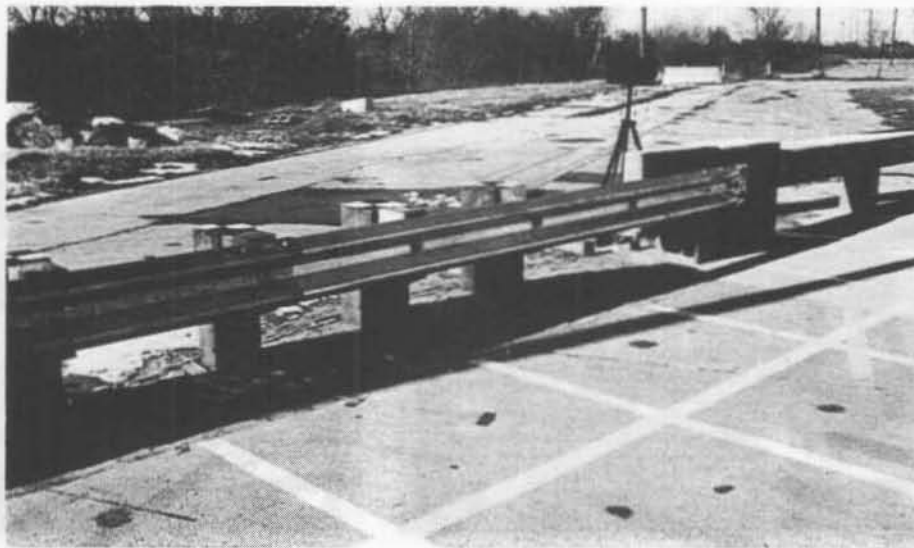
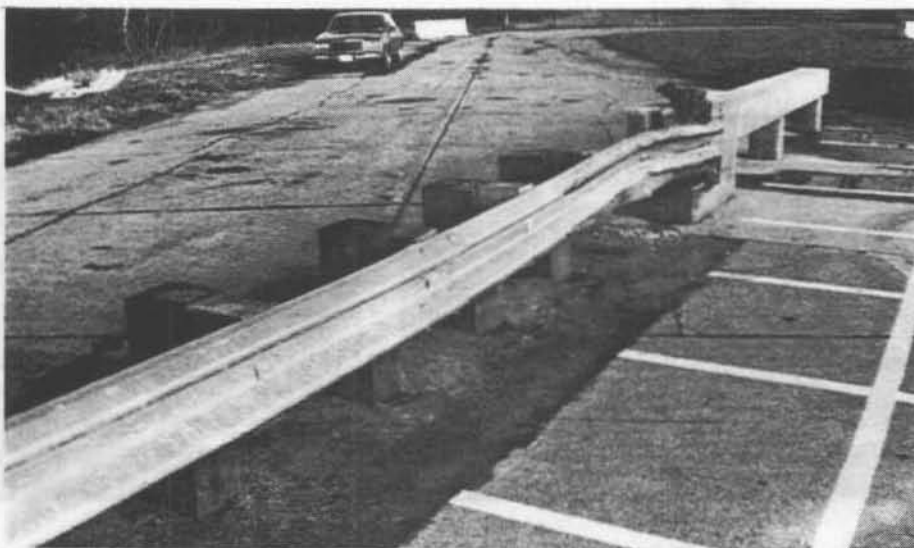
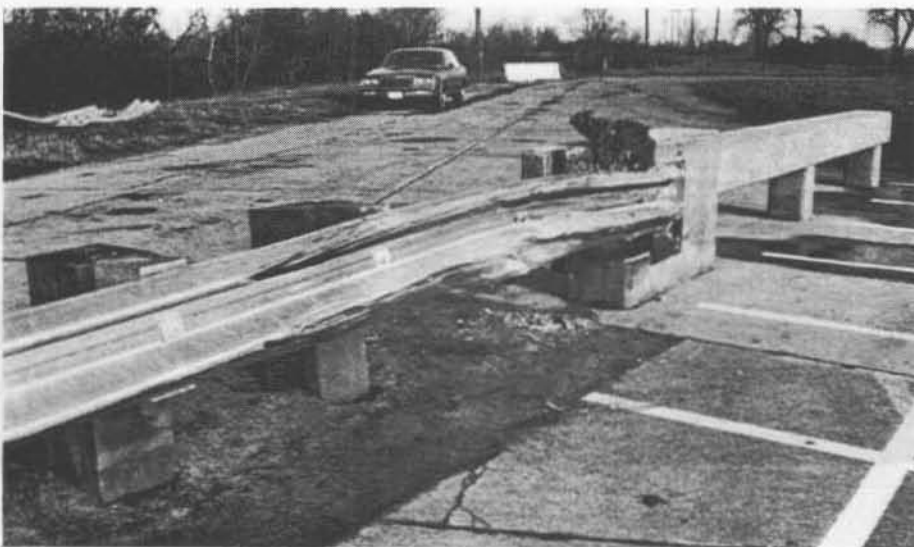
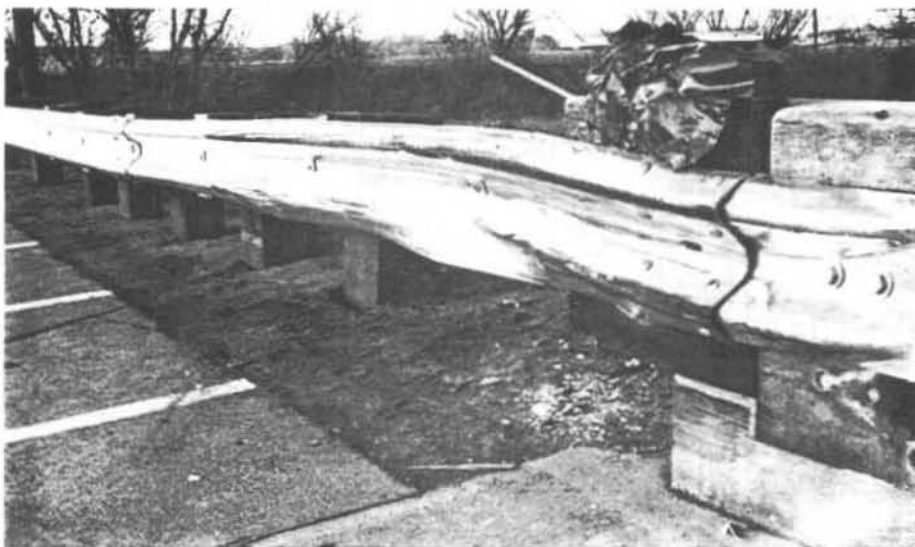
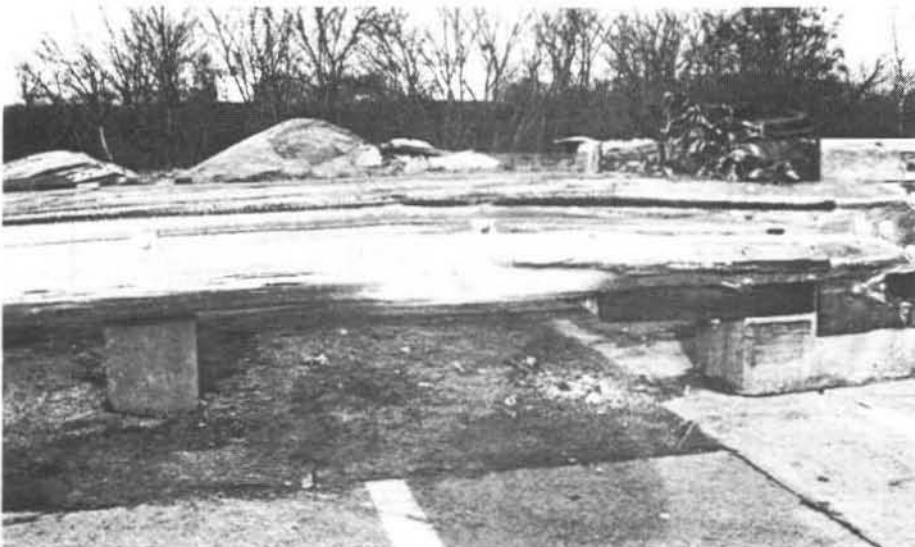
Figure 34  
PHOTOGRAPHS OF TEST NO. 6 GUARDRAIL DAMAGE

Photographs of the guardrail damage are shown in Figure 34 (2 pages), and measurements of the guardrail permanent set deflections are shown in Figure 35. The soil was frozen to a depth of 8 to 10 in. The effect of the frozen soil was readily apparent by comparing the permanent set deflections in Test No. 4 (Figure 27) with this

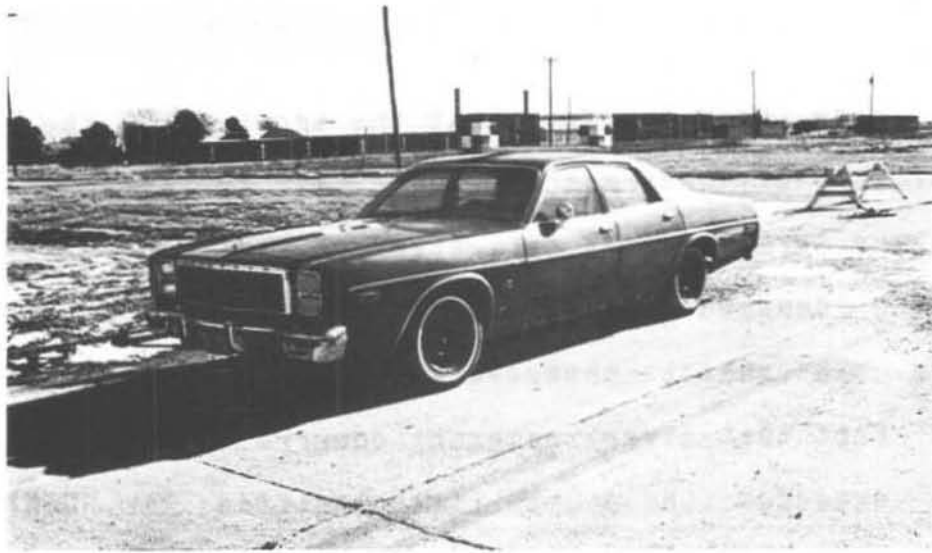
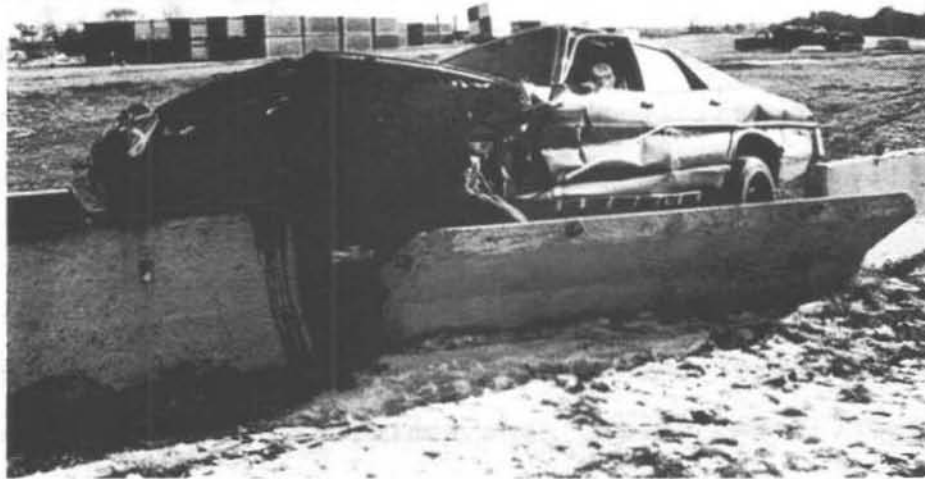
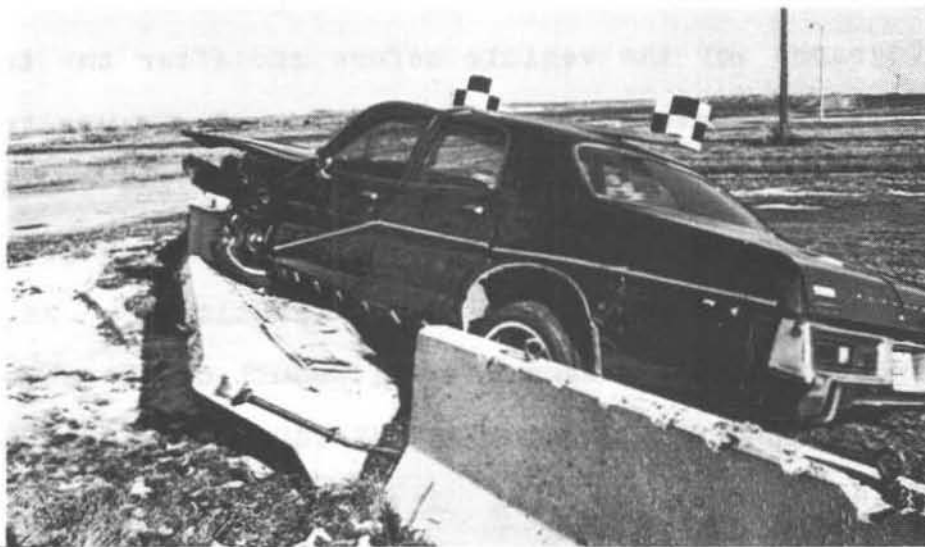
Figure 36  
PHOTOGRAPHS OF TEST VEHICLE BEFORE AND AFTER TEST NO. 6

Photographs of the vehicle before and after the test are shown in Figure 36. It was estimated that the vehicle was travelling at a speed of 10 to 15 mph when it was stopped by the CMB protecting the downstream high-speed camera. Most of the damage was incurred during impact with the Double W-Beam Transition. As evident, the vehicle was extensively damaged as a result of the severe snagging. The vehicle damage was assigned a NSC TAD rating of LFQ-7. Based on the findings in NCHRP 86 (8), it was predicted that injuries would occur in vehicles damaged to this extent in 100% of the accidents.
