DEVELOPMENT OF A TIE-DOWN SYSTEM FOR TEMPORARY CONCRETE BARRIERS

MIDWEST ROADSIDE SAFETY FACILITY

MwRSF Research Report No. TRP-03-115-02

August 16, 2002

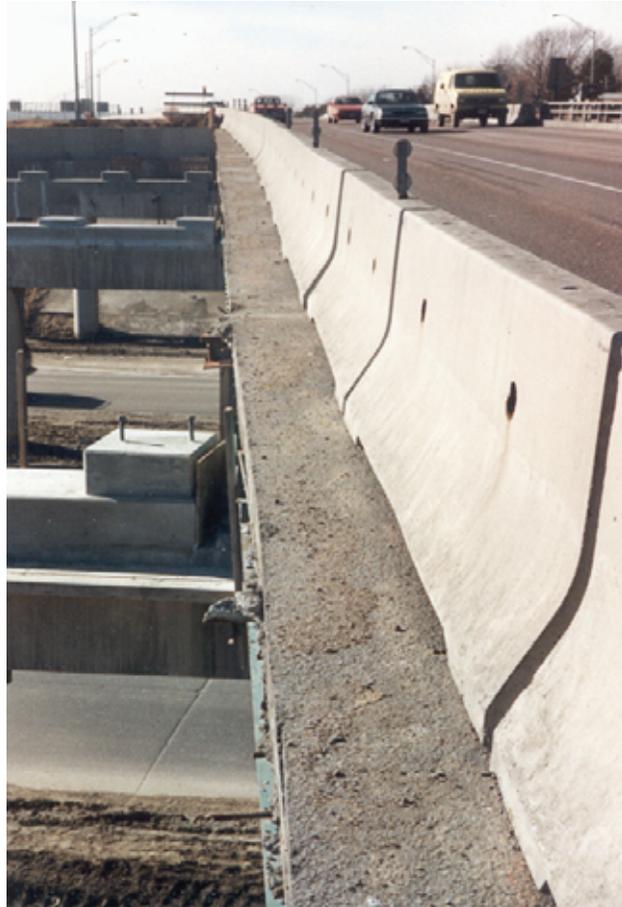
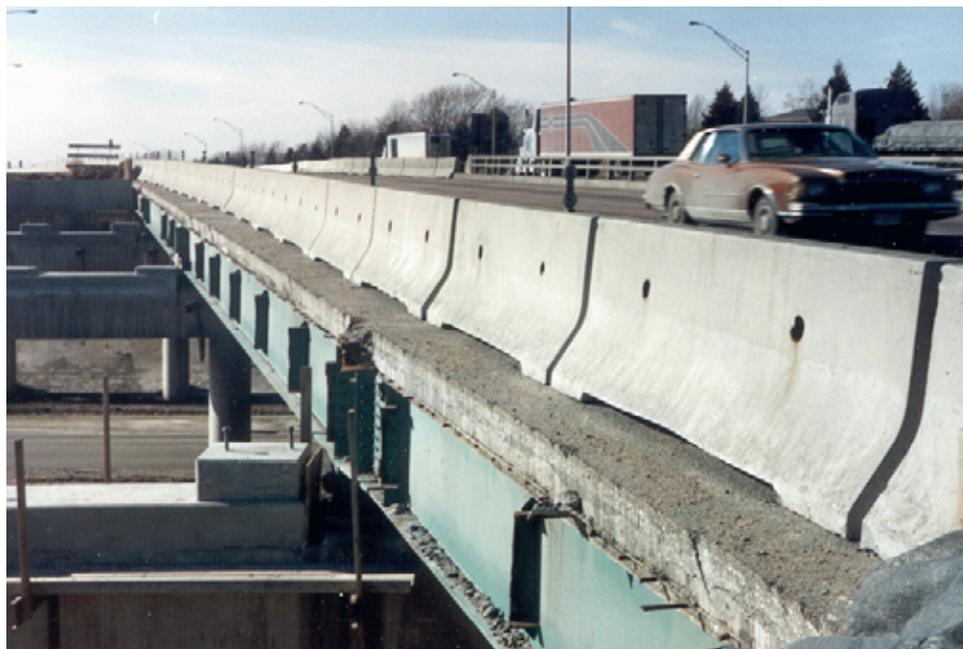
Figure 1. Temporary Barrier Positioned Near Bridge Deck Edge

During bridge construction, temporary barriers are often placed adjacent to the edge of a bridge deck in order to provide adequate lane width, as shown in Figure 1. However, freestanding barrier installations placed close to the deck edge pose a major safety hazard to errant vehicles as there is a significant risk for the barrier segments to be propelled off of the bridge. Previous testing of temporary barriers have shown deflections of more than one meter (1-2). Thus, large dynamic deflections, in conjunction with a narrow gap located behind the barriers, may prove sufficient to push the barriers off of the deck along with the impacting vehicle. Therefore, a need exists to develop a system to reduce barrier deflections and to restrain the barriers from falling off of a bridge.

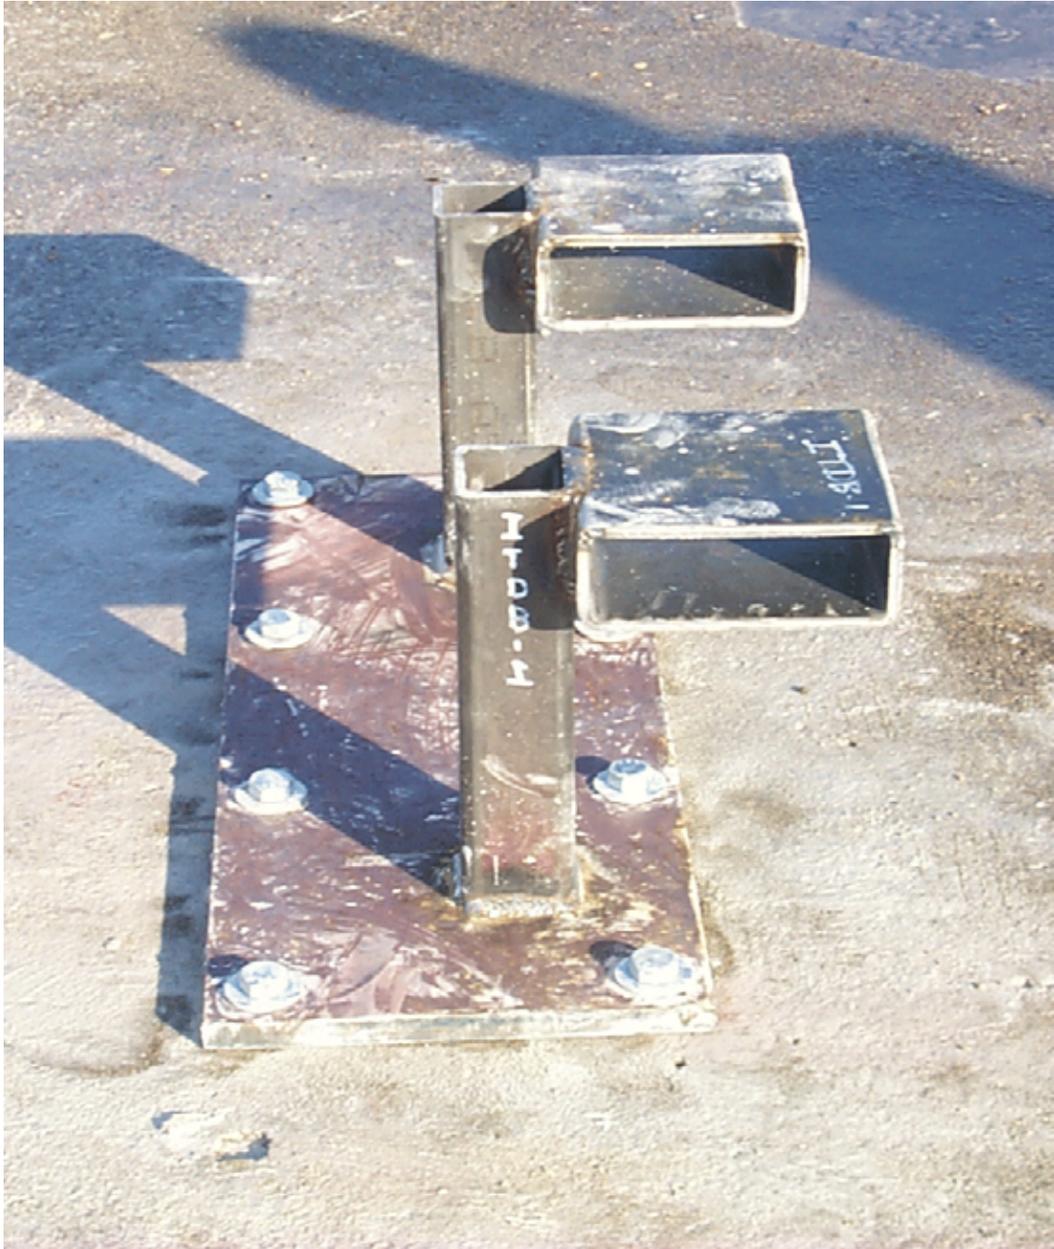
Figure 6. Backup Tower Prototype

A significant research effort was put forth into the development of the backup tower concept, including finite element computer simulation modeling and bogie testing (6). A detailed discussion of this work is beyond the scope of this report; however, a copy of a paper summarizing this work is provided in Appendix A. The results from this research led to the development of the backup tower prototype, as shown in Figure 6, that was deemed ready for full-scale compliance testing.

Subsequently, the backup tower prototype was presented to the Midwest States' Pooled Fund members for review and comment. However, the returned comments on the backup tower design were not favorable. The sponsoring states believed that the backup tower design was too large and heavy to easily install, and that it required too many drop-in anchors. As a result, the states requested that a smaller system with less rigorous anchorage be developed. It was noted that reducing the size and quantity of the system's anchorage would result in a significant increase in barrier deflection. However, discussions with the states revealed that some deflection was acceptable. This was true as long as the deflections were reduced from those observed in tests on free-standing temporary barriers, and all of the barrier segments were restrained from falling off of the bridge deck. The researchers agreed with the states' comments and altered their focus toward a design concept that

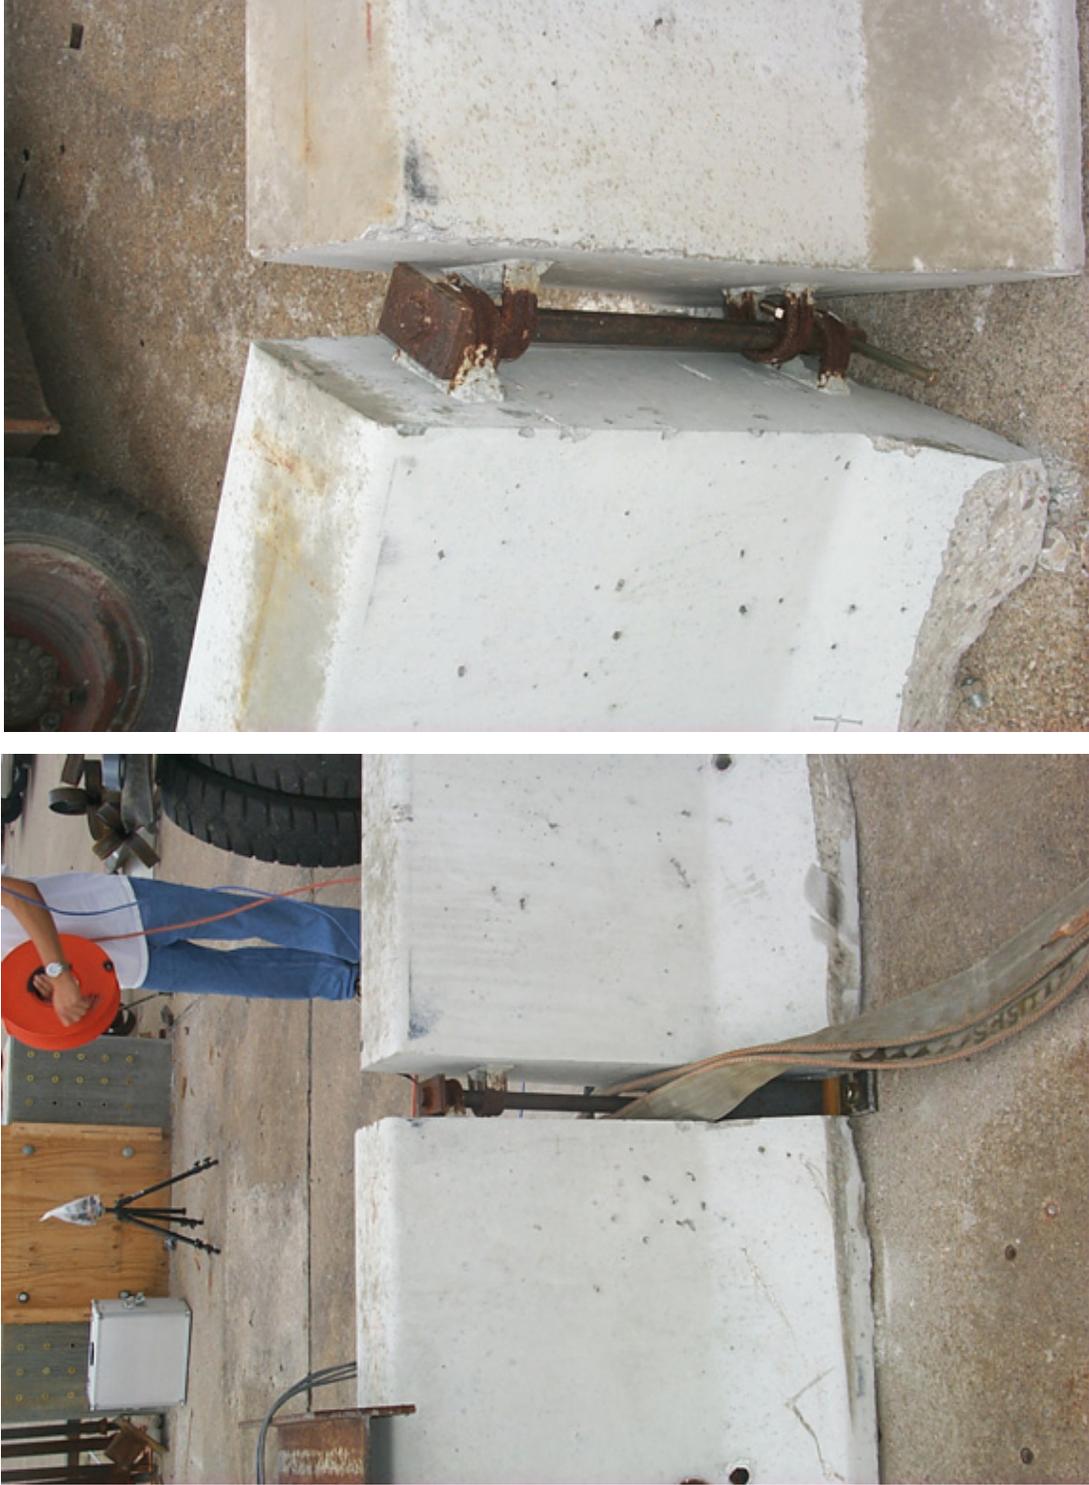
Figure 16. Configuration for Bogie Testing of Strap Tie-Down Concept, Test ITDB-2

Developmental testing for the tie-down system for use with F-shape temporary concrete barriers consisted of a single, dynamic bogie test of the double steel strap concept (test no. ITDB-2). As mentioned previously, this test was conducted in order to verify the performance of the tie-down strap used in conjunction with actual barriers. Specifically, the test was designed to evaluate the deflection of the strap, the failure of the drop-in anchors, and loading of the barrier joint and steel strap. The test was conducted by laterally loading a single barrier joint that contained one double tie-down strap. The barrier joint was loaded by a cable and nylon tow strap that was also attached to the back of a rolling bogie vehicle. When the cable slack was removed, the cable became taut and applied the dynamic load to the barrier joint. Details of the dynamic bogie test are given below.

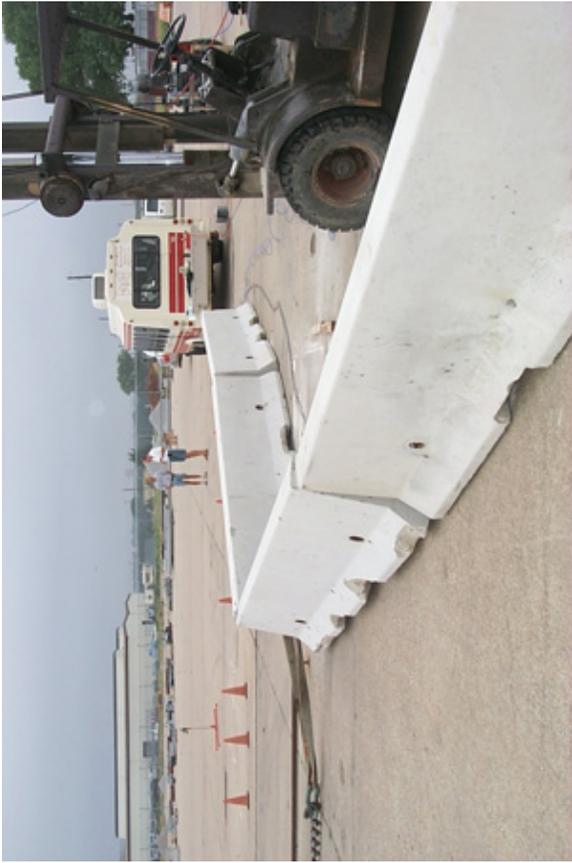
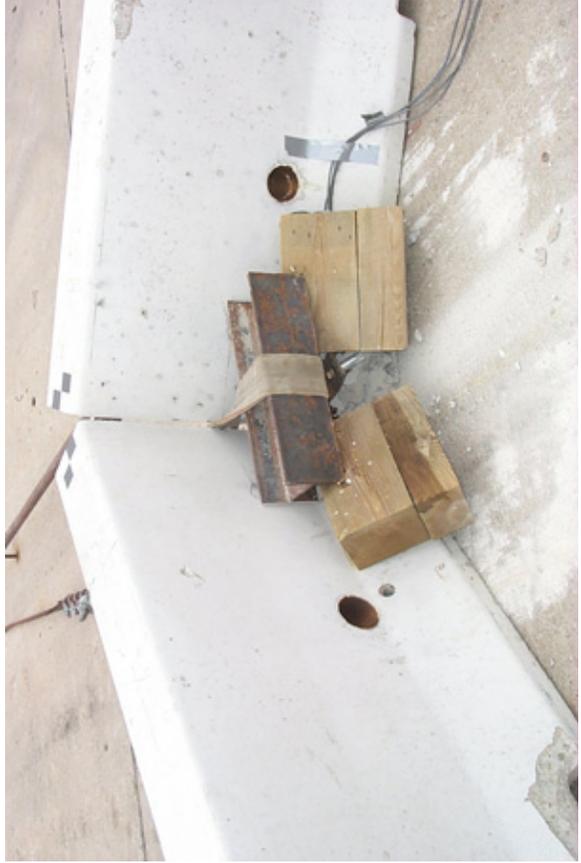
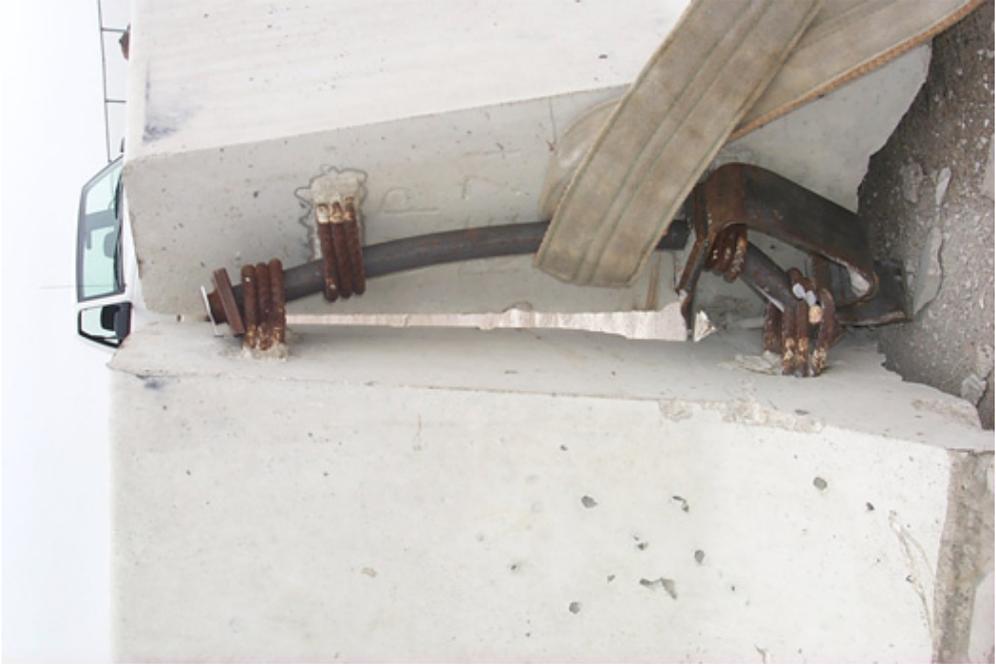
Figure 18. Bogie Test Results, Test ITDB-2

The results of the bogie test showed that the tie-down strap performed as designed. The steel strap deformed significantly as it was loaded by movement of the vertical pin. With the steel strap deformation, both drop-in anchors were pulled out of the concrete. Post-test photographs detailing the strap deformation and anchor pullout are shown in Figures 19 and 20. As determined by an analysis of the accelerometer data, the maximum lateral load applied to the barrier joint containing the tie-down strap was 144.7 kN. As previously noted, the capacity of the double steel strap was significantly greater than that of the single strap design, and further calculations showed that the two-sided strap design was capable of supporting the weight of three barrier sections deflected off of the bridge deck. Based on the observed performance of the double steel strap design in the bogie

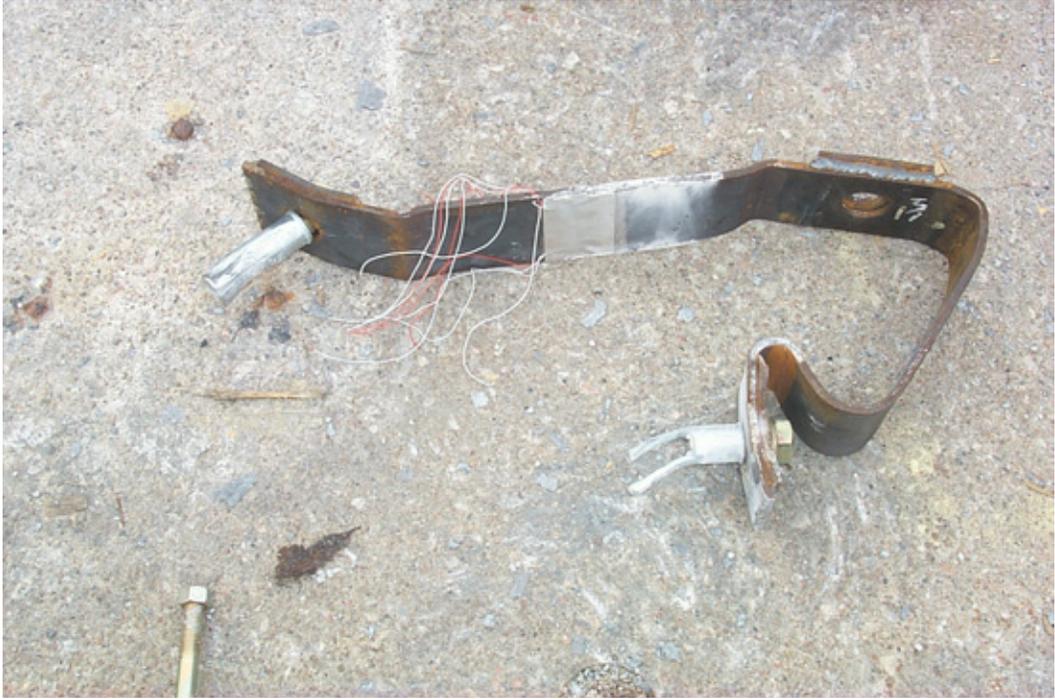
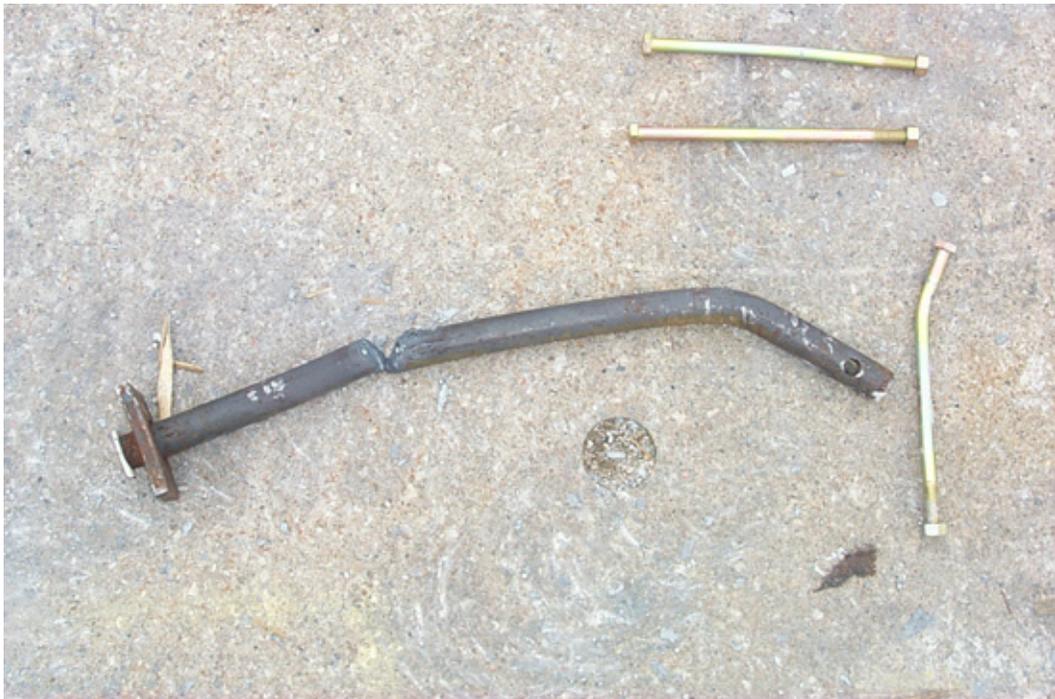
Figure 20. Bogie Test Results, Test ITDB-2

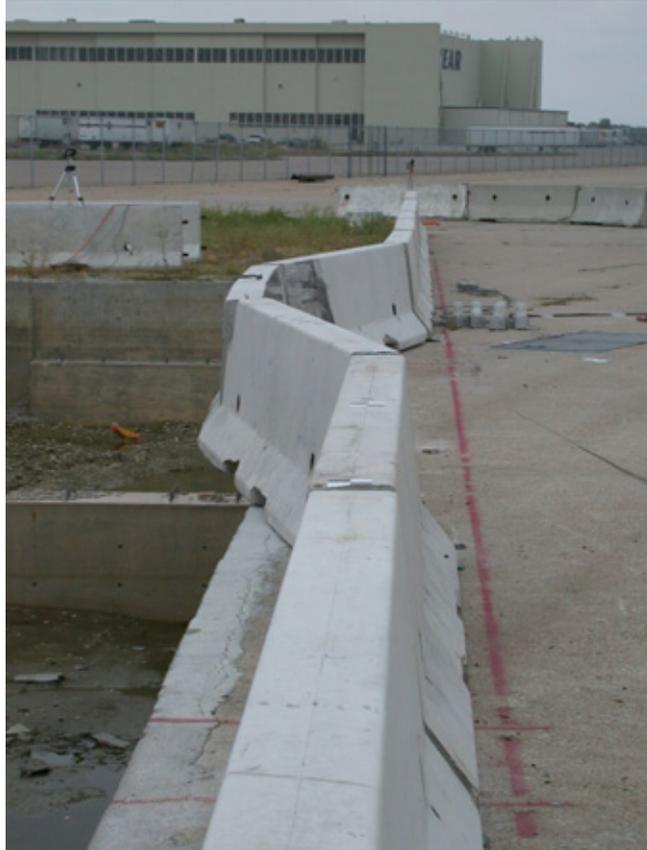
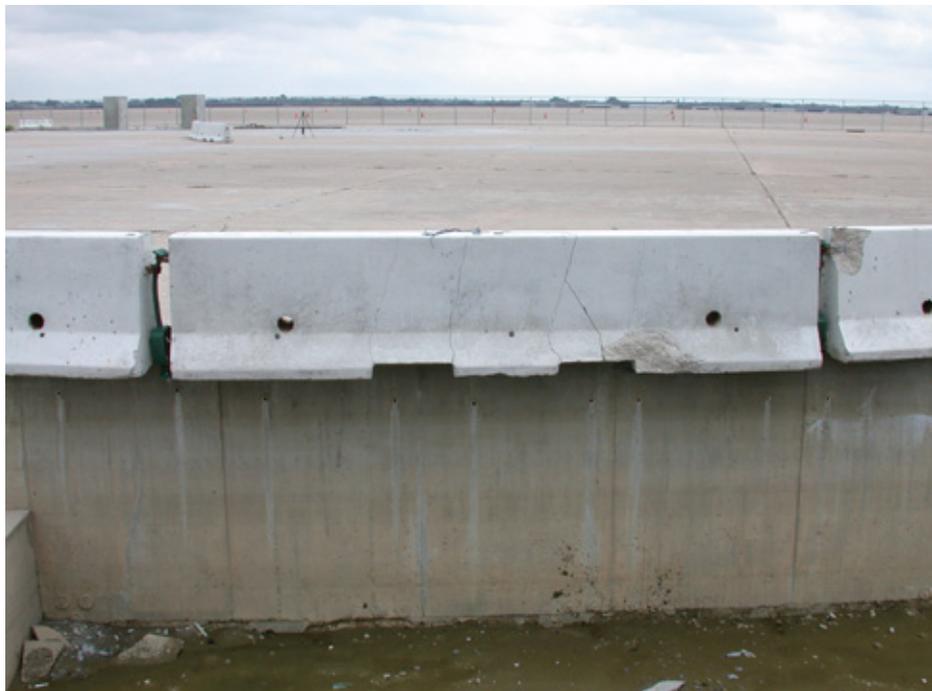
Figure 40. System Damage, Test Test ITD-1

Damage to the tie-down temporary barrier system was moderate, as shown in Figures 40 through 42. Tire marks and scrapes were visible on the front face of barrier segment nos. 7 through 9. Spalling of the concrete and tire marks were also observed on the upstream end of barrier segment no. 8 at the joint between barrier segment nos. 8 and 9. Barrier no. 7 showed concrete damage on the top of its upstream end in the form of a small concrete piece broken off of the front face and a larger piece broken off of the backside. Four major vertical cracks were observed on the back side of barrier segment no. 8.

In addition to the concrete damage, damage was also noted with respect to the barrier joints and the tie-down straps. Deformation of the vertical pins occurred to the joint between barrier segment nos. 3 and 4 and through the joint between barrier segment nos. 12 and 13. While most of the pin deformations were small, the pins at the joints between barrier segments nos. 6 through 11 showed larger flexural deformations. Several of the rebar loops at these locations also were deformed, but all of the loops remained solid and intact.

Deformation of the tie-down strap was observed at the joints located between barrier segment nos. 6 through 11. The deformation of the straps at the joints between barrier segment nos. 7 through 10 was very extensive. In addition, the straps at the joints between barrier segment nos. 7 through 9 were pulled completely out of the concrete. The drop-in anchors restraining these straps all failed due to the pullout of the drop-in anchor, except for the front strap anchor of the strap between barrier segment nos. 7 and 8. This front-side anchor was sheared and/or cut off by the steel rim of the right-rear wheel as the vehicle passed by the joint. All of the other straps remained effectively anchored to the concrete.

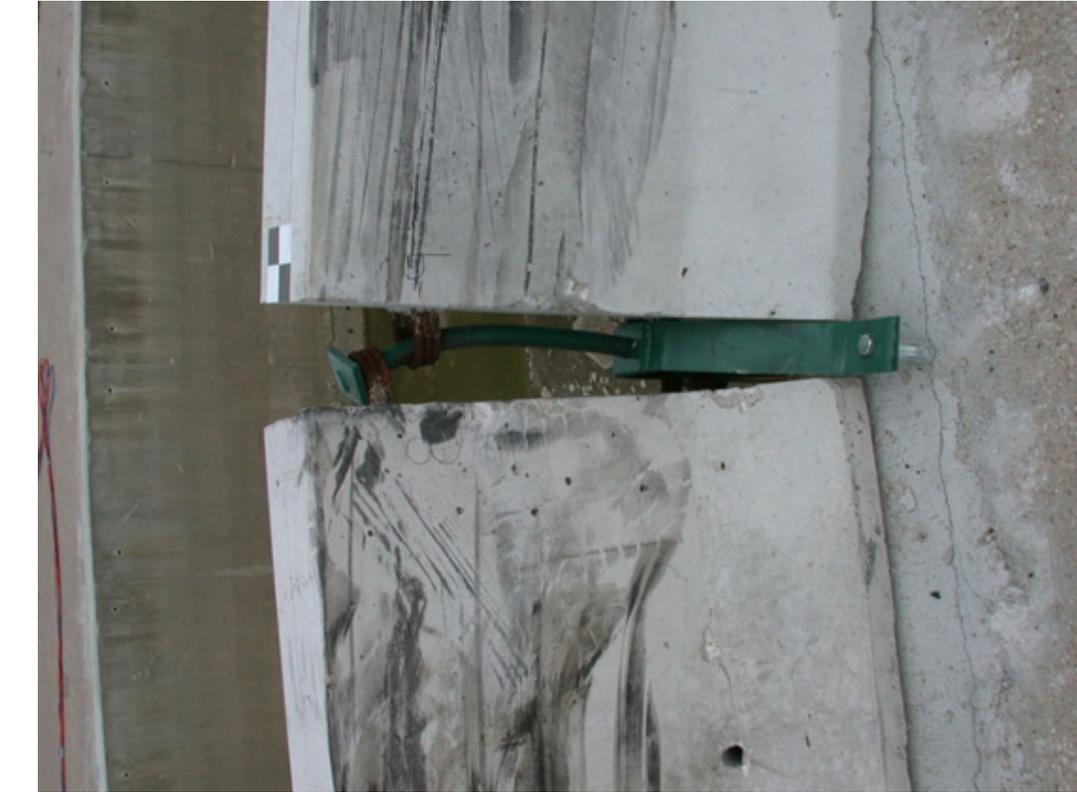
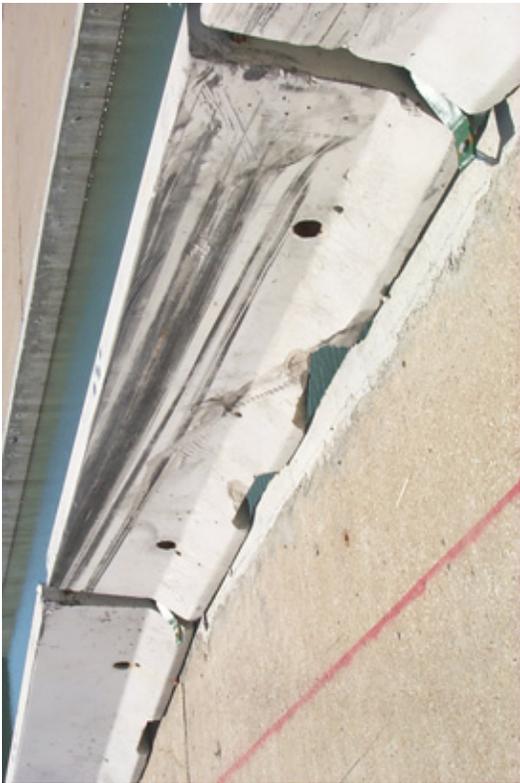
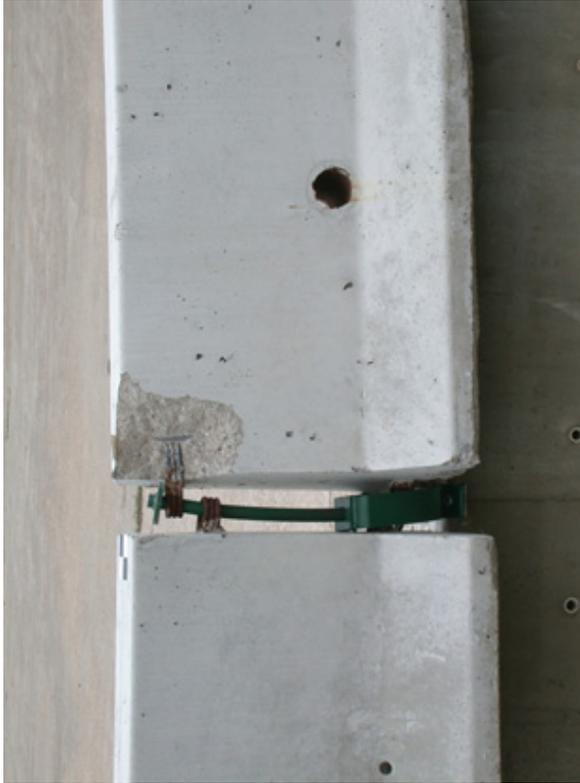
Figure 41. System Damage, Test ITD-1

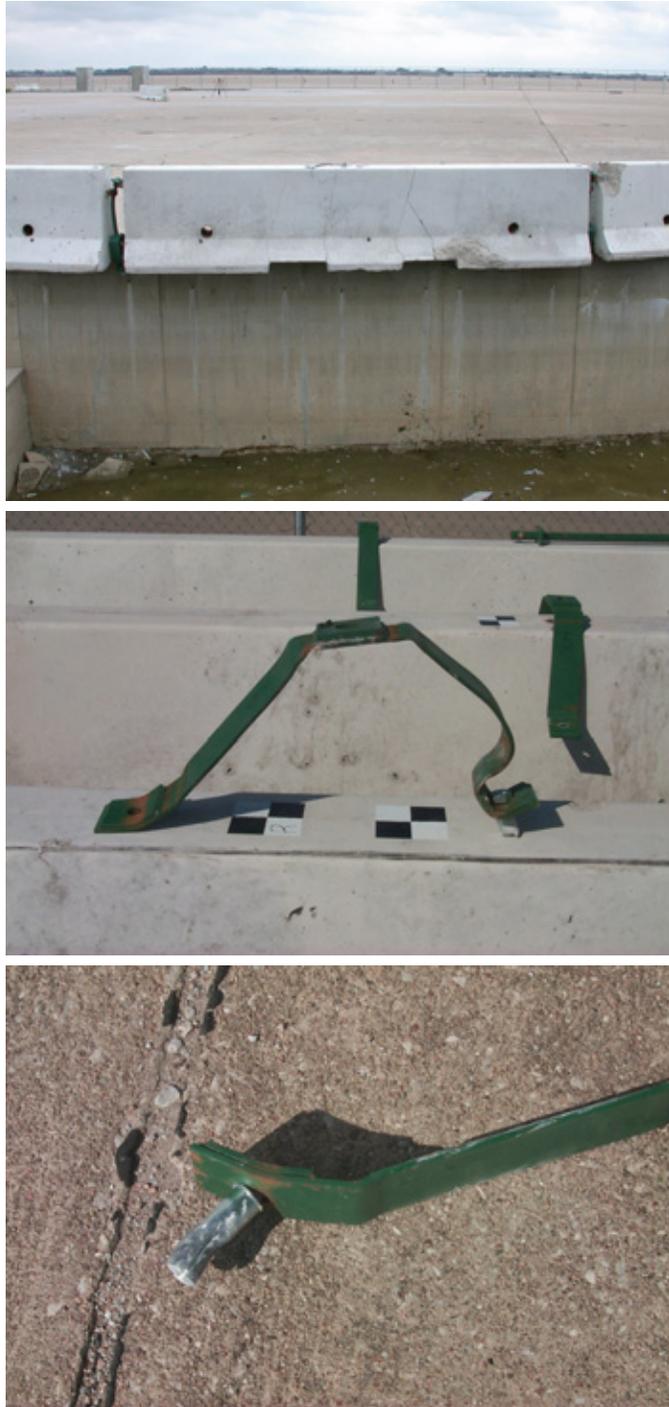
Figure 42. System Damage, Test ITD-1

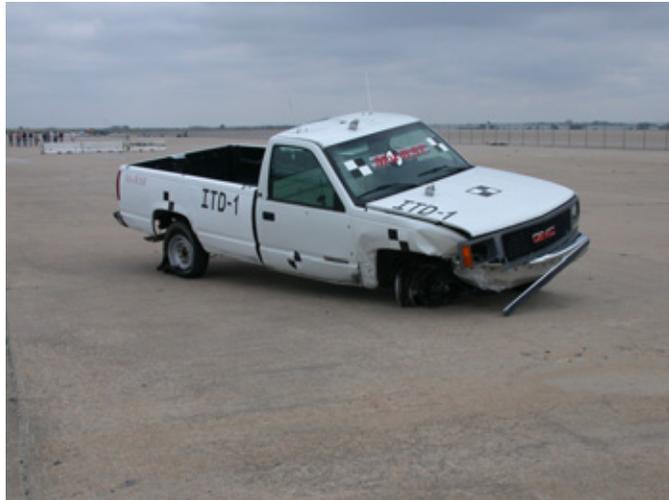
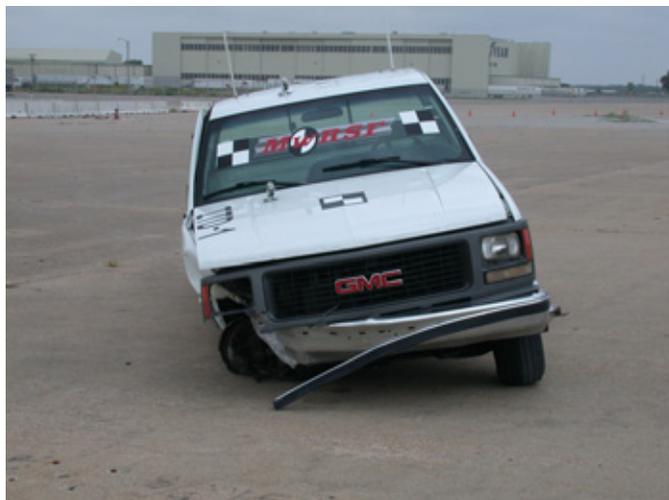
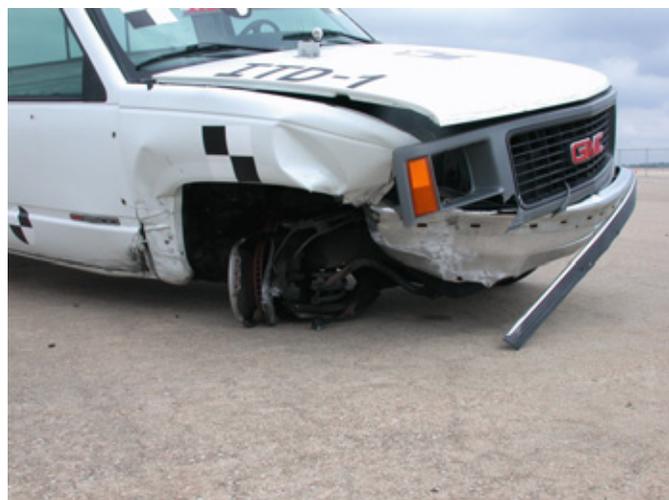
Figure 43. Vehicle Damage, Test ITD-1

Vehicle damage was moderate, as shown in Figures 43 through 44. The majority of the damage to the pickup truck was focused on the right-front corner and right side where the impact occurred. The right side of the front bumper was bent inward around the frame horn. The right-front fender was crushed inward and dented as well. Damage was observed to the right-front suspension components which consisted of bent control arms and a disengaged tie rod. The right-front tire and the outside of the steel rim were disengaged from the main body of the wheel assembly during impact. The right-rear tire was torn open and deflated but was still attached to the rim. Scrapes and dents from the vehicle contact with the barriers was observed on the bottom of the truck bed and right side door. No damage to the engine hood nor roof was observed. There was no broken glass on the vehicle.

Minor damage was observed in the interior occupant compartment of the vehicle, including a tear along the weld on the forward passenger-side floor pan and deformation of the passenger-side floor pan. The occupant compartment deformations were measured and recorded for the floorboard and dash. A maximum vertical deflection of 70 mm was found near the center of the floor on the driver side. Maximum lateral and longitudinal deflections of the floor pan were measured as 57 mm and 146 mm, respectively. Maximum dash deflection was reported to be approximately 6 mm. Although modest deflections were observed, they were not believed to pose as serious hazard to the occupants of the vehicle. Complete occupant compartment deformation details are given in Appendix F.

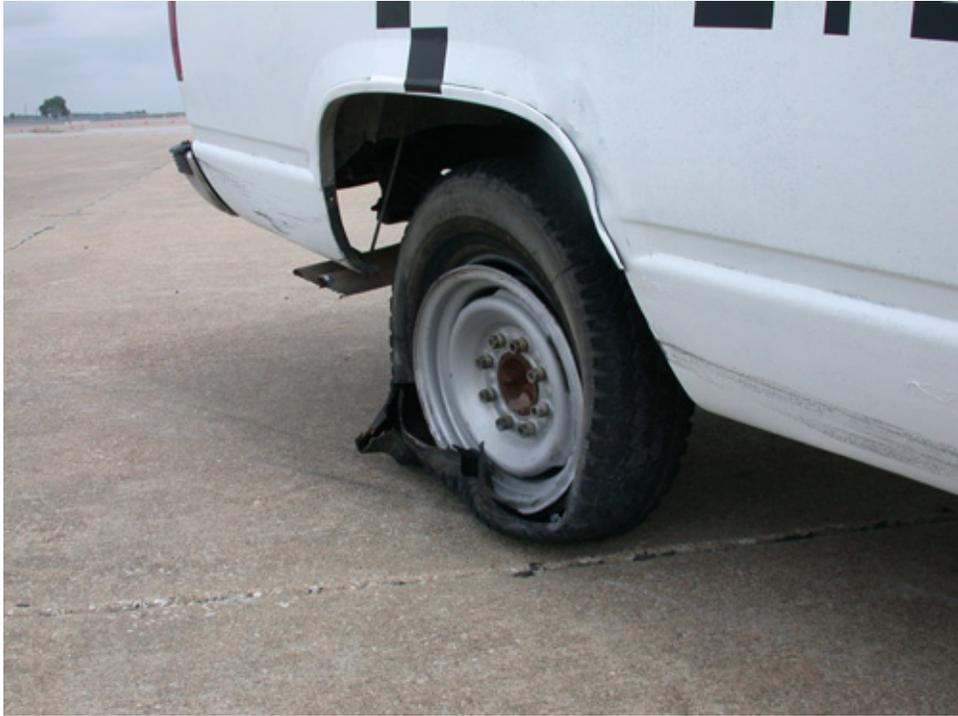
Figure 44. Vehicle Damage, Test ITD-1

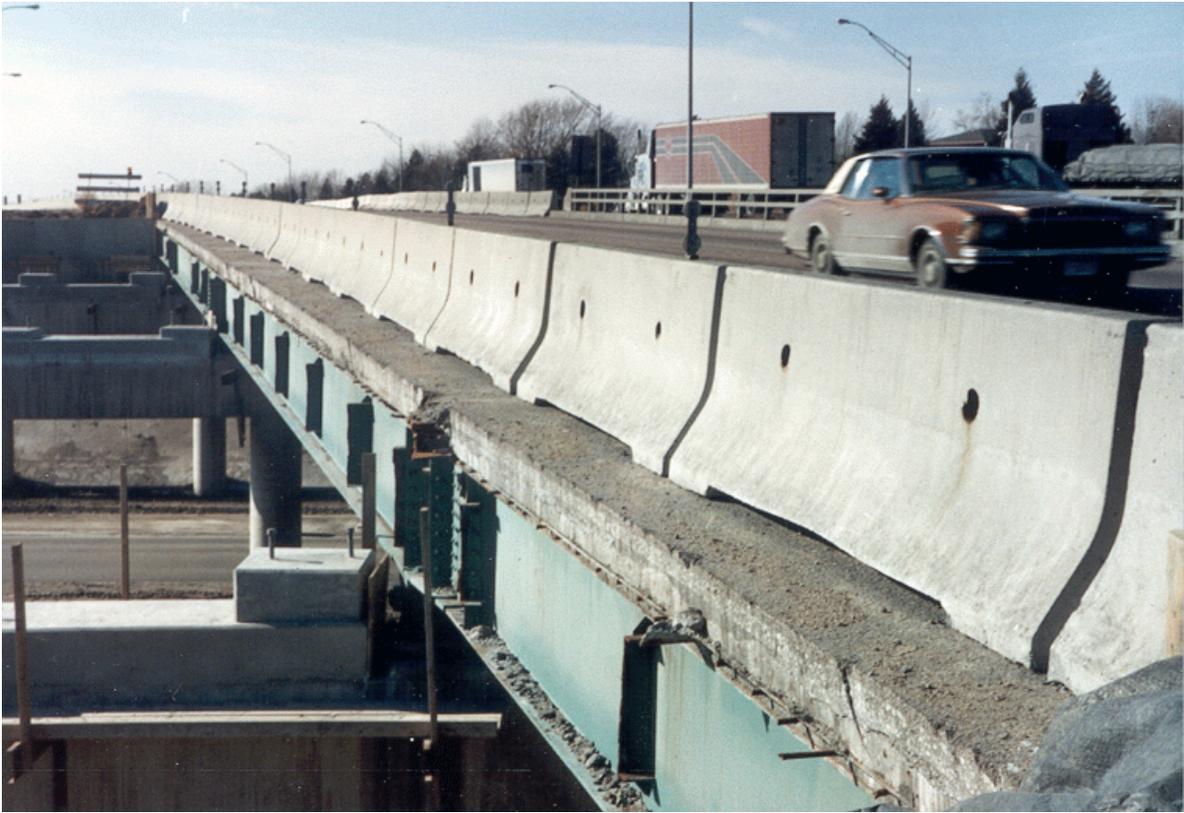
Figure 1. Temporary Barrier Installation on Bridge Deck

A common installation of temporary barriers is placement of the barriers on the edge of a bridge deck that is under construction, as shown in Figure 1. However, installations such as this pose a major safety hazard to errant vehicles impacting the temporary barriers. Previous testing of temporary barriers, such as the one shown in Figure 1, have shown deflections of over 1 meter [1,2]. Deflections of that magnitude, when combined with the narrow gap behind the barriers, would prove sufficient to push the barriers off of the deck along with the impacting vehicle.

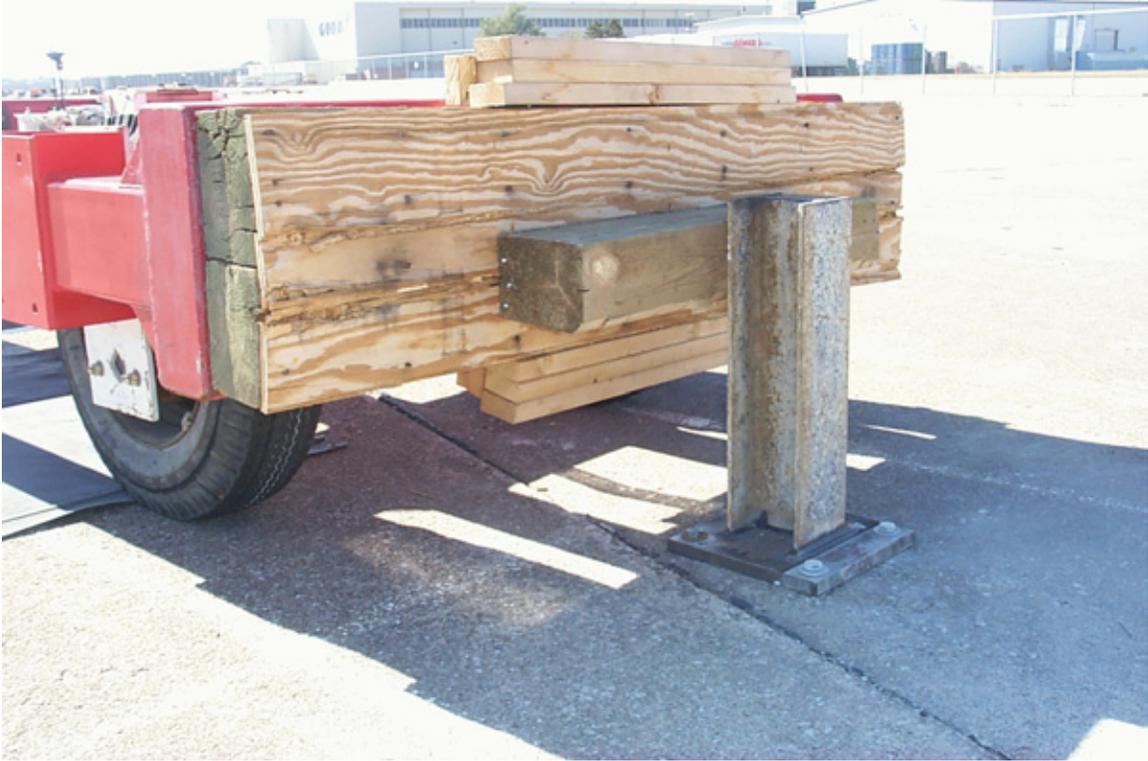
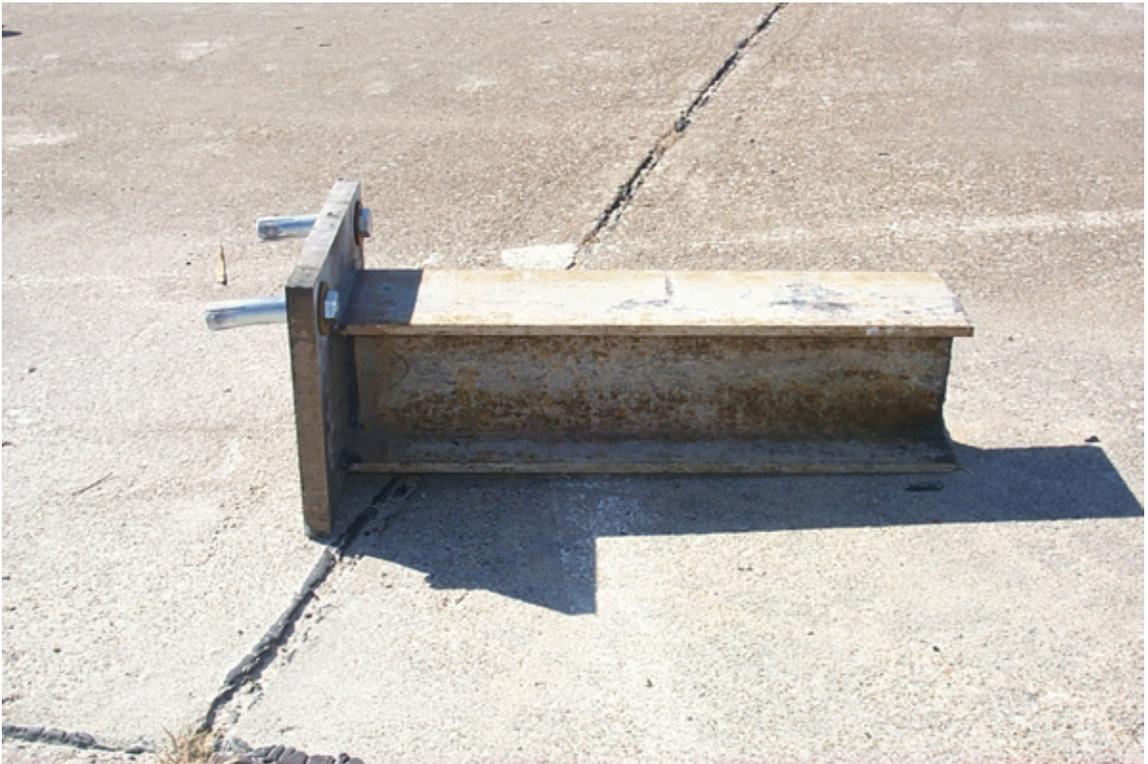
Figure 5. Drop-In Anchor Component Testing
