NCHRP Report 350 Evaluation of the Nebraska Thrie-Beam Transition

Midwest Roadside Safety Facility

Research Report No. TRP-03-70-98

May 1998

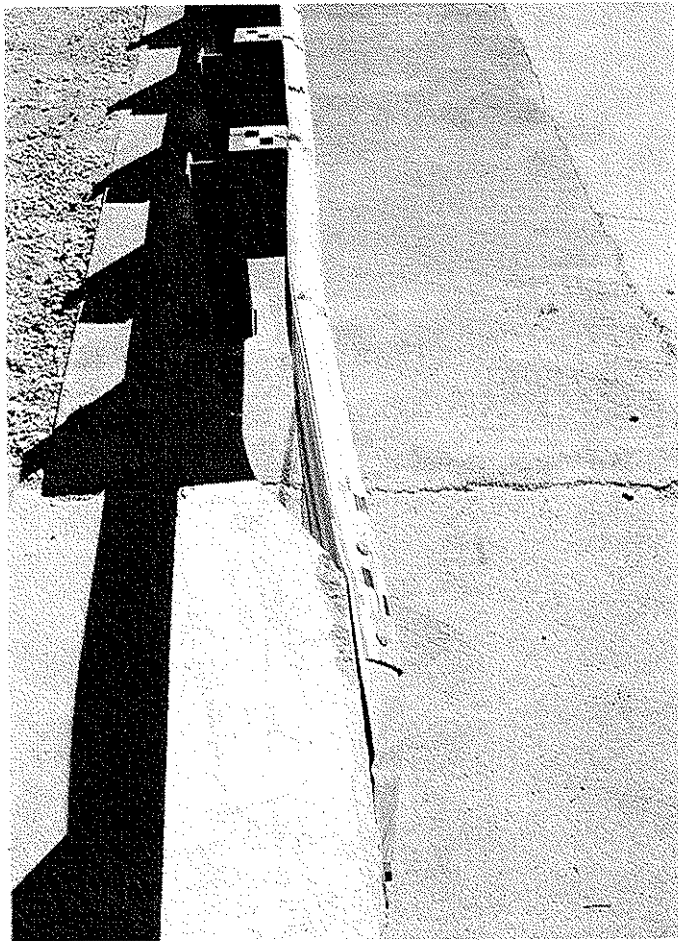
Figure 9. System Damage, Test NEBT-1 (continued).

Damage to the system was minimal, as shown in Figure 9. The maximum permanent set deflection in the guardrail of 71 mm (2 $\frac{13}{16}$ in.) occurred at the midspan between the bridge end and the first post. The first post fractured the flowable fill around its base, as a result of rotation during impact. There was

slight cracking of the flowable fill around post no. 2, but no deformation of the post. Damage to the bridge end was very minor, and consisted of tire marks and minor concrete spalling. The tire marks indicated approximately 3 in. of wheel snag on the flat end of the concrete abutment. There were no cracks in the bridge end, and no repair would be necessary for this component of the system.

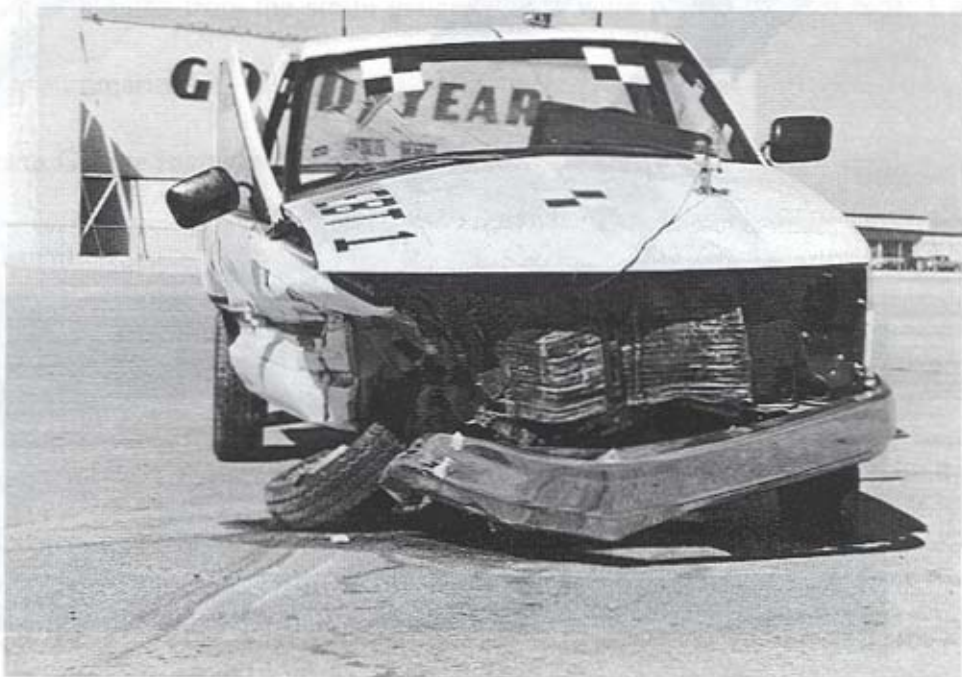
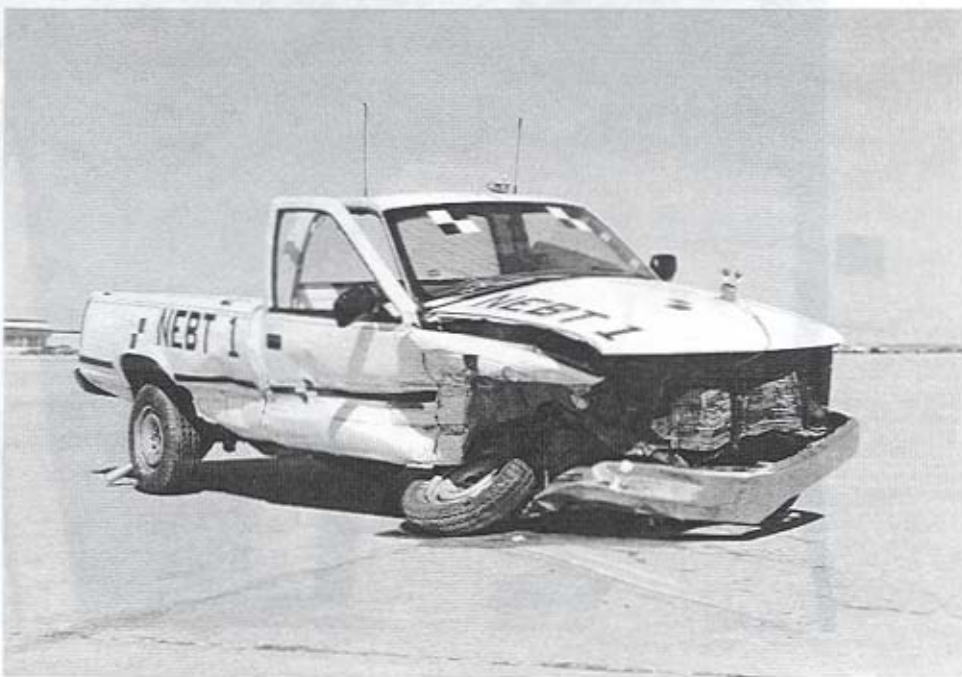
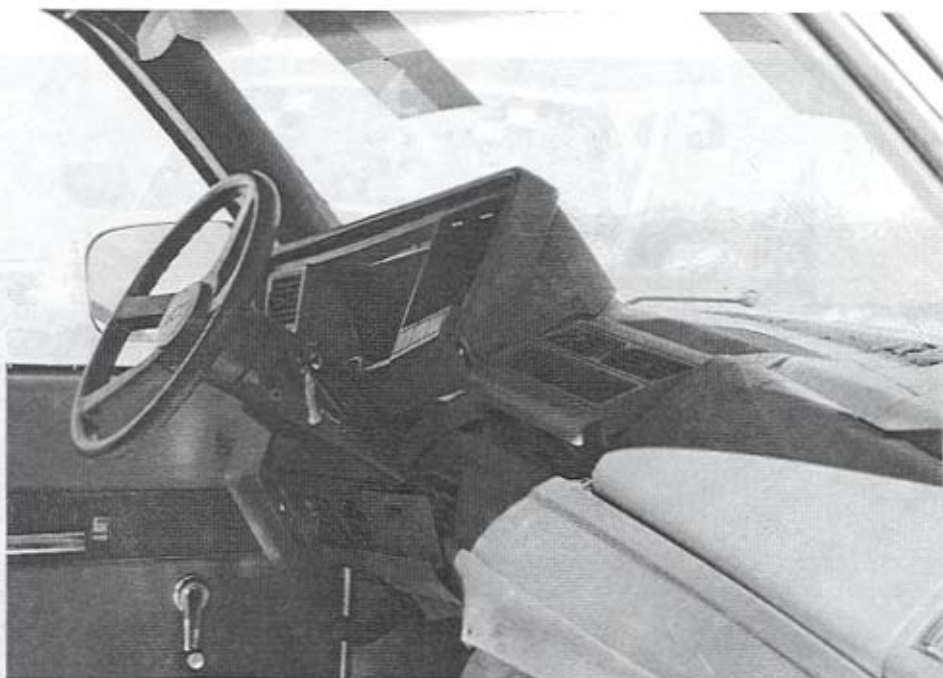
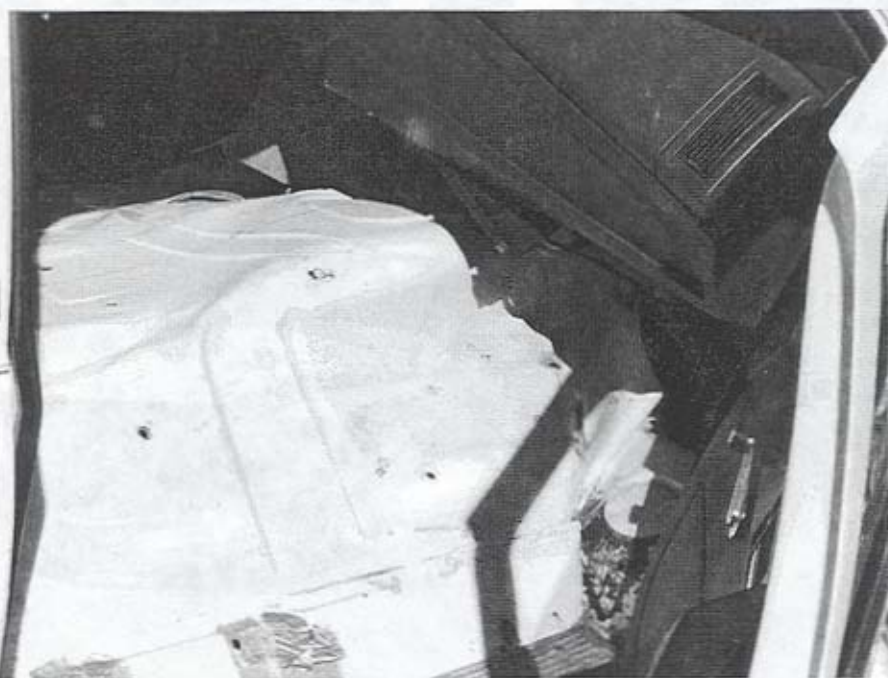
Figure 10. Vehicle Damage, Test NEBT-1.

The vehicle damage was considerable, as shown in Figure 10. The entire right-front corner of the vehicle was severely crushed, resulting in deformation of the occupant compartment. The upper control arm was disengaged from the right-front wheel assembly, allowing the wheel to pivot outward and snag on the end of the abutment. Most of the right side of the vehicle was damaged as a result of contact with the transition system.

Deformation measurements in the occupant compartment indicated that the maximum longitudinal and lateral deformations occurred on the right-front corner of the floorboard, which was the closest point to the impacted region. The deformation in the occupant compartment appeared to be more typical of what would be expected during a side-impact type loading, rather than the typical deformation caused by the wheel being forced back into the firewall. The longitudinal deformation was measured to be 165 mm (6½ in.), while the lateral deformation was 121 mm (4¾ in.). The maximum vertical occupant compartment deformation of 244 mm (9.6 in.) occurred in the left-rear corner of the passenger side floorboard. The dash was also deformed, with measurements indicating a 152-mm (6-in.) vertical deformation and 267-mm (10½-in.) deformation in the longitudinal direction.

As a result of the excessive occupant compartment deformation, the performance of Test NEBT-1 on the Nebraska Guardrail to Bridge Rail Transition was determined to be unsuccessful according to the criteria set forth in NCHRP Report 350 (2).

Based on the system performance witnessed during the testing described herein, it is recommended that the Nebraska transition design be modified to include a rubrail. A properly designed rubrail would prevent the snagging which occurred on the end of the bridge rail, and reduce the amount of occupant compartment deformation to an acceptable level.
