# INVESTIGATION AND DYNAMIC TESTING OF WOOD AND STEEL POSTS FOR MGS ON A WIRE-FACED, MSE WALL

PUBLICATION NO. FHWA-CFL/TD-12-008

FEBRUARY 2012

**CENTRAL FEDERAL LANDS HIGHWAY DIVISION  
12300 WEST DAKOTA AVENUE  
Lakewood, CO 80228**

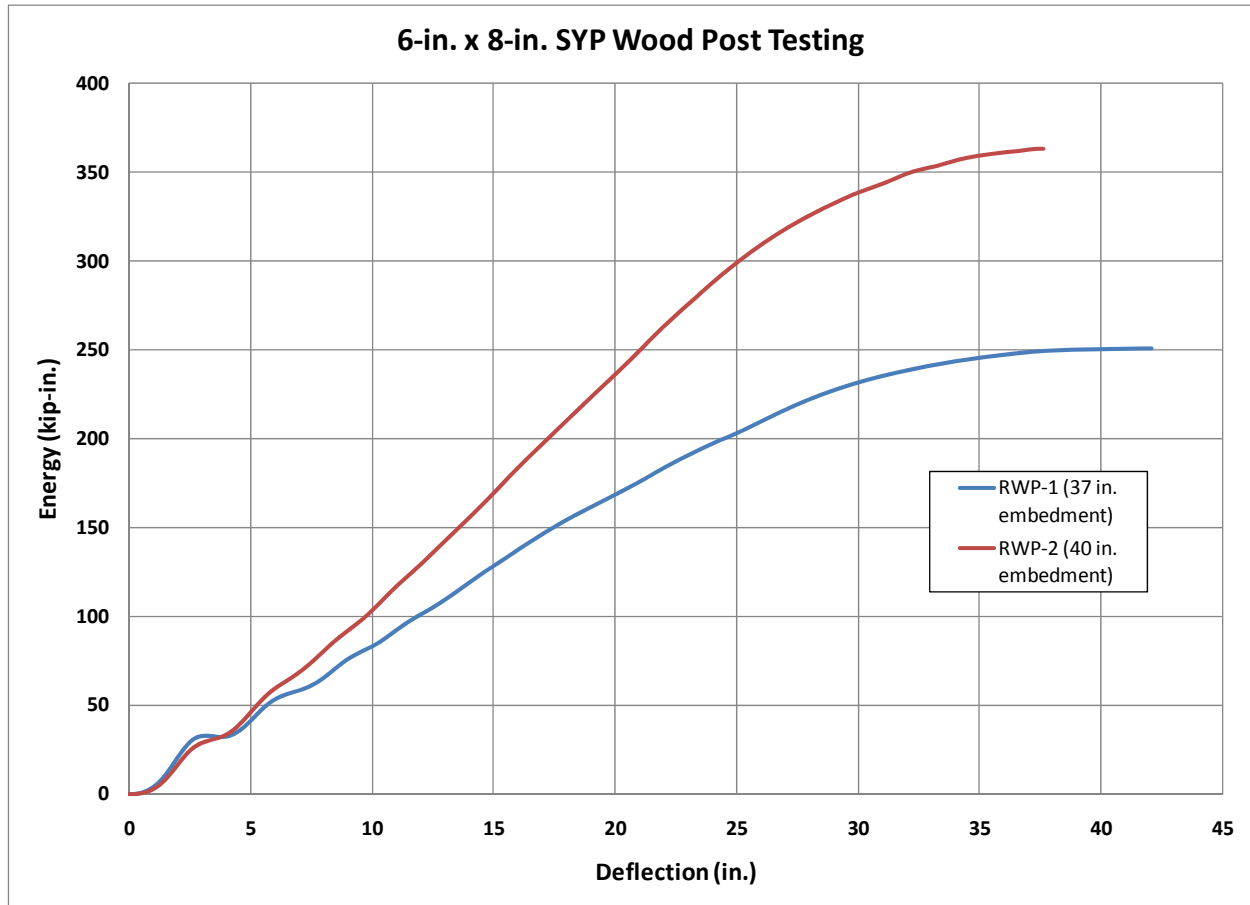
**Figure 2. Graph. Energy vs. Deflection, 6-in. x 8-in. SYP Wood Post Testing.<sup>[4]</sup>**

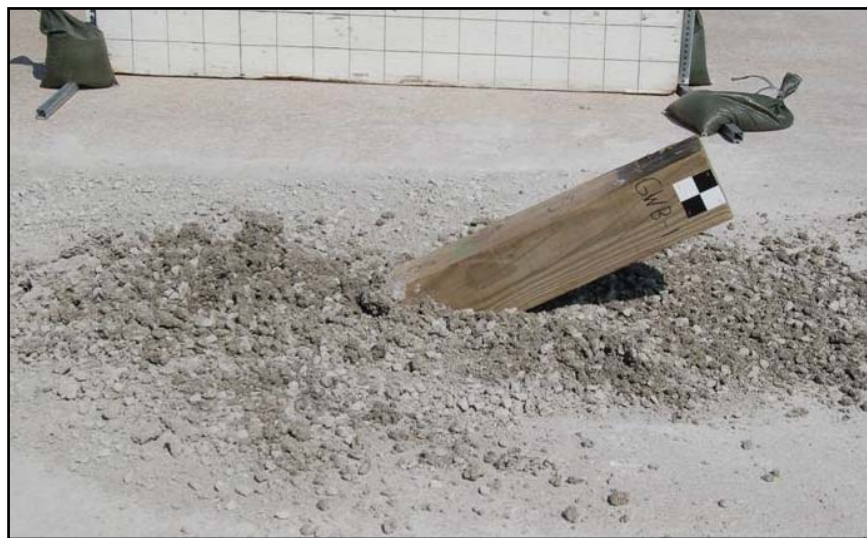
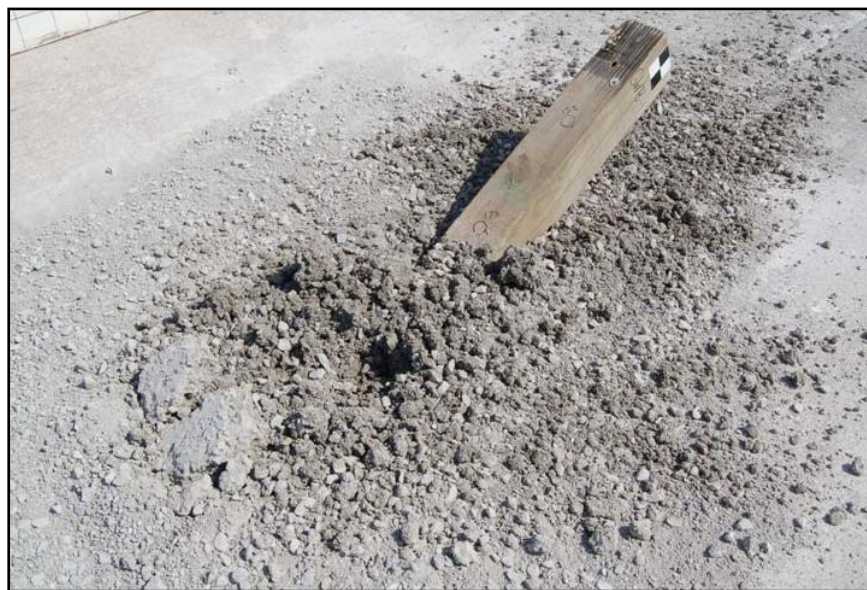
**Figure 13. Photo. Time Sequential and Post-Impact Photographs, Test No. GWB-1.**

g. Post After Impact – Side view

h. Post After Impact – Front

Force vs. deflection and energy vs. deflection curves were created from the accelerometer data and are shown in Figure 12. Initially, inertial effects resulted in a peak force of 9.7 kips (43.0 kN) over the first few inches of deflection. After the initial peak, the resistive force remained relatively constant at approximately 5.5 kips (24.5 kN) through a deflection of 35 in. (889 mm). The force then subsided through the remaining 13.5 in. (343 mm) of deflection. The post rotating in soil absorbed a total of 220.0 kip-in. (25.1 kJ) of energy. Time-sequential photographs and post-impact photographs are shown in Figure 13.

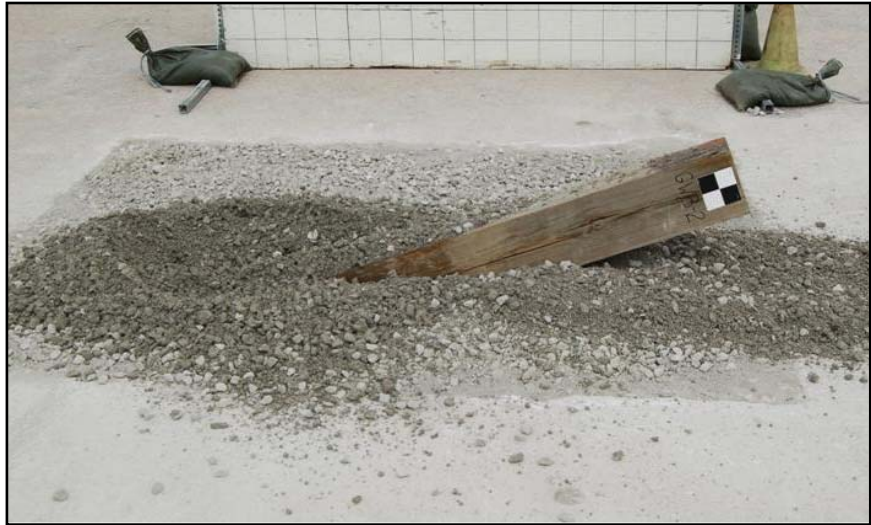
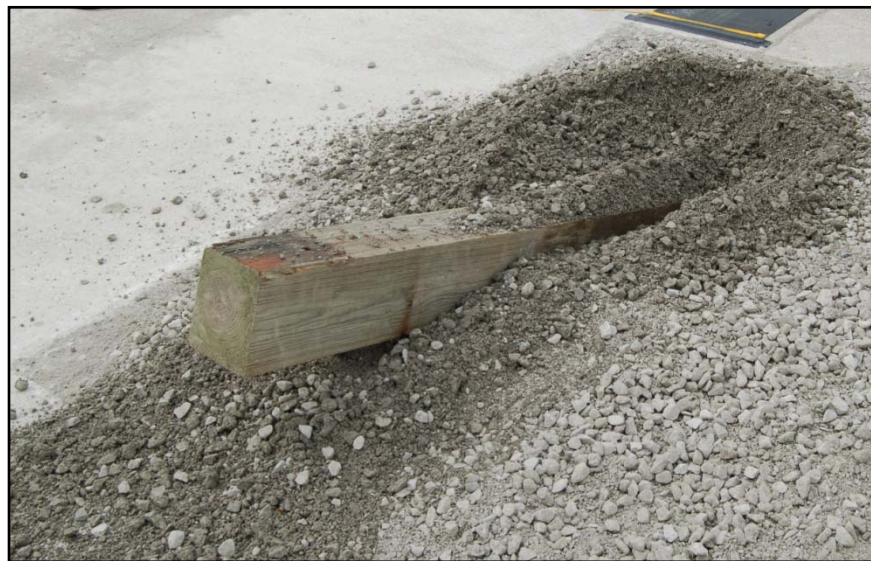
**Figure 15. Photo. Time Sequential and Post-Impact Photographs, Test No. GWB-2.**

g. Post After Impact – Side view

h. Post After Impact – Rear Quarter View

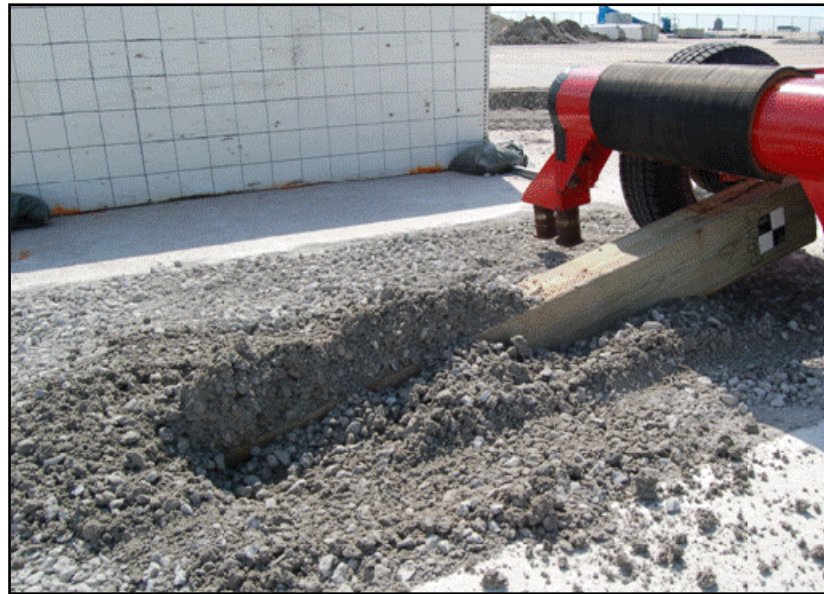
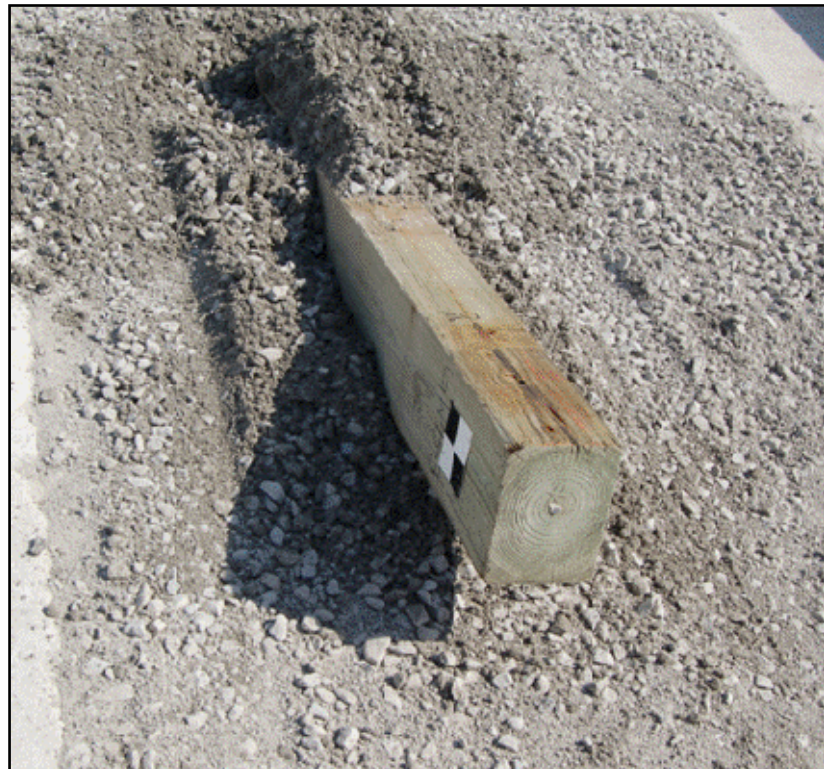
**Figure 17. Photo. Time Sequential and Post-Impact Photographs, Test No. GWB-3.**

g. Post After Impact – Side view

h. Post After Impact – Rear Quarter View

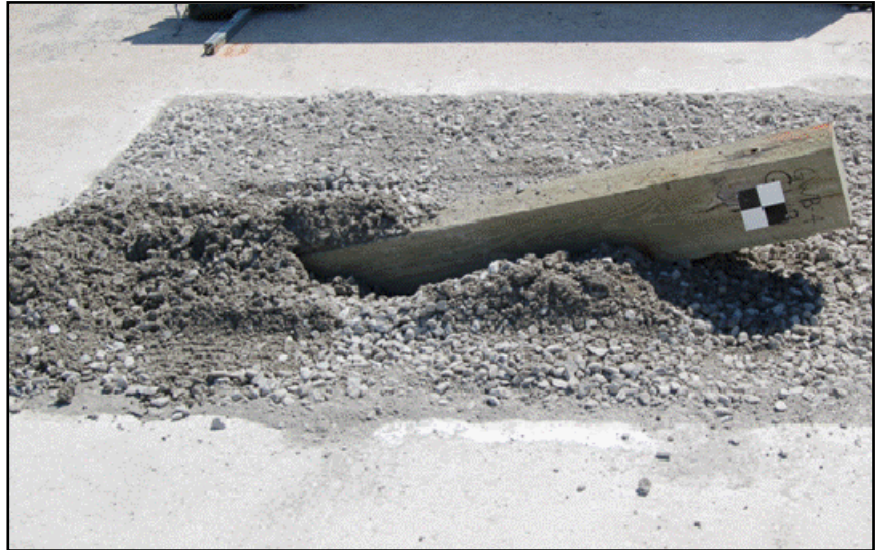
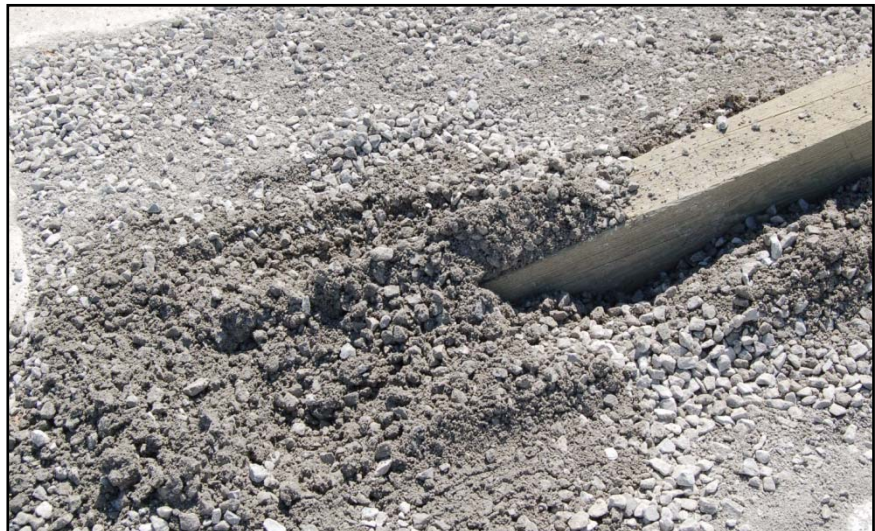
**Figure 19. Photo. Time Sequential and Post-Impact Photographs, Test No. GWB-4.**

g. Post After Impact – Side view

h. Post After Impact – Front Quarter View

Force vs. deflection and energy vs. deflection curves were created from the accelerometer data and are shown in Figure 18. Inertial effects resulted in a peak force of 10.2 kips (45.2 kN) over the first few inches of deflection. After the initial peak, the resistive force remained between approximately 4.5 kips (20.0 kN) and 3.0 kips (13.3 kN) through 30 in. (762 mm) of deflection. The force then steadily decreased to zero at 44.9 in. (1,140 mm) of deflection. The post rotating in soil absorbed a total of 129.3 kip-in. (14.6 kJ) of energy. Time-sequential photographs and post-impact photographs are shown in Figure 19.

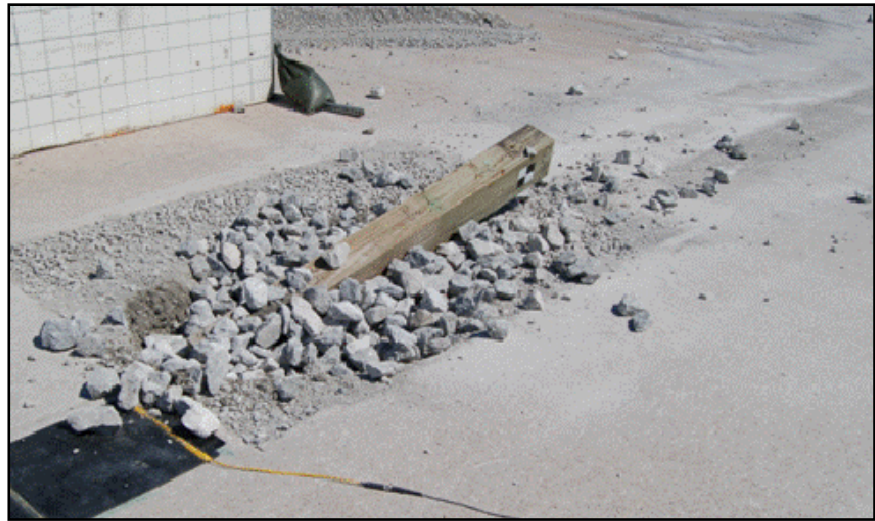
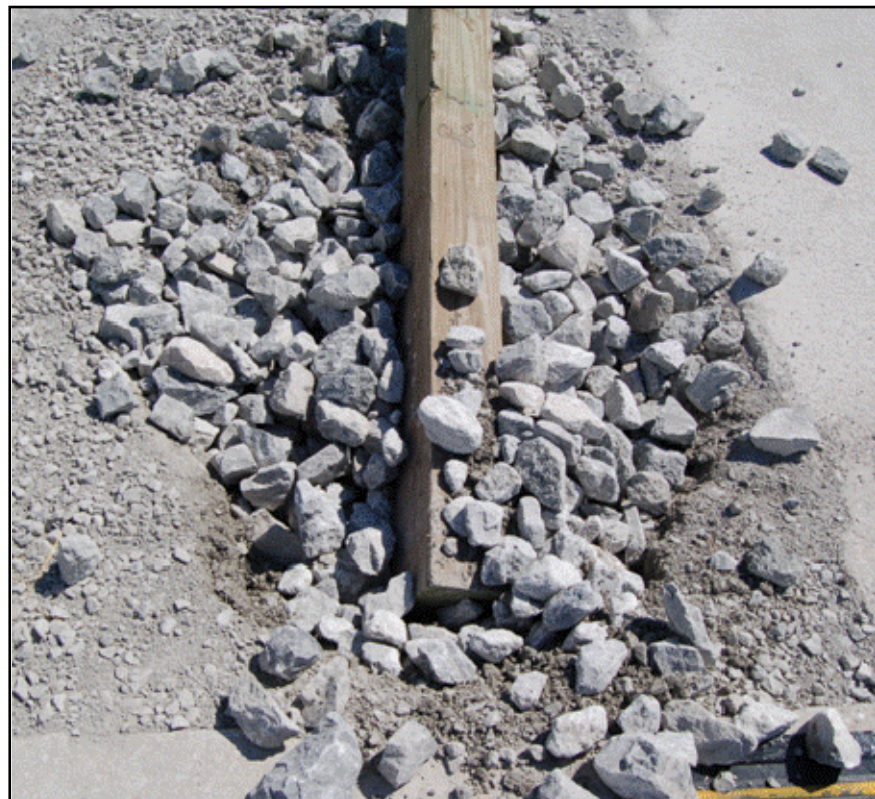
**Figure 21. Photo. Time Sequential and Post-Impact Photographs, Test No. GWB-5.**

g. Post After Impact – Side view

h. Post After Impact – Front View

Force vs. deflection and energy vs. deflection curves were created from the accelerometer data and are shown in Figure 20. Inertial effects resulted in a peak force of 8.4 kips (37.4 kN) during the first few inches of deflection. After the initial peak, the force varied between approximately 5 kips (22 kN) and 1 kip (4 kN). The post rotating in soil absorbed a total of 126.3 kip-in. (14.3 kJ) of energy. Time-sequential photographs and post-impact photographs are shown in Figure 21.

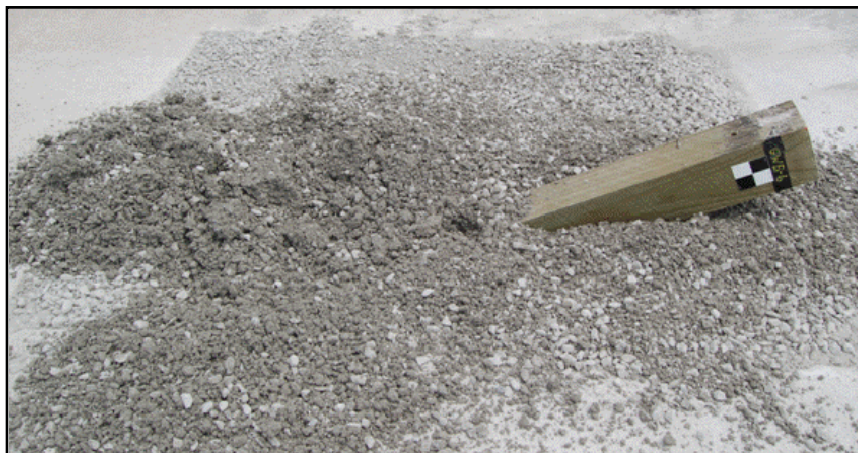
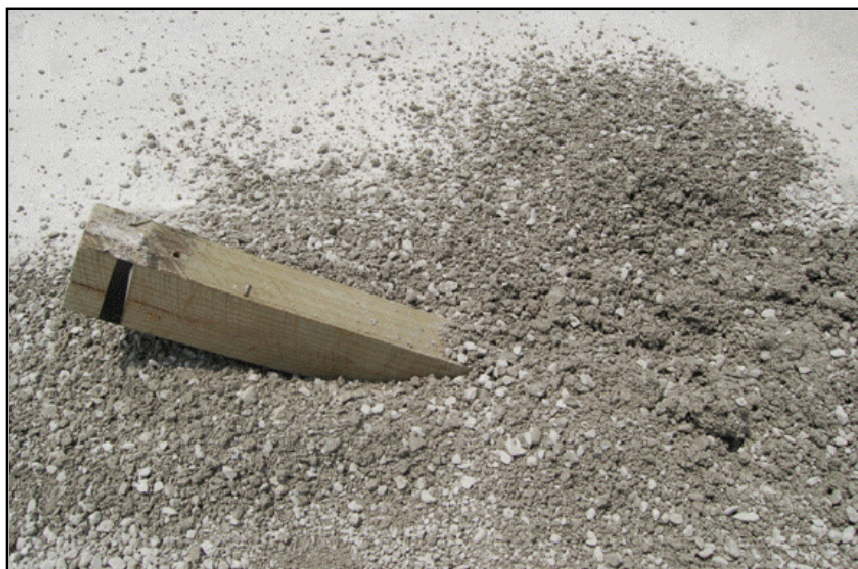
**Figure 23. Photo. Time Sequential and Post-Impact Photographs, Test No. GWB-6.**

g. Post After Impact – Side View

h. Post After Impact – Side View

Force vs. deflection and energy vs. deflection curves were created from the accelerometer data and are shown in Figure 22. Inertial effects resulted in a peak force of 8.7 kips (38.9 kN) during the first few inches of deflection. After the initial peak, the resistive force was approximately 7 kips (31 kN) through 15 in. (381 mm) of deflection. Then, the force steadily decreased to zero at a deflection of 40.5 in. (1,029 mm). The post rotating in soil absorbed a total of 177.3 kip-in. (20.0 kJ) of energy. Time-sequential photographs and post-impact photographs are shown in Figure 23.

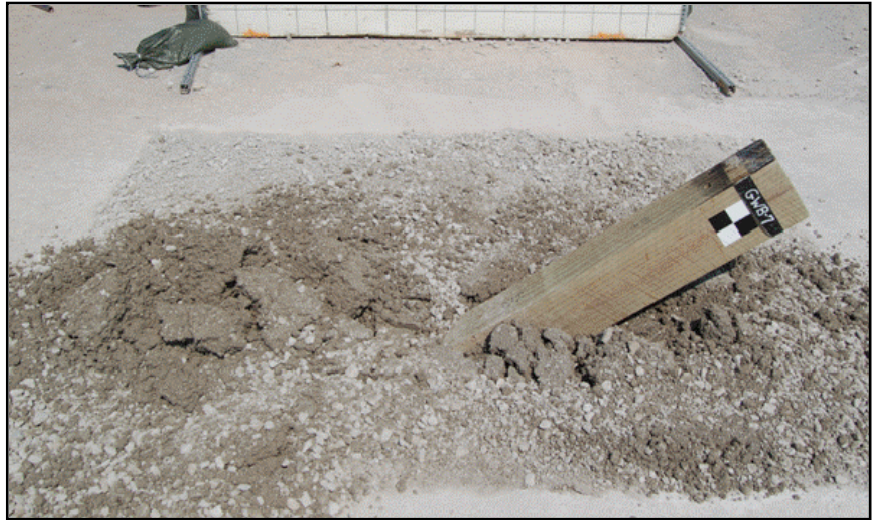
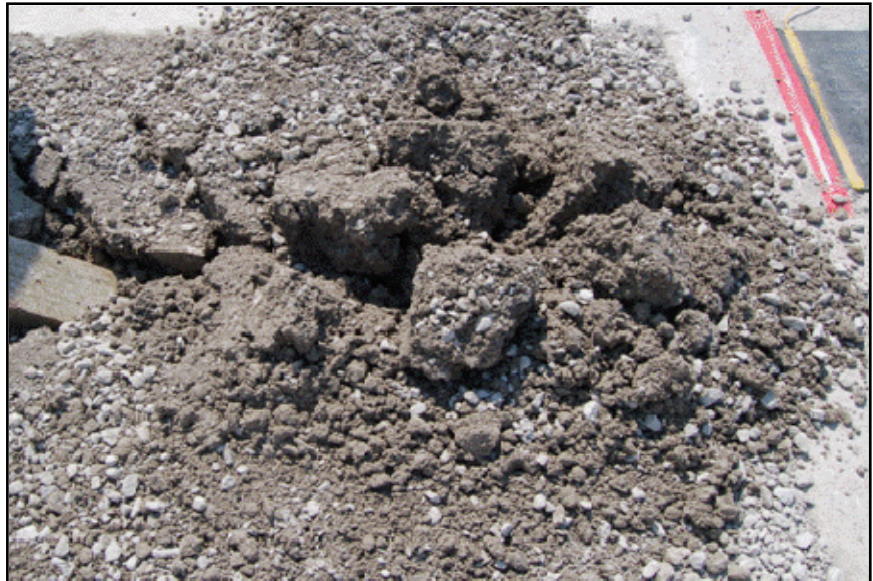
**Figure 25. Photo. Time Sequential and Post-Impact Photographs, Test No. GWB-7.**

g. Post After Impact – Side view

h. Soil Displaced During Event on the Front Side of Post

Force vs. deflection and energy vs. deflection curves were created from the accelerometer data and are shown in Figure 24. Inertial effects resulted in a peak force of 8.6 kips (38.0 kN) through the first few inches of deflection. After the initial peak, the force remained relatively constant at approximately 6 kips (27 kN) through 30 in. (762 mm) of deflection. The resistive force then decreased to zero at a deflection of 40.8 in. (1,036 mm). The post rotating in soil absorbed a total of 207.5 kip-in. (23.4 kJ) of energy. Time-sequential photographs and post-impact photographs are shown in Figure 25

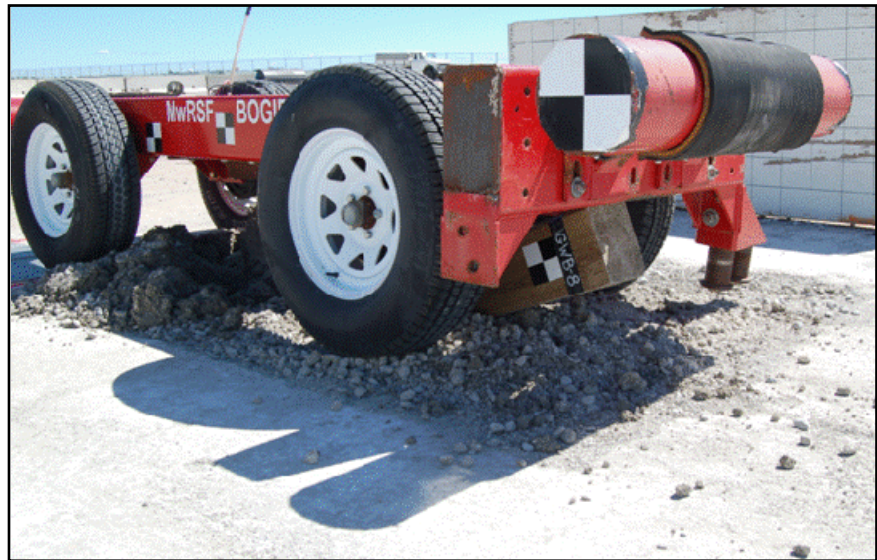
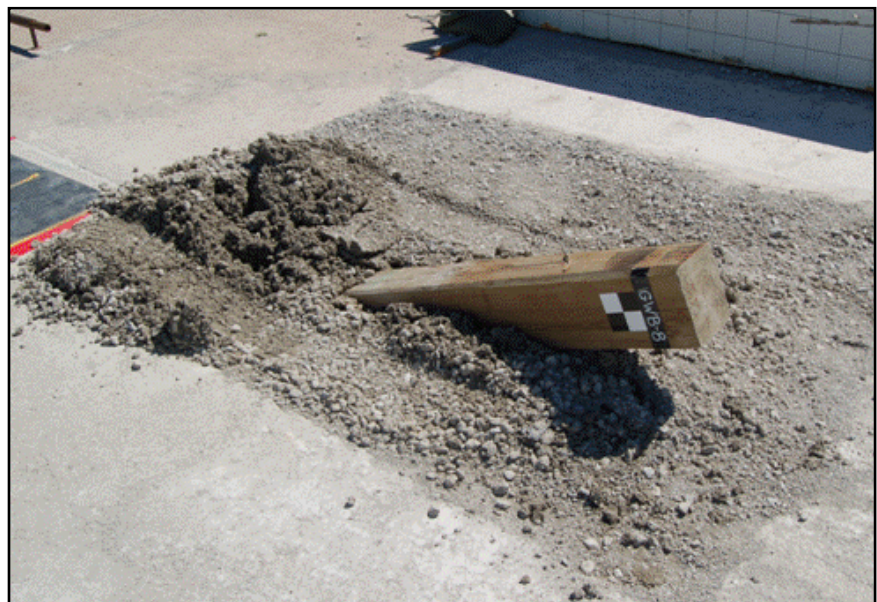
**Figure 27. Photo. Time Sequential and Post-Impact Photographs, Test No. GWB-8.**

g. Post After Impact – Rear Quarter View

h. Post After Impact – Rear Quarter View

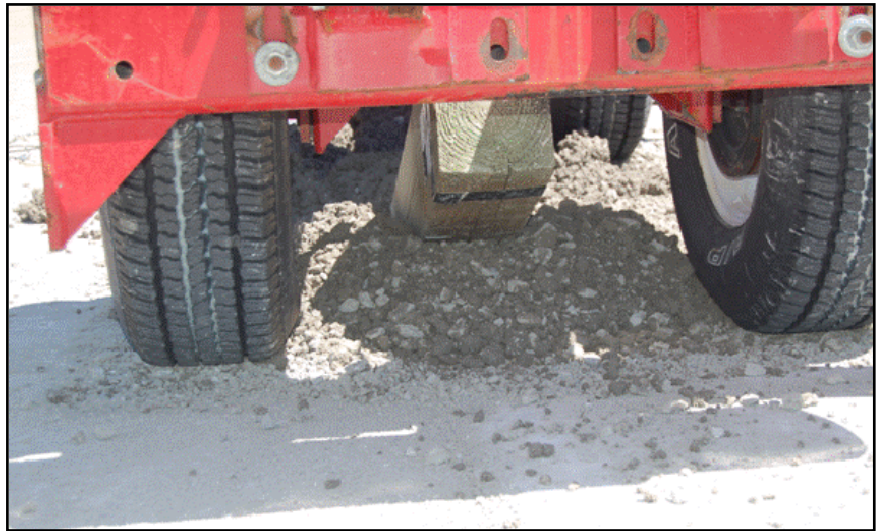
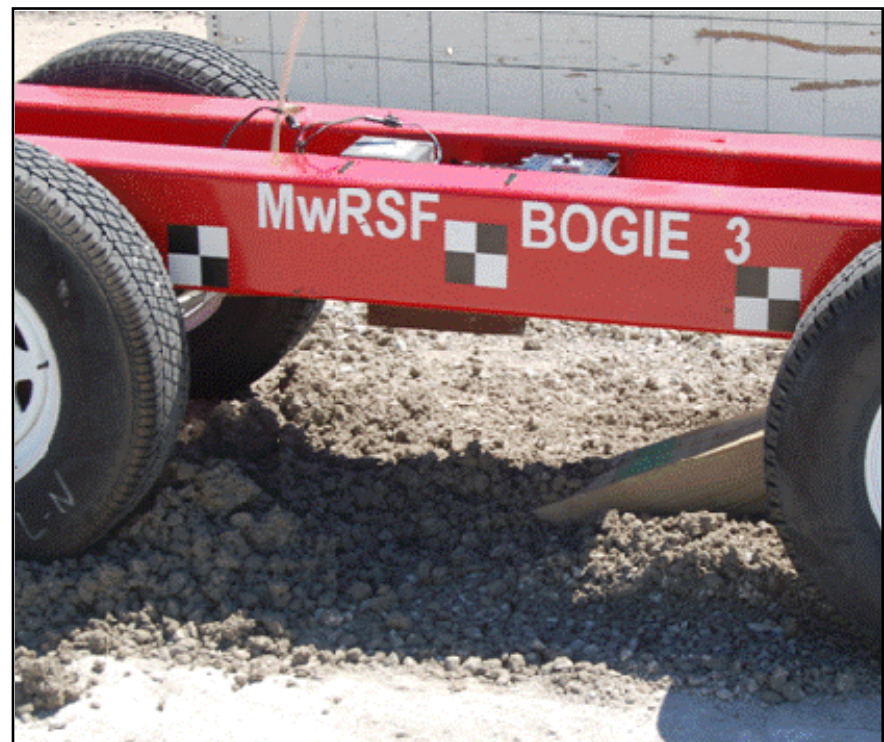
**Figure 29. Photo. Time Sequential and Post-Impact Photographs, Test No. GWB-9.**

g. Post After Impact – Rear View

h. Post After Impact – Side View

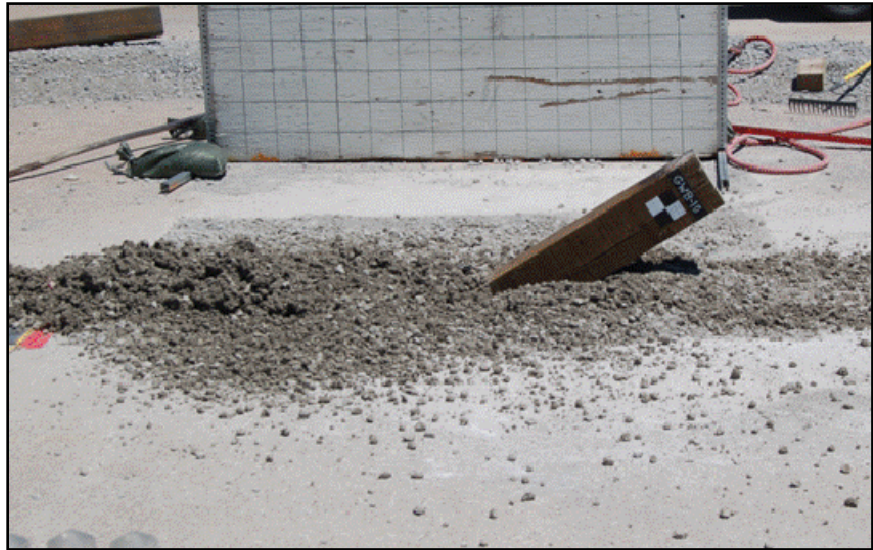
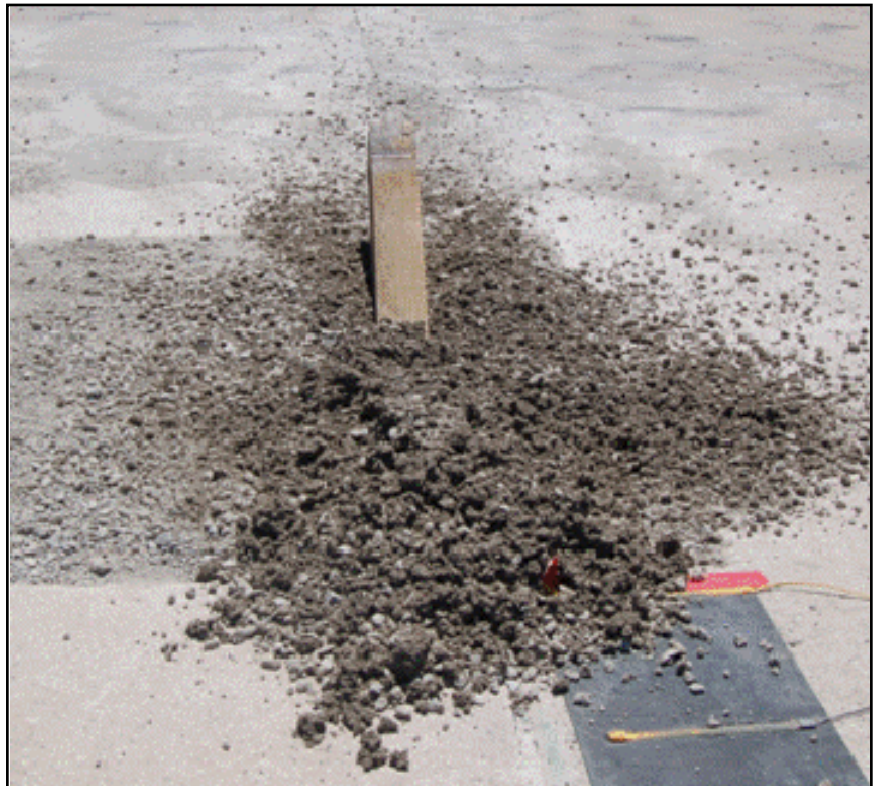
**Figure 31. Photo. Time Sequential and Post-Impact Photographs, Test No. GWB-10.**

g. Post After Impact – Side view

h. Post After Impact – Front View

Force vs. deflection and energy vs. deflection curves were created from the accelerometer data and are shown in Figure 30. Inertial effects resulted in a peak force of 14.6 kips (64.9 kN) through the first few inches of deflection. After the initial peak, the force remained relatively constant at approximately 5 kips (22 kN) over 30 in. (762 mm) of deflection. The force then decreased to zero at a deflection of 45.5 in. (1,156 mm). The post rotating in soil absorbed a total of 223.5 kip-in. (25.3 kJ) of energy. Time-sequential photographs and post-impact photographs are shown in Figure 31.

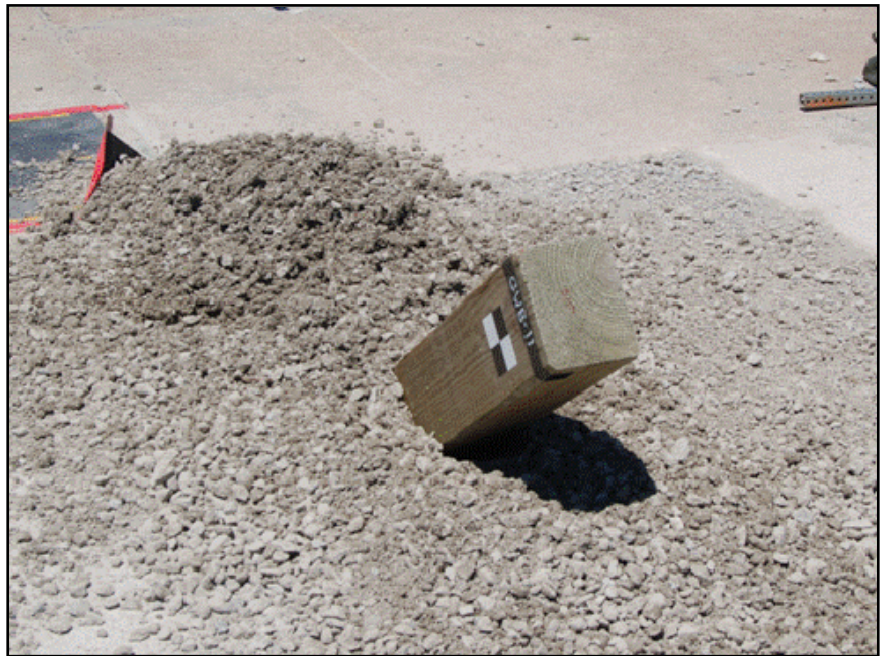
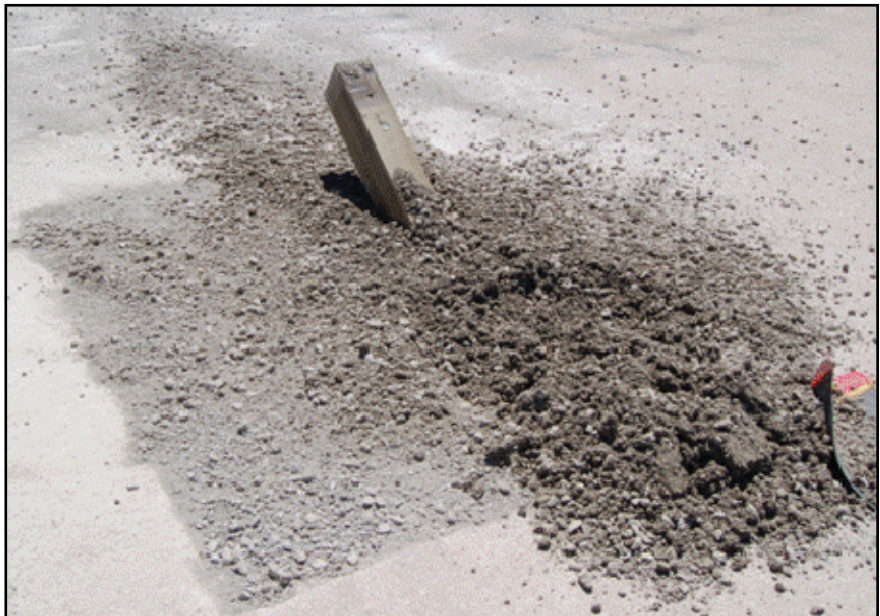
**Figure 33. Photo. Time Sequential and Post-Impact Photographs, Test No. GWB-11.**

g. Post After Impact – Rear Quarter View

h. Post After Impact – Front Quarter View

Force vs. deflection and energy vs. deflection curves were created from the accelerometer data and are shown in Figure 32. Inertial effects resulted in a peak force of 14.8 kips (65.8 kN) through the first few inches of deflection. After the initial peak, the force remained relatively constant at approximately 6 kips (27 kN) through 30 in (762 mm) of deflection. The force then decreased to zero at a deflection of 45.8 in. (1,164 mm). The post rotating in soil absorbed a total of 233.5 kip-in. (26.4 kJ) of energy. Time-sequential photographs and post-impact photographs are shown in Figure 33.

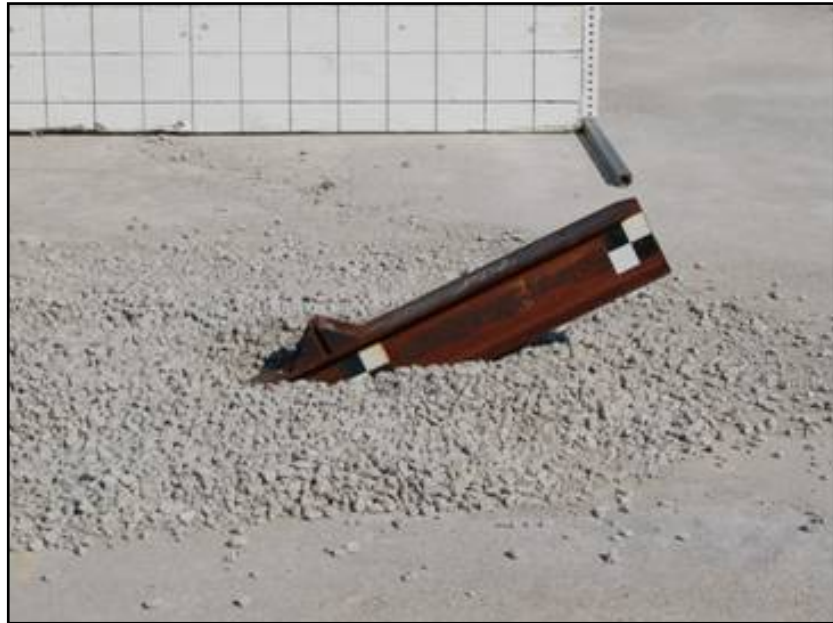
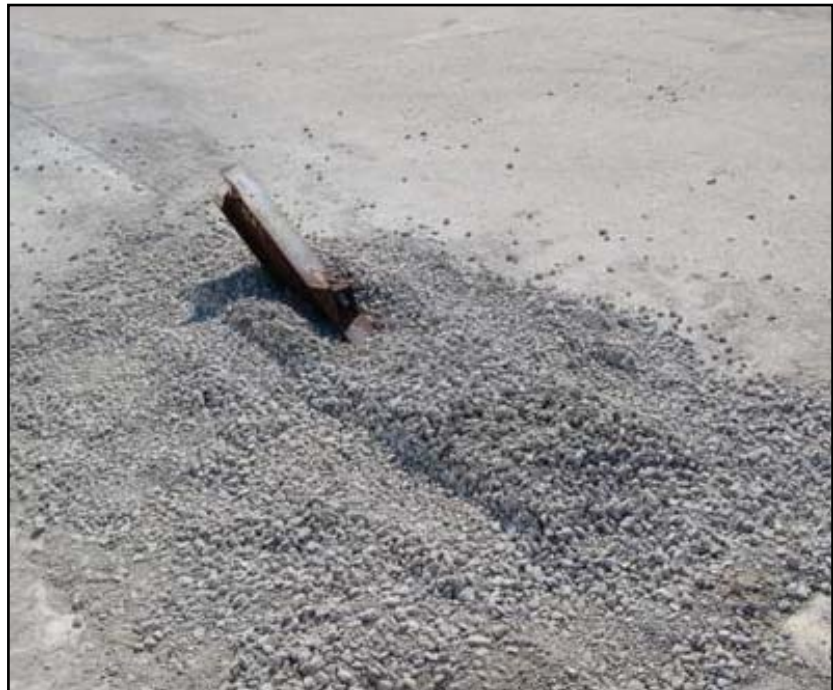
**Figure 40. Photo. Time Sequential and Post-Impact Photographs, Test No. GWB-12.**

g. Post After Impact – Side view

h. Post After Impact – Front Quarter View

Force vs. deflection and energy vs. deflection curves were created from the accelerometer data and are shown in Figure 39. The resistive force quickly increased to around 12 kips (53 kN) and remained relatively constant through a deflection of 11 in. (279 mm). After this plateau, the force steadily decreased until reaching zero at a deflection of 33.8 in. (860 mm). The maximum resistive force was 12.8 kips (57.1 kN), and the post rotating in soil absorbed a total of 236.1 kip-in. (26.7 kJ) of energy. Time-sequential photographs and post-impact photographs are shown in Figure 40.

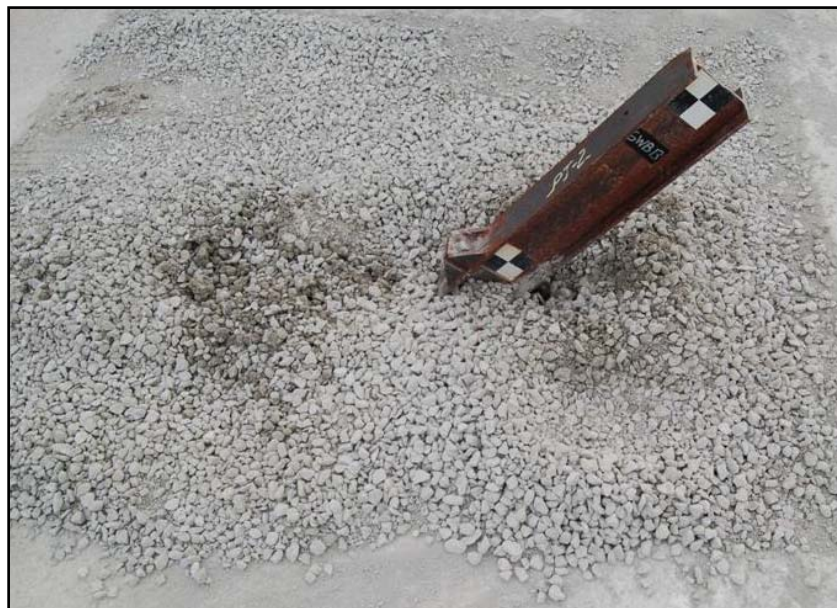
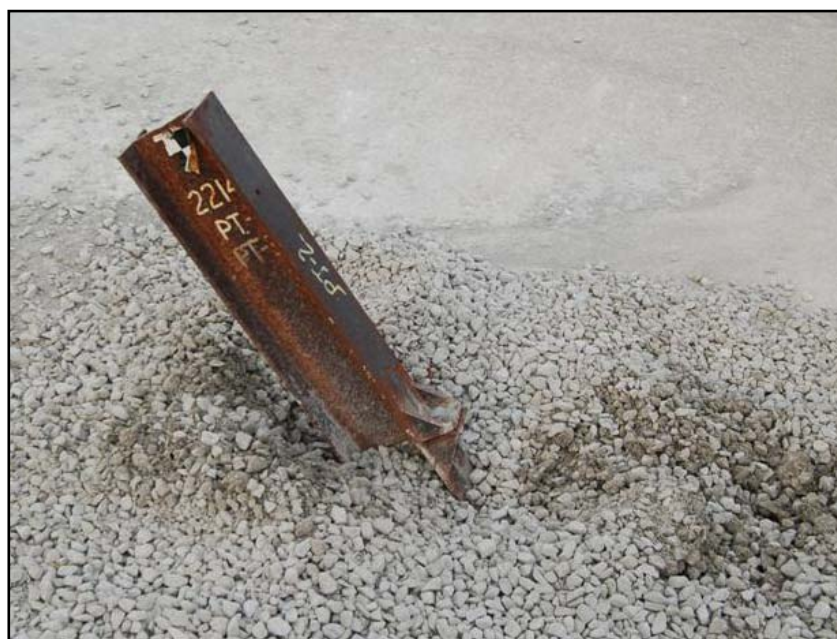
**Figure 42. Photo. Time Sequential and Post-Impact Photographs, Test No. GWB-13.**

g. Post After Impact – Side view

h. Post After Impact – Front Quarter View

Force vs. deflection and energy vs. deflection curves were created from the accelerometer data and are shown in Figure 41. Similar to test no. GWB-12, the resistive force quickly increased to approximately 12 kips (53 kN) and stayed relatively constant for a deflection of 10 in. (254 mm). After this plateau, the force steadily decreased until reaching zero at a deflection of 31.3 in. (795 mm). The maximum resistive force was 12.8 kips (57.1 kN), and the post rotating in soil absorbed a total of 247.7 kip-in. (28.0 kJ) of energy. Time-sequential photographs and post-impact photographs are shown in Figure 42.

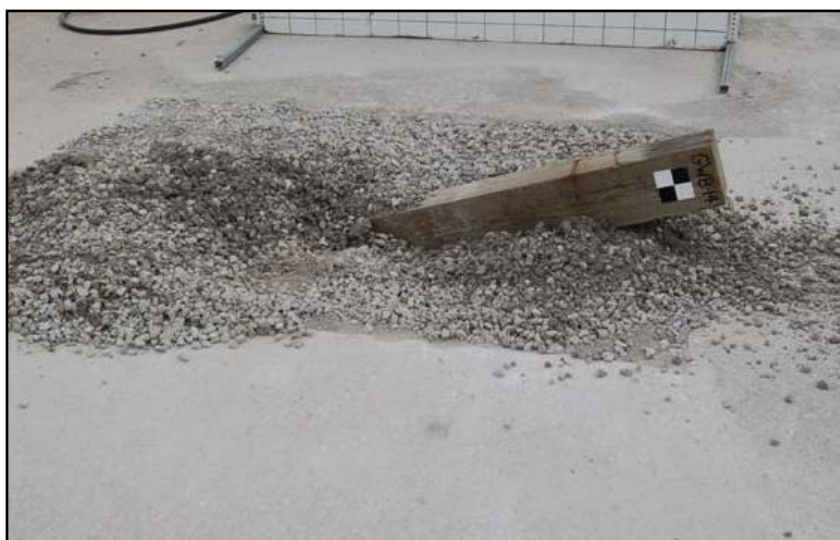
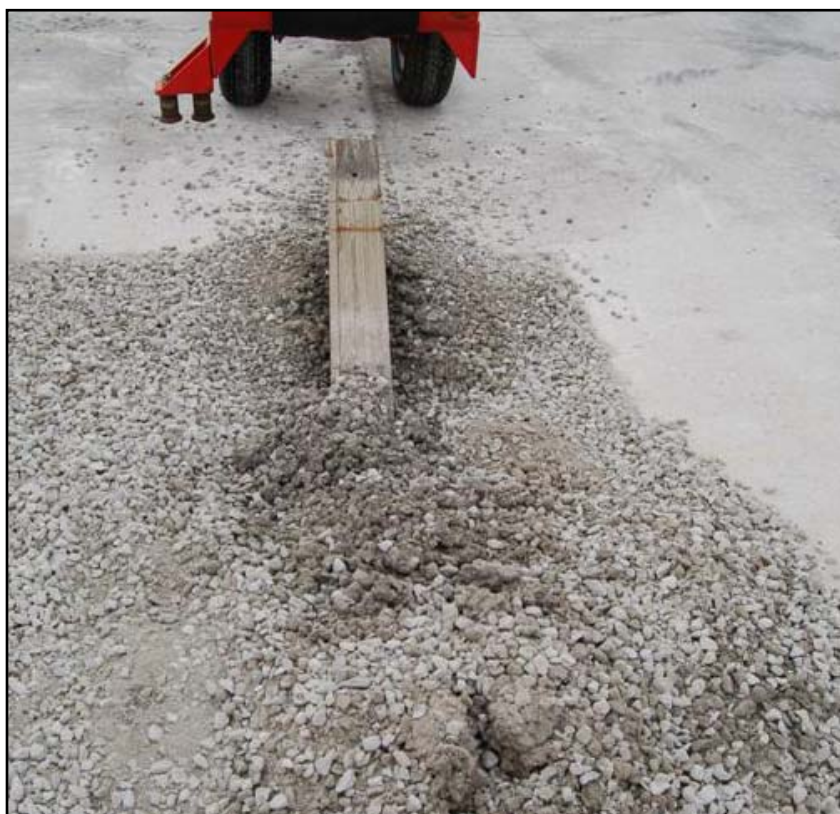
**Figure 44. Photo. Time Sequential and Post-Impact Photographs, Test No. GWB-14.**

g. Post After Impact – Side view

h. Post After Impact – Front View

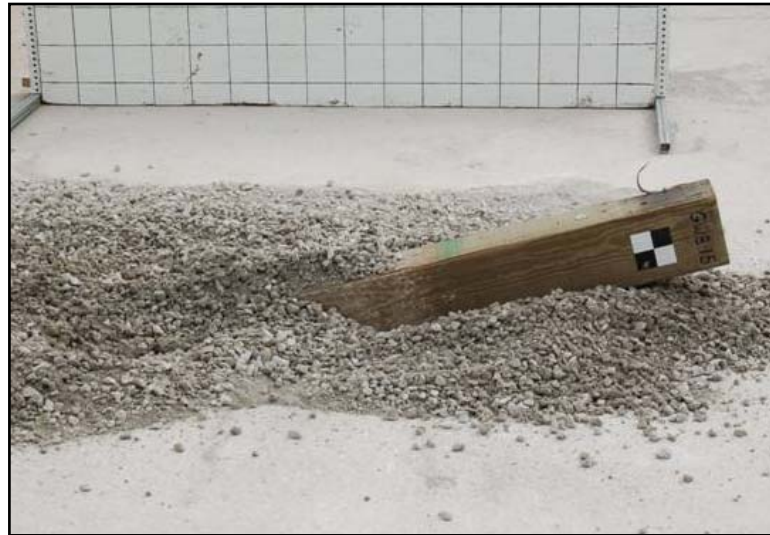
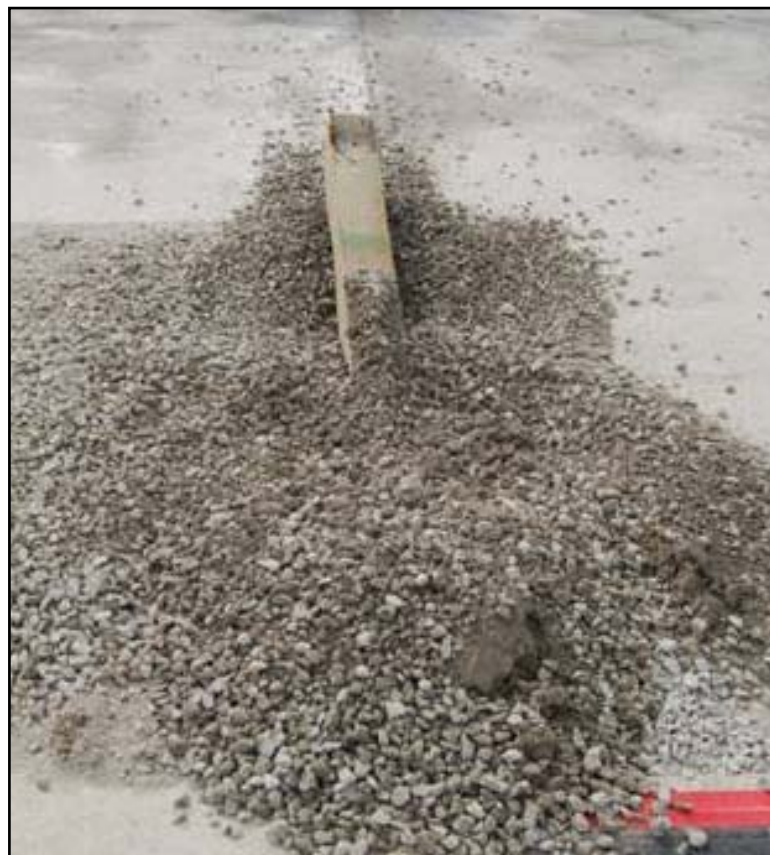
**Figure 46. Photo. Time Sequential and Post-Impact Photographs, Test No. GWB-15.**

g. Post After Impact – Side view

h. Post After Impact – Front View

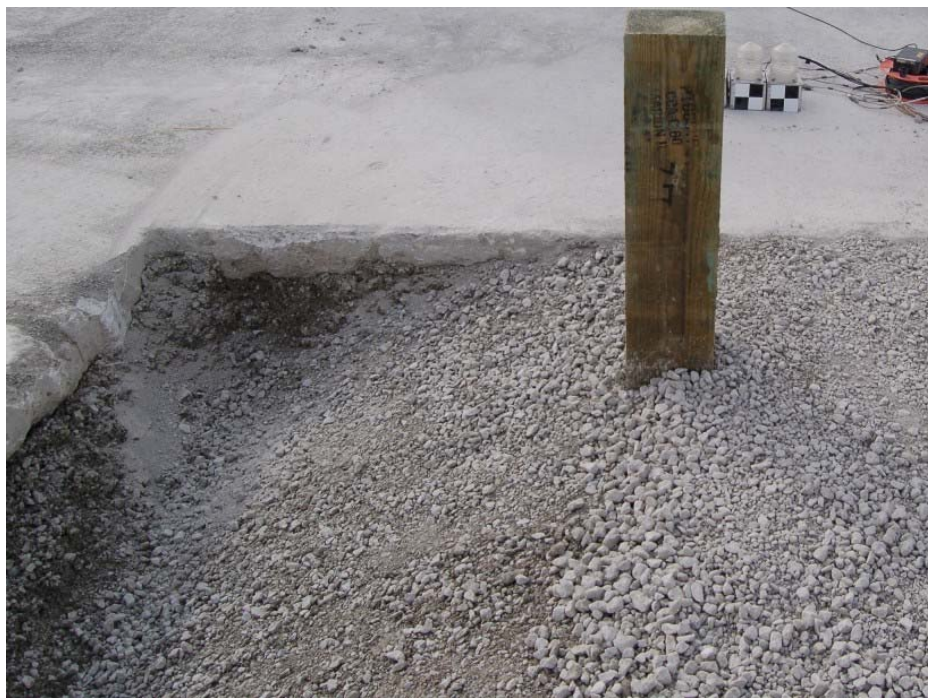
**Figure 48. Photo. Round 3 Test Setup on 3H:1V Fill Slope.**

b. Test Profile View

For the third round of dynamic testing, a total of eight tests were initially planned. Test nos. GWR4-1 through GWR4-4 were to be conducted with 6-in. x 8-in. (152-mm x 203-mm) wood posts, while test nos. GWR5-1 through GWR5-2 and GWR5-3 through GWR5-4 were to be conducted with W6x9 (W152x13.4) and W6x8.5 (W152x12.6) steel posts, respectively, as shown in Table 14. All eight tests were intended to evaluate the post-soil resistance for a post placed at the slope break point of a 3H:1V fill slope, as shown in Figure 48.

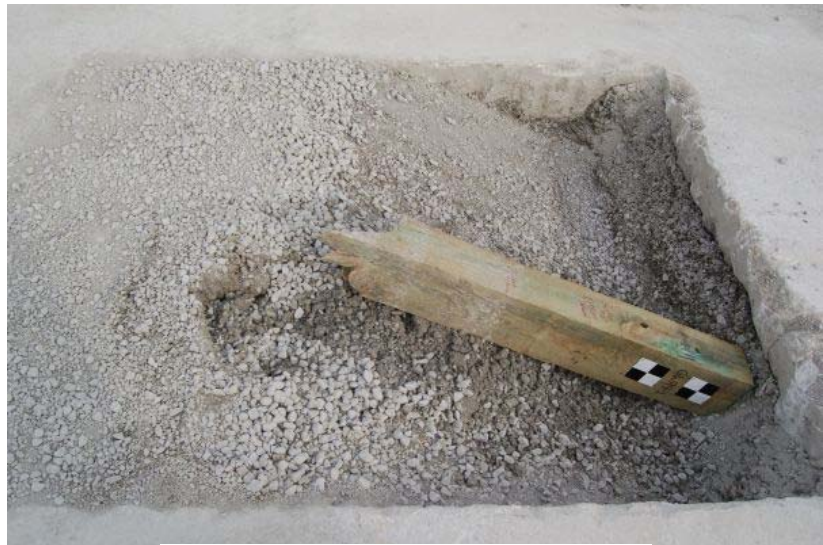
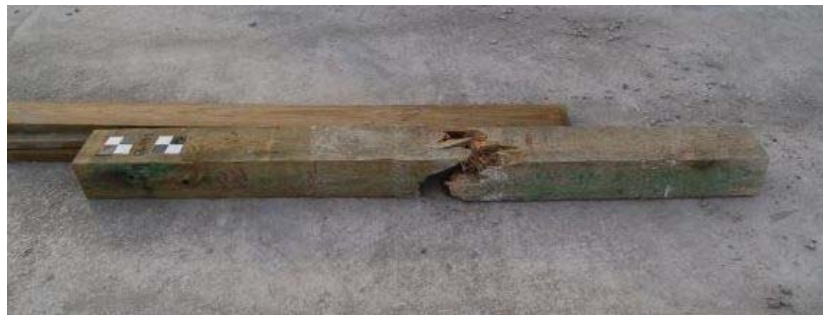
g. Post After Impact – Side view

h. Full View of Post After Impact

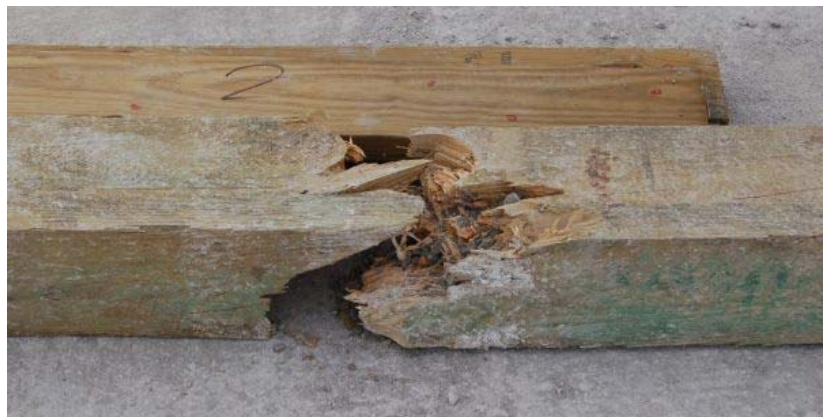
i. Close up of Post Fracture

**Figure 50. Photo. Time Sequential and Post-Impact Photographs, Test No. GWR4-1.**

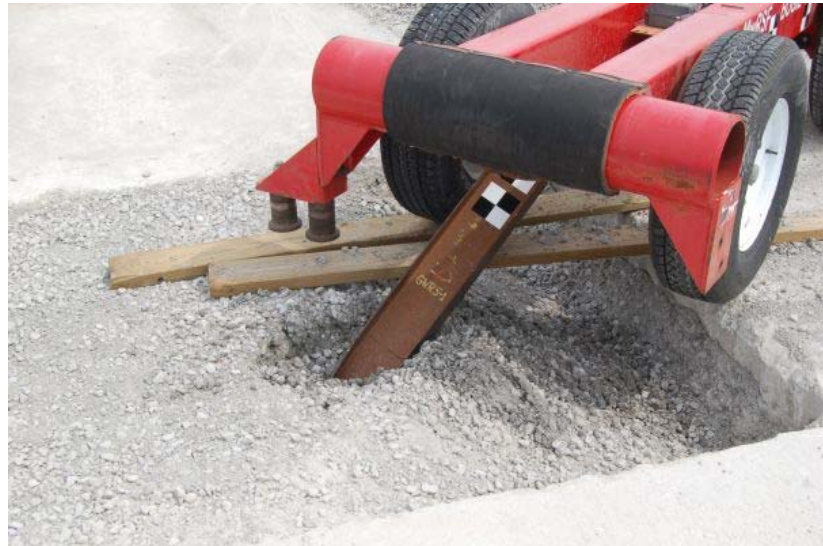
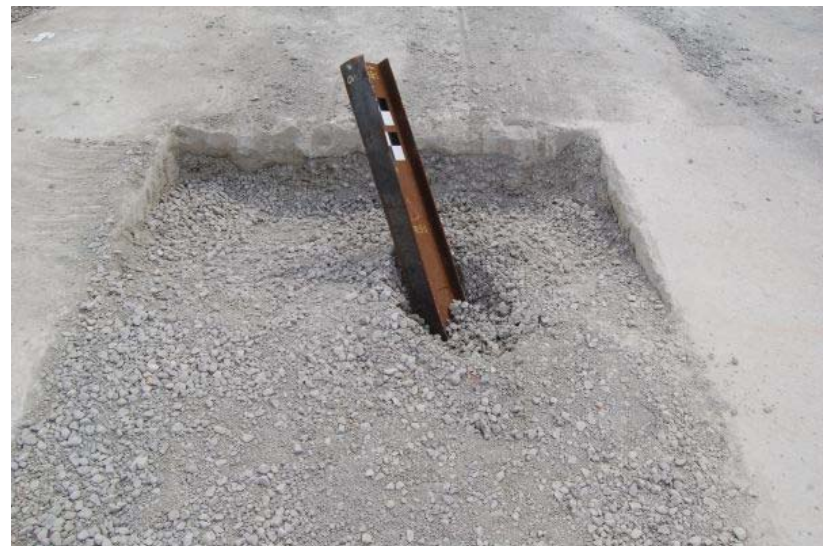
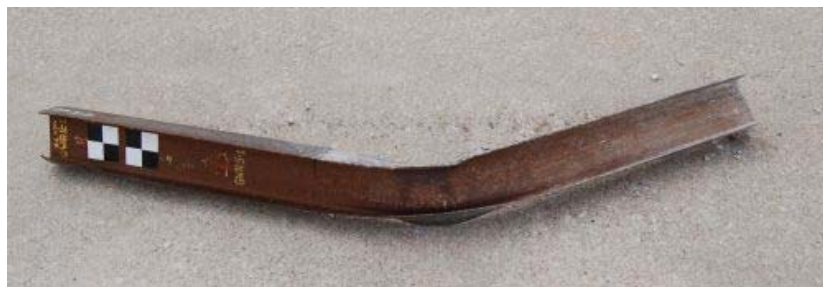
**Figure 52. Photo. Time Sequential and Post-Impact Photographs, Test No. GWR5-1.**

g. Post After Impact – Side view

h. Post After Impact – Front View

i. Post After Impact – Removed, Showing Deformation

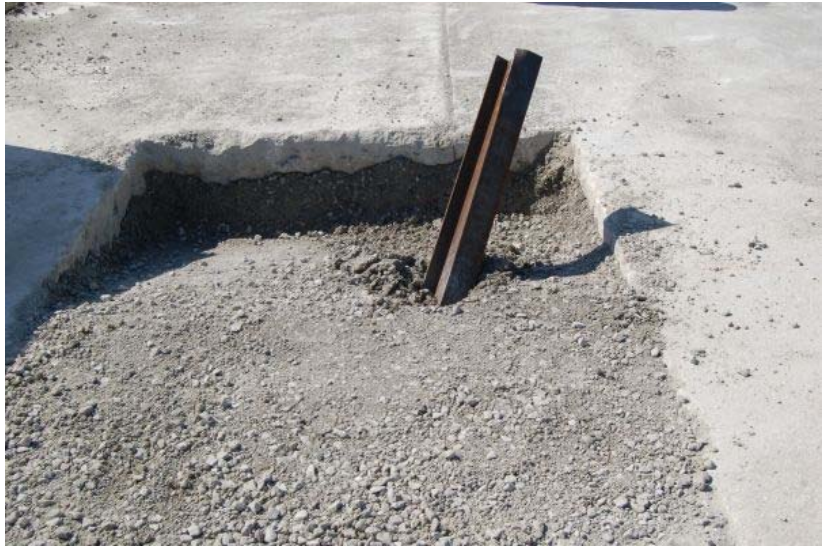
g. Post After Impact – Front View
