# INVESTIGATION AND DYNAMIC TESTING OF WOOD AND STEEL POSTS FOR MGS ON A WIRE-FACED, MSE WALL

PUBLICATION NO. FHWA-CFL/TD-12-008

FEBRUARY 2012

**CENTRAL FEDERAL LANDS HIGHWAY DIVISION  
12300 WEST DAKOTA AVENUE  
Lakewood, CO 80228**

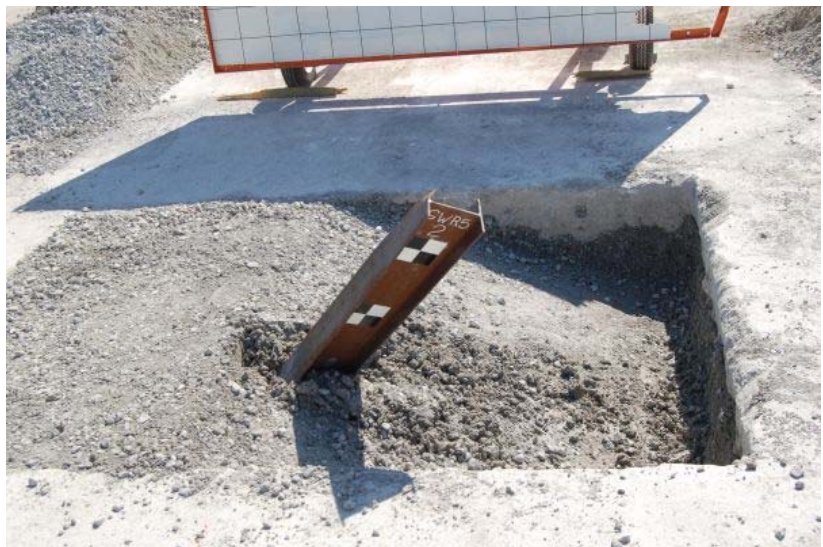
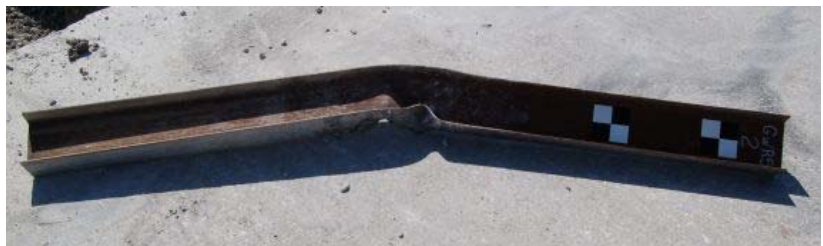
h. Post After Impact – Side view

i. Post After Impact – Removed, Showing Deformation

**Figure 54. Photo. Time Sequential and Post-impact Photographs, Test No. GWR5-2.**

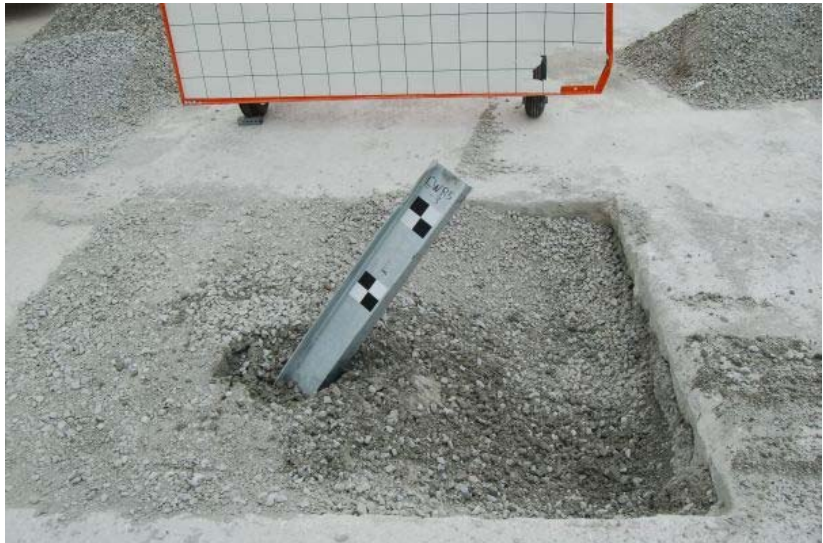
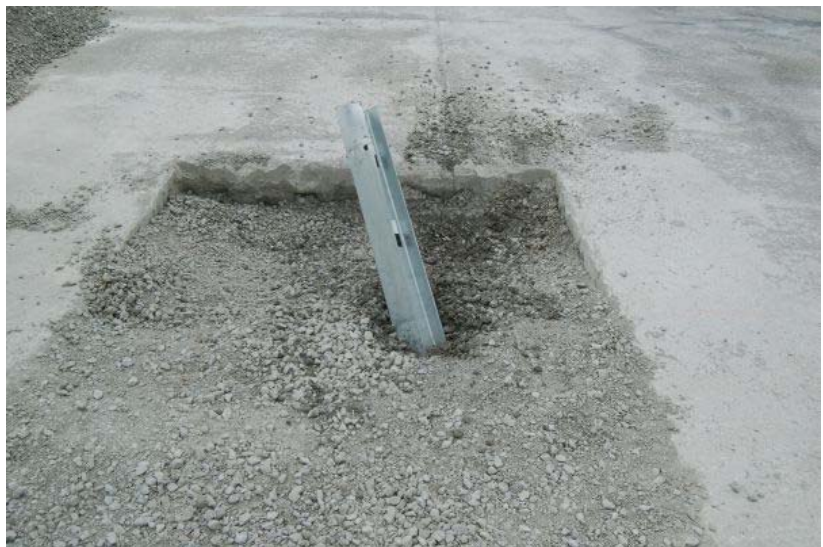
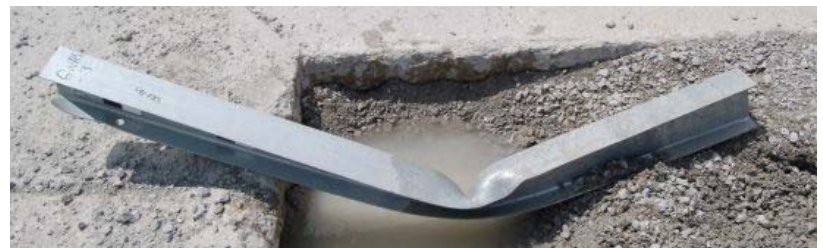
g. Post After Impact – Side view

h. Post After Impact – Front View

i. Post After Impact – Removed, Showing Deformation

**Figure 56. Photo. Time Sequential and Post-Impact Photographs, Test No. GWR5-3.**

Force vs. deflection and energy vs. deflection curves were created from the accelerometer data and are shown in Figure 57. The load quickly increased to and peaked at 14.0 kips (62.1 kN) and then steadily declined until reaching zero at the maximum deflection of 34.5 in. (877 mm). The post rotating in soil absorbed a total of 237.1 kip-in. (26.8 kJ) of energy. Time-sequential photographs and post-impact photographs are shown in Figure 58.

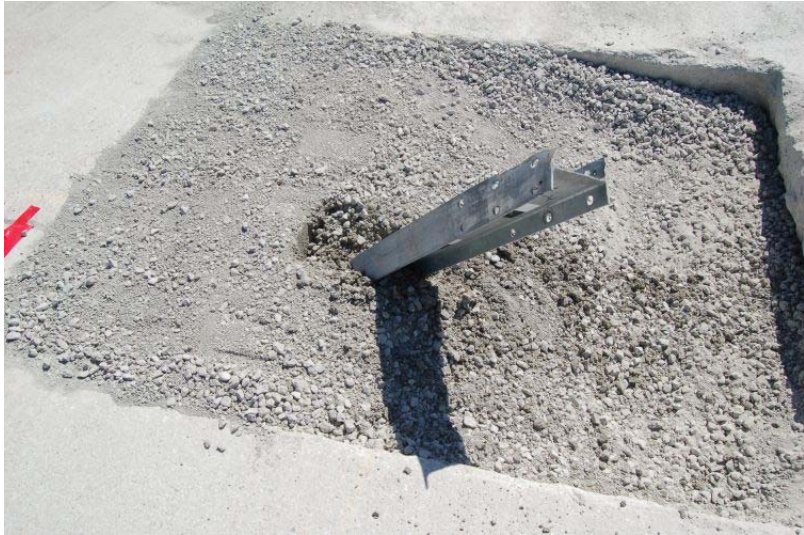
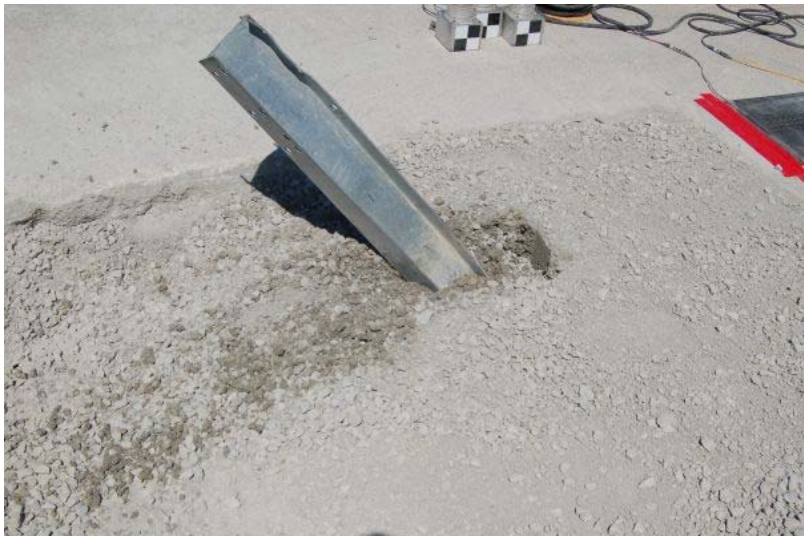
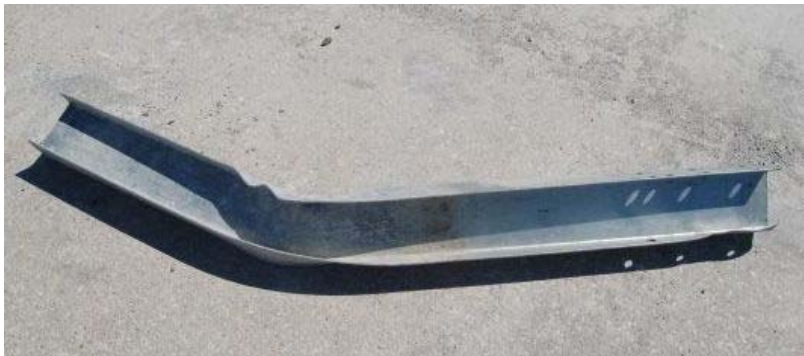
g. Post After Impact – Side view

h. Post After Impact – Rear Quarter

i. Post After Impact – Removed, Showing Deformation

**Figure 58. Photo. Time Sequential and Post-Impact Photographs, Test No. GWR5-4.**

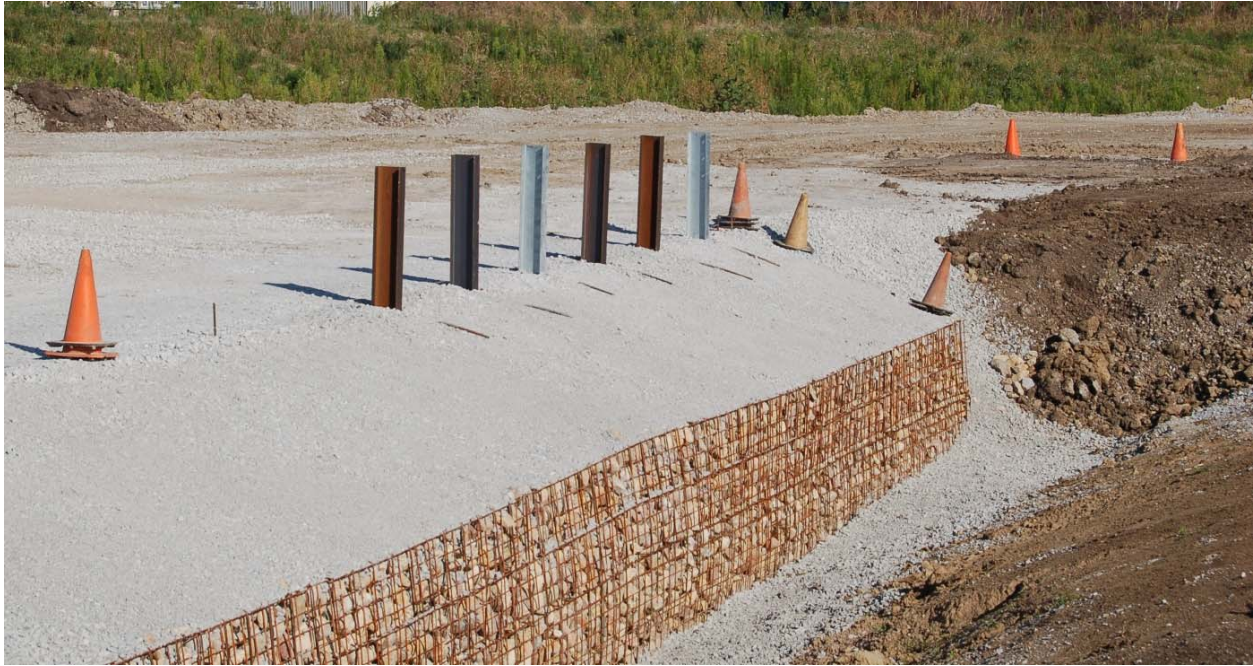
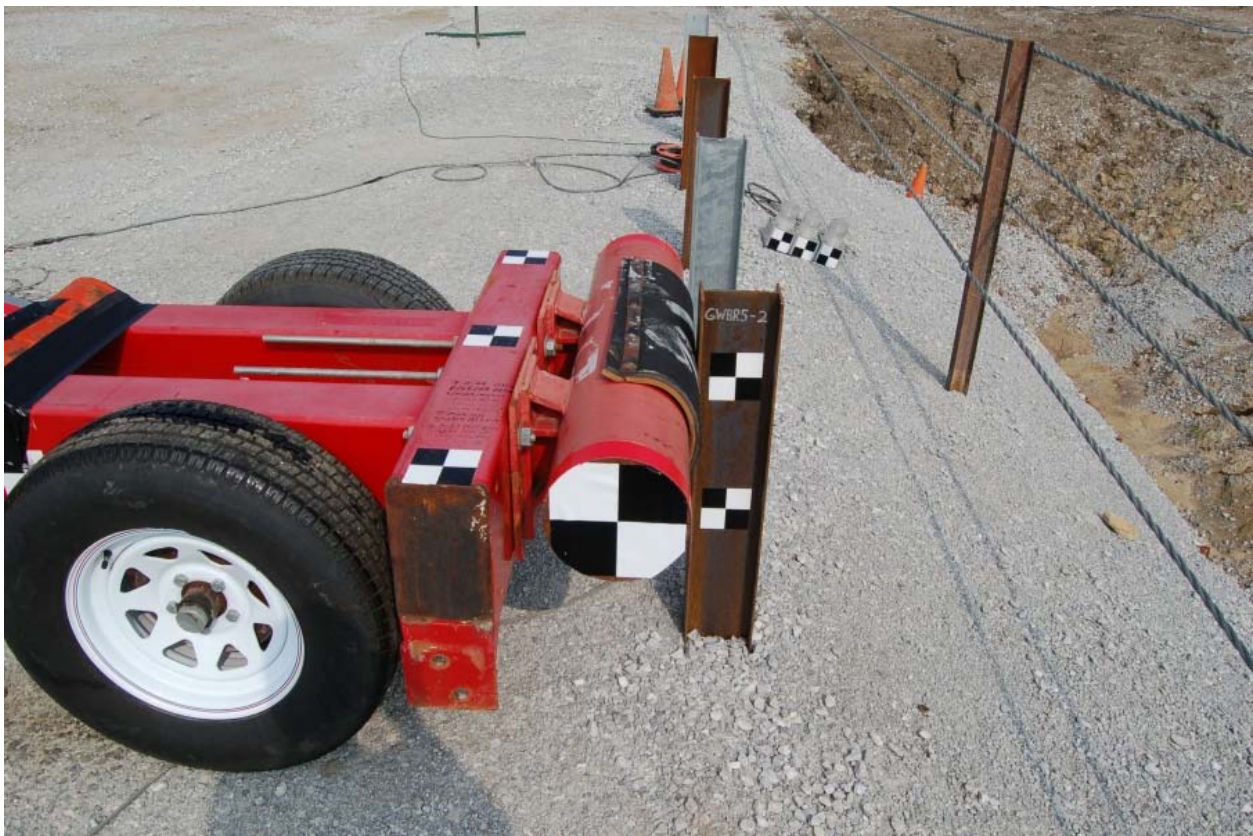
a. Post Locations

b. Impact Location

**Figure 60. Photo. Round 4 Test Setup on Wire-Faced, MSE Wall with a 3H:1V Fill Slope.**

For the fourth round of dynamic testing, six tests were conducted. The steel posts conformed to the W6x9 (W152x13.4) and W6x8.5 (W152x12.6) sections with various lengths and embedment depths, as shown in Table 17. The posts were impacted 24 $\frac{7}{8}$  in. (632 mm) above the ground line at 20 mph (32 km/h). The posts were placed at the slope break point of a 3H:1V fill slope located on the top of the wire-faced, MSE wall, as shown in Figure 60. The MSE wall was constructed of steel wire cages filled with 2-in. to 4-in. (51-mm to 102-mm) wall-facing rock at the exterior edge. The soil material within the interior wire mesh layers and on top of the MSE wall was placed with a roller compactor using AASHTO Grading B strong soil material. To match common field installation methods, the posts were driven into position through the top soil layer and into the wire mesh layers found within the interior region of the MSE wall.

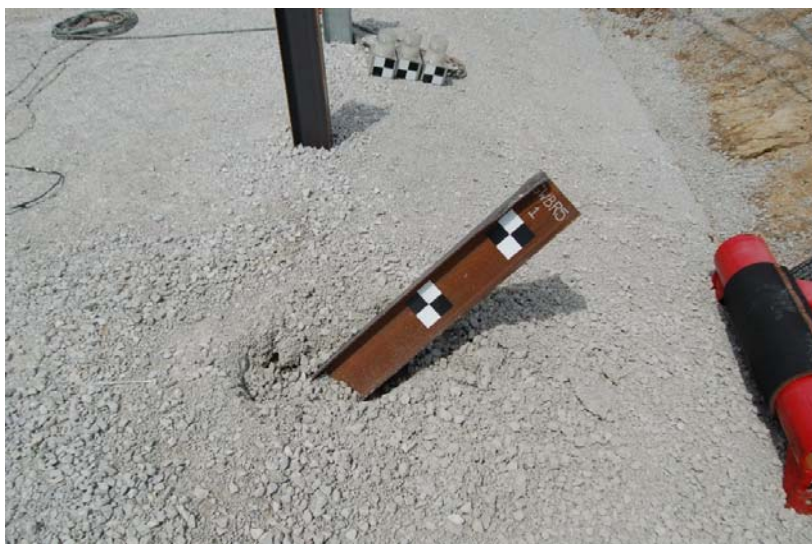
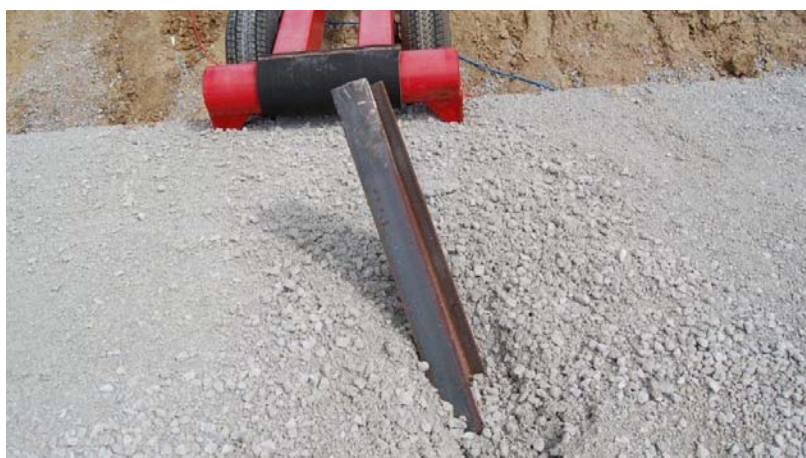
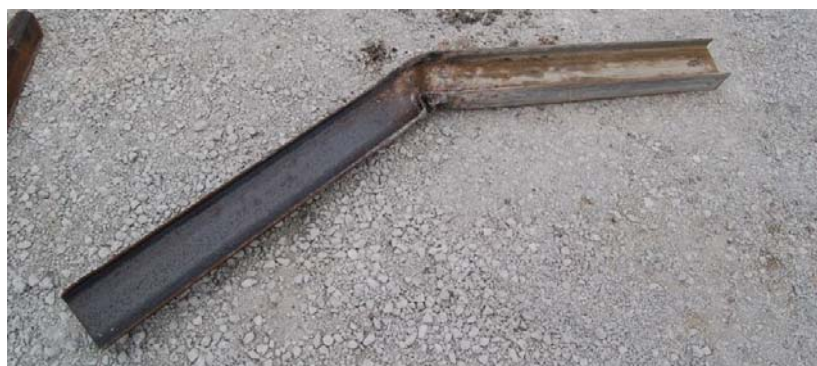
g. Post After Impact – Side view

h. Post After Impact – Front View

i. Post After Impact – Removed, Showing Deformation

**Figure 62. Photo. Time Sequential and Post-Impact Photographs, Test No. GWBR5-1.**

Force vs. deflection and energy vs. deflection curves were created from the accelerometer data and are shown in Figure 61. The load quickly increased and peaked at 16.2 kips (72.0 kN) and then declined until a deflection of 20 in. (508 mm) where it remained near 4 kips (18 kN) to a deflection of 26 in. (660 mm). The force then declined until reaching zero at the maximum deflection of 28.5 in. (724 mm). The post rotating in soil absorbed a total of 211.0 k-in. (23.8 kJ) of energy. Time-sequential photographs and post-impact photographs are shown in Figure 62.

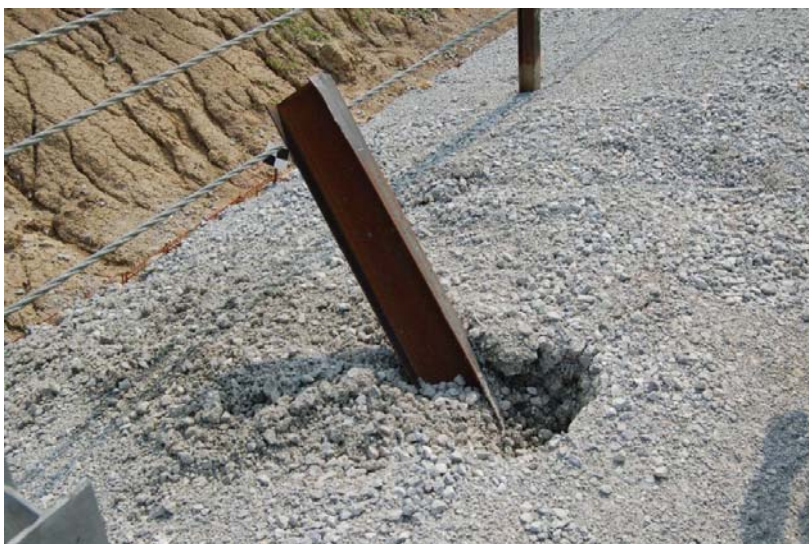
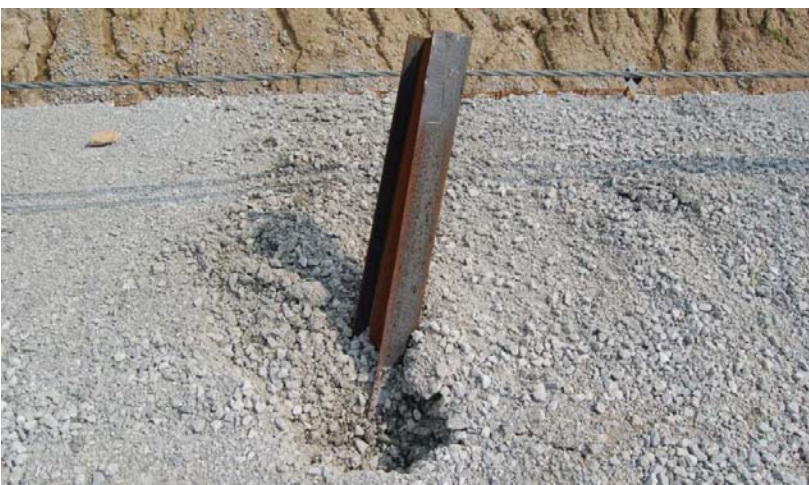
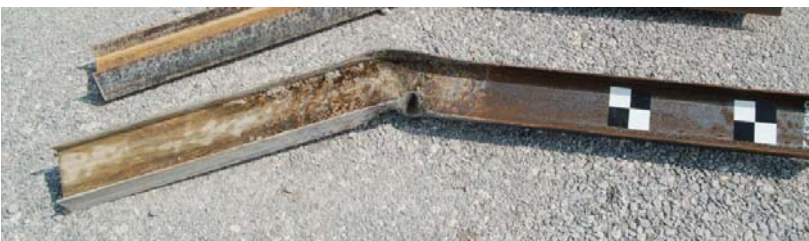
g. Post After Impact – Side view

h. Post After Impact – Front View

i. Post After Impact – Removed, Showing Deformation

**Figure 64. Photo. Time Sequential and Post-Impact Photographs, Test No. GWBR5-2.**

Force vs. deflection and energy vs. deflection curves were created from the accelerometer data and are shown in Figure 63. The load quickly increased and peaked at 15.1 kips (67.1 kN) and then steadily declined until reaching a force of approximately 2 kips (9 kN) before dropping sharply, reaching zero at the maximum deflection of 35.0 in. (889 mm). The post rotating in soil absorbed a total of 240.8 k-in. (27.2 kJ) of energy. Time-sequential photographs and post-impact photographs are shown in Figure 64.

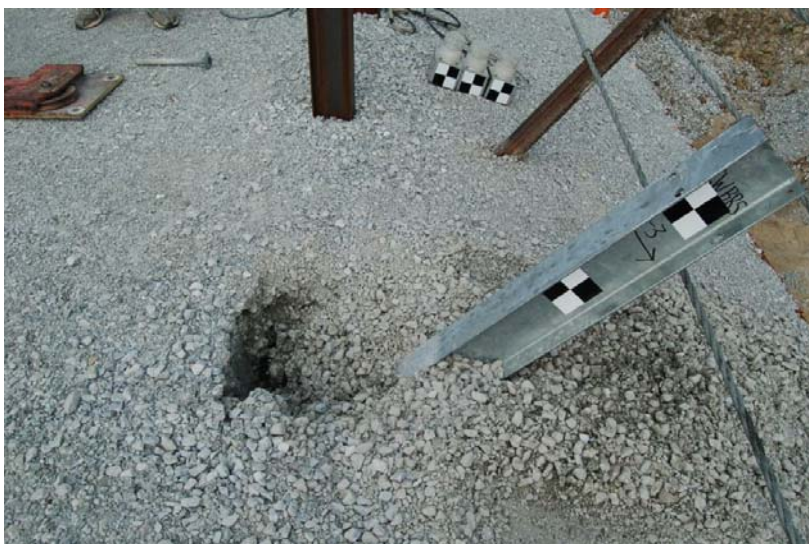
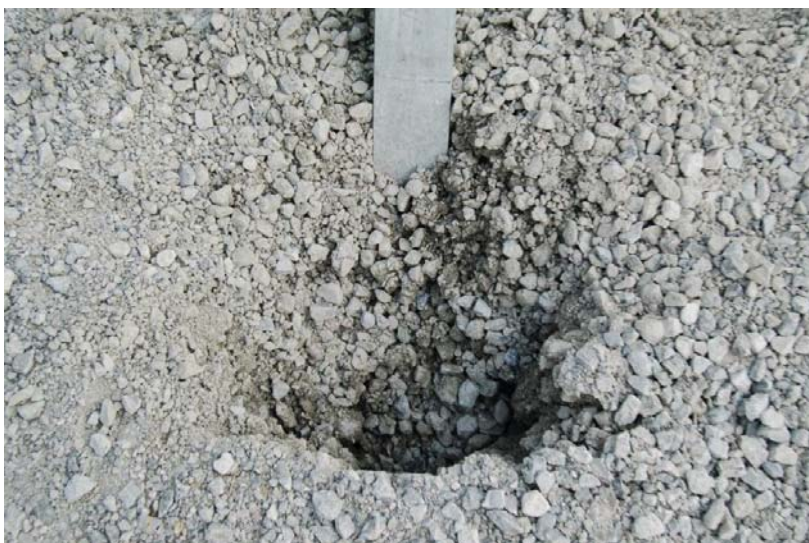
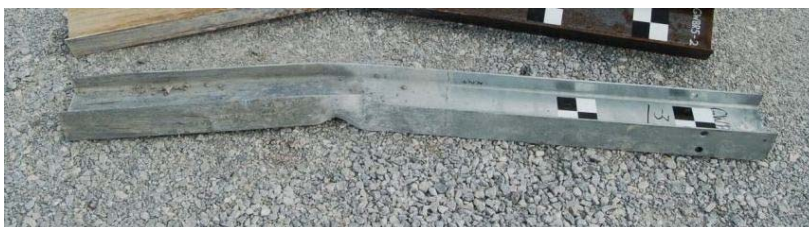
g. Post After Impact – Side view

h. Soil Displacement of Post After Impact

i. Post After Impact – Removed, Showing Deformation

**Figure 66. Photo. Time Sequential and Post-Impact Photographs, Test No. GWBR5-3.**

Force vs. deflection and energy vs. deflection curves were created from the accelerometer data and are shown in Figure 65. The load quickly increased and peaked at 13.3 kips (59.2 kN) and then steadily declined reaching zero at the maximum deflection of 43.7 in. (1,109 mm). The post rotating in soil absorbed a total of 305.4 k-in. (34.5 kJ) of energy. Time-sequential photographs and post-impact photographs are shown in Figure 66.

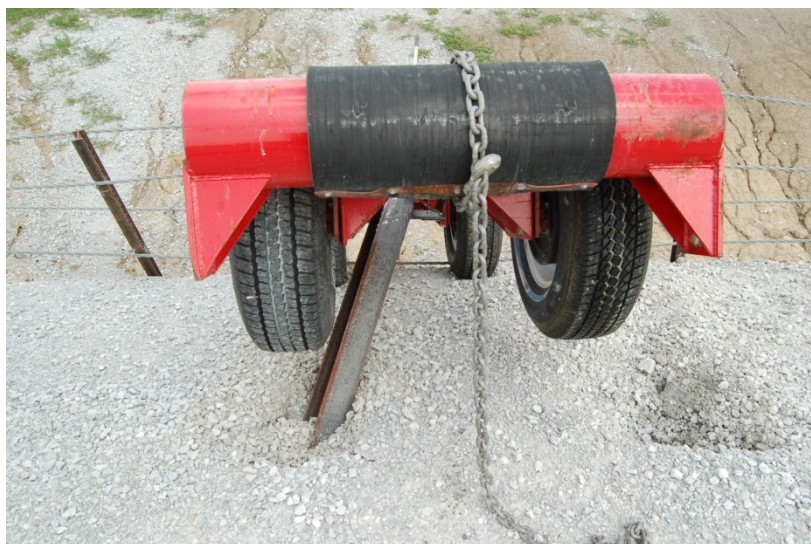
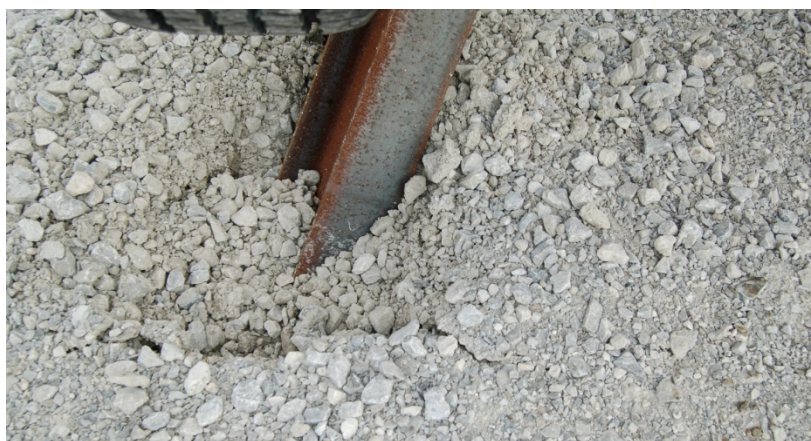
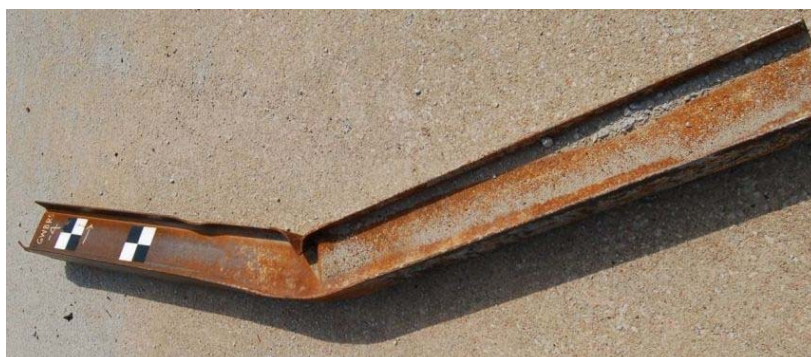
g. Post After Impact – Front View

h. Post After Impact – Displaced Soil

i. Post After Impact – Removed, Showing Deformation

**Figure 68. Photo. Time Sequential and Post-Impact Photographs, Test No. GWBR5-4.**

Force vs. deflection and energy vs. deflection curves were created from the accelerometer data and are shown in Figure 67. The load quickly increased and peaked at 15.1 kips (67.1 kN) and then steadily declined until reaching the maximum deflection of 34.2 in. (869 mm). The post rotating in soil absorbed a total of 235.7 kip-in. (26.6 kJ) of energy. Time-sequential photographs and post-impact photographs are shown in Figure 68.

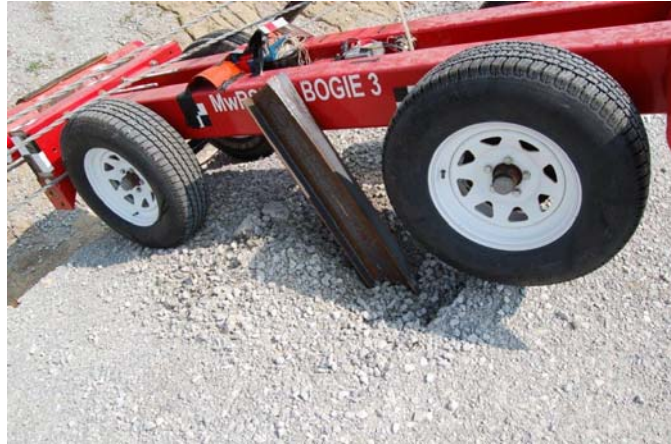
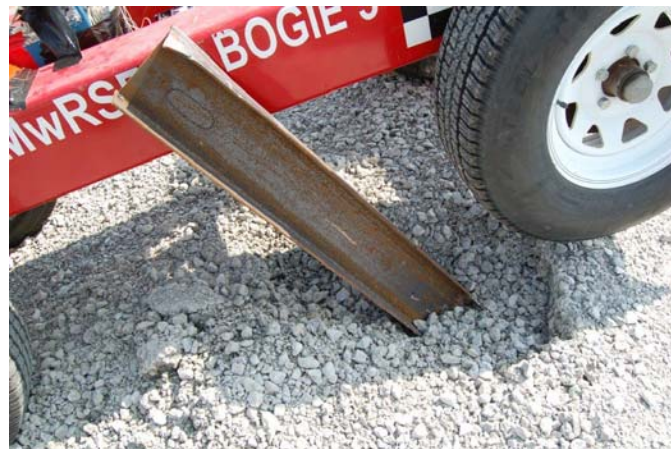
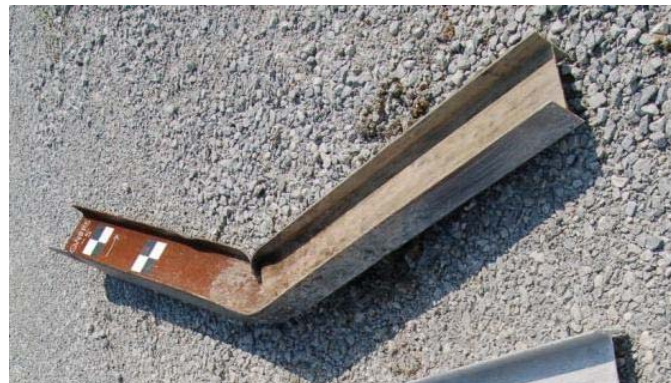
g. Post After Impact – Front Quarter View

h. Post After Impact – Side view

i. Post After Impact – Removed, Showing Deformation

**Figure 70. Photo. Time Sequential and Post-Impact Photographs, Test No. GWBR5-5.**

Force vs. deflection and energy vs. deflection curves were created from the accelerometer data and are shown in Figure 69. The load quickly increased and peaked at 14.4 kips (64.0 kN) and then steadily declined until reaching the maximum deflection of 38.5 in. (978 mm). The post rotating in soil absorbed a total of 244.5 kip-in. (27.6 kJ) of energy. Time-sequential photographs and post-impact photographs are shown in Figure 70.

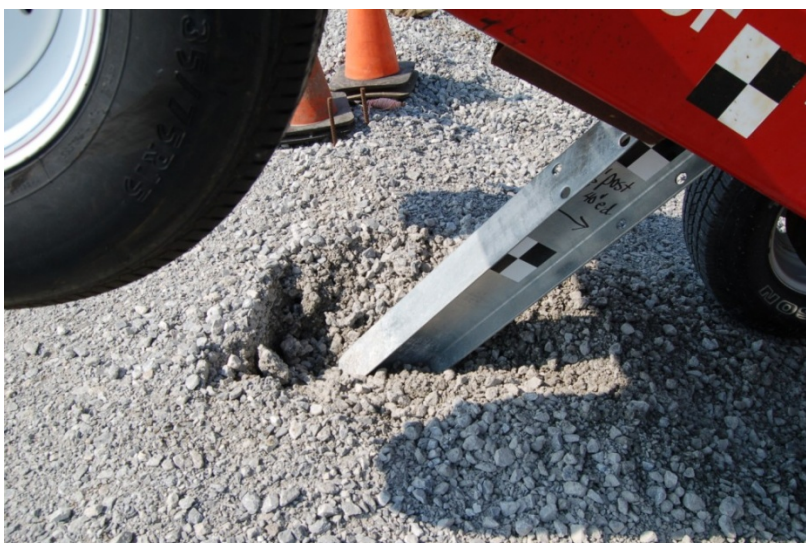
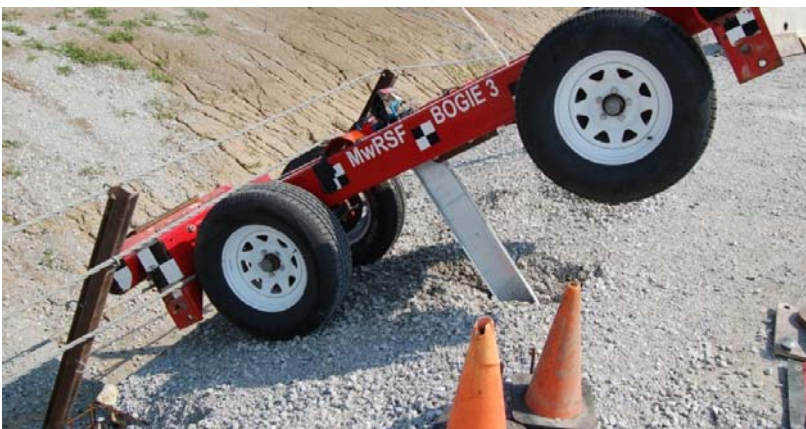
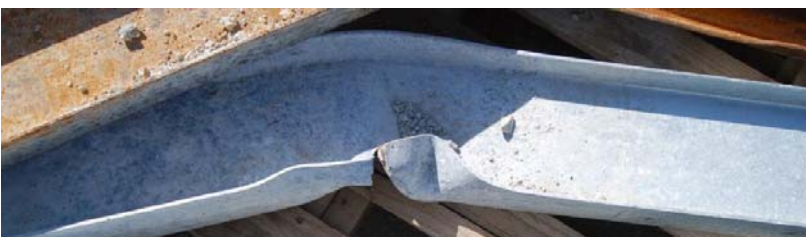
g. Post After Impact – Side view

h. Post After Impact – Side View Wide

i. Post After Impact – Removed, Showing Deformation

**Figure 72. Photo. Time Sequential and Post-Impact Photographs, Test No. GWBR5-6.**

During test no. GWBR5-6, the bogie impacted the W6x8.5 (W152x12.6) steel post at a speed of 22.9 mph (36.8 km/h) and at an orientation causing strong-axis bending in the post. The post rotated through the soil, twisted, and bent backward to a maximum deflection of 38.2 in. (969 mm) before the bogie overrode the post at 0.136 seconds after impact. Twisting of the post did not occur until the end of the test. Upon inspection of the post, the compression flange was found to be torn at the location of buckling and twisting, as shown in Figure 72.

Force vs. deflection and energy vs. deflection curves were created from the accelerometer data and are shown in Figure 71. The load quickly increased and peaked at 14.0 kips (62.2 kN) and then steadily declined until reaching zero at the maximum deflection of 38.2 in. (969 mm). The post rotating in soil absorbed a total of 251.7 kip-in. (28.4 kJ) of energy. Time-sequential photographs and post-impact photographs are shown in Figure 72.

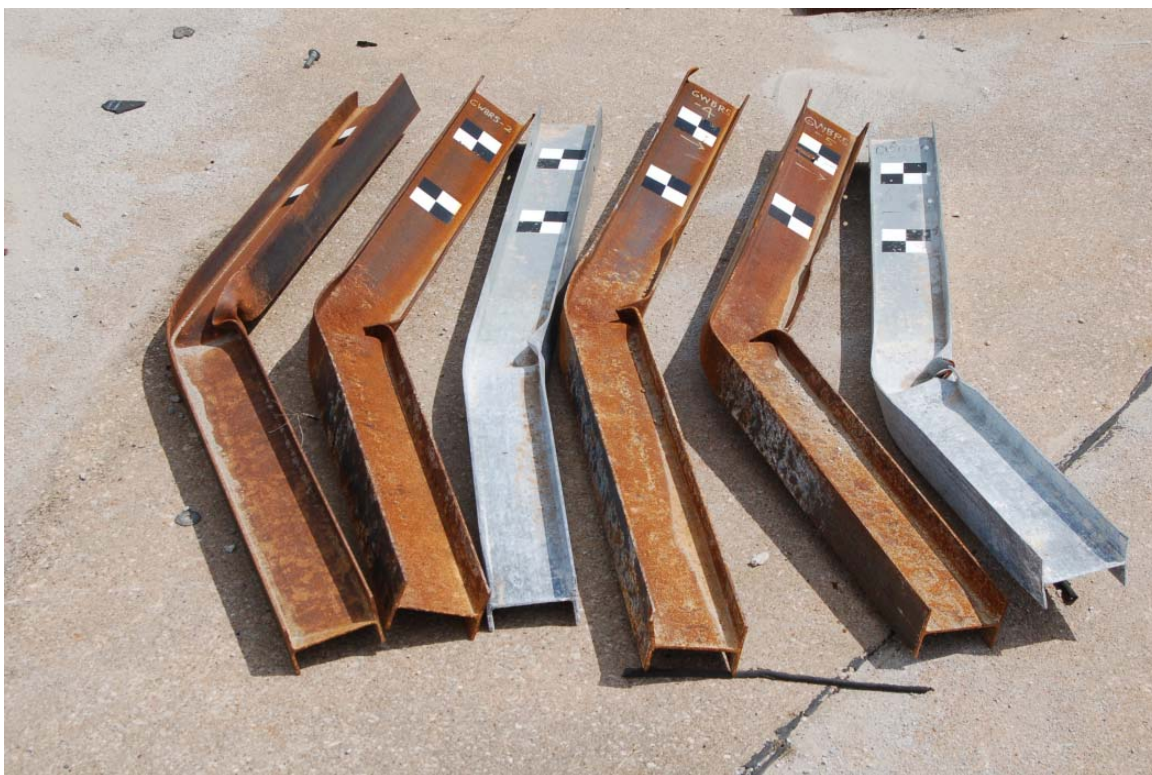
**Figure 74. Photo. Post Damage – Round 4 (Ascending Left to Right).**

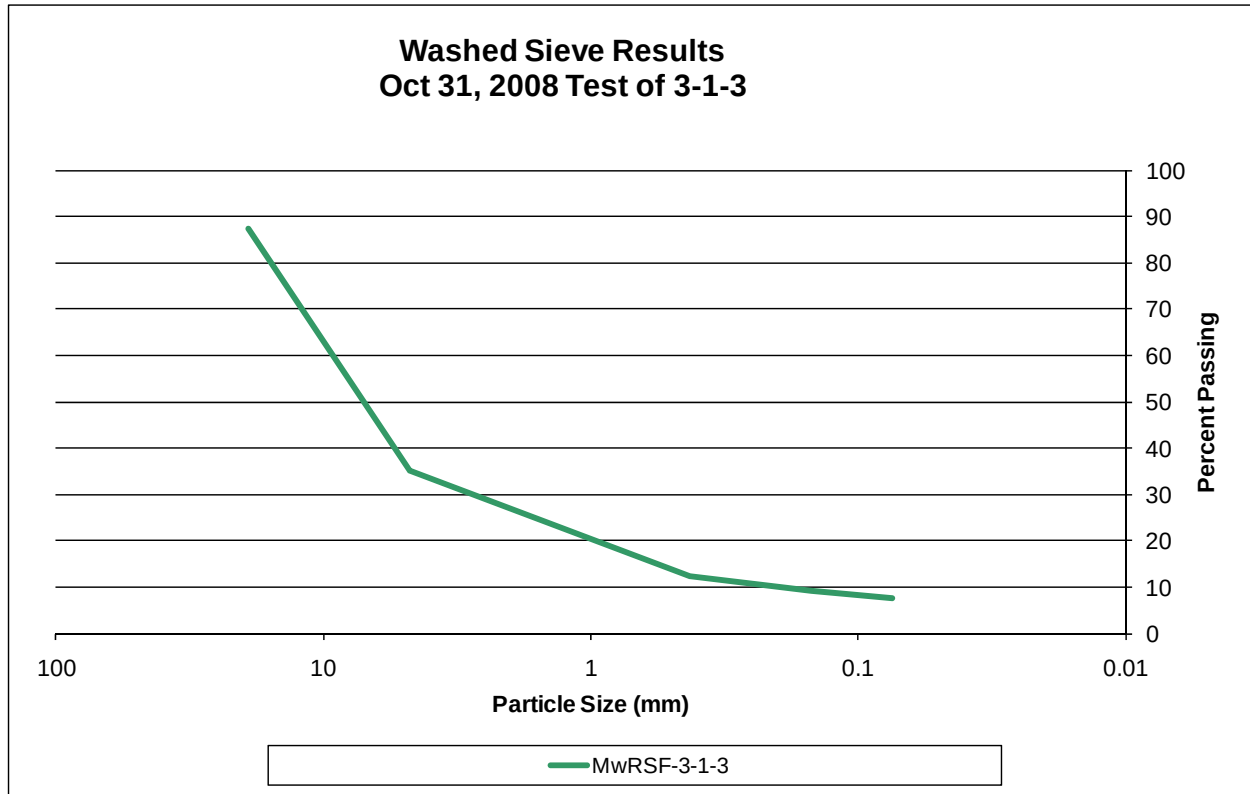
**Figure 84. Graph. Sieve Results for Test No. GWR4-1.**

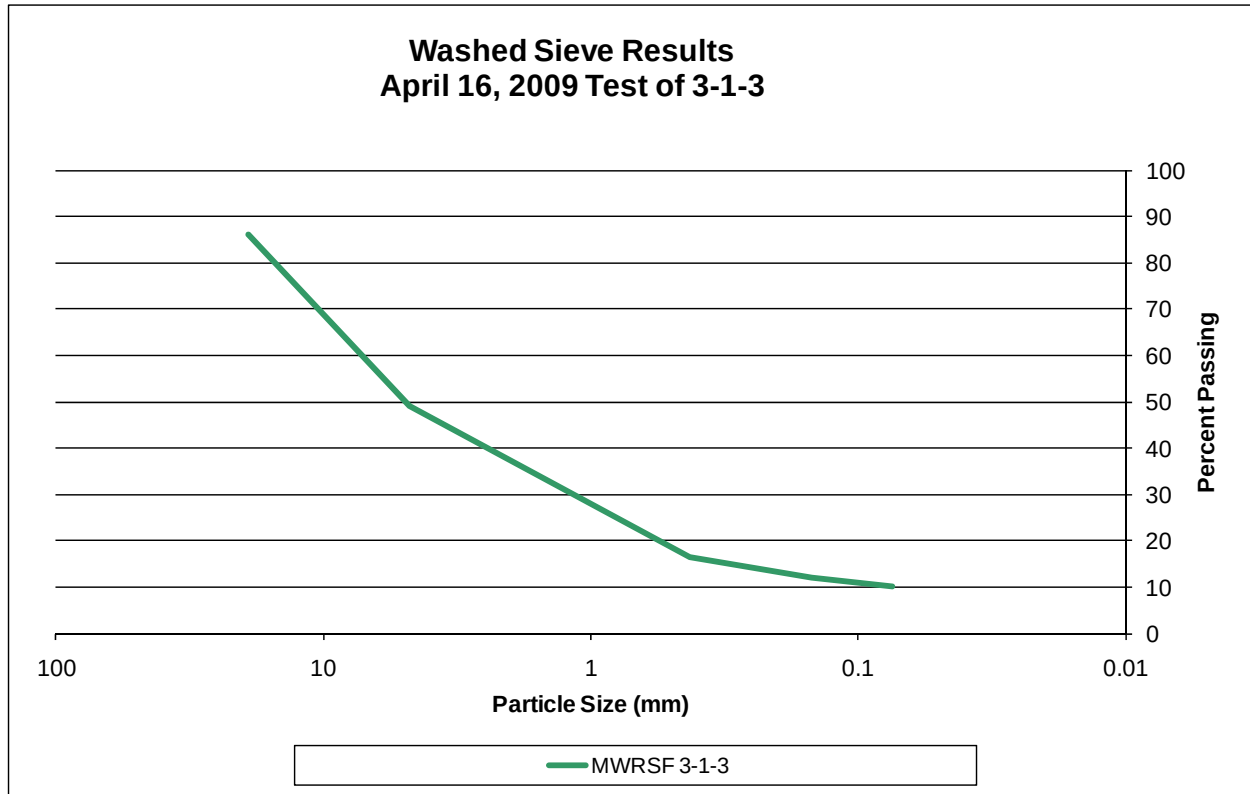
**Figure 85. Graph. Sieve Results for Test No. GWR5-1 through GWR5-4.**
