DYNAMIC IMPACT TESTING

S 75 x 8.5 STEEL POSTS

(Cable Barrier Posts)

MwRSF Research Report No. TRP-03-117-02

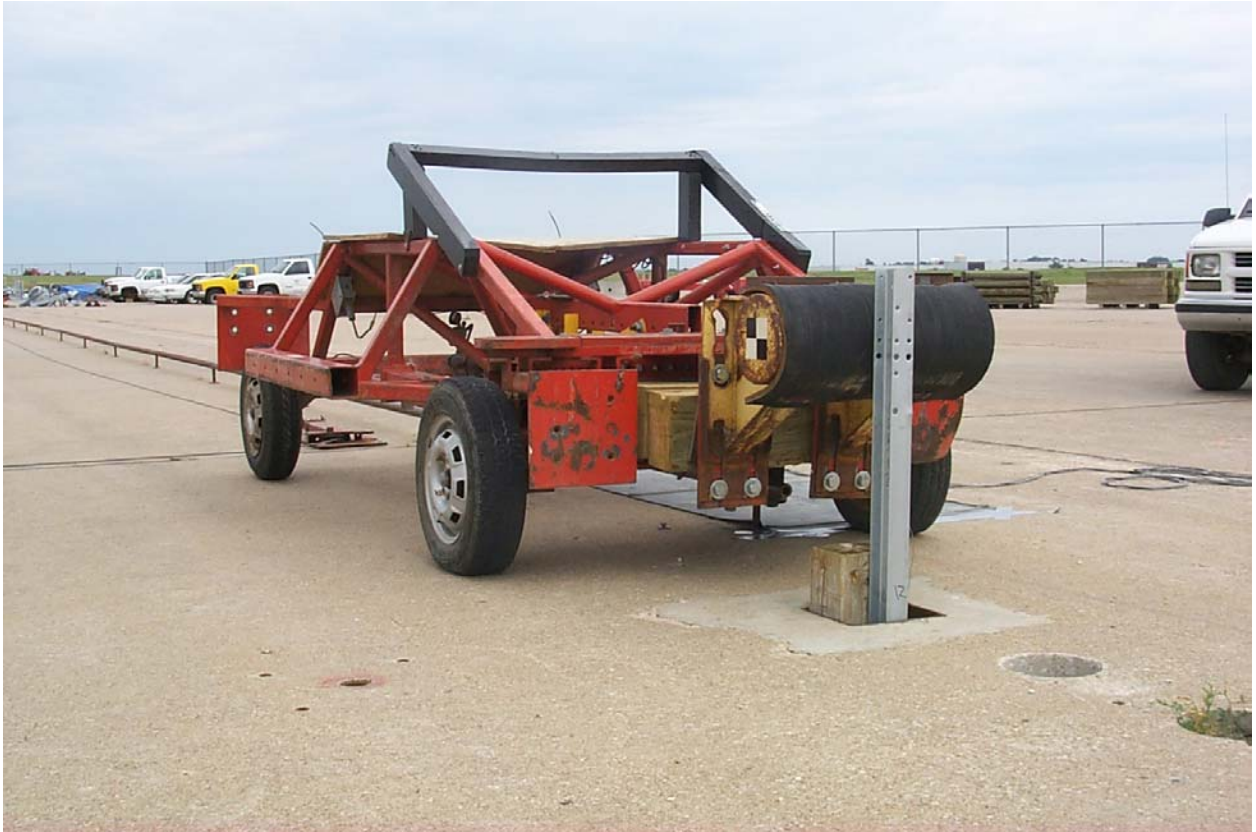
Figure 2. Bogie and the test setup

The bogie is an intricate structure made up of steel tubes welded together. An impact head, made of a 203 mm (8-inches) concrete filled standard steel pipe, was mounted to the bogie at the height of 685 mm (27 inches) above the ground. A 19 mm (3/4 inch) neoprene belting was attached to the steel pipe to minimize the local damage to the post from the impact. The bogie is shown in Figure 2.

The bogie weight was 1014 Kg (2237 lbs). Calculations prior to the testing showed that this weight, in combination with a velocity of approximately 32 kilometers per hour (20 mph or 8.8 m/s), would closely replicate the actual impact conditions that a post as a part of the guardrail system would be subjected to in a 96 kilometers per hour (60mph), 25 deg impact with a 2040 kg (4500 lbs) car.

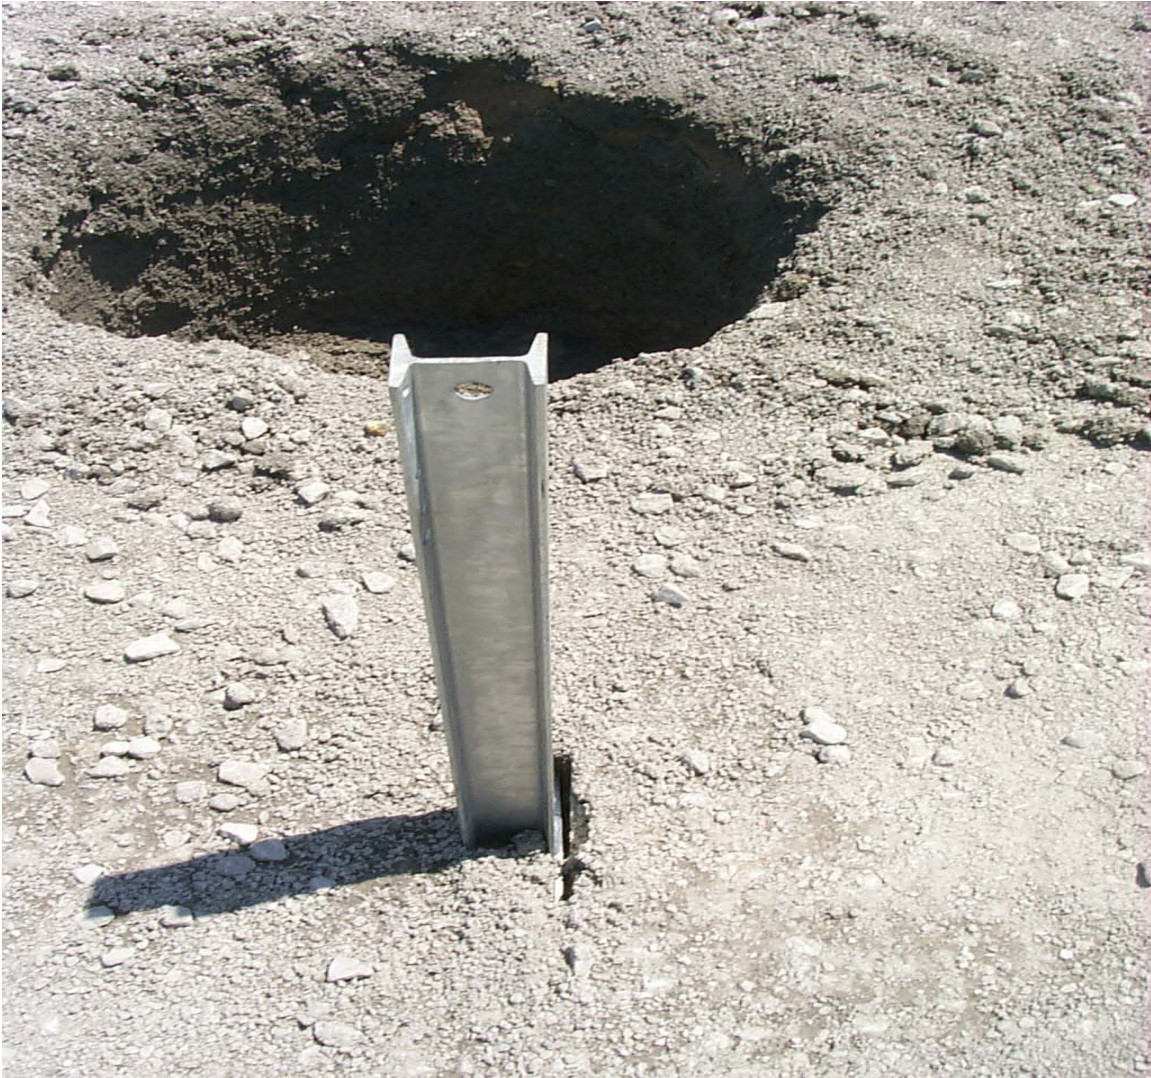
Figure 5. Post setup for the CPB-2 through CPB-4 tests

For the tests CPB-2 through CPB-7, holes measuring 0.915 meters in diameter and 0.76 meters in depth were dug out in the test area. These holes were filled with soil meeting the AASHTO standard specification for “Materials and Aggregates and Soil Aggregates Sub-base, Base and Surface Courses,” designation M147-65 (1990), grading A or B and compacted in accordance with AASHTO guide specifications for highway construction, section 304.05 and 304.07.

The moisture content was relatively dry (4% - 6%) with the primary considerations being the homogeneity, consistency and the ease of compaction. The posts were then driven into the soil as shown in Figure 5. CPB-2, CPB-3 and CPB-4 were strong axis impacts; CPB-5, CPB-6 and CPB-7 were weak impact axis impacts.

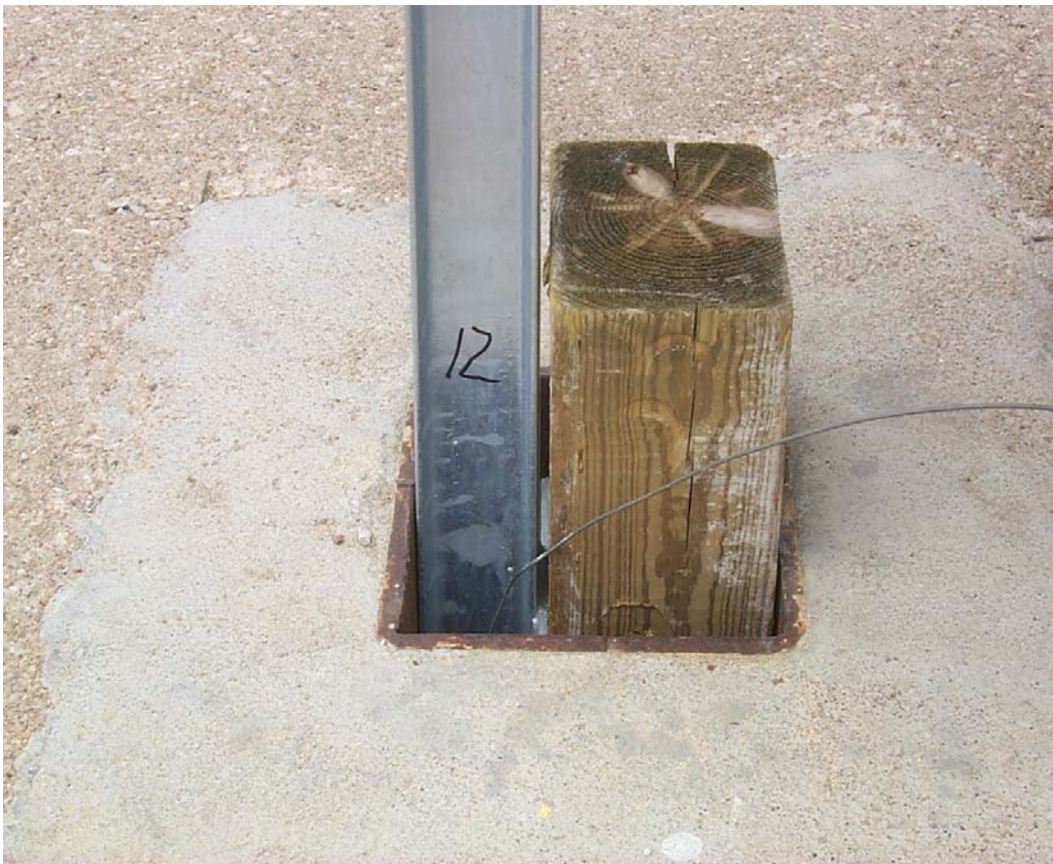
Figure 6. Post and woodblock setup for tests CPB-12 through CPB-14

For tests CPB-12 through CPB-17, a square section was cut out in the tarmac to house the post. The section was lined with mild steel to prevent the erosion of the concrete around the hole. The post was fitted into the steel lined section, with a block of wood to keep it upright and act as a footing material. The post, with the woodblock fitted in the steel lining is shown in Figure 6.

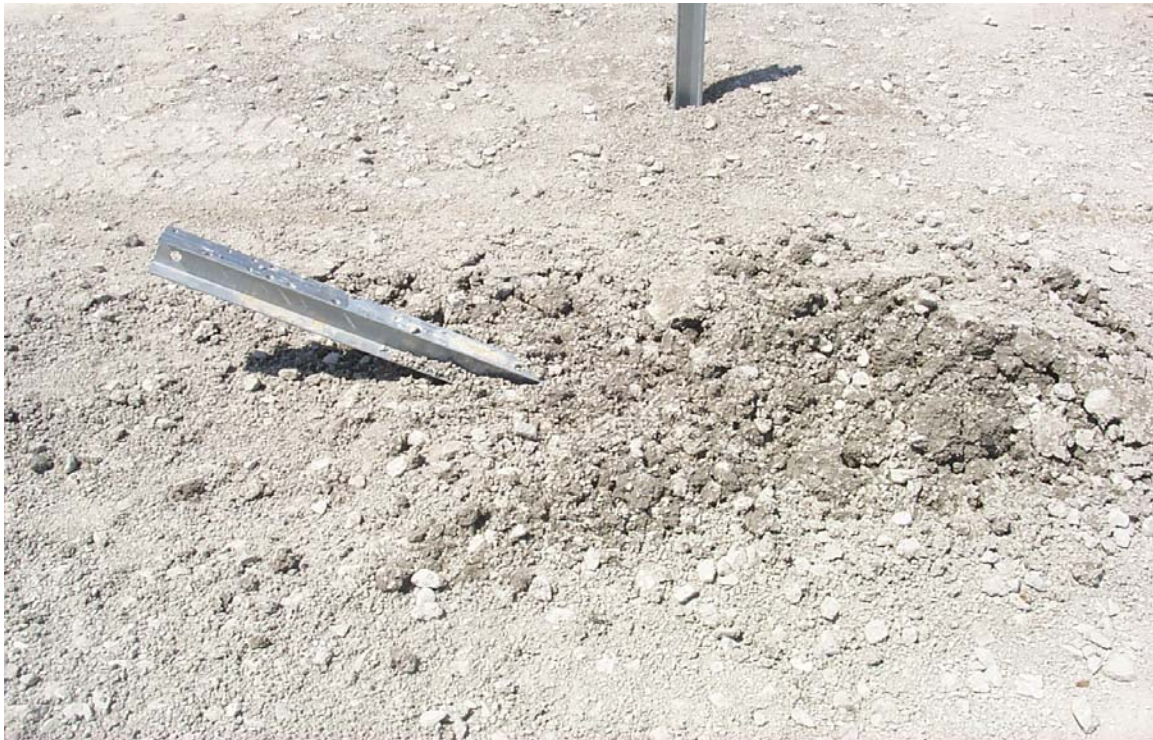
Figure 14. Post impact scenario for test CBP-2

The profile of the force-deflection curve for these tests indicates the forces acting on the posts were fairly uniform over the duration of the impact. However, the post-impact investigation showed that the post had not undergone considerable plastic deformation under the action of the impact forces. The reaction forces of the post can be attributed to the constant shear failure of the soil behind the soil plate. This failure of the soil behind the soil plate attribute to the forces. There was negligible plastic deformation of the post. Photographs and film analysis of the system clearly indicate that the soil offered resistance to the failure and pivoted the post at ground level. The post impact system (post and the soil) is shown in Figure 14.

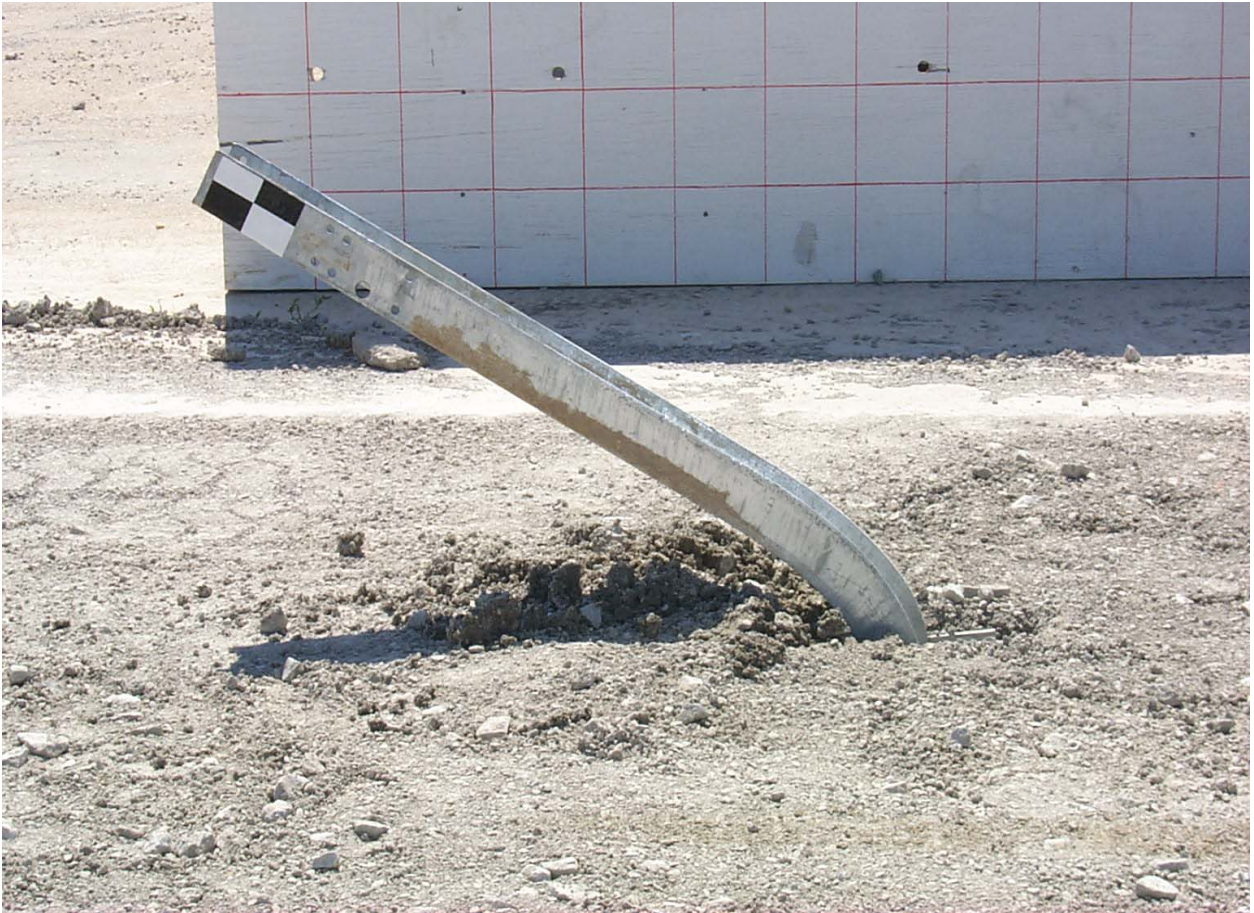
Figure 15. Plastically deformed post for test CPB-5

The profile of the force-deflection curves for the tests CPB-5 through CPB-7 show the forces were fairly uniform, however the values are considerably lower as compared to the previous tests. The post in this case, however, undergoes considerable amount of bending, as this was a weak axis impact. The deformed post is shown in Figure 15. The forces were attributed to the plastic deformation of the post. There was negligible shear failure of the soil.

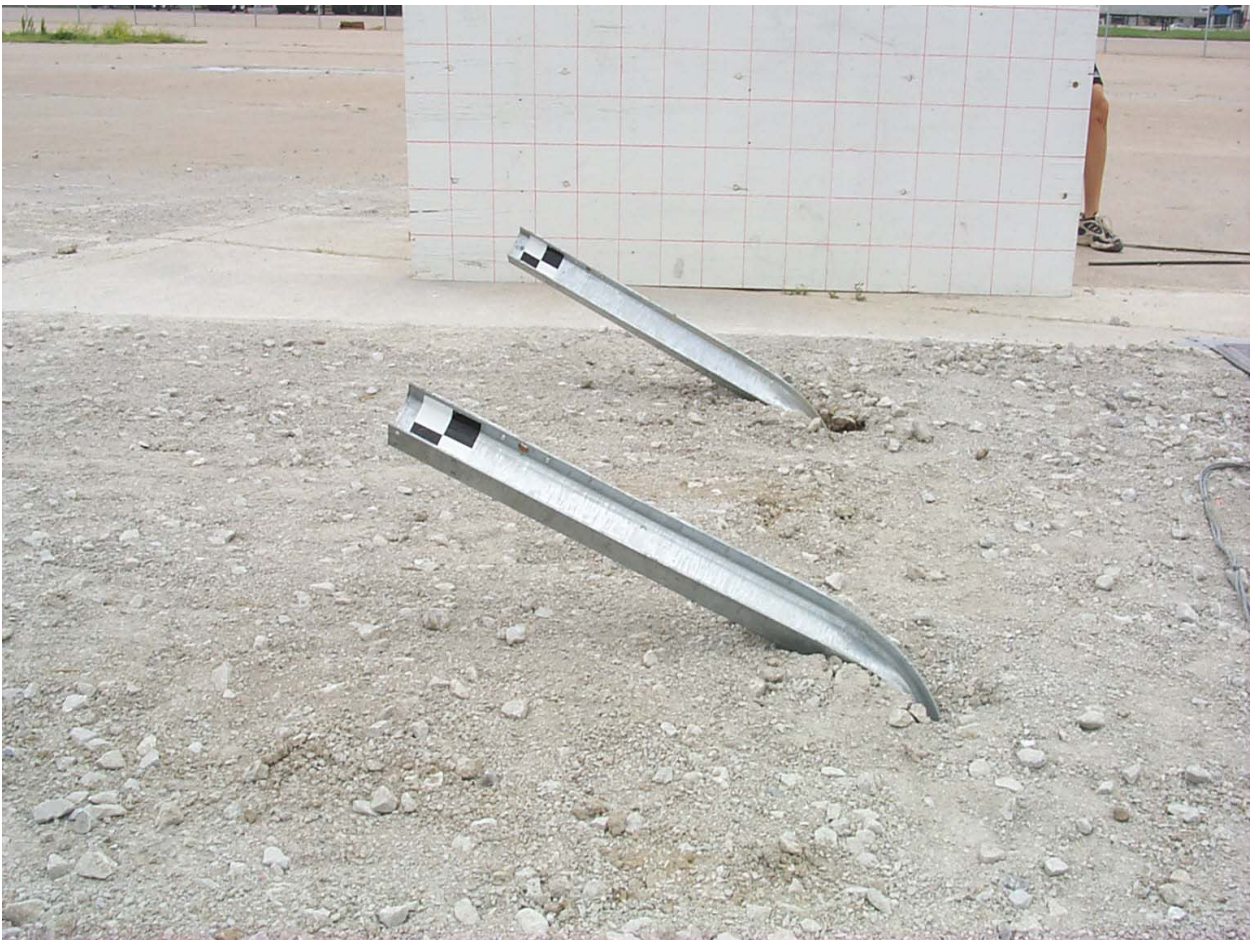
Figure 16. CPB-8 and CPB-9 deformed post geometries

The force-deflection for the tests CPB-8 through CPB-9 is shown in Figure 10. This was a strong axis impact in the native soil. The peculiarity of the test was the soil offering more resistance as compared to the standard 350 soils under the same impact conditions, resulting in prominent plastic deformation of the post. The force, as seen from the curves is uniformly distributed over the impact period with no prominent peaks of loads. The deformed posts are shown in Figure 16.

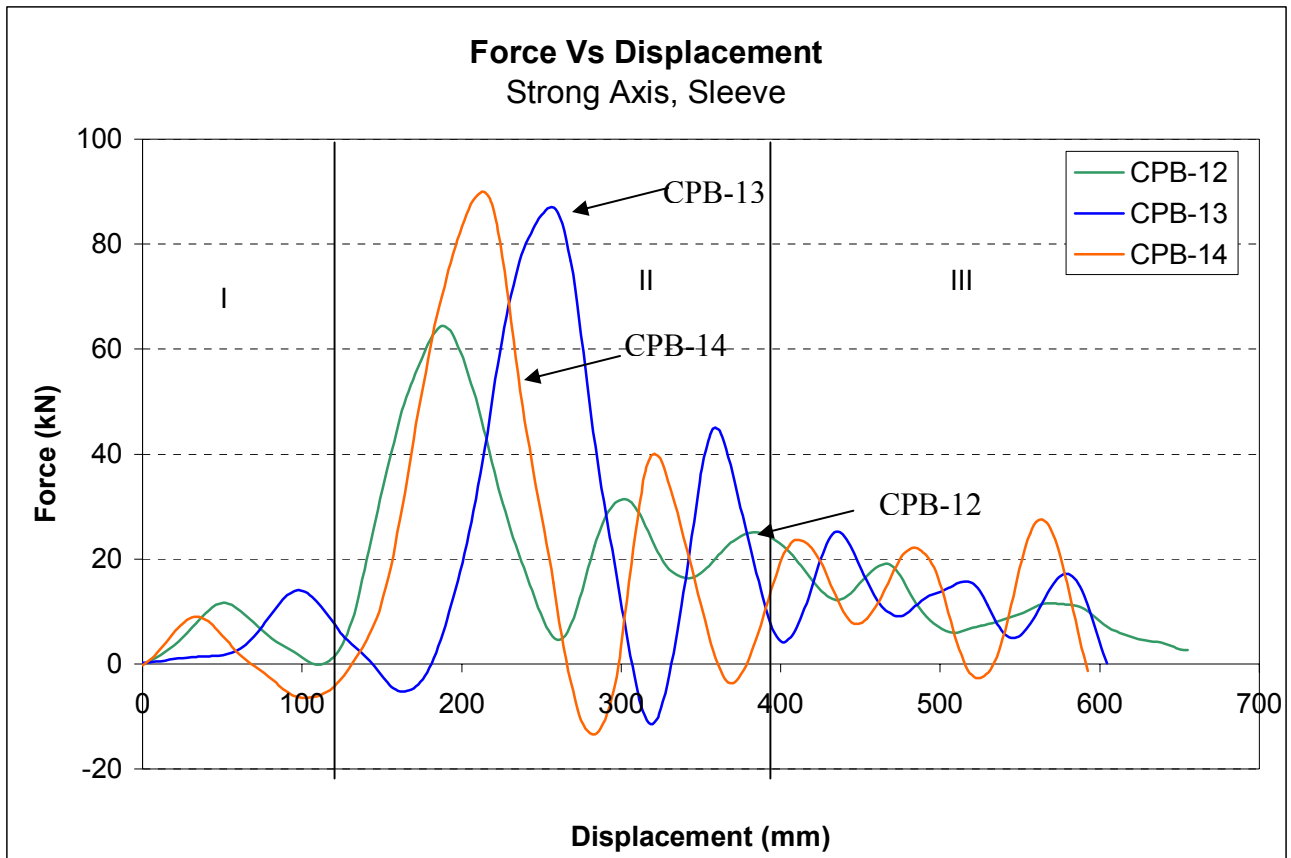
Figure 17. Force-deflection curves for the tests CPB-12 through CPB-14

The force deflection curve for the test CPB-12 through CPB-14 can be divided into three prominent regions based on the deflection of the post as shown in Figure 17.

As described in the section 2.3, the set up for the tests CPB-12 through CPB-17 was changed. In these cases, the 350 soil or the native soil was replaced with a rigid concrete sleeve. The sleeve was cut out in the tarmac at an appropriate location and was lined with a hollow steel tube approximately 225 mm square and 10 mm in thickness. A wood block was used to rigidly hold the post against the casing. The setup is shown in Figure 6. CPB-12 through CPB-14 were impacts on the strong axis of the post while CPB-15, CPB-16 and CPB-17 were the weak axis impacts.

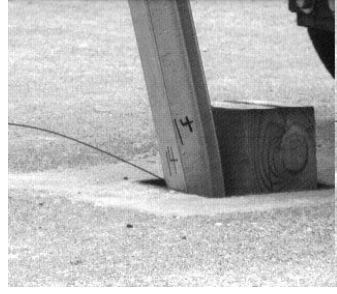
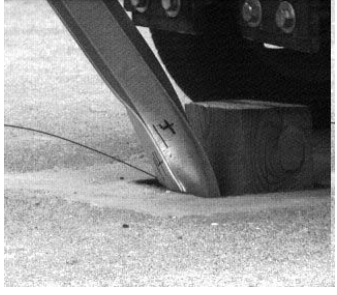
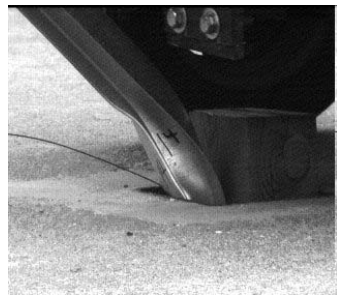
Figure 19. Documentary pictures for test CPB-14

This region covers the impact from 40 milliseconds to end of the test. In this region of the curve the forces arise mainly due to the friction of the neoprene and bogie head over the post and further compression of the webbing on to the flange. The forces were fairly constant in this region.

The documentary photographs for the test CPB-14 are shown in Figure 19.

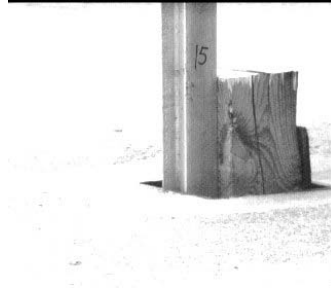
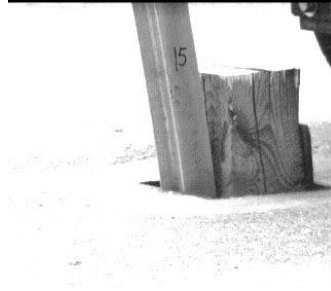
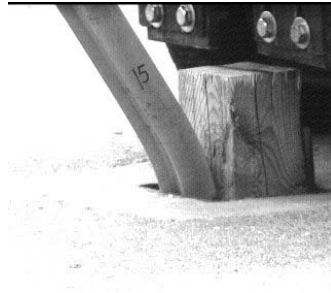
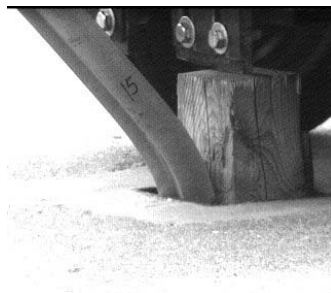
Figure 22. Documentary photographs for test CPB-15

Local buckling and crushing of the flanges in this region of the curve led to the formation of force peaks. Though the numerical value is not as high as in region II the maximum value for the force is 30 kN. The documentary photographs for the test CPB-15 are shown in Figure 22.

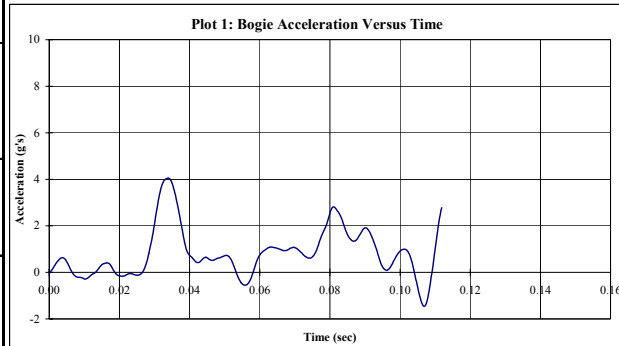
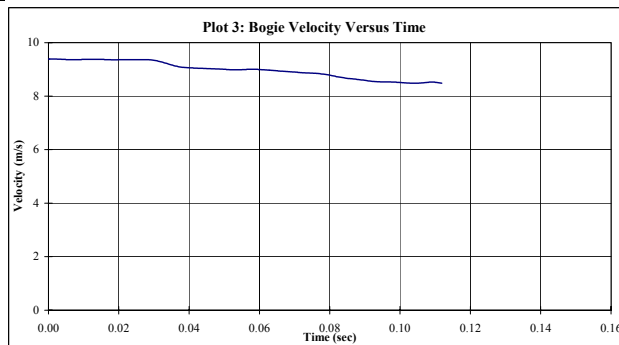
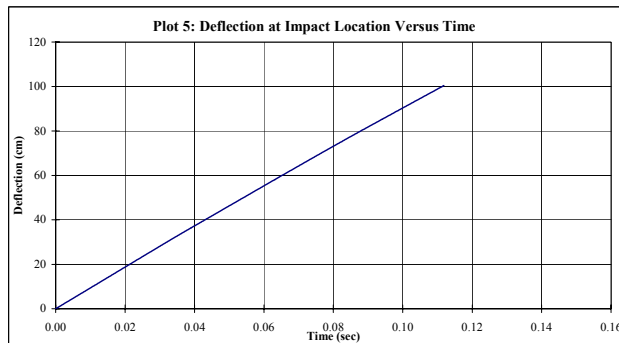
Bogie Test Summary		
Test Information		
Test Number:	CPB-17	
Test Date:	8-Jun-01	
Failure Type:	--	
Post Properties		
Post Type:	Steel	
Post Size:	S75x8.5	S3x5.7
Post Length:	160.0 cm (5.3 ft)	
Embedment Depth:	76.2 cm (30.0 in)	
Soil Properties		
Moisture Content:	--	
Gradation:	NA	
Soil Density, γ_d :	NA	kg/m ³
Compaction Method:	NA	
Bogie Properties		
Impact Velocity:	9.3 m/s	(21.0 mph) (30.8 fps)
Impact Location:	68.6 cm	(27.0 in.) above groundline
Bogie Mass:	1015 kg	(2237 lbf.)
Data Acquired		
Accelerometer Data		
Side View, S-VHS
