MINIMUM EFFECTIVE GUARDRAIL LENGTH FOR THE MGS

MIDWEST ROADSIDE SAFETY FACILITY

WISCONSIN DEPARTMENT OF TRANSPORTATION

MwRSF Research Report No. TRP-03-276-13

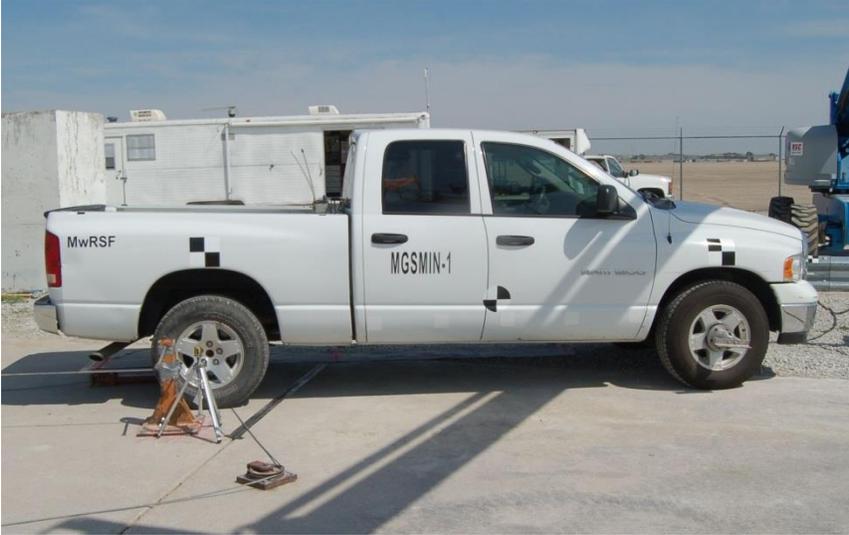
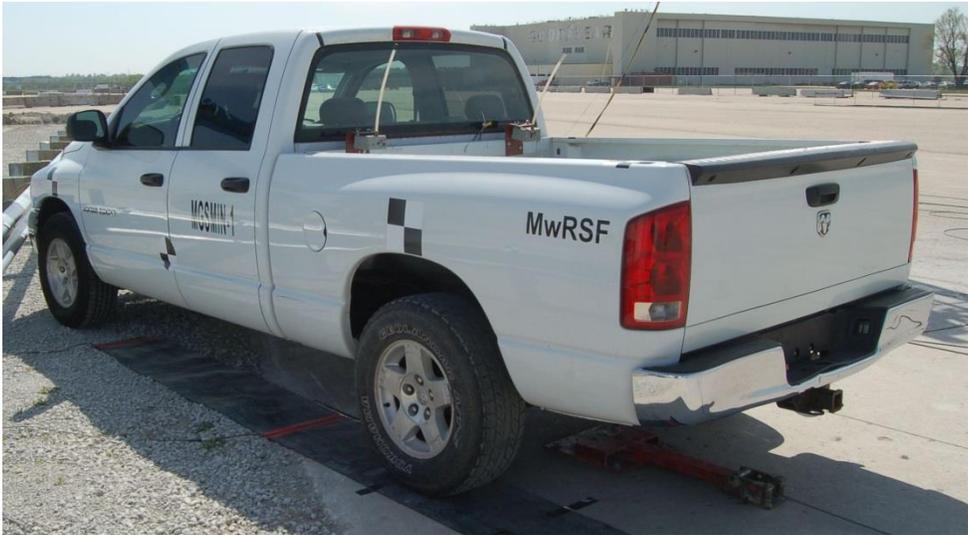
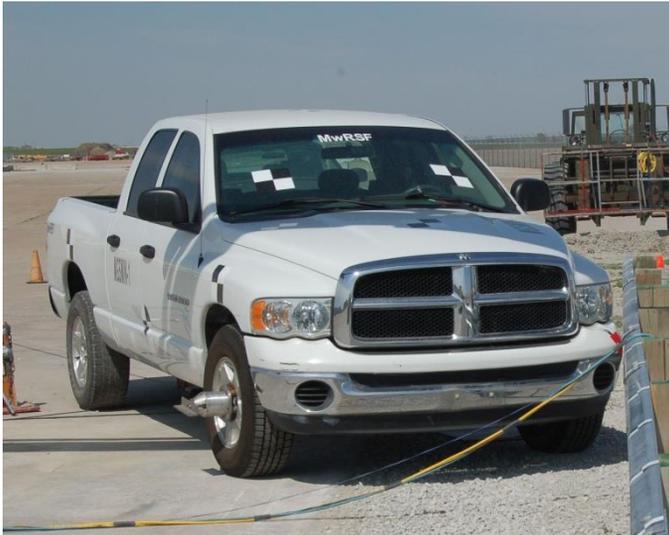
Figure 17. Test Vehicle, Test No. MGSMIN-1

For test no. MGSMIN-1, a 2005 Dodge Ram 1500 Quad Cab pickup truck was used as the test vehicle. The curb, test inertial, and gross static vehicle weights were 4,913 lb (2,228 kg), 4,956 lb (2,248 kg), and 5,126 lb (2,325 kg), respectively. The test vehicle is shown in Figure 17, and vehicle dimensions are shown in Figure 18.

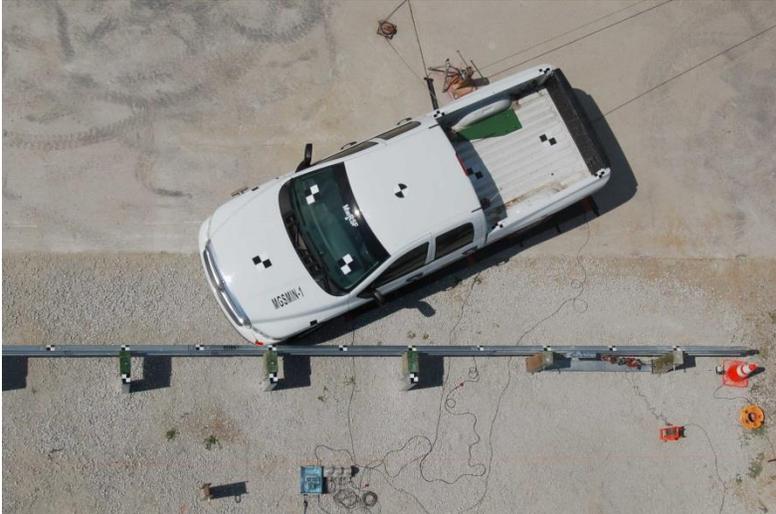
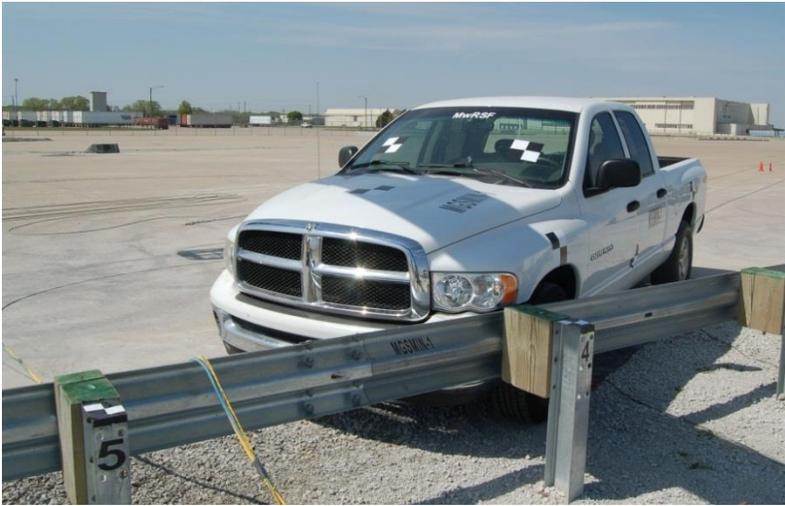
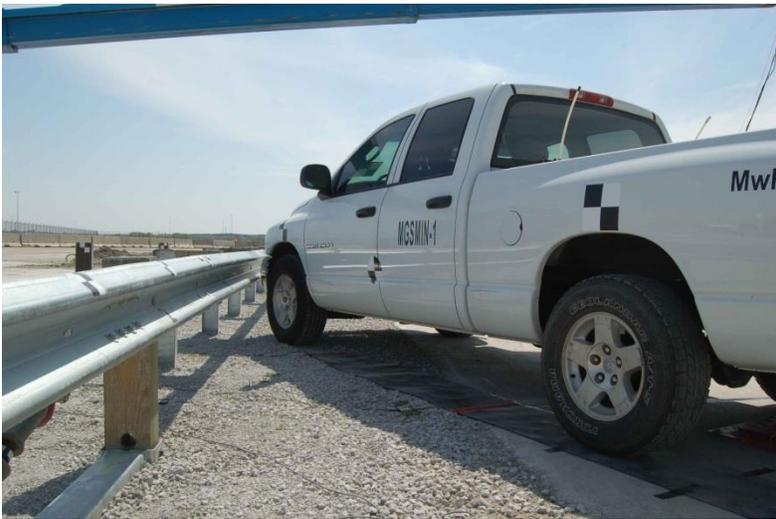
Figure 28. Impact Location, Test No. MGSMIN-1

Initial vehicle impact was to occur at the center line of post no. 4, as shown in Figure 28, which was selected using LS-DYNA simulation to test the upstream impact location for the 75-ft (22.9-m) MGS system. The actual point of impact was 4 in. (102 mm) downstream of post no. 4. A sequential description of the impact events is contained in Table 6. The vehicle came to rest facing downstream at 138 ft (42.1 m) downstream of the initial impact point and 17 ft – 6in. (5.3 m) laterally away from the front of the rail. The vehicle trajectory and final position are shown in Figures 23 and 29.

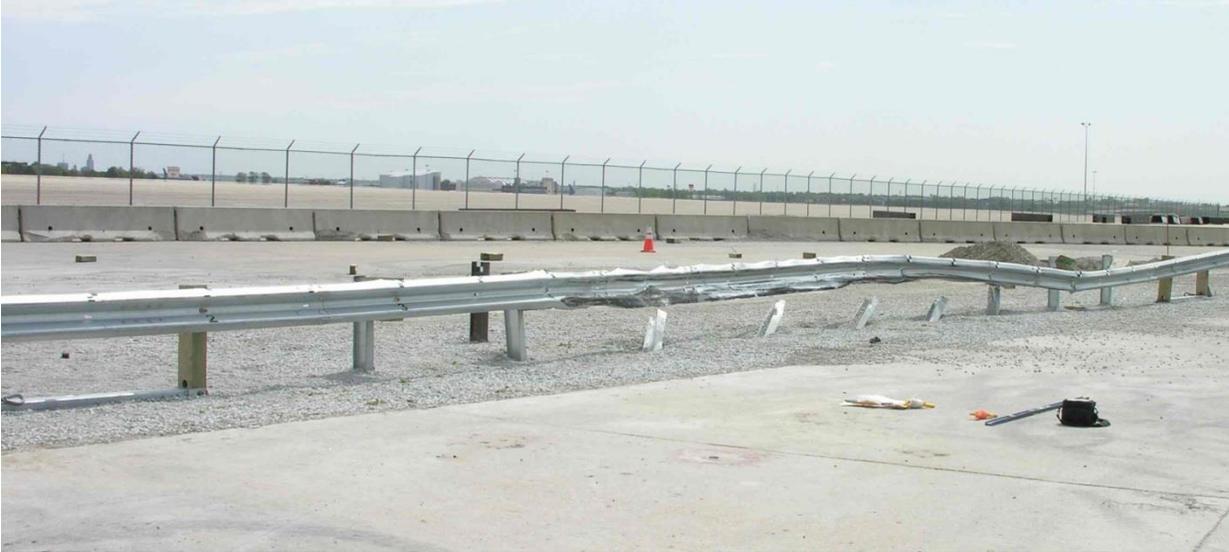
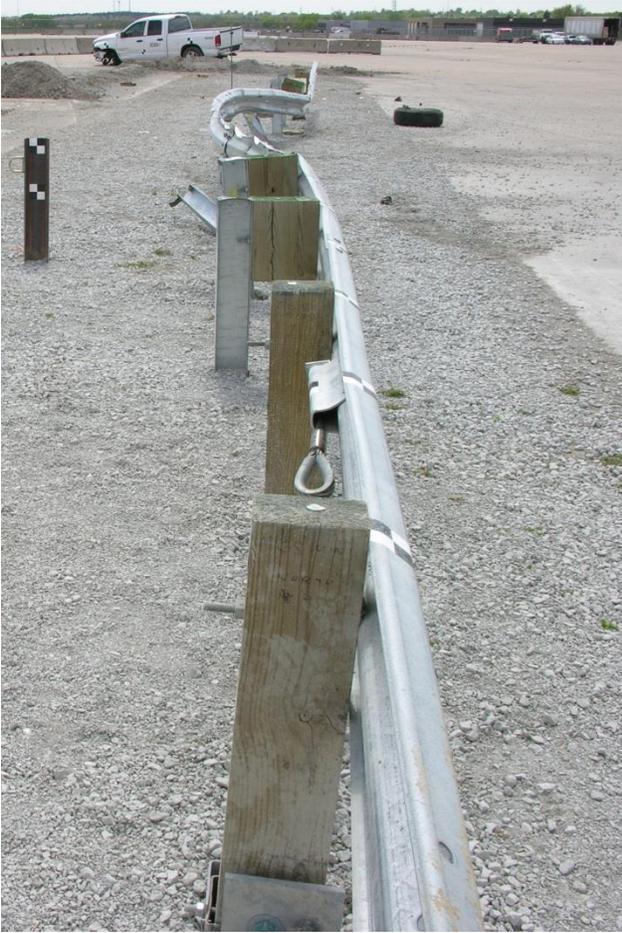
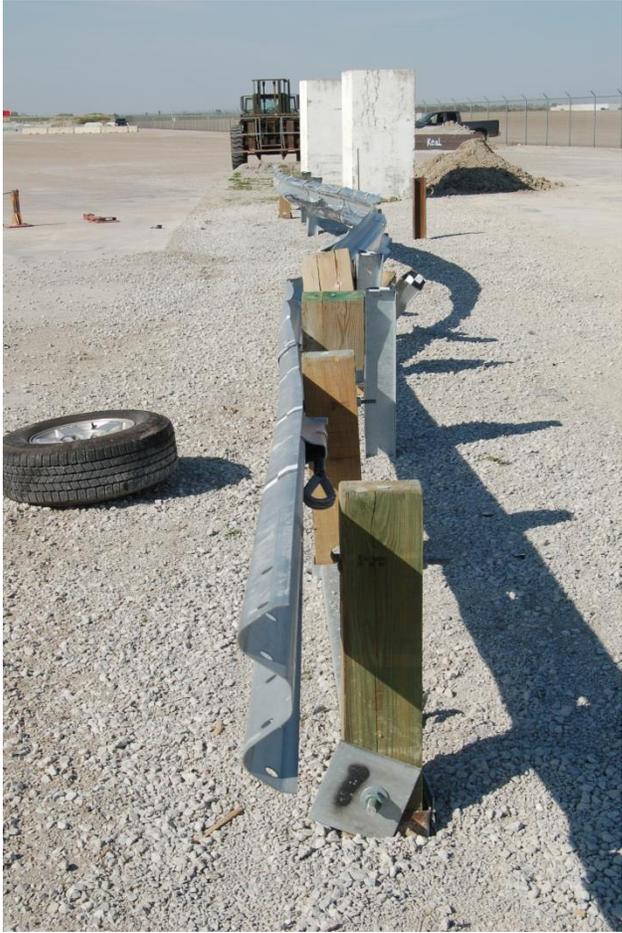
Figure 30. System Damage, Test No. MGSMIN-1

Damage to the barrier was moderate, as shown in Figures 30 through 37. Barrier damage consisted of deformed W-beam rail, contact marks on sections of guardrail and posts, deformed steel posts, and cracked wood BCT anchor posts. The length of vehicle contact along the barrier was approximately 37 ft – 2 in. (11.3 m), which spanned from 4 in. (102 mm) downstream of the centerline of post no. 4 through the centerline of post no. 10.

Numerous kinks in the top and bottom corrugations of the rail were found 8 in. (203 mm) upstream of post no. 3 through 2 in. (51 mm) downstream of post no. 11, as shown in Figures 30 and 31. Flattening of the guardrail occurred at the splice between post nos. 4 and 5 and extended to post no. 8. The bottom corrugation was folded back at post nos. 5 and 6 as well as from the splice between post nos. 7 and 8 to post no. 9. The W-beam guardrail detached from post nos. 5 through 11 and 13. A ¼-in. (6-mm) vertical tear was found at the downstream end of the slot at post no. 6. Buckles were found 2 in. (51 mm) upstream of post no. 4 near the post bolt and at

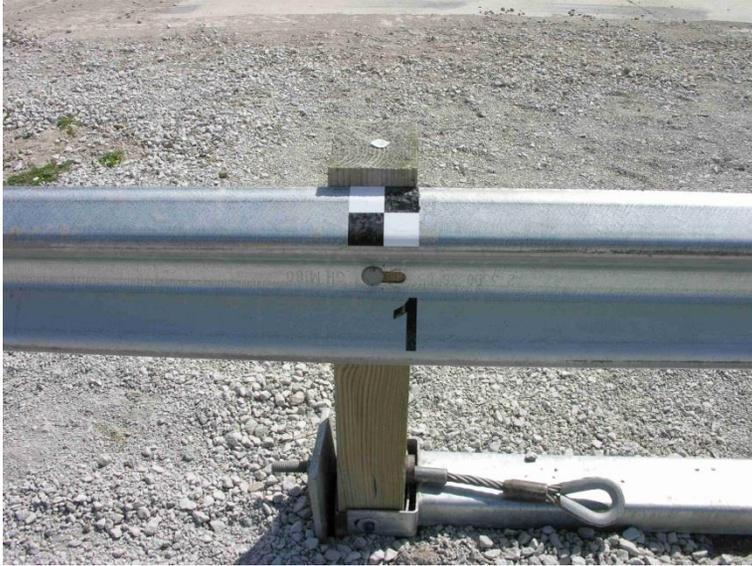
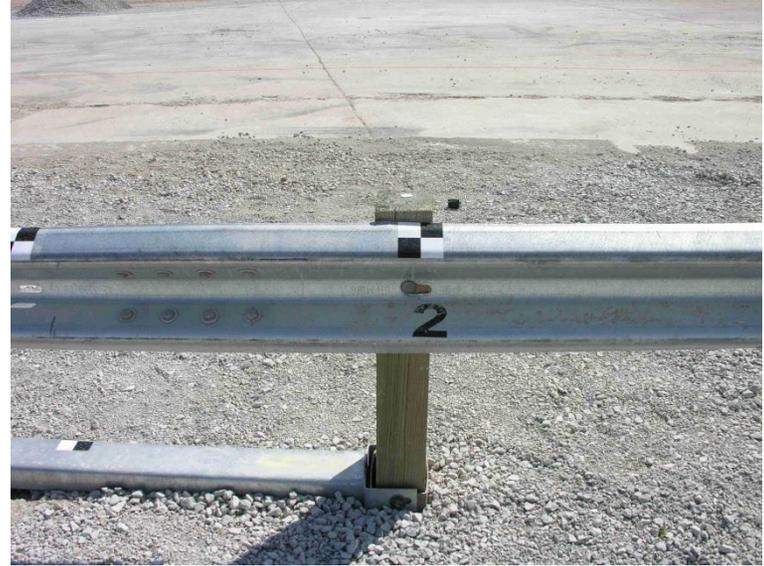
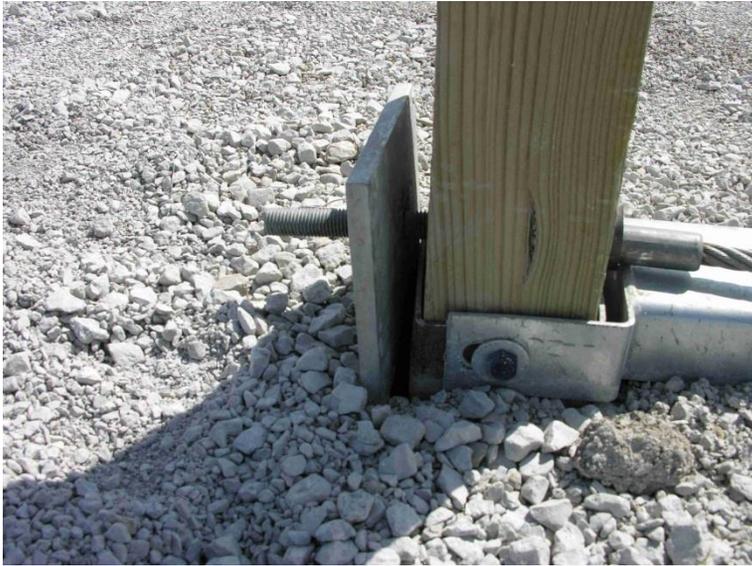
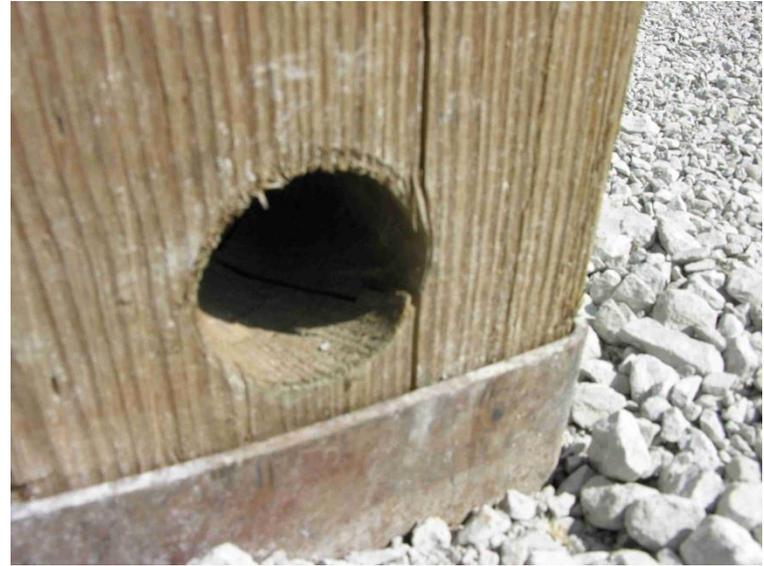
Figure 32. System Damage, Upstream Anchors, Post nos. 1 and 2, Test No. MGSMIN-1

Post no. 2 cracked in multiple places: (1) across the top of the post, 3½ in. (89 mm) from the front; (2) a 7-in. (178-mm) long vertical crack on the upstream side near the hole; and (3) a 10-in. (254-mm) long crack on the downstream side, measured from the ground up. The front of post nos. 3 and 4 twisted slightly downstream and both blockouts cracked. Furthermore, the top of the blockout at post no. 4 contained gouging from the rail. Post nos. 5 through 8 bent backward and downstream nearly to the ground, while the front flanges twisted to face upstream and the blockouts were disengaged. There were 7-in. (178-mm) long dents in the upstream front flange of post nos. 6 and 7 at locations 12 in. (305 mm) and 8 in. (203 mm) from the top, respectively. Post no. 8 had gouging of the upstream front flange between 11 in. (279 mm) and 19 in. (483 mm) from the top of the post. Additionally, post no. 8 had a 3-in. (76-mm) dent on the upstream back flange, 6½ in. (165 mm) from the top. Post no. 9 bent downstream and backwards, the front flange twisted slightly upstream, and the majority of the blockout disengaged. Post no. 10 twisted slightly downstream with splitting and cracking located throughout the blockout. The blockout of post no. 11 rotated downstream. Post no. 12 cracked significantly near the ground line. The portion between the hole and back face of post no. 12 fractured and the crack continued downward on the front side of the hole as shown in Figure 37.

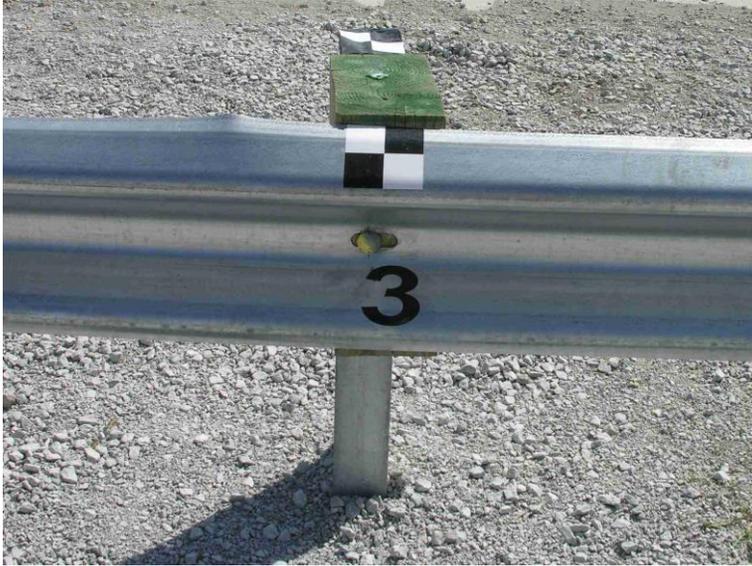
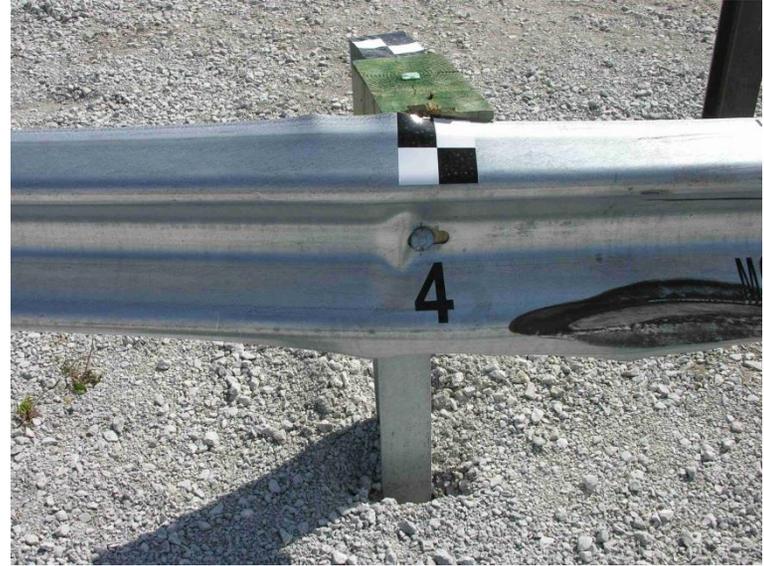
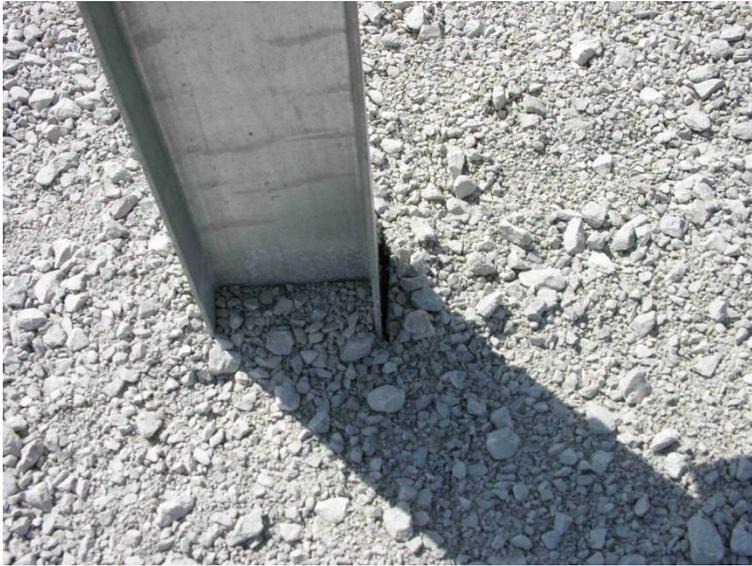
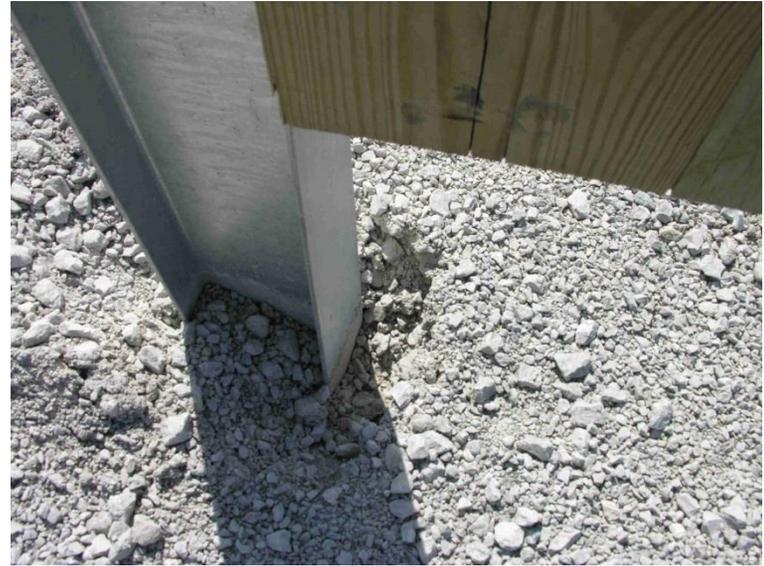
Figure 33. System Damage, Post nos. 3 and 4, Test No. MGS MIN-1

A ¾-in. (19-mm) soil gap was present at the upstream edge of post no. 1, as shown in Figure 32. Soil gaps of ⅜ in. (10 mm) and 3½ in. (89 mm) were present at the front face of post nos. 3 and 4, respectively. There was a ½-in. (13-mm) soil gap present at the downstream edge on post no. 13, as shown in Figure 37. Large soil displacements were present around the bases of post nos. 5 through 10.

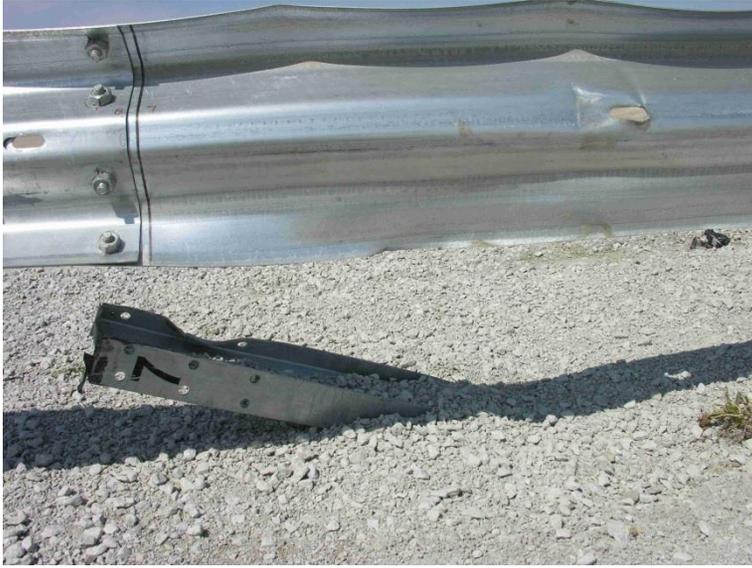
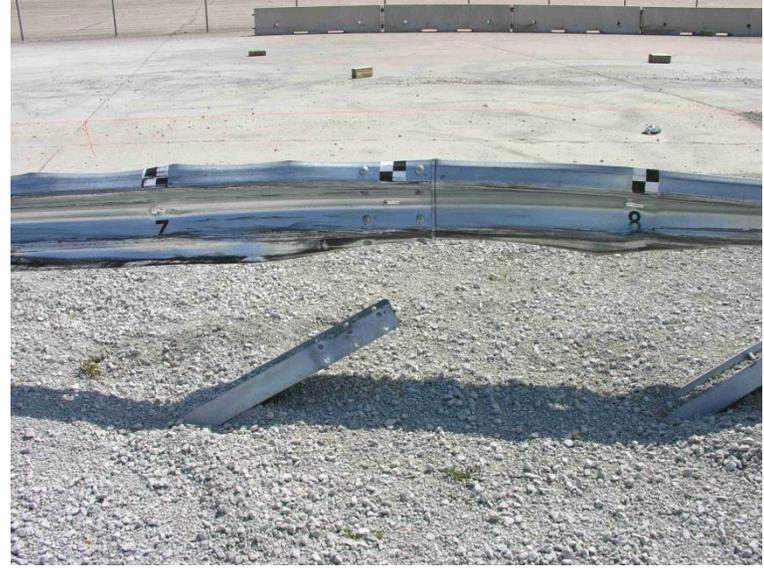
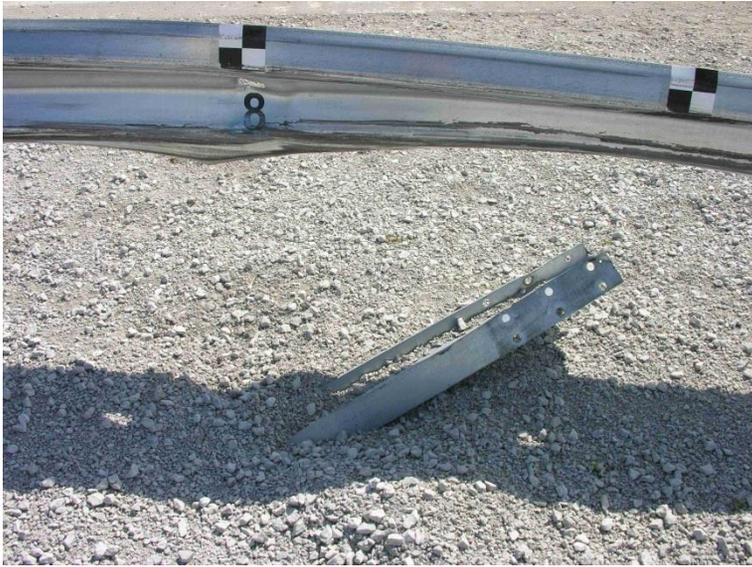
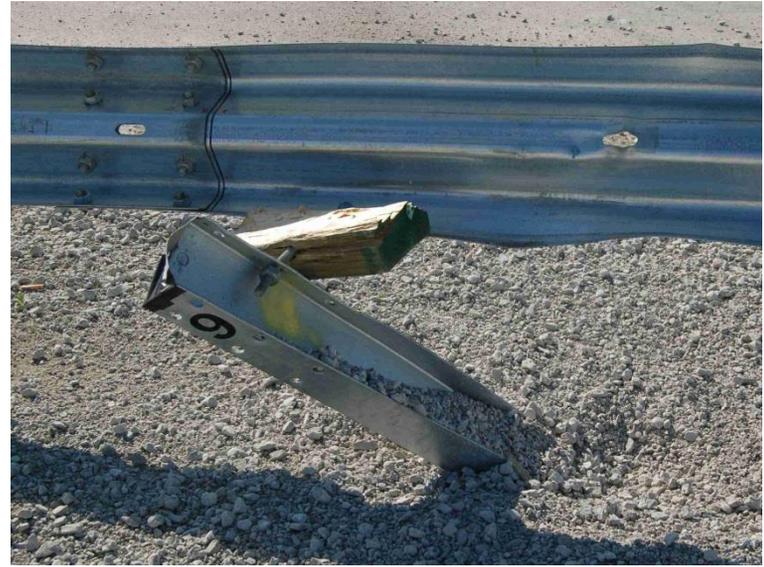
Figure 34. System Damage, Post nos. 5 and 6, Test No. MGSMIN-1

post no. 10. A dent in the rail occurred slightly upstream and above the bolt slot at post no. 5, as shown in Figure 34.

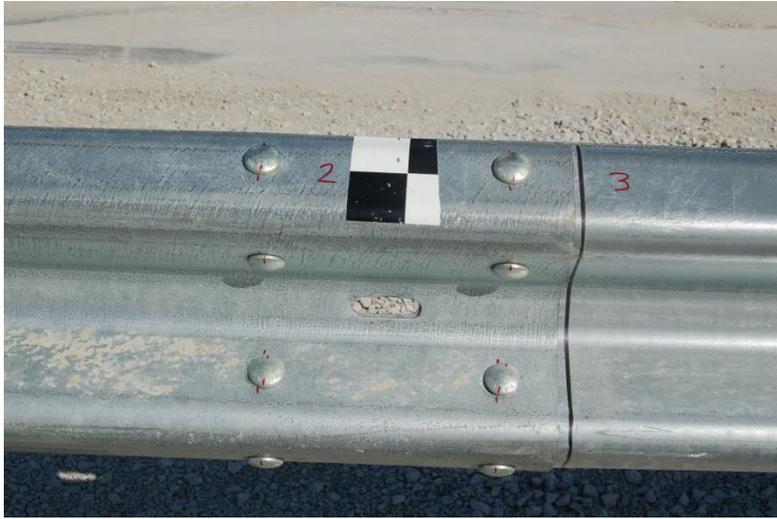
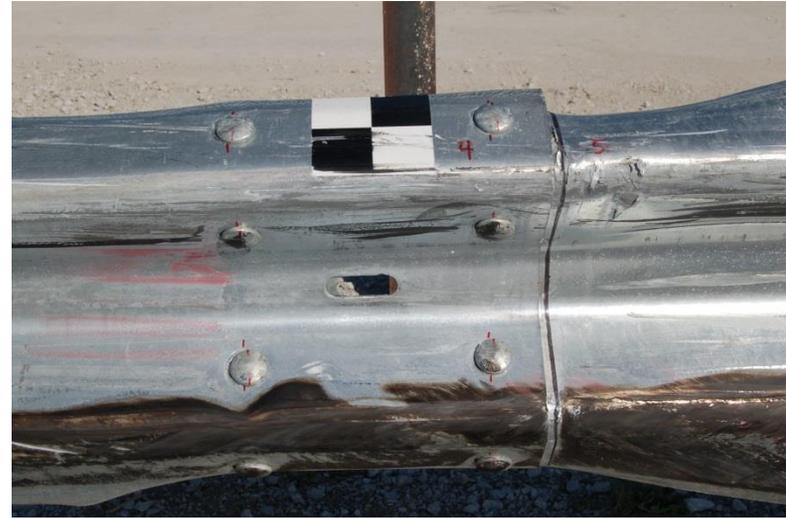
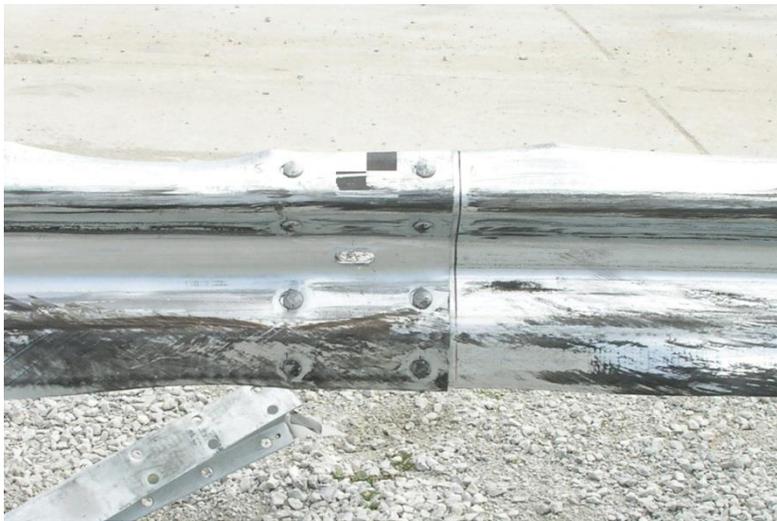
Figure 38. System Damage, Splice Slippage, Test No. MGSMIN-1

Splice 2-3

Splice 4-5

Splice 5-6

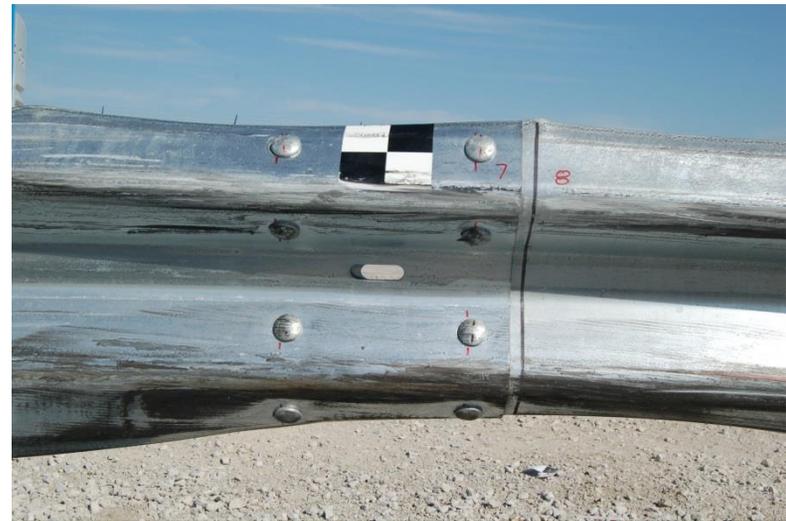
The slippage between adjacent rail segments was measured at every splice location, as shown in Table 7. Slippage at each splice location is shown in Figures 38 and 39. The maximum slippage was found to be $\frac{3}{8}$ in. (10 mm) at the splice location between post nos. 5 and 6. A complete summary of the splice separations together with details of the slippage for each of the splice bolts is provided in Appendix D.

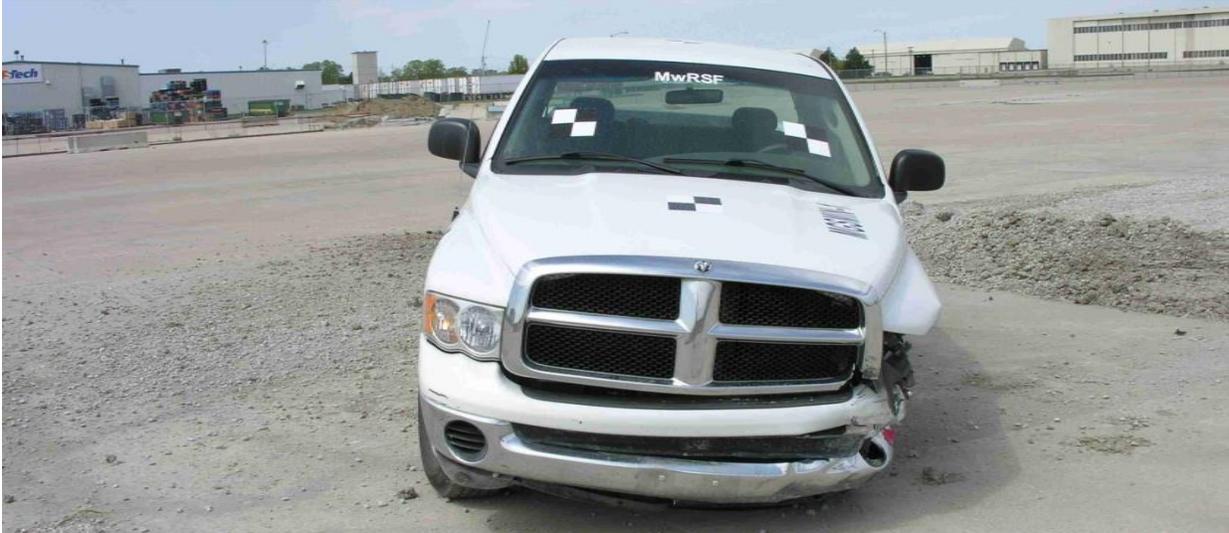
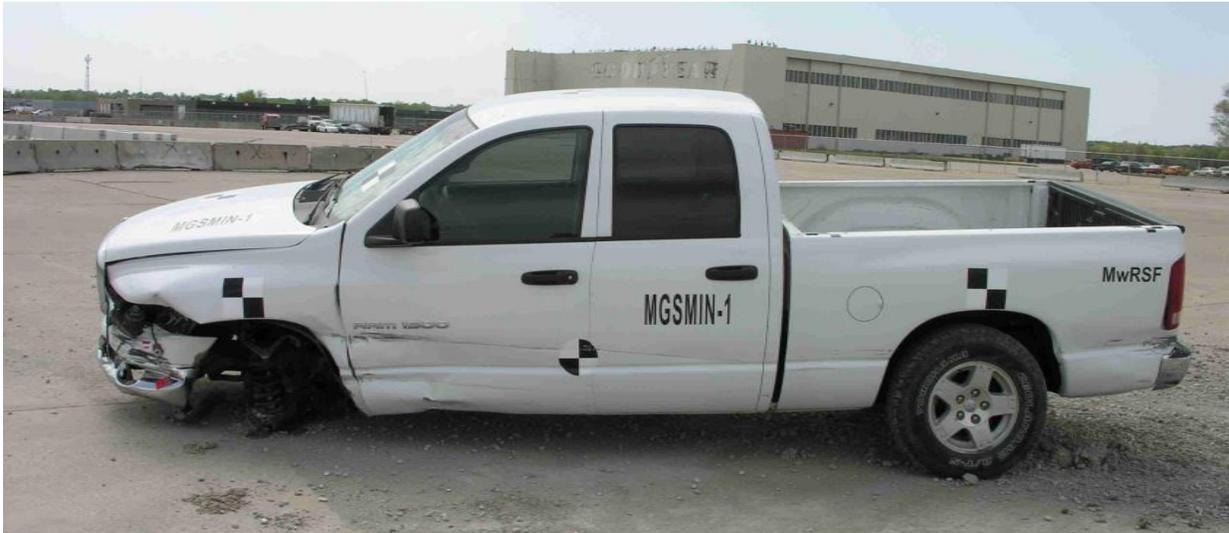
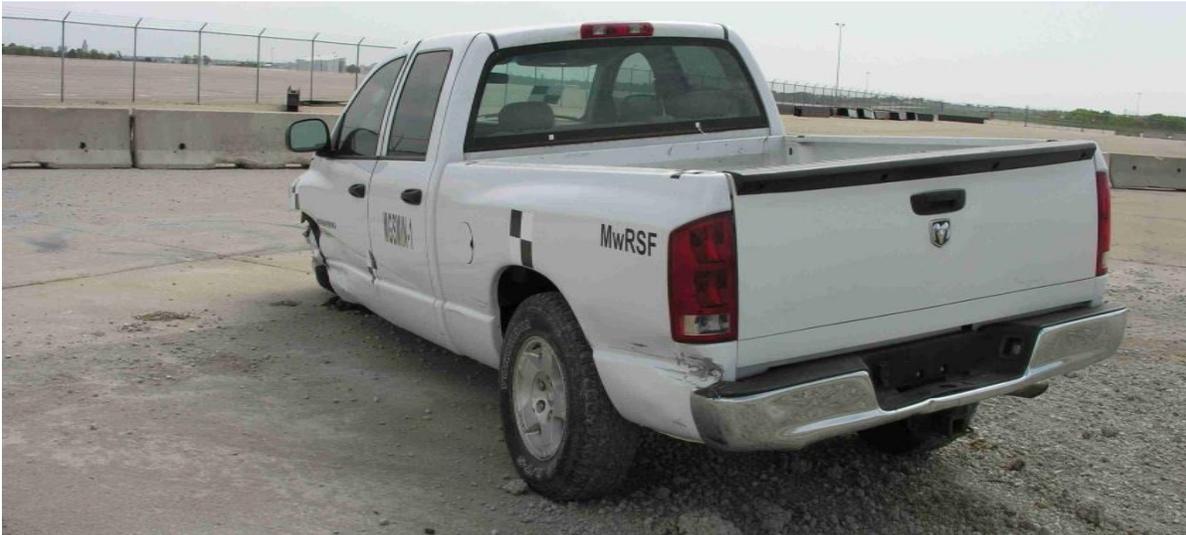
Figure 40. Vehicle Damage, Test No. MGSMIN-1

The damage to the vehicle was moderate, as shown in Figures 40 through 43. The maximum occupant compartment deformations are listed in Table 8 along with the deformation

were present on the left-rear bumper, which bent inwards. No visible damage to the interior compartment or undercarriage was observed.

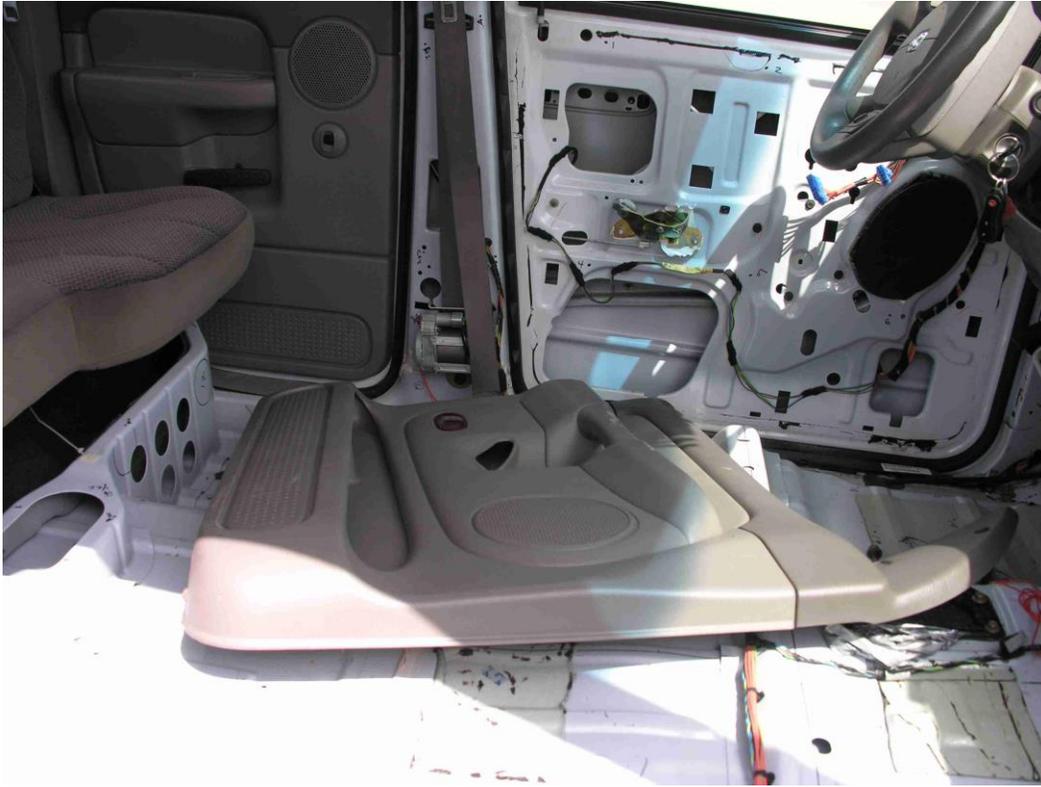
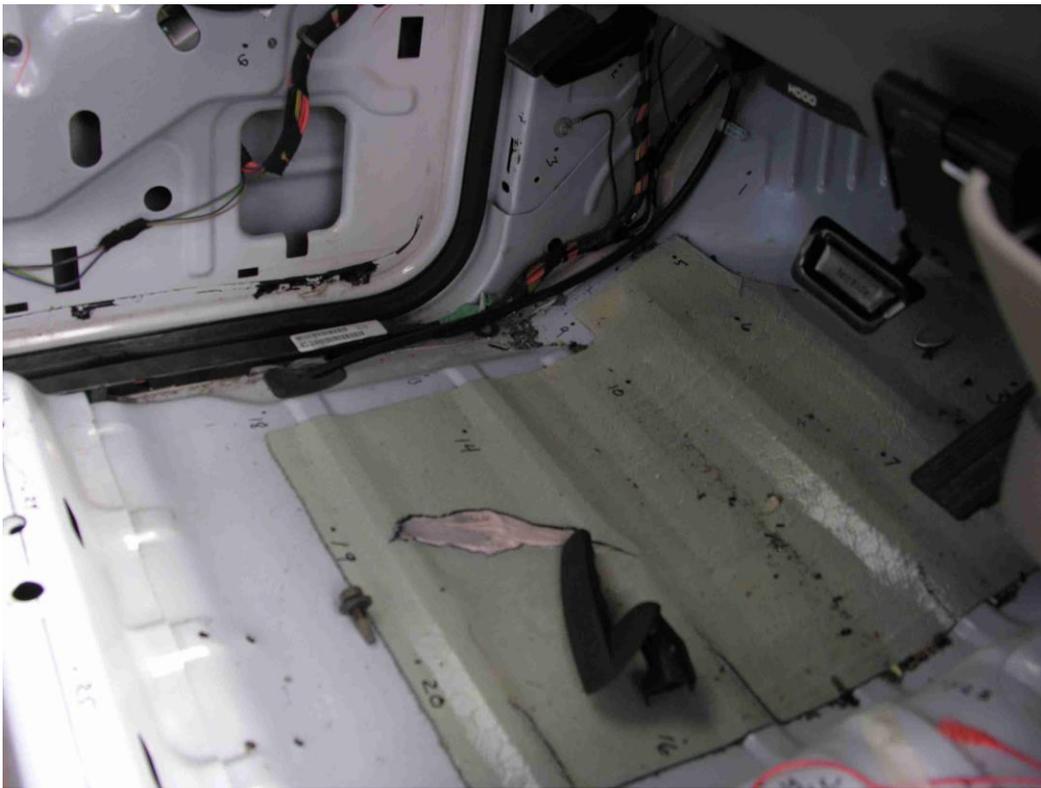
Figure 43. Occupant Compartment Deformation, Test No. MGSMIN-1

limits established in MASH for various areas of the occupant compartment. It should be noted that none of the MASH established deformation limits were violated. Complete occupant compartment and vehicle deformations and the corresponding locations are provided in Appendix E.

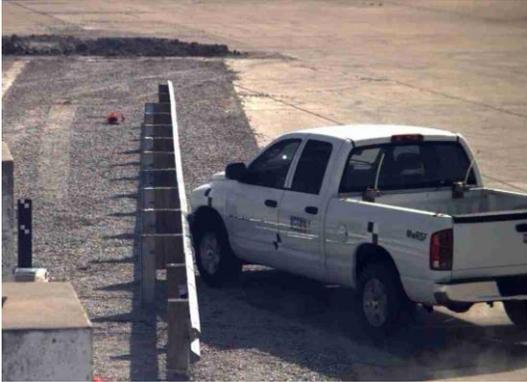
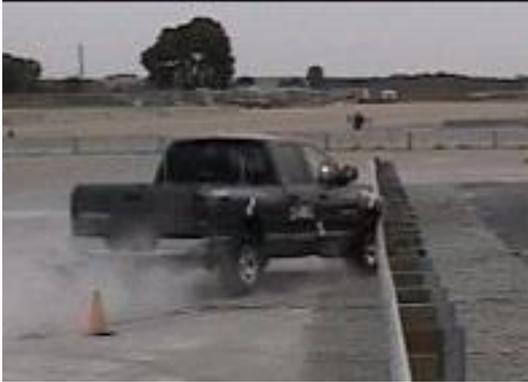
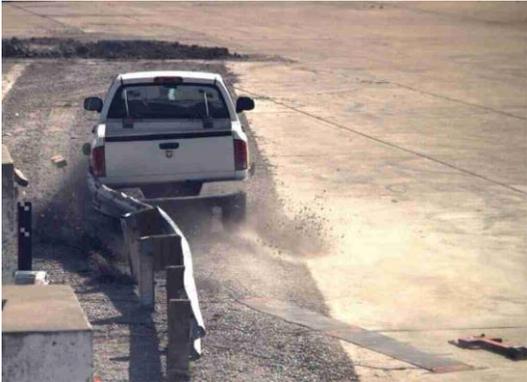
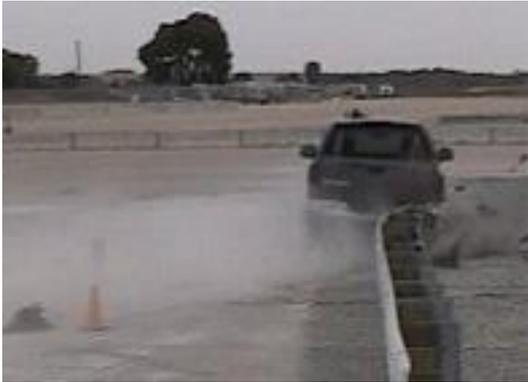
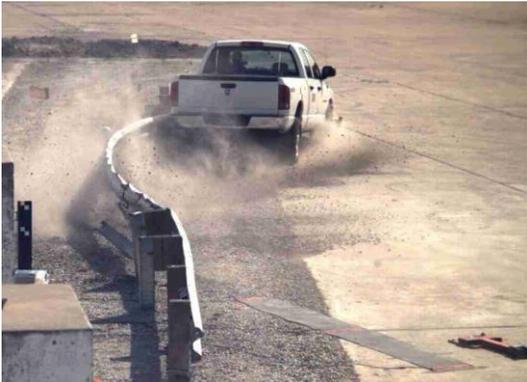
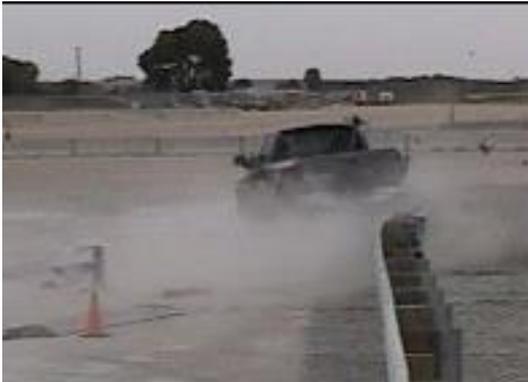
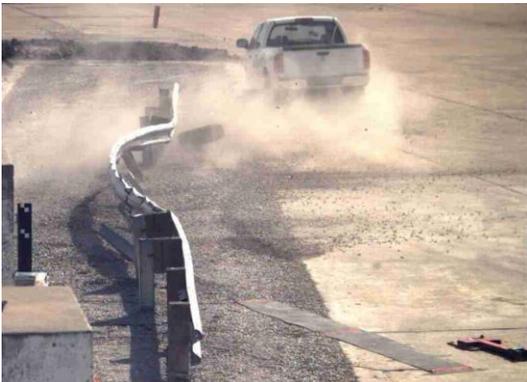
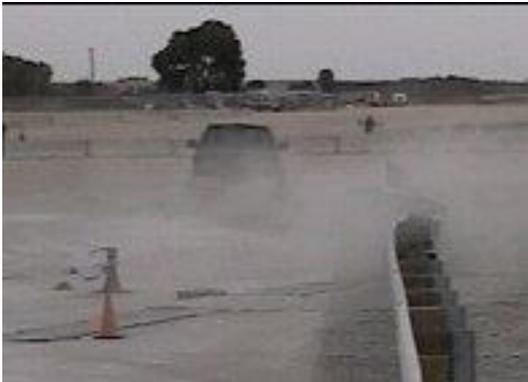
Figure 44. Rear View 2270P Tests - MGSMIN-1 (left) and 2214MG-2 (right)

A comparison of test results between the standard MGS measuring 175 ft (53.3 m) long and the reduced 75-ft (22.9-m) system is presented in Table 10. Both tests were conducted under MASH TL-3 conditions with the 2270P vehicle. Rear view sequential photos along with barrier damage and vehicle damage are shown in Figures 44 through 46, respectively.

75-ft System

175-ft System

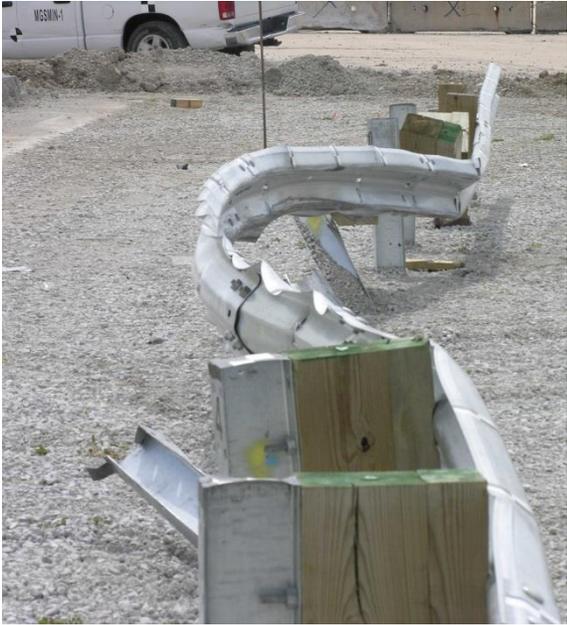
Figure 45. Barrier Damage – MGSMIN-1 (left) and 2214MG-2 (right)

75-ft System

Some differences in the rail deflection may be attributed to the soil conditions. The more recent 75-ft (22.9-m) MGS crash test was performed in soil that used a relatively new

compaction method. However, soil conditions for both tests met the minimum standards set in MASH. The 75-ft (22.9-m) MGS had a higher number of posts yield in the impact region, which resulted in a slightly longer contact length. Although the shorter system contained 16 less posts than the standard MGS, both systems exhibited similar maximum barrier deflections. The vehicle in the 75-ft (22.9-m) system experienced roll, pitch, and yaw angular displacements which closely matched those observed in the 175-ft (53.3-m) system. In addition, there were no considerable differences in the ORA or OIV values between the two tests. Thus, the reduction in system length from 175 ft (53.3 m) to 75 ft (22.9 m) did not adversely affect the overall performance of the MGS system.

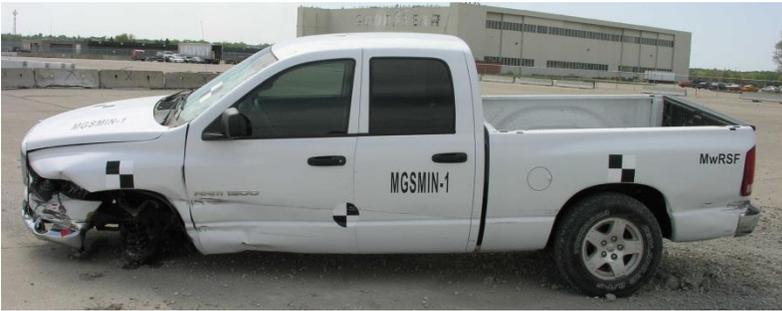
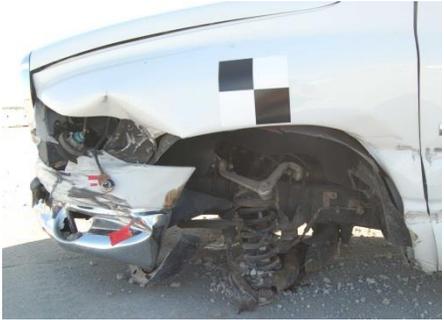
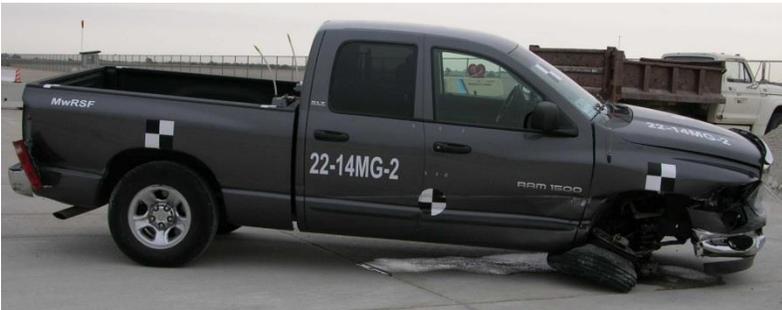
Figure 46. Vehicle Damage - MGSMIN-1 (top) and 2214MG-2 (bottom)

75-ft System

175-ft System

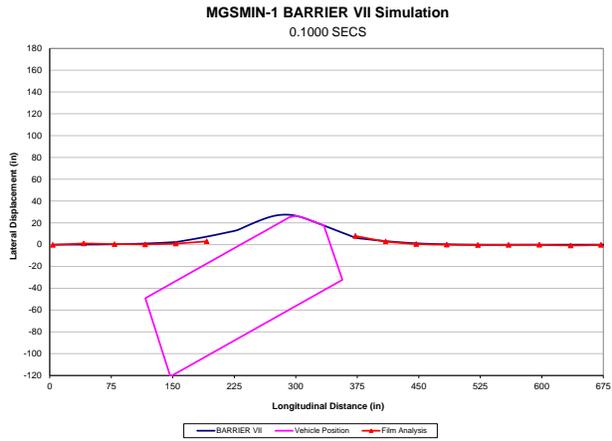
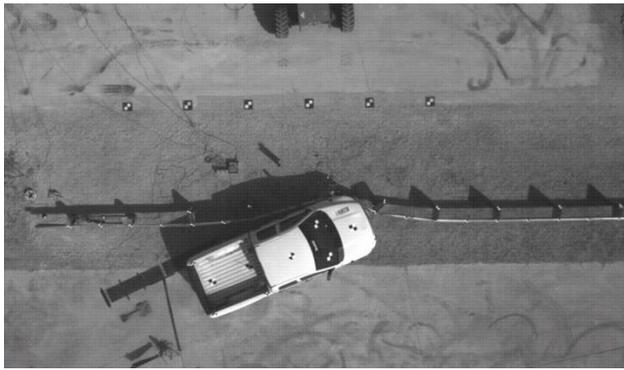
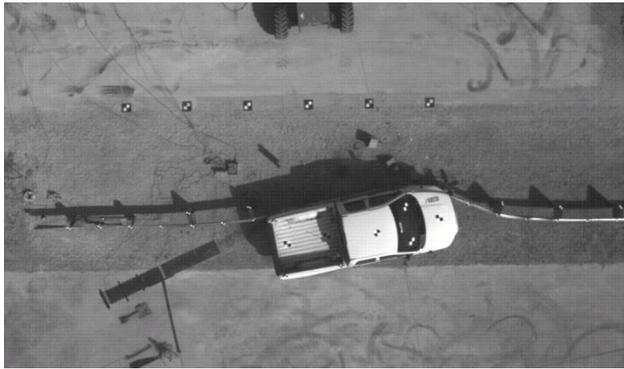
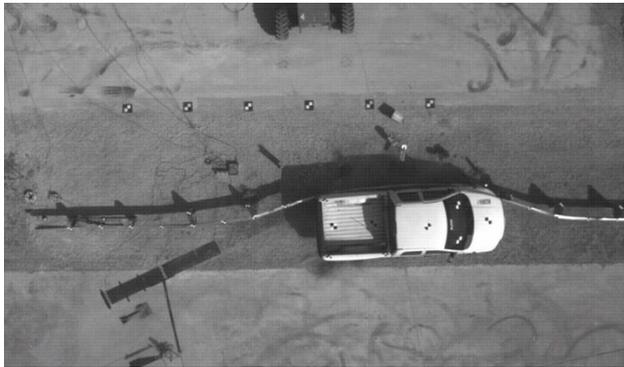
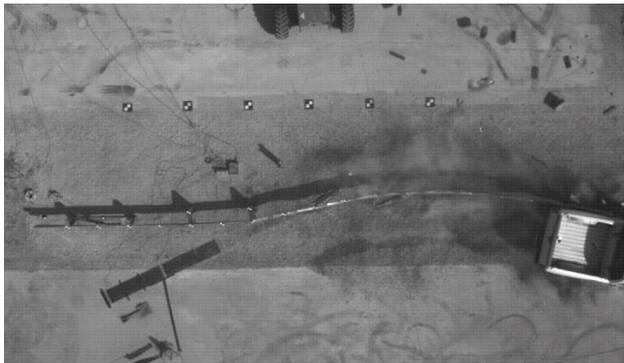
Figure 54. Sequential Figures from Simulation and Test No. MGSMIN-1

In addition to vehicle kinematics, the BARRIER VII model was validated against the deflected shape of the barrier. A graphical comparison between the calibrated baseline model and the overhead video from full-scale crash test no. MGSMIN-1 is shown in Figure 54. The comparison shows the barrier profiles from impact through exit at 100 ms intervals. There was a 13 percent difference observed in the dynamic rail deflections between the full-scale test and simulation with maximum deflections of 42.2 in. (1,072 mm) and 48.6 in. (1,234 mm), respectively. However, the BARRIER VII baseline model accurately estimated the system deflections through 600 ms of impact. After 600 ms, the simulation under-predicted the deflection of the rail; but, by this time, the vehicle had already been redirected and was exiting
