Midwest States Regional Pooled Fund Research Program
Fiscal Years 2012 and 2014 (Years 22 and 24)
Research Project Number TPF-5(193)
NDOR Sponsoring Agency Code RPFP-12-CABLE-1&2 and RPFP-14-CABLE-1

CABLE-TO-POST ATTACHMENTS FOR A NON-PROPRIETARY HIGH-TENSION CABLE BARRIER – PHASE III

MwRSF Research Report No. TRP-03-323-16

March 24, 2016

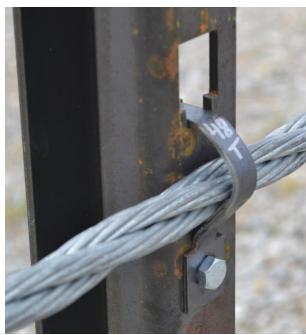
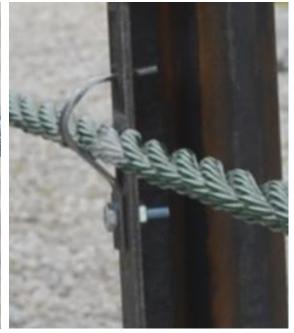
Figure 1. Bolted, Tabbed Bracket on MWP

3) a new V-notch and brass rod cable attachment located on the top of the post [1-2]. The new cable-to-post attachment bracket was fabricated from 12-gauge (2.66-mm) steel, had a tabbed top portion that extended through a keyway in the post, and was attached to the post with a ⁵/₁₆-in.

(8-mm) diameter bolt. The top of the tabbed bracket was designed to release through the keyway under relatively low vertical loading, approximately 300-400 lb (1.3-1.8 kN). However, when loaded laterally, the tabs would catch the narrow portion of the keyway and provide over 6 kips (26.7 kN) of resistance. The bolted, tabbed bracket (Version 10) is shown in Figures 1 and 2.

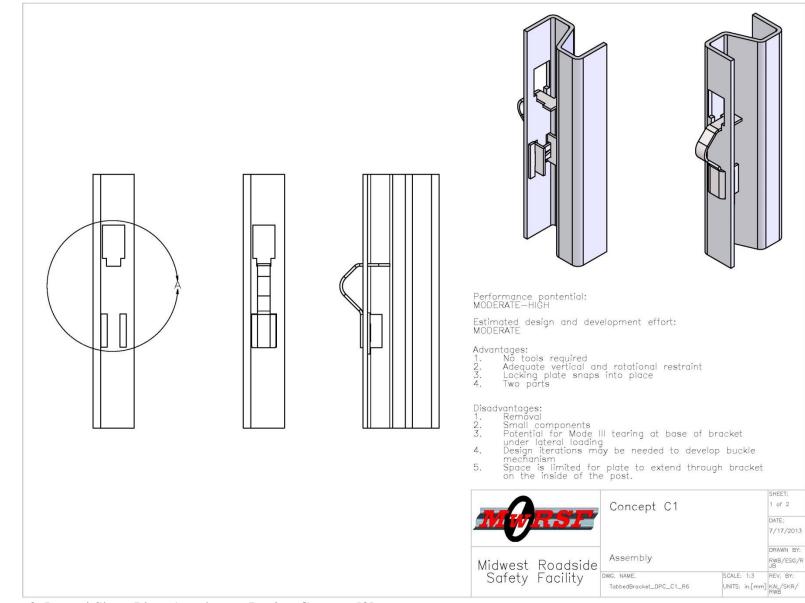
Figure 3. Lateral Shear Plate Attachment Design Concept [3]

release load was three times higher than desired. The lateral shear plate attachment design satisfied both the lateral and vertical release loads during component testing, but problems arose in the installation and removal process. Specifically, the part would not always snap into place as originally designed, and tools were required to remove the shear plate after installation. A loose attachment in the lateral shear plate design also led to concerns that the bracket may rotate and snag on the keyway (similar to the vertical test result of the drop-in shear plate design) under slightly different load circumstances. Subsequently, the bolted, tabbed bracket was recommended for continued use within the non-proprietary, four-cable barrier system until the alternative brackets were redesigned and successfully tested against these standards [3].

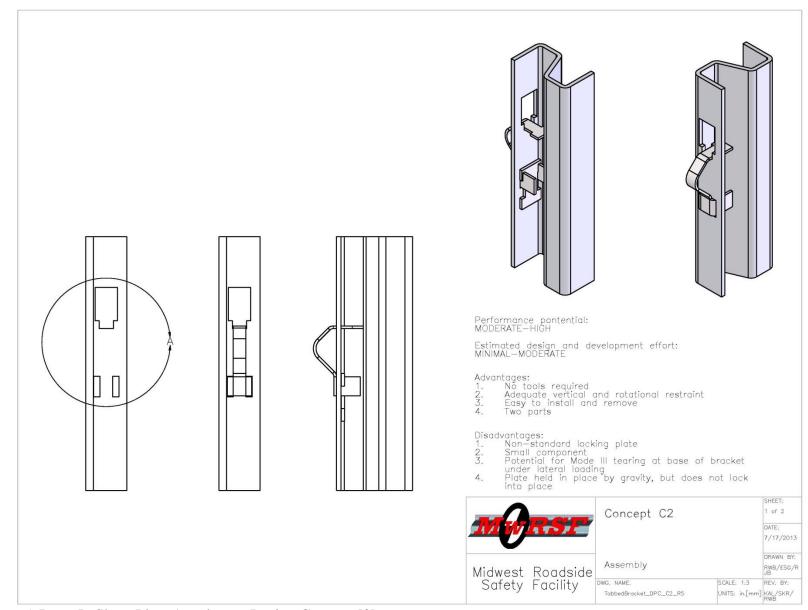
Figure 5. Drop-In Shear Plate Attachment Design Concept [3]

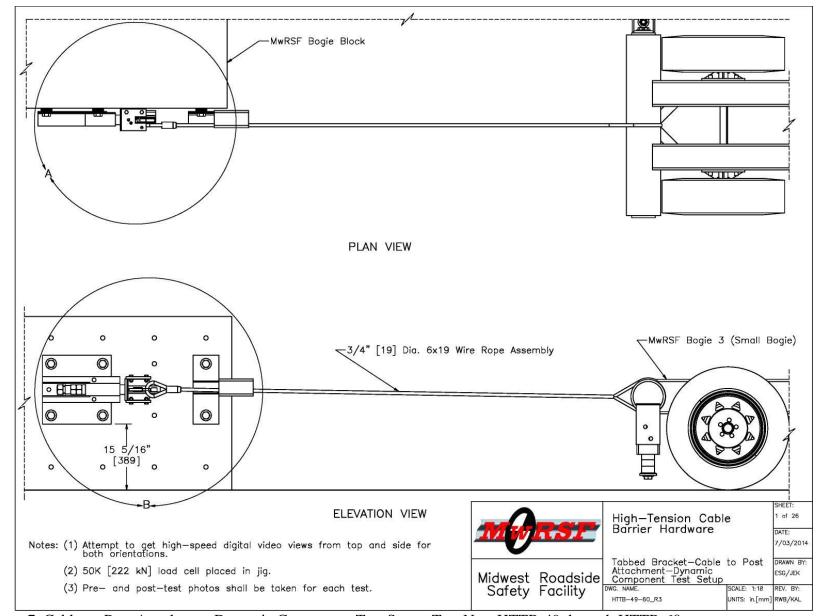
Figure 7. Cable-to-Post Attachment Dynamic Component Test Setup, Test Nos. HTTB-49 through HTTB-60

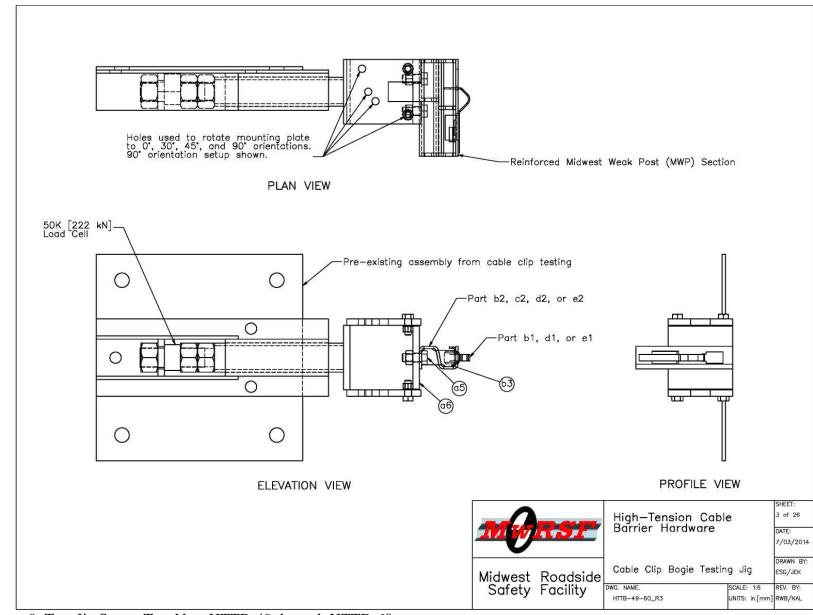
Figure 9. Test Jig Setup, Test Nos. HTTB-49 through HTTB-60

A test jig was utilized to support and anchor the test article. The short MWP post selection was bolted to a mounting plate, which could be adjusted to change the angle at which the cable pulled on the post-bracket assembly. A steel rod was used to connect and transfer loads from the mounting plate to the load cell. The steel rod was encased by a cylindrical steel tube to restrict motion to only the direction of loading. A looped cable was placed through the tabbed bracket and through a feeder tube in line with the load cell and mounting plate. The other end of the cable was attached to the bogie. The test jig was mounted to the side of a rigid concrete block, as shown in Figure 34.

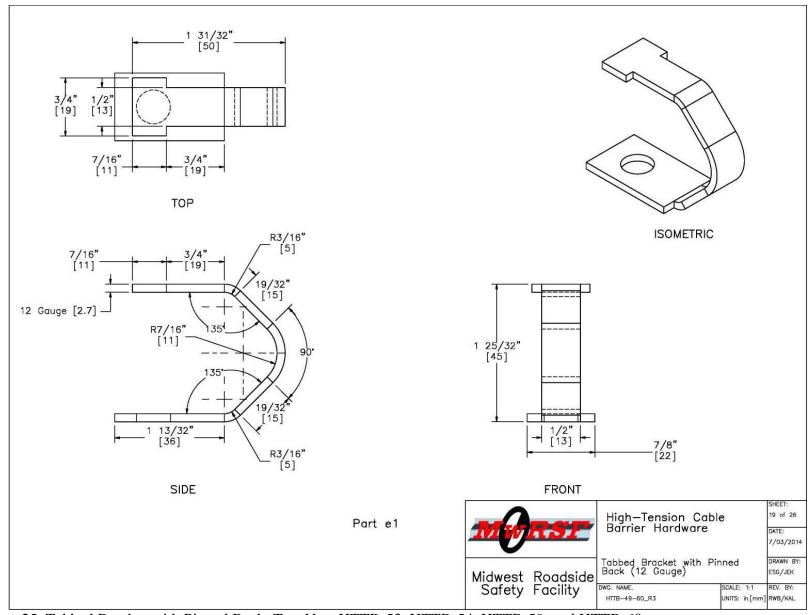
Figure 25. Tabbed Bracket with Pinned Back, Test Nos. HTTB-53, HTTB-54, HTTB-59, and HTTB-60

The pinned-back attachment design utilized a vertical pin placed inside the post to secure the bracket. The bottom of the bracket was designed to be installed through a lateral slot in the post and extend horizontally toward the web of the post, as shown in Figure 12. A winged, U-shaped bracket was then inserted over the horizontal extension and the assembly was locked into place using a vertical pin. Both the main bracket and the winged, U-shaped bracket contained ⁷/₁₆-in. (11-mm) diameter holes to accept the ³/₈-in. (10-mm) diameter pin. The wings of the U-shaped bracket were designed to bear against the inside face of the post and prevent the tabbed bracket from moving. Specific dimensions for both brackets and the vertical pin utilized in the pinned-back attachment design are shown in Figures 25 and 29, respectively.

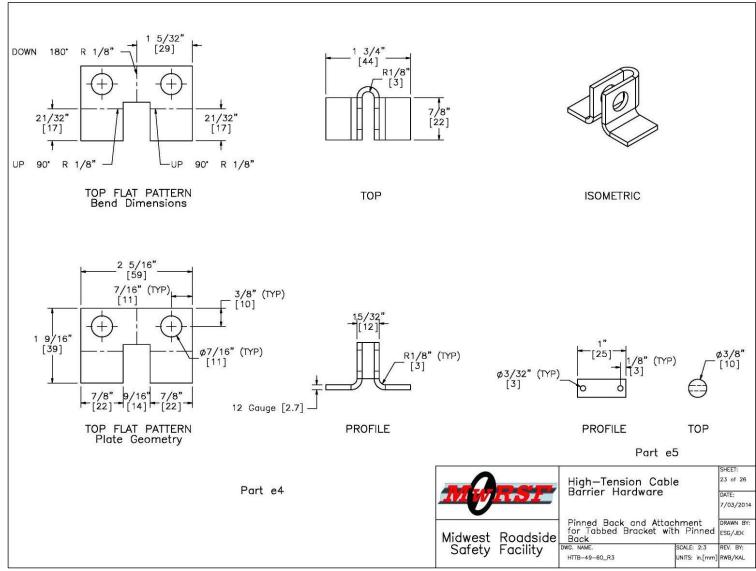
Figure 29. Pinned Back and Attachment for Tabbed Bracket with Pinned Back, Test Nos. HTTB-53, HTTB-54, HTTB-59, and HTTB-

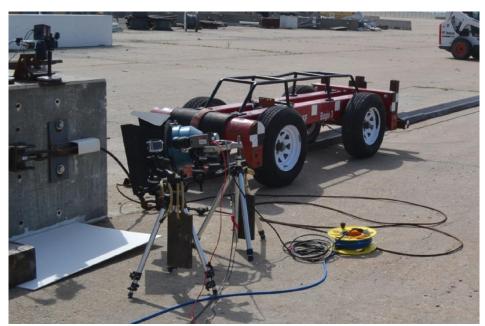
Figure 33. Rigid-Frame Bogie on Guidance Track

A rigid-frame bogie was used to pull the cable that was attached to the various tabbed bracket designs. The weight of the bogie was 1,682 lb (763 kg). A pickup truck was used to propel the bogie along a guidance track to a target speed of 5 mph (8 km/h). The pickup truck braked, allowing the bogie to be free-rolling as it approached the end of the guidance system and applied the load to the cable-to-post attachment. A remote braking system was installed on the bogie, allowing it to be brought safely to rest after the test. The bogie with the test setup is shown in Figure 33.

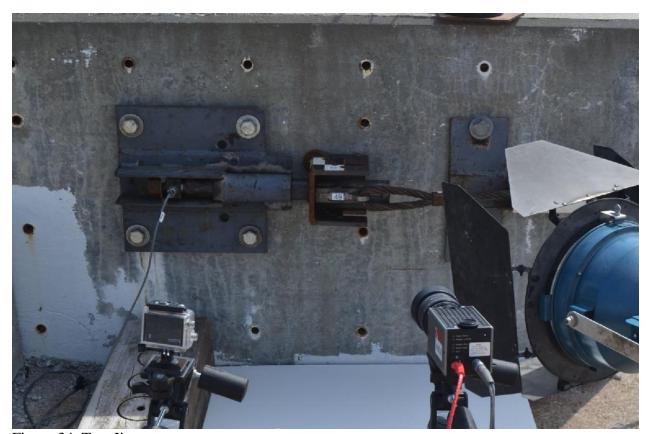
Figure 34. Test Jig

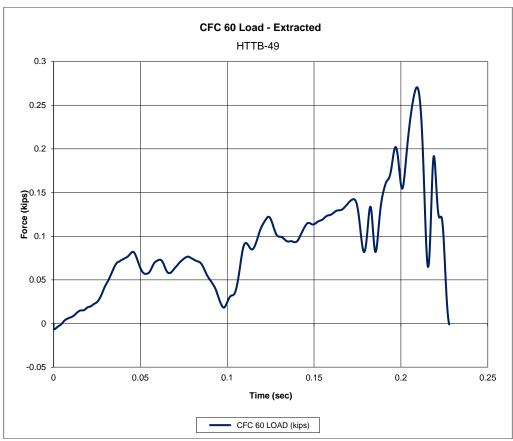
Figure 35. Force vs. Time Data, Test No. HTTB-49

Test no. HTTB-49 evaluated the tabbed bracket with the key plate attachment by loading the bracket vertically, or at an angle of 0 degrees relative to the face of the post. Once the cable was pulled into tension, the construction tolerances within the key plate connection allowed the bracket to rotate slightly outward. As the load imparted to the tabbed bracket increased, the spine of the bracket began to bend, and the bracket opened. At 0.209 seconds after the initial loading, a peak load of 0.27 kips (1.20 kN) was reached. After this peak, the force fell quickly as the bracket continued to open. The peak occurring after this time was caused by the cable briefly catching on the tabs after it released from the bracket, a phenomenon possible only because of the cable loop. In an actual installation where the cable is straight, the tabs would not be expected to snag the cable. As such, the forces associated with the snag were not considered part of the release load. The tabs completely exited the keyway by 0.220 seconds. The force vs. time curve is shown in Figure 35. Pre- and post-test photographs and sequential photographs are shown in Figures 36 and 37, respectively.

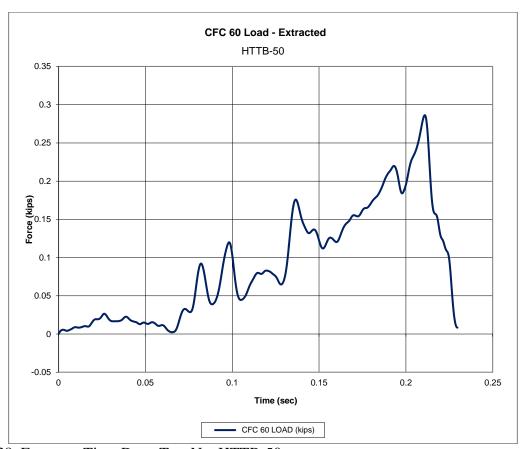
Figure 38. Force vs. Time Data, Test No. HTTB-50

Test no. HTTB-50 evaluated the tabbed bracket with the key plate attachment by loading the bracket vertically, or at an angle of 0 degrees relative to the face of the post. Once the cable was pulled into tension, the construction tolerances within the key plate connection allowed the bracket to rotate slightly outward. As the load imparted to the tabbed bracket increased, the spine of the bracket began to bend, and the bracket opened. At 0.211 seconds after the initial loading, a peak load of 0.29 kips (1.29 kN) was reached. After this peak, the force fell quickly as the bracket continued to open and the tabs were lifted out of the keyway. The tabs completely exited the keyway at 0.218 seconds. The force vs. time curve is shown in Figure 38. Pre- and post-test photographs and sequential photographs are shown in Figures 39 and 40, respectively.

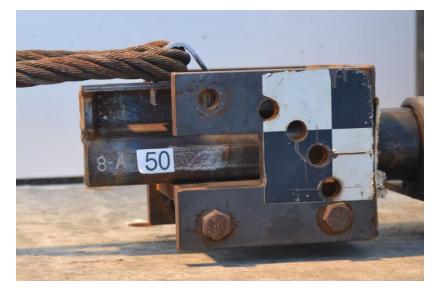
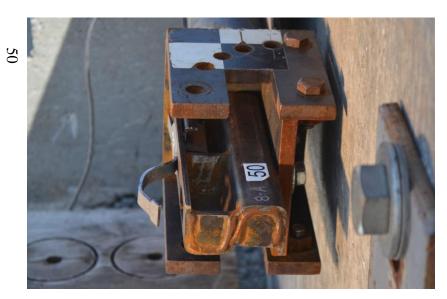
Figure 39. Pre-Test (Upper) and Post-Test (Lower) Photographs, Test No. HTTB-50

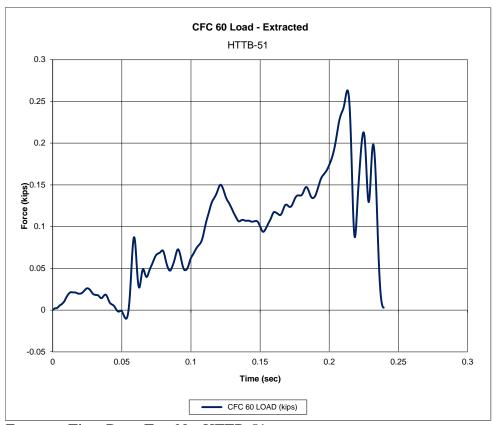
Figure 41. Force vs. Time Data, Test No. HTTB-51

Test no. HTTB-51 evaluated the tabbed bracket with the wire lock pin attachment by loading the bracket vertically, or at an angle of 0 degrees relative to the face of the post. Once the cable was pulled into tension, the construction tolerances within the wire lock pin connection allowed the bracket to rotate slightly outward. As the load imparted to the tabbed bracket increased, the spine of the bracket began to bend, and the bracket opened. At 0.213 seconds after the initial loading, a peak load of 0.26 kips (1.16 kN) was reached. After this peak, the force fell quickly as the bracket continued to open and the tabs were lifted out of the keyway. By 0.226 seconds, the tabs had completely exited the keyway. The two peaks occurring after this time were caused by the cable briefly catching on the tabs after it released from the bracket and were not considered part of the release load. The force vs. time curve is shown in Figure 41. Pre- and post-test photographs and sequential photographs are shown in Figures 42 and 43, respectively.

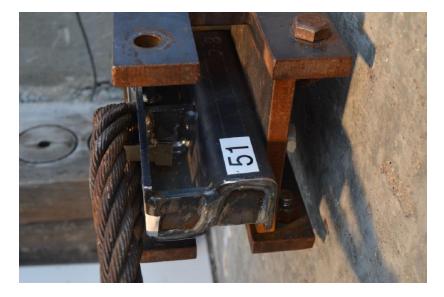
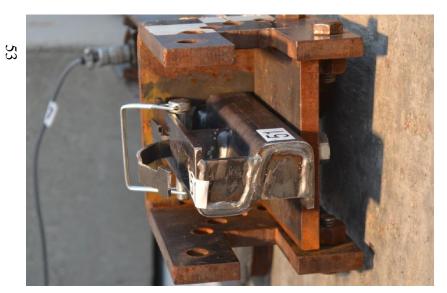
Figure 42. Pre-Test (Upper) and Post-Test (Lower) Photographs, Test No. HTTB-51

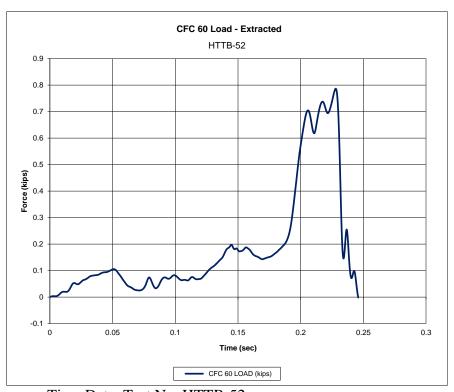
Figure 44. Force vs. Time Data, Test No. HTTB-52

Test no. HTTB-52 evaluated the tabbed bracket with the wire lock pin attachment when loaded vertically, or at an angle of 0 degrees relative to the face of the post. Once the cable was pulled into tension, the construction tolerances within the wire lock pin connection allowed the bracket to rotate slightly outward. As the load imparted to the tabbed bracket increased, the spine of the bracket began to bend, and the bracket opened. At 0.228 seconds after the initial loading, a peak load of 0.79 kips (3.51 kN) was reached. Installation tolerances allowed the bracket to twist and the tabs to catch on the side of the keyway for a short time before releasing at 0.238 seconds. After this, the force fell quickly as the bracket continued to open and the tabs were lifted out of the keyway. After the tab released from its snagged position on the keyway, bracket flexure and snag on the cable produced loads similar to the previous vertical release loads with a peak load of 0.25 kips (1.11 kN). The force vs. time curve is shown in Figure 44. Pre- and post-test photographs and sequential photographs are shown in Figures 45 and 46, respectively.

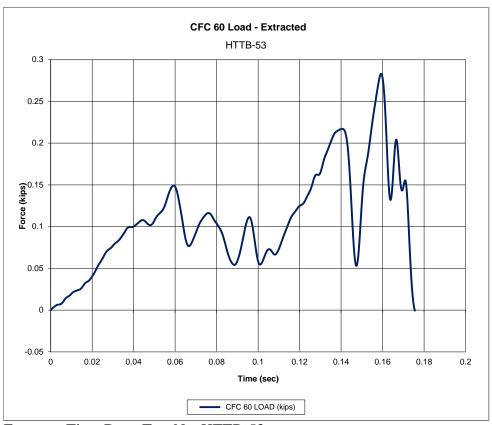
Figure 47. Force vs. Time Data, Test No. HTTB-53

Test no. HTTB-53 evaluated the tabbed bracket with the pinned-back attachment by loading the bracket vertically, or at an angle of 0 degrees relative to the face of the post. Once the cable was pulled into tension, the construction tolerances within the pinned-back connection allowed the bracket to rotate slightly outward. As the load imparted to the tabbed bracket increased, the spine of the bracket began to bend, and the bracket opened. At 0.159 seconds after the initial loading, a peak load of 0.28 kips (1.25 kN) was reached. After this peak, the force fell quickly as the bracket continued to open and the tabs were lifted out of the keyway. By 0.160 seconds, the tabs had completely exited the keyway. The two peaks occurring after this time were caused by the cable briefly catching on the tabs after it released from the bracket and were not considered part of the release load. The force vs. time curve is shown in Figure 47. Pre- and post-test photographs and sequential photographs are shown in Figures 48 and 49, respectively.

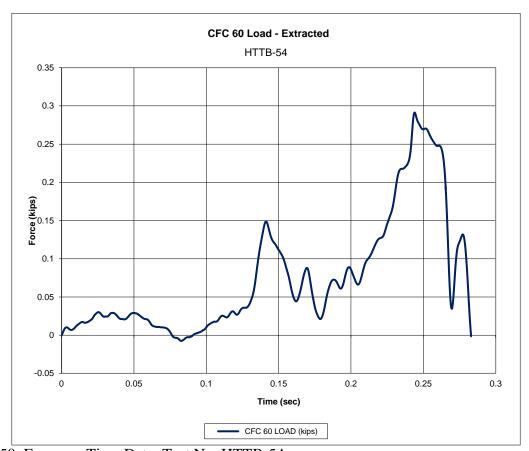
Figure 50. Force vs. Time Data, Test No. HTTB-54

Test no. HTTB-54 evaluated the tabbed bracket with the pinned-back attachment by loading the bracket vertically, or at an angle of 0 degrees relative to the face of the post. Once the cable was pulled into tension, the construction tolerances within the pinned-back connection allowed the bracket to rotate slightly outward. As the load imparted to the tabbed bracket increased, the spine of the bracket began to bend, and the bracket opened. At 0.244 seconds after the initial loading, a peak load of 0.29 kips (1.29 kN) was reached. By 0.276 seconds, the bracket had completely released the cable. The force vs. time curve is shown in Figure 50. Pre- and post-test photographs and sequential photographs are shown in Figures 51 and 52, respectively.

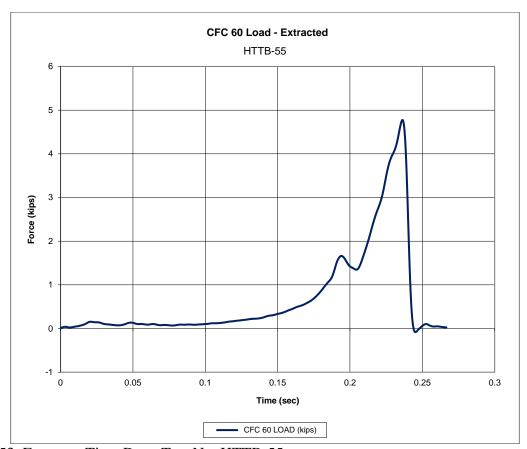
Figure 53. Force vs. Time Data, Test No. HTTB-55

Test no. HTTB-55 evaluated the tabbed bracket with the key plate attachment by loading the bracket laterally, or normal to the flange of the post. As the cable was pulled into tension, the tabs were pulled against the post flange at the bottom of the keyway. As the load increased, the spine of the bracket began to bend and stretch. At 0.236 seconds, a peak load of 4.77 kips (21.22 kN) was reached and bending of the tabs resulted in the tabs being pulled through the keyway. By 0.240 seconds, the tabs had completely exited the keyway. The spine of the bracket bent open, and the cable was released at 0.246 seconds. The force vs. time curve is shown in Figure 53. Pre- and post-test photographs and sequential photographs are shown in Figures 54 and 55, respectively.

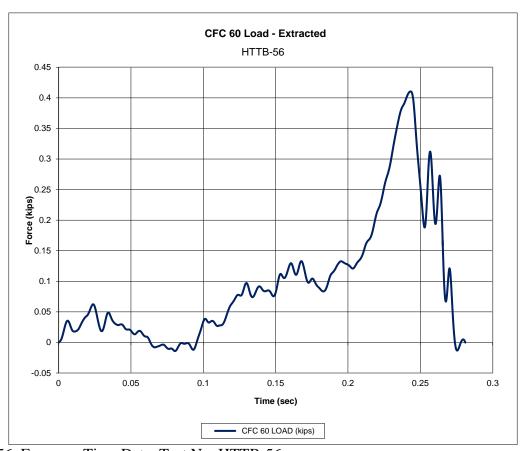
Figure 56. Force vs. Time Data, Test No. HTTB-56

Test no. HTTB-56 evaluated the tabbed bracket with the key plate attachment by loading the bracket laterally, or normal to the flange of the post. As the cable was pulled into tension, the tabs were pulled against the post flange at the bottom of the keyway. As the load increased, the spine of the bracket began to bend and stretch. At 0.184 seconds, the spine continued to bend, causing the tabs to rotate out of the keyway without ever catching on the keyway. At 0.243 seconds, a peak load of 0.41 kips (1.82 kN) was reached. The remaining force peaks were caused by further bending of the spine before the cable was released. The cable was completely released from the bracket at 0.272 seconds after initial loading. The force vs. time curve is shown in Figure 56. Pre- and post-test photographs and sequential photographs are shown in Figures 57 and 58, respectively.

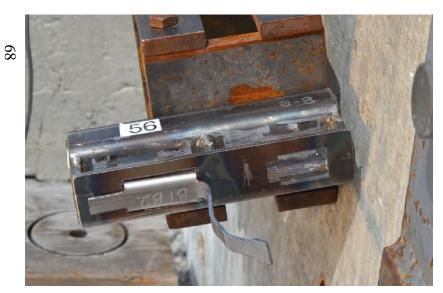
Figure 57. Pre-Test (Upper) and Post-Test (Lower) Photographs, Test No. HTTB-56

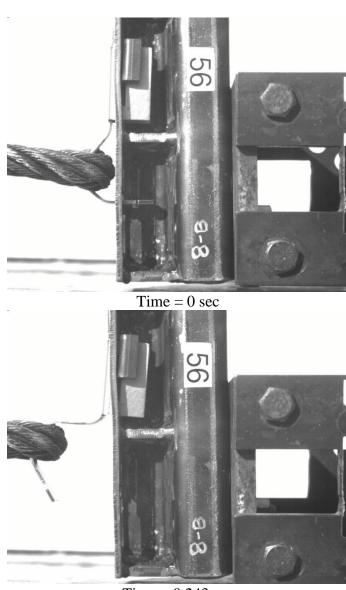
Figure 58. Sequential Photographs, Test No. HTTB-56

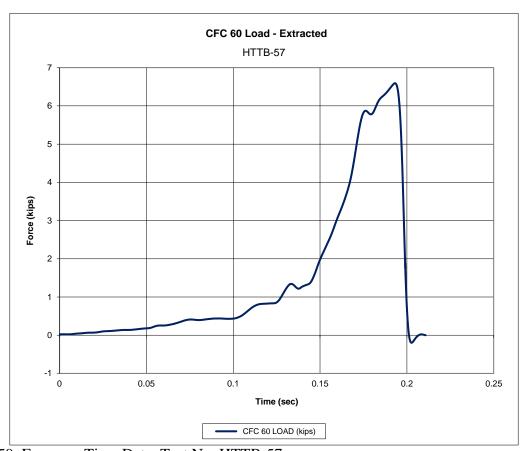
Figure 59. Force vs. Time Data, Test No. HTTB-57

Test no. HTTB-57 evaluated the tabbed bracket with the wire lock pin attachment by loading the bracket laterally, or normal to the flange of the post. As the cable was pulled into tension, the tabs were pulled against the post flange at the bottom of the keyway. As the load increased, the spine of the bracket began to bend and stretch. At 0.193 seconds, a peak load of 6.59 kips (29.31 kN) was reached. The tabs sheared off while exiting the keyway at 0.198 seconds. The cable was fully released from the bracket at 0.202 seconds. The force vs. time curve is shown in Figure 59. Pre- and post-test photographs and sequential photographs are shown in Figures 60 and 61, respectively.

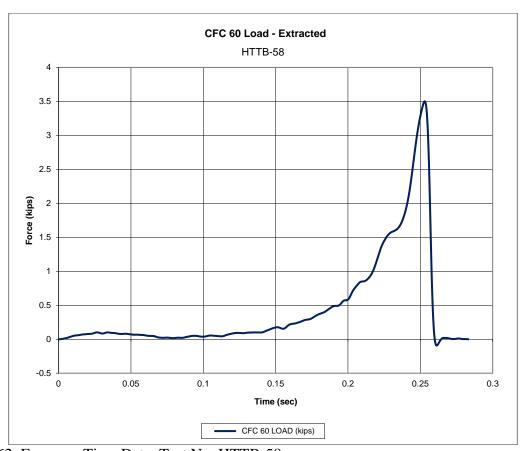
Figure 62. Force vs. Time Data, Test No. HTTB-58

Test no. HTTB-58 evaluated the tabbed bracket with the wire lock pin attachment by loading the bracket laterally, or normal to the flange of the post. As the cable was pulled into tension, the tabs were pulled against the post flange at the bottom of the keyway. As the load increased, the spine of the bracket began to bend and stretch. The tabs may not have been fully engaged with the keyway as a peak load of 3.50 kips (15.57 kN) was reached at 0.253 seconds. At this time, the tab edges sheared and the bracket exited the keyway at 0.256 seconds. The cable was fully released from the bracket at 0.264 seconds. The force vs. time curve is shown in Figure 62. Pre- and post-test photographs and sequential photographs are shown in Figures 63 and 64, respectively.

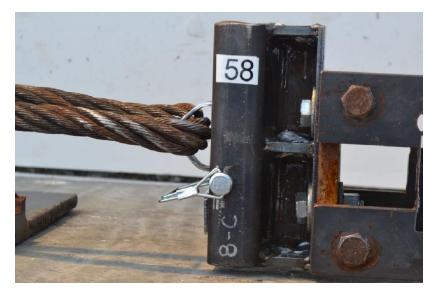
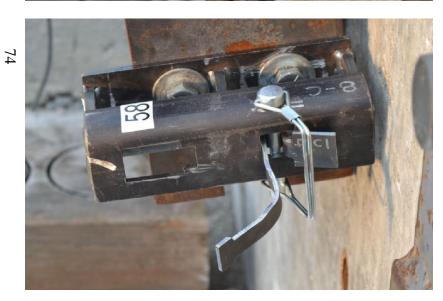
Figure 63. Pre-Test (Upper) and Post-Test (Lower) Photographs, Test No. HTTB-58

The wire lock pin bracket tests produced lateral release loads of 6.59 kips and 3.50 kips (29.3 kN and 15.6 kN). The low release load, obtained during test no. HTTB-58, did not fully engage the keyway and the tabs slipped out prior to their failure. Similar to the key plate attachment, a lack of fixity in the connection was thought to be responsible for the unexpected release of the tabs through the keyway.

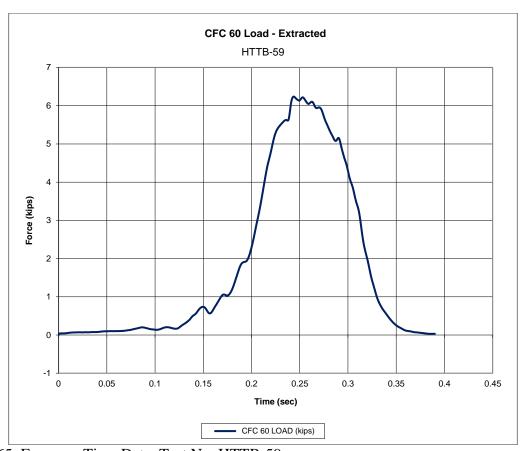
Figure 65. Force vs. Time Data, Test No. HTTB-59

Test no. HTTB-59 evaluated the tabbed bracket with the pinned-back attachment by loading the bracket laterally, or normal to the flange of the post. As the cable was pulled into tension, the tabs were pulled against the post flange at the bottom of the keyway. As the load increased, the spine of the bracket began to bend and stretch. At 0.244 seconds, a peak load of 6.24 kips (27.76 kN) was reached. The bracket continued to bend and stretch but never fractured or released from the keyway. Instead, the bogie vehicle was brought to a stop, and the load ended at 0.390 seconds. Because the tabs never released, the actual failure load would be greater than the recorded peak. The force vs. time curve is shown in Figure 65. Pre- and post-test photographs and sequential photographs are shown in Figures 66 and 67, respectively.

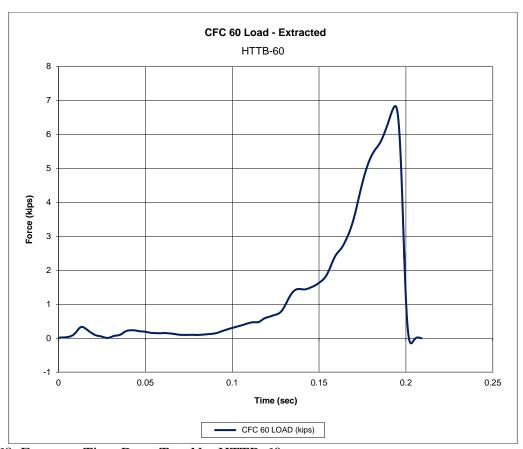
Figure 68. Force vs. Time Data, Test No. HTTB-60

Test no. HTTB-60 evaluated the tabbed bracket with the pinned-back attachment by loading the bracket laterally, or normal to the flange of the post. As the cable was pulled into tension, the tabs were pulled against the post flange at the bottom of the keyway. As the load increased, the spine of the bracket began to bend and stretch. At 0.194 seconds, a peak load of 6.84 kips (30.43 kN) was reached. The tabs sheared off while exiting the keyway shortly after this peak was reached. The force vs. time curve is shown in Figure 68. Pre- and post-test photographs and sequential photographs are shown in Figures 69 and 70, respectively. Due to a faulty trigger, the AOS high-speed digital video camera failed to record the test. Thus, video from a GoPro Hero 3 digital camera was used for sequential photographs.

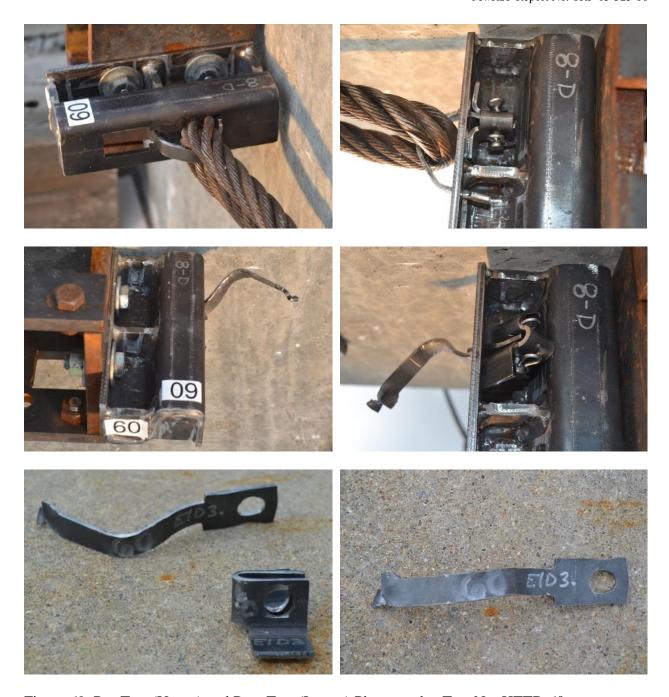
Figure 69. Pre-Test (Upper) and Post-Test (Lower) Photographs, Test No. HTTB-60

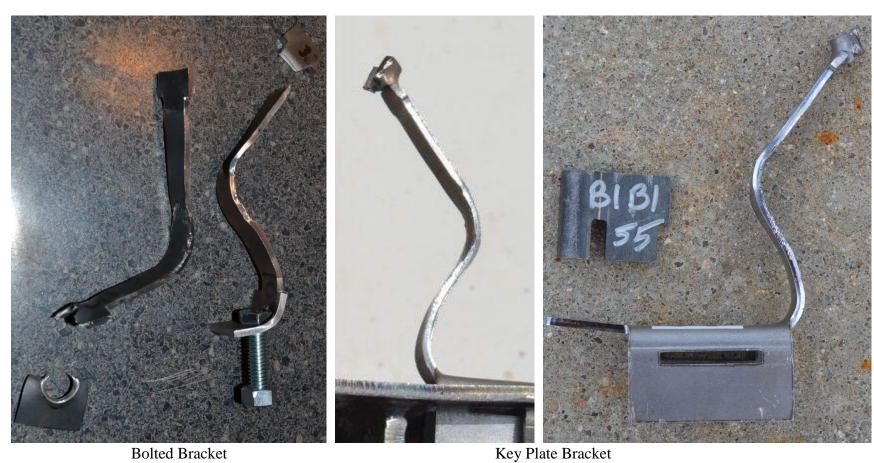
Figure 71. Lateral Test Fracture/Failure Mechanisms for Bolted Bracket and Key Plate Bracket Designs

The release/failure mechanism observed in the lateral load tests was variable, as shown in Figures 71 and 72. Two lateral tests resulted in the tabs rotating out of the keyway, a release mechanism not desired for lateral loads. Three of the tests resulted in the tabs tearing just prior to cable release, one of three failure mechanisms of the original bolted, tabbed bracket (V10). Due to the variable release mechanisms, the lateral load tests produced rather inconsistent release loads, and only half of the tests produced release loads above the 6-kip (27-kN) design value.

The key plate attachment brackets both released prior to achieving the targeted lateral load. During test no. HTTB-55 the tabs caught in the keyway and sheared off, one of the intended failure modes. However, a maximum load of only 4.77 kips (21.2 kN) was observed, well short of the desired 6 kips (27 kN). This outcome may be a result of the lack of fixity in the bracket-to-post connection that allowed the bracket to rotate slightly prior to loading of the bracket. This rotation could have resulted in the tabs being loaded out of plane and introducing Mode III fracture where there was previously only Mode II. The lack of fixity in the connection was also thought to contribute to unexpected release of the tabs in test no. HTTB-56 when the bracket opened up without the tabs ever catching on the keyway and resulted in a very low release load of 0.41 kips (1.8 kN).

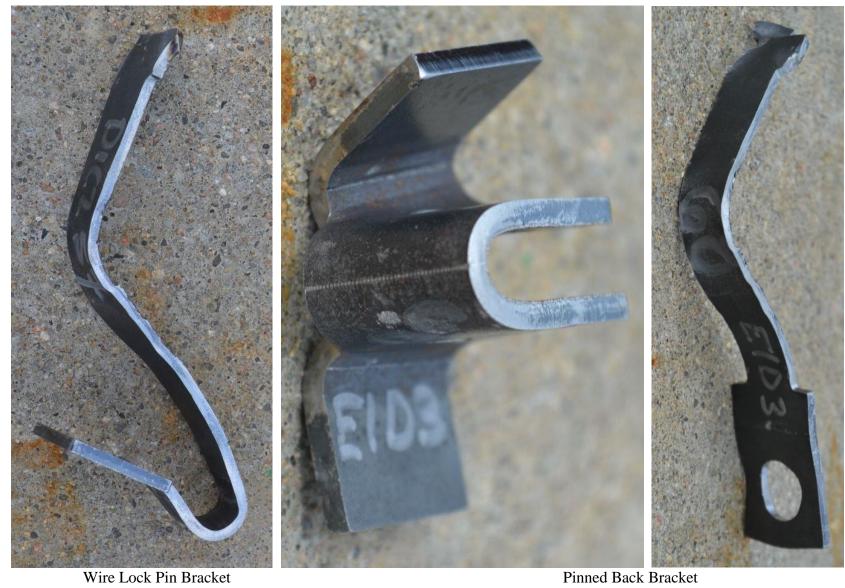
Figure 72. Lateral Test Fracture/Failure Mechanisms for Wire Lock Pin Bracket and Pinned-Back Bracket Designs

Both of the pinned-back brackets produced lateral release loads above the 6-kip (27-kN) design value. Interestingly, during test no. HTTB-59, the bracket never released the cable, and the bogie was brought to a stop. Thus, the actual failure load for that bracket would be greater than the maximum recorded force of 6.25 kips (27.8 kN). However, the connection design still resulted in a lack of fixity and a lot of allowable movement of the bracket prior to loading. Thus, a concern for potential unexpected failures similar to the other two designs still exists.

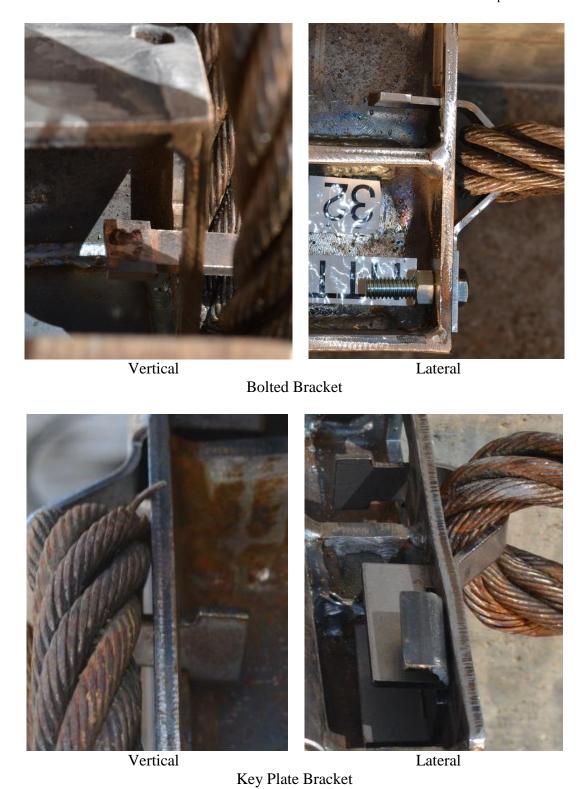
Figure 73. Pre-Test Tab Locations for Bolted Brackets and Key Plate Brackets

In general, all three of the alternative attachment designs for the tabbed brackets resulted in loose connections that allowed each bracket some "wiggle room" after attached. This freedom to rotate and translate slightly while attached to the post resulted in a variable pre-test location of

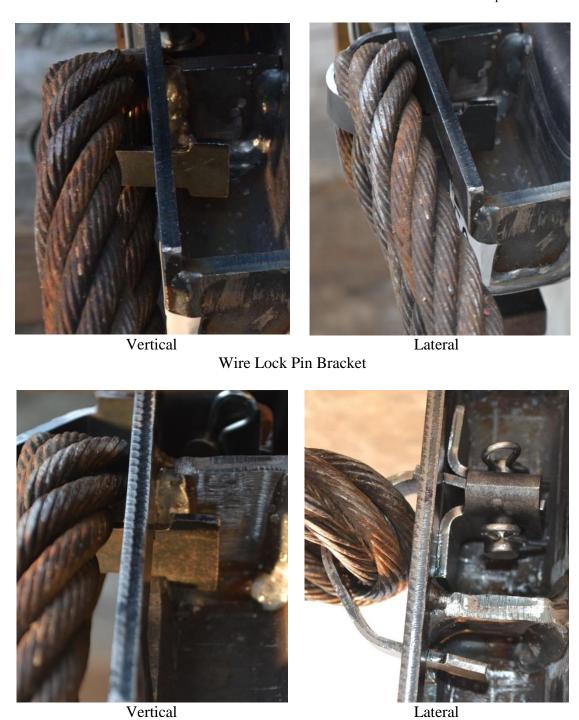
Figure 74. Pre-Test Tab Locations for Wire Lock Pin Brackets and Pinned-Back Brackets

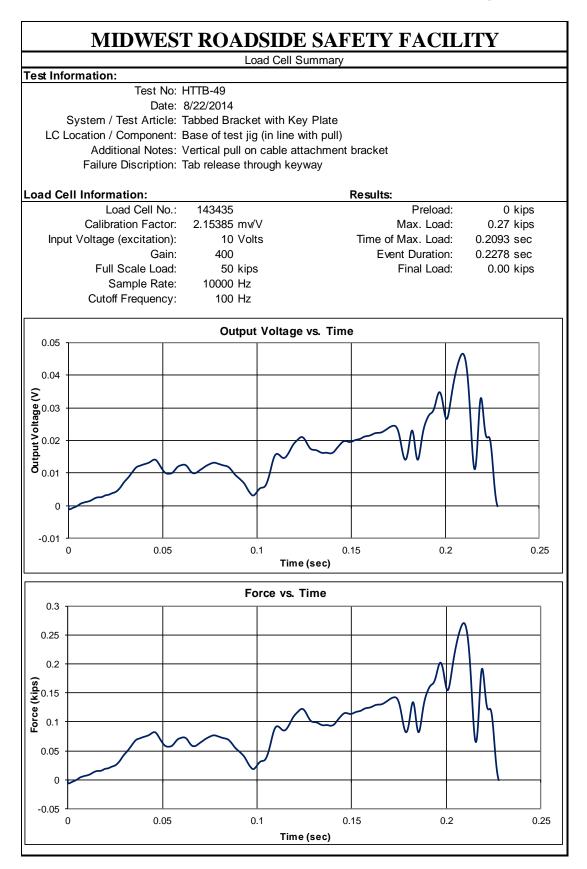
Figure B-1. Load Cell Results, Test No. HTTB-49

The results of the recorded data from the load cell for every dynamic bogie test are provided in the summary sheets found in this appendix. Summary sheets include output voltage vs. time and force vs. time plots.

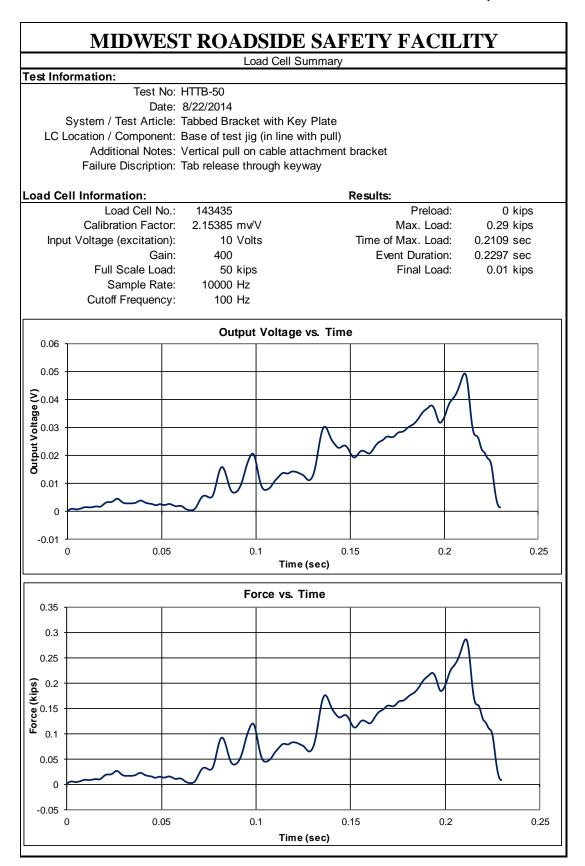
Figure B-2. Load Cell Results, Test No. HTTB-50

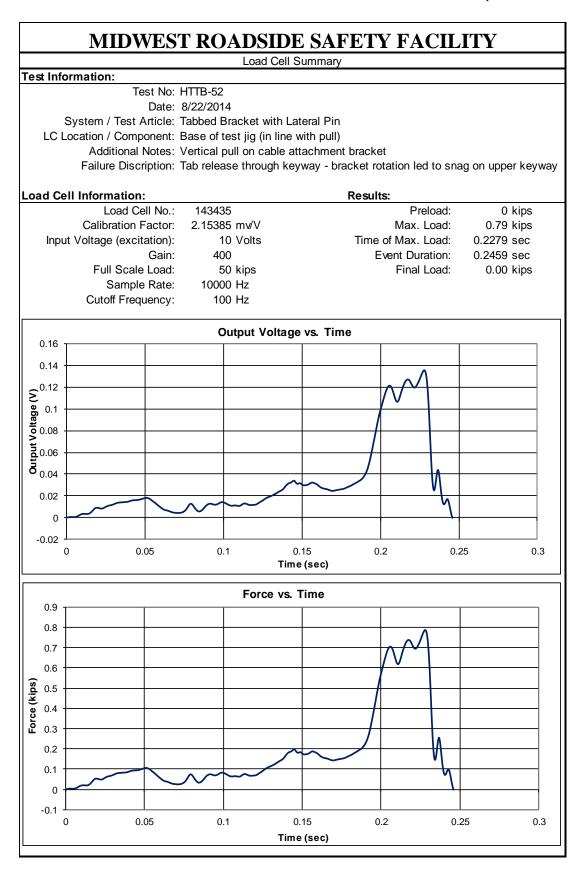
Figure B-4. Load Cell Results, Test No. HTTB-52

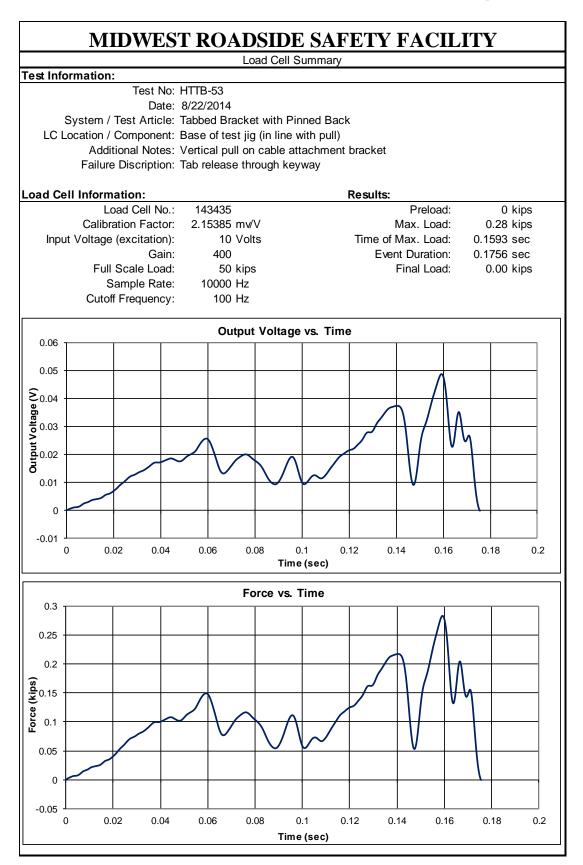
Figure B-5. Load Cell Results, Test No. HTTB-53

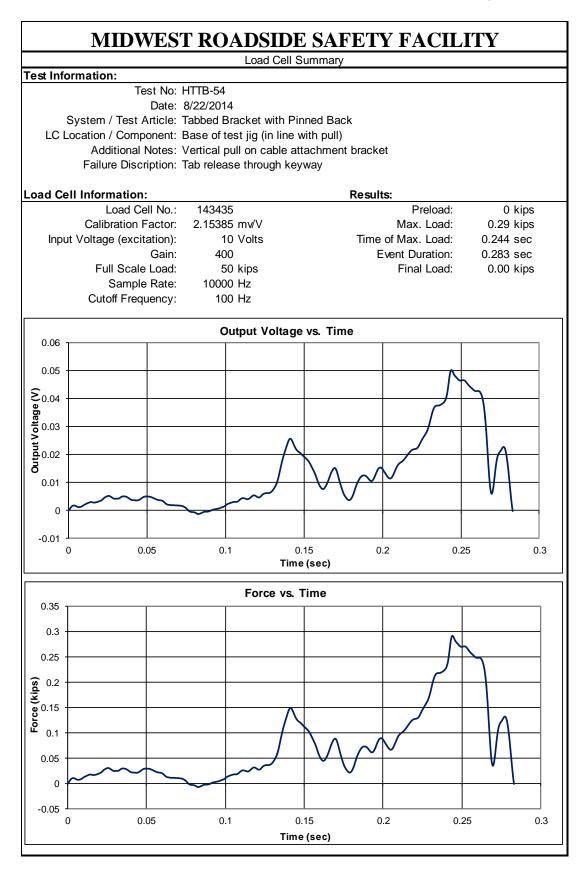
Figure B-6. Load Cell Results, Test No. HTTB-54

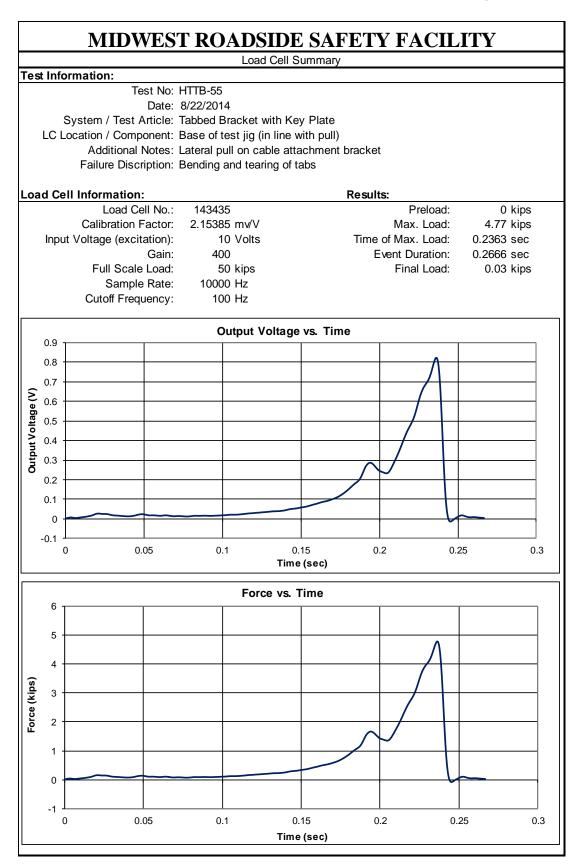
Figure B-7. Load Cell Results, Test No. HTTB-55

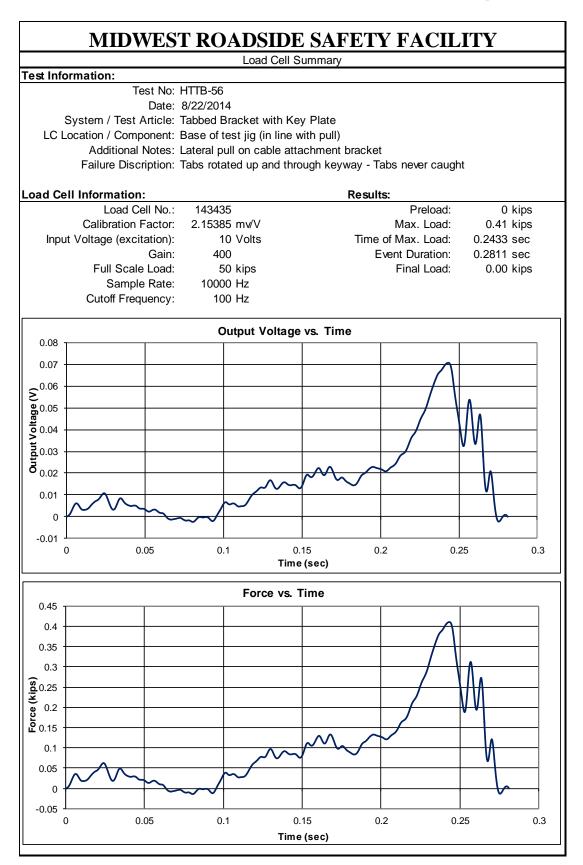
Figure B-8. Load Cell Results, Test No. HTTB-56

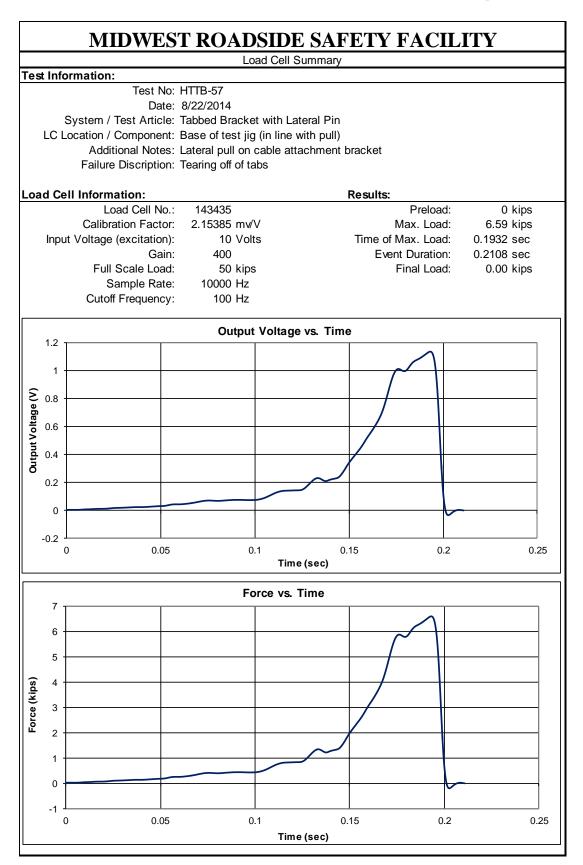
Figure B-9. Load Cell Results, Test No. HTTB-57

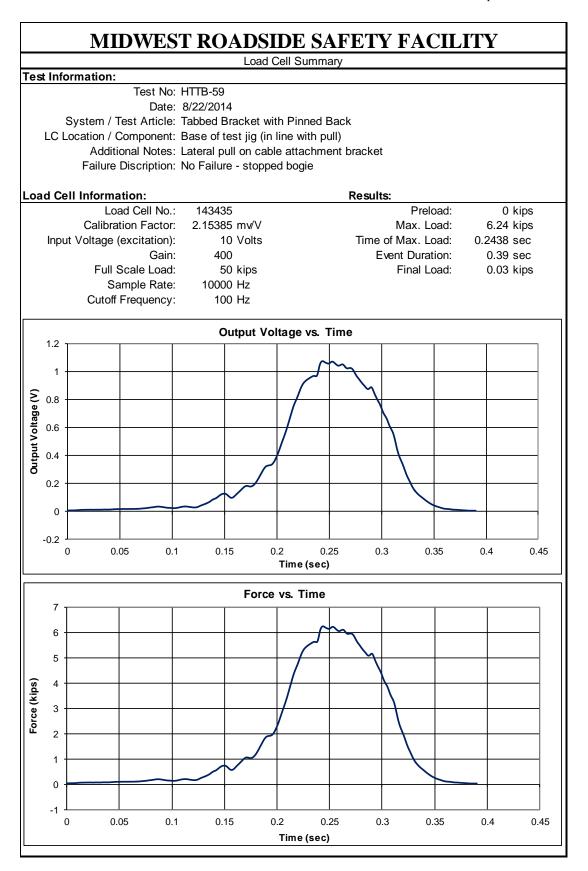
Figure B-11. Load Cell Results, Test No. HTTB-59
