Research Project Number TPF-5(193) Supplement #87

PLACEMENT OF BREAKAWAY LIGHT POLES LOCATED DIRECTLY BEHIND MIDWEST GUARDRAIL SYSTEM (MGS)

MIDWEST ROADSIDE SAFETY FACILITY

MwRSF Research Report No. TRP-03-361-17

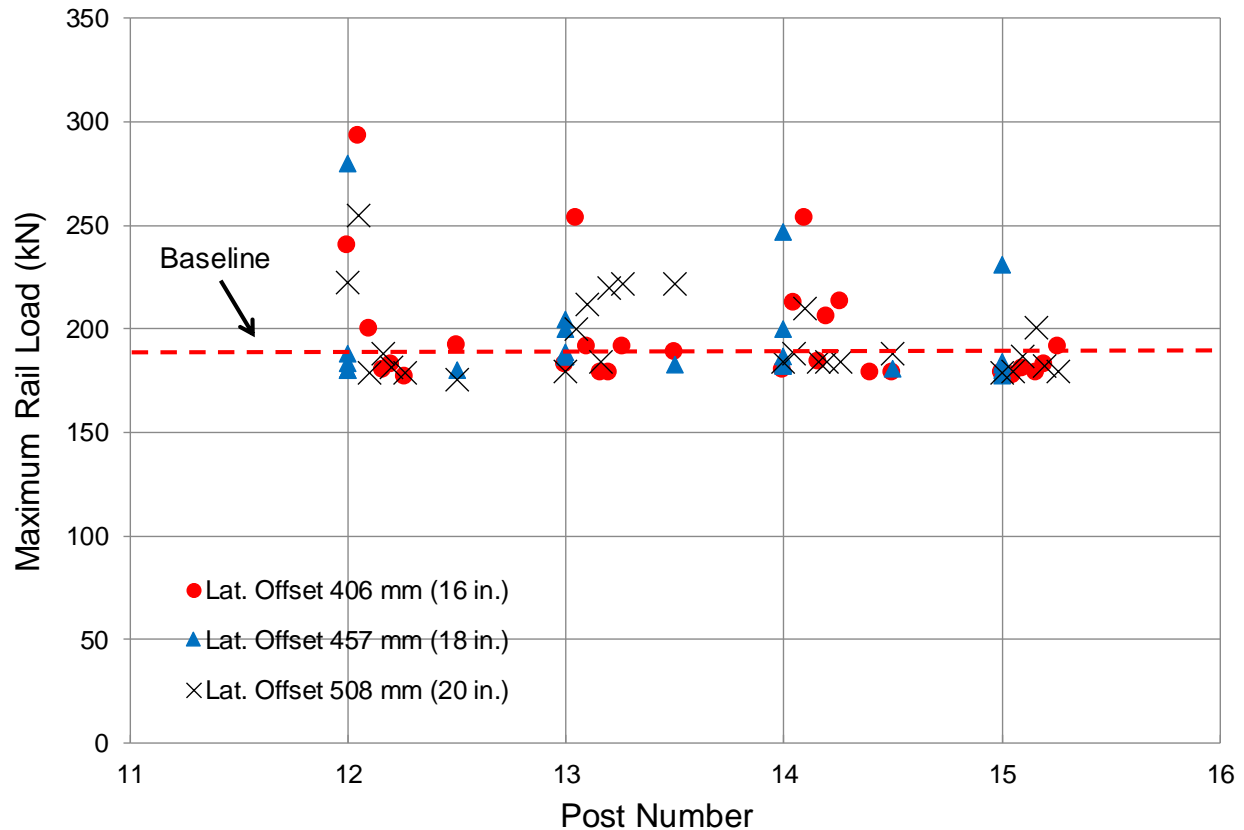
Figure 22. Maximum Rail Load – 2270P Vehicle

The maximum simulated tensile rail load at 16-, 18-, and 20-in. (406-, 457-, and 508-mm) lateral pole offsets is shown in Figure 22. The maximum tensile load on the rail was 66 kips (293.5 kN) when the pole was located at a 16-in. (406-mm) lateral offset and a 4-in. (102-mm) longitudinal offset away from post no. 12. Rail rupture was not a concern as the loads were well below the tensile capacity of the rail.

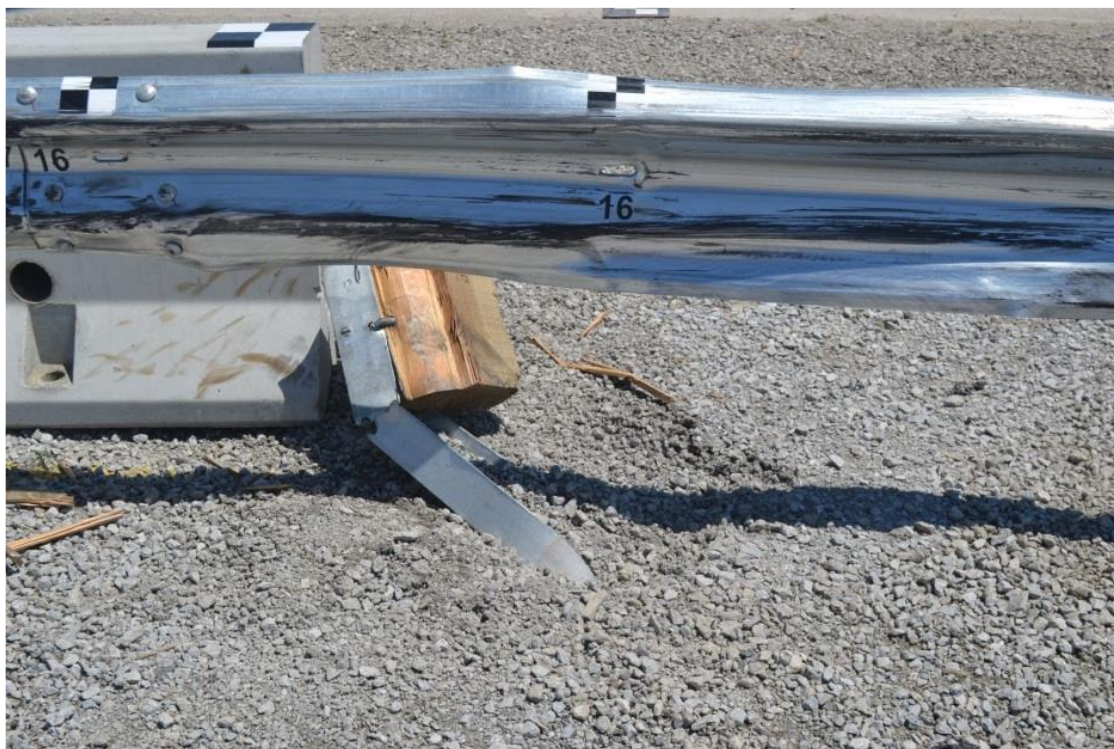
Figure 25. Test No. MGSPCB-1: (a) Post Contact with PCB and (b) Barrier Damage

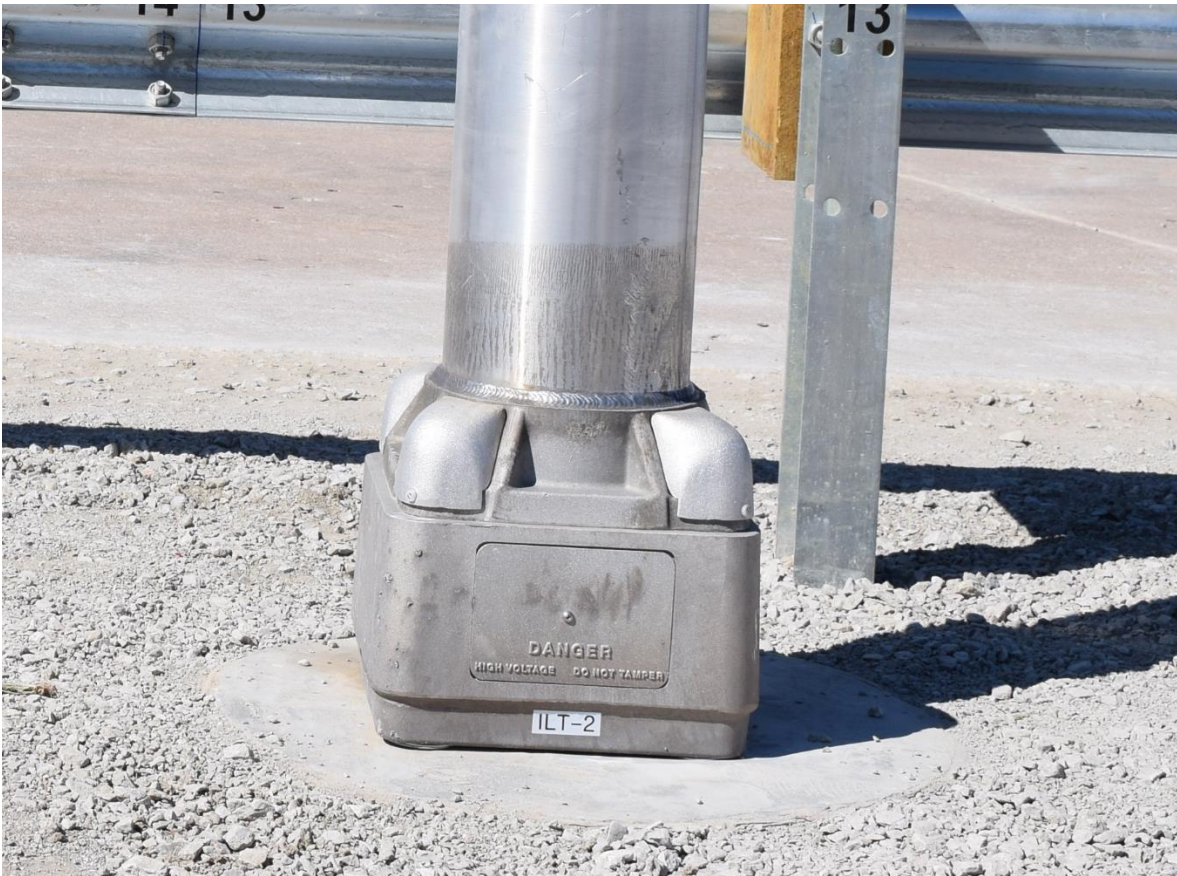
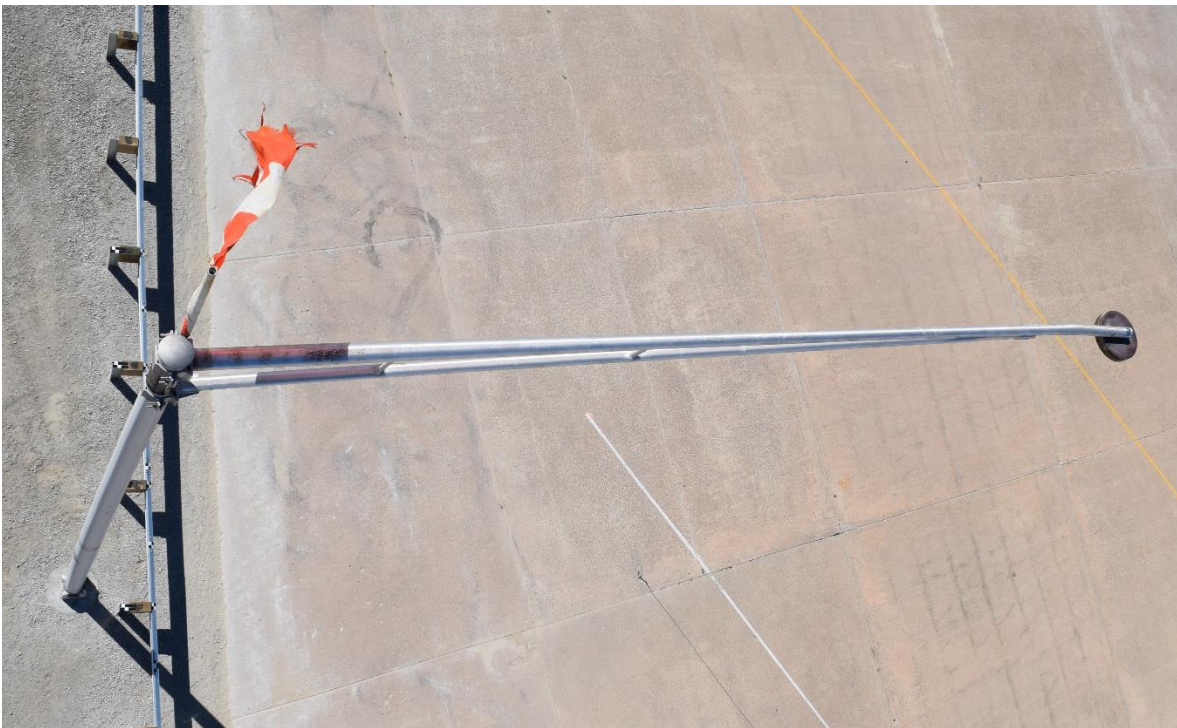
Figure 98. Test Installation, Test No. ILT-2

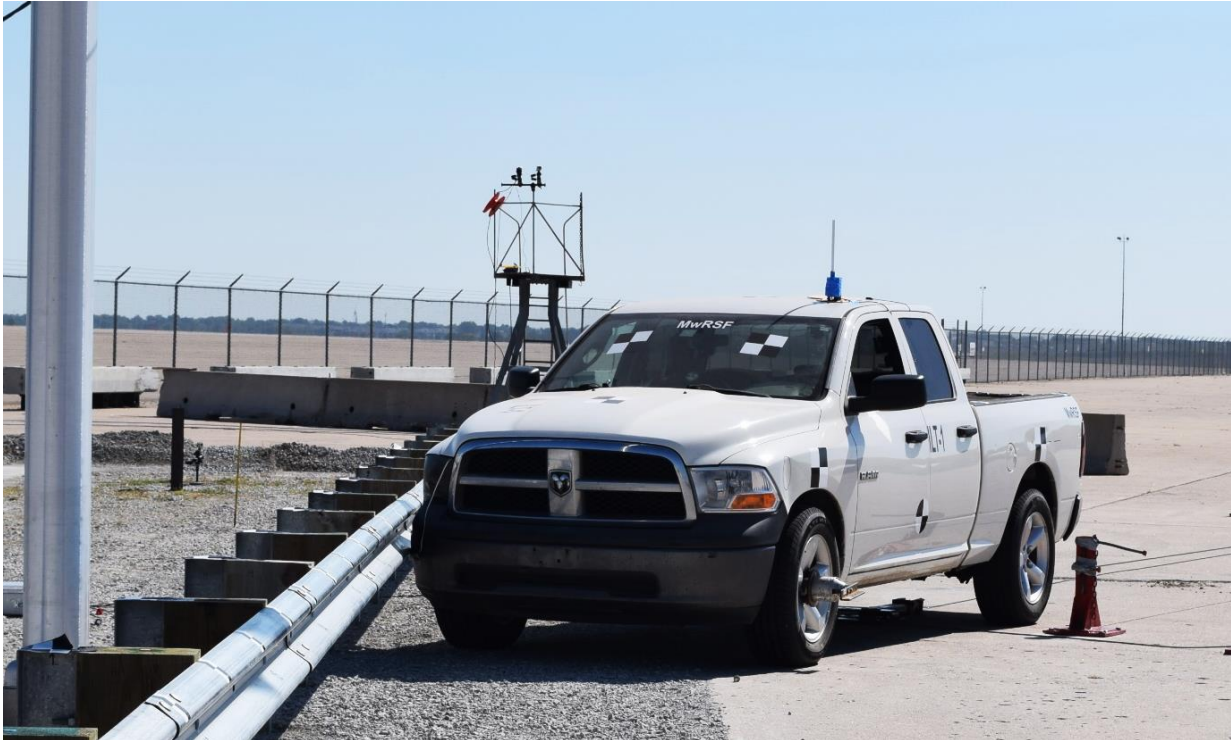
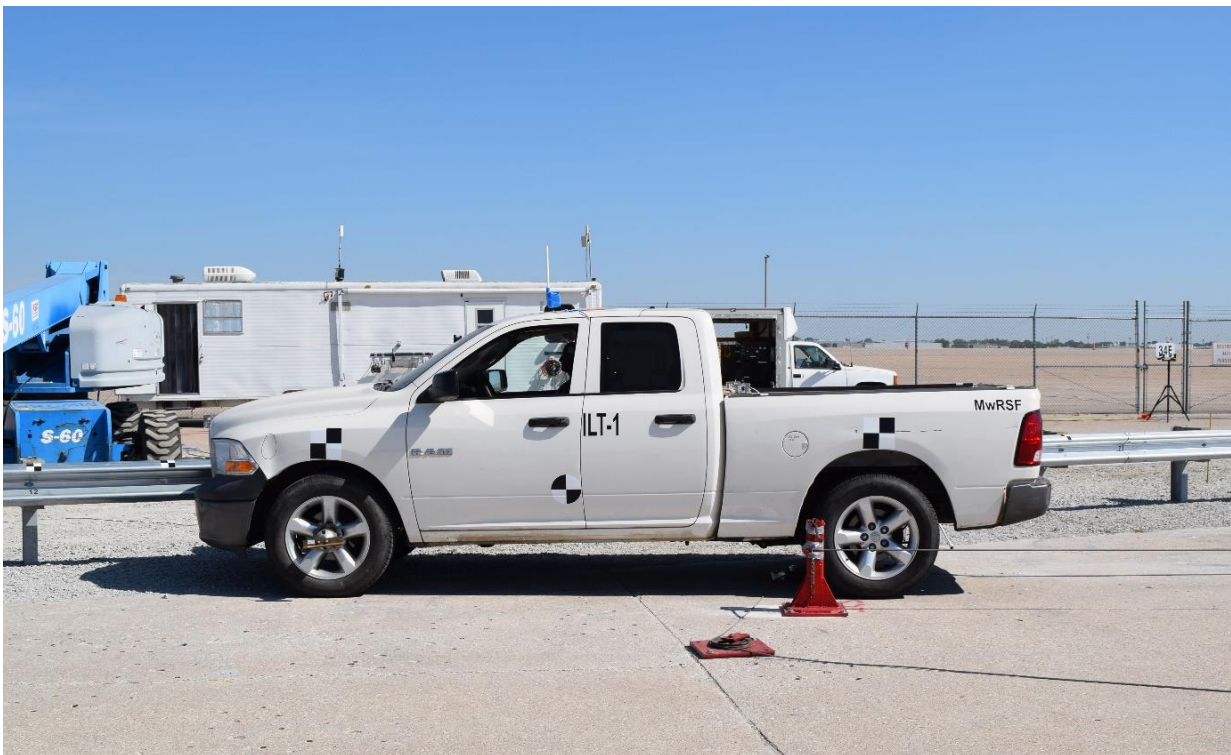
Figure 99. Test Vehicle, Test No. ILT-1

The longitudinal component of the center of gravity (c.g.) was determined using the measured axle weights. The Suspension Method [30] was used to determine the vertical component of the c.g. for the pickup truck. This method is based on the principle that the c.g. of any freely suspended body is in the vertical plane through the point of suspension. The vehicle was suspended successively in three positions, and the respective planes containing the c.g. were established. The intersection of these planes pinpointed the final c.g. location for the test inertial condition. The vertical component of the c.g. for the 1100C vehicle was determined utilizing a procedure published by SAE [31]. The location of the c.g. for test nos. ILT-1 and ILT-2 are shown in Figures 100 and 102, respectively. Data used to calculate the location of the c.g. are shown in Appendix F.

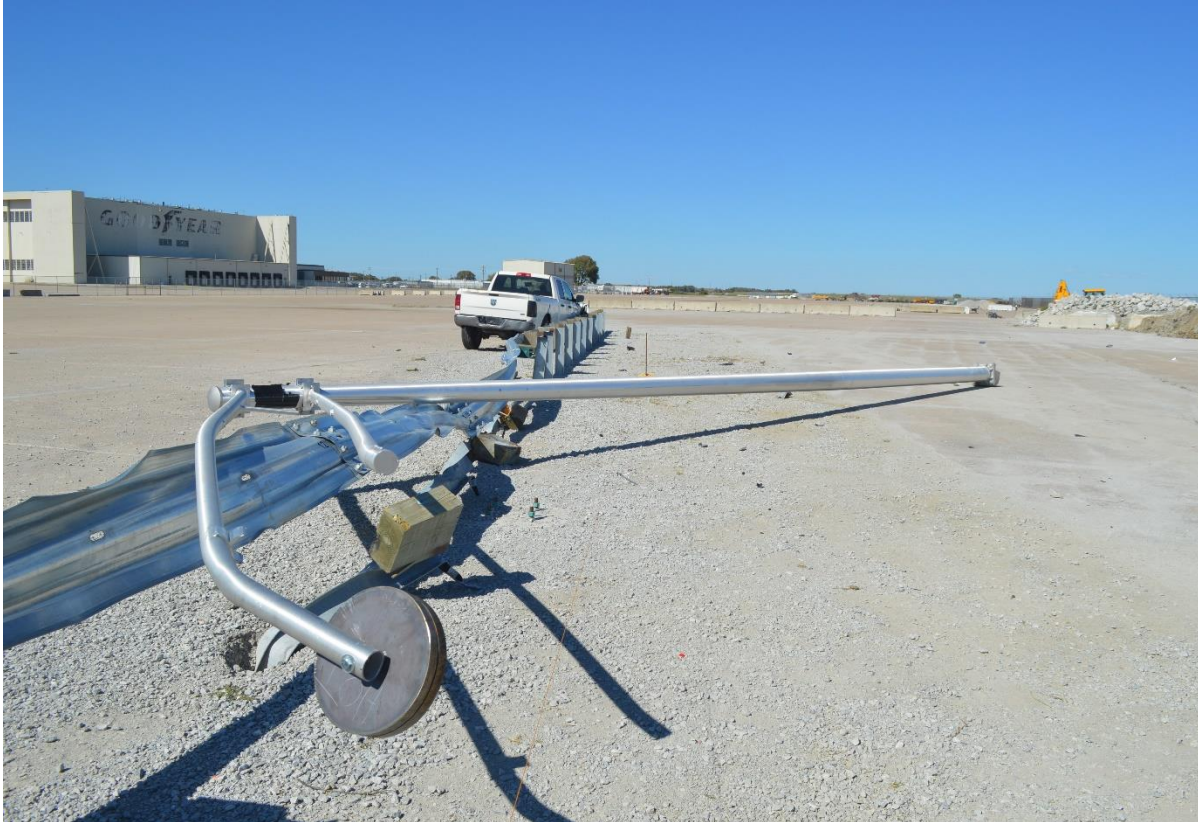
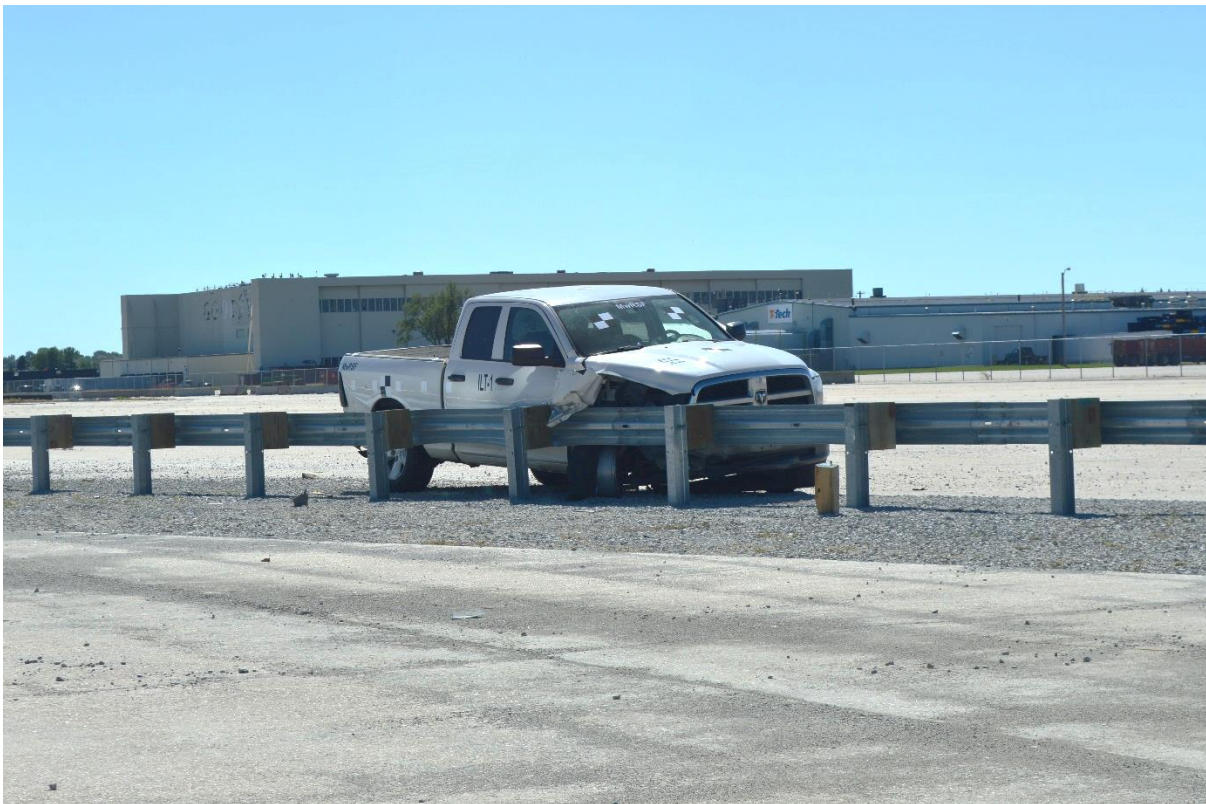
Figure 112. Vehicle Final Position and Trajectory Marks, Test No. ILT-1

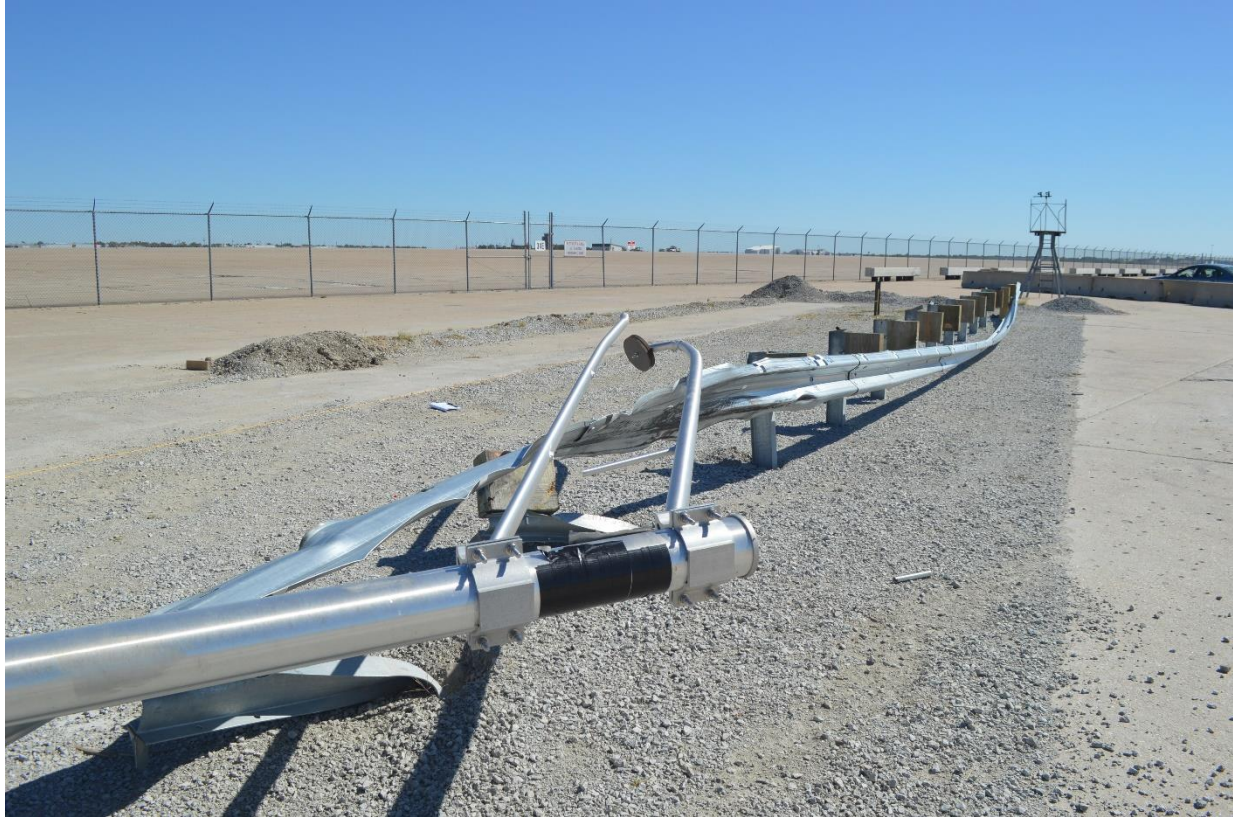
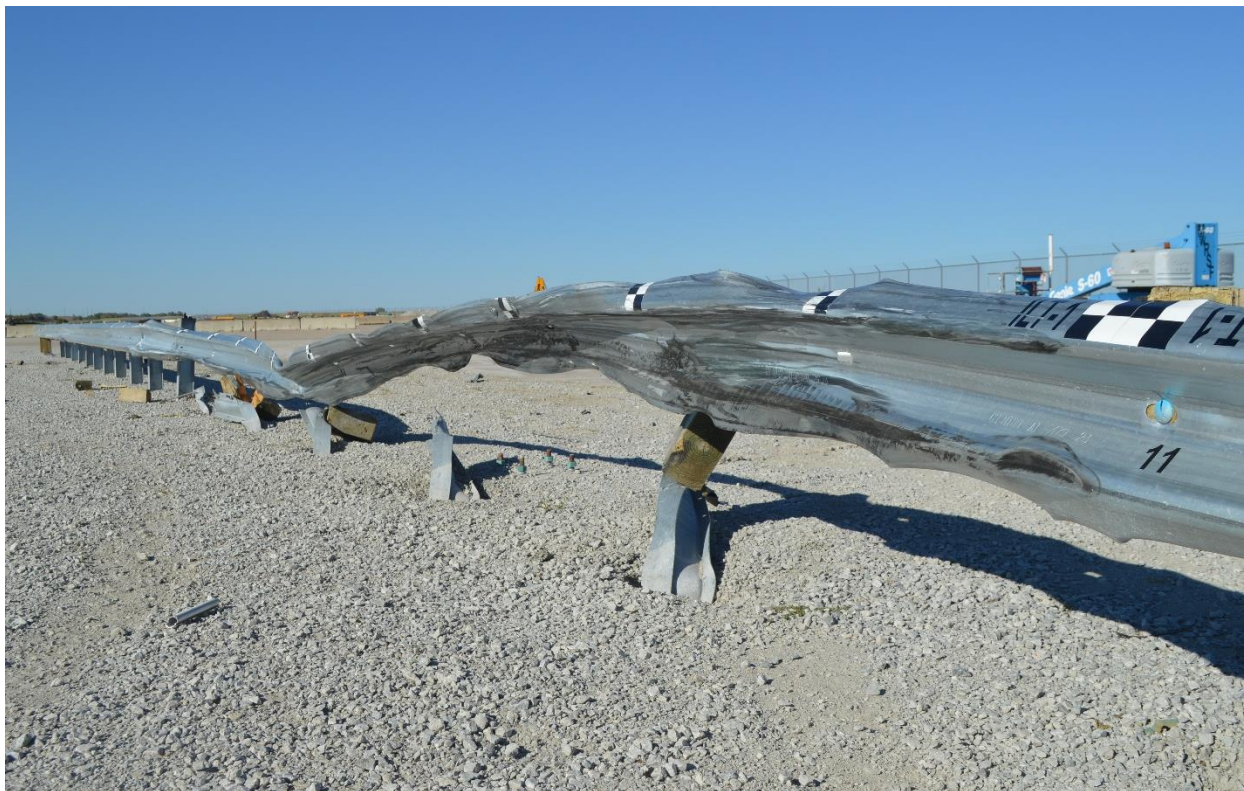
Figure 113. Midwest Guardrail System Damage, Test No. ILT-1

The maximum lateral permanent set rail deflection was 22.5 in. (572 mm) at midspan between post nos. 14 and 15, as measured in the field. The maximum lateral dynamic rail and post deflections were 44.1 in. (1,120 mm) at the midspan between post nos. 14 and 15, and 16 in. (406 mm) at post no. 13, respectively, as determined from high-speed digital video analysis. The working width of the system was 47.3 in. (1,201 mm), as measured at the midspan between post nos. 14 and 15. The light pole landed 25.9 ft (7.9 m) behind and 27 1/8 in. (689 mm) in front of the rail face.

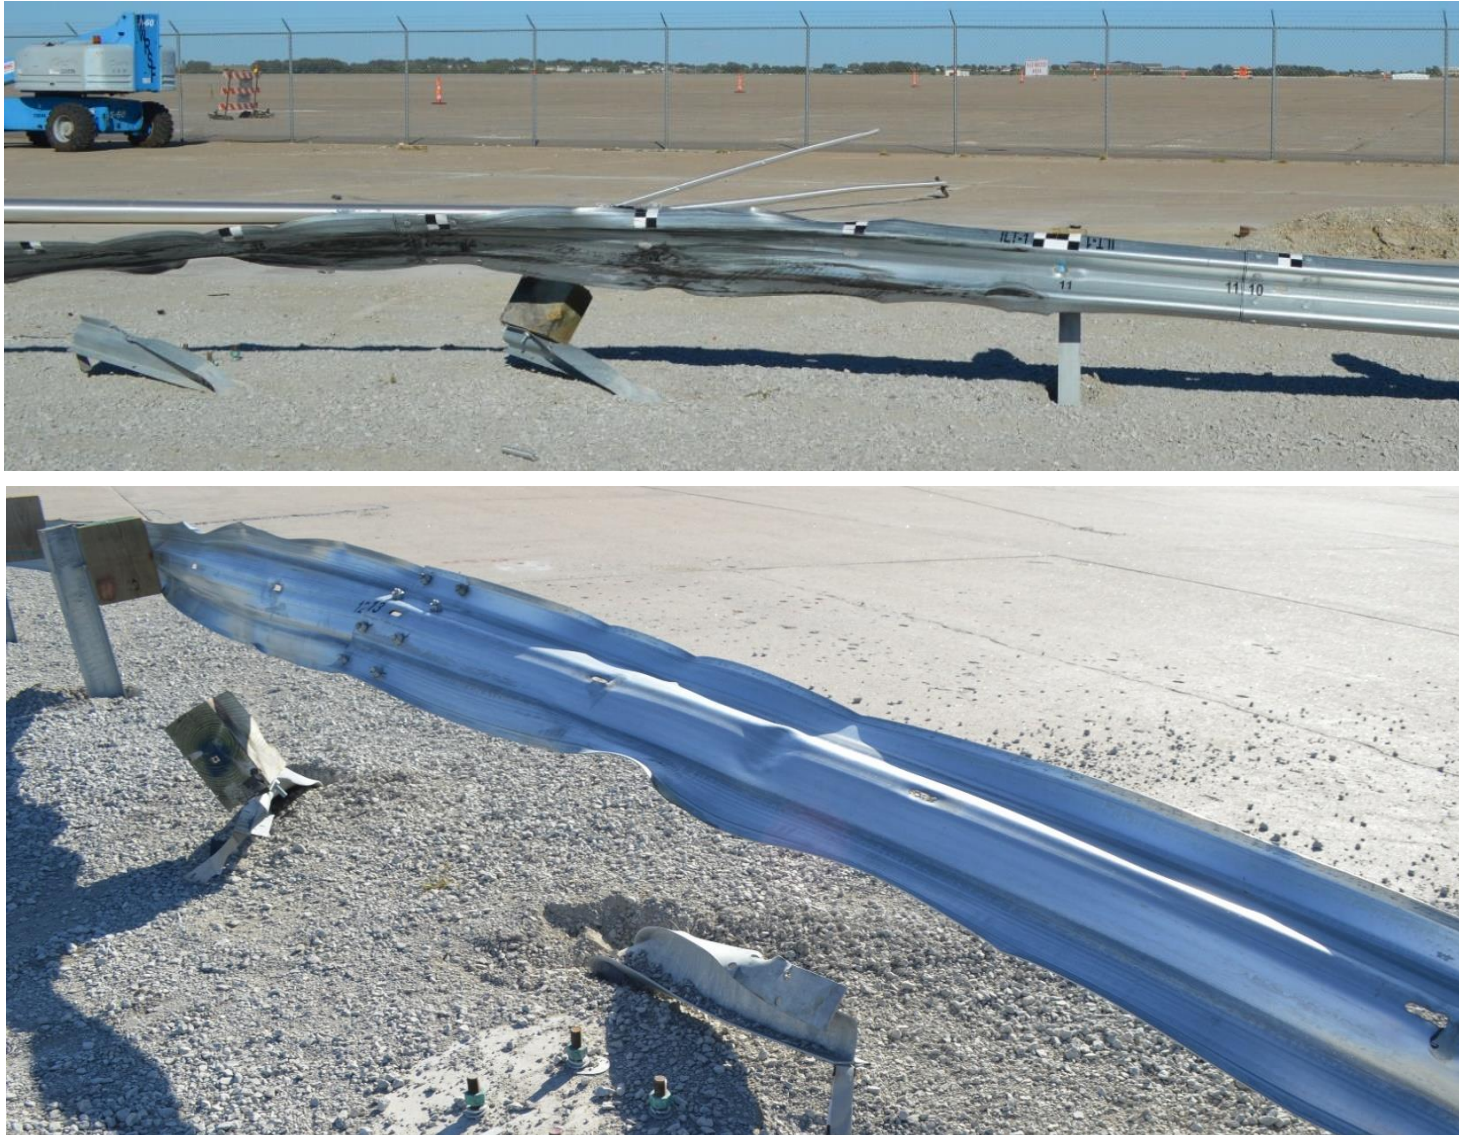
Figure 114. Rail Damage, Test No. ILT-1

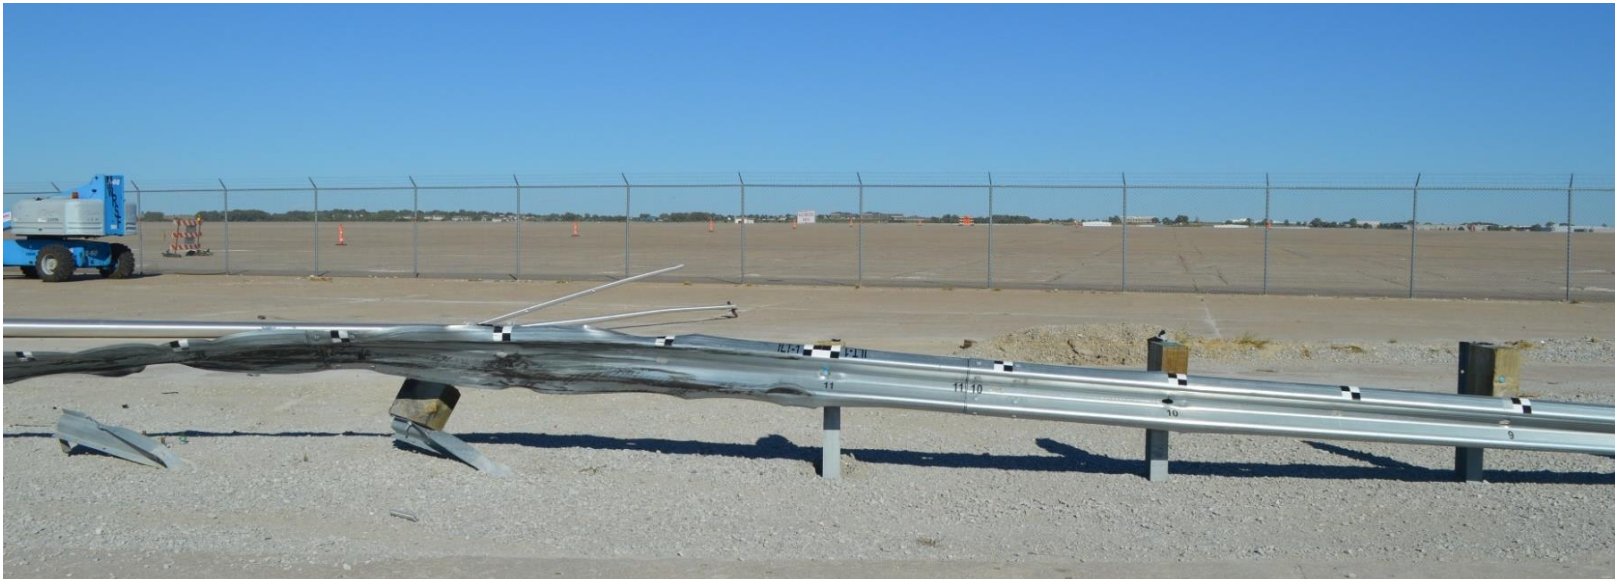
Figure 115. System Damage, Post Nos. 8 through 14, Test No. ILT-1

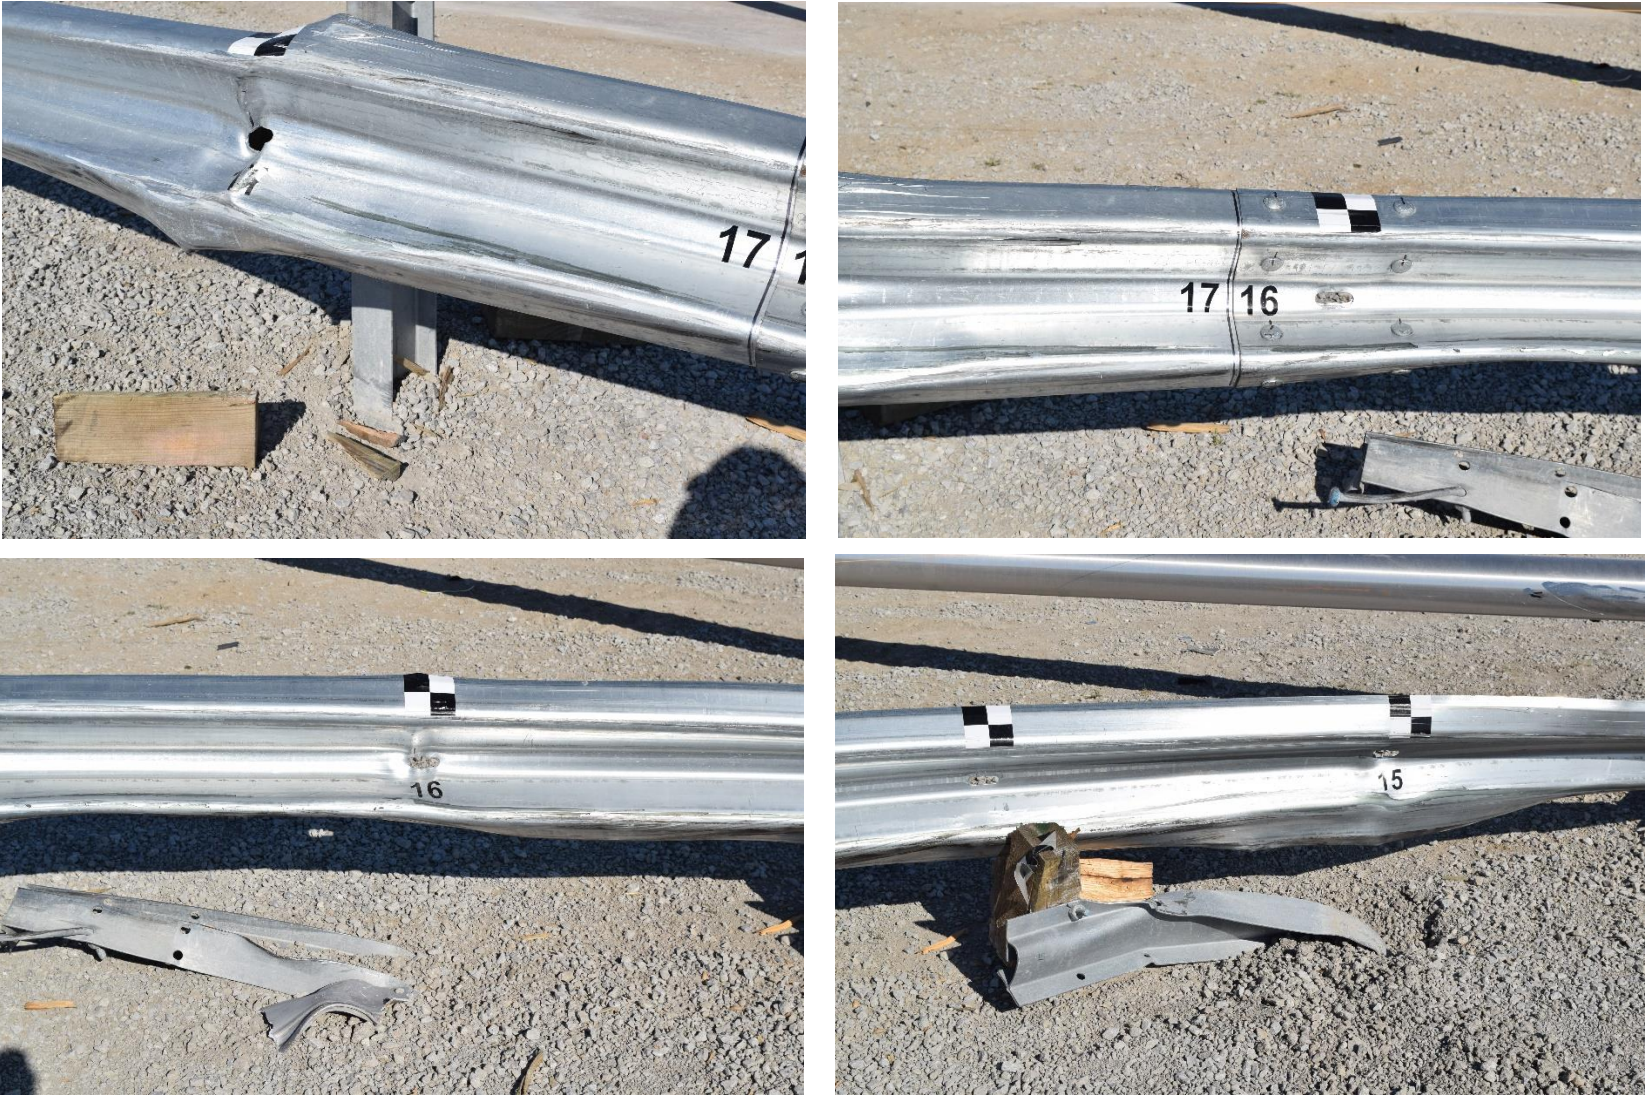
Figure 116. System Damage, Post Nos. 15 through 17 Damage, Test No. ILT-1

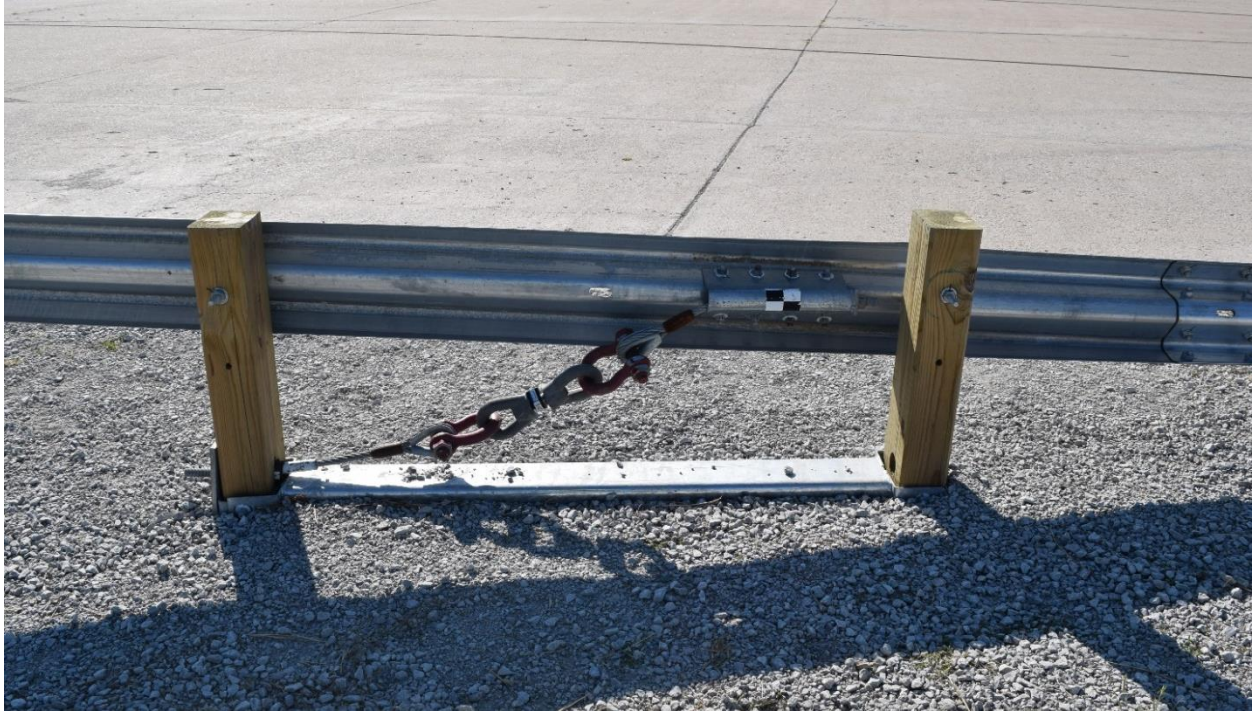
Figure 117. Upstream Anchor Damage, Test No. ILT-1

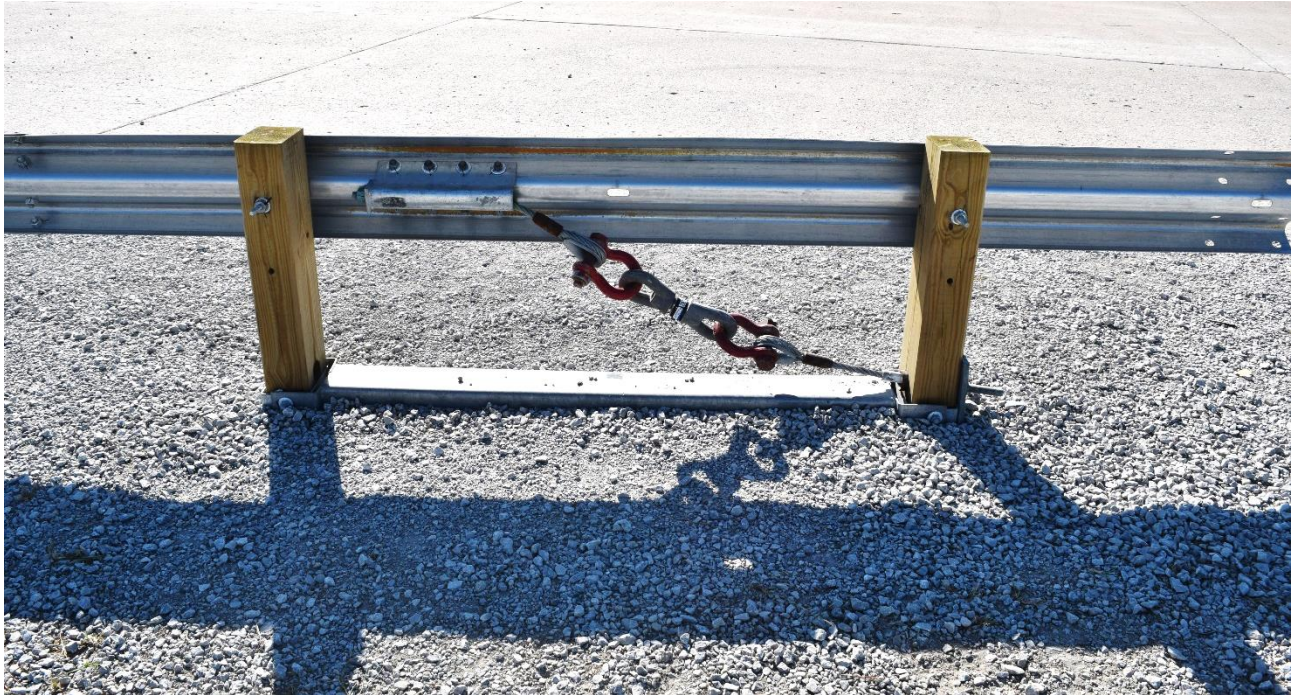
Figure 118. Downstream Anchor Damage, Test No. ILT-1

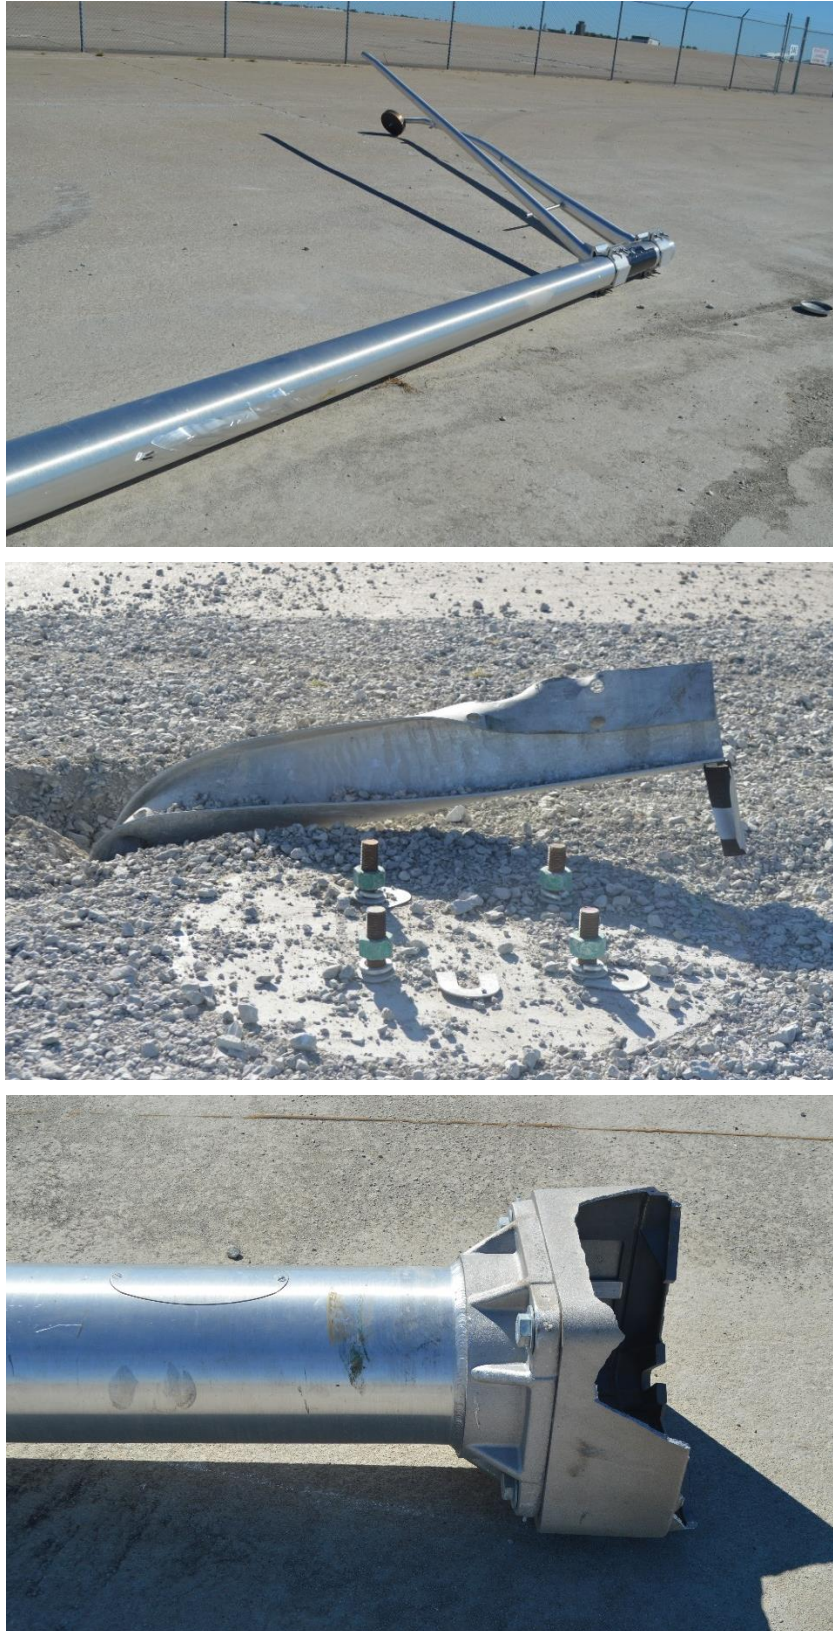
Figure 119. Pole Damage, Test No. ILT-1

In test no. ILT-1, the light pole base fractured, disengaged, thus causing the pole to fall on the guardrail, and then impacted the ground. Pole damage consisted of the base tearing out, detachment of bolt covers, fracture of mast arm braces, and contact marks on the pole and base. A 6-in. tall x 12-in. wide (152-mm tall x 305-mm wide) section on the upstream edge of the transformer base and a 6-in. tall x 4.5-in. wide (152-mm tall x 114-mm wide) section on the front side of the transformer base fractured, as shown in Figure 119. The foundation bolts were exposed, but not damaged. Contact marks were visible at 6 in. (152 mm) and 24 in. (610 mm) above the base along the front side of the pole, while scrapes were found on the back side of the pole at 31 in. above the base. The pole's mast arm braces fractured while hitting the guardrail. The vertical braces of mast arm fractured from the bottom member.

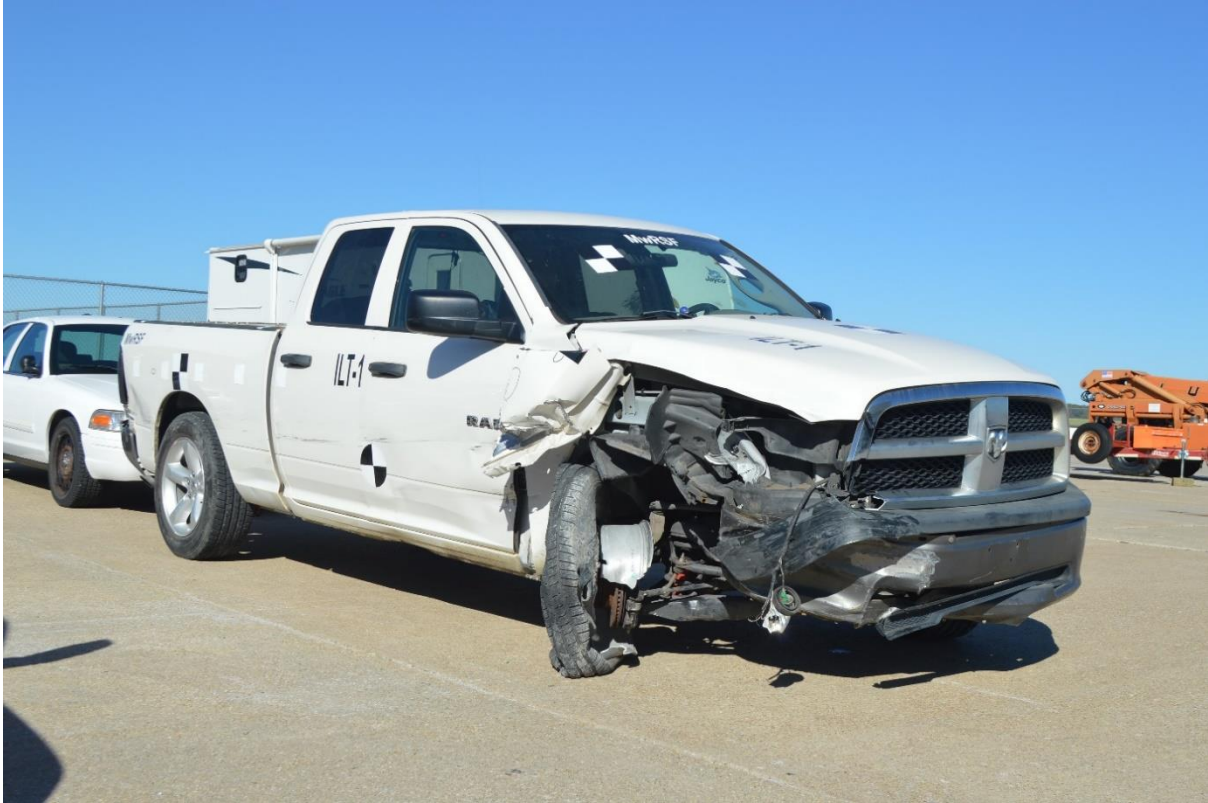
Figure 120. Vehicle Damage, Test No. ILT-1

The majority of vehicle damage was concentrated on the right-front corner and right side of the vehicle where impact occurred. A 9/16-in. (14-mm) gap formed between the hood and right fender. The right-front corner of the bumper was crushed inward approximately 8 in. (203 mm). The right fender was crushed backward to the door panel and was dented and torn behind the right-front wheel. The right-front door had a 5-in. x 2-in. x ¼-in. (127-mm x 51-mm x 6-mm) dent approximately 8 in. (203 mm) above the bottom. The right headlight fractured and crushed backward. The left taillight cracked. The right-front wheel assembly deformed and crushed inward toward the engine compartment. The right-front tire was deflated, and it had a 1½-in. (38-mm) tear in its sidewall. The right-front rim was fractured, and a 9-in. x 7-in. (229-mm x 178-mm) section disengaged. Gouges and dents were found on the right-front door and the right-front corner of the hood. A 3-in. wide x 1-in. deep x 10-in. long (76-mm x 25-mm x 254-mm) gouge was found on the right-rear bumper. The airbags did not deployed during the impact. The overall undercarriage damage included some scraping on the driver-side front knuckle assembly, a tear above the lower control arm on the frame, and scraping on the transmission cross member end on the passenger side.

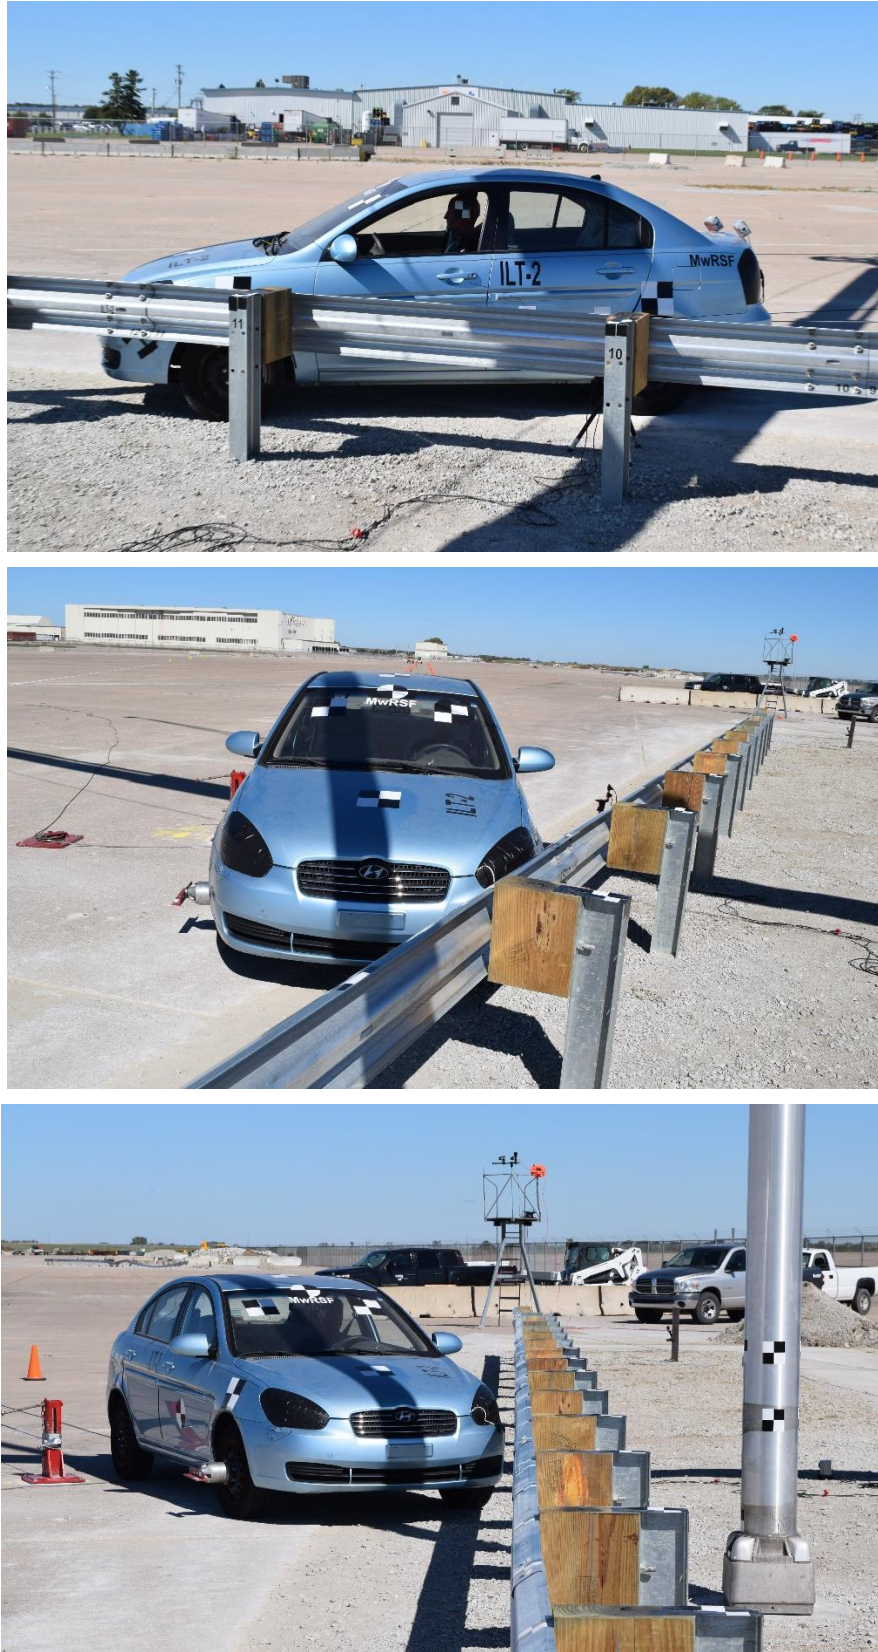
Figure 123. Impact Location, Test No. ILT-2

Upon impact, the vehicle's front bumper contacted the rail at 5¼ in. (133 mm) downstream from midspan between post nos. 11 and 12. At 0.090 seconds, vehicle bumper contacted post no. 13, and the left-front tire underrode the rail and snagged on post no. 13. Post no. 13 deflected backward but did not contact the pole nor the base. The left-front wheel barely grazed the base of the pole. Thus, the pole did not fracture. The vehicle was safely captured and redirected. At 0.320 seconds, the vehicle was parallel to the system. At 0.600 seconds, the vehicle exited the system. The vehicle came to rest 137 ft – 1 in. (41.8 m) downstream from impact and 32 ft – 5 in. (9.9 m) laterally in front of the traffic side of the guardrail system. The vehicle trajectory and final position are shown in Figure 127.

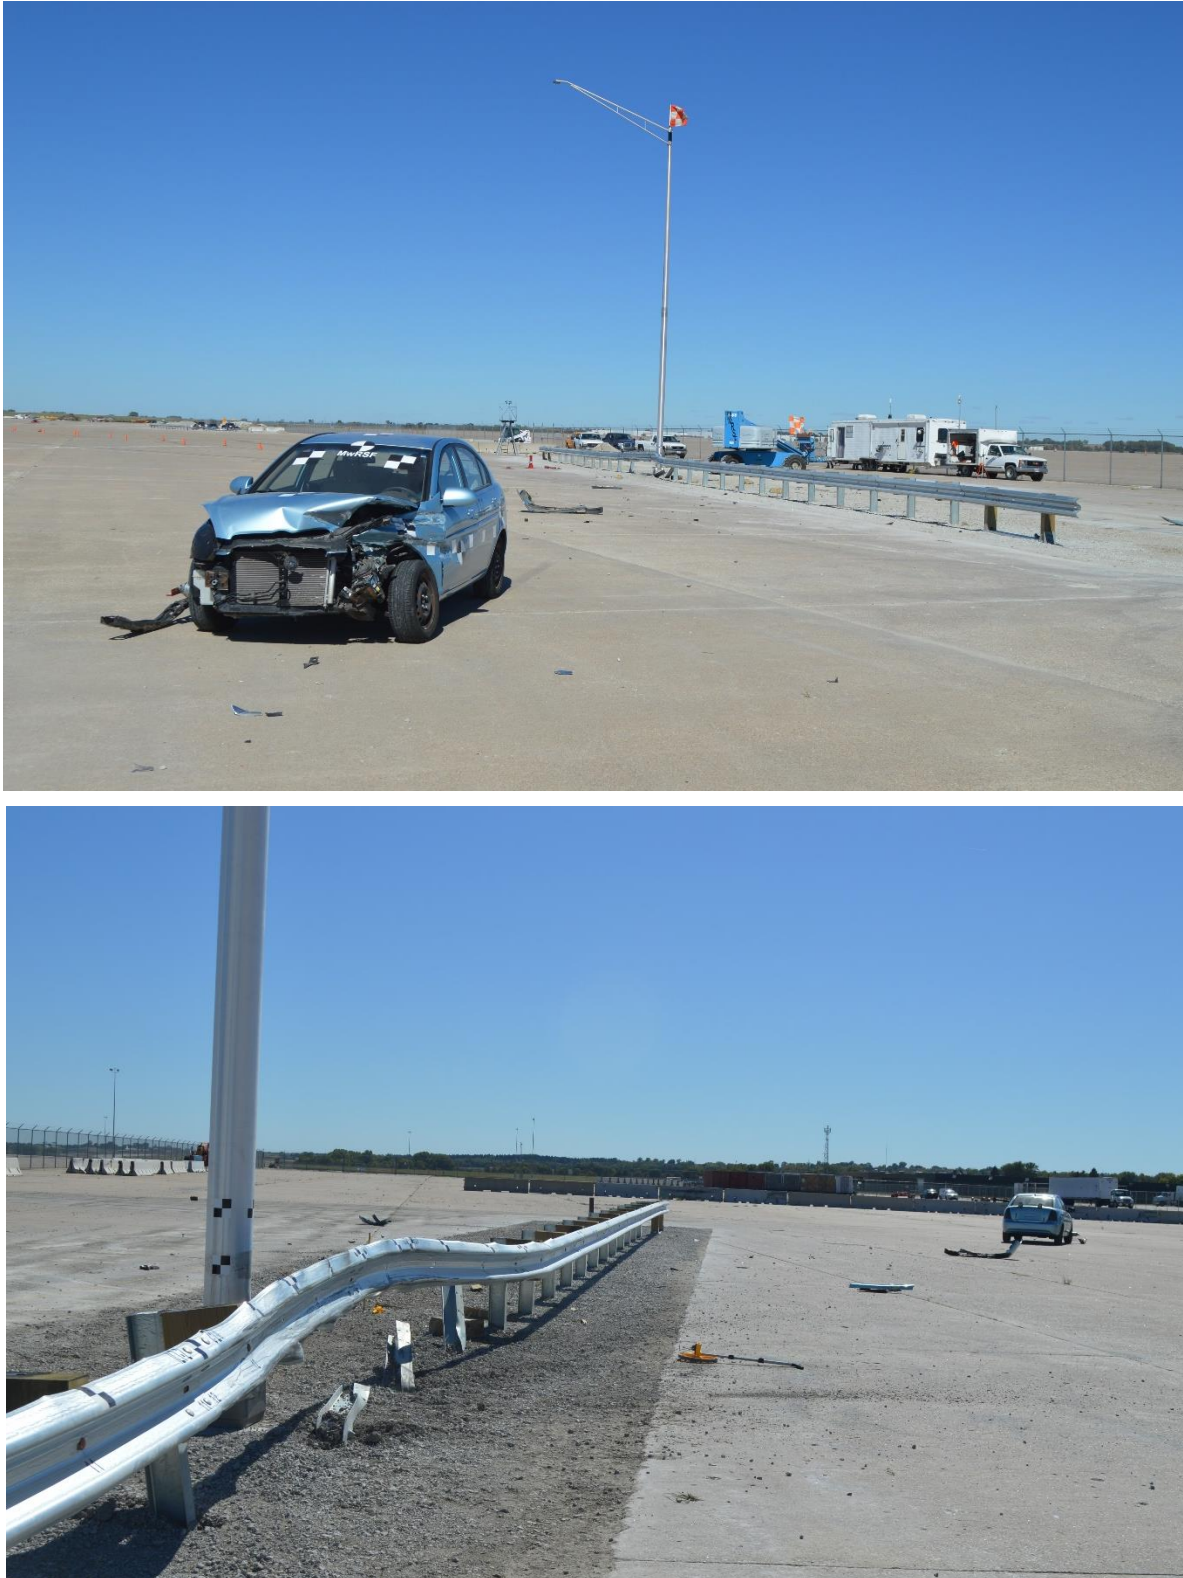
Figure 127. Vehicle Final Position and Trajectory Marks, Test No. ILT-2
