Research Project Number TPF-5(193) Supplement #87

PLACEMENT OF BREAKAWAY LIGHT POLES LOCATED DIRECTLY BEHIND MIDWEST GUARDRAIL SYSTEM (MGS)

MIDWEST ROADSIDE SAFETY FACILITY

MwRSF Research Report No. TRP-03-361-17

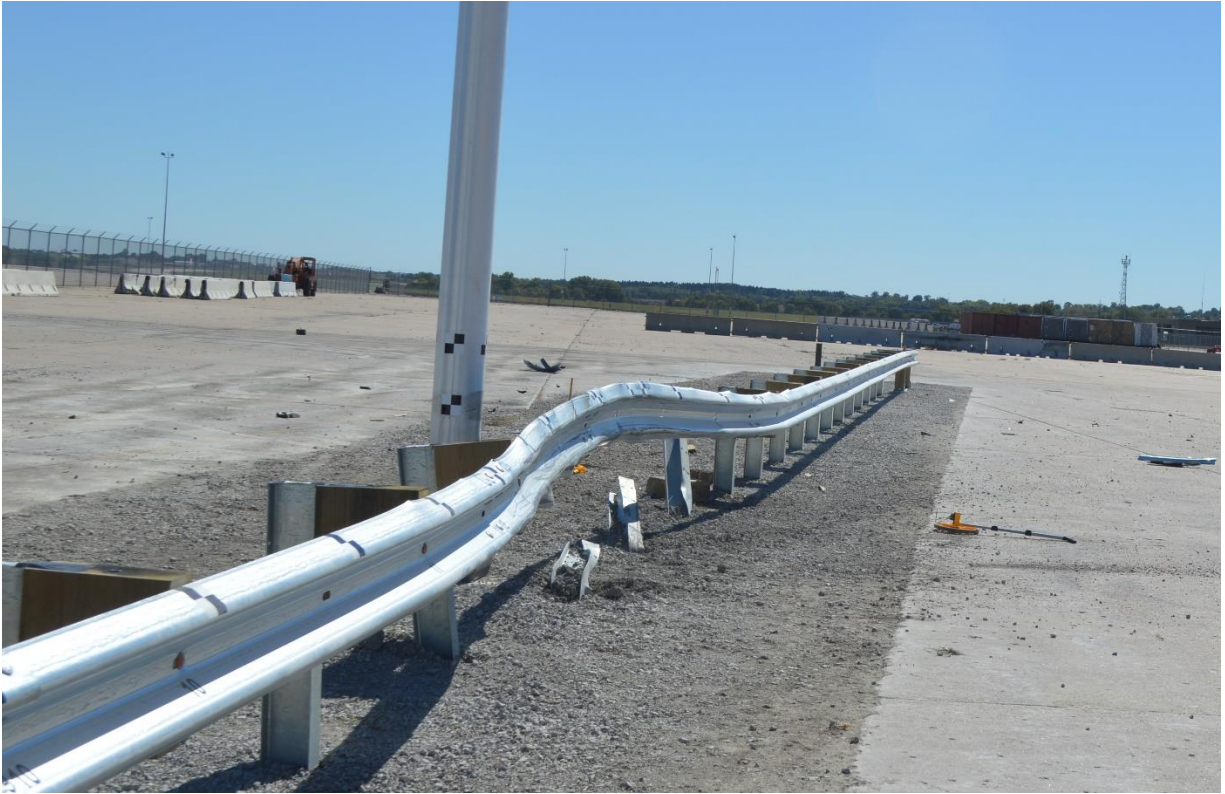
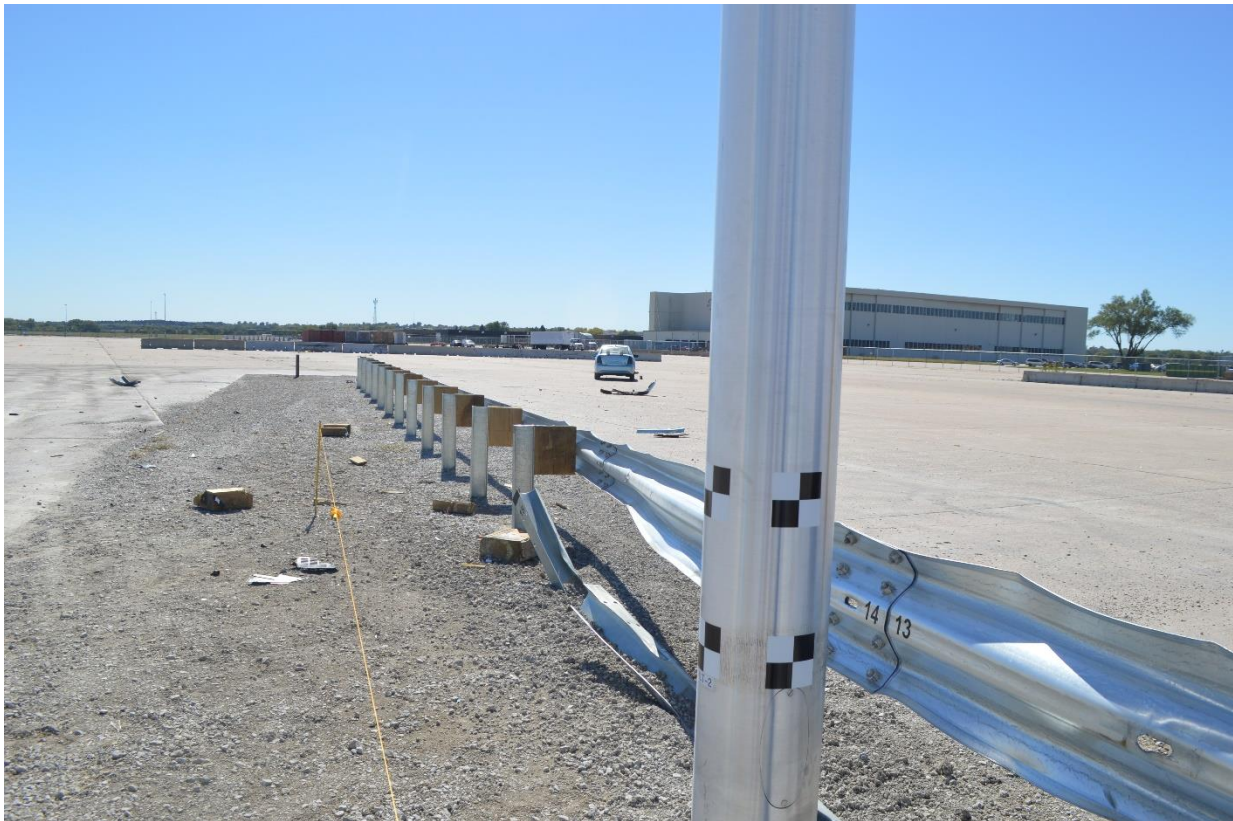
Figure 128. Midwest Guardrail System Damage, Test No. ILT-2

The maximum lateral permanent set rail deflection was 22.5 in. (572 mm) at the midspan between post nos. 13 and 14, as measured in the field. The maximum lateral dynamic rail and post deflections were 29.4 in. (747 mm) at the midspan between post nos. 13 and 14 and 15.1 in. (384 mm) at post no. 14, respectively, as determined from high-speed digital video analysis. The working width of the system was 35.8 in. (909 mm), as measured at the midspan between post nos. 13 and 14.

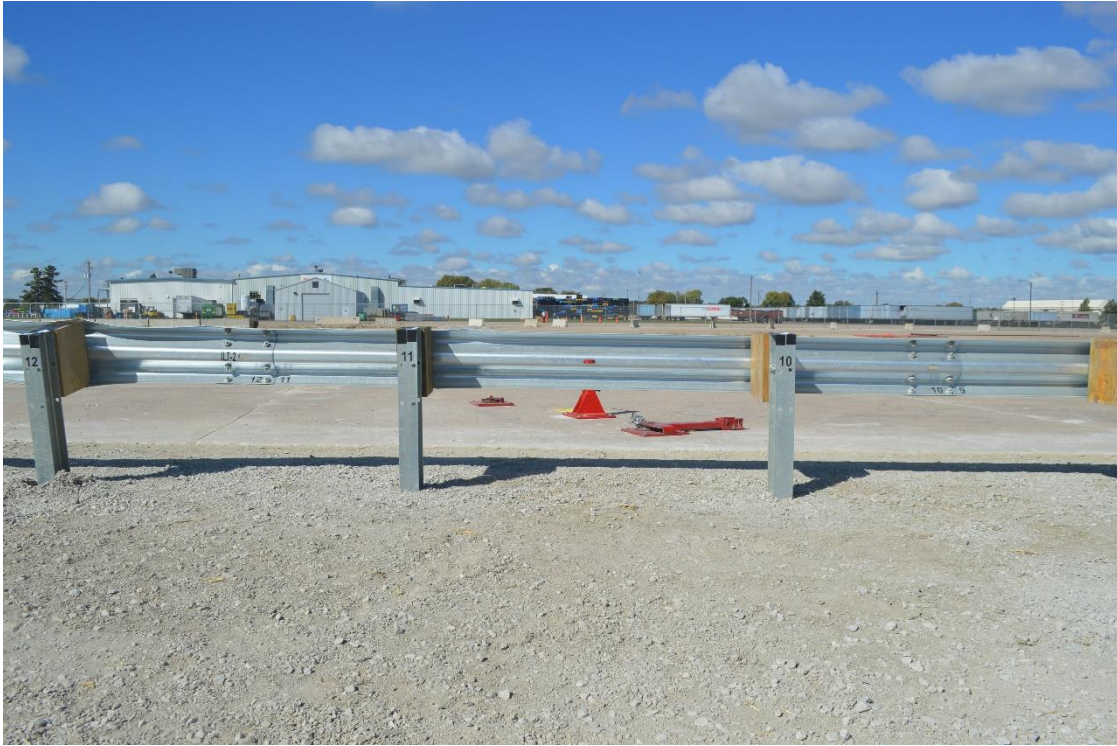
Figure 129. System Damage, Post Nos. 10 through 12, Test No. ILT-2

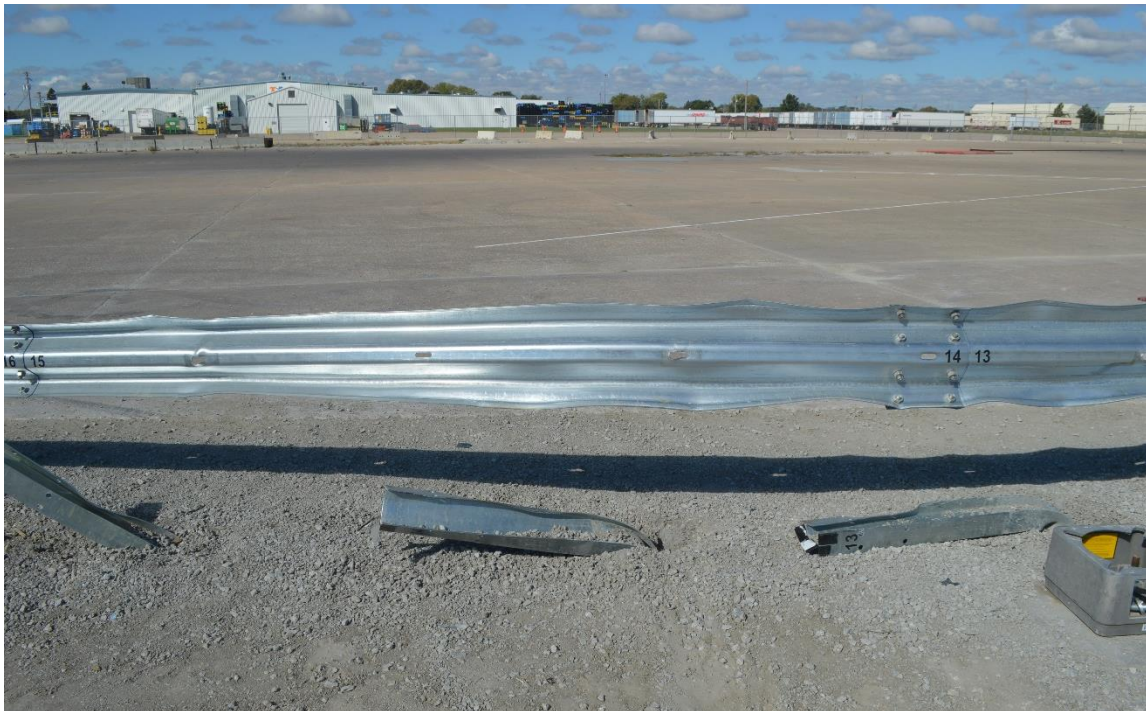
Figure 130. System Damage, Post Nos. 13 through 15, Test No. ILT-2

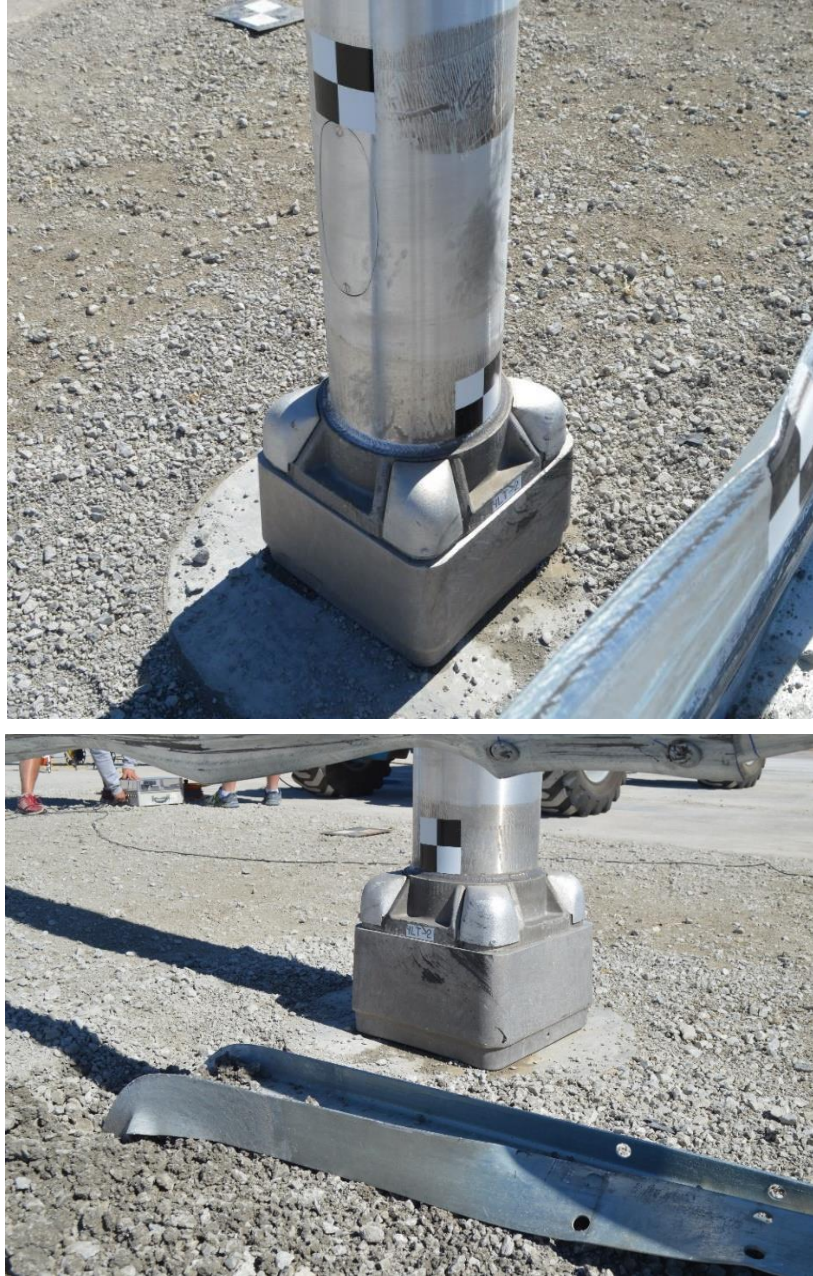
Figure 132. Pole Contact Marks, Test No. ILT-2

In test no. ILT-2, the left-front wheel barely grazed the base of the pole. Thus, the pole did not fracture. Contact marks were visible at the front side of the base, as shown in Figure 132.

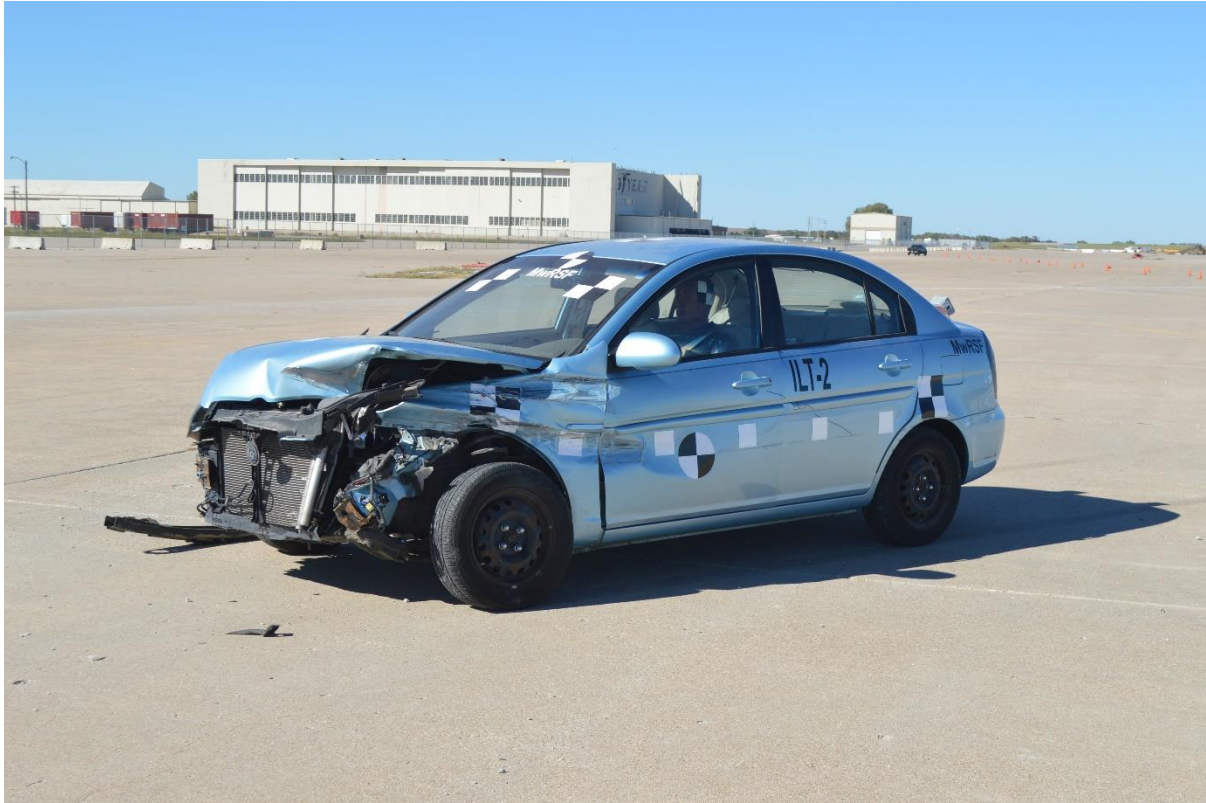
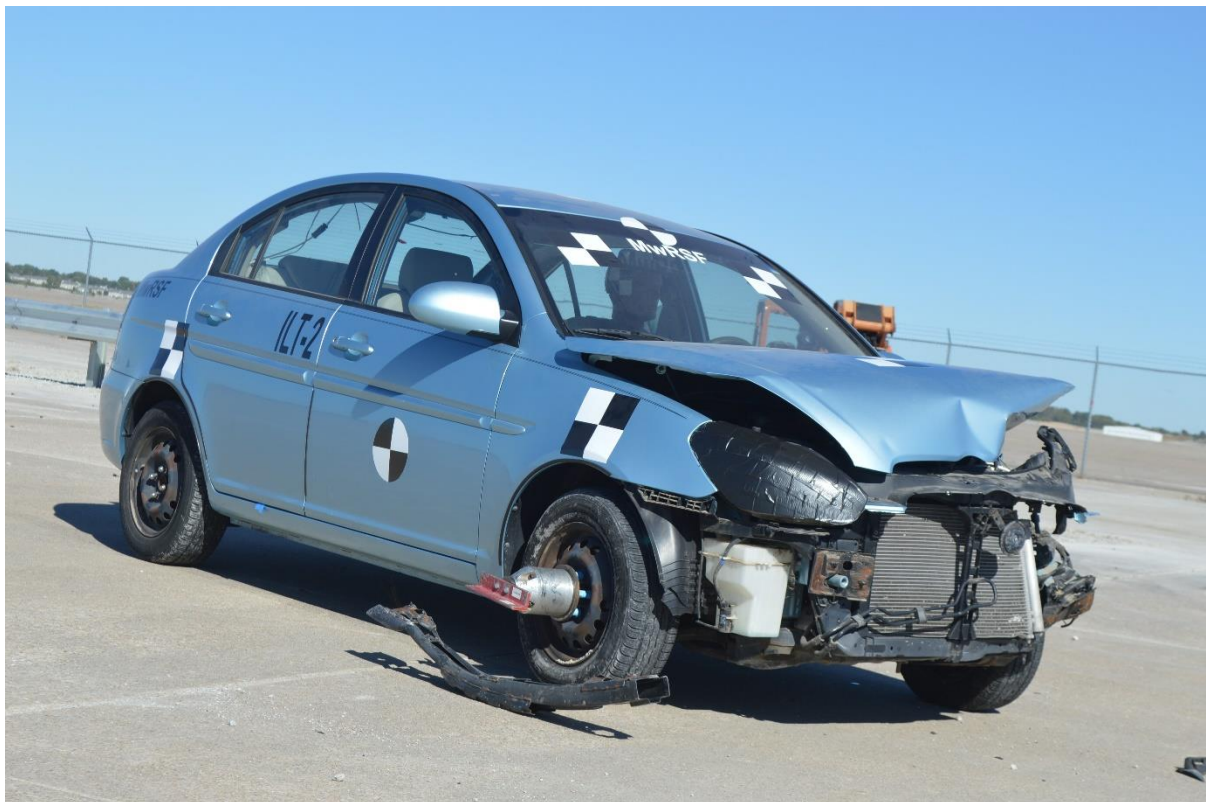
Figure 133. Vehicle Damage, Test No. ILT-2

The overall undercarriage damage of the vehicle included a scrape behind the engine cross member and a 3 in. (76 mm) of crush on the driver-side frame horn. The radiator cross member bent upward on the driver side for 2 in. (51 mm).

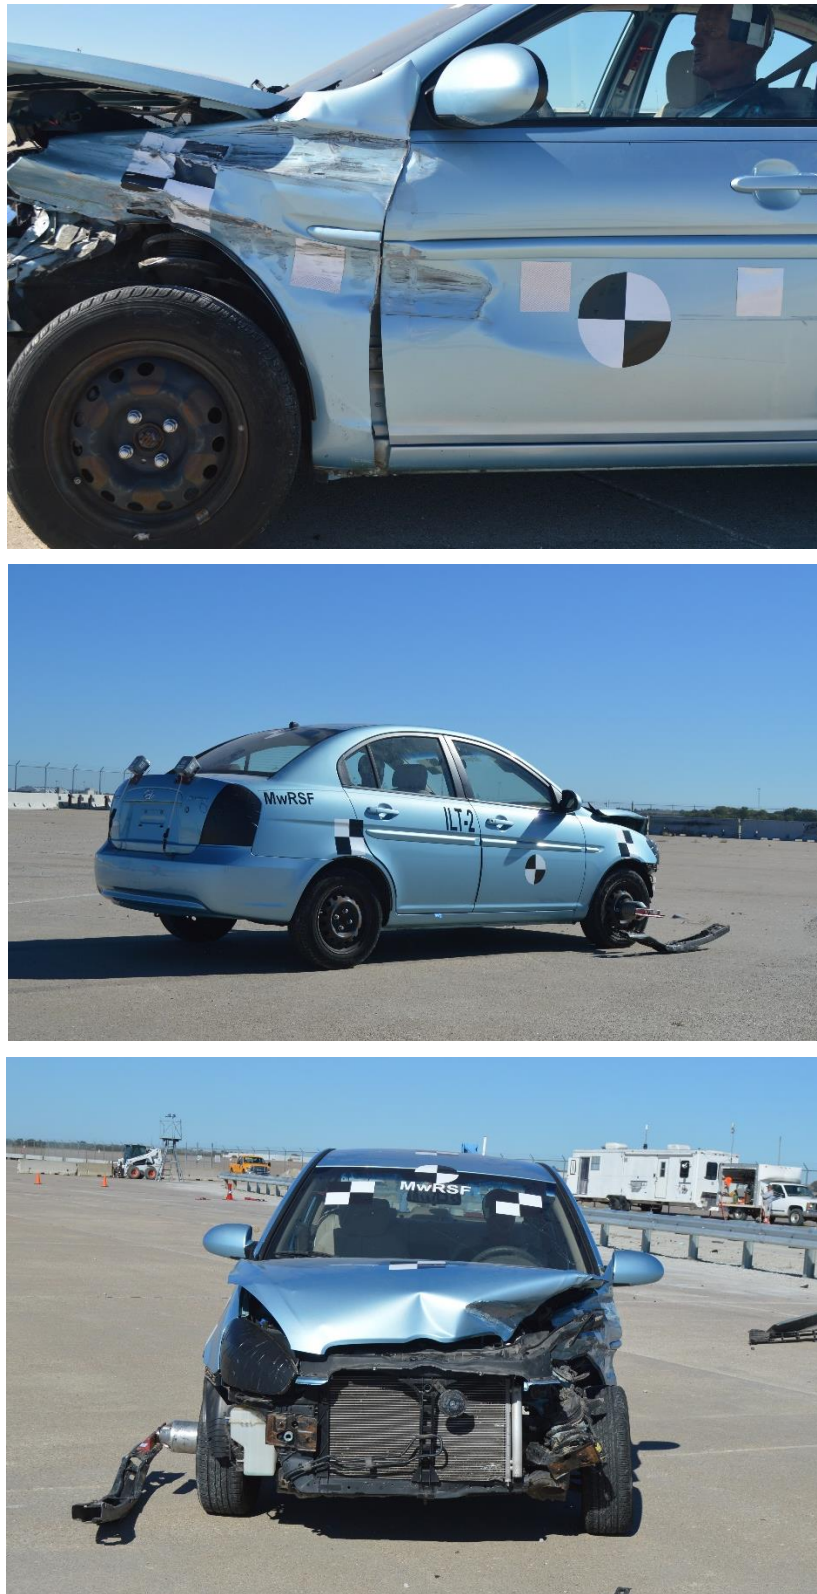
Figure 134. Vehicle Damage, Test No. ILT-2

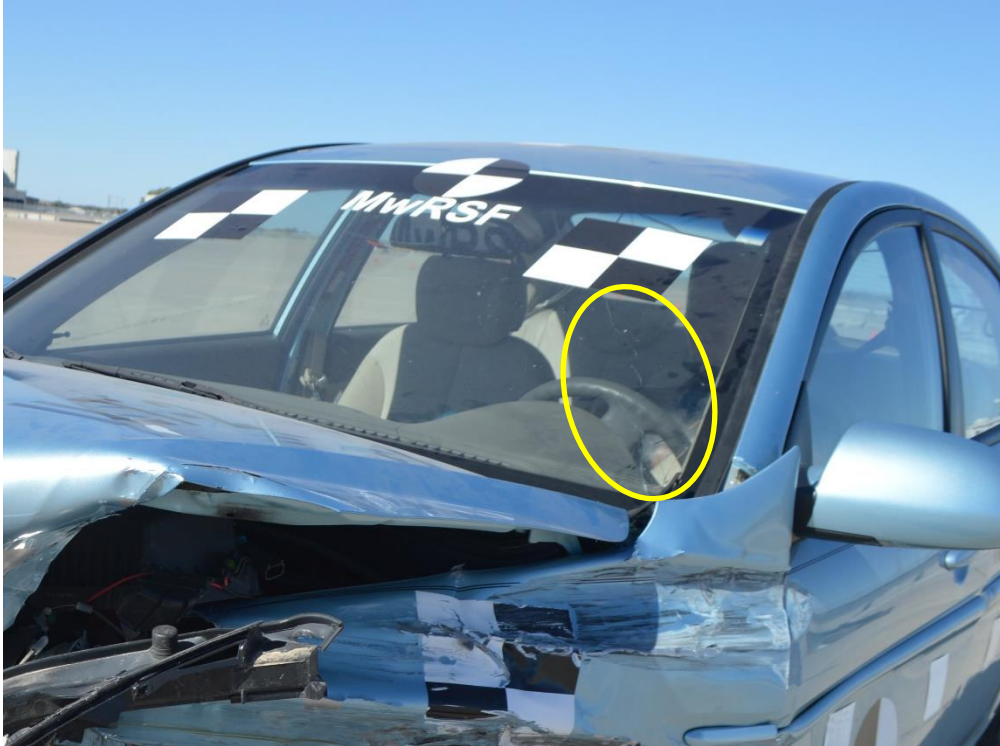
Figure 135. Vehicle Windshield Crack, Test No. ILT-2
