*Ohio Department of Transportation  
Research Project Number TPF-5(193) Supplement #117*

# **MASH TL-3 EVALUATION OF THE UNREINFORCED, SINGLE-SLOPE CONCRETE MEDIAN BARRIER**

## **MIDWEST ROADSIDE SAFETY FACILITY**

MwRSF Research Report No. TRP-03-388-18

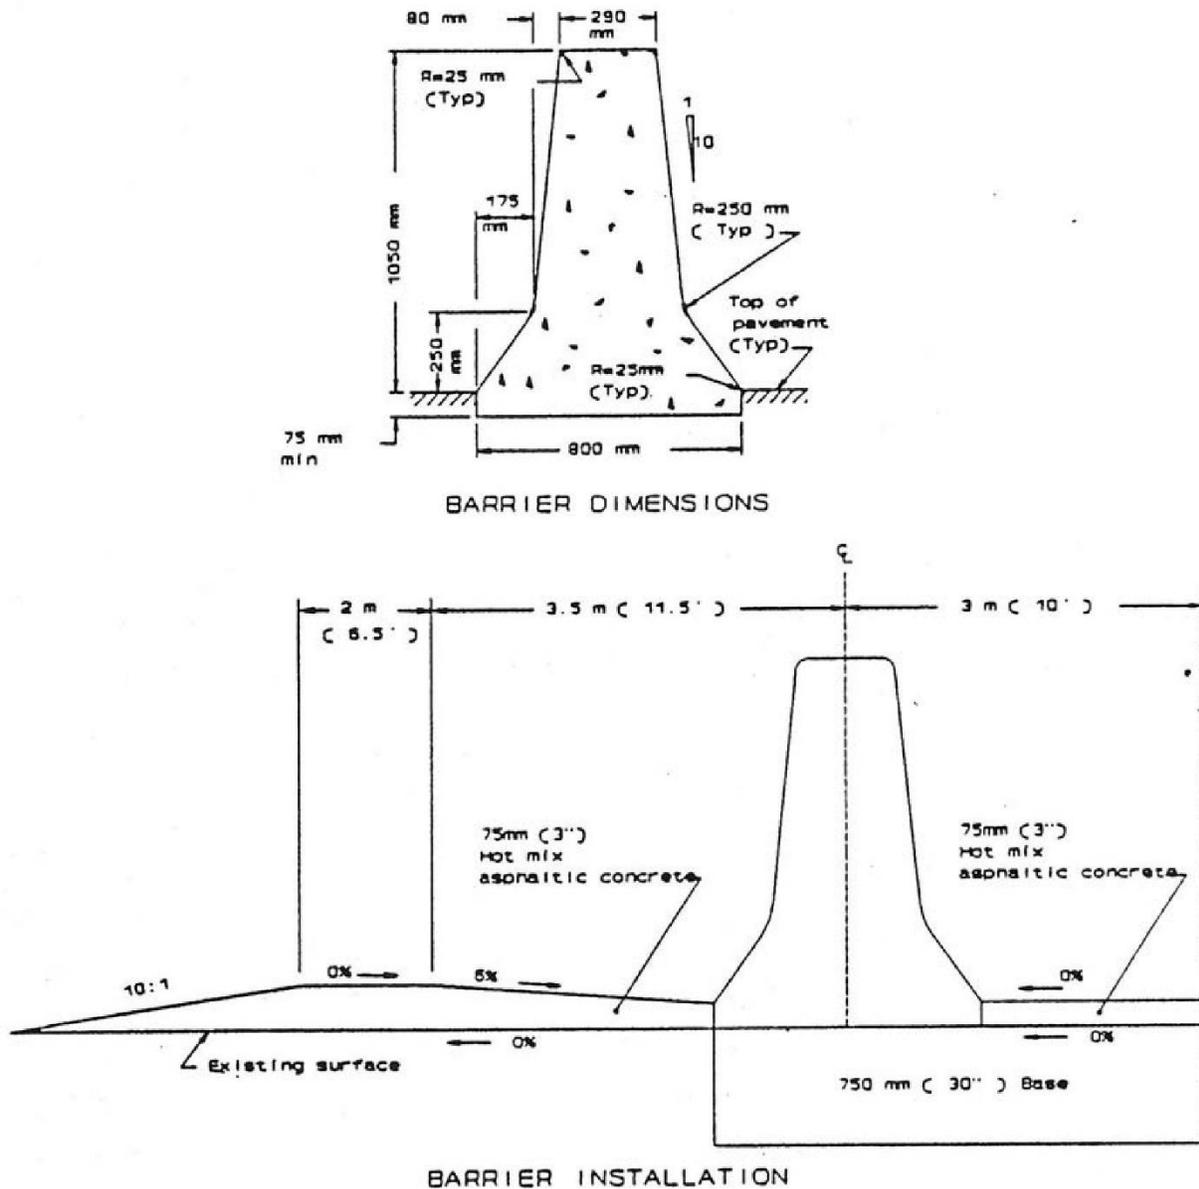
Figure 1. Ontario Tall Wall [1]

In the full-scale crash testing of the Ontario Tall Wall, an 80,000-lb (36,287-kg) tractor trailer impacted the barrier 87 ft (26.5 m) from the upstream end of the test installation at a speed of 49.6 mph (79.8 km/h) and an angle of 15.1 degrees. The tractor trailer was contained and redirected. However, the ballast used in the trailer of the test vehicle impacted and ruptured the side of the trailer as the tractor trailer rolled, resulting in some of the ballast exiting the trailer during impact. The Ontario Tall Wall barrier performed satisfactorily, meeting the guidelines set forth in NCHRP Report 230 [3] and the 1989 AASHTO *Guide Specifications for Bridge Railings* [4]. The results also demonstrated that the unreinforced, concrete Ontario Tall Wall barrier was structurally adequate to contain and redirect an 80,000-lb (36,287-kg) tractor trailer with the caveat that some of the ballast mass was lost during testing.

While the Ontario Tall Wall testing indicated that an unreinforced concrete barrier could redirect heavy vehicles, concerns about the performance of unreinforced concrete barriers remain. Unreinforced barriers may crack over time, even to the point where visual gaps may exist throughout the cross section. In this scenario, no rail continuity would exist and vehicle redirection would be dependent upon a combination of several factors, including the inertial resistance of the

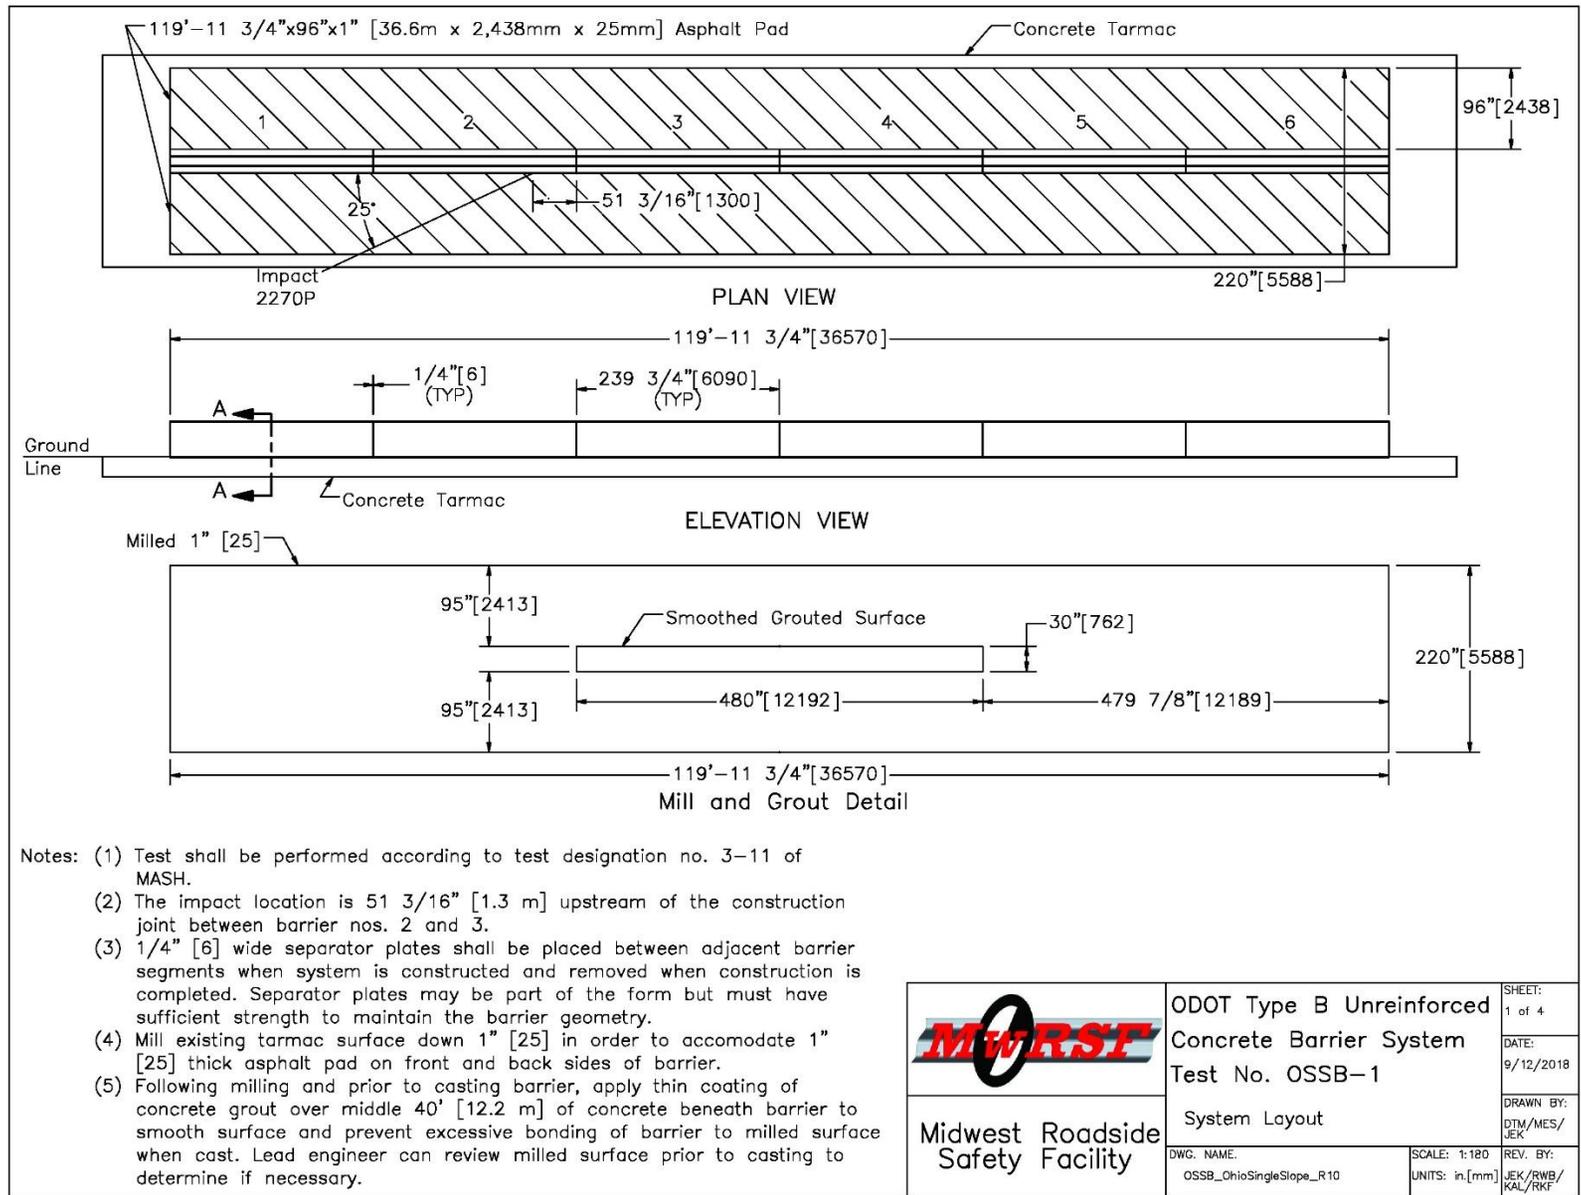
Figure 5. Test Installation Layout, Test No. OSSB-1

thickness of  $28\frac{3}{8}$  in. (721 mm) and top width of 12 in. (305 mm). A 1-in. (25-mm) deep asphalt keyway was installed on each side of the barrier that made the effective top height and base width of the barrier system 42 in. (1,067 mm) and 28 in. (711 mm), respectively. The top corners had a  $\frac{3}{4}$ -in. (19-mm) chamfer. A  $\frac{1}{4}$ -in. (6-mm) gap was placed every 20 ft (6.1 m) along the barrier installation to simulate cracking at expansion joint locations, which created six barrier segments, denoted barrier no. 1 through barrier no. 6.

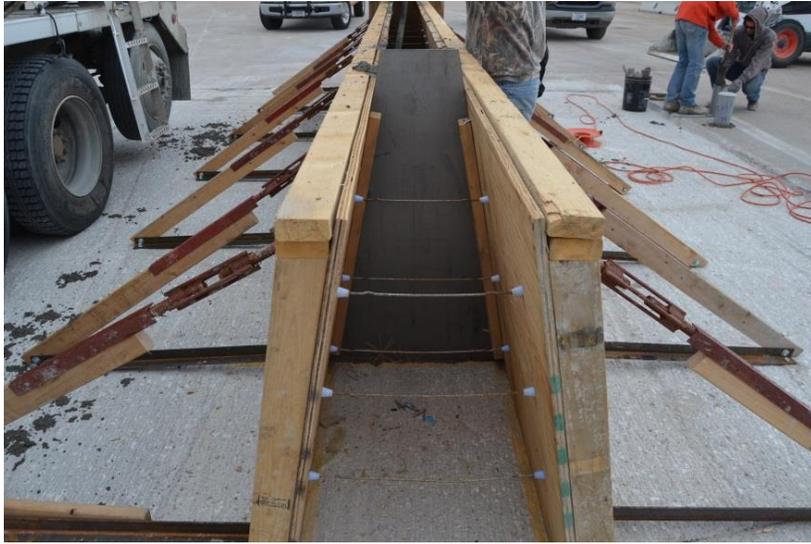
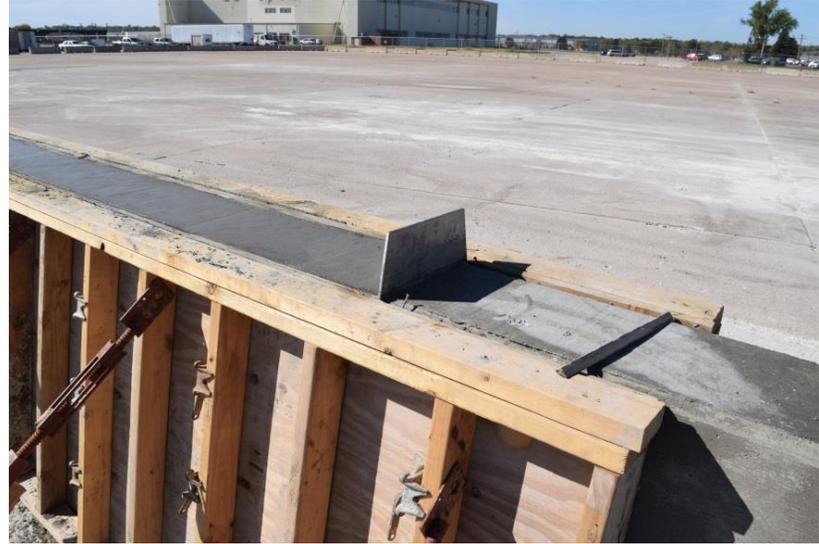
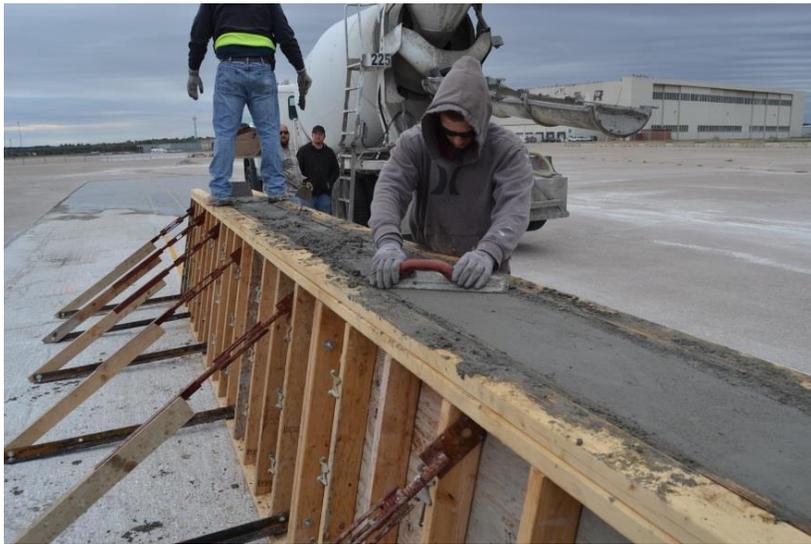
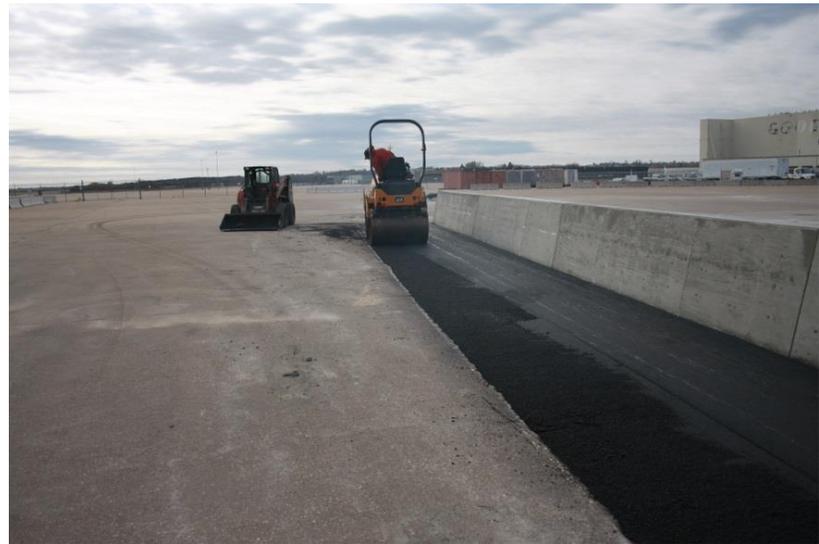
Figure 9. Test Article Construction Photographs, Test No. OSSB-1

Construction photographs of the system are shown in Figure 9. Each barrier was cast using wooden forms and a  $\frac{1}{4}$ -in. (6-mm) thick steel plate was used to maintain even gap spacing between barrier segments. Concrete cylinders from each segment were tested, as shown in Appendix A, and only barrier segment no. 4 failed to meet the required strength of 4,000 psi (27.6 MPa) prior to the date of the test. However, barrier segment no. 4 was downstream from the main impact region and was not considered critical to vehicle impact. Thus, the test was conducted with barrier segment no. 4 having a 45-day compressive strength of 3,680 psi (25.4 MPa).

The test installation consisted of an unreinforced, single-slope, concrete median barrier, as shown in Figures 5 through 8. Photographs of the test installation are shown in Figures 9 through 11. Material specifications, mill certifications, and certificates of conformity for the system materials are shown in Appendix A. The system design was based on the ODOT standard details for their barrier, as discussed previously. The tarmac surface around the system was milled down 1 in. (25 mm) to accommodate an asphalt pad on the front and back sides of the barrier. Following milling and prior to barrier casting, a thin coating of concrete grout was applied over the middle 40 ft (12.2 m) of concrete beneath the barrier to provide a smooth surface and prevent excessive bonding of the barrier to the milled surface. The barrier installation was 119 ft – 11¾ in. (36.6 m) long and 43 in. (1,092 mm) tall, and consisted of a 10.9-degree slope, which resulted in a base

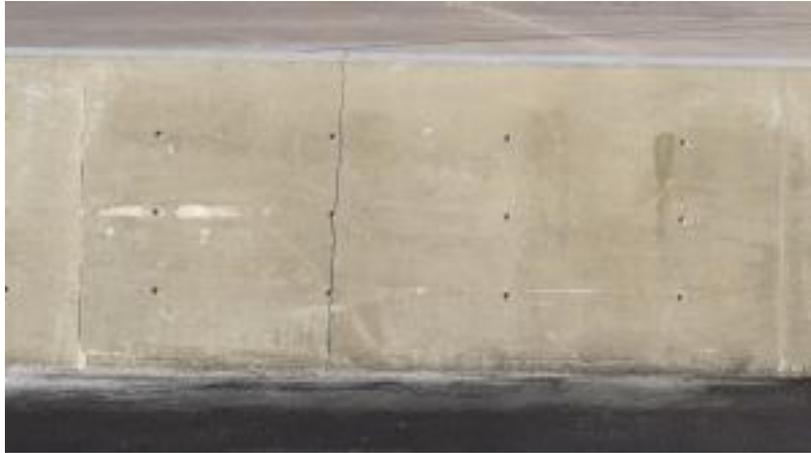
Barrier No. 1 Thermal Hairline Crack

Several imperfections in the barriers naturally occurred when removing the formwork. Thermal hairline cracks extended vertically through barriers nos. 1, 2, and 5, as shown in Figure 11. Several gouges resulting from removal of the forms can also be seen on the barrier segments. The gouges vary in size and are generally present along the vertical center of each of the barriers. Additionally, small and limited spalling on the edges of some of the gaps between barriers occurred when removing the steel plate due to the large amount of force needed to remove the plate.

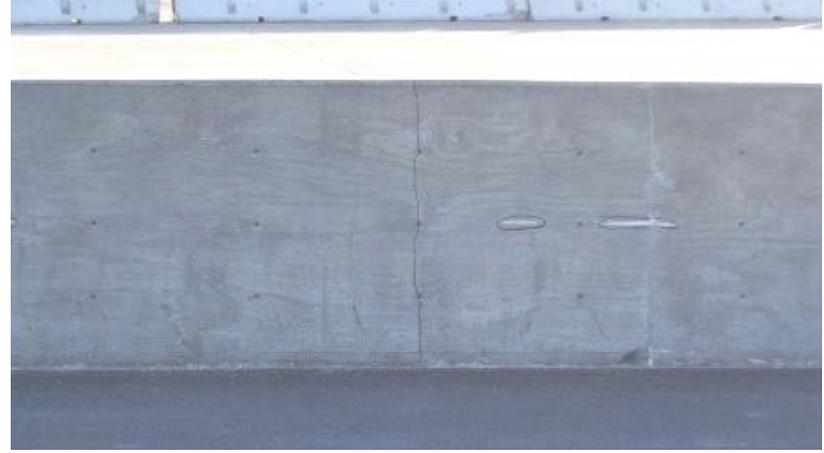
Barrier No. 5 Thermal Hairline Crack

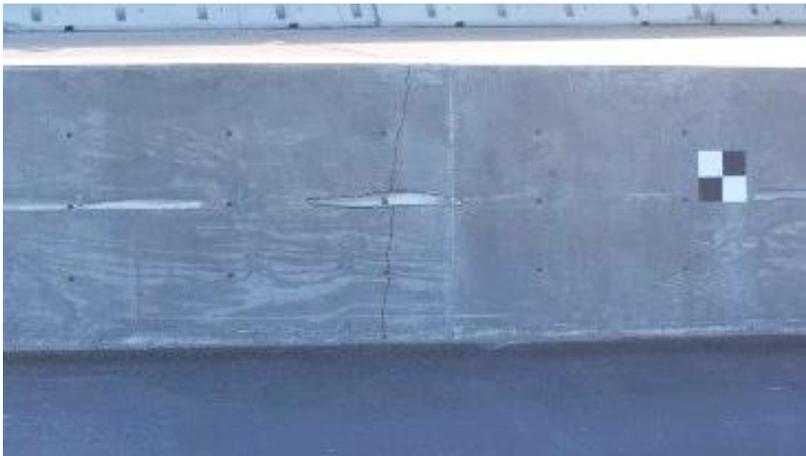
Barrier No. 2 Thermal Hairline Crack

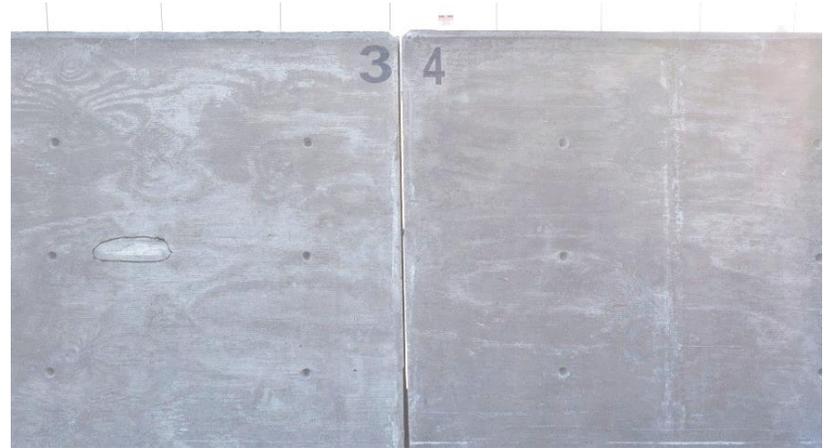
Figure 11. Barrier Imperfections, Test No. OSSB-1

Spalling of Barrier Gap

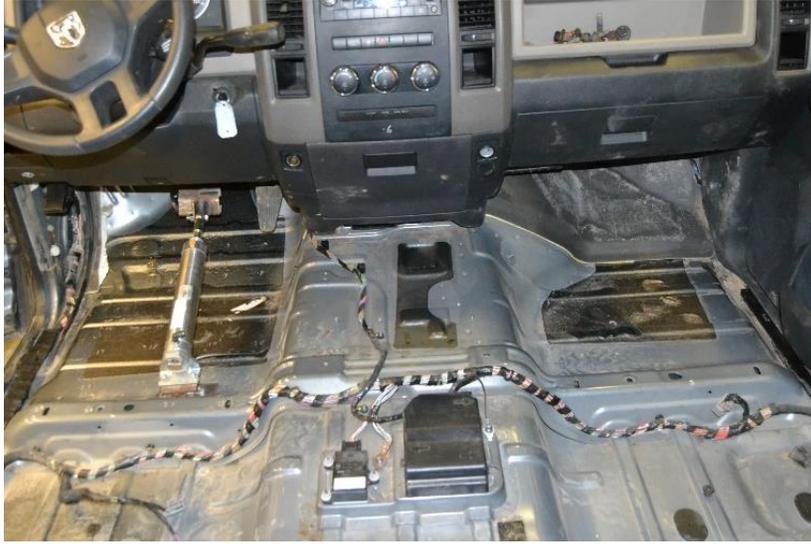
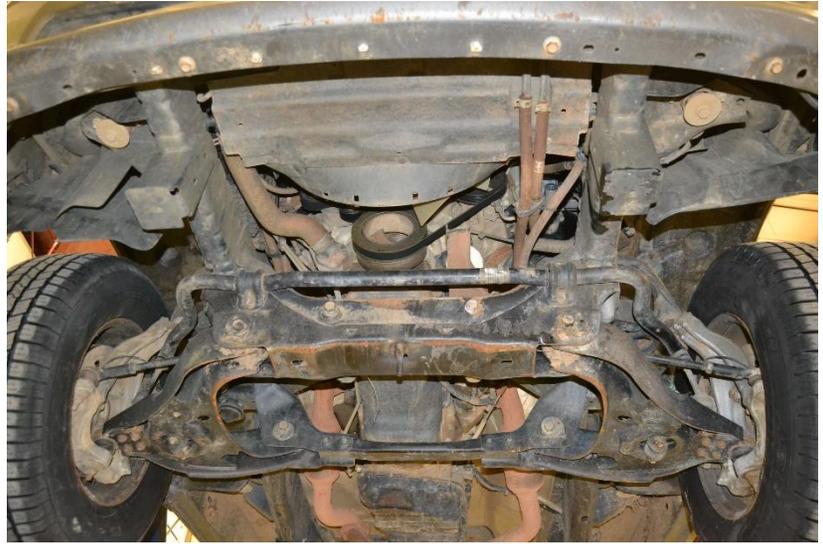
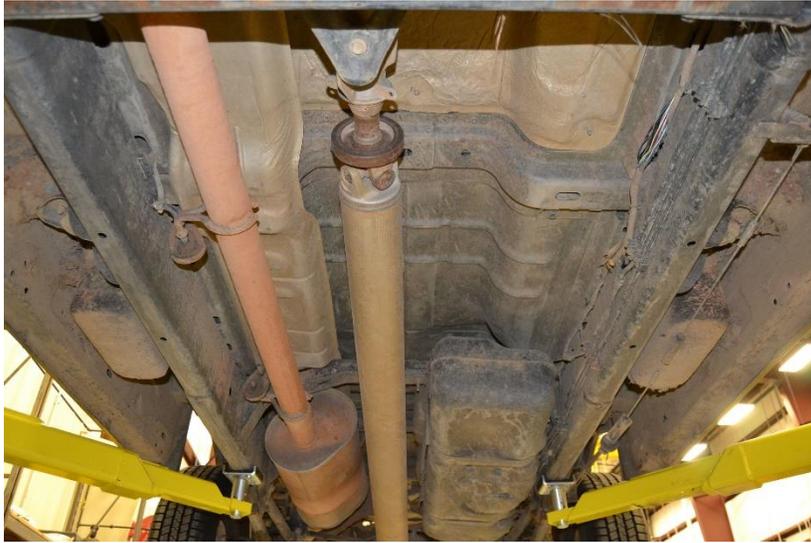
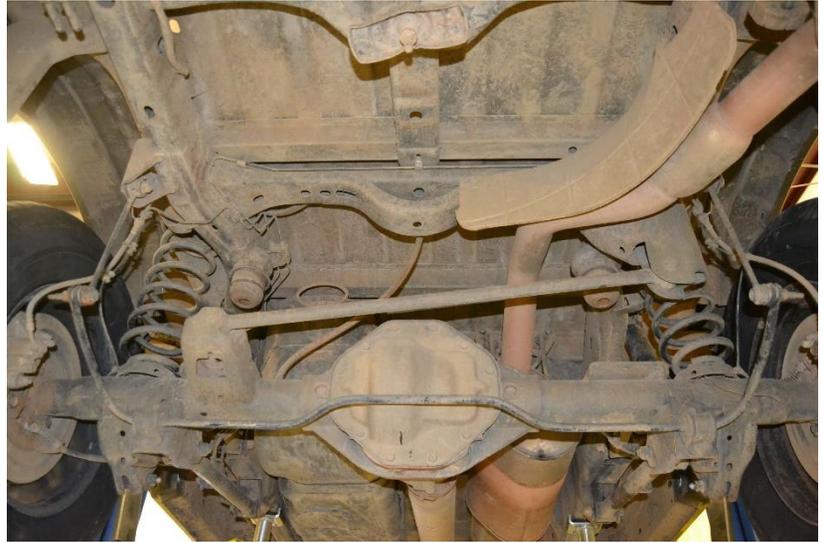
Figure 13. Test Vehicle's Interior Floorboards and Undercarriage, Test No. OSSB-1

For test no. OSSB-1, a 2011 Dodge Ram 1500 crew cab pickup truck was used as the test vehicle. The curb, test inertial, and gross static vehicle weights were 5,122 lb (2,323 kg), 5,001 lb (2,268 kg), and 5,163 lb (2,342 kg), respectively. The test vehicle is shown in Figures 12 and 13, and vehicle dimensions are shown in Figure 14.

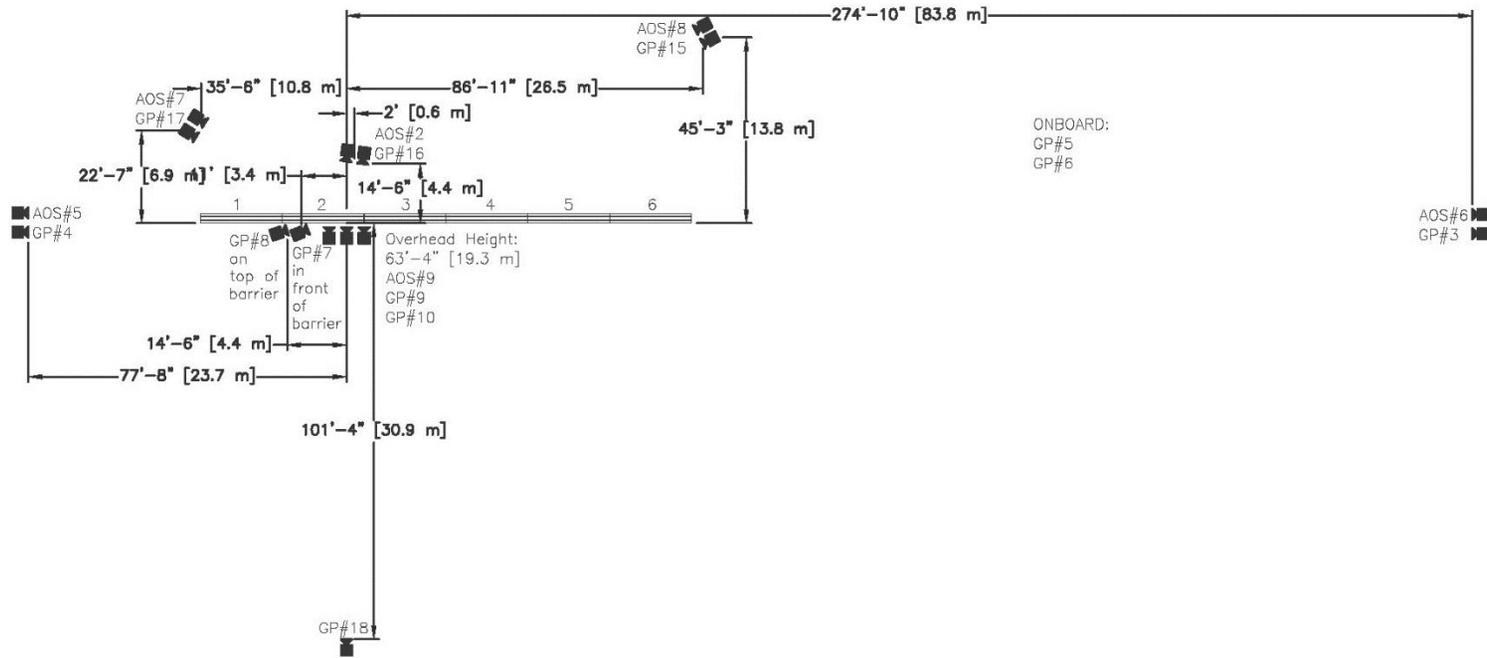
Figure 16. Camera Locations, Speeds, and Lens Settings, Test No. OSSB-1

Six AOS high-speed digital video cameras and twelve GoPro digital video cameras were utilized to film test no. OSSB-1. Camera details, camera operating speeds, lens information, and a schematic of the camera locations relative to the system are shown in Figure 16.

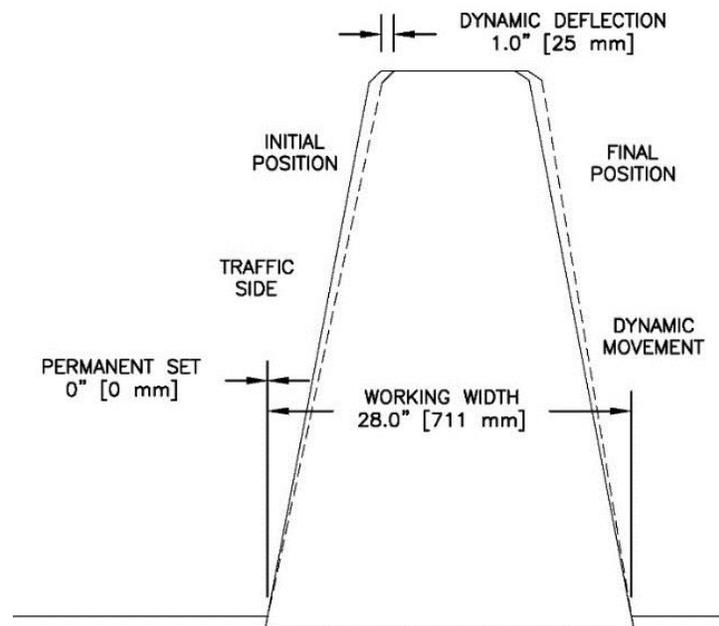
Figure 17. Permanent Set Deflection, Dynamic Deflection, and Working Width, Test No. OSSB-1

The maximum lateral permanent set deflection of the system was negligible as no displacement of the base of the barrier was observed in the asphalt. The maximum lateral dynamic barrier deflection, including tipping of the barrier along the top surface, was 1.0 in. (25 mm) near the downstream end of barrier no. 2, as determined from high-speed digital video analysis. The working width of the system was found to be 28.0 in. (711 mm), also determined from the high-speed digital video analysis. A schematic demonstrating permanent set deflection, dynamic deflection, and working width is shown in Figure 17.

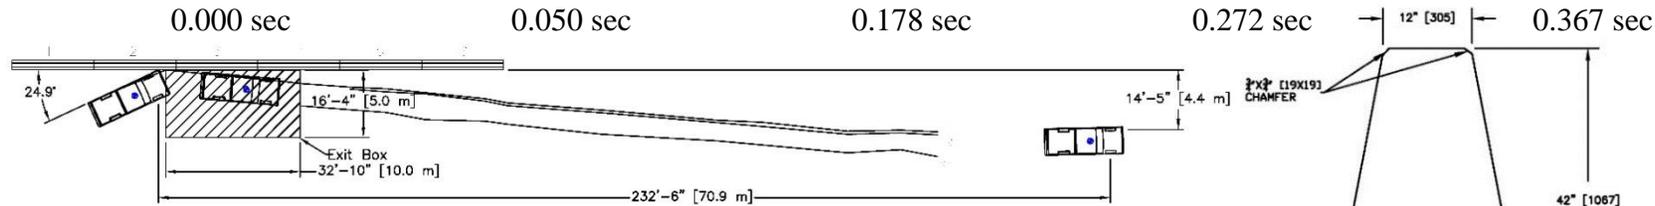
- Test Agency .....MwRSF
- Test Number.....OSSB-1
- Date .....12/17/17
- MASH 2016 Test Designation No.....3-11
- Test Article..... Longitudinal Concrete Barrier

- Test Inertial.....5,001 lb (2,268 kg)
  - Gross Static.....5,163 lb (2,342 kg)
- Impact Conditions
  - Speed .....62.8 mph (101.0 km/h)
  - Angle ..... 24.9 deg.

- Impact Location..... 52 in. (1,321 mm) US from Joint 2-3
- Impact Severity .....116.3 kip-ft (157.7 kJ) > 106 kip-ft (144 kJ) limit from MASH 2016
- Exit Conditions

- Vehicle Stopping Distance ..... 232 ft – 6 in. (70.9 m)
  - 14 ft – 5 in. (4.4 m) laterally in front
- Vehicle Damage..... Moderate
  - VDS [12] ..... 11-LFQ-4

- CDC [13]..... 11-LYEW-3
  - Maximum Interior Deformation ..... 1⅞ in. (48 mm)
- Test Article Damage..... Minimal

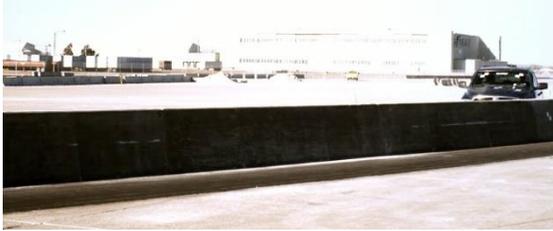
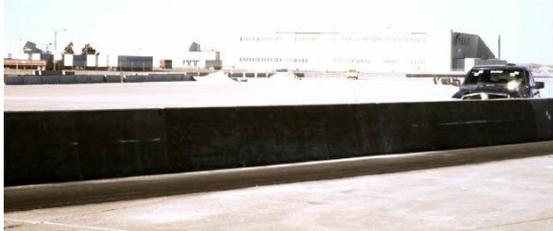
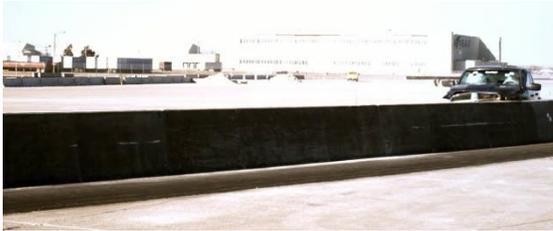
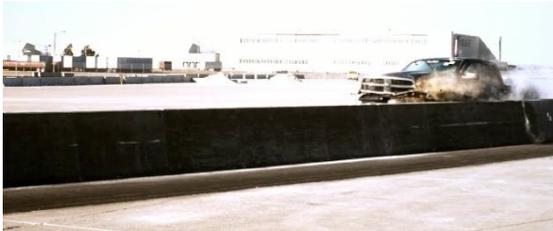
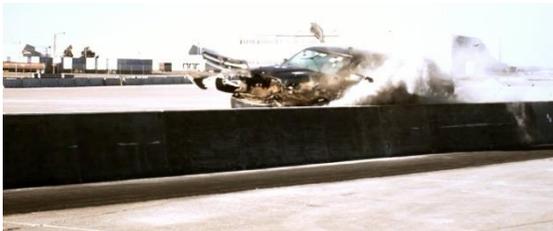
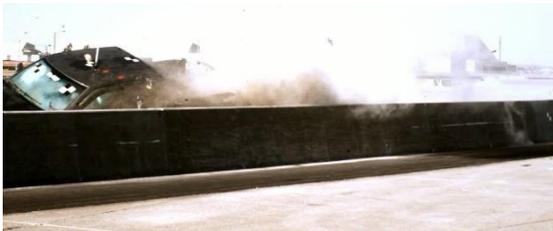
Figure 20. Additional Sequential Photographs, Test No. OSSB-1

The 5,001-lb (2,268-kg) crew cab pickup truck impacted the unreinforced, single-slope barrier system at a speed of 62.8 mph (101.0 km/h) and at an angle of 24.9 degrees. A summary of the test results and sequential photographs are shown in Figure 18. Additional sequential photographs are shown in Figure 19 through Figure 20. Documentary photographs of the crash test are shown in Figures 21 and 22.

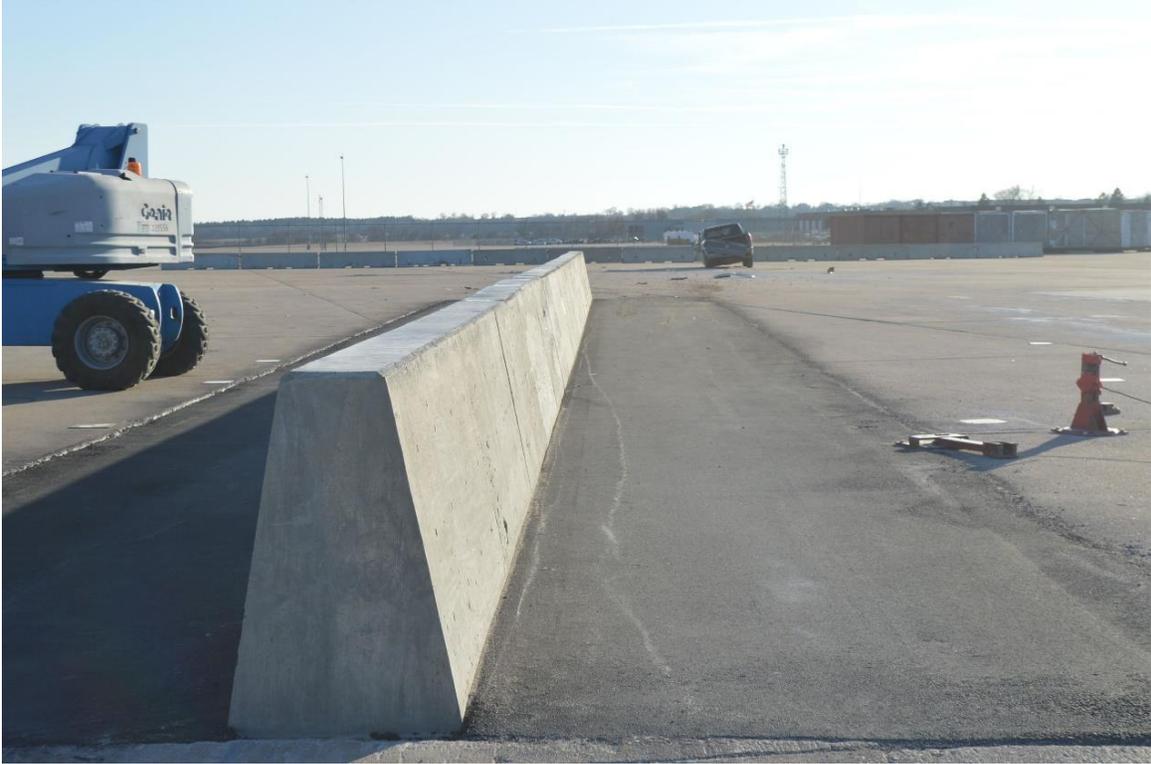
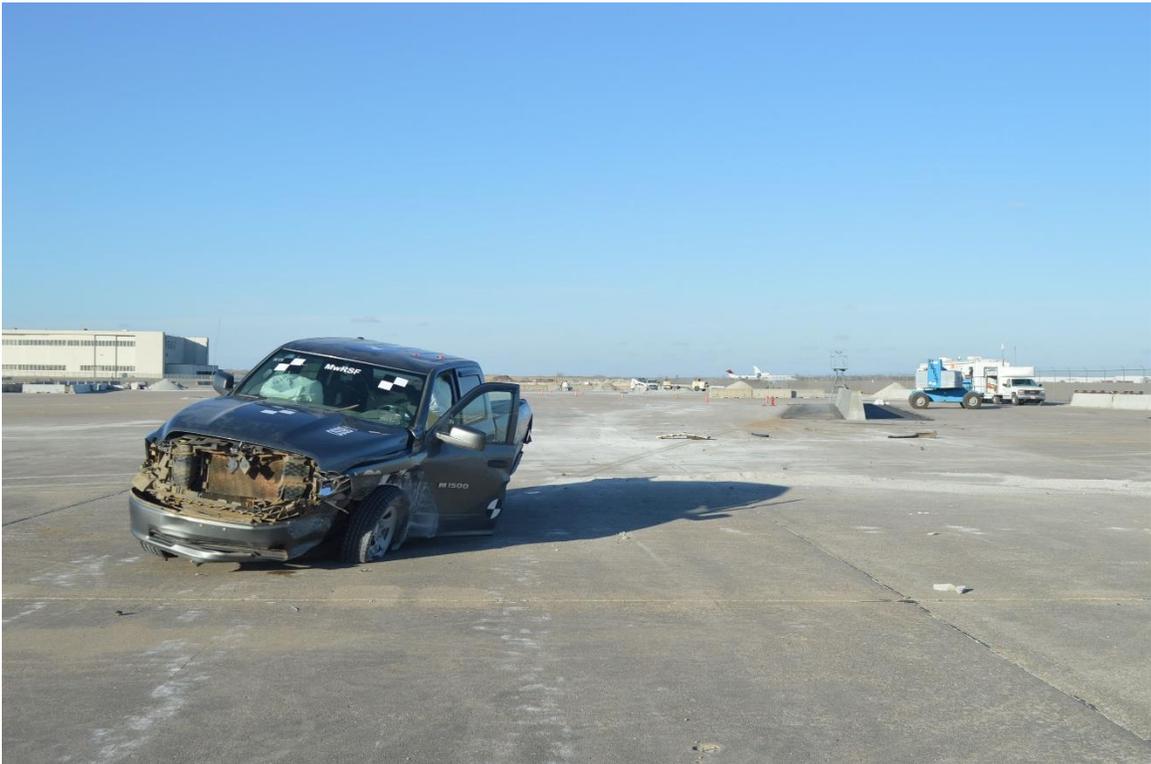
Figure 24. Vehicle Final Position and Trajectory Marks, Test No. OSSB-1

Initial vehicle impact was to occur 51<sup>3</sup>/<sub>16</sub> in. (1,300 mm) upstream from the construction joint between barrier nos. 2 and 3, as shown in Figure 23, which was selected using Table 2.7 of MASH 2016 to maximize structural loading adjacent to the simulated joint and the probability of vehicle snag. The actual point of impact was 52.0 in. (1,322 mm) upstream from the construction joint between barrier nos. 2 and 3. A sequential description of the impact events is contained in Table 4. The vehicle came to rest 232 ft – 6 in. (70.9 m) downstream from the impact location and 14 ft – 5 in. (4.4 m) laterally away from the traffic side of the barrier system after the brakes were applied. The vehicle remained stable and upright throughout vehicle redirection, and the vehicle trajectory and final position are shown in Figures 18 and 24.

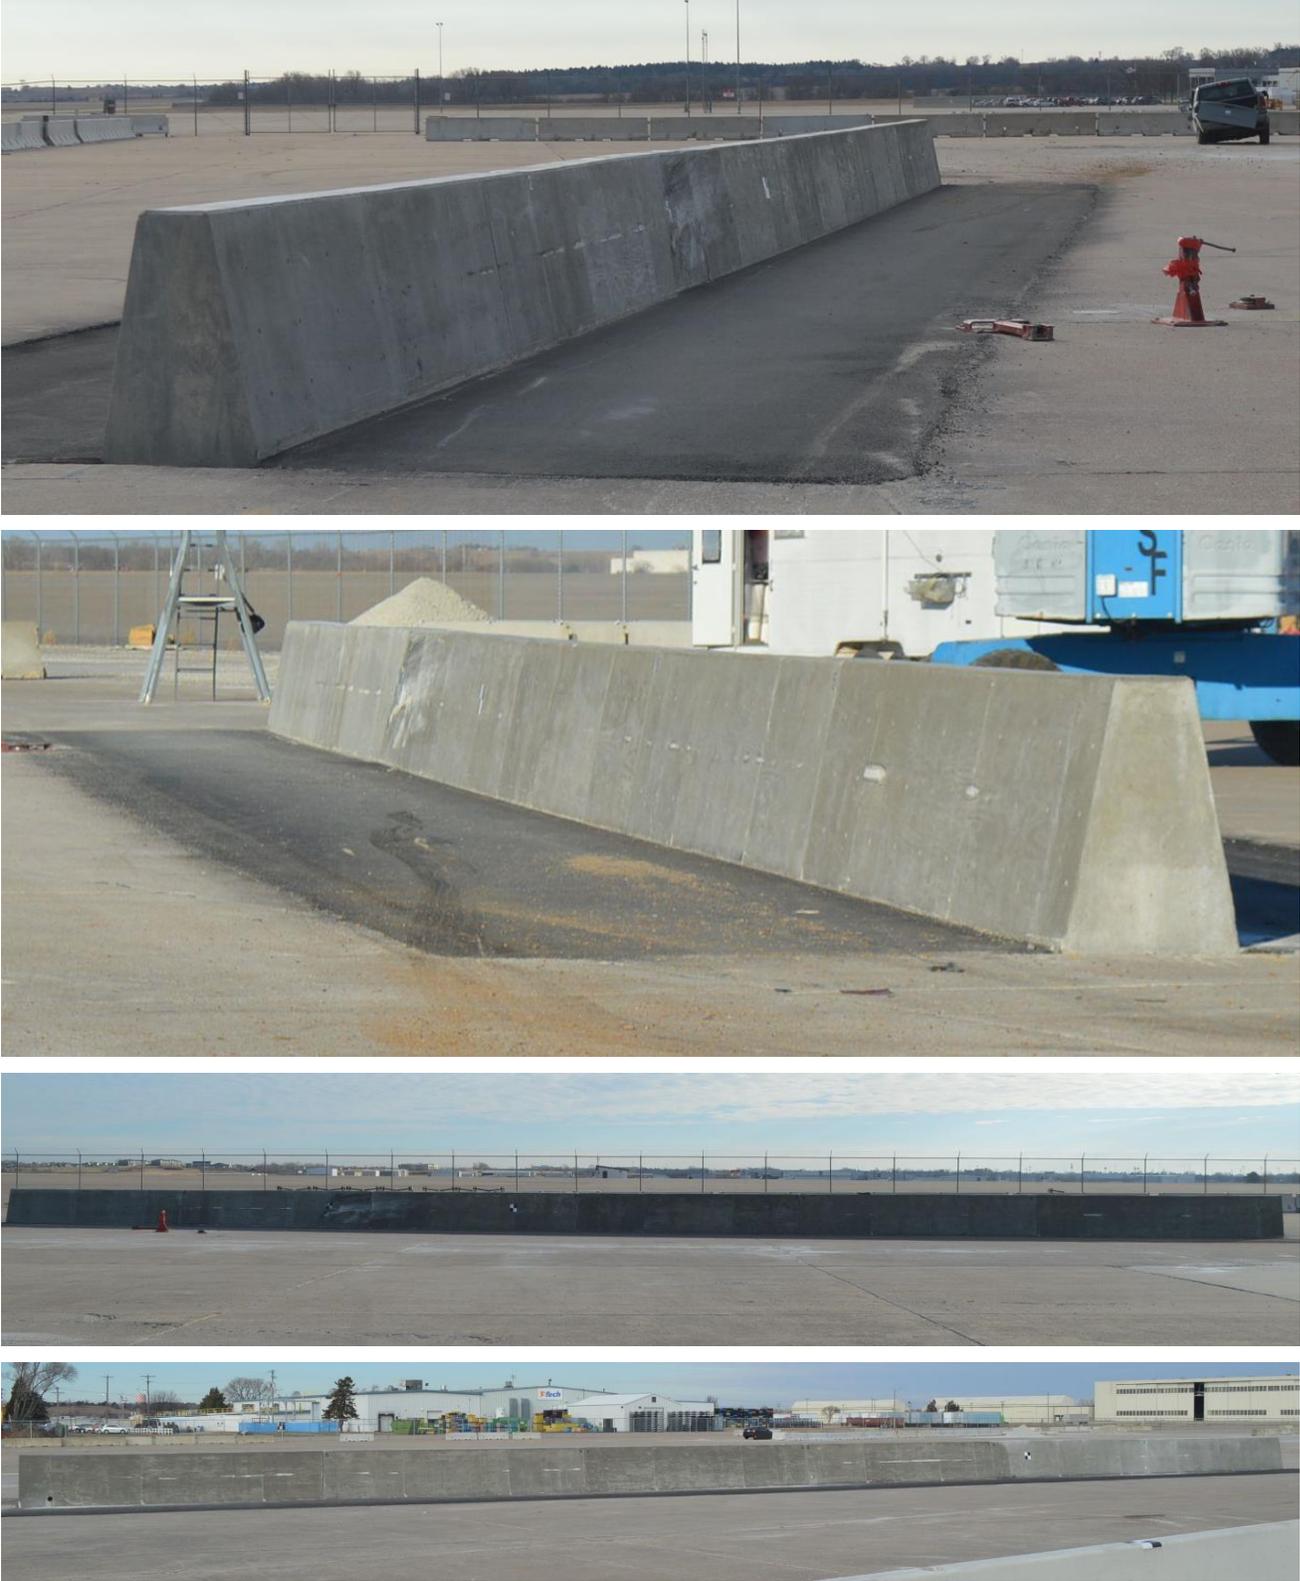
Figure 25. System Damage, Test No. OSSB-1

Damage to the test installation was minimal, as shown in Figures 25 through 28. Barrier damage consisted of contact marks, gouging and spalling of the concrete, and minor concrete cracking. The length of vehicle contact along the barrier was approximately 11 ft – 6<sup>3</sup>/<sub>8</sub> in. (3.5 m), which spanned from 5 ft – 5<sup>7</sup>/<sub>8</sub> in. (1.7 m) upstream from the center of the joint between barrier nos. 2 and 3 to 6 ft – 1/2 in. (1.8 m) downstream from the center of the joint between barrier nos. 2 and 3.

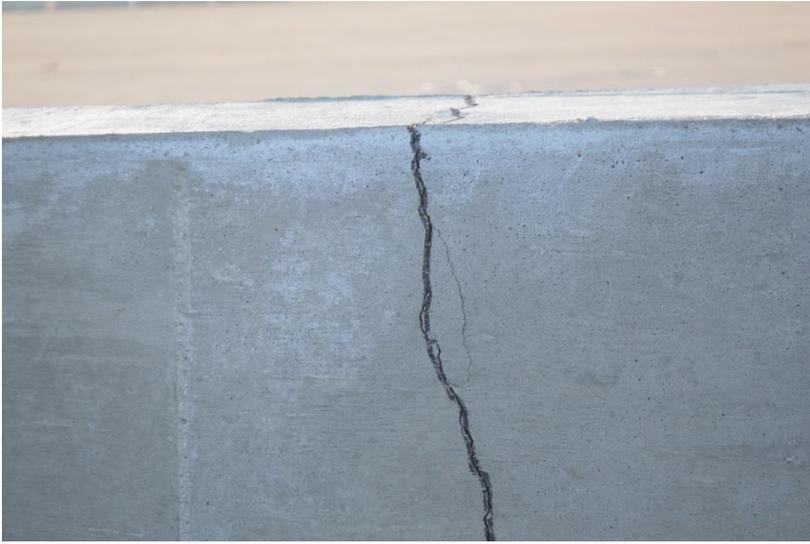
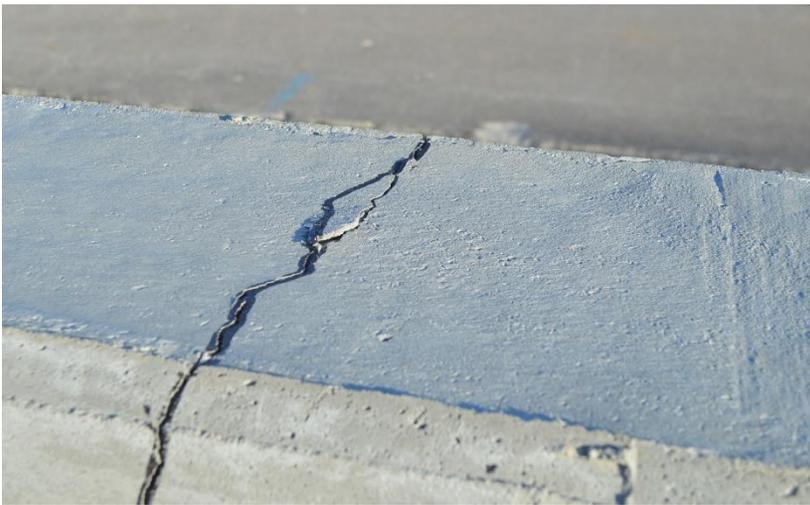
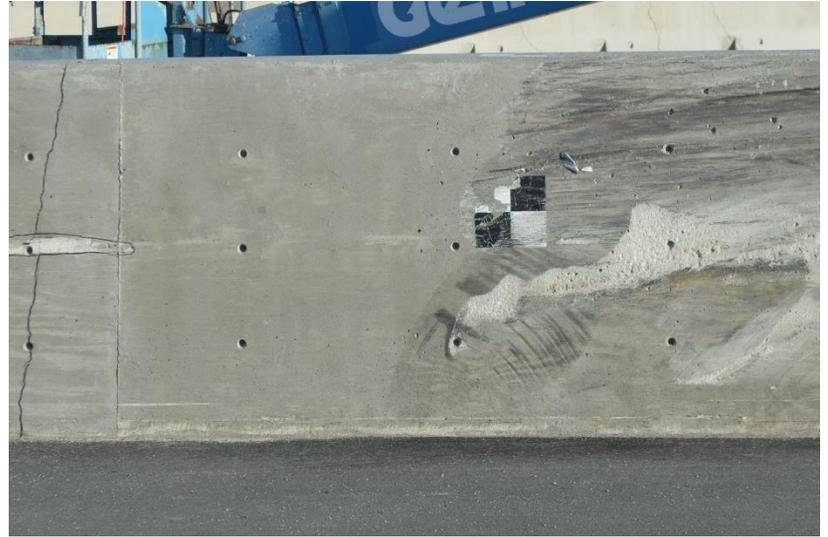
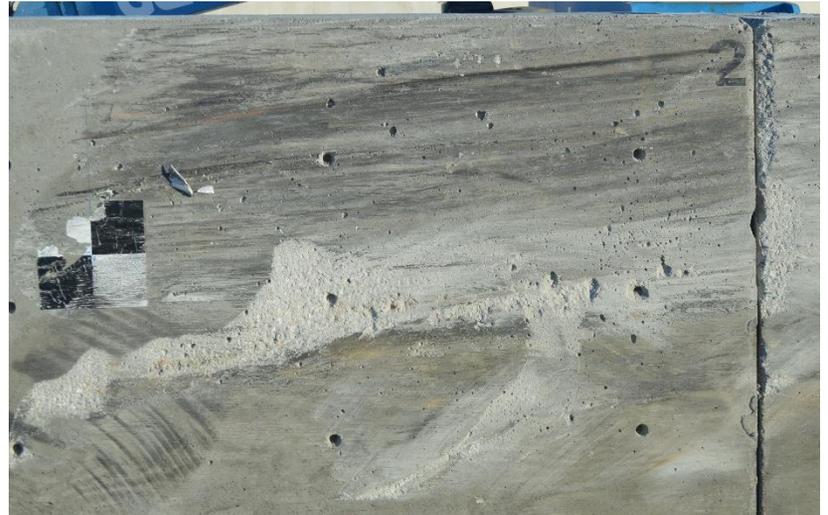
Figure 27. Barrier No. 2 Damage, Test No. OSSB-1

A 59-in. (1,499-mm) long gouge was found on the downstream end of barrier no. 2. The downstream edge of barrier no. 2 and upstream edge of barrier no. 3 were spalled on the traffic side. Minor spider web cracks stemmed from the thermal crack that resulted during construction near the center of barrier no. 2. One such crack occurred on the top of barrier no. 2 for a length of 4 in. (102 mm). Additionally, a 3½-in. (89-mm) long crack was located on the front face of barrier no. 2, 3 in. (76 mm) below the top plane of the barrier.

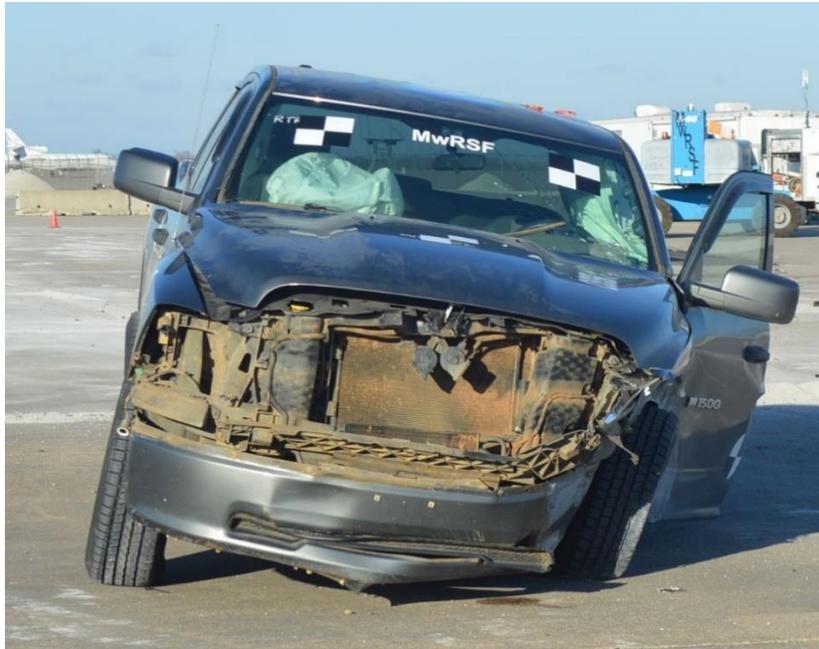
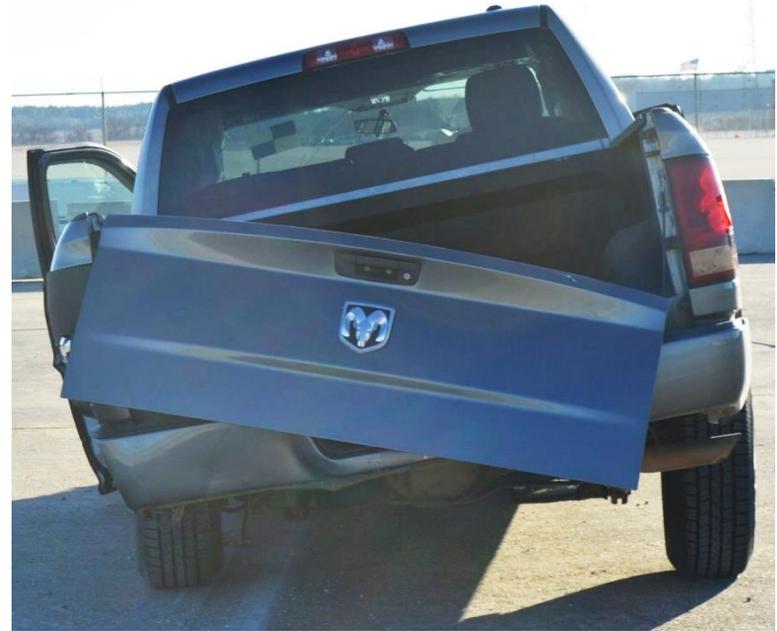
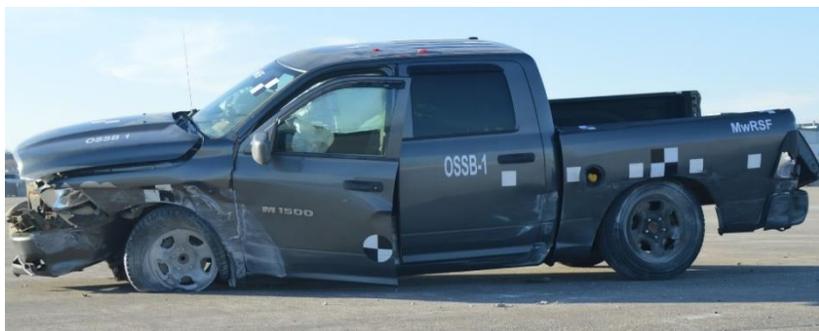
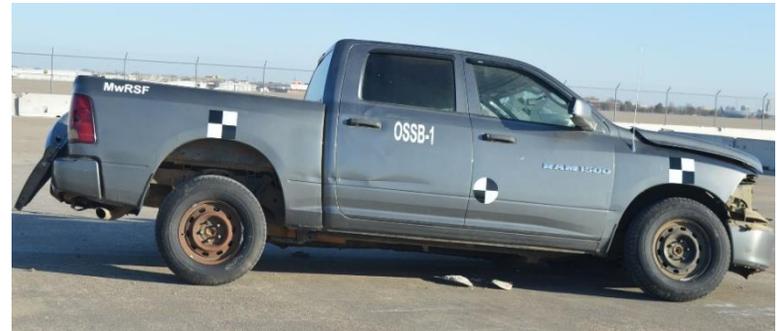
Figure 29. Vehicle Damage, Test No. OSSB-1

The damage to the vehicle was moderate, as shown in Figures 29 through 34. The maximum occupant compartment deformations are listed in Table 5 along with the deformation limits established in MASH 2016 for various areas of the occupant compartment. None of the established MASH 2016 deformation limits were violated. Complete occupant compartment and vehicle deformations and the corresponding locations are provided in Appendix C. Note that floor pan deformation and occupant compartment deformation data for reference set 2 have been omitted from Appendix C due to errors in data acquisition.

The majority of the vehicle damage was concentrated on the left-front corner and left side of the vehicle where the impact had occurred. Two buckles occurred on the left-front frame, one

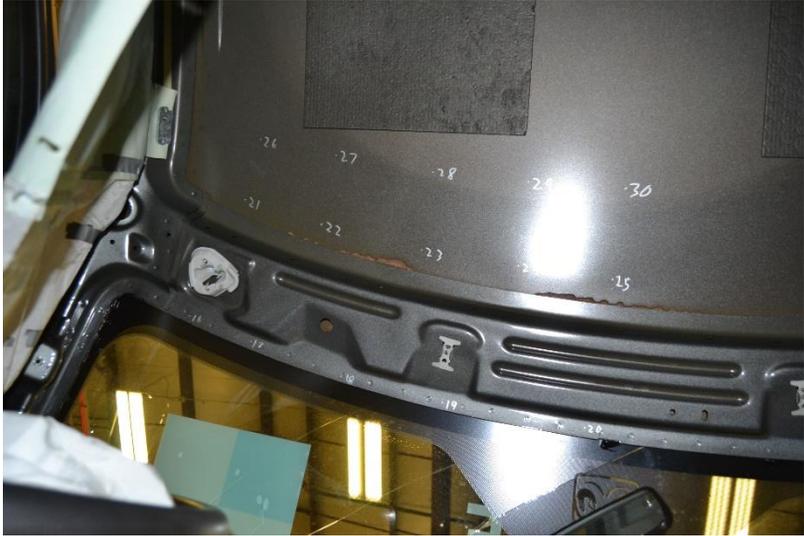
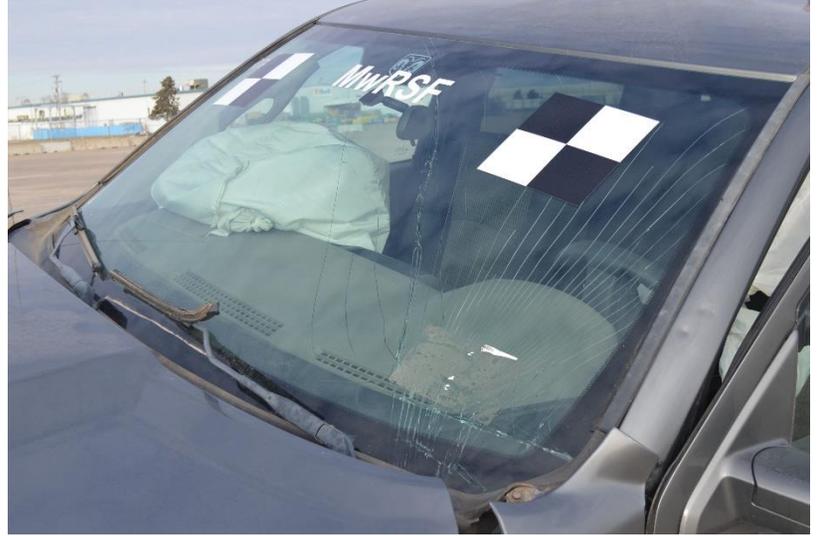
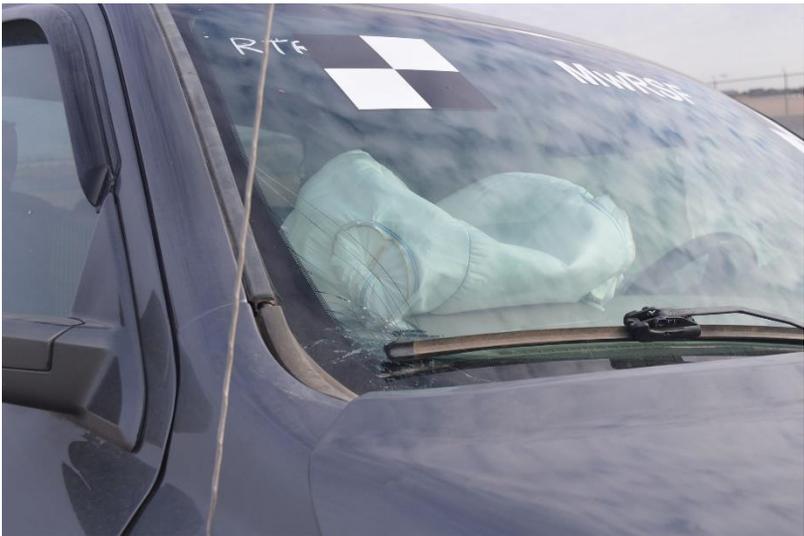
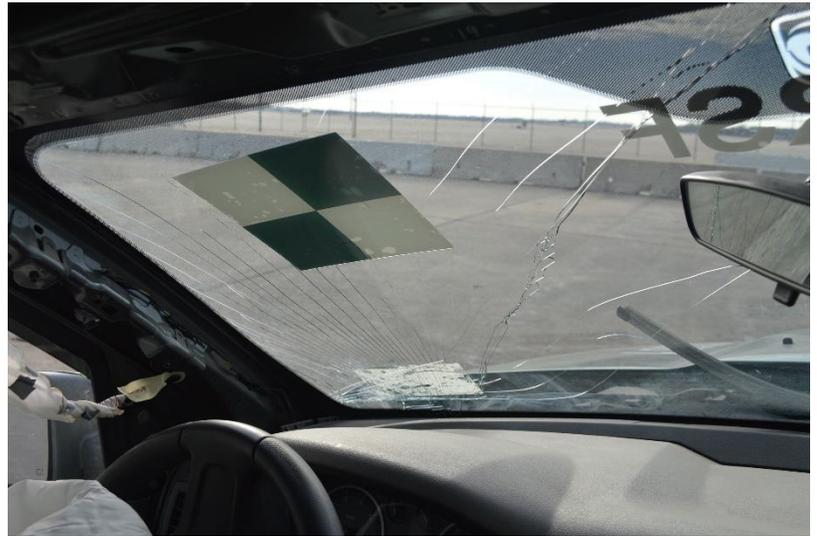
Figure 32. Vehicle Windshield Damage, Test No. OSSB-1

The left-front tire was torn and in contact with the fender, but was not disengaged from the rim. The left-front tire rim and hubcap were crushed, and the hubcap was disengaged from the tire. No engine damage occurred, and the windshield was cracked extending from its bottom-left and right corners. The remaining windows were undamaged.
