*Ohio Department of Transportation  
Research Project Number TPF-5(193) Supplement #117*

# **MASH TL-3 EVALUATION OF THE UNREINFORCED, SINGLE-SLOPE CONCRETE MEDIAN BARRIER**

## **MIDWEST ROADSIDE SAFETY FACILITY**

MwRSF Research Report No. TRP-03-388-18

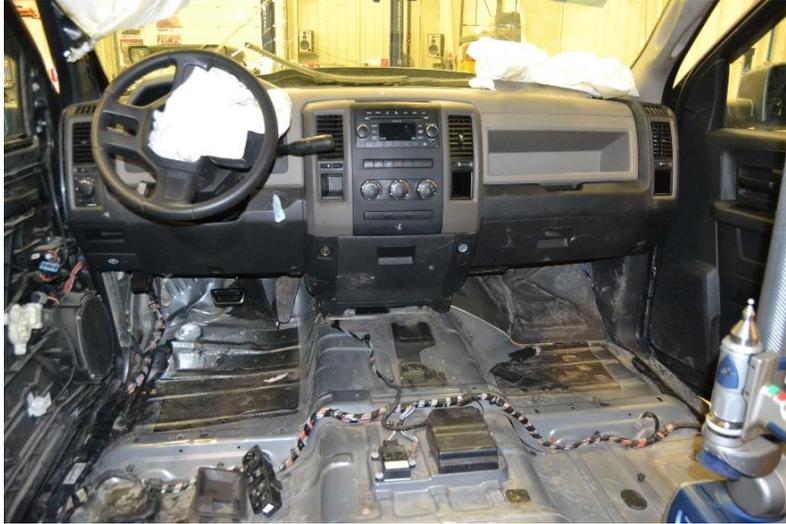
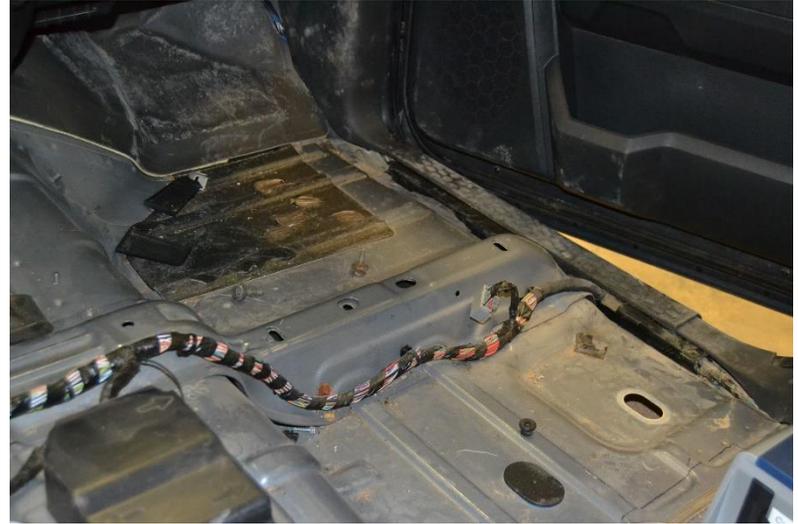
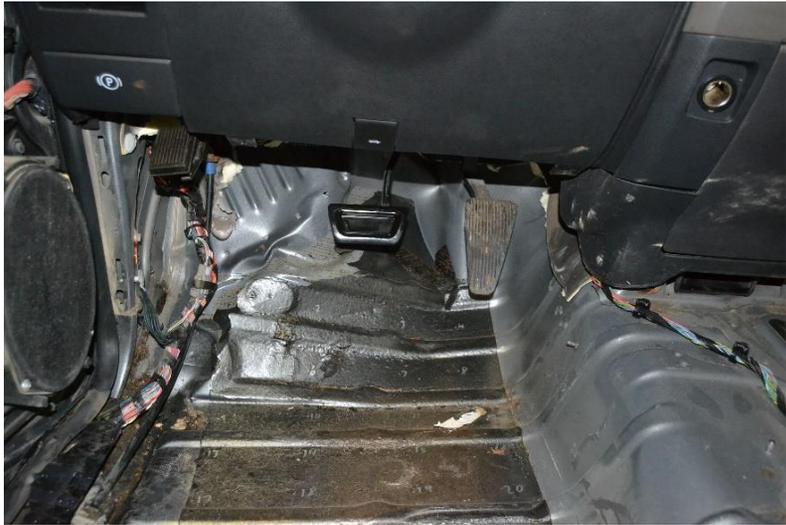
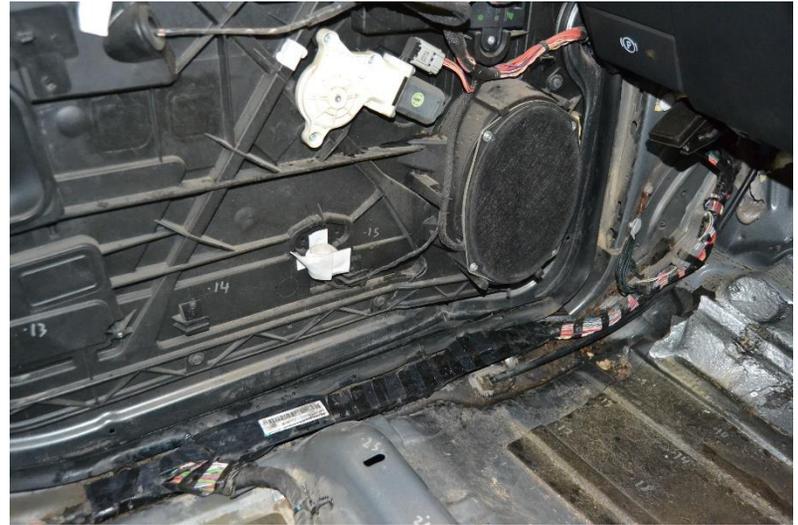
Figure 33. Occupant Compartment Damage, Test No. OSSB-1

The damage to the vehicle was moderate, as shown in Figures 29 through 34. The maximum occupant compartment deformations are listed in Table 5 along with the deformation limits established in MASH 2016 for various areas of the occupant compartment. None of the established MASH 2016 deformation limits were violated. Complete occupant compartment and vehicle deformations and the corresponding locations are provided in Appendix C. Note that floor pan deformation and occupant compartment deformation data for reference set 2 have been omitted from Appendix C due to errors in data acquisition.
