MASH TL-3 EVALUATION OF CONCRETE AND ASPHALT TIED-DOWN ANCHORAGE FOR PORTABLE CONCRETE BARRIER

MIDWEST ROADSIDE SAFETY FACILITY

MwRSF Research Report No. TRP-03-386-19

April 12, 2019

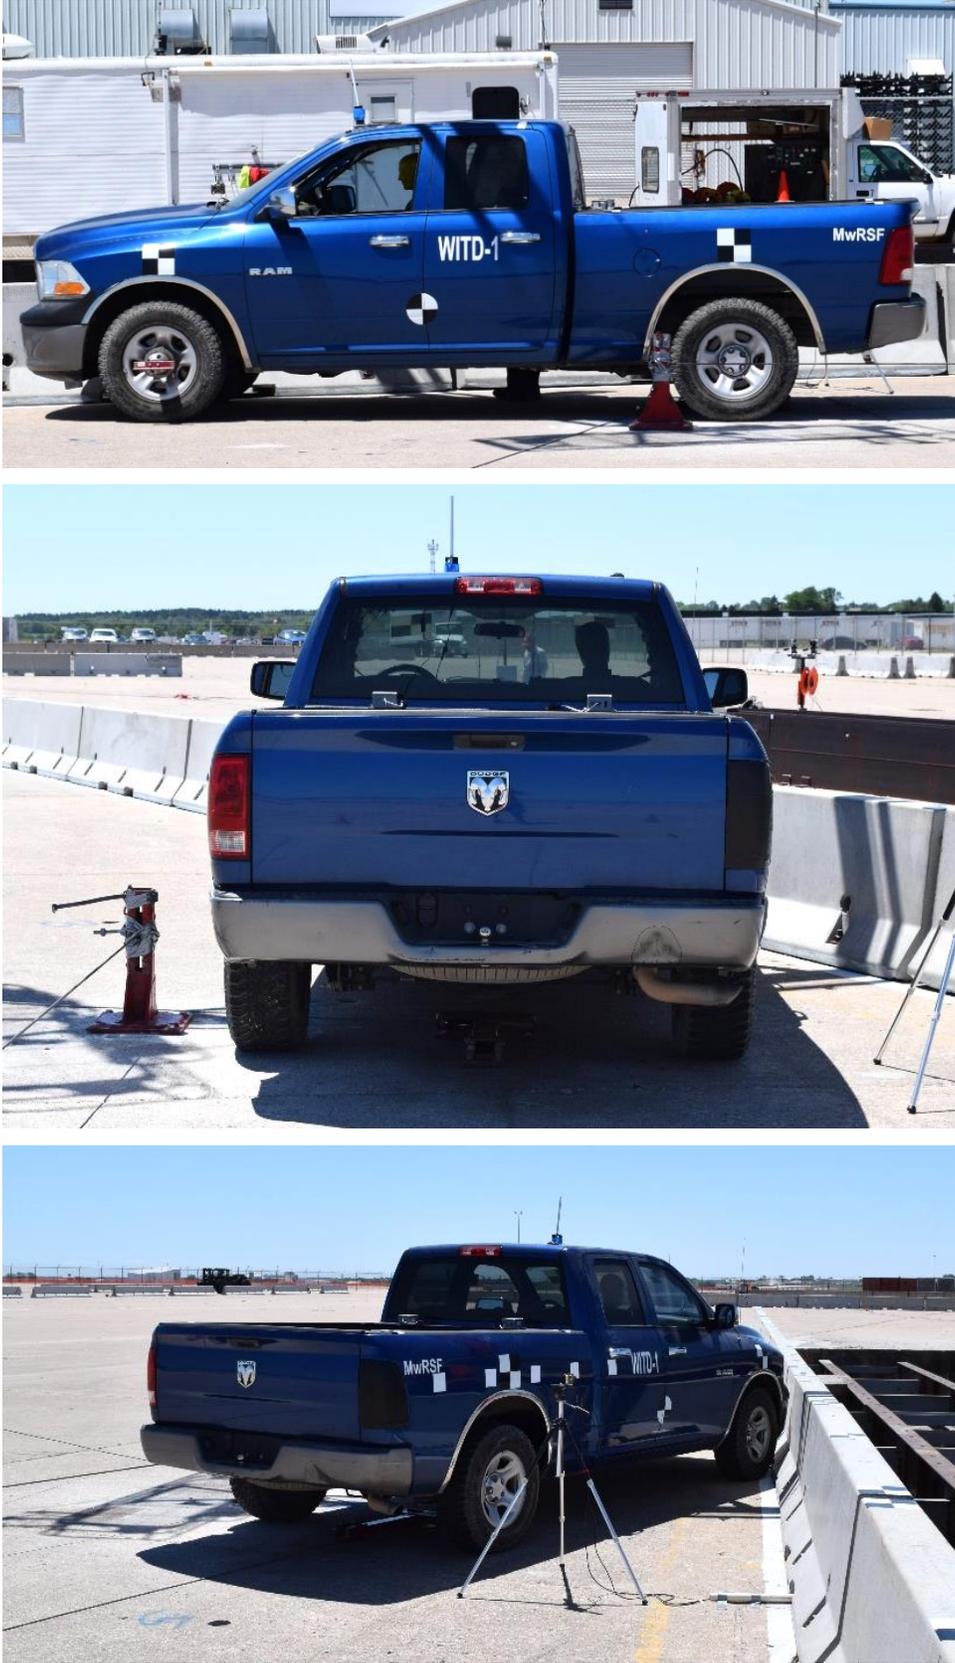
Figure 3. Test Vehicle, Test No. WITD-1

For test no. WITD-1, a 2011 Dodge Ram 1500 quad cab pickup truck was used as the test vehicle. The curb, test inertial, and gross static vehicle weights were 4,950 lb (2,245 kg), 5,000 lb (2,268 kg), and 5,154 lb (2,338 kg), respectively. The test vehicle is shown in Figures 3 and 4, and vehicle dimensions are shown in Figure 5. Note that pre-test photographs of the vehicle's undercarriage for test no. WITD-1 are not available.

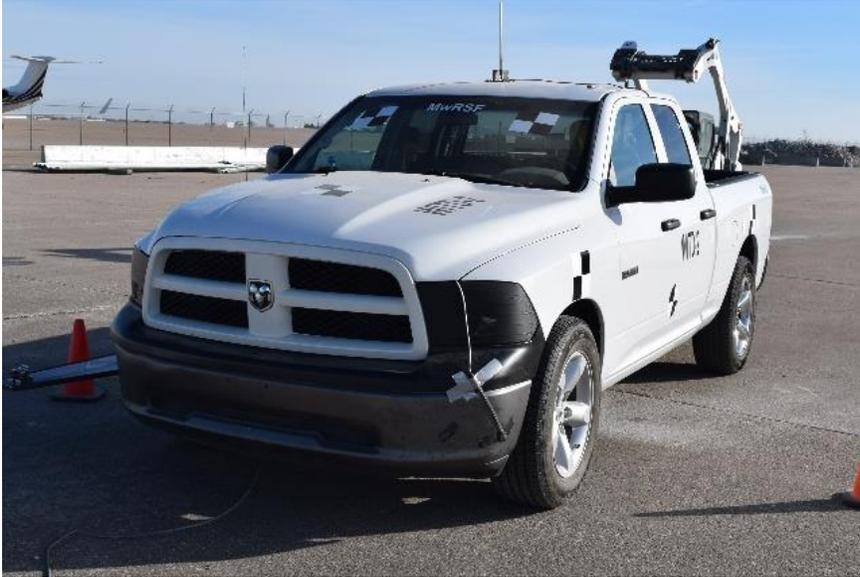
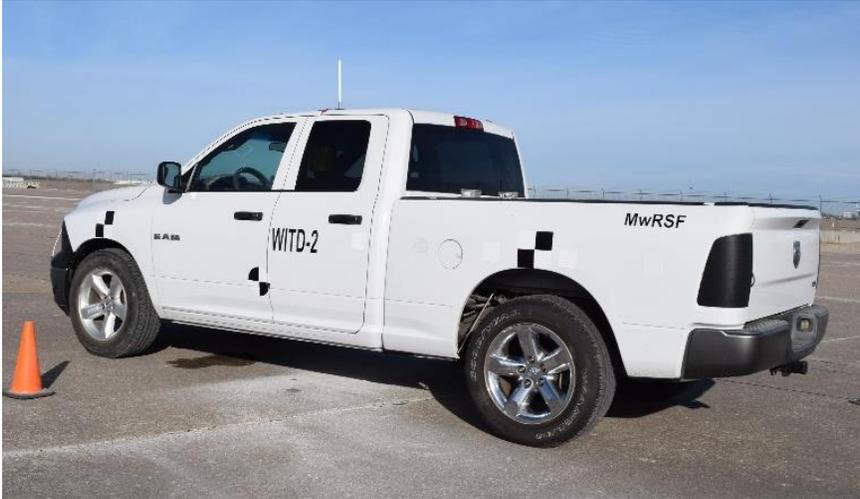
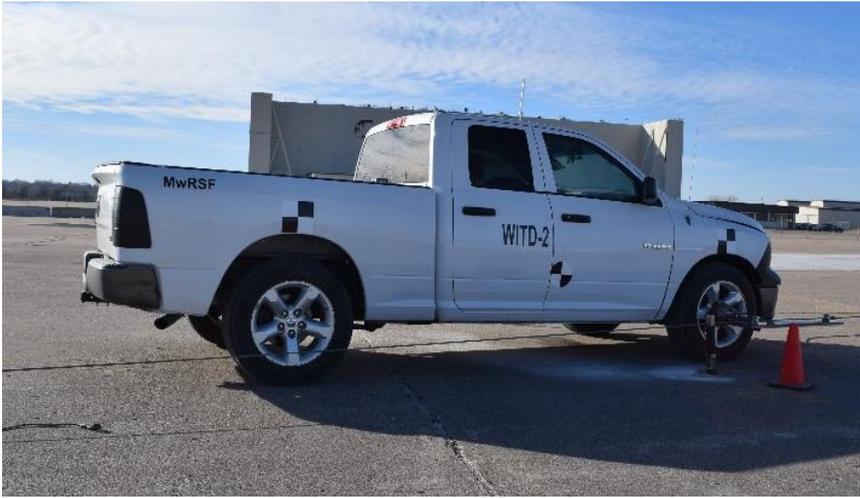
Figure 6. Test Vehicle, Test No. WITD-2

For test no. WITD-2, a 2010 Dodge Ram 1500 quad cab pickup truck was used as the test vehicle. The curb, test inertial, and gross static vehicle weights were 5,075 lb (2,302 kg), 5,003 lb (2,269 kg), and 5,157 lb (2,339 kg), respectively. The test vehicle is shown in Figures 6 and 7, and vehicle dimensions are shown in Figure 8.

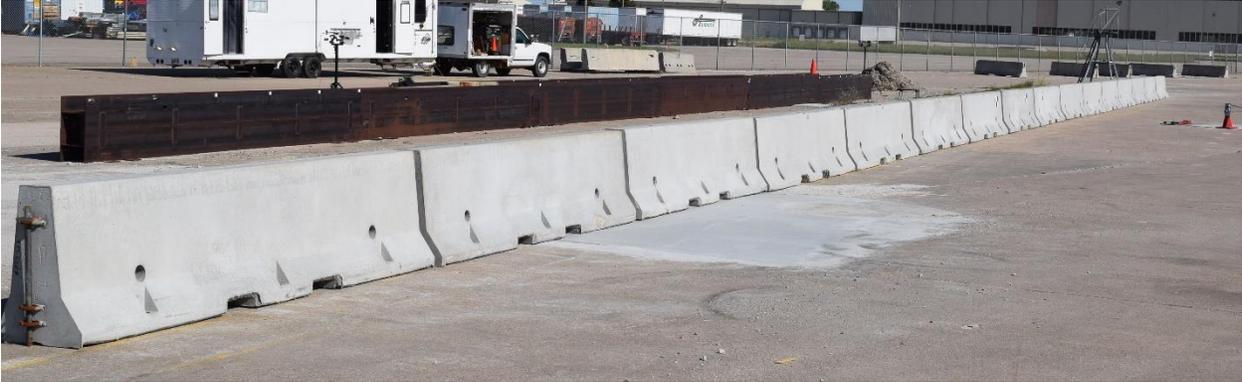
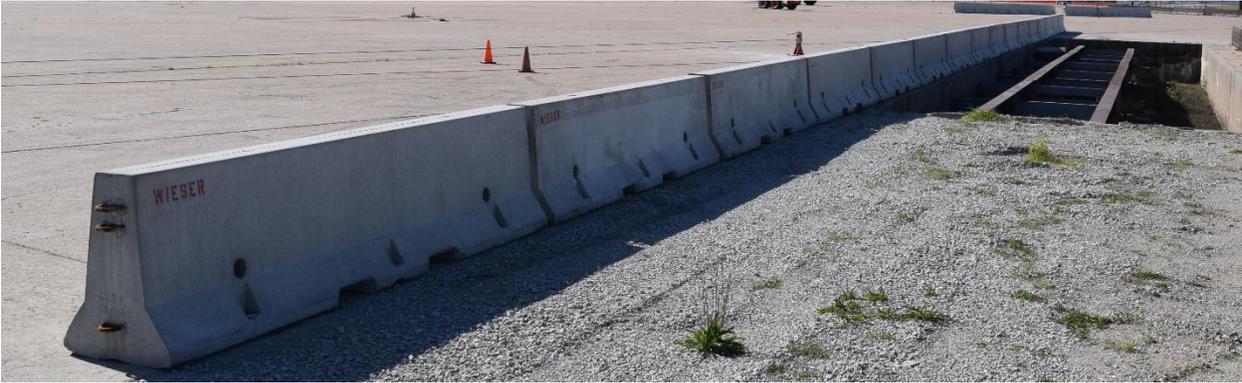
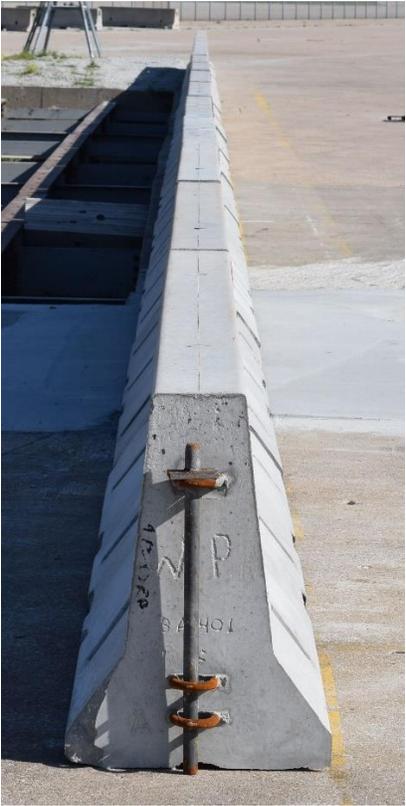
Figure 22. Test Installation Photographs, Test No. WITD-1

The test installation consisted of sixteen 12-ft 6-in. (3.8-m) long WisDOT PCBs in a bolt-through, tie-down configuration for use on concrete. The system was installed with the rear toe of the PCBs placed 1 in. (25 mm) away from the edge of the simulated bridge deck, as shown in Figures 13 through 21. Photographs of the test installation are shown in Figures 22 and 23. Material specifications, mill certifications, and certificates of conformity for the system materials are shown in Appendix A.

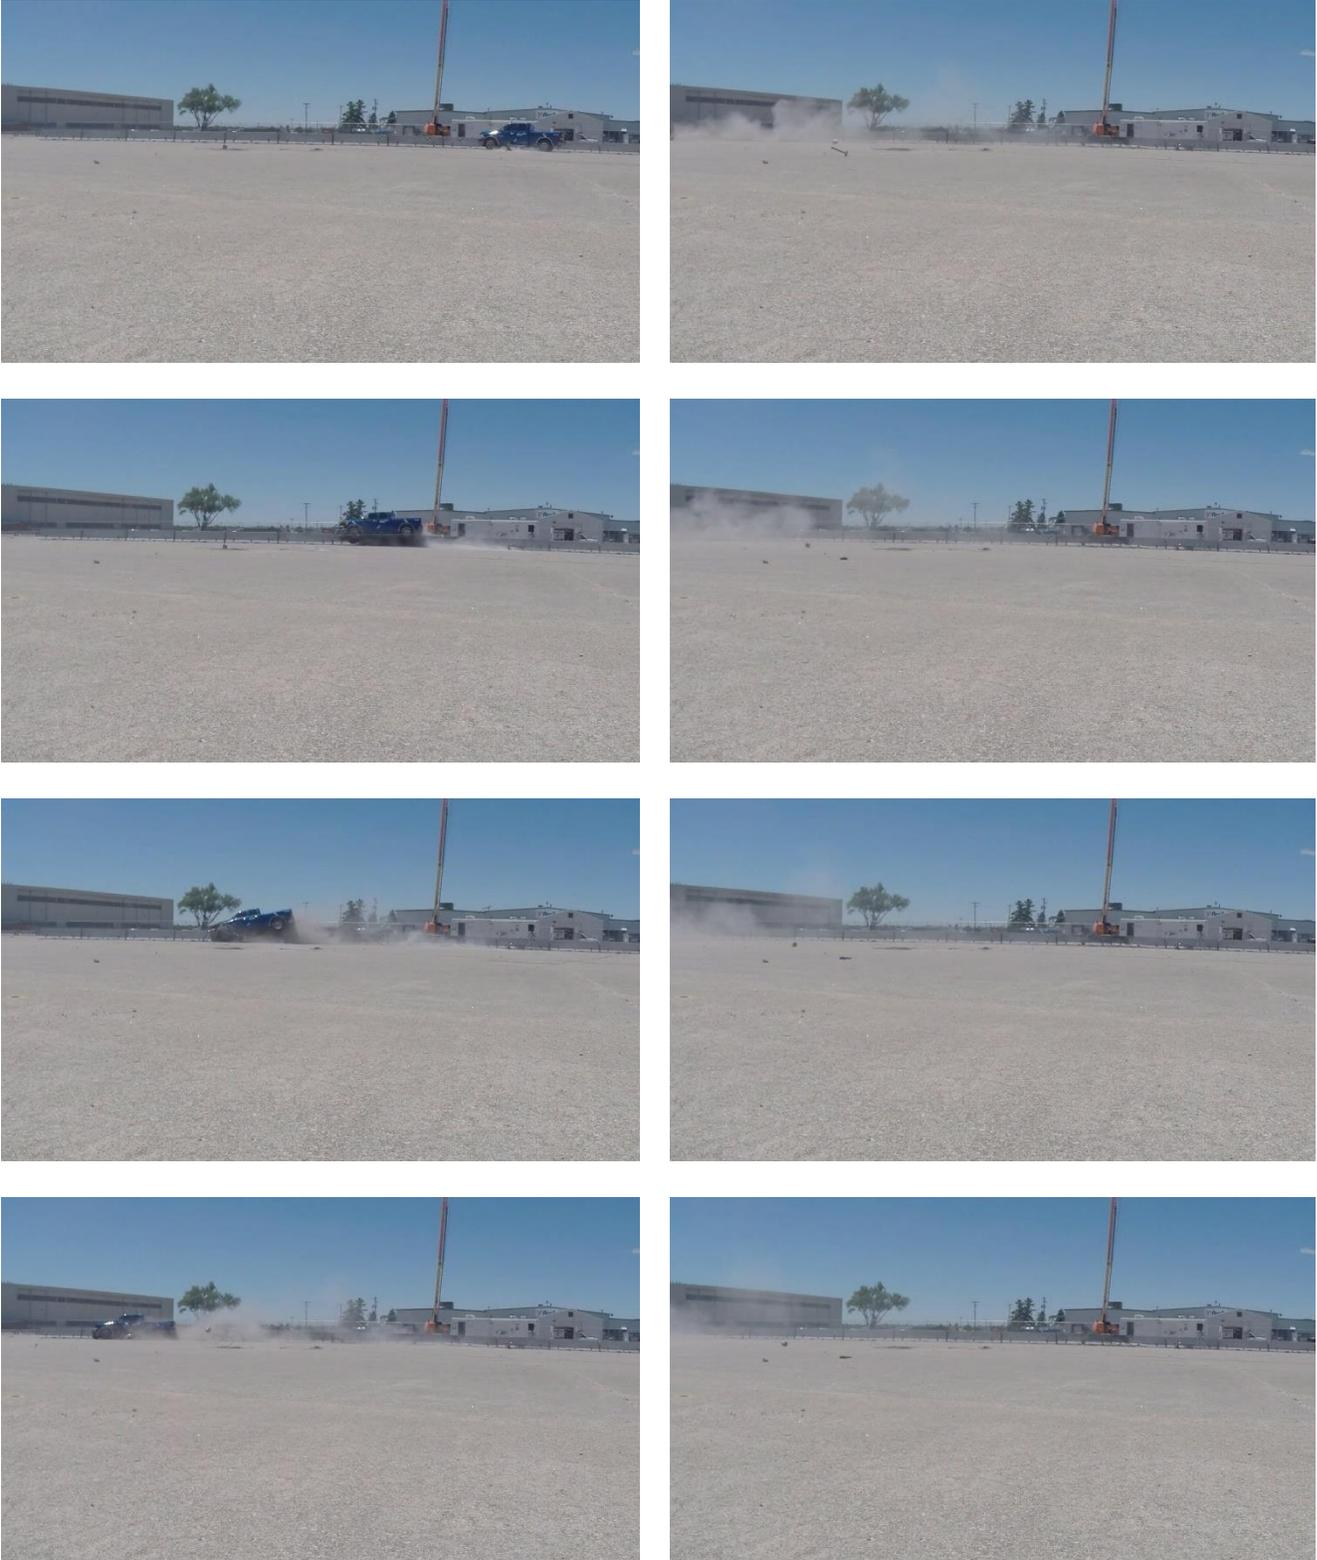
Figure 28. Additional Documentary Photographs, Test No. WITD-1

A detailed description of the sequential impact events is contained in Table 4. Sequential photographs are shown in Figures 25 and 26. Documentary photographs of the crash test are shown in Figures 27 and 28. The vehicle trajectory and final position are shown in Figure 29.

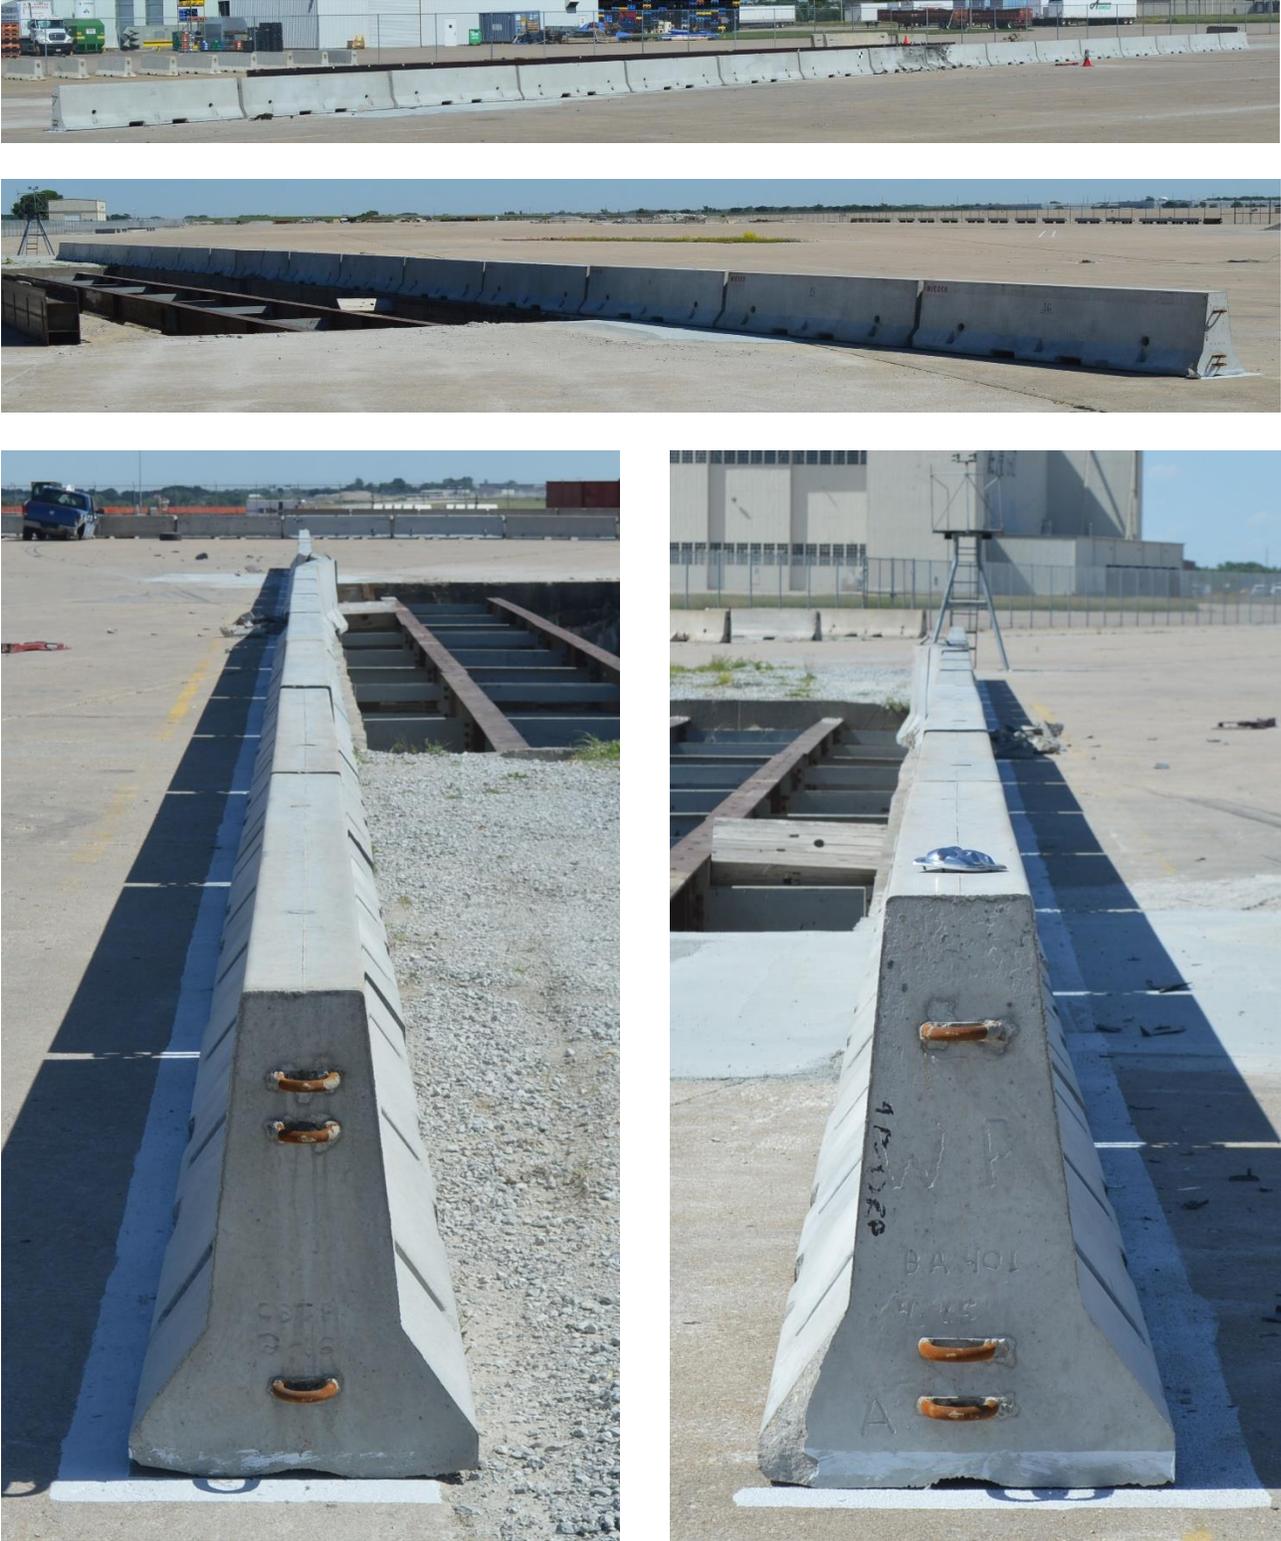
Figure 30. System Damage – Front, Back, Downstream, and Upstream Views, Test No. WITD-1

Damage to the barrier was moderate, as shown in Figures 30 through 36. Barrier damage consisted of contact marks on the front face of the concrete segments, spalling of the concrete, and concrete cracking and fracture. The length of vehicle contact along the barrier was approximately 18 ft – 1³/₄ in. (5.5 m) which spanned from 5 ft – 4³/₄ in. upstream from the downstream edge of barrier no. 8 to 3¹/₄ in. (83 mm) upstream from the downstream end of barrier no. 9.

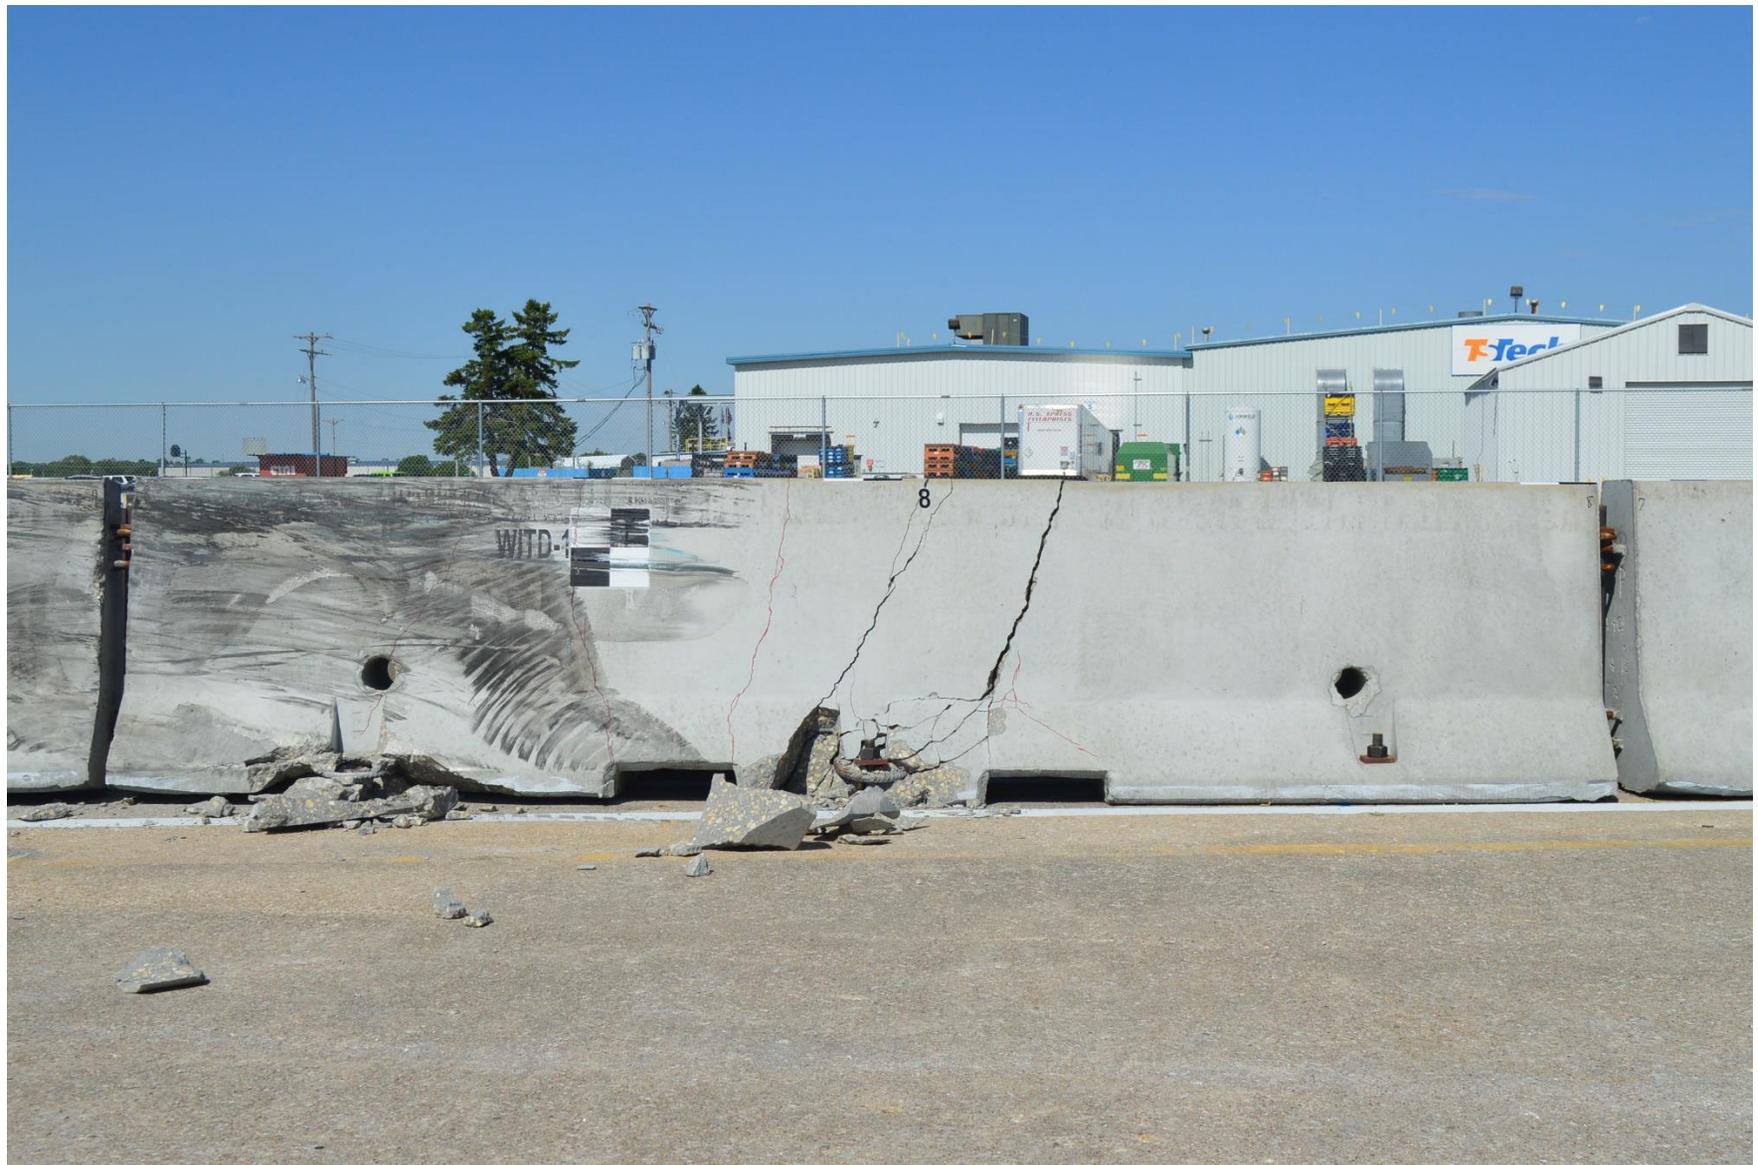
Figure 32. System Damage – Barrier No. 8 Traffic Side, Test No. WITD-1

Tire marks were visible on the front face of barrier nos. 8 and 9. The front face of barrier no. 8 also contained extensive spalling, gouging, cracking and fracturing. Two major cracks were found 7 ft – 1³/₈ in. (2.2 m) downstream from the upstream edge of barrier no. 8 and 7 ft – 4³/₈ in. (2.2 m) downstream from the upstream edge of barrier no. 8, which extended across the front, top, and partially down the rear faces of the barrier. An additional major crack was found 4 ft – 2³/₄ in. (1.3 m) upstream from the downstream edge of barrier no. 8, which extended vertically across the front face of the barrier and terminated on the top face 3 ft – 10⁵/₈ in. upstream from the downstream end of the barrier. These cracks measured 3 ft – 1/2 in. (0.9 m), 2 ft – 9⁷/₈ in. (0.9 m), and 2 ft – 9¹/₄ in. (0.8 m) in length, respectively. Minor cracks were also found across the front face of barrier no. 8 located 4 ft – 4³/₄ in. (1.3 m) downstream from the upstream edge and 2 ft – 1³/₄ in. (0.7 m) upstream from the downstream edge. Concrete spalling with disengaged pieces occurred on the front face of barrier no. 8. One disengaged piece of concrete measured 27³/₄ in. x 10¹/₂ in. x 7⁷/₈ in. (705 mm x 267 mm x 200 mm) and was located 5 ft – 1 in. (1.5 m) downstream from the upstream edge of barrier no. 8. Another disengaged piece of concrete measured 39 in. x 6¹/₂ in. x 10³/₈ in. (991 mm x 165 mm x 264 mm) and was located 3 ft – 7¹/₈ in. (1.1 m) upstream from the downstream edge of barrier no. 8. A 30¹/₂-in. (775-mm) long fracture was also found on the front face of barrier no. 8, starting 5 ft – 3 in. (1.6 m) downstream from the upstream edge of barrier no. 8 at its base and extending vertically through the entire barrier. A piece of concrete, measuring 29¹/₂ in. x 7⁷/₈ in. x 3 in. (749 mm x 194 mm x 76 mm), disengaged from the back side of barrier no. 8 approximately 6 ft – 3¹/₂ in. (1.9 m) upstream from the downstream edge of the barrier.

The anchor rods and anchor pockets in barrier nos. 8 and 9 were damaged. Anchor pocket nos. 2 and 3 (middle anchor and downstream pockets) in barrier no. 8 and all three anchor pockets in barrier no. 9 spalled and exposed the anchor pocket rebar loop bars. Anchor rod no. 3 (downstream anchor rod) in barrier no. 8 and anchor rod no.1 (upstream anchor) in barrier no. 9 bent and fractured at the ground line. The anchor pocket no. 2 (middle anchor pocket) exposed rebar loop bar in barrier no. 9 was also deformed downward. Anchor rods and anchor pockets on all remaining barriers remained undamaged.

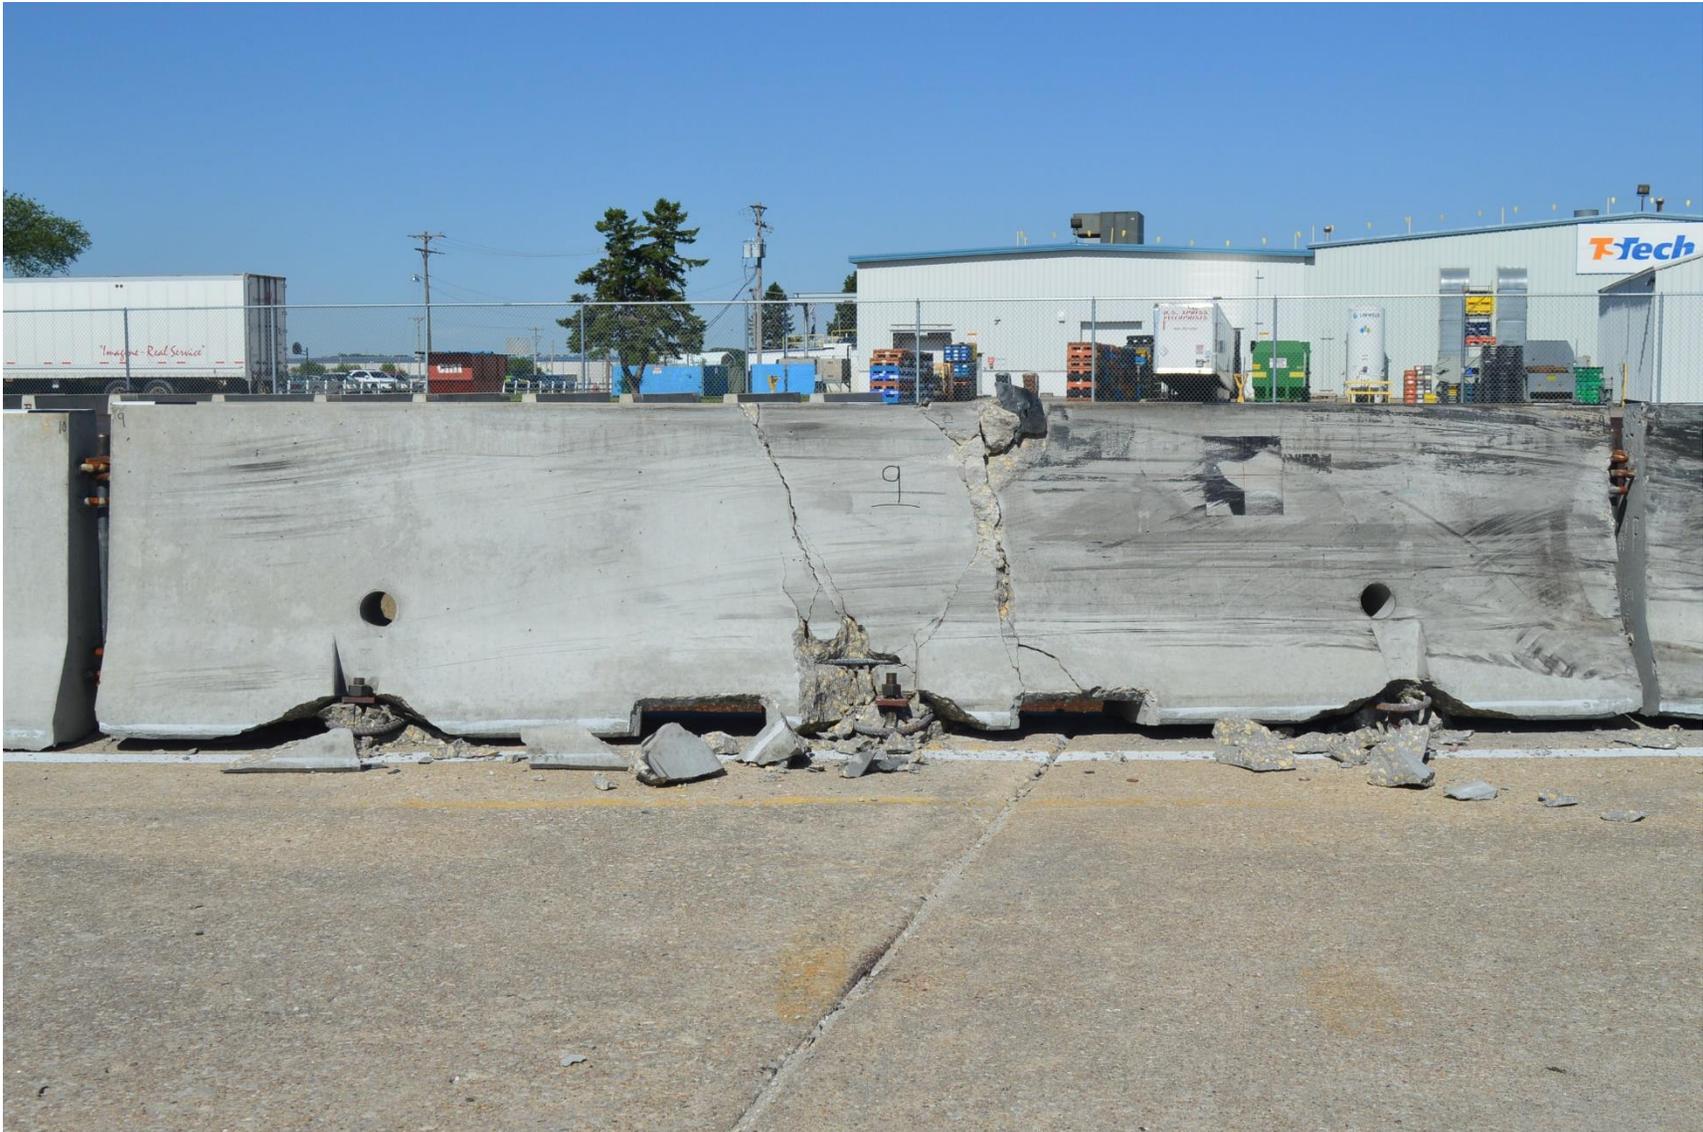
Figure 34. System Damage – Barrier No. 9 Traffic Side, Test No. WITD-1

The front face of barrier no. 9 had similar damage to the front face of barrier no. 8. A major crack originated at the base of the barrier 6 ft – 6¹/₂ in. (2.0 m) downstream from the upstream edge of barrier no. 9 and extended vertically 27¹/₂ in. (699-mm) across the front and top faces before terminating on the top rear edge. Significant spalling on the front face of barrier no. 9 occurred 1 ft – 1 in. (0.3 m) downstream from the upstream edge, 5 ft – 6¹/₈ in. (1.7 m) downstream from the upstream edge, and 2 ft – 8⁷/₈ (0.8 m) upstream from the downstream edge; the disengaged pieces measured 23 in. x 5¹/₈ in. x 20³/₄ in. (584 mm x 130 mm x 527 mm), 19¹/₂ in. x 13 in. x 6¹/₂ in. (495 mm x 330 mm x 165 mm), and 19¹/₄ in. x 5¹/₄ in. x 12³/₈ in. (489-mm x 133-mm x 314-mm), respectively. A fracture was found 4 ft – 9¹/₈ in. (1.5 m) downstream from the upstream edge of barrier no. 9 which began at the base and continued all the way through the top face. The back side of barrier no. 9 also encountered two major disengaged pieces of concrete, measuring 23¹/₂ in. (597 mm) and 65¹/₂ in. (1,664 mm) in length, and were found 9¹/₂ in. (241-mm) upstream from the downstream edge of barrier no. 9 and 1 ft – 10 in. (0.6 m) downstream from the upstream edge of barrier no. 9, respectively. The remaining barriers, as well as the joint connection pins between all barriers, showed no damage.

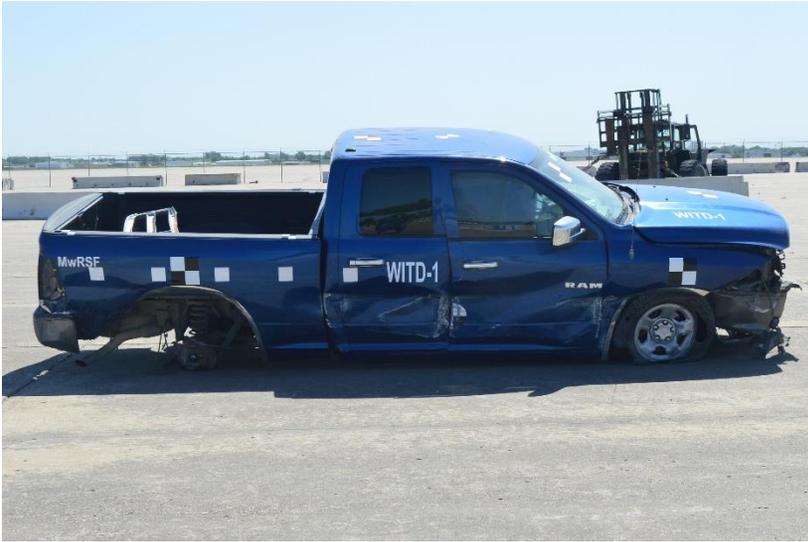
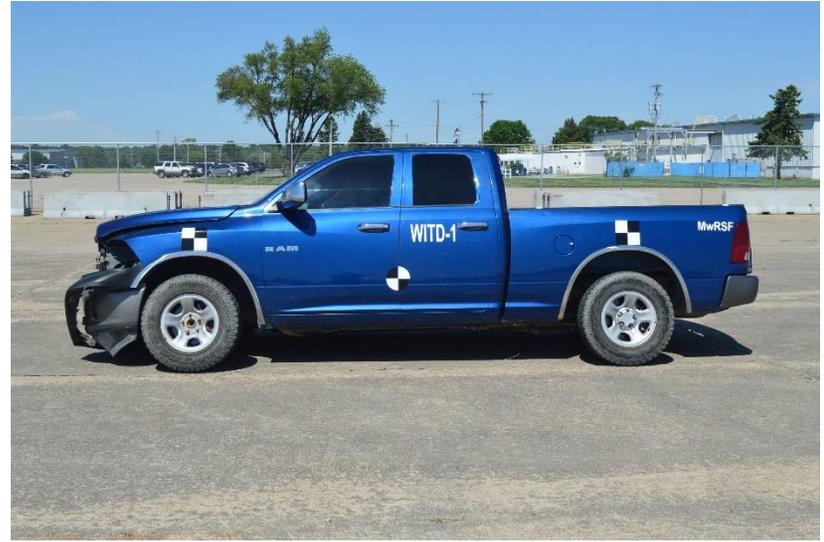
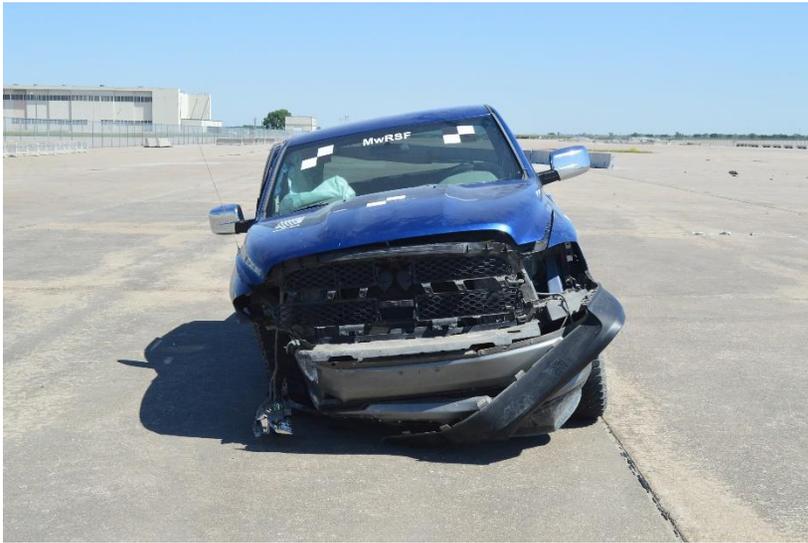
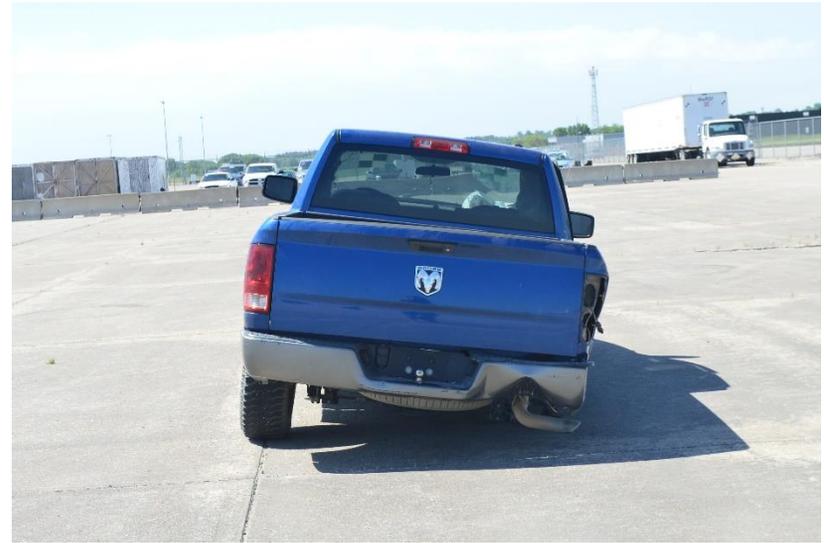
Figure 38. Vehicle Damage, Test No. WITD-1

The damage to the vehicle was moderate, as shown in Figures 38 through 43. The maximum occupant compartment intrusions are listed in Table 5 along with the intrusion limits established in MASH 2016 for various areas of the occupant compartment. MASH 2016 defines intrusion or deformation as the occupant compartment being deformed and reduced in size with no observed penetration. There were no penetrations into the occupant compartment and none of the established MASH 2016 deformation limits were violated. The A-pillar (lateral) and side door (above seat) deformed slightly outward, which is not considered crush toward the occupant, is denoted as negative numbers in Table 5, and is not evaluated by MASH 2016 criteria. Complete occupant compartment and vehicle deformations and the corresponding locations are provided in Appendix D.

The majority of the damage was concentrated on the right-front corner and right side of the vehicle where the impact occurred. Scraping and contact marks extended the entire length of the vehicle on the right side. The right-rear taillight, the right-rear wheel, the right and left headlights, the front bumper fascia, and the grille disengaged from the vehicle. Numerous dents were found along the right side of the vehicle. The largest dent measured 43½ in. x 14 in. x 1¾ in. (1,105 mm x 356 mm x 44 mm) and was located near the rear edge of the right-front door. No other dent measured more than 20 in. (508 mm) long. Small bends or buckles were found on the right quarter panel, the brake backing plate, the right-rear door, and the right fender. Several larger kinks were visible on the front bumper where impact occurred. A few notable gouges were found on the right quarter panel just behind the right-rear door, one measuring 15 in. (381 mm) in length. Smaller gouges were scattered along the front bumper. The right-front, right-rear, and left-front doors all had gaps along their rear front and top edges. The right-rear door had the largest gap of ¾ in. (83 mm) and the left-front door had the smallest gaps, never surpassing 2 in. (51 mm). Tearing was found near the right-front door, the side wall of the right-front tire, and the right side of the front bumper fascia. The right-front, left-front, and right-rear doors could not open because of their deformations. The windshield had a 25-in. x 6-in. (635-mm x 152-mm) spider-web crack. All other window glass as well as the roof remained undamaged. The left-front and left-rear wheels and doors were undamaged.

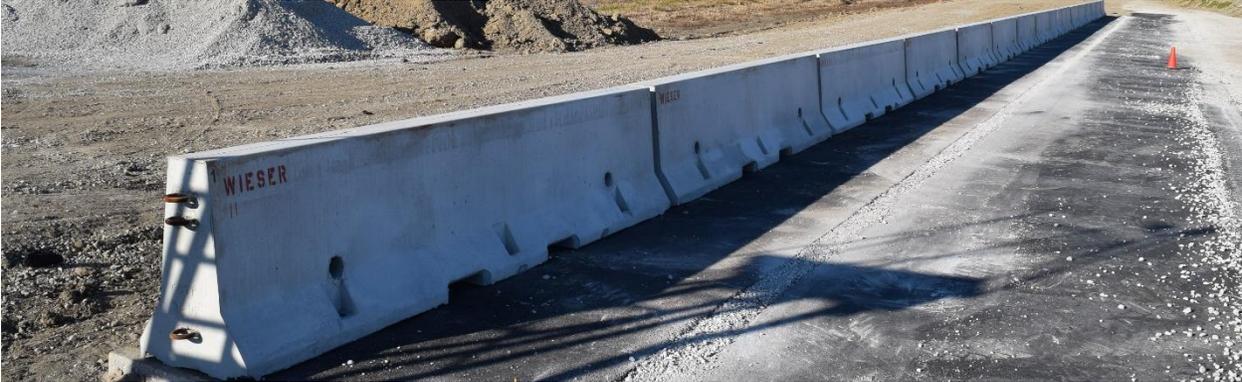
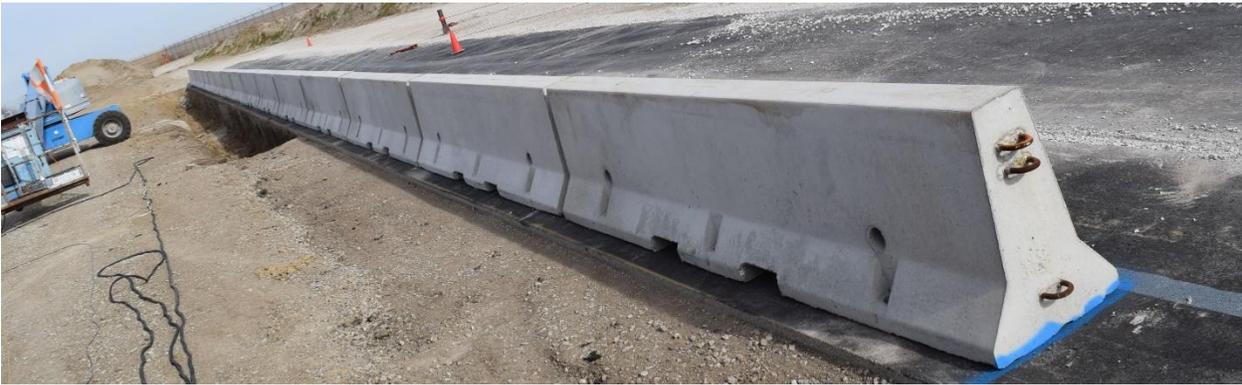
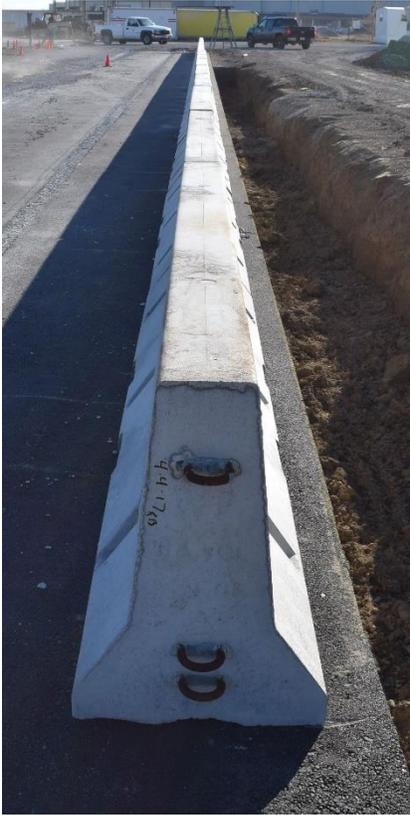
Figure 56. Test Installation Photographs, Test No. WITD-2

The test installation consisted of sixteen 12-ft 6-in. (3.8-m) long WisDOT PCBs in a pinned, tie-down configuration for use with asphalt, as shown in Figures 45 through 55. Photographs of the test installation are shown in Figures 56 and 57. Material specifications, mill certifications, and certificates of conformity for the system materials are shown in Appendix A.

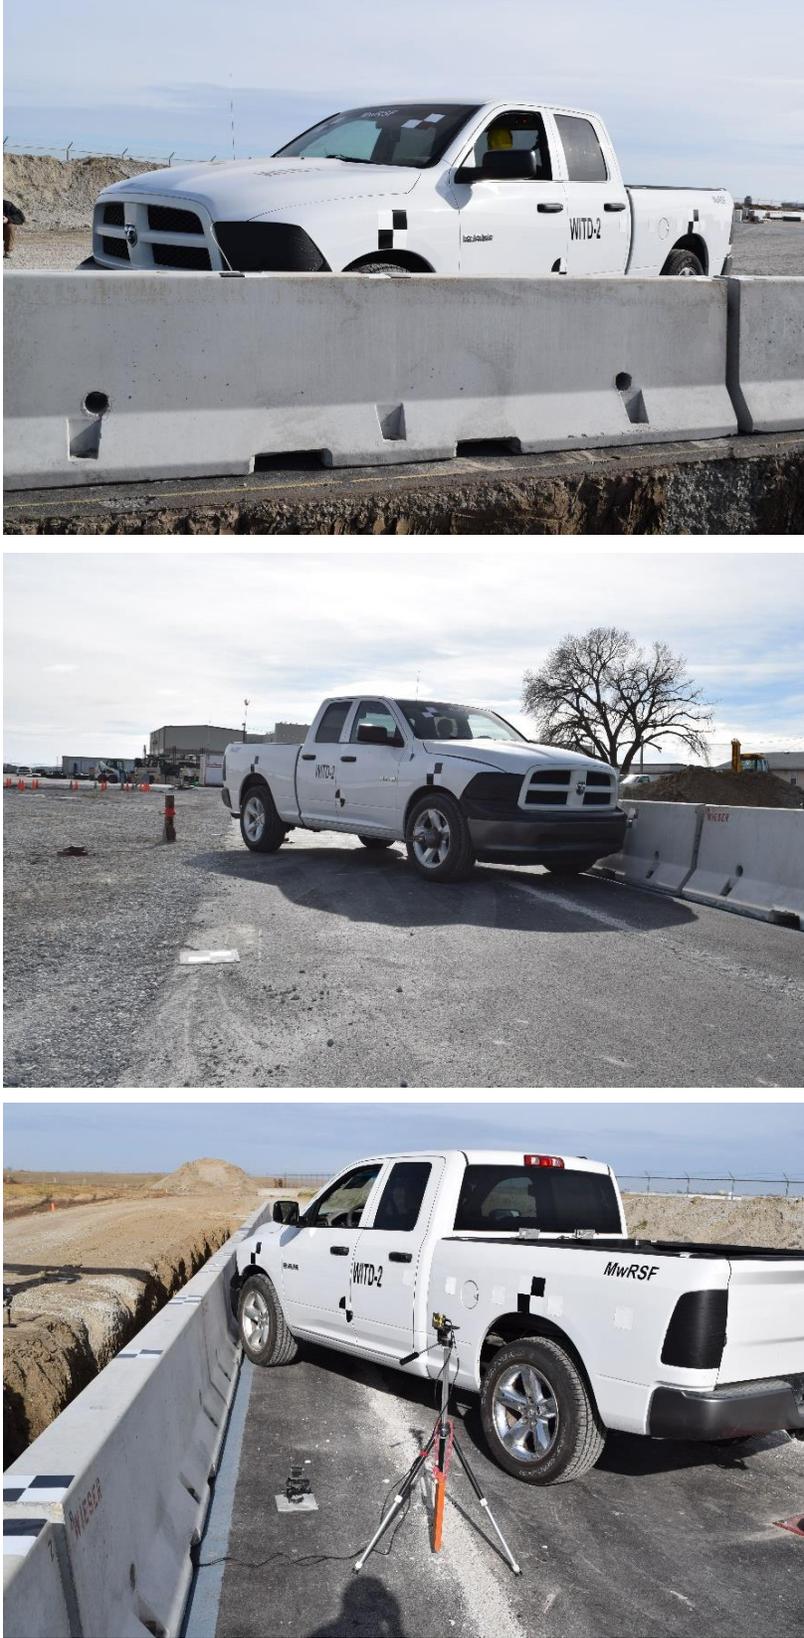
Figure 58. Impact Location, Test No. WITD-2

Initial vehicle impact was to occur 4 ft – 3³/₁₆ in. (1.3 m) upstream from the centerline of the joint between barrier nos. 9 and 10, as shown in Figure 58, which was selected using Table 2.7 of MASH 2016. The 5,003-lb (2,269-kg) quad cab pickup truck impacted the pinned, tie-down PCB system on asphalt at a speed of 62.0 mph (99.8 km/h) and at an angle of 25.1 degrees. The actual point of impact was 4.3 in. (109 mm) downstream from the target location. The vehicle came to rest 160 ft – 4 in. (48.9 m) downstream from the impact point and 8 ft – 11 in. (2.7 m) laterally behind the traffic side of the barrier after brakes were applied.

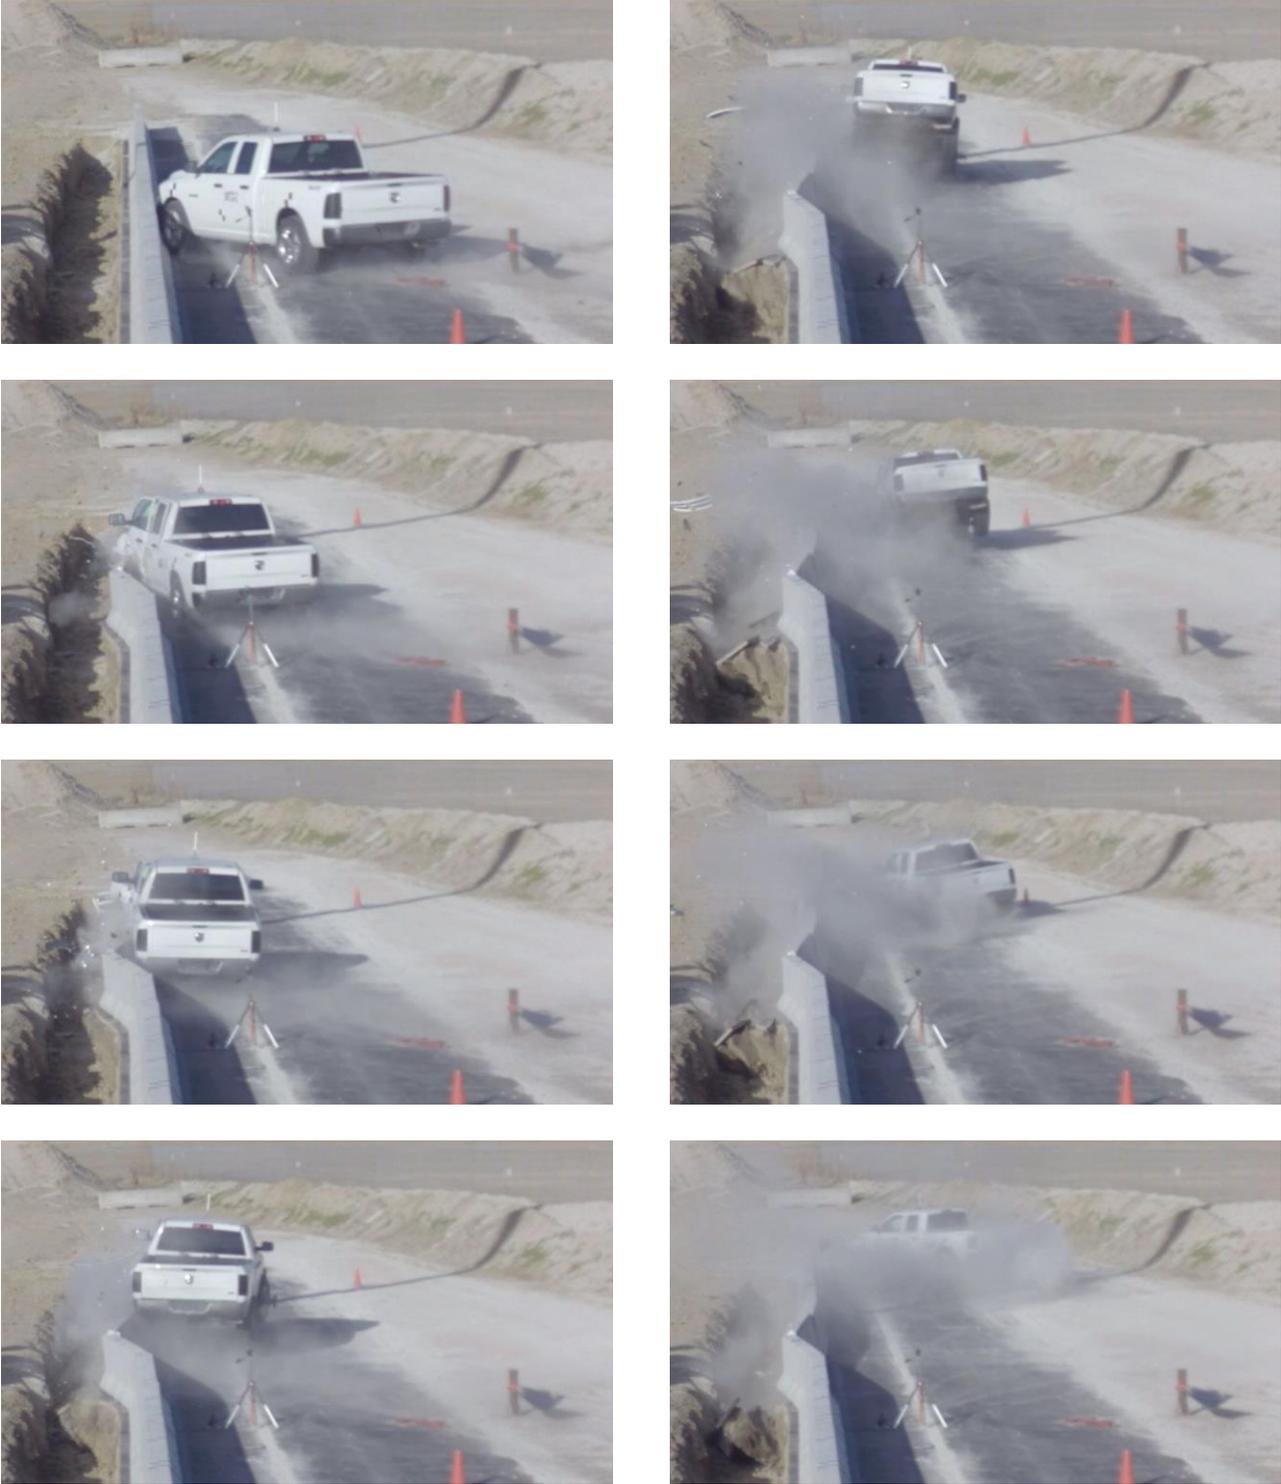
Figure 61. Documentary Photographs, Test No. WITD-2

A detailed description of the sequential impact events is contained in Table 8. Sequential photographs are shown in Figures 59 and 60. Documentary photographs of the crash test are shown in Figure 61. The vehicle trajectory and final position are shown in Figure 62.
