MASH TL-3 EVALUATION OF CONCRETE AND ASPHALT TIED-DOWN ANCHORAGE FOR PORTABLE CONCRETE BARRIER

MIDWEST ROADSIDE SAFETY FACILITY

MwRSF Research Report No. TRP-03-386-19

April 12, 2019

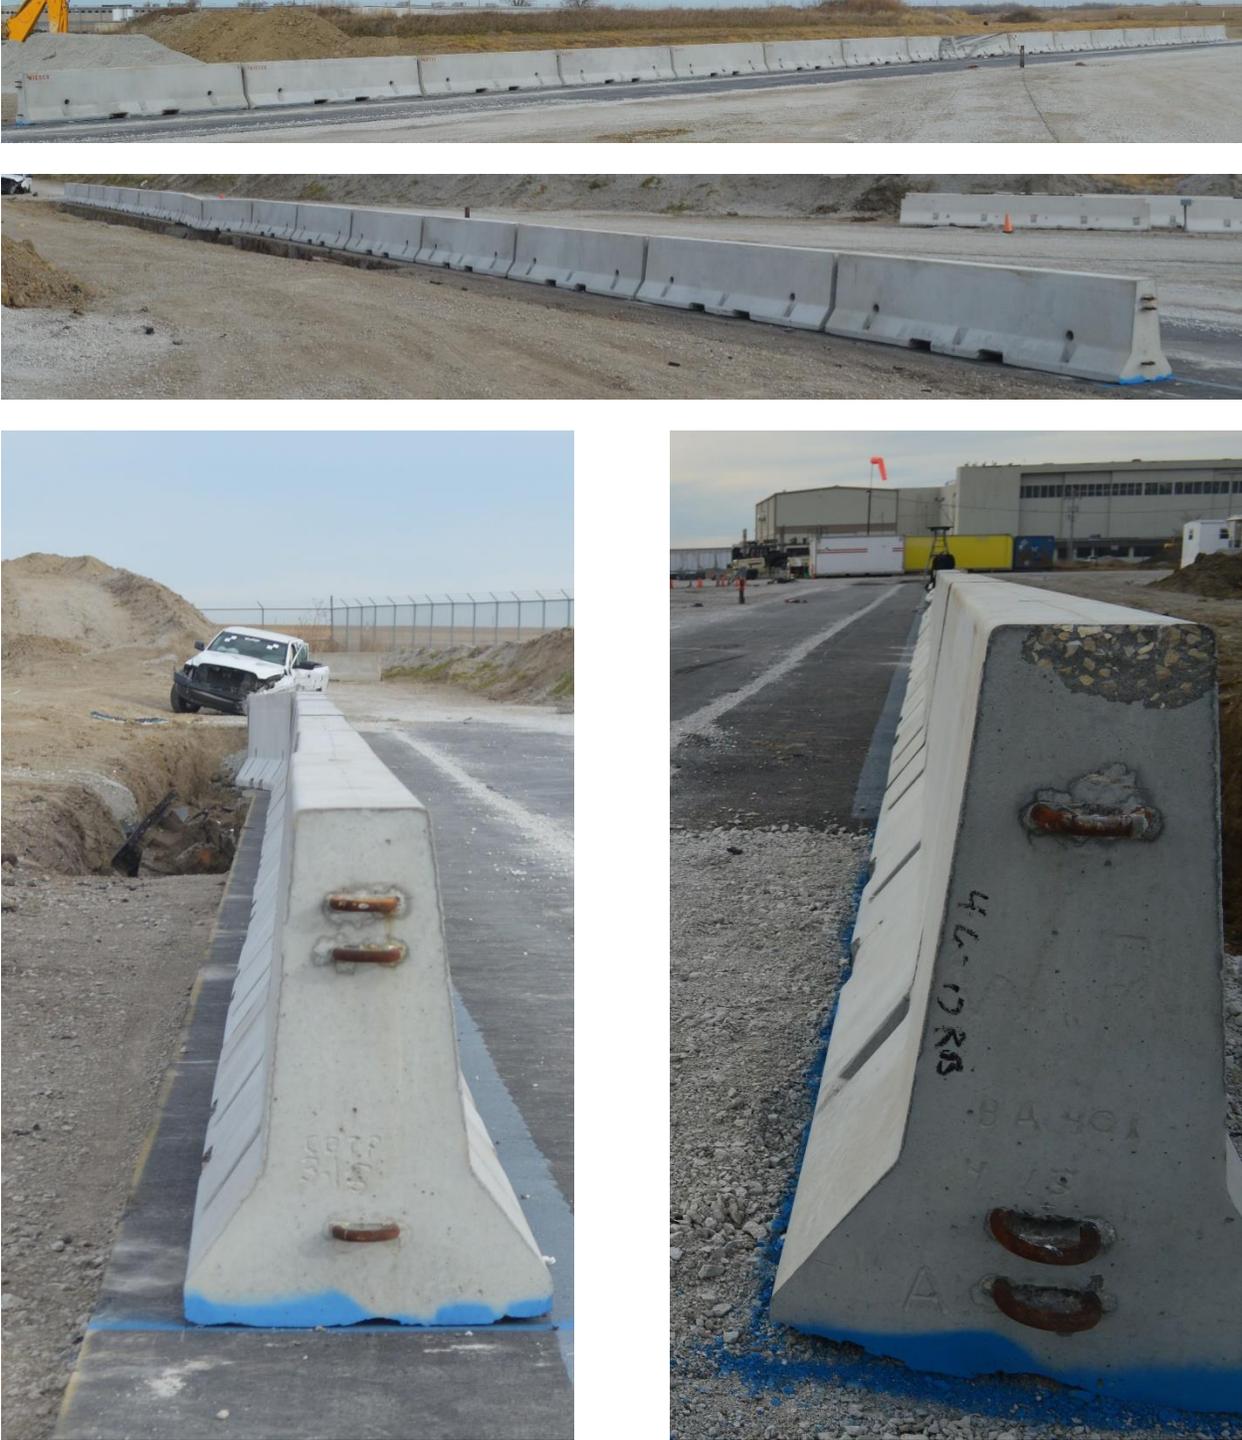
Figure 63. System Damage – Front, Back, Downstream, and Upstream Views, Test No. WITD-2

A piece of concrete at the front-upstream corner of barrier no. 10 disengaged beginning 12 in. (305 mm) from the base of barrier no. 10 and extending to the top. Spalling was found on barrier no. 11 along its upstream edge. Anchor pocket reinforcement was exposed 18 in. (457 mm) downstream from the upstream edge of barrier no. 11. However, the spalling found on barrier no. 11 was much less significant than the spalling found on barrier nos. 9 and 10. The joint connection pin located between barriers nos. 9 and 10 was bent at the top and bottom, as shown in Figure 67. The joint connection pins located between all other barriers were undamaged.

All three anchor pockets on barrier no. 8 were undamaged. The three anchor pins on barrier nos. 8 and 9 were displaced vertically. Anchor pin nos. 2 and 3 (middle and downstream anchor pins) on barrier no. 9 were also displaced laterally in the asphalt. All three anchor pins on barrier no. 10 were displaced vertically and laterally in the asphalt. The three anchor pins on barrier no. 11 were displaced vertically while anchor pin nos. 1 and 2 (upstream and middle anchor pins) were also displaced laterally in the asphalt. The remaining anchor pins and anchor pockets were undamaged.

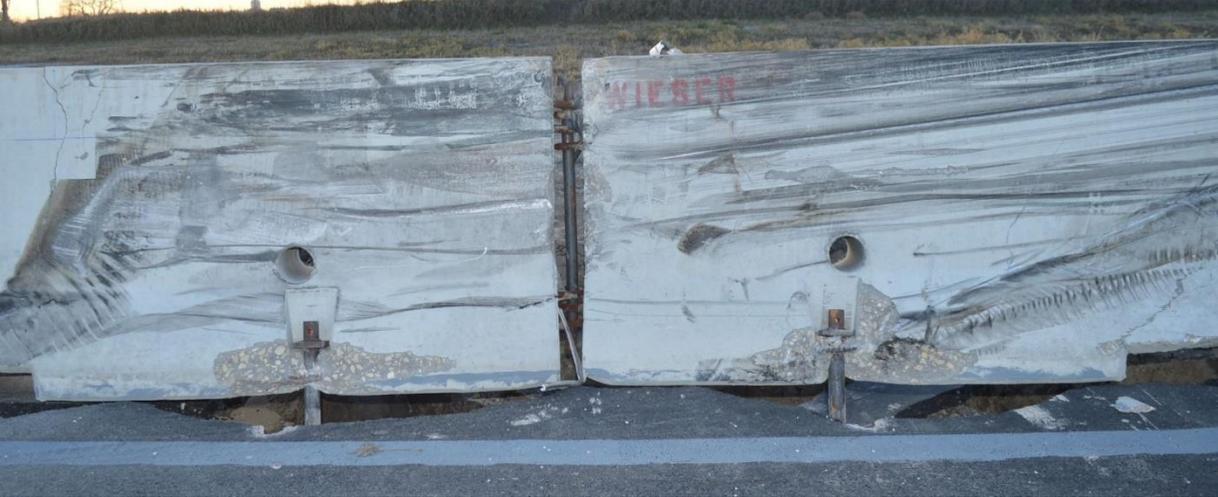
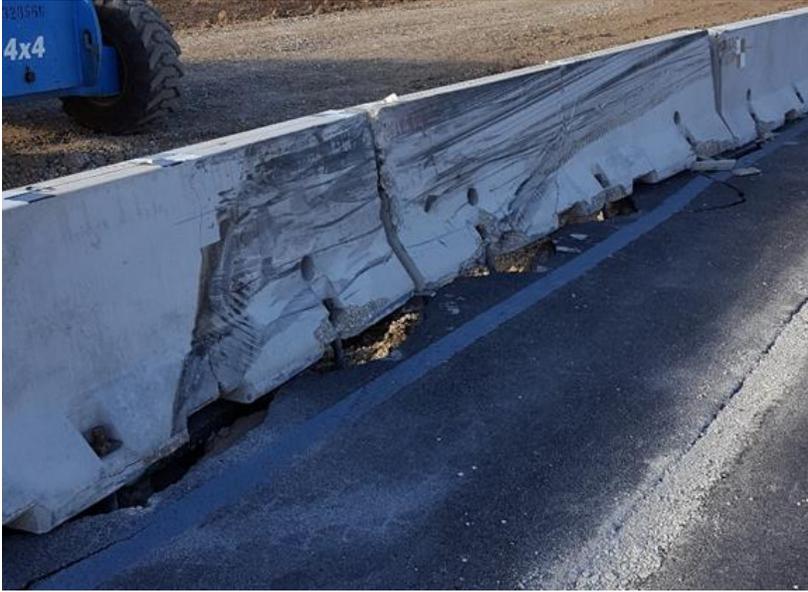
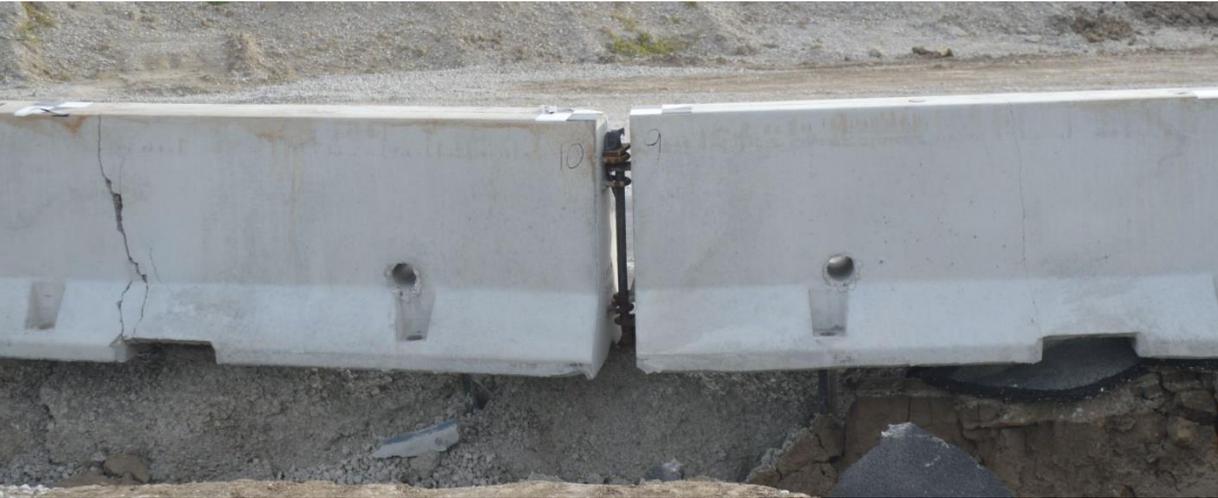
Figure 64. System Damage at Impact Location, Test No. WITD-2

Damage to the barrier was moderate, as shown in Figures 63 through 70. Barrier damage consisted of contact marks on the front face of the concrete segments, spalling of the concrete, and concrete and asphalt cracking. The length of vehicle contact along the barrier spanned from 7 in. (178 mm) downstream from the centerline of barrier no. 9 to 7 in. (178 mm) downstream from the upstream edge of barrier no. 11.

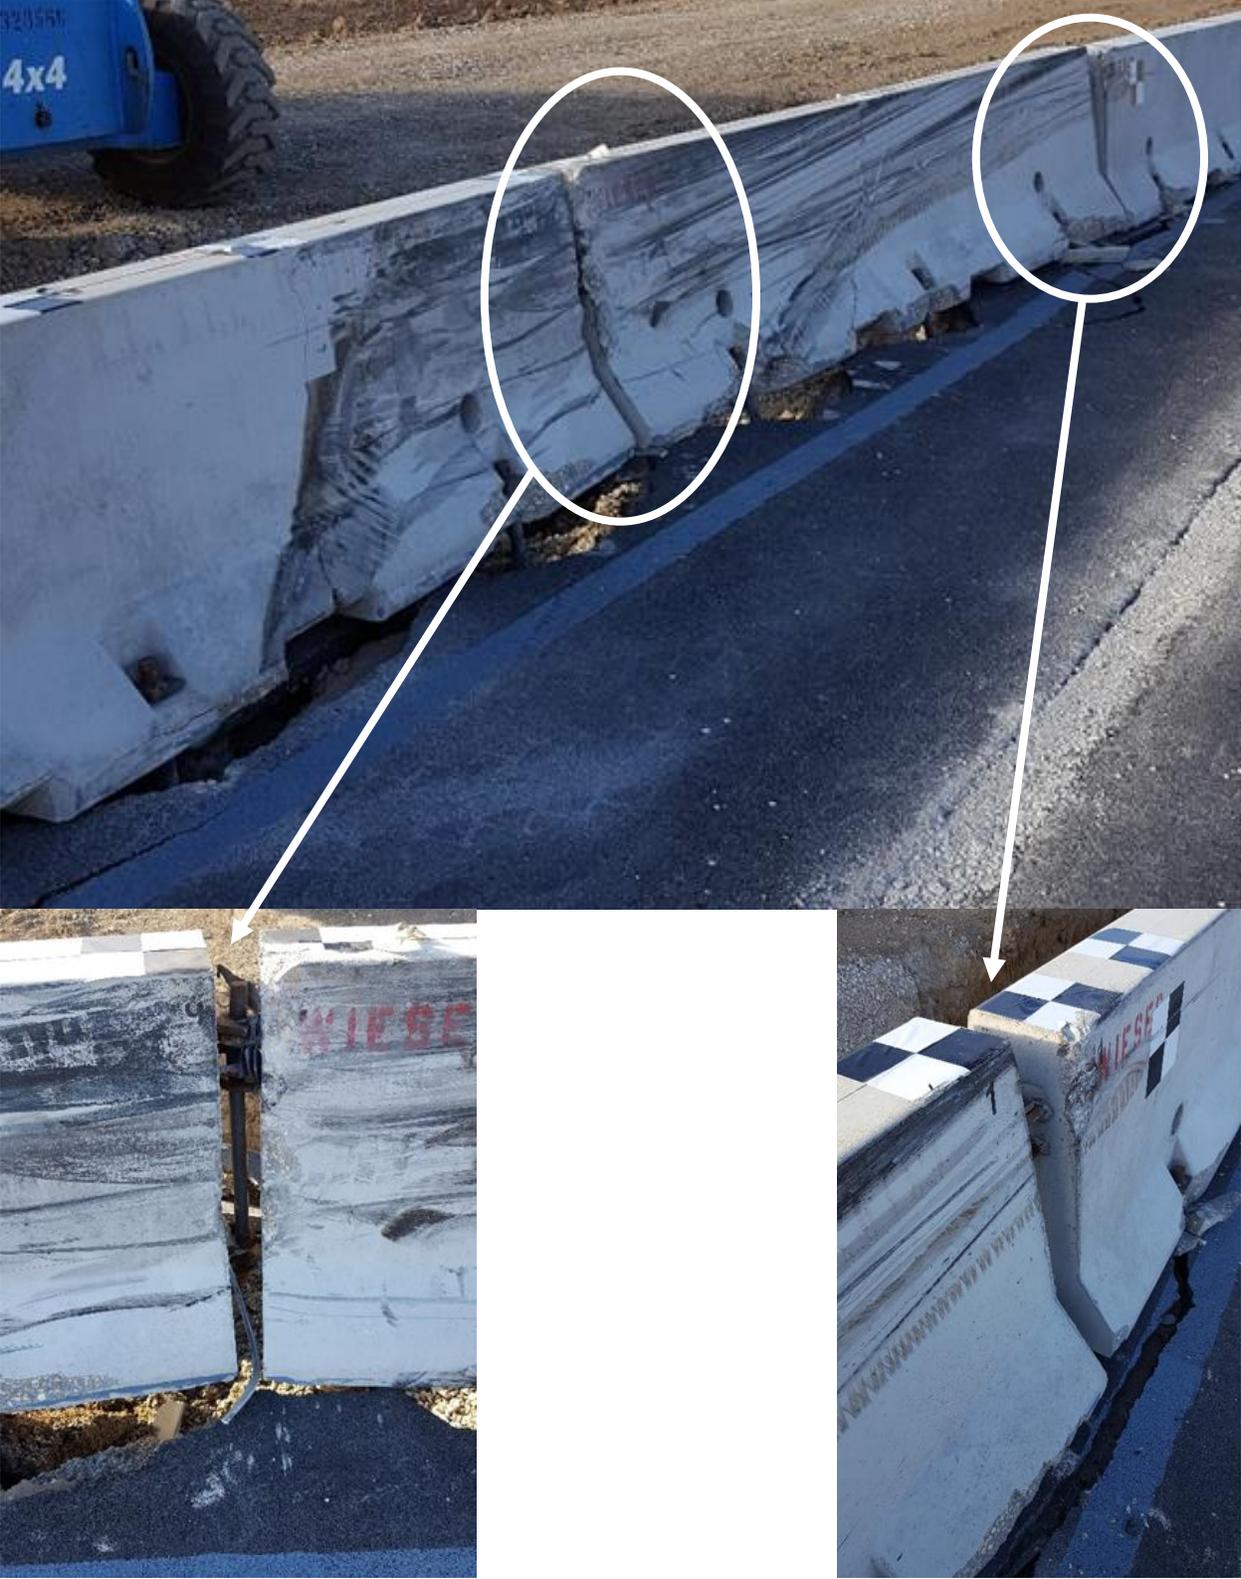
Figure 70. Barrier Joint Snag, Test No. WITD-2

deflection caused by displacement of the asphalt and soil allowed upstream barriers impacted by the vehicle to deflect/rotate back laterally, while the downstream barriers remained anchored with limited displacement. This exposed the upstream face of the downstream barrier segments and promoted snagging of the wheel and tire as it traversed the joints between barrier segments, as shown in Figure 70. The front tire climbed the toe of the PCBs as well, which increased the exposure of the upstream faces of the downstream barriers to the wheel. This wheel snag may have occurred at the joint between barrier nos. 9 and 10, the joint between barrier nos. 10 and 11, or a combination of snag at both joints. Review of the accelerometer data from the 2270P vehicle found that there were increases in the longitudinal acceleration pulses between 65 msec and 90 msec that would correlate with the timing of the wheel traversing the joint between barrier nos. 9 and 10.

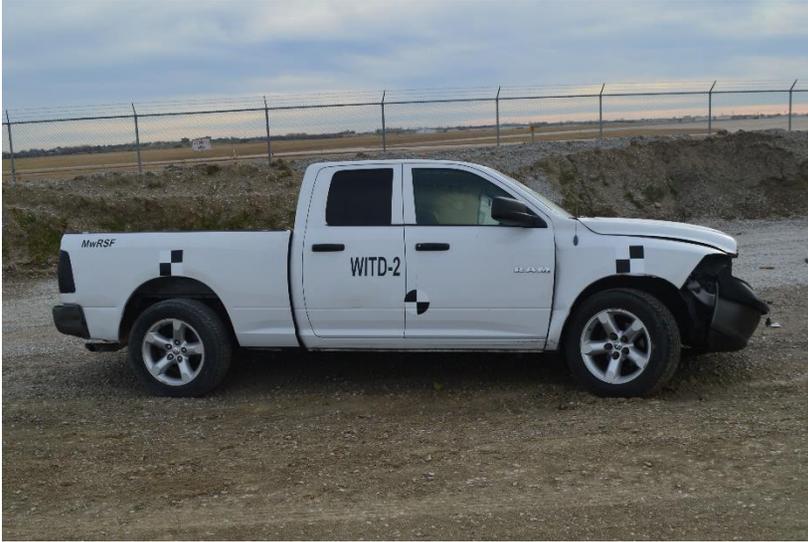
Figure 72. Vehicle Damage, Test No. WITD-2

The majority of damage was concentrated on the left-front corner and left side of the vehicle where the impact occurred. The left side of the front bumper was crushed inward and backward to a depth of 17 in. (432 mm) and the right side of the front bumper bent upward 4 in. (102 mm). The left side of the front bumper cover was ripped off starting 21 in. (533 mm) from the center. The vehicle grille completely detached, leaving a 2½-in. x 6-in. (64-mm x 152-mm) piece at the attachment point to the right of the center point. Both headlights were crushed. The left-front fender was crushed and almost disengaged from the vehicle, but remained attached at two points. The left-front wheel assembly was detached and crushed into the wheel well and toe pan. The toe pan on the left side of the vehicle deformed upward into the brake pedal and contained multiple tears, as shown in Figure 76. The left-rear wheel assembly had scrapes along the outer circumference of the rim and a 3-in. x 4-in. (76-mm x 102-mm) I-shaped puncture in the tire. The left rocker panel had a 48-in. (1,219-mm) long x 6-in. (152-mm) wide x 2-in. (51-mm) deep indentation. The left-front door was also deformed and rotated slightly counter-clockwise. The right-front fender was bent away from the front bumper. Cracking in the windshield began in the lower-right corner and expanded outward in a spider web formation. The side windows, roof, and rest of the right side remained undamaged.

The damage to the vehicle was moderate, as shown in Figures 72 through 76. The maximum occupant compartment intrusions are listed in Table 9 along with the intrusion limits established in MASH 2016 for various areas of the occupant compartment. MASH 2016 defines intrusion or deformation as the occupant compartment being deformed and reduced in size with no observed penetration. The side door (above seat and below seat) deformed outward, which is not considered crush toward the occupant, is denoted as negative numbers in Table 9, and is not evaluated by MASH 2016 criteria. Note that the maximum wheel well and toe pan deformation of 13½ in. (343 mm) exceeded the MASH 2016 intrusion limit of 9 in. (229 mm). In addition to exceeding the maximum toe pan and wheel well intrusion criteria, the intrusion of the wheel rim led to several tears in the floor pan. Thus, the occupant compartment intrusion limits were violated, which resulted in the failure of test no. WITD-2 to meet the MASH 2016 criteria. Complete occupant compartment and vehicle deformations and the corresponding locations are provided in Appendix D.

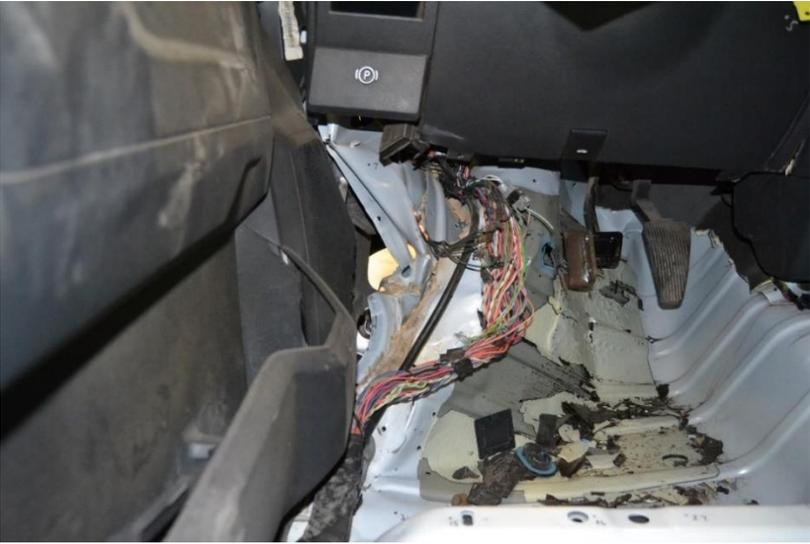
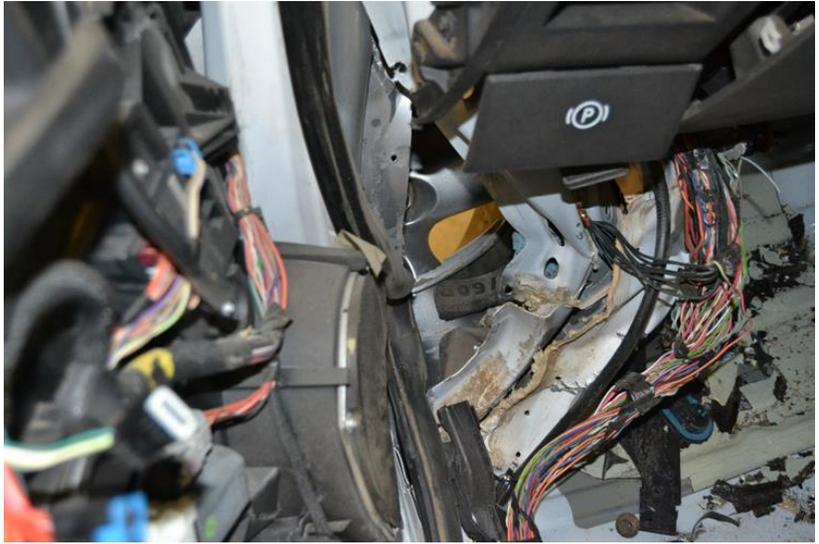
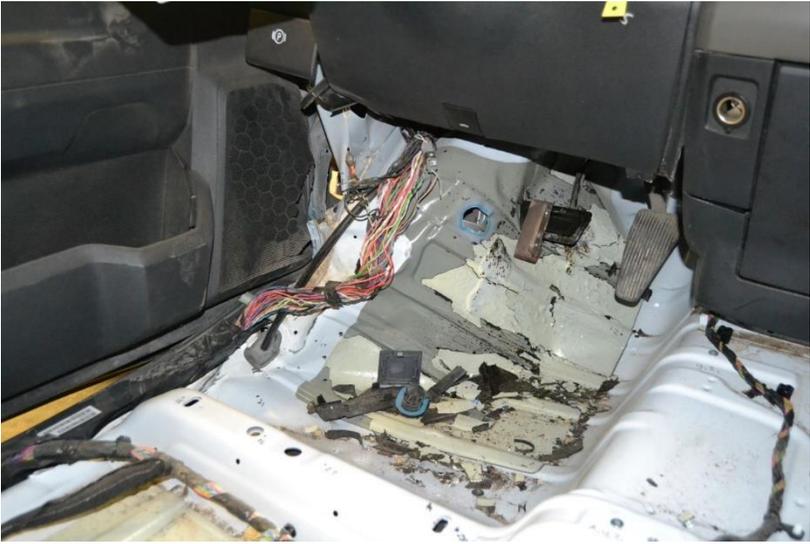
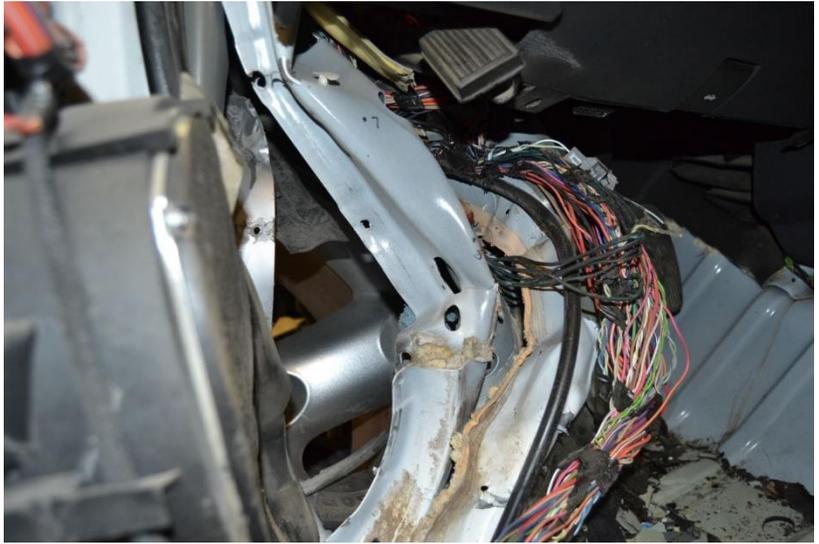
Figure 76. Occupant Compartment Damage, Test No. WITD-2

The wheel snag rotated the left-front wheel 90 degrees and pushed it back toward the floor pan of the pickup. This in turn caused excessive toe pan deformations, opened a hole in the floor pan, and allowed a portion of the wheel rim to penetrate the occupant compartment, as shown in Figure 76. The combination of the excessive occupant compartment deformations, opening of the floor pan, and penetration of the wheel rim into the occupant compartment led to the test being deemed unacceptable under the MASH TL-3 safety requirements.

While the vehicle was captured and redirected successfully in test no. WITD-2, excessive occupant compartment deformations observed in the test caused it to be deemed a failure. Further review of the test results found that wheel snag on the joint between the anchored PCB segments contributed to the excessive occupant compartment deformations. In test no. WITD-2, the impact point was selected to maximize vehicle snag and loading of the barrier joint. During the impact, the asphalt and a portion of the soil next to the excavated trench behind the system was disengaged, which allowed increased motion of the PCB segments. It is believed that the increased barrier
