*Midwest Pooled Fund Program
Fiscal Years 2018-2021 (Year 28)
Research Project Number TPF-5(193) Supplement #118
NDOT Sponsoring Agency Code RFP-18-CABLE-1*

DESIGN AND EVALUATION OF SLEEVE NUT THROUGH TENSILE TESTING

MwRSF Research Report No. TRP-03-412-19

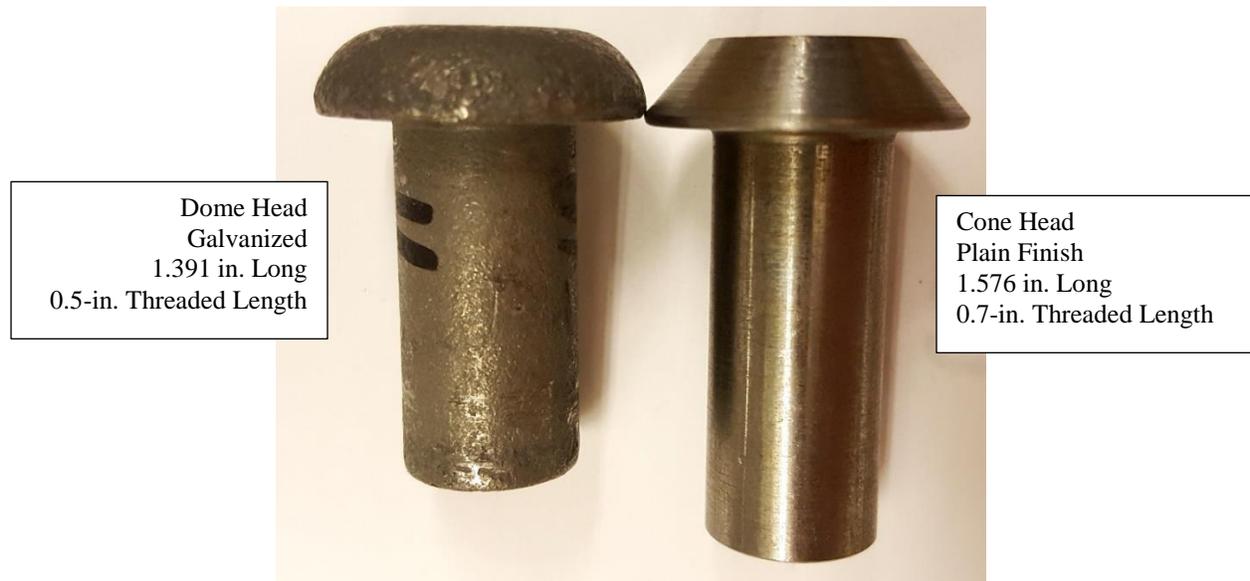
Figure 1. Illustration of Differences between Sleeve Nut Concepts

The two different head shapes were designed to be low profile in order to mitigate cable snag and reduce the possibility of floor pan tearing. Both sleeve nuts were designed to develop nominal yield and tensile forces of 5.2 kips and 6.0 kips (23.1 kN and 26.7 kN), respectively. These values are near the minimum nominal yield and tensile strength of the $\frac{5}{16}$ -in. (8-mm) diameter Grade 5 bolt, which are 92 ksi and 120 ksi (634.3 MPa and 827.4 MPa), respectively. This corresponds to a yield and tensile force capacity of 4.8 kips and 6.3 kips (21.4 kN and 28.0 kN), respectively, for the $\frac{5}{16}$ -in. (8-mm) diameter bolt. The bolted connection is necessary to maintain the fixity of the tabbed bracket, and provide positive engagement between the tab bracket and post.

All sleeve nuts were fabricated from AISI 1144 Class B Stressproof steel rod, with nominal yield and ultimate strengths of 100 ksi (689 MPa) and 115 ksi (792 MPa), respectively. Two different overall lengths, head shapes, and threaded lengths were investigated. The inner and outer diameters were the same for all sleeve nuts and measured $\frac{5}{16}$ in. (8 mm) and 0.563 in. (14 mm), respectively. The effects of plain and corrosion-resistant finishes were also investigated. Examples of the different parameters are shown in Figure 1. The test matrix is shown in Table 1. Detailed drawings are shown in Appendix A.

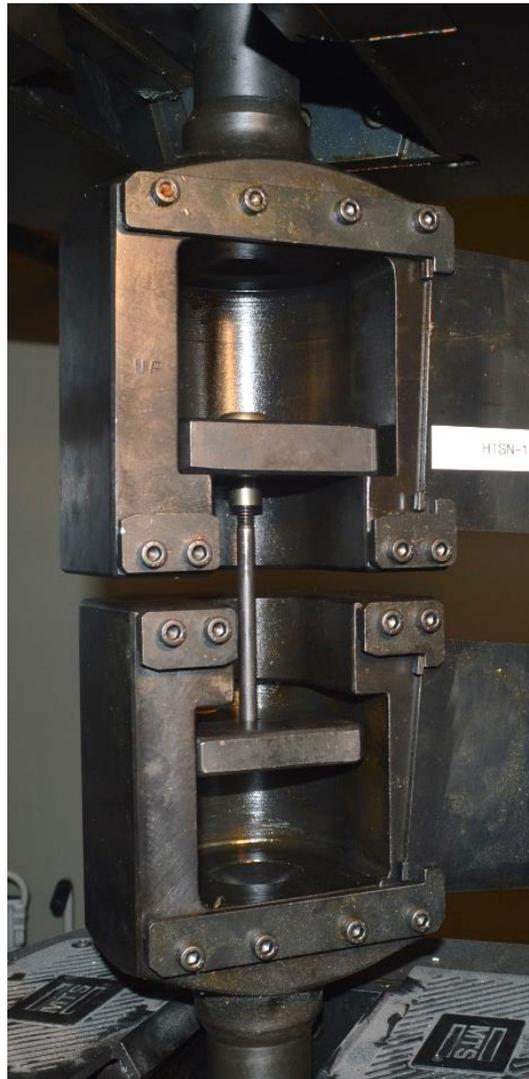
Figure 2. Tensile Test Setup

For each test, a $5/16$ -in. (8-mm) diameter Grade 5 bolt was threaded into the sleeve nut until it was snug. Typically, engagement of three threads between a bolt and nut will develop between 75 and 90 percent of the bolt strength. Therefore, one full bolt diameter deep into the sleeve nut should develop the full strength of the bolt. Each test used either a plain or a corrosion-resistant finish, as shown Table 1. The bolt and nut combinations were attached to test jigs mounted between grips of an MTS Criterion Series 60 – Model 64.106 machine, as shown in Figure 2. Pre-test photographs of the nuts and bolts are shown in Figures 3 through 6. A quasi-static tension test was conducted by slowly separating the grips of the tensile testing machine, thus creating a tensile force in the bolt and nut, until failure occurred. A total of fourteen static component tests were conducted, as shown in Table 1.

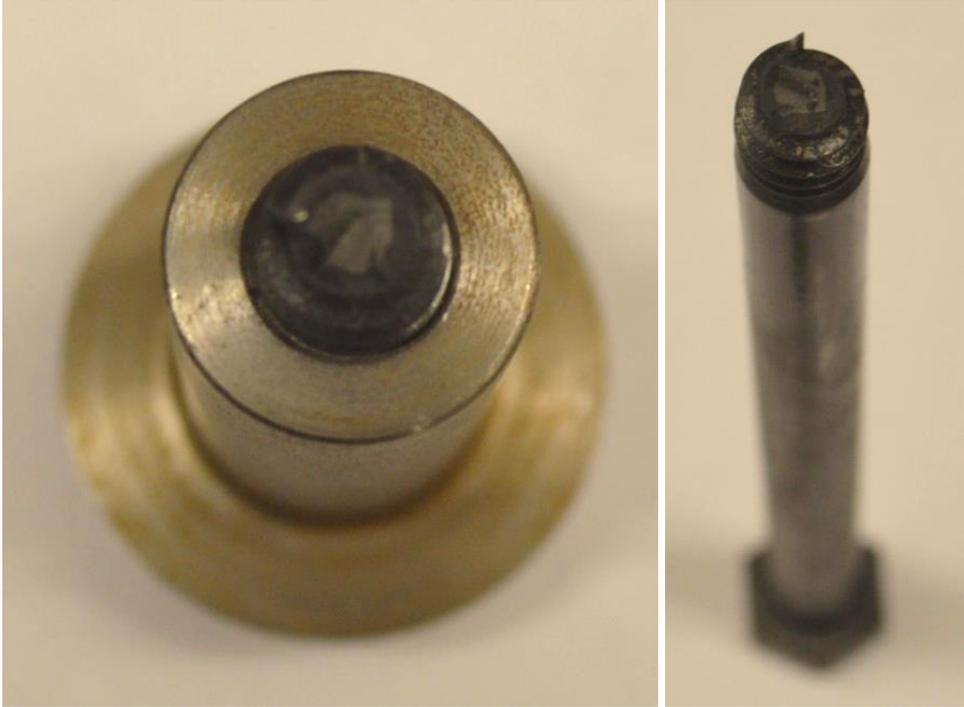
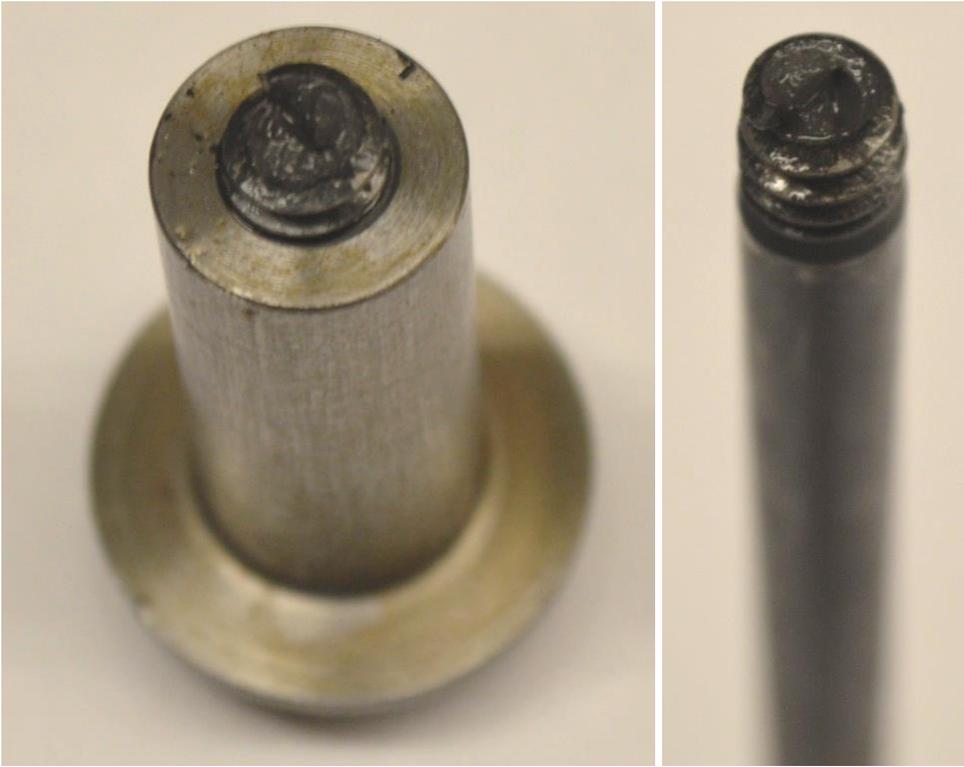
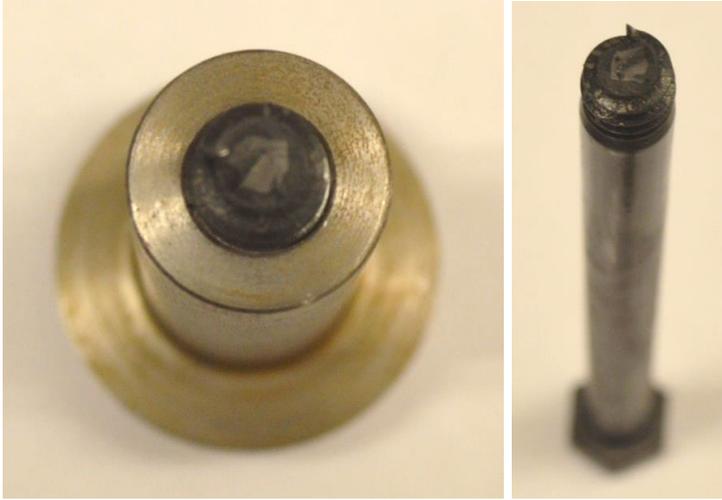
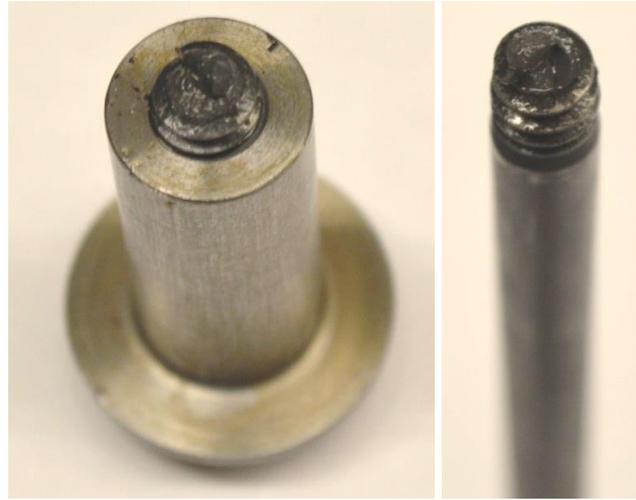
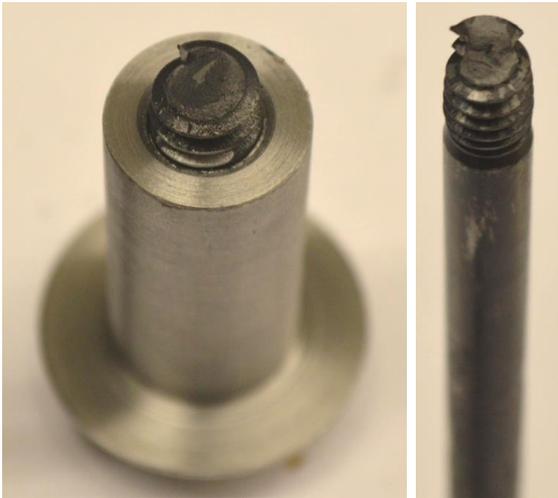
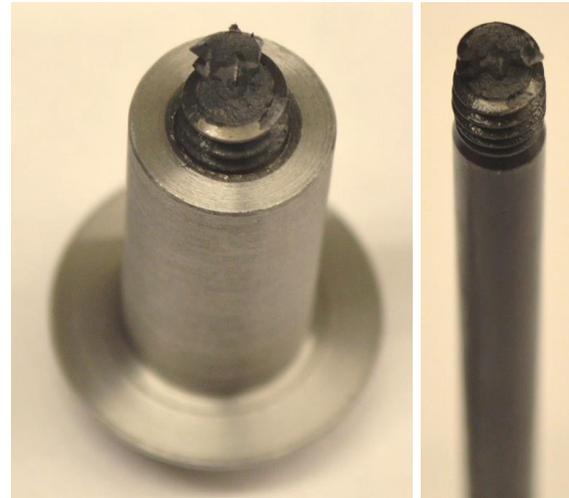
The variables in each test, test nos. HTSN-1 through HTSN-14, were the parameters of the bolts and nuts, as shown in Table 1. In every test, the $\frac{5}{16}$ -in. (8-mm) diameter Grade 5 bolt failed before the sleeve nut. Photographs of the bolt and nut damage for each test are shown in Figures 7 through 10.

After each test, the sleeve nuts were inspected for damage, markings, or permanent deformation. For each test condition, the sleeve nuts and threads remained undamaged. The fractured portion of the bolt remaining in the sleeve nut could be easily removed without any plastic damage to the threads. No differences in test results were observed based on nut galvanization or head shape.

During the initial round of testing (test nos. HTSN-1 through HTSN-6), the sleeve nut length, threaded depth, and head shape were investigated. The longer sleeve nut and deeper thread length did not make a difference in the test results. In addition, the two different head shapes did not make a difference. Therefore, all remaining tests were conducted on the shorter sleeve nut with shallower thread length. However due to the availability of head shapes of the existing sleeve nuts, both the dome and cone heads continued to be evaluated.

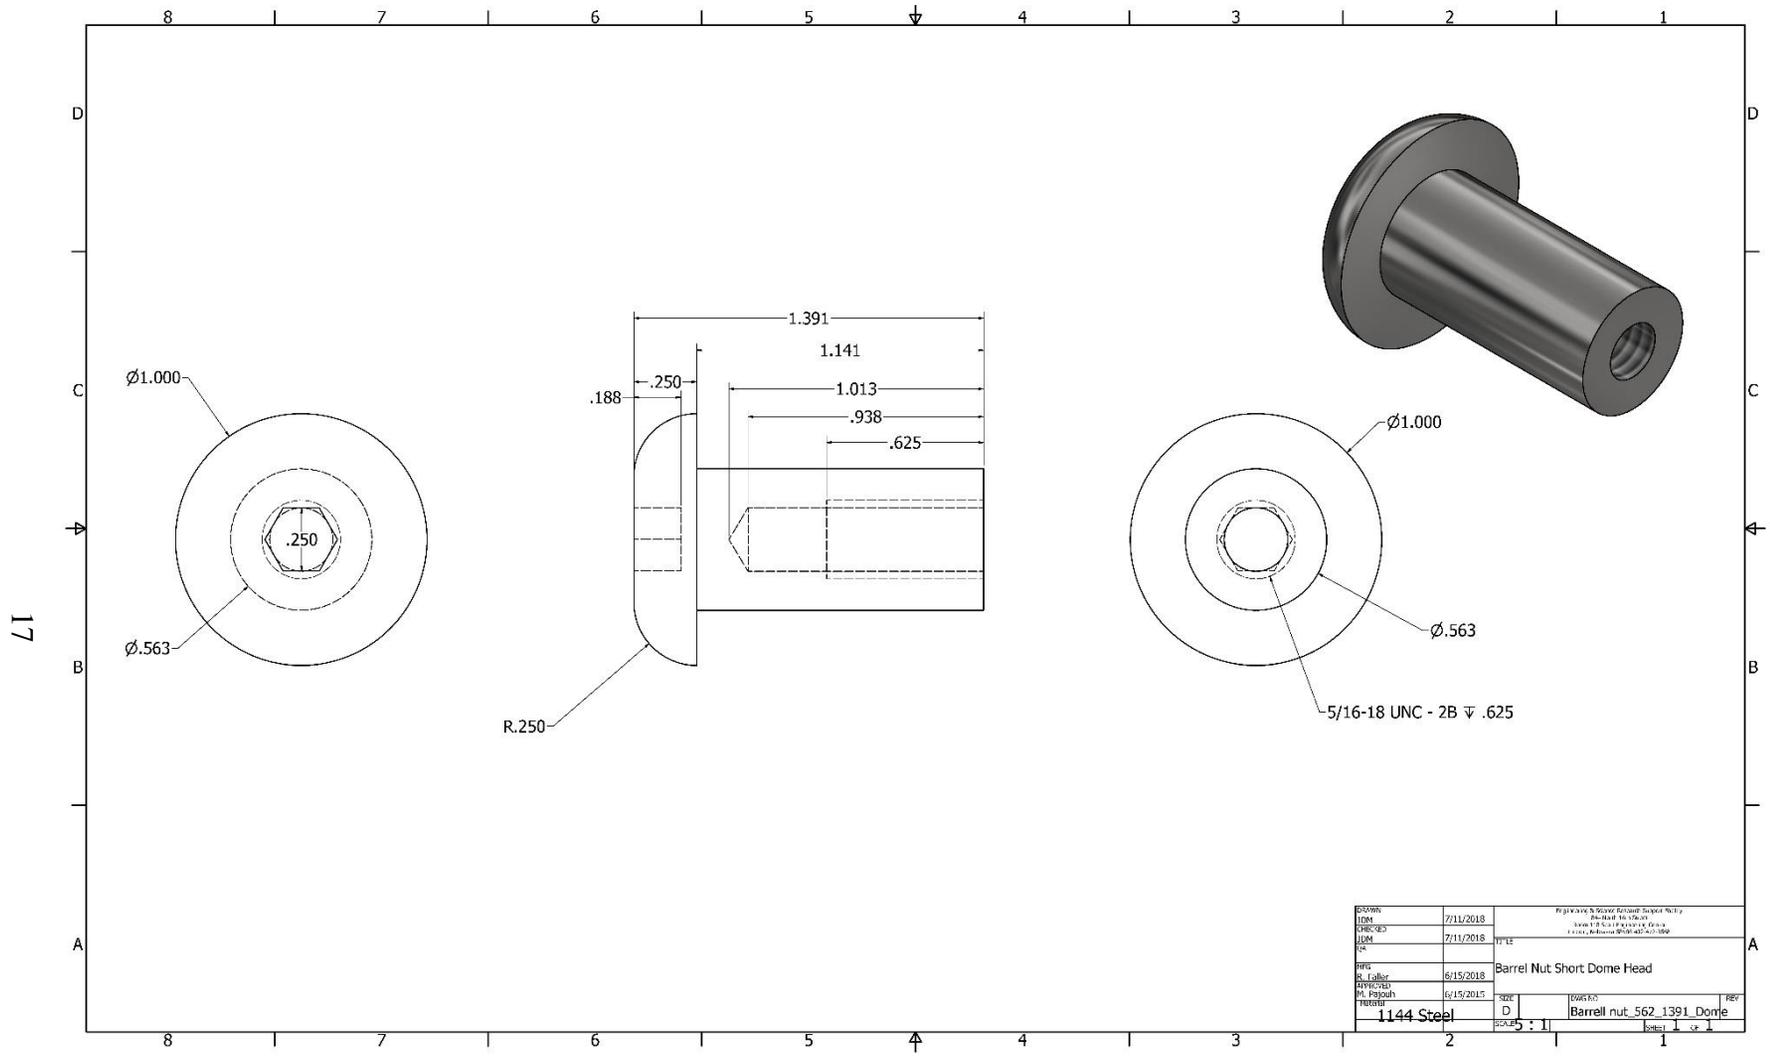
Figure 12. Recommended Barrel Nut with Dome Head Design

Based on the test results, all sleeve nut designs herein were determined to be acceptable. Each configuration developed the full tensile capacity of the $5/16$ -in. (8-mm) diameter Grade 5 bolt, which was 6.3 kips (28.0 kN) nominally. Also, according to ASTM A563 [9], mixing finishes is not recommended. Therefore, a corrosion resistant sleeve nut should only be used with a corrosion resistant bolt. The recommended final nut designs are shown in Figures 11 and 12.

In order to allow for a galvanized finish, the sleeve nut threads need to be oversized. It is left to the fabricator to determine the amount of oversizing that is required and necessary for accommodating a corrosion-resistant, $5/16$ -in. diameter, ASTM A307 or Grade 5 bolt.

Typically, engagement of three threads between a bolt and nut will develop between 75 and 90 percent of the bolt strength. Therefore, one full bolt diameter deep into the sleeve nut should develop the full strength of the bolt. In addition, the bolt length will be designed such that a maximum number of threads will be engaged between the bolt and the sleeve nut when utilized in the cable median barrier system design (i.e., bolt threaded into sleeve nut the entire threaded portion of the sleeve nut).

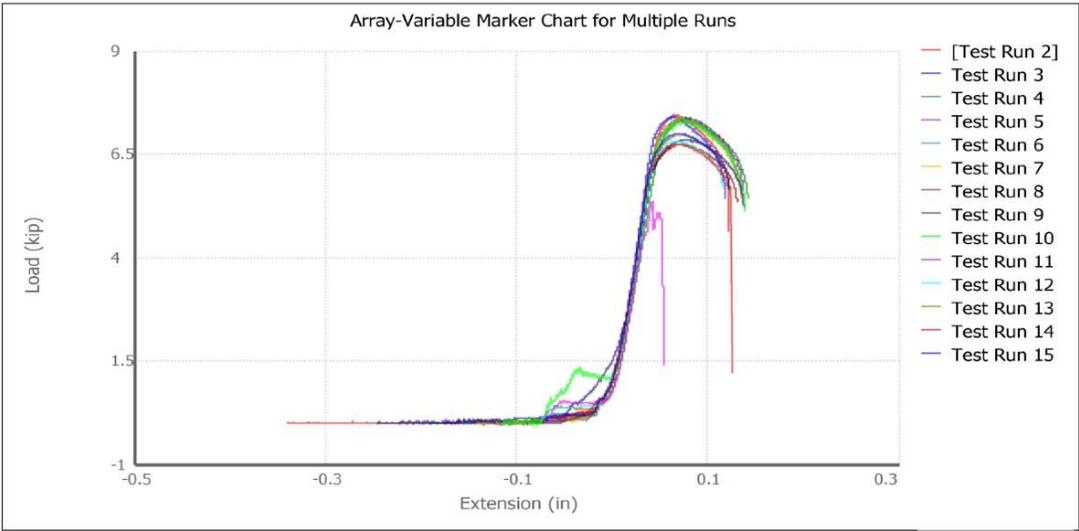
Figure C-1. MTS Test Results Summary

Name	Tagged	Load at Tensile Strength (kip)	Tensile Strength (kip/in ²)	Test ID
Test Run 2	No	7.433	141.8	HTSN-1
Test Run 3	No	7.401	141.2	HTSN-2
Test Run 4	No	7.374	140.7	HTSN-3
Test Run 5	No	7.392	141.1	HTSN-4
Test Run 6	No	7.396	141.2	HTSN-5
Test Run 7	No	7.382	140.9	HTSN-6
Test Run 8	No	6.736	128.5	HTSN-7
Test Run 9	No	6.855	130.8	HTSN-8
Test Run 10	No	7.338	140.0	HTSN-9
Test Run 11	No	5.368	102.4	HTSN-10
Test Run 12	No	6.813	130.0	HTSN-11
Test Run 13	No	6.965	132.9	HTSN-12
Test Run 14	No	6.740	128.6	HTSN-13
Test Run 15	No	7.001	133.6	HTSN-14
	Mean	7.014	133.9	
	Standard D	0.549	10.5

All nut and bolt combinations developed strength beyond the expected bolt strength, as shown in Figure C-1. The pre-loading in the sample shown in Figure C-2 was due to tension in the locking mechanism of the MTS Criterion that was meant to hold the sample in place for the test.
