*Midwest Pooled Fund Research Program
Fiscal Years 2019-2022 (Year 29)
Research Project Number TPF-5(193) Supplement #141
NDOT Sponsoring Agency Code RFPF-19-AGT-1*

EVALUATION OF FLARE RATES FOR APPROACH GUARDRAIL TRANSITIONS – PHASE I

MIDWEST ROADSIDE SAFETY FACILITY

MwRSF Research Report No. TRP-03-439a-22

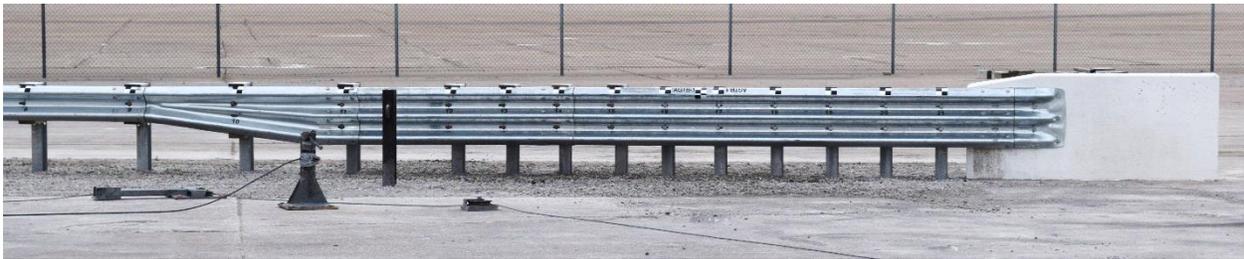
Figure 1. AGT Installation [1]

Approach guardrail transitions (AGTs) are commonly used to safeguard rigid hazards, including bridge railings and concrete parapets. A typical AGT is shown in Figure 1 [1]. AGT installations provide a safe transition in lateral stiffness between semi-rigid guardrail and rigid bridge rail installations. Oftentimes intersecting roadways or other roadside obstacles create space constraints that limit the ability to install an AGT within the desired area. Thus, a need exists to minimize the length of AGTs tangent to the roadway.

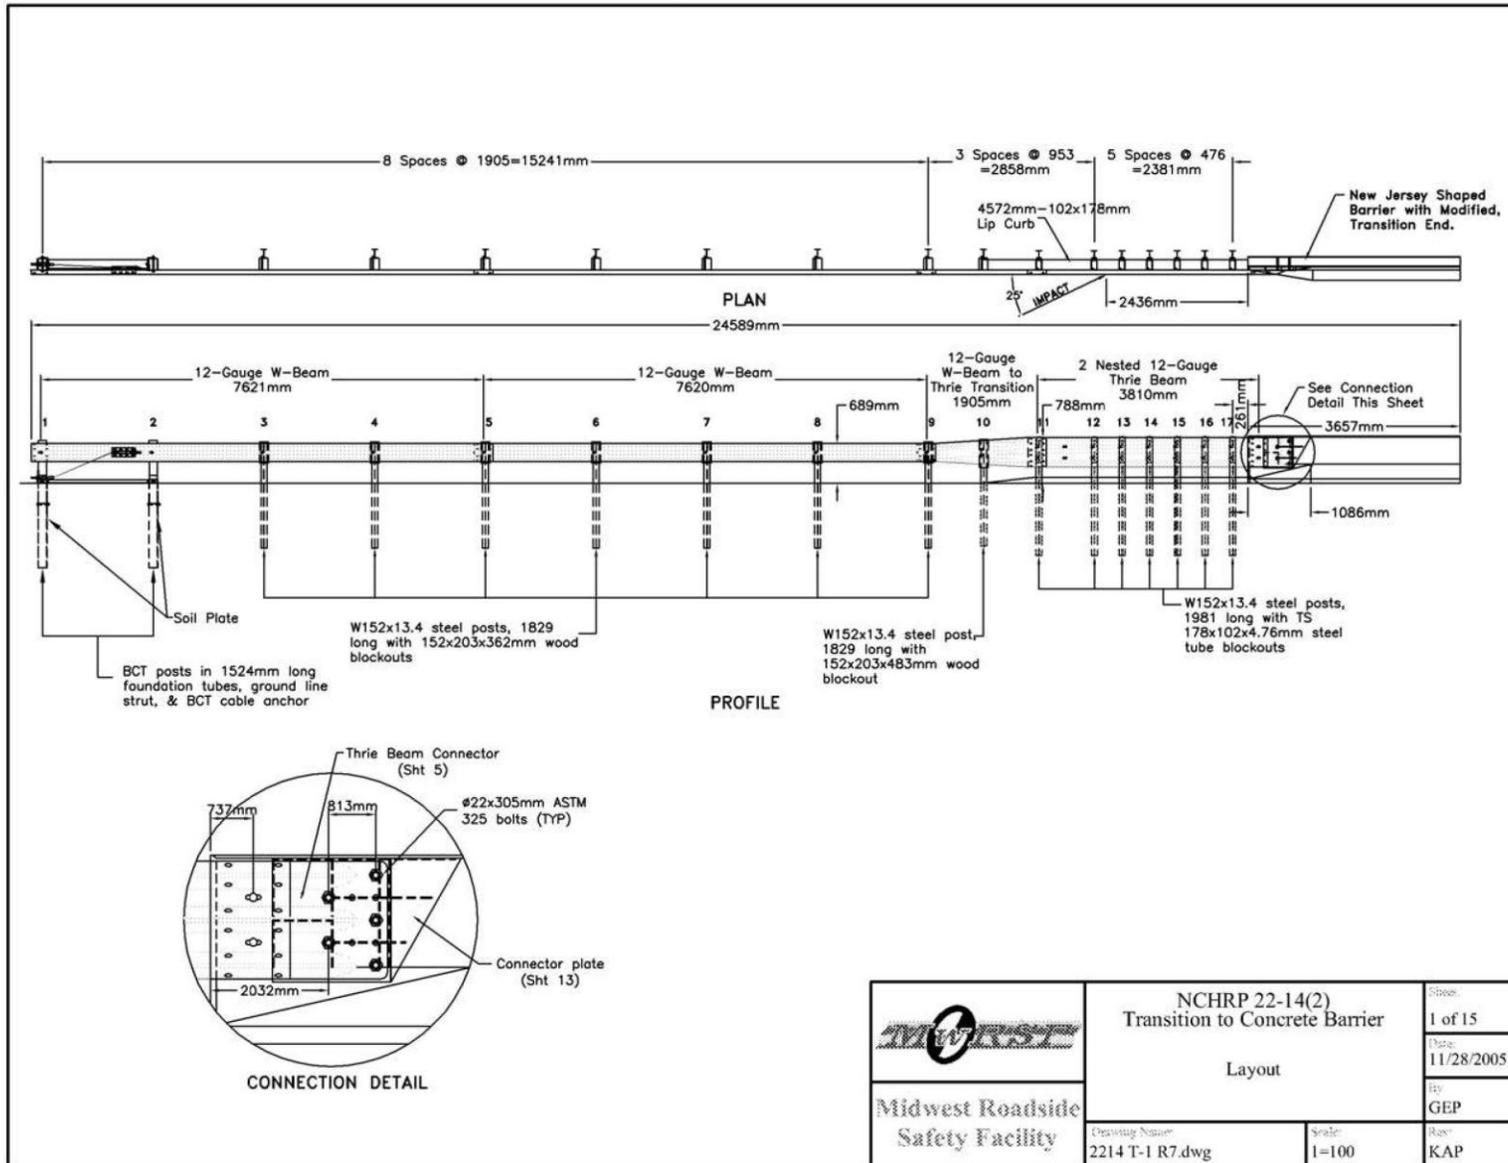
Figure 2. MASH Iowa Transition Installation Layout [8]

In test no. 2214T-1, the 5,083-lb (2,306-kg) pickup truck impacted the AGT system at a speed of 60.3 mph (97.0 km/h) and at an angle of 24.8 degrees, 7 ft – 11⁷/₈ in. (2.4 m) upstream from the upstream end of the concrete barrier. The barrier system successfully contained and redirected the vehicle with a maximum lateral dynamic deflection of 11.4 in. (289 mm) located at the centerline of post no. 15. Barrier damage was minimal, consisting of contact marks and deformed thrie-beam guardrail. Post nos. 12 through 17 rotated backward slightly and minor contact marks were found on the bottom toe of the concrete barrier. The vehicle was redirected with moderate damage and met all occupant risk criteria. Test no. 2214T-1 was determined to be acceptable according to the Update to NCHRP Report 350 (MASH 2009) TL-3 safety performance criteria for test designation no. 3-21. The crash test data for test no. 2214T-1 is summarized in Table 2, and sequential photographs are presented in Figure 3.

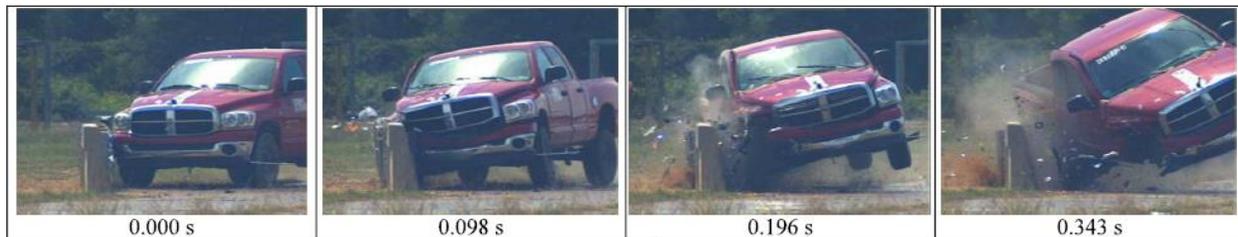
Figure 5. Sequential Photographs for Test No. 490022-4 [9]

In test no. 490022-4, the 5,002-lb (2,269-kg) pickup truck impacted the AGT system at a speed of 62.6 mph (100.7 km/h) and at an angle of 23.9 degrees, 89 in. (2.3 m) upstream from the upstream end of the concrete parapet. The barrier system successfully contained and redirected the vehicle with a maximum lateral dynamic deflection of 5.9 in. (150 mm). Post nos. 13 through 19 deflected backward and contact marks were found on the upstream face of the concrete parapet. The vehicle’s right-front tire and wheel contacted the concrete parapet during the impact and disengaged from the vehicle. The vehicle rolled onto its right side as it exited the transition. While the vehicle was successfully contained and redirected by the test installation, it did not meet all occupant risk criteria due to vehicle rollover. Test no. 490022-4 was determined to be unacceptable according to the MASH TL-3 safety performance criteria for test designation no. 3-21. The crash test data for test no. 490022-4 is summarized in Table 3 and sequential photographs are presented in Figure 5.

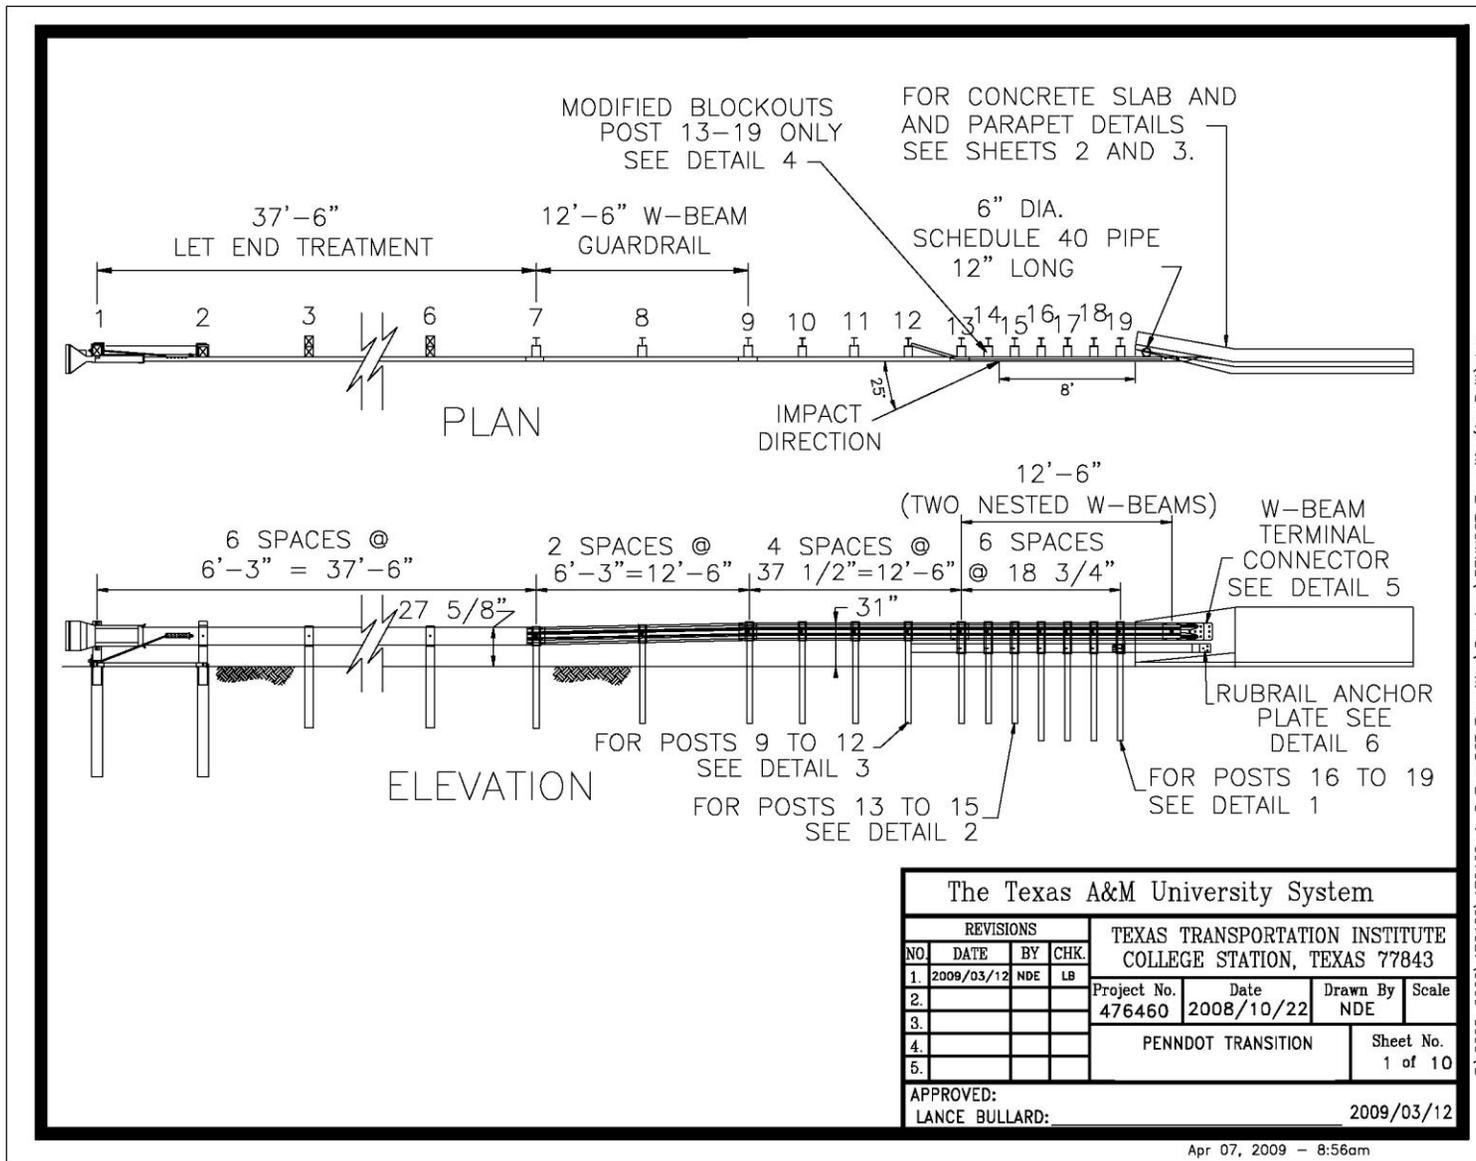
Figure 10. W-Beam with Channel Rubrail Transition Installation Layout [11]

In 2010, TTI completed a research project to develop a MASH TL-3 compliant W-beam AGT [11]. The AGT test installation in test no. 476460-1-3 was 86 ft (26.2 m) long and was constructed of 19 guardrail posts, which supported the 12-gauge (2.7-mm) W-beam and nested 12-gauge (2.7-mm) W-beam guardrail sections. In addition, the transition incorporated a “flared back” C6x8.2 rubrail. The nested W-beam guardrail was attached to the traffic face of a 16-ft 5-in. (5.0-m) long x 42-in. (1,067-mm) tall F-shape concrete parapet with a 10-gauge (3.4-mm) terminal connector welded to a steel plate. The W-beam guardrail and C6x8.2 rubrail were installed with a top mounting height of 31 in. (787 mm) and 16 in. (406 mm), respectively. The W6x8.5 steel posts within the transition region, post nos. 16 through 19, were spaced 18¾ in. (476 mm) on center and embedded at a depth of 52 in. (1,321 mm). The test installation layout is shown in Figure 10.

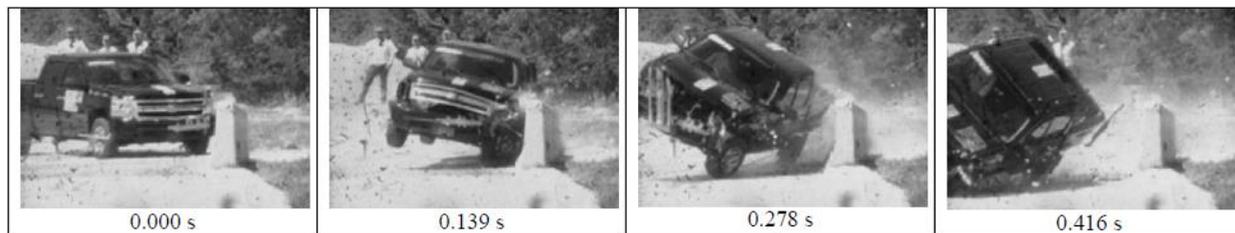
Figure 11. Sequential Photographs for Test No. 476460-1-3 [11]

In test no. 476460-1-3, the 5,029-lb (2,281-kg) pickup truck impacted the AGT system at a speed of 62.8 mph (101.1 km/h) and at an angle of 25.7 degrees, 103 in. (2.6 m) upstream from the upstream end of the concrete parapet. The barrier system successfully contained and redirected the vehicle with a maximum lateral dynamic deflection of 3.8 in. (97 mm). Deformation of both the nested W-beam and the rubrail were observed and post nos. 12 through 19 deflected backward. The test installation met all occupant risk criteria and test no. 476460-1-3 was determined to be acceptable according to the MASH TL-3 safety performance criteria for test designation no. 3-21. The crash test data for test no. 476460-1-3 is summarized in Table 5 and sequential photographs are presented in Figure 11.

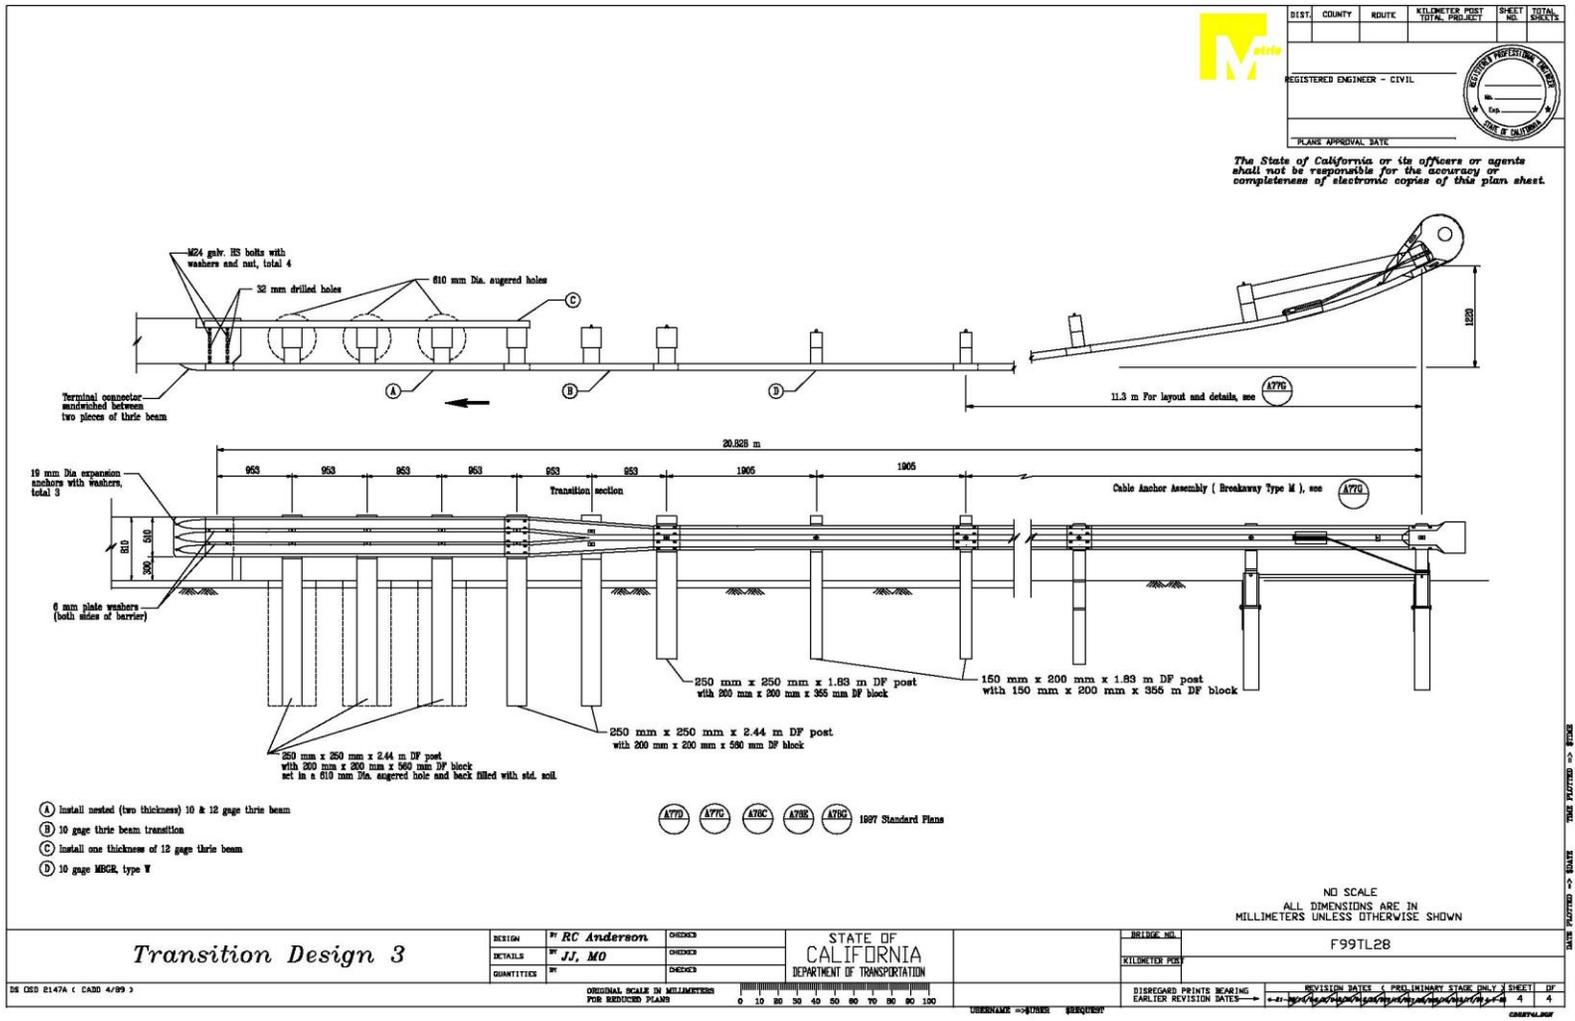
Figure 12. California Transition Layout – Design 3 [12]

In 2002, the California Department of Transportation (CALTRANS) conducted a research project to develop a bridge rail transition design to NCHRP Report 350 Test Level 4 (TL-4) criteria [12]. Three AGT designs were tested during the CALTRANS study due to the failure of the system to meet NCHRP Report 350 criteria in test nos. 516 and 517. All three designs were 68 ft – 4 in. (20.8 m) long and transitioned between a W-beam guardrail with a top rail height of 28 in. (711 mm) and a 31.9-in. (810-mm) tall concrete bridge rail. All guardrail sections in the first design were 12-gauge (2.7-mm) galvanized steel. The thrie-beam guardrail closest to the concrete bridge rail was supported by three 9.8-in. x 9.8-in (250-mm x 250-mm) Douglas Fir posts with an embedment depth of 40 in. (1,016 mm) and a post spacing of 37.5 in. (953 mm). After the failure of the first design, the guardrail section thicknesses and post embedment depths were increased in the second design, but the installation remained unsuccessful. The third design included additional post and rail updates, and was tested successfully in test nos. 514, 518, and 519. The test installation layout of the successfully tested transition (Design 3) is shown in Figure 12. The crash test data for test nos. 514 and 516 through 519 is summarized in Table 6 and sequential photographs are presented in Figures 13 through 17.

Due to the failure of the test no. 517, Design 2 was updated to resolve the excessive system deflections. Design 3 increased the thickness of the W-beam section adjacent to the W-to-thrie transition section and one of the nested thrie-beam rail sections from 12-gauge (2.7 mm) to 10-gauge (3.4 mm) and increased the post size and embedment depth of the five posts closest to the bridge rail to 9.8 in. x 9.8 in. (250 mm x 250 mm) and 64 in. (1,630 mm), respectively.

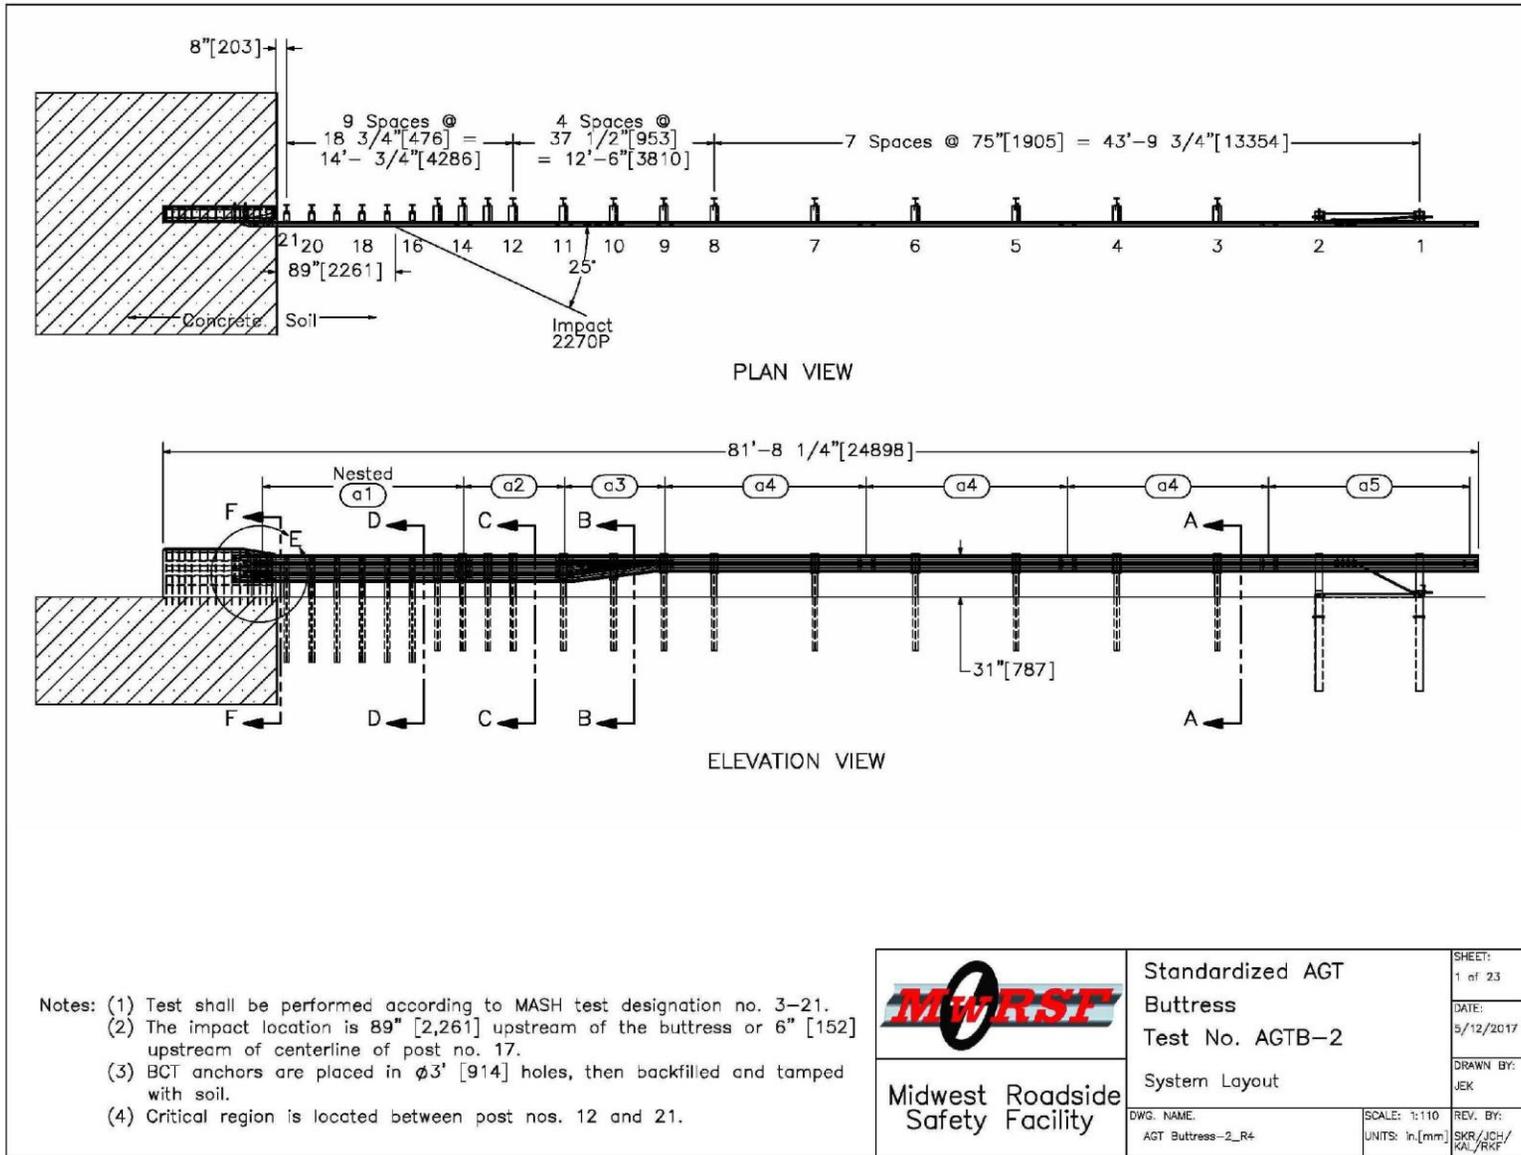
Figure 18. Standardized Transition Buttress Test Installation Layout [1]

In 2020, MwRSF completed a research project to develop a MASH TL-3 compliant AGT with a standardized concrete buttress [1]. The AGT test installations in test nos. AGTB-1 and AGTB-2 were approximately 81 ft – 8¼ in. (24.9 m) long, and consisted of 21 guardrail posts, which supported the 12-gauge (2.7-mm) W-beam and nested 12-gauge (2.7-mm) thrie-beam guardrail sections. The nested thrie-beam guardrail was attached to the traffic face of a vertical concrete buttress with a 12-gauge (2.7-mm) terminal connector and a 10-gauge (3.4-mm) terminal connector in test nos. AGTB-1 and AGTB-2, respectively. The vertical concrete buttress was 84 in. (2,134 mm) long x 36 in. (914 mm) tall and had a longitudinal chamfer on the lower upstream front face to reduce wheel snagging. The guardrail was installed with a top mounting height of 31 in. (787 mm) in both tests. The W6x8.5 steel posts within the transition region, post nos. 16 through 21, were spaced 18¾ in. (476 mm) on center and embedded at a depth of 49 in. (1,245 mm). The Standardized Transition Buttress test installation layout is shown in Figure 18 and the crash test data for test nos. AGTB-1 and AGTB-2 is summarized in Table 7. Sequential photographs are presented in Figures 19 and 20.

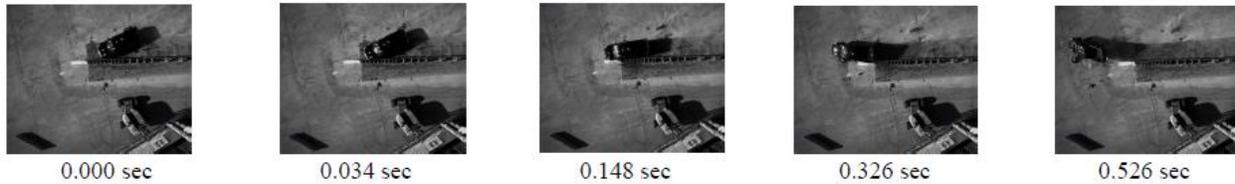
Figure 19. Sequential Photographs for Test No. AGTB-1 [1]

The 5,039-lb (2,286-kg) pickup truck impacted the AGT system at a speed of 61.9 mph (99.6 km/h) and at an angle of 24.4 degrees. The impact location was 80½ in. (2.0 m) upstream from the upstream end of the concrete parapet. The barrier system successfully contained and redirected the vehicle with a maximum lateral dynamic deflection of 6.0 in. (153 mm) located at post no. 19. Damage to the test installation was minimal, primarily consisting of contact marks and minor guardrail deformation. While the vehicle was successfully contained and redirected by the test installation, excessive accelerations that exceeded the acceptable ORA limit occurred due to floorboard buckling during the test. Test no. AGTB-1 was determined to be unacceptable according to the MASH TL-3 safety performance criteria for test designation no. 3-21.

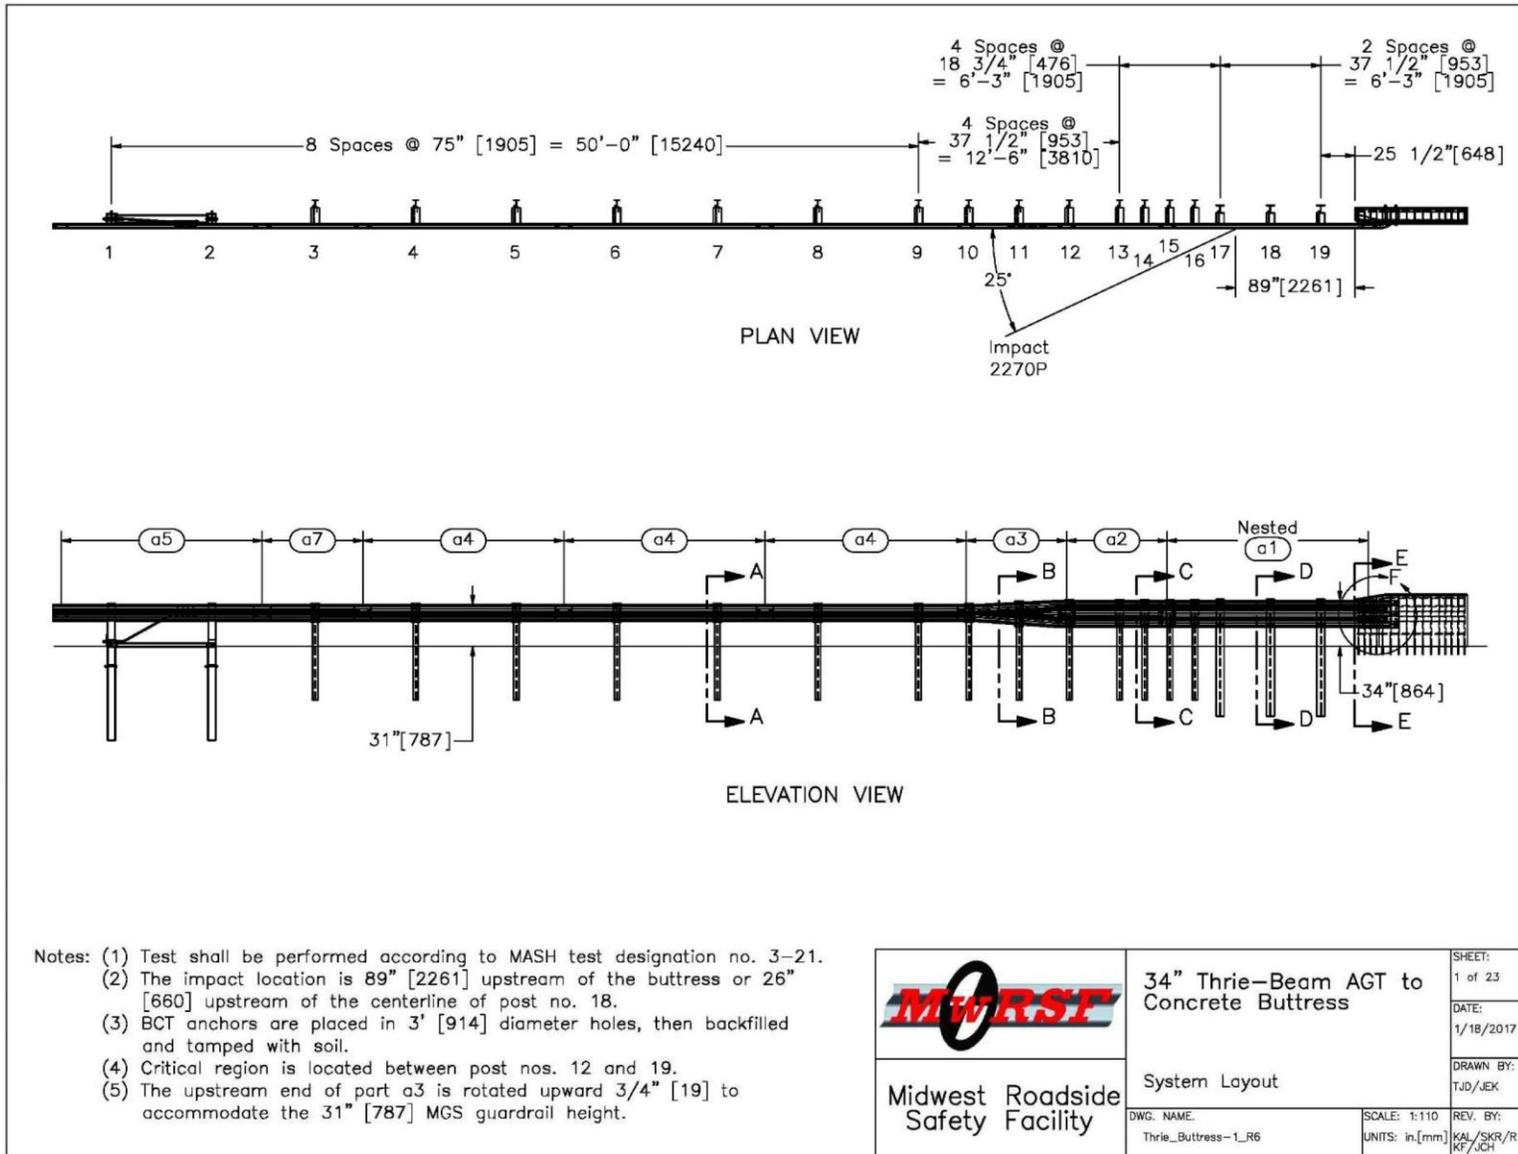
Figure 21. 34-in. (864-mm) AGT Buttress Test Installation Layout [13]

In 2019, MwRSF completed a research project to develop a MASH TL-3 compliant AGT with a 34-in. (864-mm) tall standardized concrete buttress [13]. The AGT test installation in test nos. 34AGT-1 and 34AGT-2 was 87 ft – 11¼ in. (26.8 m) long and consisted of 19 guardrail posts, which supported the 12-gauge (2.7-mm) W-beam and nested 12-gauge (2.7-mm) thrie-beam guardrail sections. The nested thrie-beam guardrail was attached to the traffic face of an 84-in. (2,134-mm) long x 39-in. (991-mm) tall vertical concrete buttress with a 10-gauge (3.4-mm) thrie-beam terminal connector. The W-beam guardrail was installed with a top mounting height of 31 in. (787 mm), which transitioned to a top mounting height of 34 in. (864 mm) over the 10-gauge (3.4-mm) symmetrical W-to-thrie transition section. The remaining length of thrie-beam guardrail maintained a 34 in. (864 mm) top mounting height. The W6x15 steel posts within the transition region, post nos. 17 through 19, were spaced 37½ in. (953 mm) on center and were embedded at a depth of 52 in. (1,321 mm). The test installation layout is shown in Figure 21 and the crash test data for test nos. 34AGT-1 and 34AGT-2 is summarized in Table 8. Sequential photographs are presented in Figures 22 and 23.

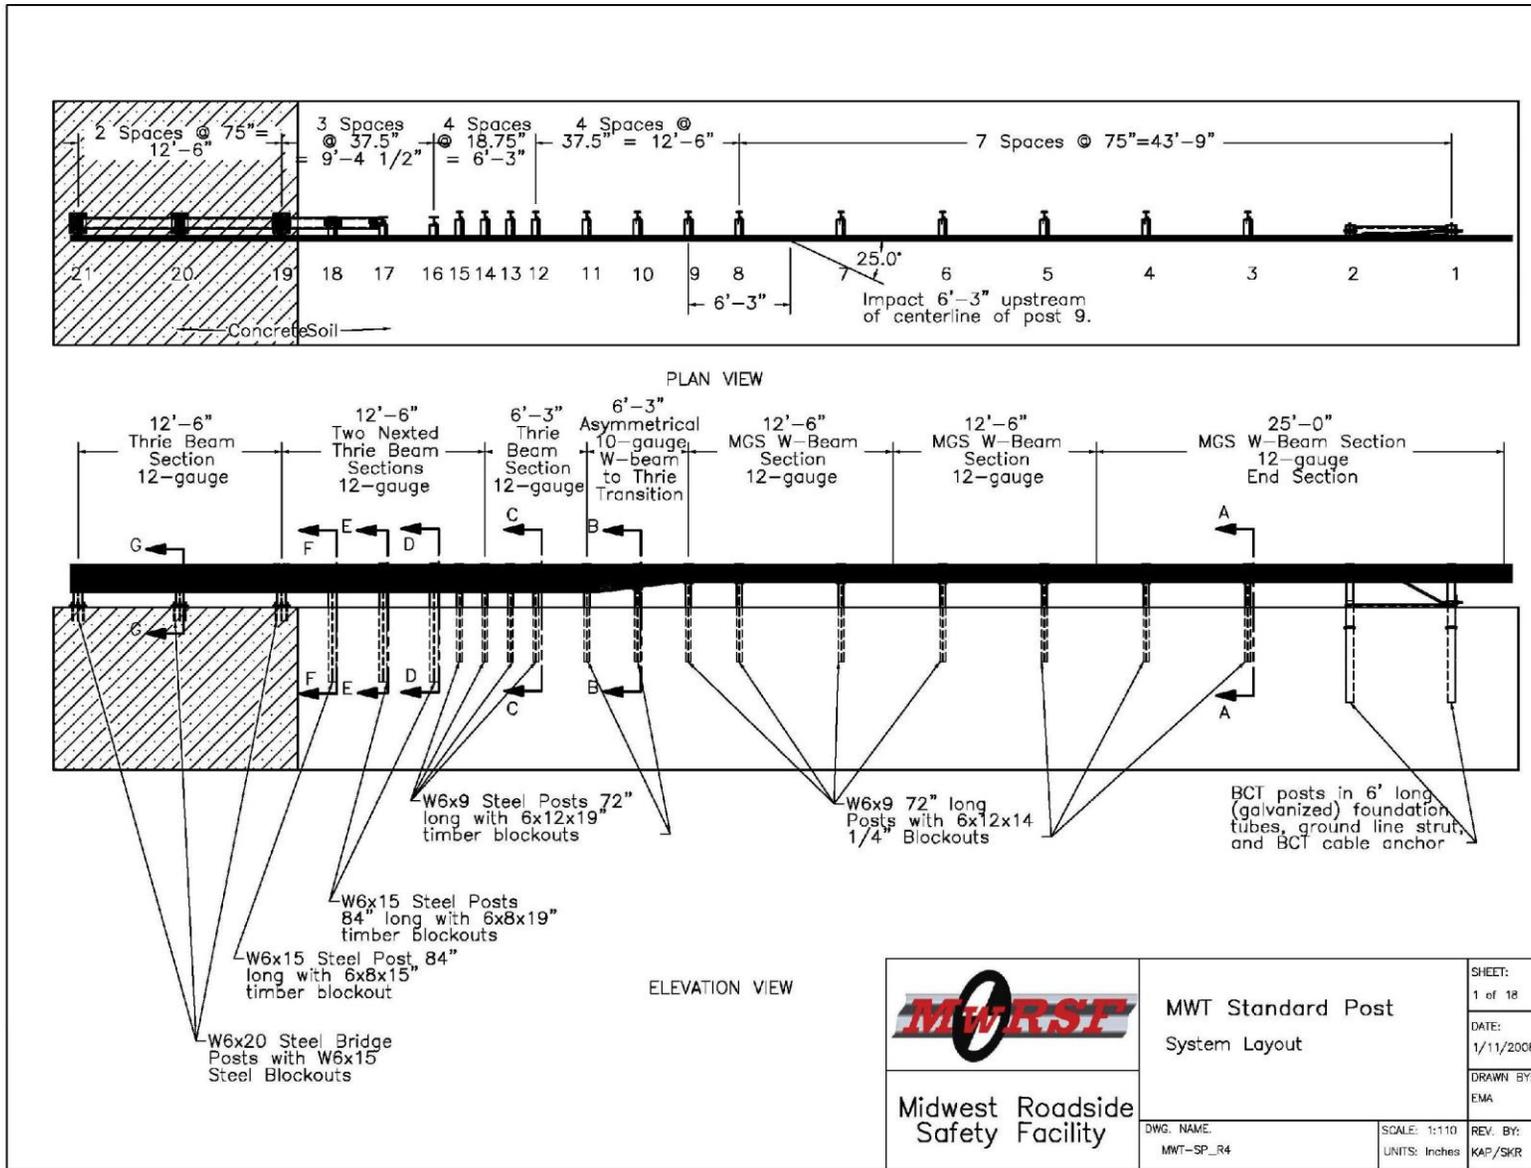
Figure 24. MGS Stiffness Transition Test Installation Layout [14]

In 2010, MwRSF conducted a research project to develop a MASH TL-3 compliant AGT that connects to the MGS [14]. Test nos. MWTSP-1 through MWTSP-3 were conducted to evaluate the upstream end of a stiffness transition for the propensity of vehicle pocketing and wheel snag. The test installation for test nos. MWTSP-1 through MWTSP-3 was 87 ft – 6 in. (26.7 m) long and consisted of five major structural components as shown in Figure 24: (1) standard 12-gauge (2.66-mm) W-beam rail attached to a simulated anchorage device, (2) asymmetrical 10-gauge (3.42-mm) W-to-thrie transition element, (3) standard 12-gauge (2.66-mm) thrie-beam guardrail, (4) nested 12-gauge (2.66-mm) thrie-beam guardrail, and (5) a thrie-beam-and-channel bridge railing system. All guardrail had a top mounting height of 31 in. (787 mm). Post nos. nos. 1 and 2 were timber posts in steel foundation tubes, and functioned as part of an anchorage system used to develop the required tensile capacity of a tangent guardrail terminal. Post nos. 3 through 15 were W6x9 steel posts embedded 40 in. (1,016 mm) and post nos. 16 through 18 were W6x15 steel posts embedded 55½ in. (1,400 mm). Bridge post nos. 19 through 21 were W6x20 steel posts rigidly attached to the concrete tarmac. The crash test data for test nos. MWTSP-1 through MWTSP-3 is summarized in Table 9 and sequential photographs are presented in Figures 25 through 27.

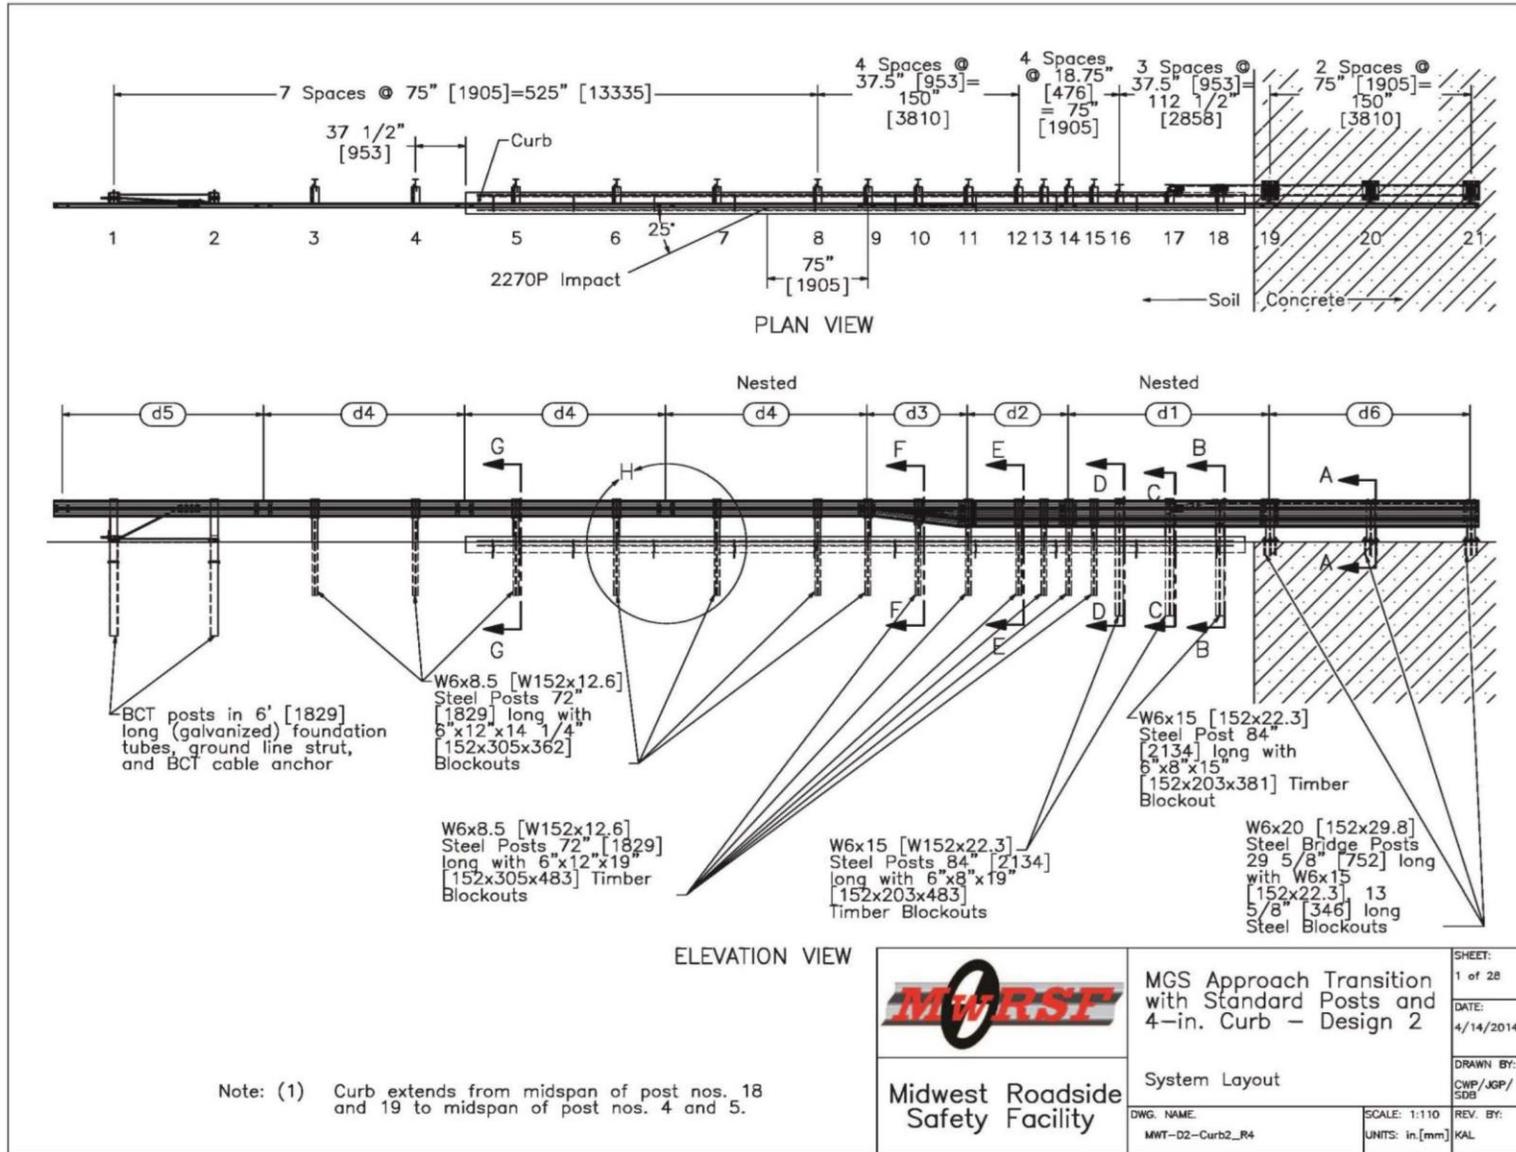
Figure 28. MGS Stiffness Transition with Curb Test Installation Layout [15]

In 2014, MwRSF conducted a research project to develop a MASH TL-3 compliant AGT that connects to the MGS and incorporates a 4-in. (102-mm) tall concrete curb [15]. Test nos. MWTC-1 through MWTC-3 were conducted to evaluate the propensity of vehicle pocketing and wheel snag at the upstream end of the stiffness transition. The test installation was 87 ft – 6 in. (26.7 m) long and consisted of five major structural components as shown in Figure 28: (1) standard 12-gauge (2.66-mm) W-beam rail attached to a simulated anchorage device, (2) asymmetrical 10-gauge (3.42-mm) W-to-thrie transition element, (3) standard 12-gauge (2.66-mm) thrie-beam guardrail, (4) nested 12-gauge (2.66-mm) thrie-beam guardrail, and (5) a thrie-beam-and-channel bridge railing system. All guardrail had a top mounting height of 31 in. (787 mm). Post nos. nos. 1 and 2 were BCT posts in steel foundation tubes, and functioned as part of an anchorage system. Post nos. 3 through 15 were W6x8.5 steel posts embedded 40 in. (1,016 mm) and post nos. 16 through 18 were W6x15 steel posts embedded 55 $\frac{1}{8}$ in. (1,400 mm). Bridge post nos. 19 through 21 were W6x20 steel posts rigidly attached to the concrete tarmac. The crash test data for test nos. MWTC-1 through MWTC-3 is summarized in Table 10 and sequential photographs are presented in Figures 29 through 31.

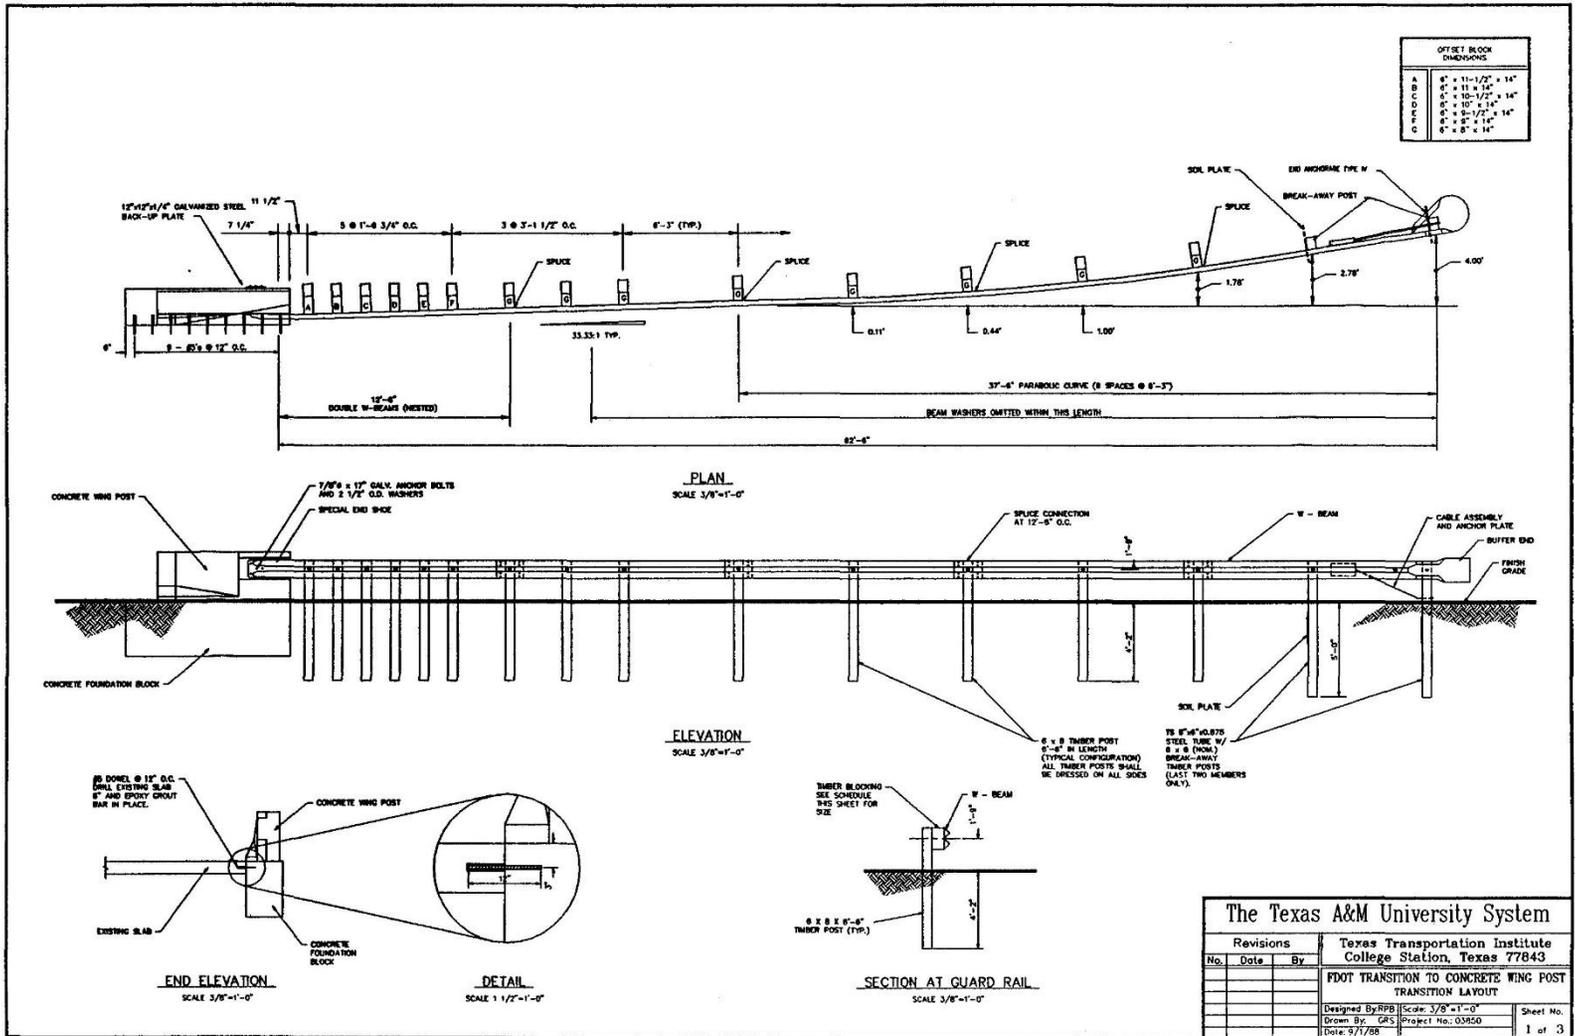
Figure 35. Florida Transition Test Installation Layout [17]

In 1989, TTI crash tested and evaluated the performance of an AGT connected to a bridge traffic rail wing post [17]. The test no. 0385-1 installation overall length was 62-ft 6-in. (19.1 m) and incorporated a parabolic curve over the upstream 37-ft 6-in. (11.4 m) of the test installation as well as a 33.33:1 flare rate initiated at the downstream end of the transition. The test installation was constructed of 16 6-in. x 8-in. (152-mm x 203-mm) timber posts with blockouts, which supported the W-beam guardrail. The six farthest downstream posts had a post spacing of 18¾ in. (476 mm) on center and were embedded at a depth of 50 in. (1,270 mm). The downstream end of the AGT test installation was anchored to a 32-in. (813-mm) tall rigid concrete wing post barrier. The test installation is shown in Figure 35. The crash test data for test no. 0385-1 is summarized in Table 12 and sequential photographs are presented in Figure 36.

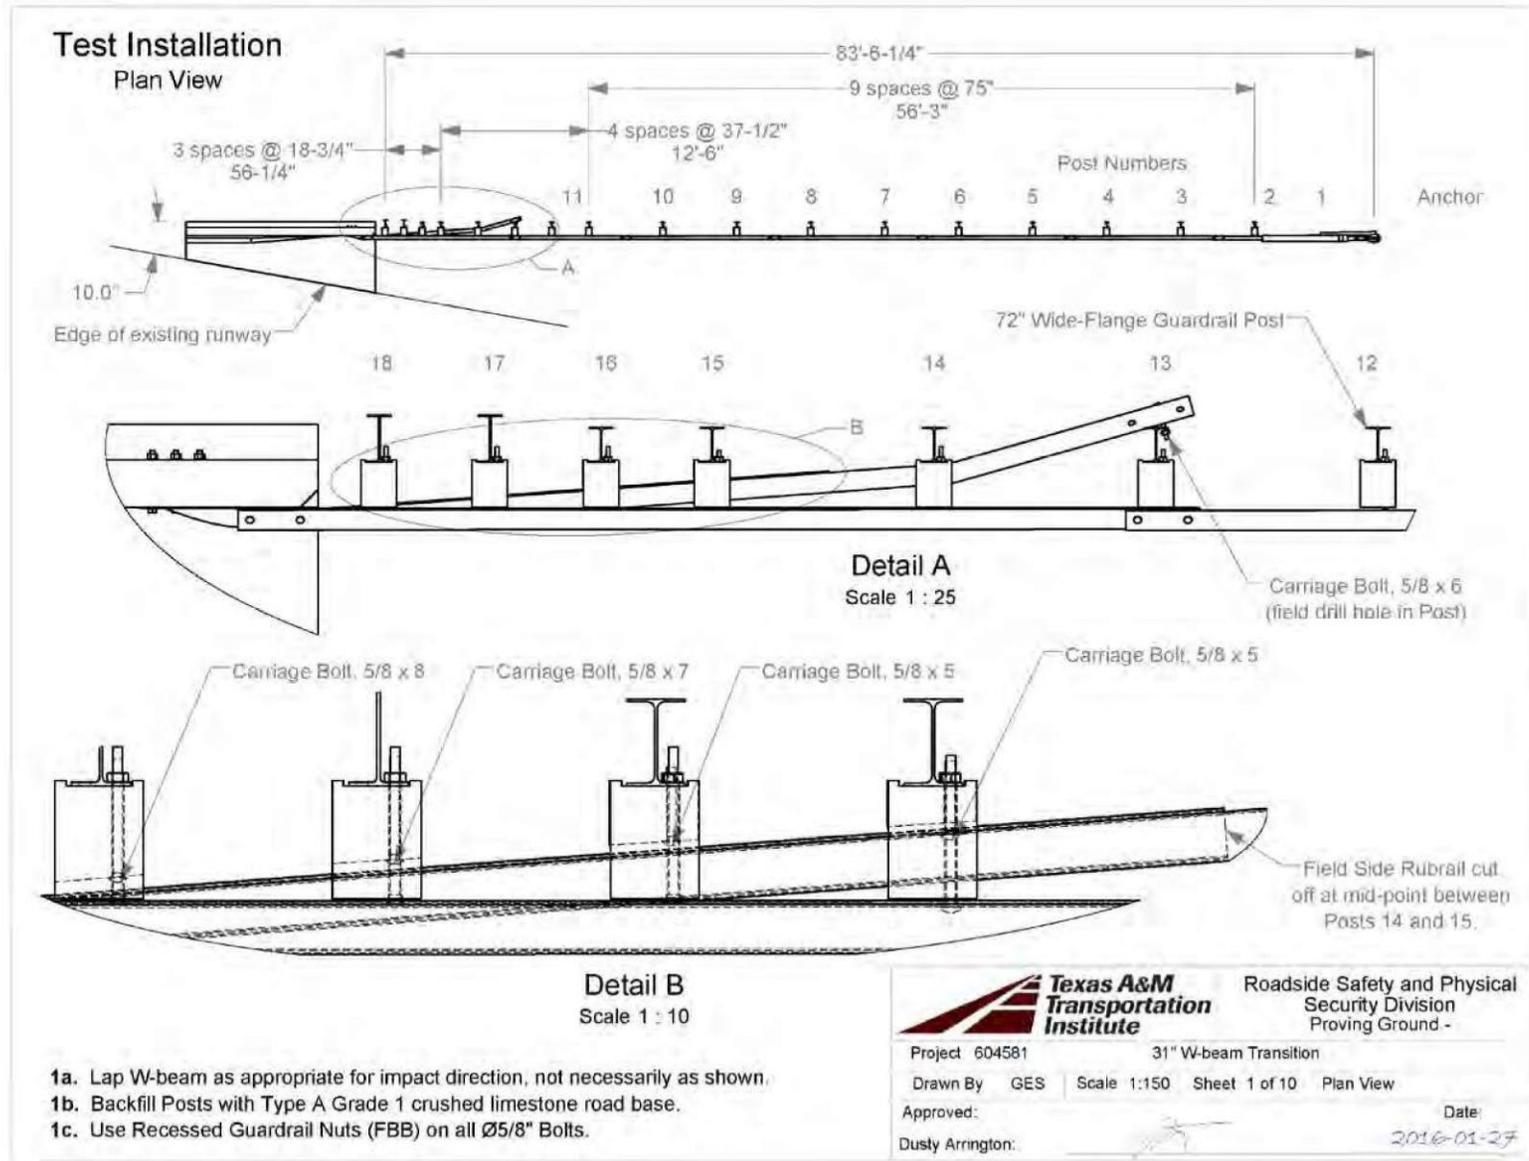
Figure 37. TTI Stacked W-Beam Test Installation Layout [18]

In 2016, TTI investigated the crashworthiness of a stacked W-beam AGT design for use with a 31-in. (787-mm) guardrail system [18]. The test no. 604581-1 AGT test installation had an overall length of 100 ft – 8 in. (30.7 m). The barrier system was constructed with 18 guardrail posts, which supported the 12-gauge (2.7-mm) W-beam guardrail and nested 12-gauge (2.7-mm) W-beam rubrail. The W-beam guardrail was installed with a top rail height of 31 in. (787 mm). The W-beam rubrail spanned from post nos. 13 to 18 and was installed below the W-beam guardrail with a centerline rail height of 10⁷/₈ in. (276 mm). Post nos. 3 through 16 and post nos. 17 and 18 were W6x8.5 and W8x13 steel posts, respectively. Post nos. 2 through 11, post nos. 11 through 15, and post nos. 15 through 18 were spaced at 75 in. (1,905 mm), 37¹/₂ in. (953 mm), and 18³/₄ in. (476 mm), respectively. The downstream end of the test installation was anchored to a 32-in. (813-mm) tall F-shape concrete parapet. The test installation is shown in Figure 37.
