*Midwest Pooled Fund Research Program
Fiscal Years 2019-2022 (Year 29)
Research Project Number TPF-5(193) Supplement #141
NDOT Sponsoring Agency Code RFPF-19-AGT-1*

EVALUATION OF FLARE RATES FOR APPROACH GUARDRAIL TRANSITIONS – PHASE I

MIDWEST ROADSIDE SAFETY FACILITY

MwRSF Research Report No. TRP-03-439a-22

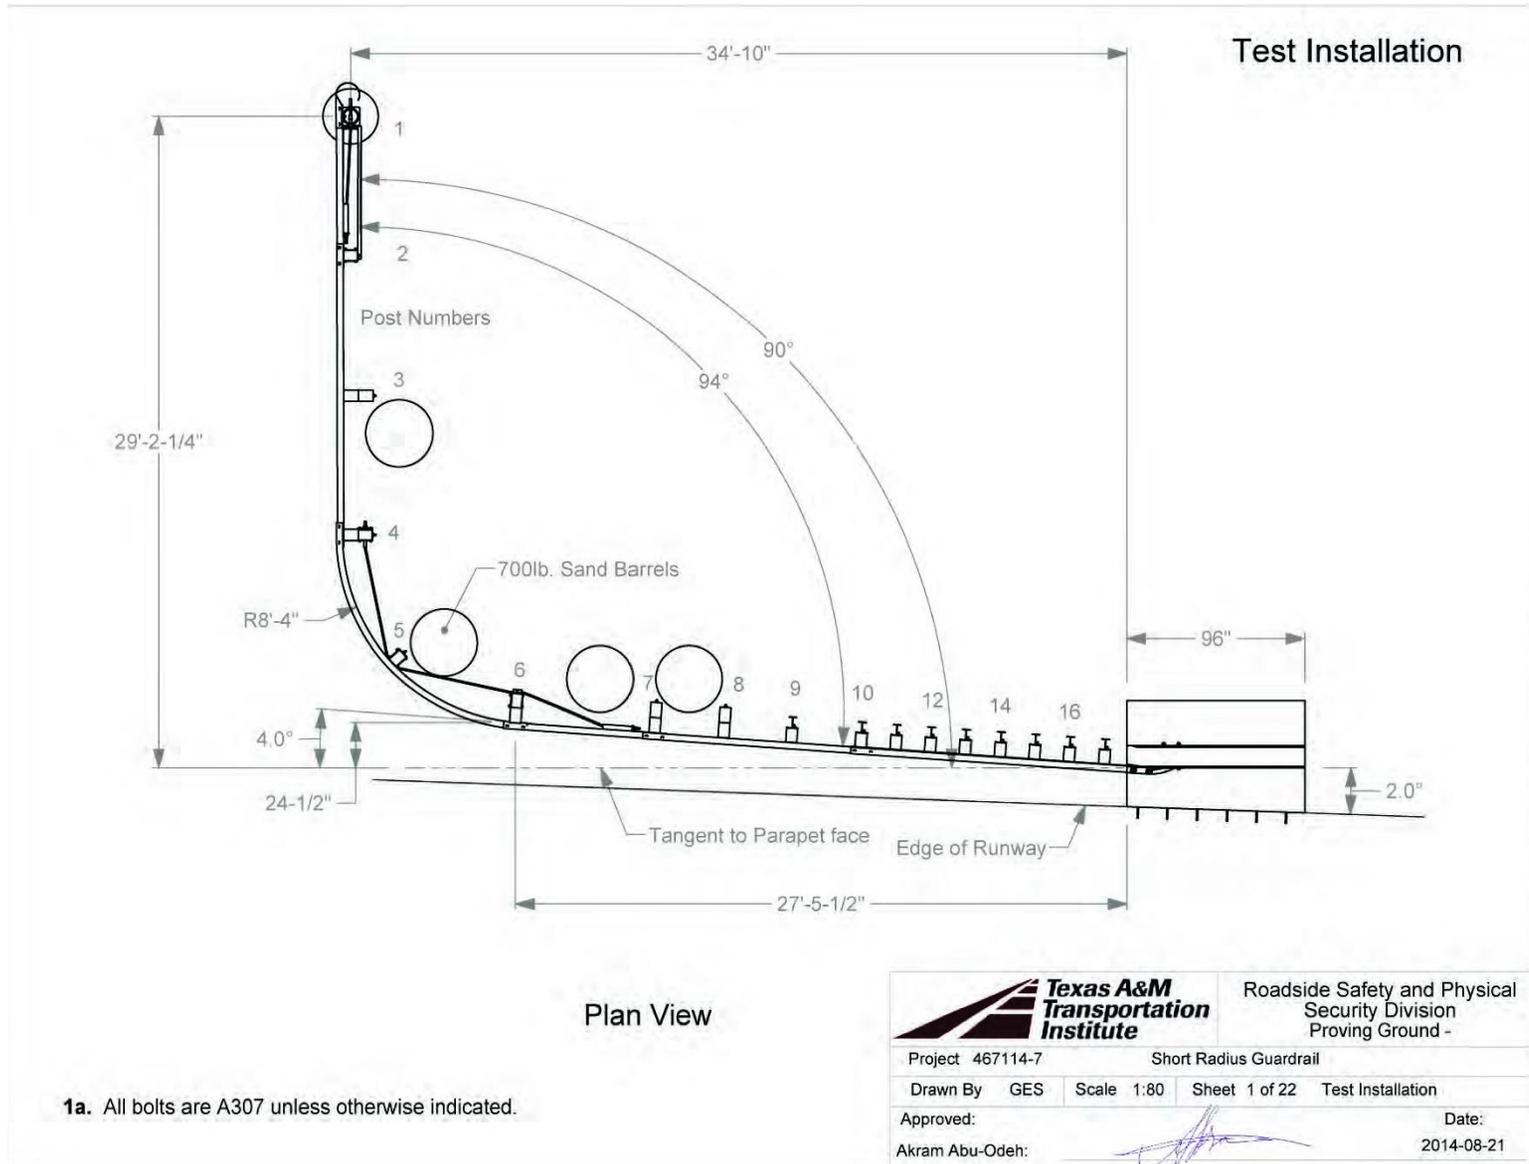
Figure 39. MASH TL-3 Short Radius Guardrail Test Installation – Test No. 467114-7 [19]

roadway. The length of guardrail along the primary roadway transitioned to a 32-in. (813-mm) tall vertical concrete parapet and incorporated a 4-degree flare away from the primary roadway. The guardrail sections were 12-gauge (2.7-mm) thrie-beam guardrail with a top rail height of 31 in. (787 mm) and were supported by 16 guardrail posts. Post nos. 1 through 7, 7 through 11, and 11 through 16 were spaced at 75 in. (1,905 mm), 37½ in. (953 mm), and 18¾ in. (476 mm), respectively. Post nos. 2 through 8 were modified timber posts and post nos. 9 through 16 were W6x8.5 steel posts. Along the primary roadway, post nos. 9 and 10 and post nos. 11 through 16 were embedded at depths of 40 in. (1,016 mm) and 52 in. (1,321 mm), respectively. An anchor cable spanned the curved guardrail section from post nos. 4 to 7 and four 700-lb (318-kg) sand barrels were placed behind the guardrail. The system was modified for test no. 467114-7 by adding an additional W6x8.5 steel post between post no. 10 and the concrete parapet. The test no. 467114-7 installation layout is shown in Figure 39. The crash test data for test nos. 467114-3 through 467114-7 is summarized in Table 14 and sequential photographs are presented in Figures 40 through 44.

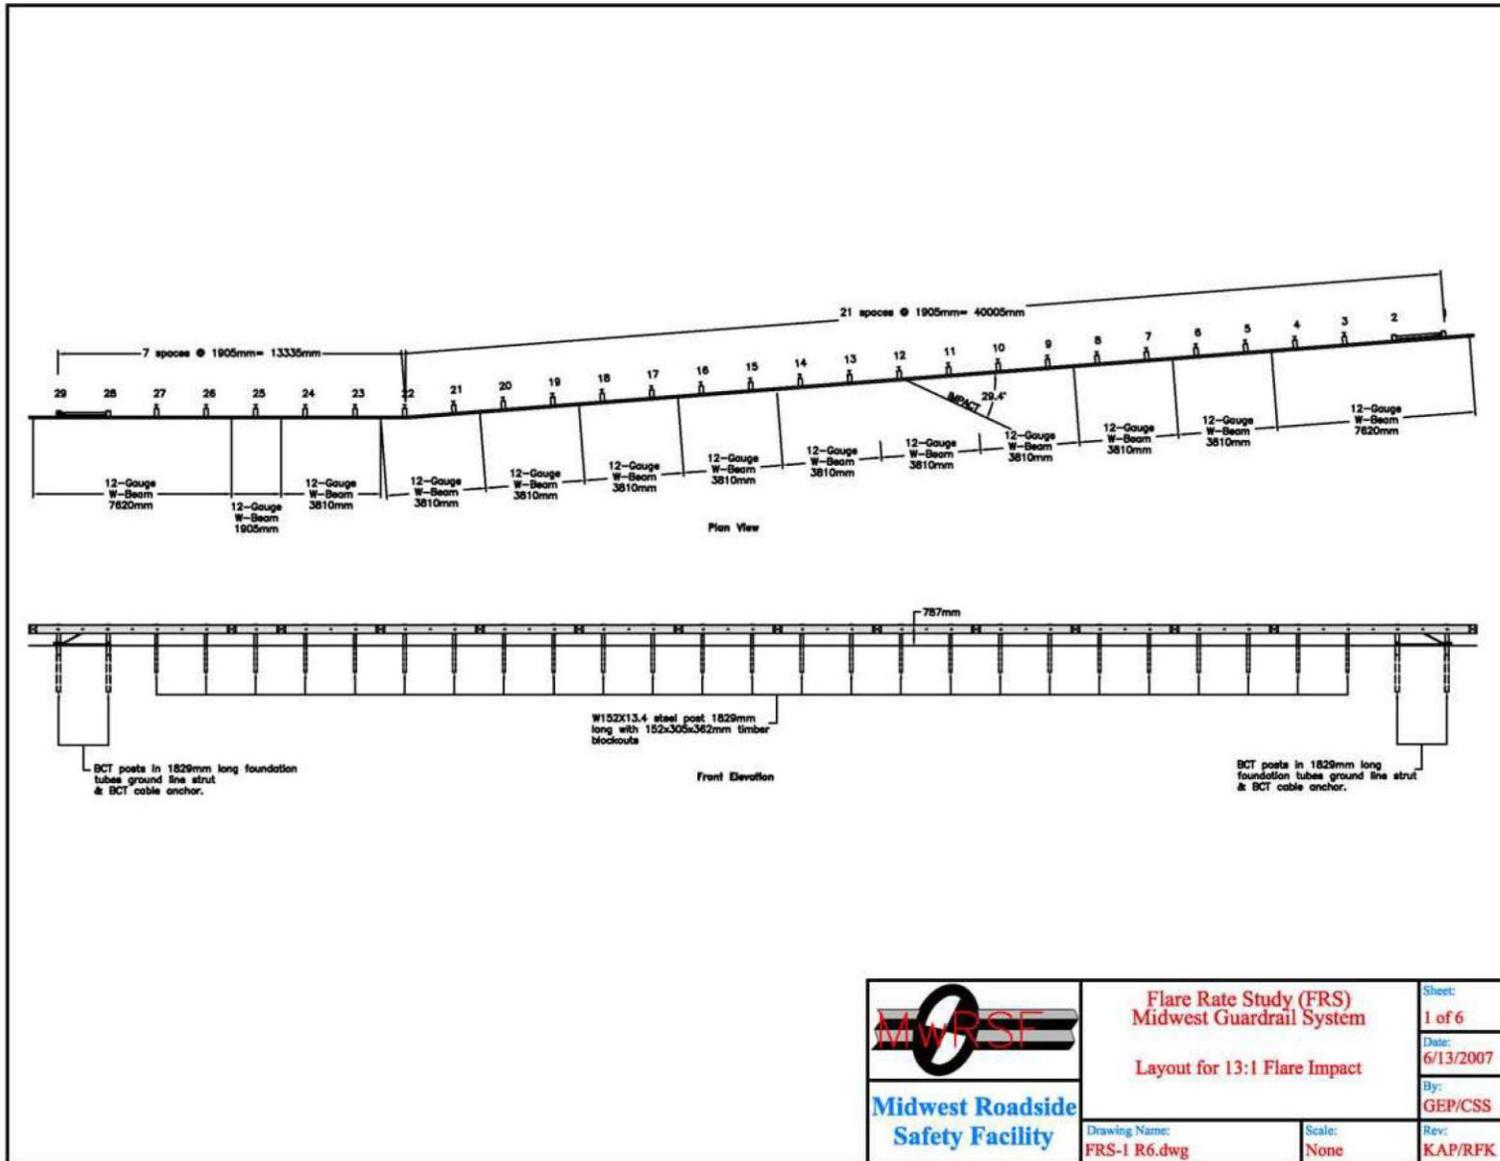
Figure 45. MGS – Flare Rates, 13:1 (4.4 degrees from roadway) Flared Test Installation [2]

Test nos. FR-1 through FR-5 were conducted to determine the critical flare rates for the MGS. Three system layouts with flare rates of 13:1 (4.4 degrees from roadway), 7:1 (8.1 degrees from roadway), and 5:1 (11.3 degrees from roadway), were evaluated. The three designs were identical except for the flare rate of the system. The two farthest upstream and downstream posts in the systems were 5½-in. x 7½-in. (140-mm x 190-mm) timber anchorage posts. The remaining posts in the systems were W6x9 steel posts embedded at a depth of 40 in. (1,016 mm) with a post spacing of 75 in. (1,905 mm). The guardrail posts supported the 12-gauge (2.7-mm) W-beam guardrail, which was installed with a top rail height of 31 in. (787 mm). The test installation layout of the 13:1 (4.4 degrees from roadway) flare rate is shown in Figure 45. The crash test data for test nos. FR-1 through FR-5 is summarized in Table 15 and sequential photographs are presented in Figures 46 through 50.

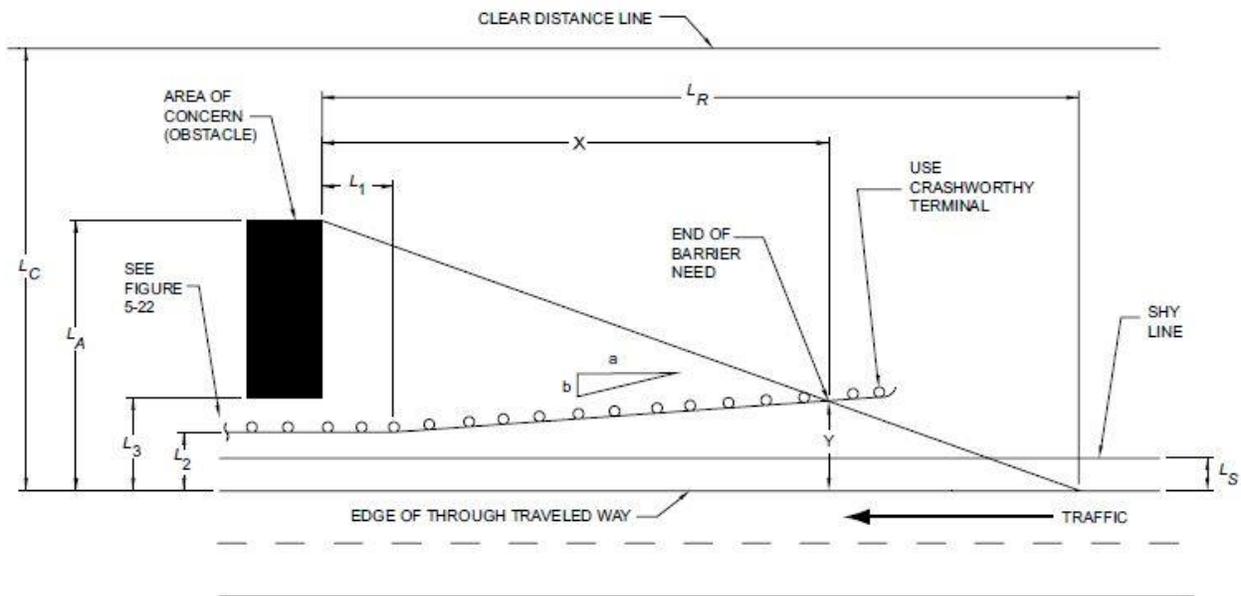
Figure 51. LON Layout [20]

The lateral area of concern (L_A) is the lateral extent of the hazard being safeguarded, measured from the edge of the traveled roadway. The runout length (L_R) is the longitudinal distance along the roadway measured from the location that the vehicle departs the roadway to the beginning of the area of concern. The tangent transition length (L_1) is the length of guardrail that is parallel to the roadway measured from the upstream end of the rigid barrier to the beginning of the flared section. Barrier offset (L_2) is a measure of the distance between the guardrail installation and the edge of the traveled roadway. These variables as well as the required LON (X) and the lateral offset (Y) are illustrated in Figure 51.

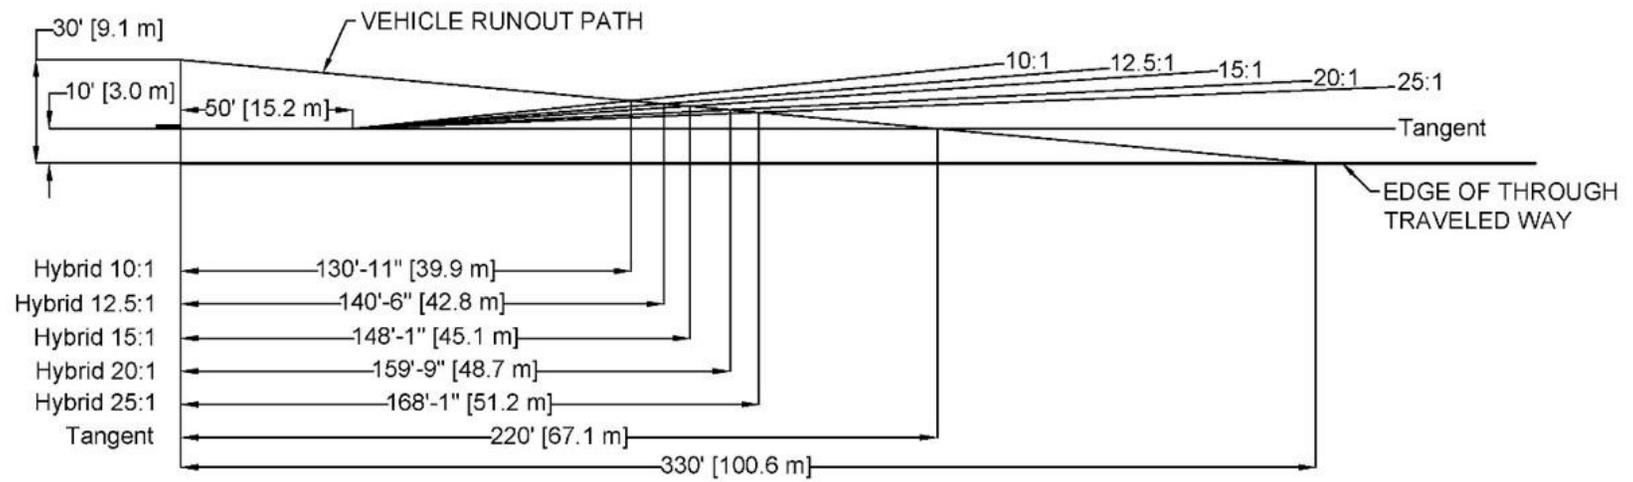
Lateral Area of Concern: 30.0 ft (9.1 m)
 Runout Length: 330.0 ft (100.6 m)
 Barrier Offset: 10.0 ft (3.0 m)

Figure 53. Hybrid Flare AGT LON Diagram

A direct comparison between the pure 15:1 (3.81 degrees from roadway) and 12.5:1 (4.57 degrees from roadway) flare rates initiated at the buttress and the hybrid 15:1 and 12.5:1 flare rates initiated 50 ft upstream of the buttress is shown in Figure 54. Compared to the pure flared configuration, the hybrid flared configuration LON is increased 21 ft – 2 in. (6.5 m) at the 15:1 flare rate and 23 ft – 6in. (7.2 m) at the 12.5:1 flare rate.

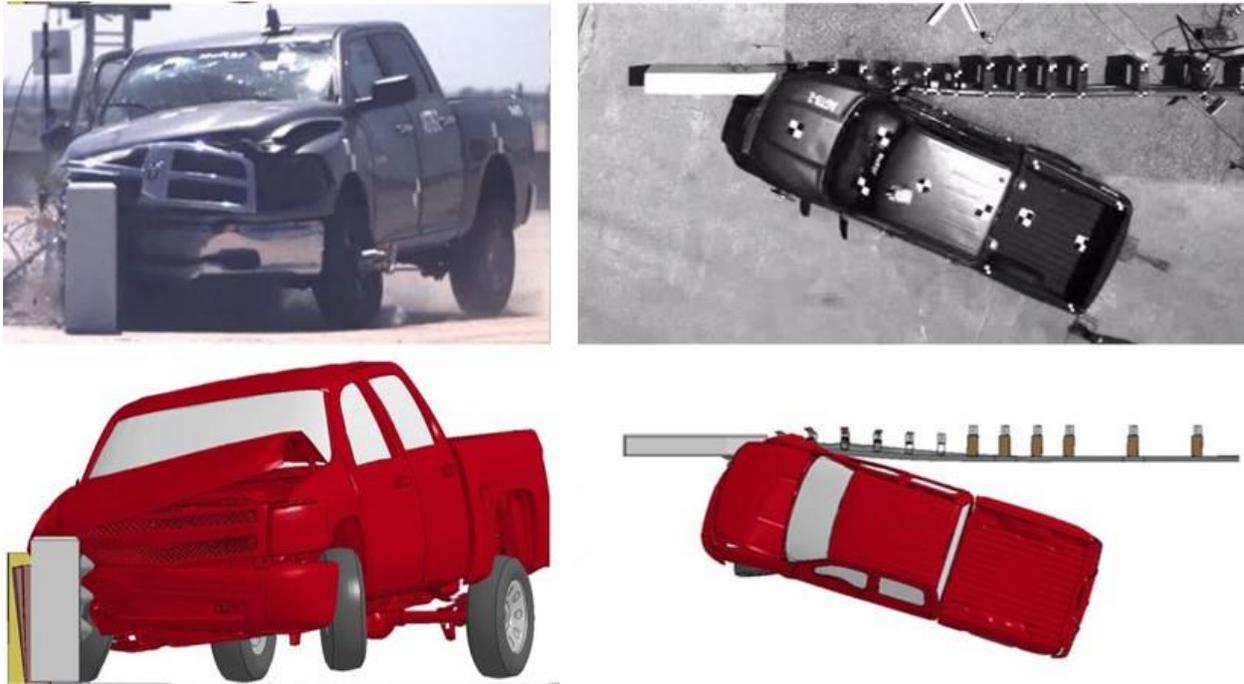
Figure 57. Full-Scale Crash Test No. AGTB-2 (Top) and Silverado Simulation (Bottom) [22]

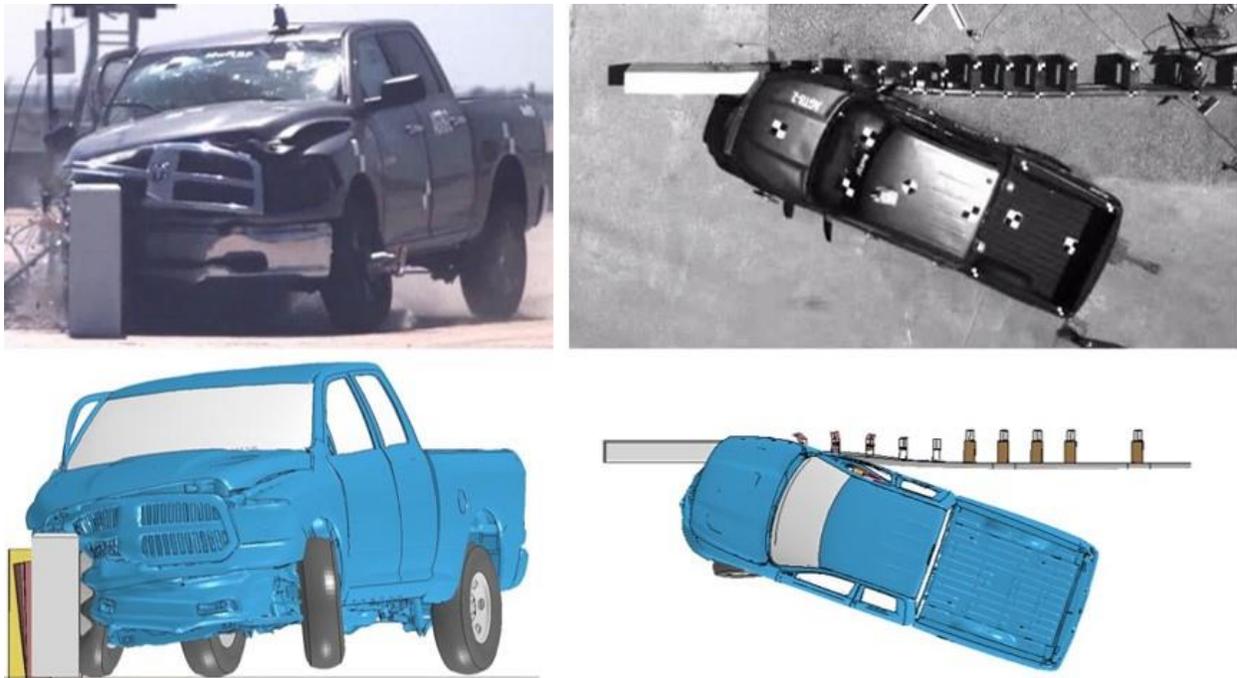
Figure 59. Full-Scale Crash Test No. AGTB-2 (Top) and Ram Simulation (Bottom) [22]

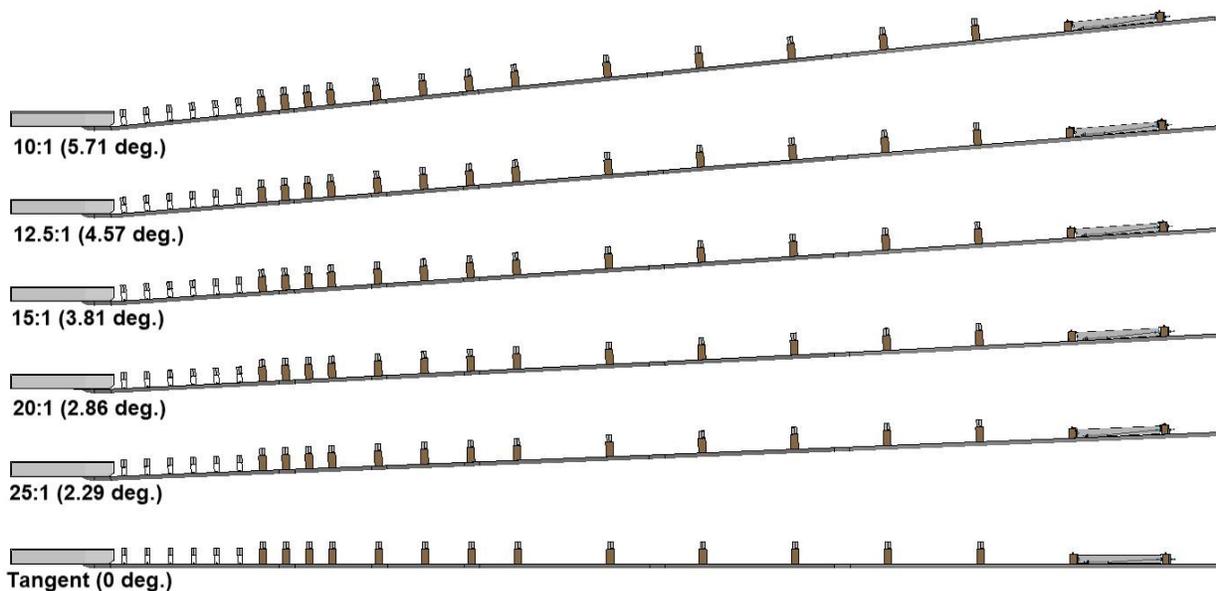
Figure 62. Modeled Flared Installations

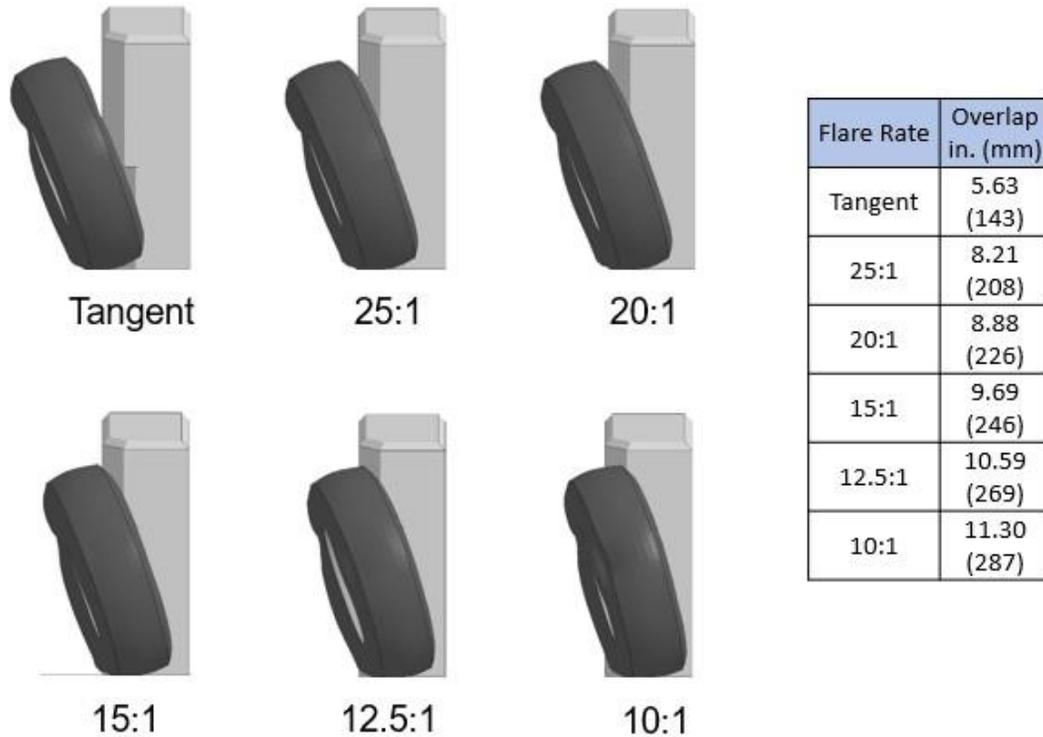
Figure 69. Flared AGT Comparison of Silverado Tire-Buttruss Overlap

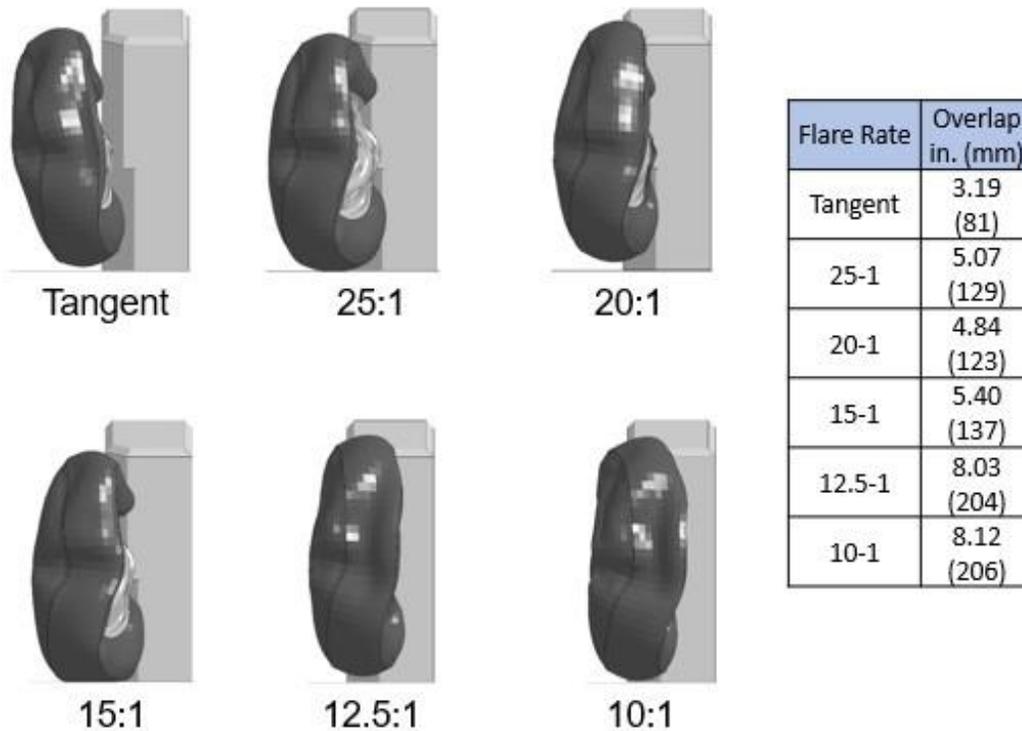
Figure 72. Flared AGT Comparison of Ram Tire-Buttress Overlap

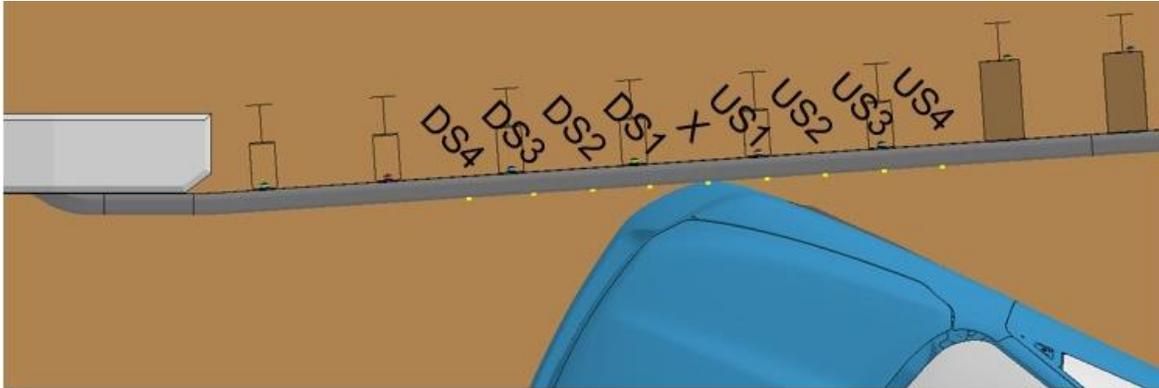
Figure 75. 2270P CIP Study Impact Locations

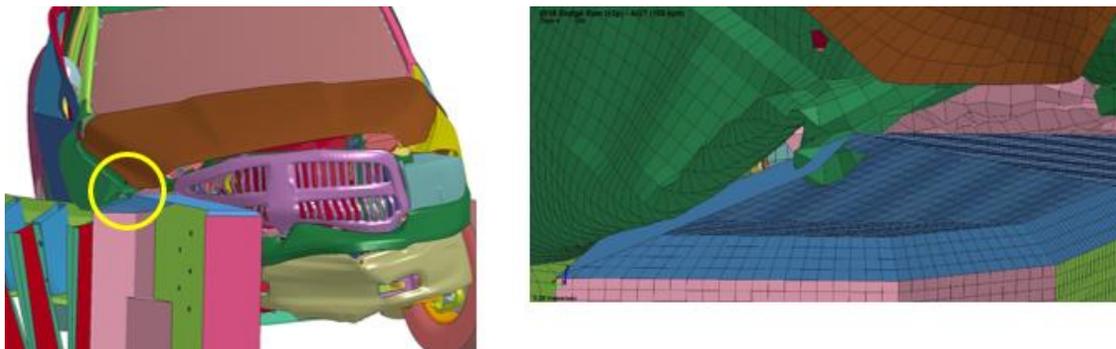
Figure 76. Fender-Buttress Penetration – 15:1 Flare Rate at US3 Impact Location

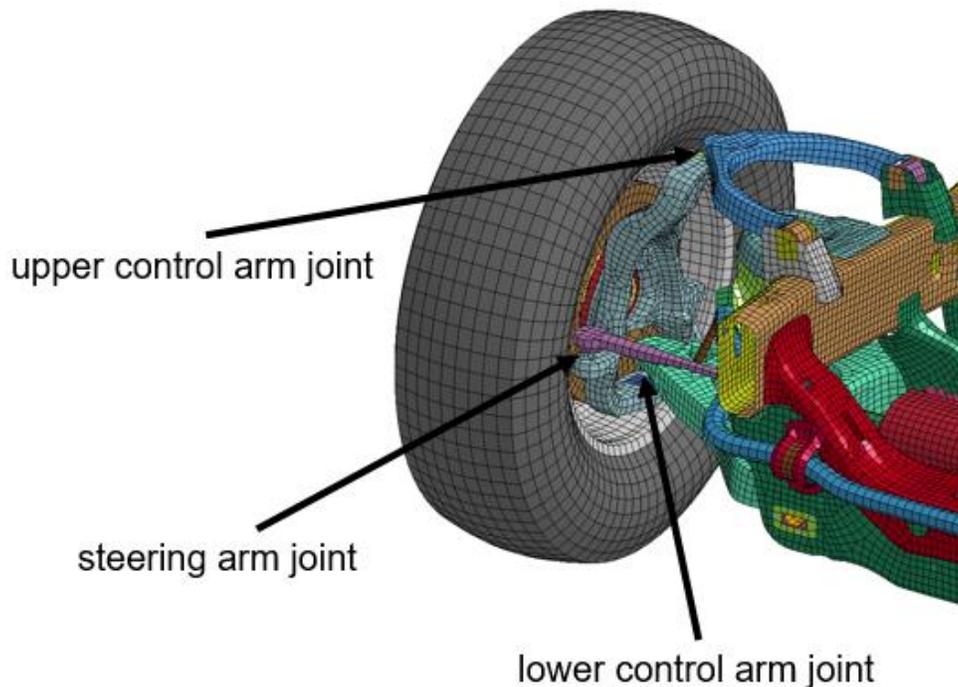
Figure 77. Ram Vehicle Model Right-Front Suspension Joints

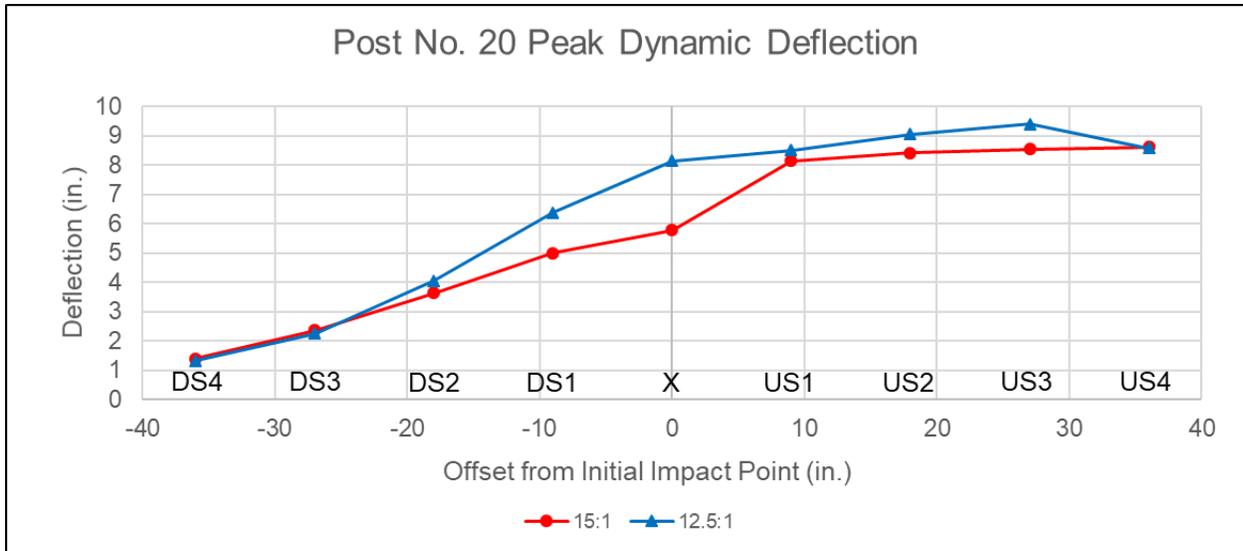
Figure 79. Post No. 20 Deflection

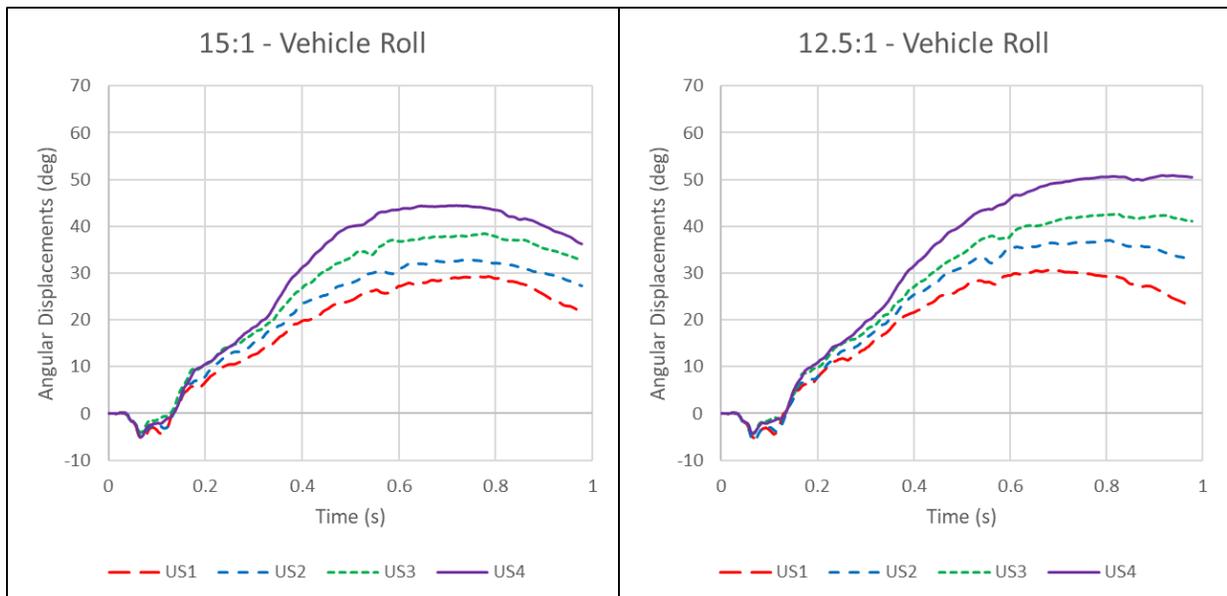
Figure 80. Euler Roll Angular Displacement – 15:1 (Left); 12.5:1 (Right)

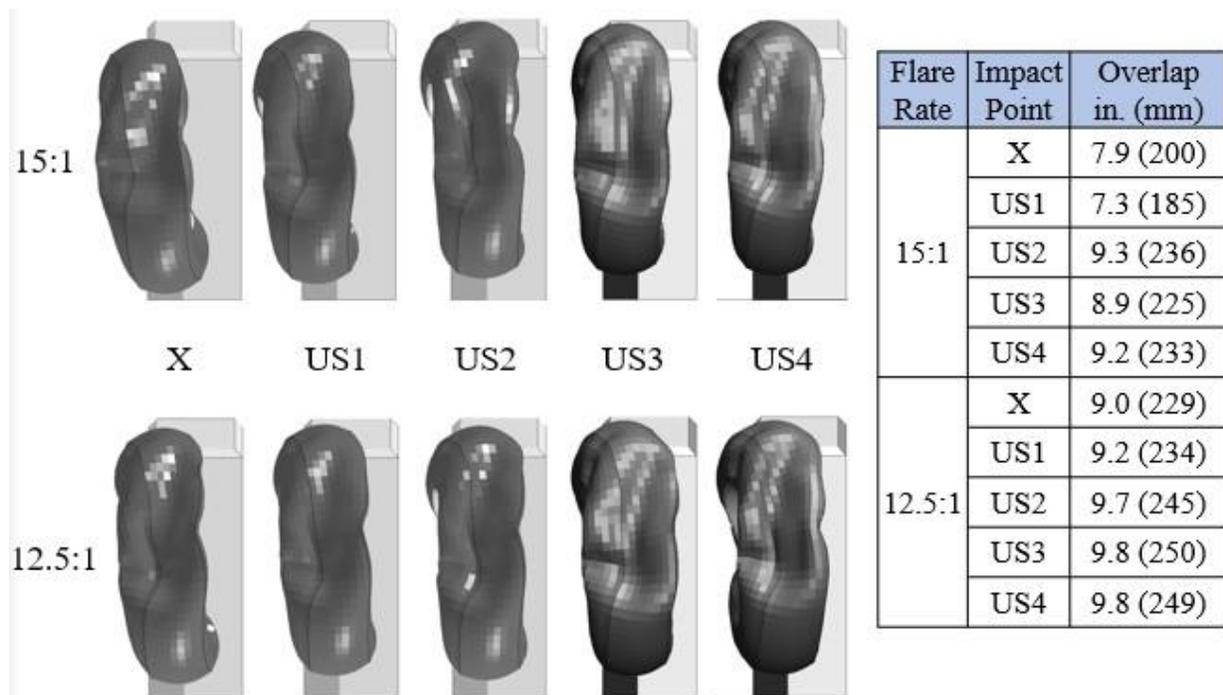
Figure 81. Tire-Buttress Overlap

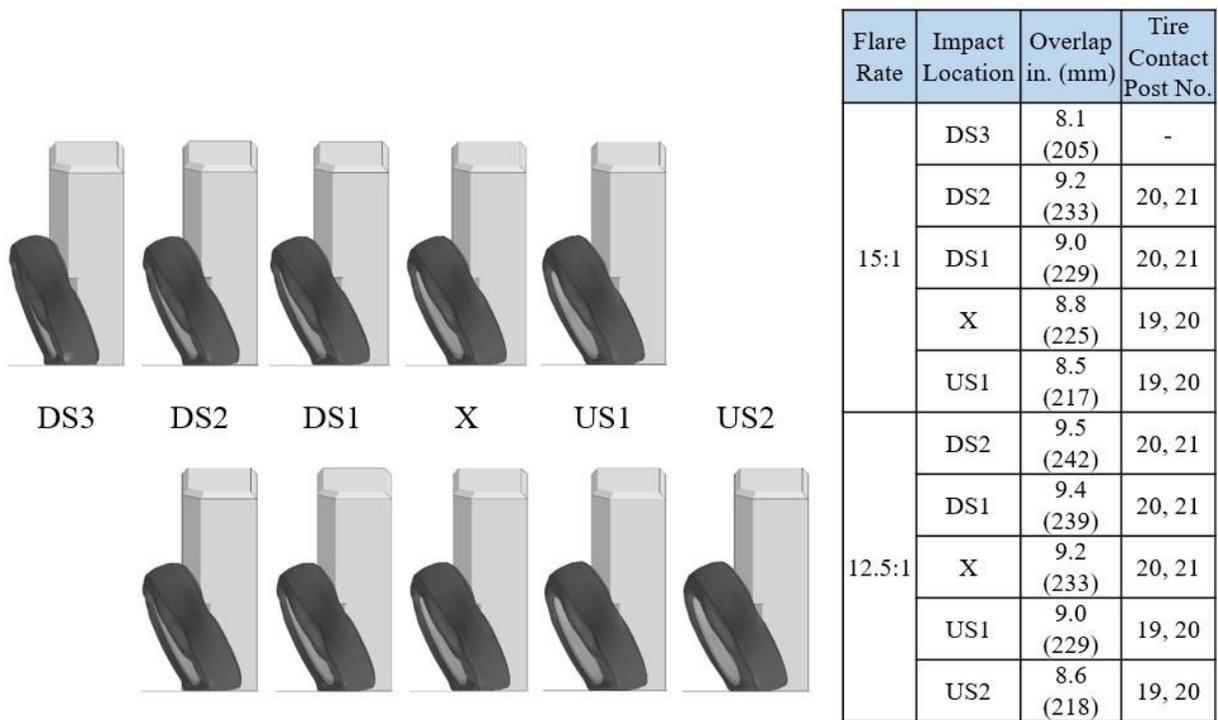
Figure 87. 1100C Right-Front Tire-Buttress Overlap

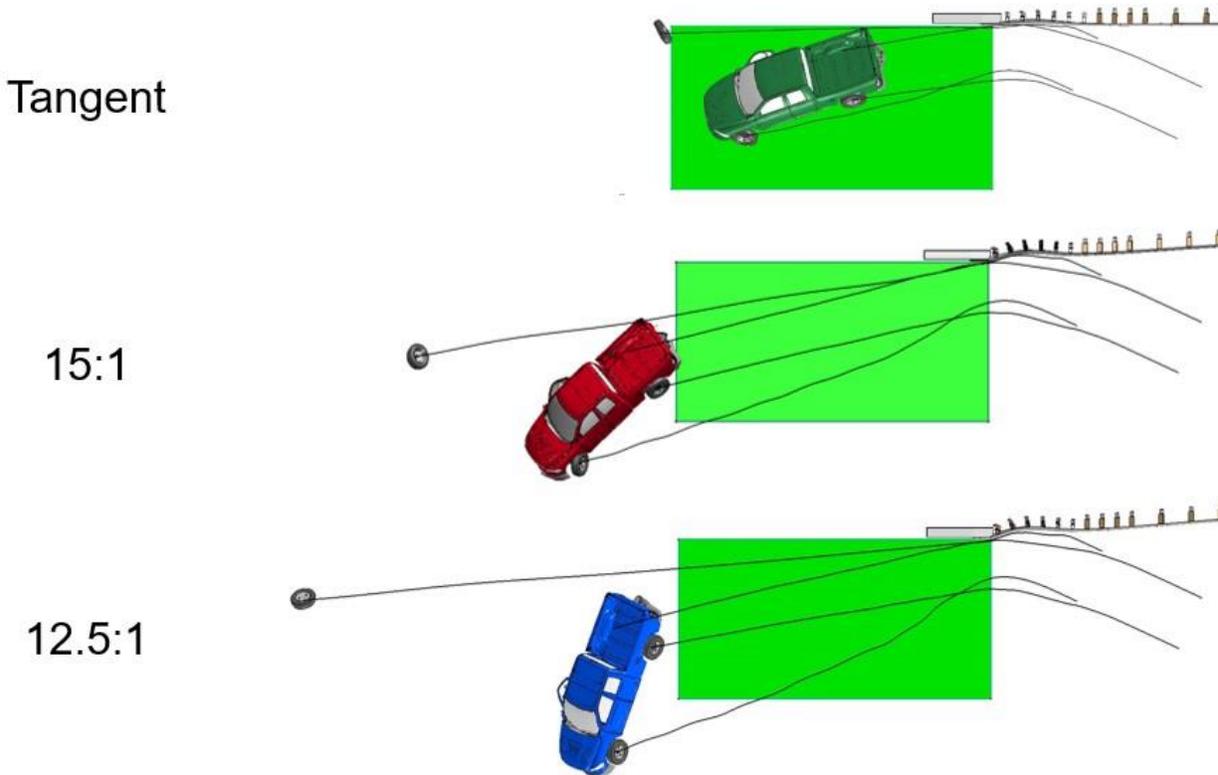
Figure 93. 2270P Vehicle Trajectory and Exit Box

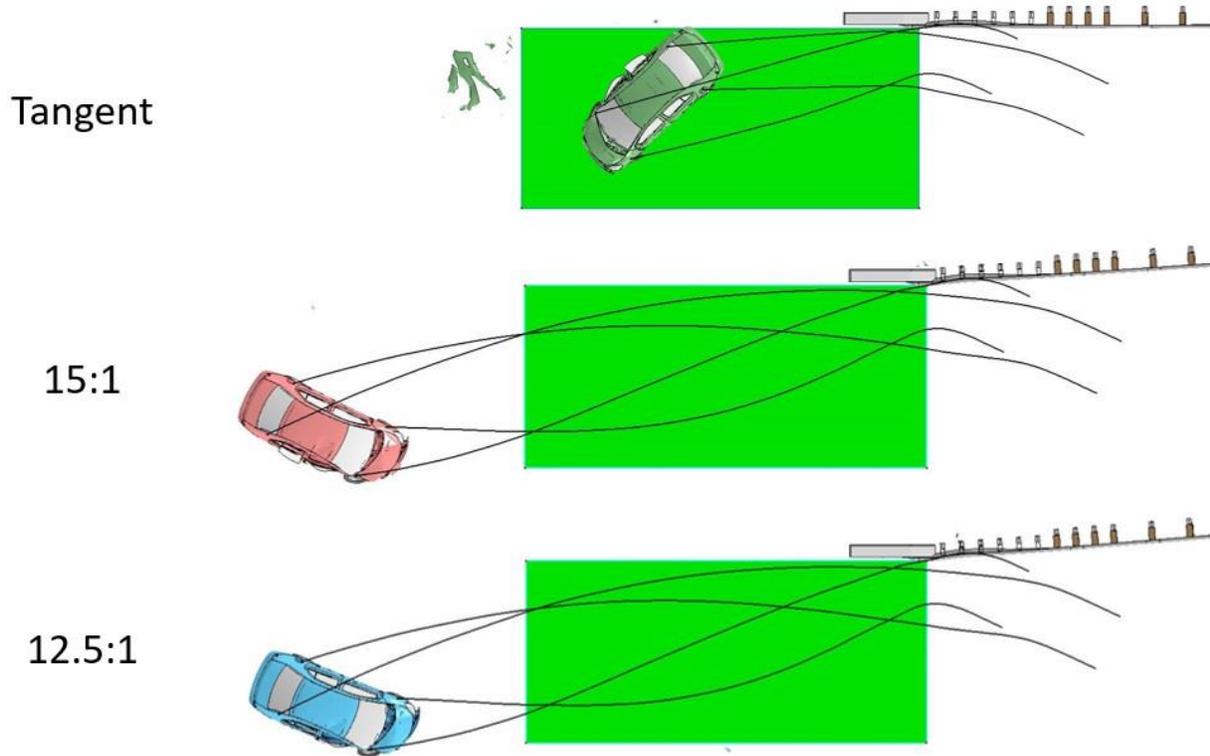
Figure 94. 1100C Vehicle Trajectory and Exit Box
