# **MASH 2016 EVALUATION OF A NON- PROPRIETARY TYPE III BARRICADE: MASH TEST DESIGNATION NO. 3-72**

## **MIDWEST ROADSIDE SAFETY FACILITY**

MwRSF Research Report No. TRP-03-416-20

September 25, 2020

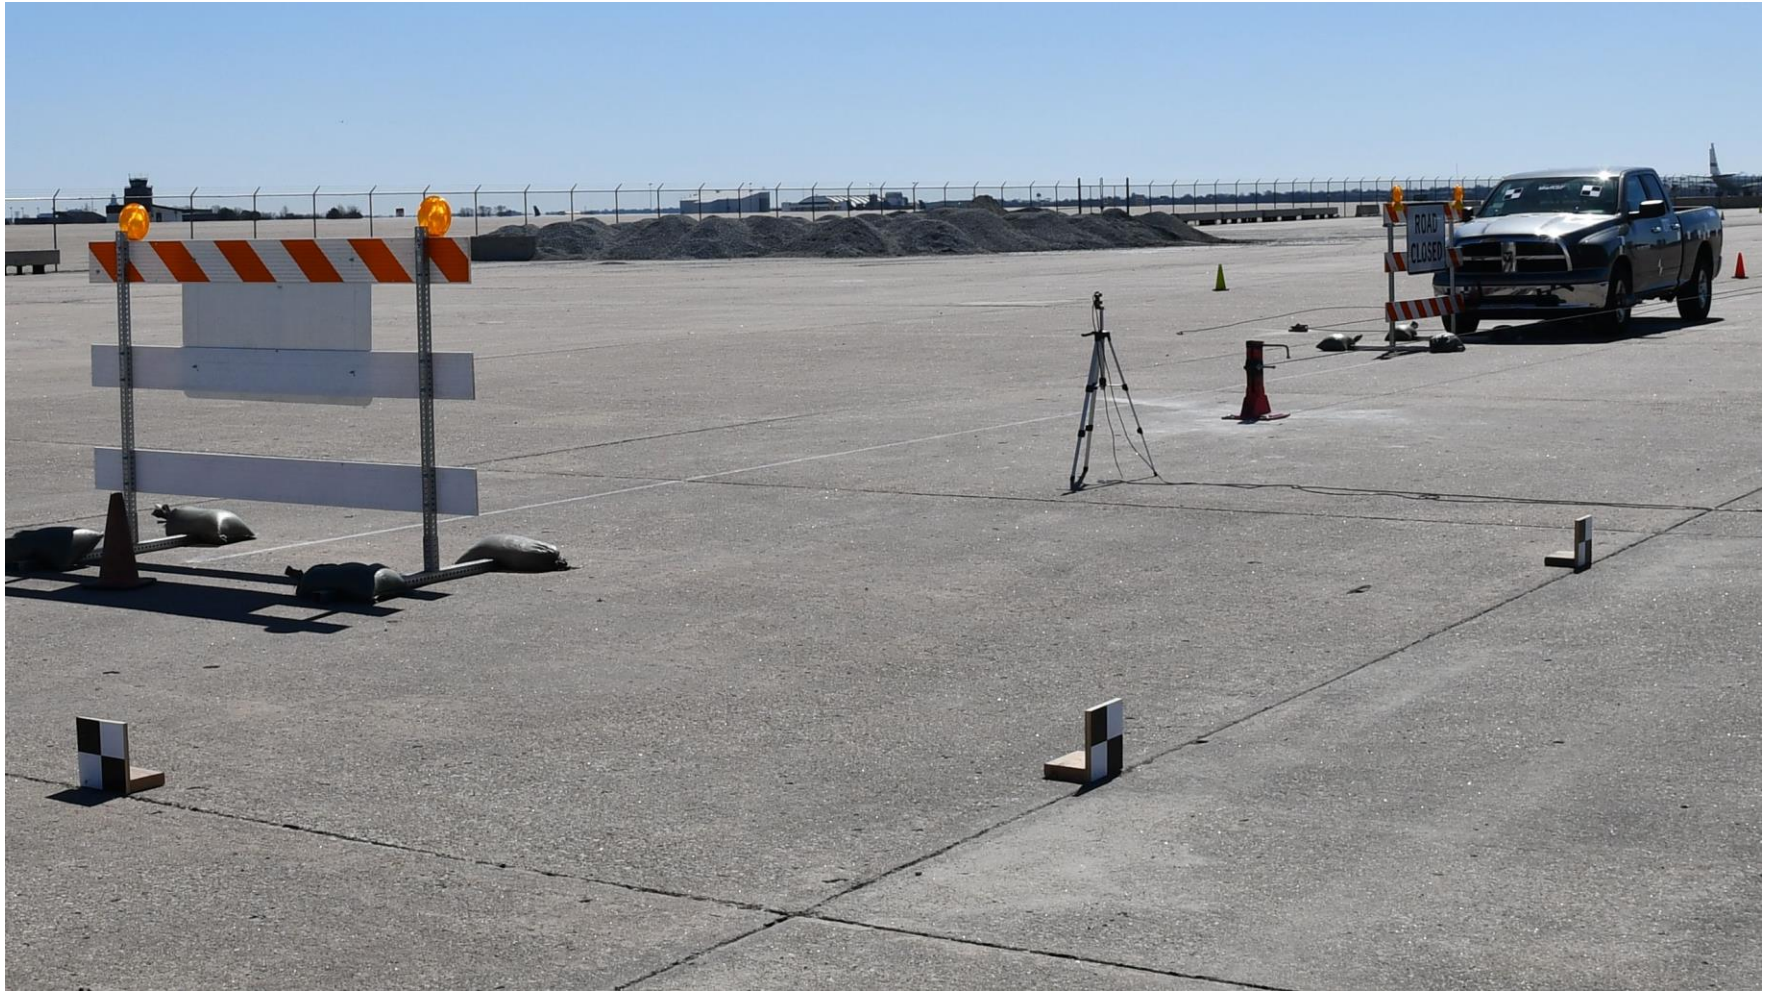
Figure 11. Test Impact Point, Test No. WZNP-2

Two identical Type III barricades were evaluated. System A was oriented at 90 degrees, end-on to the vehicle. System B was oriented at 0 degrees, or head-on to the vehicle. Initial vehicle impact with System A was to occur with a right quarter-point offset from the centerline of the vehicle and initial vehicle impact with System B was to occur with a left quarter-point offset from the centerline of the vehicle, as shown in Figure 11.

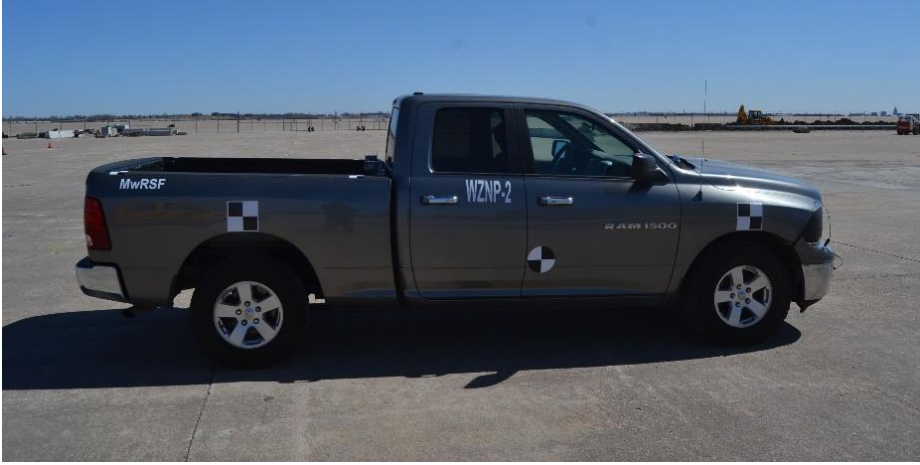
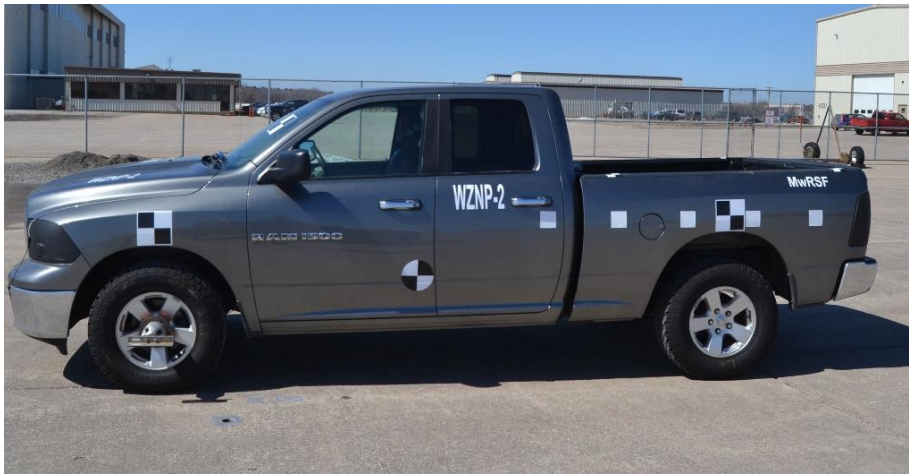
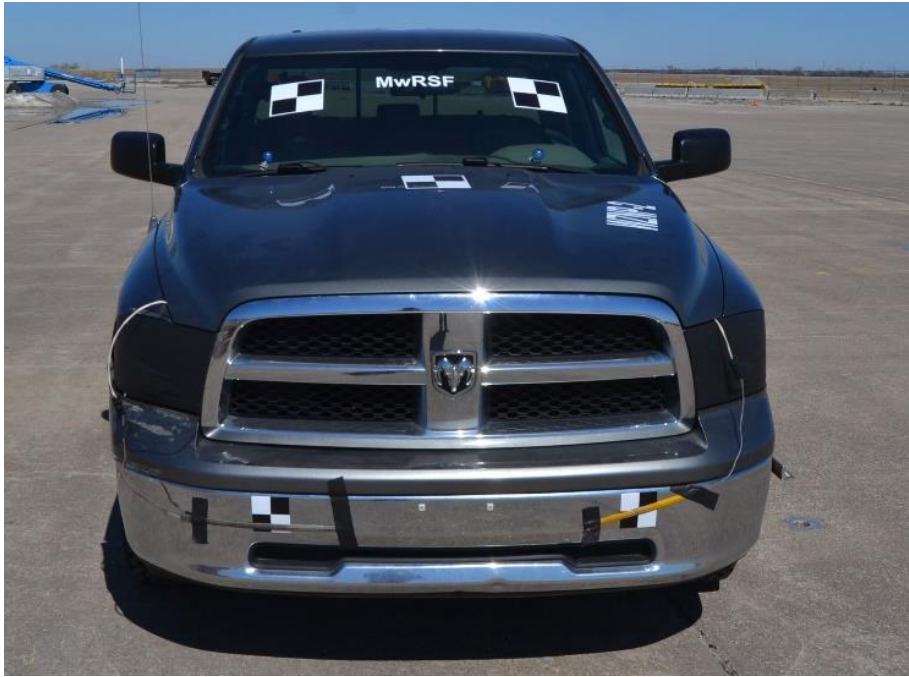
Figure 12. Test Vehicle, Test No. WZNP-2

For test no. WZNP-2 a 2011 Dodge Ram 1500 quad cab pickup truck was used as the test vehicle. The curb, test inertial, and gross static vehicle weights were 5,105 lb (2,316 kg), 5,001 lb (2,268 kg), and 5,165 lb (2,343 kg), respectively. MASH recommends using test vehicles within 6 model years on the day the test is conducted. Additionally, vehicles within 6 model years of the award date of the research project, which was in 2015, were allowed at the time. Thus, a test vehicle older than 6 years from the test date was utilized, and all dimensions and properties of the test vehicle met the requirements in MASH. The test vehicle is shown in Figures 12 and 13, and vehicle dimensions are shown in Figure 14.

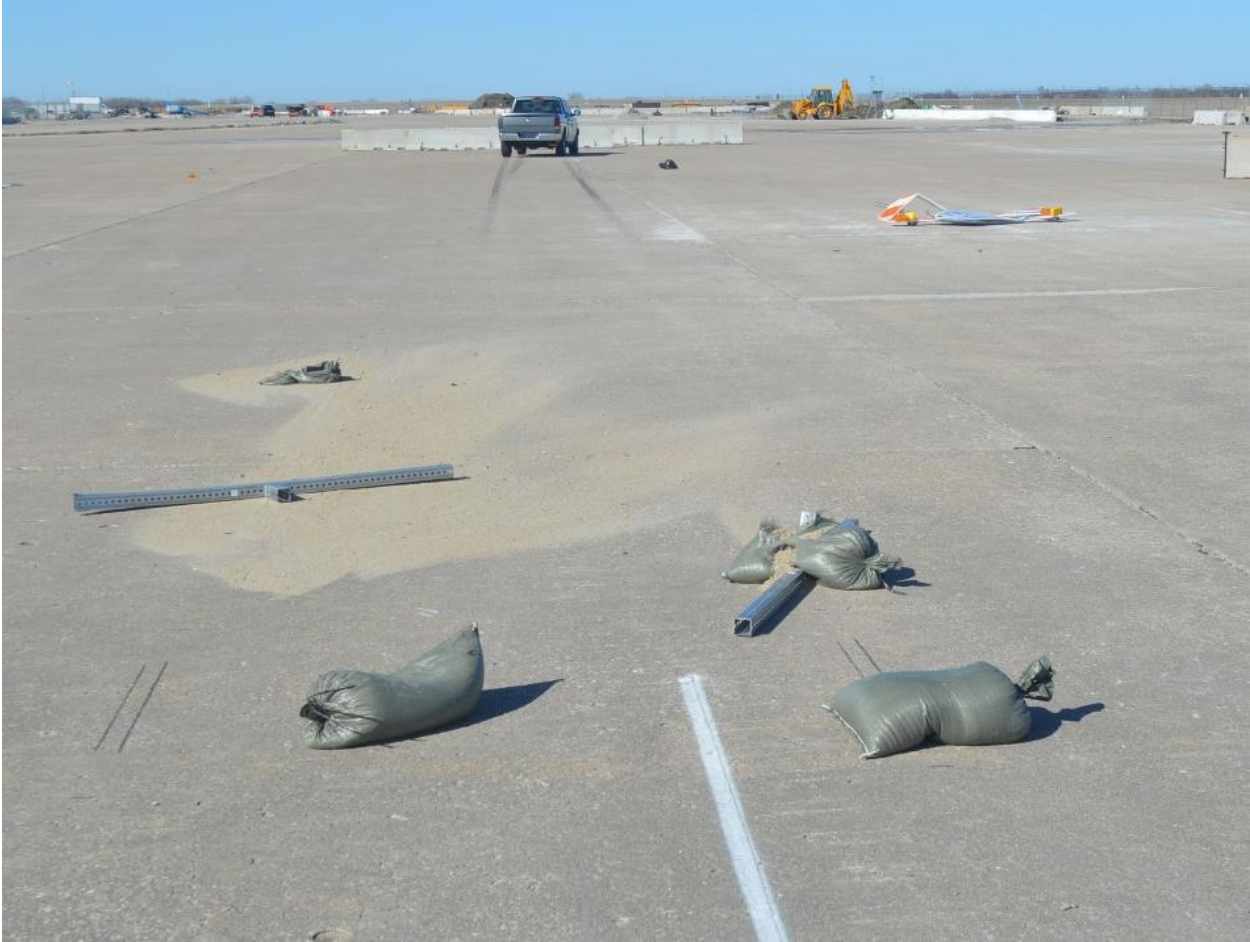
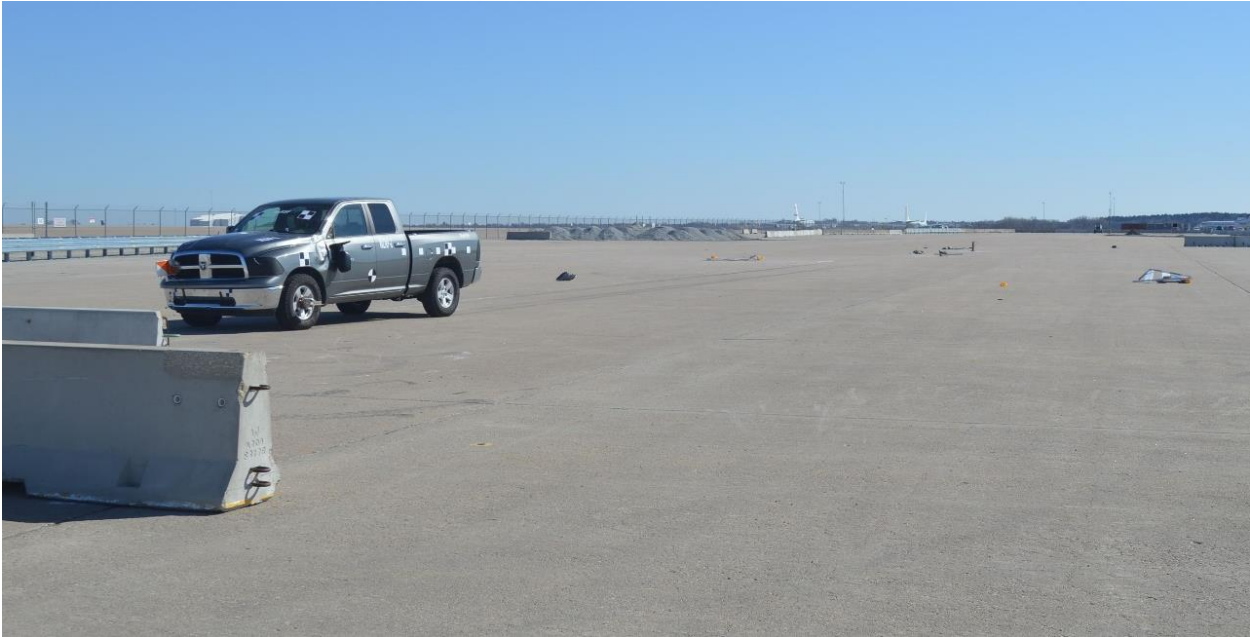
Figure 23. Vehicle Trajectory and Final Position, Test No. WZNP-2

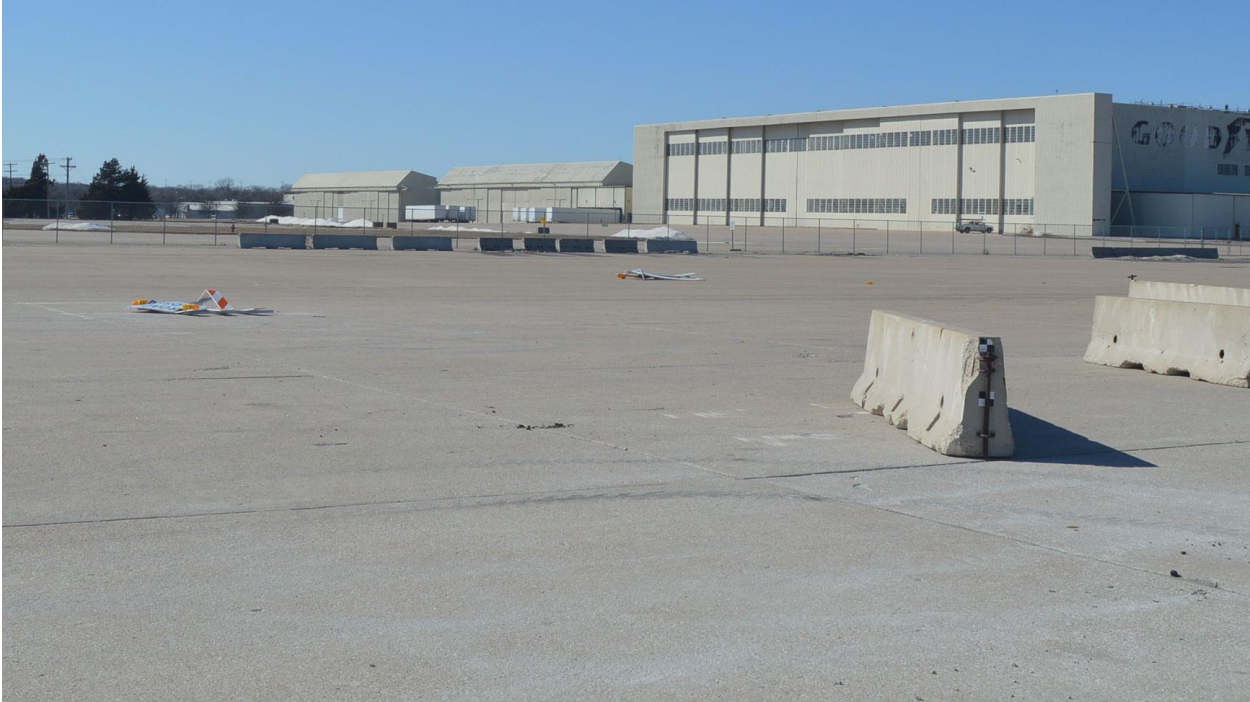
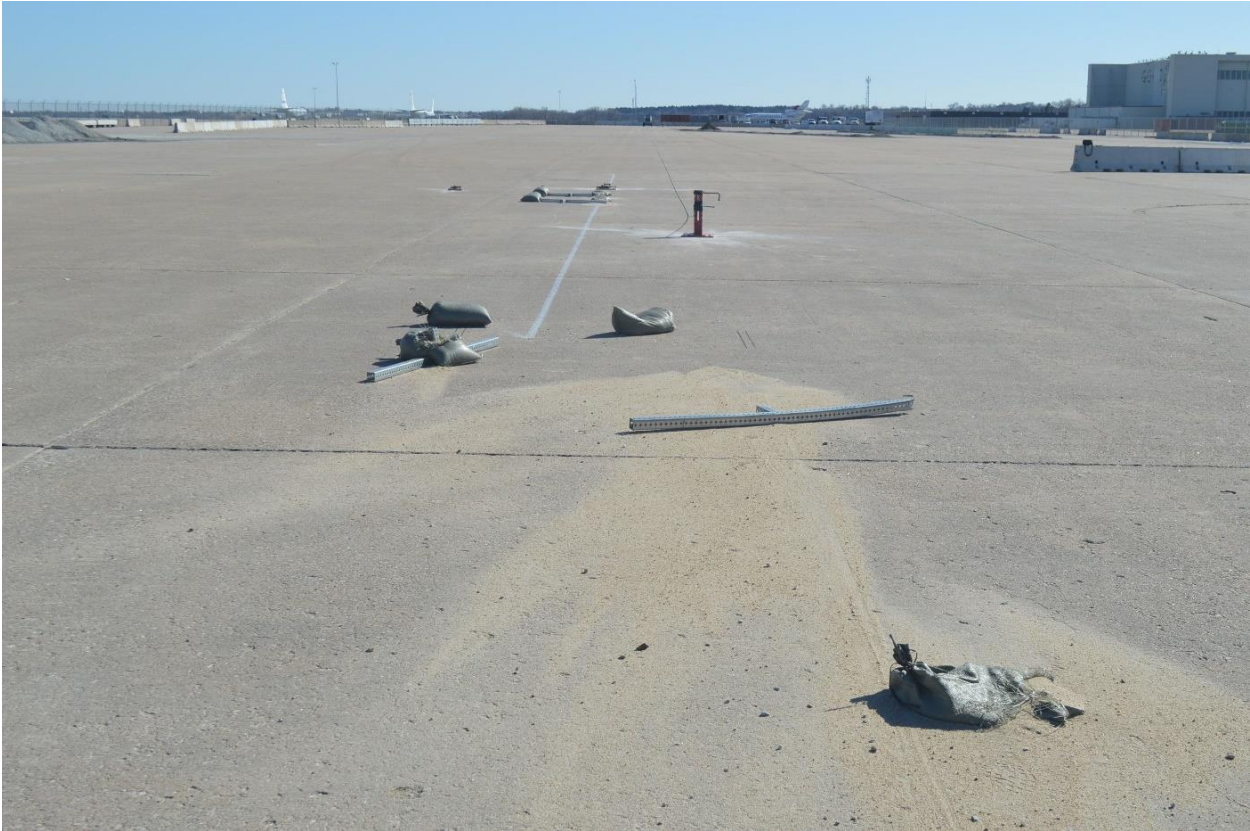
Damage to the barricades was extensive, as shown in Figures 24 through 28. Barricade damage consisted of punctured sandbags, bent uprights and legs, bent and torn barricade panels, and bolts pulled through the barricade panels. The vehicle readily disengaged both barricades from their bases.

Figure 24. Overall System A and System B Damage, Test No. WZNP-2

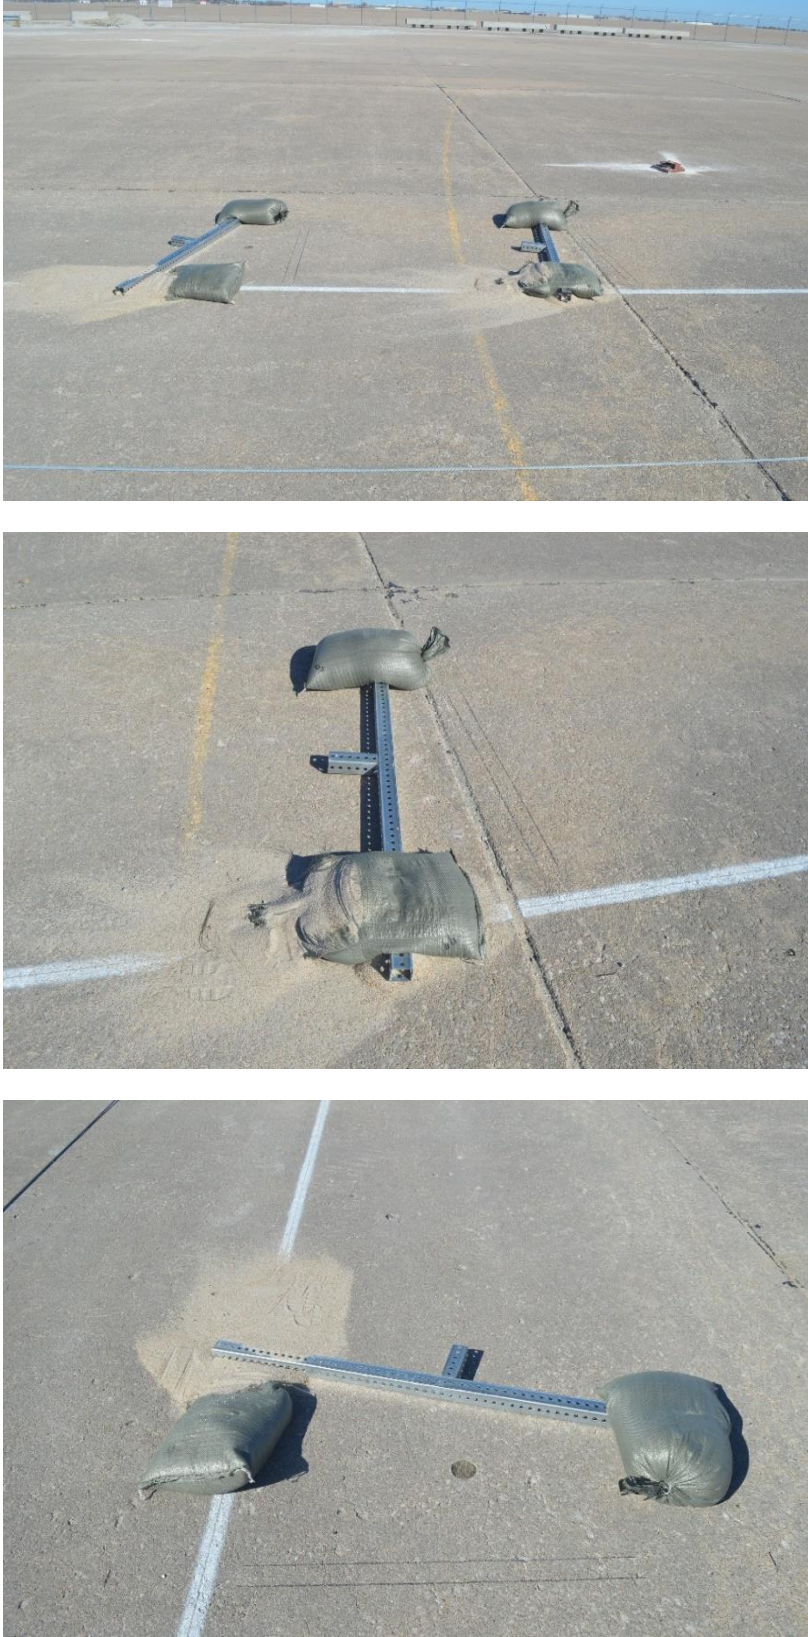
System A was facing perpendicular to the direction of travel. The centerline of the system was aligned to the right quarter-point and offset from the centerline of the vehicle. The two uprights disengaged from each leg upon impact. The upstream left and downstream left sandbags were torn open. The upstream end of the middle barricade panel tore. The upstream upright was bent inward toward the center of the sign. The bottom barricade panel was deformed. Three bolts were partially pulled out of the bottom barricade panel. Two bolts were pulled out of the middle barricade panel, and one was partially pulled out. Three bolts were pulled out of the aluminum sign.

Figure 25. System A Damage, Test No. WZNP-2

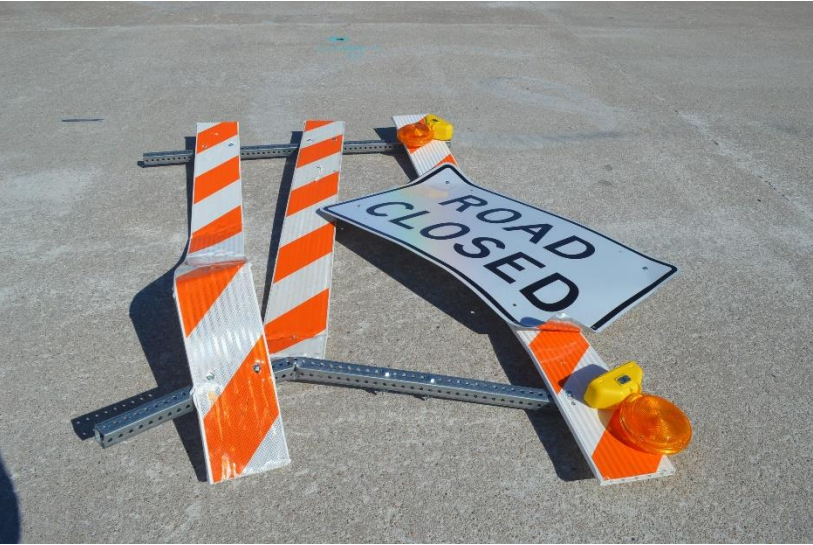
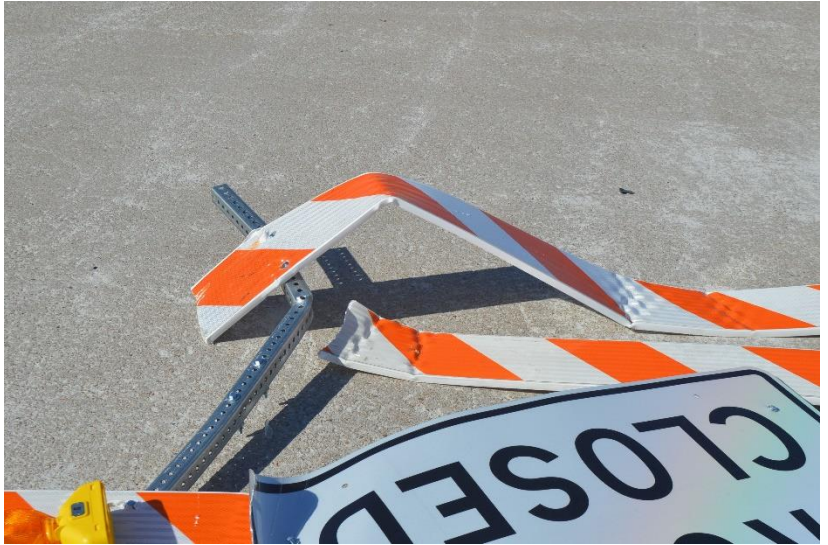
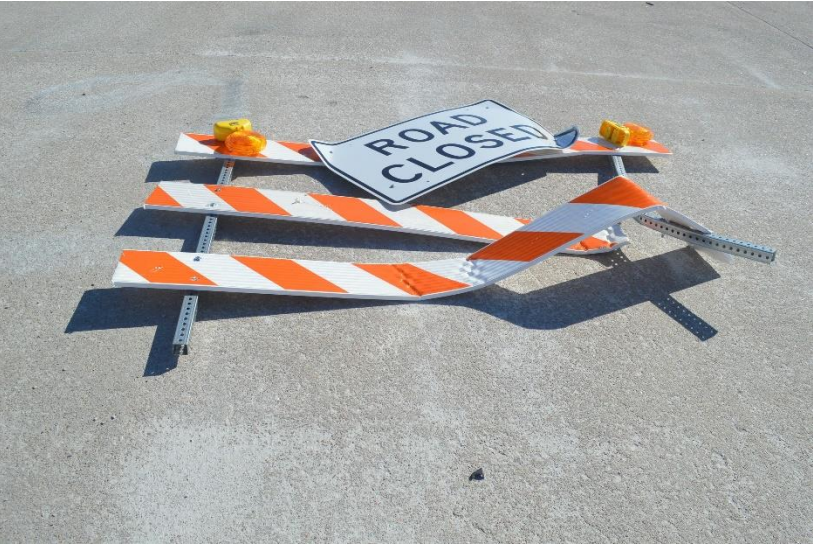
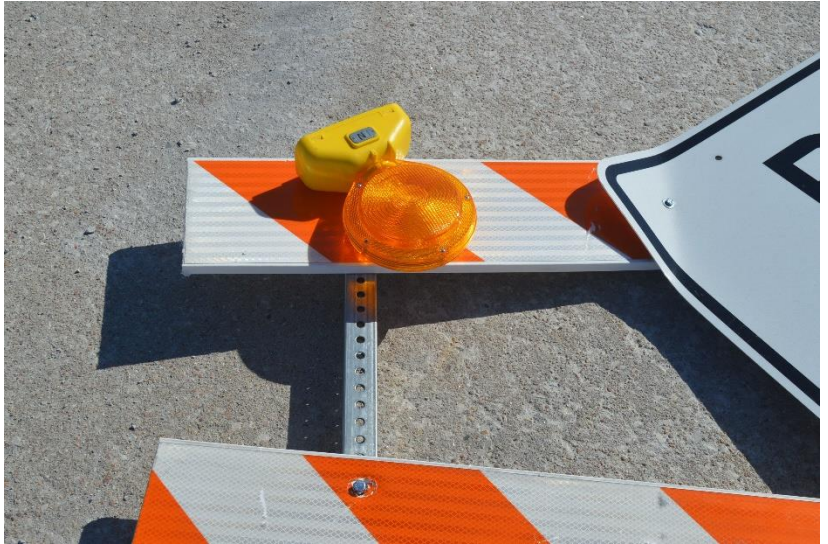
Figure 26. Additional System A Damage, Test No. WZNP-2

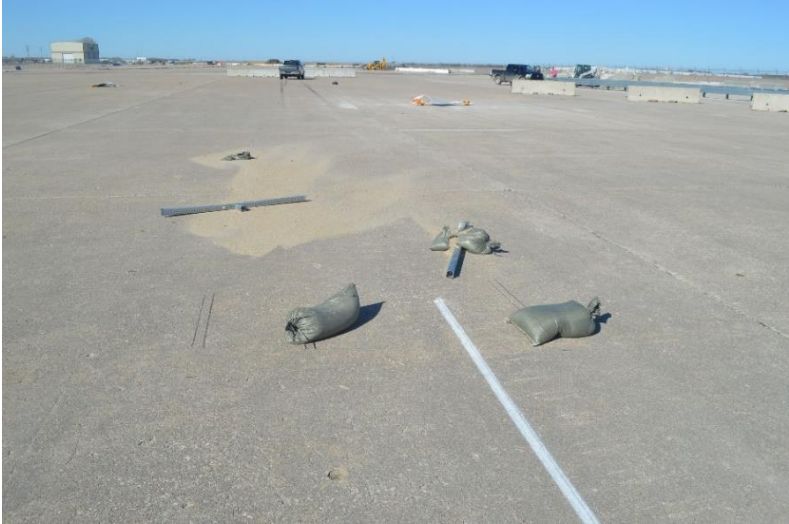
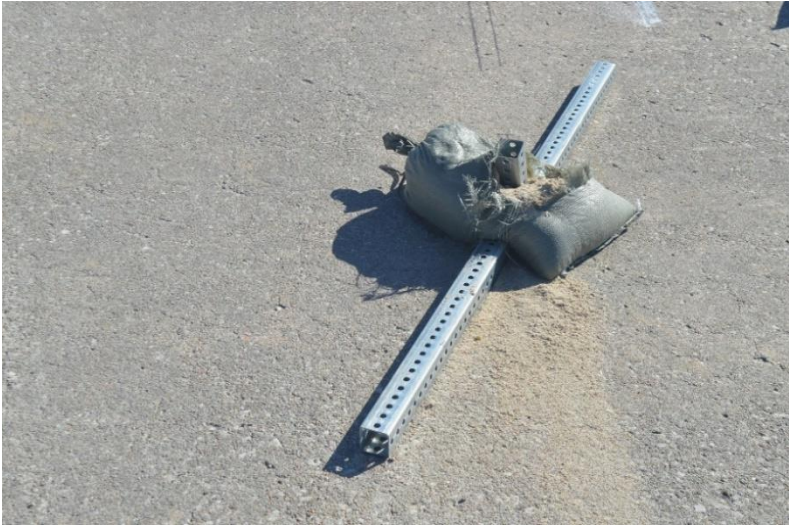
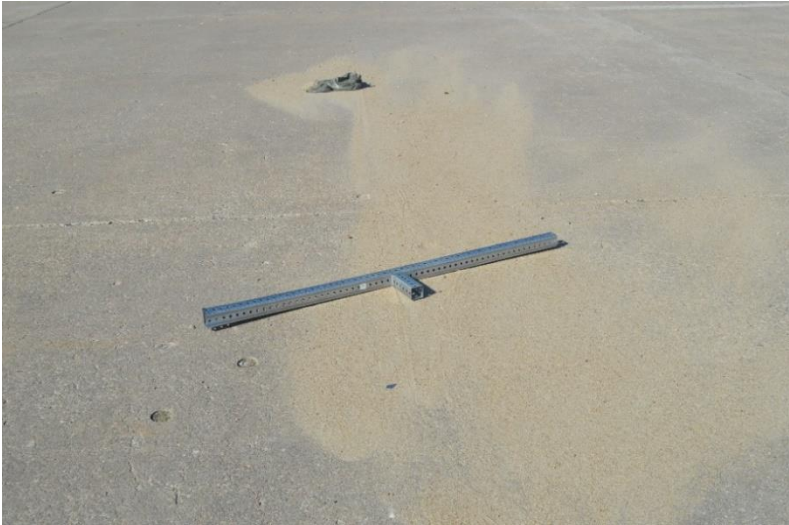
System B was oriented to face the direction of travel. The centerline of the system was aligned to the left quarter-point and offset from the centerline of the vehicle. The downstream right and the downstream left sandbags were torn open. The upstream leg was deformed. The right upright was bent 17 in. (432 mm) from the bottom. The aluminum sign was bent. Both warning lights were rotated, and the left light lens disengaged from the warning light system. One bolt was pulled out of the bottom barricade panel, and three bolts were partially pulled out. The two left side bolts on the middle barricade panel were pulled out. The aluminum sign bolts were partially pulled out of the middle barricade panel and thoroughly pulled out of the top barricade panel.

Figure 27. System B Damage, Test No. WZNP-2

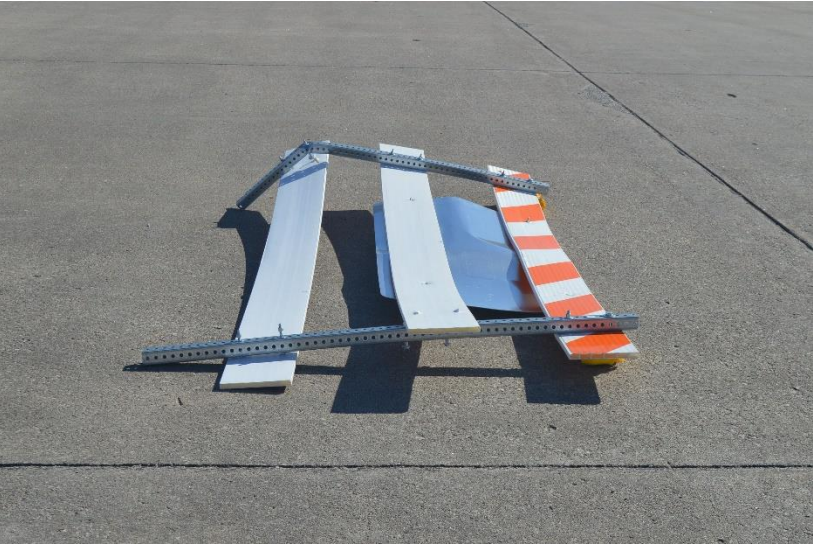
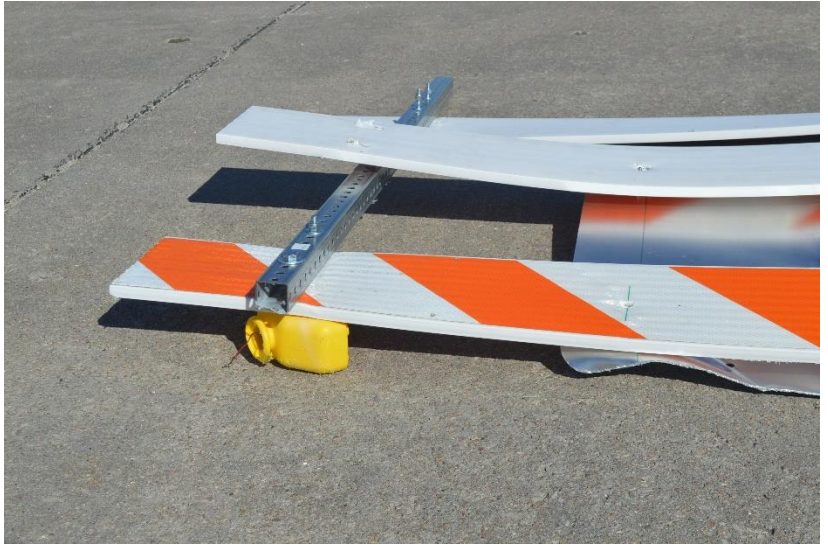
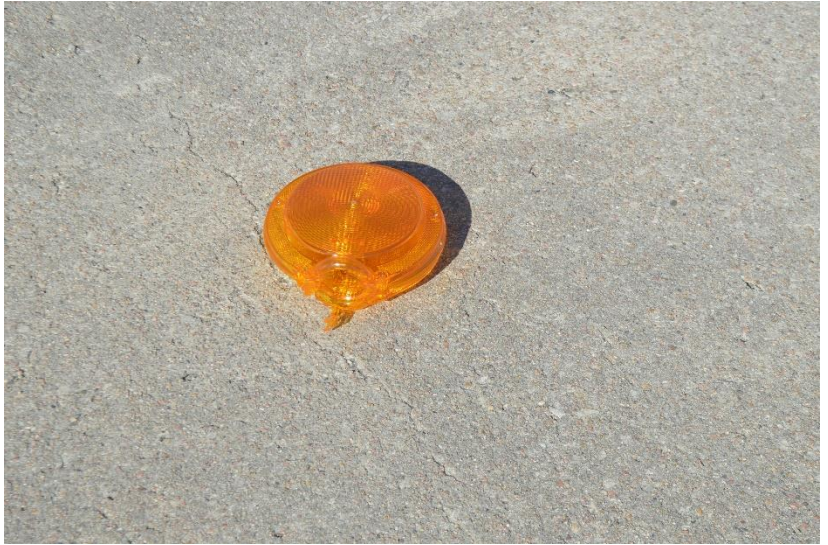
Figure 28. Additional System B Damage, Test No. WZNP-2

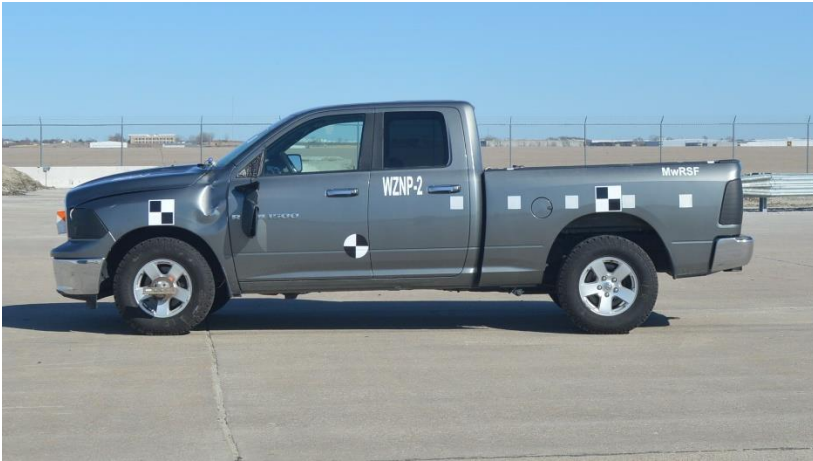
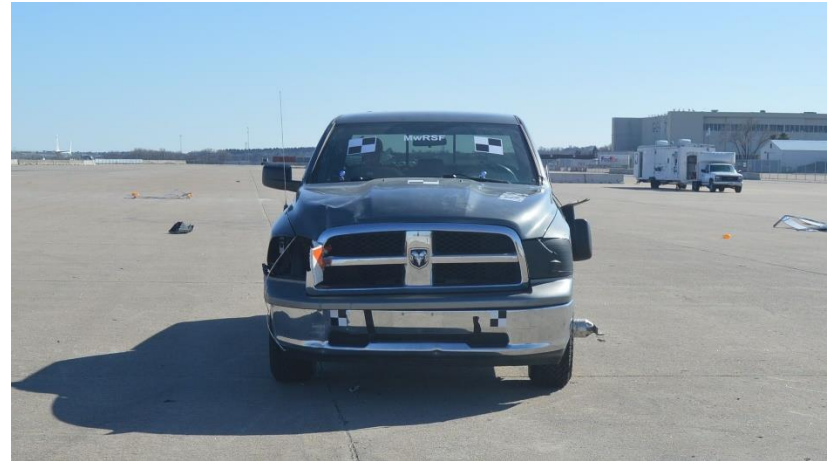
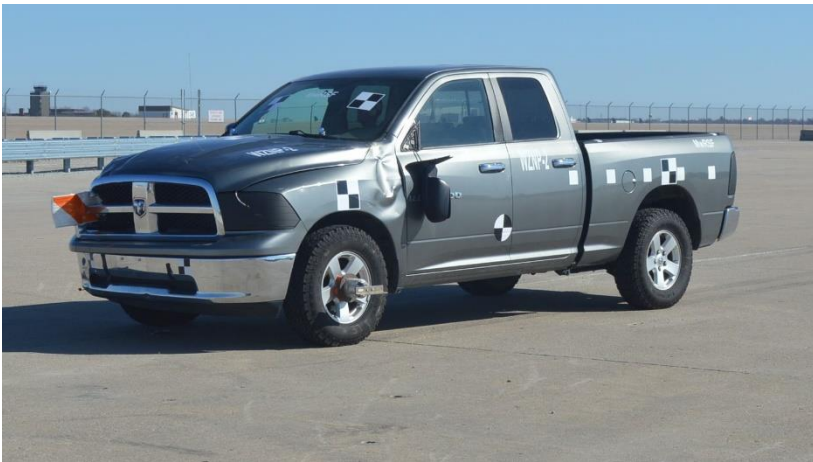
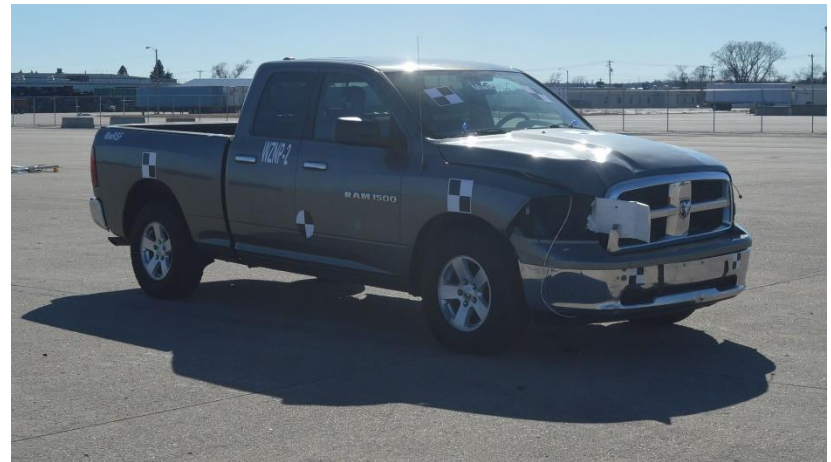
The damage to the vehicle was minimal, as shown in Figures 29 through 31. The maximum occupant compartment intrusions are listed in Table 6 along with the intrusion limits established in MASH 2016 for various areas of the occupant compartment. MASH 2016 defines intrusion or deformation as the occupant compartment being deformed and reduced in size with no observed penetration. Note that none of the established MASH 2016 deformation limits were violated. Complete occupant compartment and vehicle deformations and the corresponding locations are provided in Appendix C.

The majority of the damage was concentrated on the right-front corner where the vehicle impacted System A. The torn piece of the middle panel from System A was stuck inside the right side of the grille. A small dent was found on the left side of the front bumper. A vertical crush line extending from the bottom of the bumper to the top of the hood was found on the vehicle. The right headlight was disengaged from the vehicle. A dent was found on the left-front fender. The left mirror was partially disengaged from the vehicle. The roof, remaining window glass, and undercarriage remained undamaged.

Figure 29. Vehicle Damage, Test No. WZNP-2

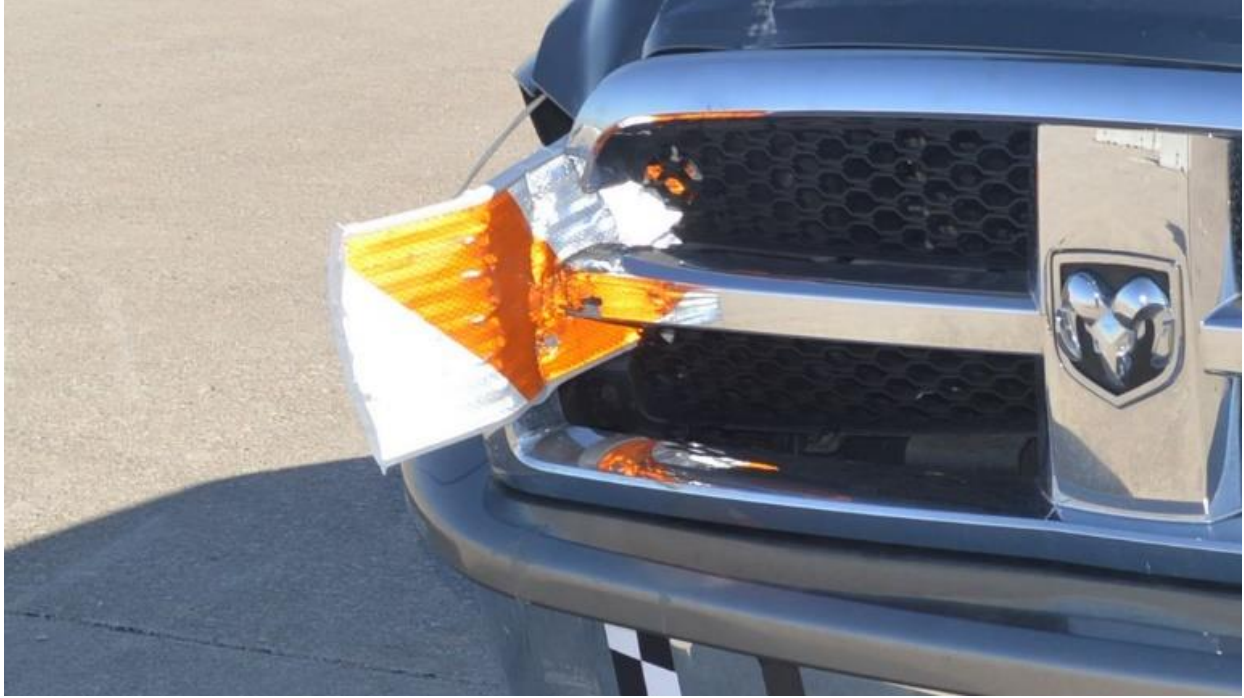
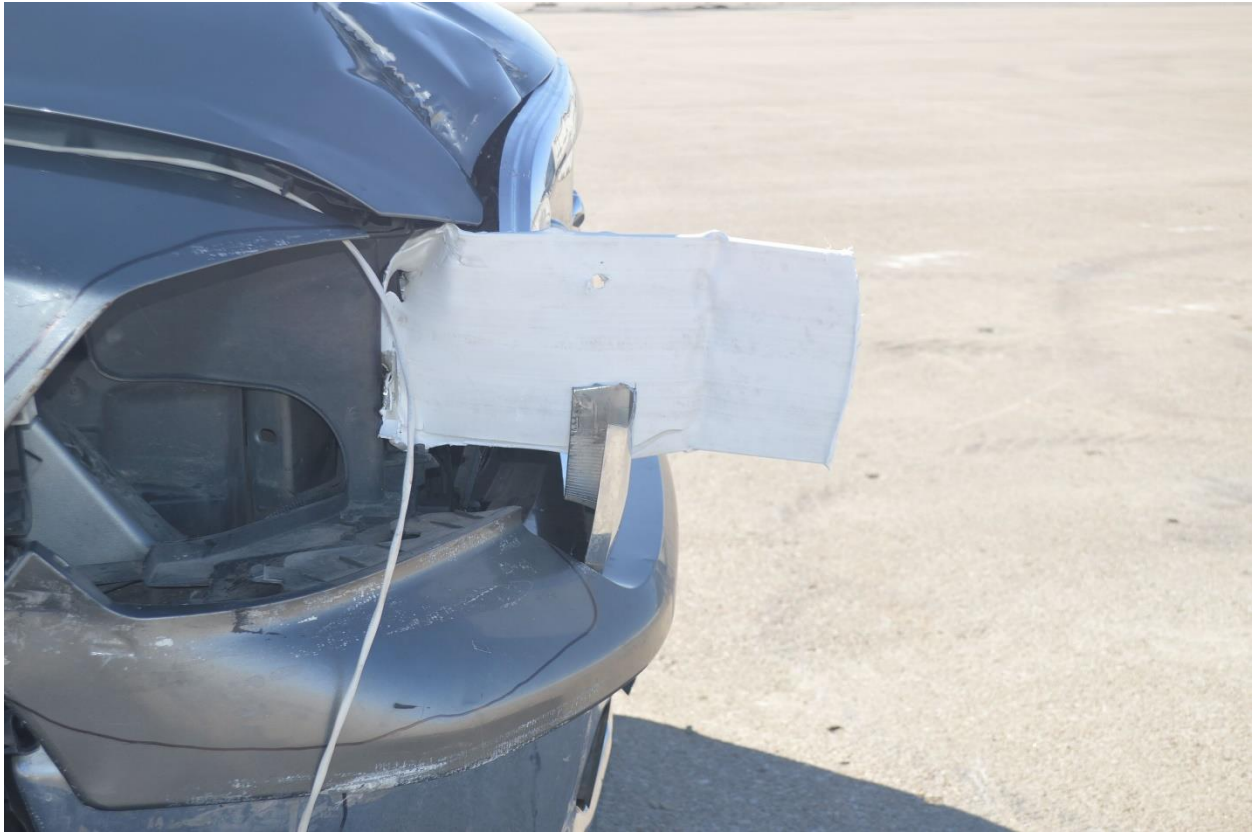
Figure 30. Vehicle Damage Details, Test No. WZNP-2

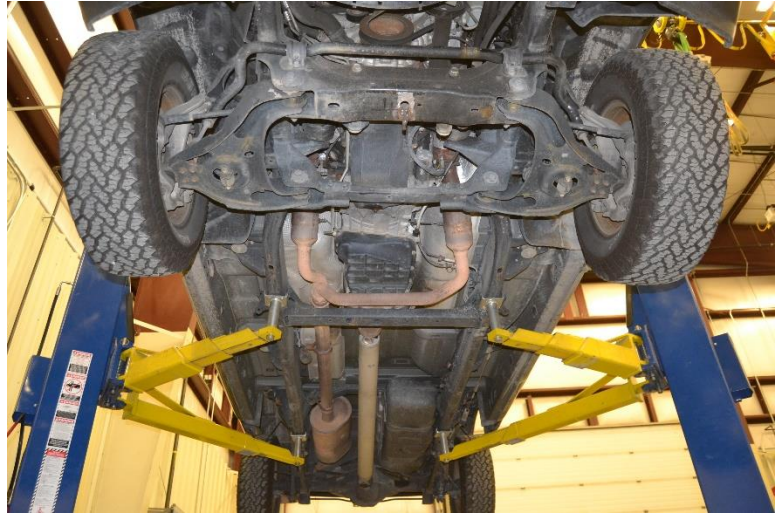
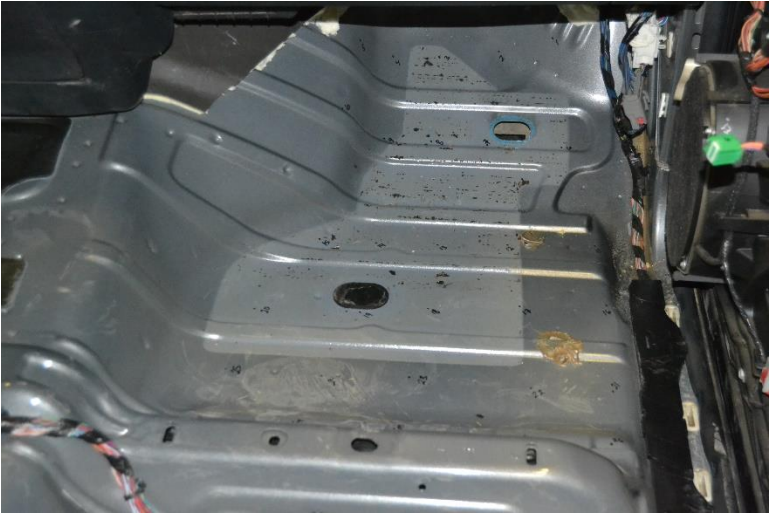
Figure 31. Occupant Compartment and Undercarriage Damage, Test No. WZNP-2

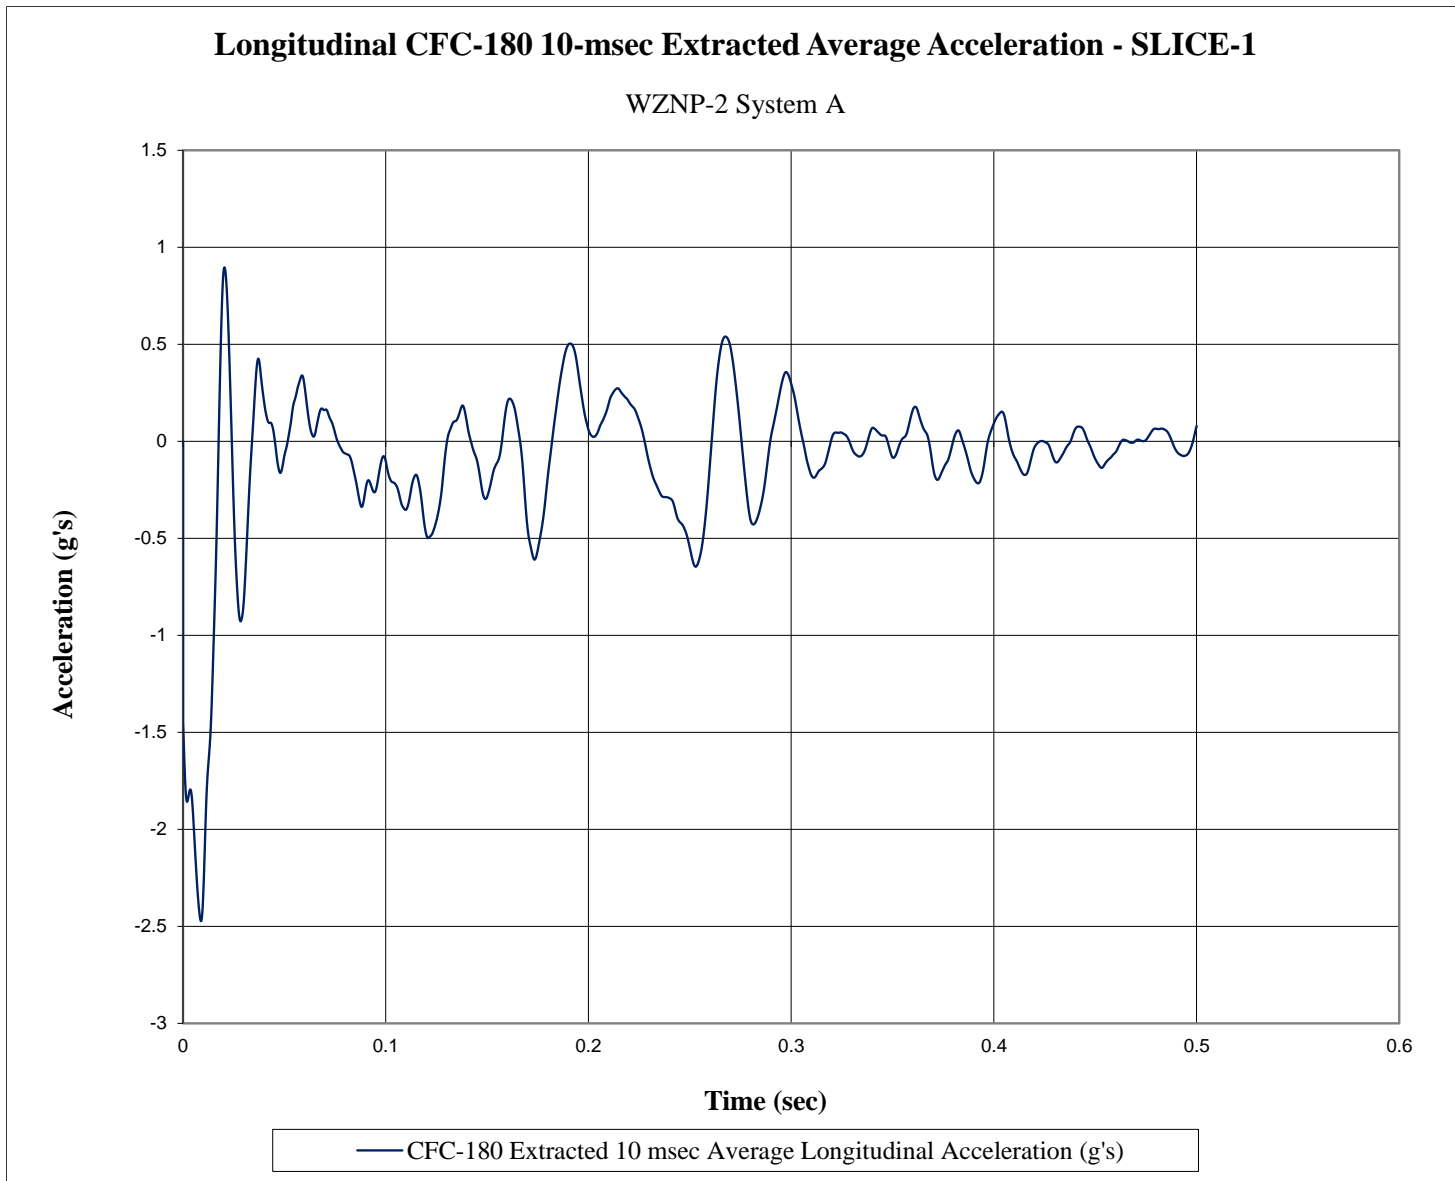
Figure D-1. 10-ms Average Longitudinal Deceleration System A (SLICE-1), Test No. WZNP-2

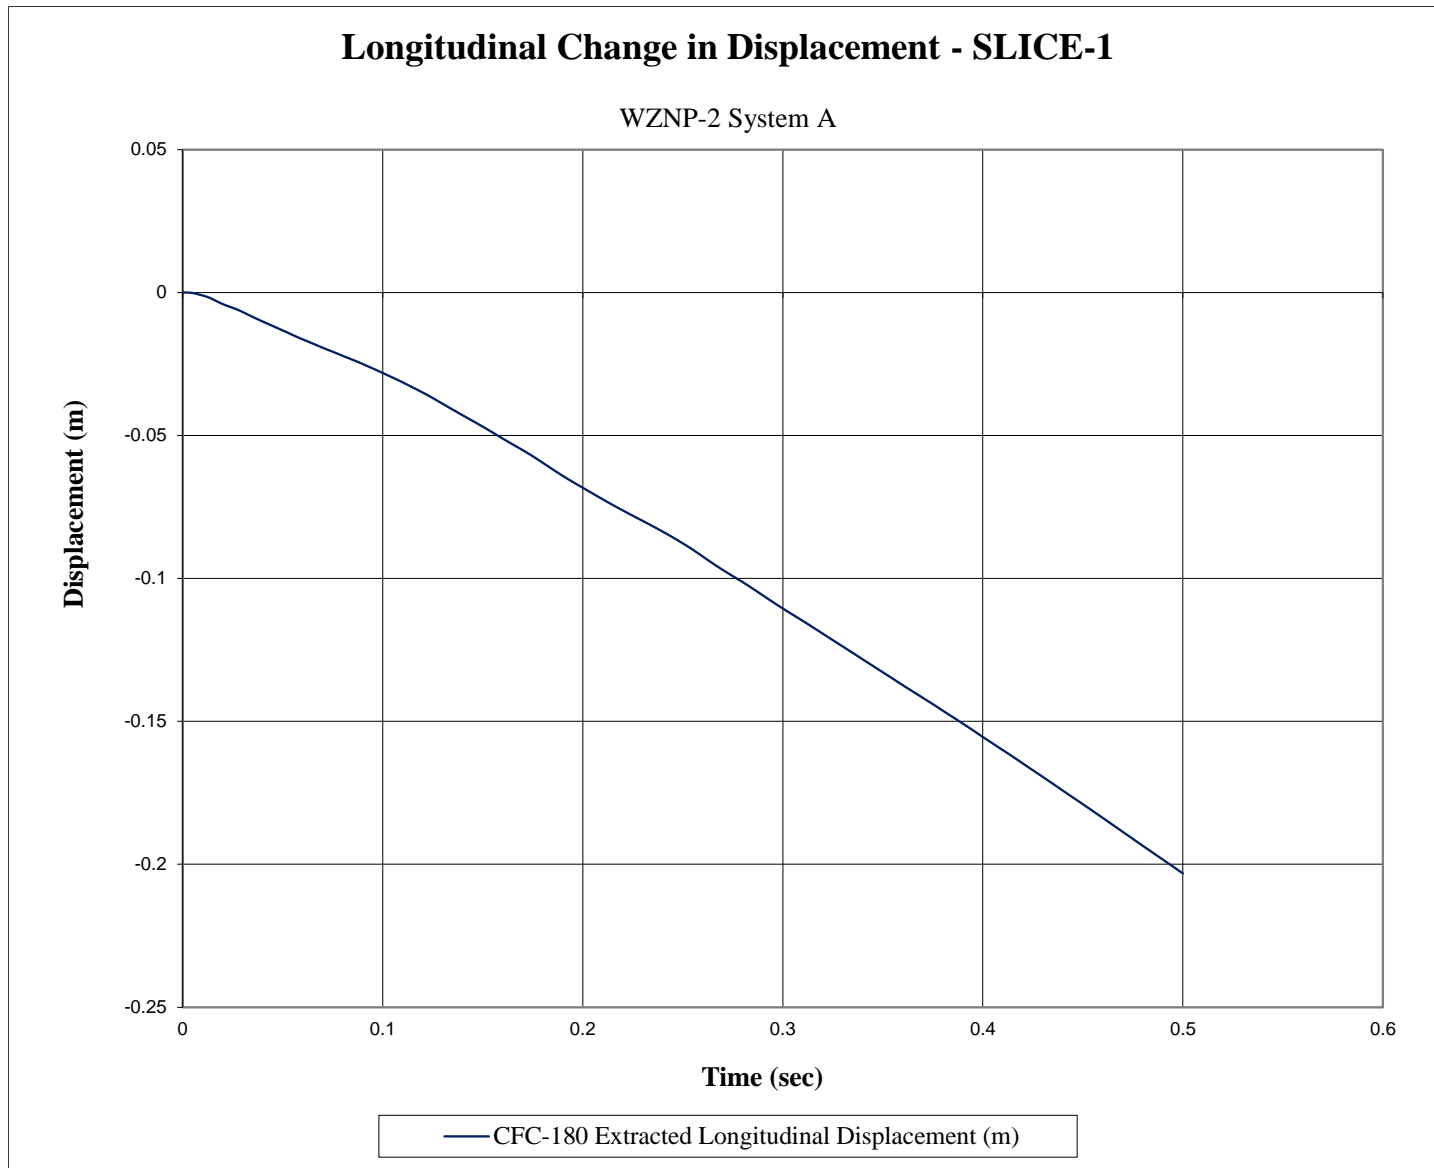
Figure D-3. Longitudinal Occupant Displacement System A (SLICE-1), Test No. WZNP-2
