# **MASH 2016 EVALUATION OF A NON- PROPRIETARY TYPE III BARRICADE: MASH TEST DESIGNATION NO. 3-72**

## **MIDWEST ROADSIDE SAFETY FACILITY**

MwRSF Research Report No. TRP-03-416-20

September 25, 2020

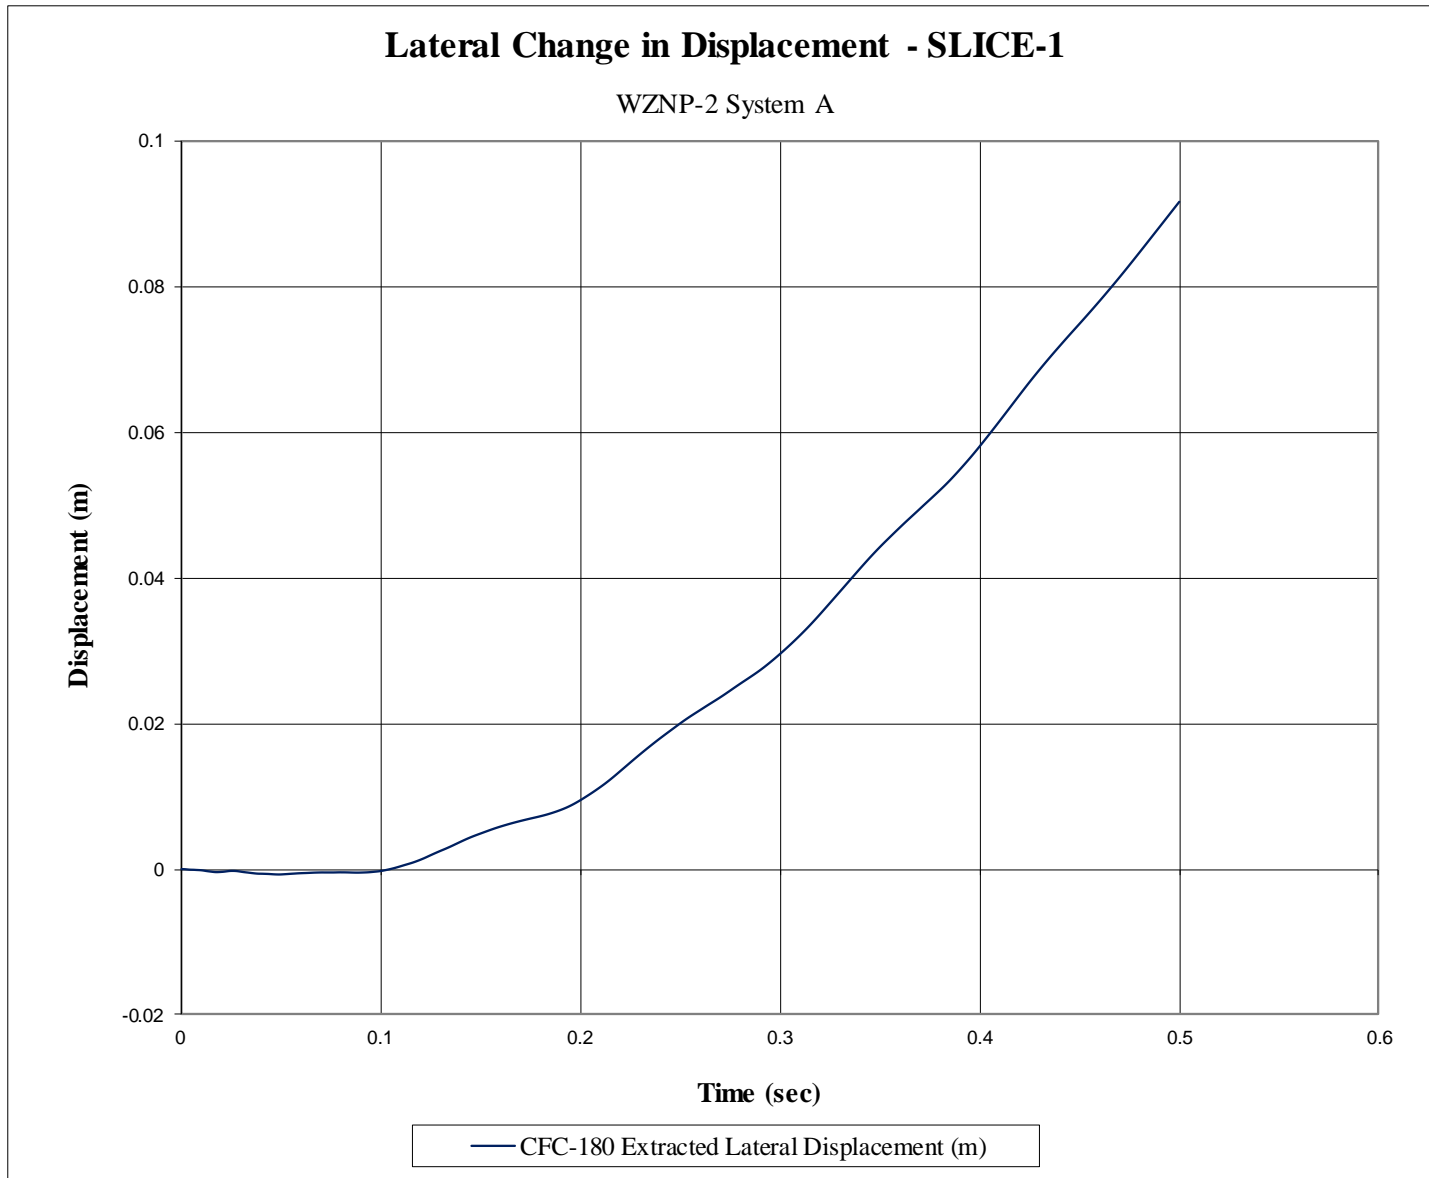
Figure D-6. Lateral Occupant Displacement System A (SLICE-1), Test No. WZNP-2

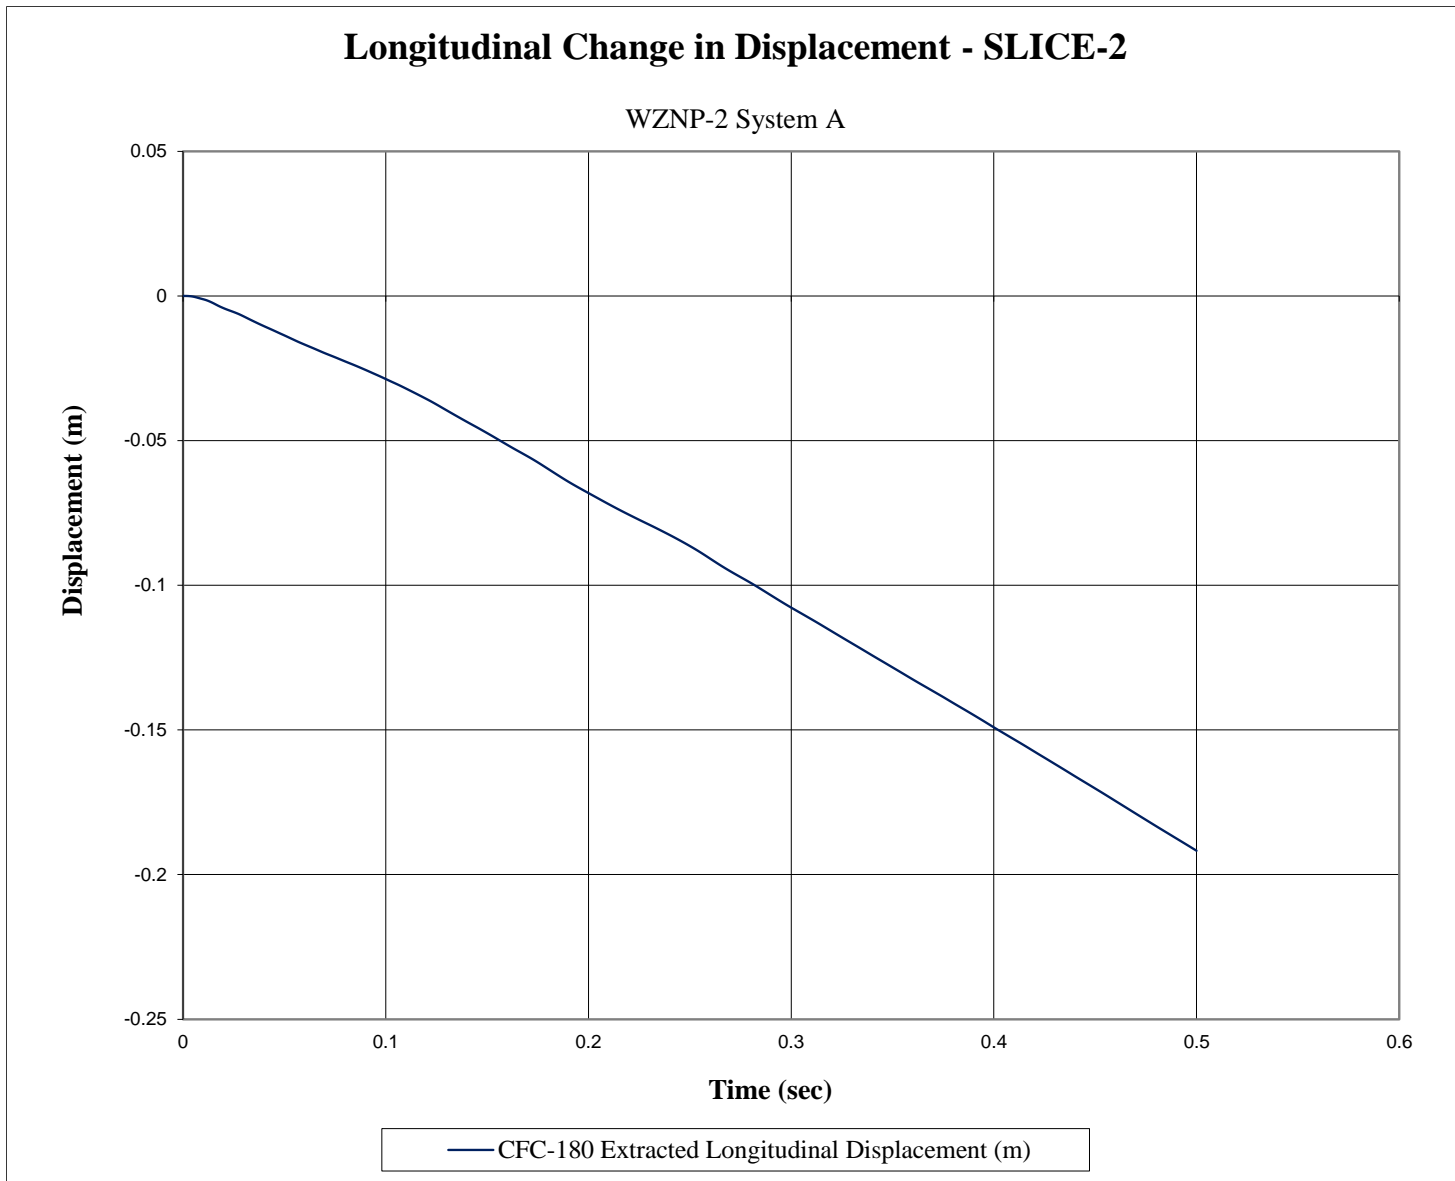
Figure D-11. Longitudinal Occupant Displacement System A (SLICE-2), Test No. WZNP-2
