FULL-SCALE VEHICLE CRASH TESTS *on* **NEBRASKA RURAL MAILBOX DESIGNS**

Sponsored by
Nebraska Department of Roads
RESI (0099) P415

August, 1987

ABSTRACT

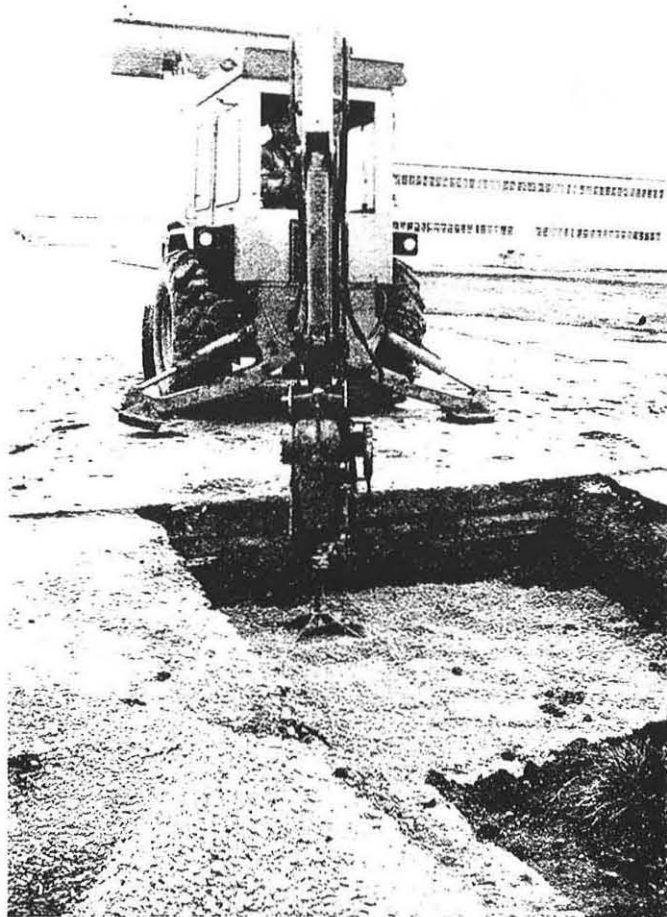
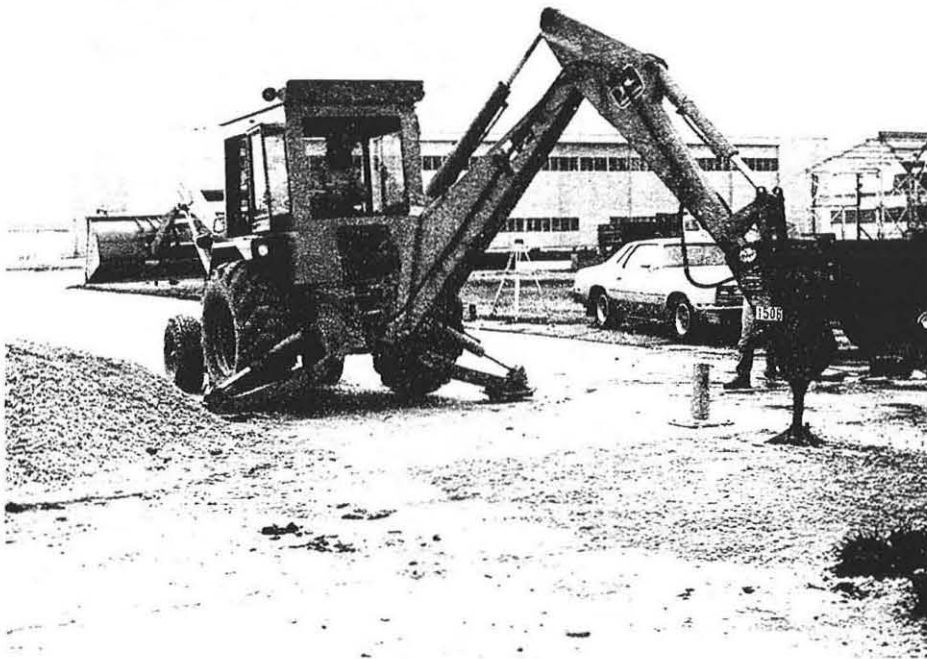
Figure 3. Photos Showing Placement of Strong Soil

The soil properties and compaction procedures at the test site met the guidelines given in the recommended procedures by NCHRP 230 (1). The strong and weak soils were placed and compacted in 6 to 12 in. layers using a hydraulic, vibrating

tamper with a flat plate mounted onto a backhoe, as shown in Figure 3. The strong soil was compacted to an average density of 95% maximum dry density at an average moisture content of 10%. The results of the strong soil tests, conducted by Geotechnical Services, Inc., are presented in Appendix A. A Troxler Nuclear Density Gage, shown in Figure 4, was used to determine moisture content and compaction.

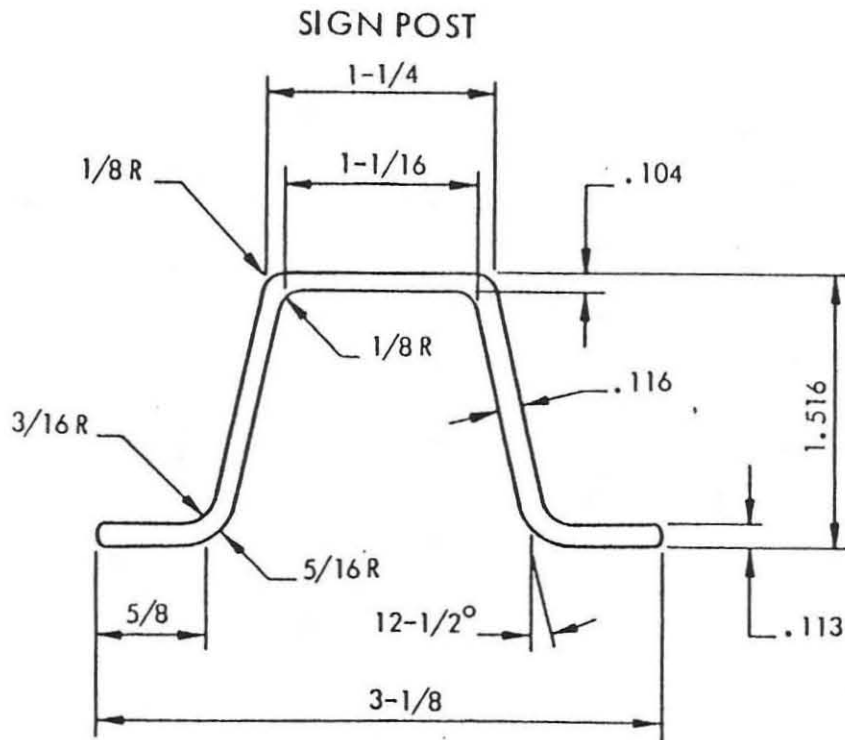
Figure 13. Mailbox Post Dimensions and Breakaway Feature

WEIGHT - 2.00 LBS/FT

AREA, A (In²) - .59

The post system consisted of four main parts, the top post, the base post, the retainer strap, and the anti-twist plate.

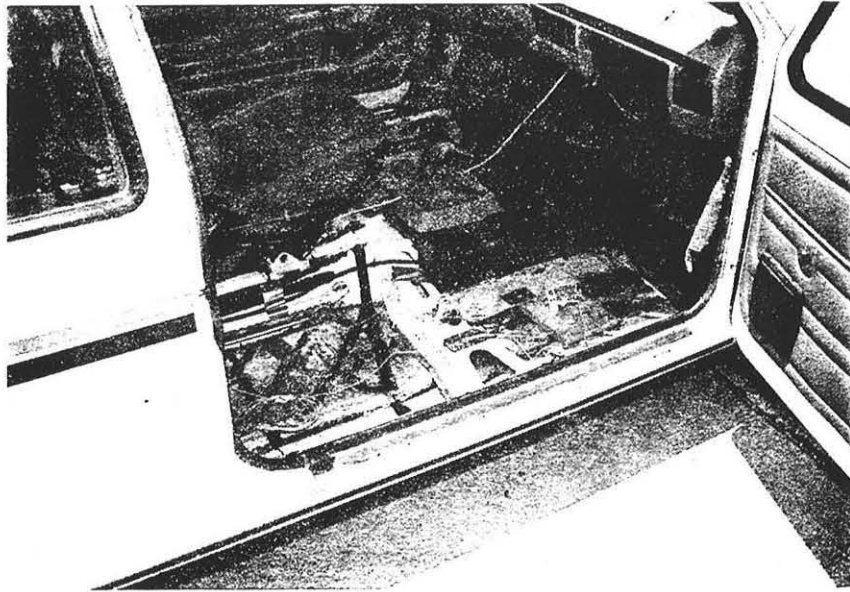
Figure 18. Photos Of Mounted Accelerometers

Two piezoresistive accelerometers, (model 7264) with a range of 200 g's, were used to measure the accelerations in the longitudinal direction of the vehicle. The accelerometers were attached to metal blocks which were mounted to the front floorboards of both the left side (driver) and right side (passenger). Photos of the accelerometers mounted in the test vehicle are shown in Figure 18. The signals from the accelerometers were first sent to the Metraplex FM multiplexed data acquisition system (series 300), and then to the Honeywell 101 analog tape recorder for permanent storage. A flowchart of the accelerometer signals passing through the data acquisition system is shown in Figure 19. Photos of the system located in the test vehicle and the back of a station wagon are shown in Figure 20. The computer program used to analyze and plot the accelerometer data is given in Appendix B.

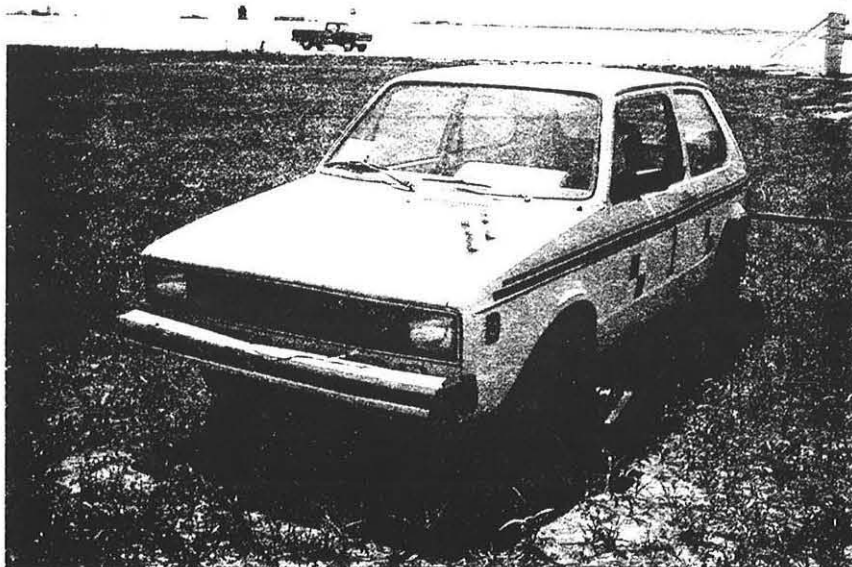
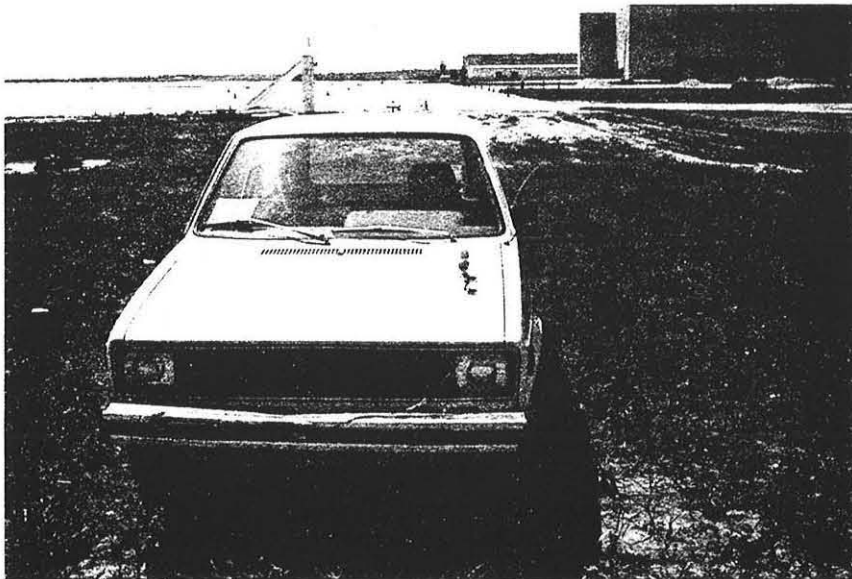
Figure 31. Damages To Test Vehicle, Test 1

The vehicle received no damage with the exception of a small dent in the bumper as shown in Figure 31. The damage was

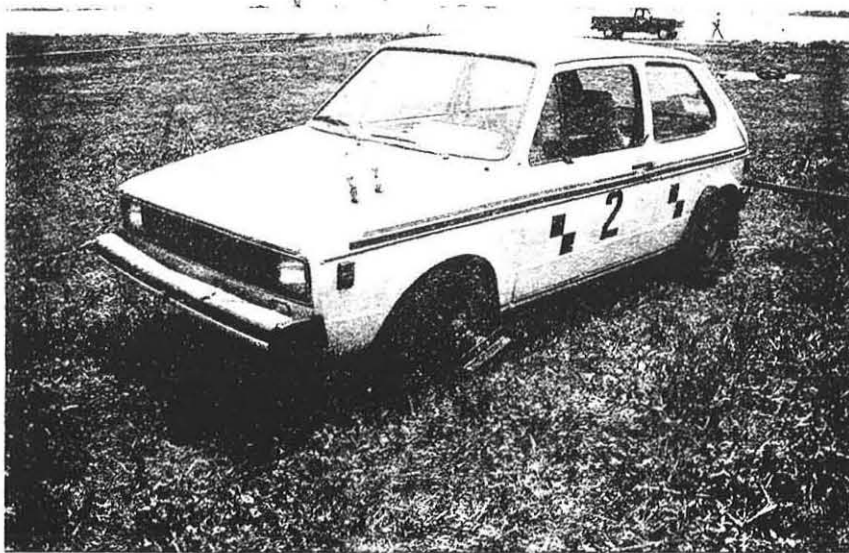
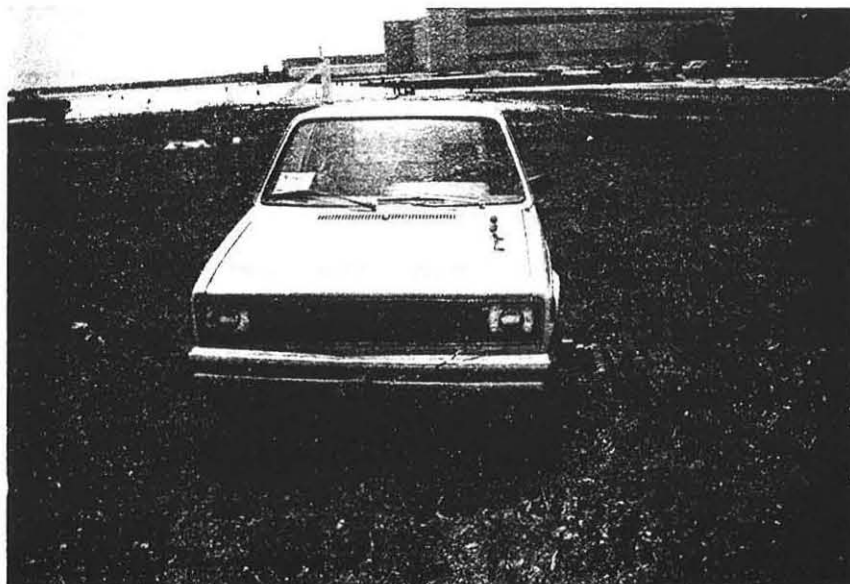
Figure 41. Damages To Test Vehicle, Test 2

The only damages to the vehicle were a small dent in the front end of the hood and a minor dent in the bumper and front lower right fender as shown in Figure 41. Table 5 gives the TAD and VDI damage ratings.

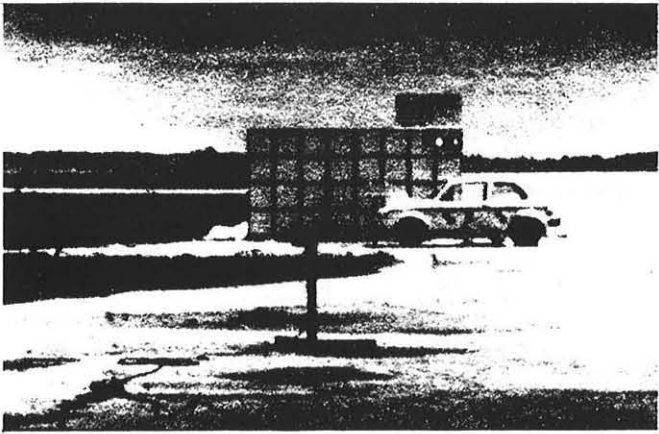
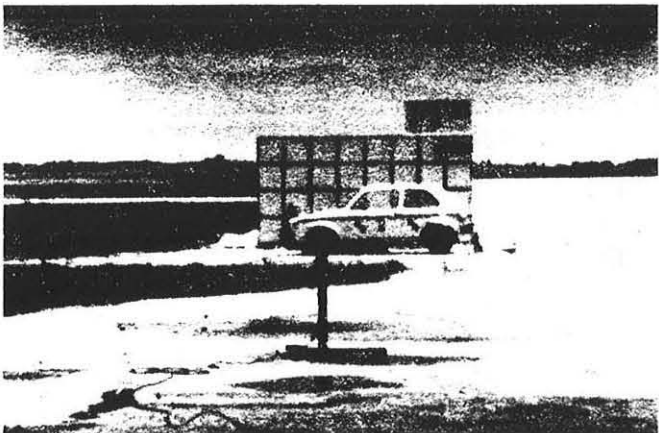
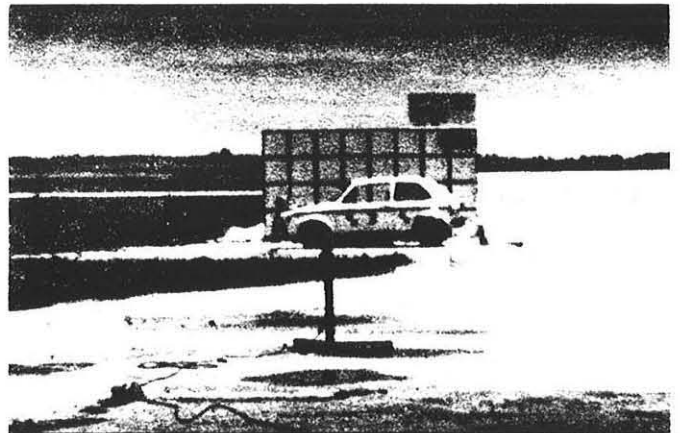
Figure 42 . Sequential Photos, Test 3

<u>TIME (sec)</u>	<u>EVENT</u>
0.000	Impact
0.002	Post begins bending
0.006	Post wrapping around bumper
0.016	Mailbox hits hood
0.040	Mailbox on hood and post being pulled out
0.080	Post dragging through sand
0.090	Mailbox loses contact with hood

The results of Test 3 are shown in Table 7, and the sequential photos from the high-speed film are presented in Figure 42. The time-event summary is given in Table 8. After impact, the post wrapped around the bumper while the mailbox struck the hood of the car. As the car traveled forward, the mailbox remained on the hood while the post assembly was pulled from the ground. At approximately 0.090 sec after impact, the mailbox assembly started to lose contact with the hood. The base post, top post, and mailbox all remained intact after they came to a rest 366 feet away, when it was run over by the vehicle. Damage to the mailbox system is shown in the photos given in Figure 43.

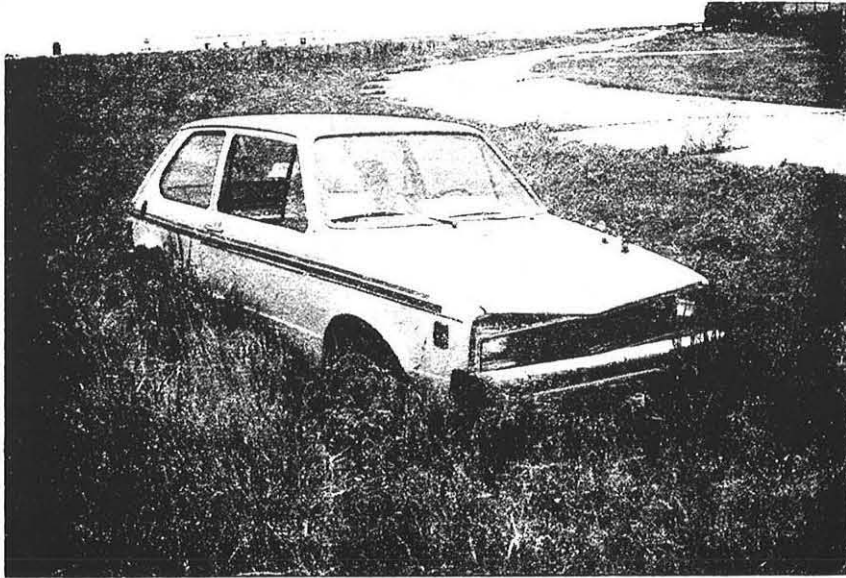
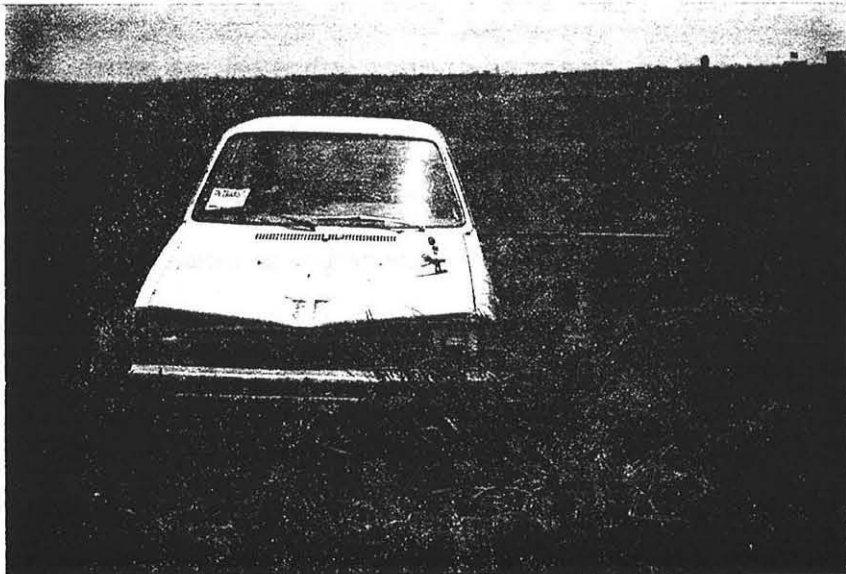
Figure 44. Damages To Test Vehicle, Test 3

The most noticeable damages to the vehicle were a punctured and dented hood and a busted plastic grill plate as shown in Figure 44. The TAD and VDI damage ratings are given in Table 7.

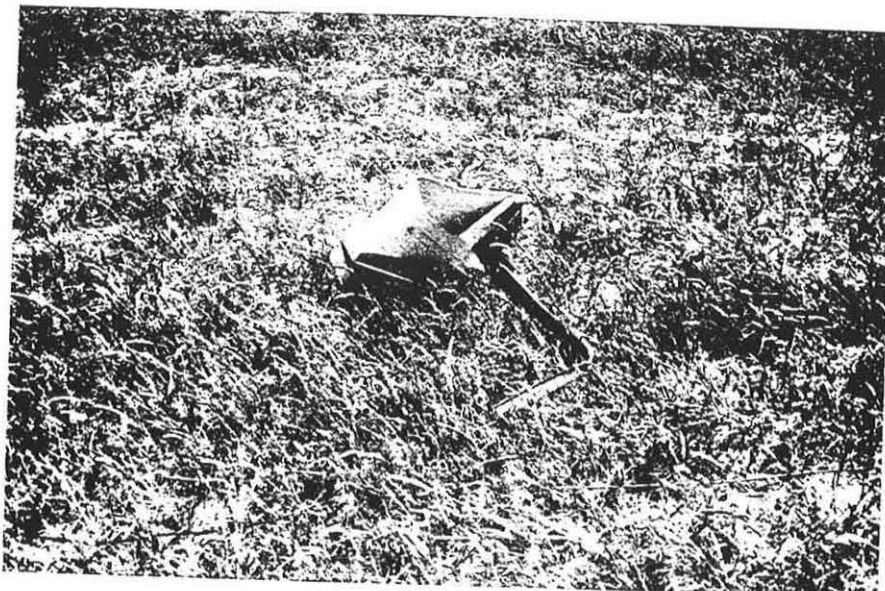
Figure 46. Damages To Mailbox System, Test 4

A summary of the Test 4 results is given in Table 9. The sequential photos are shown in Figure 45 and time-event summary is given in Table 10. As the vehicle moved through the impact, the mailbox post wrapped around the bumper, and then the top section of the post separated from the base post. The base post remained embedded in the soil. The mailbox then struck the hood and was carried for a distance before being thrown from the car. The final resting place of the mailbox assemble was 130 feet from the point of impact. Photos of the damaged mailbox can be viewed in Figure 46. A diagram of the base post position after impact is shown in Figure 47.

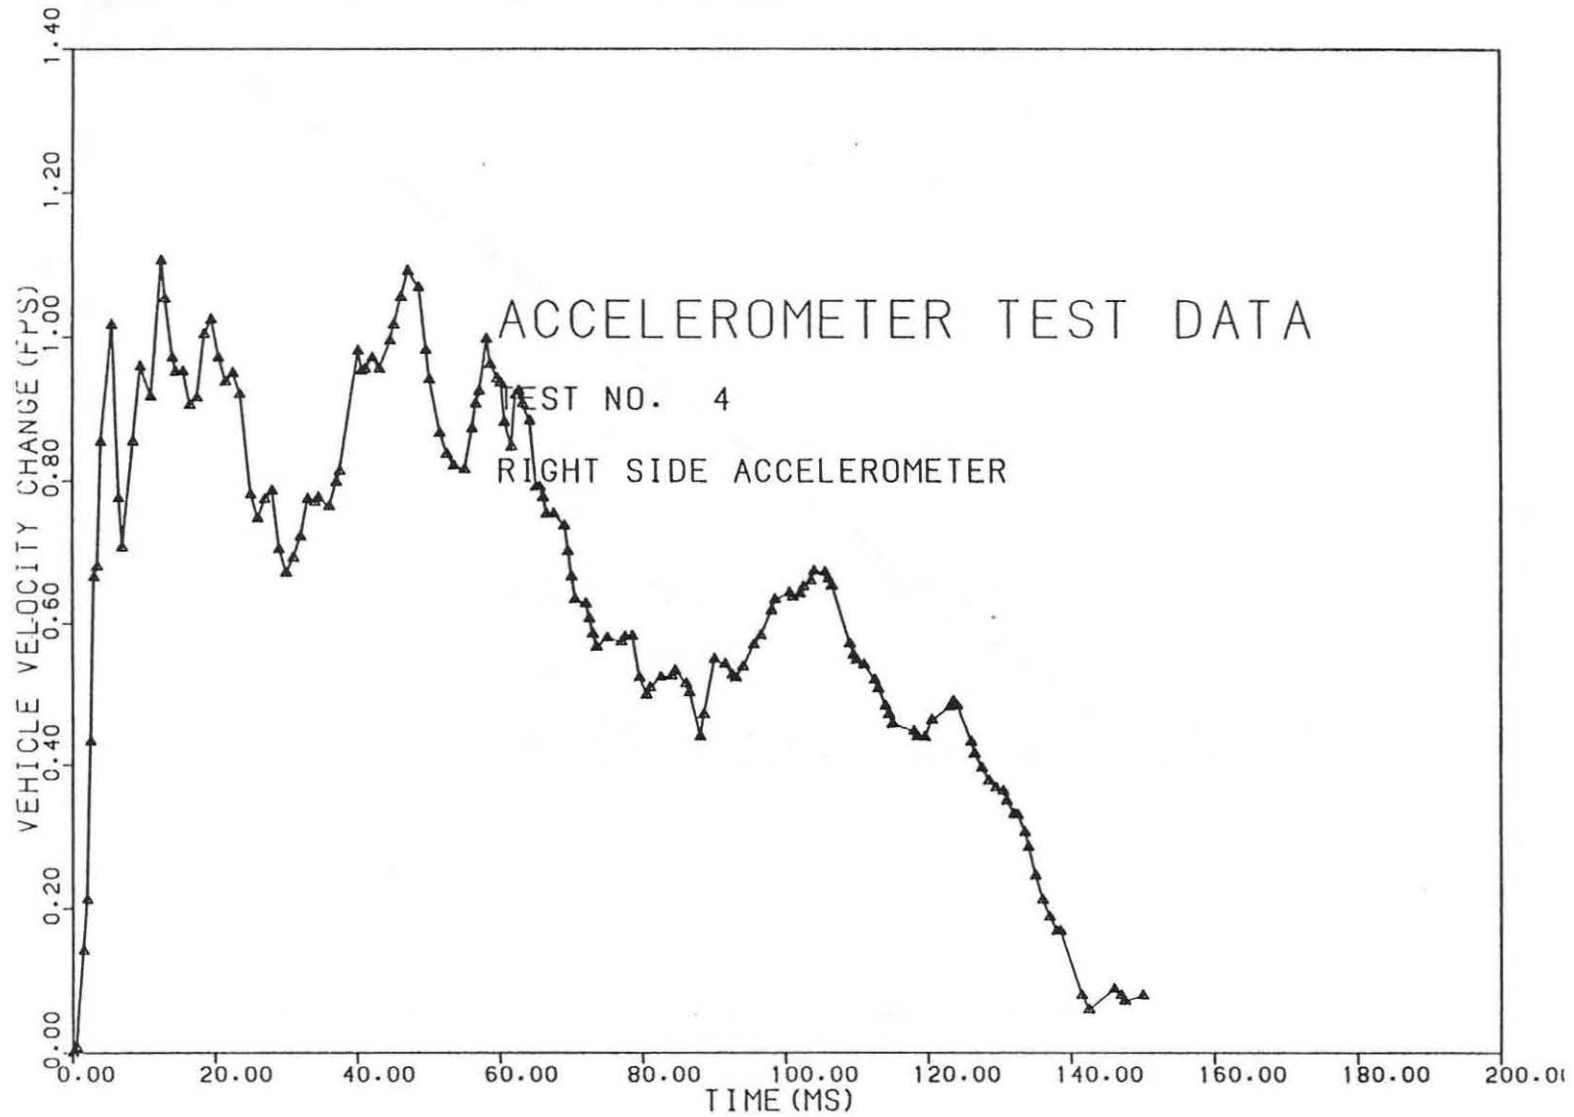
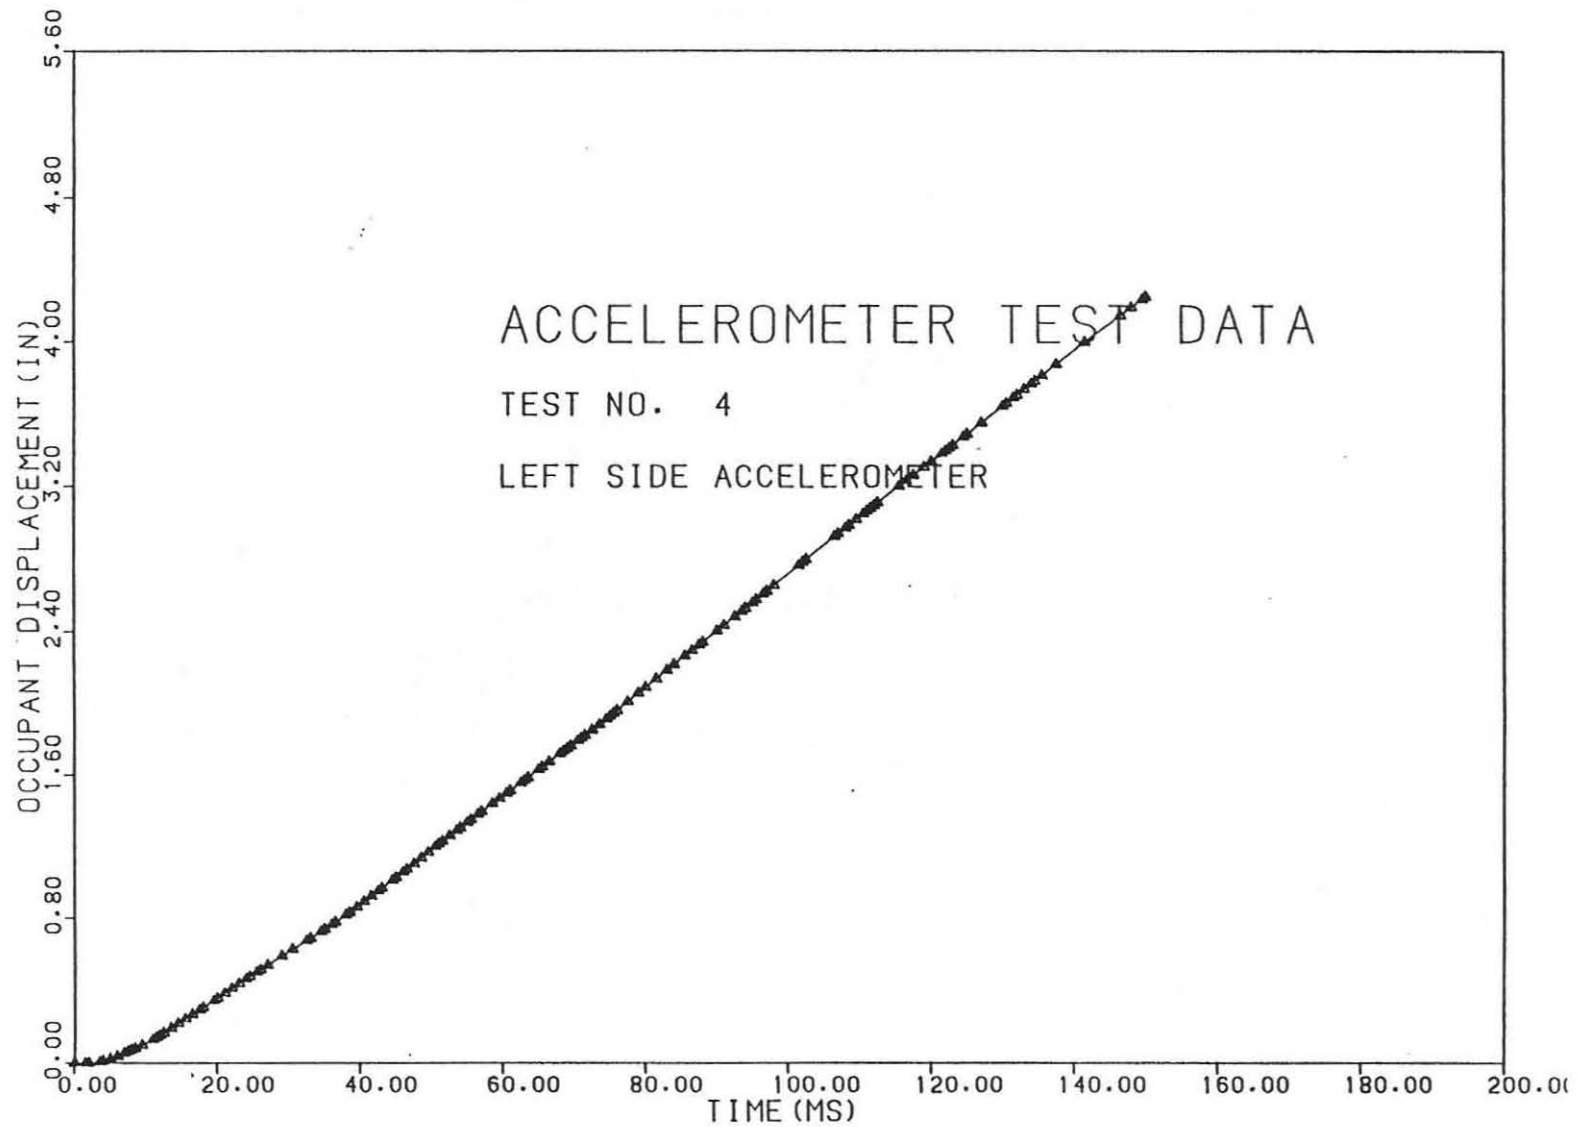
Plots of deceleration, change in velocity, and occupant displacement versus time are shown in Figures 48 through 53. It is noted that a minor inconsistency showed up when comparing the results obtained from the left and right accelerometers.

2. In each test the change in velocity of the vehicle was well below the recommended limit of 15 fps and also the preferable limit of 10 fps.
3. In each test where accelerometer data was available, the maximum 0.010 sec average deceleration was well below the recommended limit of 15 g's.

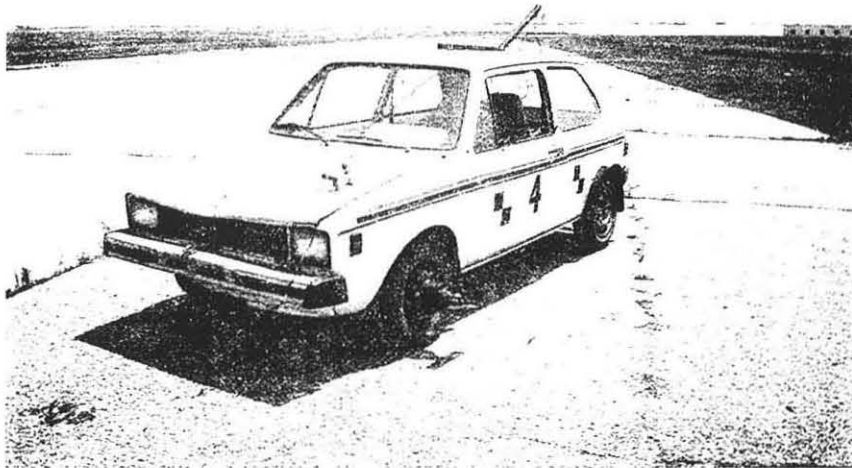
Figure 54. Damages To Test Vehicle, Test 4

The vehicle's hood received the most significant damage although the center grill area received some dents as shown in Figure 54. Table 9 gives the TAD and VDI damage ratings for Test 4.
