MID-AMERICA TRANSPORTATION CENTER

Report # MATC-UNL: 004-24

MASH TL-6 Evaluation of a 62-in. Tall, Single-Slope, Concrete Median Barrier

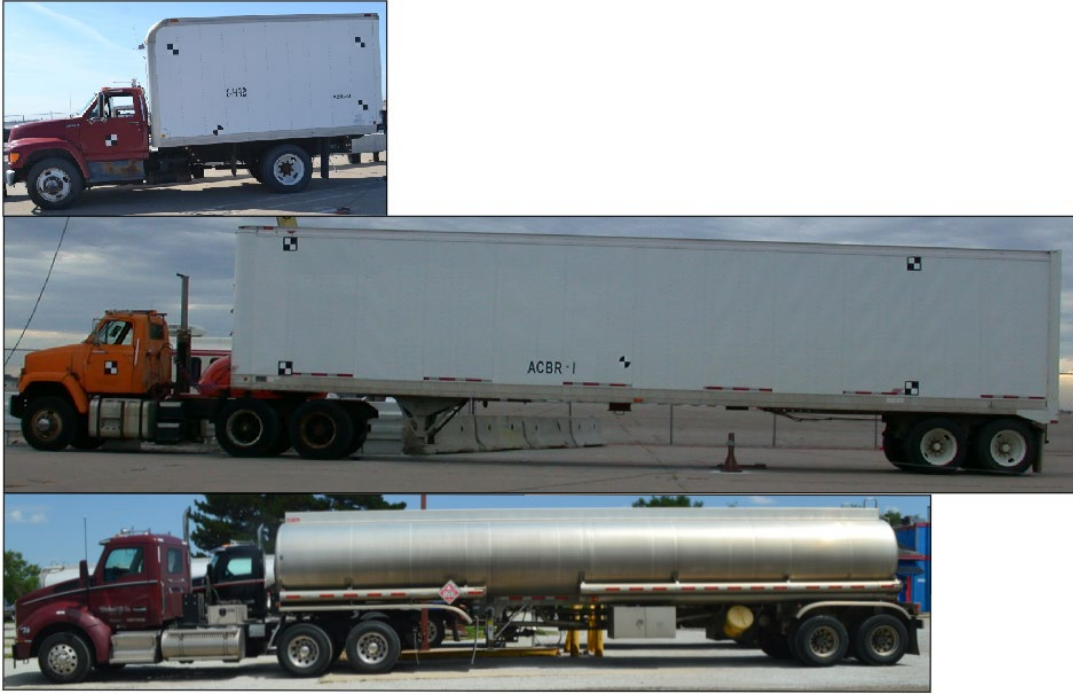
Figure 1.1 TL-4 (22,000-lb), TL-5 (79,300-lb), and TL-6 (79,300-lb) Vehicle Side View [3]

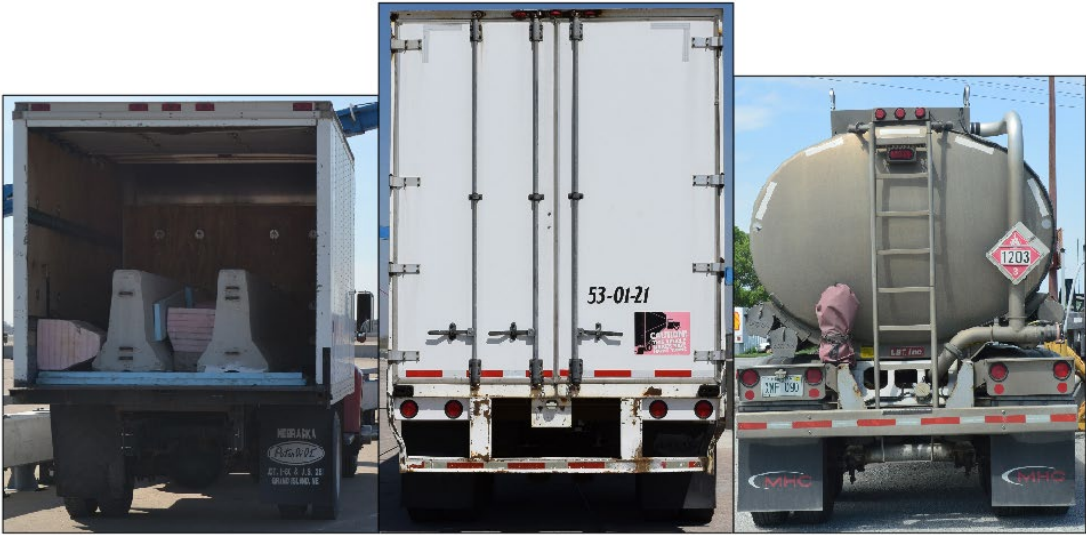
Figure 1.2 TL-4 (20,000-lb), TL-5 (80,000-lb), and TL-6 (80,000-lb) Vehicle Rearview [3]

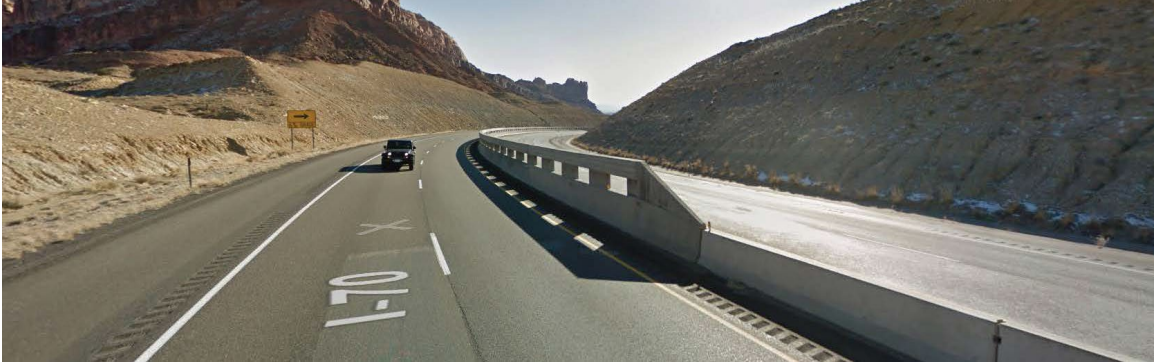
Figure 2.5 Utah DOT 84-in. Tall Roman Wall Installation [3]

The Utah DOT installed an 84-in. tall modification of the TTI Roman Wall in a narrow median on a large curve on Interstate 70, as shown in Figure 2.5. The Utah DOT has also utilized an 84-in. tall solid concrete wall, which was installed on the roadside to shield a railroad line adjacent to a curved highway, as shown in Figure 2.6.

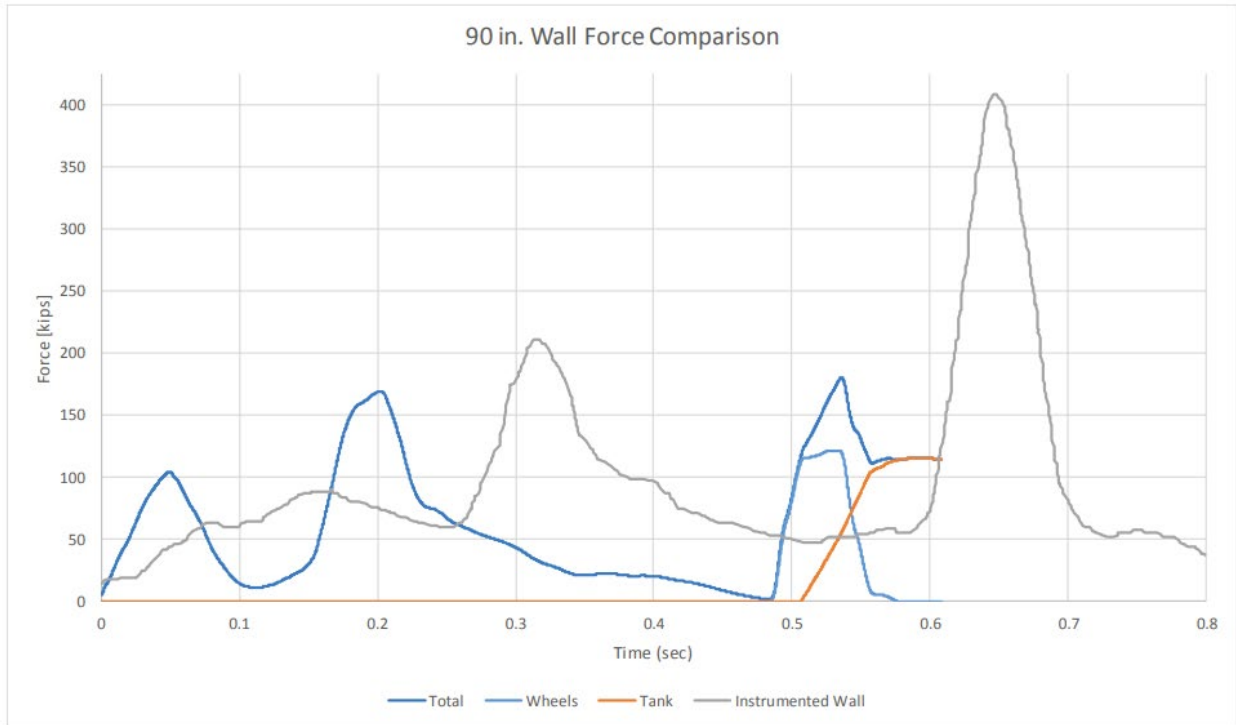
Figure 2.12 Wall Force Comparison [3]

Whitfield extracted the forces exerted on the barrier from the rigid walls and applied a 50-ms rolling average to match the filtering performed on the instrumented wall test data. The forces from all rigid walls were summed to obtain the resulting total load. The loads from the simulation and the instrumented wall test are shown in Figure 2.12. When comparing the forces, three distinct peaks were observed corresponding to three impact events: the impacting front-right bumper corner of the tractor, the truck tandem axle, and the trailer tandem axle in a phenomenon known as “tail slap.” The time at which these impacts occurred varied between the test and initial simulation model, however, the time between peaks was similar between the instrumented wall test and the simulation.

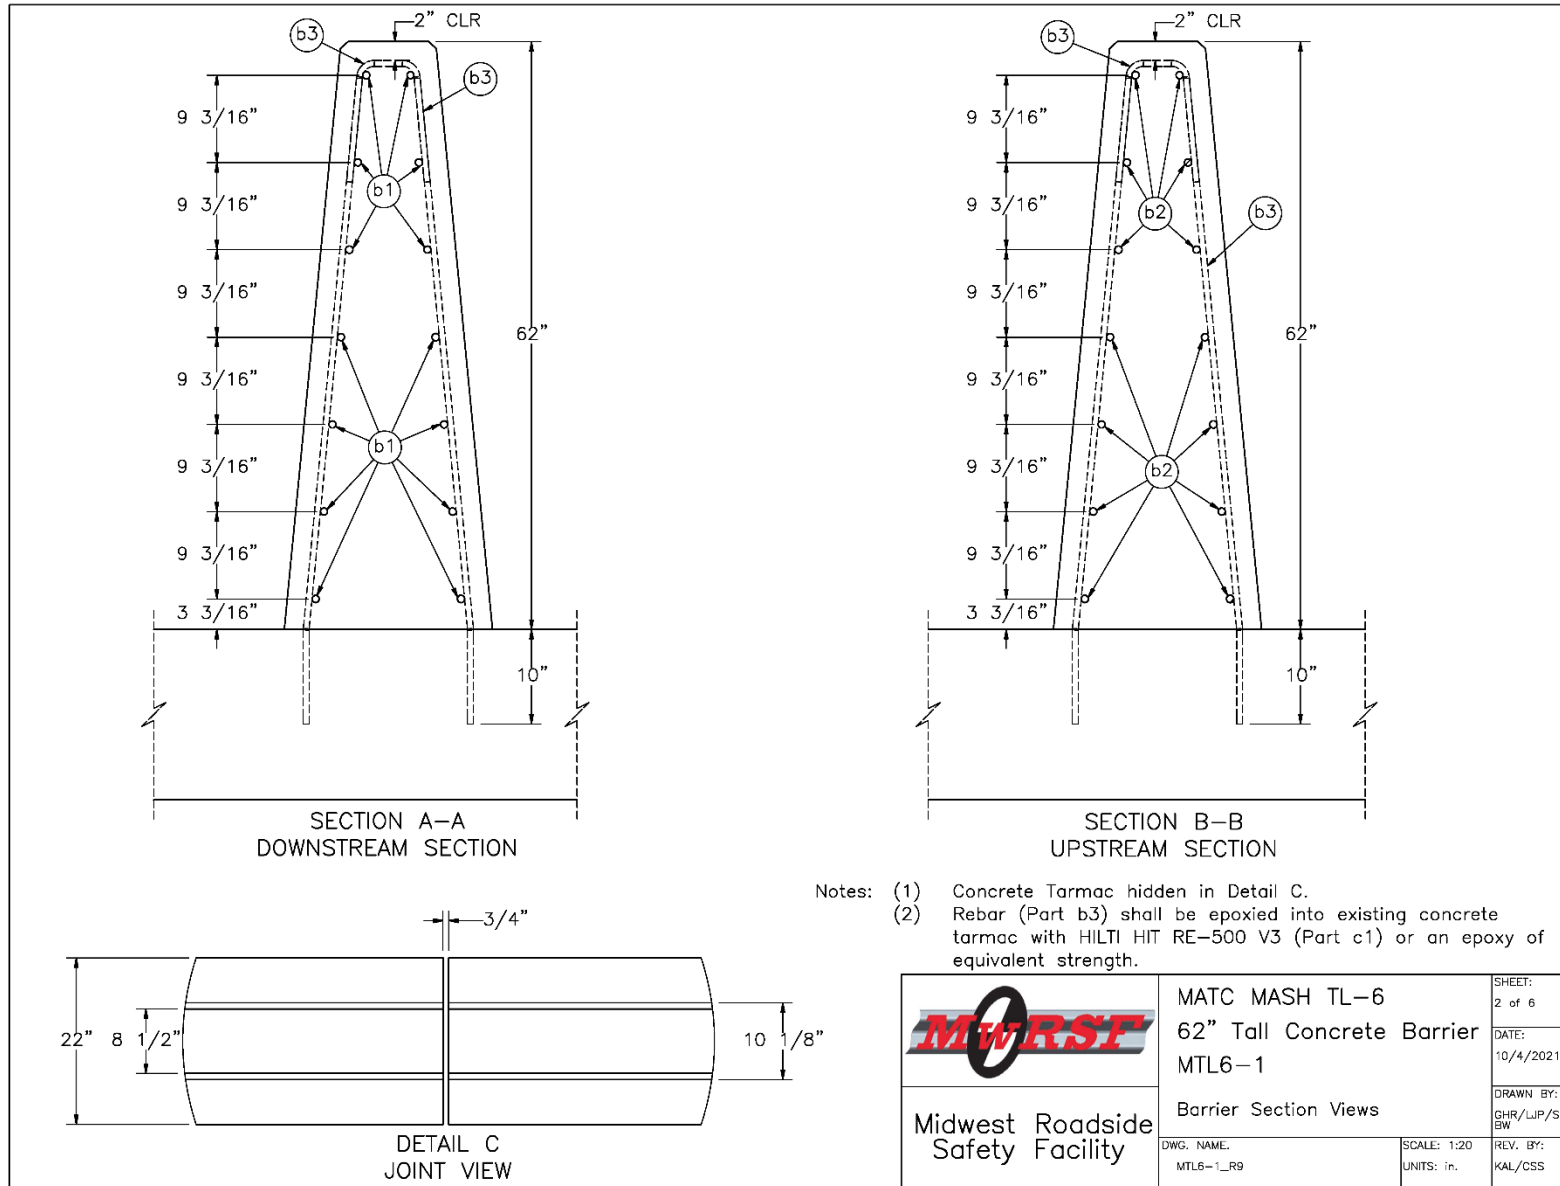
Figure 3.7 Barrier Section Views, Test No. MTL6 1

All steel rebar had a minimum yield strength of 60 ksi. The barrier was reinforced with seven equally-spaced #6 longitudinal bars on both the front and back sides of the barrier located $9\frac{3}{16}$ in. on center, with the bottom bar located at $3\frac{3}{16}$ in. and the upper bar located at $58\frac{3}{16}$ in., as shown in Figure 3.7. Vertical stirrup reinforcement consisted of two lapped and bent #5 stirrup bars embedded in MwRSF's existing concrete tarmac to a depth of 10 in. using Hilti HIT-RE 500 V3 epoxy anchor adhesive to develop the full strength of the bars. The stirrups were spaced 5 in. apart in the barrier end sections and 12 in. apart in the interior sections. A 2-in. clear cover was used around all concrete reinforcement.

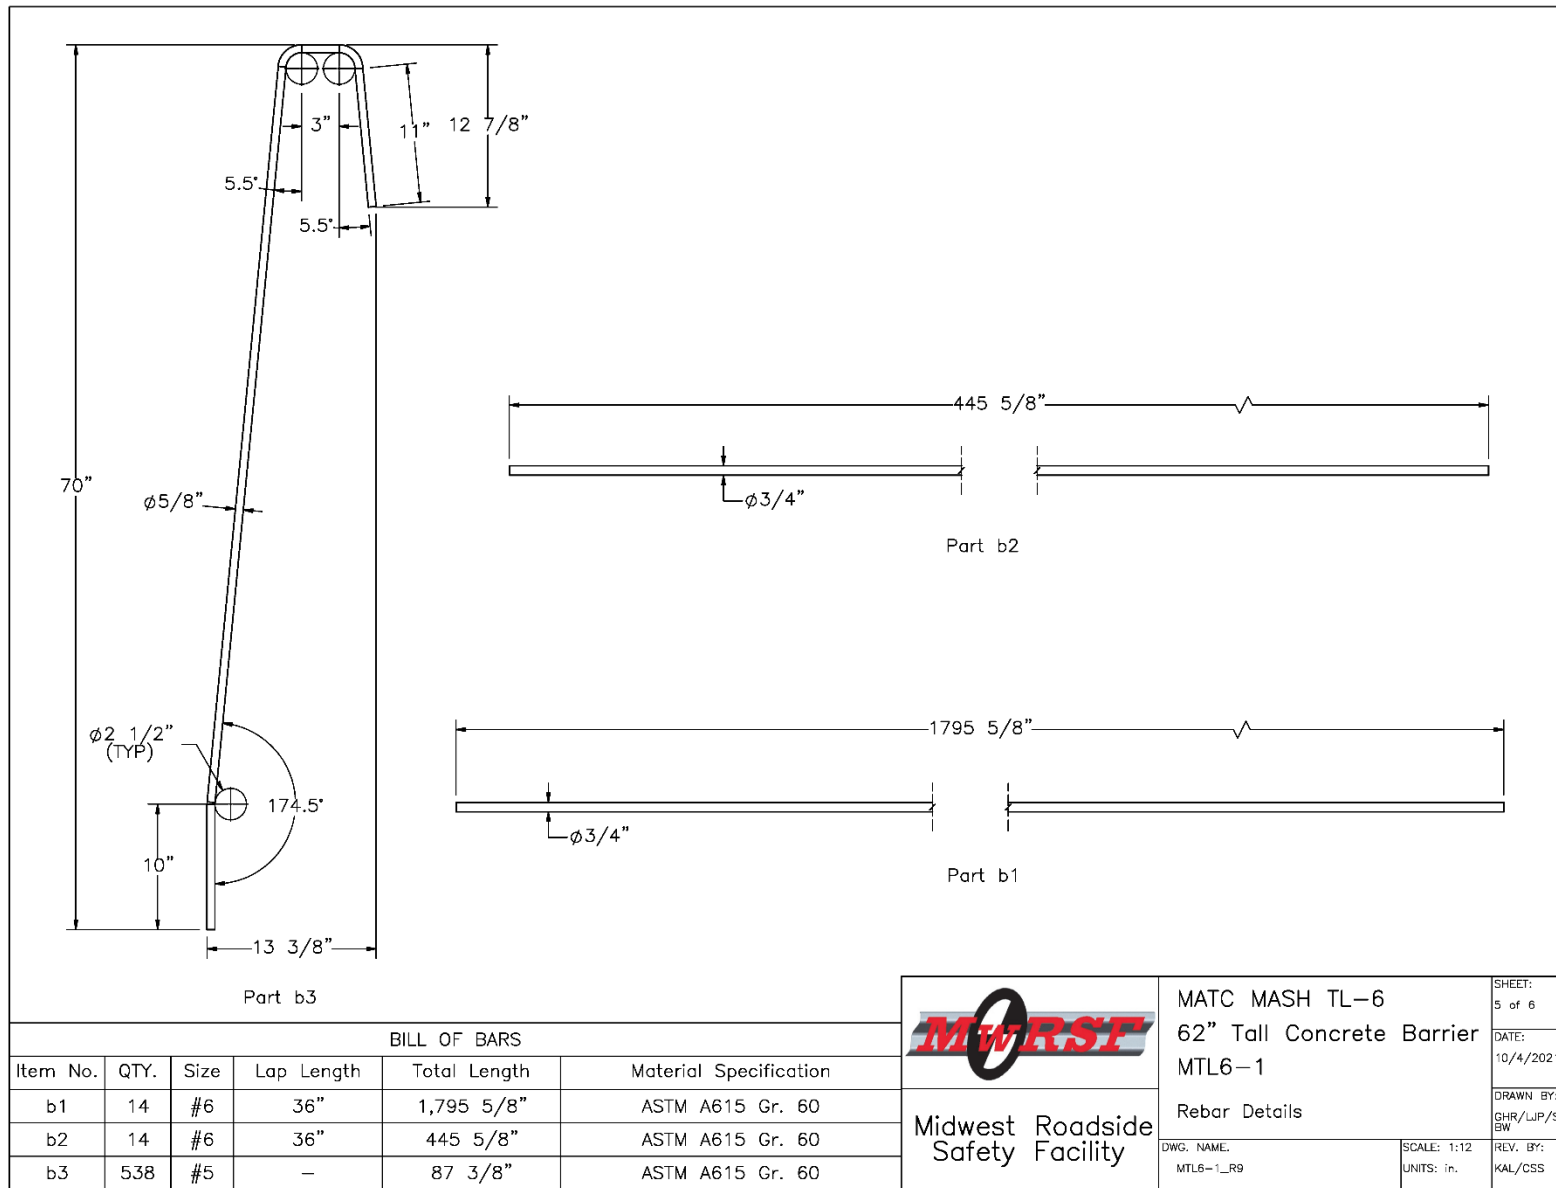
Figure 3.10 Rebar Details, Test No. MTL6 1

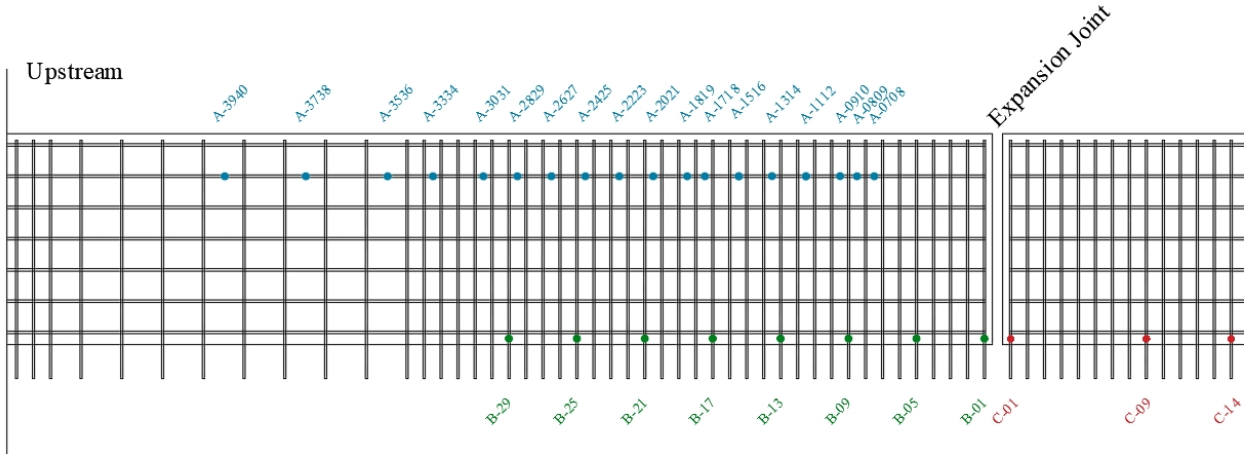
Figure 5.17 Location of Strain Gauges, Test No. MTL6-1

Eight linear potentiometers were installed on the back side of the barrier near the top, as seen in Figure 5.16. Two were placed downstream from the expansion joint and six were placed upstream. Strain gauges were placed on reinforcing bars both upstream and downstream from the expansion joint, as illustrated in Figure 5.17. Each linear potentiometer had a 0.90-in. diameter cross-section with an operational temperature range between -40 and 190°F and up to 95 percent humidity, was rated to IP64 (dust and water resistant), and utilized rod end joints for increased mounting flexibility. The strain gauges were single-axis GOBLET F-series foil strain gauges with a 5-mm gauge length and 350 Ohm gauge resistance. During testing, output voltage signals were sent from the transducers to a National Instruments PCI-6071E data acquisition board, acquired with LabView software, and stored on a personal computer at a sample rate of 10,000 Hz. Specifications for the foil strain gauges are shown in Figures 5.18 and 5.19.

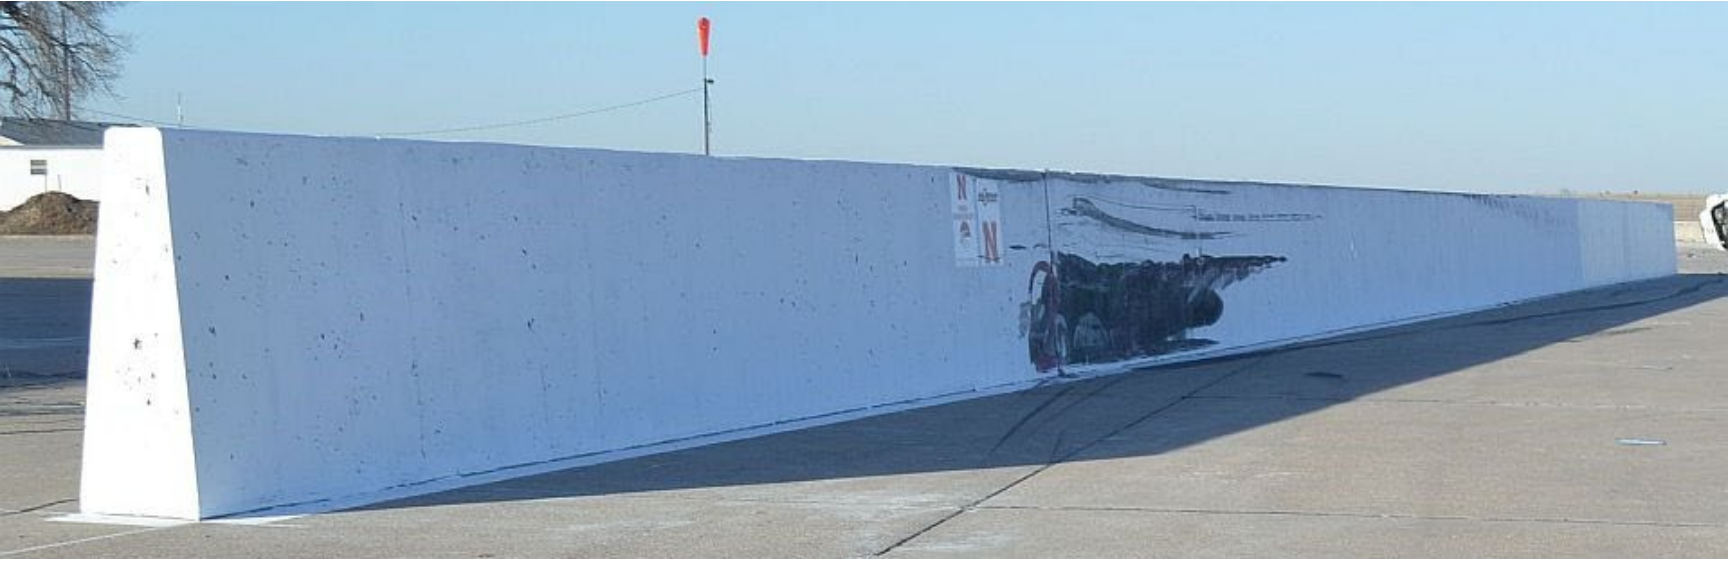
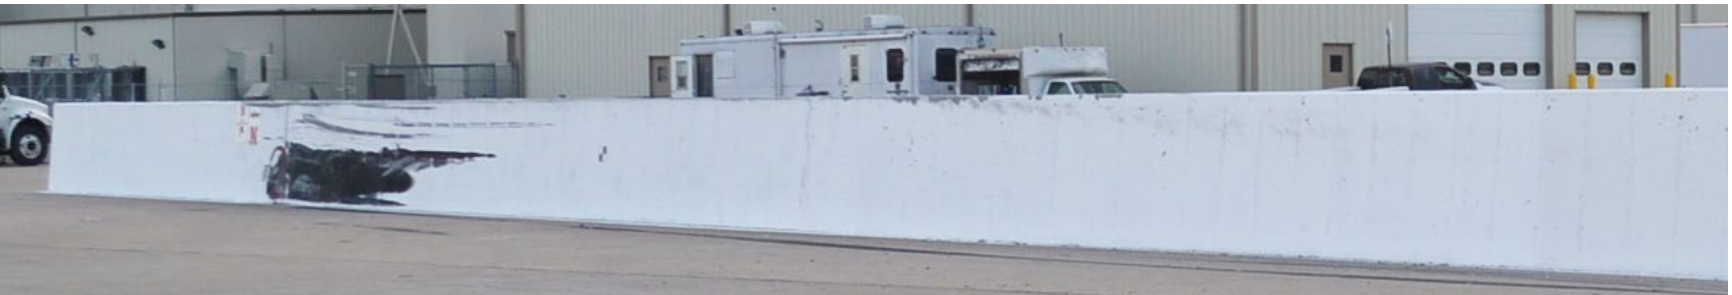
Figure 6.11 System Damage, Test No. MTL6-1

Tire contact marks on the front face of the barrier began 6 ft – 10 in. upstream from the expansion joint and ended approximately 26 ft downstream from the expansion joint. The overall width of the tire contact marks varied, but the highest point was 38.5 in. above the tarmac. Contact marks from other portions of the vehicle were observed up to the top of the barrier and gouging or spalling occurred along the top-front edge of the barrier from 6 ft – 10 in. upstream from the expansion joint to approximately 77 ft – 8 in. downstream from the expansion joint. Additional intermittent gouging and chipping along the top-front edge of the barrier extended through the end of vehicle contact.

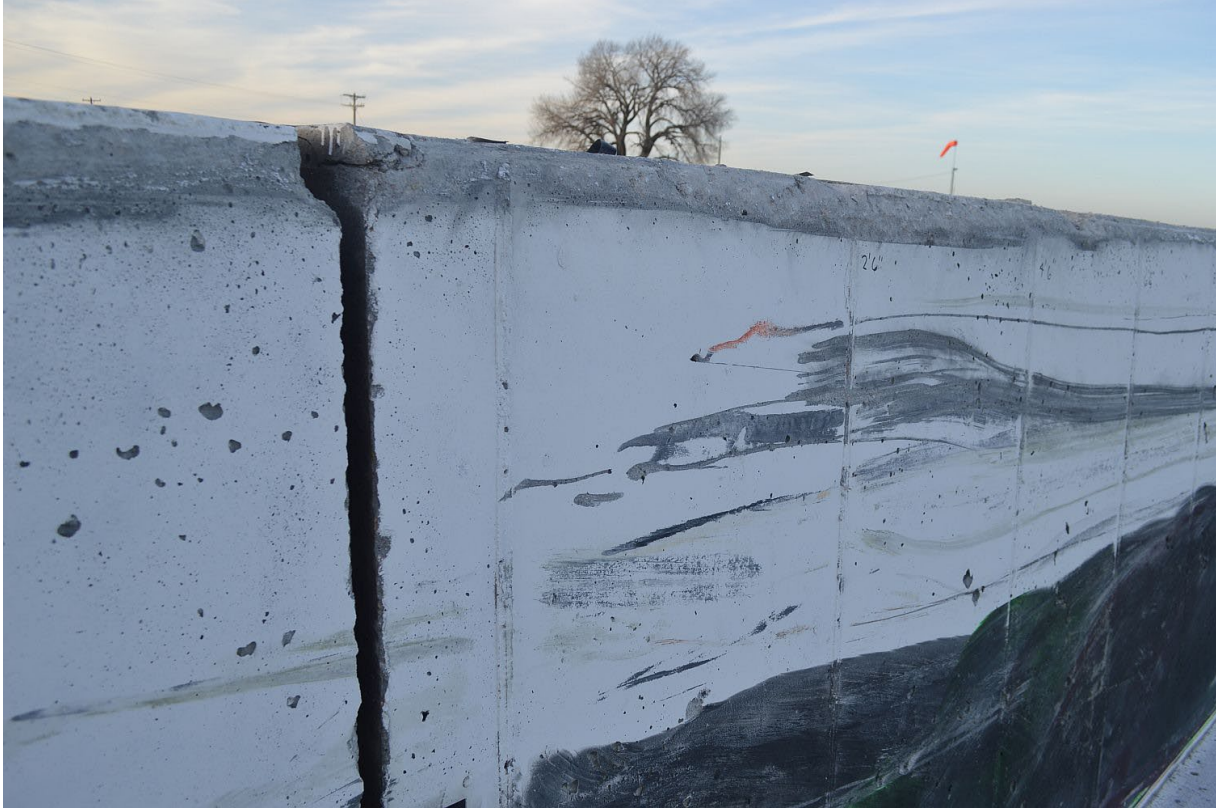
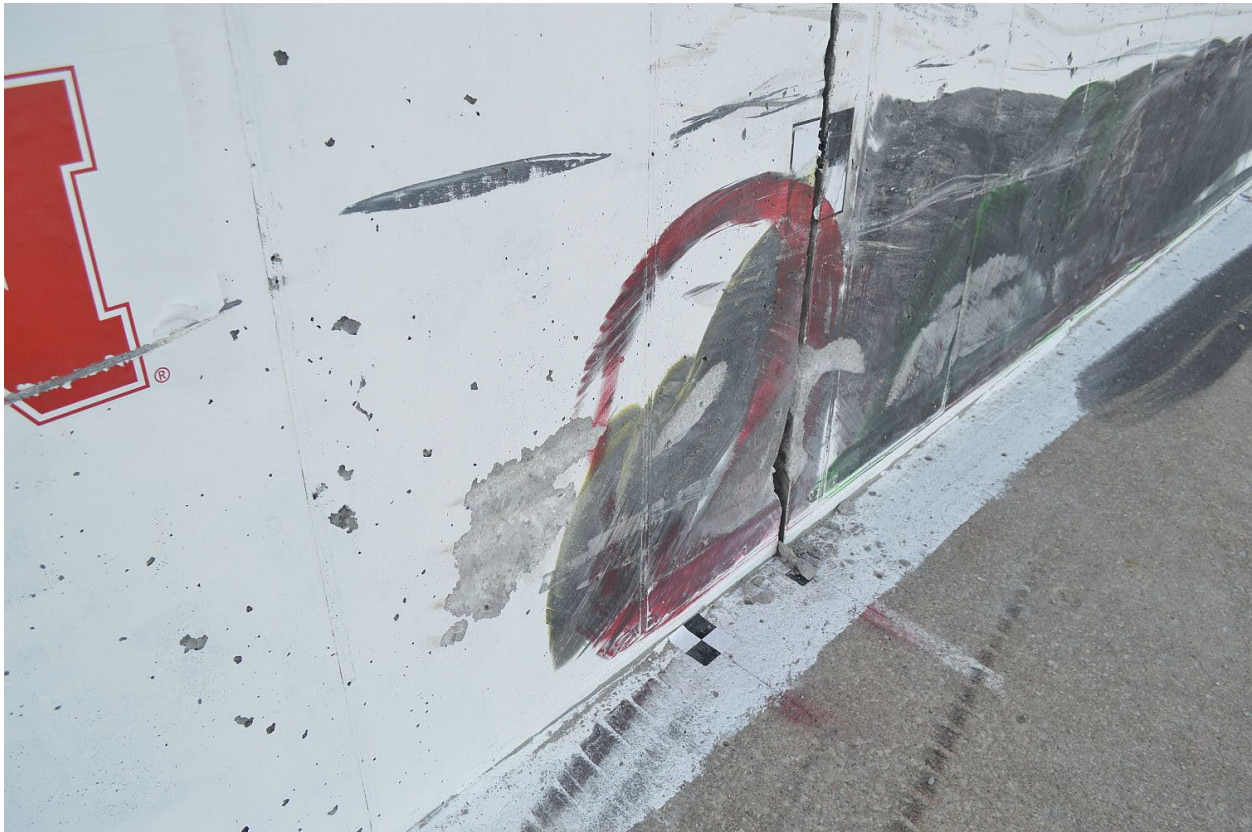
Figure 6.13 System Damage Near Expansion Joint, Test No. MTL6-1

Additional gouging and chipping were observed on the front face of the barrier, in the 3 ft to either side of the expansion joint. At the expansion joint location, the top-front corners of the barrier segments were broken off to a depth of approximately ½ in. as was 13 in. of the upstream front edge, beginning 5 in. above the tarmac. No reinforcing bars were exposed by this damage.

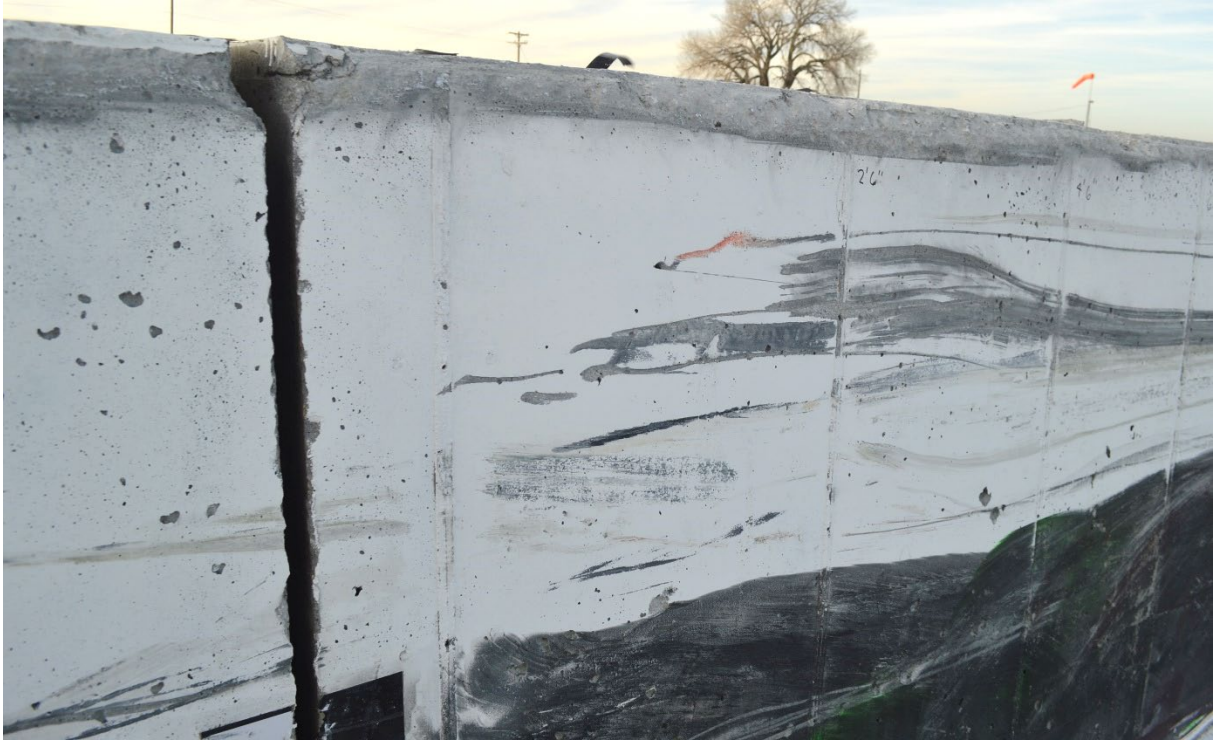
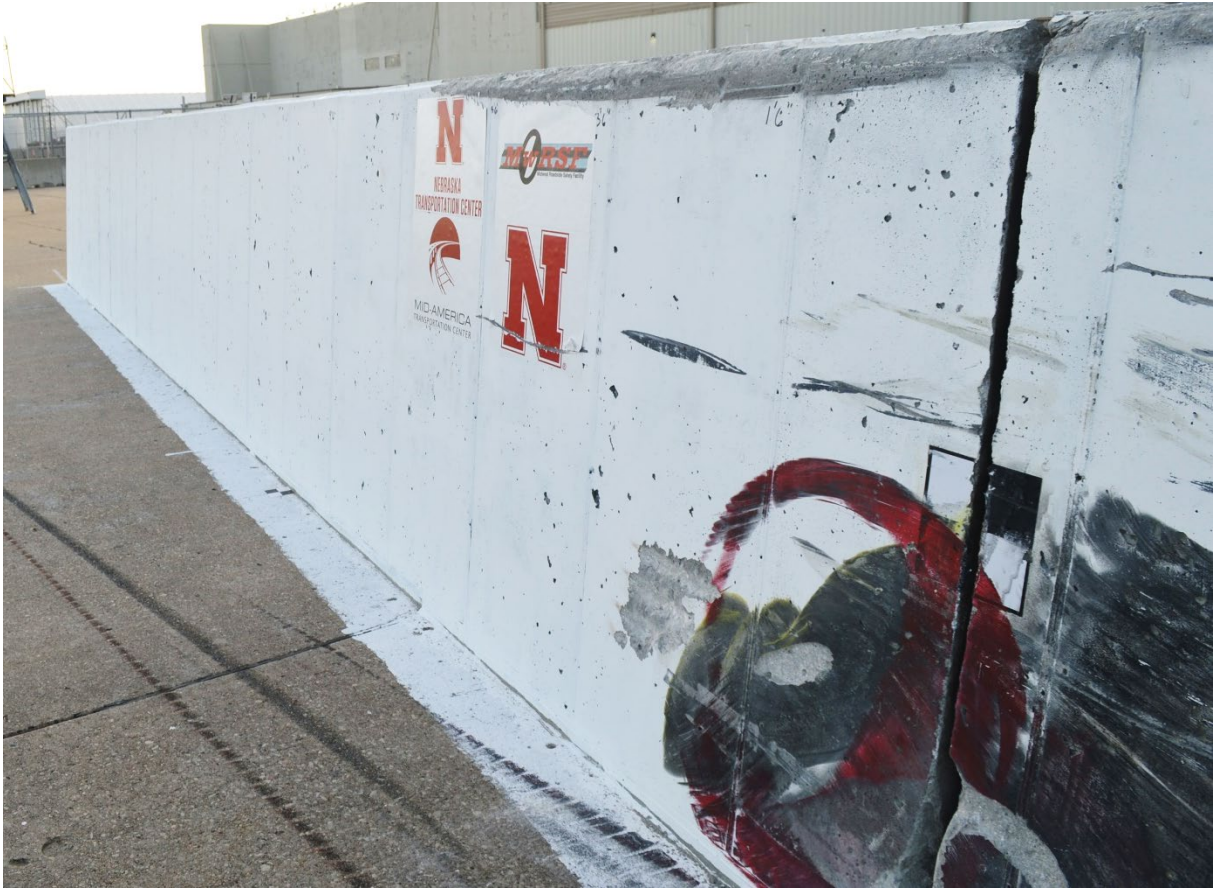
Figure 6.14 System Damage Near Expansion Joint, Test No. MTL6-1

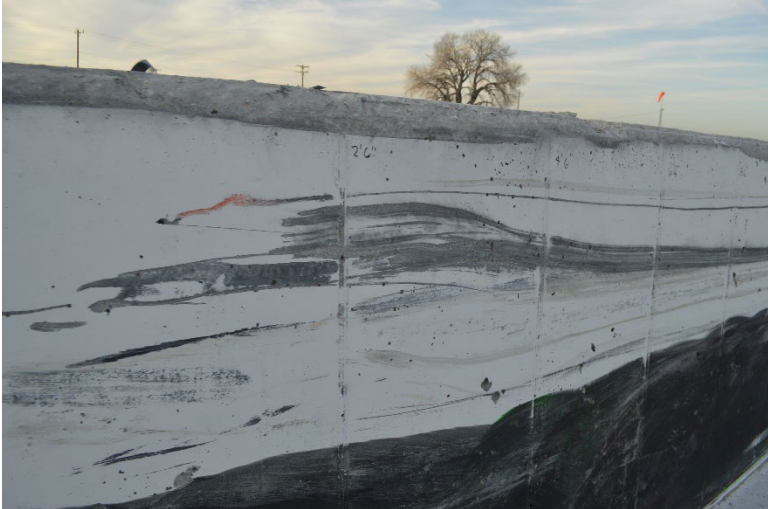
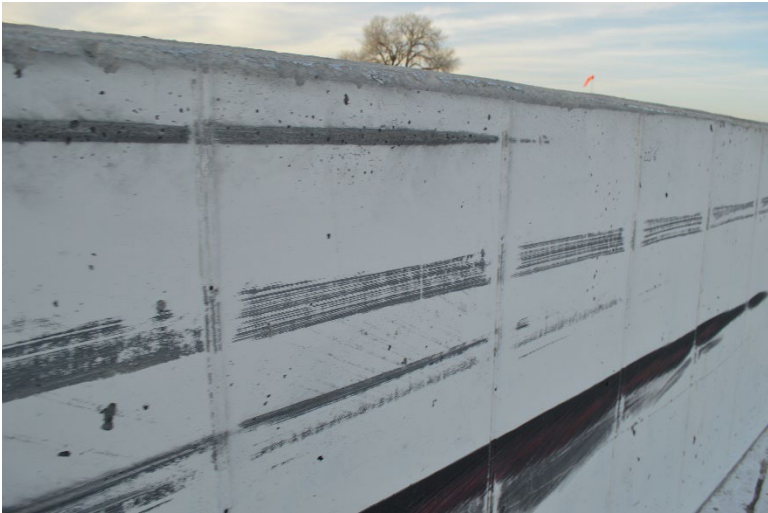
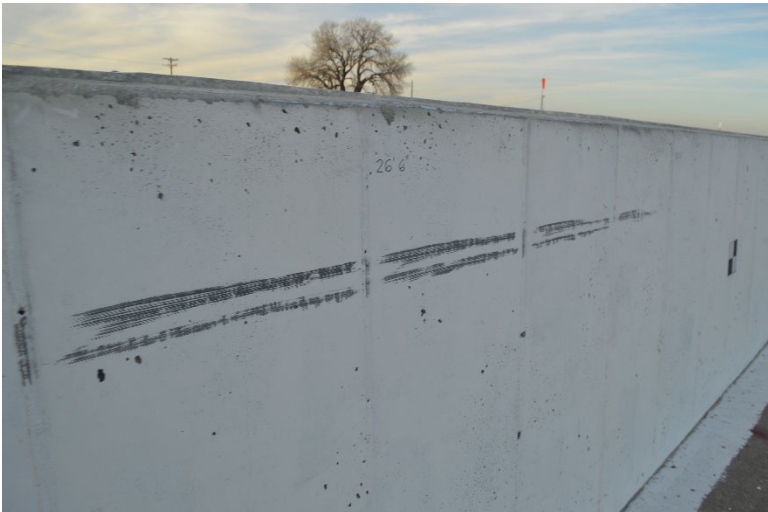
Figure 6.15 Scraping Damage along Top Impact-Side Edge of Barrier, Test No. MTL6-1

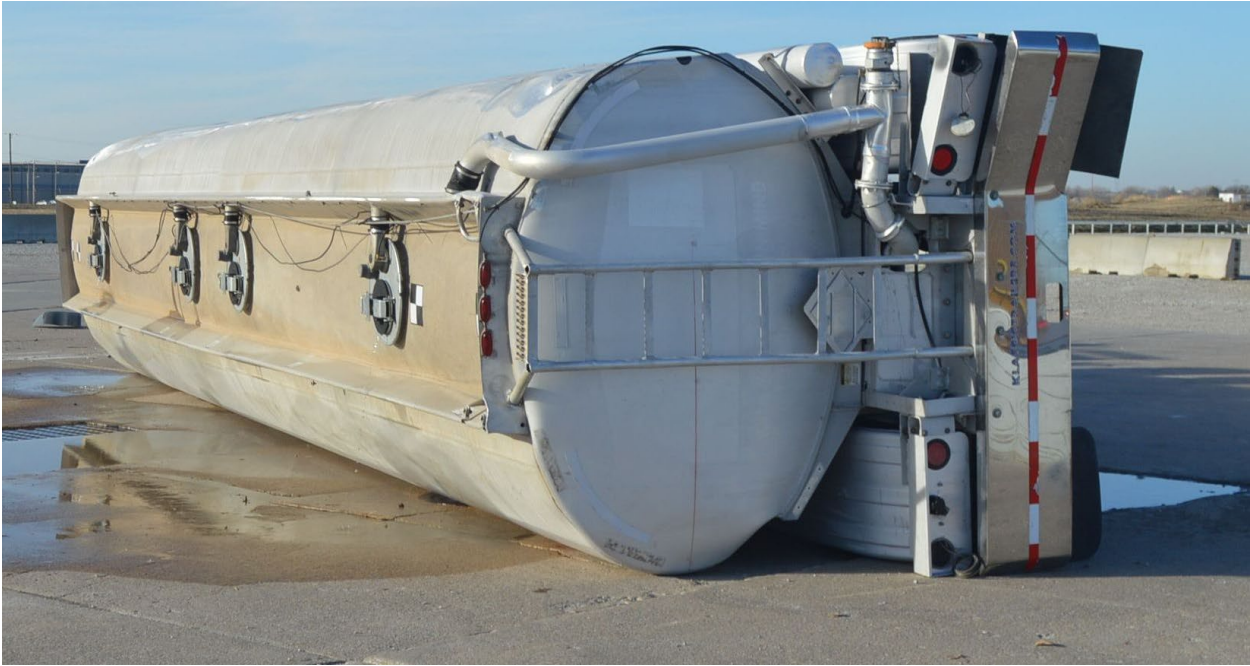
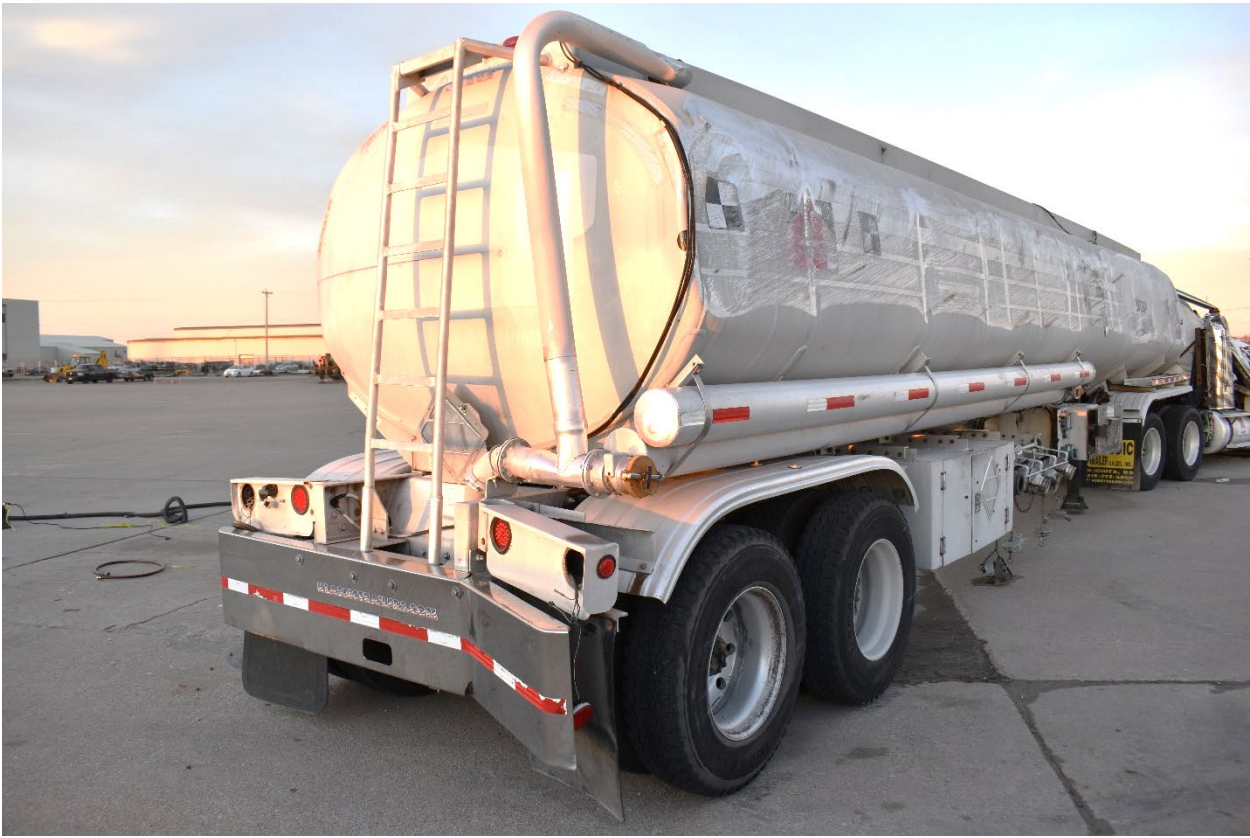
Figure 6.22 Trailer Damage, Test No. MTL6-1

The trailer experienced extensive damage to the left, top, and right sides. Scraping, minor gouging, and some peeling of the aluminum jacket were observed near interior baffle locations. Scrub marks were observed on the left side of the trailer at the impact height of the barrier, and two large dents were observed at the same height: one in the front, and one in the back. The left-side wheel hubs were scraped and gouged. The right side of the trailer experienced extensive scraping in the vertical direction corresponding to sliding on the concrete tarmac, with multiple small tears and holes observed in the aluminum jacket especially near the internal baffles. The right side was flattened and crushed inward along the entire middle section where the vehicle rolled and skidded, and several tears were observed in the jacket measuring between 2 and 3 in.

long. The top of the trailer was scraped, and the longitudinal safety rails were slightly deformed. One tear was observed in the undercarriage of the tank. The suspension, wheels, frame, and undercarriage of the trailer were not damaged.

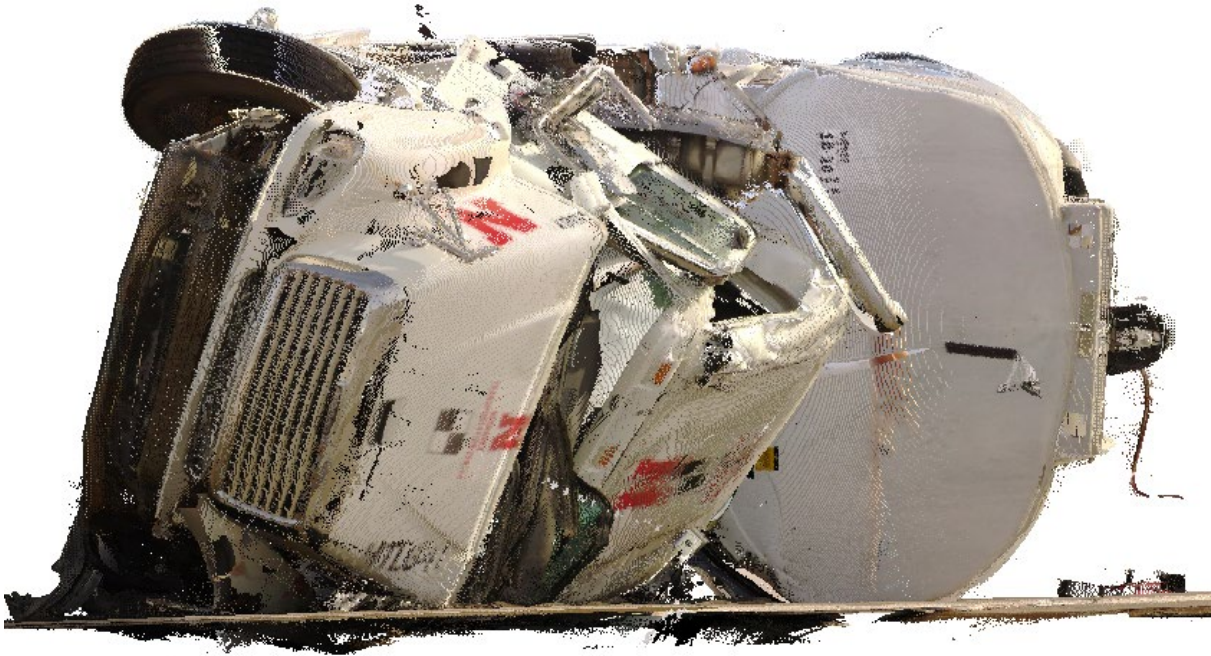
Figure 6.32 Vehicle Scan Results, Tractor Damage, Test No. MTL6-1
