APPROACH GUARDRAIL TRANSITION RETROFIT TO EXISTING BUTTRESSES & BRIDGE RAILS

NEBRASKA DEPARTMENT OF TRANSPORTATION

MwRSF Research Report No. TRP-03-480-24

September 5, 2024

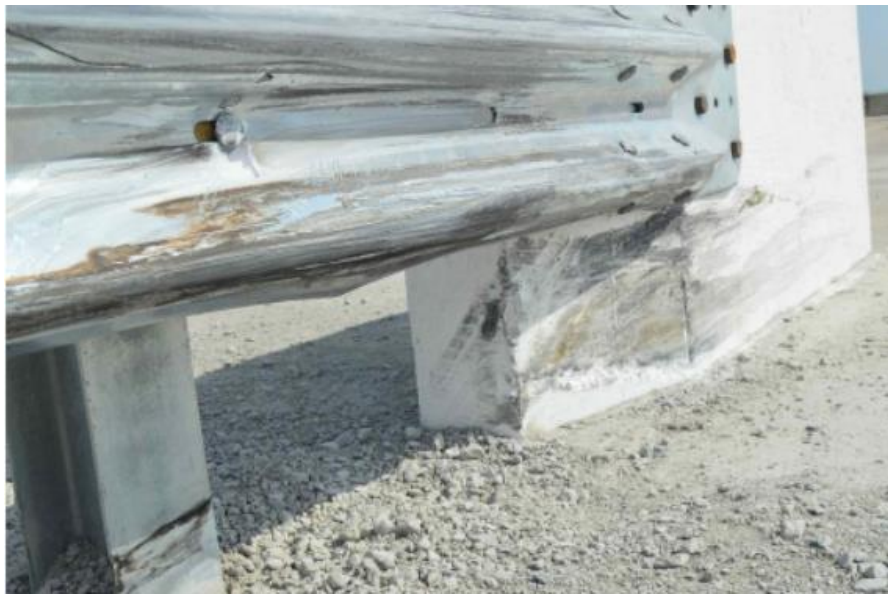
Figure 20. Wheel Snag on 34-in. AGT during MASH Crash Testing [2]

Previous MASH testing has shown that wheels can and will extend underneath AGT rails and contact the concrete buttress. As shown in Figure 20, tire marks on the buttress from the MASH testing of NDOT's 34-in. AGT can be seen extending nearly 10 in. past the front face of the buttress. The 4 $\frac{1}{2}$ -in. x 18-in. tapered face of the standardized buttress greatly reduced the magnitude of the wheel snag as compared to the perpendicular surface circled in Figure 19.

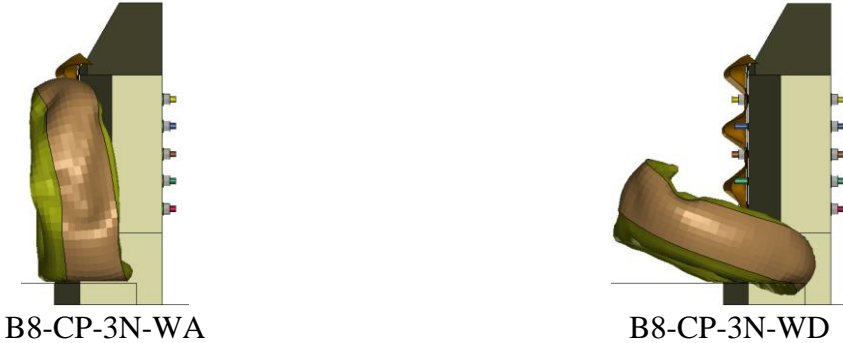
Figure 74. Tire-Buttress Overlap, Buttress 8 without Wheel Snag Retrofits

The lateral overlap of the impacting tires across the upstream face of the concrete buttress are listed in Table 15. Looking at the two simulations that did not involve any wheel snag retrofits, the maximum overlap numbers did not appear to be significantly different than those from the previous simulations on Buttresses 5 and 6. However, a difference was noted in the position of the wheel at the time of maximum overlap. Because of the large gap underneath the cantilevered segment, the wheel was allowed to remain at this lateral offset for a longer time, as shown in Figure 74. Thus, the wheel impacted and severely snagged on the lower vertical face of the buttress, particularly for the simulation involving wheel disengagement.
