MODIFICATION AND EVALUATION OF THE ASPHALT PIN TIE-DOWN FOR F-SHAPE PCB: TEST NO. WITD-4

MwRSF Research Report No. TRP-03-488-24

December 17, 2024

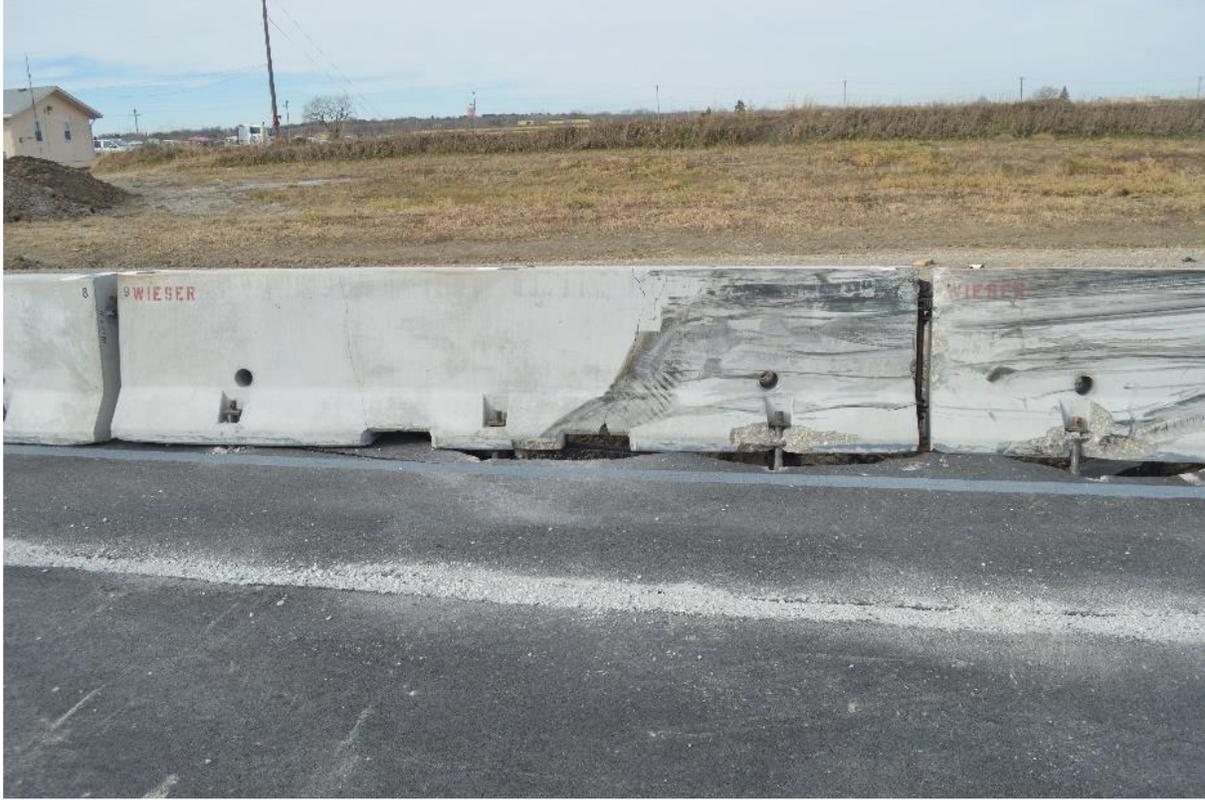
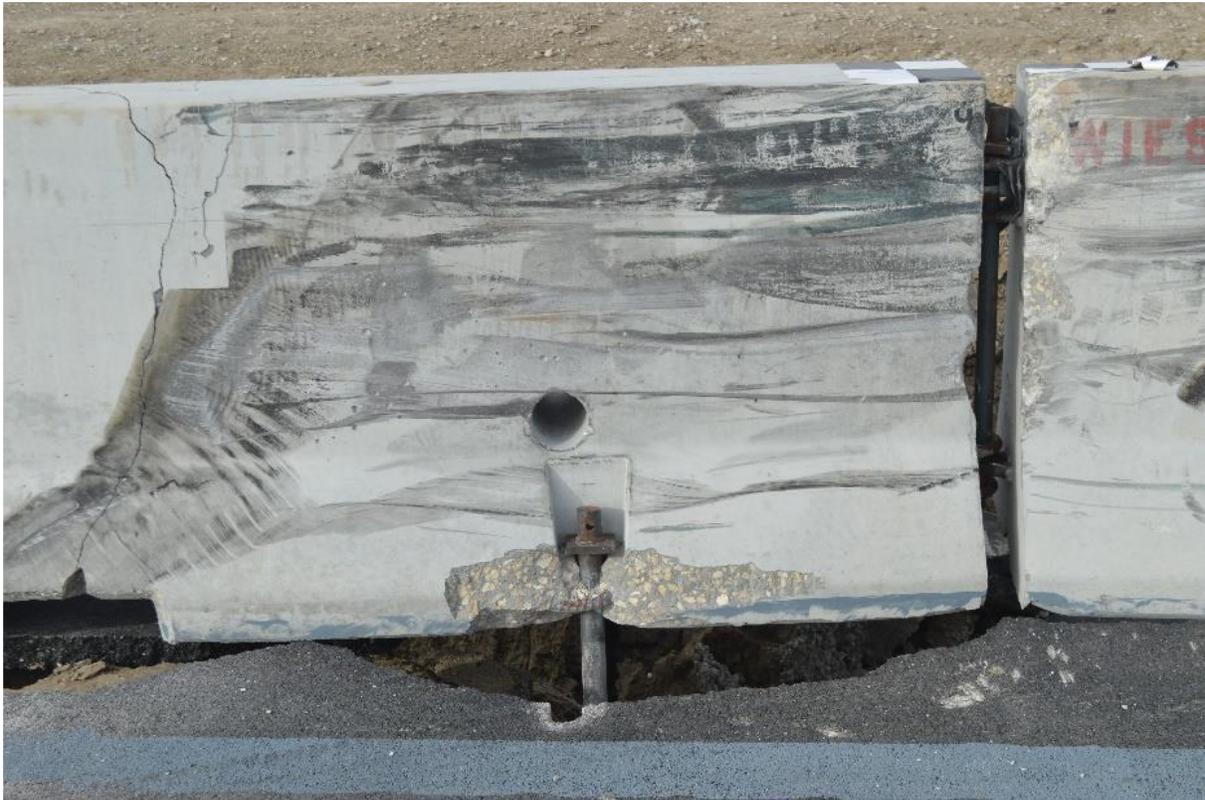
Figure 2. Barrier Joint Snag, Test No. WITD-3

During test no. WITD-2, the front-left tire snagged on the first barrier joint it encountered, as shown in Figure 2. The cause of the wheel snag was similar to what was observed in previous testing of the asphalt tie-down anchorage, in that the upstream barrier was loaded and deflected/rotated back laterally while the downstream barrier remained anchored. This exposed the face of the downstream barrier and promoted snagging of the wheel and tire as it traversed the joint. The front tire climbed the toe of the PCB barrier as well, which increased the exposure of the face of the downstream barrier to the wheel.

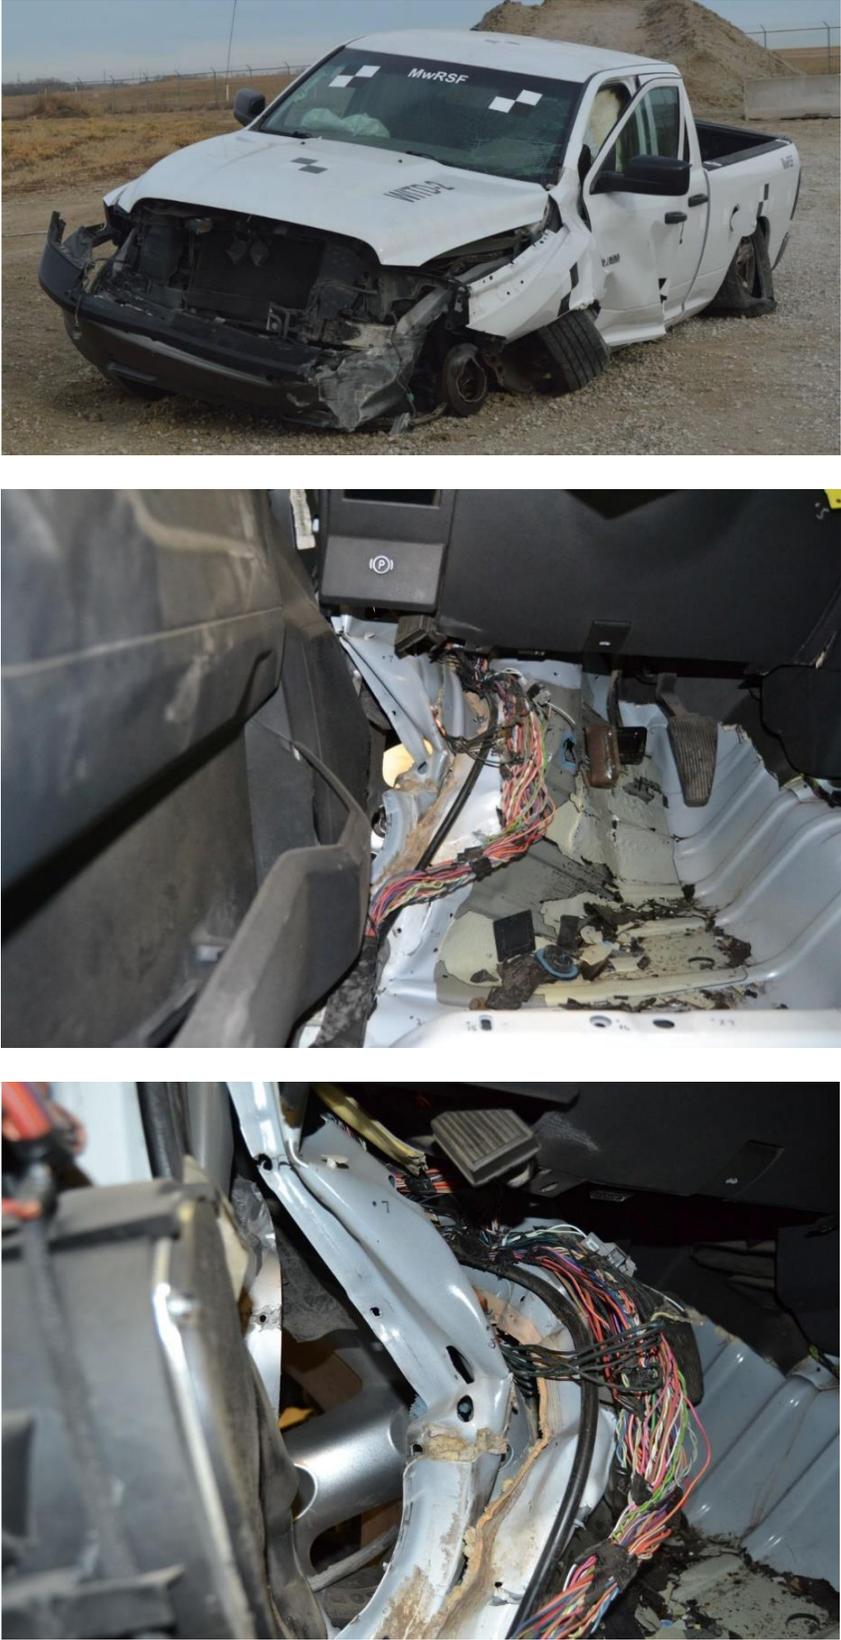
Figure 3. Occupant Compartment Damage, Test No. WITD-2

As a result of snagging on the joint, the front-left wheel rotated 90 degrees and was pushed back toward the floor pan of the pickup. This caused excessive floor pan deformations, opened a hole in the floor pan, and allowed a portion of the wheel to penetrate into the occupant compartment, as shown in Figure 3. The maximum deformation of the floor pan area was 13.2 in., which exceeded the 9-in. MASH limit for floor pan deformation. The combination of excessive occupant compartment deformation and the penetration of the wheel into the occupant compartment led to the test being deemed unacceptable under the MASH TL-3 safety requirements.

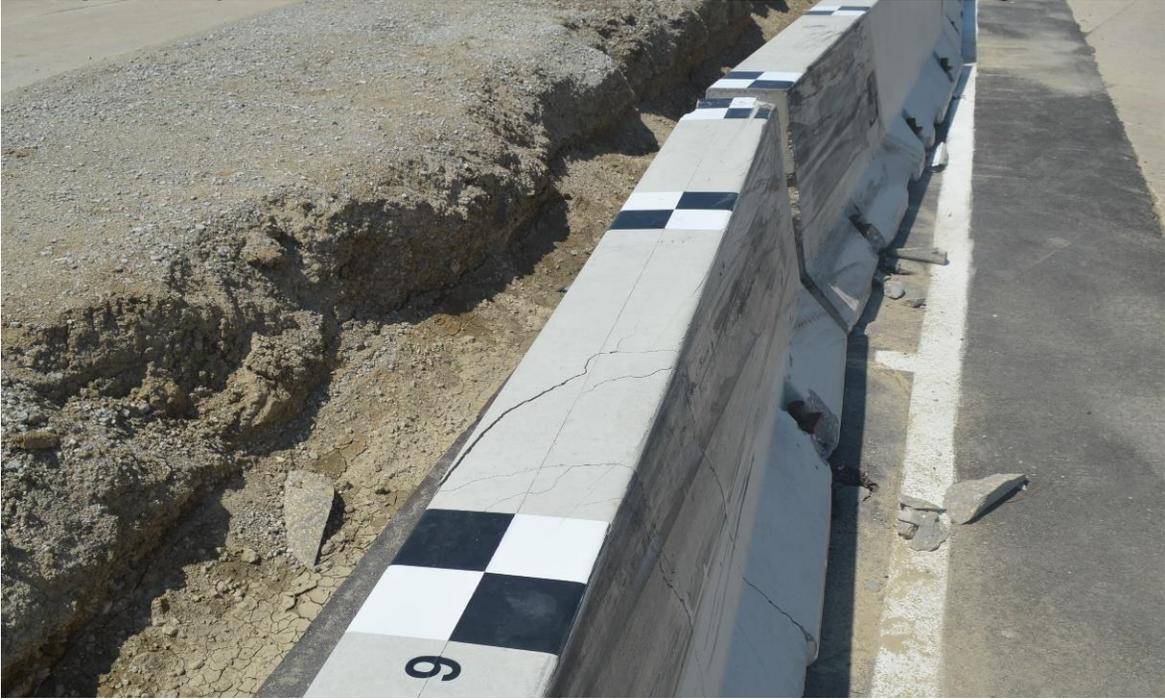
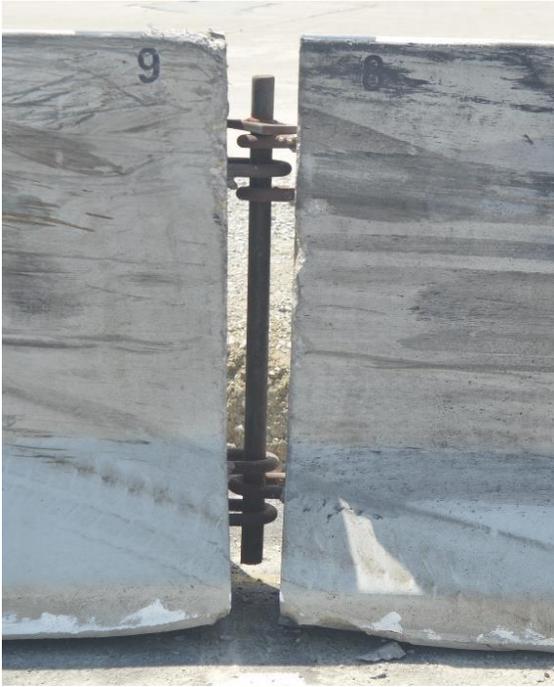
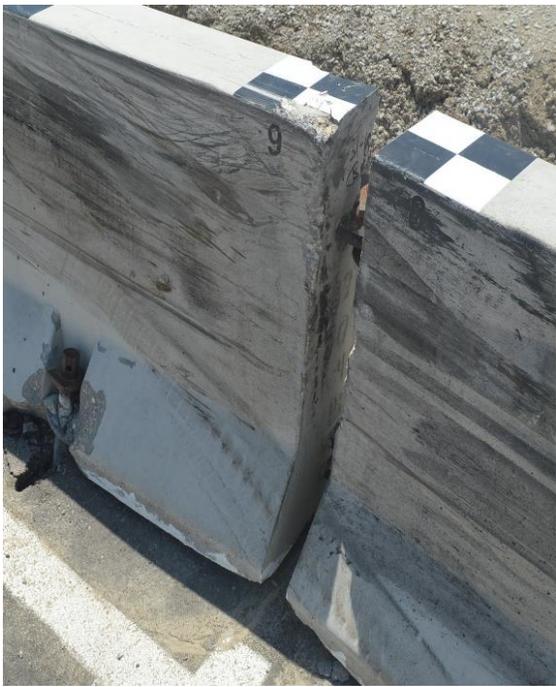
Figure 4. Barrier Joint Snag, Test No. WITD-3

In test no. WITD-3, wherein the barrier offset was increased from 6 in. to 18 in., the 2270P vehicle impacted the barrier system at a speed of 61.9 mph and an angle of 25.1 degrees. The impact point for this test was selected to maximize vehicle snag and loading of the barrier joint. The vehicle was captured and successfully redirected. There was little to no damage to the asphalt or soil disengagement as was seen in the NCHRP Report 350 and WITD-2 crash tests. Dynamic deflection for test no. WITD-3 was 16.3 in., as compared to 18.4 in. in NCHRP Report 350 and 24.5 in. in the WITD-2 crash tests. The right-front tire snagged on the upstream face of barrier no. 9, as shown in Figure 4. The cause of the wheel snag was similar to previous tests of the asphalt tie-down anchorage, in that the upstream barrier was loaded and deflected/rotated backward while the downstream barrier remained anchored. This exposed the face of the downstream barrier and promoted snagging of the wheel and tire as it traversed the joint. The front tire climbed the toe of the PCB segment, which also increased the exposure of the face of the downstream barrier to the wheel. As a result of the snagging behavior, the right-front wheel was pushed backward into the floor pan. This caused excessive floor pan deformations and a tear at the seam where the floor pan, toe pan, and kicker panel meet, as shown in Figure 5. Maximum deformation of the floor pan area was 10.4 in., which exceeded the 9-in. MASH floor pan deformation limit and led to the test being deemed unacceptable under MASH TL-3 safety requirements.

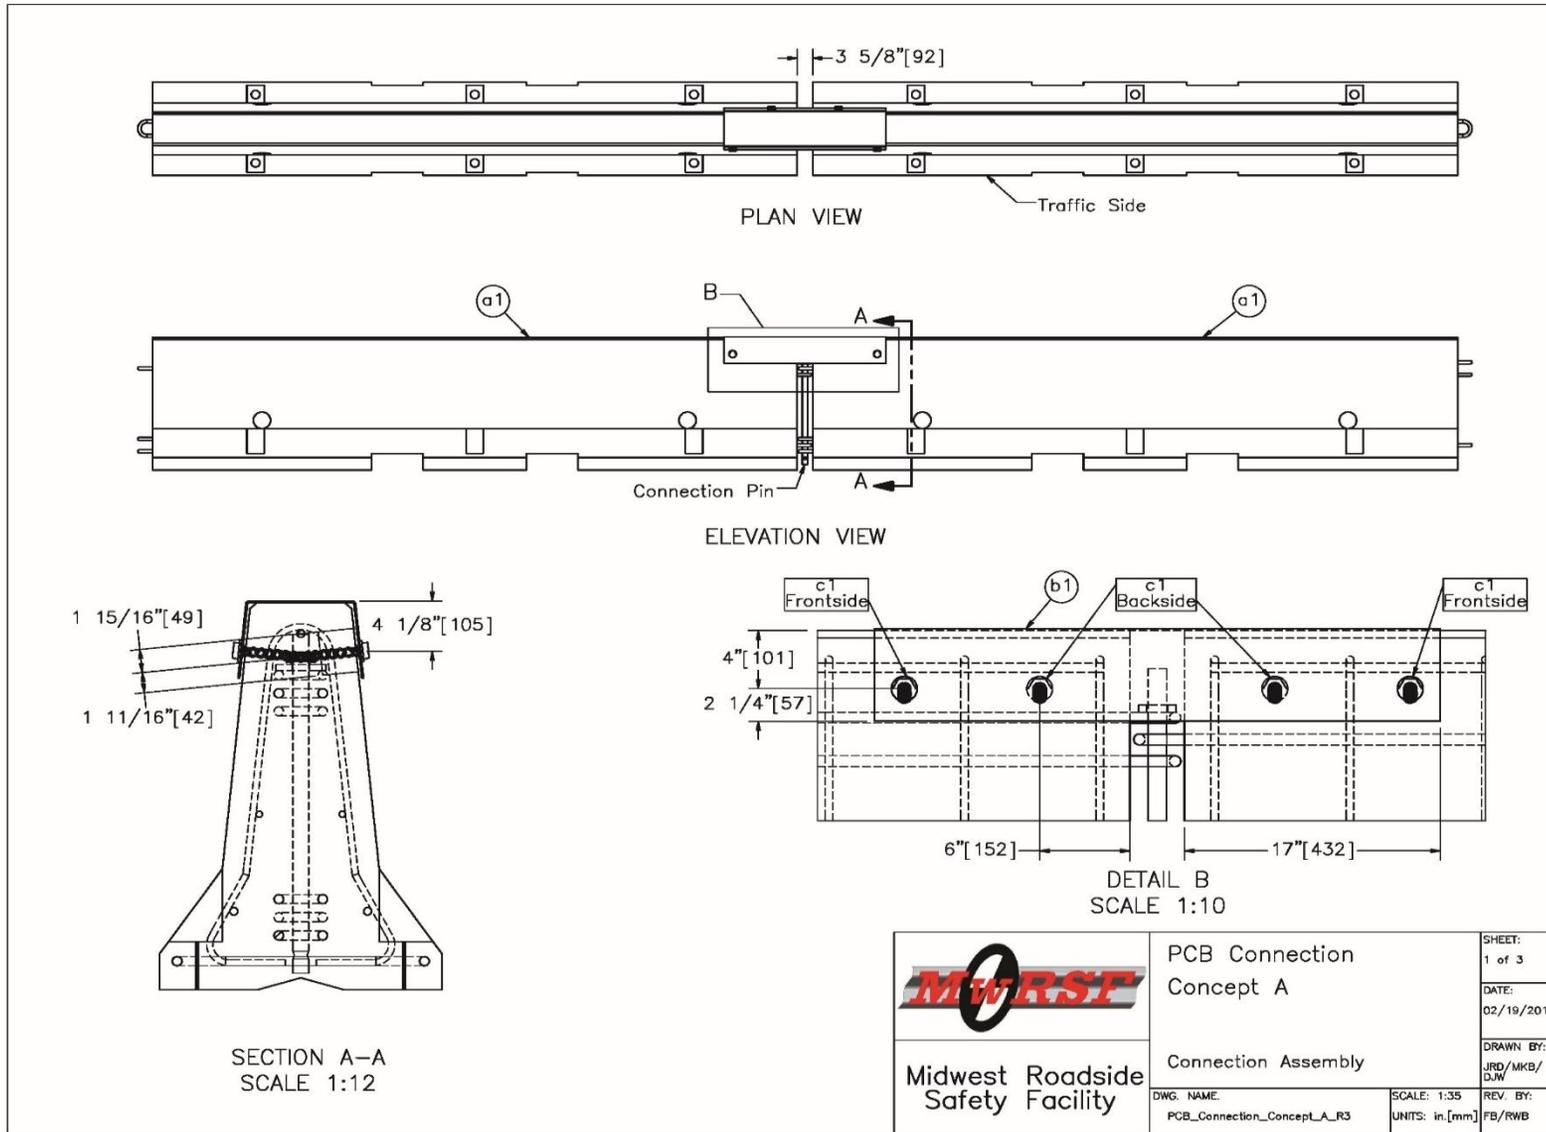
Figure 6. Design Concept A

Design Concept A consisted of a steel saddle cap that spanned across the joint between adjacent barrier segments, as shown in Figures 6 and 7. The saddle cap was fabricated from a 37⁵/₈-in. long x 1/8-in. thick, U-shaped, steel plate that sat on the top of the barrier segments and extended 6³/₄ in. down each side of the barrier. The saddle cap was anchored to the adjacent barrier segments with four 3/4-in. diameter wedge bolt mechanical anchors along the sides of the saddle cap. Design Concept A was intended to provide shear transfer across the barrier segment joint

and restrain relative lateral displacement of the barrier segments. Additionally, the sides of the saddle cap would provide a degree of physical shielding and wheel snag mitigation for the upper portion of the barrier joint. One benefit of this concept was that it was symmetric with respect to the front and back sides of the barrier, which would reduce the potential for the retrofit to be installed in an improper orientation. The primary drawback of this type of installation was the need for additional steel components and anchorage hardware at every joint in the PCB system.

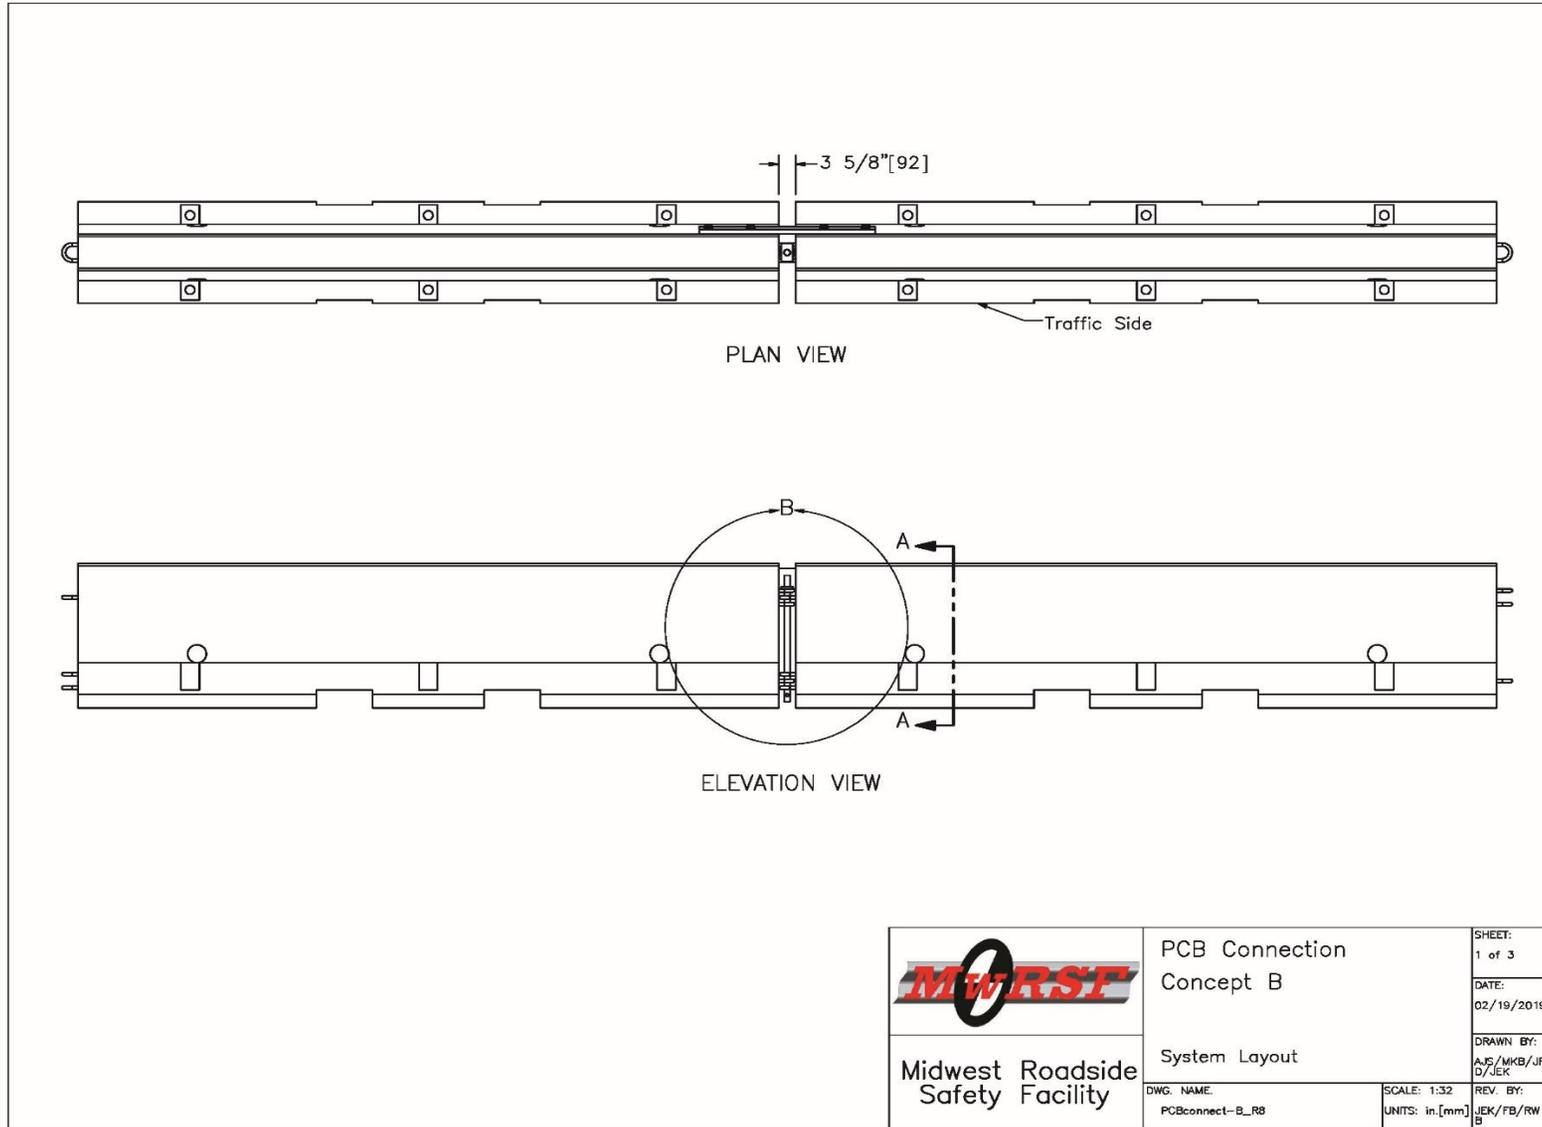
Figure 8. Design Concept B

Design Concept B consisted of a steel shear plate that spanned across the joint between adjacent barrier segments, as shown in Figures 8 through 10. The 37⁵/₈-in. long x 6-in. wide x 1-in. thick steel plate was mounted on the non-traffic side face of the barrier segment, centered 4 in. down from the top of the barrier segment, and centered longitudinally across the barrier joint. The shear plate was anchored to the barrier segments with four 3/4-in. diameter wedge bolt mechanical anchors. Design Concept B was intended to provide shear transfer across the barrier segment joint and restrain relative lateral displacement of the barrier segments. The concept only required hardware mounted on the non-traffic side of the barrier segments and four anchors. The concept was not symmetric with respect to the front and back sides of the barrier, which could increase the potential for the retrofit to be installed in an improper orientation. Another drawback of this installation was the need for additional steel components and anchorage hardware at every joint in the PCB system.

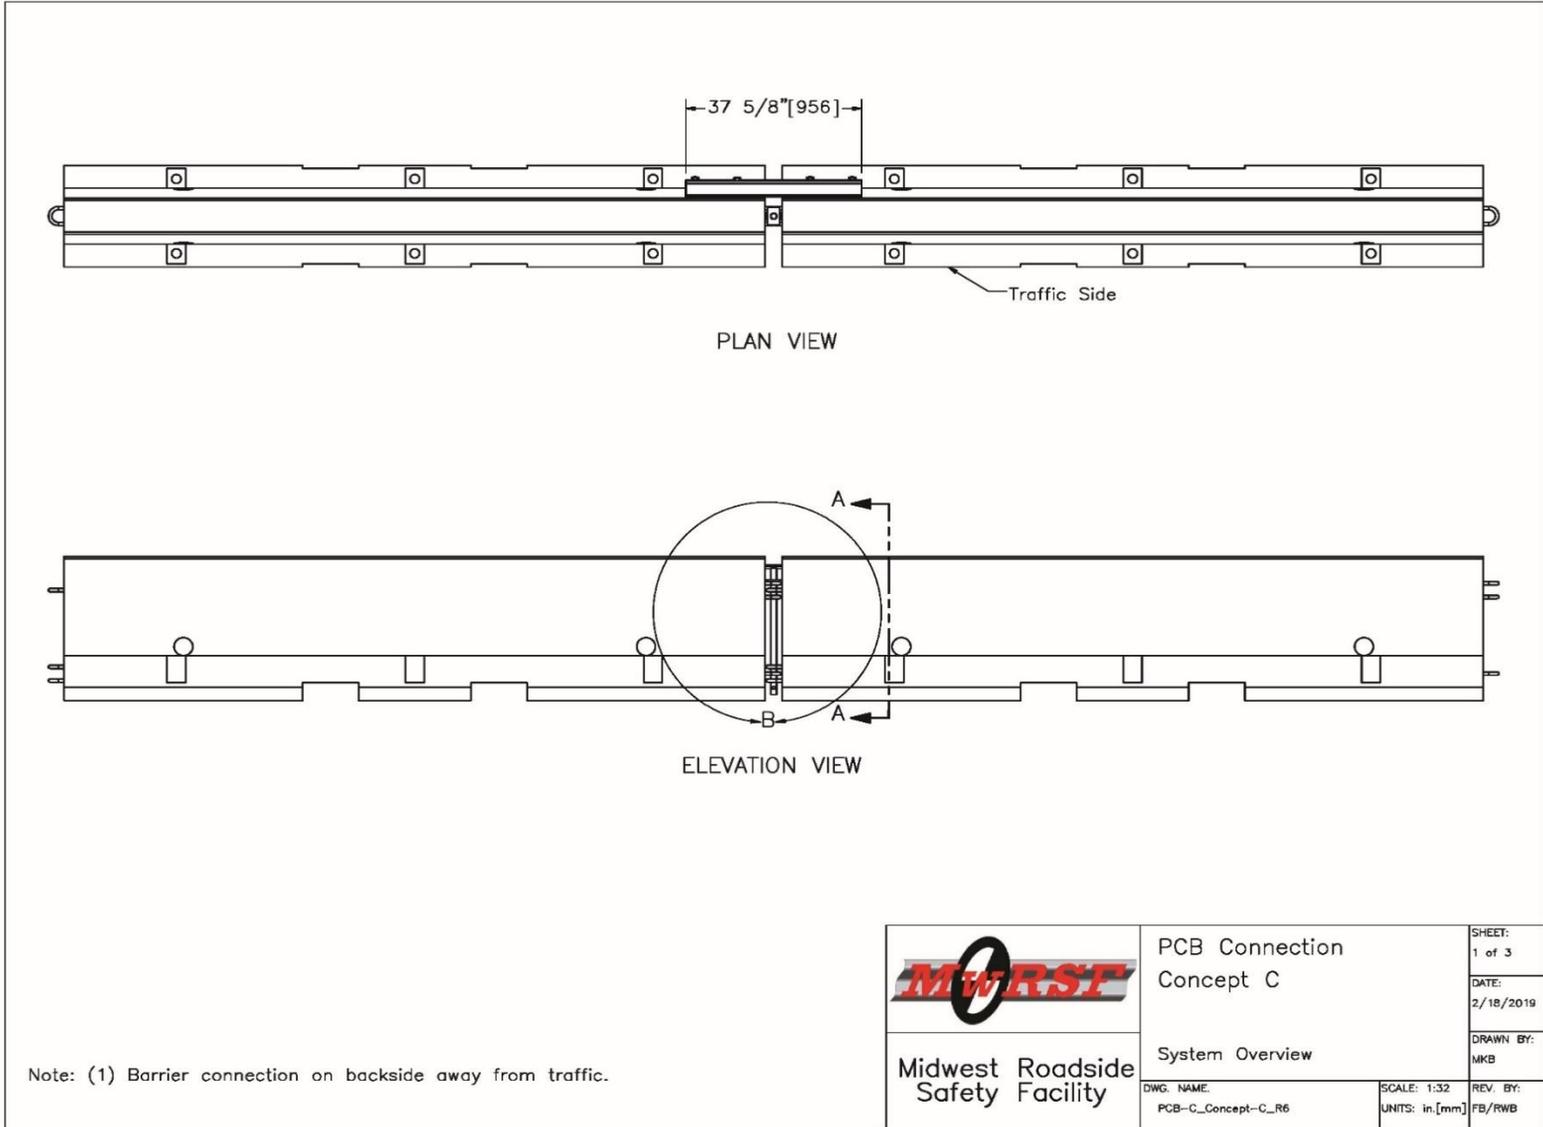
Figure 11. Design Concept C

Design Concept C consisted of a steel shear tube that spanned across the joint between adjacent barrier segments, as shown in Figures 11 through 13. The 37⁵/₈-in. long HSS3¹/₂x3¹/₂x¹/₄ tube was mounted on the non-traffic side face of the barrier segment, centered 4 in. down from the top of the barrier segment, and centered longitudinally across the barrier joint. The shear tube was anchored to the barrier segments with four ³/₄-in. diameter x 4³/₄-in. long hex bolts threaded into ³/₄ in. Red Head drop-in anchors. Design Concept C was intended to provide shear transfer across the barrier segment joint and restrain relative lateral displacement of the barrier segments. The concept only required hardware mounted on the non-traffic side of the barrier segments and four anchors. The concept was not symmetric with respect to the front and back sides of the barrier, which could increase the potential for the retrofit to be installed in an improper orientation. Another drawback of installation was the need for additional steel components and anchorage hardware at every joint in the PCB system.

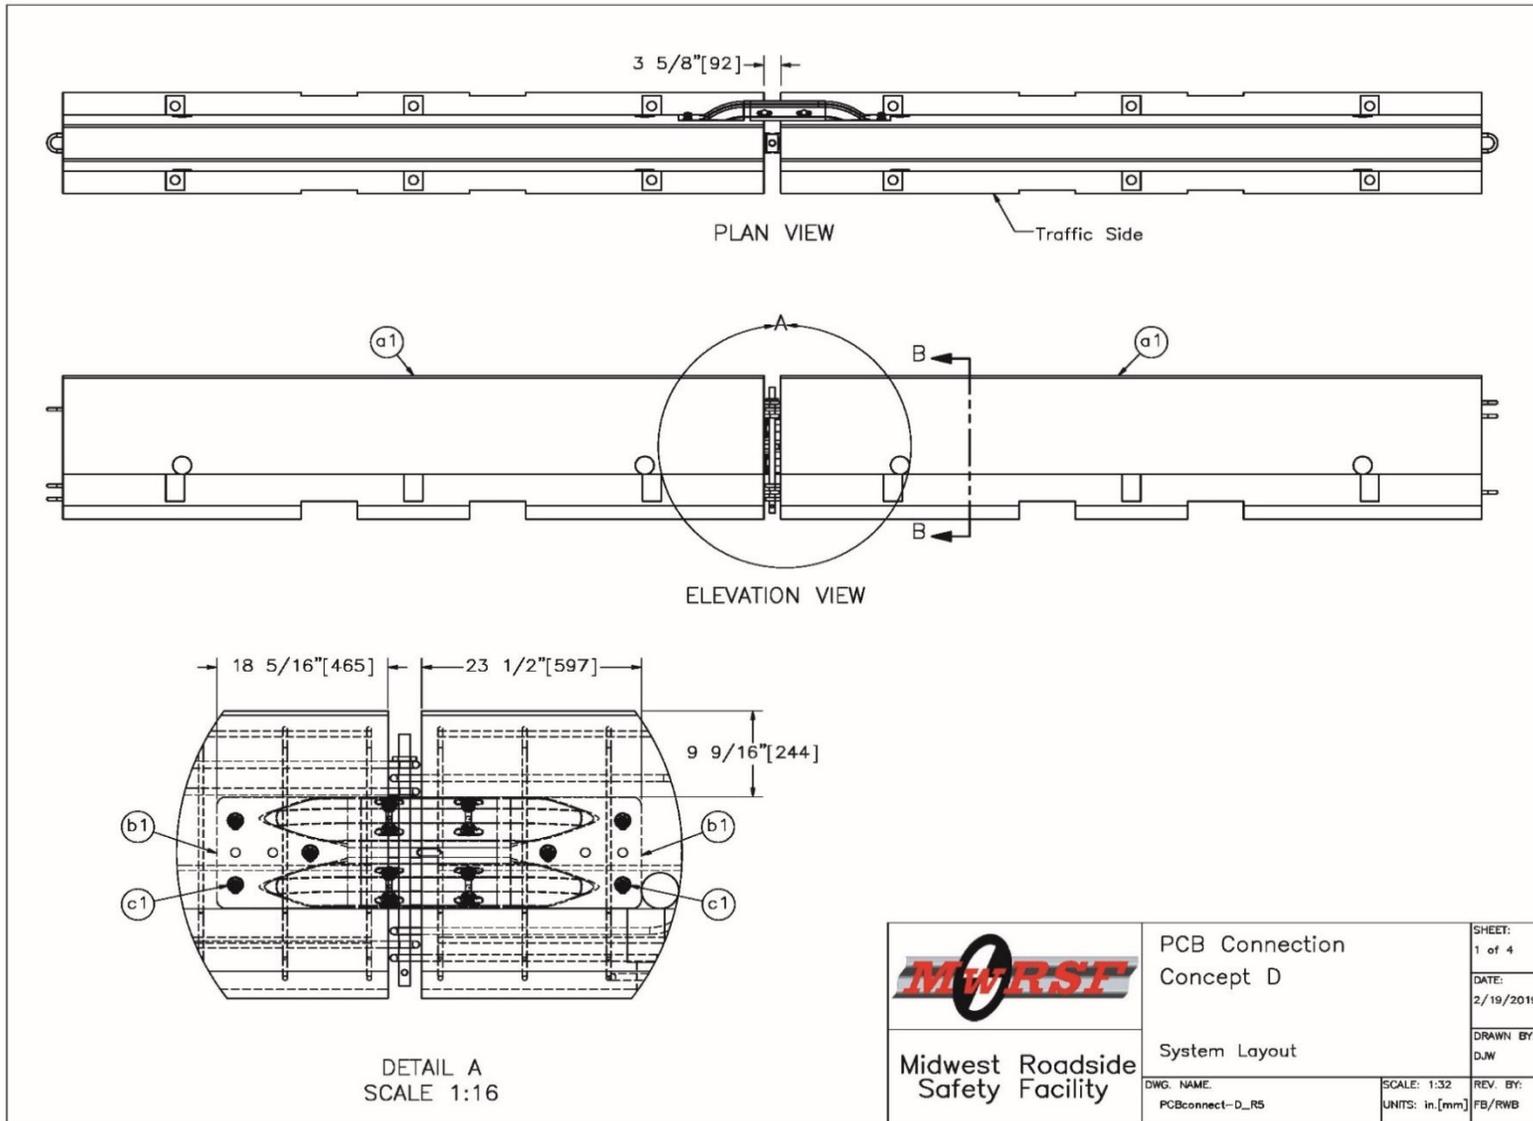
Figure 14. Design Concept D

Design Concept D consisted of two 10-gauge W-beam terminal connectors that spanned across the joint between adjacent barrier segments, as shown in Figures 14 through 16. The 30-in. long W-beam terminal connectors were mounted on the non-traffic side face of the barrier segment, aligned vertically with the lower edge of the W-beam at the inflection point of the upper two sloped faces of the F-shape barrier, and centered longitudinally across the barrier joint. The W-beam terminal connectors were spliced together with standard splice bolts and anchored to the barrier segments with three $\frac{3}{4}$ -in. diameter wedge bolt mechanical anchors. Design Concept D was intended to provide shear transfer across the barrier segment joint and restrain relative lateral displacement of the barrier segments. Ideally, the W-beam would have been mounted higher on the face of the barriers for more effective restraint of the upper section of the barrier segments, but the placement of the mechanical anchors interfered with the reinforcing steel. The concept only required hardware mounted on the non-traffic side of the barrier segments and used standard guardrail components. The concept was not symmetric with respect to the front and back sides of the barrier, which could increase the potential for the retrofit to be installed in an improper orientation. Another drawback of this installation was the need for additional steel components and anchorage hardware at every joint in the PCB system.

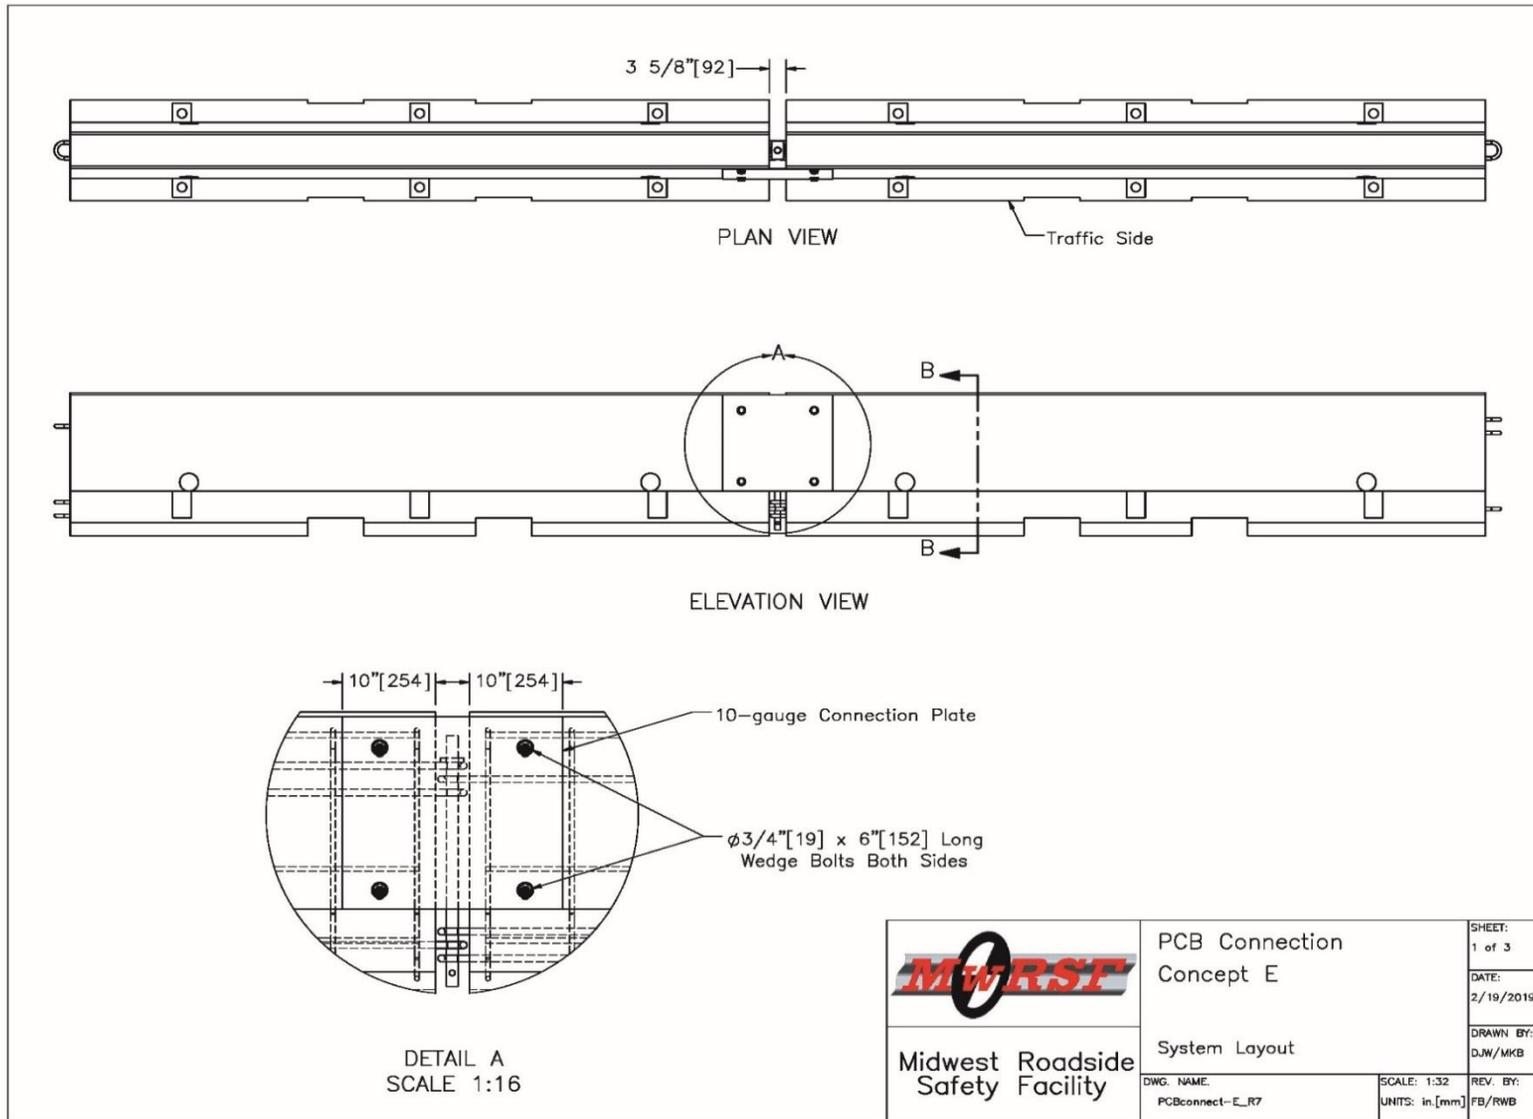
Figure 17. Design Concept E

Design Concept E consisted of a steel shear plate that spanned across the joint between adjacent barrier segments, as shown in Figures 17 through 19. The 23⁵/₈-in. long x 21⁵/₈-in. wide, 10-gauge steel plate was mounted on the traffic side face of the barrier segment, spanned the entire height of the upper sloped face of the barrier segments, and was centered longitudinally across the barrier joint. The shear plate was anchored to the barrier segments with four ¾-in. diameter wedge bolt mechanical anchors. Design Concept E was intended to provide shear transfer across the barrier segment joint and restrain relative lateral displacement of the barrier segments. Additionally, the plate would provide some degree of physical shielding and wheel snag mitigation for the upper portion of the barrier joint. The concept only required hardware mounted on the traffic side of the barrier segments and four anchors. The concept was not symmetric with respect to the front and back sides of the barrier, which could increase the potential for the retrofit to be installed in an improper orientation. Another drawback of this installation was the need for additional steel components and anchorage hardware at every joint in the PCB system.

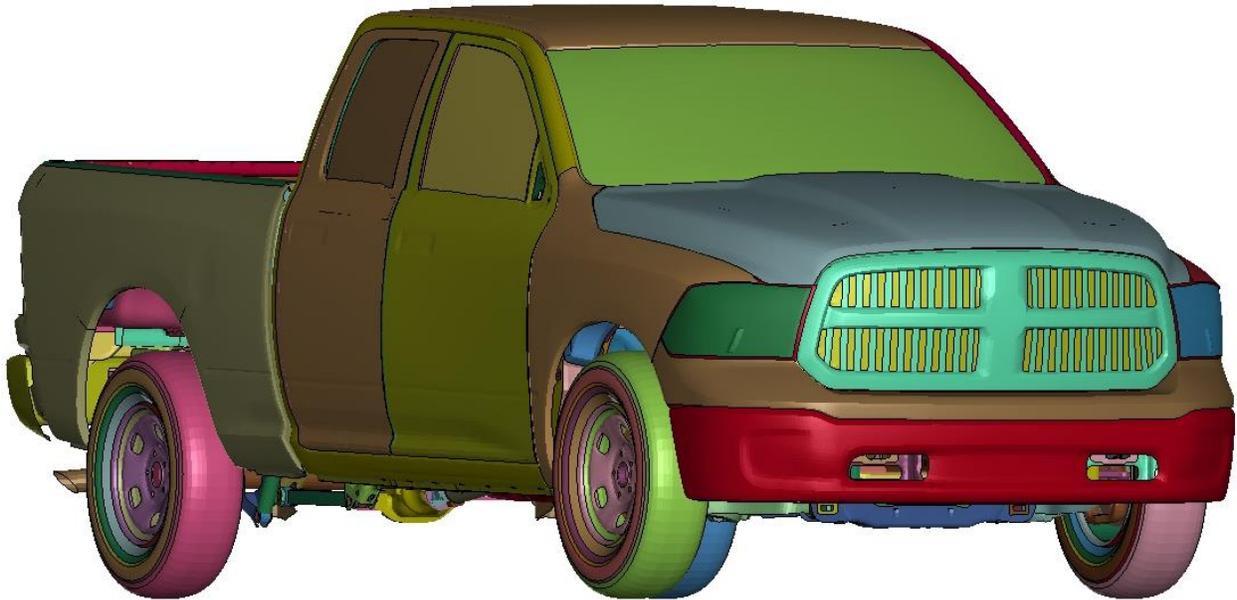
Figure 25. 2270P Pickup Truck Model

The 2270P pickup truck model was a 2018 Dodge Ram originally developed by the Center for Collision Safety and Analysis Team at George Mason University [13] and modified by MwRSF personnel for use in roadside safety applications. An image of the Dodge Ram model is shown in Figure 25.

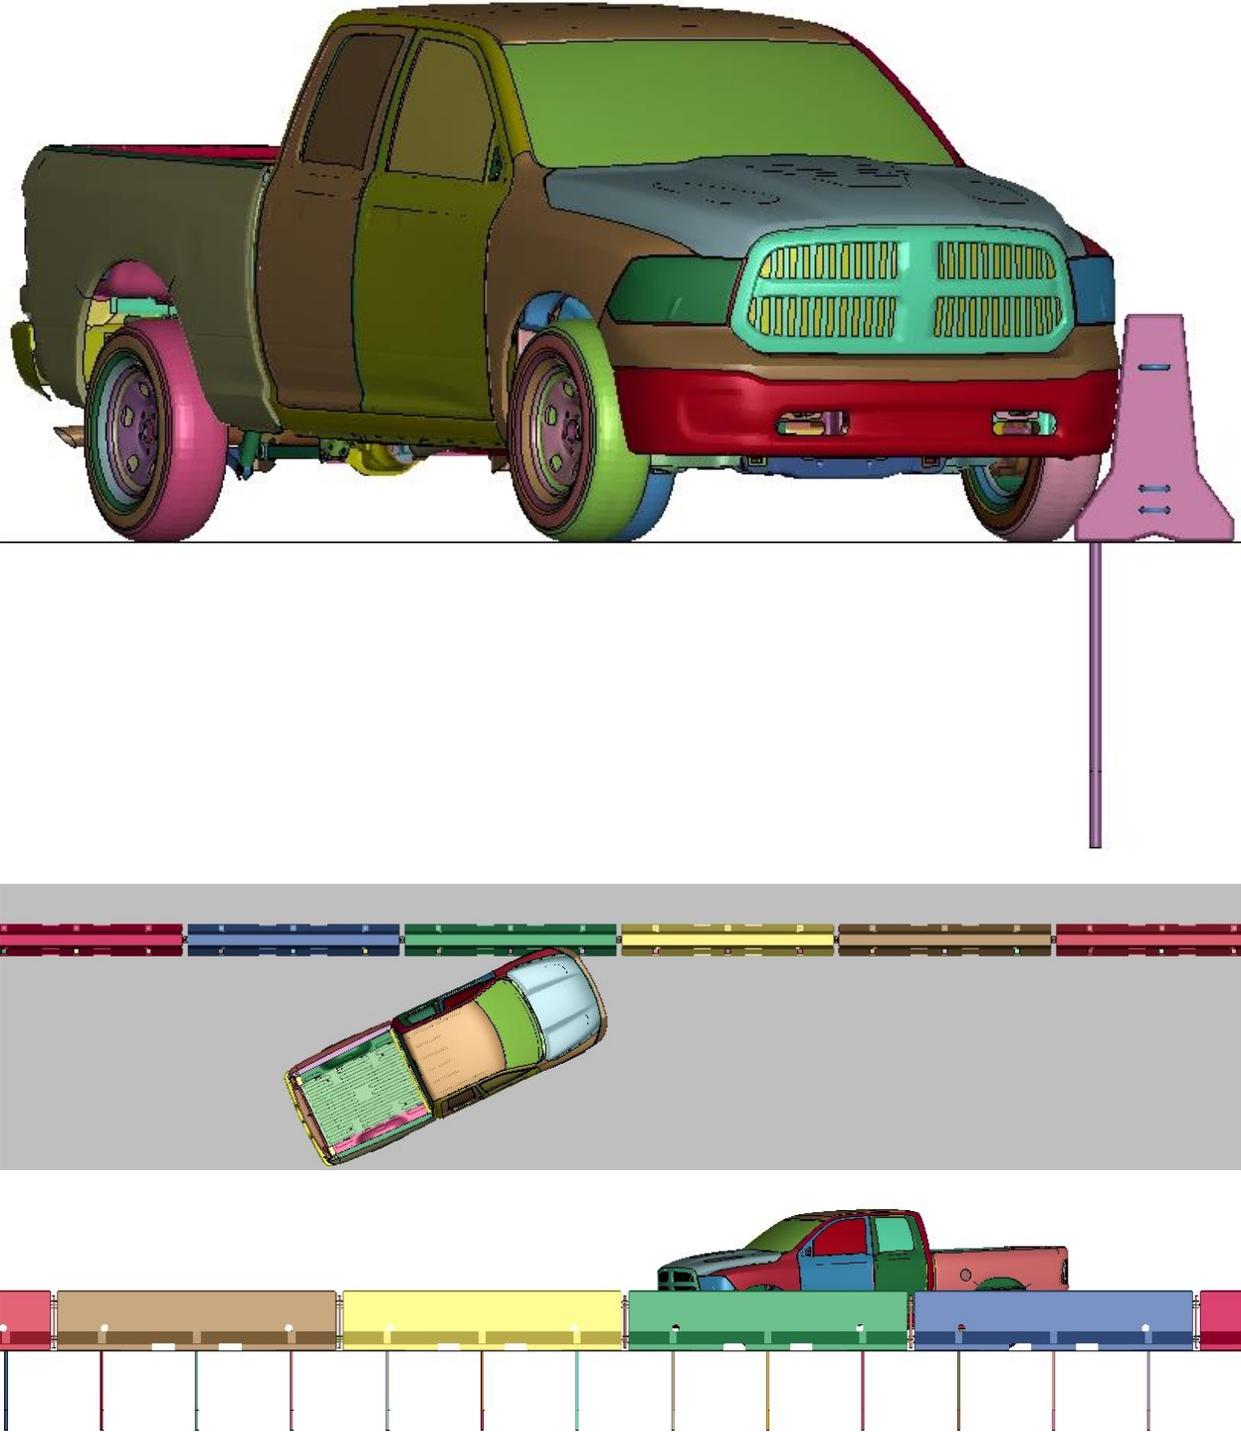
Figure 26. Baseline Model

The baseline model was simulated with a 2270P pickup truck impacting the system at a speed of 62 mph and an angle of 25 degrees at a location 4.3 ft upstream from the joint center between barrier nos. 8 and 9, as shown in Figure 26. The system consisted of 16 F-shape PCBs with asphalt pins installed in all three traffic-side bolt pockets in each PCB, for a total of 48 asphalt pins. The barriers were positioned with a 4-in. joint spacing, leaving no gap between the connection loops and connection pins, as would be the appropriate joint spacing if the barriers were pulled taut.

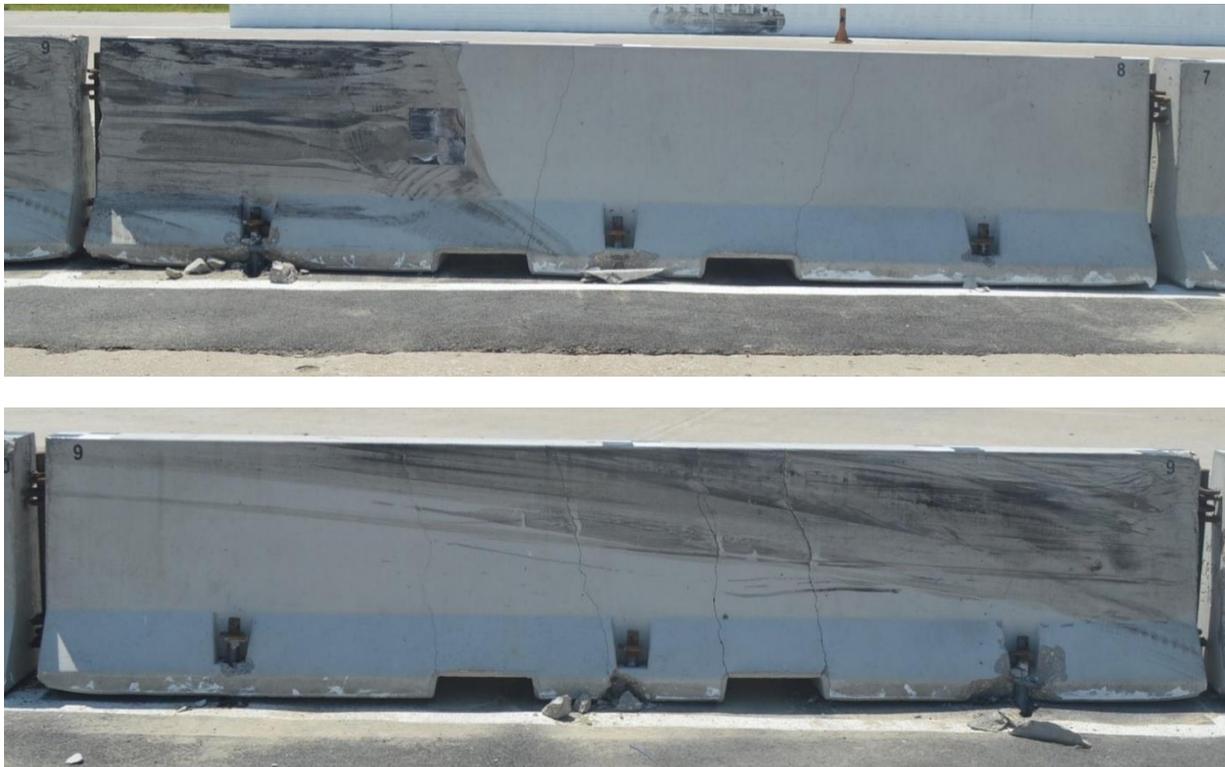
Figure 27. Barrier Nos. 8 and 9 Damage, Test No. WITD-3

The dynamic deflection and relative lateral barrier displacement discrepancies between the model and test no. WITD-3 could have potentially been caused by two factors: the barriers being modeled as rigid and the 4-in. joint spacing. Barrier nos. 8 and 9 both experienced fractures and toe break out at the anchor pins during test no. WITD-3, likely increasing the dynamic deflections, as shown in Figure 27. A non-rigid barrier model with damage would have likely produced more accurate deflections, however, the project scope did not account for creation of such a model. The 4-in. joint spacing may have also contributed to the deflection discrepancy. To reiterate, the 4-in. joint spacing only occurs when the barriers are pulled taut after the connection pin is installed between two adjacent barriers, which was performed prior to test no. WITD-3. However, given allowable barrier tolerances, joint spacing is often less than 4 in. Loop bar tolerances can cause certain loops to be pulled taut while others may have some gaps. To illustrate barrier tolerances, in test no. WITD-3 there is a visible gap between the connection loop of barrier no. 6 and the connection pin, although the barriers were pulled taut, as shown in Figure 28. As such, the joint spacing of the baseline model was decreased from 4 in. to 3.5 in.

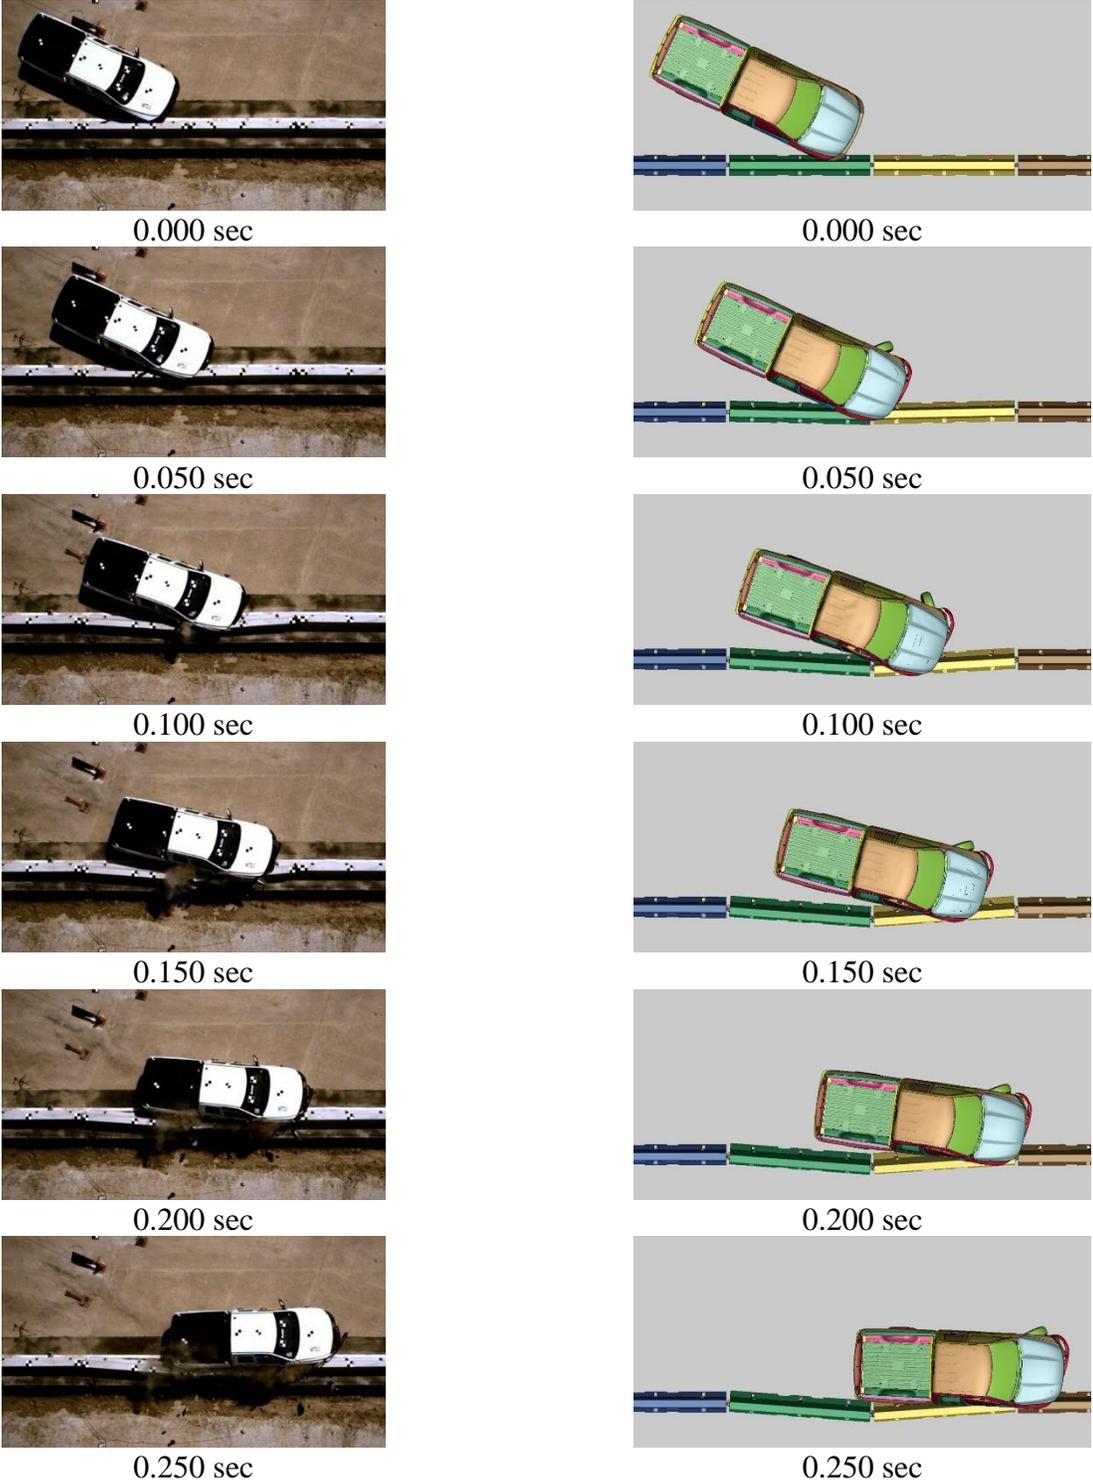
Figure 29. Overhead Sequential Photographs, Test No. WITD-3 (left) and Baseline Model (right)

The RSVVP analysis showed that the model with 3.5-in. joint spacing was sufficient in predicting test no. WITD-3 lateral vehicle velocity, but not longitudinal velocity, as shown in Appendix B. Visual comparisons of the baseline model and test no. WITD-3, as shown in Figures 29 and 30, showed that the behavior of the vehicle and the barrier were similar between the full-scale test and the baseline simulation. The dynamic deflection of the model with 3.5-in. joint spacing was 16.3 in. as compared to 10.6 in. and 16.3 in. in the original baseline model and test no. WITD-3, respectively. Further, the relative lateral barrier displacement of the model with 3.5-in. joint spacing was 1.31 in. as compared to 0.36 in. and 3.28 in. in the original baseline model and test no. WITD-3, respectively. The baseline model with 3.5-in. joint spacing captured the wheel snag, as shown in Figure 31. For illustration purposes, the impacted barrier was hidden to highlight the severity of the wheel snag. Note the amount of overlap between the wheel and barrier, and the wheel's rotation as it traverses the joint.
