MODIFICATION AND EVALUATION OF THE ASPHALT PIN TIE-DOWN FOR F-SHAPE PCB: TEST NO. WITD-4

MwRSF Research Report No. TRP-03-488-24

December 17, 2024

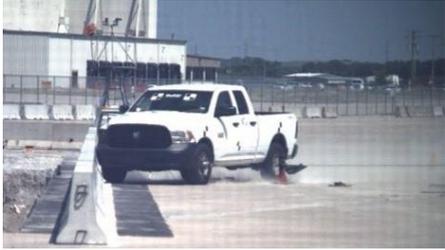
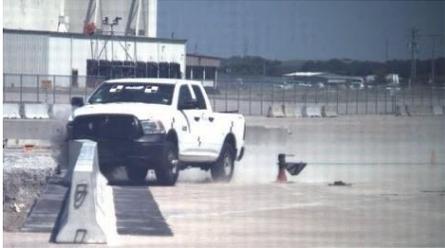
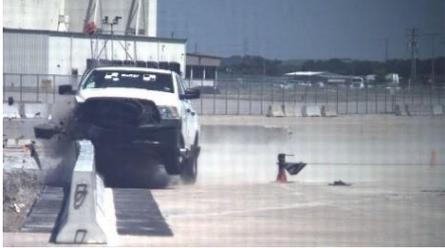
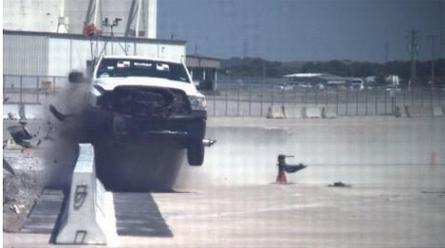
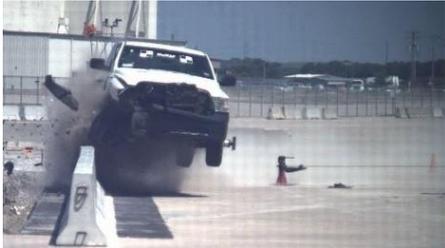
Figure 29. Overhead Sequential Photographs, Test No. WITD-3 (left) and Baseline Model (right)

The RSVVP analysis showed that the model with 3.5-in. joint spacing was sufficient in predicting test no. WITD-3 lateral vehicle velocity, but not longitudinal velocity, as shown in Appendix B. Visual comparisons of the baseline model and test no. WITD-3, as shown in Figures 29 and 30, showed that the behavior of the vehicle and the barrier were similar between the full-scale test and the baseline simulation. The dynamic deflection of the model with 3.5-in. joint spacing was 16.3 in. as compared to 10.6 in. and 16.3 in. in the original baseline model and test no. WITD-3, respectively. Further, the relative lateral barrier displacement of the model with 3.5-in. joint spacing was 1.31 in. as compared to 0.36 in. and 3.28 in. in the original baseline model and test no. WITD-3, respectively. The baseline model with 3.5-in. joint spacing captured the wheel snag, as shown in Figure 31. For illustration purposes, the impacted barrier was hidden to highlight the severity of the wheel snag. Note the amount of overlap between the wheel and barrier, and the wheel's rotation as it traverses the joint.

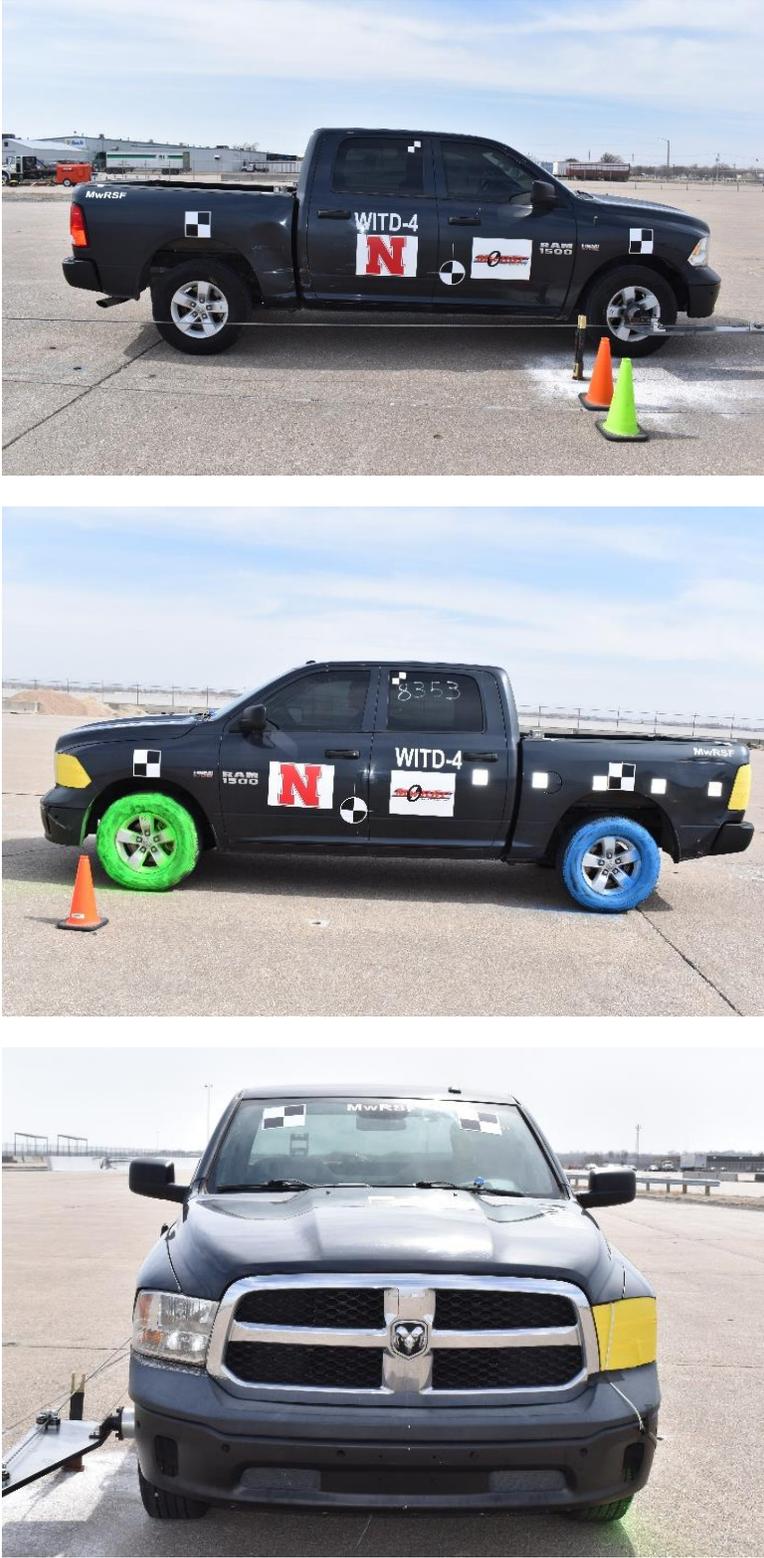
Figure 40. Test Vehicle, Test No. WITD-4

For test no. WITD-4, a 2017 Dodge Ram 1500 crew cab pickup truck was used as the test vehicle. The curb, test inertial, and gross static vehicle weights were 5,242 lb, 5,019 lb, and 5,183 lb, respectively. The test vehicle is shown in Figure 40, and photos of the pre-test floorboards and undercarriage are shown in Figure 41. Vehicle dimensions are shown in Figure 42.

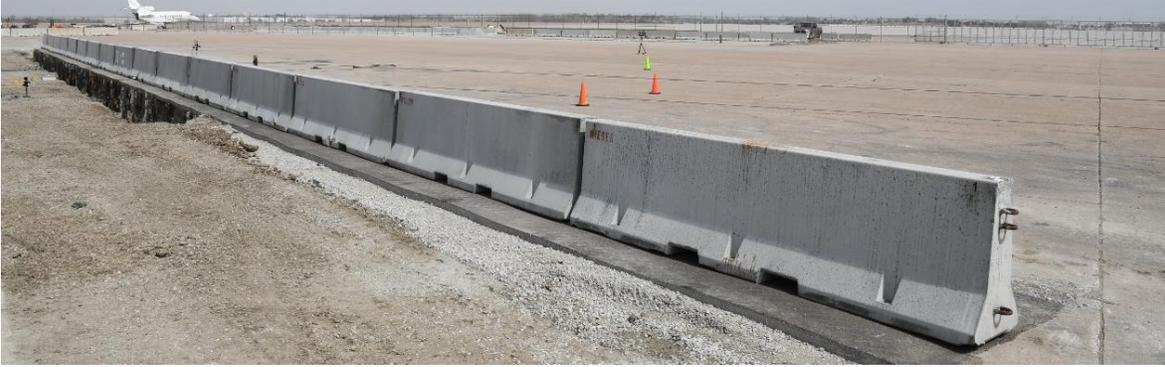
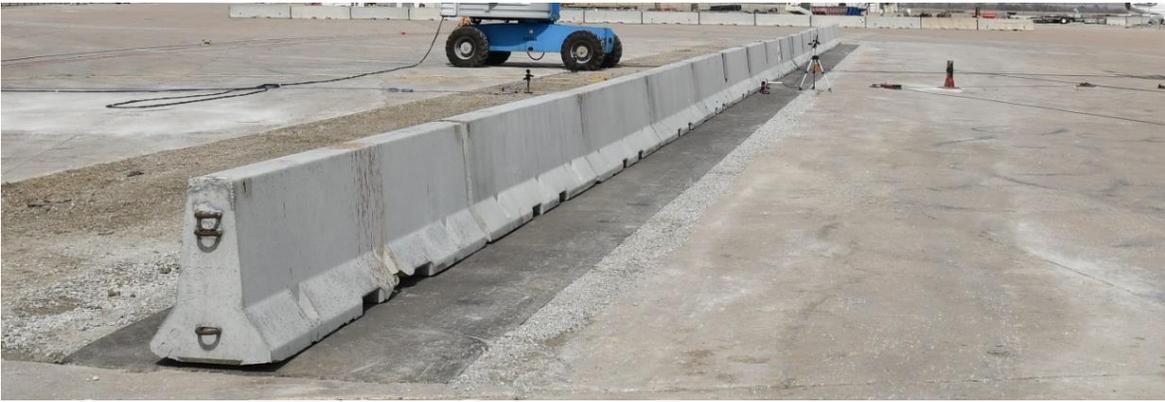
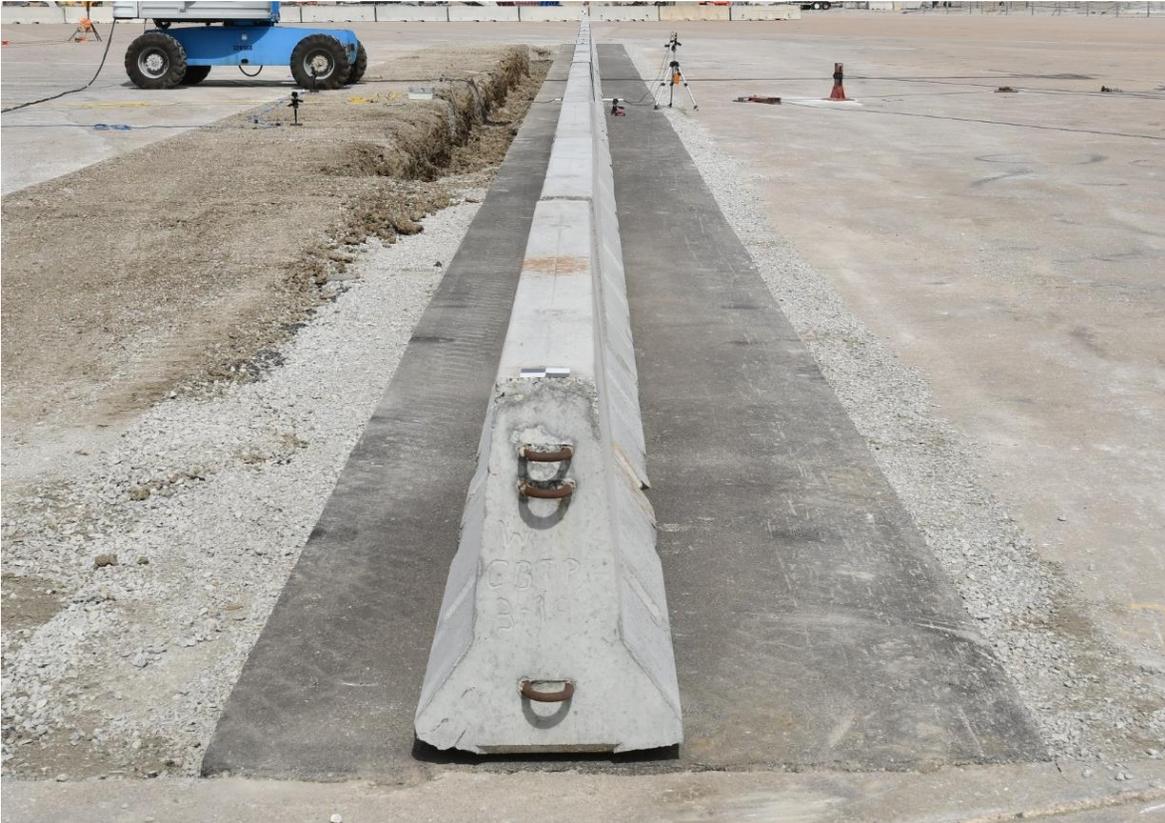
Figure 60. Test Installation Photographs, Test No. WITD-4

The test installation consisted of sixteen 12-ft 6-in. long F-shape PCBs with a steel pin tie-down anchorage system for use with asphalt surfaces, as shown in Figures 45 through 59. The system was installed with the rear toe of the PCBs placed 18 in. away from the edge of both a 2-in. thick asphalt pad and a 36-in. wide x 36-in. deep trench. Photographs of the test installation are shown in Figures 60 and 61. Material specifications, mill certifications, and certificates of conformity for the system materials are shown in Appendix D.

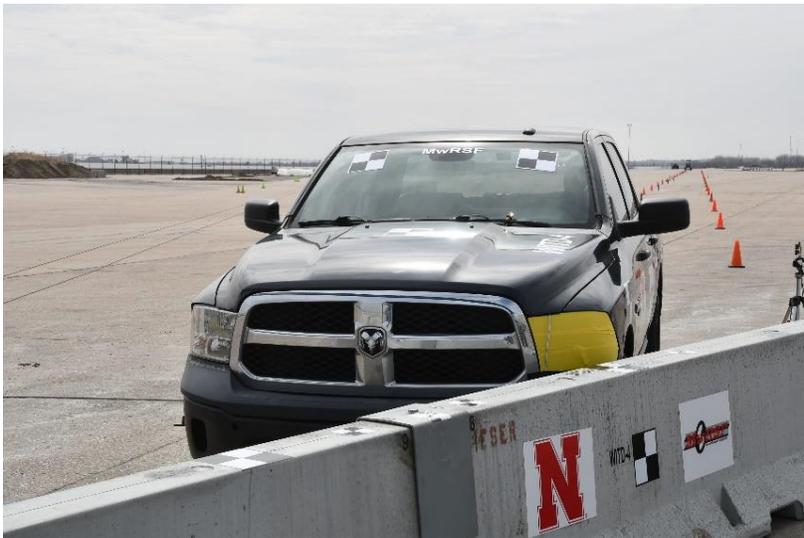
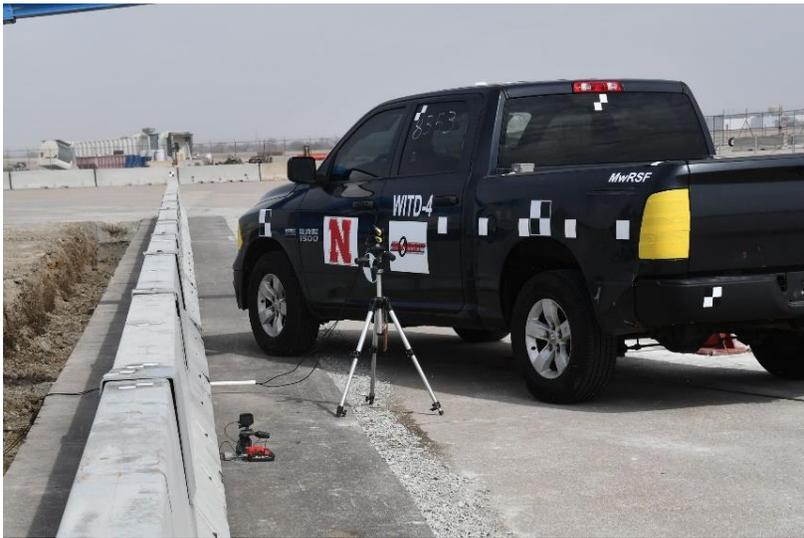
Figure 62. Impact Location, Test No. WITD-4

Initial vehicle impact was to occur 51⁵/₈ in. upstream from the centerline of the joint between barrier nos. 8 and 9, as shown in Figure 62, which was selected using Table 2.7 of MASH. The 5,019-lb crew cab pickup truck impacted the anchored PCB system at a speed of 61.9 mph and at an angle of 25.0 degrees. The actual point of impact was 1.7 in. downstream from the target impact location, as shown in Figure 62. During the test, the vehicle was captured and redirected by the anchored F-shape PCB system. As the vehicle was redirected, the lower leading edge of the left-front door snagged on the saddle cap and was displaced rearward and outward. There was little deformation to the saddle cap. After brakes were applied, the vehicle came to rest 200.7 ft downstream from the impact point and 27.2 ft laterally in front of the traffic side of the barrier.

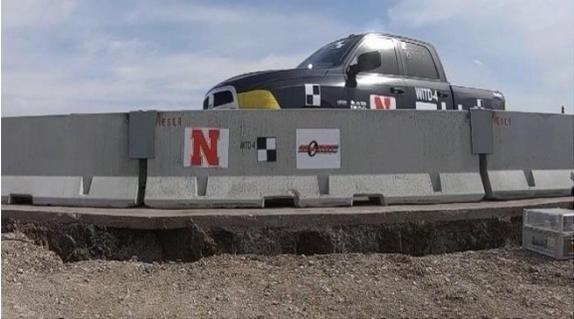
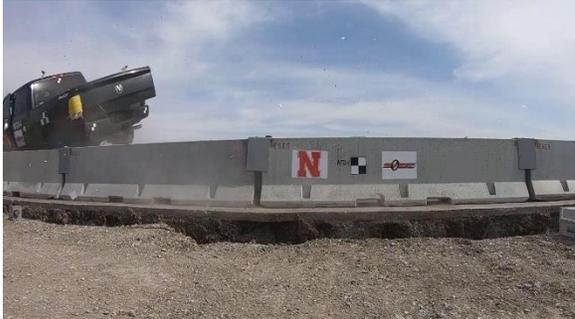
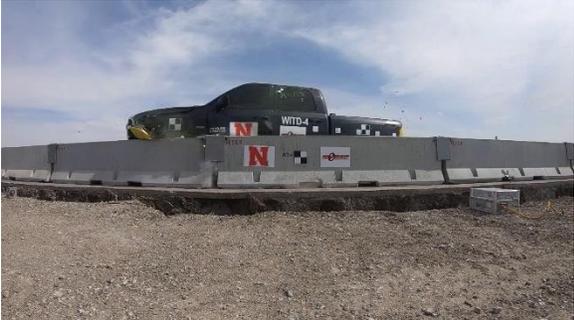
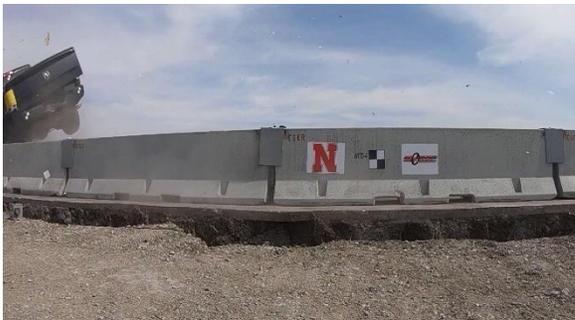
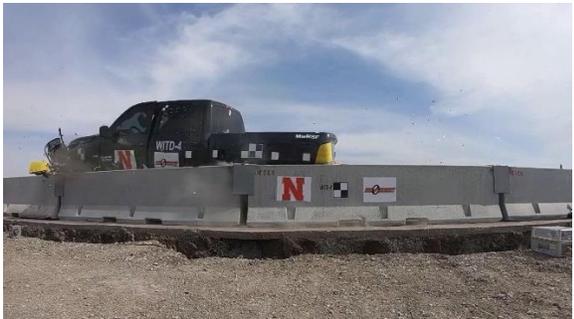
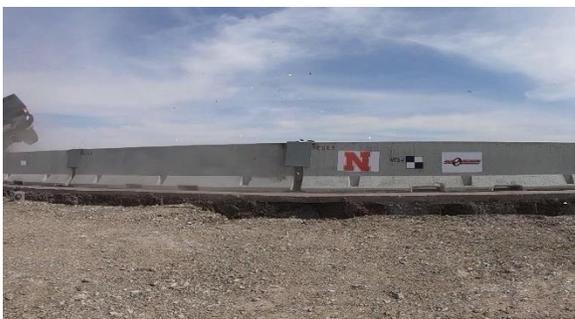
Figure 65. Documentary Photographs, Test No. WITD-4

A detailed description of the sequential impact events is contained in Table 6. Sequential photographs are shown in Figures 63 and 64. Documentary photographs of the crash test are shown in Figures 65 and 66. The vehicle trajectory and final position are shown in Figure 67.

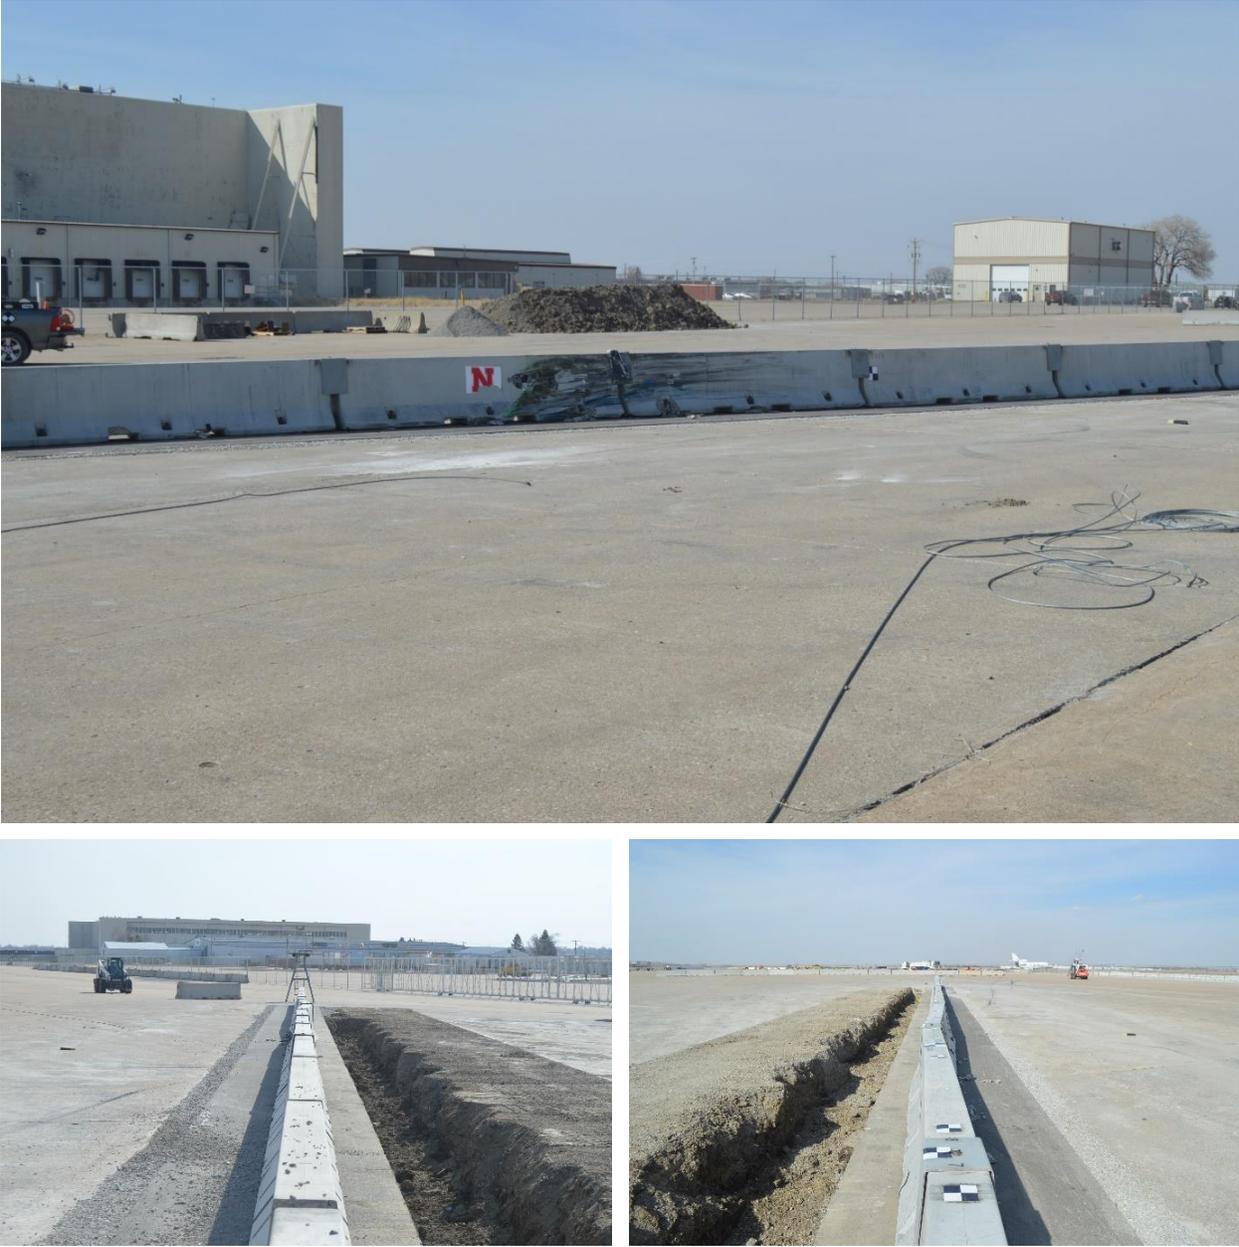
Figure 68. Overall System Damage, Test No. WITD-4

Damage to the barrier was moderate, as shown in Figures 68 through 71. Barrier damage consisted of contact marks on the front face of the concrete segments and concrete spalling, cracking, and fracture. The length of vehicle contact along the barrier was approximately 20 ft – 1¾ in., which began 7¼ in. upstream from the joint of barrier nos. 8 and 9.

Tire marks were visible on the front face of barrier nos. 8 and 9. Concrete spalling and breakout occurred on the front side at each anchor pocket of barrier no. 8, at the upstream and middle anchor pockets of barrier no. 9, and at the middle anchor pocket of barrier no. 10. Dimensions of concrete that disengaged from barrier no. 8 at the upstream, middle, and downstream anchor pockets were 11-in. long x 1½-in. wide x ½-in. deep, 24-in. long x 4-in. wide x 3-in. deep, and 20¾-in. long x ½-in. wide x ¾-in. deep, respectively. There was a vertical crack originating at the downstream drainage slot of barrier no. 8 that extended through the top of the barrier. There was cracking local to the upstream edge of the upstream drainage slot on the back side of barrier no. 8. Dimensions of concrete that disengaged from barrier no. 9 at the upstream and middle anchor pockets were 19¾-in. long x 10-in. wide x 2-in. deep, 24½-in. long x 3½-in. wide x 2½-in. deep, respectively. There was cracking at the barrier no. 9 downstream anchor pocket that measured 15¾-in. long x 6-in. wide. There was a vertical crack originating at the upstream drainage slot of barrier no. 9 that extended through the top of the barrier. Dimensions of concrete that disengaged from barrier no. 10 at the middle anchor pocket were 19½-in. long x 4-in. wide x 2½-in. deep. Slight cracking was caused at barrier no. 8 upstream, barrier no. 9 middle, and barrier no. 10 middle anchor pockets during pre-test anchor bolt installation. All anchor pins in barrier nos. 8 through 10 were displaced vertically.

There were contact marks and scrapes on the saddle cap at the joint of barrier nos. 8 and 9 and contact marks on the saddle cap at the joint of barrier nos. 9 and 10. Slight outward bulging of the saddle cap at the joint between barrier nos. 8 and 9 was observed. There was a segment of the vehicle door panel sheet metal that snagged and wrapped around the saddle cap that wedged between the saddle cap and barrier. There was a crack in the asphalt pad beginning at the downstream anchor pin of barrier no. 8 and extended laterally through the pad up to the trench. The lateral end of the asphalt pad on the front side of the barrier was heaved upwards. Soil and asphalt disengagement adjacent to the trench did not occur.

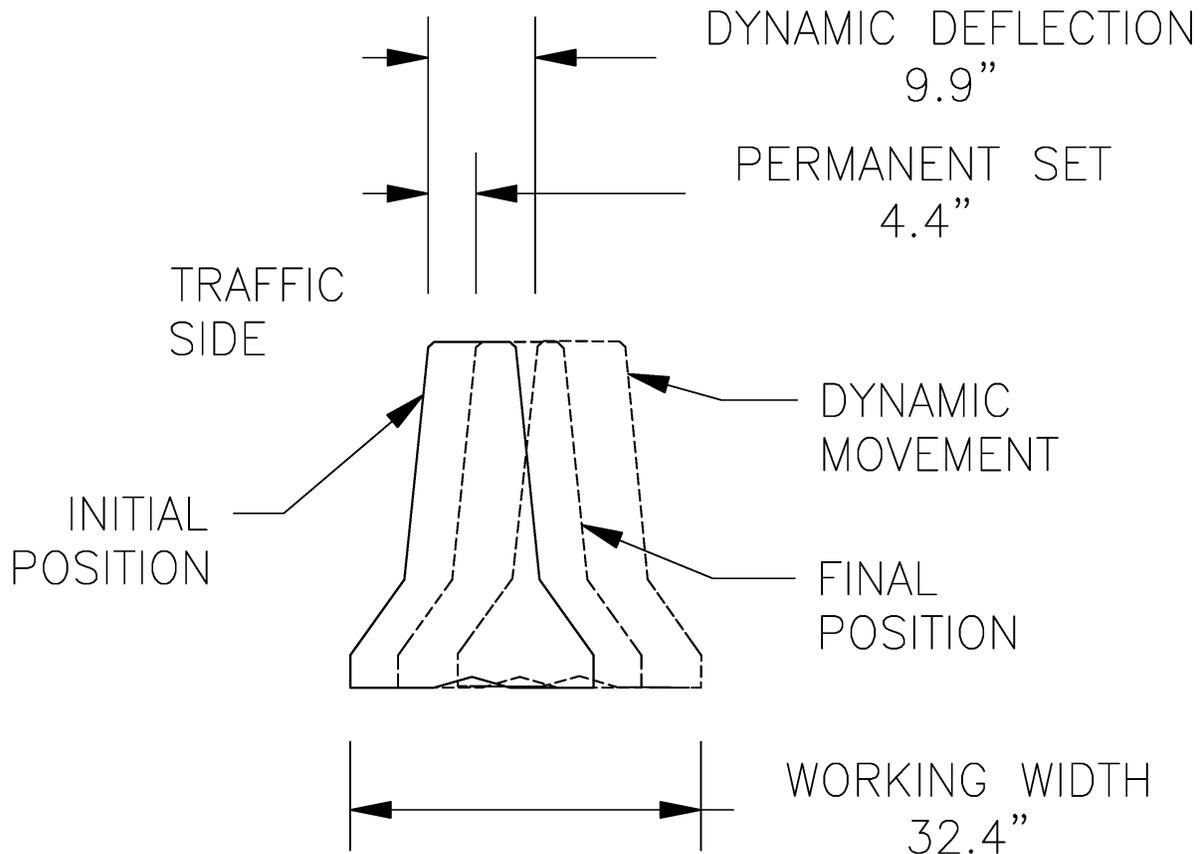
Figure 72. Permanent Set, Dynamic Deflection, and Working Width, Test No. WITD-4

The maximum lateral permanent set of the barrier system was 4.4 in. at the downstream end of barrier no. 8, as measured in the field. The maximum lateral dynamic deflection was 9.9 in. at the upstream end of barrier no. 9, as determined from high-speed digital video analysis. The working width of the system was 32.4 in., also determined from high-speed digital video analysis. A schematic of the permanent set deflection, dynamic deflection, and working width is shown in Figure 72.

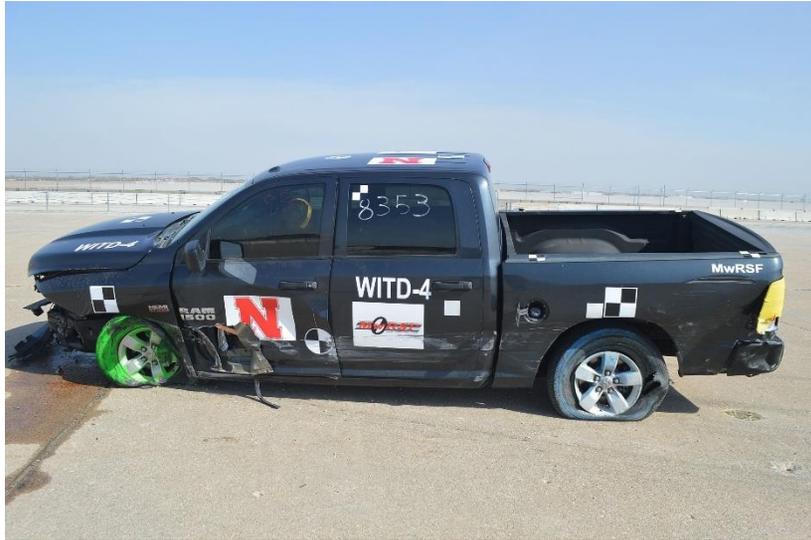
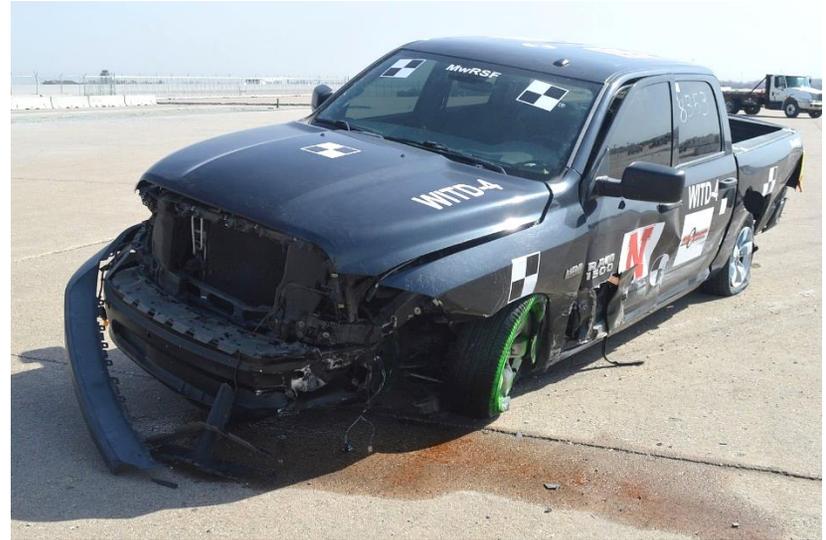
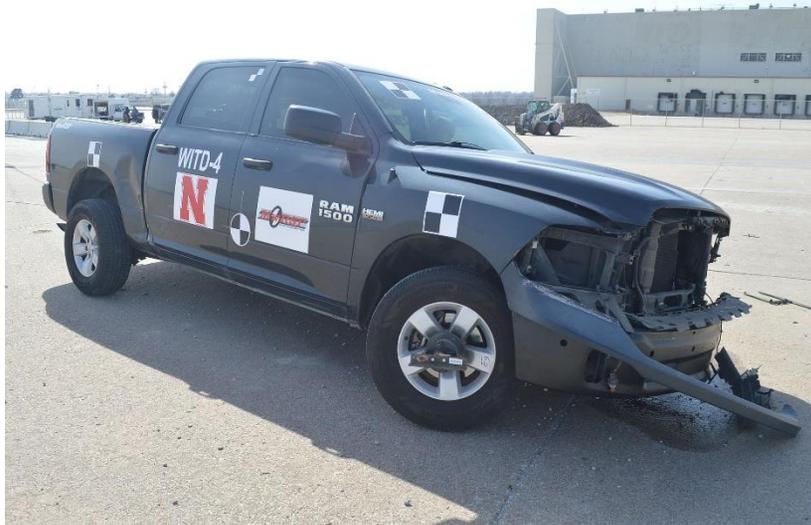
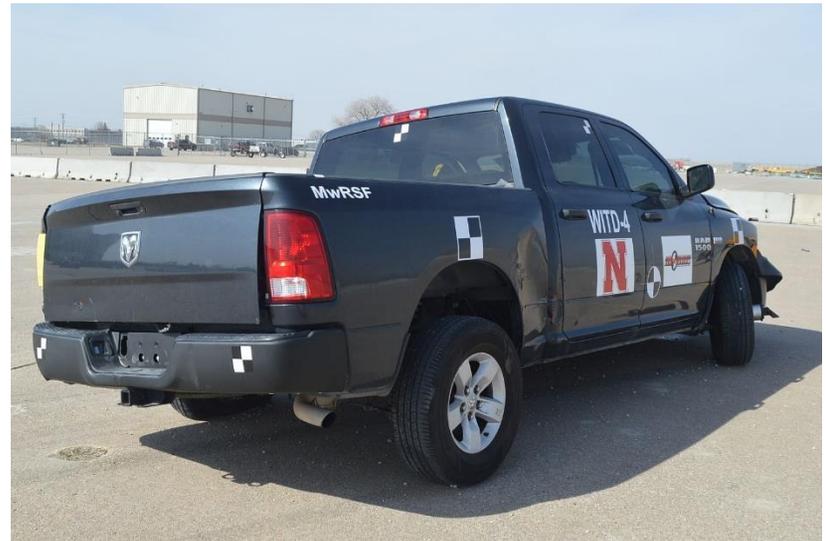
Figure 73. Vehicle Damage, Test No. WITD-4

The majority of damage was concentrated on the left side of the vehicle. The left-front corner of the vehicle was crushed inward and the left-front door was torn. The grille disengaged

and the left-front bumper was crushed and scraped. The headlights were disengaged from the vehicle. Damage to the left fender included the leading edge being crushed rearward at the headlight opening and the area behind the left tire was scraped and crushed. The left-front and left-rear tires were punctured, and the left-front wheel was deformed and scraped. The lower leading edge of the left-front outer door panel was torn rearward approximately 17 in., opening a 7-in. tall x 1½-in. wide hole at the leading edge that was peeled outward 2 in. A dent spanned from the middle to the rear of the left-front door, causing the door to wrinkle by the handle. Scrapes followed the rearward tear, and the door was shifted rearward. The left-rear door was scraped along its entire width and scrapes and dents were found on the rear of the door frame. Dents were also found behind the left-rear wheel well and at the left side of the rear bumper. The tailgate was detached.

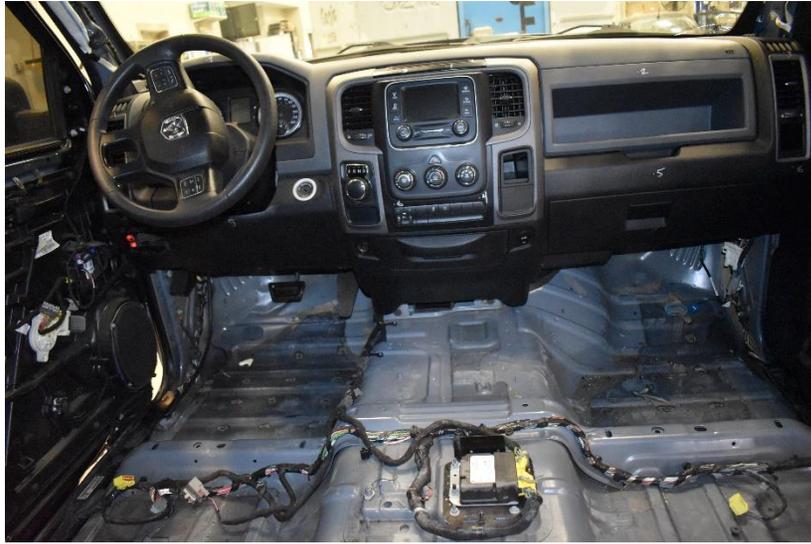
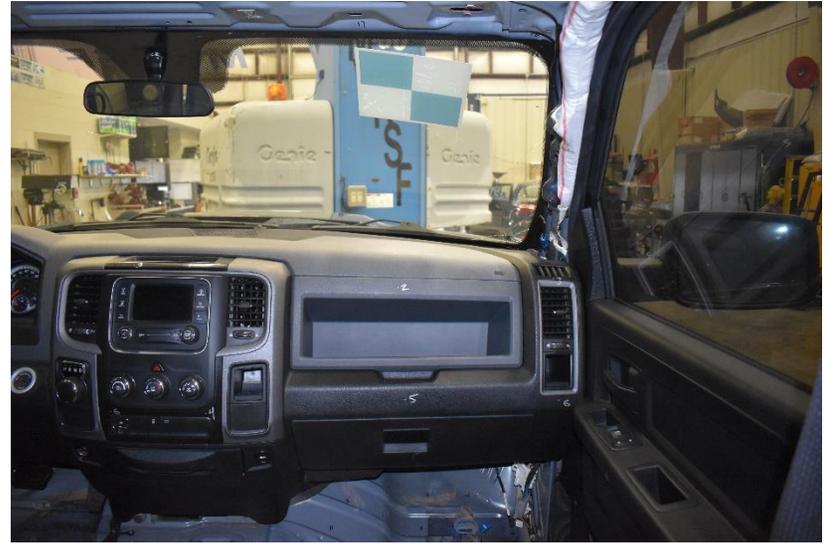
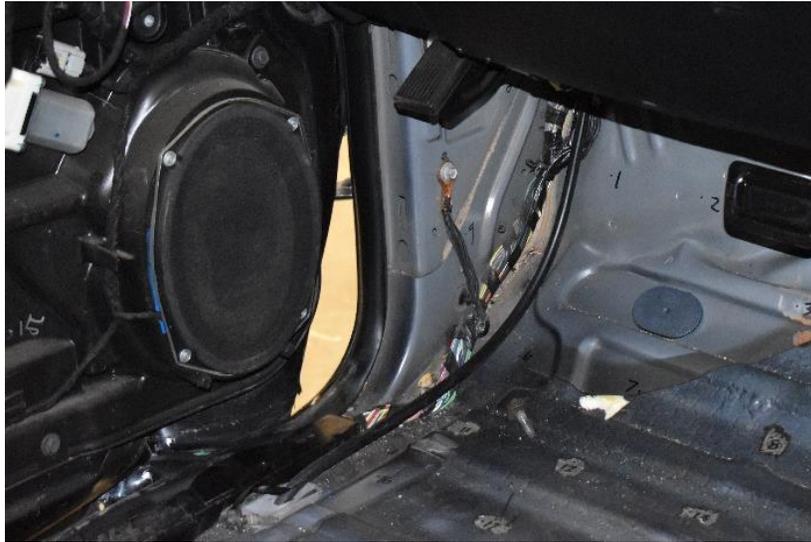
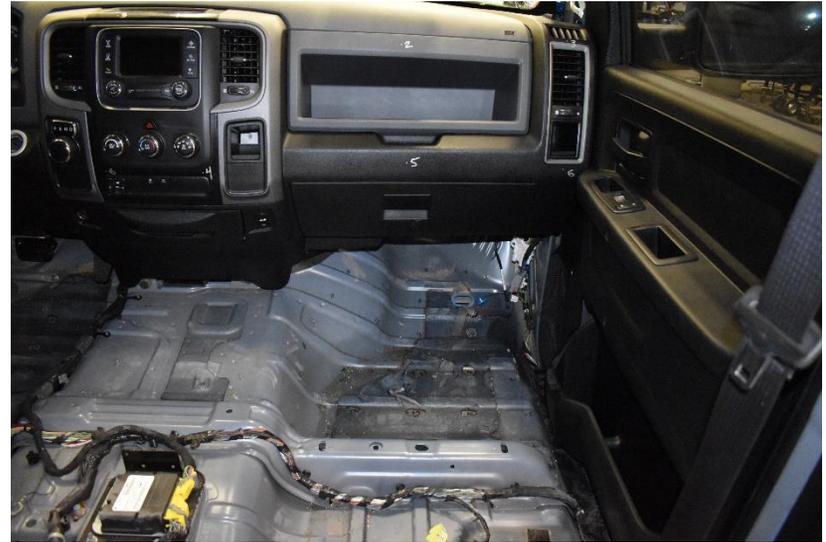
Figure 75. Vehicle Occupant Compartment Damage, Test No. WITD-4

Damage to the vehicle was moderate, as shown in Figures 73 through 76. The maximum occupant compartment intrusions are listed in Table 7 along with the intrusion limits established in MASH for various areas of the occupant compartment. Complete occupant compartment and vehicle deformations, as well as the corresponding locations are provided in Appendix E. MASH defines intrusion or deformation as the occupant compartment being deformed and reduced in size with no observed penetration. Outward deformations, which are denoted as negative numbers in Appendix E, are not considered crush toward the occupant, and are not evaluated by MASH criteria.

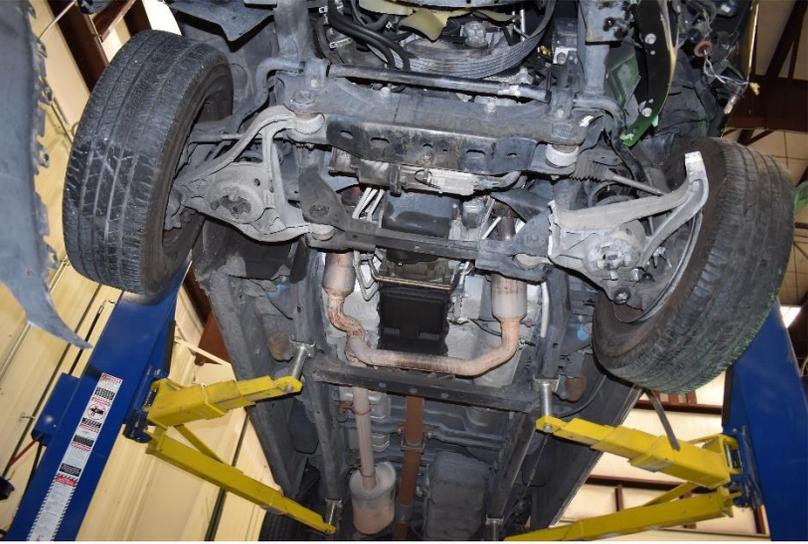
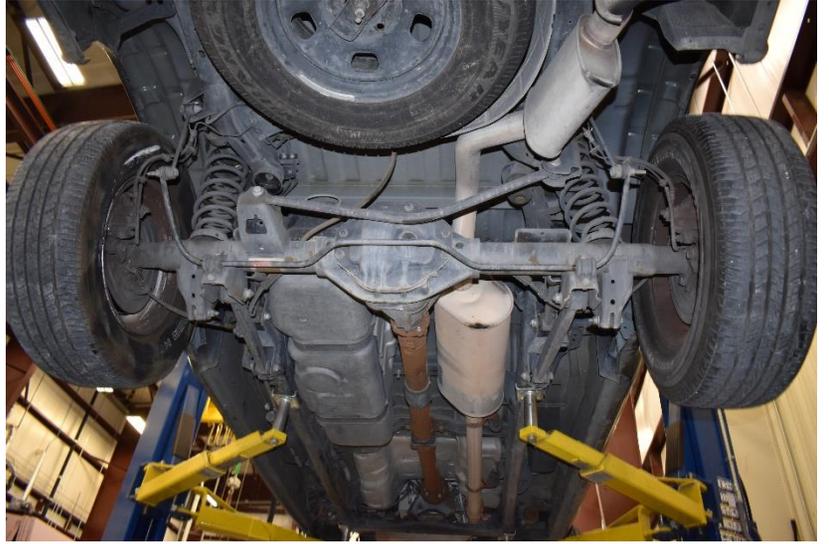
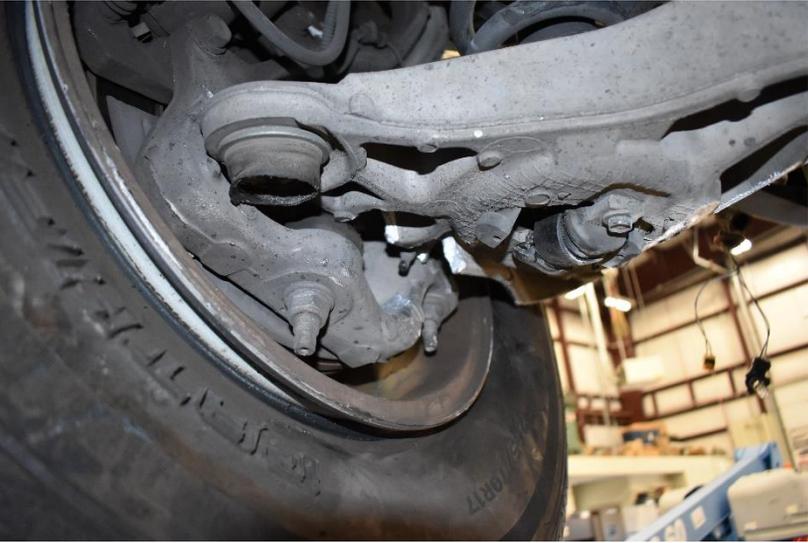
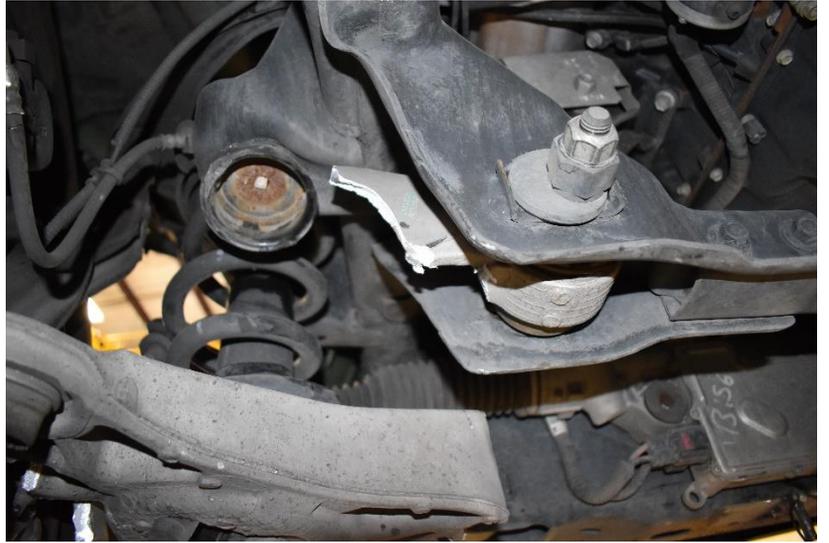
Figure 76. Vehicle Undercarriage Damage, Test No. WITD-4

Underneath the vehicle, the left-front shocks were bent backward, the bump stop was disengaged, the bump stop housing was bent rearward, the bump stop of the left-rear shocks was disengaged, and the axle was bent. The sway bars were shifted laterally, the end links of the left-front sway bars were bent rearward at both connection points, and the bottom connection disengaged from the control arm. The steering knuckle assemblies were scraped on the left side and the control arm at the ball joint was disconnected from the steering knuckle. The left-lower control arm was broken at both mounts on the cross members and at the steering knuckle, along with a small nick on the right lower control arm. The panhard bar in the rear suspension was severely bent and the tie rod on the left side was bent rearward. The rear axle of the drivetrain was bent and the overall frame of the chassis had a bow in the middle of both frame rails. The middle cross member was slightly twisted, and the frame horn on the left side was bent into the middle of the vehicle.

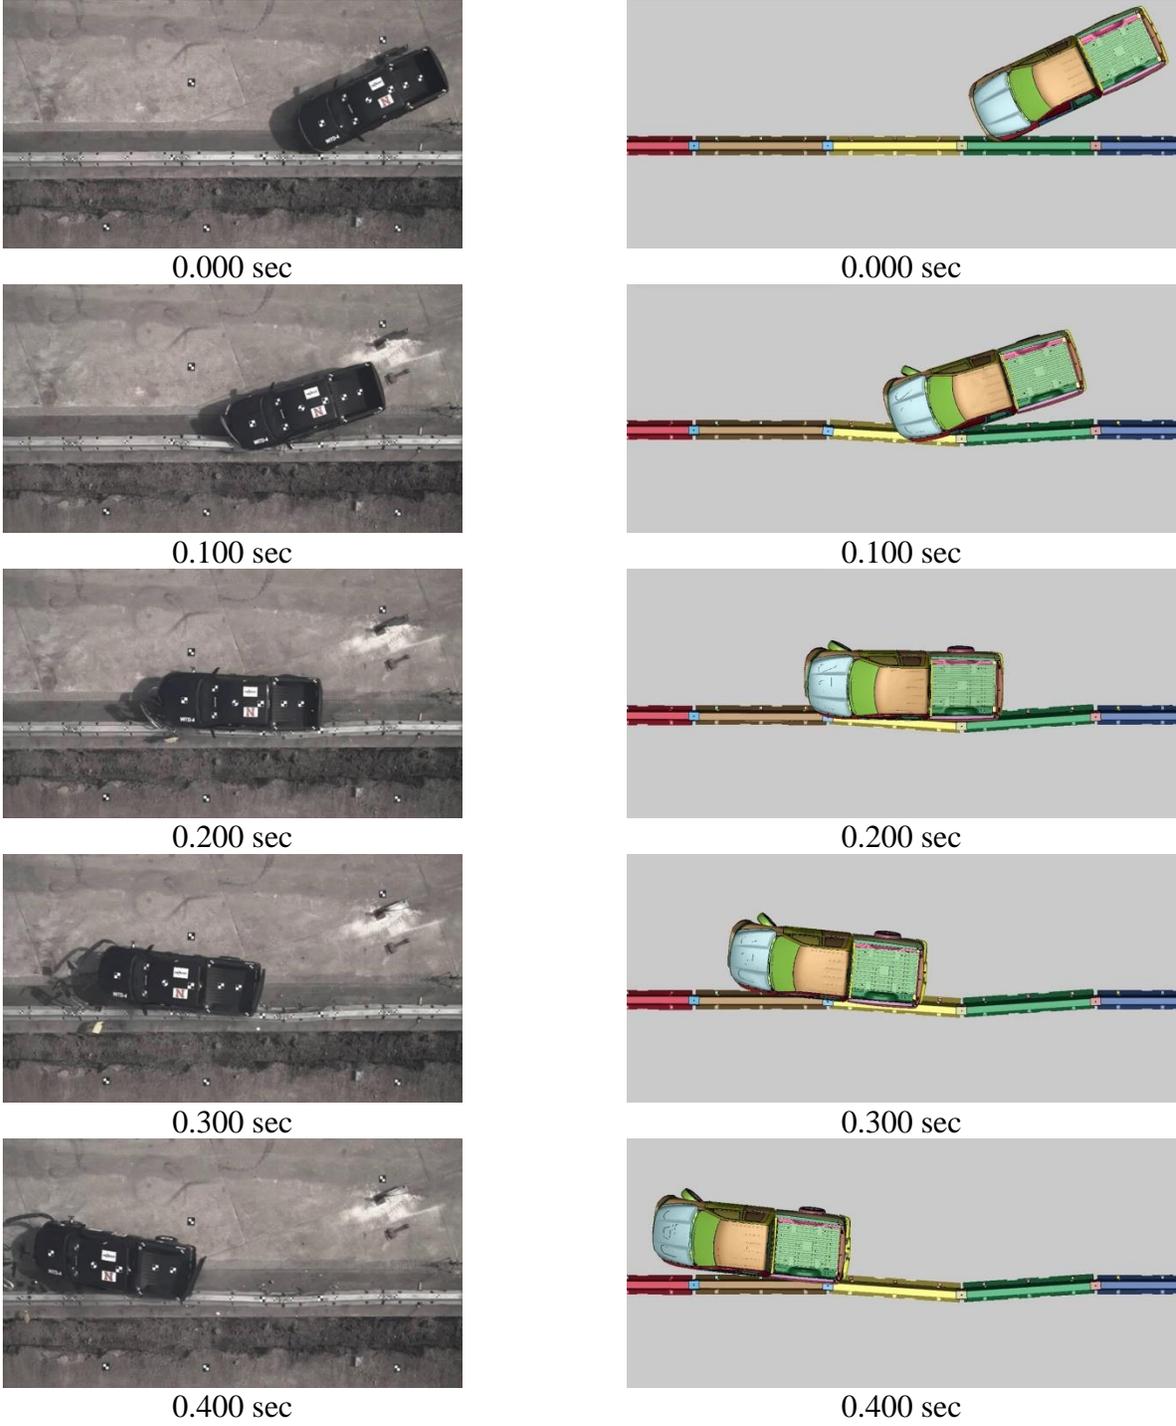
Figure 79. Overhead Sequential Photographs, Test No. WITD-4 (left) and FEA Model (right)

Visual comparisons of test no. WITD-4 and the FEA model, as shown in Figures 79 and 80, demonstrate that the behavior of the vehicle and barrier were similar between the full-scale test and the baseline simulation. A comparison of OIVs, ORAs, and dynamic deflection are in Table 10. There was good agreement between test no. WITD-4 and model OIVs and ORAs. Although the baseline model accurately predicted test no. WITD-3 dynamic deflection, the model with the saddle cap underpredicted test no. WITD-4 dynamic deflection by 3 in. Moreover, the final saddle cap model did not predict door snag on the saddle cap and underestimated the relative lateral barrier displacement by approximately 0.3 in. Exclusion of concrete damage from the model potentially contributed to the underprediction of model dynamic deflection and door snag.

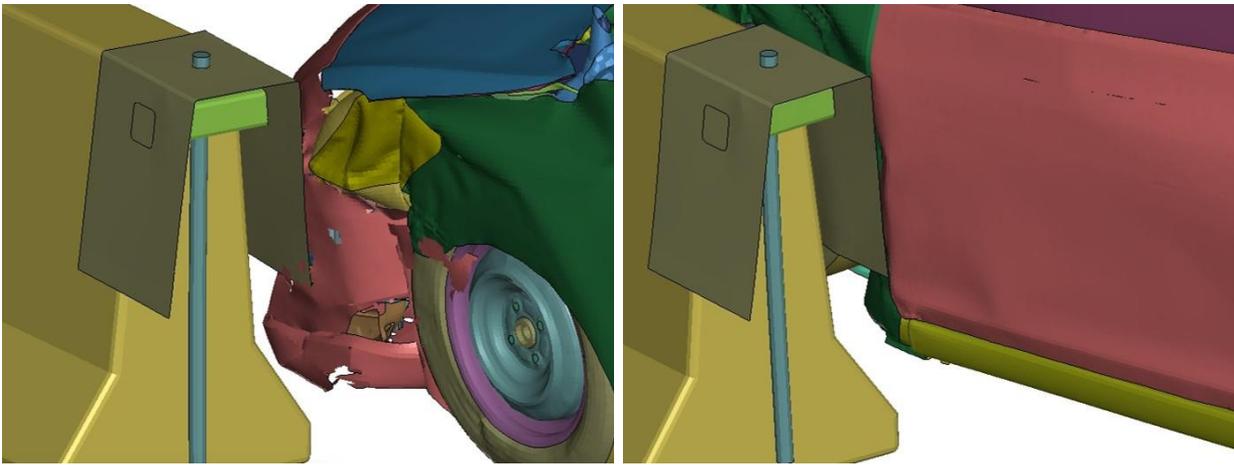
Figure 81. 1100C Vehicle Gouge (left) and Door-Saddle Cap Interaction (right)

Since the final saddle cap model with the 2270P vehicle failed to predict door snag on the saddle cap, an additional model with the 1100C vehicle model was simulated for further evaluation of the system, shown in Figure 81. Occupant risk measures were acceptable, and the wheel did not snag at the joint, however, the saddle cap gouged the bumper. Although the 1100C vehicle door did not snag on the saddle cap, the model displayed more potential for door snag than the 2270P vehicle model. Given the door snag in test no. WITD-4 and the potential snag displayed in the 1100C vehicle model, a small car test on the system developed herein is recommended.

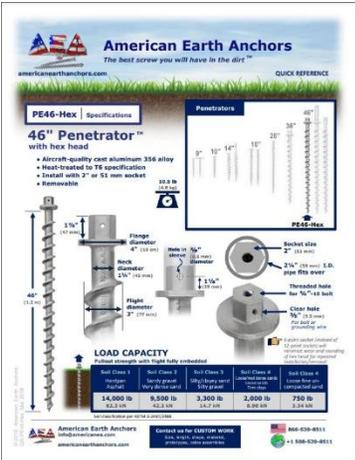
Figure A-2. Soil/Earth Anchors

Concept description: use soil/earth anchors with or without pre-drilled holes to increase vertical resistance.
