EVALUATION OF FLARED APPROACH GUARDRAIL TRANSITIONS: TEST NO. FLAGT-1

MIDWEST ROADSIDE SAFETY FACILITY

MwRSF Research Report No. TRP-03-439b-25

May 16, 2025

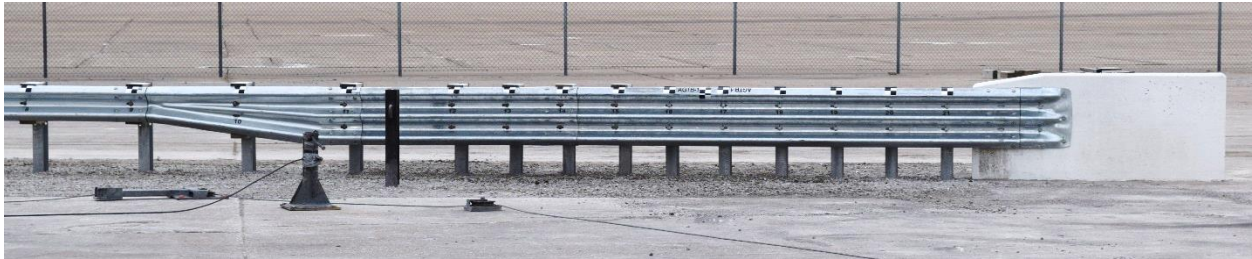
Figure 1. AGT Installation [1]

Approach guardrail transitions (AGTs) are commonly used to safeguard rigid hazards, including bridge railings and concrete parapets. A typical AGT is shown in Figure 1 [1]. AGT installations provide a gradual transition in lateral stiffness between semi-rigid guardrail and rigid bridge rail in order to prevent vehicle snag and pocketing within the barrier. Often, intersecting roadways or other roadside obstacles create space constraints that limit the ability to install an AGT within the desired area. Thus, a need exists to minimize the length of AGTs tangent to the roadway.

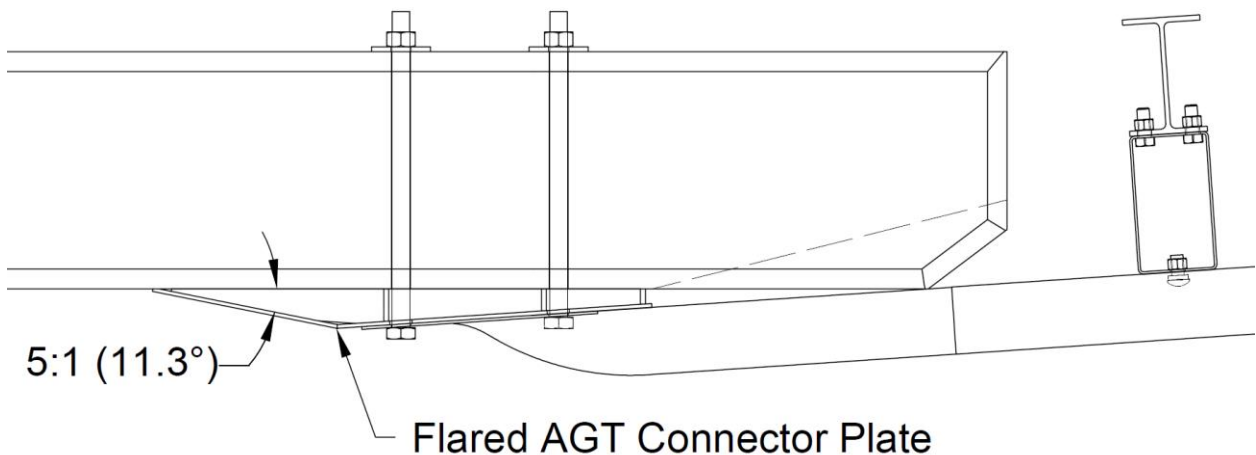
Figure 5. Option 3 – Angled Connector Plate Assembly, Enlarged

Use of an angled connector plate assembly would enable the use of standard AGT components (i.e., the standardized transition buttress and unbent thrie beam segments). However, the connector plate assembly would be an additional required component and the plate would extend 2 in. from the face of the buttress into the traveled way, which could result in a snag hazard in the reverse direction. To mitigate the snag hazard, the downstream end of the connector plate would transition back to the traffic-side face of the standardized concrete buttress with a 5:1 taper. Steel connection plates with a 5:1 taper/slope have demonstrated acceptable safety performance in previous MASH TL-3 crash testing [9].

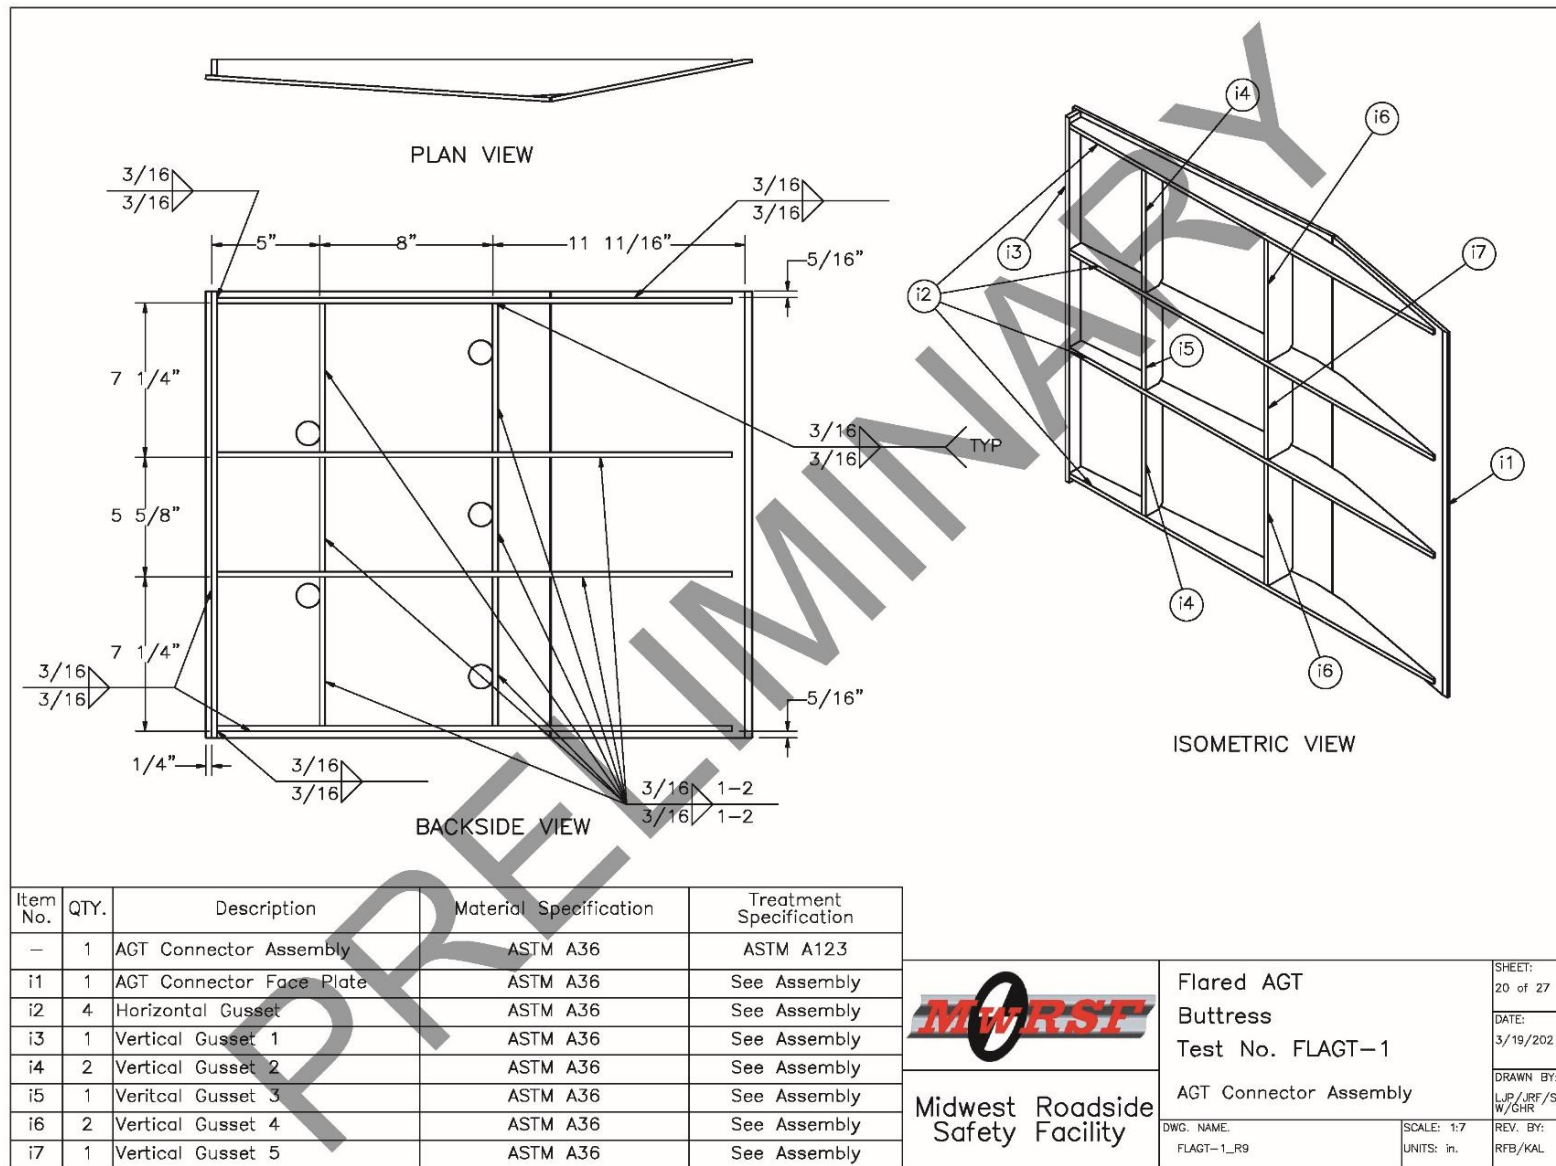
Figure 29. AGT Connector Plate Assembly, Test No. FLAGT-1

detailed in Figures 29 through 31. The angled connector plate assembly was constructed with a $\frac{3}{16}$ -in. thick steel face plate and $\frac{1}{4}$ -in. thick steel gussets. The plate extended 2 in. laterally from the traffic-side face of the buttress and the downstream end of the plate tapered flush with the face of the buttress via a 5:1 slope to mitigate snag in the reverse direction. As shown in Figure 33, the 10-gauge thrie-beam terminal connector had $1\frac{1}{4}$ -in. tall by 1-in. wide splice slots oriented in the vertical direction to improve constructability of the nested thrie-beam splice connection. Five $\frac{7}{8}$ -in. diameter ASTM F3125, Grade 120 heavy hex head bolts were used to connect the guardrail and connector assembly to the buttress.

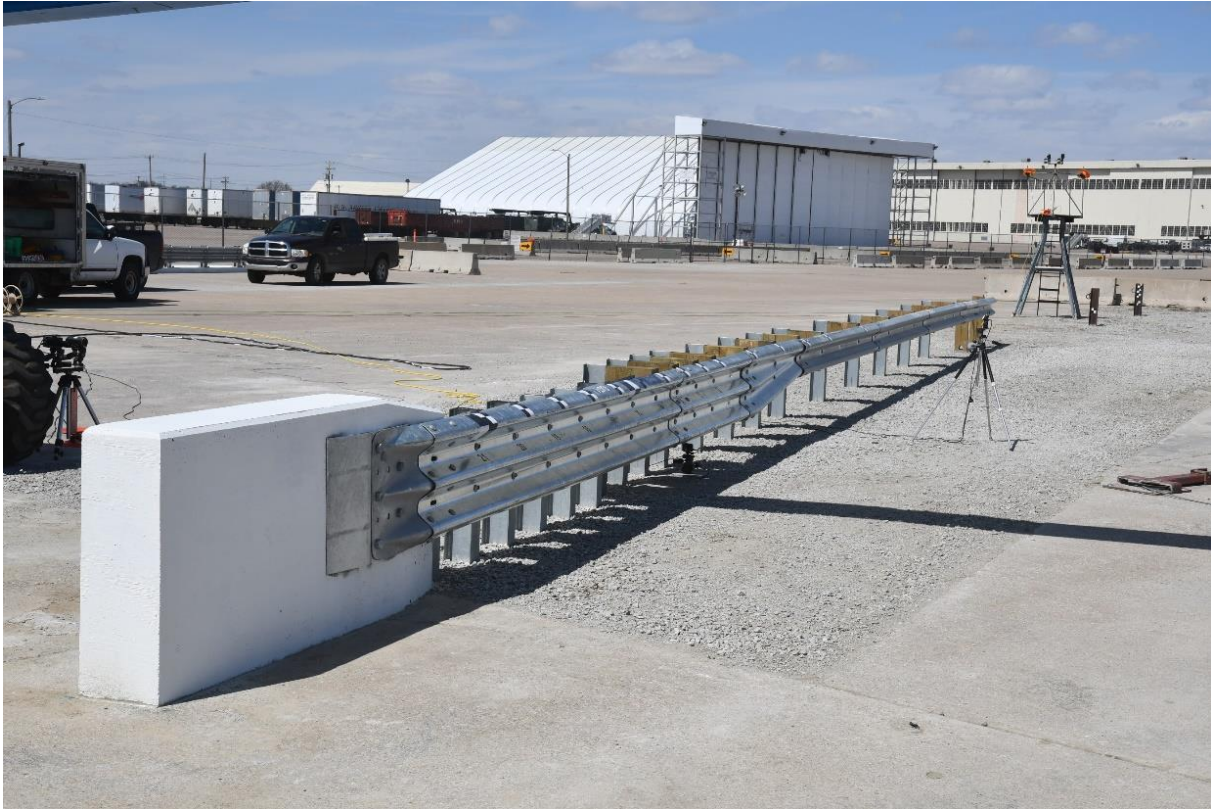
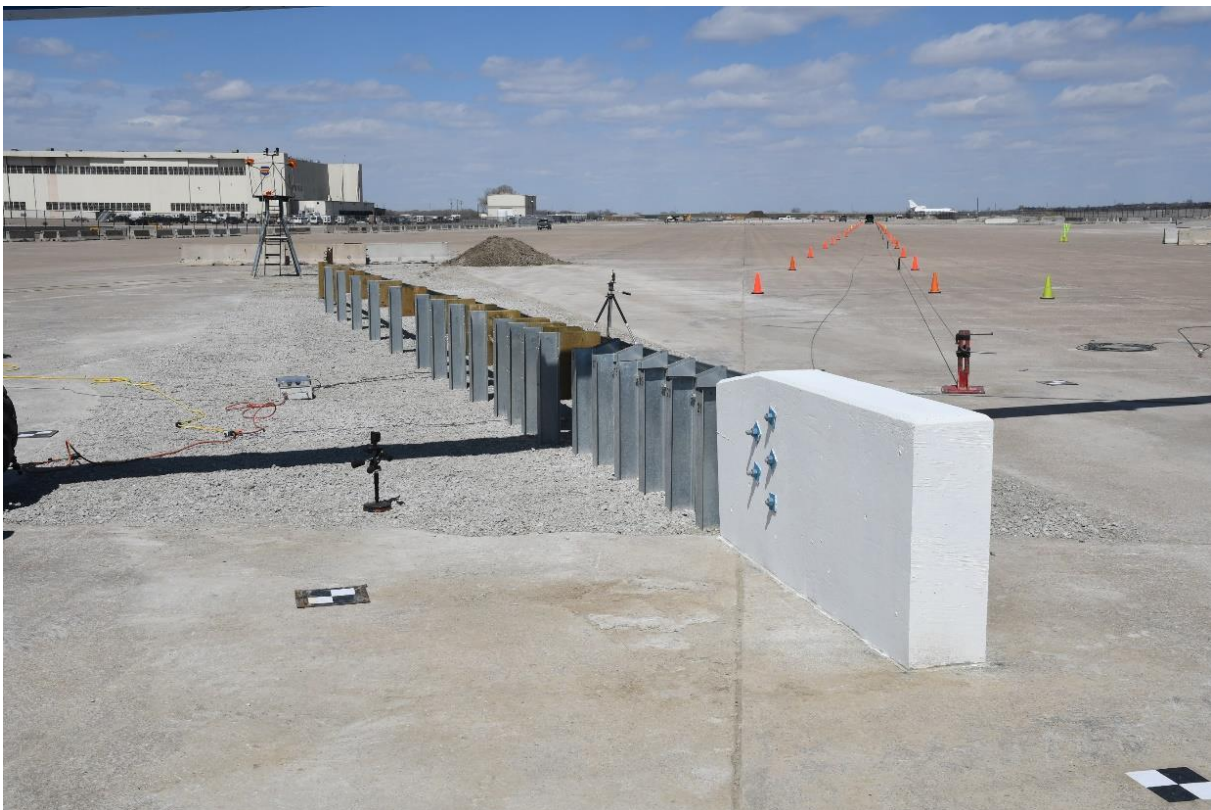
Figure 37. Test Installation Photographs

The flared AGT test installation was approximately 81 ft – 6 in. long and consisted of five main components: (1) a concrete buttress, (2) a thrie-beam AGT, (3) standard MGS, (4) a guardrail anchorage system, and (5) the flared AGT connector plate. Design details for test no. FLAGT-1 are shown in Figures 10 through 36. Photographs of the test installation are shown in Figures 37 and 38. Material specifications, mill certifications, and certificates of conformity for the system materials are shown in Appendix B.

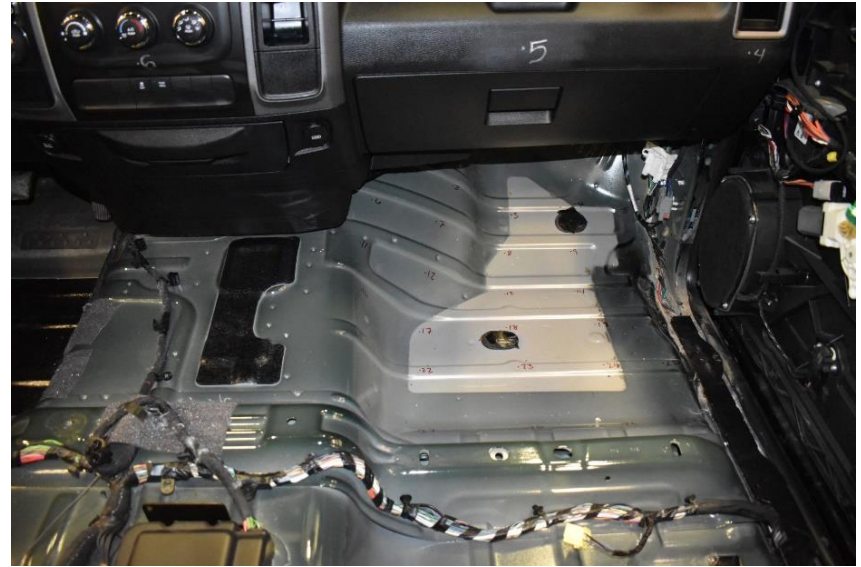
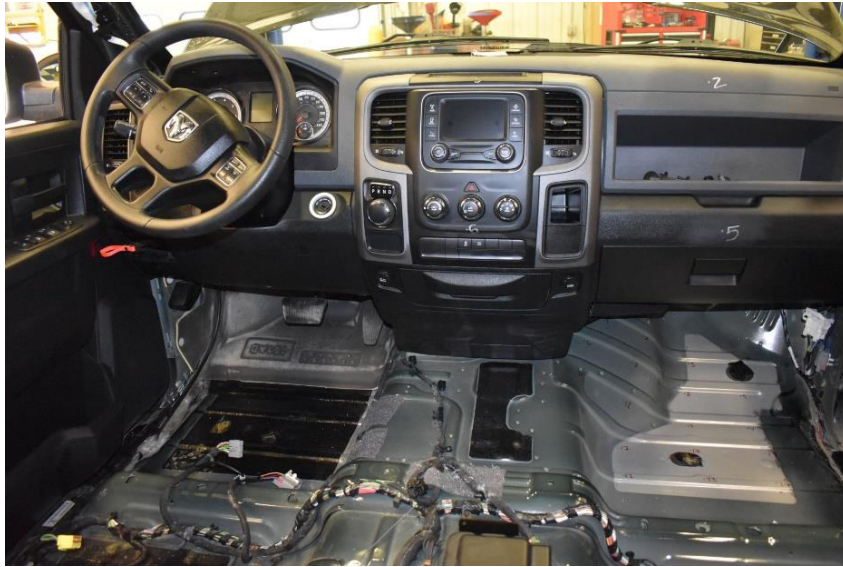
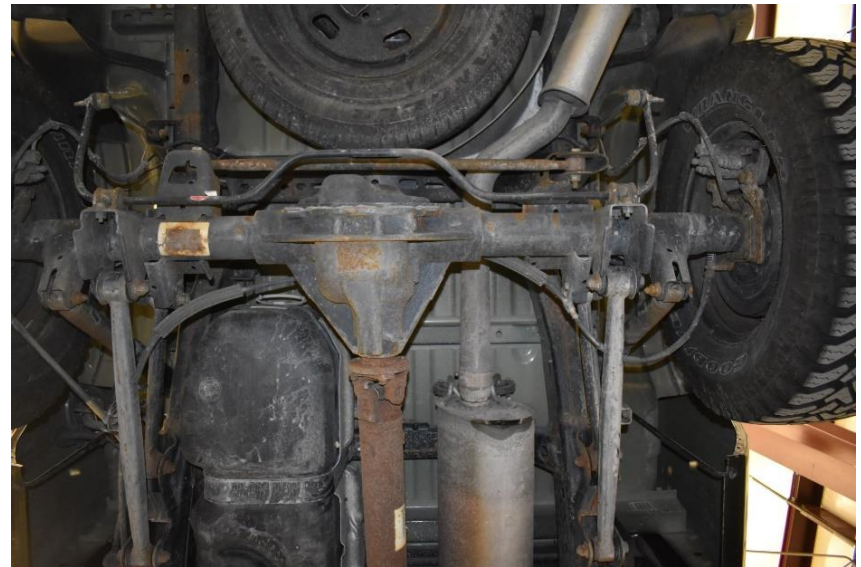
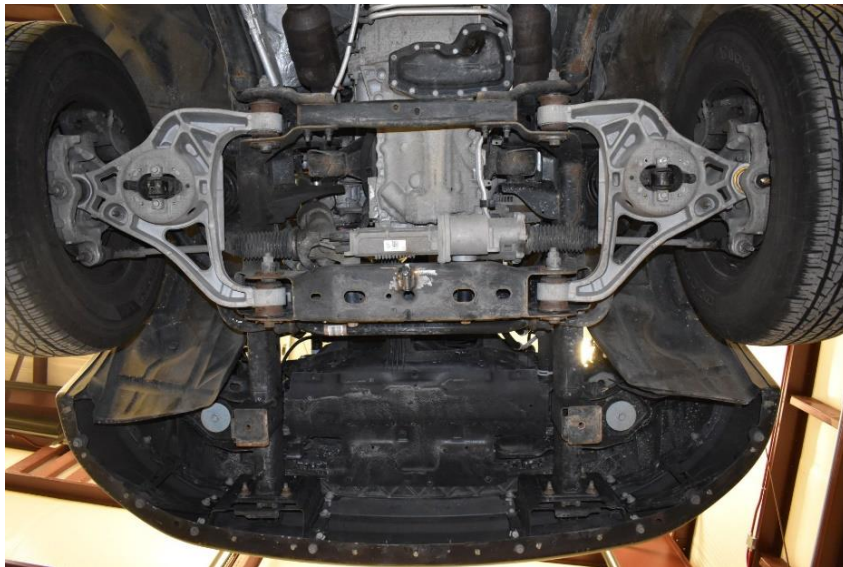
Figure 40. Test Vehicle's Interior Floorboards and Undercarriage, Test No. FLAGT-1

For test no. FLAGT-1, a 2016 Ram 1500 quad cab pickup truck was used as the test vehicle. The curb, test inertial, and gross static vehicle weights were 4,910 lb, 5,003 lb, and 5,163 lb, respectively. The test vehicle is shown in Figures 39 and 40, and vehicle dimensions are shown in Figure 41. The rear track width of the vehicle (69 in.) was 0.5 in. greater than the maximum value specified in MASH (67 in. \pm 1.5 in.).

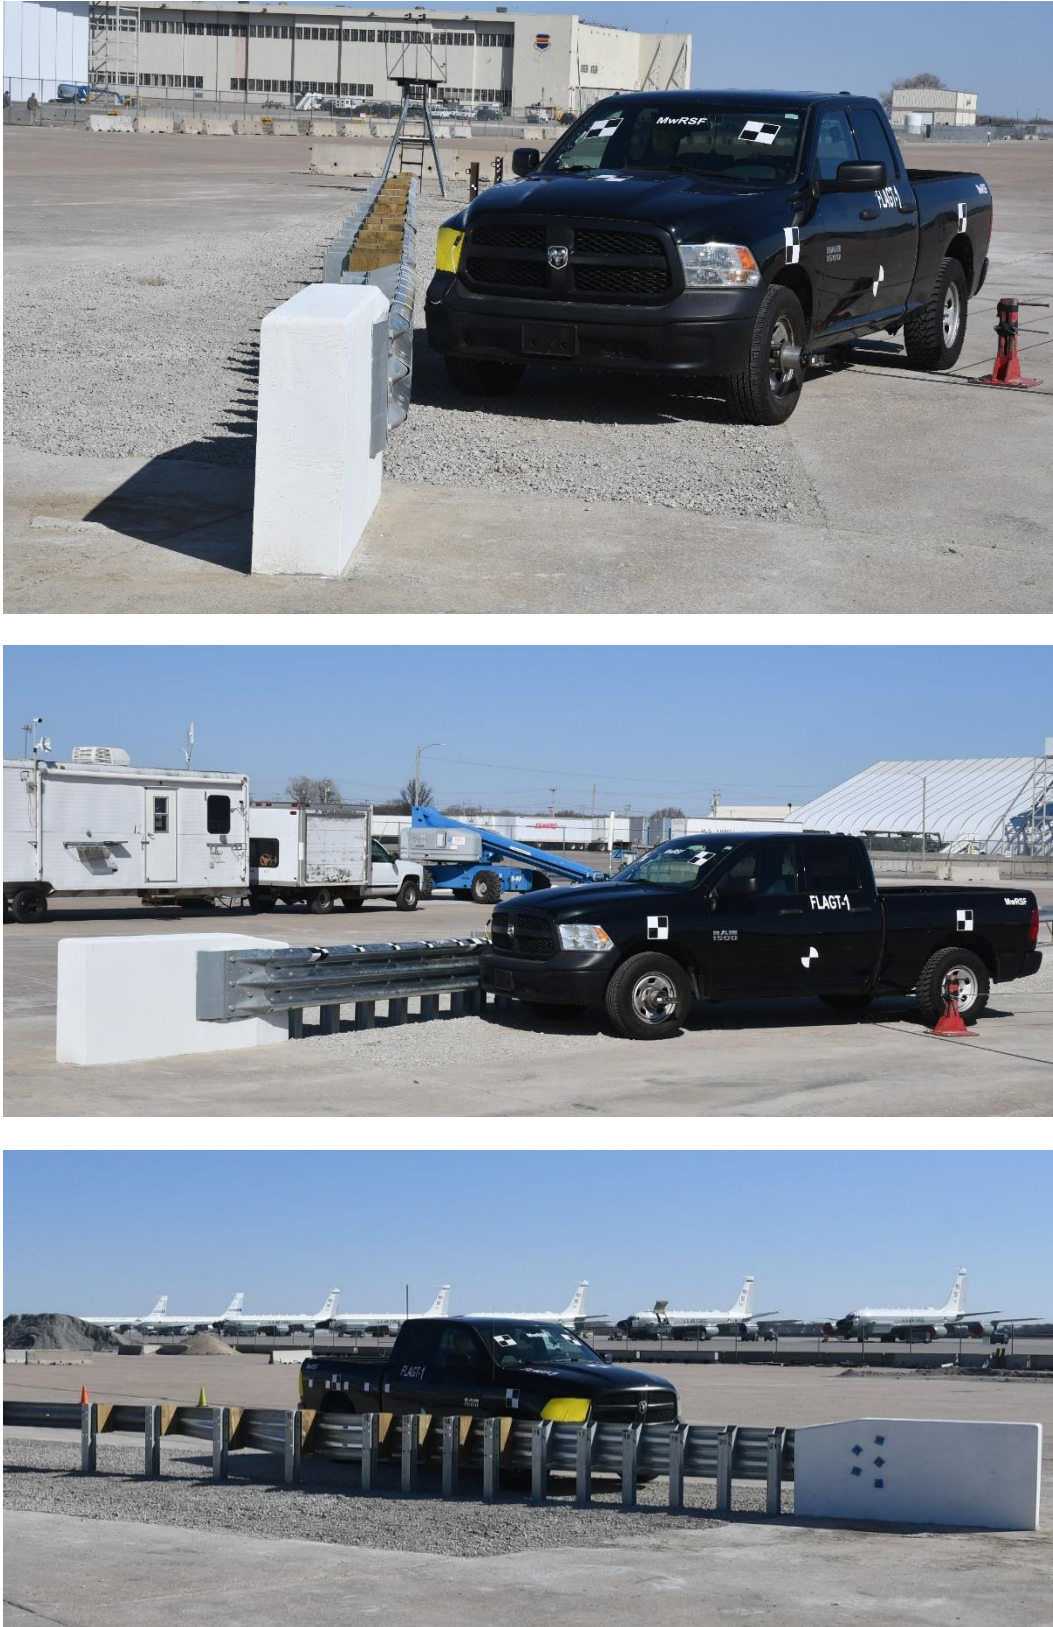
Figure 44. Impact Location, Test No. FLAGT-1

Initial vehicle impact was to occur 93 in. upstream from the upstream edge of the concrete buttress, as shown in Figure 44, which was selected during Phase I of this project using computer simulations to maximize the probability of vehicle snag [5]. The 5,003-lb quad cab pickup truck impacted the 15:1 flared AGT at a speed of 63.2 mph and at an angle of 25.4 degrees relative to the roadway, which corresponded to 29.2 degrees relative to the flared guardrail. The actual point of impact was 90 in. upstream from the edge of the concrete buttress.

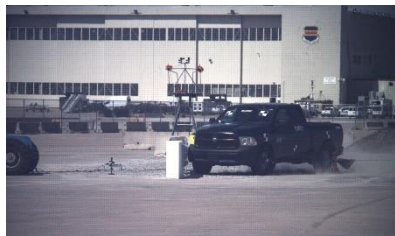
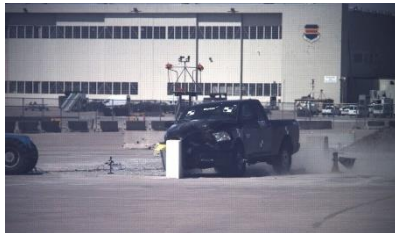
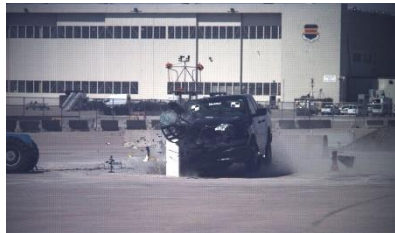
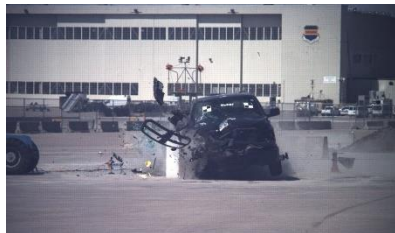
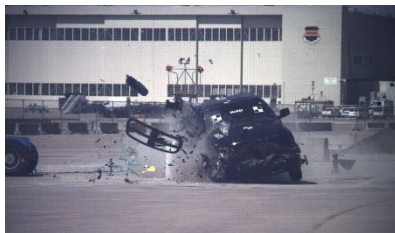
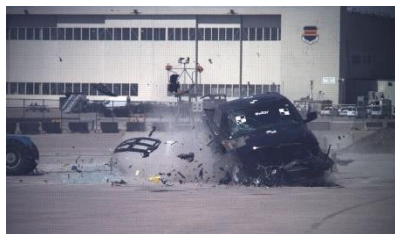
0.432	Vehicle pitched downward, vehicle yawed toward system, and vehicle exited system at a speed of 28.6 mph and an angle of -11 degrees.
0.458	Vehicle's left-front tire regained contact with ground.

3.124	Vehicle came to rest.

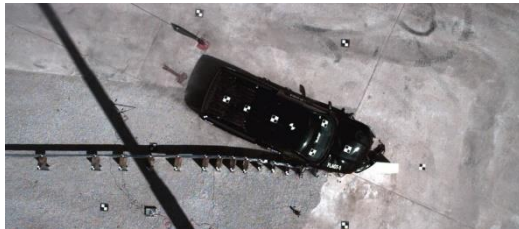
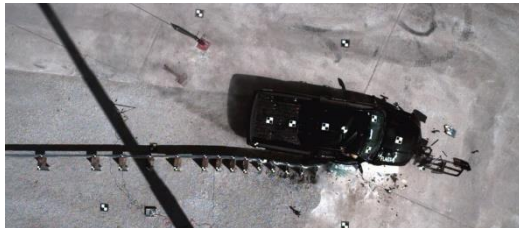
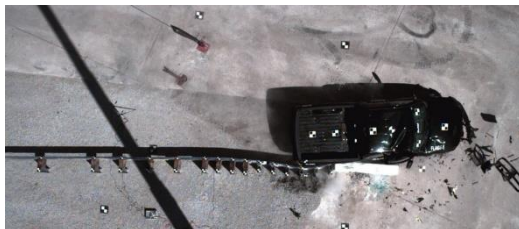
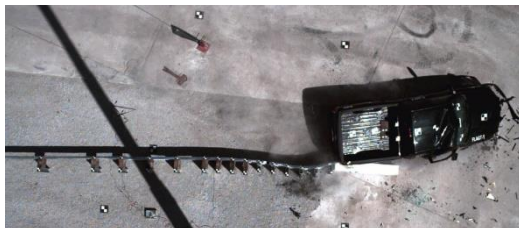
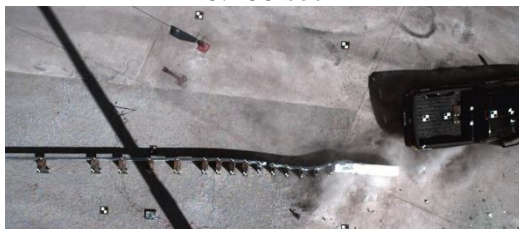
Figure 46. Additional Sequential Photographs, Test No. FLAGT-1

The vehicle was contained and redirected by the flared AGT, and the vehicle remained stable throughout the impact event. However, the increased effective impact severity associated with the flared installation resulted in increased system deflections as compared to other MASH TL-3 AGTs. The nested thrie beam kinked at the end of the concrete buttress, and the vehicle snagged on the kink and the buttress as it was being redirected, causing high magnitude decelerations to the vehicle. After exiting the system, the brakes were applied remotely, and the vehicle came to rest approximately 76.6 ft downstream from the upstream end of the concrete buttress and 3.6 ft in front of the system. A detailed description of the sequential impact events is contained in Table 4. Sequential photographs are shown in Figures 45 and 46. Documentary photographs of the crash test are shown in Figures 47 and 48. The vehicle trajectory and final position are shown in Figure 49.

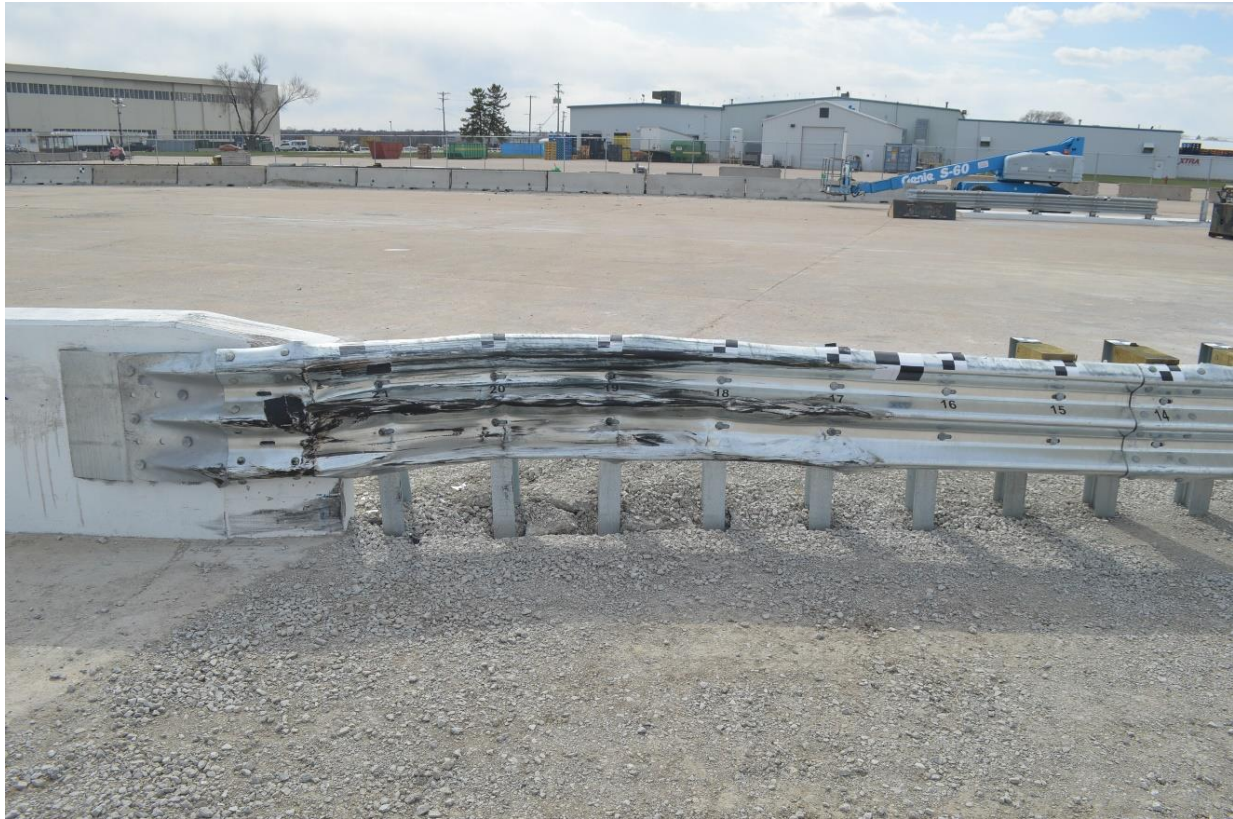
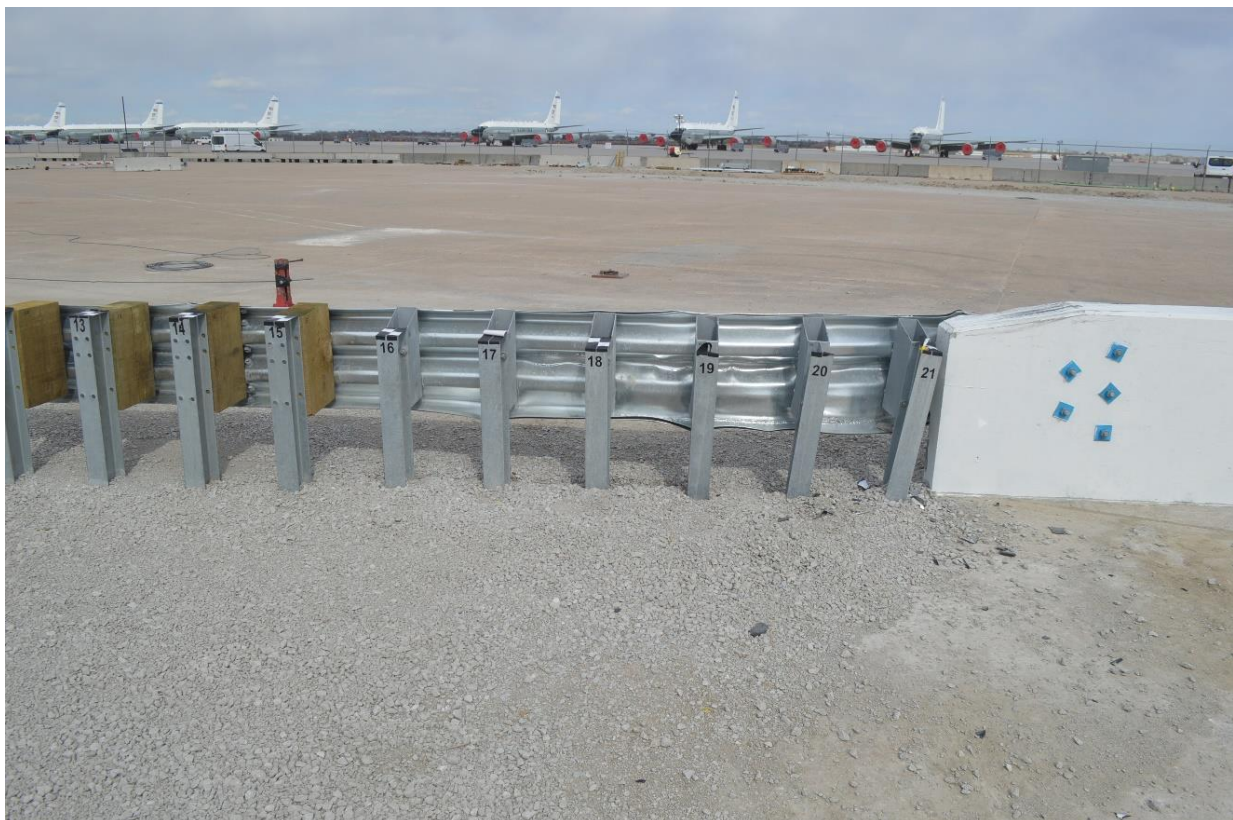
Figure 50. System Damage, Test No. FLAGT-1

Damage to the barrier was moderate, as shown in Figures 50 through 54. The overall length of vehicle contact along the barrier was approximately 12 ft – 3 in. and began 10 in. upstream from the center line of post no. 17. Contact marks in this region were found along the face of the thrie-beam rail, the sloped top surface of the concrete buttress, and along the front of the buttress. Additionally, tire marks were observed on the lower taper of the buttress and extended 1½ in. laterally onto the upstream face of the buttress.

Damage to the rail segments consisted of various dents, kinks, gouges, and flattening of the nested thrie beam rails. The majority of the dents and gouges were on the middle corrugation, while the bottom corrugation of the guardrail was flattened beginning at post no. 17. Small kinks were present on the top and bottom corrugations of the guardrail near post nos. 14 through 20. A large kink through the entire cross section of the thrie beam was found at the edge of the concrete buttress.

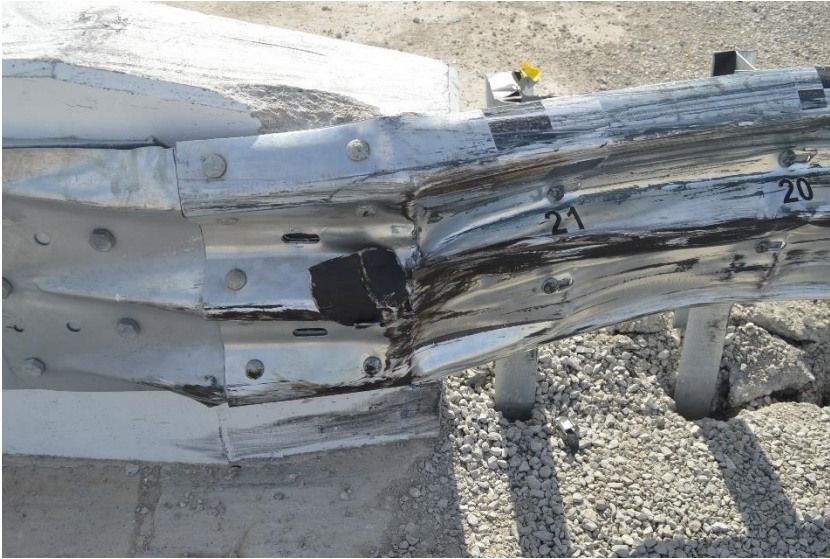
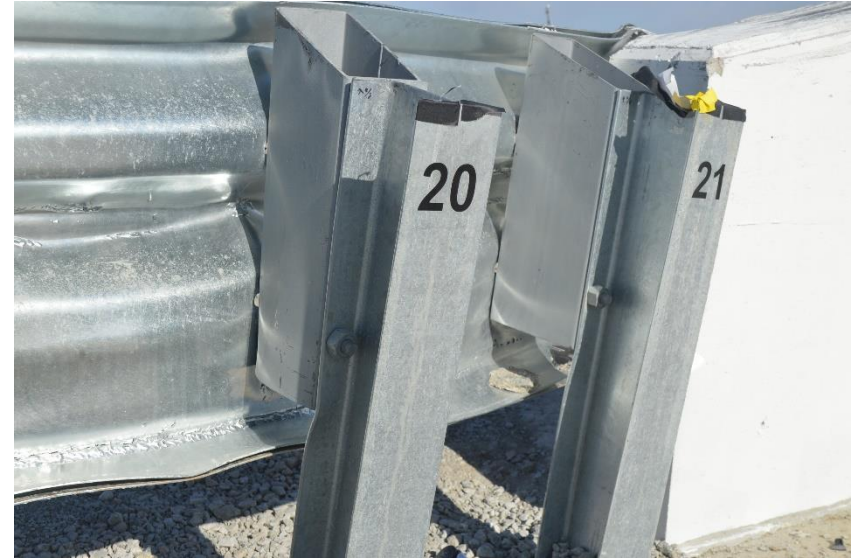
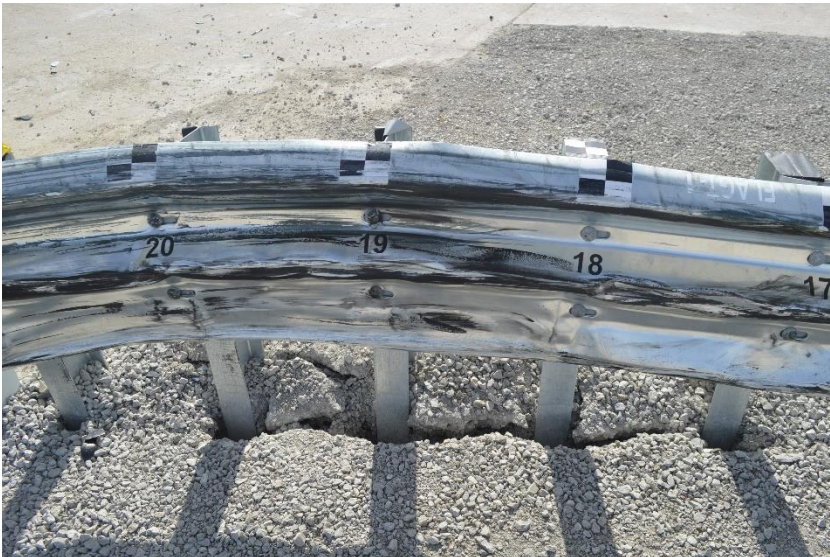
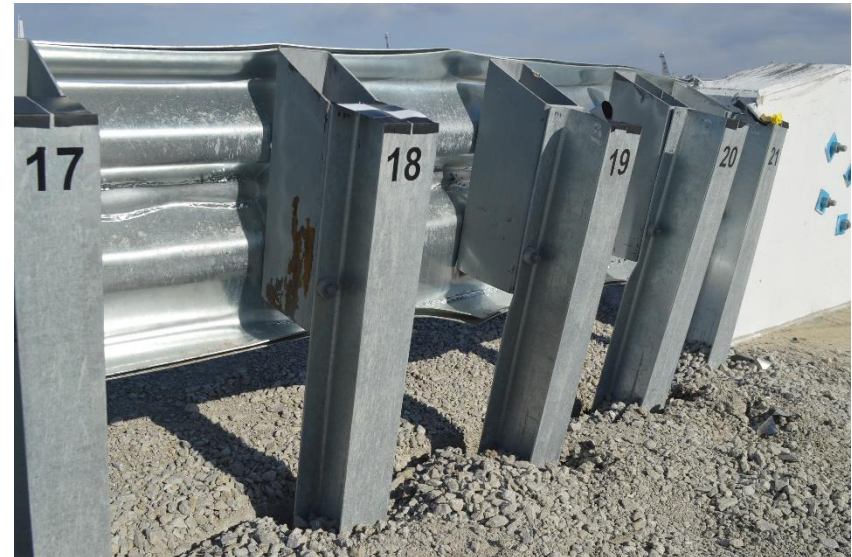
Figure 52. Post Nos. 18 through 21 Damage, Test No. FLAGT-1

Post nos. 1 through 15 all twisted slightly to face downstream (toward impact). Post nos. 14 through 21 rotated backward, and a large soil crack had formed along the front flanges of post nos. 17 through 20. The soil crack had a depth of at least 15 in. and maximum width of 4 in. near post no. 19. Various contact marks were observed on the blockouts of post nos. 18 through 20, and localized buckling and deformations were found on the front flanges of post nos. 19 and 20.

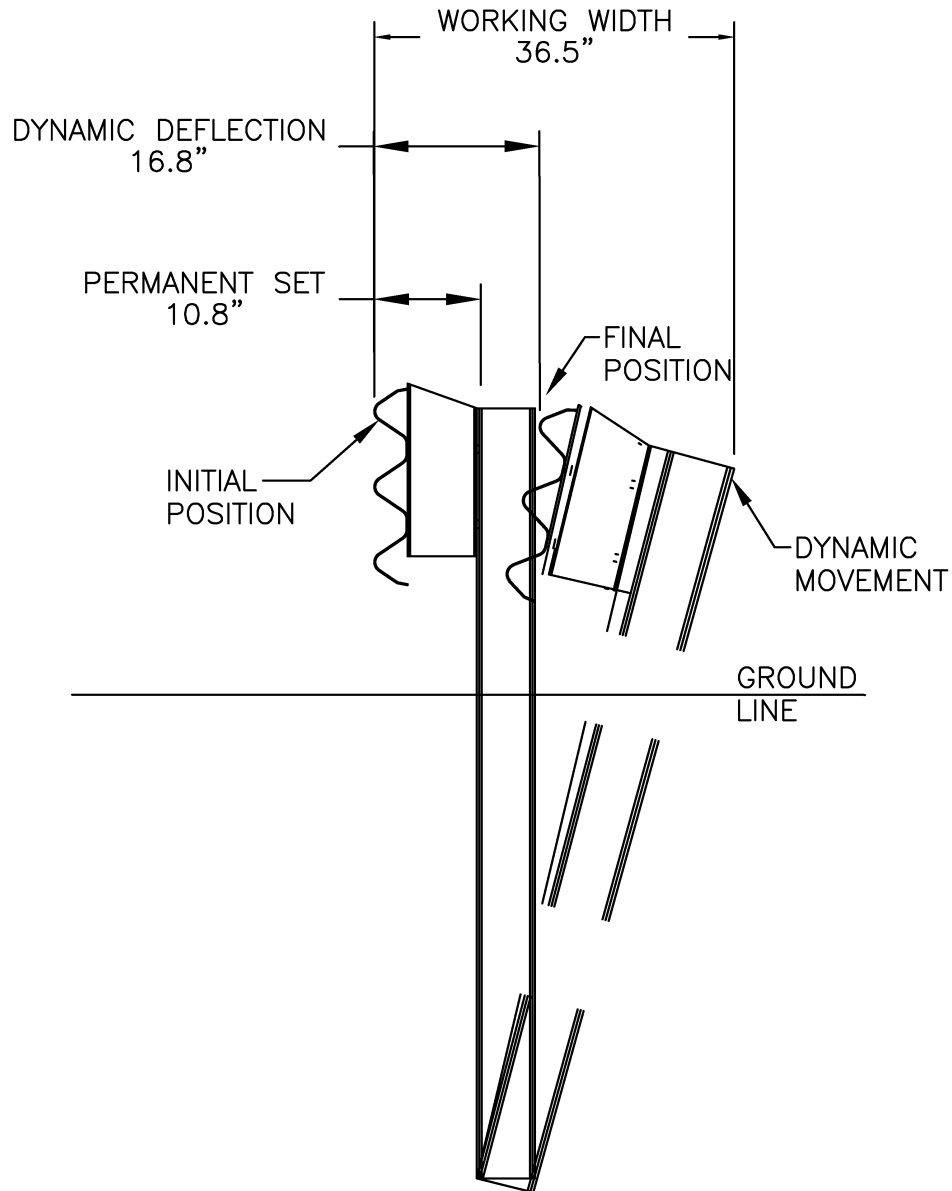
Figure 55. Permanent Set Deflection, Dynamic Deflection, and Working Width, Test No. FLAGT-1

The maximum lateral permanent set of the barrier system was 10.8 in., which occurred in the guardrail between post nos. 19 and 20, as measured in the field. The maximum lateral dynamic barrier deflection was 16.8 in. located at post no. 19, as determined from high-speed digital video analysis. The working width of the system was found to be 36.5 in., determined from high-speed digital video analysis. A schematic of the permanent set deflection, dynamic deflection, and working width is shown in Figure 55.

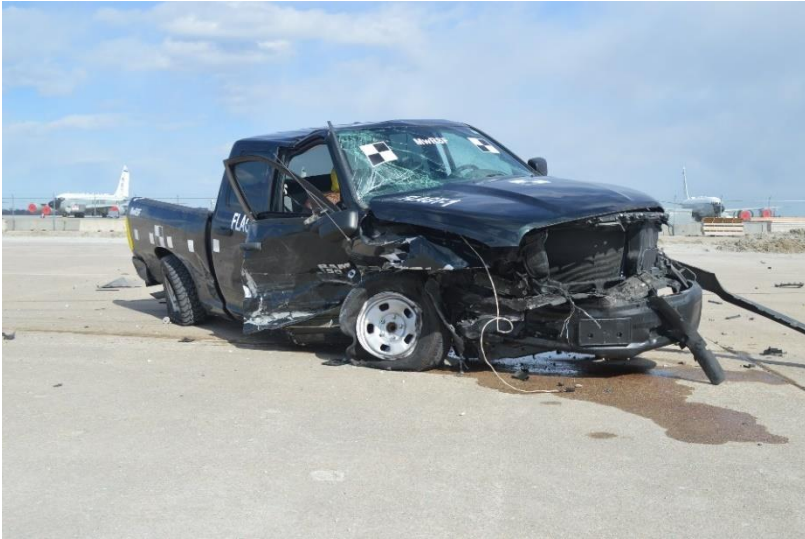
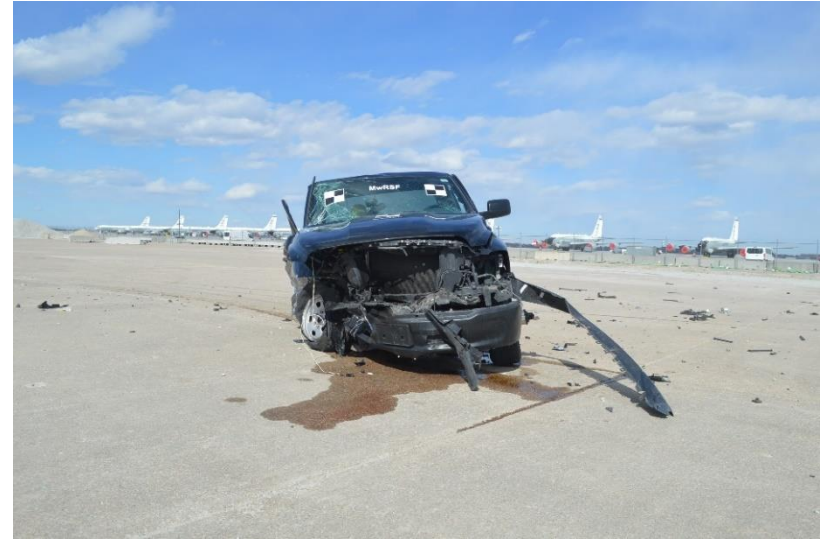
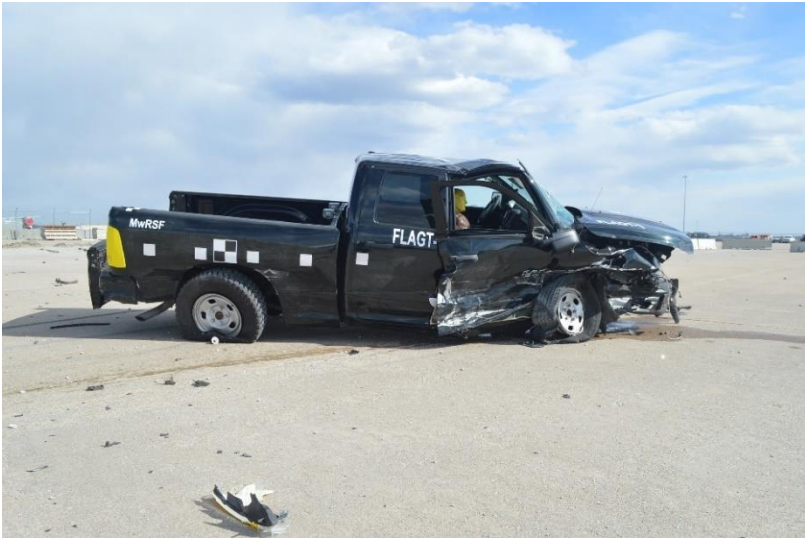
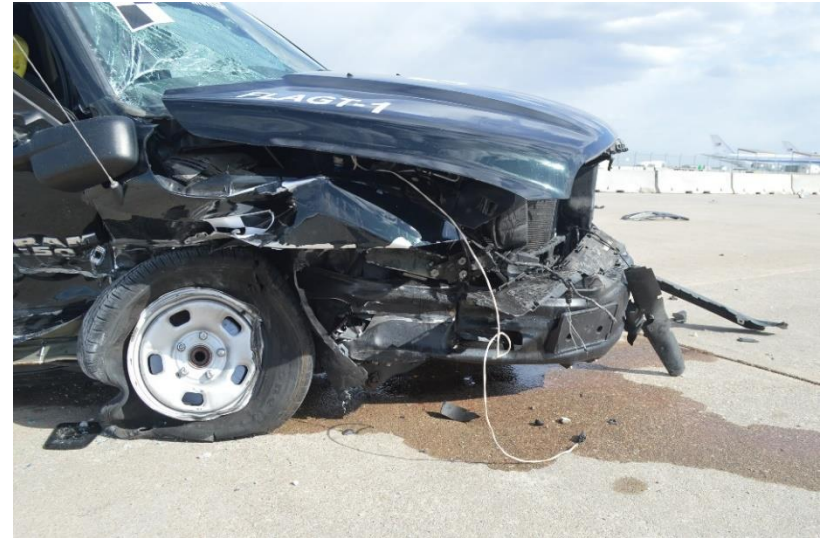
Figure 56. Vehicle Damage, Test No. FLAGT-1

The damage to the vehicle was severe, as shown in Figures 56 and 57. Majority of the exterior damage was concentrated on the right-front area of the vehicle where the impact had occurred. The right-front corner of the vehicle and the right-front door were both crushed inward. The grille was disengaged, the right side of the front bumper was crushed inward, and the left side of the bumper was pushed out slightly. The right-front fender panel was completely crushed inward. There were scrapes, dents and gouges present along the entire right side of the vehicle, but they were concentrated on the bottom half of the right-side doors. Both right-side wheels were deflated.

The front right and left front shocks and springs were bent rearward, and the front-right bump stop disengaged. The rear right spring was also disengaged. The sway bar shifted and the right-front steering knuckle was scraped. The right lower control arm disconnected from the cross member, the right tie rod was bent, and the gearbox was cracked. The right side axle tube was bent severely and the engine mounts completely disengaged. The oil pan was punctured and crushed on the right side, and the casting was fractured on the pan.

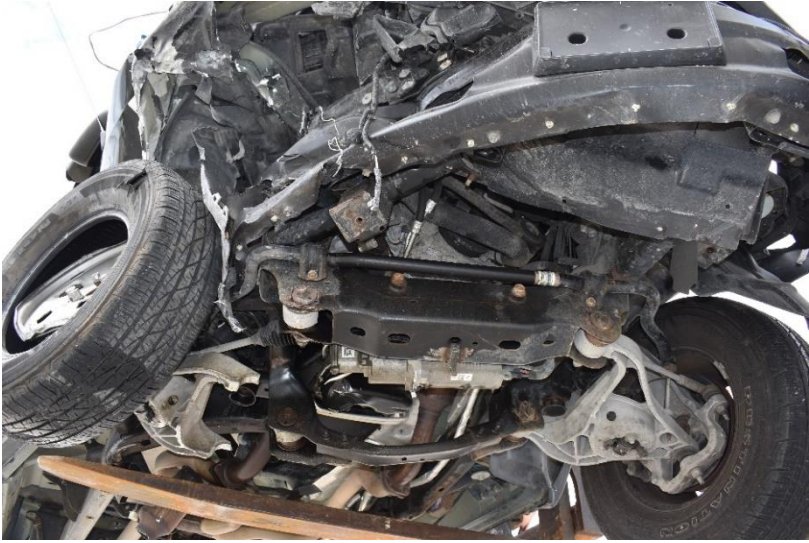
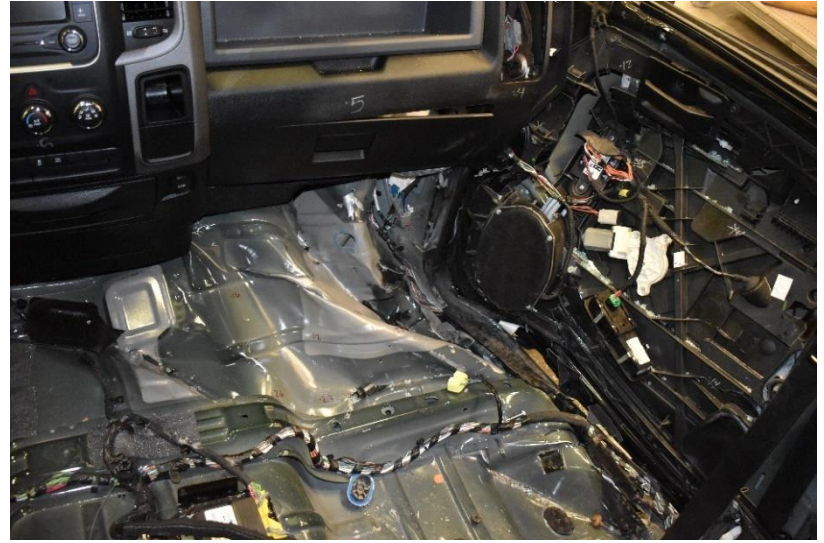
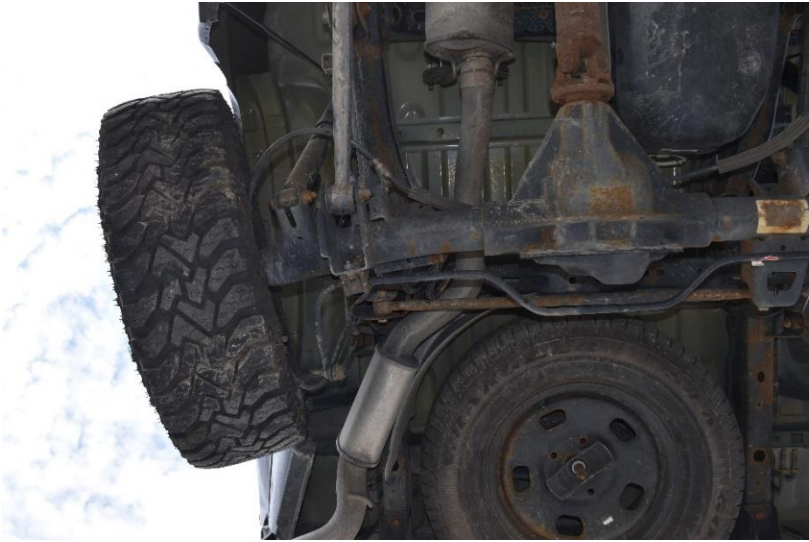
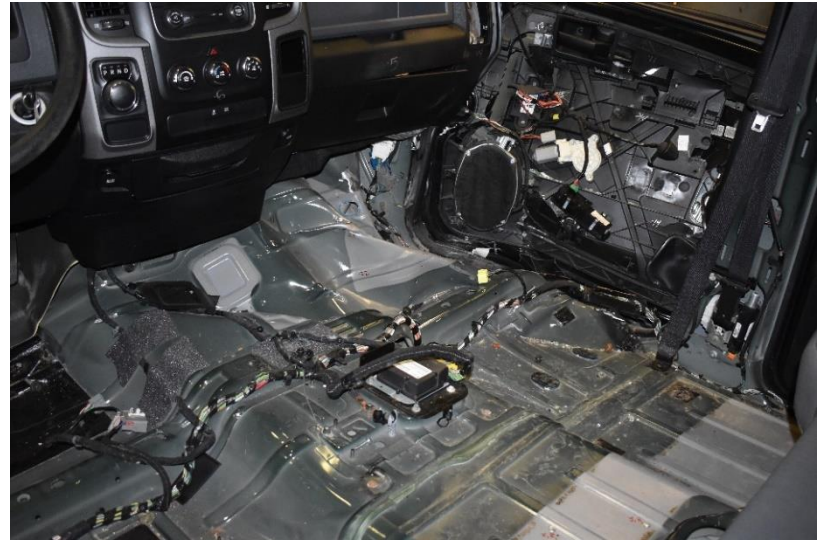
Figure 57. Vehicle Damage, Undercarriage and Occupant Compartment, Test No. FLAGT-1

The chassis of the vehicle was severely deformed around the contact area. The right-side engine cross members were bent backward, and scrapes were found along the right side of the transmission cross member. The right frame horn was completely crushed inward and the left frame horn was facing slightly outward. The windshield was severely cracked due to loading and displacement of the A-pillar, but the windshield remained in place. The front-right window was shattered and disengaged from the vehicle due to contact with the simulated occupant.

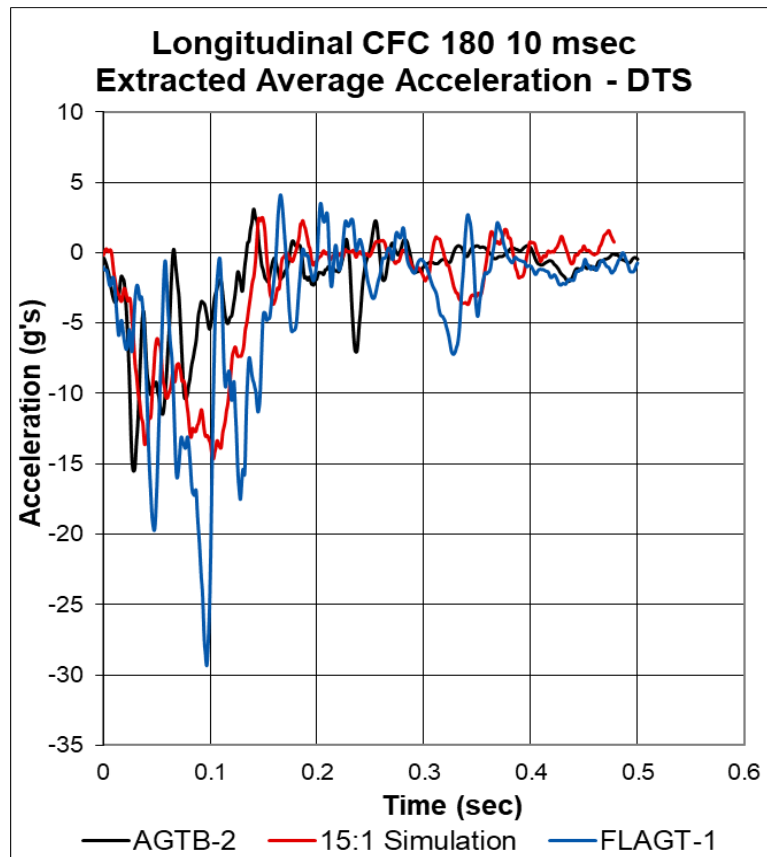
Figure 59. Comparison of Longitudinal CFC 180 10-msec Extracted Average Accelerations

A review of the longitudinal acceleration data showed a high-magnitude spike centered about 95 ms after initial impact. As shown in Figure 59, this spike was well above the accelerations observed during the rest of the impact and a departure from the acceleration observed in previous MASH evaluations of AGTs. Shown in Figure 59, the "AGTB-2" [1] data represents a MASH test designation no. 3-21 impact into the same AGT tested herein, only installed tangent to the roadway (i.e., without a flare), and the "15:1 Simulation" data was taken from the simulation analysis conducted on the 15:1 flared AGT during Phase I of this project [5]. Neither of these previous analyses showed vehicle snagging nor had test curves with high acceleration spikes. At 95 ms into test no. FLAGT-1, the vehicle was in direct contact with the guardrail kink and the upstream end of the concrete buttress, as shown in Figure 60.
