EVALUATION OF FLARED APPROACH GUARDRAIL TRANSITIONS: TEST NO. FLAGT-1

MIDWEST ROADSIDE SAFETY FACILITY

MwRSF Research Report No. TRP-03-439b-25

May 16, 2025

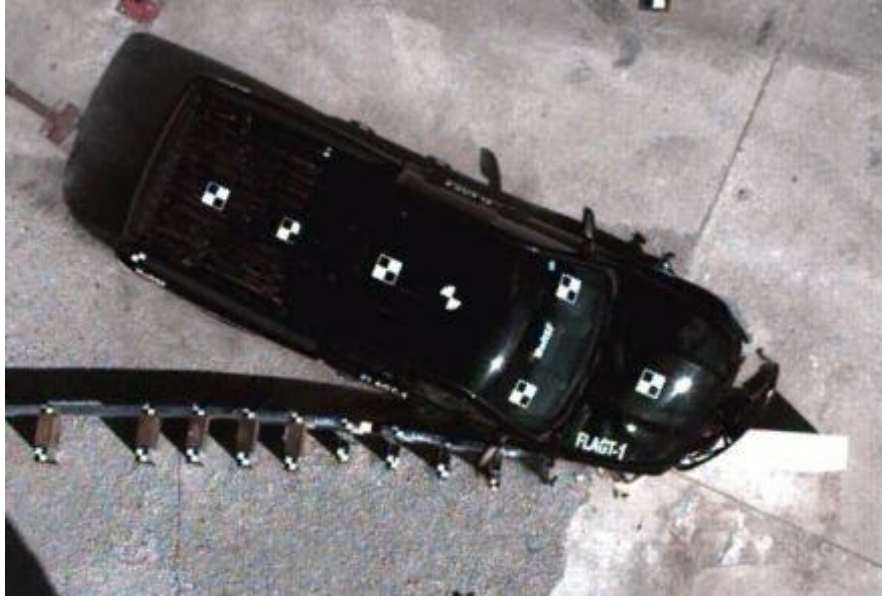
Figure 60. Overhead View of Test No. FLAGT-1, 95 ms after Impact

A review of the longitudinal acceleration data showed a high-magnitude spike centered about 95 ms after initial impact. As shown in Figure 59, this spike was well above the accelerations observed during the rest of the impact and a departure from the acceleration observed in previous MASH evaluations of AGTs. Shown in Figure 59, the "AGTB-2" [1] data represents a MASH test designation no. 3-21 impact into the same AGT tested herein, only installed tangent to the roadway (i.e., without a flare), and the "15:1 Simulation" data was taken from the simulation analysis conducted on the 15:1 flared AGT during Phase I of this project [5]. Neither of these previous analyses showed vehicle snagging nor had test curves with high acceleration spikes. At 95 ms into test no. FLAGT-1, the vehicle was in direct contact with the guardrail kink and the upstream end of the concrete buttress, as shown in Figure 60.

As noted previously in Section 6.4, tire contact marks were found on the lower taper and upstream end of the concrete buttress. However, this is not uncommon for MASH tests on AGTs with the standardized transition buttress. The amount of lateral overlap of the tire on the buttress in test no. FLAGT-1 was estimated to be 6 in., as measured from the front face of the buttress. This tire overlap fell between two other MASH test designation no. 3-21 tests on tangent AGTs with the standardized transition buttress. Test no. AGTB-2 [1] had 5 in. of tire overlap, while test no. 34AGT-1 [25] had 6.5 in. of tire overlap. This indicated that the wheel snag on the buttress was similar to previous successful MASH tests. Thus, the excessive decelerations and occupant compartment crush were not the result of wheel snag, but instead were caused by the vehicle snagging on the kink and the concrete buttress behind the guardrail.

The large kink that formed in the nested thrie beam was a damage characteristic not observed in previous MASH testing of AGTs. It is believed that excessive guardrail deflections within the nested thrie beam region of the AGT led to the formation of this kink. System deflections were expected to be higher than previous MASH AGTs due to the increase in impact severity associated with the flared guardrail. However, the lateral deflections of the flared AGT in test no. FLAGT-1 were significantly higher than predicted.

The unusually high deflections within the AGT posts were also evident by the large soil crack that opened up along the front flanges of the transition posts. This was another damage characteristic not observed in previous successful MASH testing of AGTs. The posts themselves did not plastically bend during the impact, rather, the soil behind the posts shifted and allowed the posts to rotate back to achieve high system deflections. Design changes to increase the post-soil strength and reduce the system deflections may be necessary to create a crashworthy AGT flared at a 15:1 rate. These design changes will be explored in the next phase of the project.

Detailed evaluation of test no. FLAGT-1 revealed that excessive guardrail deflections resulted in a large kink forming in the nested three beam rails at the upstream end of the concrete buttress. The pickup truck snagged on this guardrail kink and the rigid buttress directly behind it, which caused excessive occupant compartment intrusion and decelerations. The flared AGT will need to be redesigned to limit system deflections and create a crashworthy barrier.
