UPDATE TO CABLE BARRIER LITERATURE REVIEW

MIDWEST ROADSIDE SAFETY FACILITY

MwRSF Research Report No. TRP-03-227-10

August 12, 2010

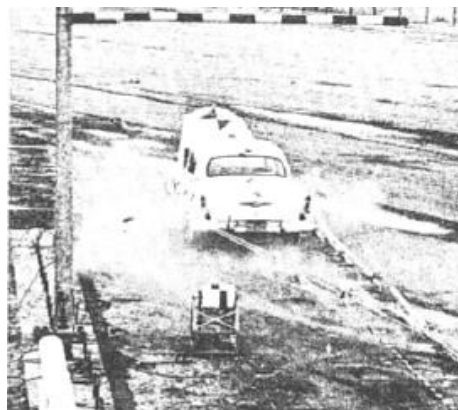
Figure 2. Sequential Photographs, Test No. 14, 1958 [7]

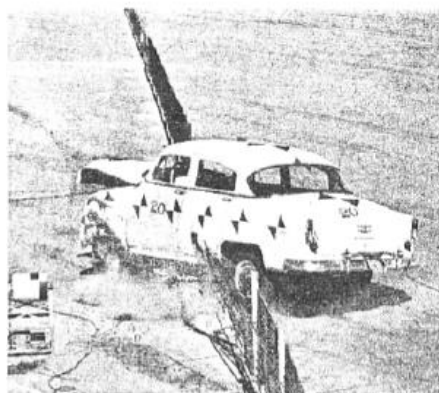
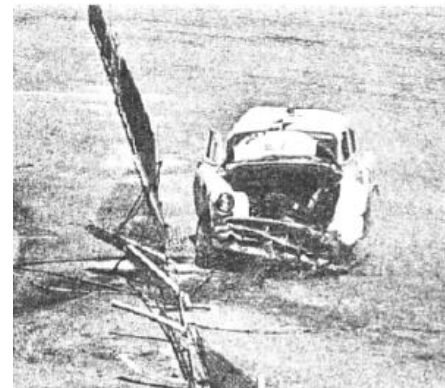
Figure 3. Sequential Photographs, Test No. 20, 1959 [7]

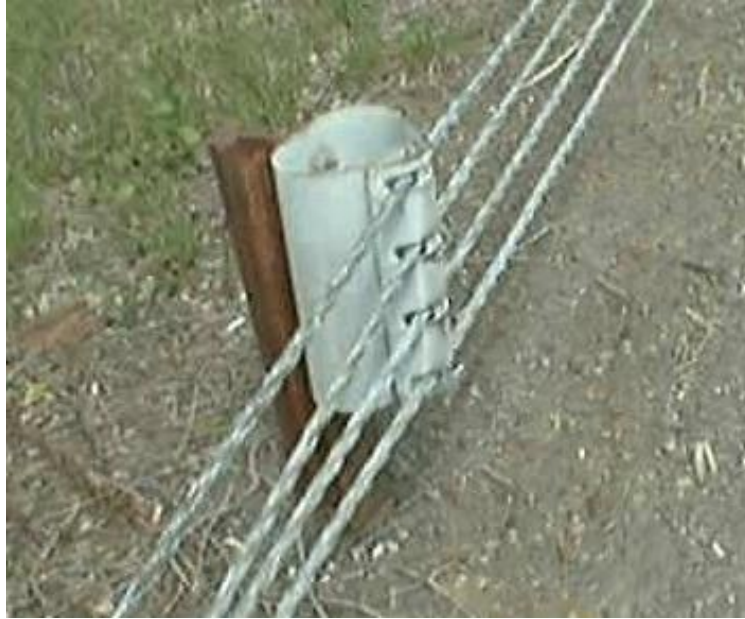
The strong-wood post system was determined to be acceptable with the minor retainer clip modifications. Sawing the posts at the base was not recommended, since it did not appreciably reduce occupant risk for the impact. However, it should be noted that the strong-post cable guardrail system was also installed with steel posts. Modifications to this system were not evaluated. However, little money was budgeted for upgrading existing deficient systems, so researchers focused on the system they believed could be most easily and inexpensively improved. An example of a steel-post system installed in the field is shown in Figure 11.

Figure 11. Steel-Post 4-Cable Guardrail System Installed In Field [15]

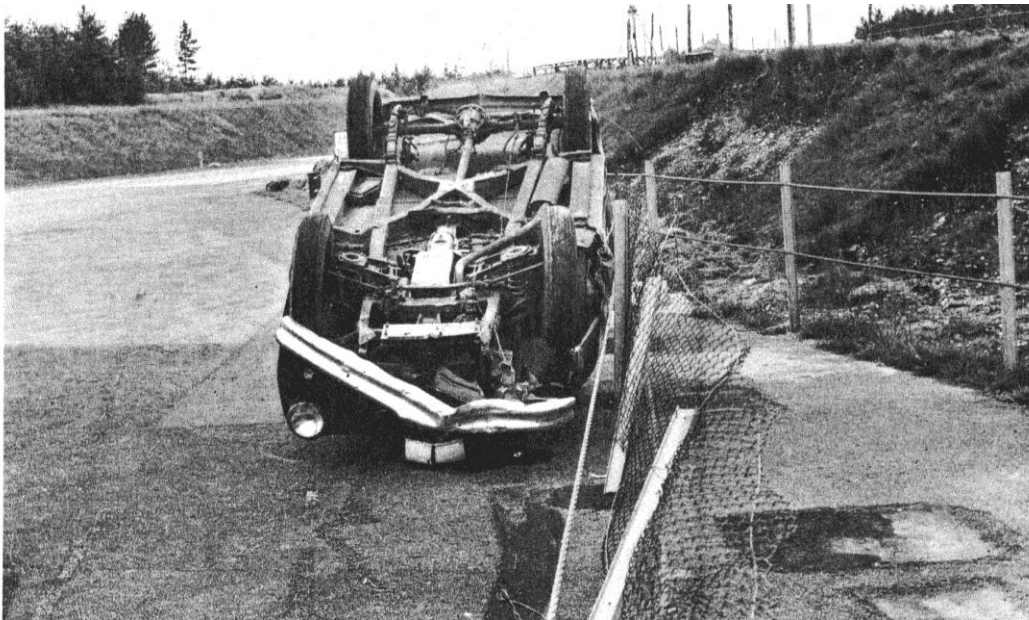
Test no. 19 was conducted as a retest of test no. 17 at a higher speed. The vehicle impacted the barrier at 58 mph (93 km/h) and 10.5 degrees. The vehicle overrode the traffic-side cable when the banding clips failed, and the right-front wheels became trapped by the cables. Following redirection, the vehicle yawed and rolled over. The final position of the test vehicle following test no. 19 is shown in Figure 14.

Figure 14. Vehicle Final Position, Test No. 19, 1967 [17]

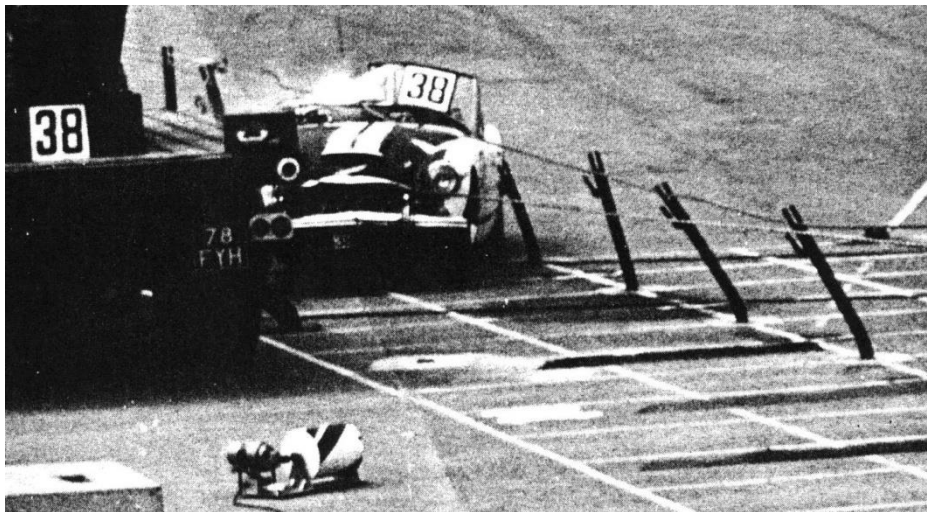
In test no. 38, researchers evaluated the system under a worst-case vehicle impact. A low-profile sports car impacted the system at 64 mph (103 km/h) and 24 degrees, and the results were unsatisfactory. The upper cable released from the posts and slid over the hood and into the A-pillar, where it caused the windshield to release. The upper cable then impacted the dummy's neck region, and the lower cable slid up the vehicle's hood. The vehicle underrode the system and contacted a fixed object behind the barrier. It should be noted that the path of the vehicle was uncontrolled due to an equipment malfunction prior to impact. The cable impact with the windshield is shown in Figure 17.

Figure 17. Upper Cable Impact Into Windshield, Test No. 38, 1967 [18]

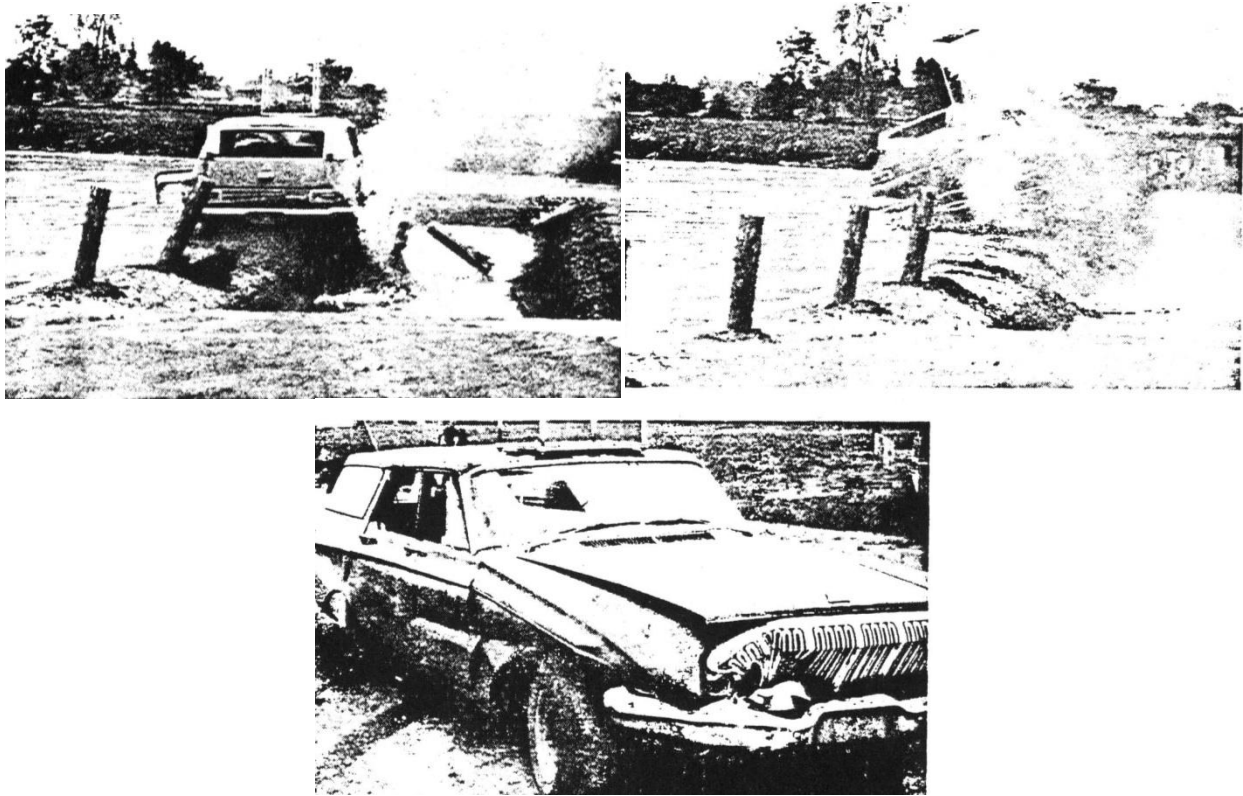
In test no. 3-68, three modifications were made to the system: (1) the length of the installation was increased to 350 ft (106.8 m); (2) the system was installed at the break point of a 3:1 ditch; and (3) the "Concrete" anchor was utilized. Three $\frac{1}{2}$ -in. (13-mm) diameter Grade 110 cables were torqued to 30 lb-ft for an approximate tension of 785 lb (3.50 kN) prior to test no. 3-68. The test vehicle impacted the cable barrier system at a test speed and angle of 50 mph (80 km/h) and 25 degrees, respectively. The vehicle was smoothly redirected but made secondary contact with the barrier system, resulting in cable entrapment in the front wheel well and subsequent spin-out. It was believed that the spin-out behavior observed in the test was related to the extension of the vehicle's suspension as it passed over the ditch. Test results from test no. 3-68 are shown in Figure 25.

Figure 25. Impact 3-68, 1968 [19]

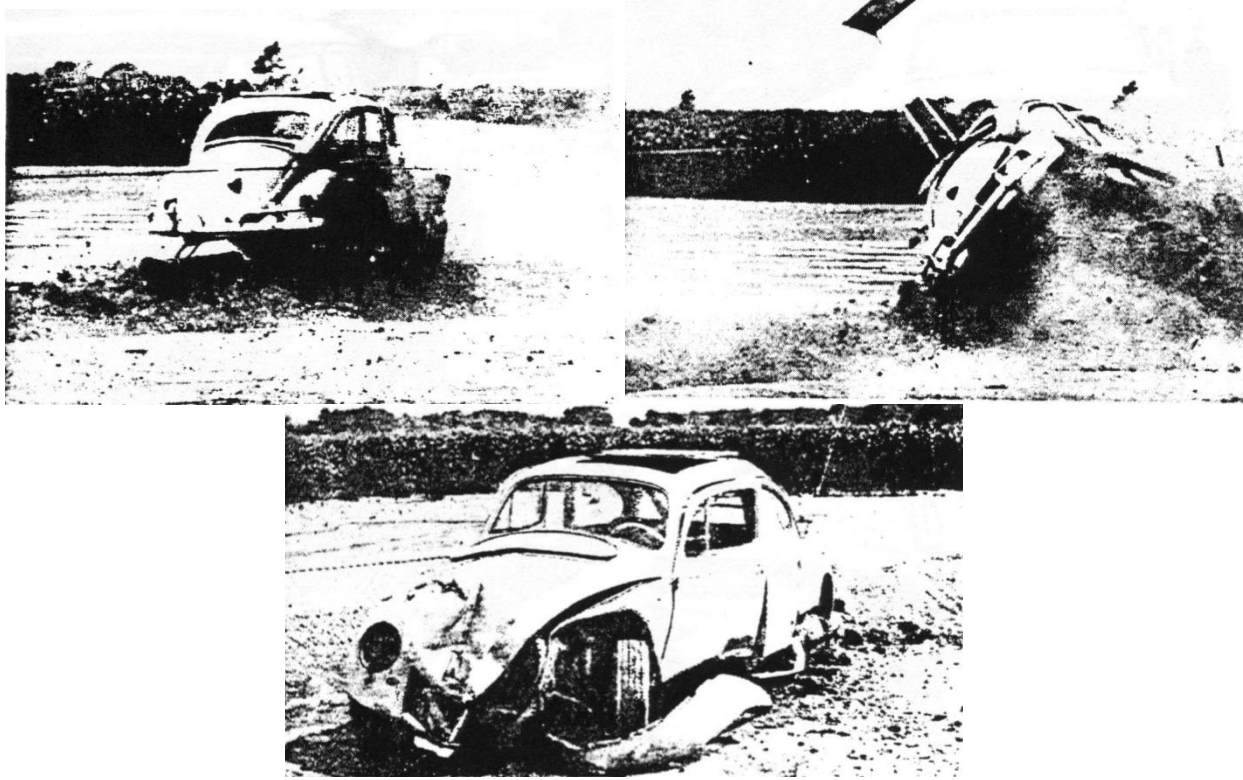
The system tested in test no. 5-68 was retested with a small car in test no. 9-68. The test vehicle impacted the system at 52 mph (84 km/h) and 25 degrees. During the test, the body of the small car separated from the chassis after the cables formed a groove above the headlight. Researchers examined the body of the small car and discovered that it was corroded and held in place by plaster and newspaper in some locations. Despite the failure of the car body, the cables formed a groove above the headlight at the hood level, indicative of acceptable barrier performance. Thus the test was judged to be successful. Test results from test no. 9-68 are shown in Figure 26.

Figure 26. Test No. 9-68, 1968 [19]
