## **AESTHETIC BARRIER LITERATURE REVIEW**

### **MIDWEST ROADSIDE SAFETY FACILITY**

MwRSF Research Report No. TRP-03-197-07 (Revised)

April 10, 2008

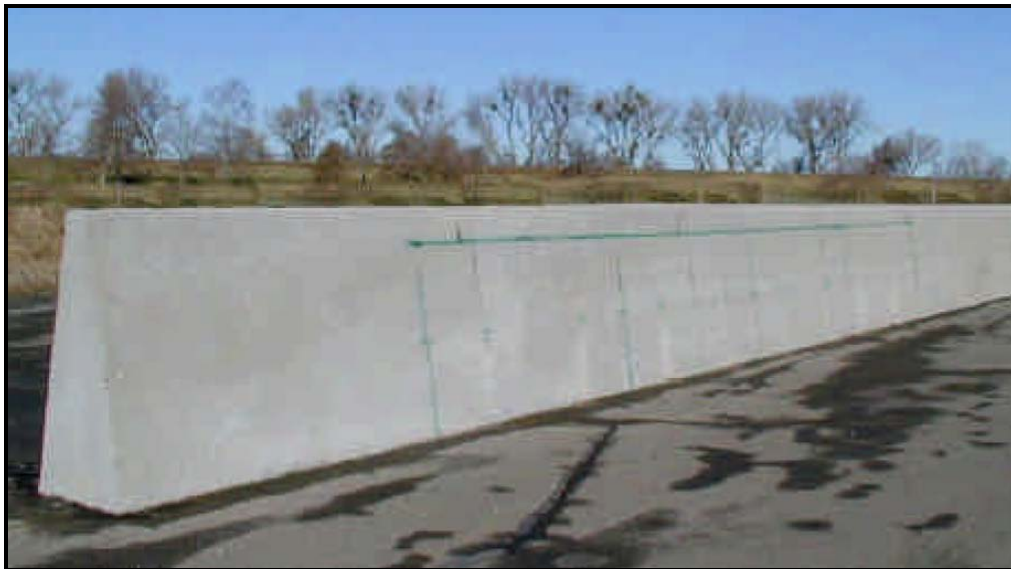
**Figure 1. Existing Type 60 Profile Used For Testing**

In 2002, Peter et al. (2) conducted tests (TL-3) on a deep cobble-reveal textured barrier with a Type 60 profile. The Type 60 barrier used as a base profile for all textured barrier testing is shown in Figure 1 and the assembled texture barrier used for testing is shown in Figures 2 and 3. The test results are provided in Figure A-1.

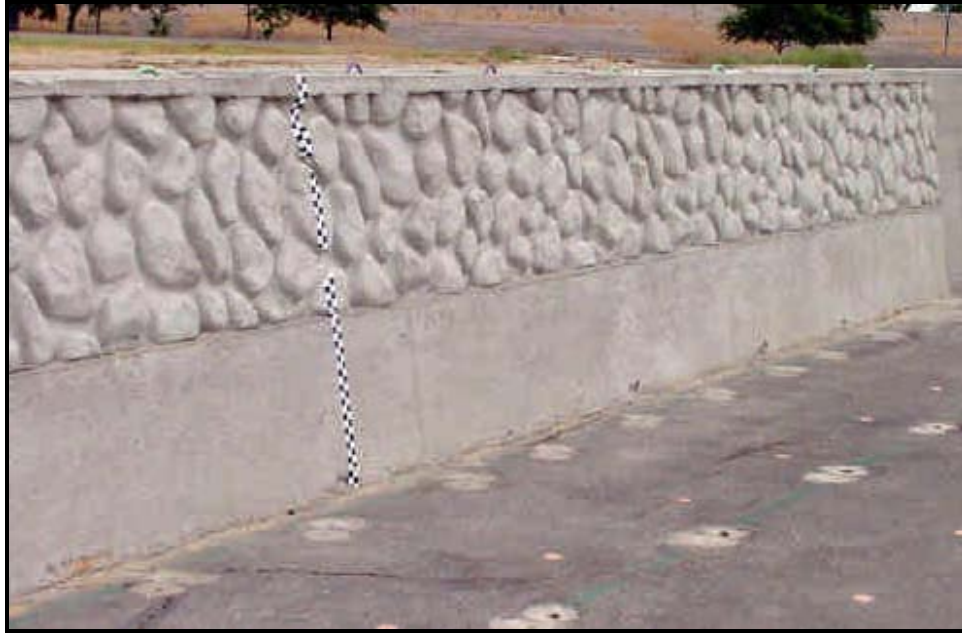
**Figure 2. Deep Cobble-Revealed Textured Barrier Prior to Testing**

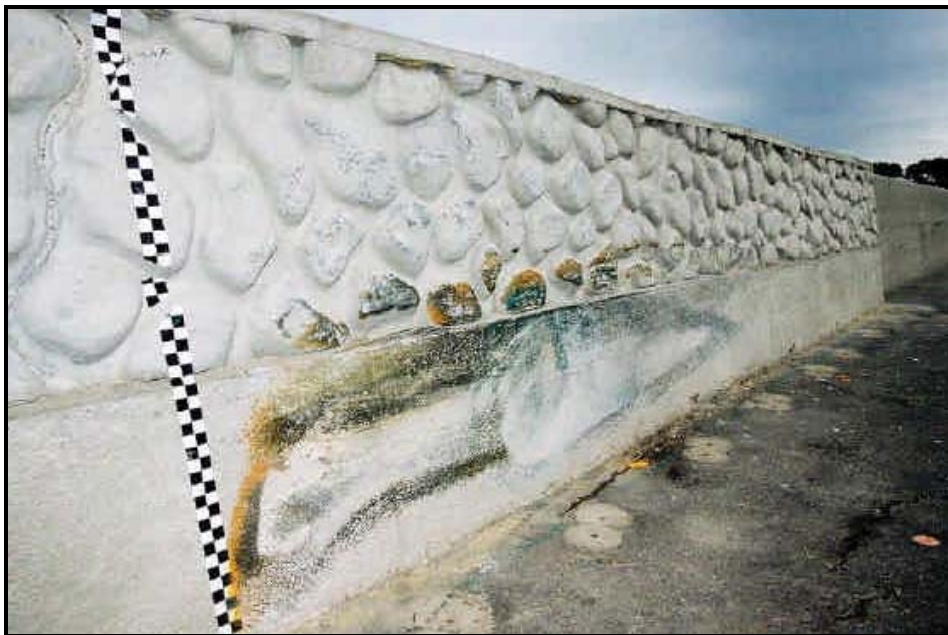
**Figure 3. Deep Cobble-Revealed Textured Barrier Following Testing**

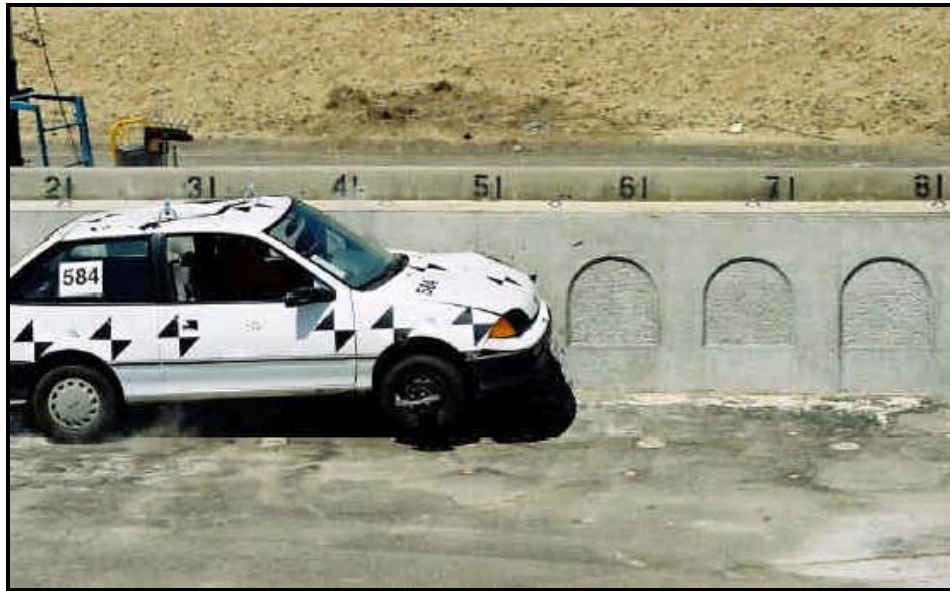
**Figure 4. Mission Arch Textured Barrier Prior to Testing**

In 2002, Peter et al. (2) conducted tests (TL-3) on a mission arch textured barrier with a Type 60 profile. The assembled barrier used for testing is shown in Figures 4 and 5. The test results are provided in Figure A-2.

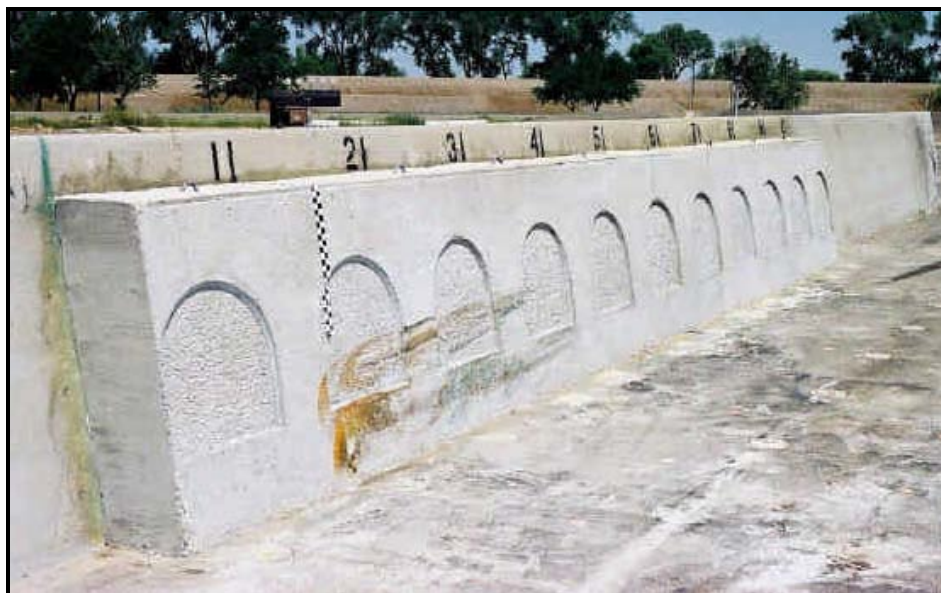
**Figure 5. Mission Arch Textured Barrier Following Testing**

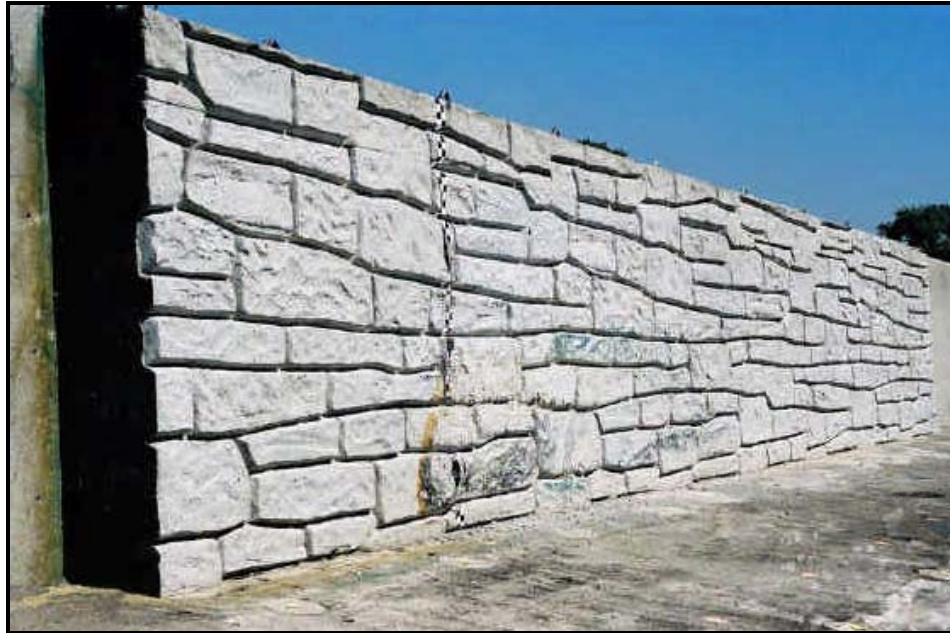
**Figure 7. Dry Stack Stone Textured Barrier Following Testing**

In 2002, Peter et al. (2) conducted tests (TL-3) on a dry stack stone textured barrier with a Type 60 profile. The assembled barrier used for testing is shown in Figures 6 and 7. The test results are provided in Figure A-3.

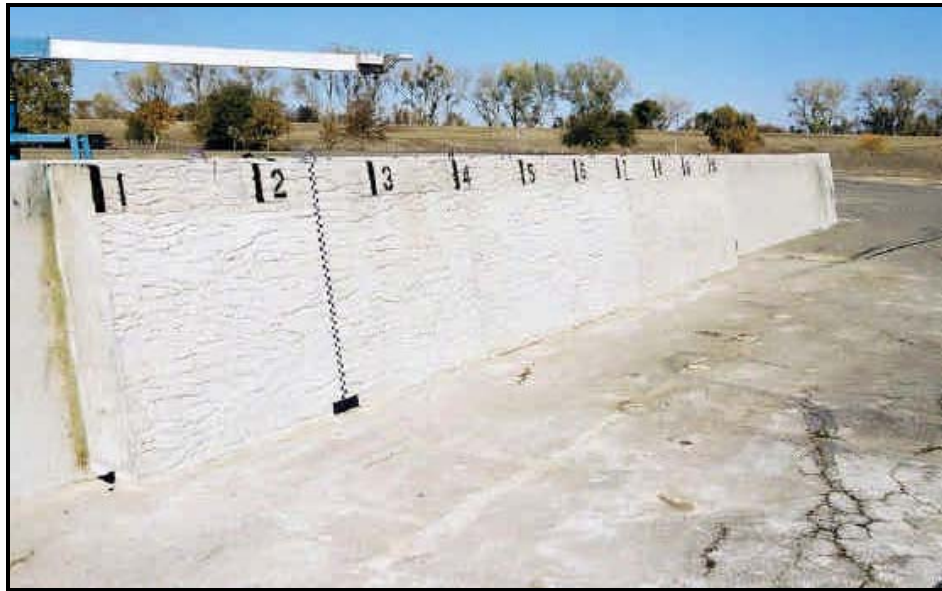
**Figure 8. Fractured Granite Textured Barrier Prior to Testing**

In 2002, Peter et al. (2) conducted tests (TL-3) on a fractured granite textured barrier with a Type 60 profile. The assembled barrier used for testing is shown in Figures 8 and 9. The test results are provided in Figure A-4.

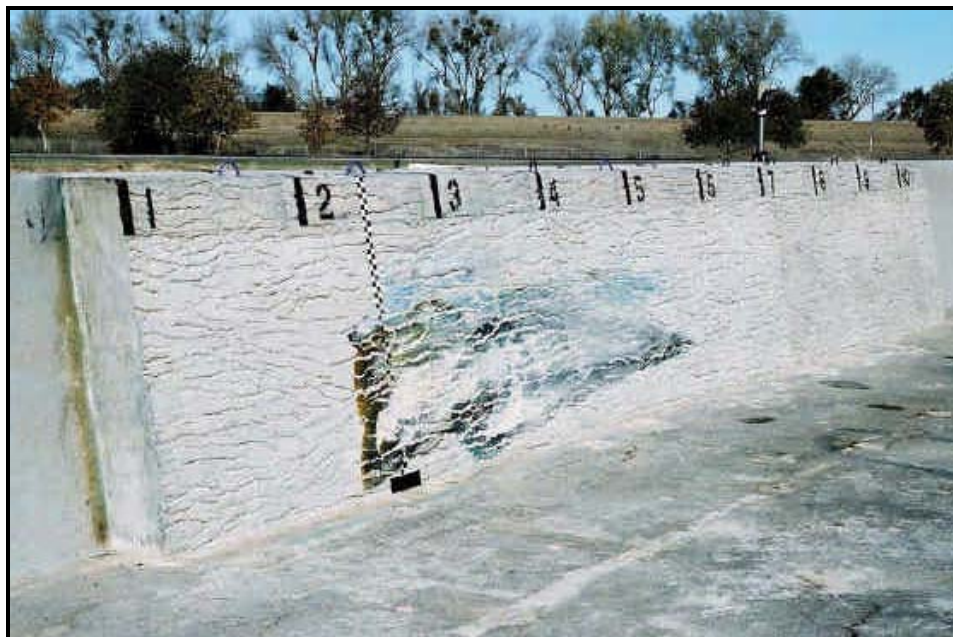
**Figure 9. Fractured Granite Textured Barrier Following Testing**

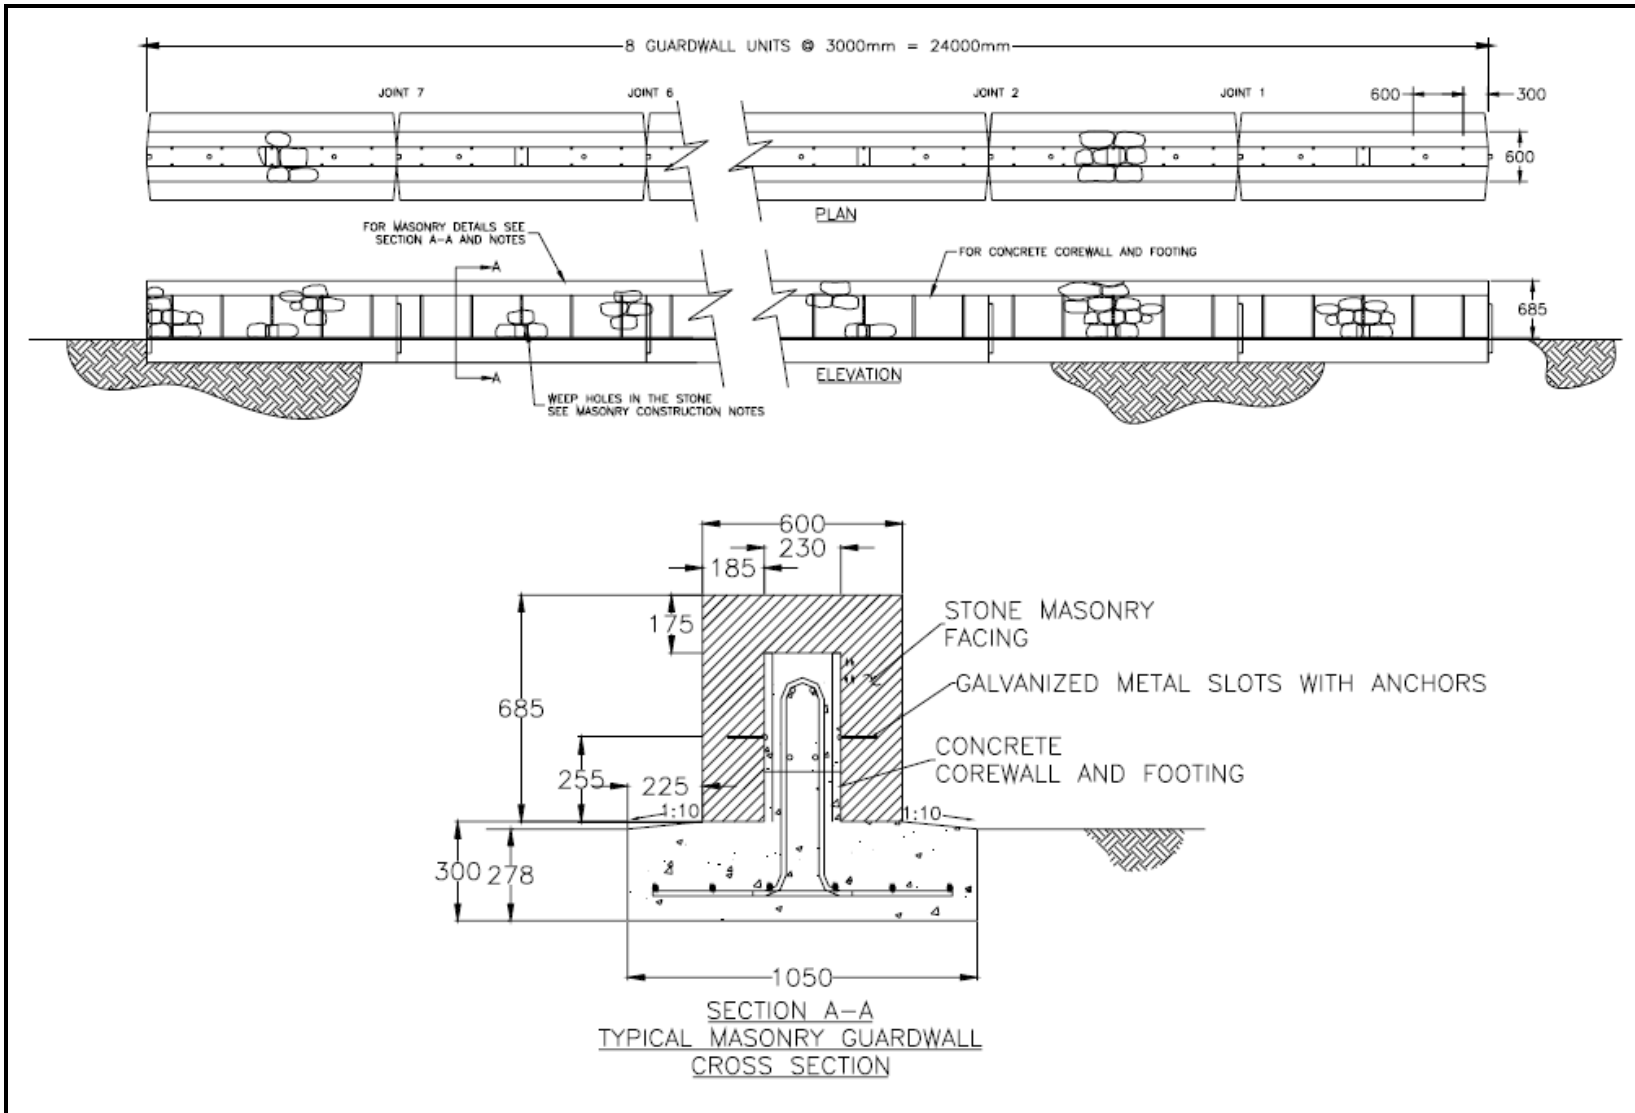
**Figure 12. Layout and Cross Section of Rough Stone Masonry Guardwall**

In 2004, Bullard, Jr. et al. (3) conducted tests (TL-3) on a reinforced precast or cast-in-place concrete stone veneered highway barrier. The assembled barrier used for testing is shown in Figures 10 and 11, the layout is shown in Figure 12, and the test results are provided in Figure A-5.

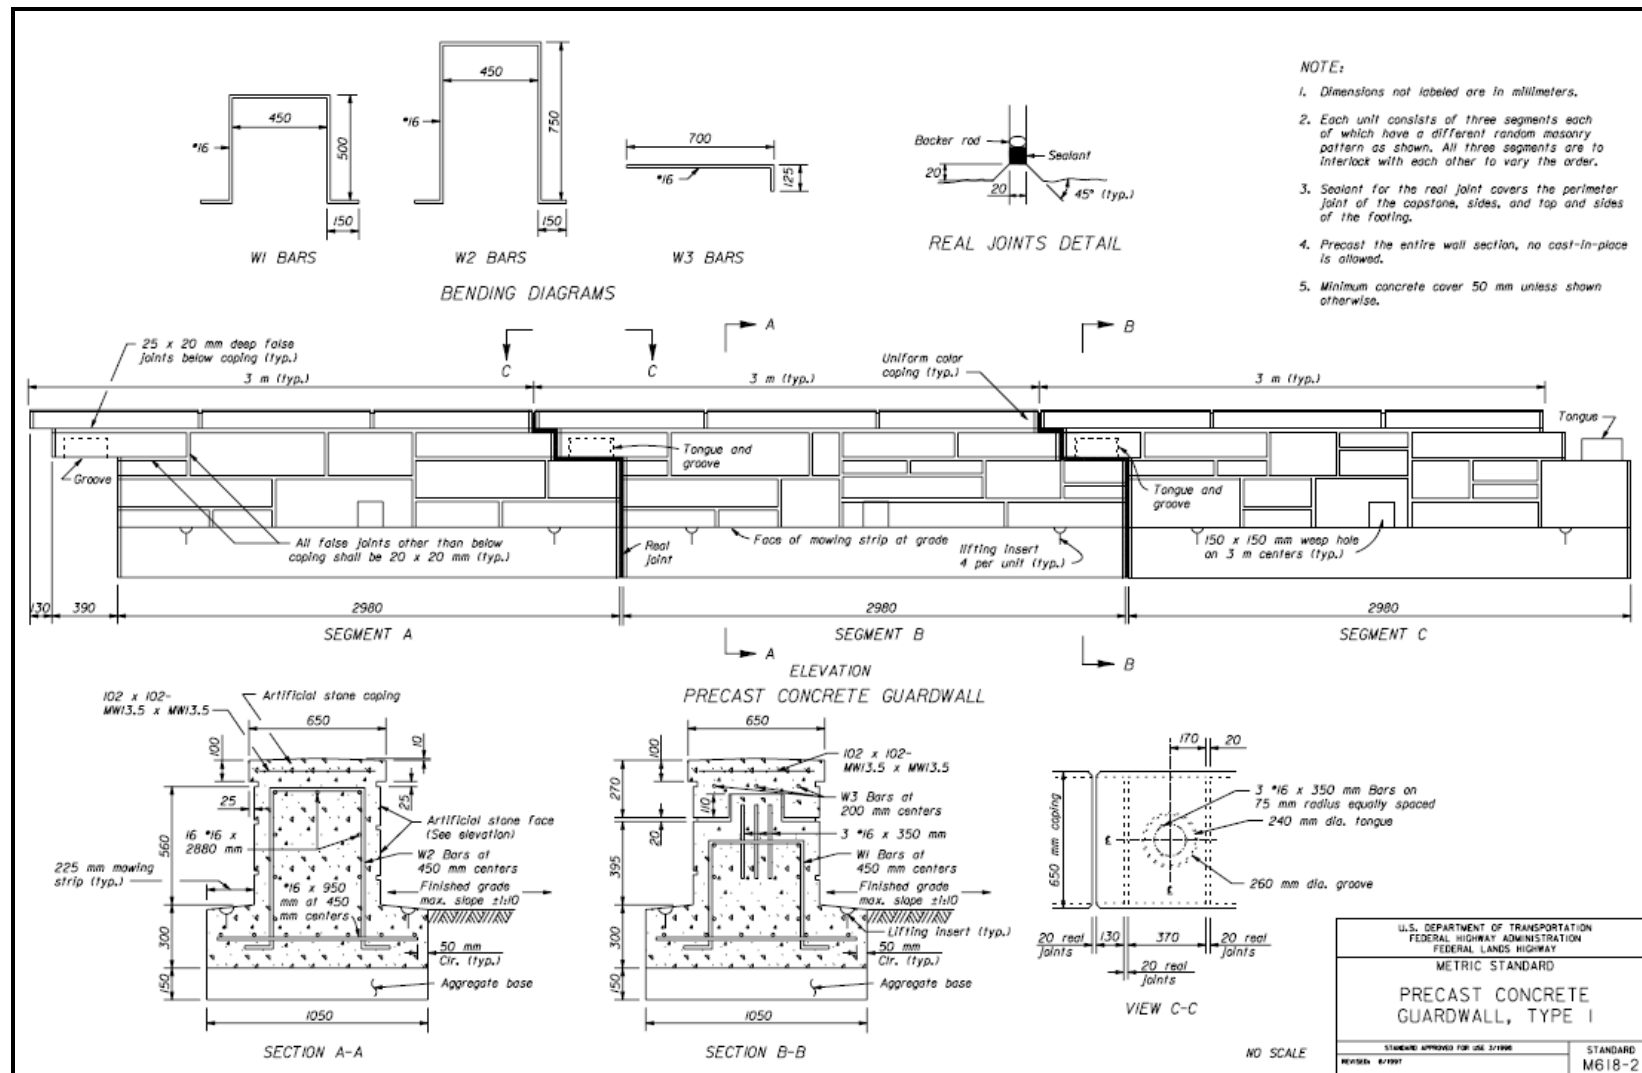
Figure 15. Layout and Cross Section of Pre-cast Concrete Guardwall

This Pre-cast Concrete Guardwall has been crash tested and meets the requirements of NCHRP Report 230 (4). Though never crash tested to TL-3, the FHWA has accepted this guardwall for use on federal highways (5). The assembled barrier in use on a federal highway is shown in Figures 12 and 13, and the layout is shown in Figure 14.

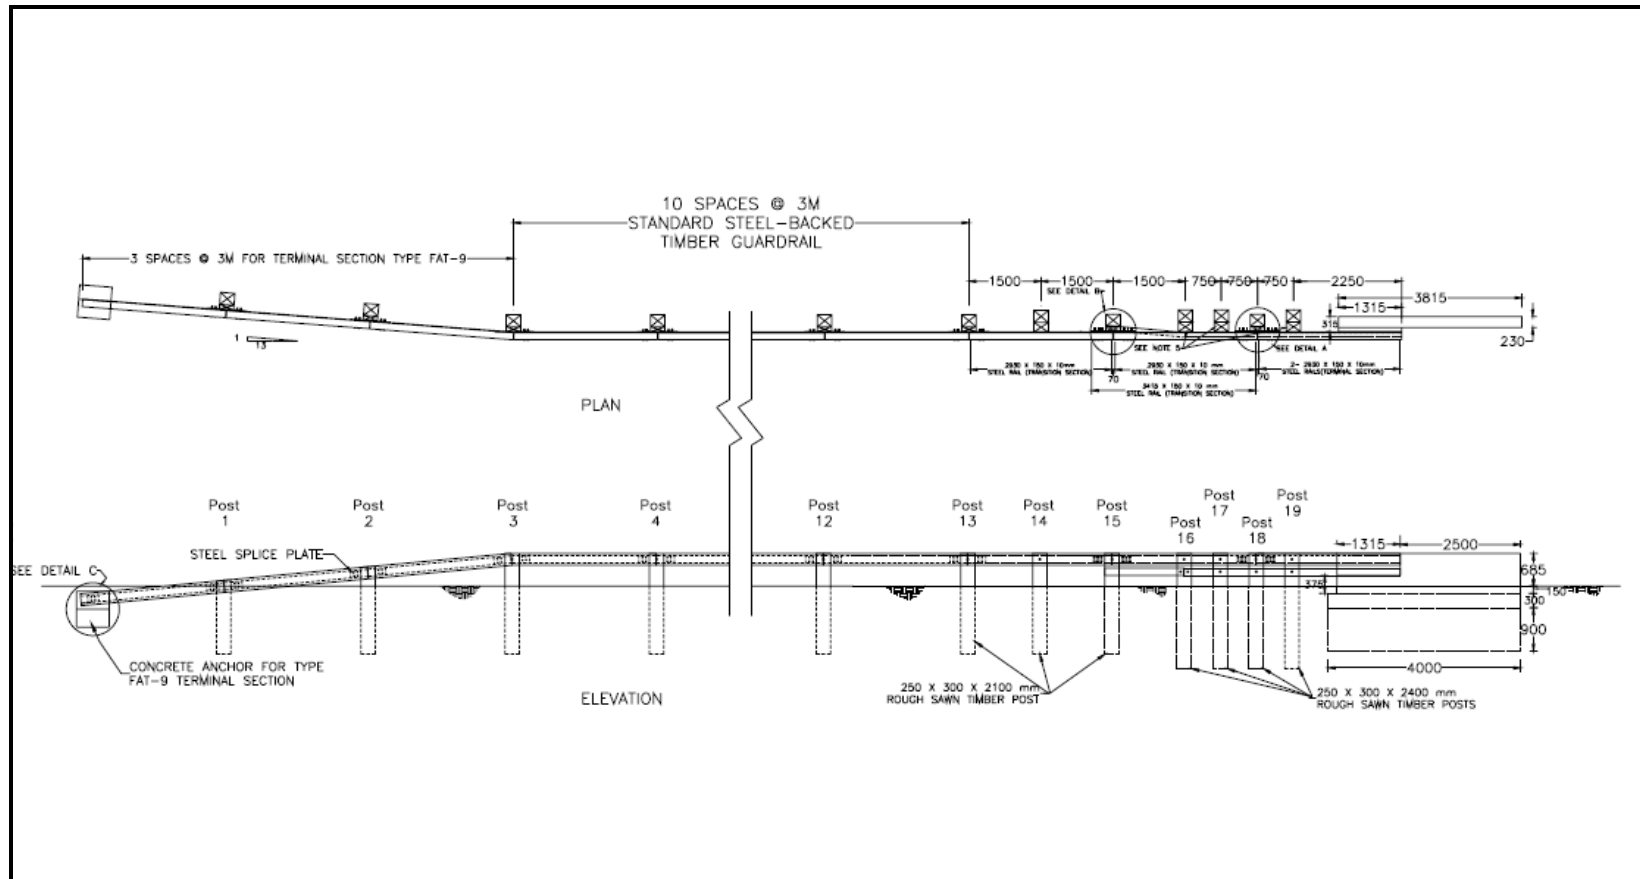
Figure 18. Layout of Type A Steel-Backed Timber Guardrail

In 2004, Bullard, Jr. et al. (3) conducted tests (TL-3) on a steel-backed wood post and wood rail. The assembled guardrail used for testing is shown in Figures 16 and 17, the layout is shown in Figure 18, and the test results are provided in Figure A-6.

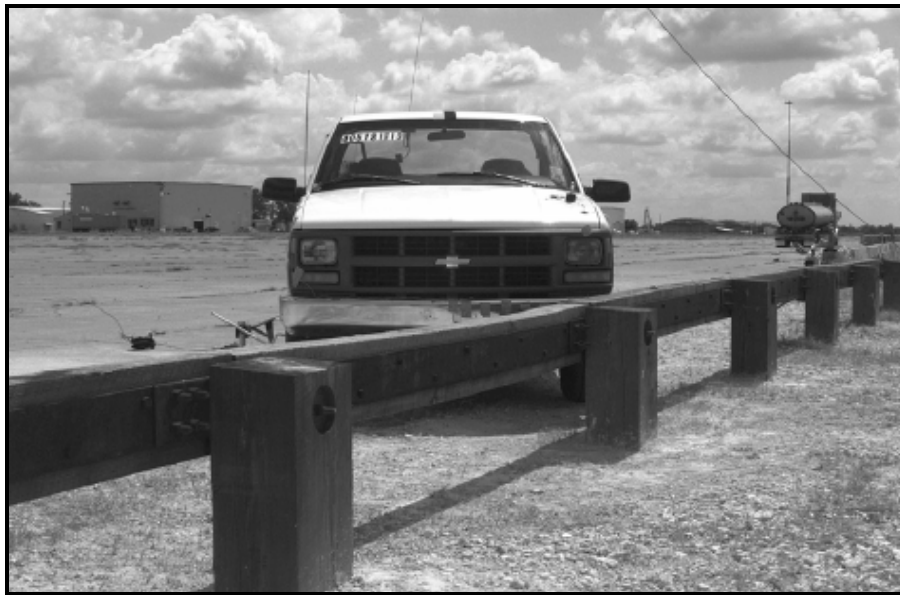
**Figure 20. Field Side View of Type B Steel-Backed Timber Guardrail**

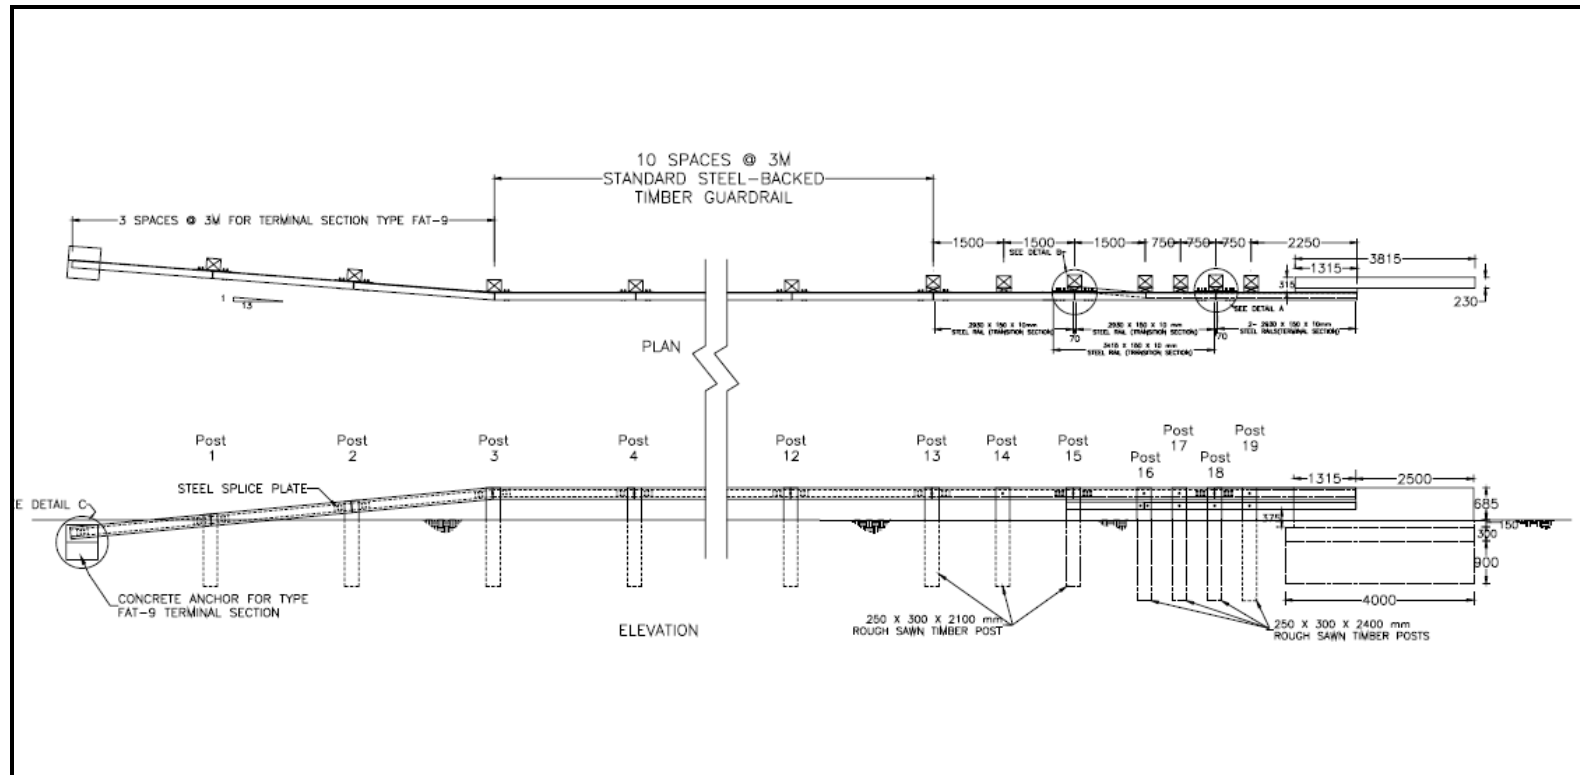
Figure 21. Layout of Type B Steel-Backed Timber Guardrail

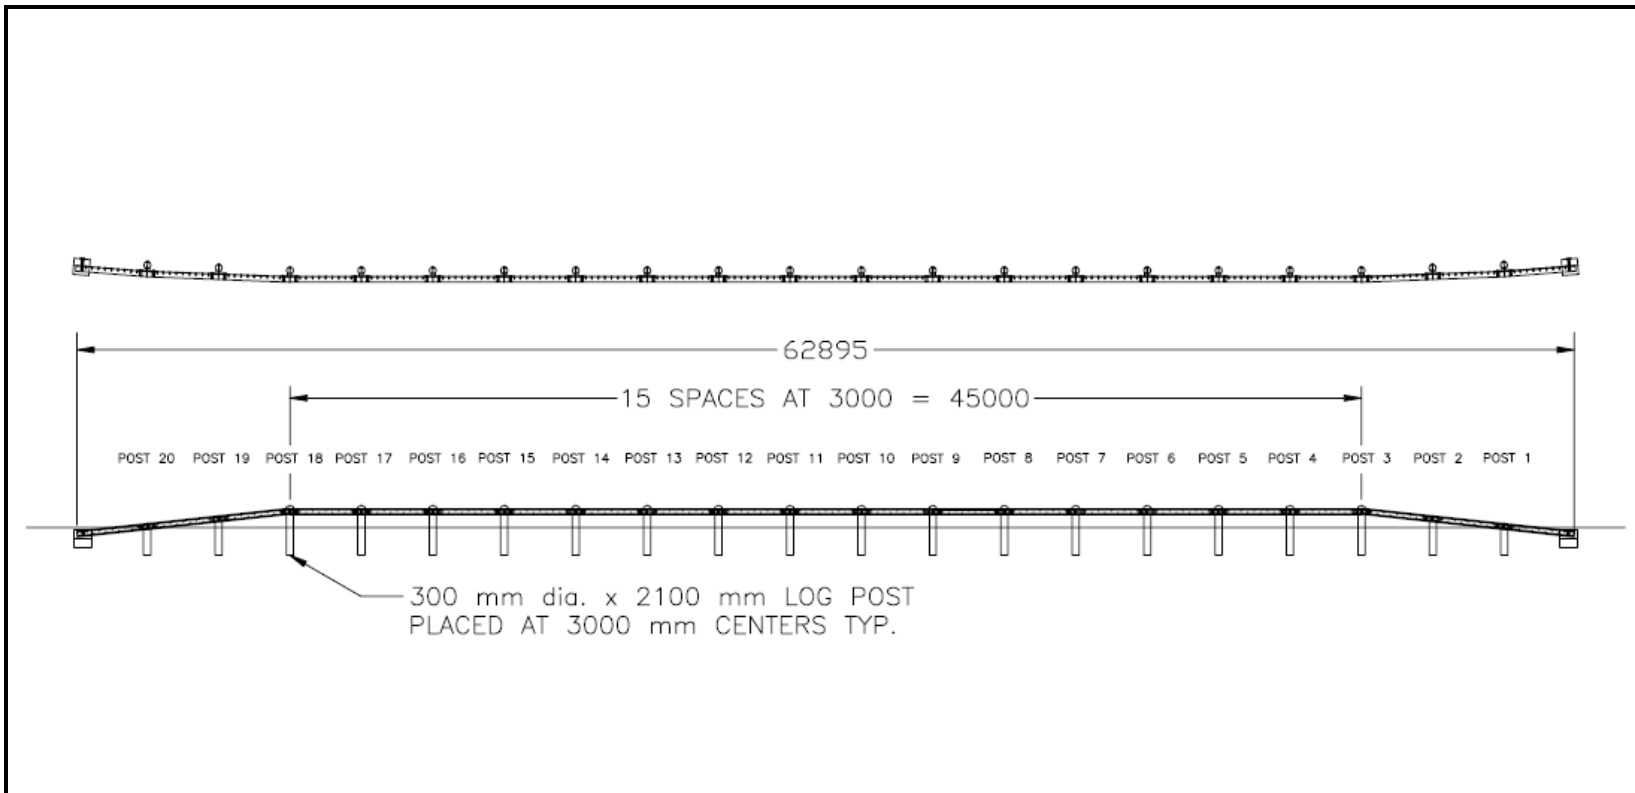
**Figure 24. Layout of Steel-Backed Timber Round Log Rail**

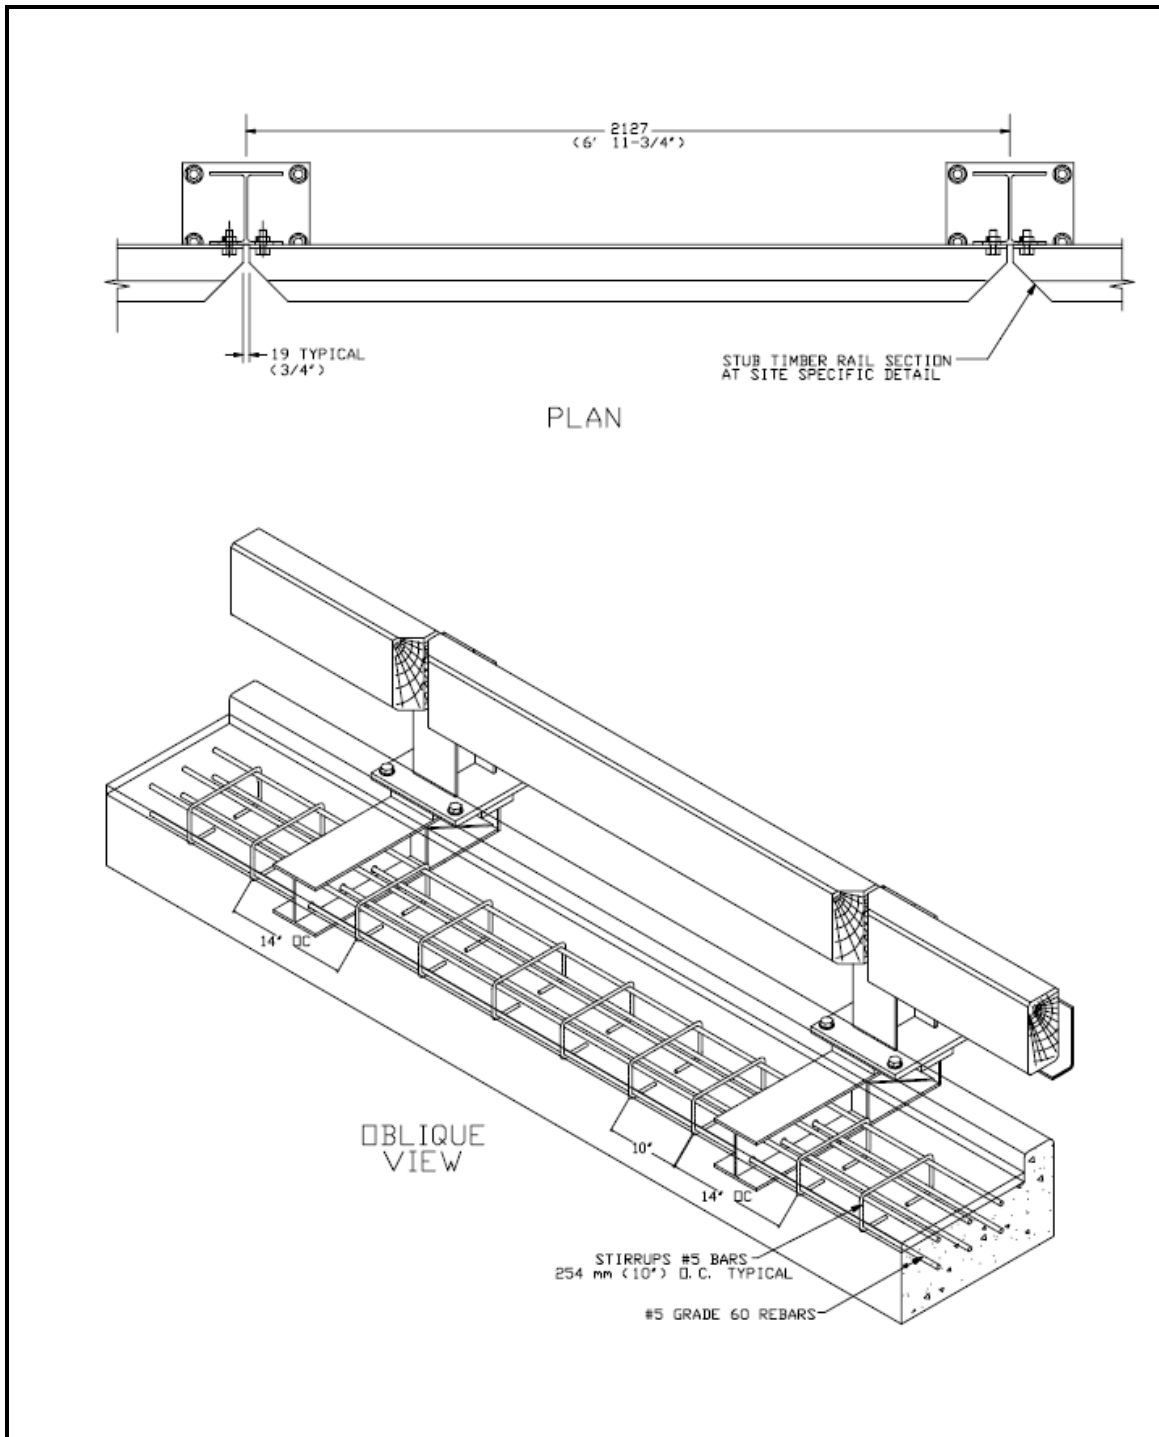
**Figure 27. Plan and Oblique Views of Glacier Removable Rail**

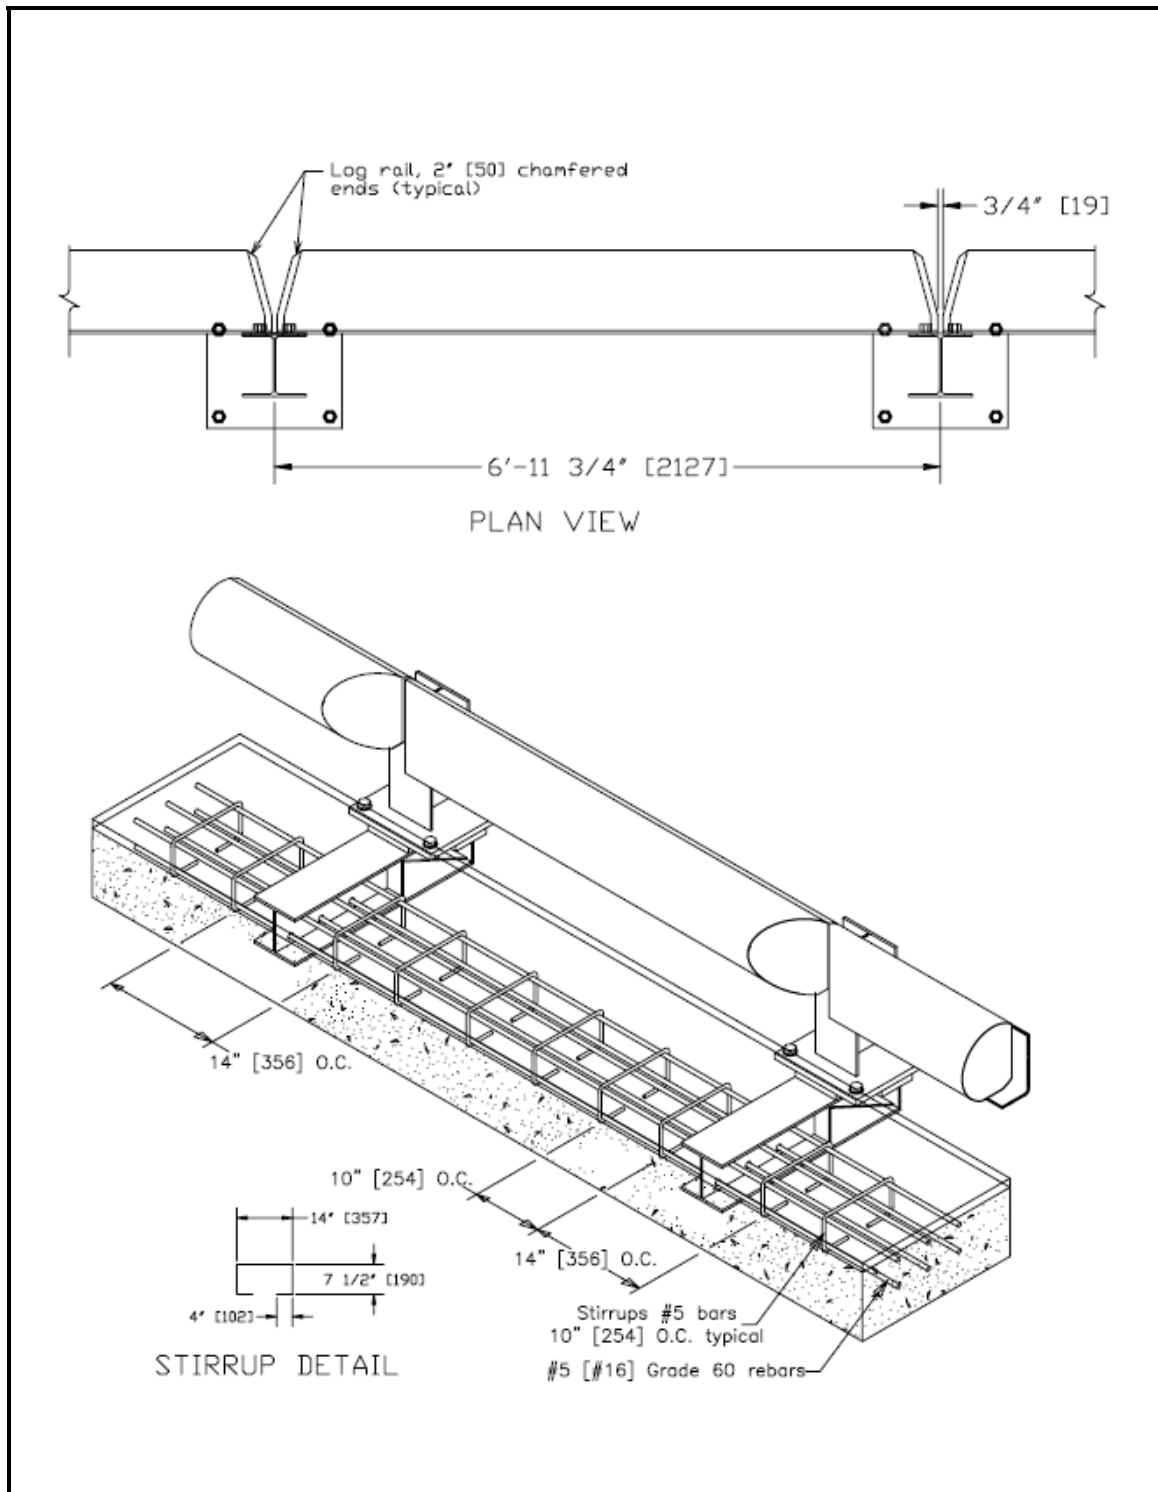
**Figure 30. Plan and Oblique Views of Glacier Removable Rail**

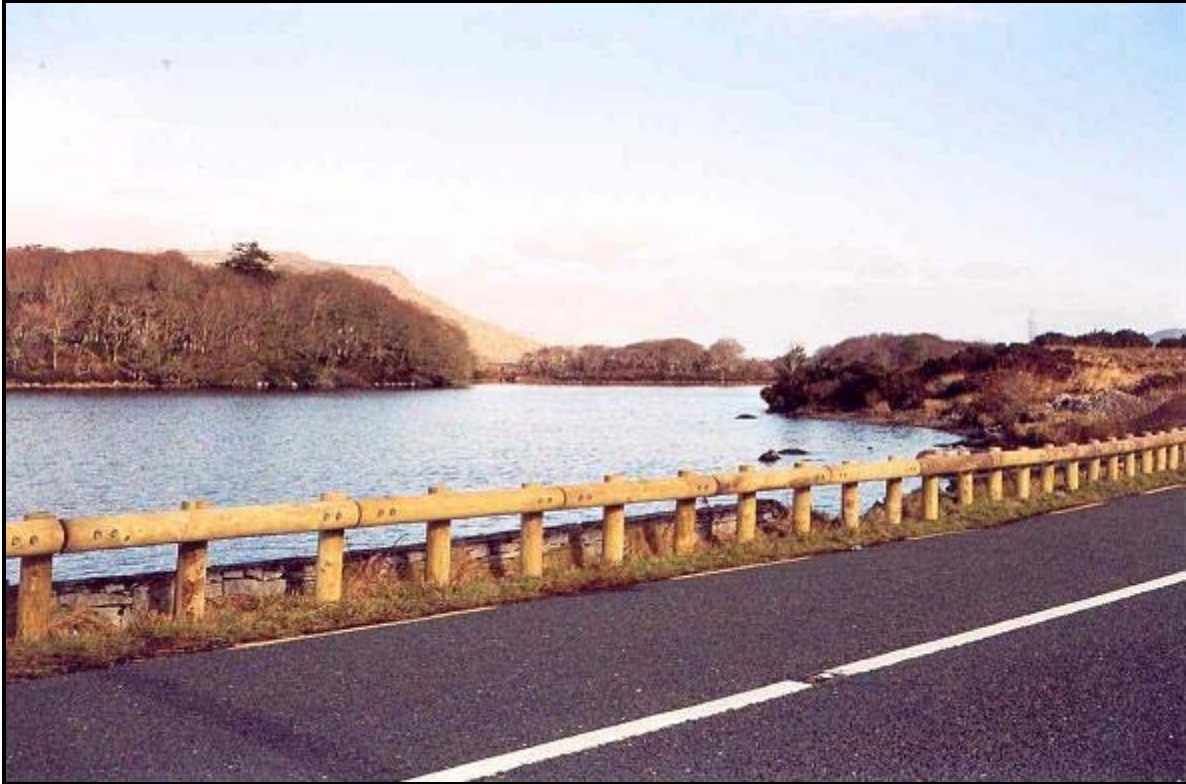
**Figure 34. Ironwood Guardrail in Use on a Federal Highway**

In 1999, Hubbell (7) conducted tests (TL-3) on a composite wood and steel rail system. The assembled guardrail in use on a federal highway is shown in Figures 34, the layout is shown in Figure 35, and the test results are provided in Figures A-16 and A-17.

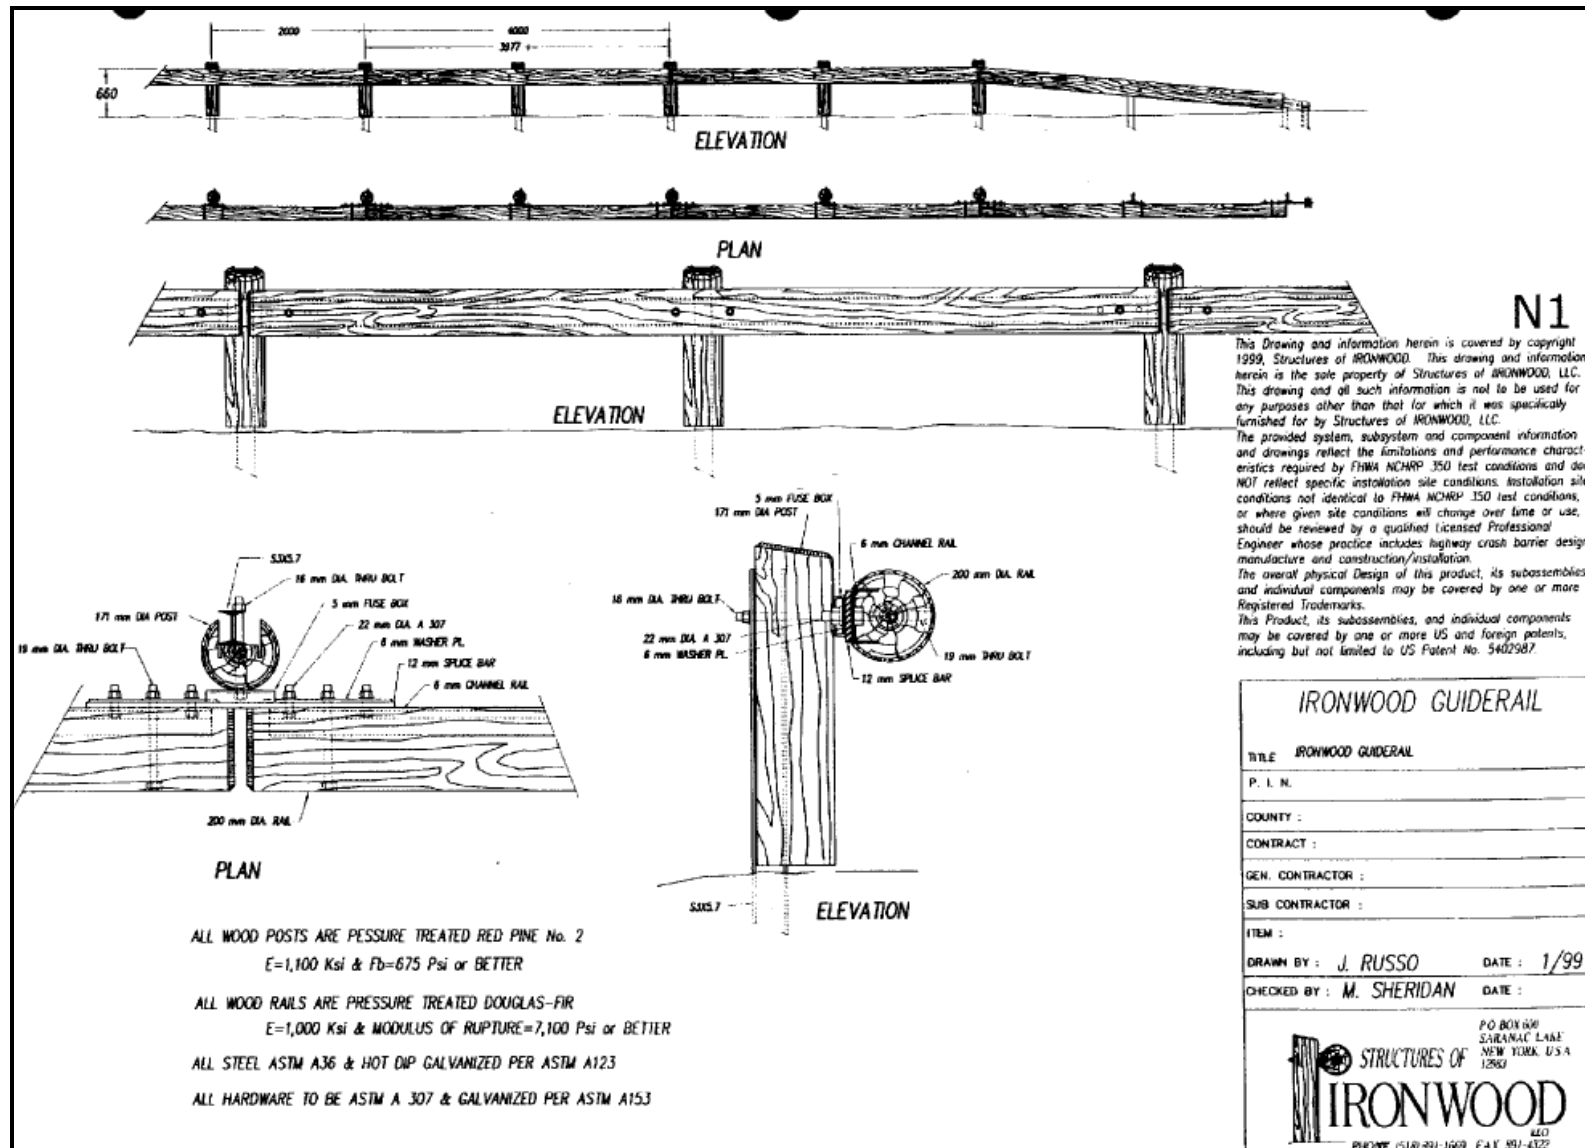
Figure 35. Layout and Cross Section of Ironwood Guardrail

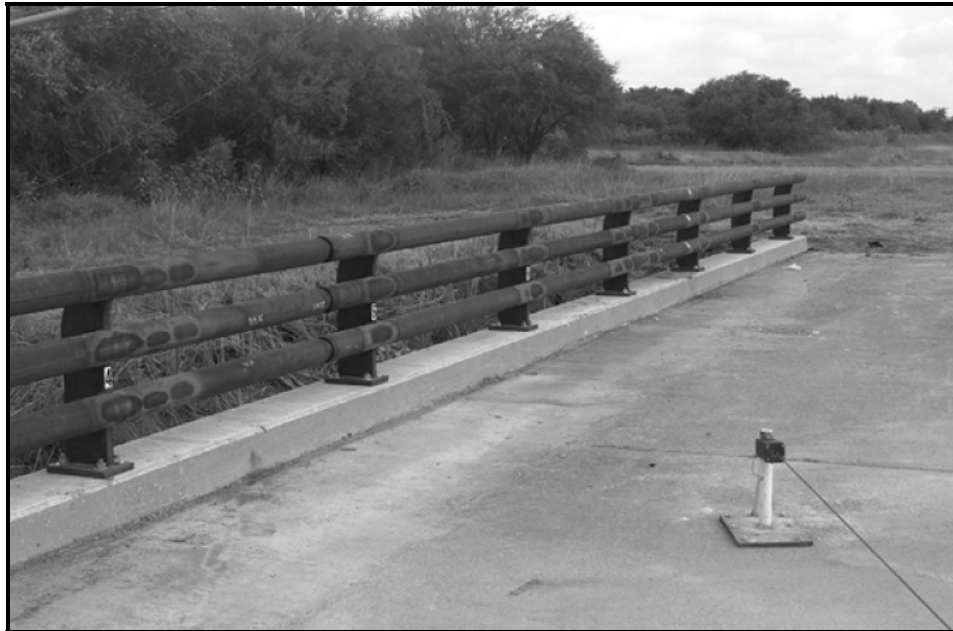
**Figure 36. Traffic Side View of GWMP Bridge Rail**

In 2004, Bullard, Jr. et al. (3) conducted tests (TL-3) on a steel tri-rail mounted on curb bridge rail, which is a bam-and-post system consisting of three steel pipe rail elements welded to flat steel plate posts. The assembled bridge rail used for testing is shown in Figure 36, the layout is shown in Figure 37, and the test results are provided in Figure A-18.

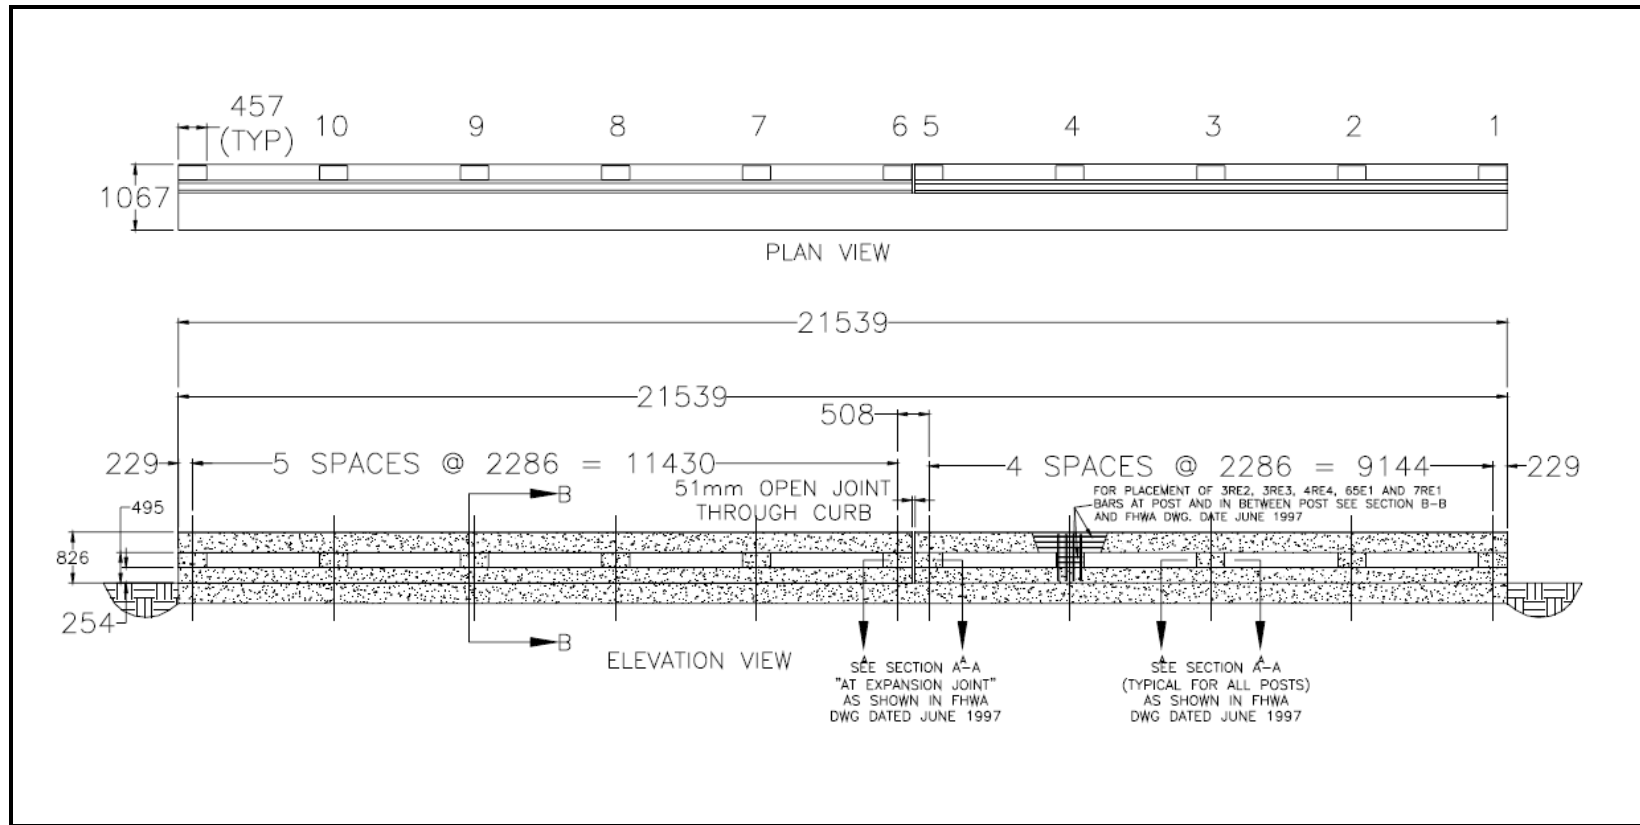
**Figure 40. Layout of Natchez Trace Bridge Rail**

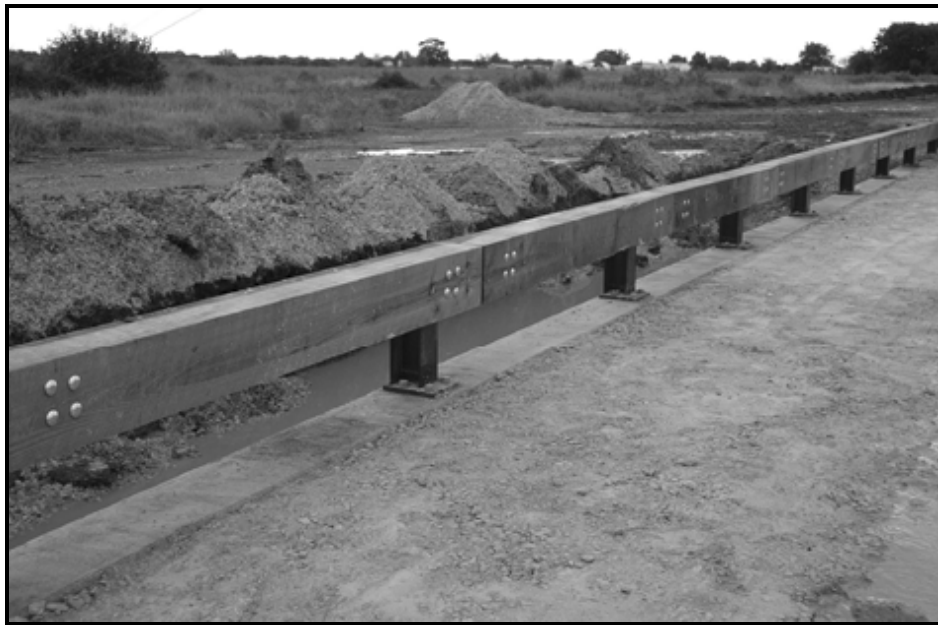
**Figure 41. Traffic Side View of Tubular Steel-Backed Timber Bridge Rail**

In 2004, Bullard, Jr. et al. (3) conducted tests (TL-3) on a tubular steel-backed timber beam-and-post railing system. The assembled bridge rail used for testing is shown in Figures 41 and 42, the layout is shown in Figure 43, and the test results are provided in Figure A-21.

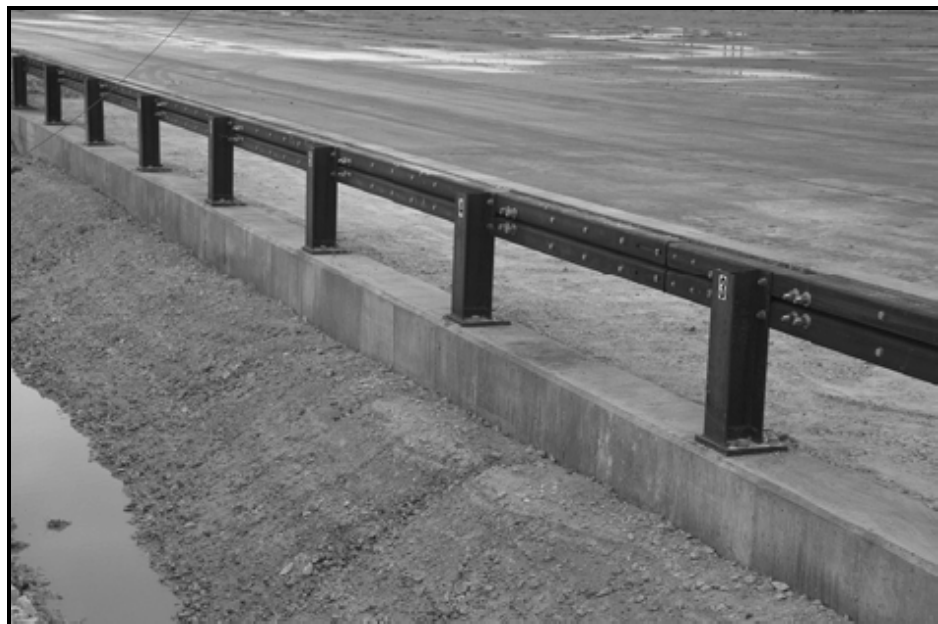
**Figure 42. Field Side View of Tubular Steel-Backed Timber Bridge Rail**
