## **AESTHETIC BARRIER LITERATURE REVIEW**

### **MIDWEST ROADSIDE SAFETY FACILITY**

MwRSF Research Report No. TRP-03-197-07 (Revised)

April 10, 2008

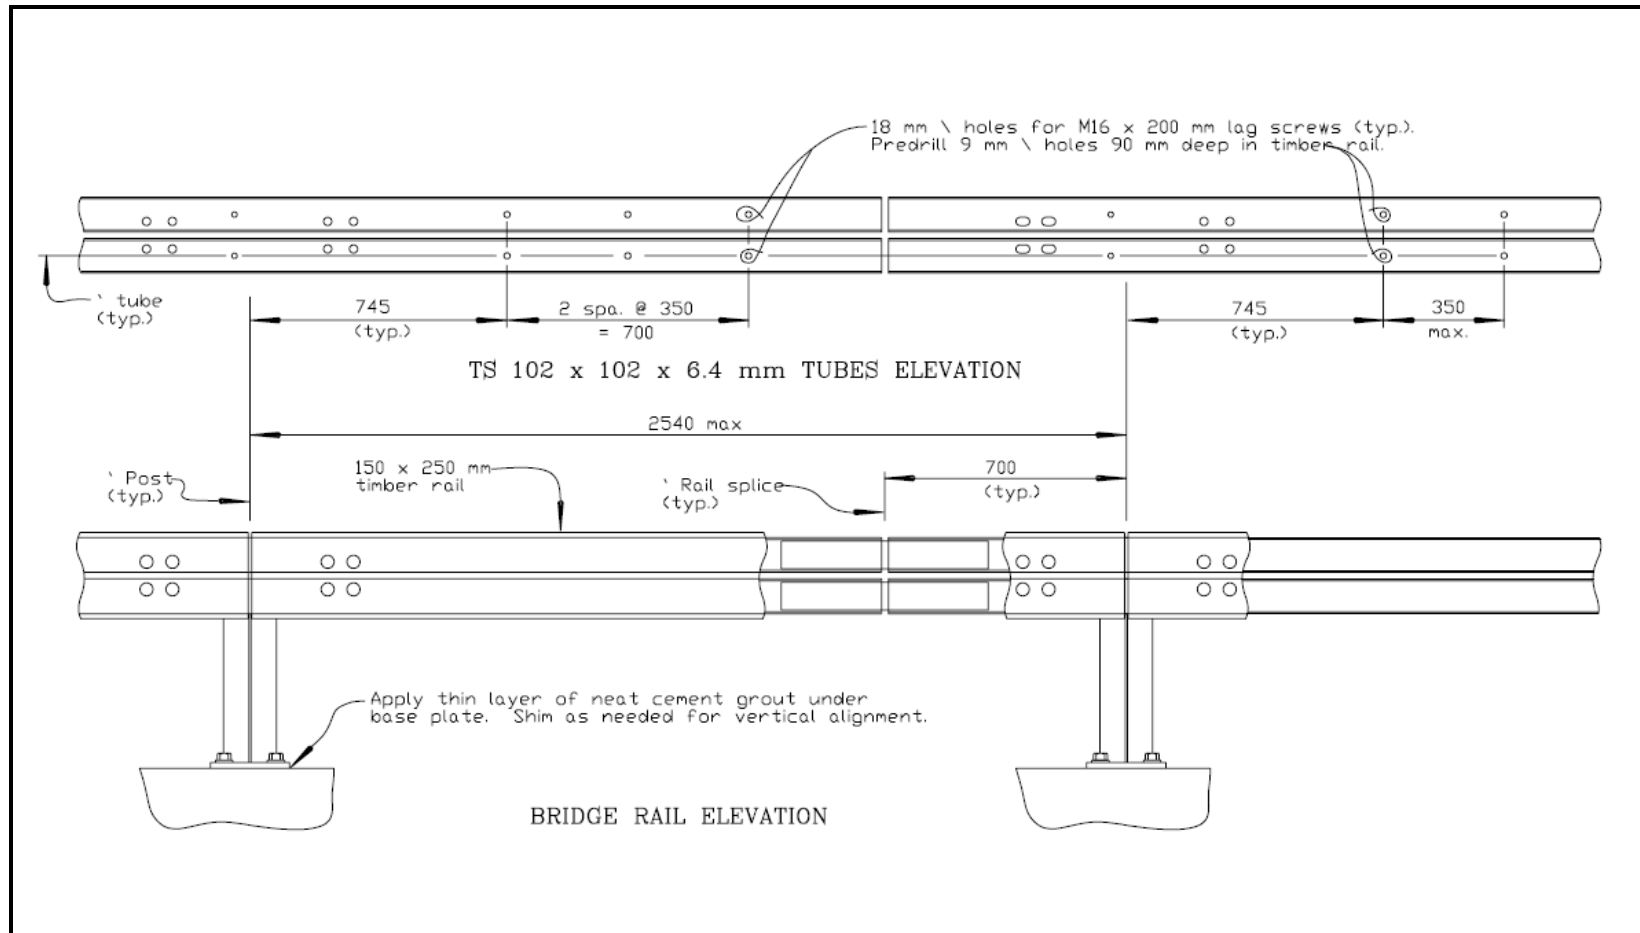
**Figure 43. Layout of Tubular Steel-Backed Timber Bridge Rail**

In 2004, Bullard, Jr. et al. (3) conducted tests (TL-3) on a tubular steel-backed timber beam-and-post railing system. The assembled bridge rail used for testing is shown in Figures 41 and 42, the layout is shown in Figure 43, and the test results are provided in Figure A-21.

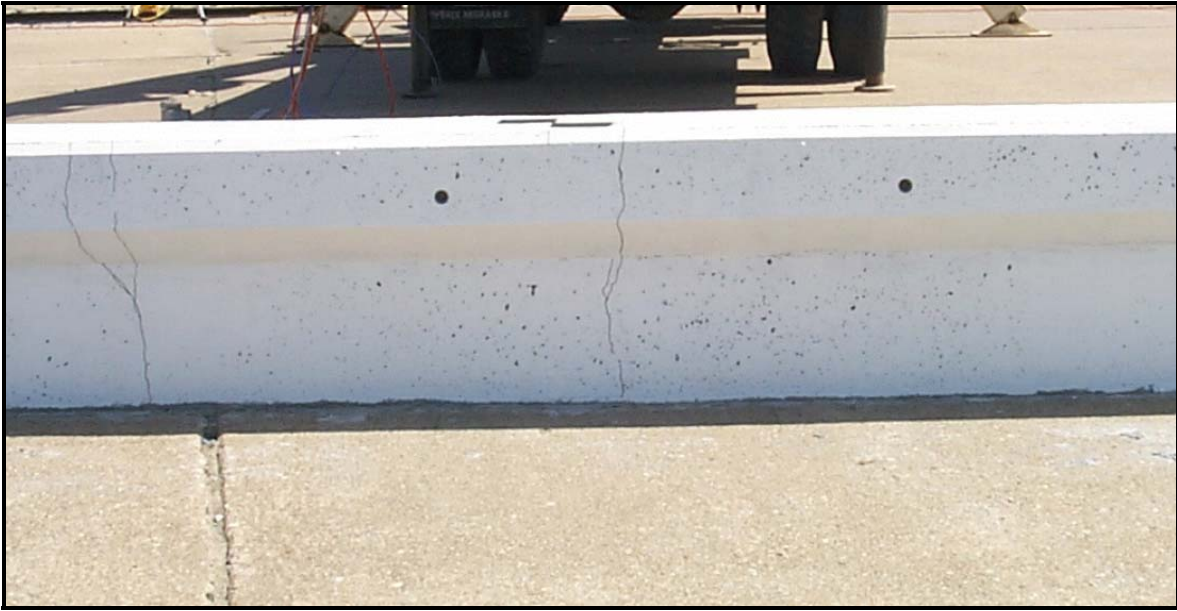
**Figure 44. NDOR Low-Profile Bridge Rail**

In 2002, Polivka et al. ([15](#)) conducted tests (TL-2) on a reinforced concrete bridge railing system. The assembled bridge rail used for testing is shown in Figures 44 and 45, the layout is shown in Figure 46, and the test results are provided in Figures A-22.

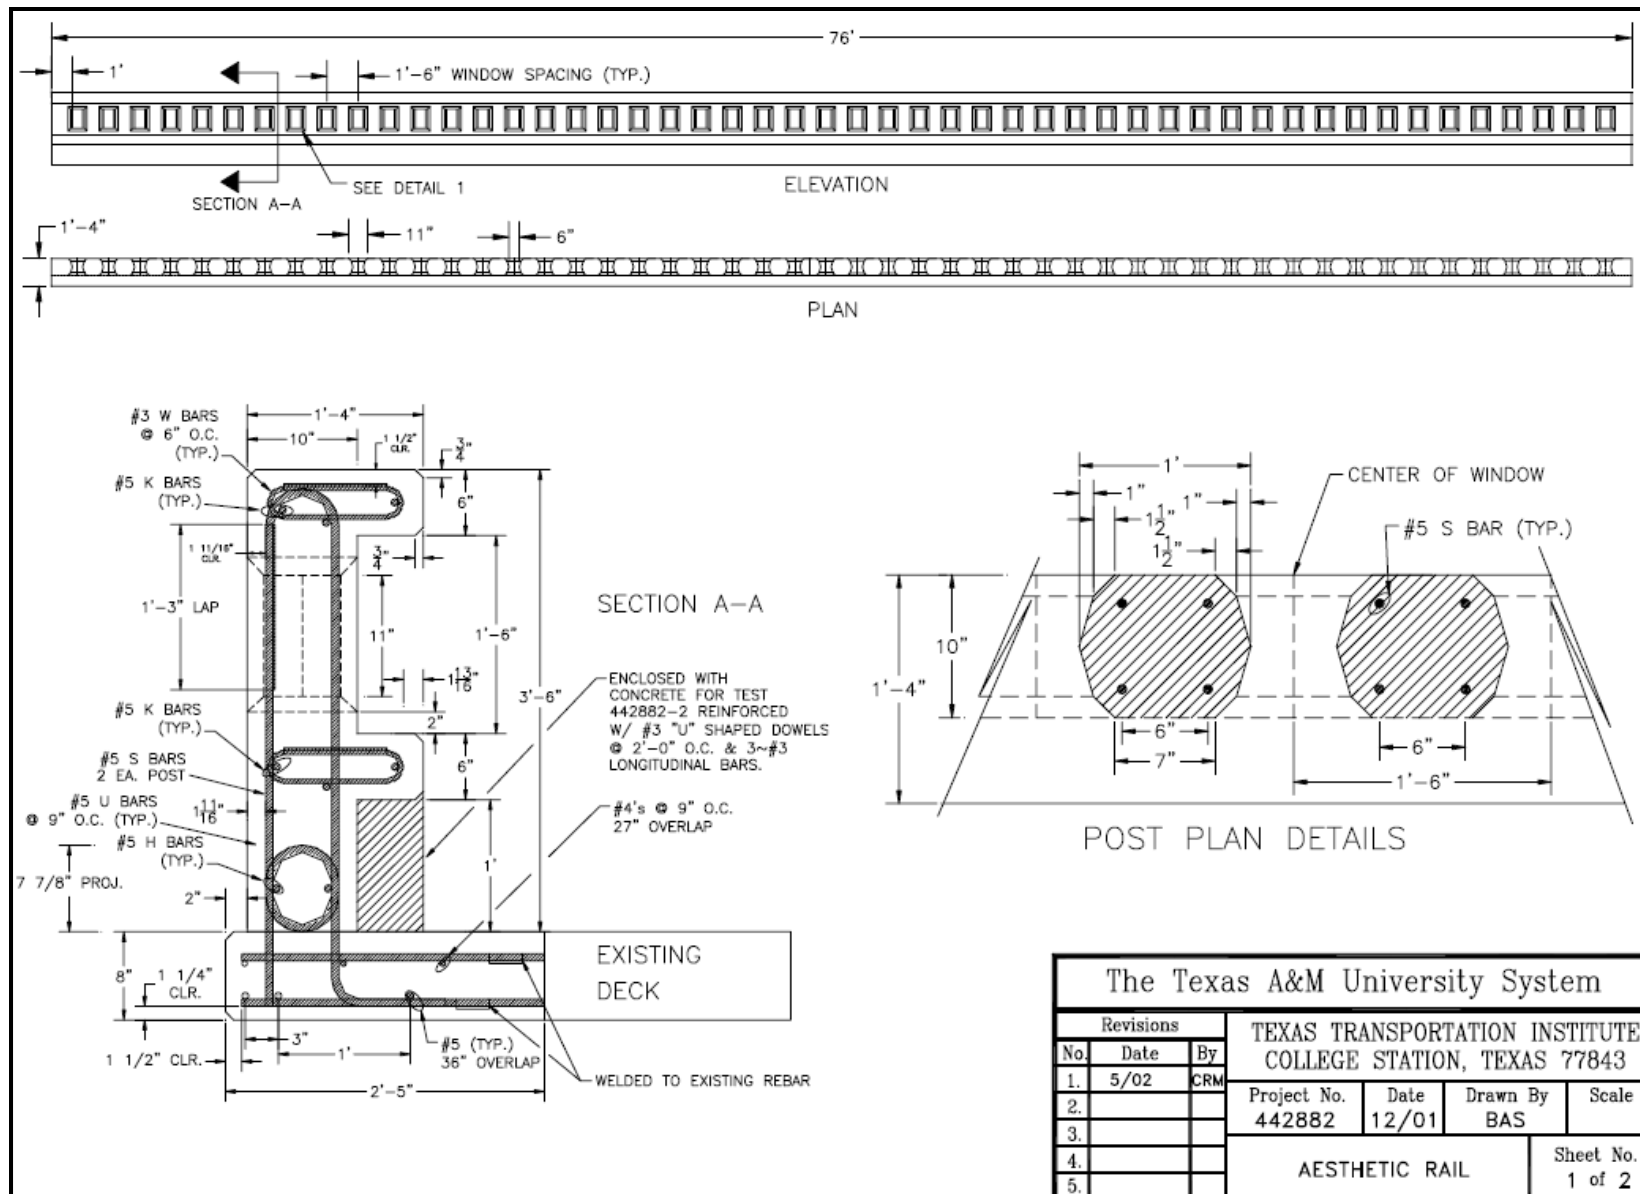
Figure 52. Layout of TxDOT F411 Bridge Rail

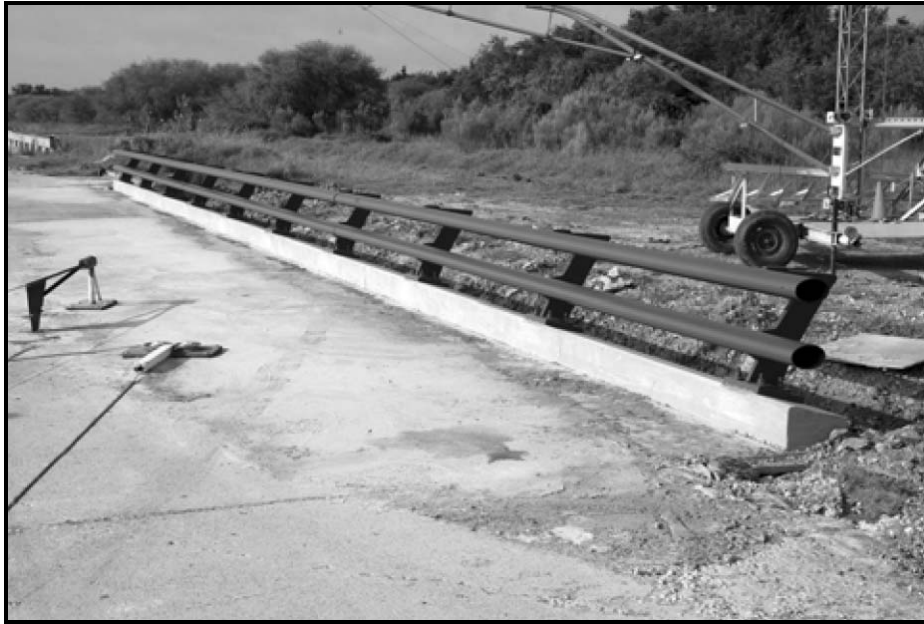
**Figure 53. TxDOT T77 Bridge Rail**

In 2002, Bullard, Jr. et al. (9) conducted tests (TL-3) on an aesthetic tubular steel bridge railing system. The assembled bridge rail used for testing is shown in Figures 53 and 54, the layout is shown in Figure 55, and the test results are provided in Figures A-26 and A-27.

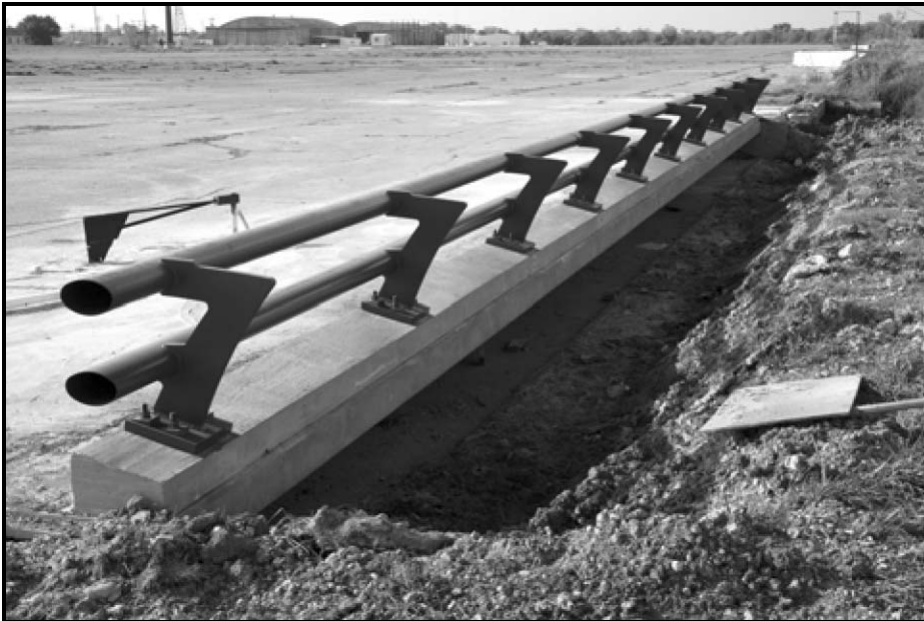
**Figure 54. TxDOT T77 Bridge Rail**

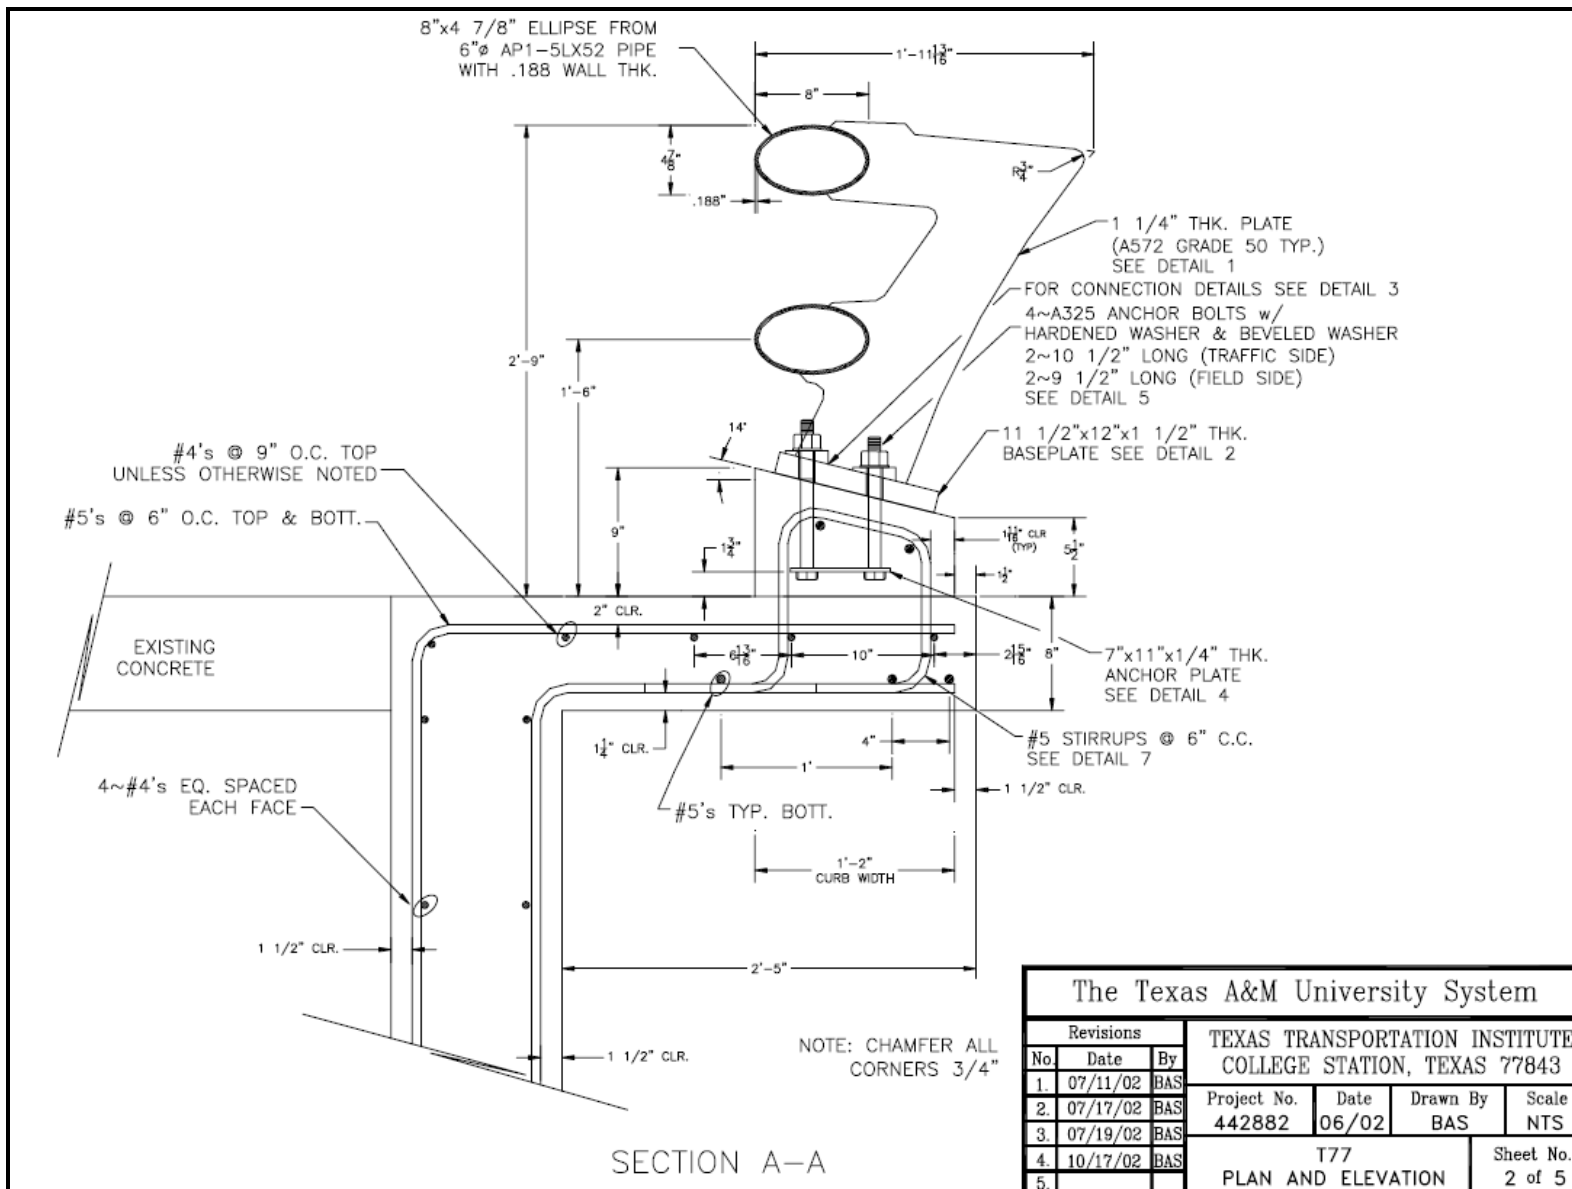
Figure 55. Layout of TxDOT T77 Bridge Rail

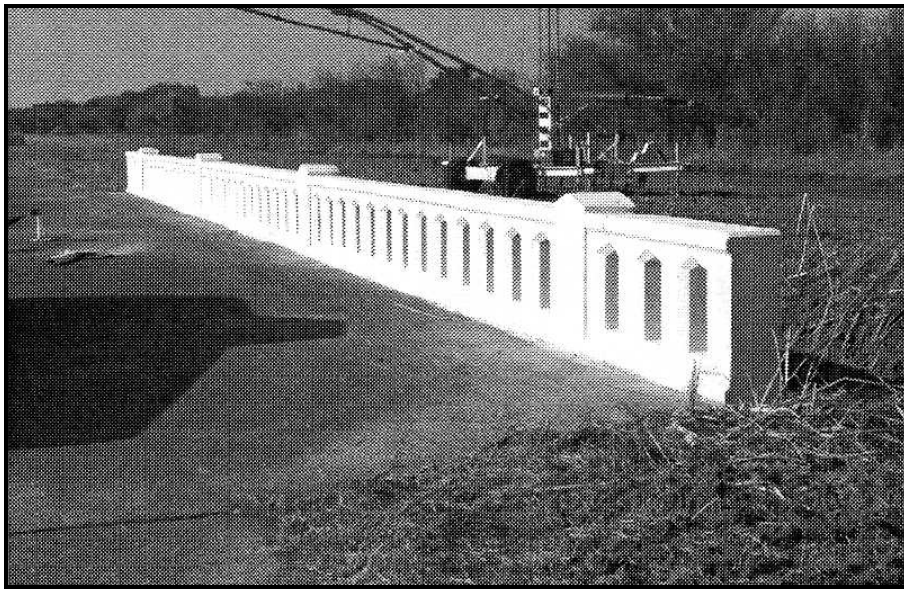
**Figure 56. TxDOT T411 Bridge Rail**

In 1998, Buth et al. (10) conducted tests (TL-3) on an aesthetic concrete bridge railing system. The assembled bridge rail used for testing is shown in Figures 56 and 57, the layout is shown in Figure 58, and the test results are provided in Figures A-28.

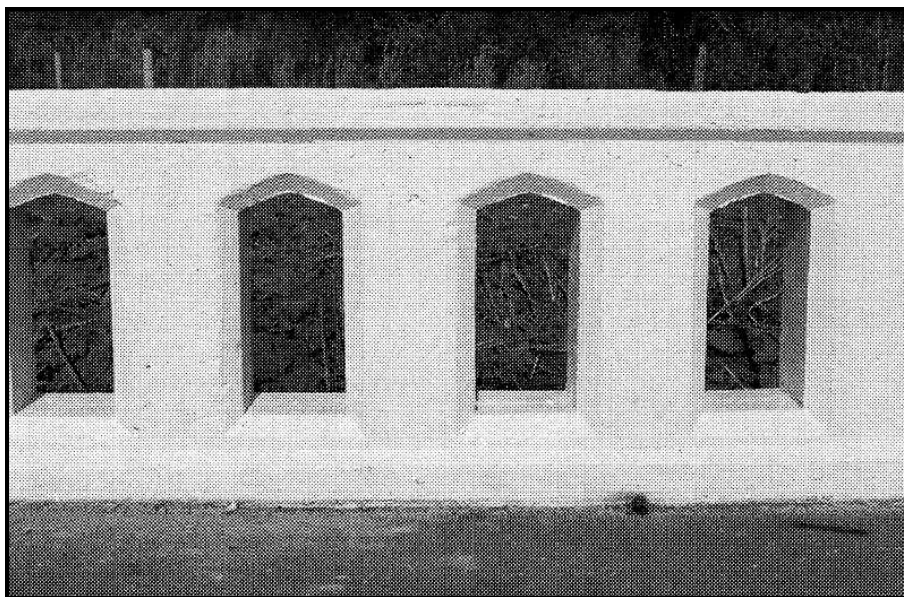
**Figure 57. TxDOT T411 Bridge Rail**

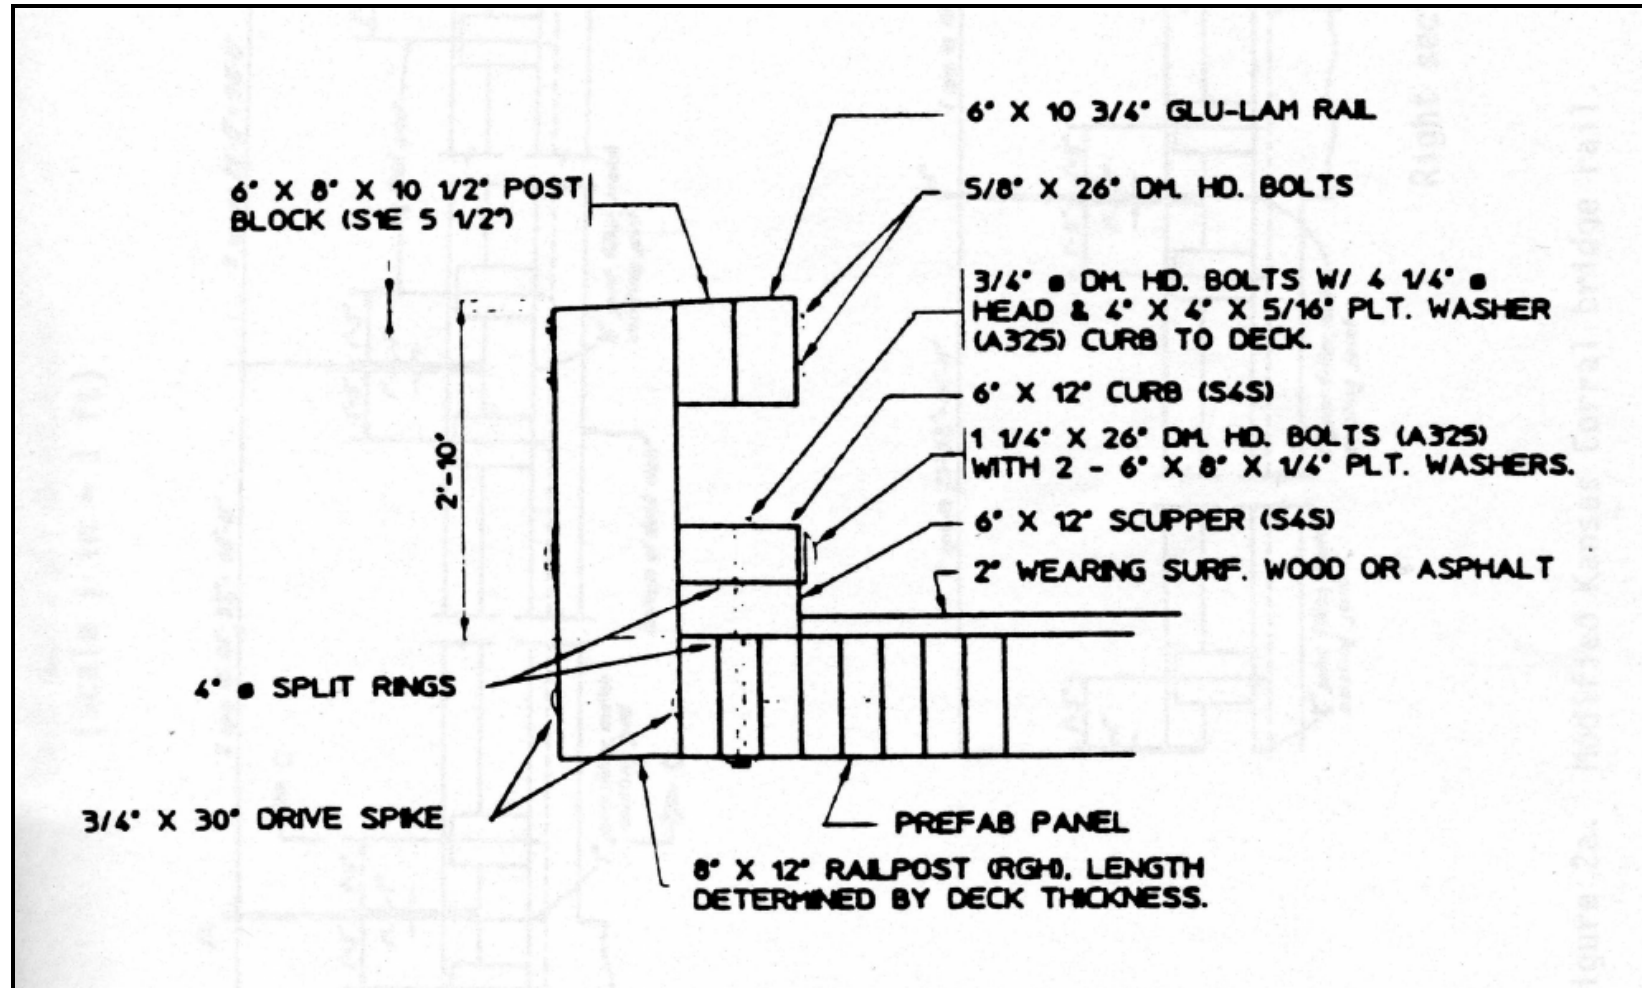
Figure 61. Cross Section of Forest Service Glulam Bridge Rail

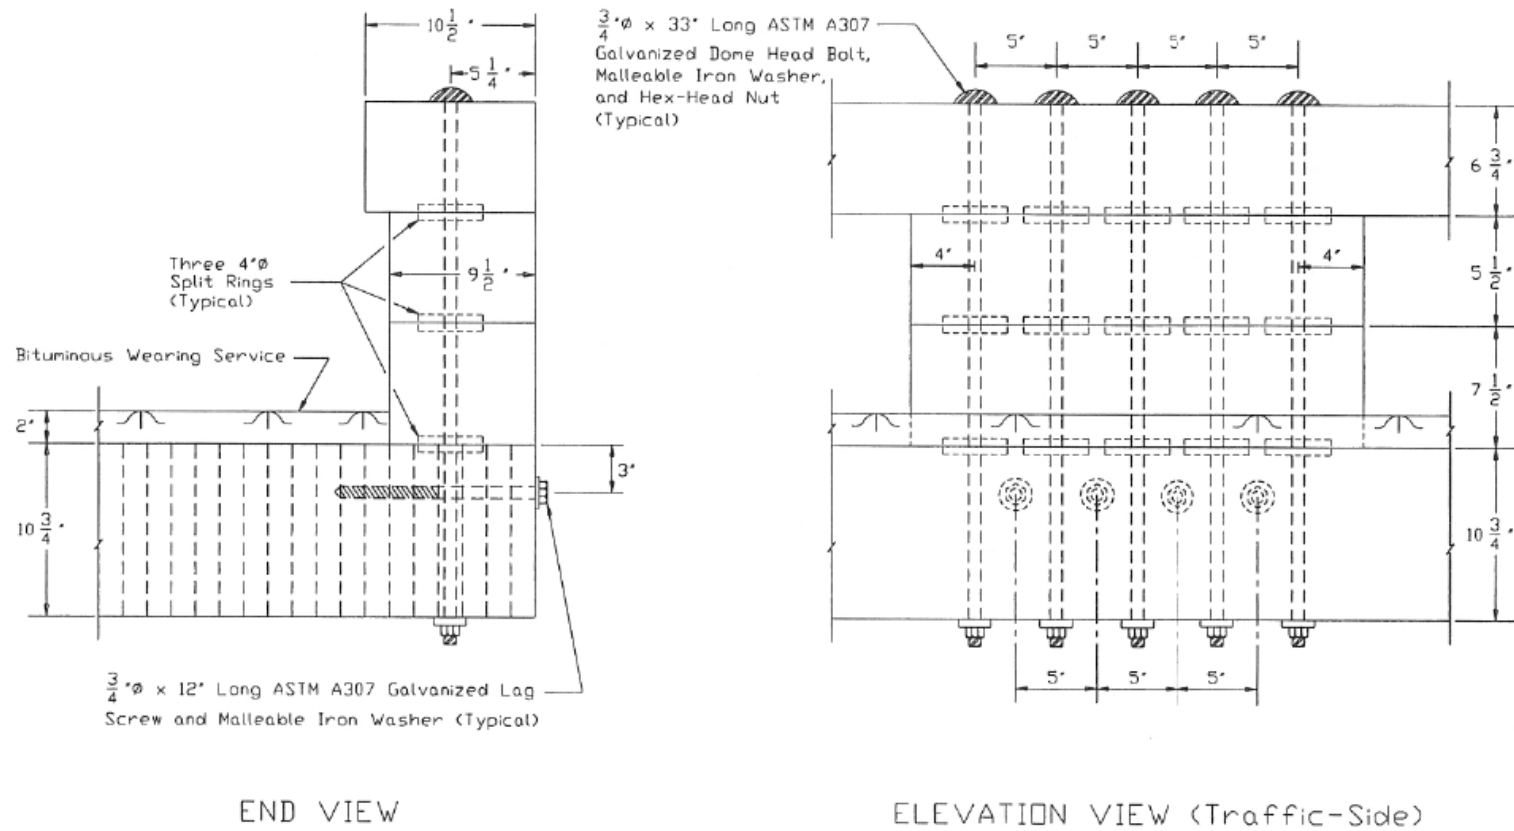
**Figure 64. Cross Section of Curb-Type Glulam Bridge Rail**

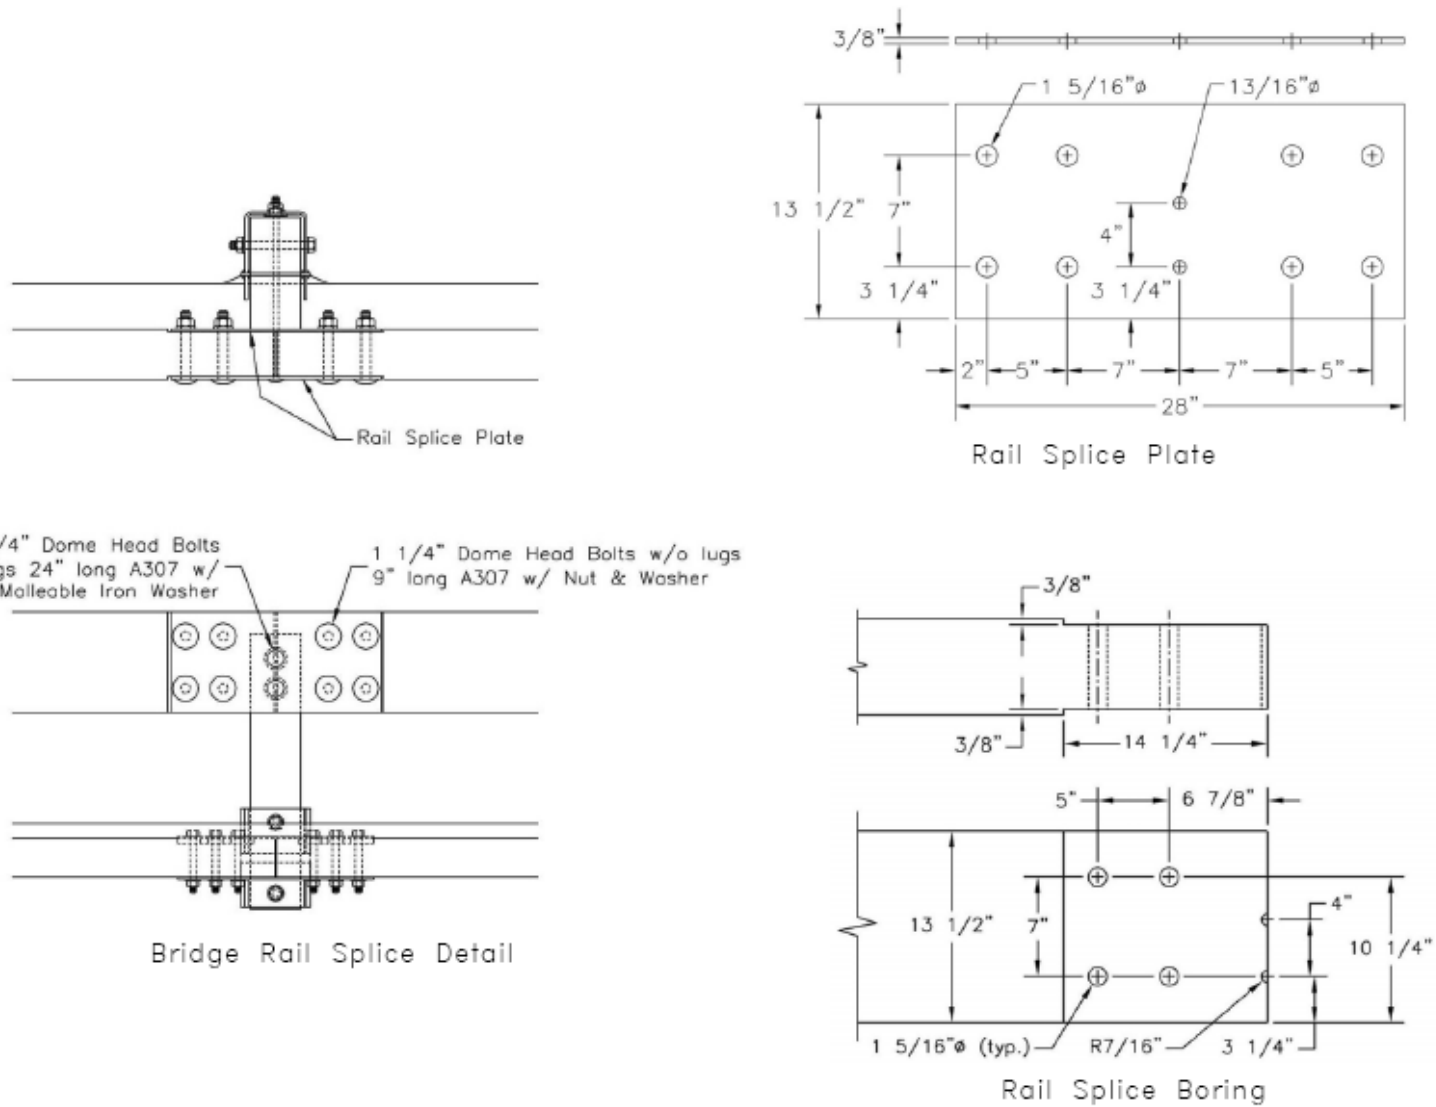
Figure 67. Splice Details of FPL Glulam Bridge Rail

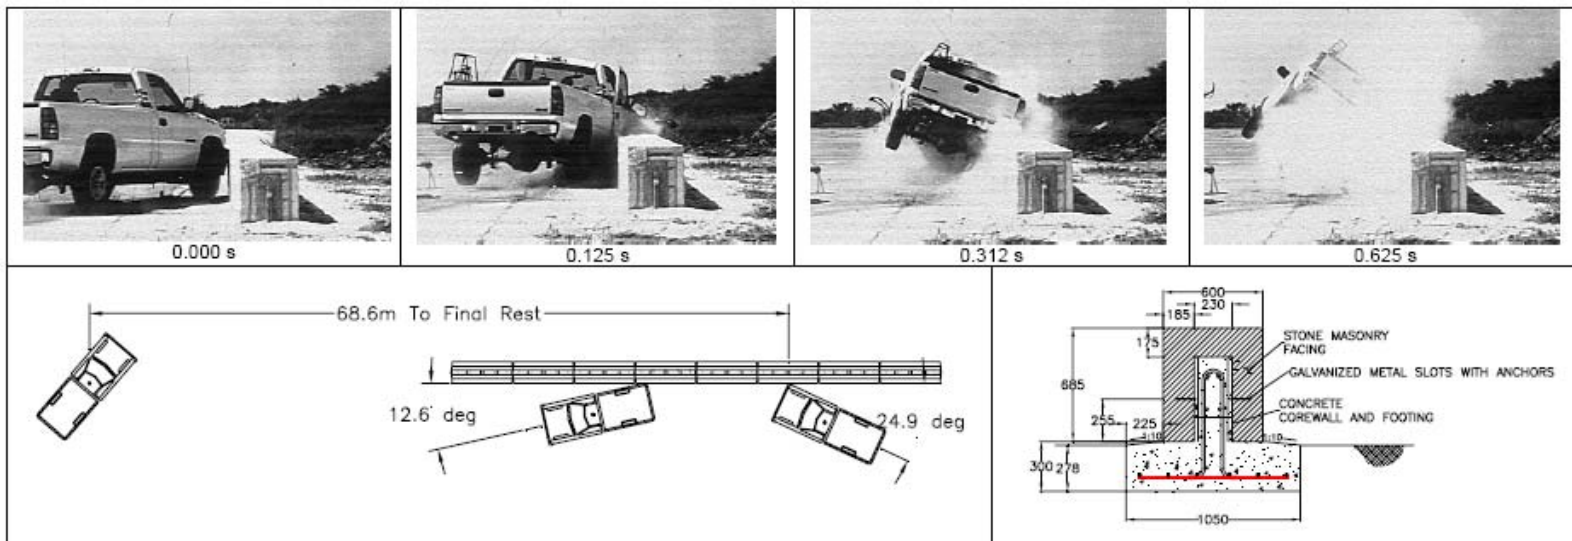
Figure A-5. Rough Stone Masonry Guardwall

Test Agency ..... Texas Transportation Institute  
 Test No. .... 405181-1  
 Date ..... 6/29/00
