ANALYSIS, DESIGN, AND DYNAMIC EVALUATION OF A TL-2 ROUGH STONE MASONRY GUARDWALL

MIDWEST ROADSIDE SAFETY FACILITY (MwRSF)

MwRSF Report No. TRP-03-217-09

May 6, 2009

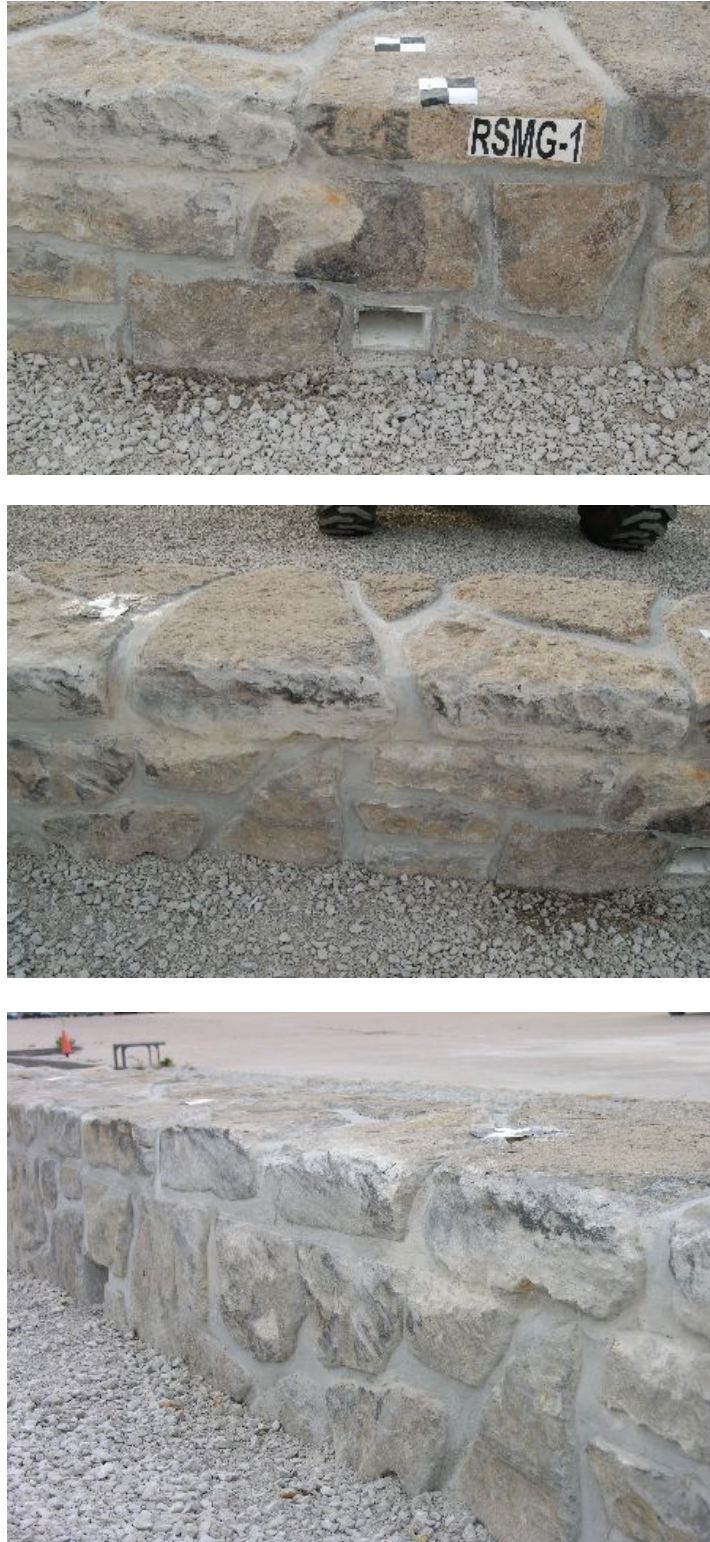
Figure 48. System Damage, Test No. RSMG-1

Damage to the barrier was minimal, as shown in Figures 47 and 48. Damage consisted only of contact marks along the barrier. Contact marks were found beginning at impact and continuing downstream for 141 in. (3.58 m). The contact marks extended from the top to the bottom of the barrier for the first 98 in. (2.49 m).

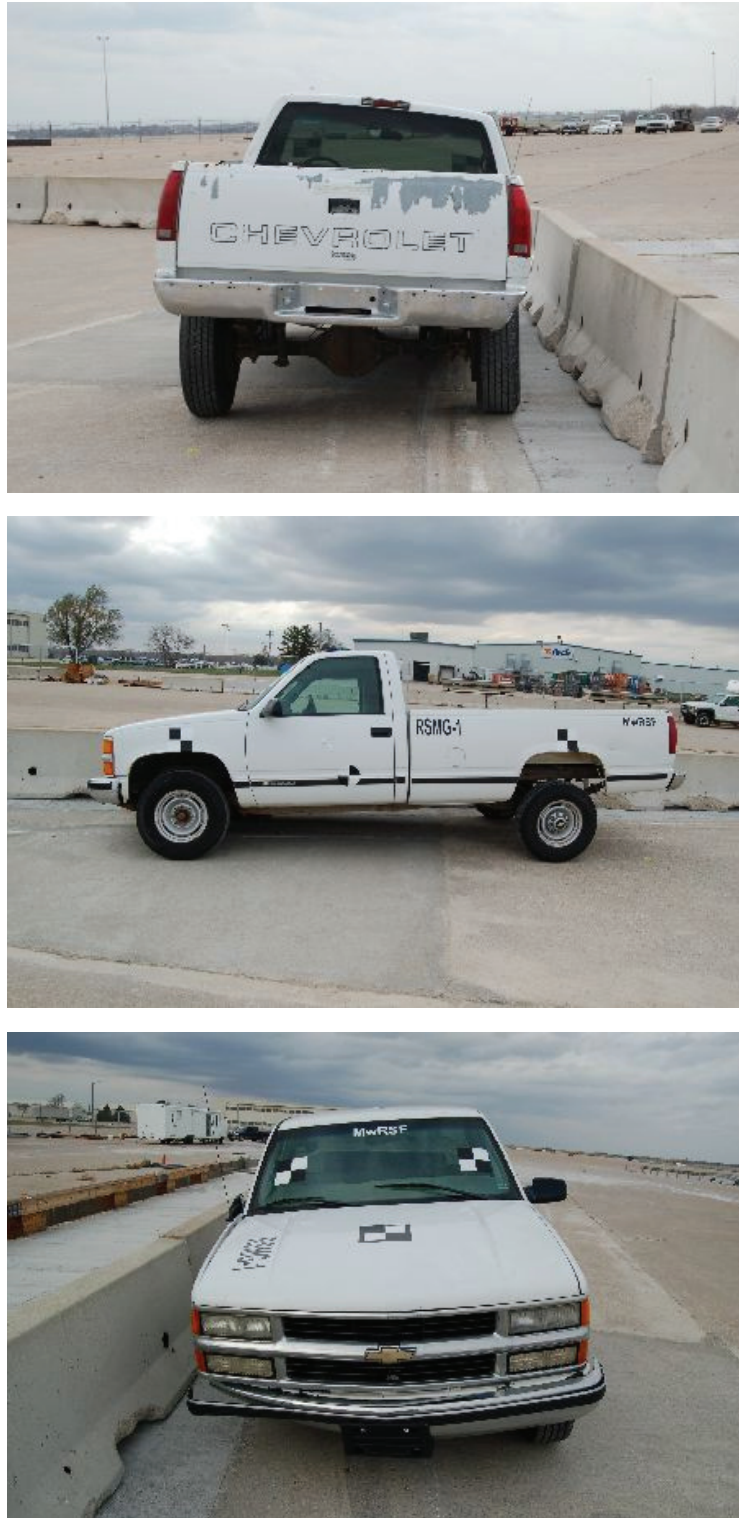
Figure 49. Vehicle Damage, Test No. RSMG-1

The damage to the vehicle was moderate, as shown in Figures 49 through 52. Damage was concentrated primarily at the right-front corner of the vehicle. The right-front bumper was crushed inward, and the frame connection was bent upward. The right-front quarter panel was folded inward. The top of the quarter panel was detached slightly from the hood, and the bottom of the quarter panel was scratched and dented inward. The right-front fog lights were scratched and cracked, and the front-right steel rim was bent and dented inward. The right-front tire was detached at the bottom part of the rim and deflated.

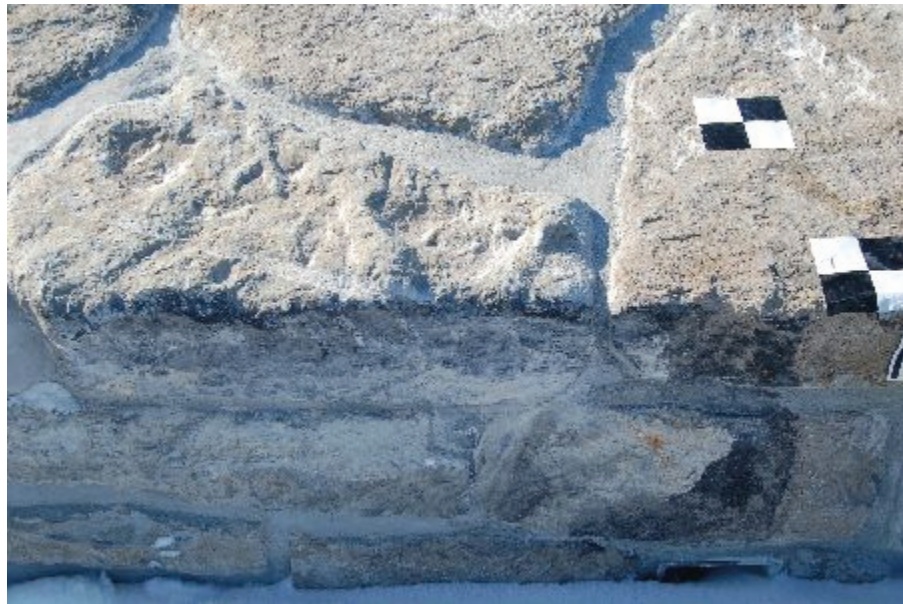
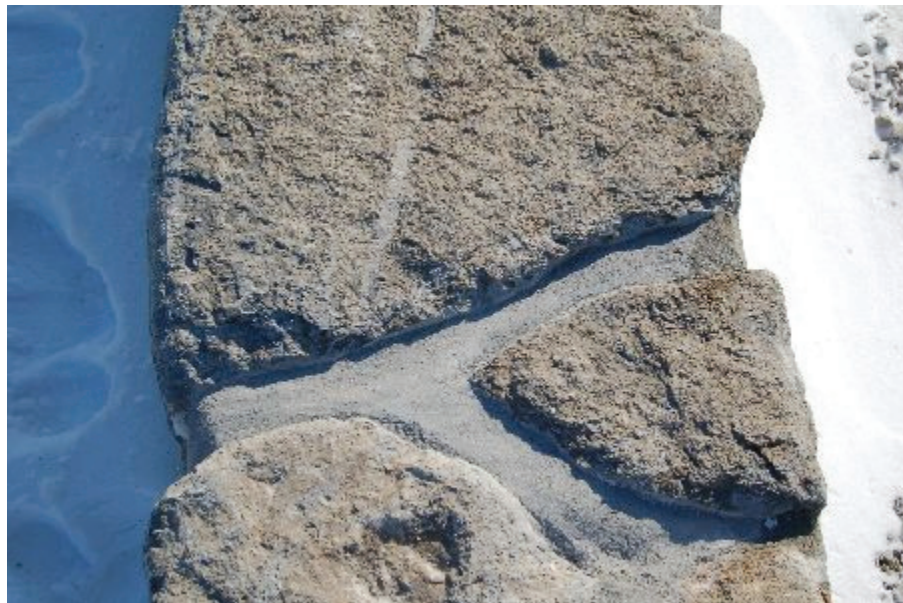
Figure 62. System Damage, Test No. RSMG-2

Damage to the barrier was minimal, as shown in Figures 62 through 64. Damage consisted of contact marks and scratches along the barrier. Scratches were found along the vertical face of the wall at the location of impact and along the top face of the wall beginning 15 ft (4.6 m) from the upstream end of the barrier and continuing downstream for 5 ft (1.5 m). A scratch was found on the vertical face of the wall 20 ft (6.1 m) from the upstream end. A large scratch was observed on the top edge of the guardwall 24-ft 8-in. (7.52 m) from the upstream end. Scratches were also found on the top and vertical faces of the wall 54-ft 8-in. (16.67 m) from the upstream end. Black contact marks were found on the vertical face of the barrier at 58 ft (17.7 m), and a large scratch was found on the top face of the barrier at 61 ft (18.6 m). A 3 ft (0.9 m) long scratch was observed on the top face of the barrier's downstream end.

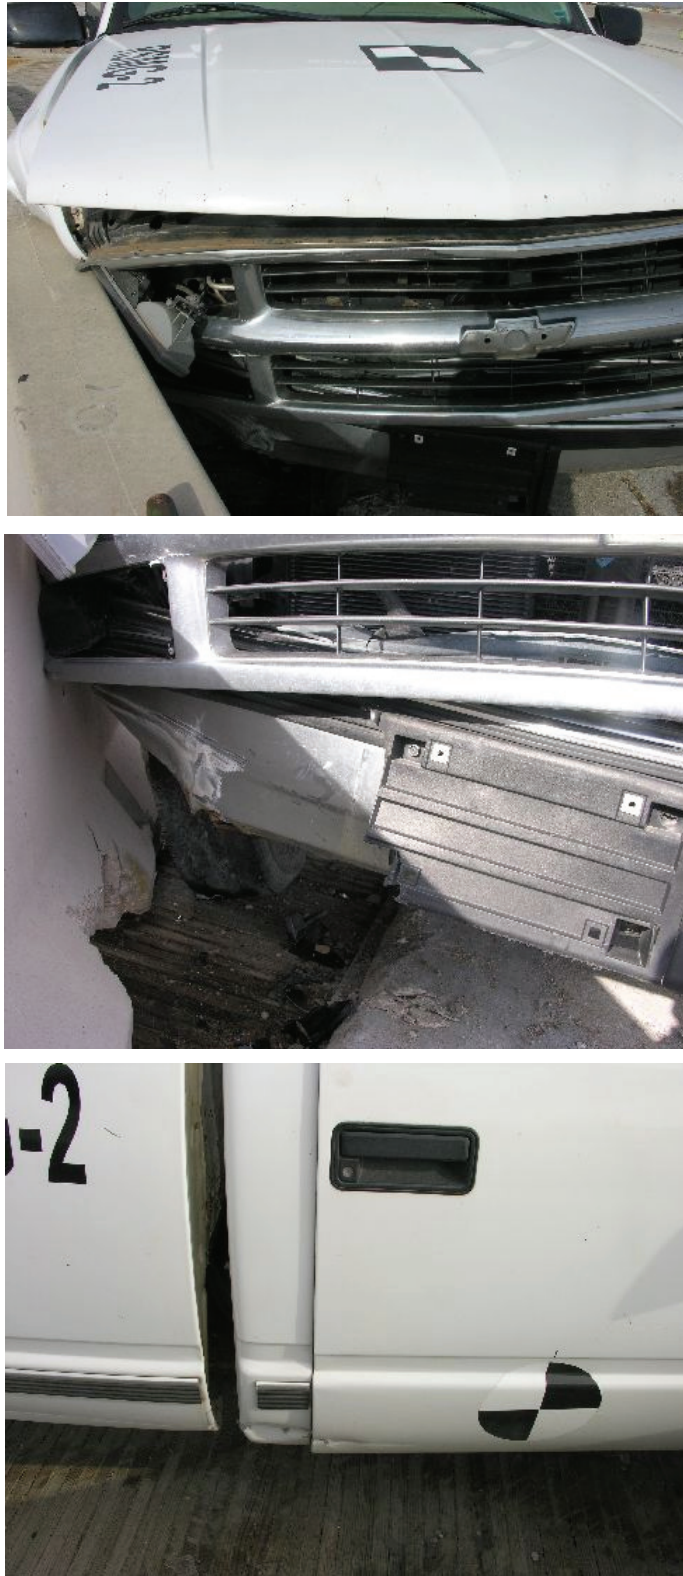
Figure 65. Vehicle Damage, Test No. RSMG-2

The damage to the vehicle was moderate, as shown in Figures 65 through 68. Damage was concentrated primarily to the right-front corner of the vehicle. The front grill was removed from the vehicle, and the bumper was dislocated and crushed on the right side. The right-side headlight and blinker were destroyed. The right-front quarter panel was severely damaged, and the right-front tire was deflated. The right-front wheel was still attached but had been pushed underneath the vehicle. There were also some scrapes found on the lower edge of the right-side door.
