**PERFORMANCE LIMITS FOR 152-MM (6-IN.) HIGH
CURBS PLACED IN ADVANCE OF THE MGS
USING MASH-08 VEHICLES
PART I: VEHICLE-CURB TESTING AND
LS-DYNA ANALYSIS**

MIDWEST ROADSIDE SAFETY FACILITY

MwRSF Research Report No. TRP-03-205-09

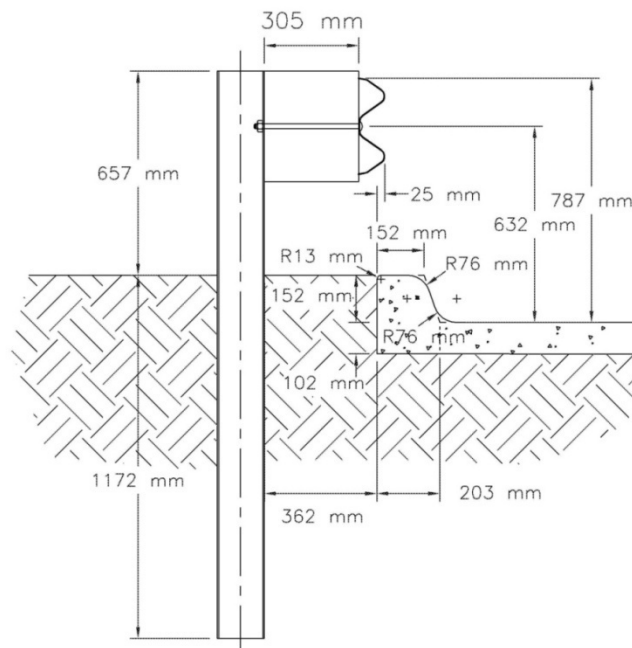
Figure 2. NPG-5 System Setup

The only full-scale crash test of the MGS and curb combination was performed by MwRSF in test no. NPG-5 (2-3). A 152-mm (6-in.) AASHTO Type B curb was constructed such that the center of the curb's front face was placed 152 mm (6 in.) in front of the front face of the guardrail. The top mounting height of the guardrail remained at 787 mm (31 in.), which was measured from the gutter line to the top of the W-beam rail, as shown in Figure 2.

A 1,986-kg (4,378-lb) pickup truck impacted the MGS installed over a concrete curb at a speed of 96.6 km/h (60.1 mph) and at an angle of 25.8 degrees. The pickup truck struck the curb first and then was contained and smoothly redirected by the MGS system. The vehicle did not penetrate nor ride over the guardrail and remained upright during and after the collision. Vehicle roll, pitch, and yaw angular displacements were noted and were deemed acceptable according to the TL-3 safety performance criteria found in NCHRP Report No. 350.

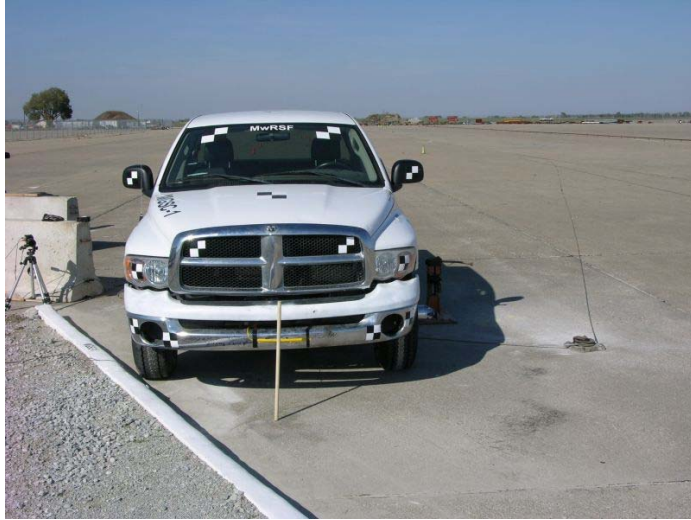
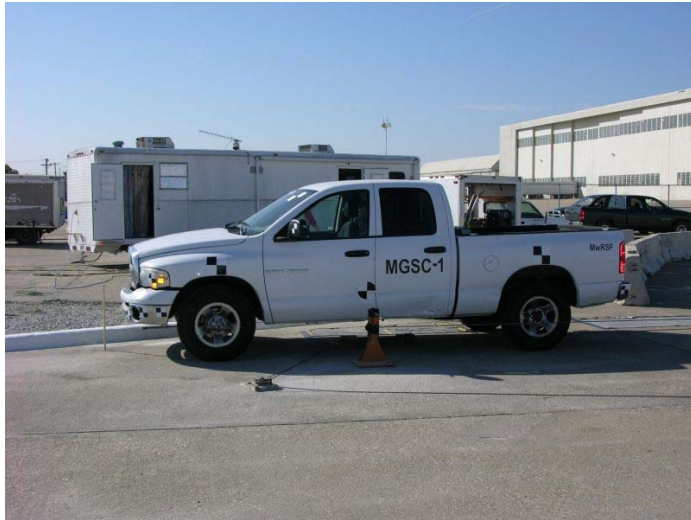
Figure 3. Test Vehicle, Test MGSC-1

For test nos. MGSC-1 and MGSC-2, a 2003 Dodge Ram 1500 ($\frac{1}{2}$ ton) Quad Cab pickup truck was used as the test vehicle. The test inertial and gross static weights were both 2,253 kg (4,966 lbs). The test vehicle is shown in Figures 3 and 4, and vehicle dimensions are shown in Figure 5.

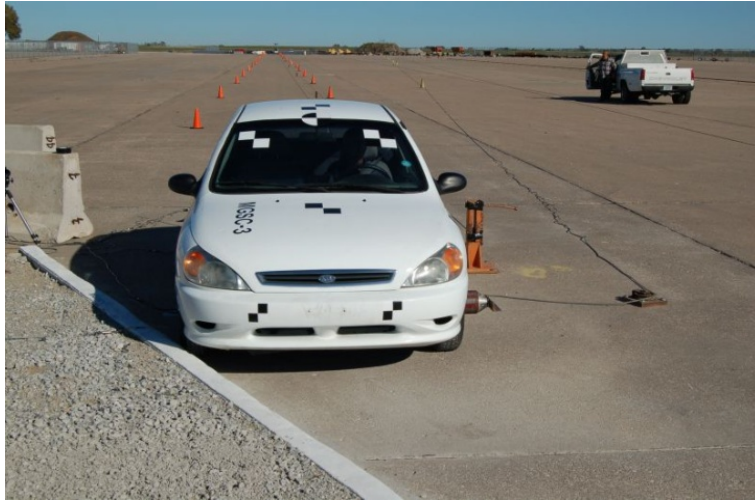
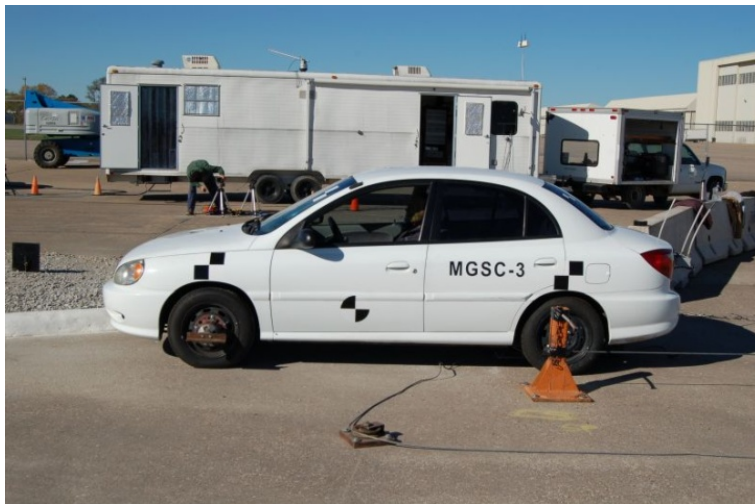
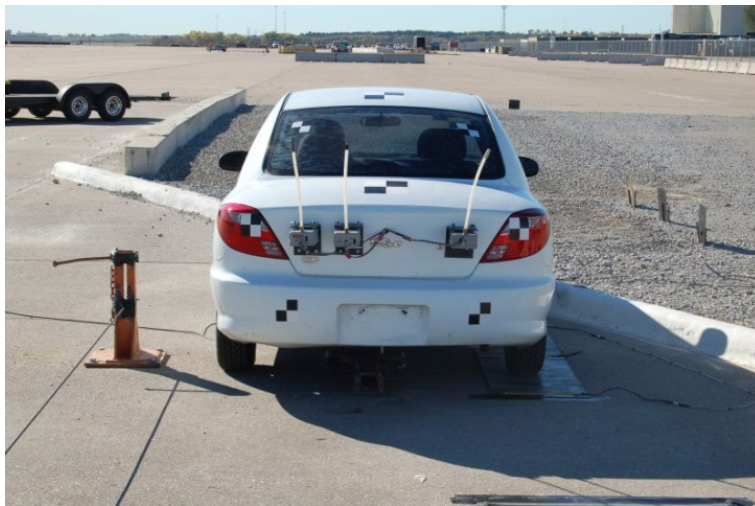
Figure 6. Test Vehicle, Test MGSC-3

For test no. MGSC-3, a 2002 Kia Rio passenger car was used as the test vehicle. The test inertial and gross static weights were 1,079 kg (2,378 lbs) and 1,154 kg (2,544 lbs), respectively. The test vehicle is shown in Figure 6, and vehicle dimensions are shown in Figure 7.

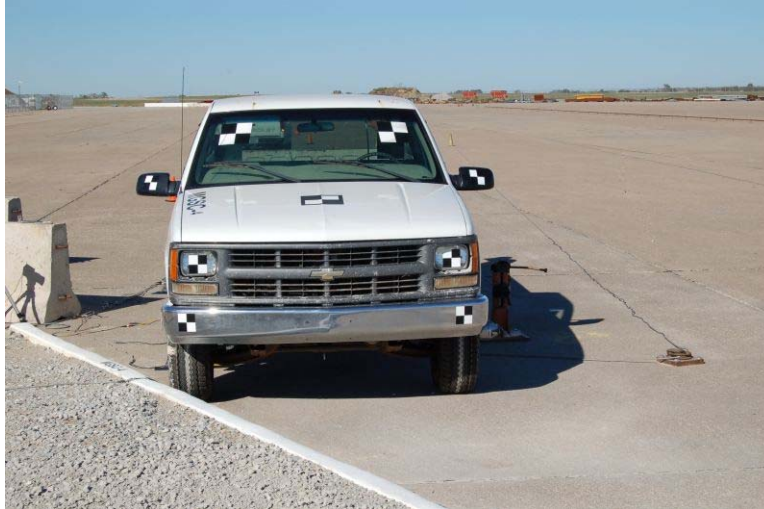
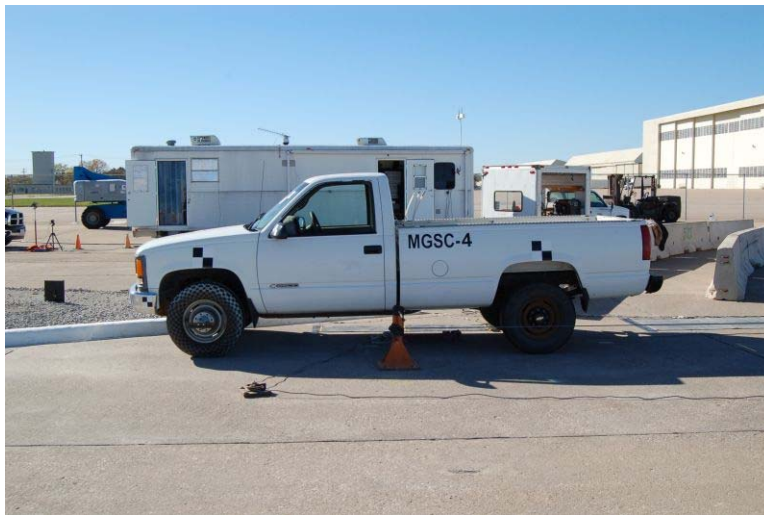
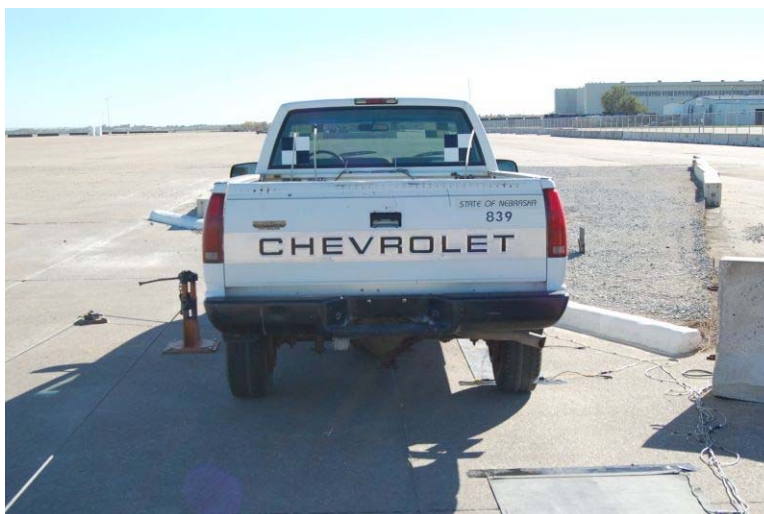
Figure 8. Test Vehicle, Test MGSC-4

For test no. MGSC-4, a 1999 Chevrolet C2500 ($\frac{3}{4}$ ton) pickup was used as the test vehicle. The test inertial and gross static weights were both 2,032 kg (4,479 lbs). The test vehicle is shown in Figure 8, and vehicle dimensions are shown in Figure 9.

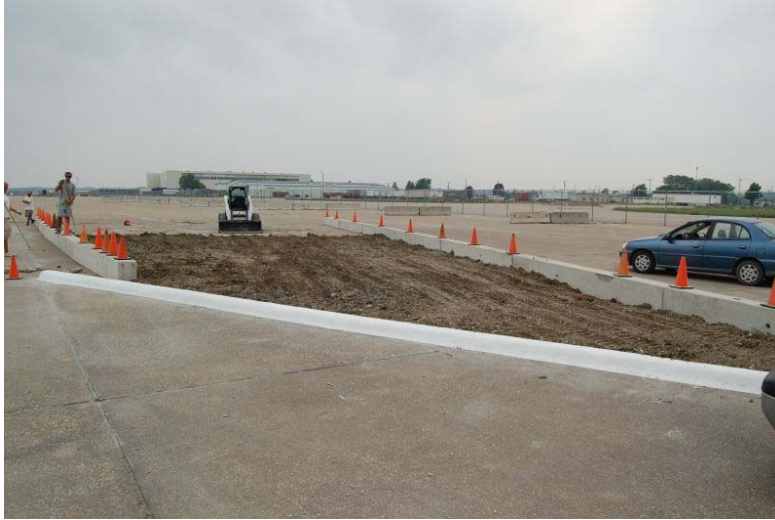
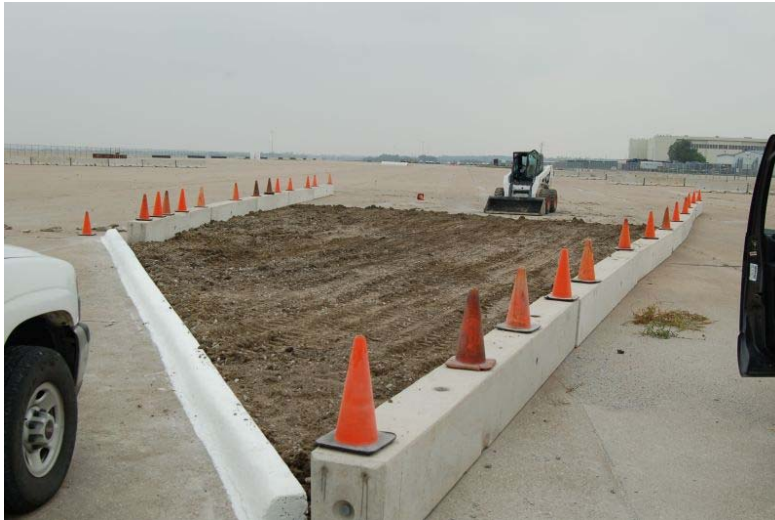
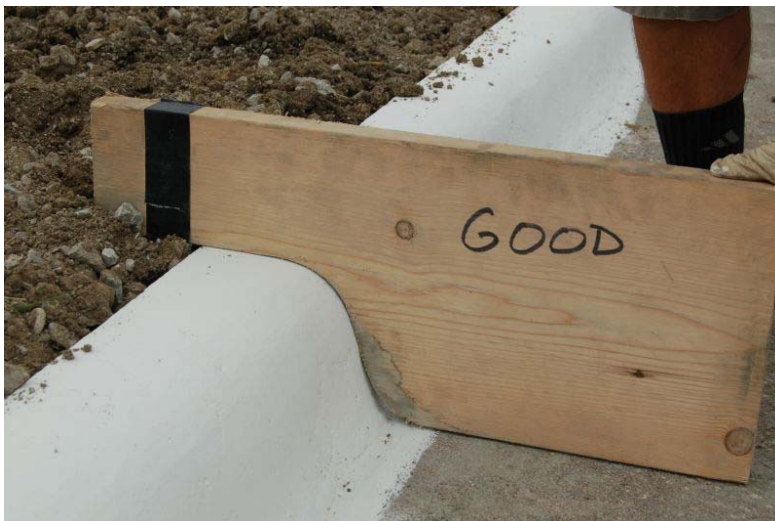
Figure 16. 152-mm (6-in.) AASHTO Type B Curb Construction and Test Layout
29

The 10.7-m (35-ft) long test installation consisted of 152-mm (6-in.) high AASHTO Type B curb doweled into the existing concrete apron. Design details are shown in Figures 13 through 15. The corresponding English-unit drawings are shown in Appendix A. Photographs of the test installation are shown in Figure 16.

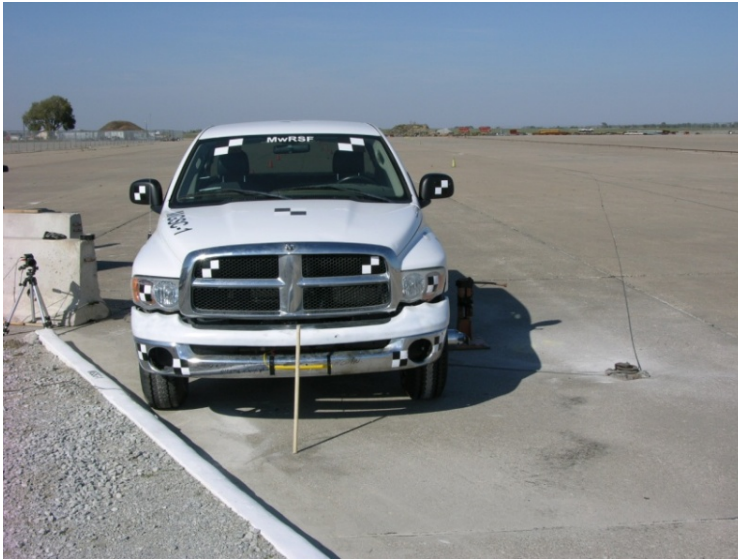
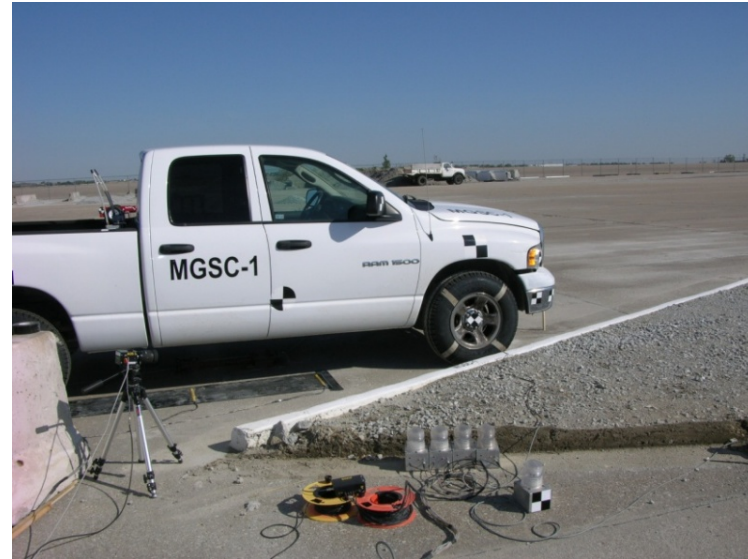
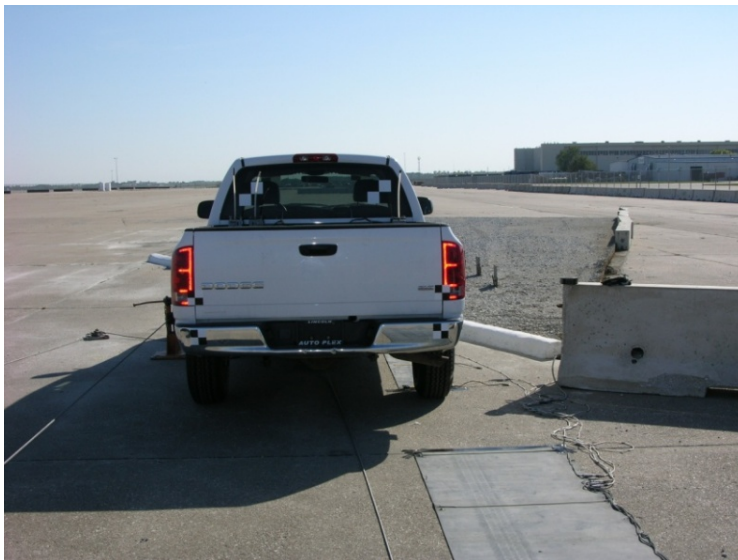
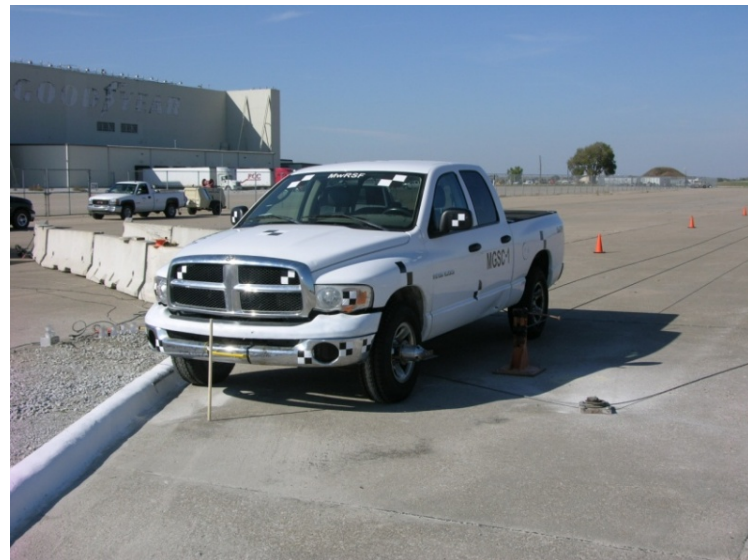
Figure 21. Impact Location, Test MGSC-1

The 2,253-kg (4,966-lb) Dodge Ram 1500 Quad Cab pickup truck impacted the 152-mm (6-in.) high, AASHTO Type B curb at a speed of 100.0 km/h (62.2 mph) and at an angle of 25 degrees with respect to the curb. The impact location is shown in Figure 21. The test sequential photographs are shown in Figures 22 through 24.

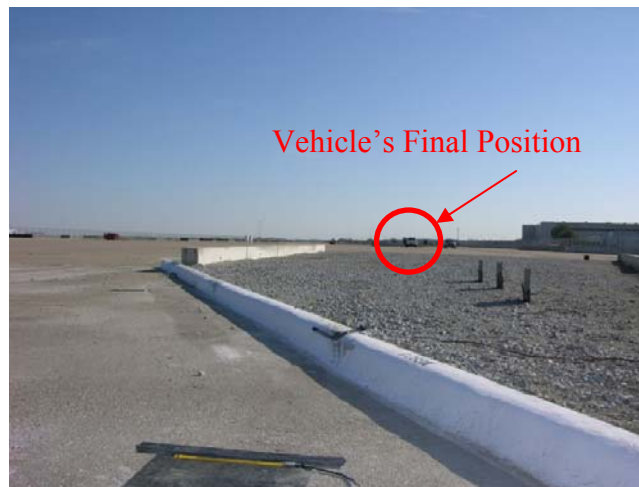
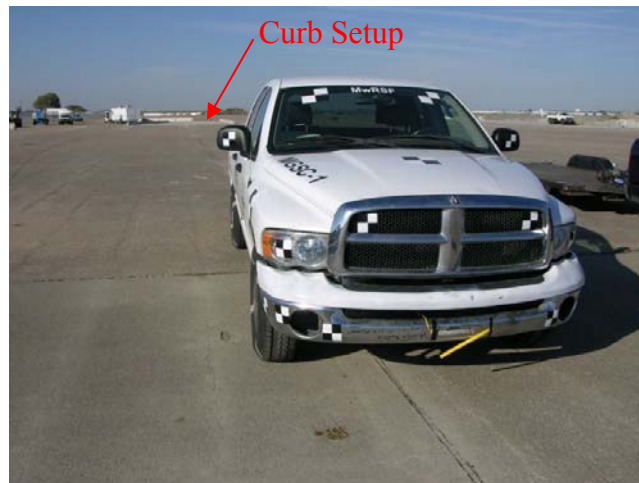
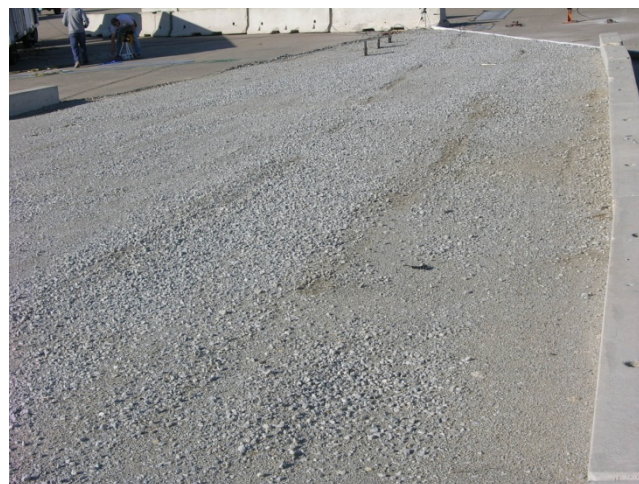
Figure 25. Vehicle Final Position and Trajectory, Test MGSC-1

For this impact condition on the 152-mm (6-in.) high, AASHTO Type B curb, the heading angle of the vehicle was basically unaffected as the vehicle sustained nearly the same vehicle path after impacting the curb. The final vehicle position and trajectory are shown in Figure 25.

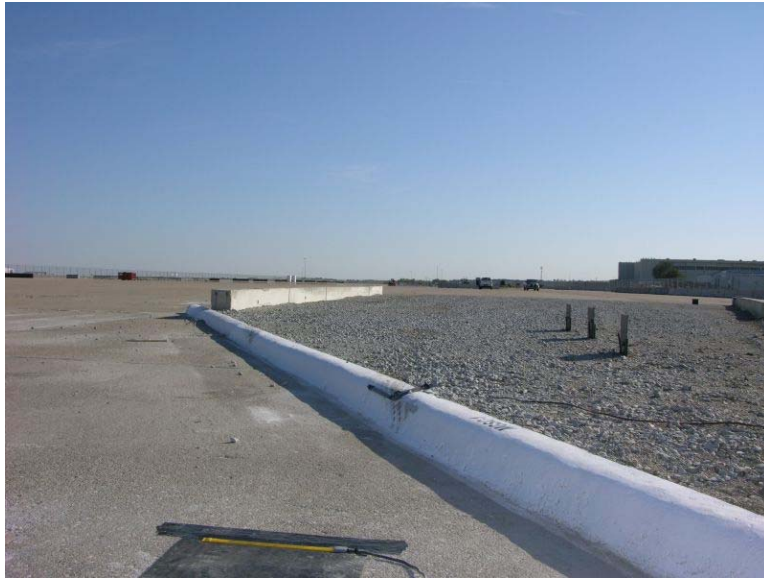
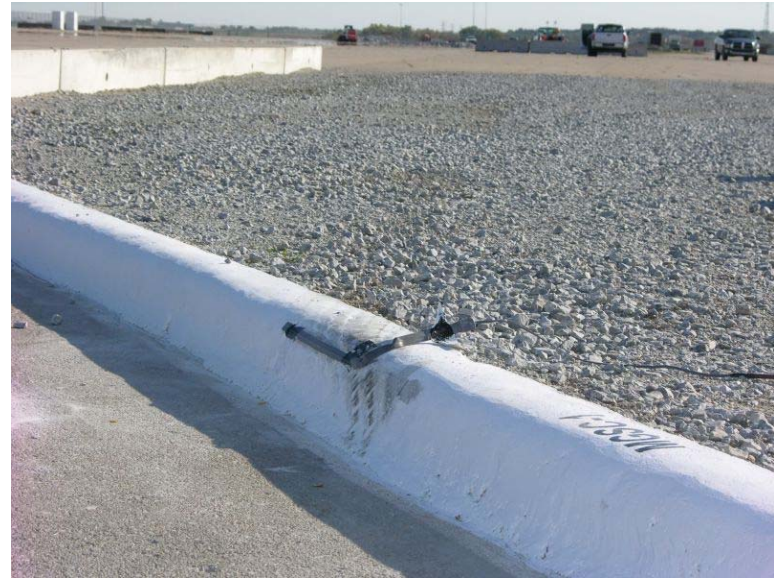
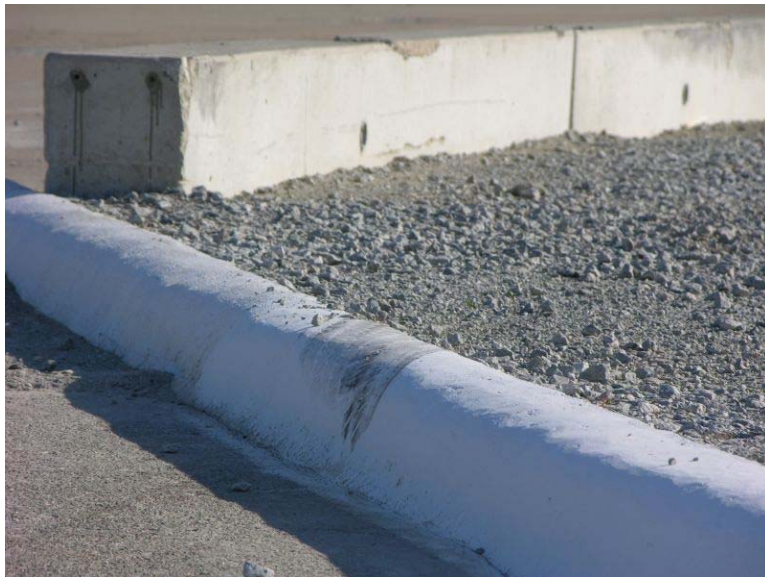
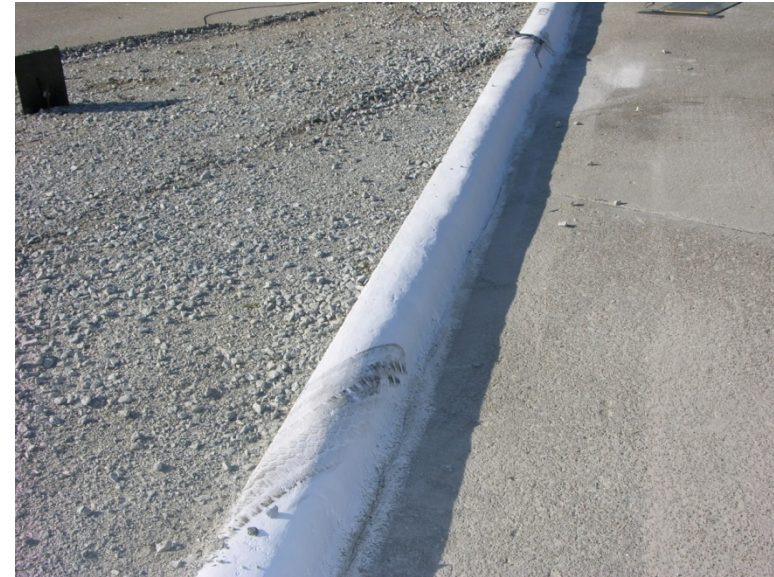
Figure 26. System Damage, Test MGSC-1

Damage to the curb system was negligible, as shown in Figure 26. No cracks or fractures were observed on the curb. Two contact marks were observed on the top and traffic-side faces of the curb. Tire marks and scrapes occurred at 3.23 m (10.6 ft) and 7.32 m (24 ft) from the upstream end of the curb.

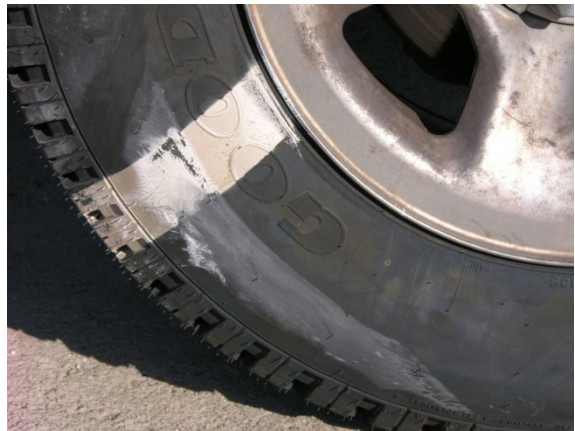
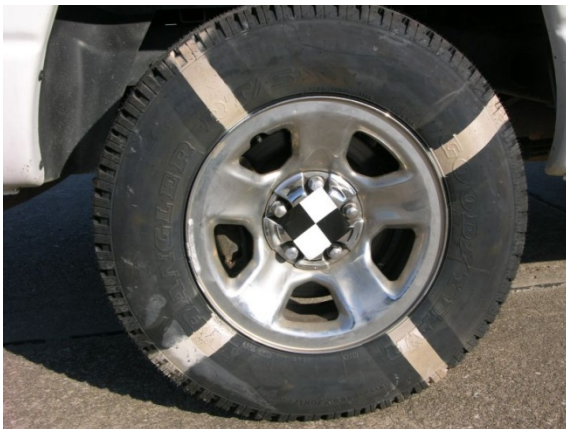
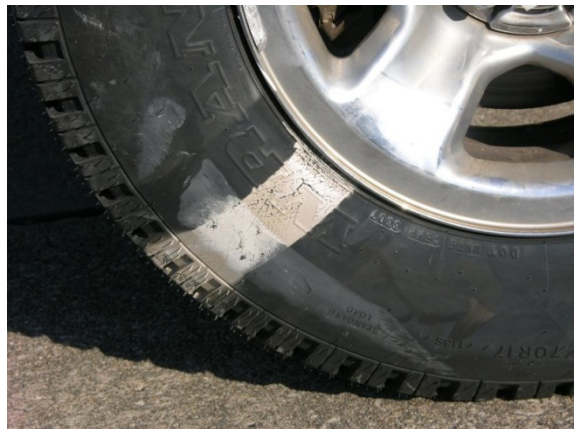
Figure 27. Vehicle Damage, Test MGSC-1

Exterior vehicle damage was minor, as shown in Figure 27. Minor scrapes and scratches were found on the vehicle's tires due to the impact with the curb. No wheel deformations or suspension damages were observed. The remainder of the vehicle was intact.

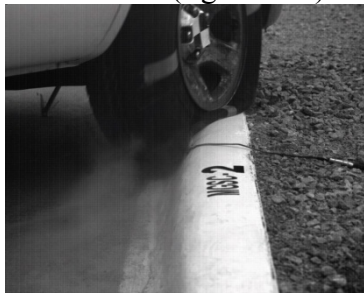
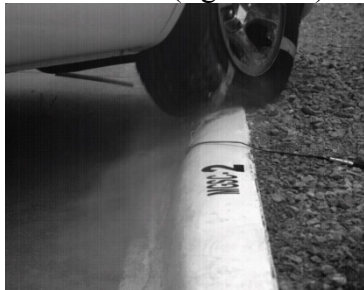
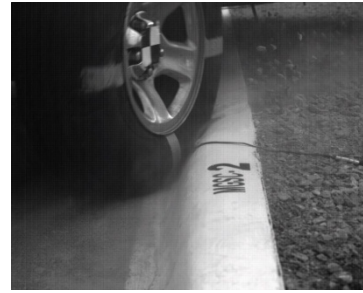
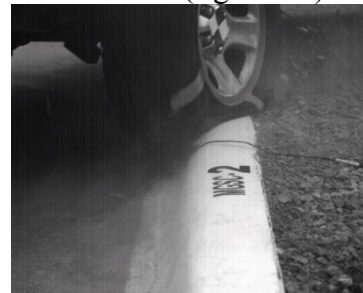
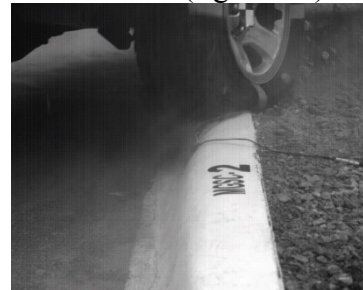
Figure 38. Additional Sequential Photographs, Test MGSC-2

The right-front tire first impacted the curb at 3.23 m (10.6 ft) from the upstream end of the curb. After impact, the vehicle's front end pitched upward and rolled counter-clockwise. At 0.014 sec, the right-front suspension reached maximum compression. At 0.126 sec, the right-rear tire impacted the curb. At 0.132 sec, the left-front tire impacted the curb and caused the pickup's clockwise roll. At 0.138 sec, the right-rear suspension reached maximum compression. At 0.170 sec after impact, the right-rear tire became airborne and then re-contacted the ground at 0.258 sec. At 0.270 sec, the front suspension compression was released and reached its maximum extension. At 0.302 sec, the compressed right-rear suspension rebounded to its maximum extension. At 0.306 sec, the pickup started to roll counter-clockwise. At 0.346 sec, both of the pickup's rear tires became airborne. At 0.386 sec, the vehicle's front end started to pitch downward. At 0.456 sec, the pickup started to yaw clockwise. At 0.512 sec, the vehicle's right-rear tire contacted the ground. At 0.648 sec, the vehicle's left-rear tire landed on the ground.

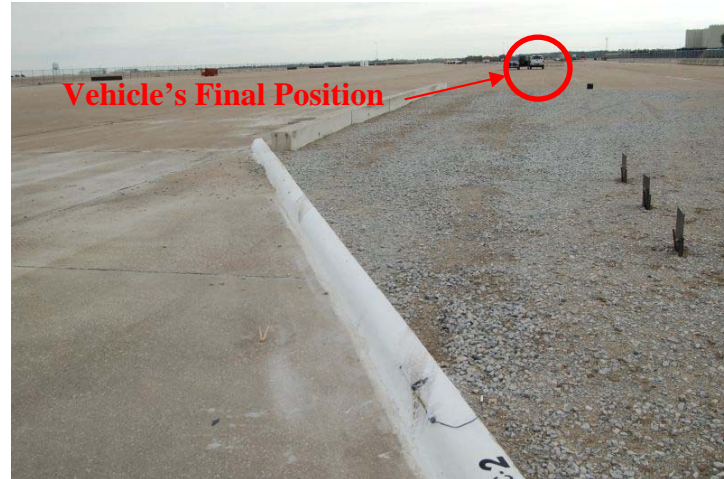
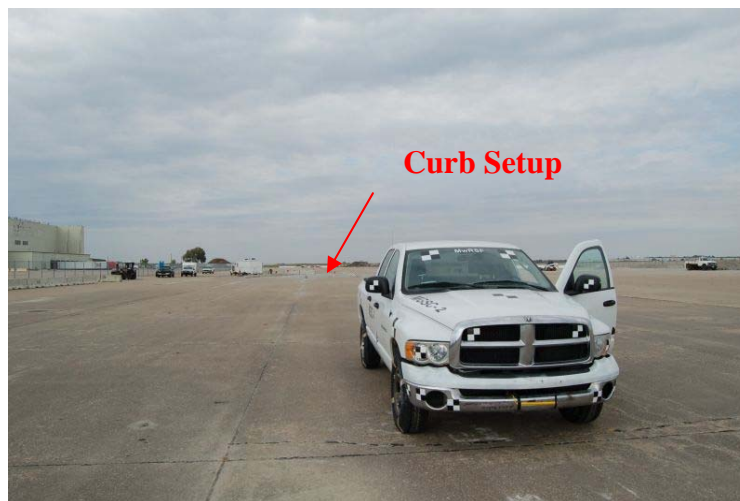
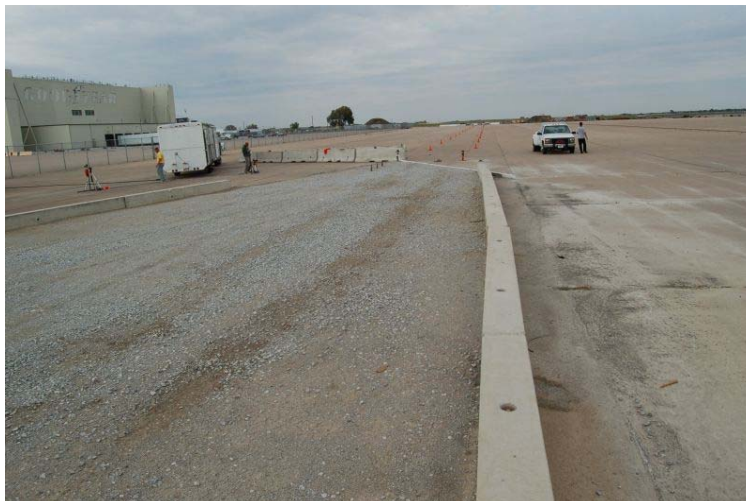
Figure 40. Vehicle's Final Position and Trajectory, Test MGSC-2

For this impact condition on the 152-mm (6-in.) high AASHTO Type B curb, the heading angle of the vehicle was basically unaffected, as the vehicle maintained nearly the same vehicle path after hitting the curb. The final vehicle position and trajectory are shown in Figure 40.

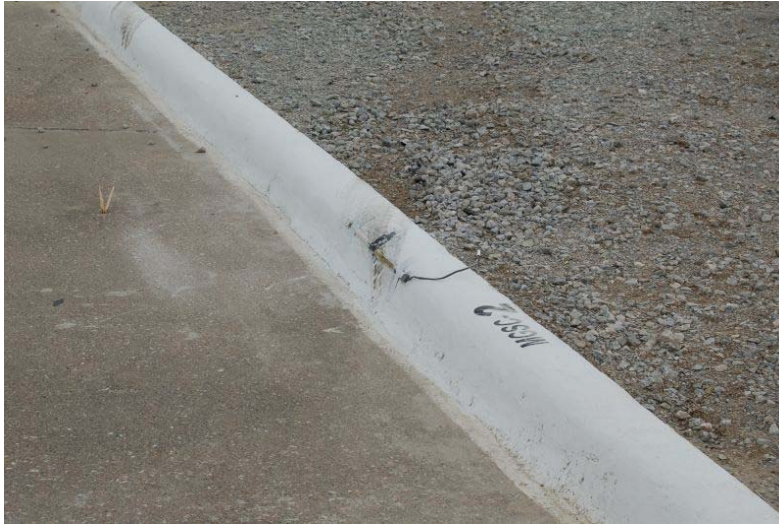
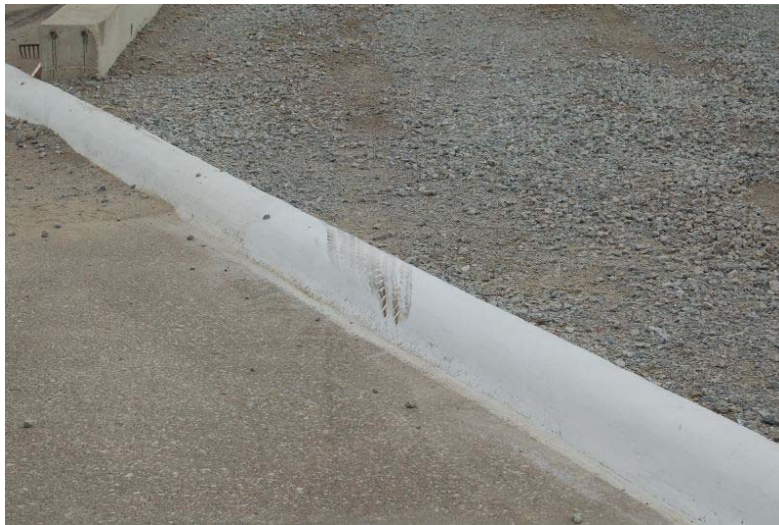
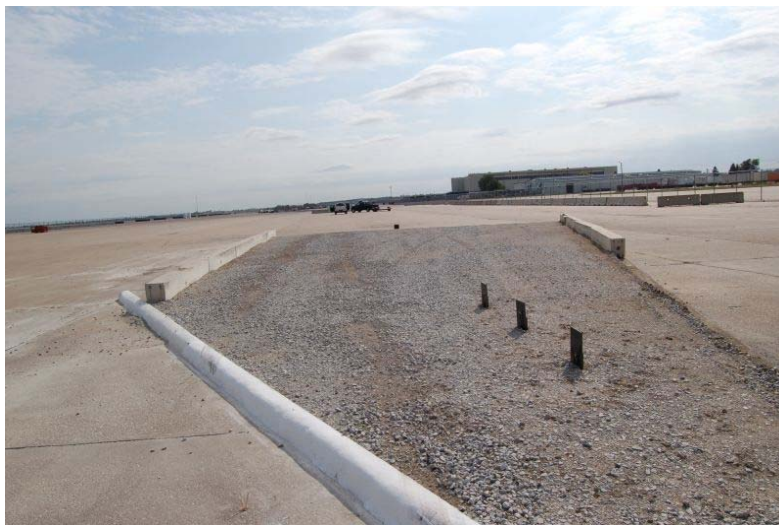
Figure 41. System Damage, Test MGSC-2

Damage to the curb system was negligible, as shown in Figure 41. No cracks or fractures were observed on the curb. Two contact marks were observed on the top and traffic-side faces of the curb. Tire marks and scrapes occurred at a point 3.23 m (10.6 ft) and another point 7.32 m (24.0 ft) from the upstream end of the curb.

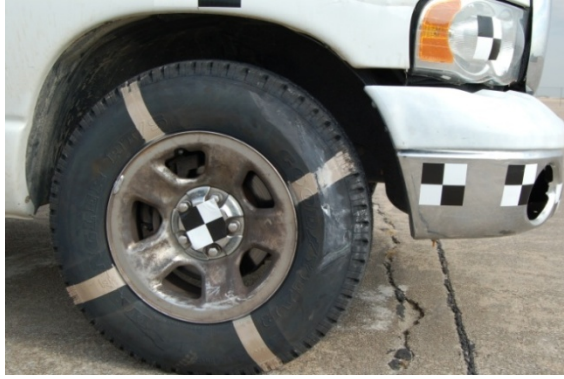
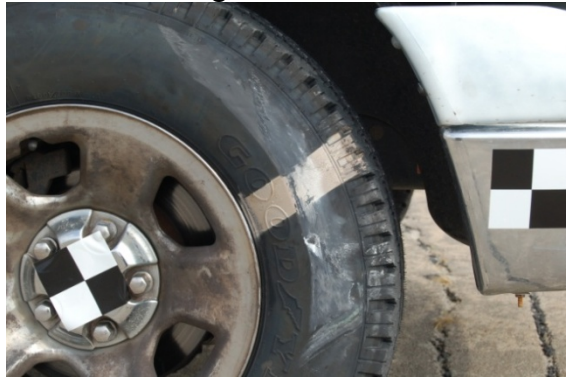
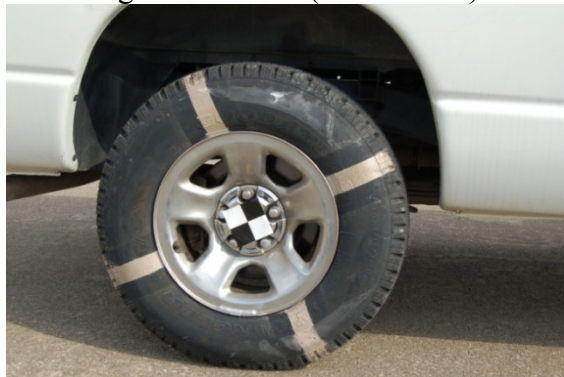
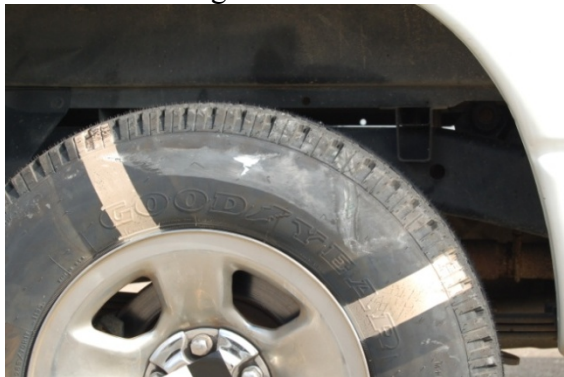
Figure 42. Vehicle Damage, Test MGSC-2

Exterior vehicle damage was minor, as shown in Figure 42. Minor scrapes and scratches were found on the vehicle tires due to the impact with the curb. No wheel deformation or suspension damage was observed. The remainder of vehicle was intact.

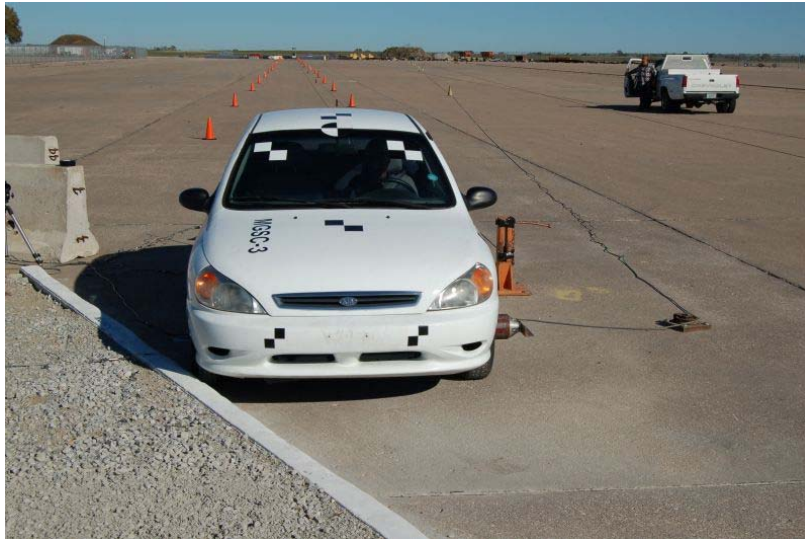
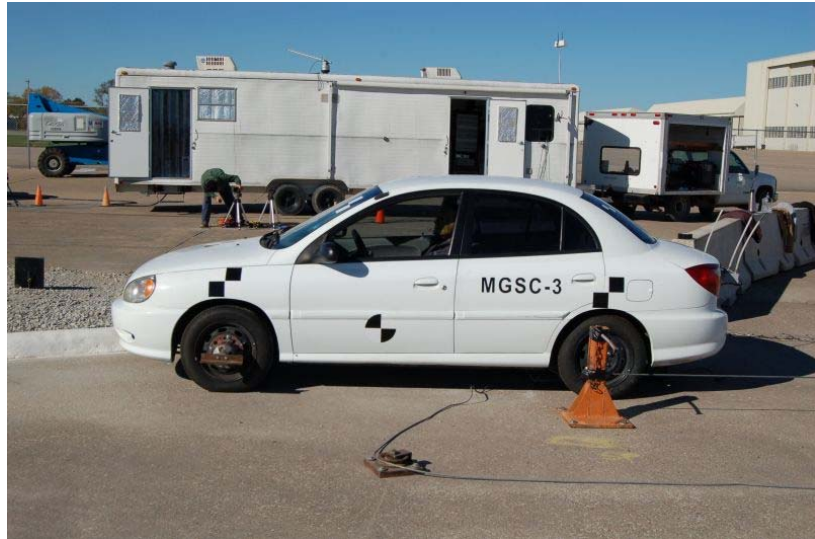
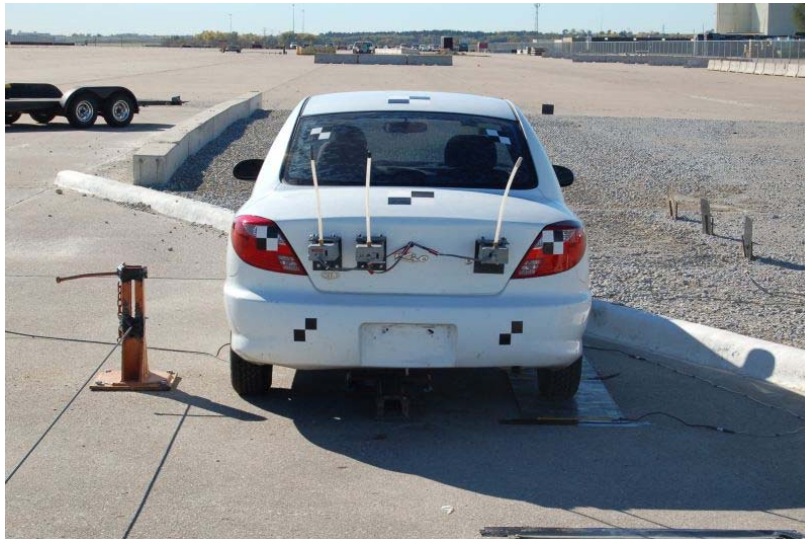
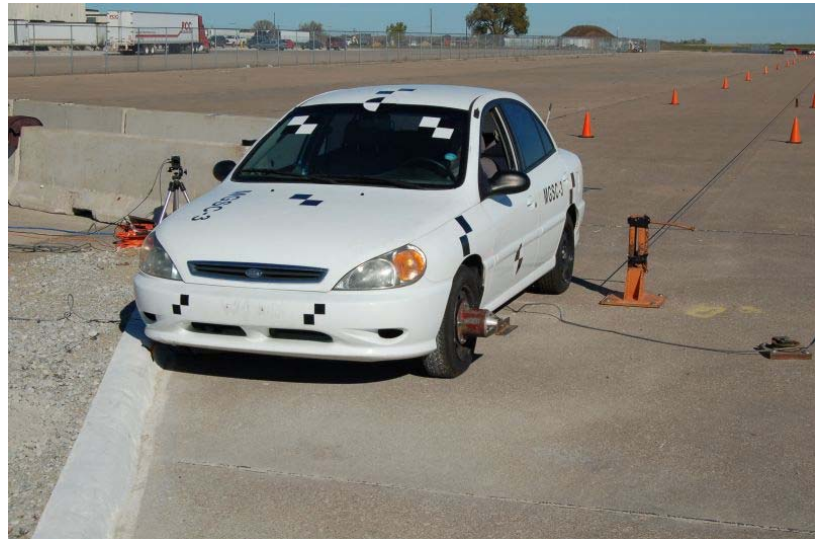
Figure 51. Impact Location, Test MGSC-3

The 1,154-kg (2,544-lb) Kia Rio impacted the 152-mm (6-in.) high, AASHTO Type B curb at a speed of 99.1 km/h (61.6 mph) and at an angle of 25 degrees. The impact location is shown in Figure 51. The sequential photographs are shown in Figures 52 through 54.

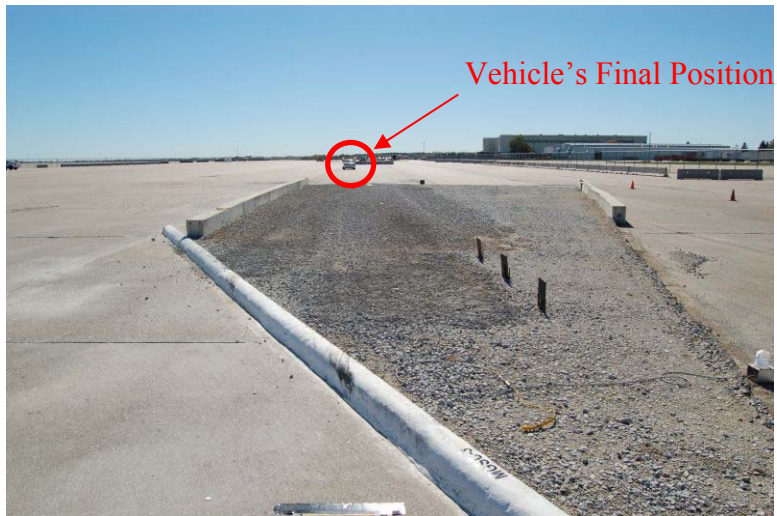
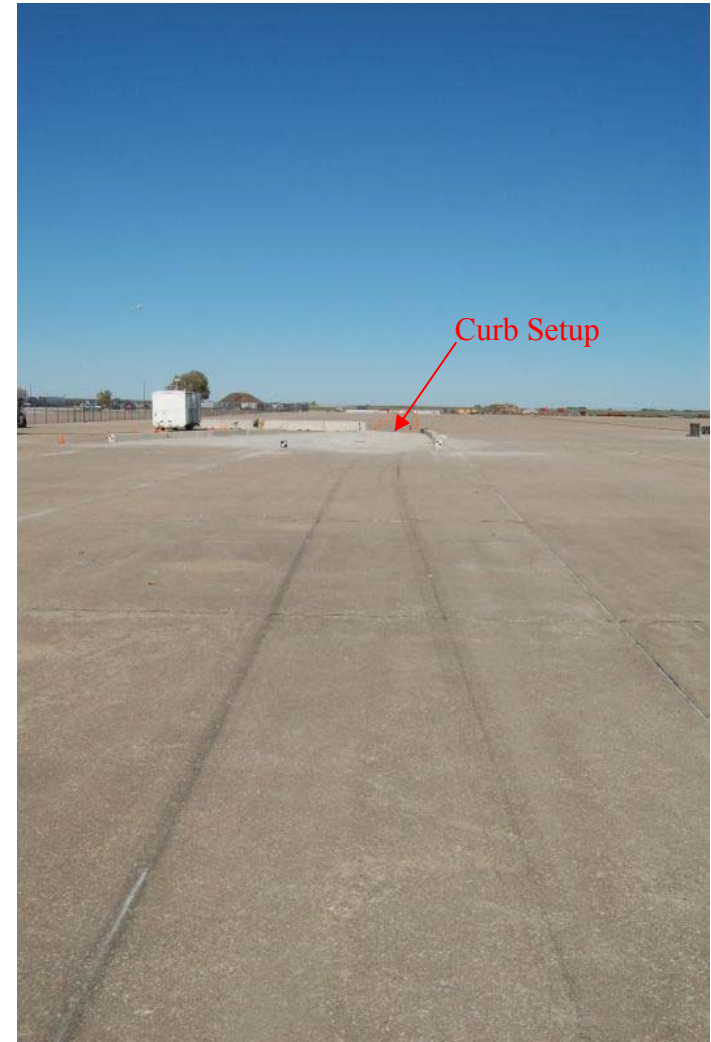
Figure 55. Vehicle Final Position and Trajectory, Test MGSC-3

For this impact condition on the 152-mm (6-in.) high AASHTO Type B curb, the heading angle of the small passenger car was basically unaffected by the curb impact. The final vehicle position and trajectory are shown in Figure 55.

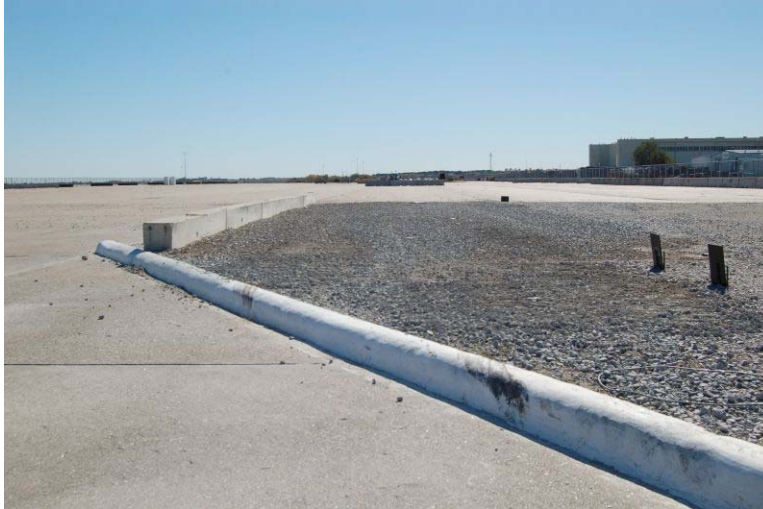
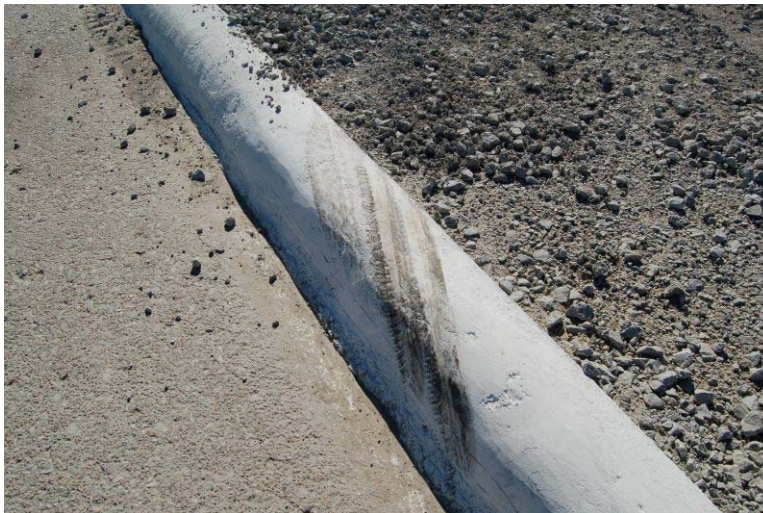
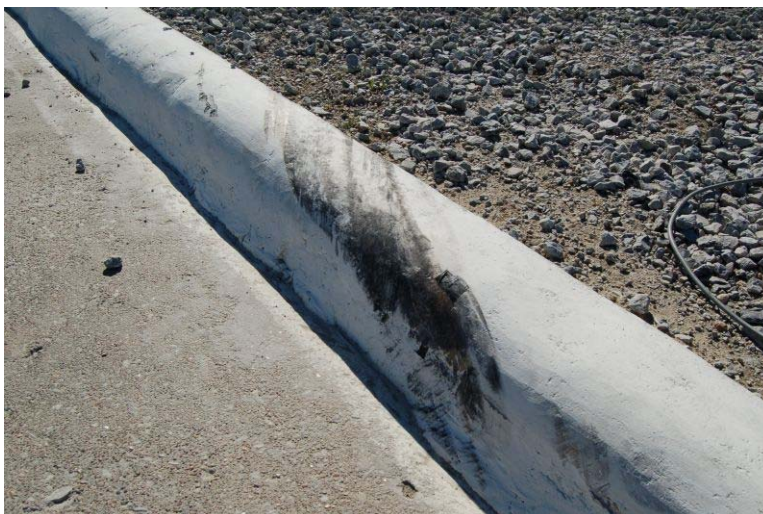
Figure 56. System Damage, Test MGSC-3

Damage to the curb system was negligible, as shown in Figure 56. No cracks or fractures were observed on the curb. Two contact marks were observed on the top and traffic-side faces of the curb. Two tire marks, each of length 864 mm (34 in.), were found on the curb; one 3.4 m (11.2 ft) from the upstream end of the curb, and another 7.0 m (22.8 ft) from the downstream end of the curb.

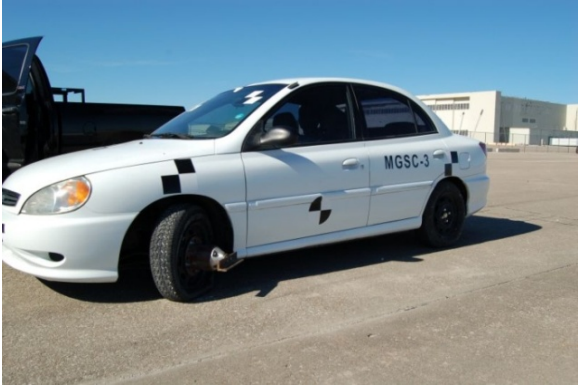
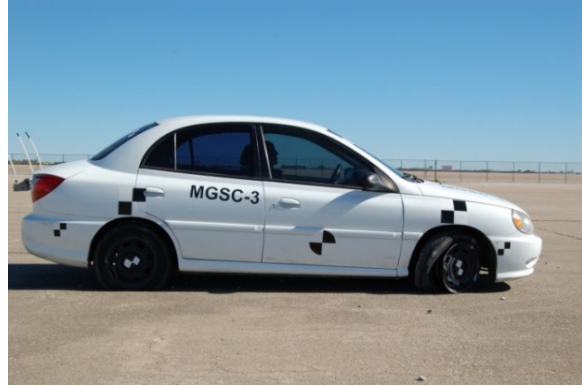
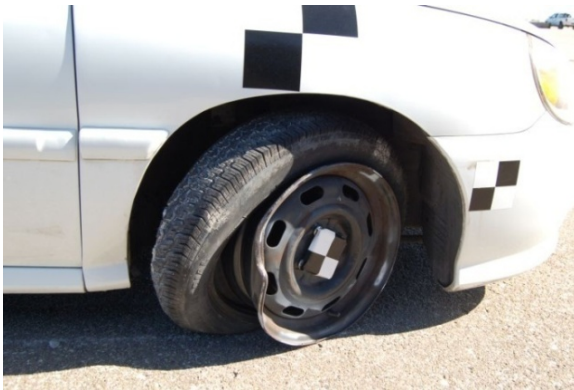
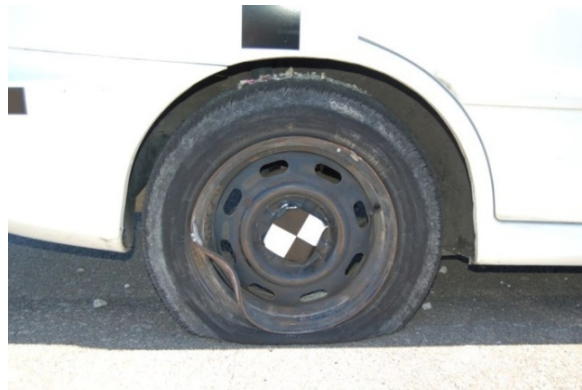
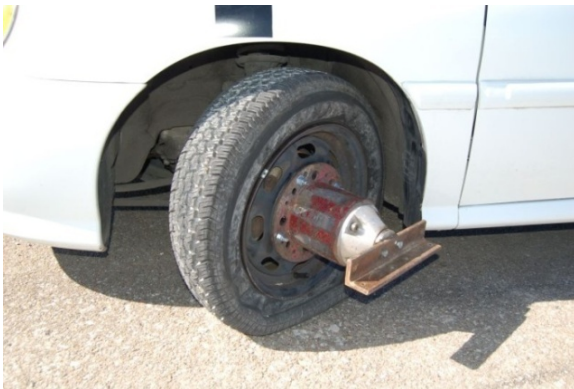
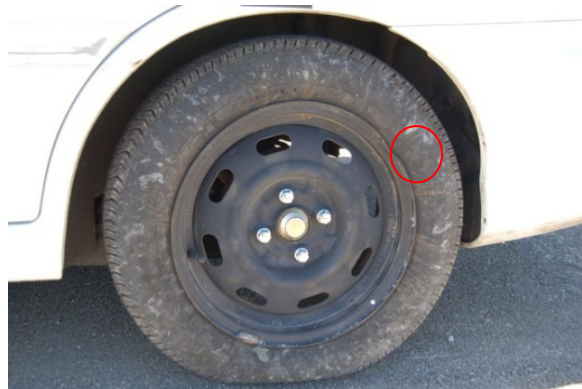
Figure 57. Vehicle Damage, Test MGSC-3

Exterior vehicle damage was moderate, as shown in Figure 57. The damage consisted of tire scratches, wheel deformations, and deflated tires. The right-front wheel rim was severely deformed due to the impact. The right-front tire was flat, with half of the tire off the rim. Scratches were found both on the right-front tire and the right-front rim. The right-rear wheel rim was severely dented where the impact occurred. The right-rear tire became flat but still remained on the rim. Scratches were found on both the right-rear tire and the right-rear wheel rim. Minor bends were found on the left-front wheel rim, but no major dents were found. The left-front tire was deflated but still remained on the rim. Scratches were found on both the left-front tire and the left-front wheel rim. A minor dent was found on the left-rear wheel rim where the impact occurred. The left-rear tire was still inflated. Scratches were found on the sidewall of the left-rear tire. No suspension damage was observed. The rest of vehicle was intact.

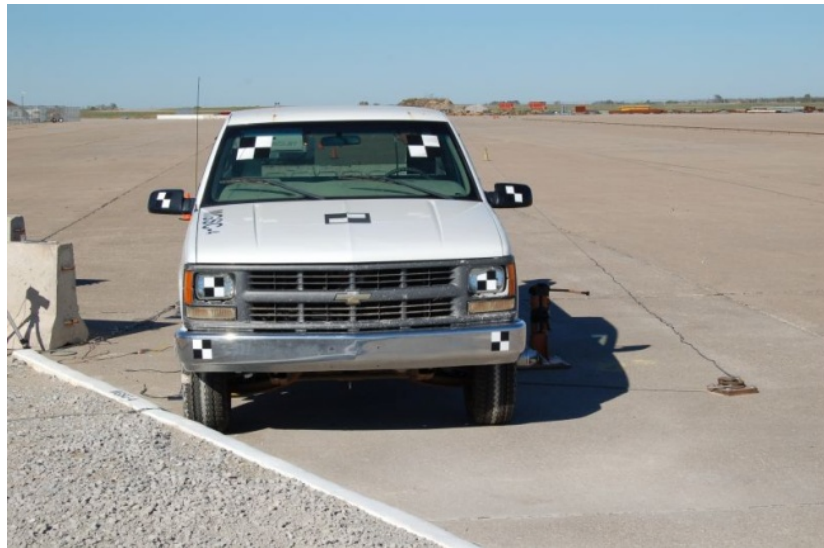
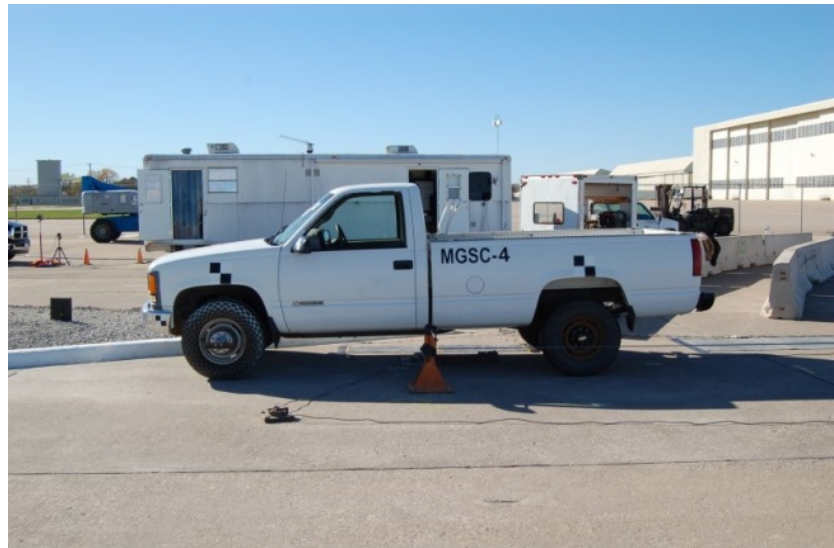
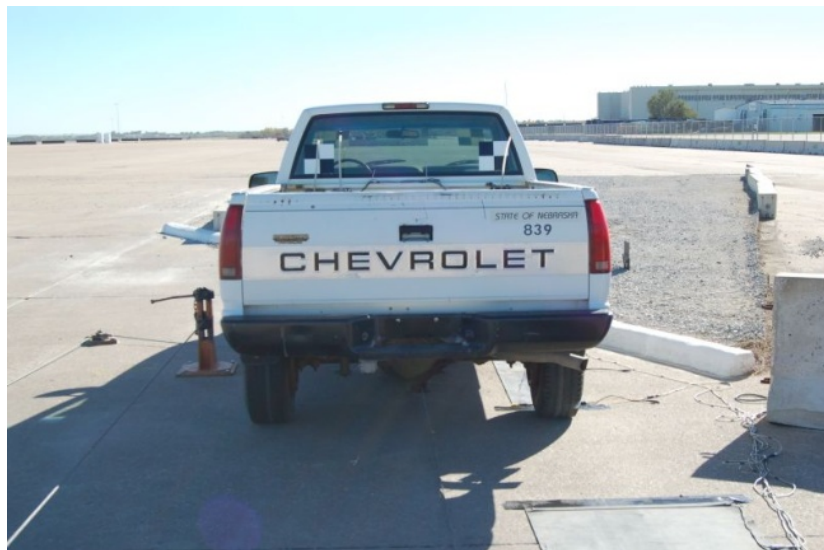
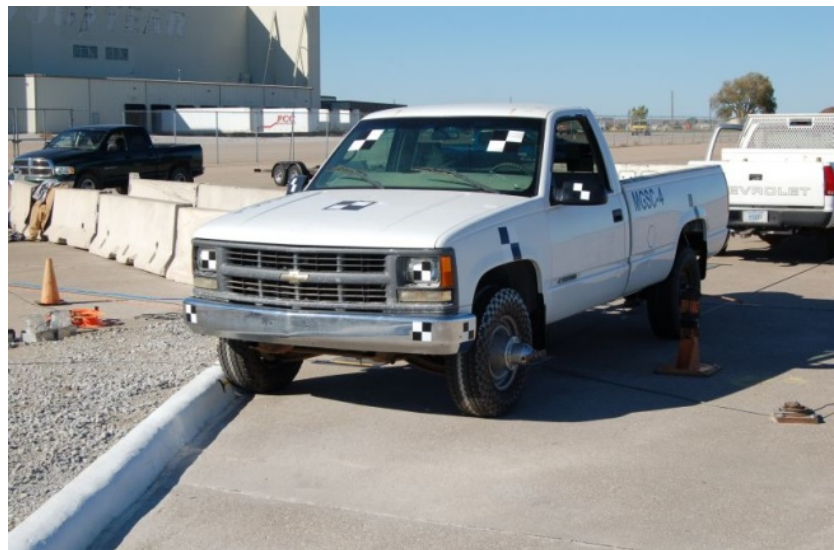
Figure 66. Impact Location, Test MGSC-4

The 2,032-kg (4,479-lb) Chevrolet C2500 pickup truck impacted the AASHTO Type B curb at a speed of 100.6 km/h (62.5 mph) and at an angle of 25 degrees. The impact location is shown in Figure 66. Sequential photographs are shown in Figures 67 through 69.
