**PERFORMANCE LIMITS FOR 152-MM (6-IN.) HIGH
CURBS PLACED IN ADVANCE OF THE MGS
USING MASH-08 VEHICLES
PART I: VEHICLE-CURB TESTING AND
LS-DYNA ANALYSIS**

MIDWEST ROADSIDE SAFETY FACILITY

MwRSF Research Report No. TRP-03-205-09

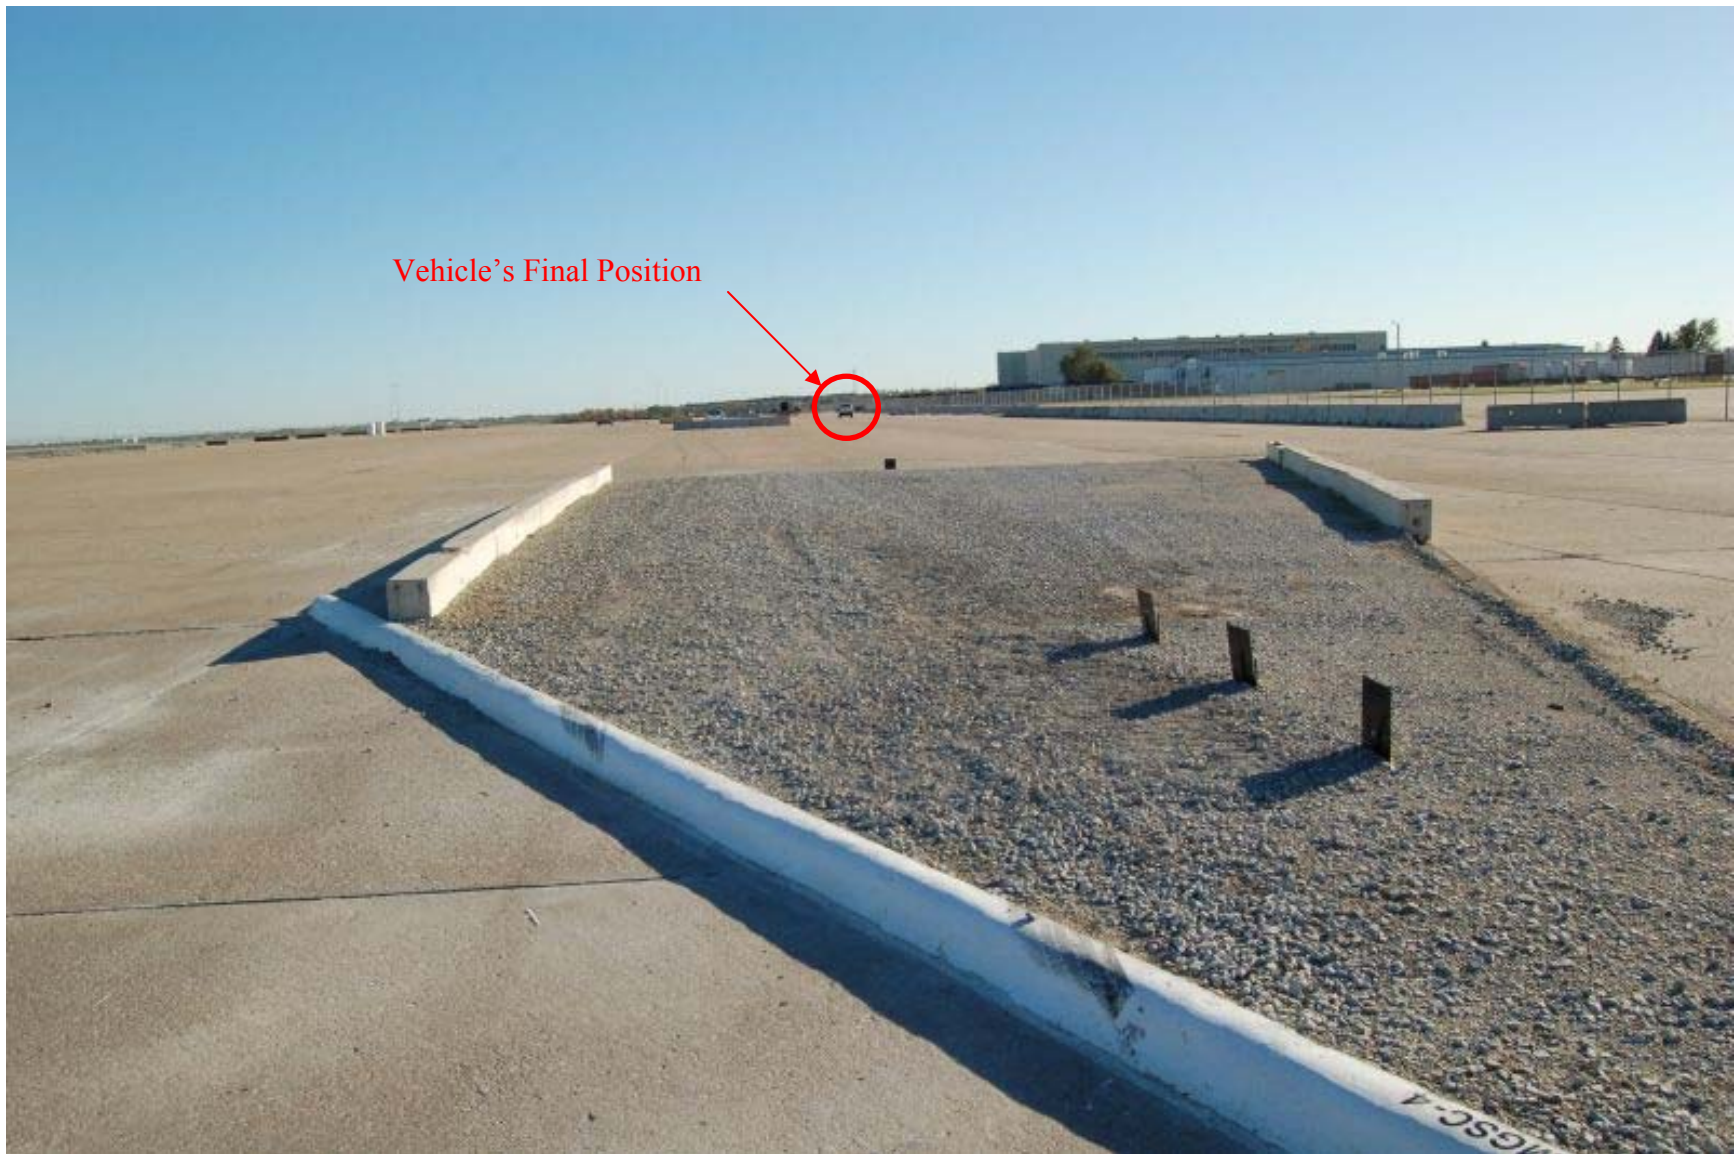
Figure 70. Vehicle Final Position and Trajectory, Test MGSC-4

For this impact condition on the 152-mm (6-in.) high, AASHTO Type B curb, the heading angle of the vehicle was basically unaffected, as the vehicle maintained nearly the same

vehicle path after striking the curb. The final vehicle position and trajectory are shown in Figure 70.

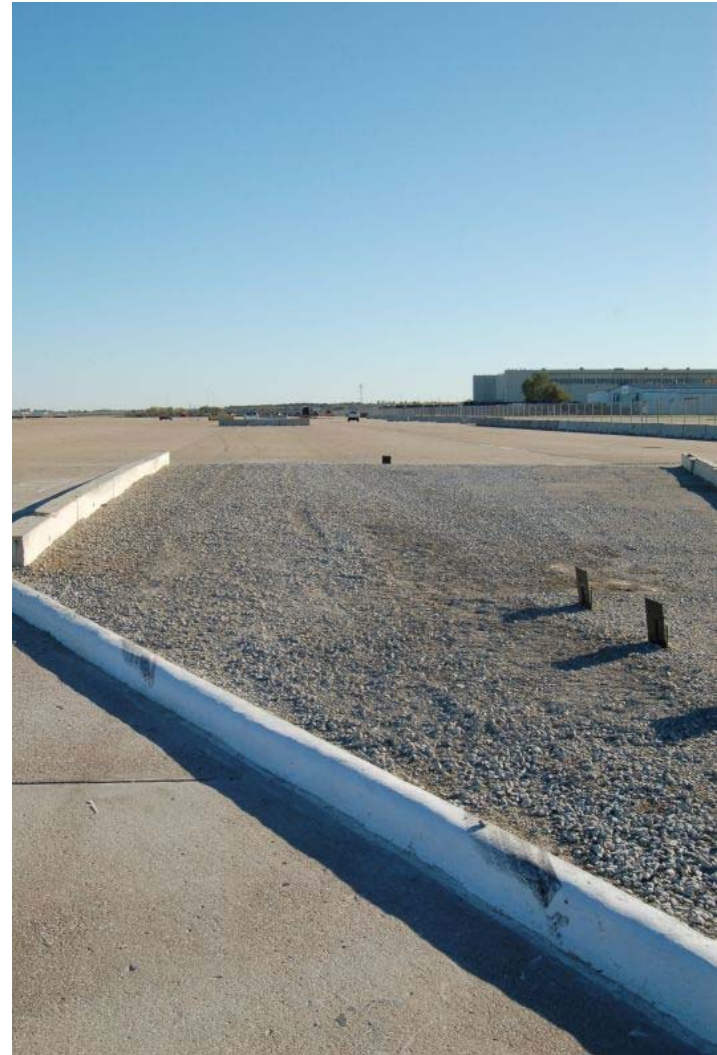
Figure 71. System Damage, Test MGSC-4

Damage to the curb system was negligible, as shown in Figures 71. No cracks or fractures were observed on the curb. Two contact marks were observed on the top and traffic-side faces of the curb. Tire marks and scrapes occurred at 3.04 m (10 ft) and 6.82 m (22.4 in.) from the upstream end of the curb.

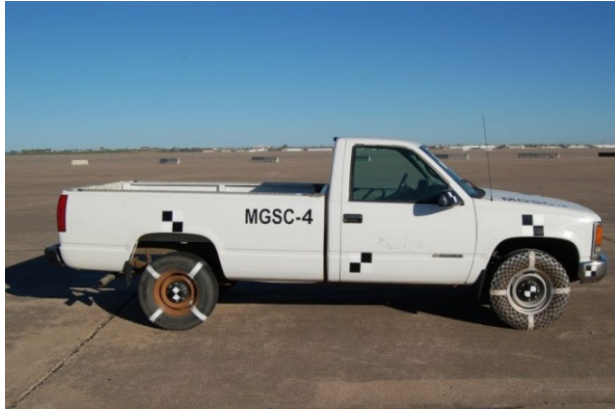
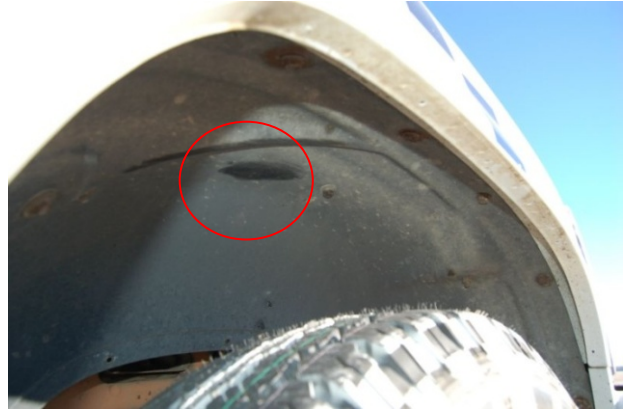
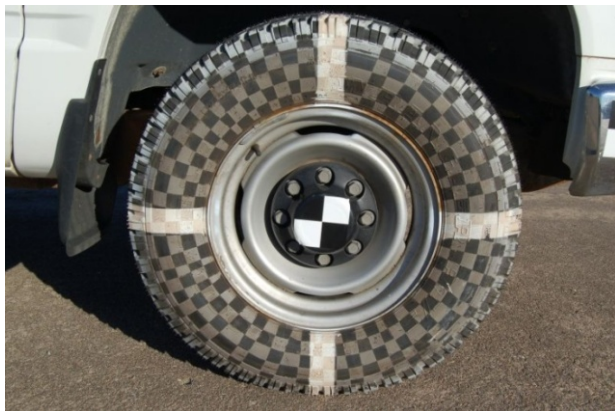
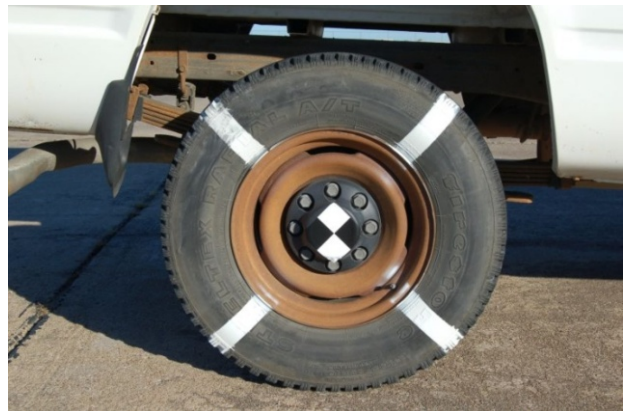
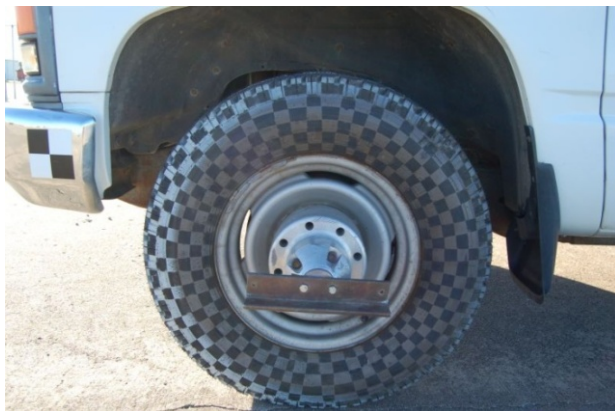
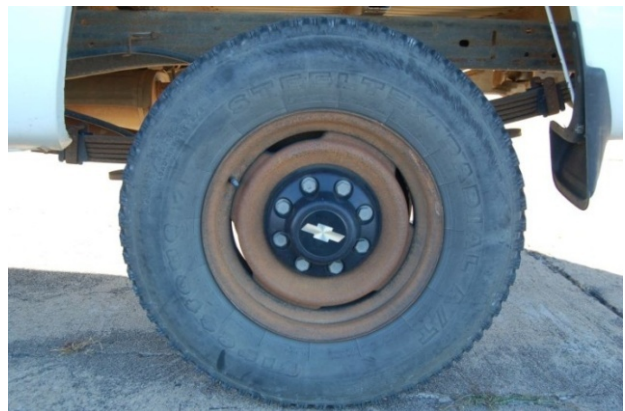
Figure 72. Vehicle Damage, Test MGSC-4

Exterior vehicle damage was minor, as shown in Figure 72. Minor scrapes and scratches were found on the tires of the vehicle due to the impact with the curb. A tire contact mark was found on the top of the right-front wheel well. No wheel deformation or suspension damage was observed. The rest of vehicle was intact.

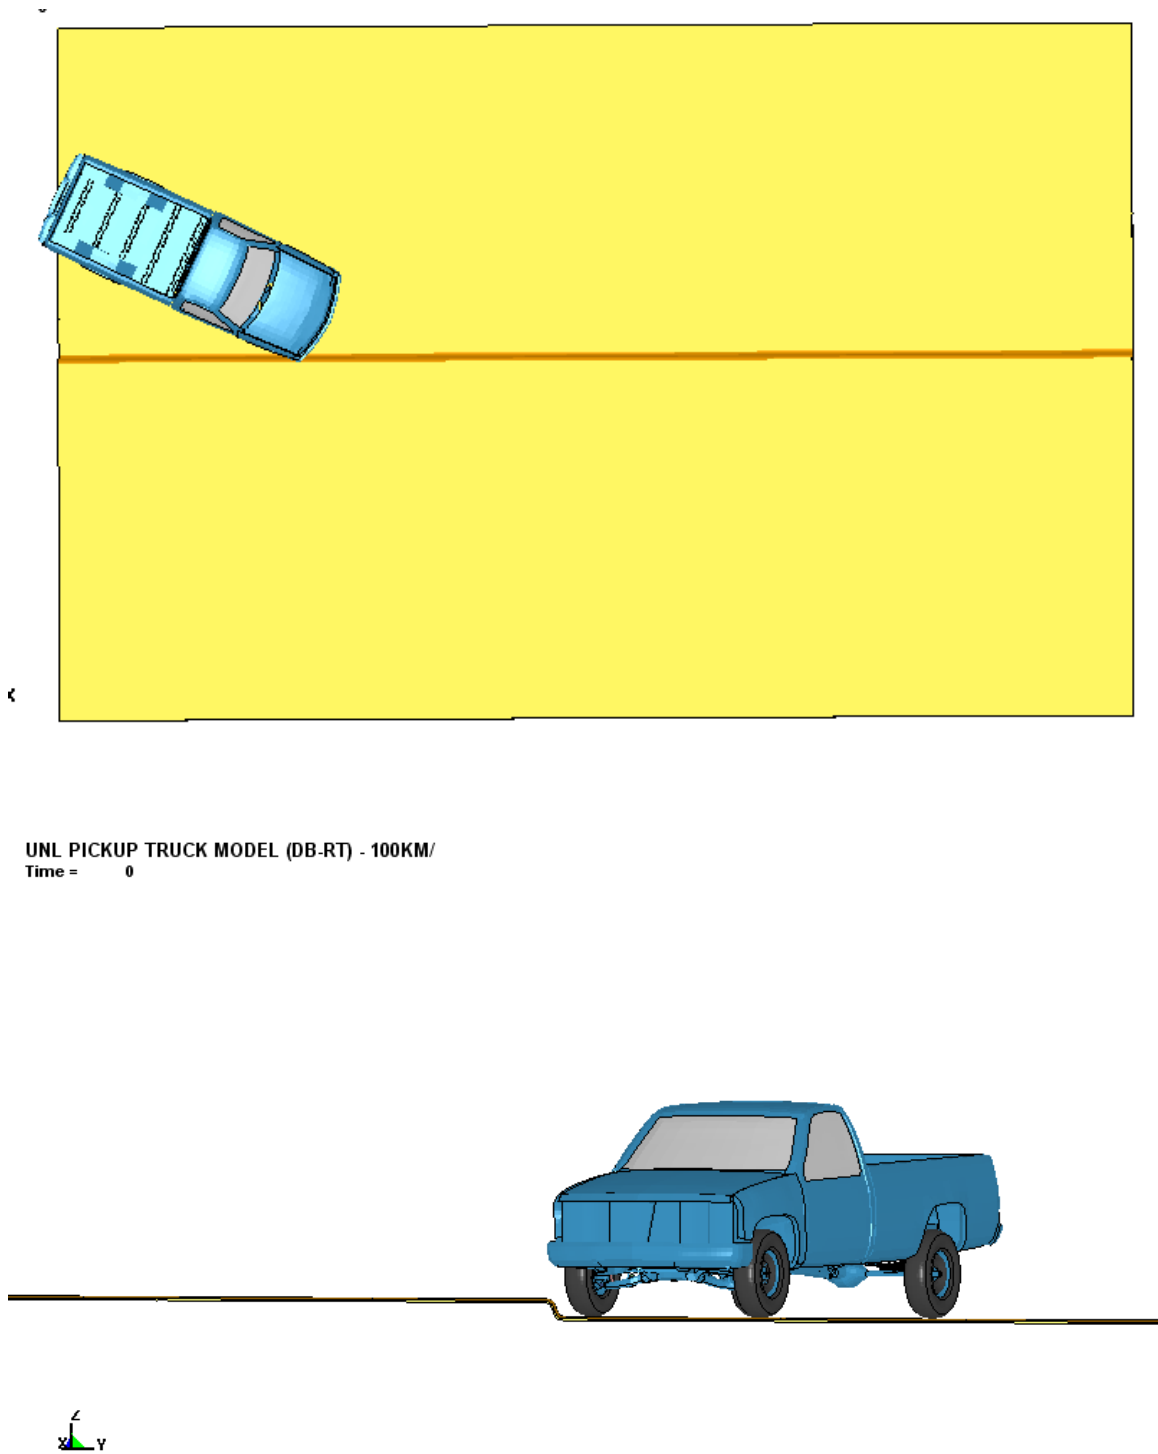
Figure 94. 2000P-Curb Impact LS-DYNA Model

A separate investigation was performed to compare different ground modeling methods in LS-DYNA. The ground and the curb were modeled with one continuous layer of rigid body solid elements, as shown in Figure 95, and the interaction between the tire and the ground/curb was processed using contact command *Contact-Automatic-Single-Surface. Considering the actual contact surface, a gap of half of the tire shell thickness was initially defined between the tire and the ground to match the real-life position, as shown in Figure 95.

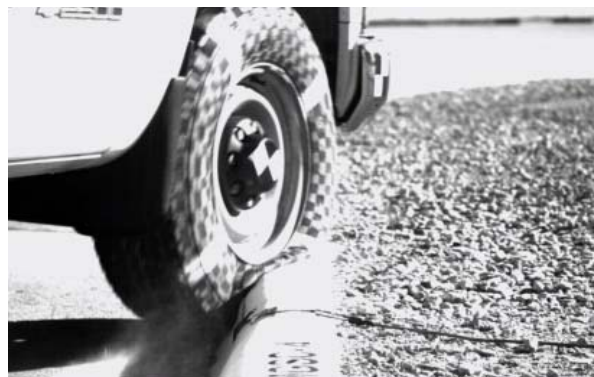
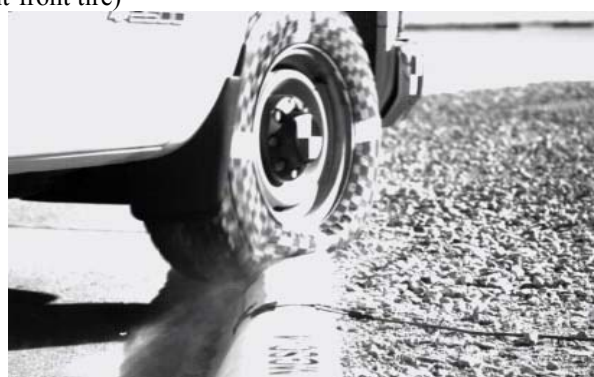
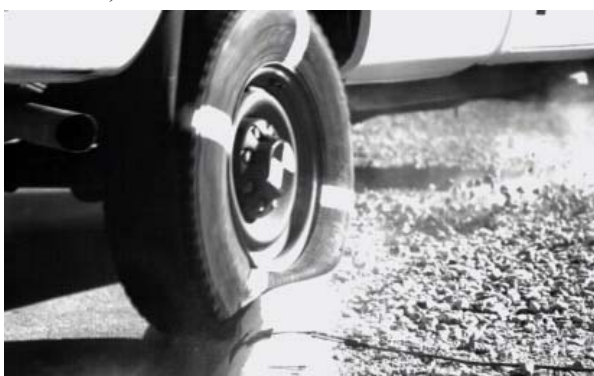
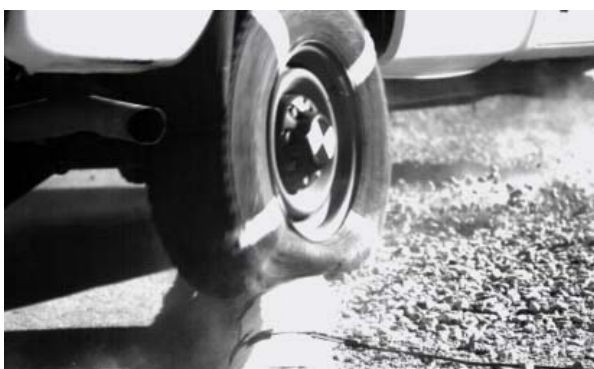
Figure 97. Tire Deformation Comparison

The tire model's accuracy was critical to the vehicle-curb impact simulation. The UNL-simplified tire model was used in the simulation (14). Vehicle tire model deformations upon impact presented an agreement with the physical test, as shown in Figure 97.

In the physical test, the vehicle's tires hit the curb in the order of right-front tire, right-rear tire, left-front tire, and left-rear tire. The right-rear tire and left-front tire impact the curb at almost the same time. The left-rear tire left the ground slightly in front of the curb, and later contacted it, as shown in the lower picture of Figure 98. In the simulation, only three tires impacted the curb, which were the right-front tire, right-rear tire, and left-front tire and were in the same order as the physical test. The right-rear tire and left-front tire impacted the curb almost at the same time as the physical test. The left-rear tire also became airborne in front of the curb, but the tire was too high to impact the curb, as shown in Figure 98.

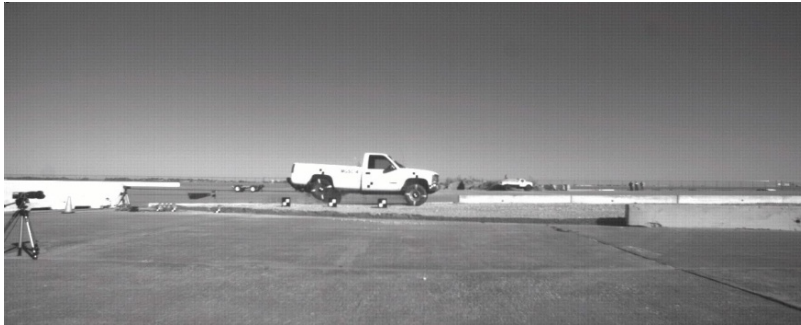
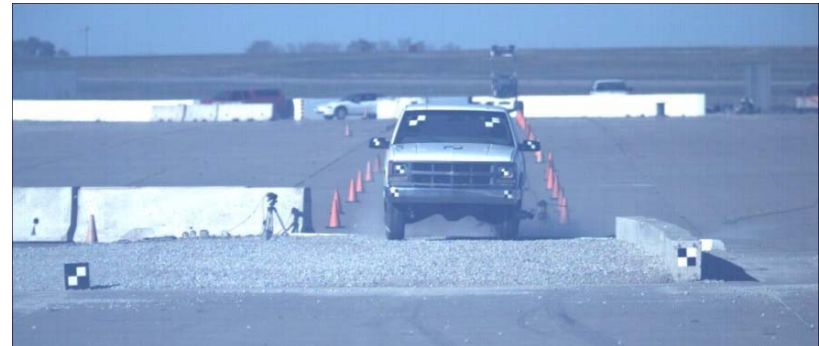
Figure 100. Cargo Box Presented Large Deformation in the Simulation

It was noticed that the front tires turned to the left upon impact in the simulation, which did not occur in the physical test, as shown in Figure 100. It implied that the joint stiffness in the

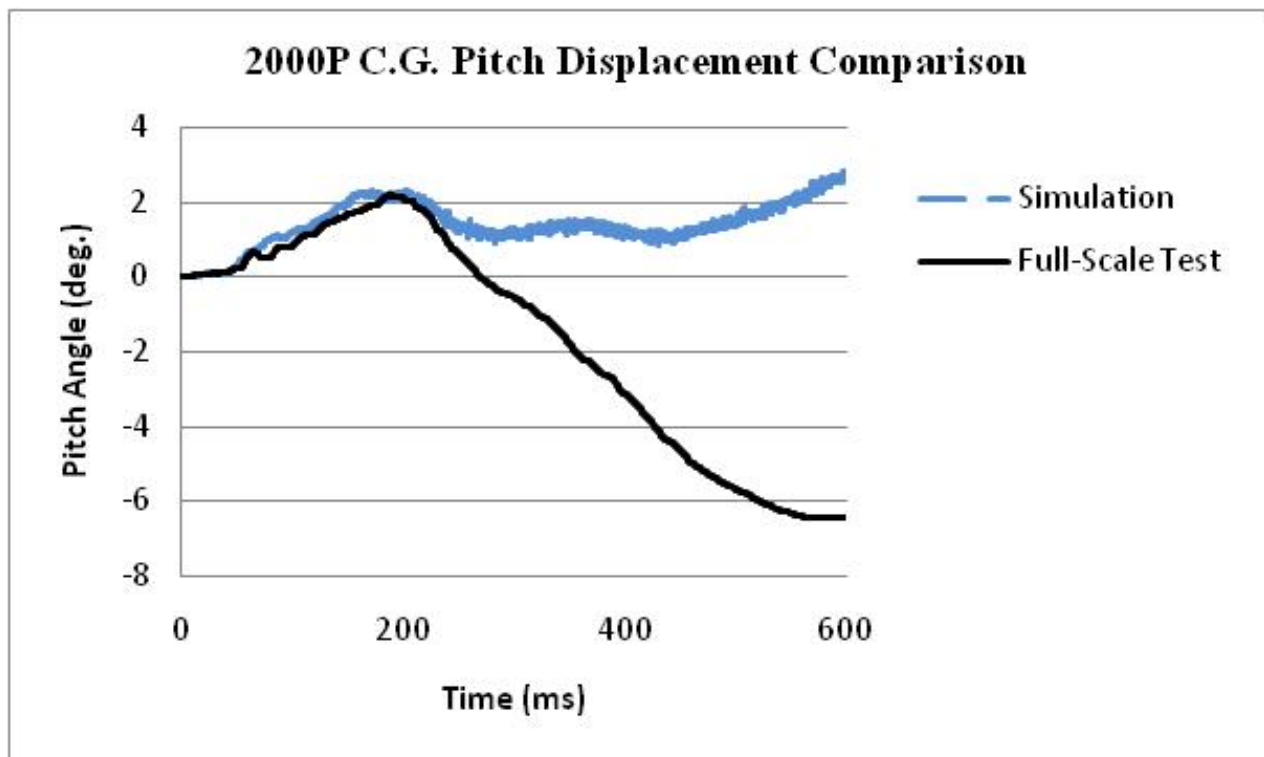
Figure 101. C.G. Pitch Movement Comparison

Both the simulation and physical test vehicles had a similar peak value for the pitch angle at about the same time, as shown in Figure 101. However, after reaching the peak value, the simulation result dramatically diverged from the physical test result. The pickup truck had a significant dive movement in the physical test, while the simulation was still fairly flat. This result was similar to the results observed during Plaxico's simulation effort (15).

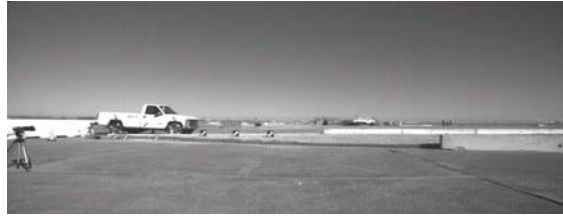
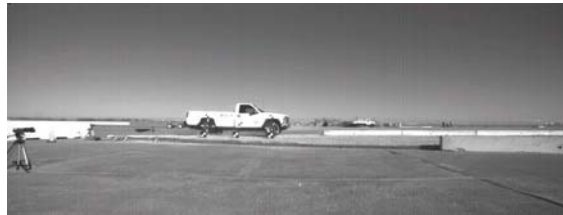
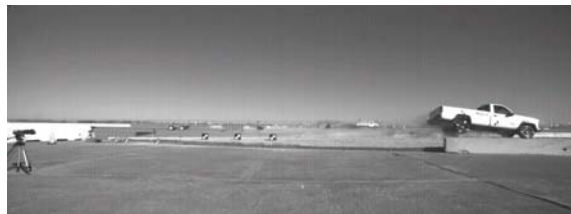
Figure 102. Vehicle Post-Curb-Impact Trajectory Comparison-Side View

The vehicle's post-curb-impact attitude is compiled in Figures 102 and 103. The simulation agreed with the physical test at the early portion behind the curb, but it behaved quite differently later. There were multiple reasons that could cause the lower pitch-down movement in the model, such as inaccurate rear suspension and tire behaviors or inaccurate body-weight distribution over the vehicle.

rear leaf suspension's unloading curve has a different path than its loading curve due to the friction between each layer of leaf springs. Considering that the rebound of the rear suspension affects the vehicle's pitch movement, future investigation is recommended to validate the rear suspension's unloading performance. Also, the damper's accuracy significantly affects vehicle-suspension rebound. The current damper is modeled with a simplified spring element. To capture the vehicle's behavior after curb impact, future efforts are needed to improve the current damper model.

Besides the rear suspension, the observed lower pitch movement was also likely caused by the inaccurate body-load distribution over the vehicle model. A simplified two-mass model was used as an analogy to analyze the vehicle's post-curb-impact pitch behavior, as shown in Figure 104. The front ball represented the vehicle's front sprung mass M_1 , and the rear ball represented the vehicle's rear unsprung mass M_2 . After curb impact, the front ball and the rear ball performed a parabolic movement. Each ball climbed up and started to drop after reaching the peak, but the rear ball always had a delay behind the front ball. Thus, the front ball was always higher than the rear ball before the peak value, and the rear ball was always higher than the front ball after the peak value. It was similar to the vehicle's pitch up before the peak and pitch down after the peak. The pitch angle was controlled by the relative weights of each ball. Usually, the more different M_1 and M_2 are, the larger the pitch angle will be. Thus, the simulation implied the rear mass M_2 was too similar to the front mass M_1 , which made the pickup model have a smaller pitch-down angle than was observed in the physical test.

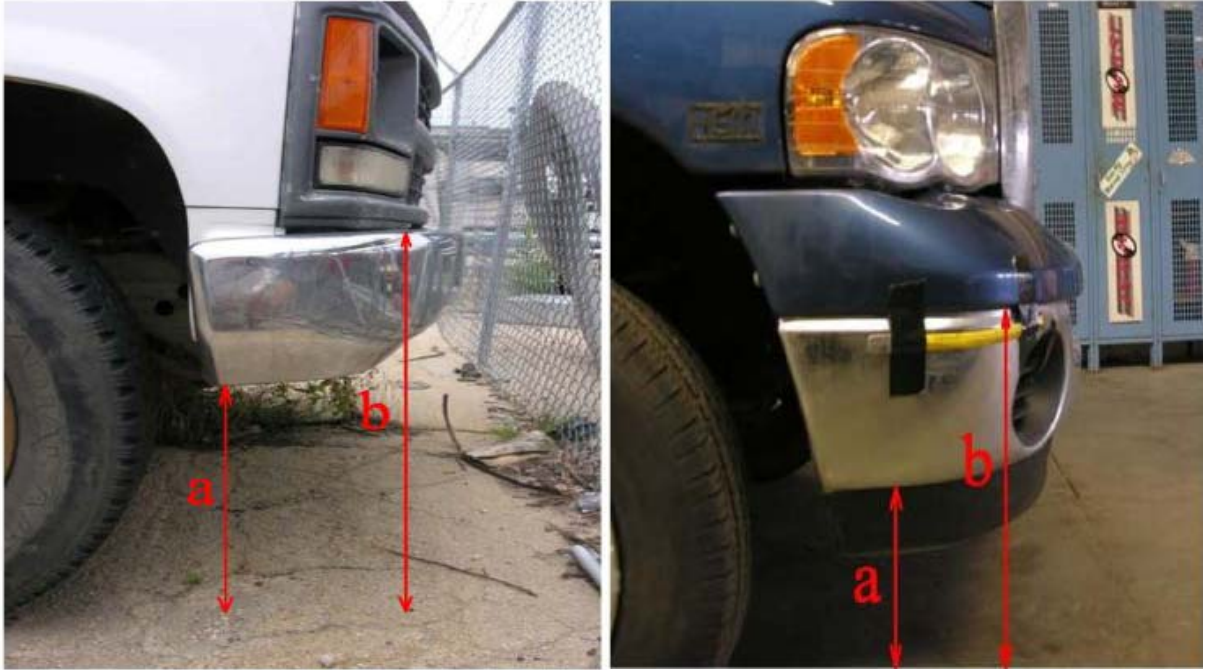
Figure 108. Bumper Comparison – 2000P and 2270P

First, a comparison of 2000P and 2270P bumpers was conducted. The 2270P bumper consists of 3 portions, including a bottom plastic portion, a middle metallic portion, and a top plastic portion, while the 2000P bumper only has one metallic portion, as shown in Figure 108. Physical tests proved both the bottom and top plastic portions were fairly weak and usually are easily damaged during impacts, as shown in Figure 109. Thus, only the middle metallic portion can actually function as a bumper and sustain resultant forces from the guardrail during impact. Comparison showed that the size of 2270P bumper's middle portion was similar to the 2000P bumper size (Table 3), which implied that the 2000P can be used as a reasonable reference to estimate 2270P's critical impact height.

Table 3. 2000P and 2270P Comparison (as shown in Figure 108)

Bumper Bottom Edge Height (a)	Bumper Top Edge Height (b)	C.G. Height
2000P	451 mm (17.8 in.)	660 mm (26 in.)	667 mm (26.3 in.)
2270P	400 mm (15.7 in.)	635 mm (25 in.)	719 mm (28.3 in.)

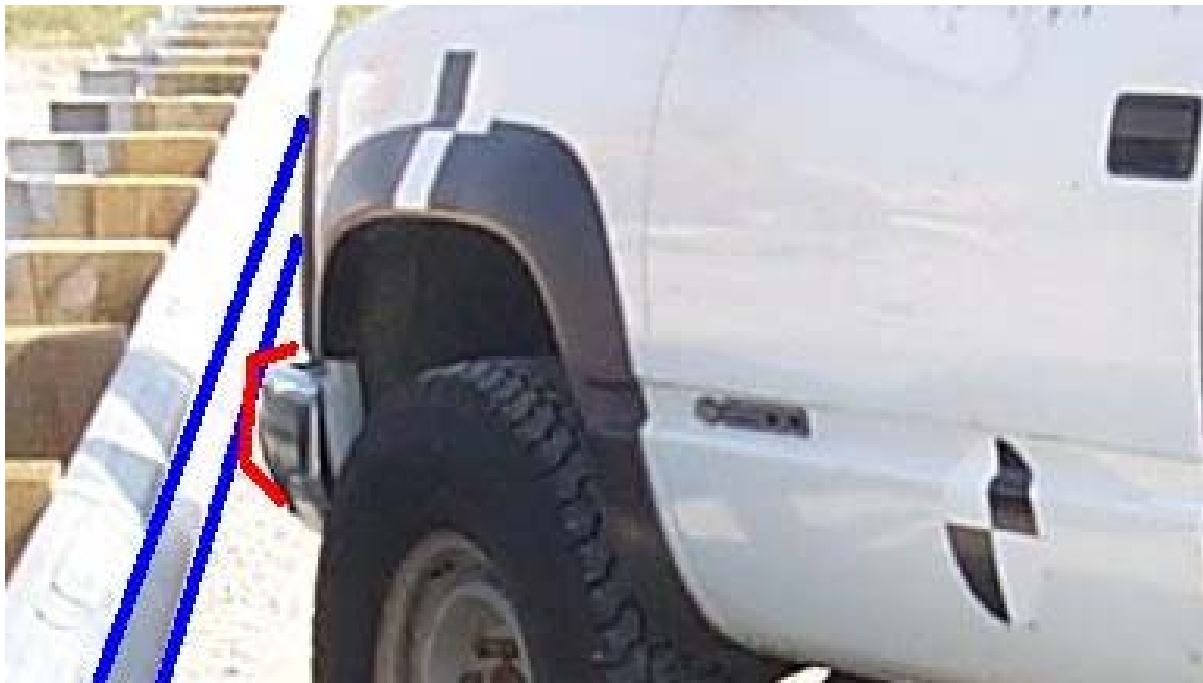
Figure 111. NPG-2 Bumper Impact Height

The W-beam has two corrugations, which are the key components to engaging a vehicle during impact. The top corrugation centerline is 728 mm (28.7 in.) above the ground and the bottom is 534 mm (21 in.) above the ground, as shown in Figure 110. The positions of each pickup bumper and the W-beam corrugations in the previous full-scale tests are listed in Table 5 and are shown in Figures 111 through 117.

In all of the successful full-scale tests listed in Table 5, the top edge of the pickup's front bumper was always lower than the top corrugation of the W-beam rail, as shown in Figures 112 through 115. In all the unsuccessful full-scale tests, the top edge of the pickup's front bumper was at or above the W-beam's top corrugation height, as shown in Figures 111, 116, and 117. Thus, it was concluded from these full-scale tests that a conservative critical override impact height for the pickup truck and MGS guardrail would place the top edge of the bumper at the same height as the centerline of the W-beam's top corrugation, as shown in Figure 118. Normally, the centerline of the W-beam's top corrugation is 728 mm (28.7 in.) from the ground, as shown in Figure 110.

Test No. (Pickup Model)	Top Edge of Front Bumper	Centerline of W-beam Top Corrugation	Test Result
NPG-2 (4X4 Drive)	781 mm (30.7 in.)	728 mm (28.7 in.)	Pickup rode over MGS and rolled over behind MGS
NPG-3 (2000P)	660 mm (26 in.)	728 mm (28.7 in.)	Passed
NPG-4 (2000P)	705 mm (27.8 in.)	728 mm (28.7 in.)	Passed
MIW-1 (2000P)	660 mm (26 in.)	608 mm (23.9 in.)	Pickup rolled over
MIW-2 (2000P)	660 mm (26 in.)	608 mm (23.9 in.)	Pick went airborne and landed on the guardrail
MG-1 (2000P)	635mm (25 in.)	728 mm (28.7 in.)	Passed
MG-2 (2270P)	635mm (25 in.)	728 mm (28.7 in.)	Passed

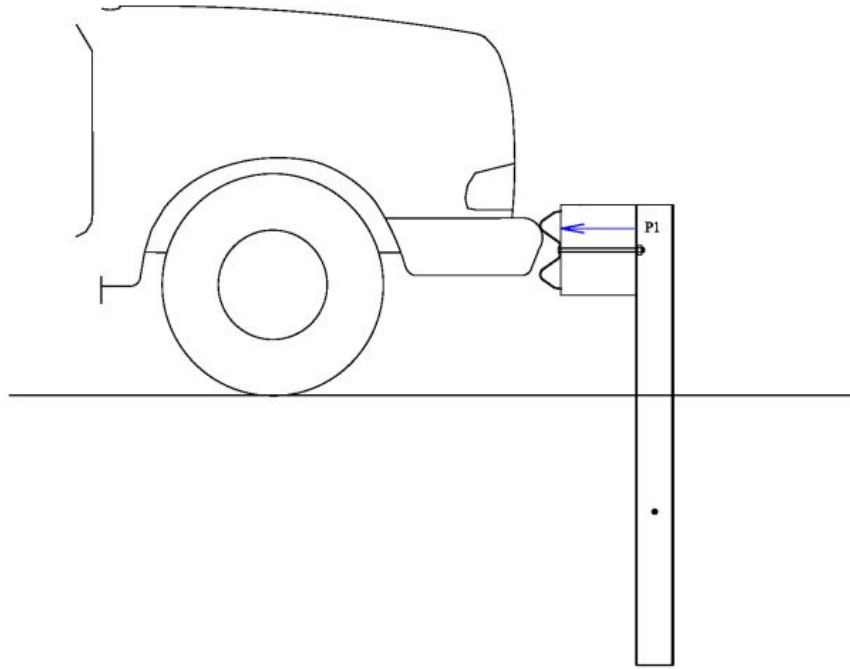
Figure 119. Illustration of Pre-Impact Condition

The external forces applied on a bumper during a guardrail impact are illustrated in Figure 119. When the bumper first contacts the guardrail, the force (P1) between the guardrail and the bumper is in the lateral direction; this is the force that redirects the vehicle. The guardrail post is then pushed backward and rotated due to this force, as shown in Figure 120. The post rotation causes the W-beam rail to rise up and generates an resultant force (P2) to the vehicle. The force P2 lifts the vehicle and causes the vehicle to potentially vault over the guardrail. To prevent the vehicle from vaulting the guardrail, there has to be an opposing force P3 that provides downward resistance and allows for vehicle capture using vehicle-rail interlock. The force P3 can be obtained only if the pickup is engaged by the W beam. This can be accomplished if the bumper is below the W-beam's corrugation, as shown in Figure 118. Otherwise, the pickup's bumper would slip over the W-beam and possibly result in vehicle override. This conclusion is identical to the previous analysis of the full-scale tests. Furthermore, by reviewing the previous full-scale tests, it was noticed that failed test bumpers were mostly deformed on the

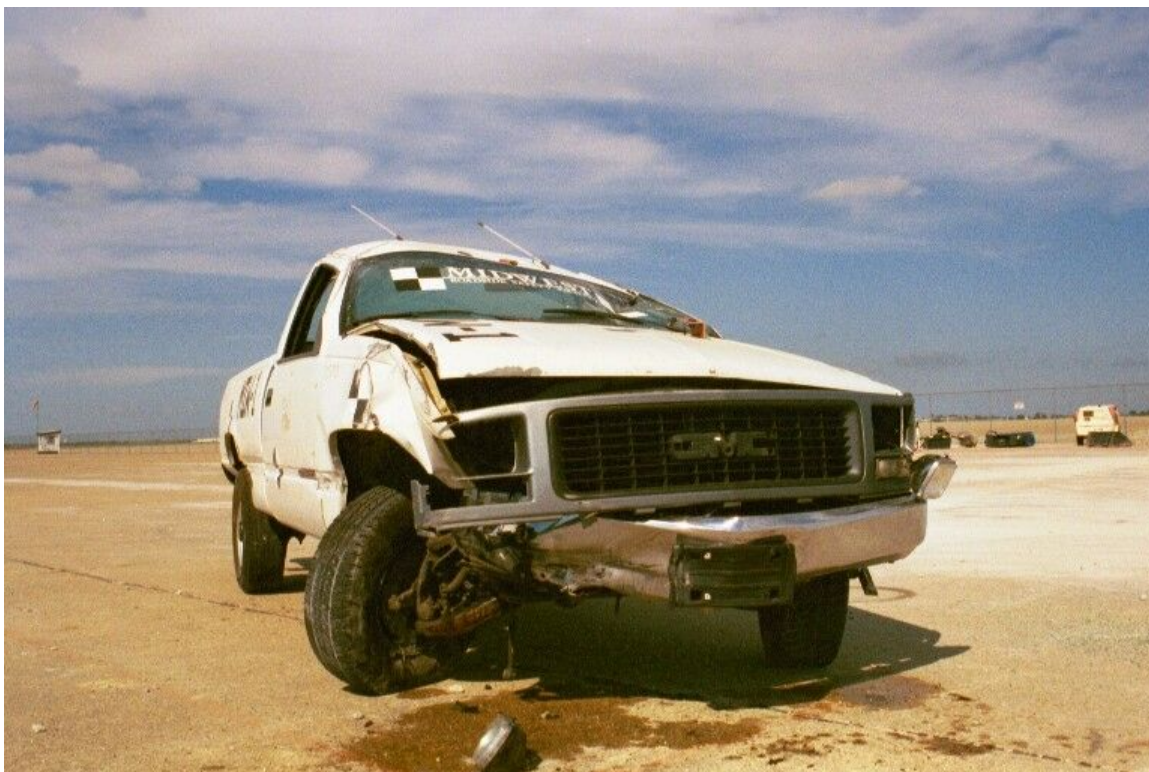
Figure 121. Bumper Deformation in Test MIW-1 (Failed)

bottom and the front faces, which demonstrates that the forces were applied from the bottom and the front during impact, as shown in Figure 121. Additionally, in all the successful tests, bumpers were deformed on the top and the front faces, as shown in Figure 122.

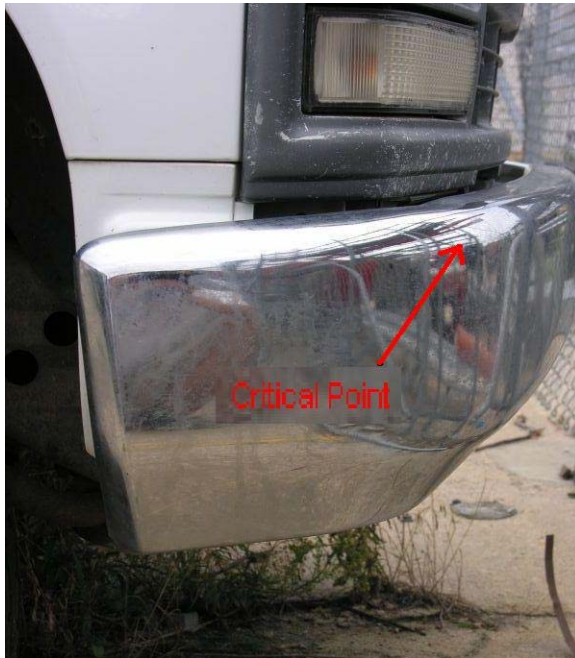
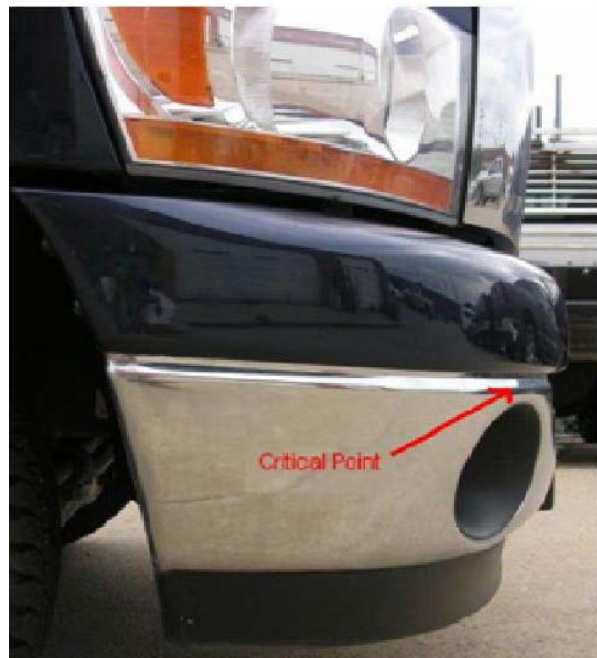
Figure 124. Pickup-W-beam Guardrail Override Critical Impact Point, 2000P and 2270P

From the analysis of the pickup truck impact into the MGS at a 25-degree angle, the critical override impact height of the Chevrolet C2500 $\frac{3}{4}$ ton pickup truck (2000P) was determined to be the top of the bumper's corner on the impact side, as shown in Figure 124. The critical override impact height of the $\frac{1}{2}$ -ton Dodge Ram 1500 Quad Cab pickup truck (2270P) was determined to be the top of the bumper's metal corner on the impact side, as shown in Figure 124. The conclusions are identical to those obtained from both full-scale crash tests (test nos. MGSC-1 and MGSC-2).

The critical impact height for the pickup and MGS guardrail is the lowest height that can prevent the pickup from overriding the guardrail. Based on the investigation of previous full-scale pickup and W-beam guardrail crash tests, analytical analysis, and LS-DYNA simulation, it is believed that the critical override impact event happens when the top edge of the pickup truck's bumper is flush with the centerline of the top corrugation of the W-beam rail.

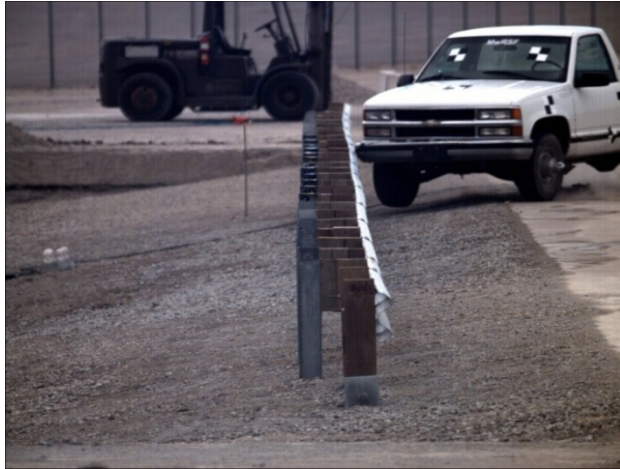
Figure 125. Vehicle's Front Suspension Extended Due to the Slope

However, there is at least one case in which the guardrail can still capture the vehicle without capturing the bumper. In 2006, MwRSF performed a full-scale crash test of the MGS with an approach slope (Test MGSAS-1) (17). A 2000P pickup truck impacted the MGS system on an 8:1 approach slope at a speed of 100.4 km/h (62.4 mph) and at an angle of 25 degrees. The pickup's front bumper slid over the W-beam's top corrugation upon impact, but the pickup was still captured by the guardrail. Normally, the vehicle's front suspension is compressed due to gravity on the flat ground. However in this case, the pickup's front suspension was extended because of the slope. Therefore, the clearance between the top of the right-front tire and the bottom of the bumper was increased, as shown in Figure 125. Although the bumper went above the W-beam, the W-beam rail was trapped between the bumper and the tire, and it captured the vehicle, as shown in Figure 126. This result also explained why the tire was ripped off during the crash, as shown in Figure 127. This result is very similar to the case when the pickup's front suspension was extended after curb impact. Although, under some situations, the vehicle can be contained without engaging the bumper, the bumper height was used to assist the pickup-MGS impact analysis as a conservative consideration.

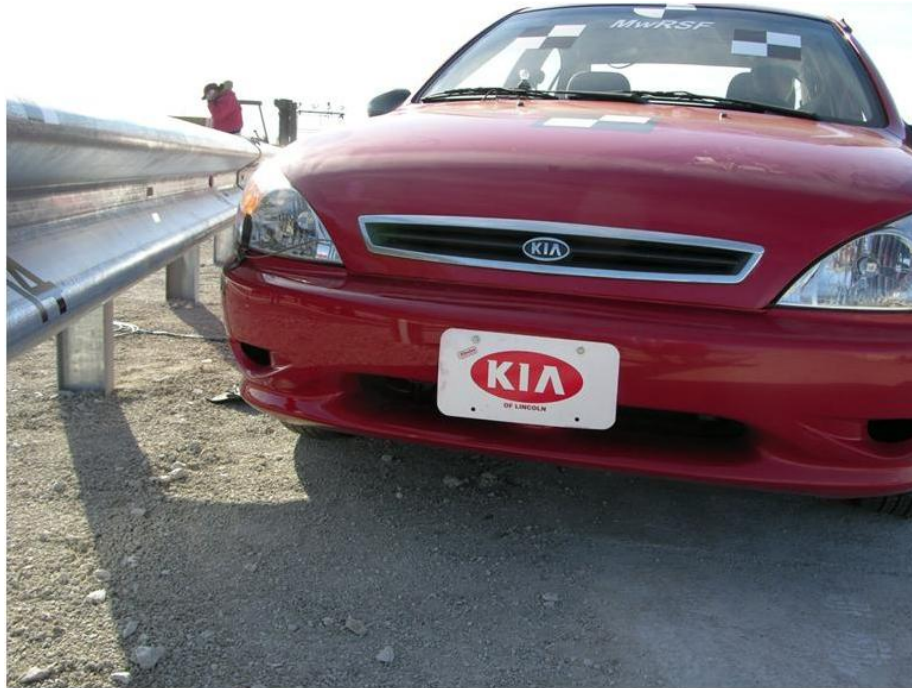
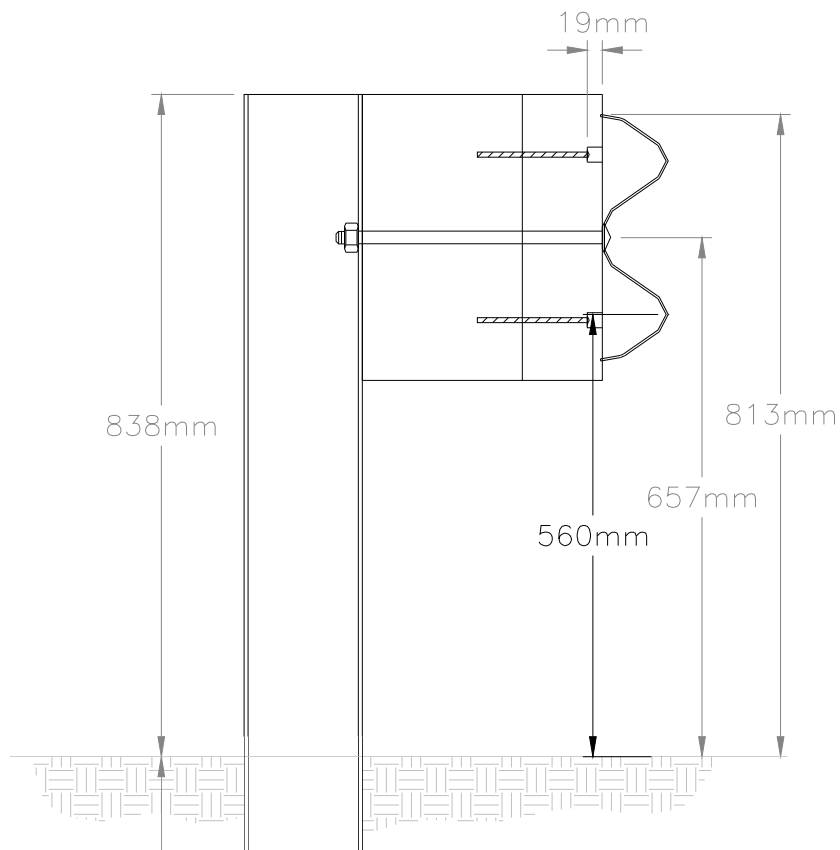
Figure 128. Small Passenger Car and MGS Impact, Test 2214MG-3

In the 2214MG-3, the centerline of the bottom corrugation of the W-beam rail was 560 mm (22 in.) above the ground, which was 89 mm (3.5 in.) higher than the small passenger car front bumper corner, as shown in Figure 128. Since the 2214MG-3 system safely redirected the small passenger car, a small car-MGS impact condition is deemed safe as long as the bumper corner is less than 89 mm (3.5 in.) below the bottom corrugation centerline of W-beam; otherwise, there might be a possibility for the small car to underride the MGS.

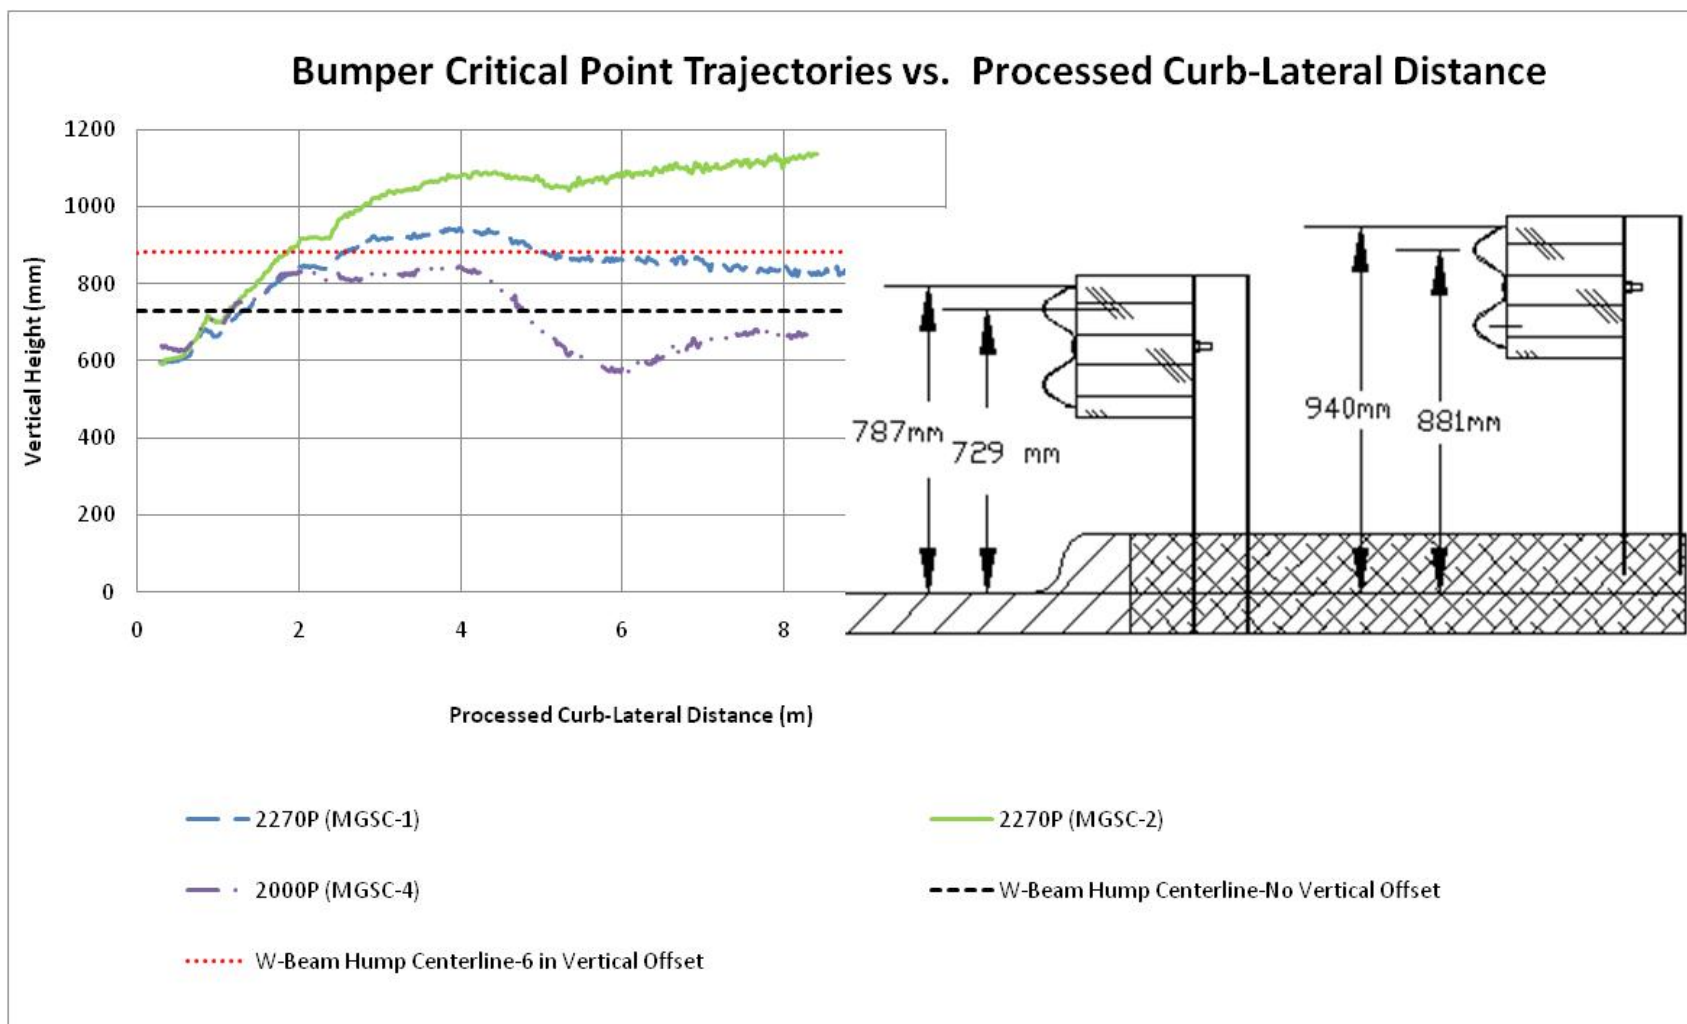
Figure 130. Pickup Bumper Critical Override Impact Point Trajectories

For the Option II installation, the 2000P bumper's critical impact point is always below the W-beam's top corrugation after the impact with curb. The 2270P bumper's critical impact point was above the top corrugation centerline between 2.53 m (8.3 ft) and 5.03 m (16.5 ft) behind the curb in test MGSC-1 and beyond 1.87 m (6.11 ft) behind the curb in test MGSC-2, as shown in Figure 130. The 1100C bumper's critical impact point was below the safe height before 0.98 m (3.14 ft) and beyond 4.6 m (15.1 ft), as shown in Figure 131.

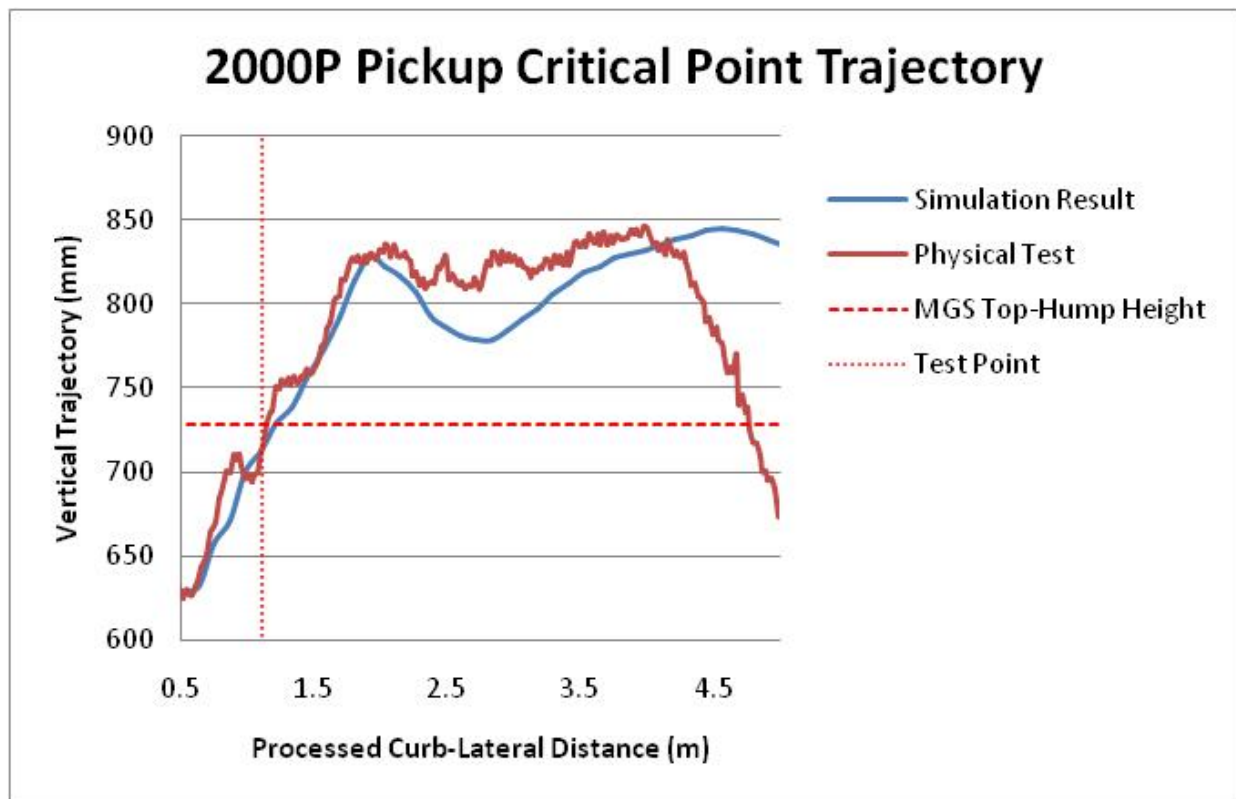
Figure 141. Simulation No. 2 Test Location—1.1m (3.61 ft)

At the 1.1-m (3.61-ft) offset location, the pickup's bumper was below the centerline of the W-beam's top corrugation upon impact with the rail. After the first impact, the vehicle moved forward, causing the W-beam to deform ahead of the vehicle. The deformation of the rail pushed the posts backward before the vehicle actually impacted them, as is seen in physical tests. Due to the backward rotation of the posts, the actual height of the W-beam rail, ahead of the vehicle, was lowered during impact. Thus, the pickup's bumper moved above the W-beam's top corrugation after the first impact. The W-beam rail did not engage the bumper. The vehicle

became airborne during the impact with the guardrail, but it did not vault over the guardrail. The vehicle was contained on the traffic side and was redirected by the MGS system. After the vehicle was redirected, the right-rear tire side-slapped the guardrail in the air. The impact force on the right-rear tire from the guardrail caused the pickup to yaw clockwise and to roll over, as shown in Figures 145 and 146. Thus, the MGS-Curb system failed to safely contain a 2000P pickup truck at this offset location according to the simulation. However, the simulation indicates that the 2000P pickup truck may not override the guardrail at this location. Furthermore, it was noticed in this simulation that the rebound force from the side impact of the vehicle's right-rear tire and the guardrail was somewhat unrealistic. It was difficult to determine if the system's failure resulted from the unrealistic rear side impact at this point.
