Development of an Effective Flared Guardrail Terminal

June 1997

1. Performing Organization Report No. TRP-03-56-96	2. Report Date June 1997	3. Type of Report Final Report
4. Title and Subtitle Development of an Effective Flared Guardrail Terminal

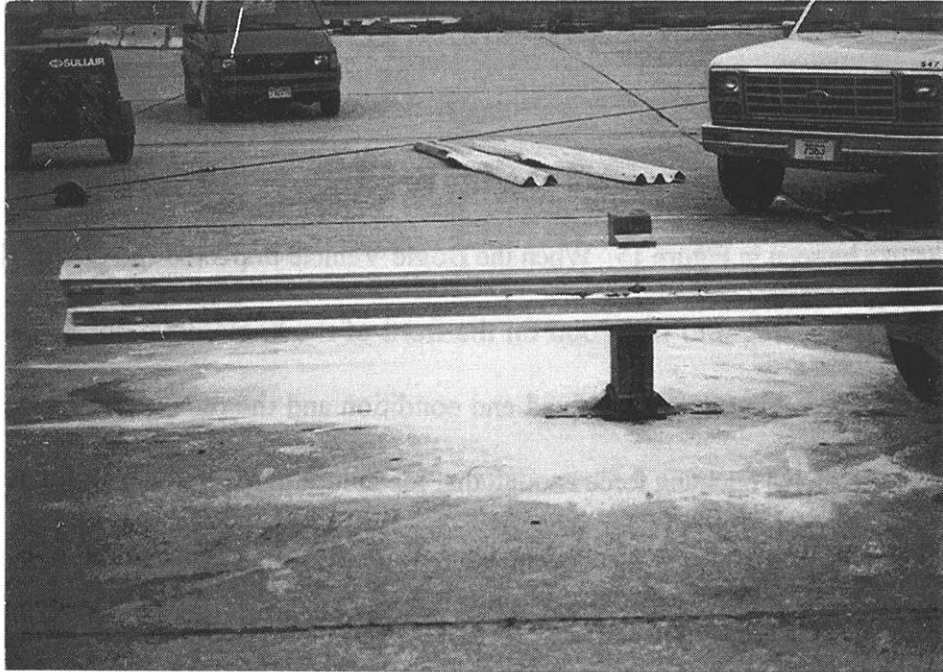
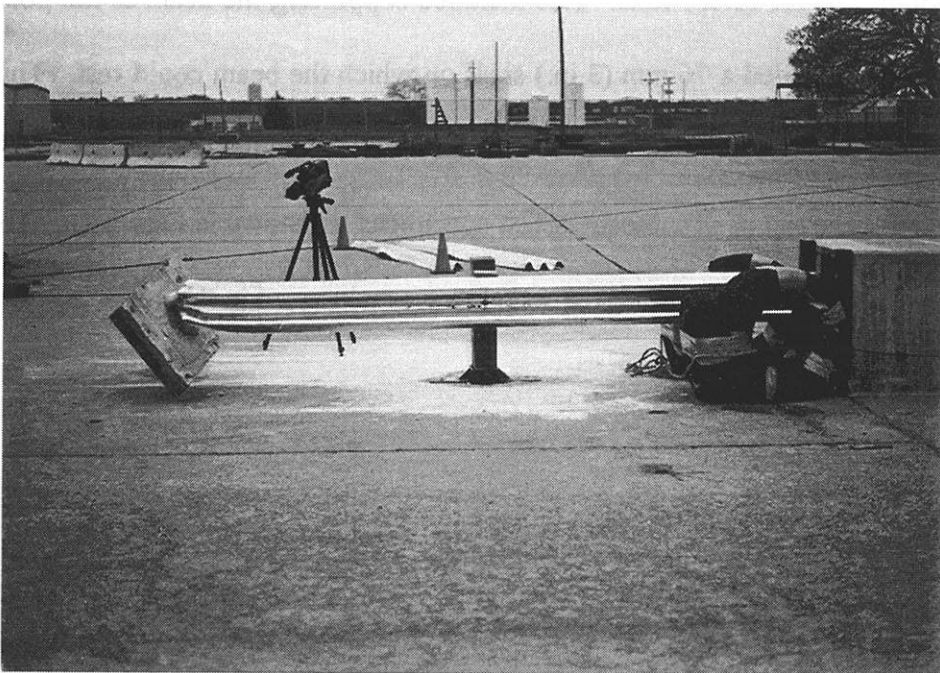
This test consisted of a standard 12 gauge W-beam fixed to the post with a bolt at the center location, as can be seen in Figure 15. When the Bogie Vehicle impacted the end of this beam at 9.45 m/s (21.1 mph), it dug into the wood on the front of the bogie, in effect providing a fixed end condition. The combination of the fixed end condition and the reduced effective buckling length raised the critical global buckling force enough that the failure mode in the beam was a local buckling on the end that the impact took place. The force from the impact caused the welds connecting the impact head to the bogie to fail.

Figure 15. Test KDW1A before and after impact.

The bogie was subsequently repaired and steps were taken to reduce the severity of the impact conditions for future tests. This included supporting the beam at the post with an angled bracket which provided a 76 mm (3 in.) shelf on which the beam could rest. This resulted in the doubling of the effective buckling length in the direction which the failure occurs. A flared end was also attached to the end of all subsequent test specimens, as shown in Figure 16. This prevented the end of the beam from gouging into the wood as was witnessed in this test.

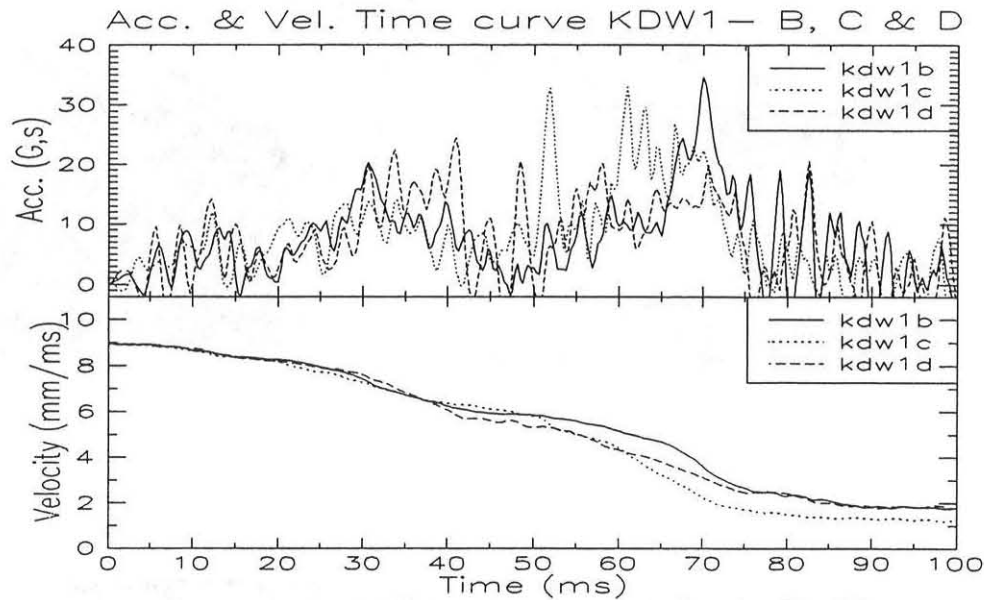
The acceleration and change in velocity plots for this test are presented in Figure 19. The accelerometer plot represents the deceleration of the center of mass of the bogie vehicle. This curve is integrated to obtain the change in velocity curve.

Figure 19. Accelerations and change in velocity for standard W-beams.

The acceleration and change in velocity plots for this test are presented in Figure 19. The results from the unmodified W-beam tests were not uniform in these last three cases involving unflattened W-beams, despite having similar initial conditions. The differences are attributed to the unpredictability of sudden dynamic buckling process. The remainder of the tests with the modified W-beams and the three beams gave similar results for each individual set of test specimen.

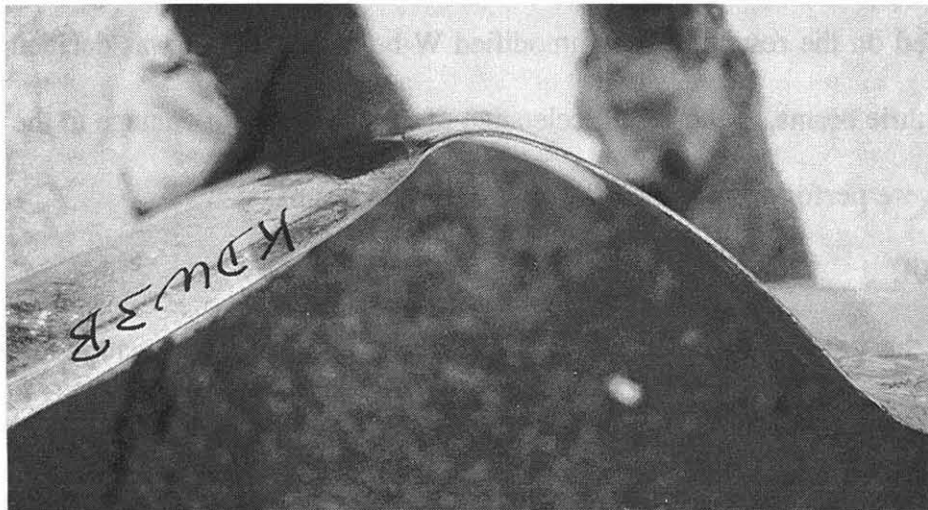
Figure 24. Test KDW3B before, during, and after impact.

The configuration for this test was identical to that of the previous one (KDW3A). In this test the 100% flattened W-beam was impacted by the bogie vehicle traveling at 9.1 m/s (20.3 mph). During the impact, the beam buckled by folding in the middle and rear end of the flattened section. Photographs of this test are presented in Figure 24, and plots of the accelerometer and change in velocity data are shown in Figure 25.

Since the results from these two tests were so similar, it was decided to test only two samples. The beam did not absorb much of the bogie's energy, resulting in the impact with the post and the concrete block in these tests.

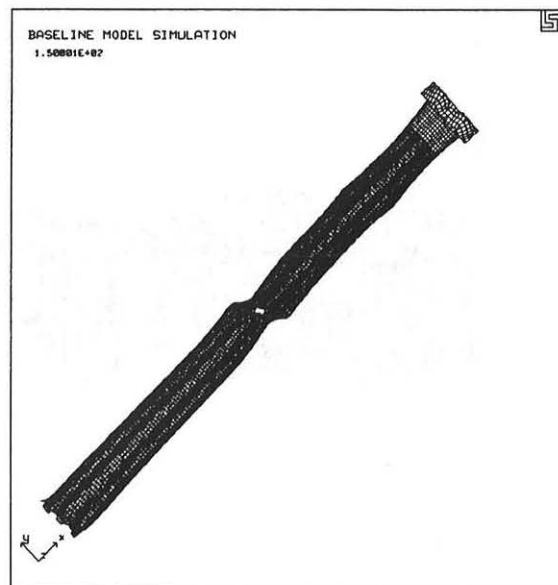
Figure 46. Failure geometry from simulation.

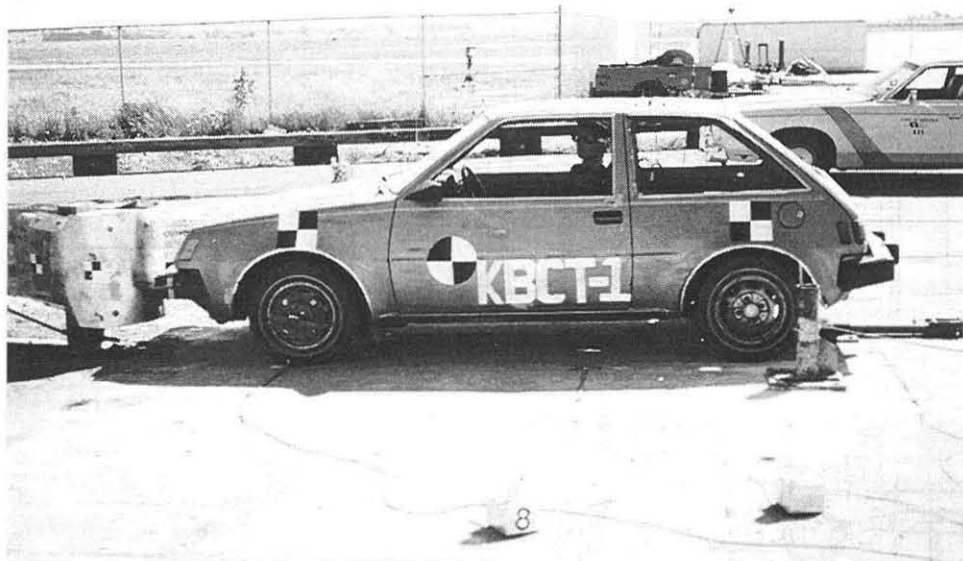
Figure 62. Test vehicle for Test KBCT-1.

A 1981 Dodge Champ, having a test inertial mass of 845 kg (1863 lbs), was used as the test vehicle for Test KBCT-1. Photographs of this test vehicle are shown in Figure 62, and vehicle properties are presented in Figure 63.

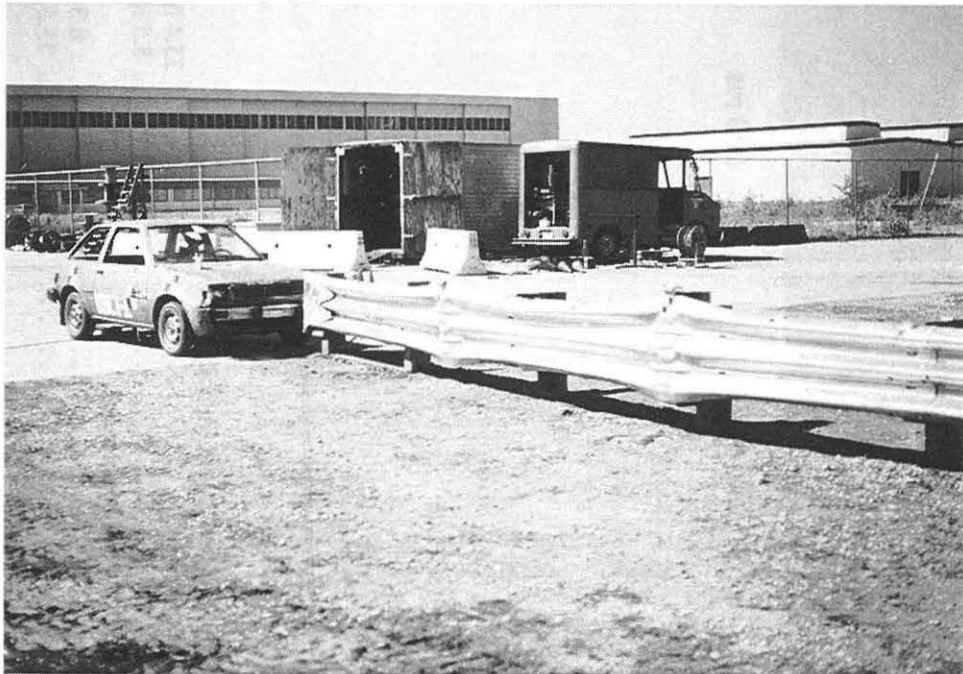
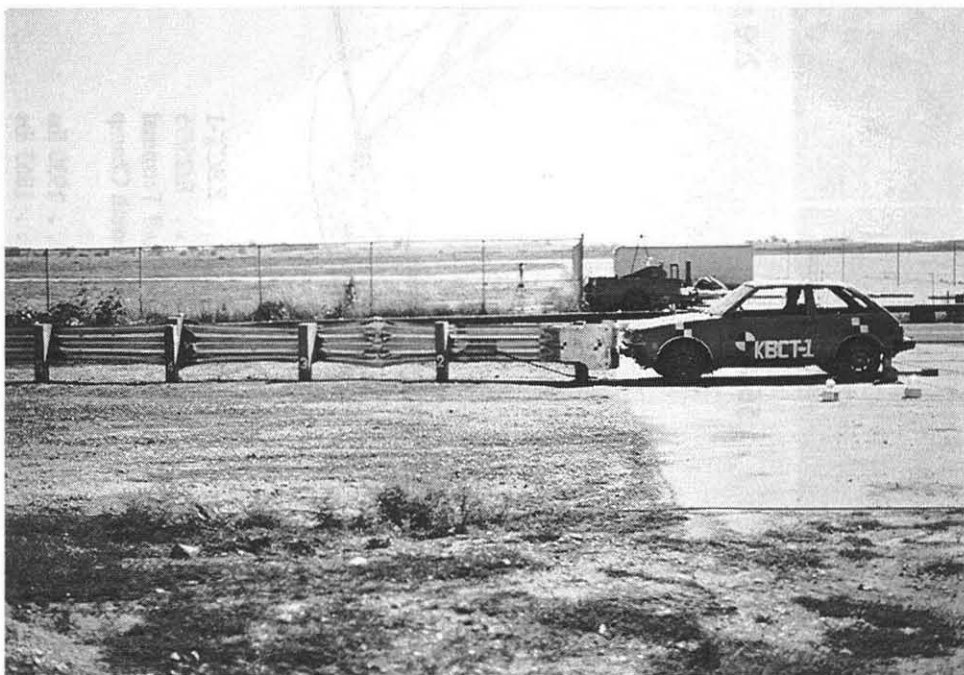
Figure 63. Vehicle and system prior to impact.

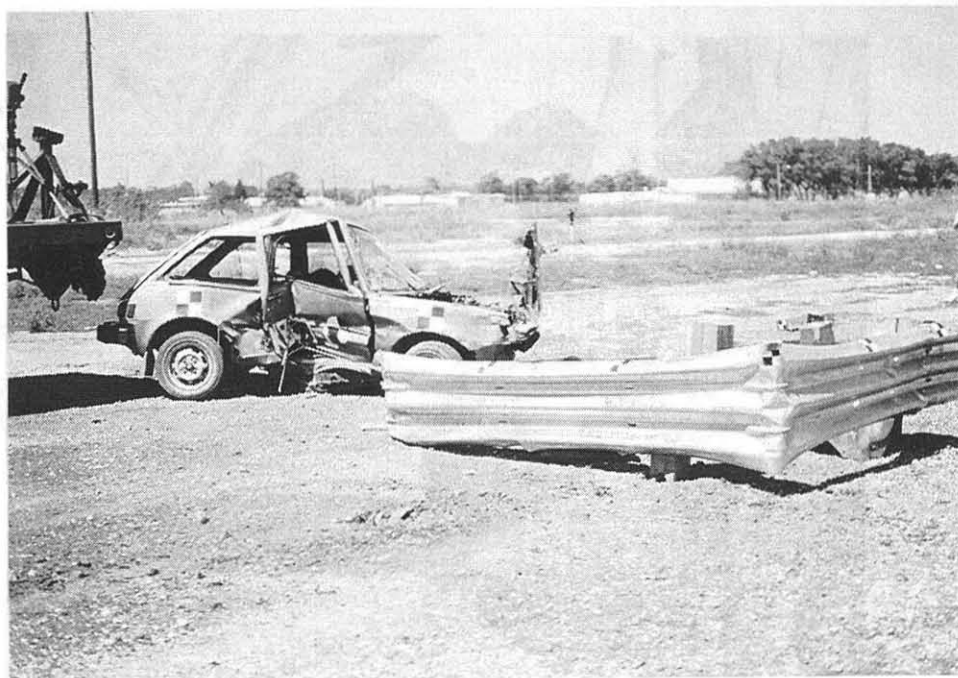
Figure 67. Vehicle trajectory, Test KBCT-1.

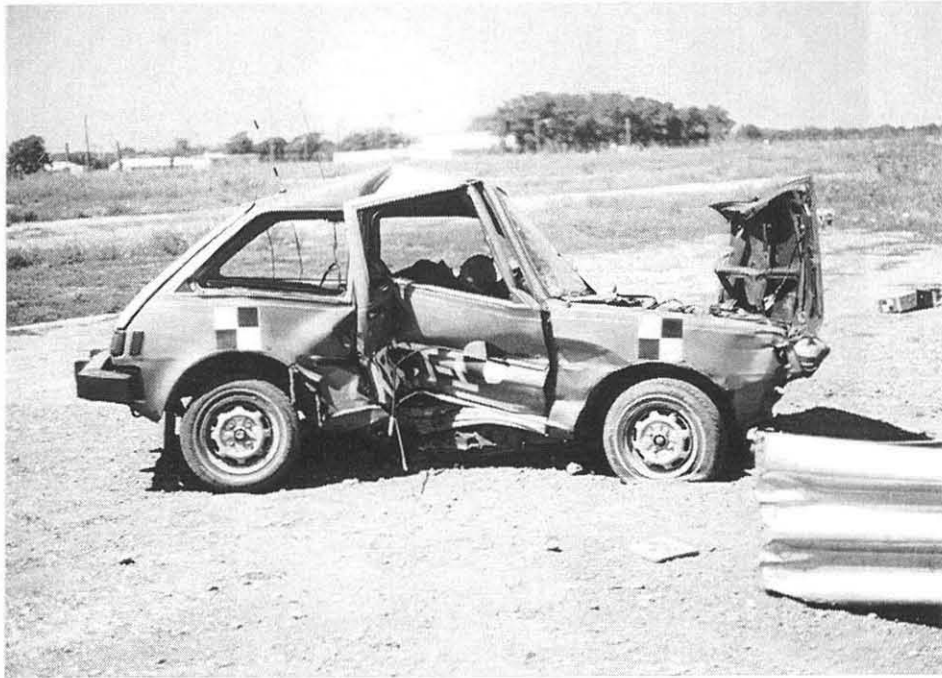
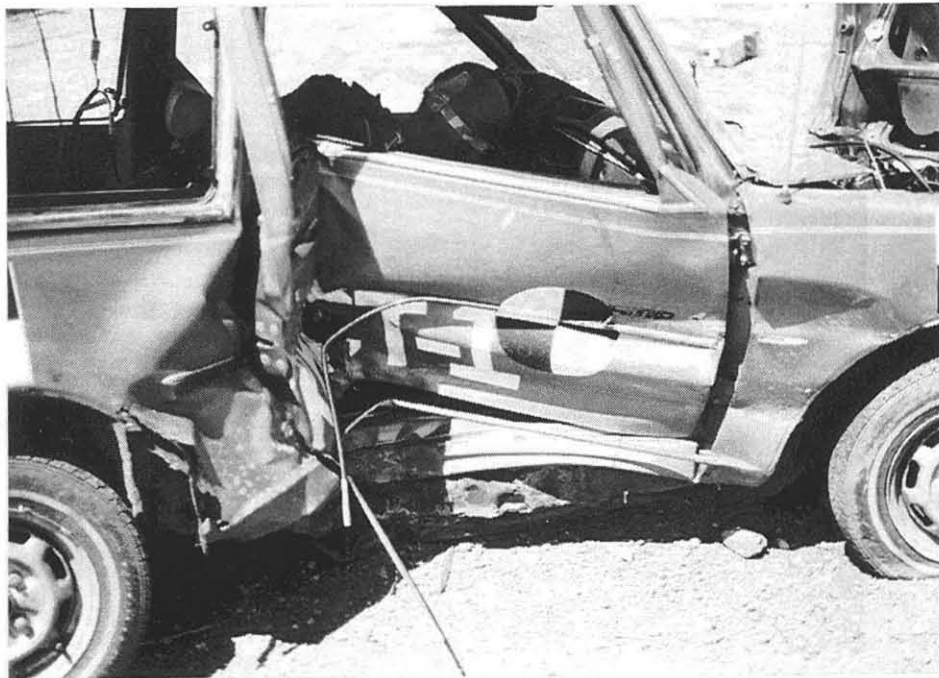
Figure 68. Vehicle damage, Test KBCT-1.
